ELK RIVER WATERSHED GROUP FISH PASSAGE RESTORATION PLANNING

December 31, 2020

Version 0.0.4

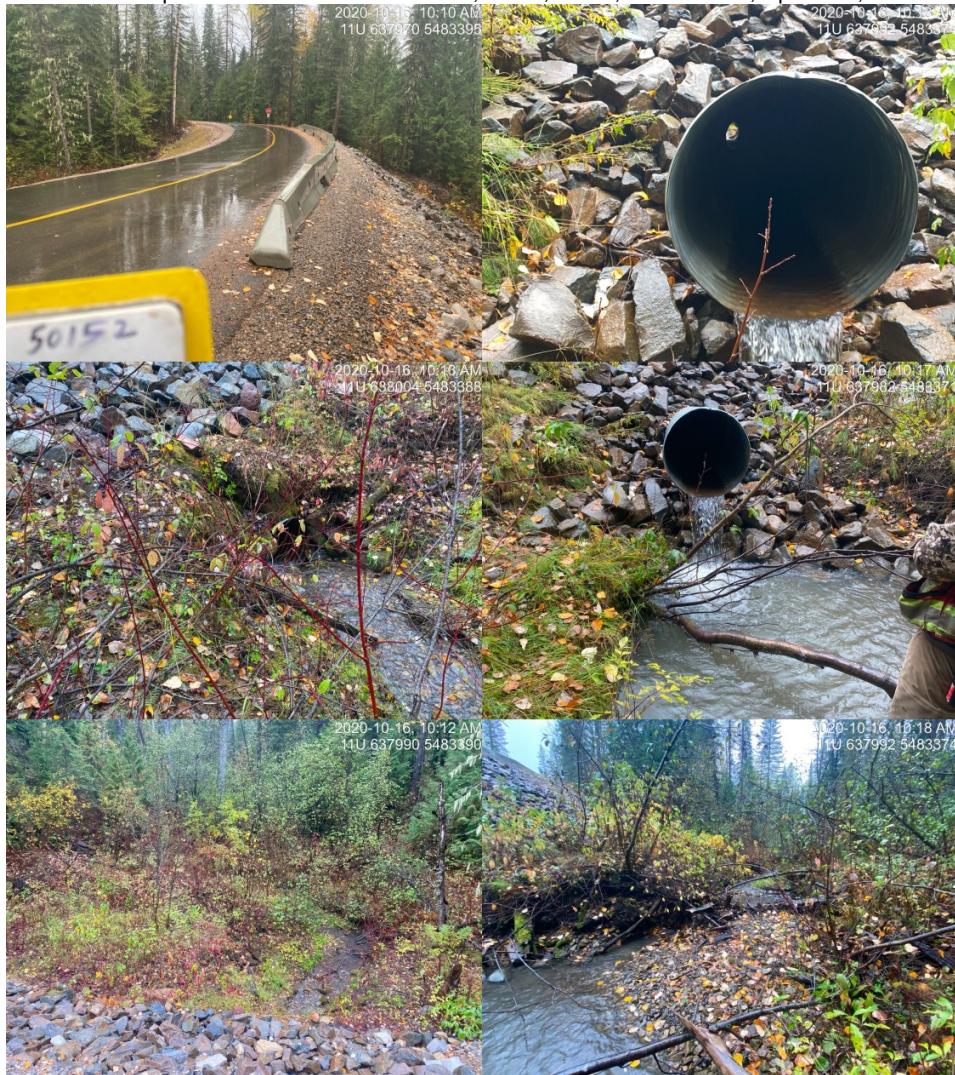
As noted, the culvert located at PSCIS 50152 appeared to have been replaced in 2020 with fresh rock, road fill and pavement present. At the time of the survey, the un-embedded and non-backwatered 0.9m diameter crossing was considered a barrier to upstream fish passage with a pipe length of 30m, a culvert slope of 1.5%, a stream width ratio of 2.9 and an outlet drop of 0.9m (Table [5.1](#)). Water temperature was 5°C, pH was 8.5 and conductivity was 286uS/cm.

Photos: From top left clockwise: Road/Site Card, Barrel, Outlet, Downstream, Upstream, Inlet.

Structure replacement with an open bottomed structure is recommended to provide access to the habitat located upstream of PSCIS crossing 50152. The cost of the work is estimated at \$438000 for a cost benefit of \$6200/linear m and \$8000/m².

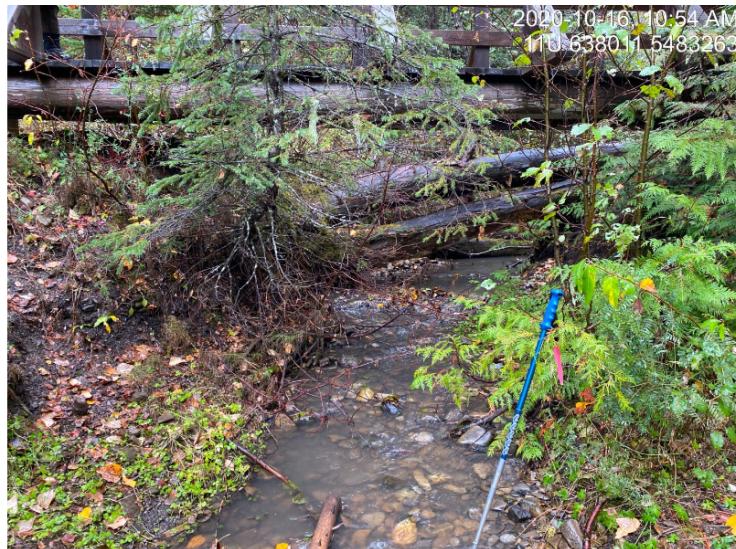
**Figure 5.1: Typical habitat downstream of PSCIS crossing 50152.**

The stream was surveyed downstream from the culvert for 140m to Lizard Creek. Overall, total cover amount was rated as moderate with undercut banks dominant. Cover was also present as small woody debris, large woody debris, and overhanging vegetation (Table [5.2](#), Figure [5.1](#)). The average channel width was 2.7m, the average wetted width was 2.1m and the average gradient was 4%. The dominant substrate was cobbles with gravels subdominant. Downstream of the crossing, numerous fry were observed, there were frequent sections of gravels suitable for salmonid spawning and there were no barriers or obstacles to fish passage. Habitat was rated as high value for fry/juvenile salmonid rearing.

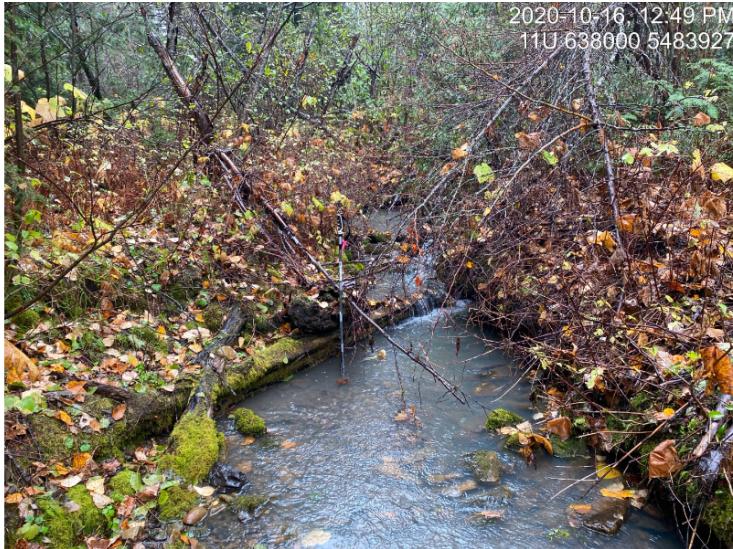
Figure 5.2: Typical habitat upstream of PSCIS crossing 50152.

The stream was surveyed upstream from the culvert for 675m. Overall, total cover amount was rated as moderate with undercut banks dominant. Cover was also present as small woody debris, large woody debris, deep pools, and overhanging vegetation (Table [5.2](#), Figure [5.2](#)). The average channel width was 2.6m, the average wetted width was 2m and the average gradient was 3%. There were numerous fry observed throughout the area surveyed and abundant gravels suitable for resident westslope cutthroat trout spawning were noted. Habitat value was rated as high for salmonid rearing and spawning.

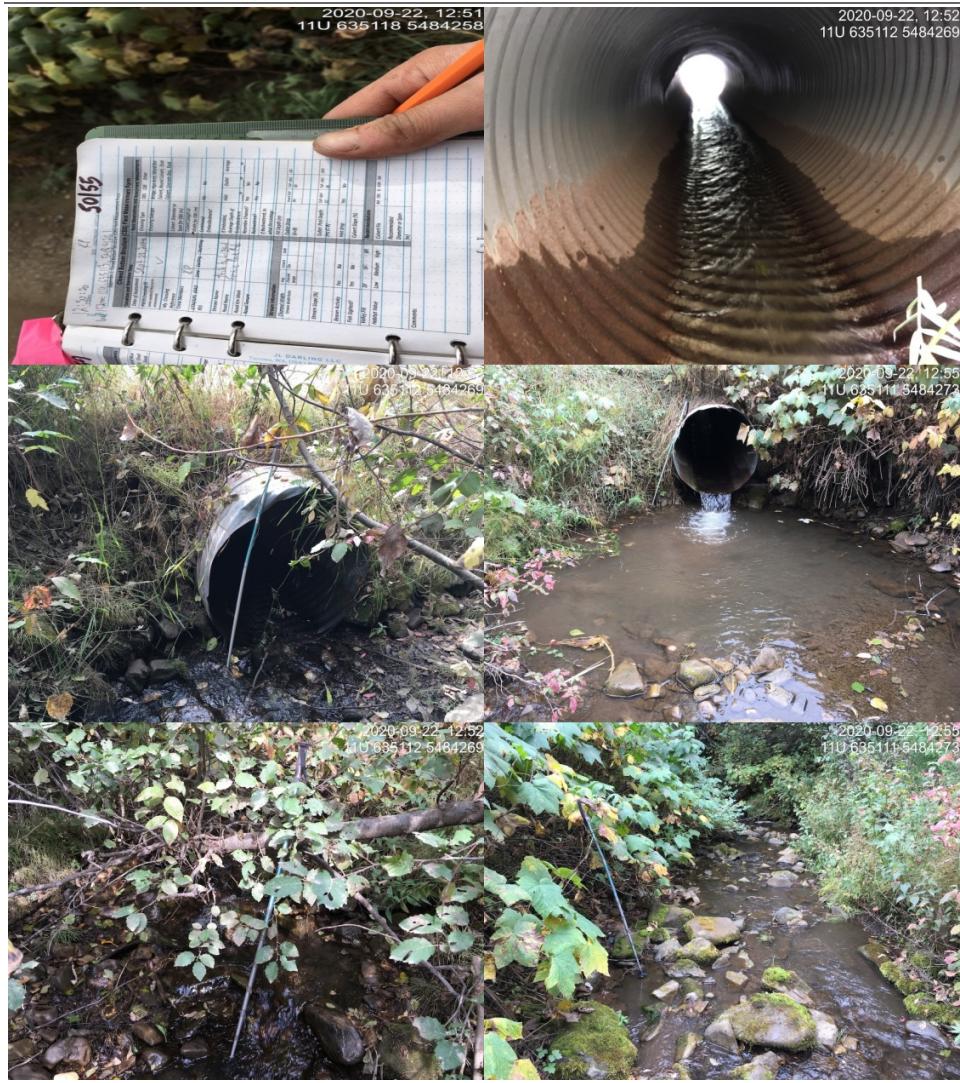
Photos: From top left clockwise: Road/Site Card, Barrel, Outlet, Downstream, Upstream, Inlet.

Structure replacement with an open bottomed culvert is recommended to provide unconstrained access to the habitat located upstream of PSCIS crossing 50155. The cost for work is estimated at \$125000 for a cost benefit of \$14400/linear m and \$16200/m².

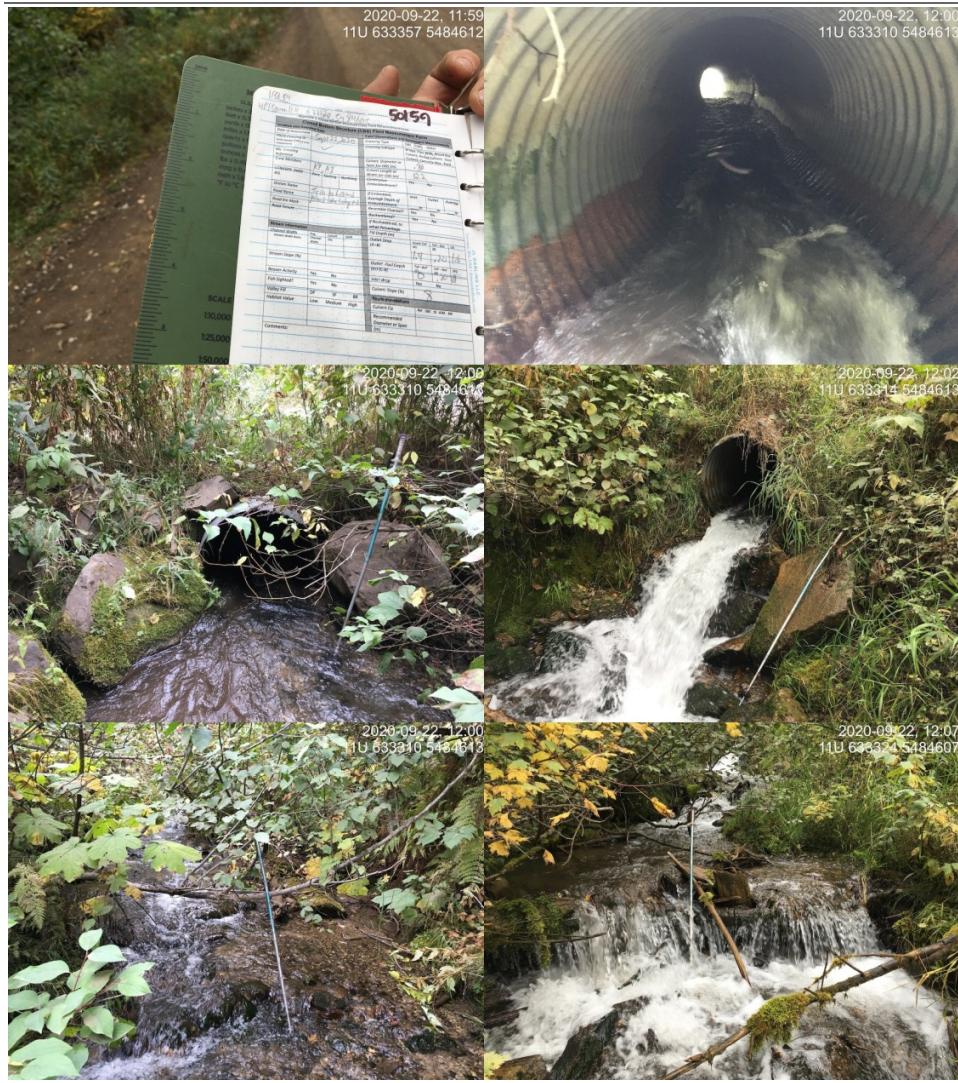
Photos: From top left clockwise: Road/Site Card, Barrel, Outlet, Downstream, Upstream, Inlet.

Structure replacement with a bridge is recommended to provide access to the habitat located upstream of PSCIS crossing 50159. The cost for the work is estimated at \$125000 for a cost benefit of \$2800/linear m and \$3400/m².

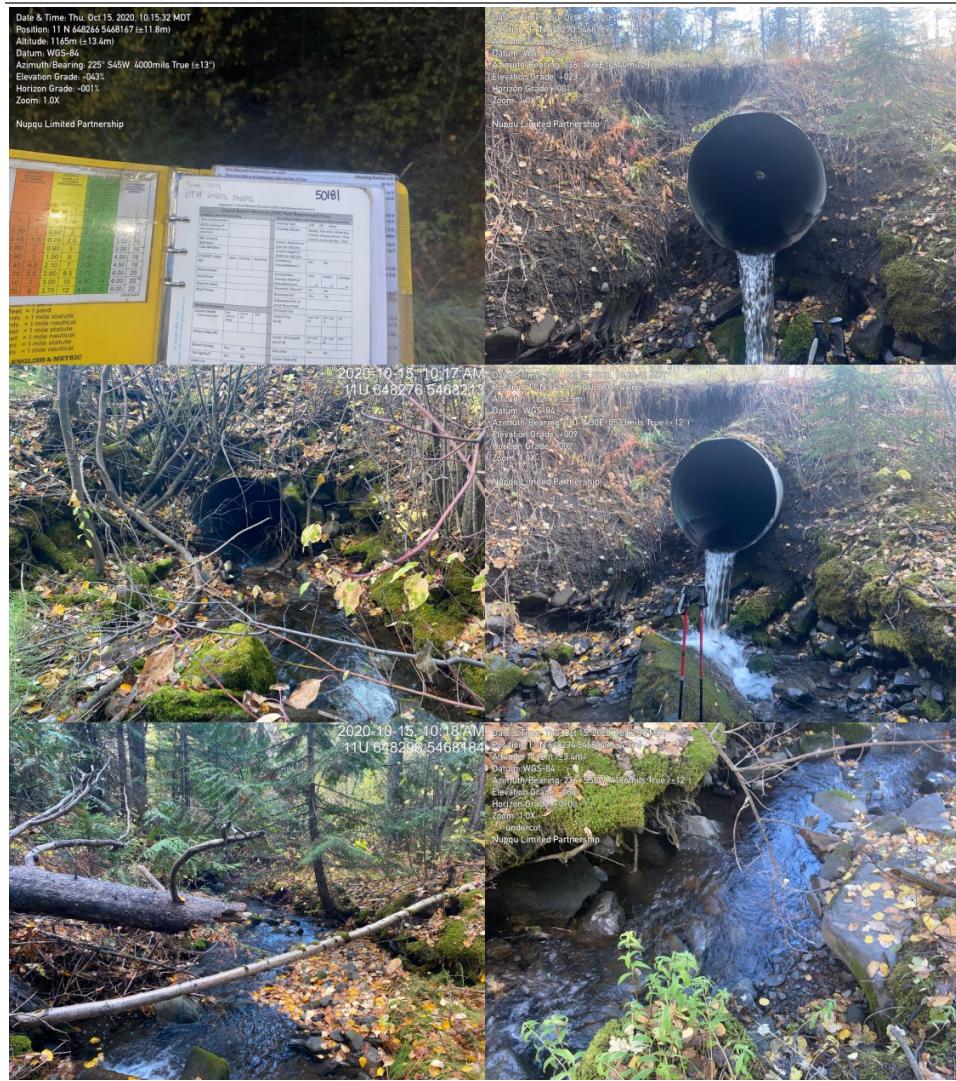
Photos: From top left clockwise: Road/Site Card, Barrel, Outlet, Downstream, Upstream, Inlet.

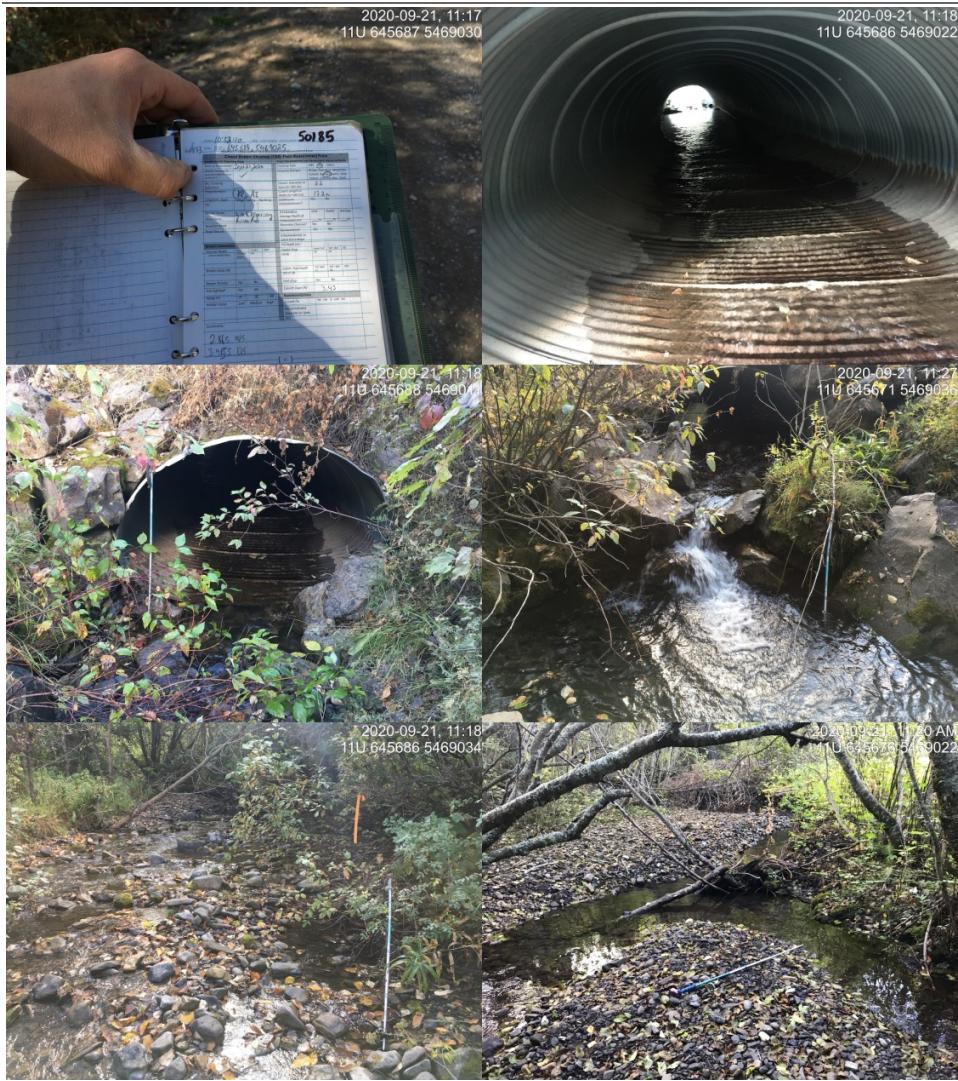
Photos: From top left clockwise: Road/Site Card, Barrel, Outlet, Downstream, Upstream, Inlet.

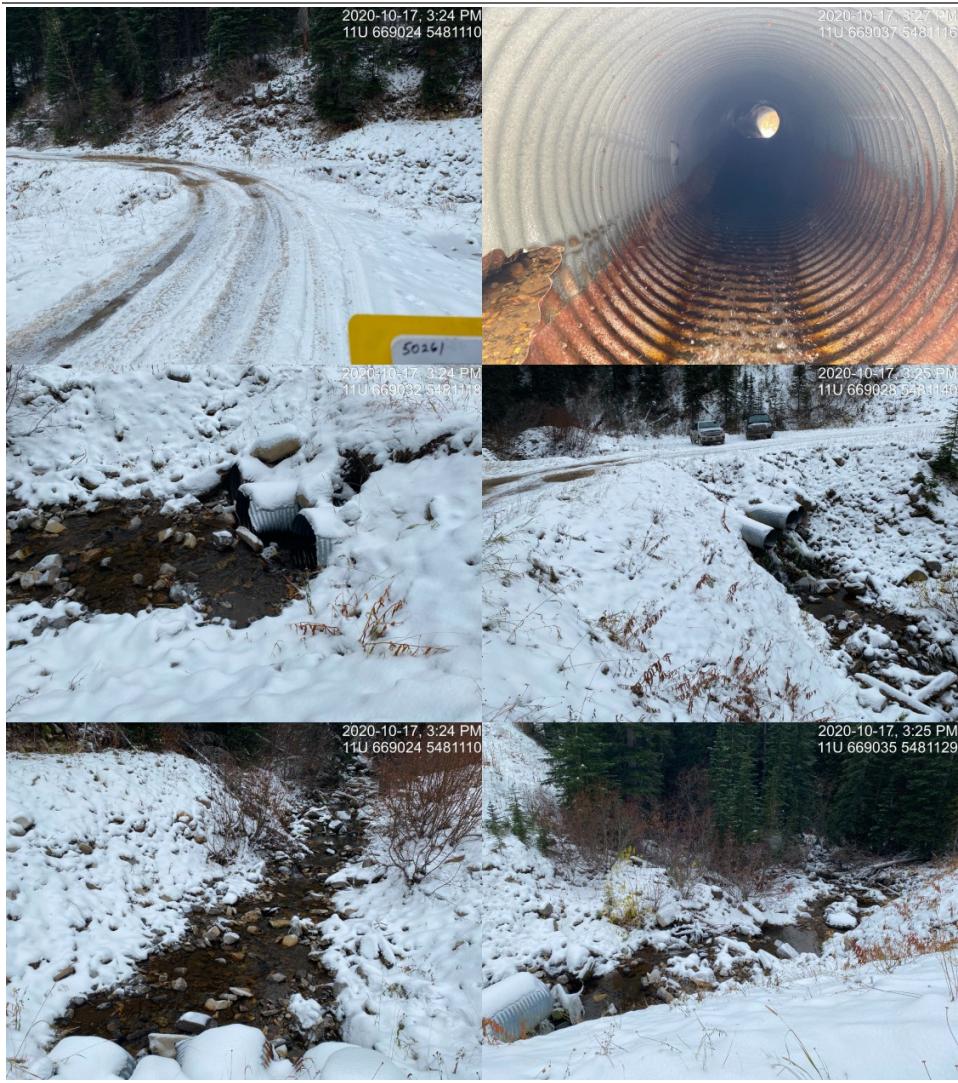
Photos: From top left clockwise: Road/Site Card, Barrel, Outlet, Downstream, Upstream, Inlet.

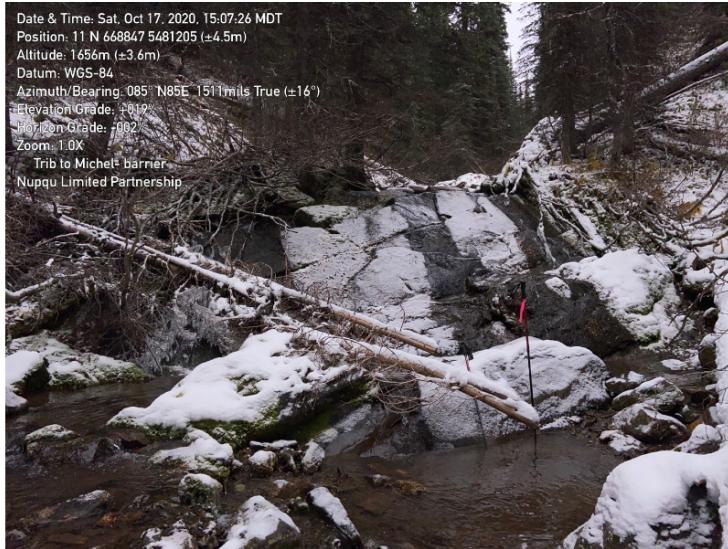
Figure 5.17: Chute barrier located 200 downstream of PSCIS crossing 50261.

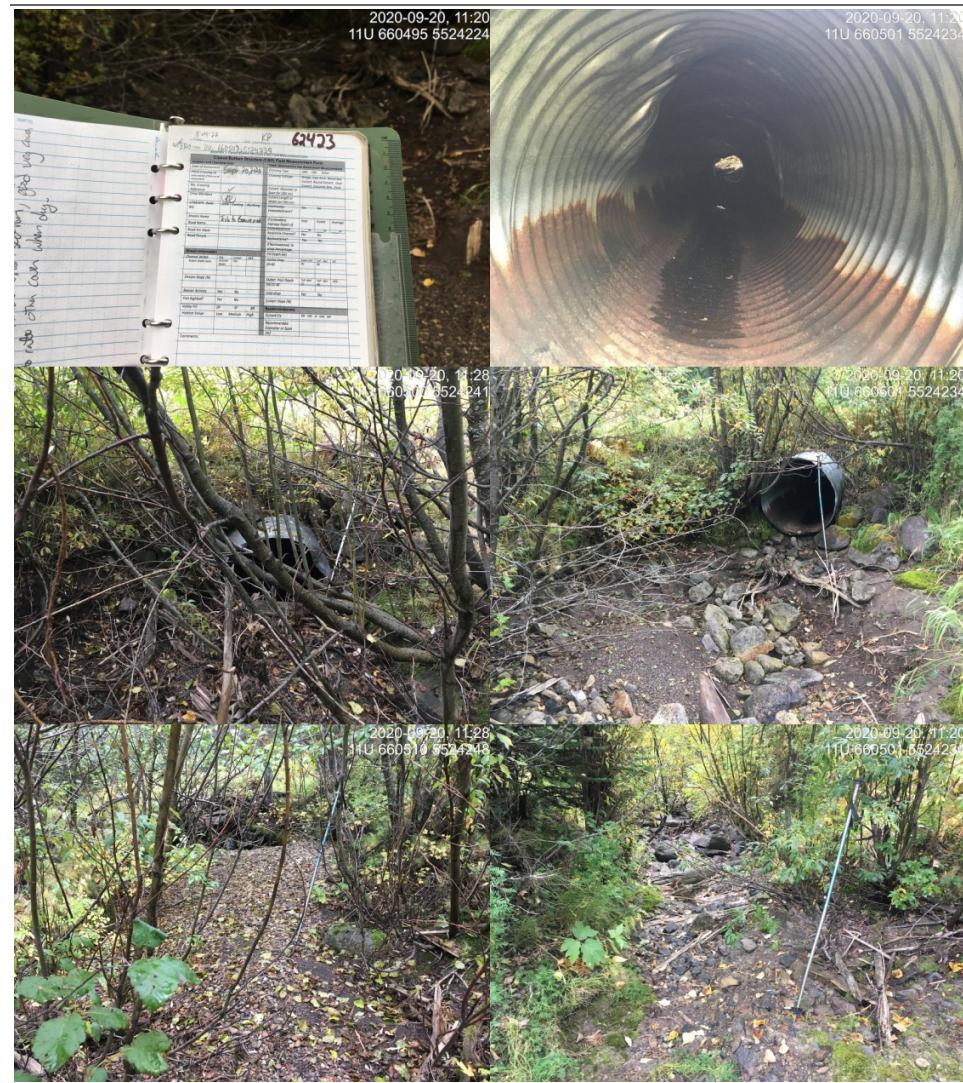
primarily fines above its confluence. There was however, a visible channel in this location with a ford (PSCIS 197563) located approximately 600m upstream of PSCSIS 62423. Overall, total cover amount was rated as moderate with undercut banks dominant. Cover was also present as small woody debris, large woody debris, and boulders (Table 5.20, Figure 5.19). The average channel width was 1.2m, the average wetted width was 0.8m and the average gradient was 4.4%. Harriet Lake Creek gradients modelled at 19% just upstream of the bridge located 1km upstream and too steep for upstream westslope cutthroat passage (>20%) at 2.2km. Habitat value was rated as medium for fry and juvenile westslope cutthroat rearing in Harriet Creek and low in the unnamed tributary mapped as Grave Creek due to a lack of flow.

Photos: From top left clockwise: Road/Site Card, Barrel, Outlet, Downstream, Upstream, Inlet.

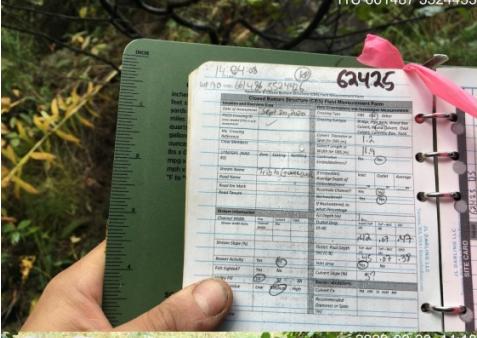
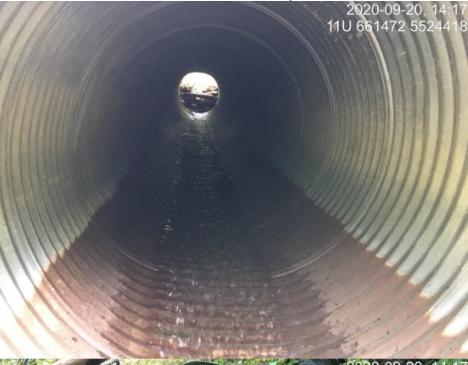
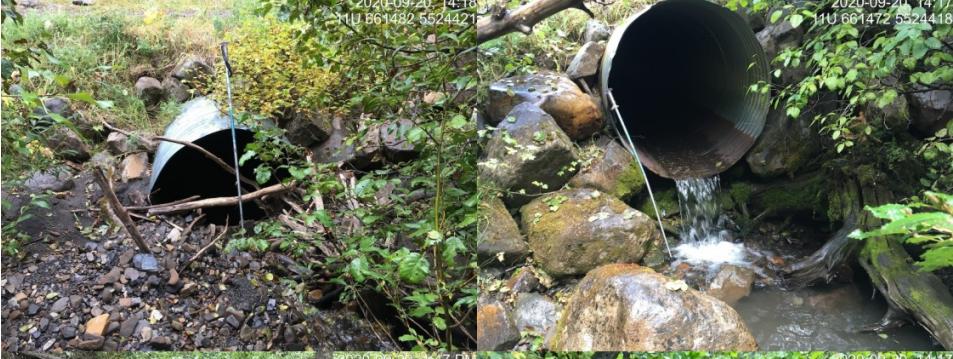
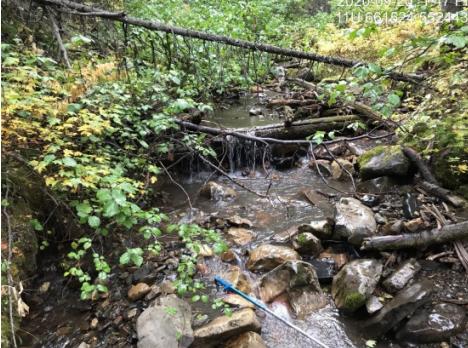
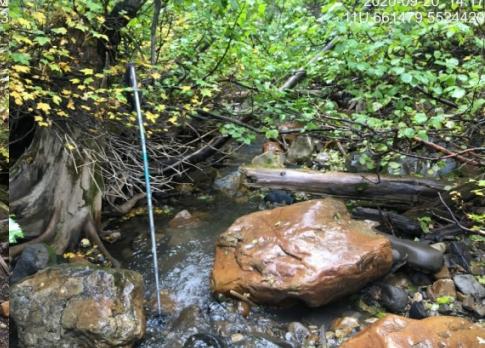
Table 5.22: Summary of fish passage reassessment for PSCIS crossing 62426.

| Habitat Value | Medium | Valley Fill | Deep Fill |
|---|--|--|--|
| Photos: From top left clockwise: Road/Site Card, Barrel, Outlet, Downstream, Upstream, Inlet. | | | |

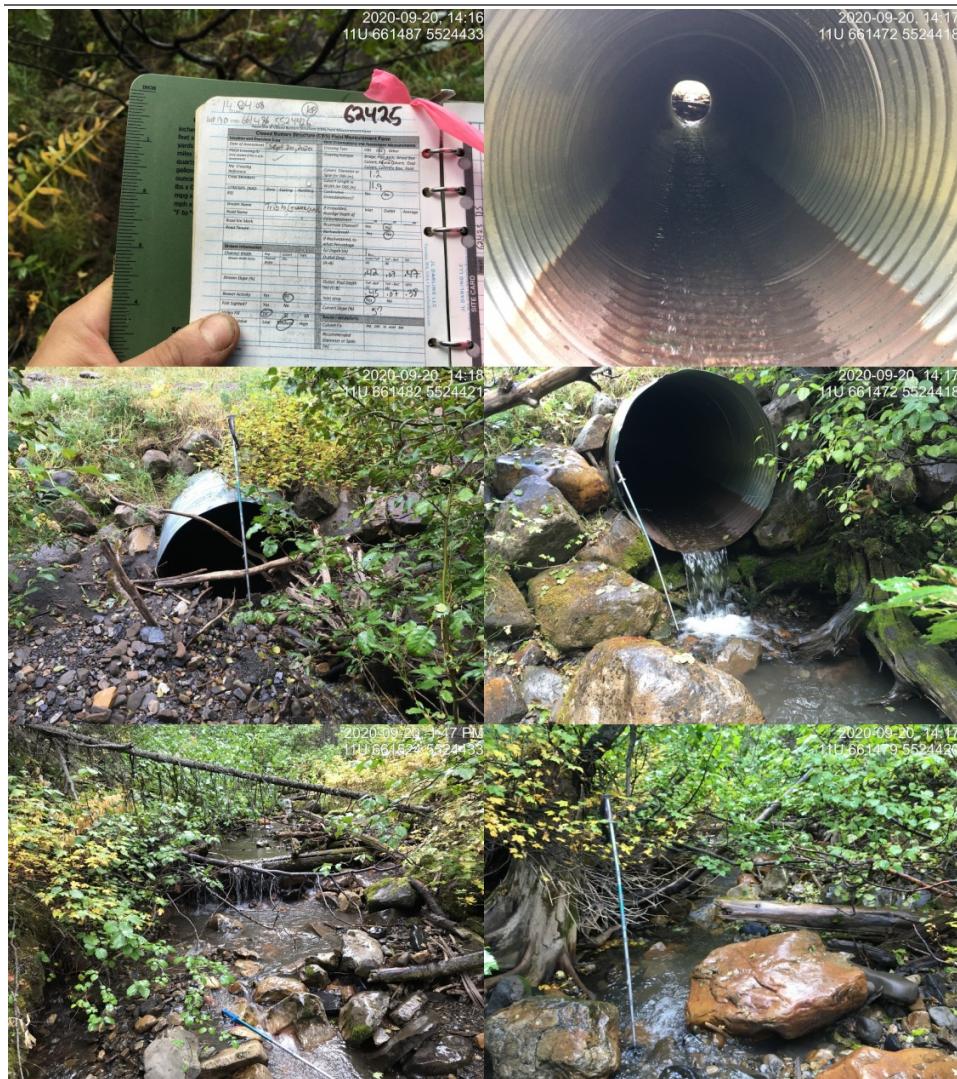
Photos: From top left clockwise: Road/Site Card, Barrel, Outlet, Downstream, Upstream, Inlet.

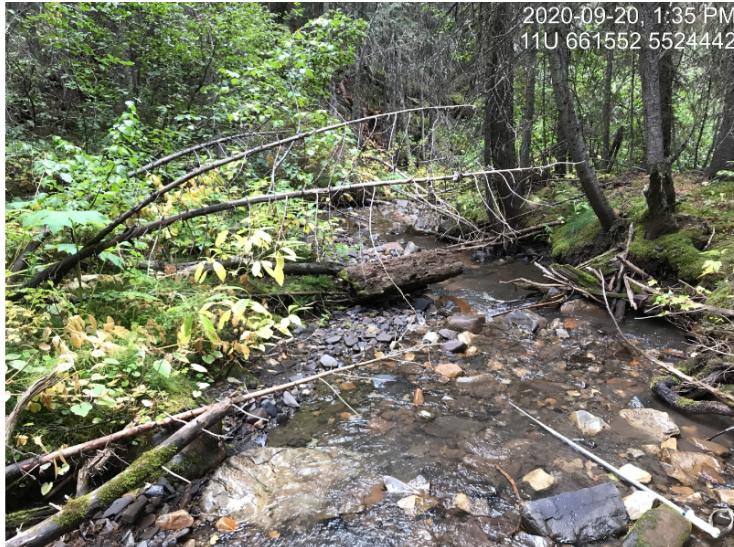
The stream was surveyed upstream from 62425 for 170m to 62426. Overall, total cover amount was rated as moderate with deep pools dominant. Cover was also present as large woody debris and boulders (Table 5.23, Figure 5.22). The average channel width was 3.5m, the average wetted width was 2.1m and the average gradient was 5%. There were abundant gravels suitable for resident westslope cutthroat trout spawning throughout (Figure 5.23). Some debris jam steps to 0.8m in height were observed and there were approximately 15 westslope cutthroat trout (approximately 170mm long) in the outlet pool for crossing 62426. Habitat value was rated as high for fry/juvenile salmonid rearing.

The stream was surveyed upstream from 62426 for 650m. Overall, total cover amount was rated as moderate with deep pools dominant. Cover was also present as boulders (Table 5.23, Figure 5.22). The average channel width was 3.5m, the average wetted width was 1.6m and the average gradient was 11.9%. This stream channel showed evidence of recent disturbance with eroding banks, multiple channels and aggraded sections throughout. Steps (0.6 - 0.9m in height) due to large woody debris debris jams were frequent throughout surveyed area and at a point approximately 200 m upstream of the road-stream crossing to the top end of the area surveyed, cover was limited to sporadic pools up to 0.3m deep. As mentioned previously, the historic channel was abandoned at 175m upstream of 62426 (UTM: 11 U 661748 5524558, Figure 5.23) with no flow observed within its banks. One of the tributaries that enters Grave Creek approximately 250m upstream of 62426 was accessed off of an adjacent spur road with a rapid assessment conducted 250m upstream from the confluence with Grave Creek (UTM: 11U 662083 5524708). The average channel width at this location was 1.9m and the average gradient was 9%. Immediately upstream, the gradient in this tributary was 20% representing grades not likely passable for westslope cutthroat trout migrating upstream. Overall, habitat value upstream of 62426 within the mainstem of Grave Creek was rated as medium with moderate rearing potential for fry/juvenile westslope cutthroat trout.

Figure 5.22: Typical habitat upstream of PSCIS crossing 62425 and downstream of PSCIS crossing 62426.

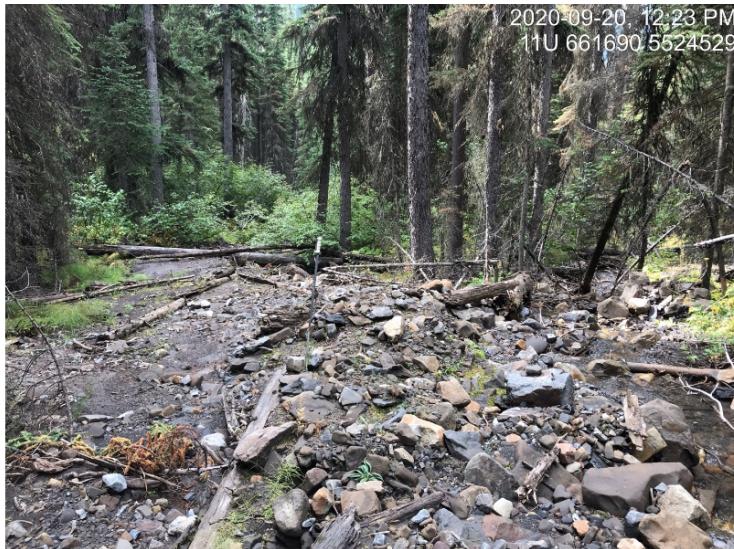
Figure 5.23: Grave Creek redirection out of historic channel located upstream of PSCIS crossing 62426.

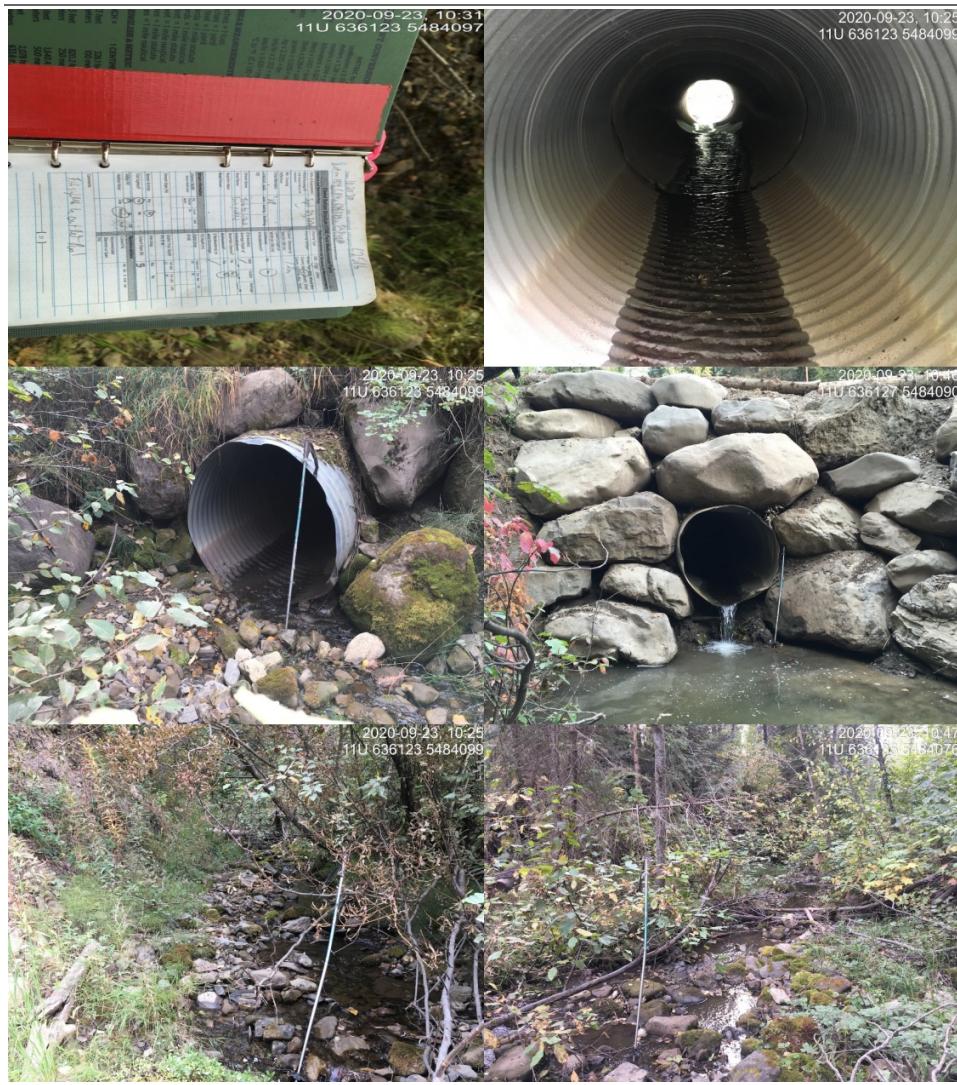
Photos: From top left clockwise: Road/Site Card, Barrel, Outlet, Downstream, Upstream, Inlet.

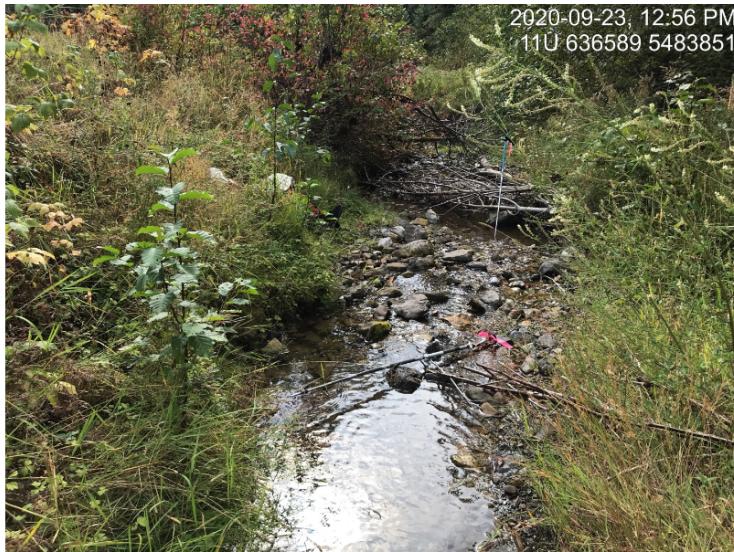
overhanging vegetation (Table 5.25, Figure 5.24). The average channel width was 2m, the average wetted width was 1.3m and the average gradient was 7.6%. There were abundant gravels suitable for resident westslope cutthroat trout spawning throughout (Figure 5.24). Fry were observed within the area surveyed to 540m upstream of the culvert where gradients increased to >20% for a distance of approximately 15m. Although no sampling was conducted, no fish were observed above this high gradient section. Habitat value was rated as high for fry/juvenile salmonid rearing.

Figure 5.24: Typical habitat downstream of PSCIS crossing 62516.

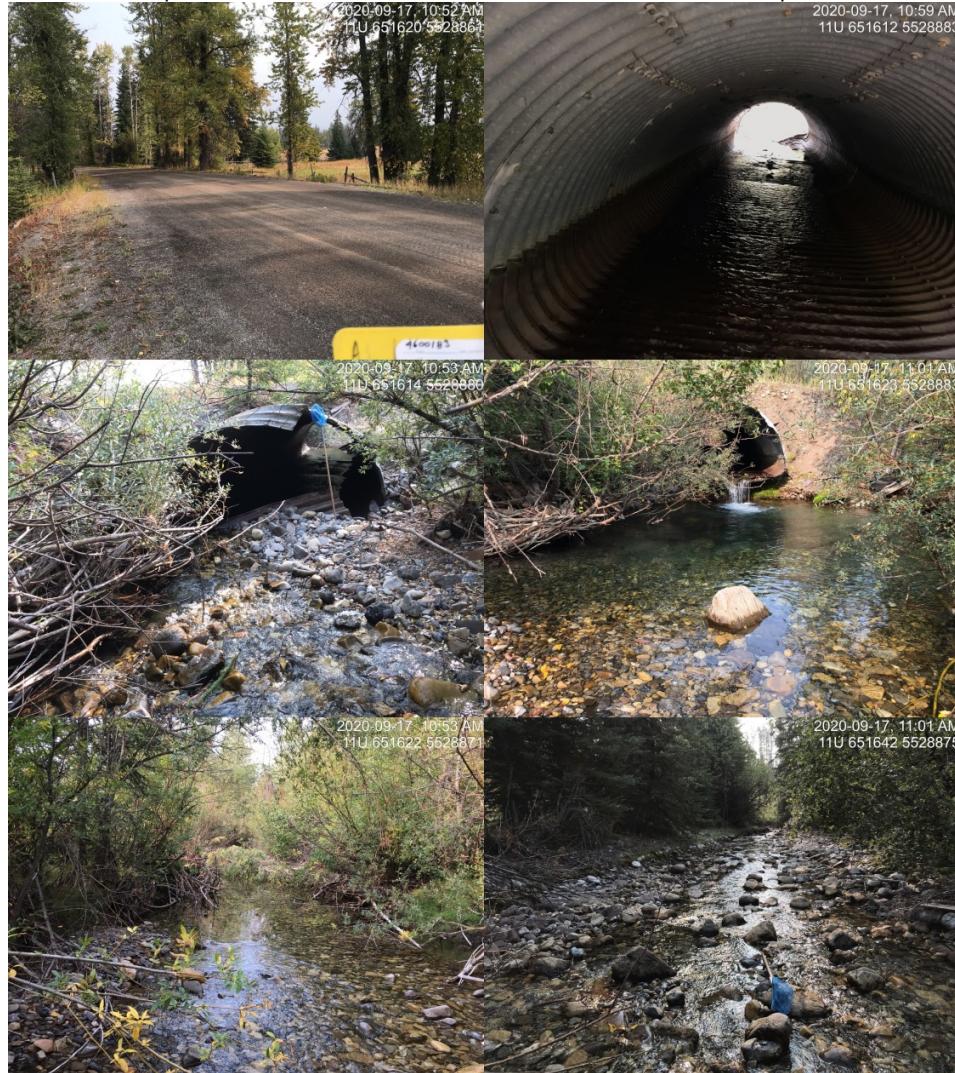
Photos: From top left clockwise: Road/Site Card, Barrel, Outlet, Downstream, Upstream, Inlet.

| 197533 | Brule Creek | Busato Rd | 651626 5528888 | RB, WCT, BT | 0.1 | High | high | Recommend exploring deactivation as a potential remediation action. Culvert is located 125m below crossing 197559. |

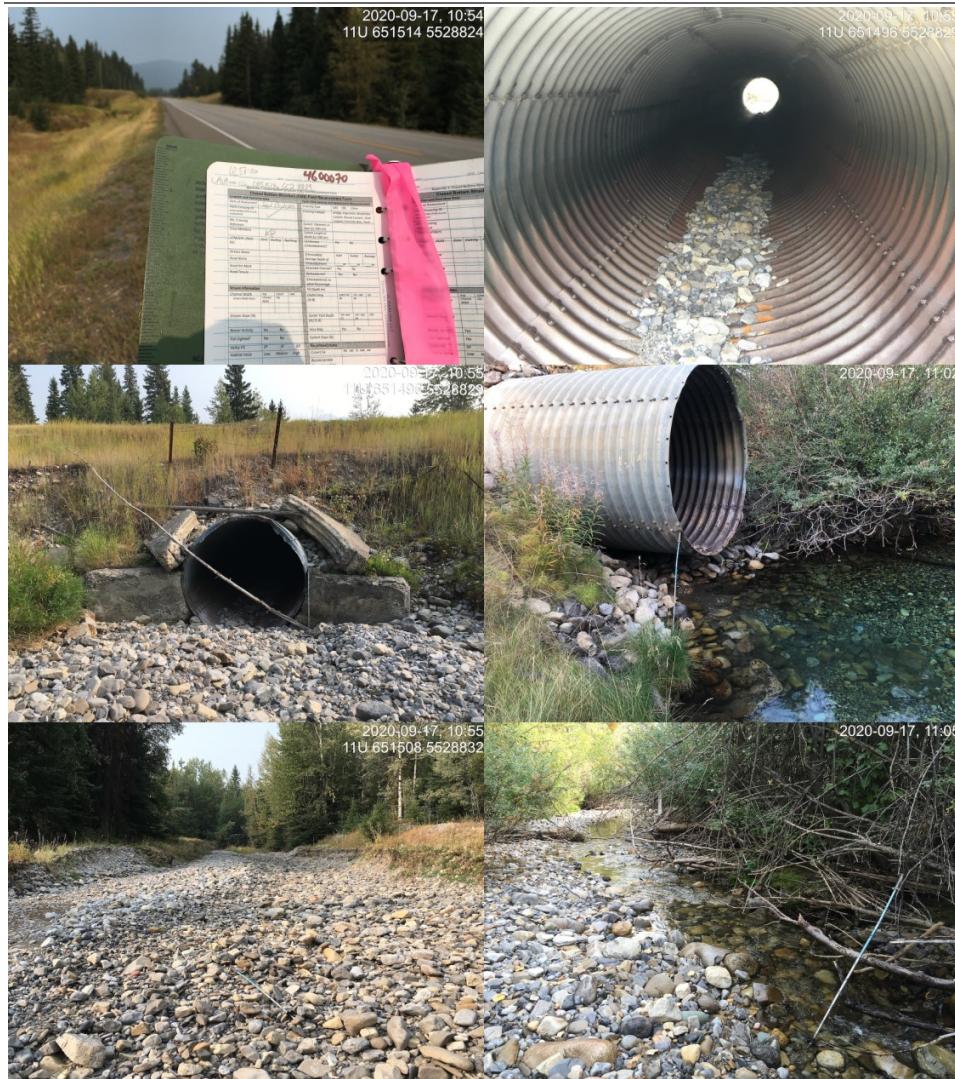
Photos: From top left clockwise: Road/Site Card, Barrel, Outlet, Downstream, Upstream, Inlet.

As properties on Busato Road could be accessed from either side of the road, removal of PSCIS 197533 could be explored as an option for providing access to the 125m of habitat located upstream and below PSCIS 197533. However, to facilitate an estimate of “worst case scenario”, costs for replacement of both crossing 197533 and 197533 with bridges are estimated at \$710000 and

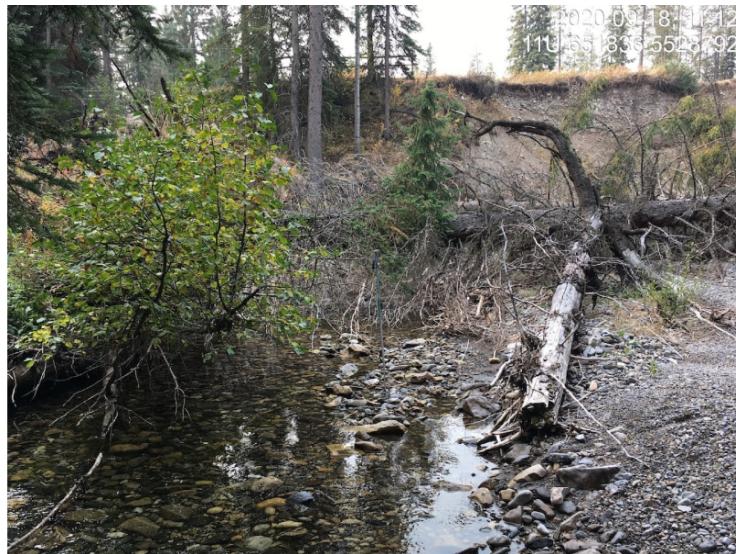
Figure 5.27: Typical habitat downstream of PSCIS crossing 197533.

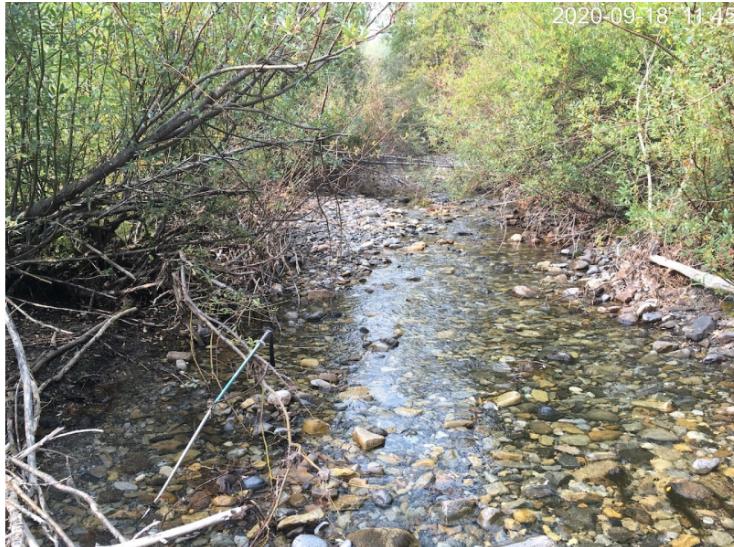
Figure 5.28: Typical habitat upstream of PSCIS crossing 197533 and downstream of PSCIS crossing 197533.

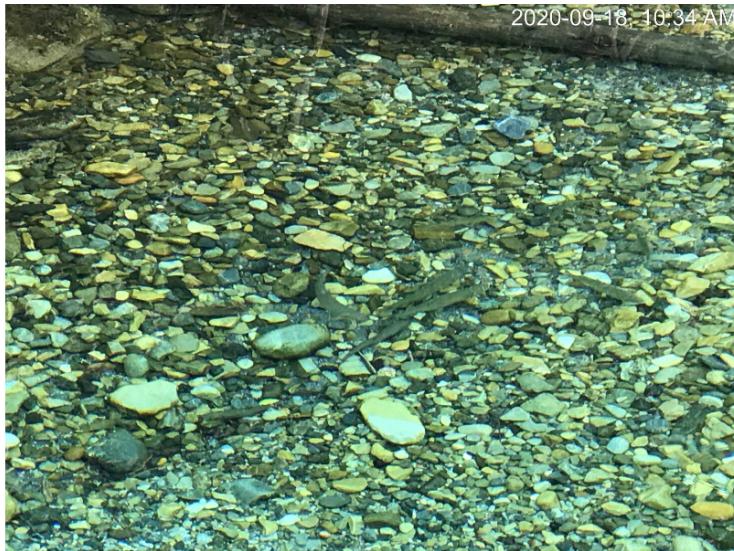
Figure 5.29: Westslope cutthroat trout in outlet pool downstream of PSCIS crossing 197559.

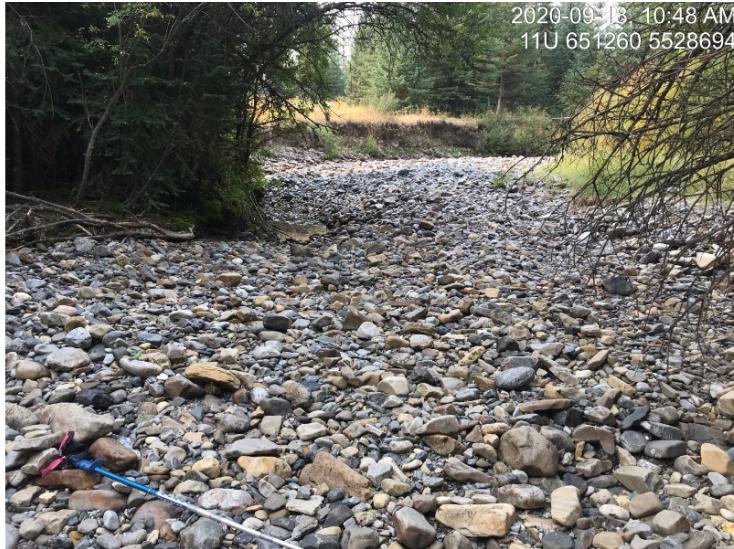
Figure 5.30: Subsurface flow area upstream of PSCIS crossing 197559.

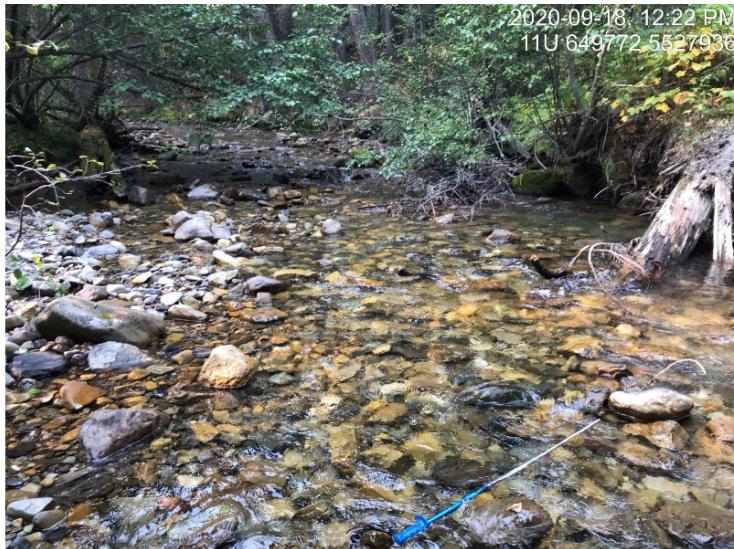
The stream was surveyed immediately upstream from 197559 for 1200m and then another 600m beginning at the ford (PSCIS 197536) 2km upstream for a total of 1600m. The channel was dewatered immediately upstream of Highway 43 with intermittent pools only to a distance approximately 670 m upstream. Upstream of the dewatered area, stream flows increased with increasing upstream distance. Overall, total cover amount was rated as moderate with deep pools dominant. Cover was also present as boulders and undercut banks (Table 5.28, Figure 5.28). The average channel width was 5.5m, the average wetted width was 2.3m and the average gradient was 3.5%. Overall, habitat upstream of 197559 was rated as high value habitat present suitable for resident and fluvial salmonid rearing and spawning.

Figure 5.31: Typical habitat above dewatered area upstream of PSCIS crossing 197533.

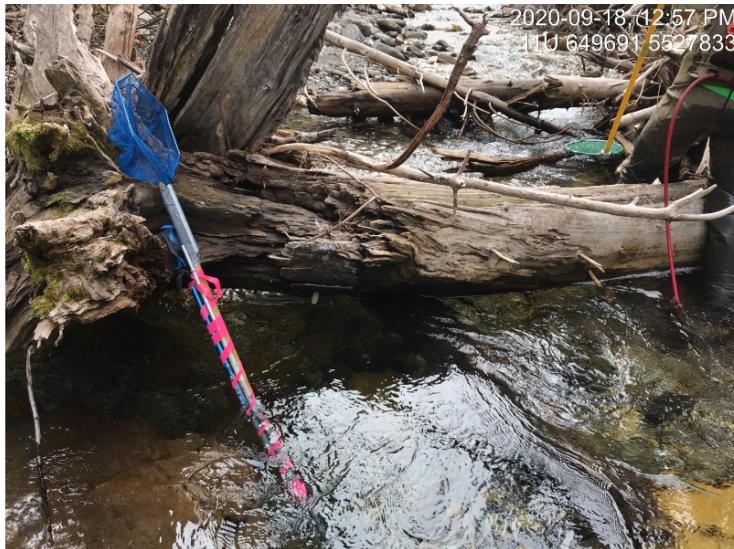
Figure 5.32: Habitat within electrofishing site upstream of PSCIS crossing 197533.

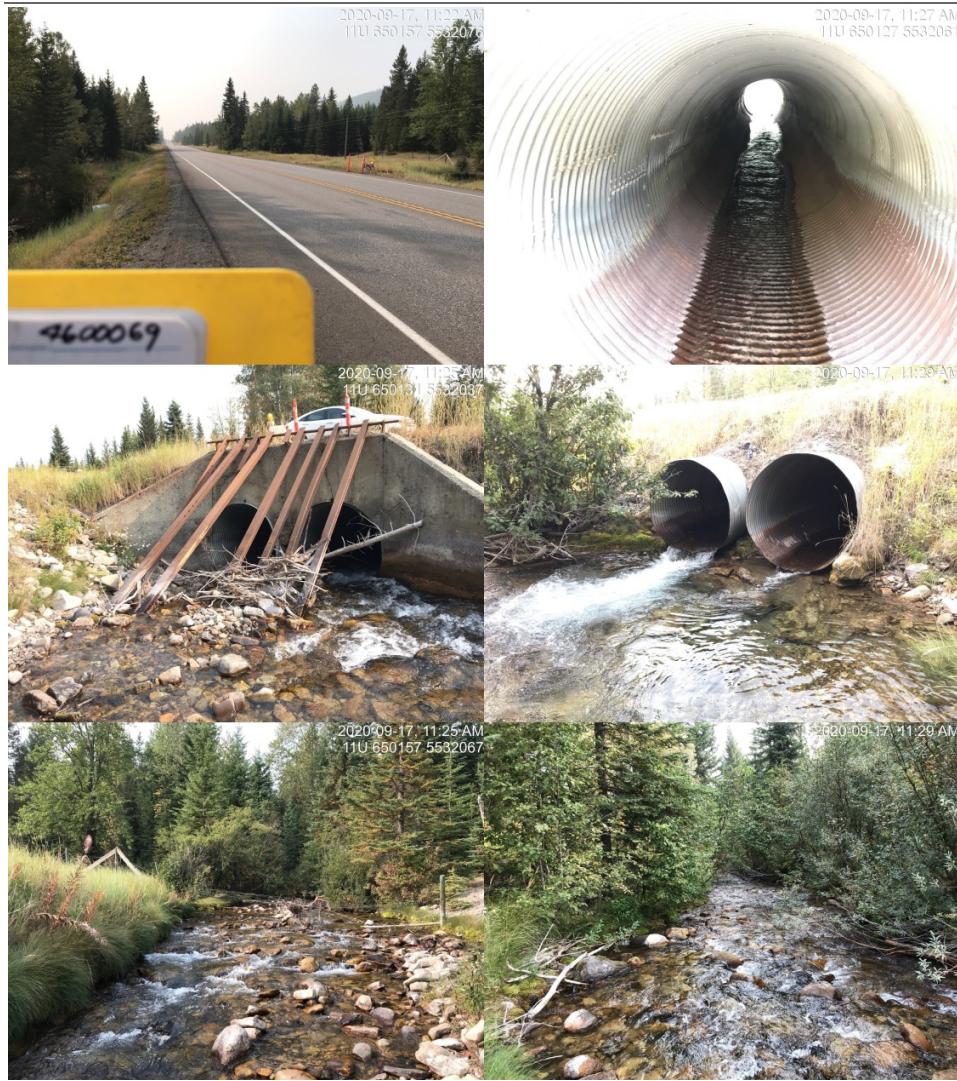
Photos: From top left clockwise: Road/Site Card, Barrel, Outlet, Downstream, Upstream, Inlet.

Structure replacement with an open bottomed structure is recommended to provide access to the habitat located upstream of PSCIS crossing 197534. The cost of the work is estimated at \$2500000 for a cost benefit of \$4600/linear m and \$10000/m².

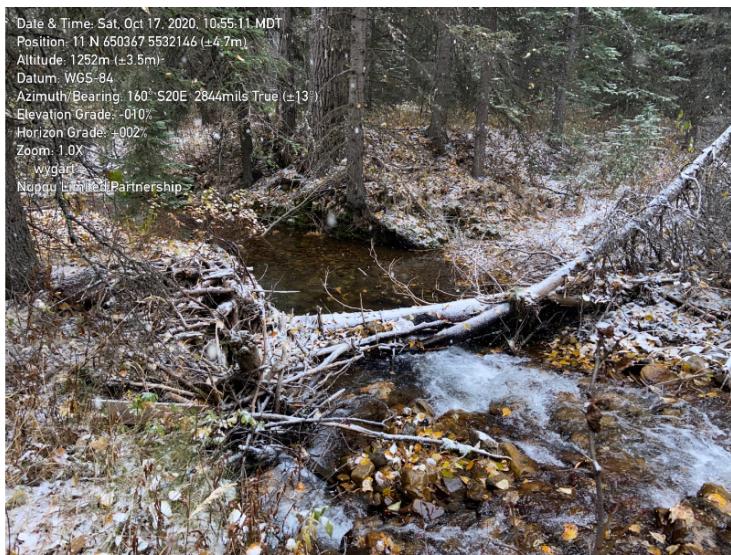
Figure 5.33: Habitat downstream of PSCIS crossing 197534.

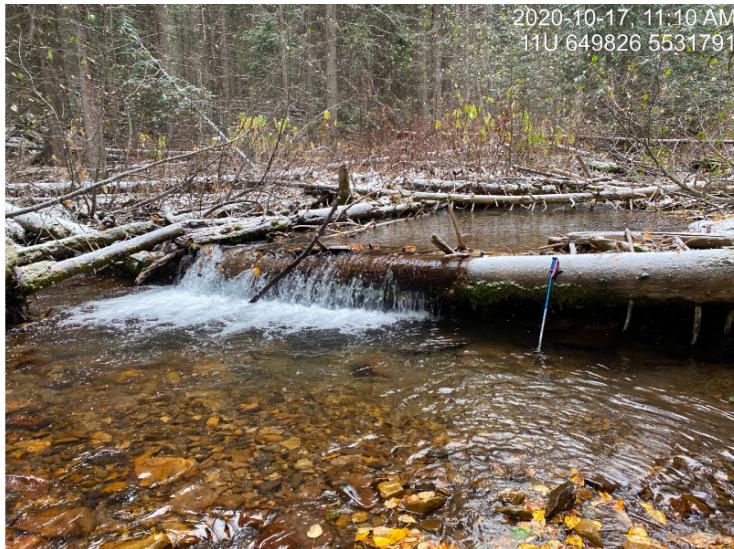
There is an estimated 11.6km of mainstem Weigert Creek habitat available upstream of PSCIS 197534 with habitat rated as high value, representing an important migration corridor with high rearing and spawning potential for resident and fluvial salmonids. Highway 43 is the responsibility of the Ministry of Transportation and Infrastructure. The crossing was ranked as a high priority for proceeding to design for replacement with an open bottomed structure.

Figure 5.34: Habitat upstream of PSCIS crossing 197534.
