ELK RIVER WATERSHED GROUP FISH PASSAGE RESTORATION PLANNING

December 31, 2020

Version 0.0.4

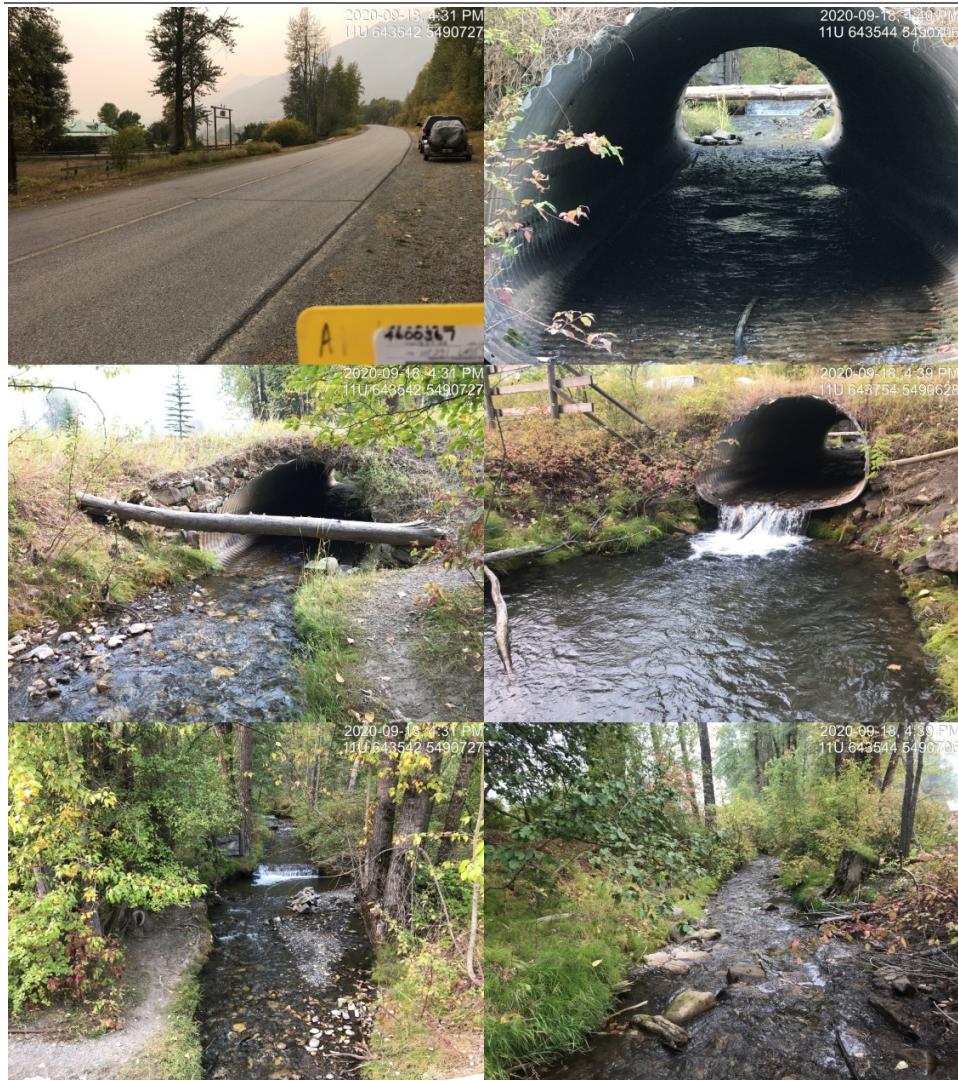
carry transported gravel further downstream and improve fish habitat immediately below the crossing (Robinson 2008). The works were not completely successful in preventing aggradation, as dredging was reported in 2019 (Marlim Ecological Consulting 2019) with only approximately 30cm of headboard observed within the highway stream crossing structure during 2020 surveys.

Photos: From top left clockwise: Road/Site Card, Barrel, Outlet, Downstream, Upstream, Inlet.

Structure replacement with an open bottomed structure is recommended to provide access to the habitat located upstream of PSCIS crossing 197542. The cost of the work is estimated at \$1e+06 for a cost benefit of \$7200/linear m and \$12600/m².

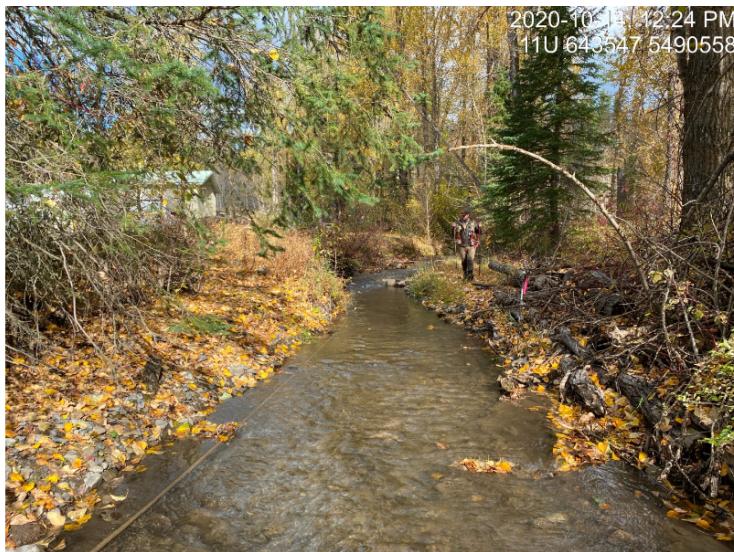
**Figure 5.35: Typical habitat downstream of PSCIS crossing 197542.**

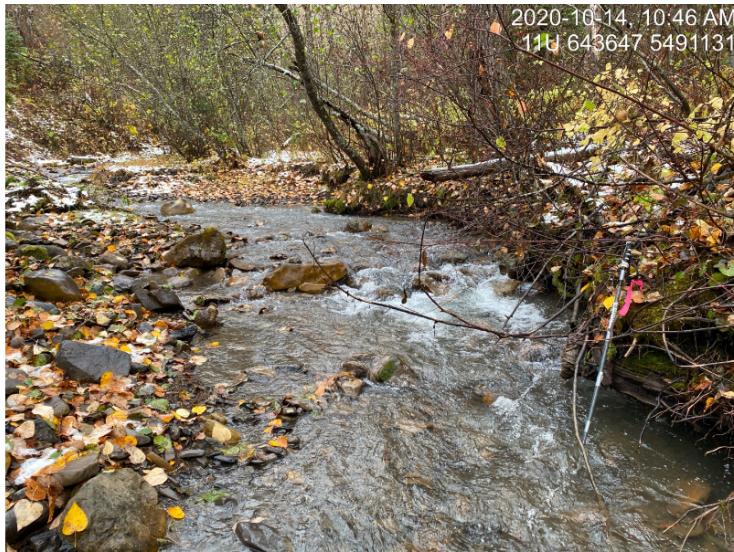
and may present an obstruction to upstream fish passage for fry and juvenile salmonids at some flows. Overall, total cover amount was rated as moderate with dominant. Cover was also present as small woody debris, undercut banks, deep pools, and overhanging vegetation (Table 5.33, Figure 5.38). The average channel width was 6.1m, the average wetted width was 3.8m and the average gradient was 3.5%. The dominant substrate was cobbles with gravels subdominant. There were frequent pools formed by small and large woody debris ranging from 0.3 - 0.7m in depth with a debris jam near top of site (11U 643668 5491243) measured at 1.2m in height. Pockets of gravels suitable for resident and fluvial salmonids were present and there were areas of erosion notable on the right bank of the stream.

Figure 5.38: Typical habitat upstream of PSCIS crossing 197542.

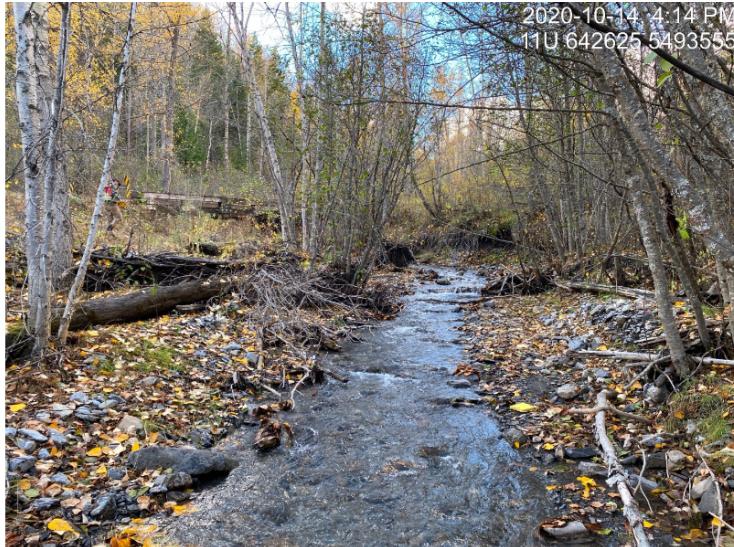
Within the 75m section of stream surveyed 2.5km upstream of Dicken Road, stream conditions were similar to those observed downstream with an average channel width of 4.6m and gravel dominated substrate (Figure 5.39). Overall, upstream of PSCIS 197542 was rated as high habitat value, containing habitat with moderate rearing and spawning potential for resident and fluvial salmonids.

Figure 5.39: Habitat upstream of PSCIS crossing 197542 approximatley 2.5km.

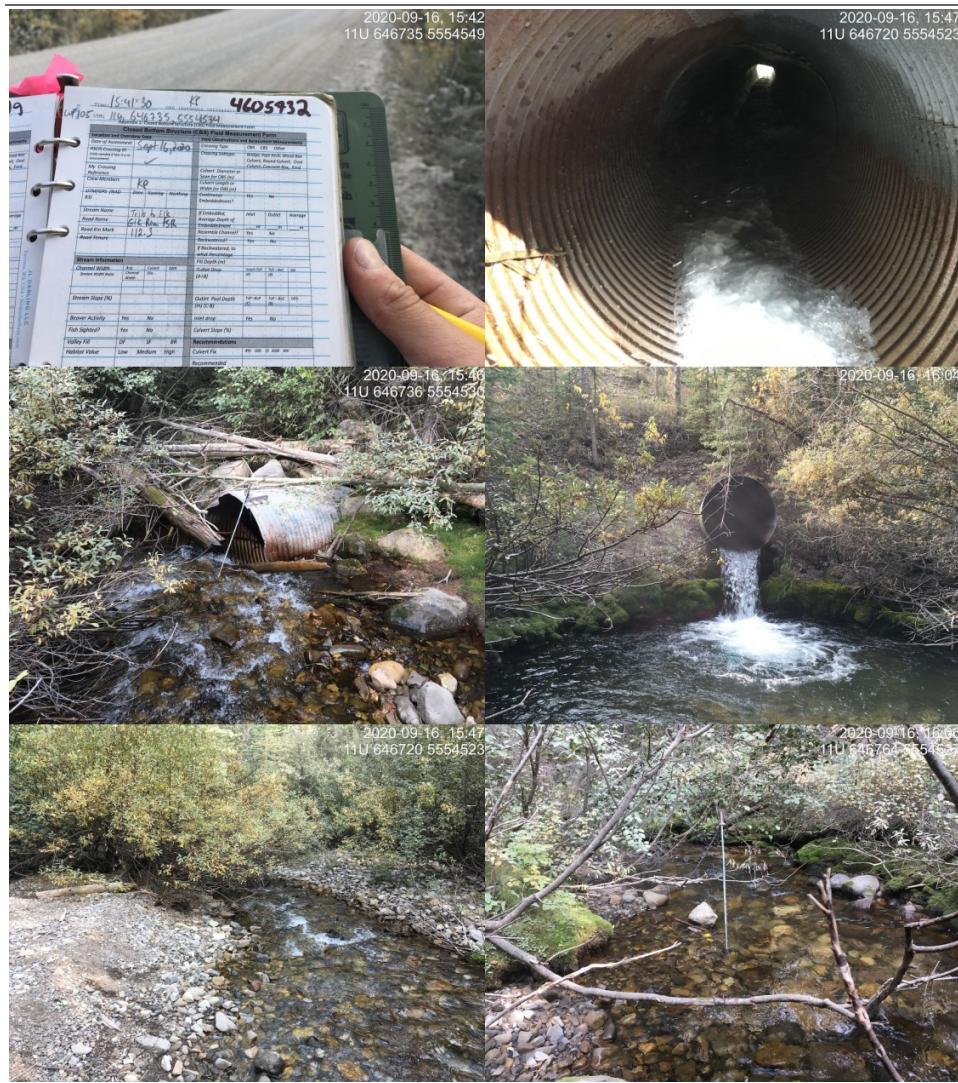
| Location and Stream Data | | Crossing Characteristics – | |
|---|---|---|---|
| Photos: From top left clockwise: Road/Site Card, Barrel, Outlet, Downstream, Upstream, Inlet. | | | |

Structure replacement with an open bottomed culvert is recommended to provide access to the habitat located upstream of PSCIS crossing 197555. Due to the large amount of fill on the road (8) the size of a replacement bridge was estimated at 25m. The cost for work is estimated at \$312000 for a cost benefit of \$19200/linear m and \$33700/m².

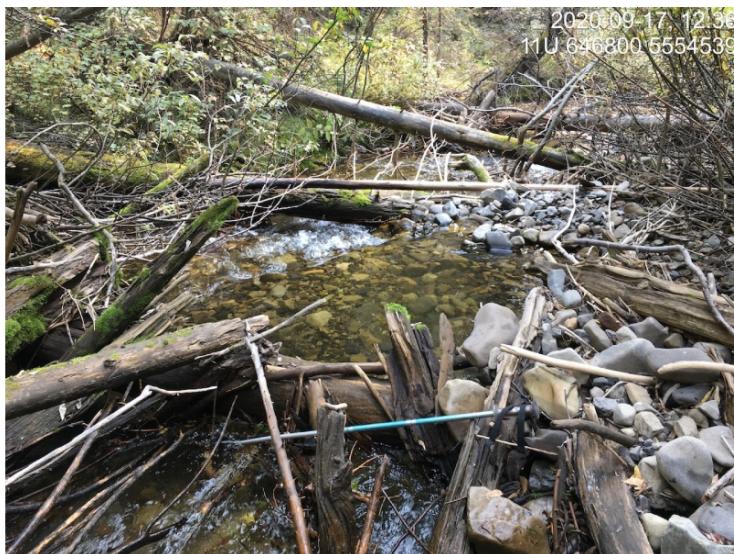
Figure 5.40: Typical habitat downstream of PSCIS crossing 197555.

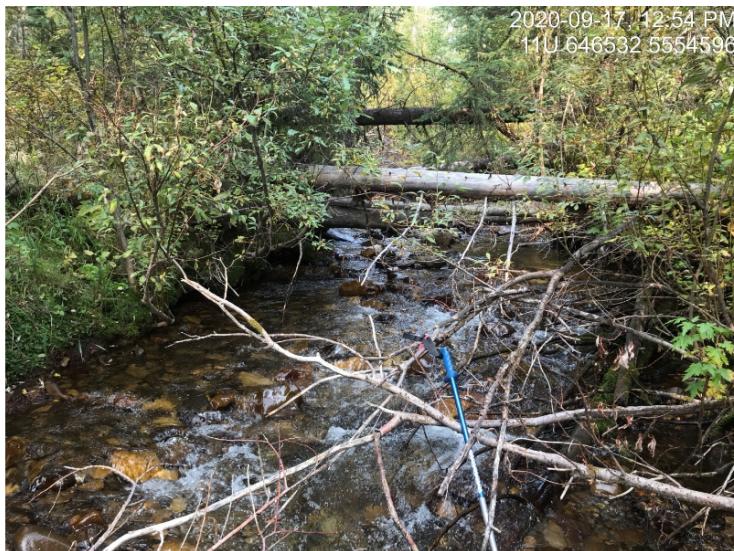
Figure 5.41: Typical habitat upstream of PSCIS crossing 197555.

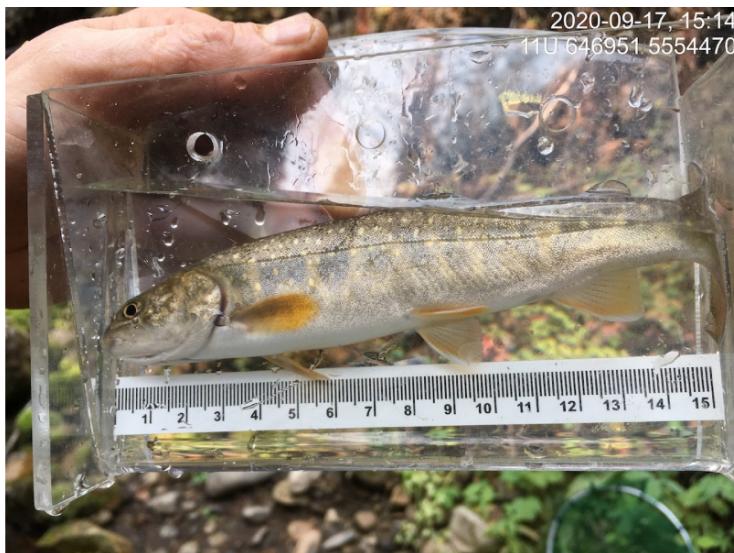
To assess potential impacts of the culvert on fish communities in the stream, electrofishing was conducted upstream and downstream of the crossing. One 150m site was sampled upstream and one 315m site was sampled downstream. One bull trout was captured downstream and no fish were captured upstream (Figure 5.42). Raw results are included in digital format as [Attachment 2](#) and summarized in Table 5.36.

Figure 5.42: Bull trout captured downstream of PSCIS crossing 197555.
