DRAFT - Bulkley River and Morice River Watershed Groups Fish Passage Restoration Planning

Prepared for
Habitat Conservation Trust Fund
BC Fish Passage Remediation Program
Canadian Wildlife Federation

Prepared by
Al Irvine, B.Sc., R.P.Bio.
New Graph Environment
6 Regent St
Nelson, BC V1L 2P1

DRaFT - Version 0.0.5
2021-03-11

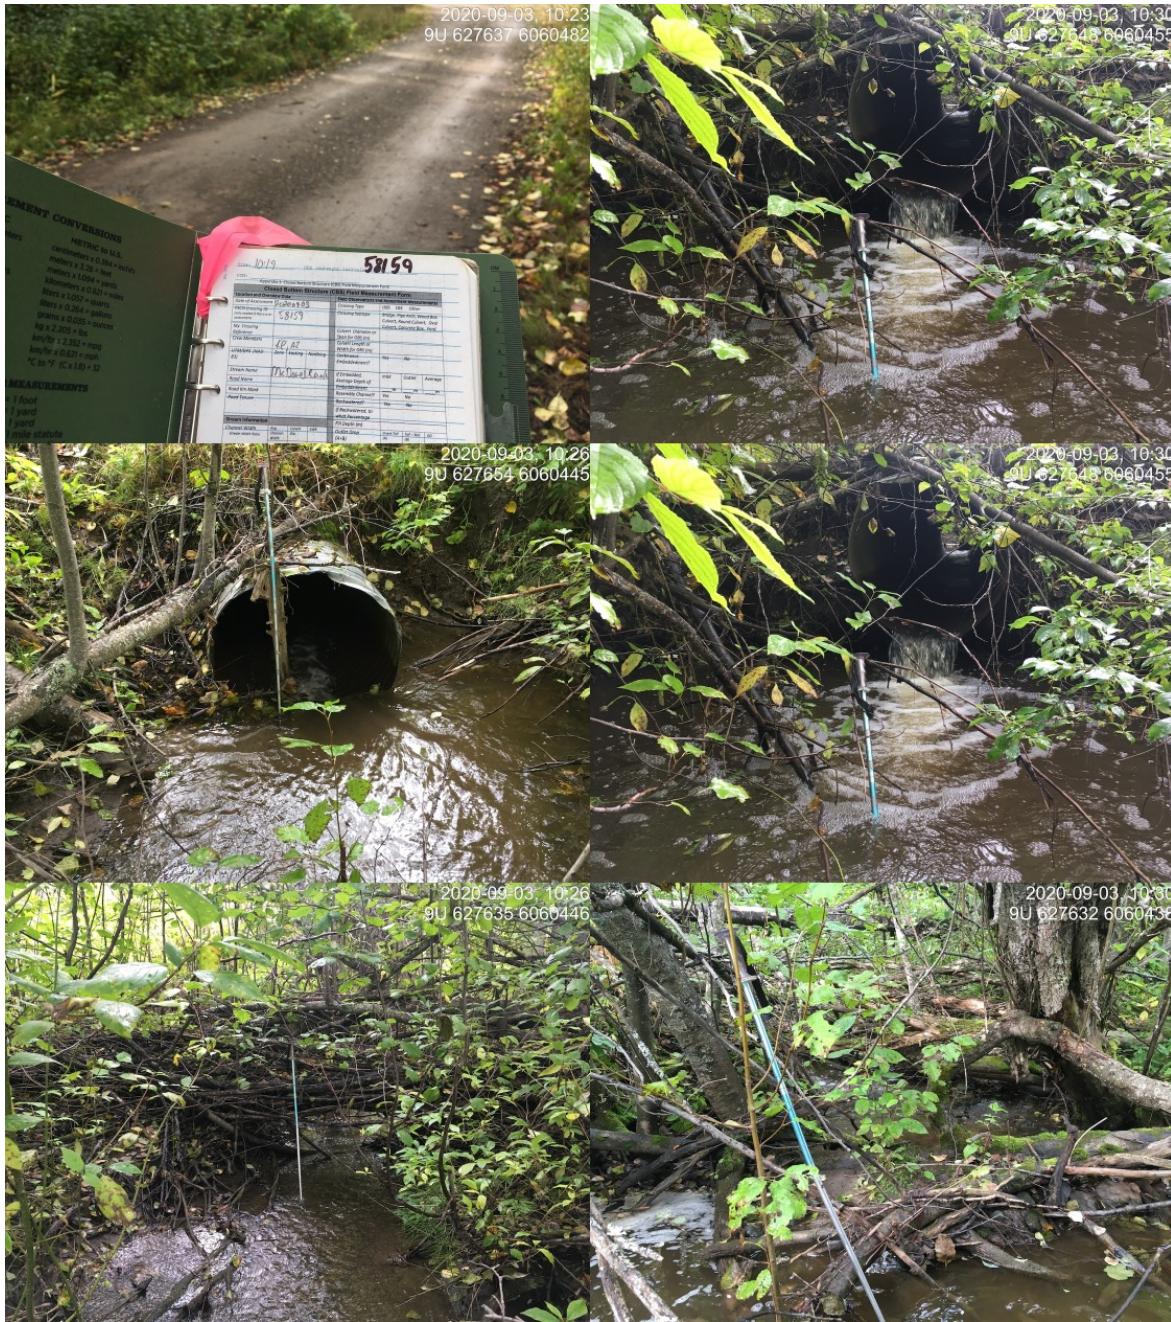
Comments: Stream flows through the Woodmere Nursery from small culvert on burn pile access road to the Highway. Electrofishing conducted. Abundant cover available primarily as overhanging vegetation and cobbles. Upstream culvert under Highway 16 has been recently replaced by horizontal drilling. Baffles at upstream crossing. Coho fry captured below the Highway crossing.

Date	2020-09-03	Crossing Sub Type	Round Culvert
PSCIS ID	58158	Diameter (m)	2.5
External ID	–	Length (m)	53
Crew	AI, KP	Embedded	Yes
UTM Zone	9	Depth Embedded (m)	0.5
Easting	628044	Resemble Channel	Yes
Northing	6060527	Backwatered	No
Stream	McDowell Creek	Percent Backwatered	–
Road	Highway 16	Fill Depth (m)	4
Road Tenure	MoTi highway	Outlet Drop (m)	0.36
Channel Width (m)	2.5	Outlet Pool Depth (m)	0.45
Stream Slope (%)	3	Inlet Drop	Yes
Beaver Activity	No	Slope (%)	5.5
Habitat Value	High	Valley Fill	Deep Fill
Final score	34	Barrier Result	Barrier
Fix type	Replace with New Open Bottom Structure	Fix Span / Diameter	13
Photos: From top left clockwise: Road/Site Card, Barrel, Outlet, Downstream, Upstream, Inlet.

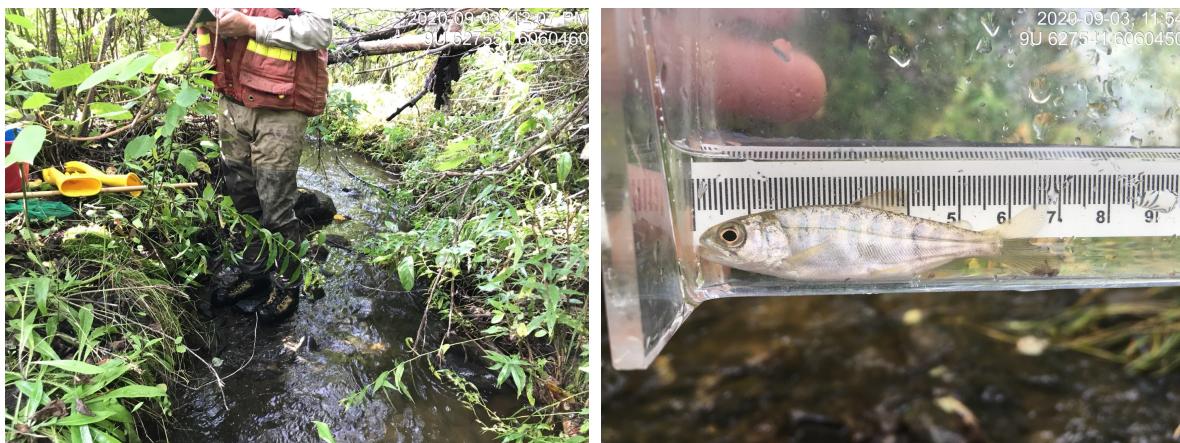
Figure 5.3: Left: Typical habitat downstream of PSCIS crossing 58159. **Right:** Chinook captured downstream of PSCIS crossing 58159.

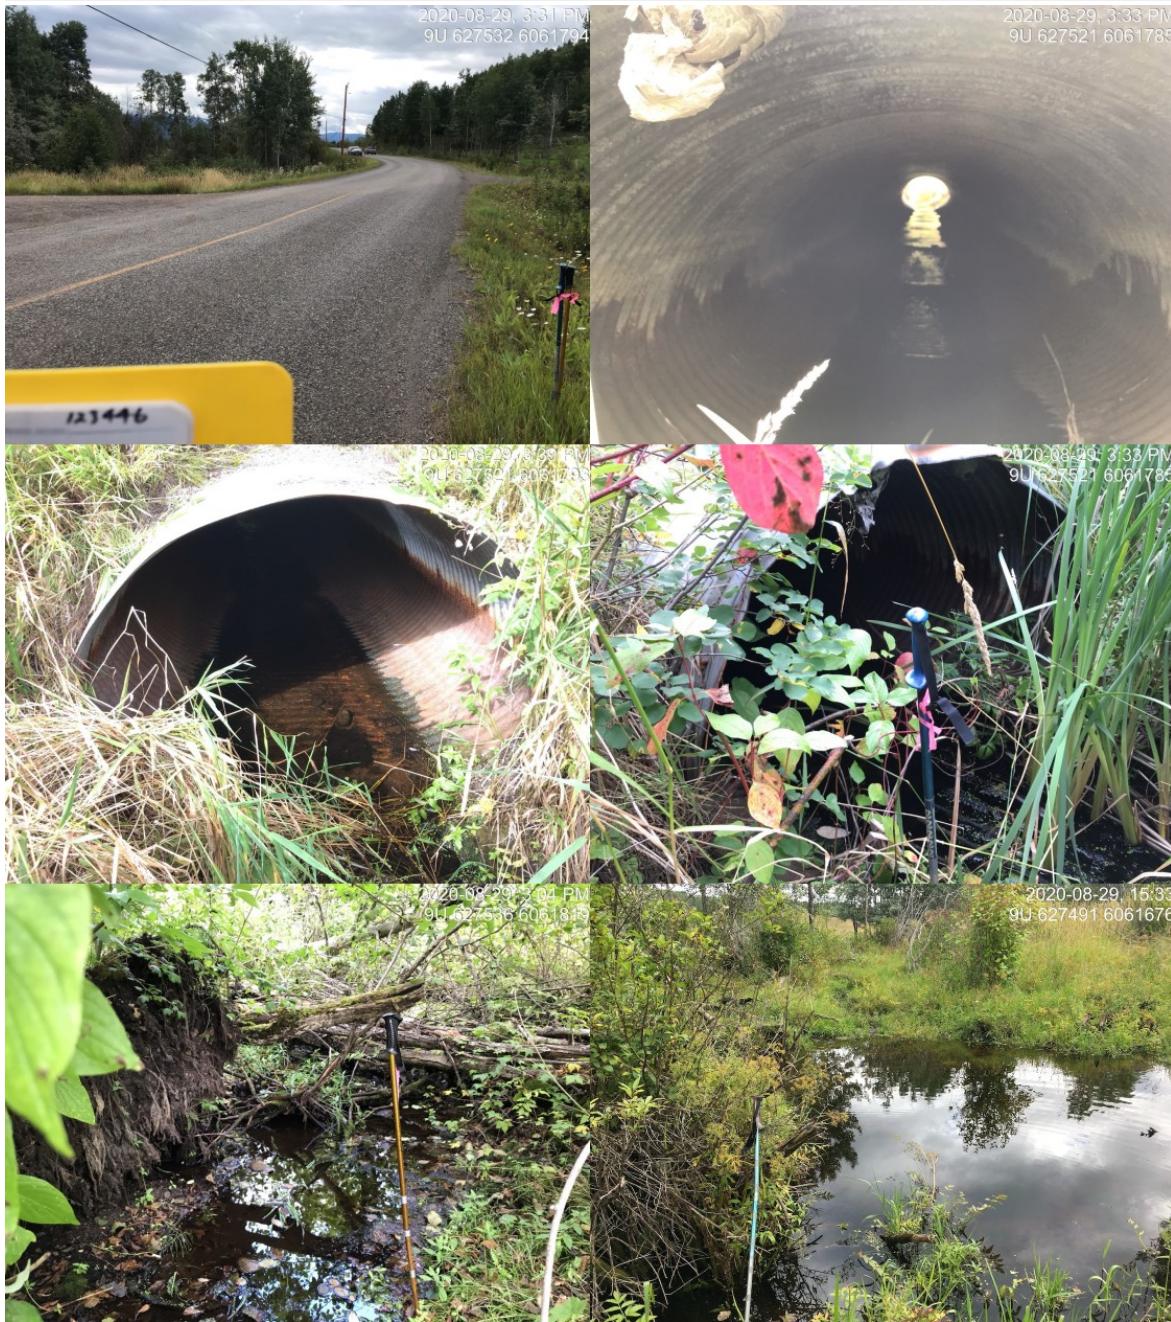
Table 5.11: Summary of fish passage assessment for PSCIS crossing 123463.

Comments: Important migration corridor to get to Tyee Lake from Bulkley River. Crossing does not appear to be barrier to most life stages/species at most flows.

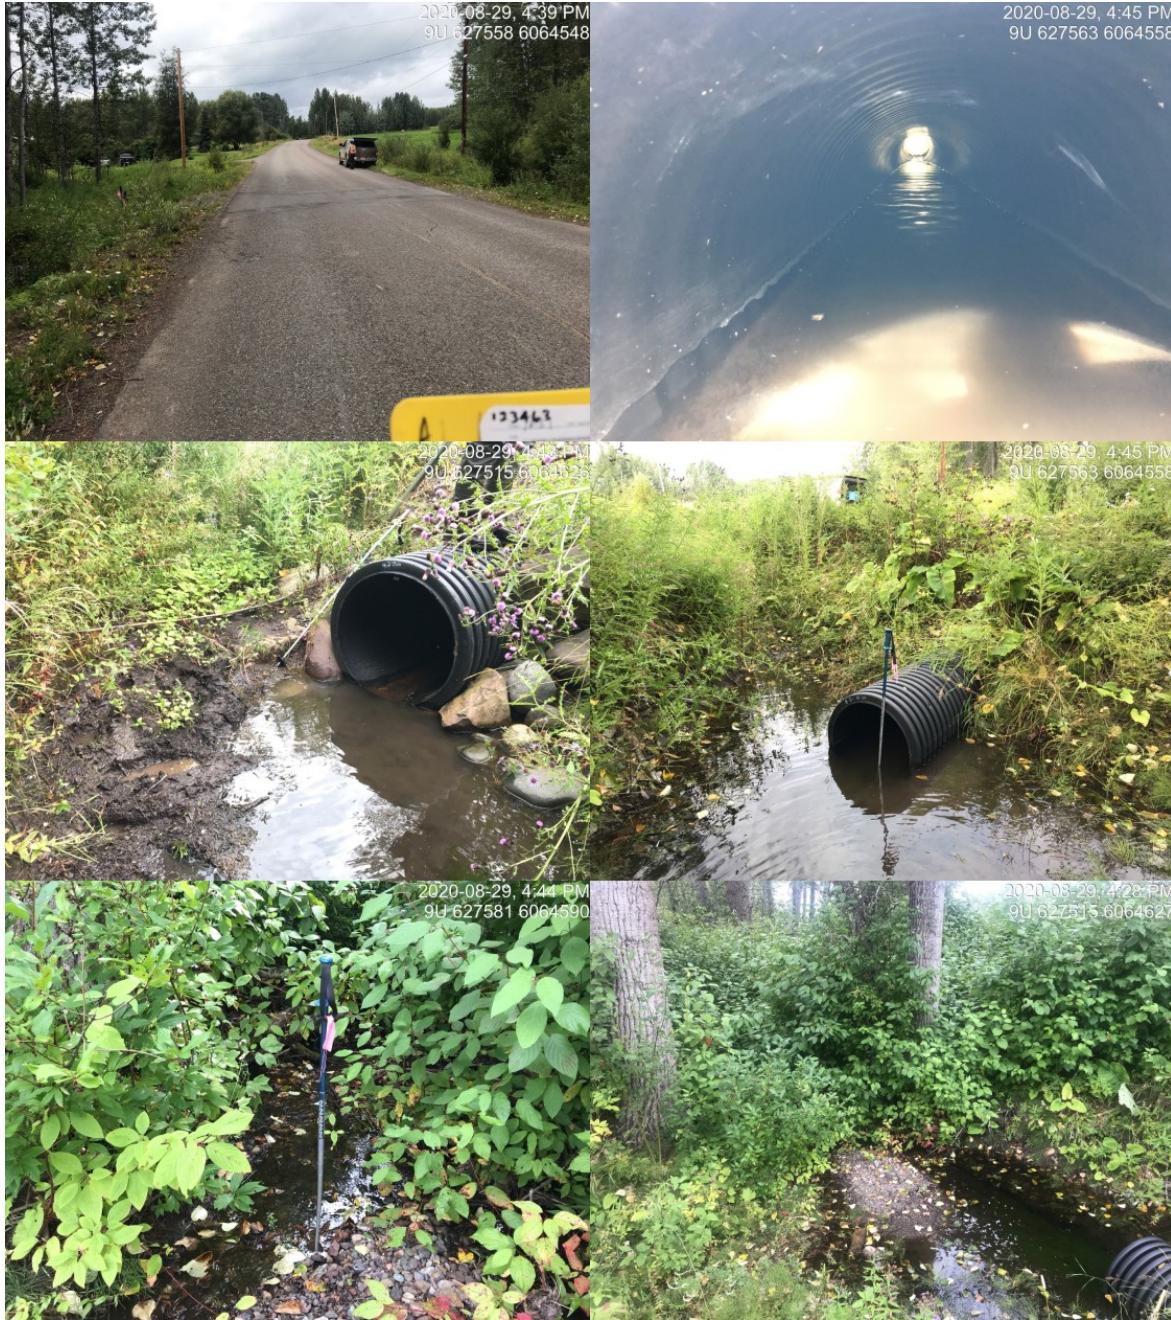
Comments: No habitat confirmation conducted in 2020. Newly replaced crossing. ID# 8 21 18 01 .

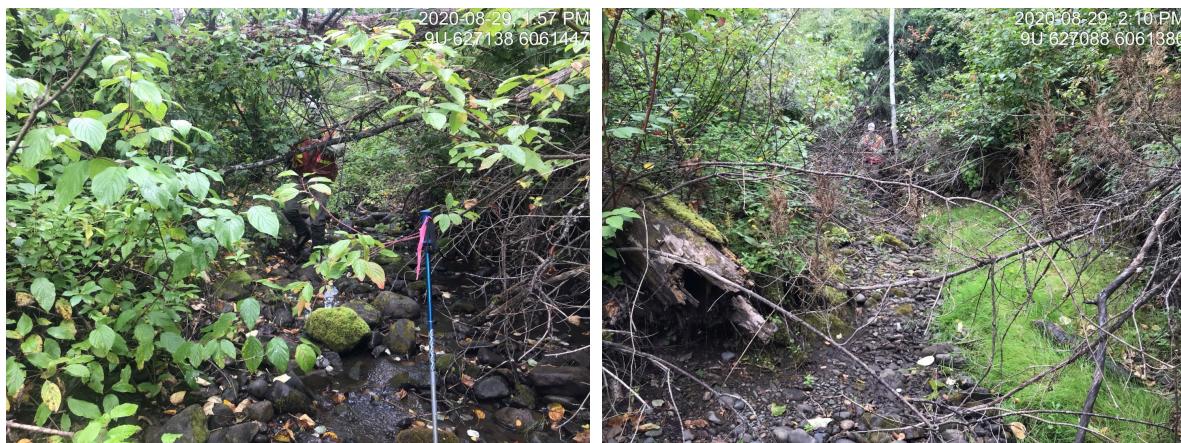
Figure 5.6: Left: Typical habitat downstream of PSCIS crossing 123445. Right: Typical habitat downstream of PSCIS crossing 123445.

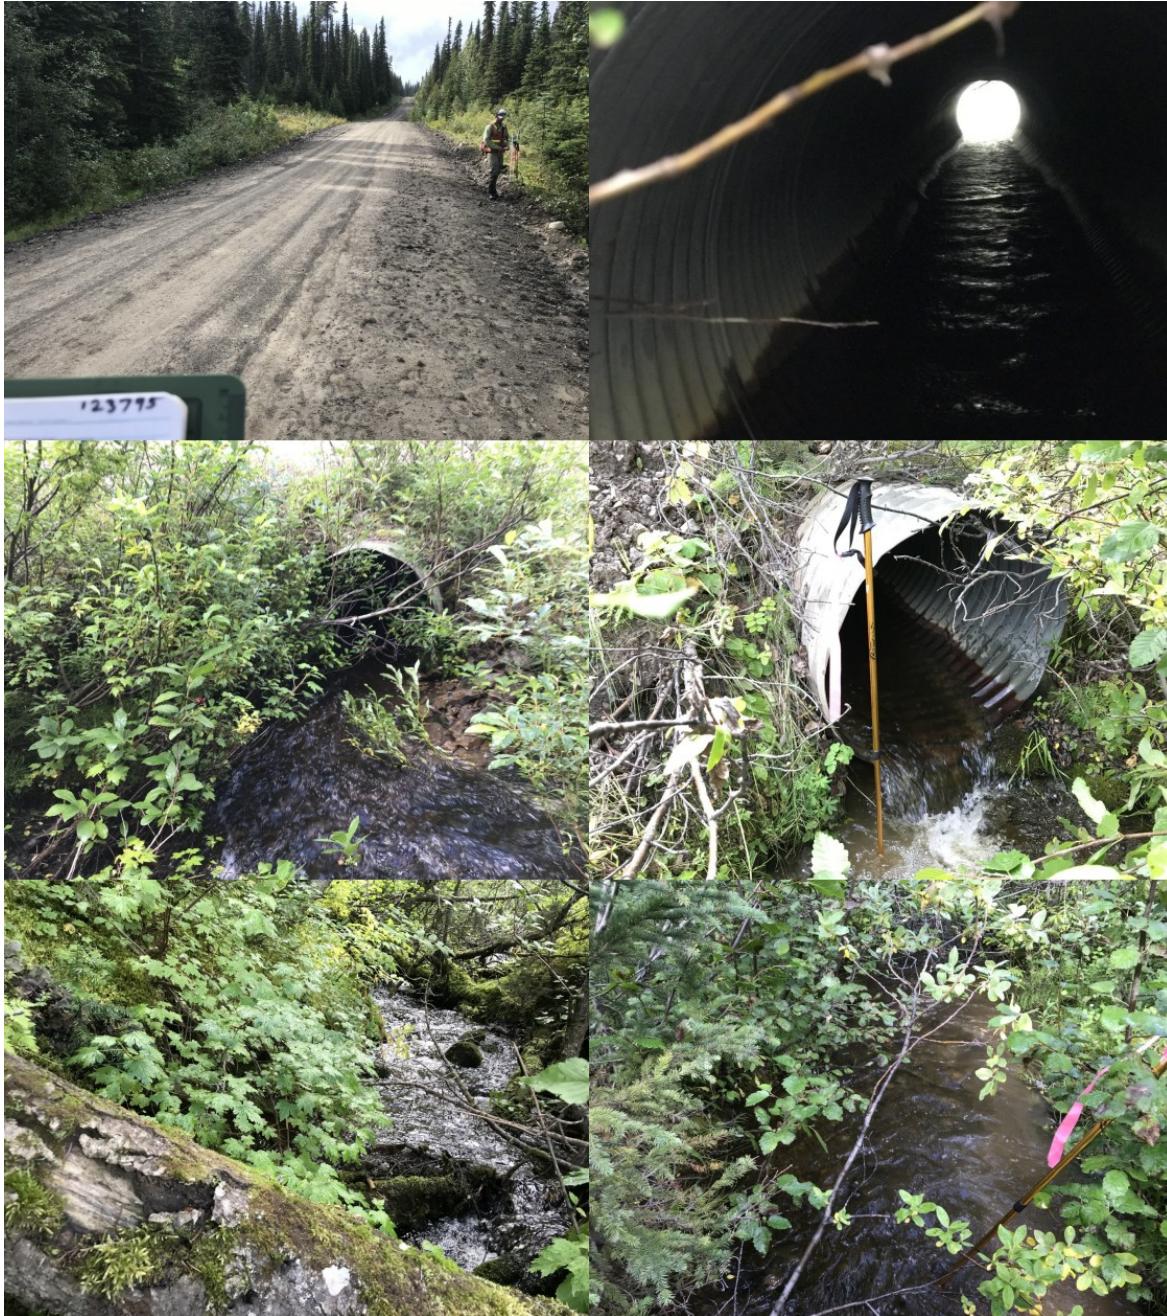
Comments: Smaller stream with good flow. Salmon point (juvenile) noted upstream. Recommend sampling upstream and downstream and habitat assessment of stream at associated PSCIS crossing 123785.

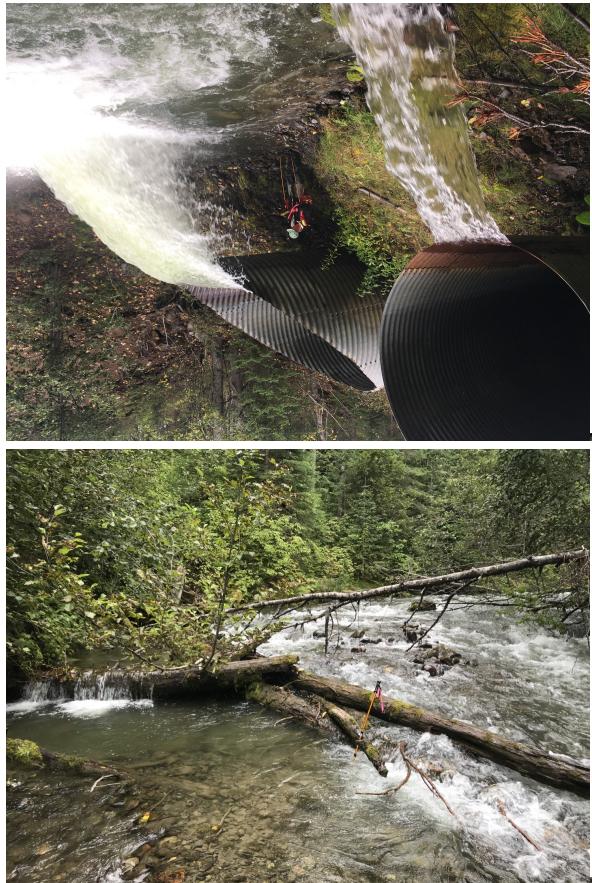
Comments: Unpassable to all life stages and species. Fill depth is approximately 35m. Salomid (50cm) observed trying to ascend to outlet of main pipe.

Figure 5.13: Left: Outlets of PSCIS crossing 124487. Right: Typical habitat downstream of crossing 124487 below the railway bridge and adjacent to the Bulkley River mainstem.

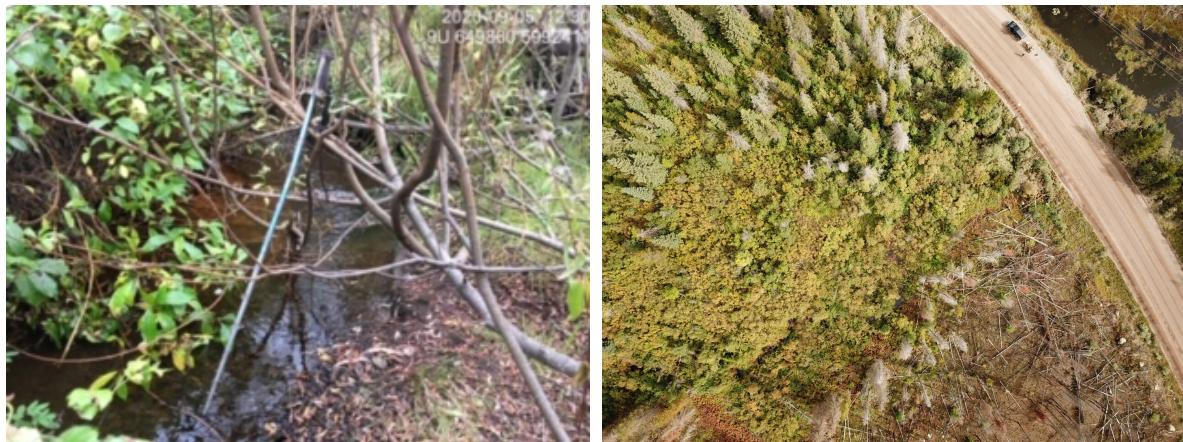
Figure 5.22: Left: Typical habitat downstream of PSCIS crossing 197360. Right: Aerial view of typical habitat downstream of PSCIS crossing 197360.

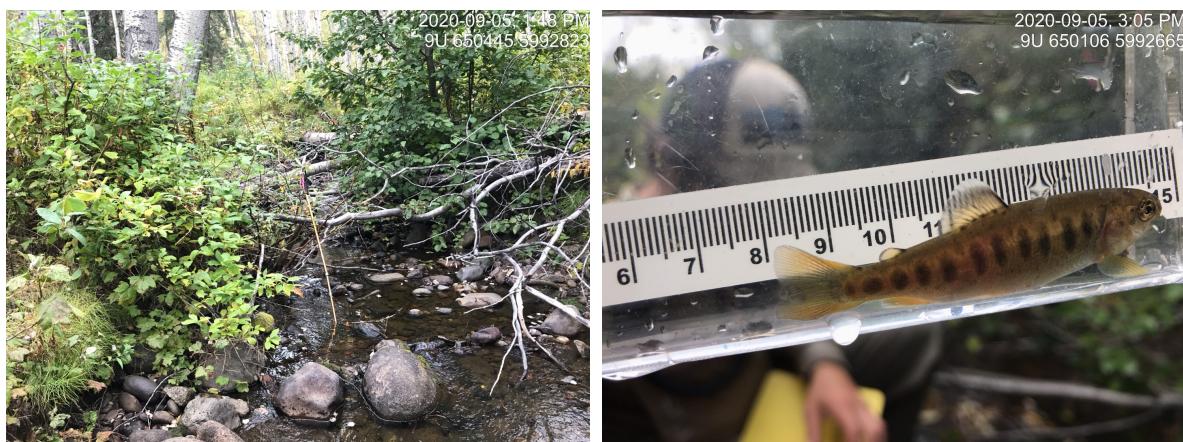
Figure 5.23: Left: Typical habitat upstream of PSCIS crossing 197360. Right: Rainbow trout captured upstream of PSCIS crossing 197360.

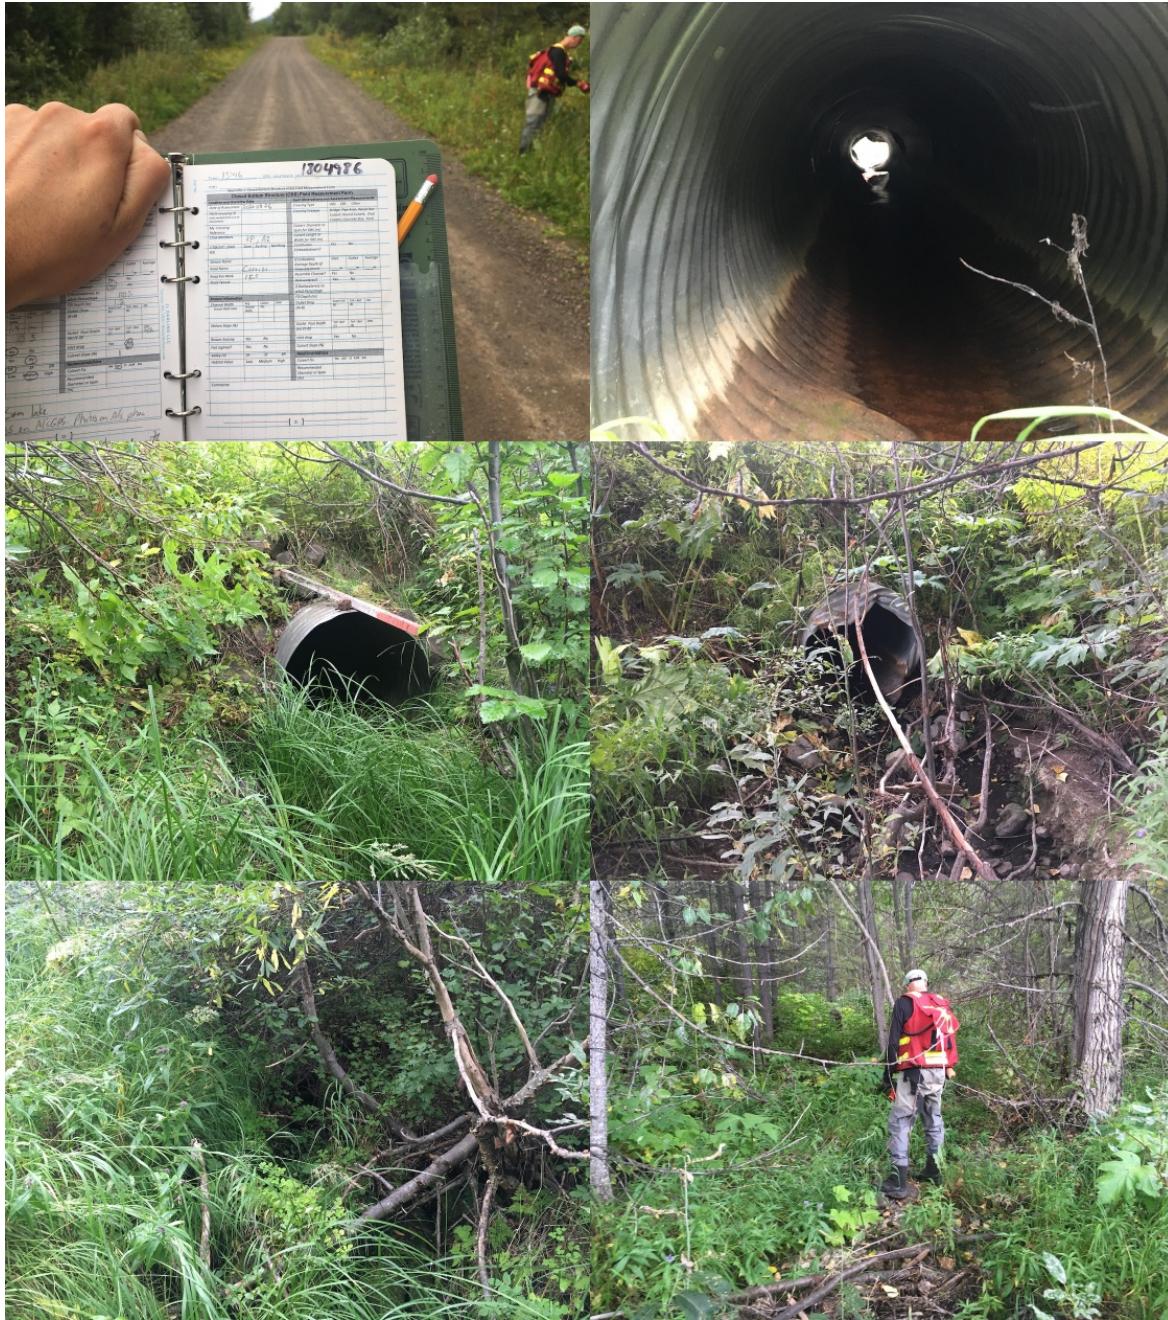
Comments: Suspect no fish. Multiple fish survey sites located downstream. Dry at time of survey.

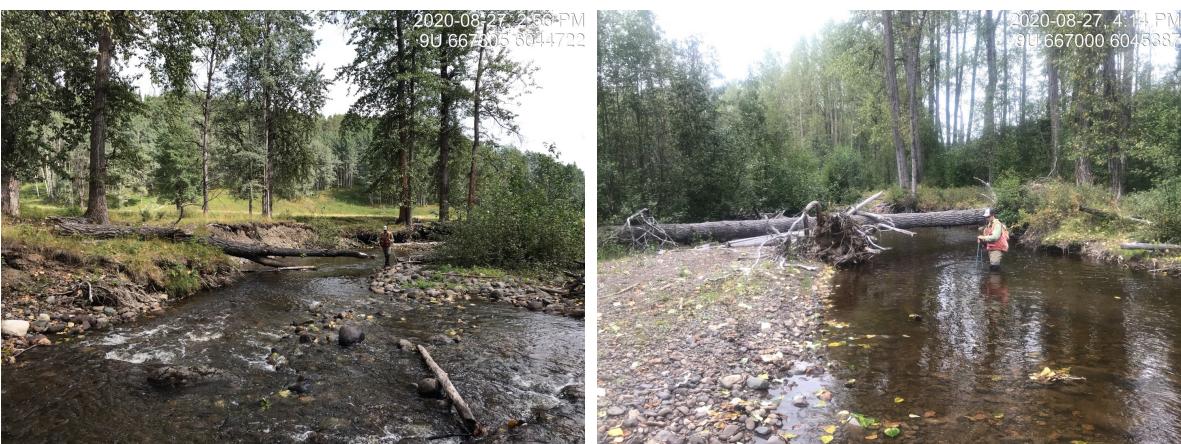
The stream was surveyed upstream from 197658 for 1400m (Figure 5.27). Within the area surveyed, total cover amount was rated as moderate with deep pools dominant. Cover was also present as small woody debris, large woody debris, boulders, undercut banks, and overhanging vegetation (Table 5.45). The average channel width was 12.9m, the average wetted width was 7.9m and the average gradient was 2.1%. The dominant substrate was cobbles with boulders subdominant. Within the area surveyed, riparian areas adjacent to both banks were used as rangeland with several cattle access points on the stream and evidence of understory shrub degradation from cattle grazing. The large stream had high habitat complexity including numerous pools up to 2m deep and frequent glide sections to 1m deep throughout. There were extensive areas of gravel suitable for spawning for resident and anadromous salmonid species. Habitat value was rated as high for resident and anadromous salmonid rearing and spawning.

Figure 5.27: Left: habitat upstream of PSCIS crossing 197658. Right: Habitat upstream of PSCIS crossing 197658.

Structure replacement with a bridge (15.1m span) is recommended to provide access to the habitat located upstream of PSCIS crossing 197658. The cost of the work is estimated at \$7,550,000 for a cost benefit of 0.8 linear m/\$1000 and $10.3\text{m}^2/\$1000$.

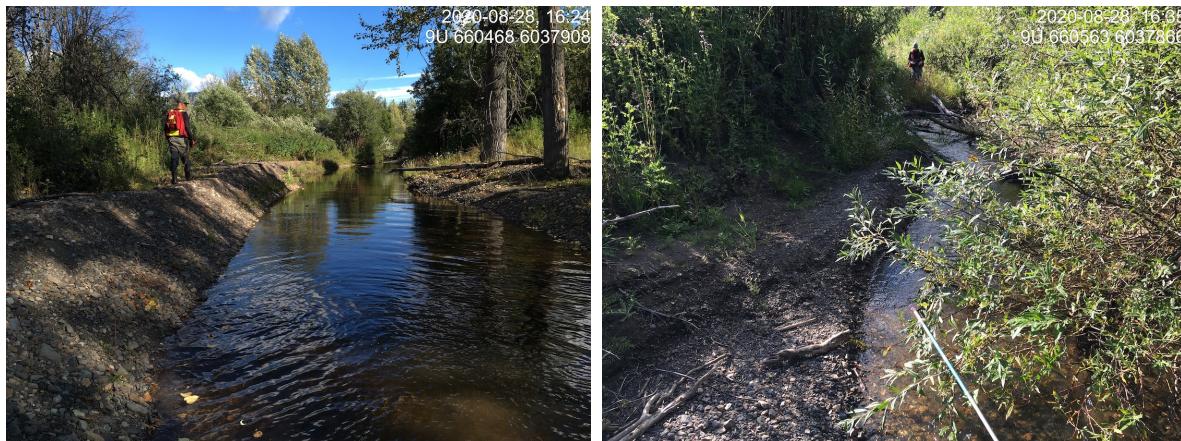
Figure 5.37: Left: Typical habitat downstream of PSCIS crossing 197664. Right: Typical habitat downstream of PSCIS crossing 197664.

Costs to replace 197665 and 197664 with bridges are estimated at \$5,000,000 per crossing. Structure replacement with an embedded culvert is recommended for 3042 (streambed simulation - 3m span) with an estimated cost of \$25,000 resulting in cost benefits of 68 linear m/\$1000 and 156.4m²/\$1000.

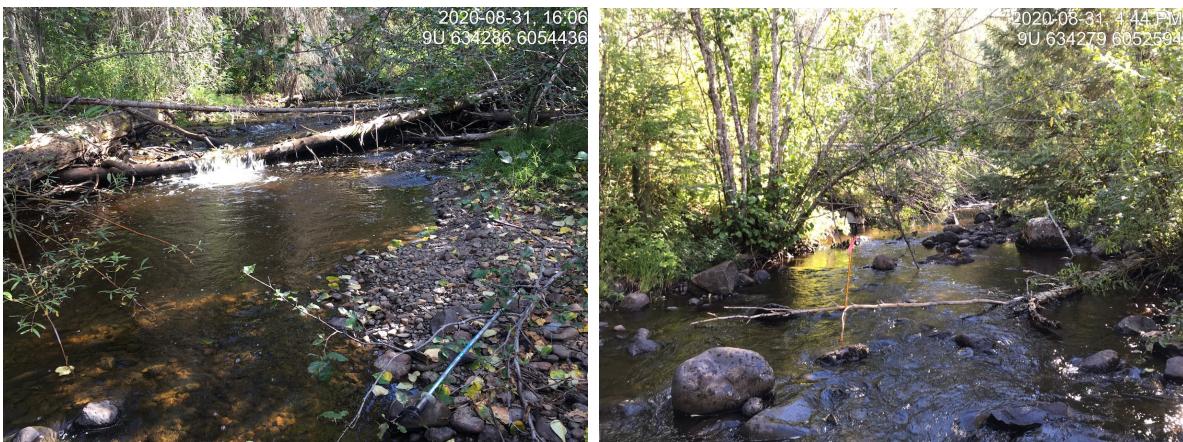
Coffin Creek was surveyed upstream from 124504 for 415m and again upstream approximately 2.2km at a powerline ford crossing (Figure [5.44](#)). Within the area surveyed, total cover amount was rated as moderate with undercut banks dominant. Cover was also present as small woody debris, large woody debris, boulders, deep pools, and overhanging vegetation (Table [5.71](#)). The average channel width was 5.8m, the average wetted width was 3.5m and the average gradient was 2.3%. The stream in the areas surveyed was noted as having high complexity with occasional patches of gravels suitable for spawning present. Habitat value was rated as high for younger life stages of resident and anadromous salmonid rearing and resident adult salmonid spawning.

Figure 5.44: Left: Habitat upstream of PSCIS crossing 124504. Right: Habitat 2.1km upstream of PSCIS crossing 124504.
