## DRAFT - Bulkley River and Morice River Watershed Groups Fish Passage Restoration Planning

Prepared for  
Habitat Conservation Trust Fund  
BC Fish Passage Remediation Program  
Canadian Wildlife Federation

Prepared by  
Al Irvine, B.Sc., R.P.Bio.  
New Graph Environment  
6 Regent St  
Nelson, BC V1L 2P1

DRaFT - Version 0.0.1  
2021-02-24

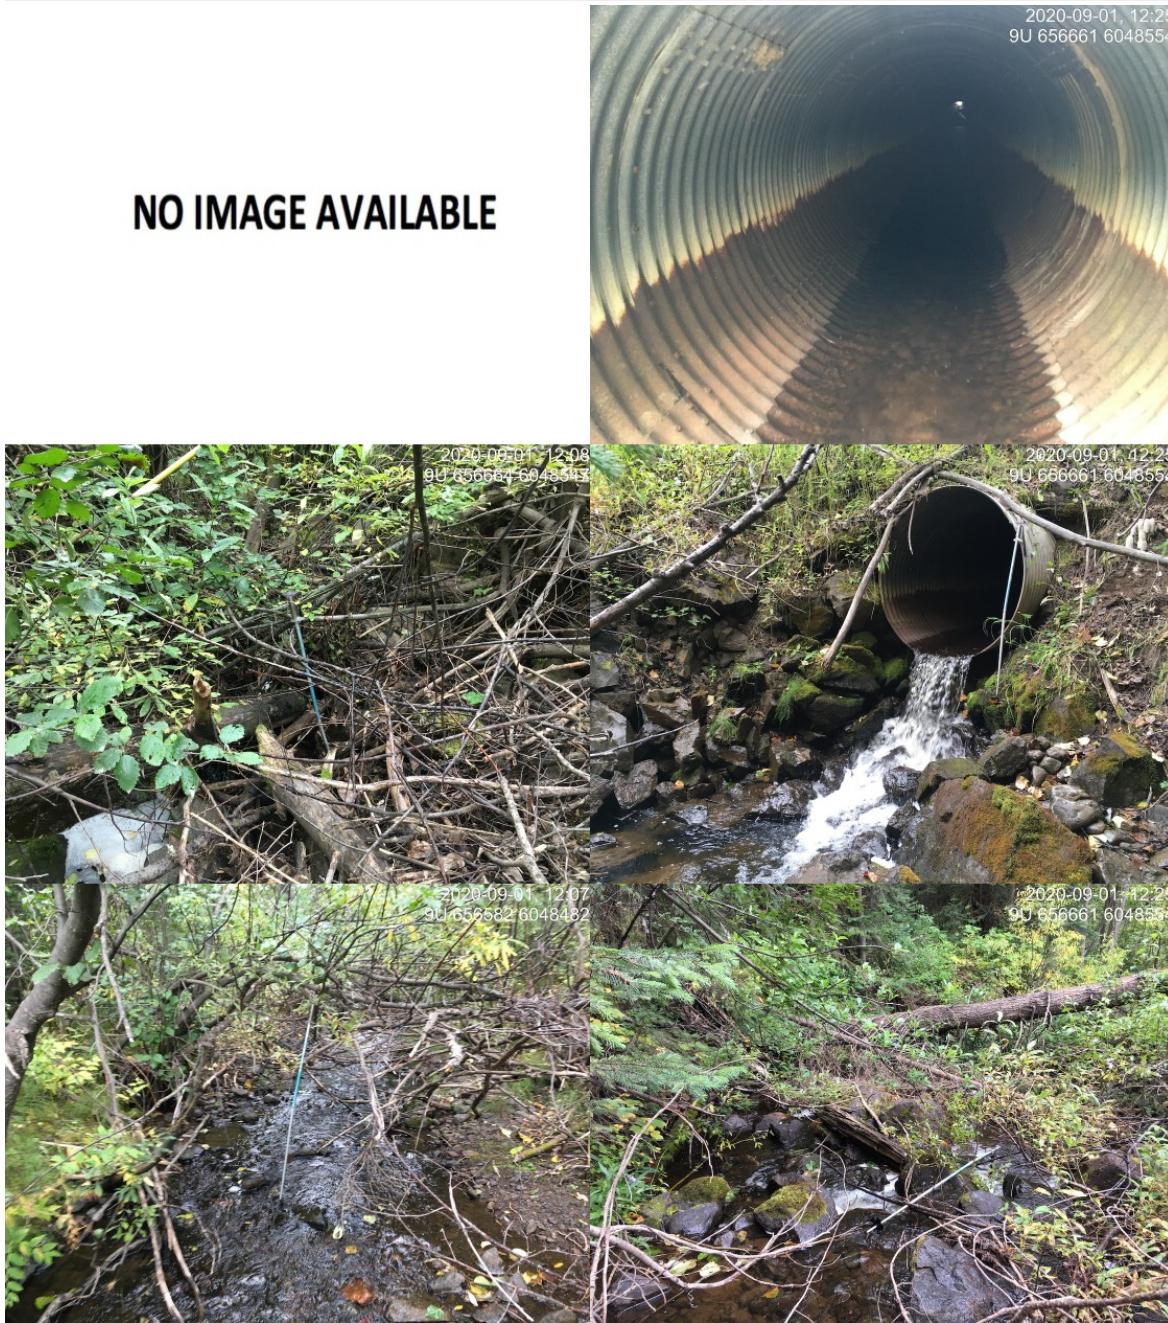
Comments: Inlet plugged with small and large woody debris. Fry and juvenile fish observed upstream.

Replacement of PSCIS crossing 3139 with a bridge (13m span) is recommended. The cost of the work is estimated at \$162,000 for a cost benefit of 45.1 linear m/\$1000 and 148.7m<sup>2</sup>/\$1000.

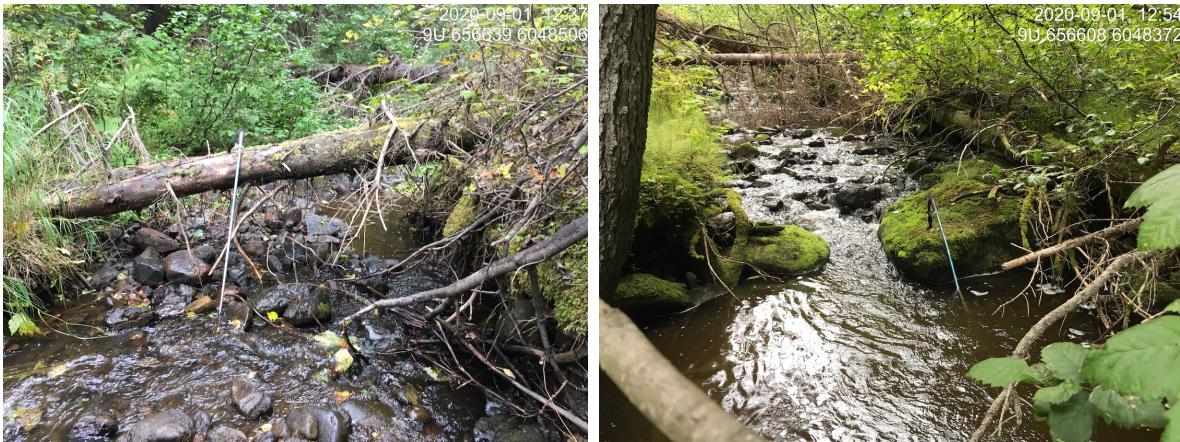
Figure 5.1: Left: Habitat downstream of PSCIS crossing 3139. Right: Habitat downstream of crossing 3139.

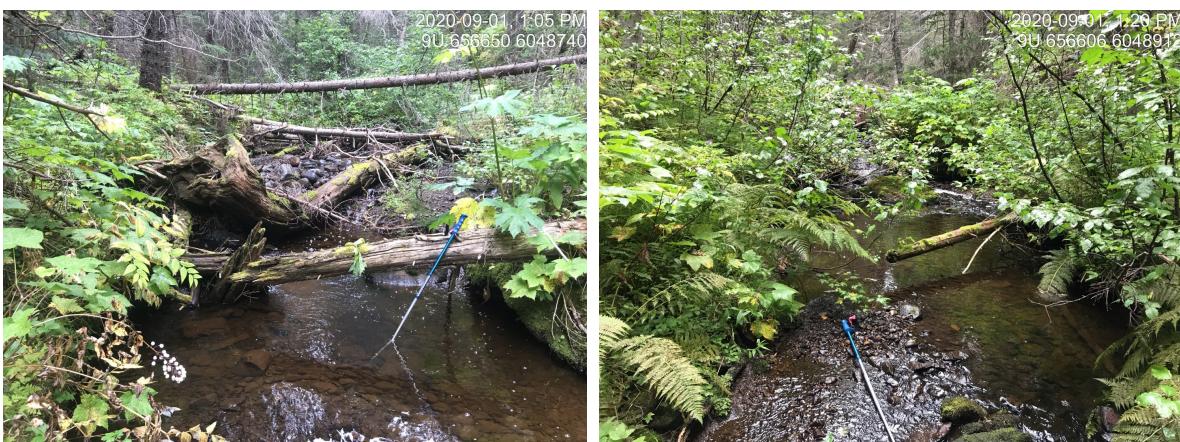
Figure 5.2: Left: Habitat upstream of PSCIS crossing 3139. Right: Habitat upstream of PSCIS crossing 3139.

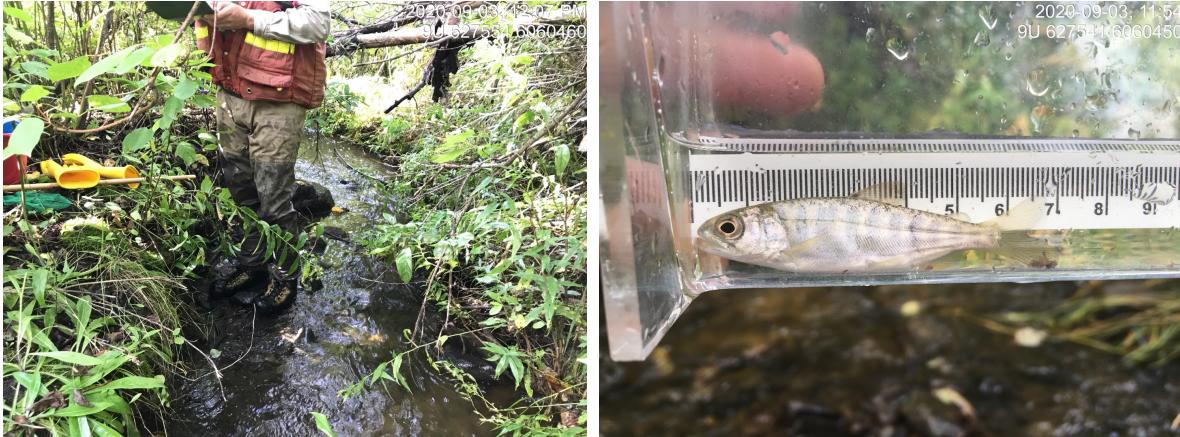
Figure 5.3: Left: Typical habitat downstream of PSCIS crossing 58159. Right: Chinook captured downstream of PSCIS crossing 58159.

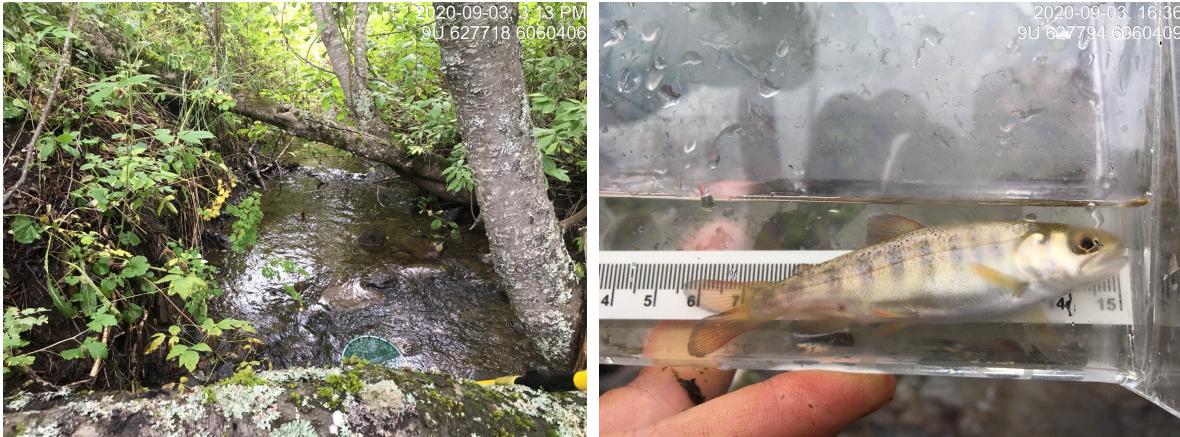
Figure 5.4: Left: Typical habitat upstream of PSCIS crossing 58159. Right: Coho captured upstream of PSCIS crossing 58159.

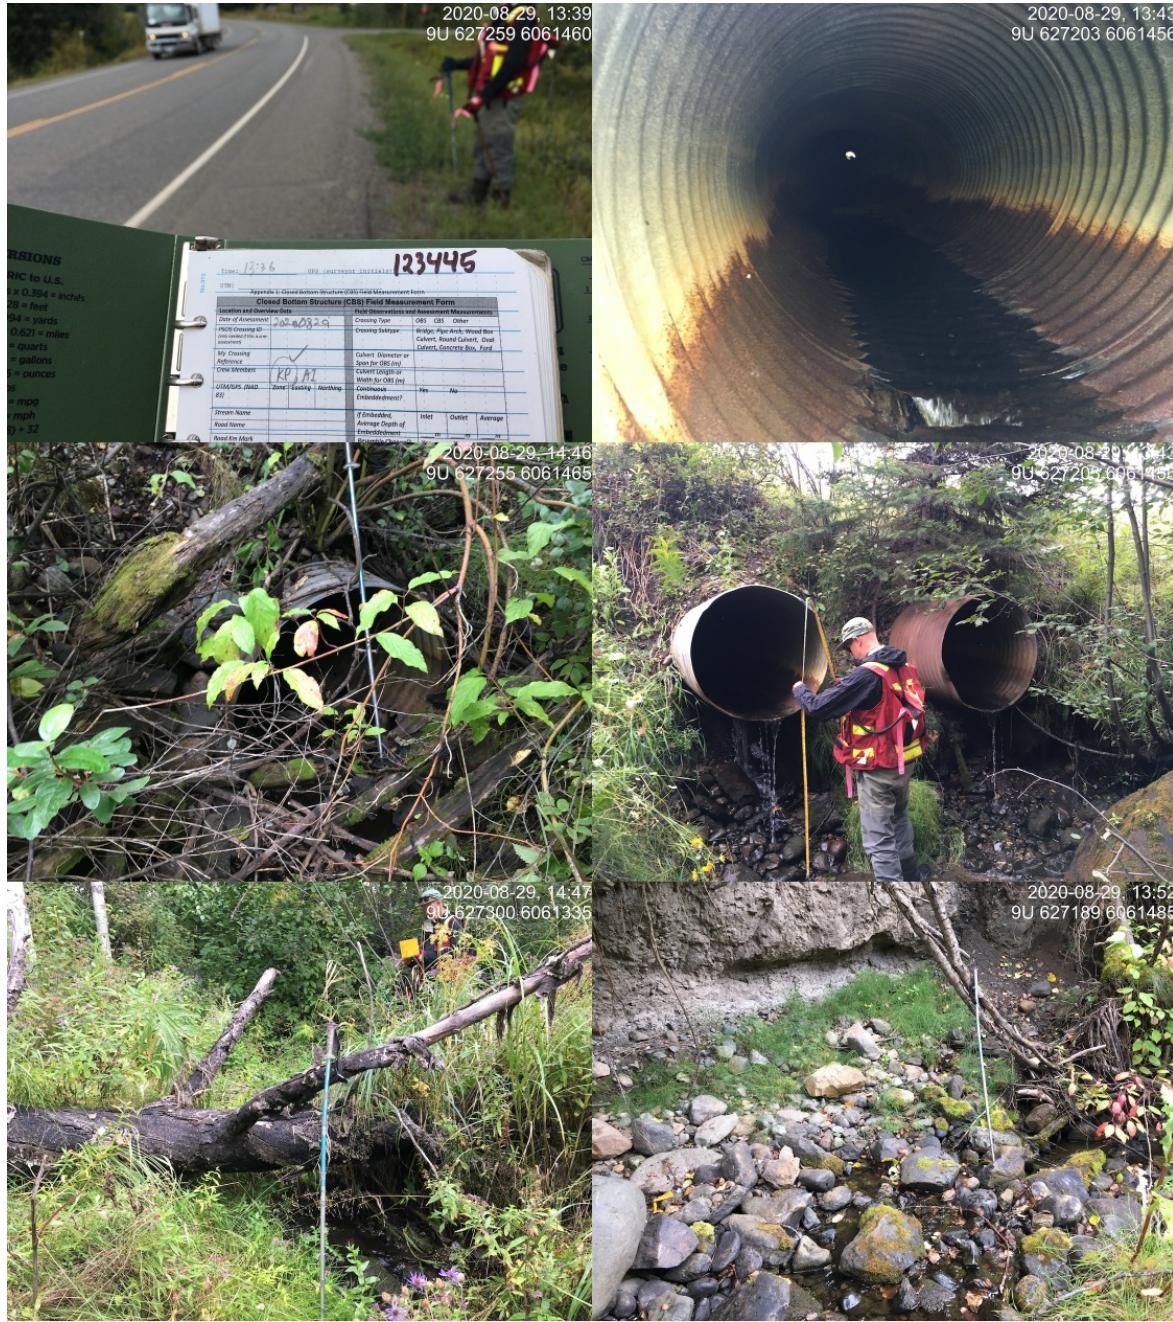
Table 5.9: Summary of fish passage assessment for PSCIS crossing 123446.

Comments: Important migration corridor to Tyee Lake. Large outlet drop seems unlikely passable by any life stage or species.

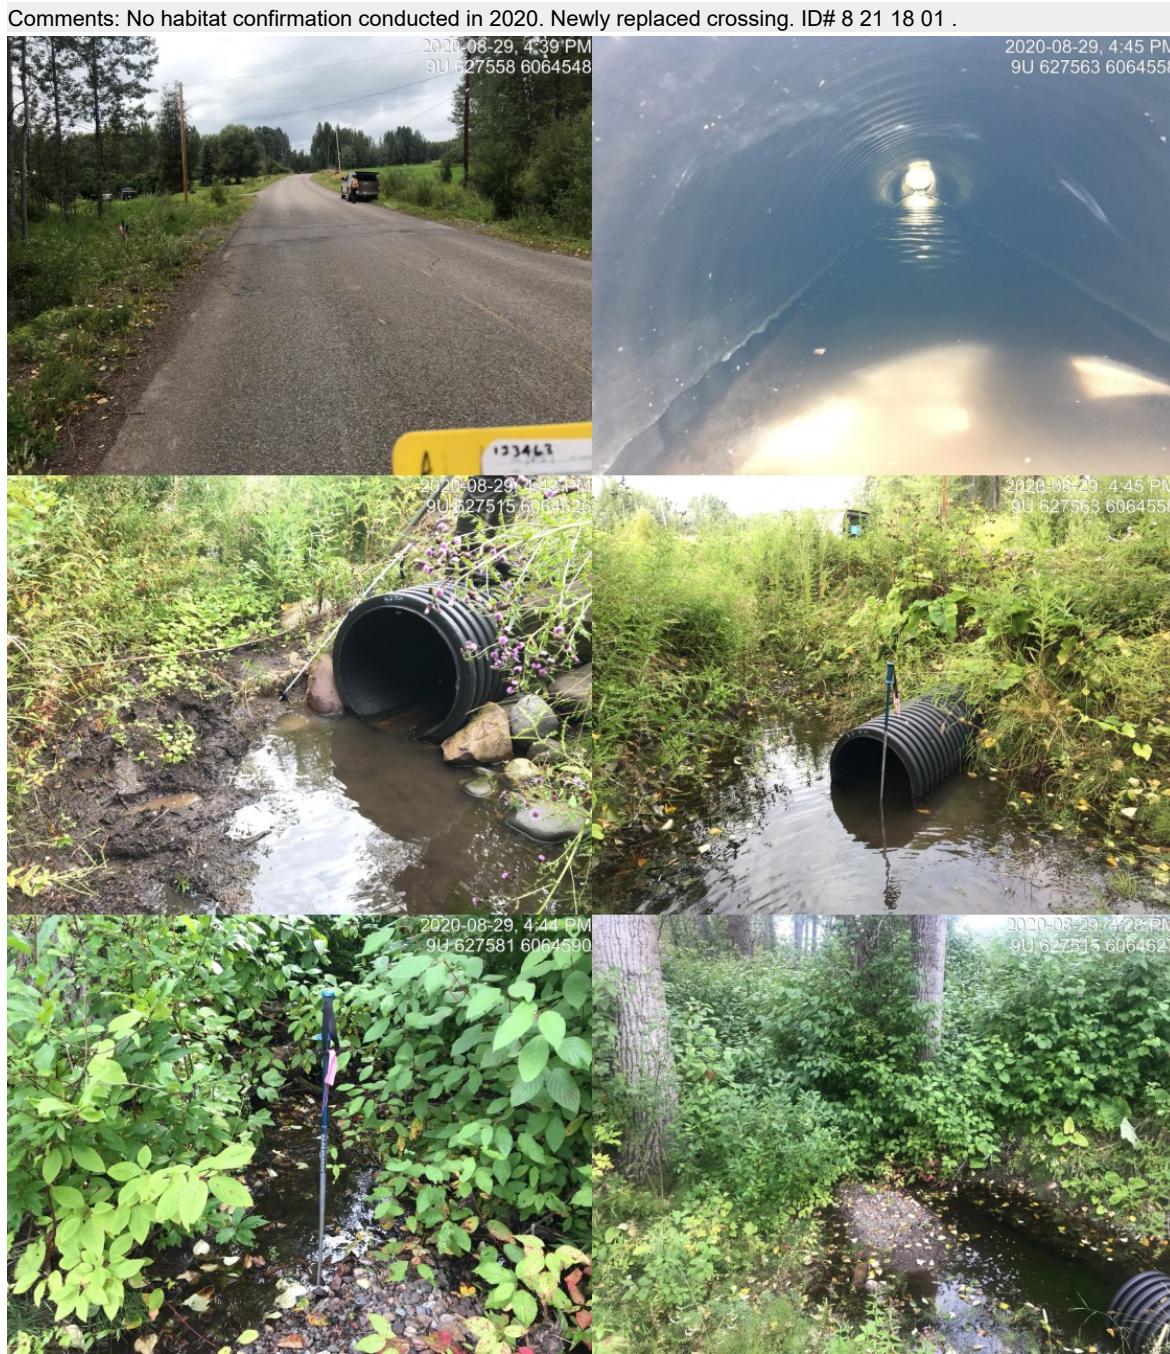
Date	2020-08-29	Crossing Sub Type	Round Culvert
PSCIS ID	123463	Diameter (m)	0.6
External ID	-	Length (m)	18
Crew	AI, KP	Embedded	No
UTM Zone	9	Depth Embedded (m)	-
Easting	627570	Resemble Channel	No
Northing	6064562	Backwatered	Yes
Stream	Victor Creek	Percent Backwatered	30
Road	Tyee Lake Road	Fill Depth (m)	1
Road Tenure	MoTi local	Outlet Drop (m)	0
Channel Width (m)	1.8	Outlet Pool Depth (m)	0.3
Stream Slope (%)	1	Inlet Drop	No
Beaver Activity	No	Slope (%)	3
Habitat Value	Medium	Valley Fill	Deep Fill
Final score	29	Barrier Result	Barrier
Fix type	Replace Structure with Streambed Simulation CBS	Fix Span / Diameter	5

Photos: From top left clockwise: Road/Site Card, Barrel, Outlet, Downstream, Upstream, Inlet.

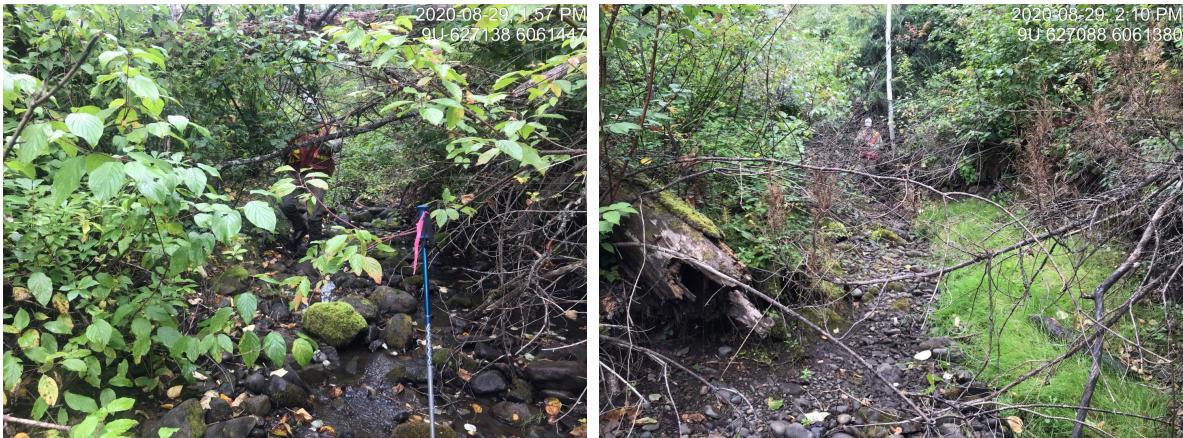
Figure 5.6: Left: Typical habitat downstream of PSCIS crossing 123445. Right: Typical habitat downstream of PSCIS crossing 123445.

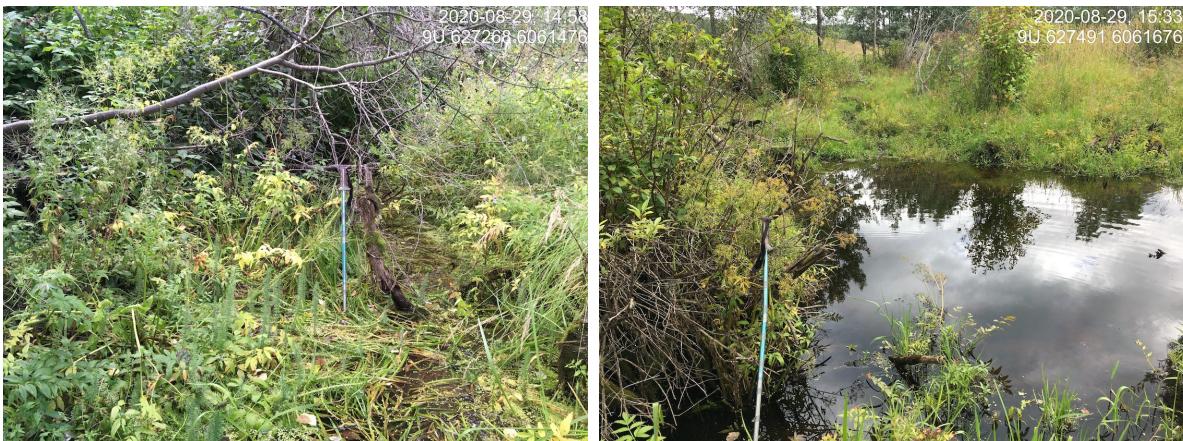
Figure 5.7: Left: Habitat upstream of PSCIS crossing 123445. Right: Habitat upstream of PSCIS crossing 123445.

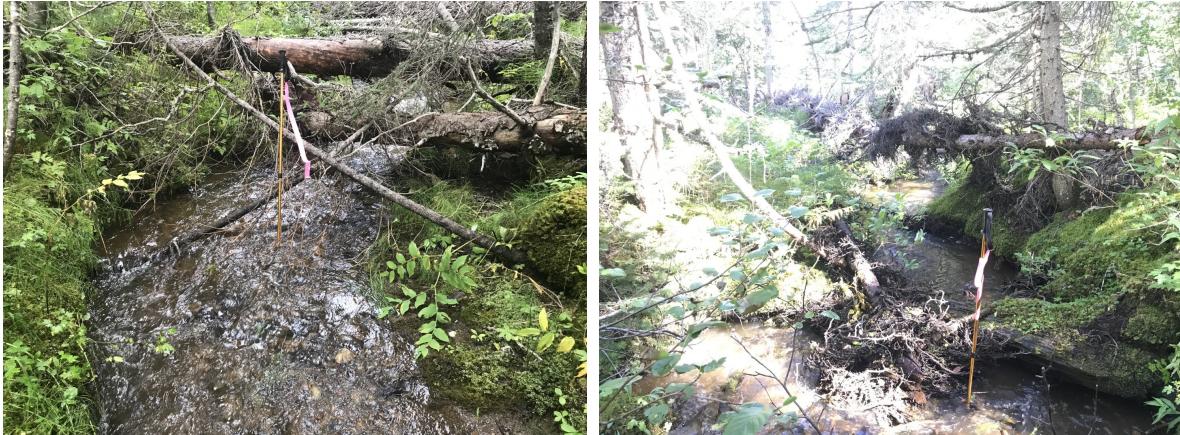
Figure 5.9: Left: Habitat downstream of PSCIS crossing 123794. Right: Habitat downstream of crossing 123794.

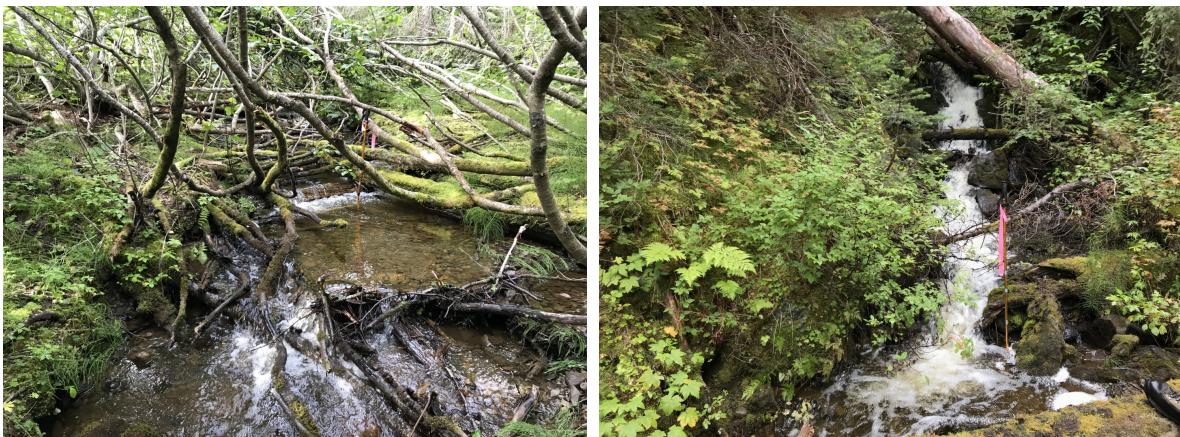
Figure 5.10: Left: Habitat upstream of PSCIS crossing 123794. Right: Cascade upstream of PSCIS crossing 123794.

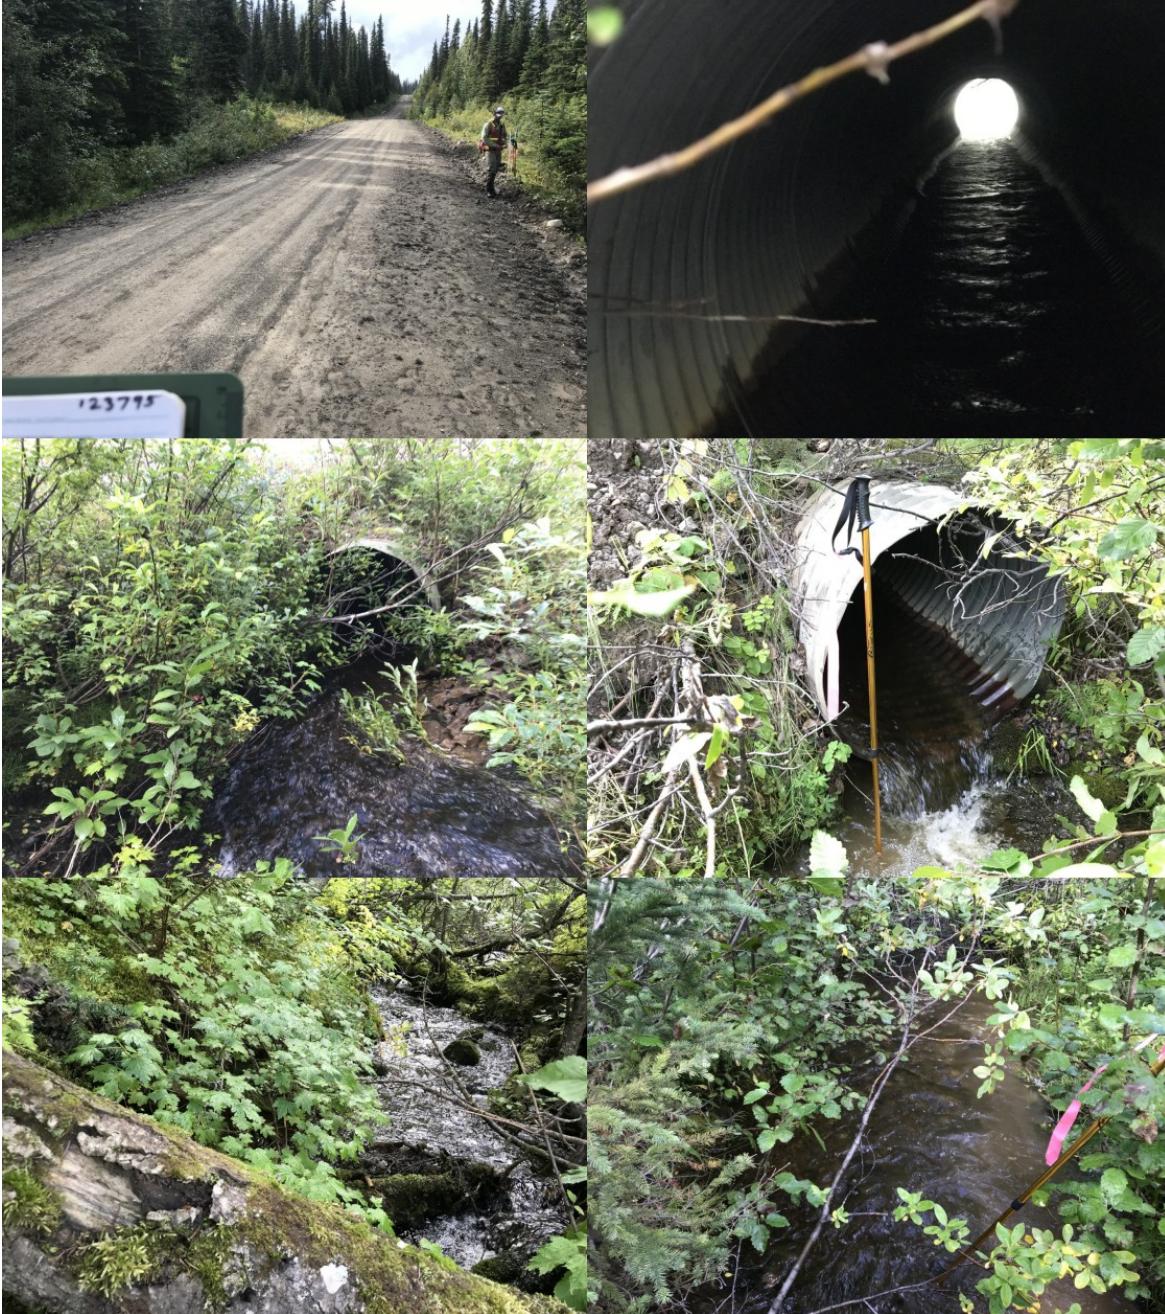
Comments: Smaller stream with good flow. Salmon point (juvenile) noted upstream. Recommend sampling upstream and downstream and habitat assessment of stream at associated PSCIS crossing 123785.

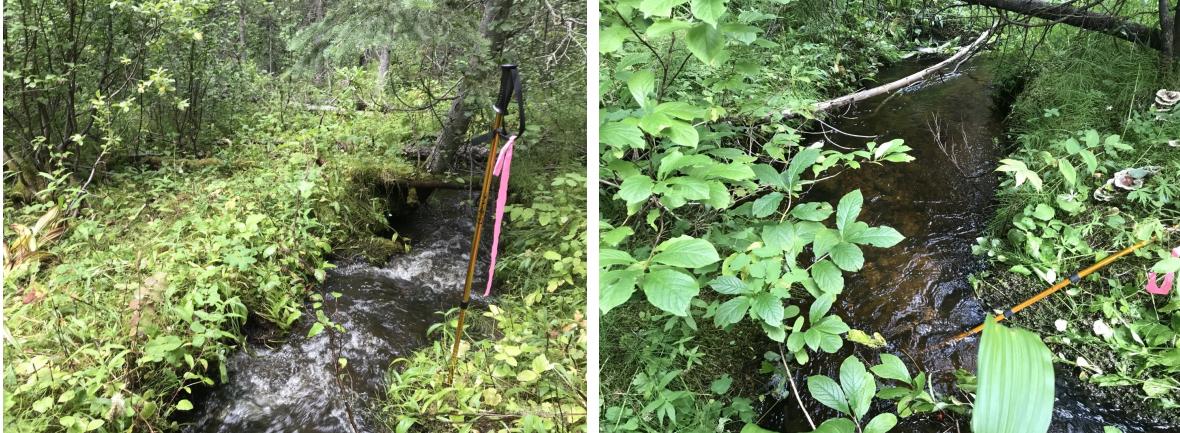
Figure 5.11: Left: Habitat downstream of PSCIS crossing 123795. Right: Habitat downstream of crossing 123795.

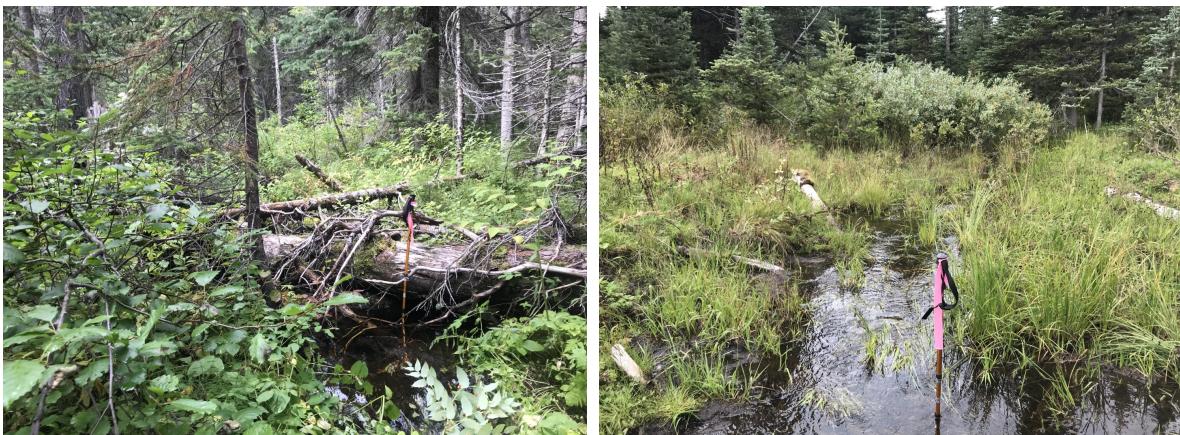
Figure 5.12: Left: Habitat upstream of PSCIS crossing 123795. Right: Cascade upstream of PSCIS crossing 123795.

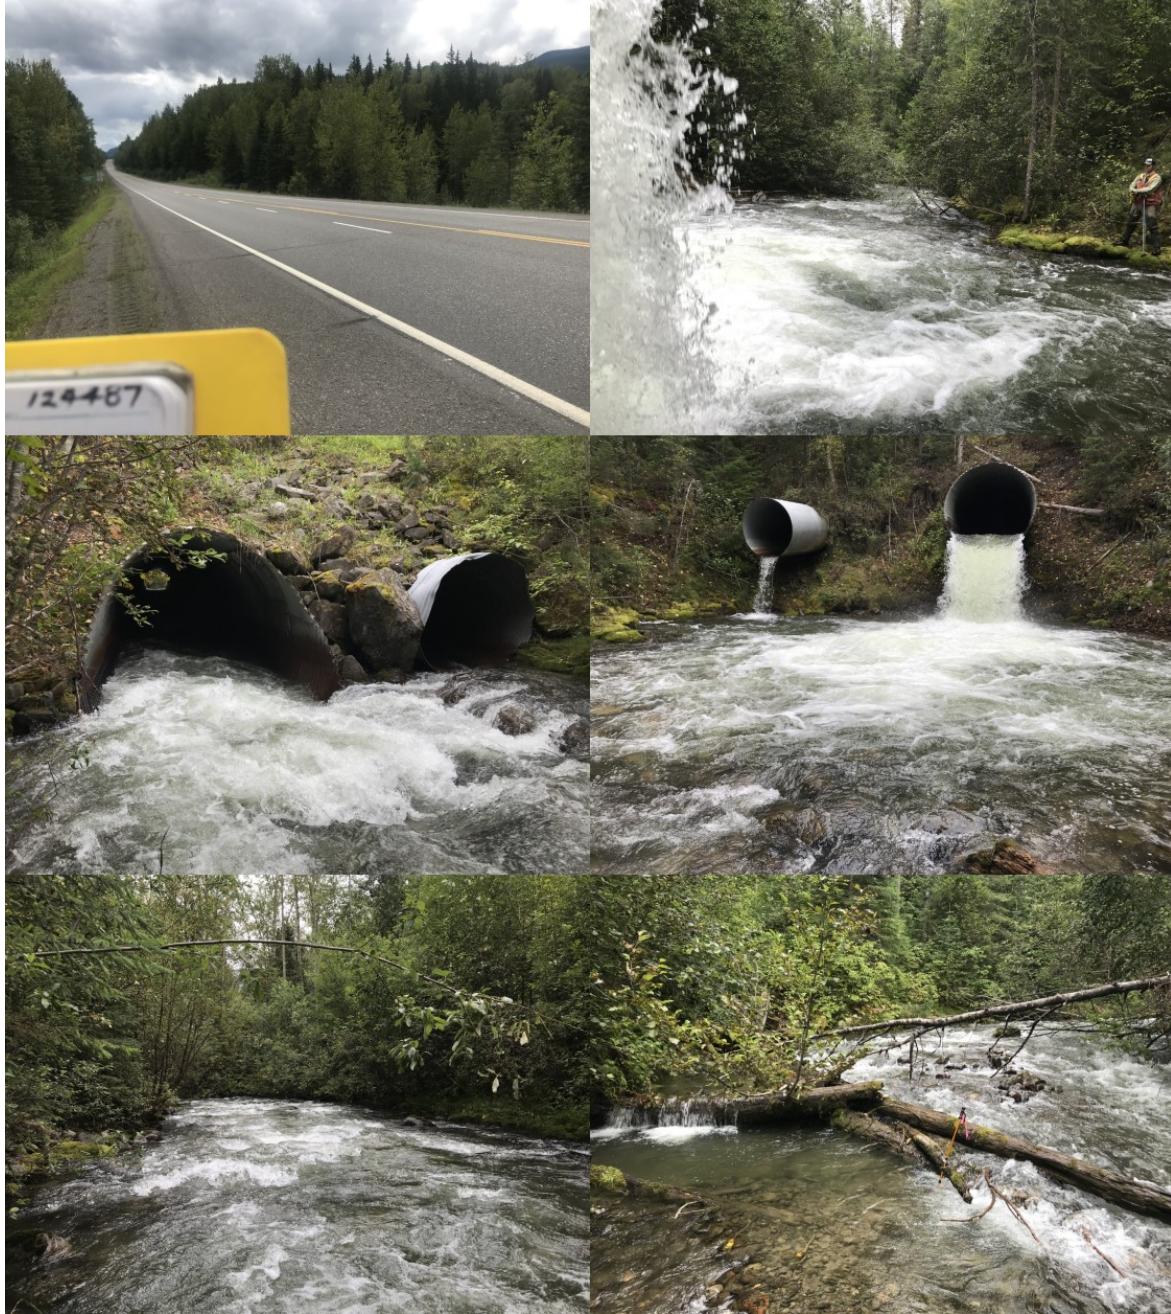
Comments: Unpassable to all life stages and species. Fill depth is approximately 35m. Salomid (50cm) observed trying to ascend to outlet of main pipe.

Photos: From top left clockwise: Road/Site Card, Barrel, Outlet, Downstream, Upstream, Inlet.

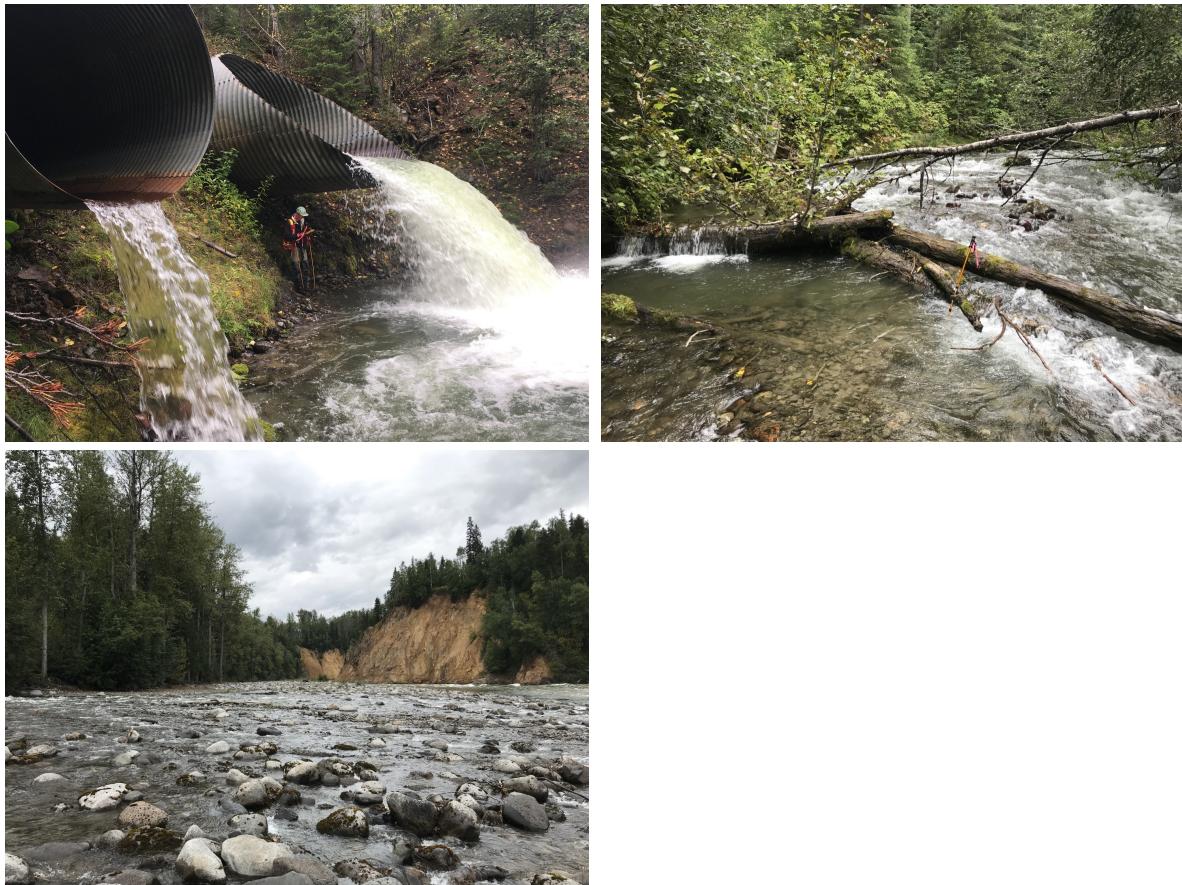
Figure 5.13: Left: Outlets of PSCIS crossing 124487. Right: Typical habitat downstream of crossing 124487 below the railway bridge and adjacent to the Bulkley River mainstem.

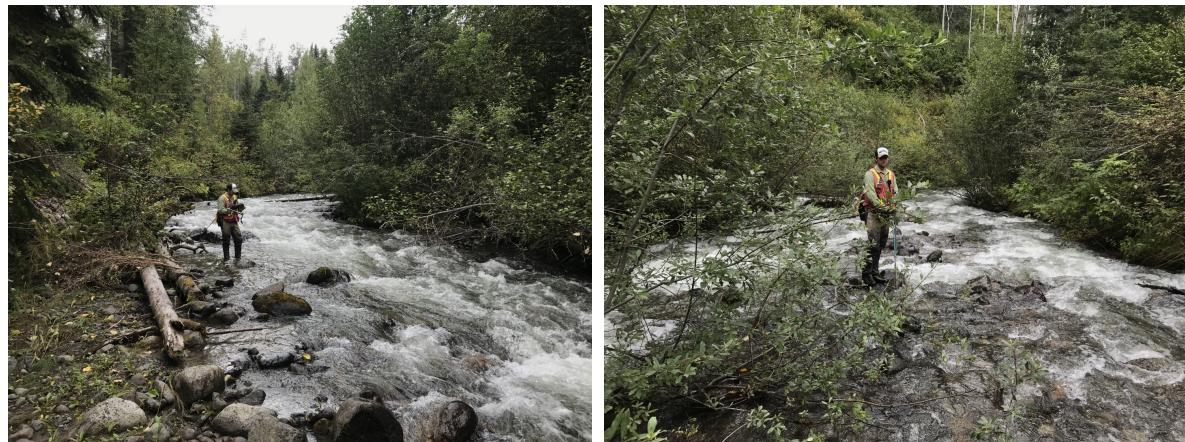
Figure 5.14: Left: habitat upstream of PSCIS crossing 124487. Right: Habitat upstream of PSCIS crossing 124487.

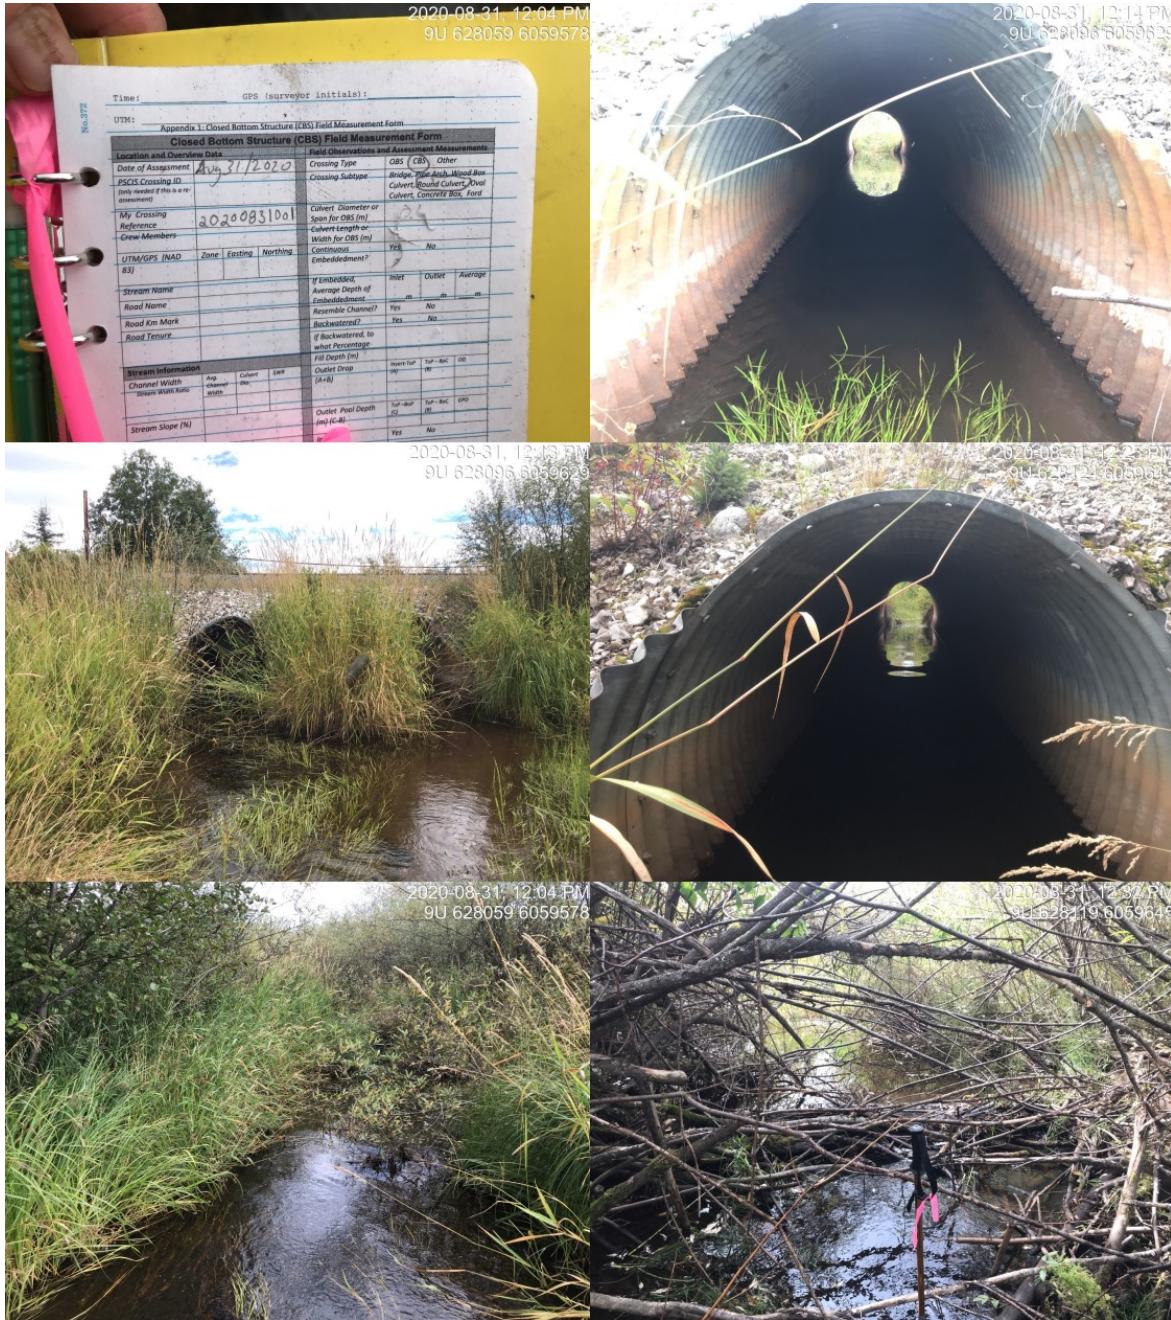
Comments: Passable and fully backwatered structure. Landowner reports that lamprey (~40cm x 20) at crossing inside of the culvert in the past.

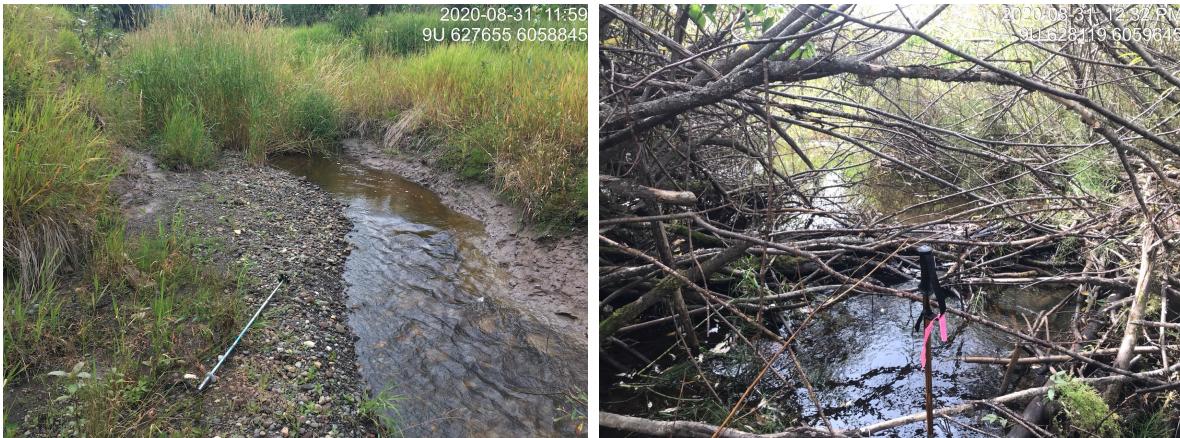
Figure 5.15: Left: Habitat downstream of PSCIS crossing 124500. Right: Habitat downstream of crossing 124500 below the railway culverts.

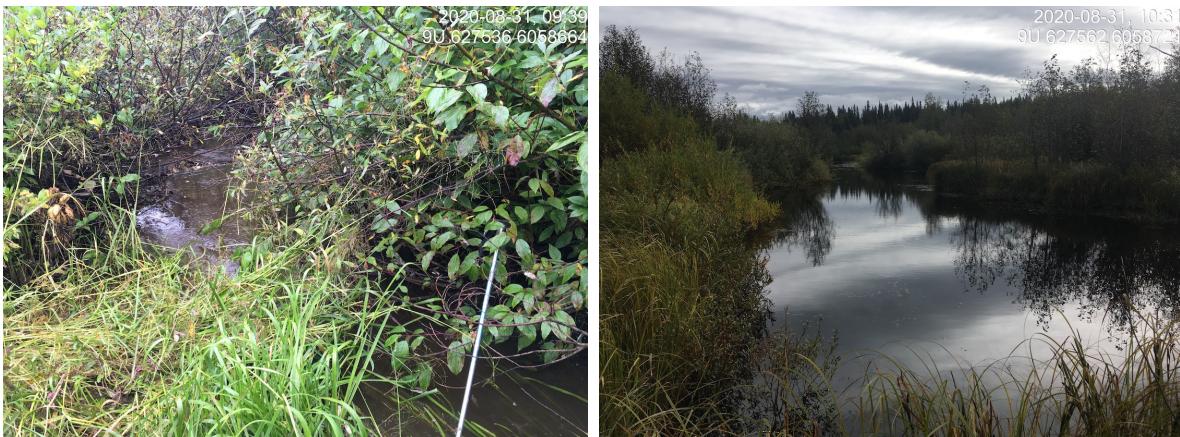
Figure 5.16: Left: Habitat upstream of PSCIS crossing 124500. Right: Habitat upstream of PSCIS crossing 124500.

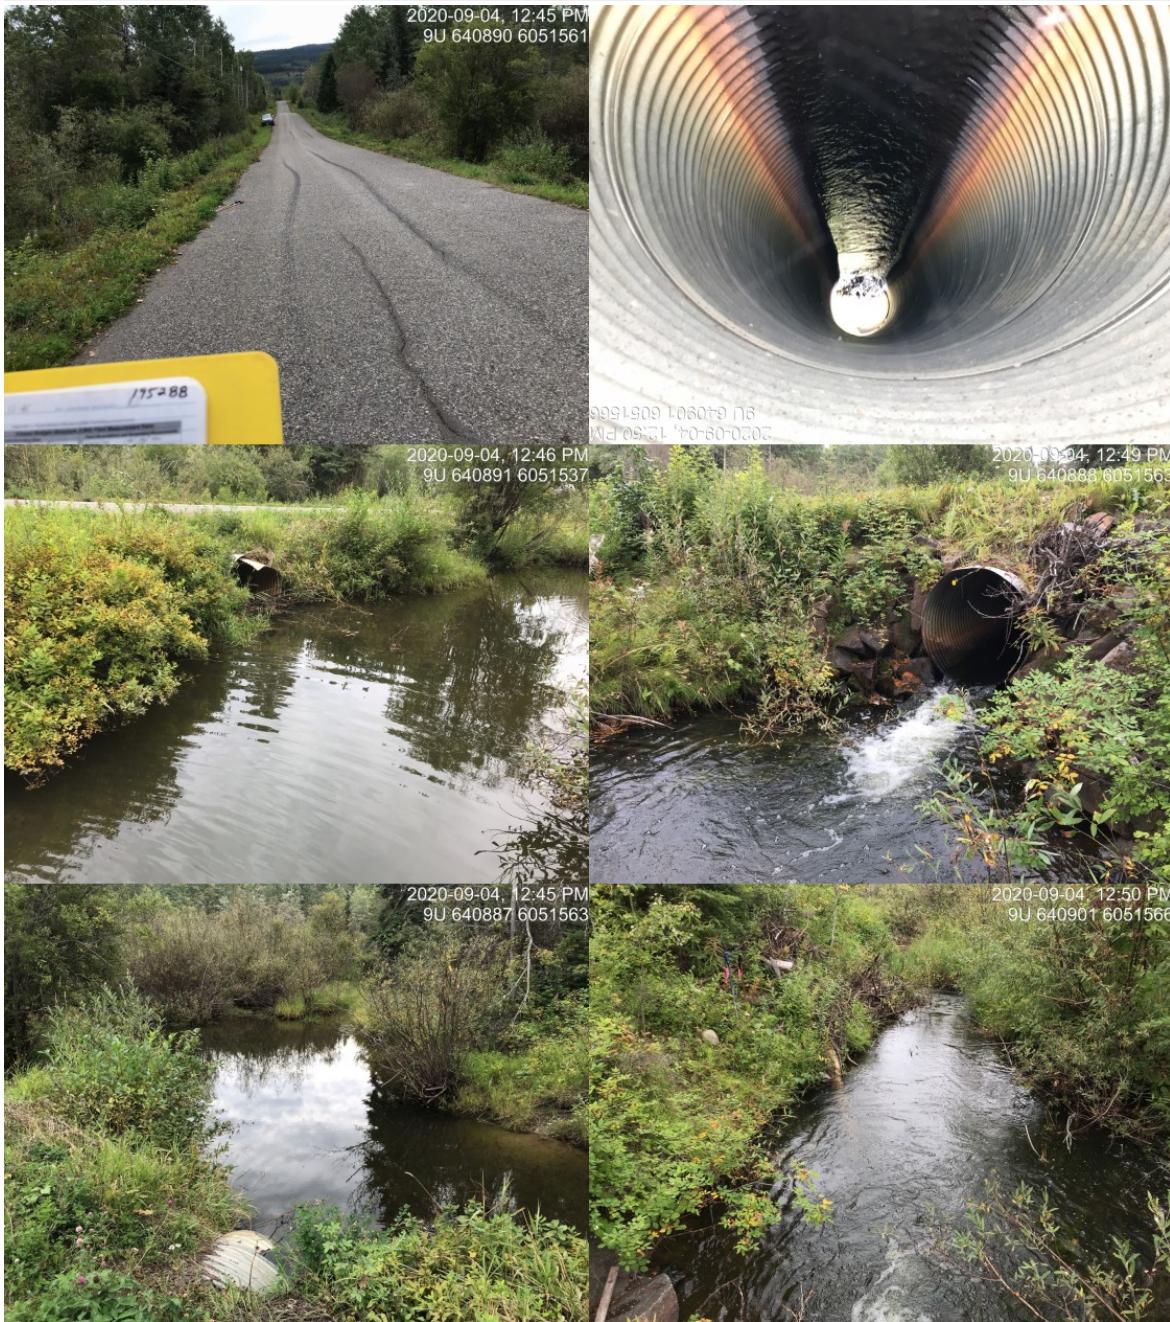
Comments: Wetland type habitat upstream and downstream. Drone flight conducted upstream to map immediate area upstream.

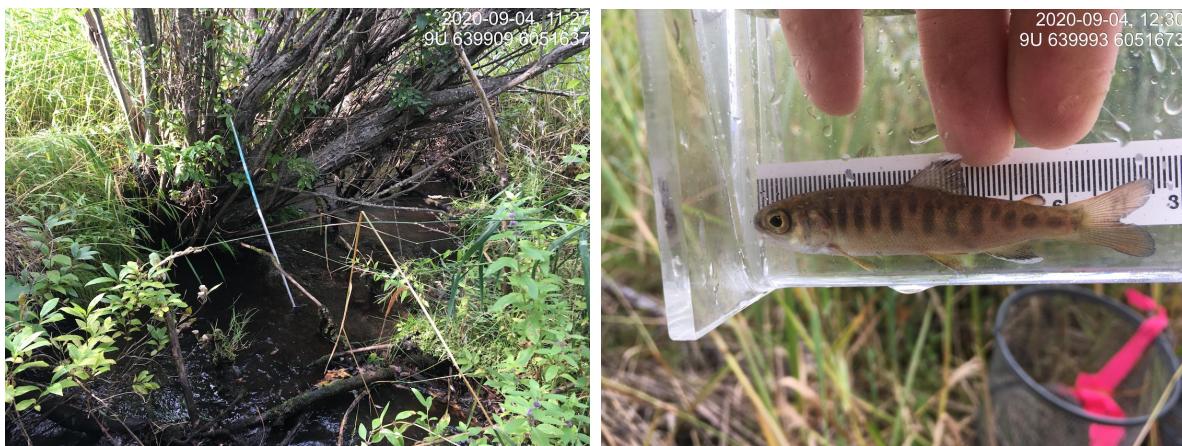
Figure 5.20: Left: Typical habitat downstream of PSCIS crossing 195290. Right: Coho captured downstream of PSCIS crossing 195290.

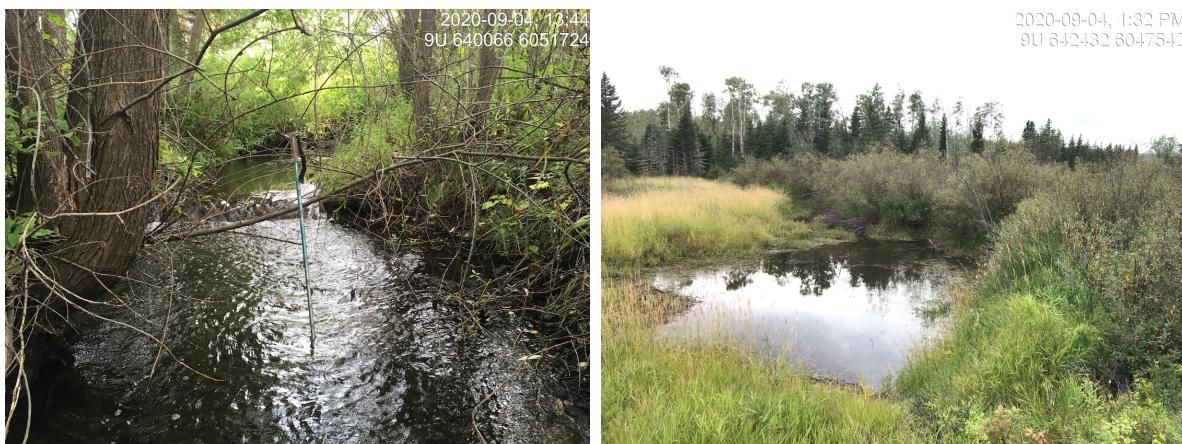
Figure 5.21: Left: Typical habitat upstream of PSCIS crossing 195290. Right: Wetland habitat upstream of PSCIS crossing 195290.

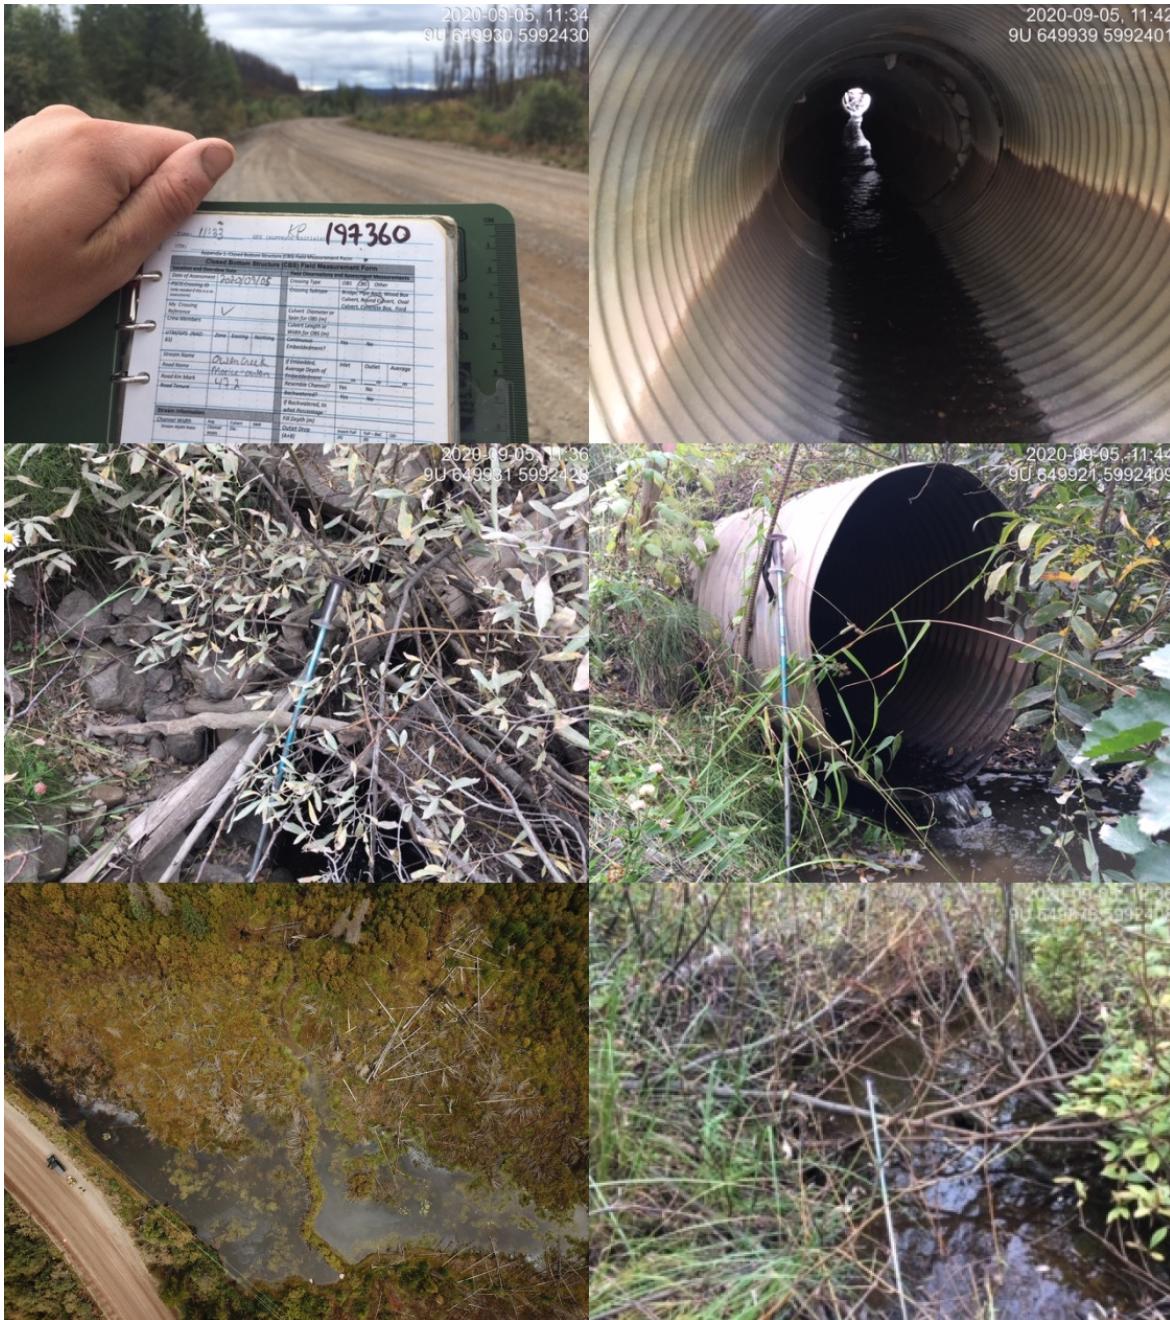
Comments: Wetland type habitat for first 300m upstream then 3m wide channel with cover available in all forms with pools suitable for juvenile RB and CO overwintering. Abundant gravels and small cobbles throughout suitable for CO or RB/ST spawning.

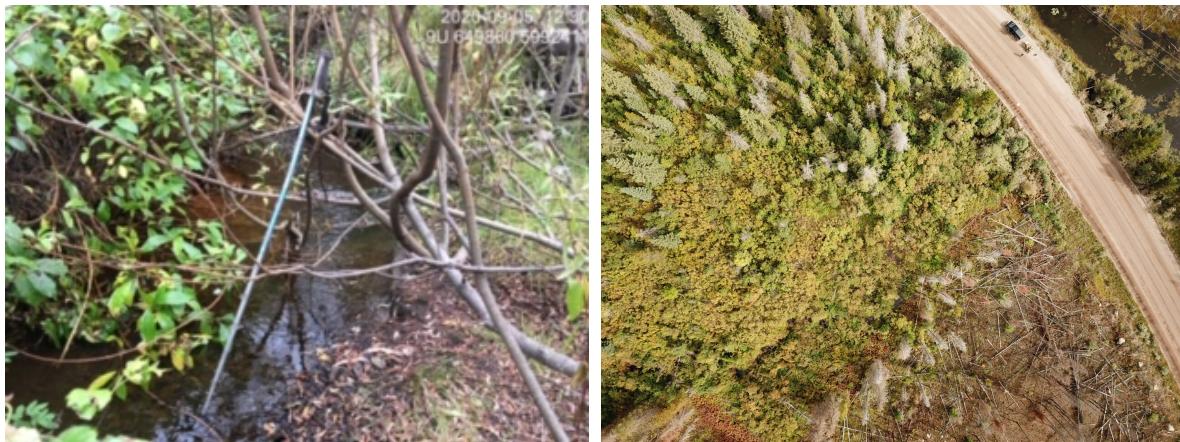
Figure 5.24: Left: Typical habitat downstream of PSCIS crossing 197360. Right: Aerial view of typical habitat downstream of PSCIS crossing 197360.
