## DRAFT - Bulkley River and Morice River Watershed Groups Fish Passage Restoration Planning

Prepared for  
Habitat Conservation Trust Fund  
BC Fish Passage Remediation Program  
Canadian Wildlife Federation

Prepared by  
Al Irvine, B.Sc., R.P.Bio.  
New Graph Environment  
6 Regent St  
Nelson, BC V1L 2P1

DRaFT - Version 0.0.1  
2021-02-24

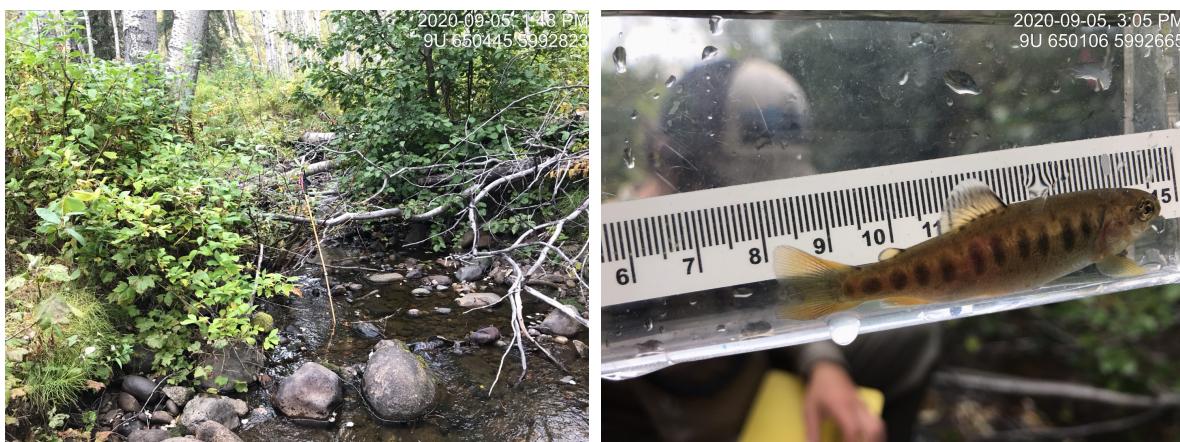
Figure 5.25: Left: Typical habitat upstream of PSCIS crossing 197360. Right: Rainbow trout captured upstream of PSCIS crossing 197360.

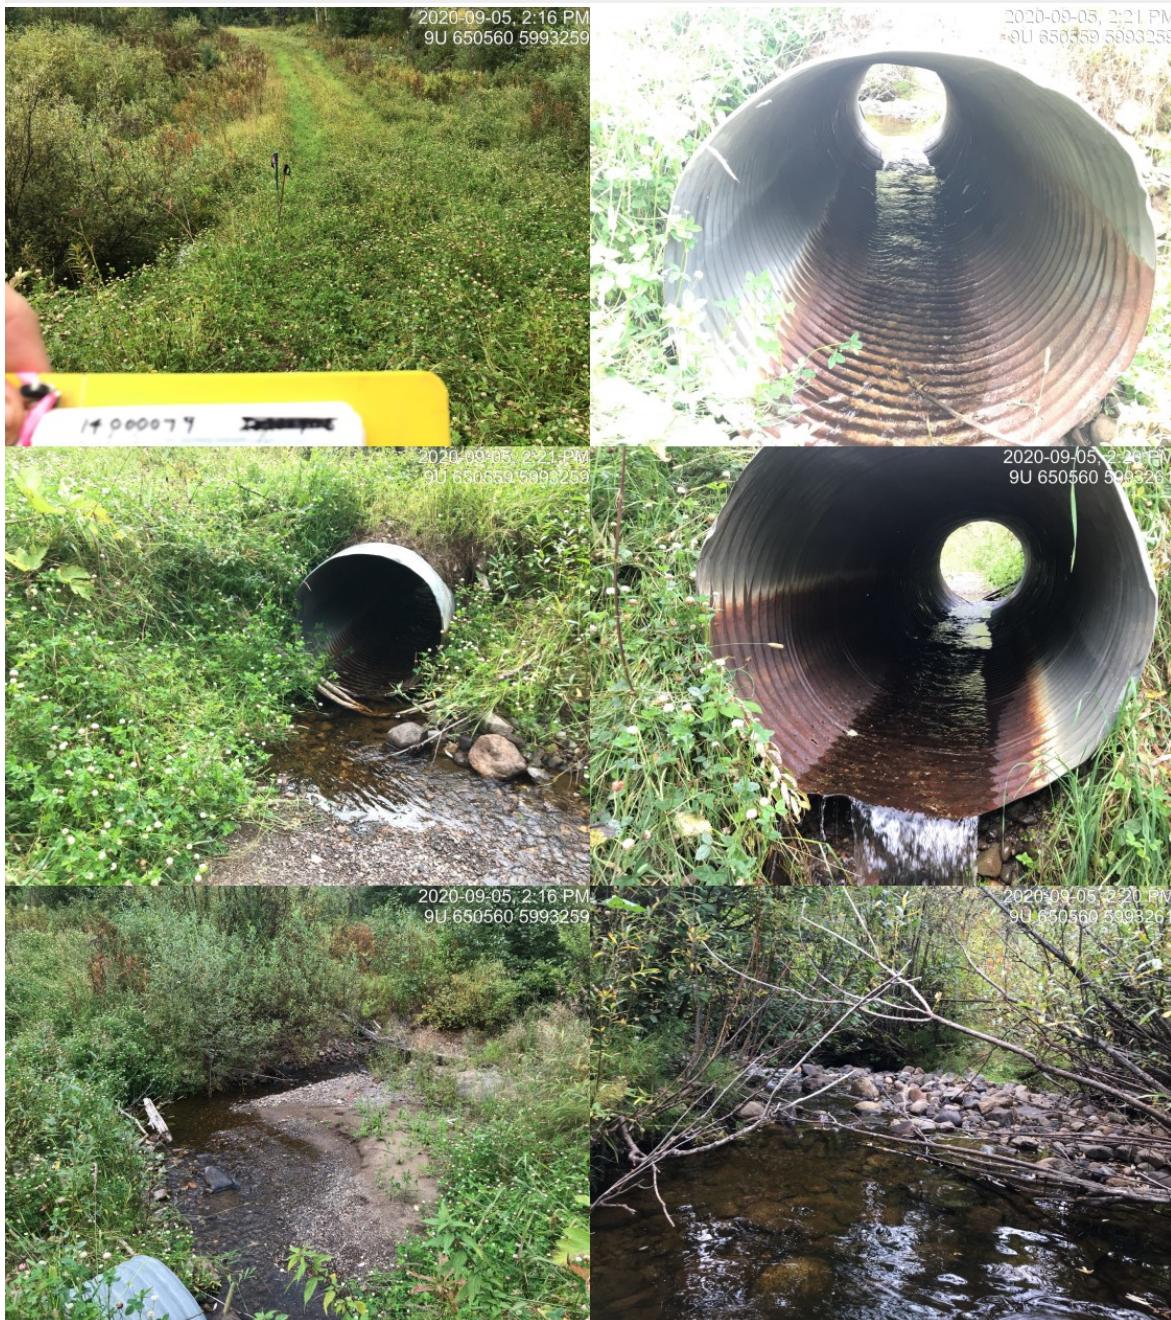
Comments: Extensive rearing habitat and gravels suitable for spawning. Stream eventually flows into top end of Owen Lake.

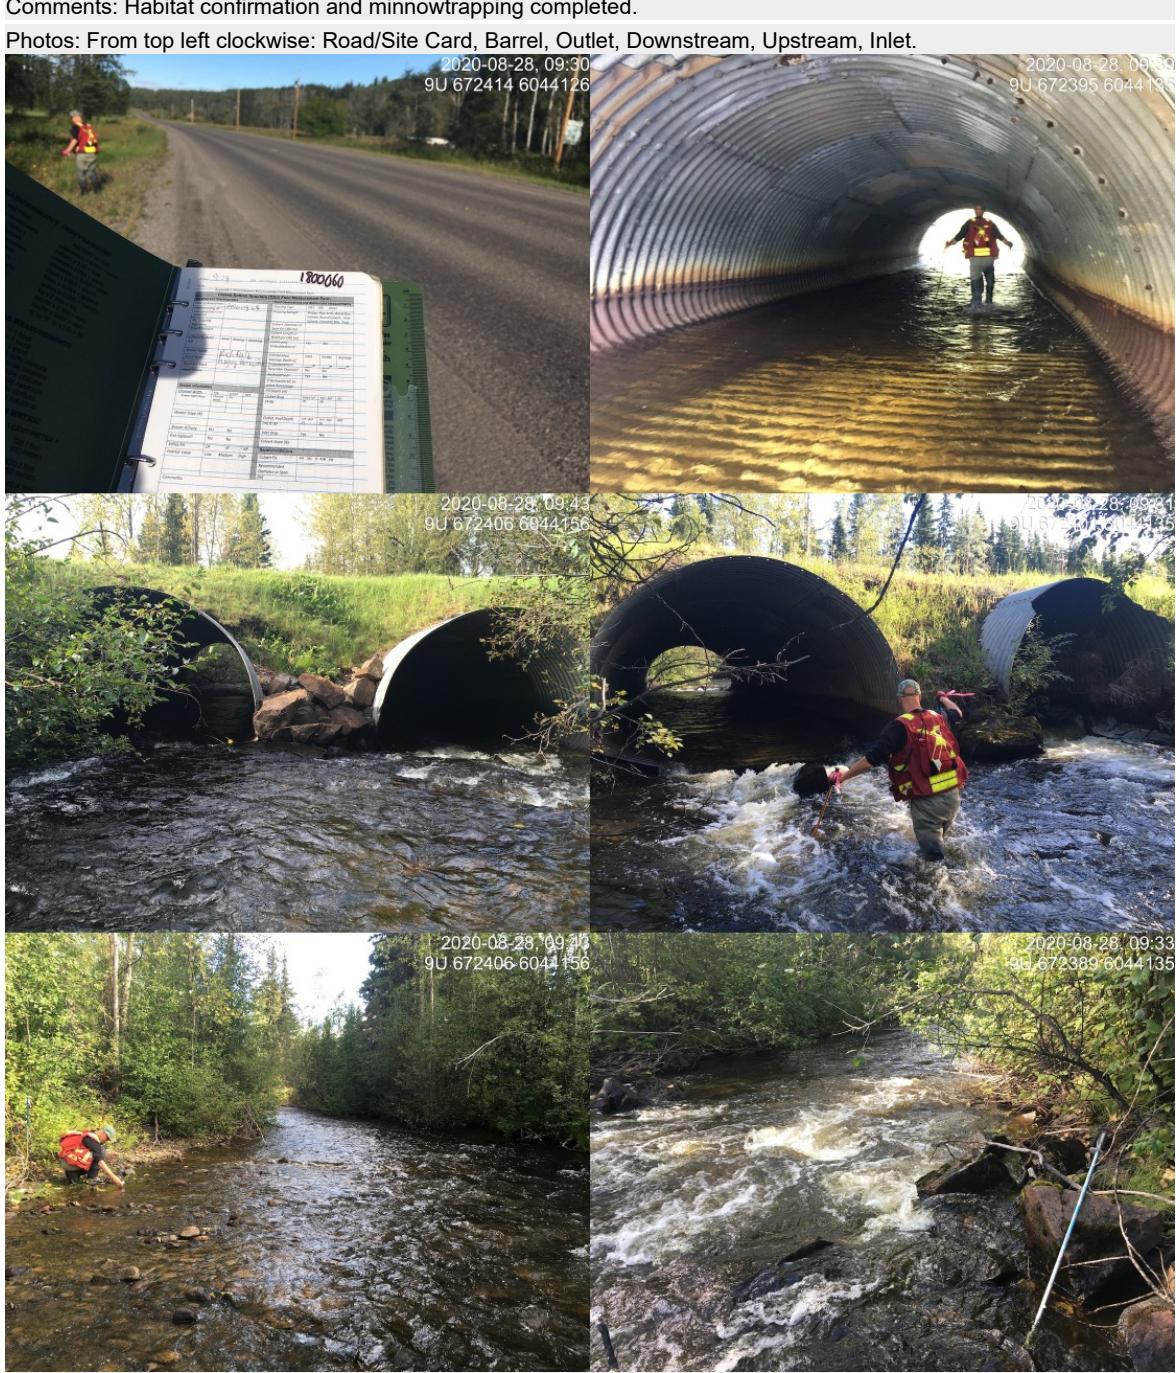
The crossing at the highway presents a barrier not only to some fry and juvenile salmonids due to the small outlet drop and high flow velocities within the pipes but also to adult salmon migrating upstream to spawn during low flows due to shallow water depths in the pipes. Future electrofishing surveys upstream and downstream of the crossing are recommended to provide presence/absence as well as density data for chinook salmon, coho salmon and other species. Highway 16 is the responsibility of the Ministry of Transportation and Infrastructure and was ranked as a high priority for proceeding to design for replacement. Restoration of riparian forests, cattle exclusion, bank stabilization and habitat complexing as per NCFDC (1998) could be considered alongside fish passage restoration activities and an assessment of the passability of the debris jam just upstream of the crossing is recommended when fish passage restoration works at the highway are initiated.

Stream Slope (%)	1.5	Inlet Drop	No
Beaver Activity	No	Slope (%)	2
Habitat Value	High	Valley Fill	Deep Fill
Final score	29	Barrier Result	Barrier
Fix type	Replace with New Open Bottom Structure		Fix Span / Diameter
Comments: Habitat confirmation and minnowtrapping completed.			
Photos: From top left clockwise: Road/Site Card, Barrel, Outlet, Downstream, Upstream, Inlet.

Structure replacement with a bridge (16.5m span) is recommended to provide access to the habitat located upstream of PSCIS crossing 197662. The cost of the work is estimated at \$8,250,000 for a

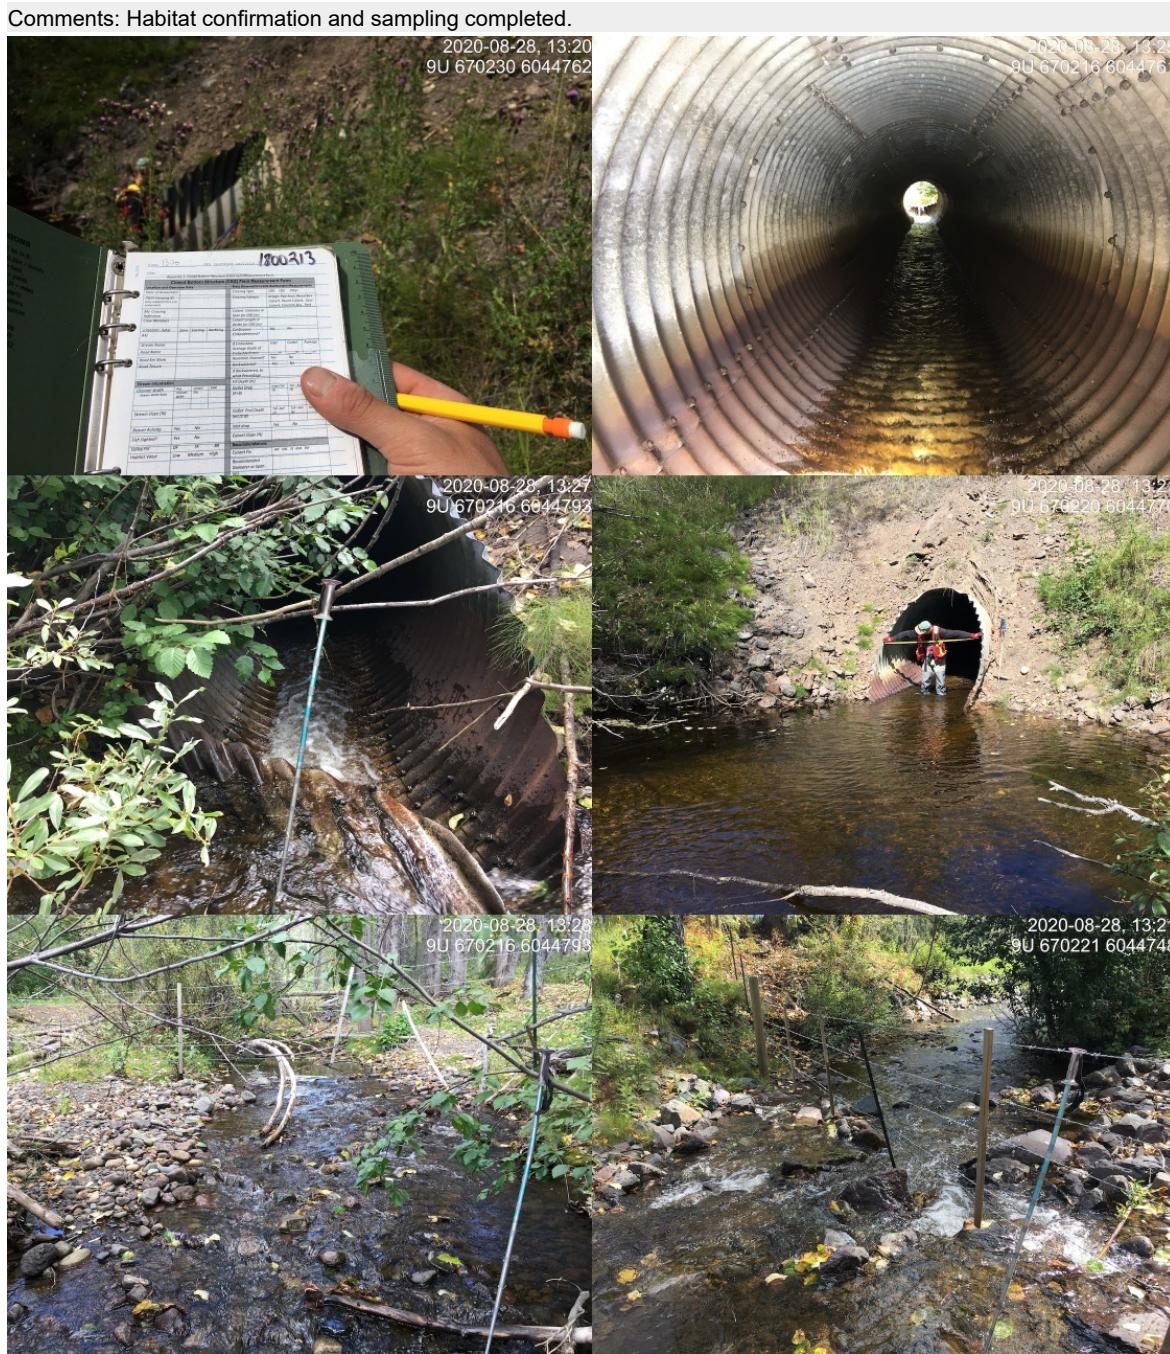
At the time of the survey, the 197663 on Highway 16 was un-embedded, non-backwatered and considered a barrier to upstream fish passage according to the provincial protocol. The pipe was 1.75m in diameter with a length of 25m, a culvert slope of 2%, a stream width ratio of 3.6 and an outlet drop of 0m (Table [5.41](#)). The inlet of the culvert was damaged with the metal folded up by incoming debris. Water temperature was 11°C, pH was 8.1 and conductivity was 186uS/cm.

Location and Stream Data	.	Crossing Characteristics –	
Date	2020-08-28	Crossing Sub Type	Round Culvert
PSCIS ID	197663	Diameter (m)	1.75
External ID	–	Length (m)	25
Crew	KP, AI	Embedded	No
UTM Zone	9	Depth Embedded (m)	–
Easting	670240.8	Resemble Channel	No
Northing	6044772	Backwatered	No
Stream	Johnny David Creek	Percent Backwatered	–
Road	Highway 16	Fill Depth (m)	3
Road Tenure	MoTi highway	Outlet Drop (m)	0
Channel Width (m)	6.3	Outlet Pool Depth (m)	1.35
Stream Slope (%)	5.5	Inlet Drop	Yes
Beaver Activity	No	Slope (%)	2
Habitat Value	High	Valley Fill	Deep Fill
Final score	24	Barrier Result	Barrier
Fix type	Replace with New Open Bottom Structure	Fix Span / Diameter	10.3
Photos: From top left clockwise: Road/Site Card, Barrel, Outlet, Downstream, Upstream, Inlet.

Structure replacement with bridges for 197663 (10.3m span) and 3054 (31m span) are recommended to provide access to the habitat located upstream. An estimate of cost for replacement of 197663 is \$5,150,000 resulting in cost benefits of 1.9 linear m/\$1000 and  $12.8\text{m}^2/\$1000$ . An estimate of cost for replacement of 3054 is \$388,000 resulting in cost benefits of 19.3 linear m/\$1000 and  $50.3\text{m}^2/\$1000$ .

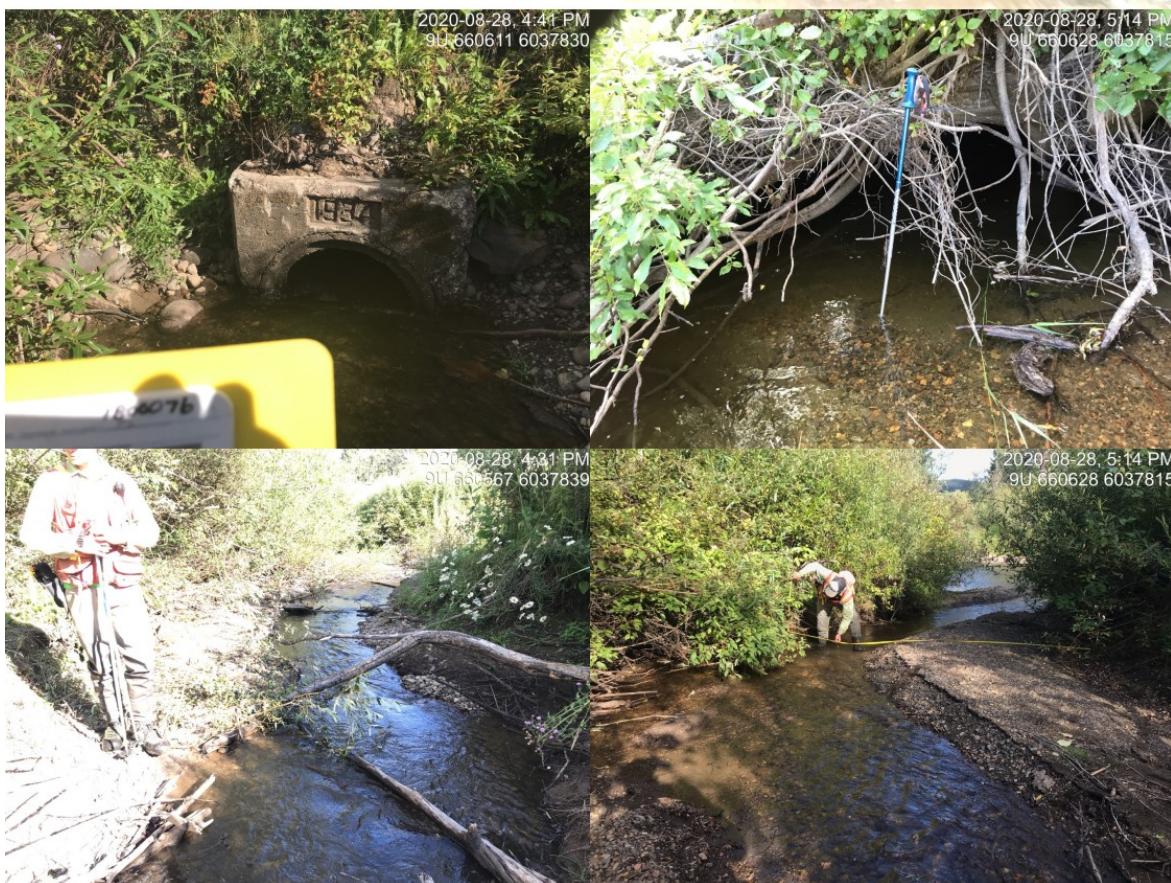
At the time of the survey, crossing 197665 structures under the CN Railway were fully embedded and considered passable according to the provincial protocol. Each of the two pipes were 0.9m in diameter with lengths of 25m, culvert slopes of 1%, a stream width ratio of 3.9 and outlet drops of 0m (Table 5.47). At the time of the survey, only one of the pipes was passing water and this structure appeared to be potentially failing as the top of the concrete structure was tilted towards the Bulkley River.

2020-08-28, 4:41 PM  
9U 660611 6037830

Costs to replace 197665 and 197664 with bridges are estimated at \$5,000,000 per crossing. Structure replacement with an embedded culvert is recommended for 3042 (streambed simulation - 3m span) with an estimated cost of \$25,000 resulting in cost benefits of 68 linear m/\$1000 and  $156.4\text{m}^2/\$1000$ .

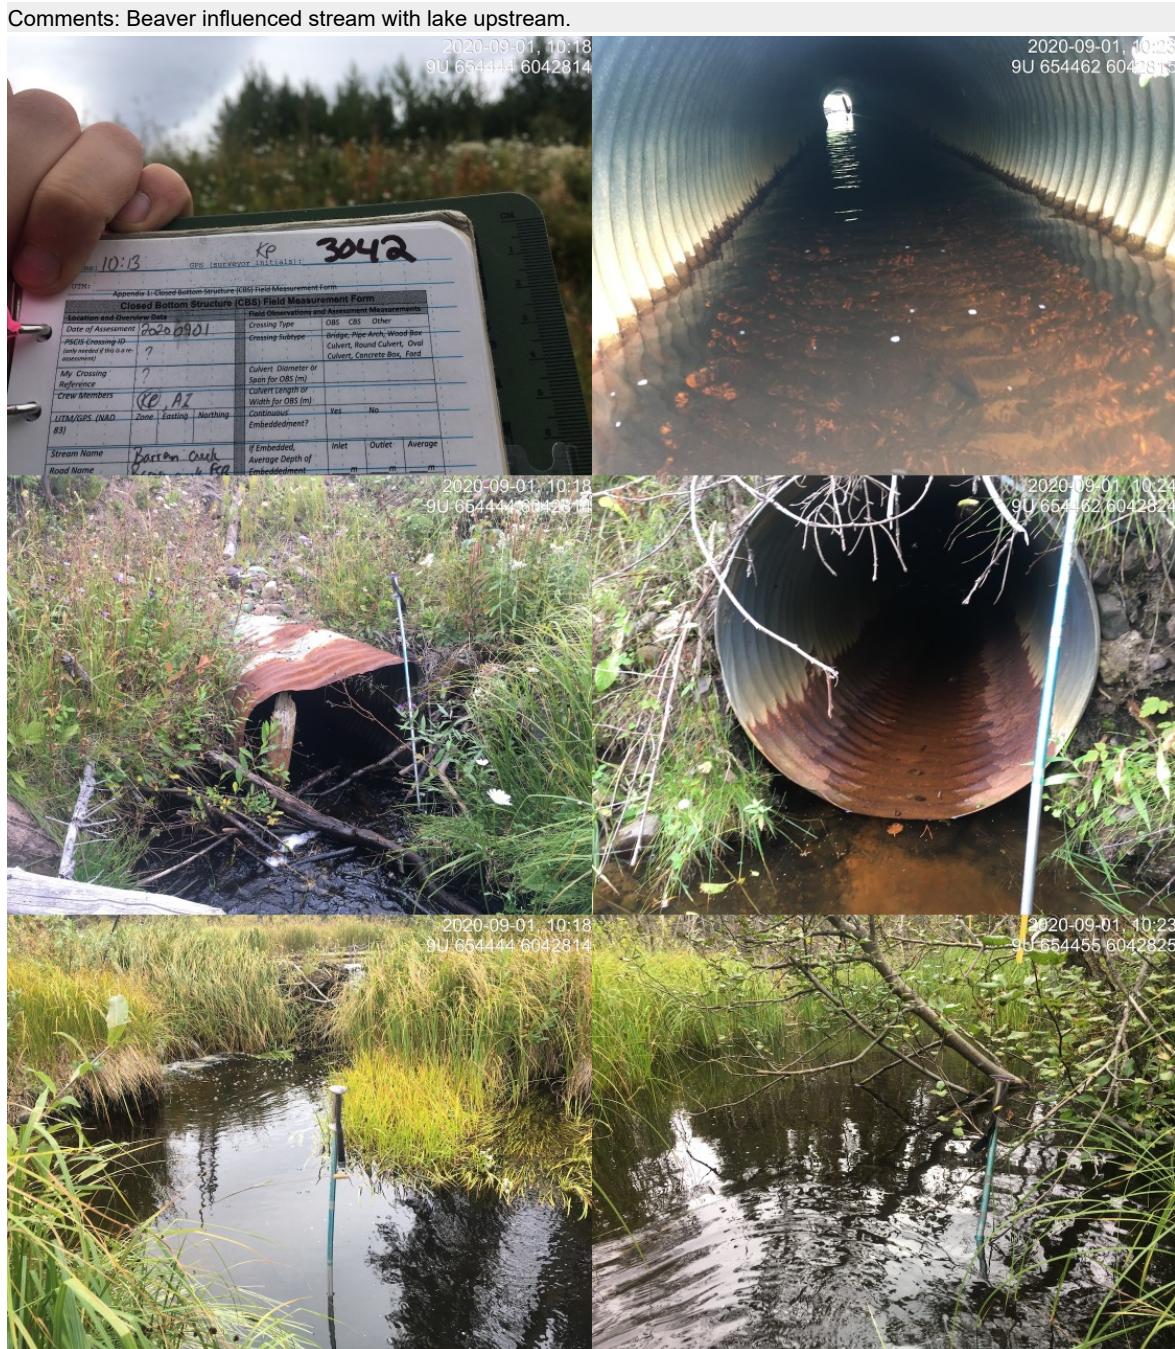
Table 5.49: Summary of fish passage assessment for PSCIS crossing 3042.

Date	2020-09-01	Crossing Sub Type	Round Culvert
PSCIS ID	3042	Diameter (m)	1
External ID	–	Length (m)	23
Crew	KP, AI	Embedded	No
UTM Zone	9	Depth Embedded (m)	–
Easting	654451	Resemble Channel	No
Northing	6042827	Backwatered	No
Stream	Barren Creek	Percent Backwatered	–
Road	Barren Creek FSR	Fill Depth (m)	2
Road Tenure	MoTi highway	Outlet Drop (m)	0
Channel Width (m)	1	Outlet Pool Depth (m)	0.5
Stream Slope (%)	0.5	Inlet Drop	Yes
Beaver Activity	Yes	Slope (%)	1.5
Habitat Value	Medium	Valley Fill	Deep Fill
Final score	21	Barrier Result	Barrier
Fix type	Replace Structure with Streambed Simulation CBS	Fix Span / Diameter	3
Photos: From top left clockwise: Road/Site Card, Barrel, Outlet, Downstream, Upstream, Inlet.

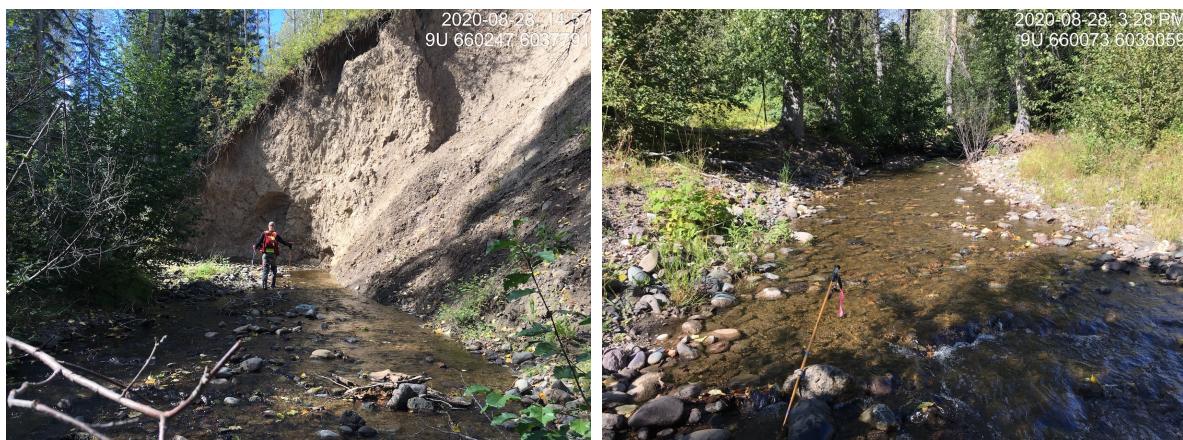
active cut was noted approximately 100m upstream of culvert. It is suspected that this area is constantly depositing gravels into stream. There extensive areas of gravels suitable for CO spawning. Riparian vegetation consisted of a mature cottonwood forest with right bank armouring and riparian removal along the adjacent private road. Habitat was rated as high value for resident and anadromous salmonid rearing and spawning.

Figure 5.40: Left: Habitat upstream of PSCIS crossing 197664 and location of cutslope. Right: Habitat upstream of PSCIS crossing 197664.

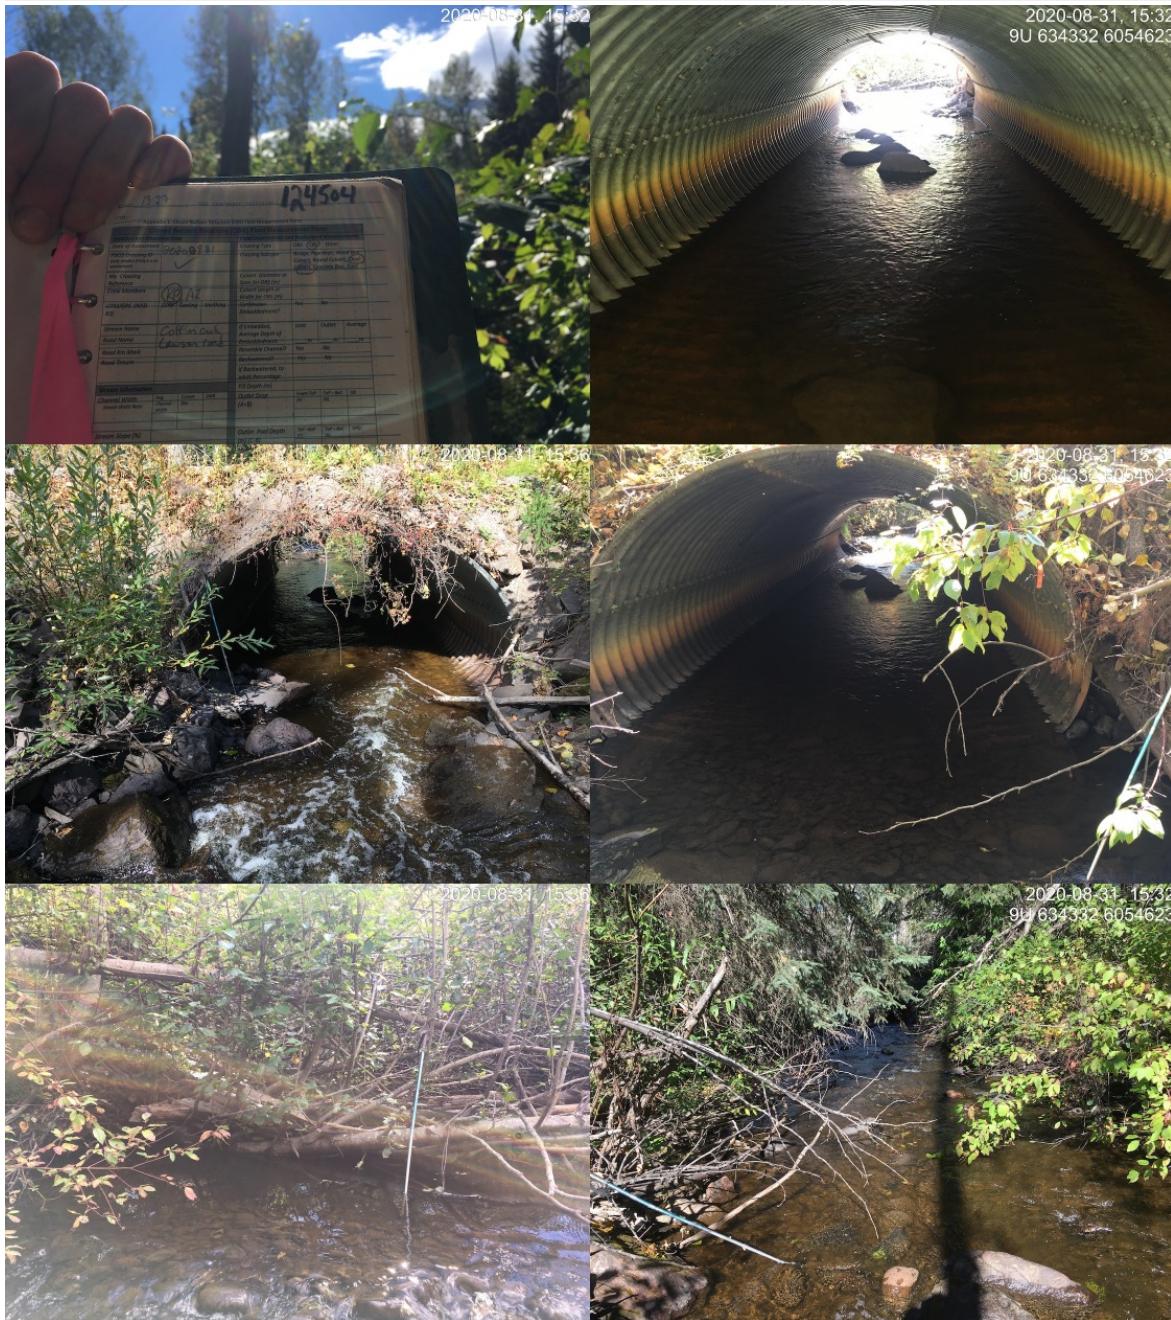
Table 5.56: Summary of fish passage assessment for PSCIS crossing 124504.

Comments: Partially embedded with several large boulders (30 - 50cm) in culvert. No outlet drop at the time of survey but there may be at lowest flow levels.
