## DRAFT - Bulkley River and Morice River Watershed Groups Fish Passage Restoration Planning

Prepared for  
Habitat Conservation Trust Fund  
BC Fish Passage Remediation Program  
Canadian Wildlife Federation

Prepared by  
Al Irvine, B.Sc., R.P.Bio.  
New Graph Environment  
6 Regent St  
Nelson, BC V1L 2P1

DRaFT - Version 0.0.4  
2021-03-10

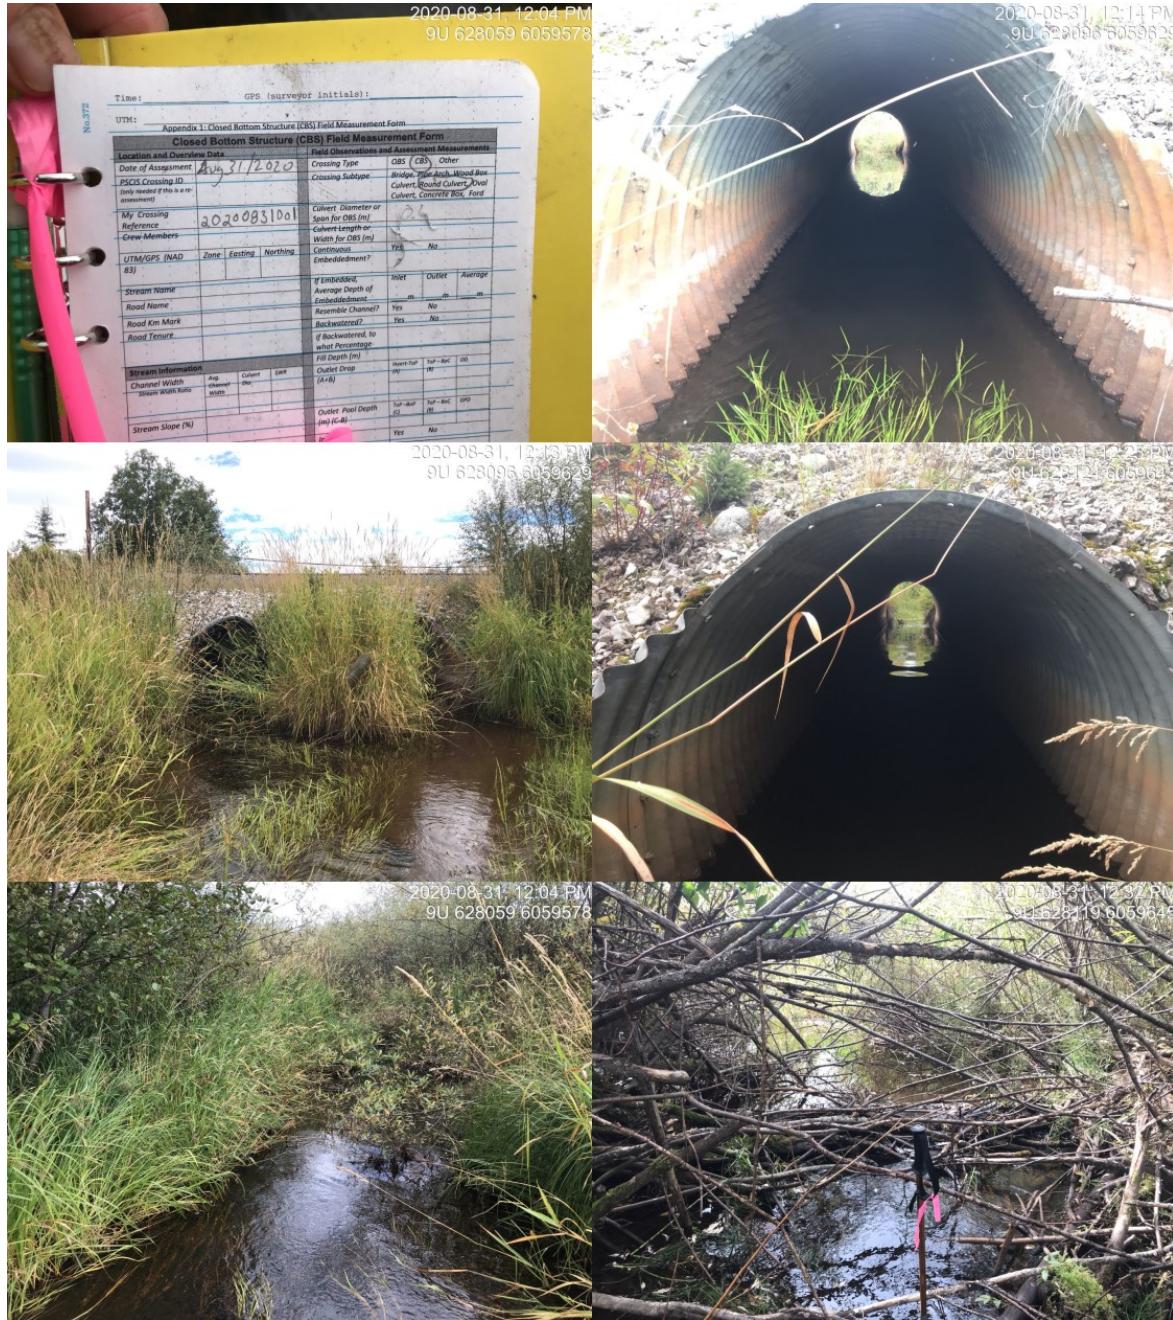
Table 5.25: Summary of habitat details for PSCIS crossing 124500.

Comments: Passable and fully backwatered structure. Landowner reports that lamprey (~40cm x 20) at crossing inside of the culvert in the past.

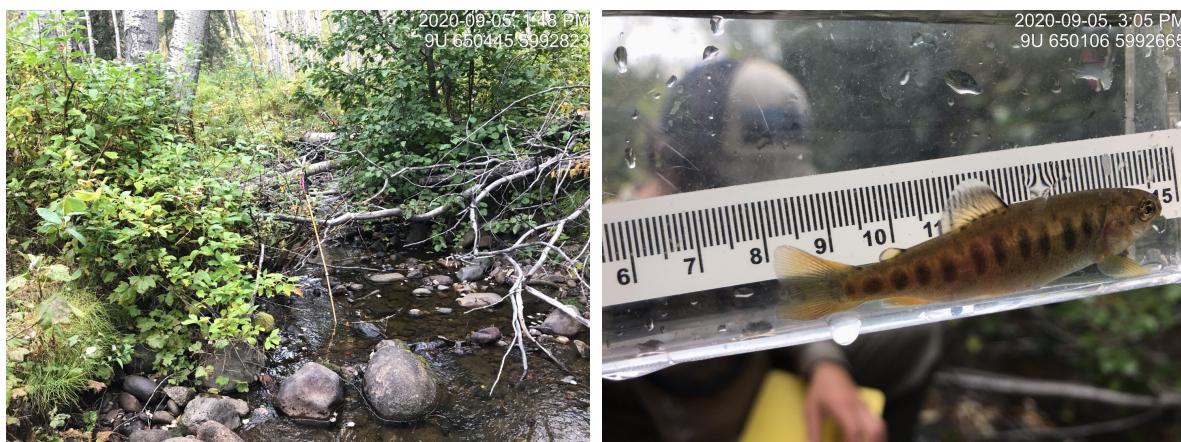
Figure 5.23: Left: Typical habitat upstream of PSCIS crossing 197360. Right: Rainbow trout captured upstream of PSCIS crossing 197360.

Structure replacement with a bridge (10m span) is recommended to provide access to the habitat located upstream of PSCIS crossing 197360. In addition to not facilitating high velocities and erosion due resulting from flow constriction, structures with large openings in relation to stream channel size have been demonstrated to reduce the likelihood of structure blockage due to beaver (Jensen et al. 2001). The cost of the work is estimated at \$125,000 for a cost benefit of 9.6 linear m/\$1000 and 31.7m<sup>2</sup>/\$1000.

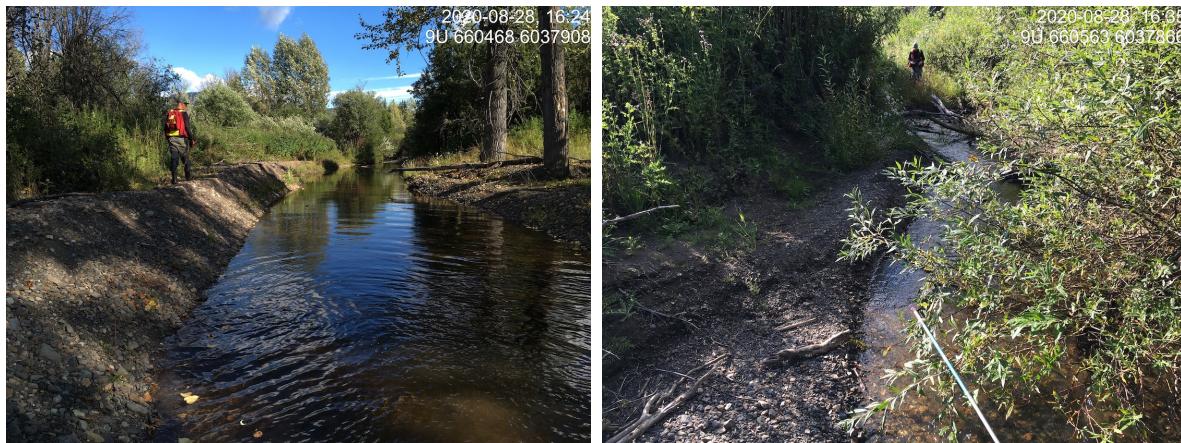
Figure 5.37: Left: Typical habitat downstream of PSCIS crossing 197664. Right: Typical habitat downstream of PSCIS crossing 197664.

The stream was surveyed upstream from 197665 for 100m to Highway 16 (Figure 5.37). Within the area surveyed, total cover amount was rated as moderate with overhanging vegetation dominant. Cover was also present as small woody debris (Table 5.62). The average channel width was 4.7m, the average wetted width was 2.7m and the average gradient was 1.8%. Abundant gravels and small cobbles suitable for resident, fluvial, adfluvial and anadromous salmonid spawning were present throughout the area surveyed. Habitat was rated as moderate value with habitat present suitable for resident and anadromous fry/juvenile salmonid rearing and spawning.

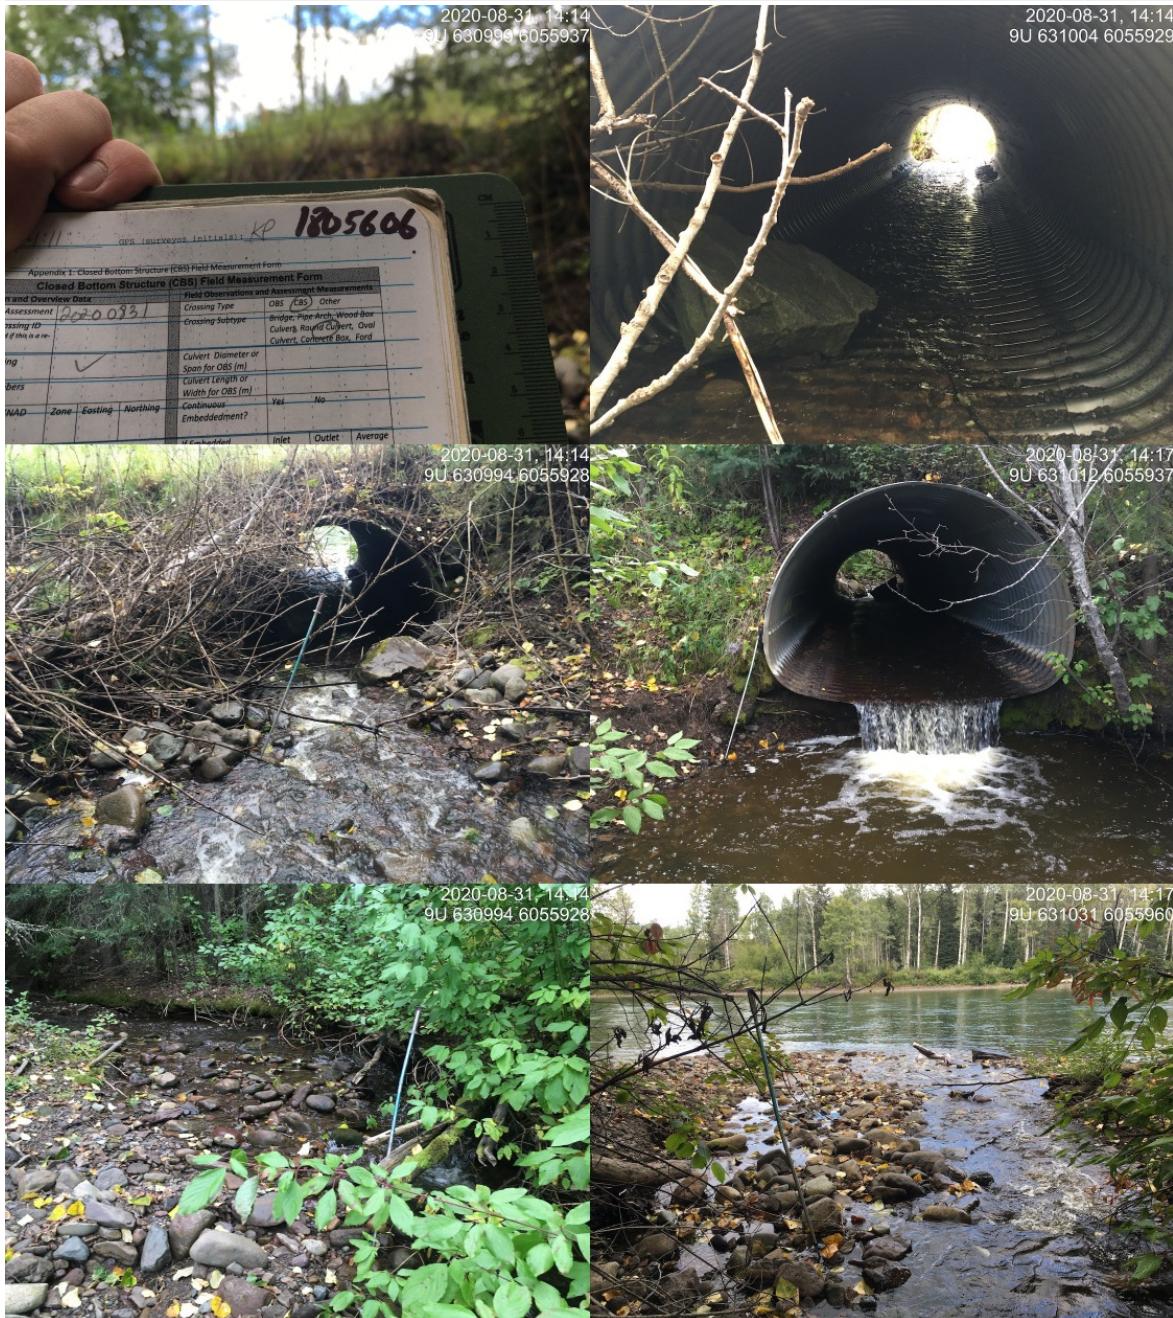
Wilson and Rabnett (2007) recommended that PSCIS crossing 197667 be a high priority for remedial works to backwater the crossing by establishing a series of pools to step up to the outfall pool. In the spring of 2016, Gaboury and Smith (2016) noted that the baffled concrete box culvert (PSCIS 124501) at Lawson Road was likely a significant impediment to upstream fish passage at various discharges due to the height of the outfall drop, steep culvert slope and high water velocities. Rehabilitation designs for both crossings were prescribed by Gaboury and Smith (2016) and in both cases included the installation of downstream backwatering structures. Smith (2018) reported that in 2017, the Wet'suwet'en First Nation constructed three rock riffles and a right-bank berm to backwater the Lawson Road (124501) outlet. For the railway crossing (197667), CN Rail indicated that the design proposed was not feasible for installation, so at the time of reporting, remedial actions had not yet been implemented (pers. comm. Karla Graf, CN Environment, Manager-Environmental Impact). A map of the watershed is provided in map attachment [093L.118](#).

Photos: From top left clockwise: Road/Site Card, Barrel, Outlet, Downstream, Upstream, Inlet.

Comments: Approximately 17m from the outlet to the Bulkley River.

A cost estimate for replacing 197667 with a bridge (10m span) is \$5,000,000, resulting in cost benefits of 0.7 linear m/\$1000 and  $3\text{m}^2/\$1000$ . Although 124501 on Lawson Road was considered passable for most species/life stages during most flows, an estimate of cost for replacement (10m span) is \$500,000 resulting in cost benefits of 5.6 linear m/\$1000 and  $26.9\text{m}^2/\$1000$ .
