# **Elk River Watershed Group Fish Passage Restoration Planning**

**Prepared for Canadian Wildlife Federation**

**New Graph Environment**

**2020-12-31 DRaft**

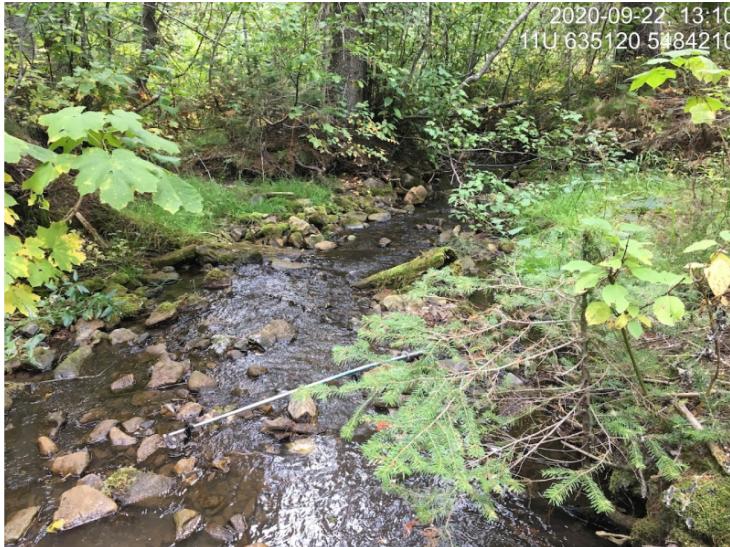
Figure 5.4: Typical habitat downstream of PSCIS crossing 50155.

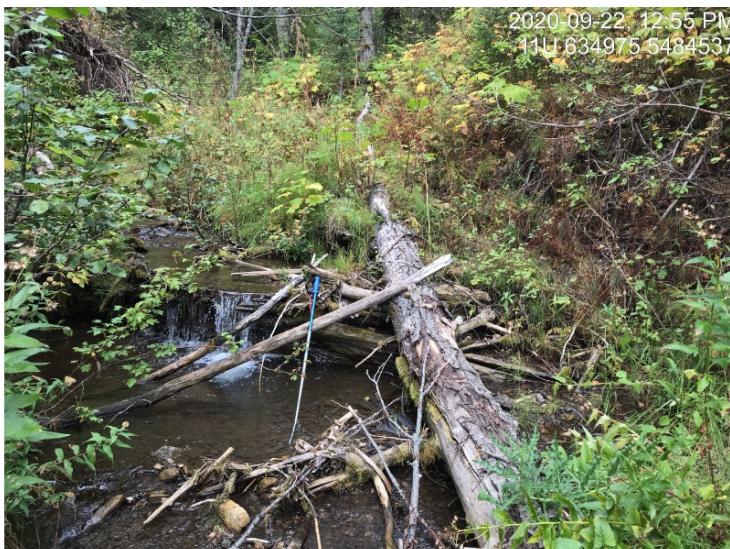
Figure 5.5: Typical habitat upstream of PSCIS crossing 50155.

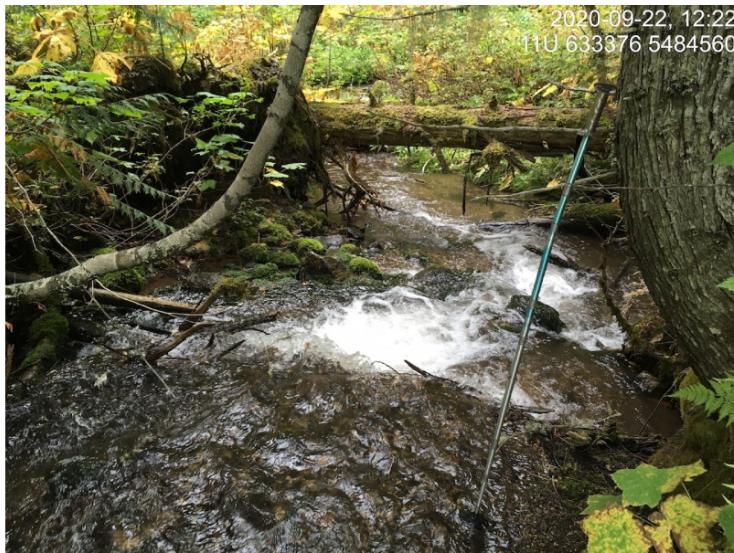
**Figure 5.6: Typical habitat downstream of PSCIS crossing 50159.**

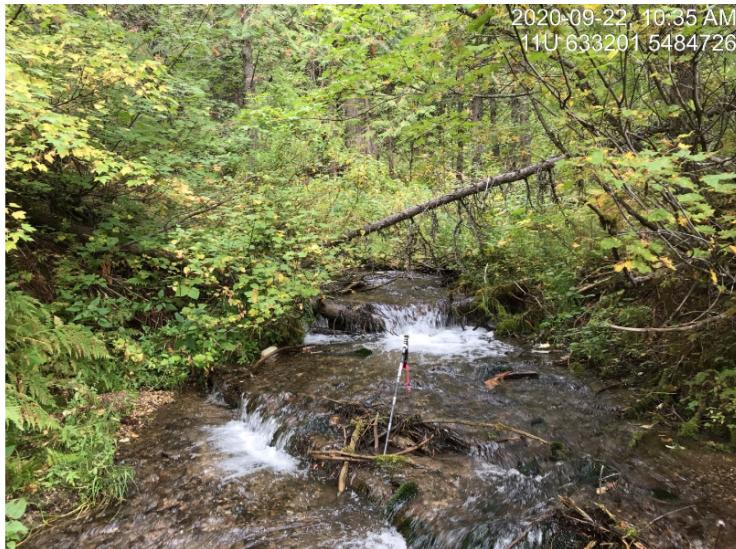
Figure 5.7: Typical habitat upstream of PSCIS crossing 50159.

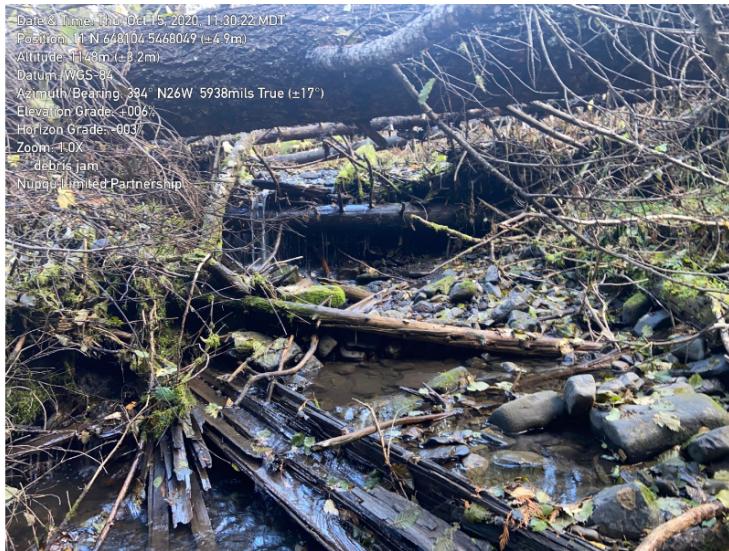
Figure 5.9: Typical habitat downstream of PSCIS crossing 50181.

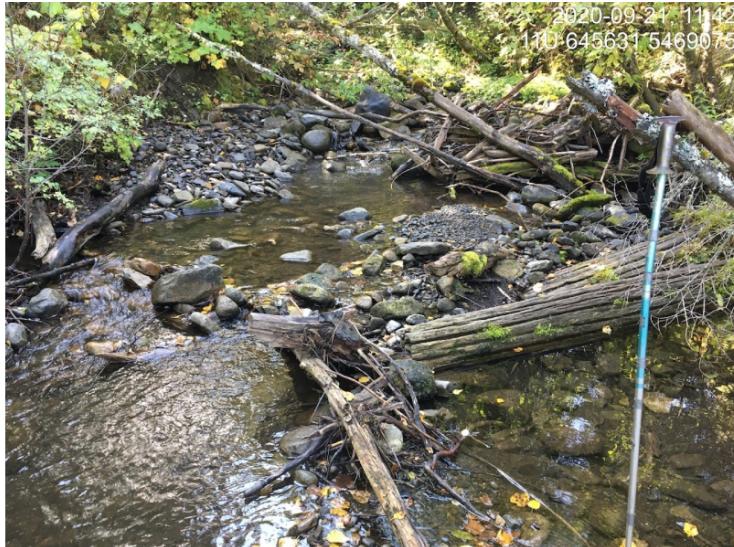
Figure 5.13: Typical habitat downstream of PSCIS crossing 50185.

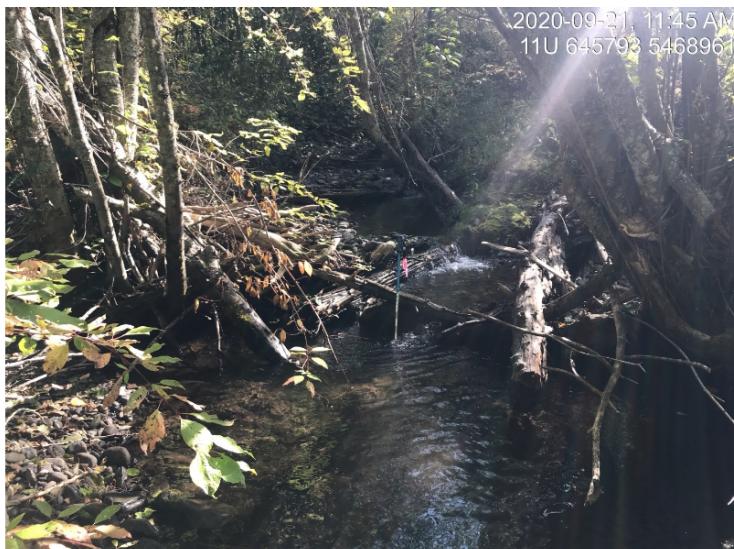
Figure 5.14: Typical habitat upstream of PSCIS crossing 50185.

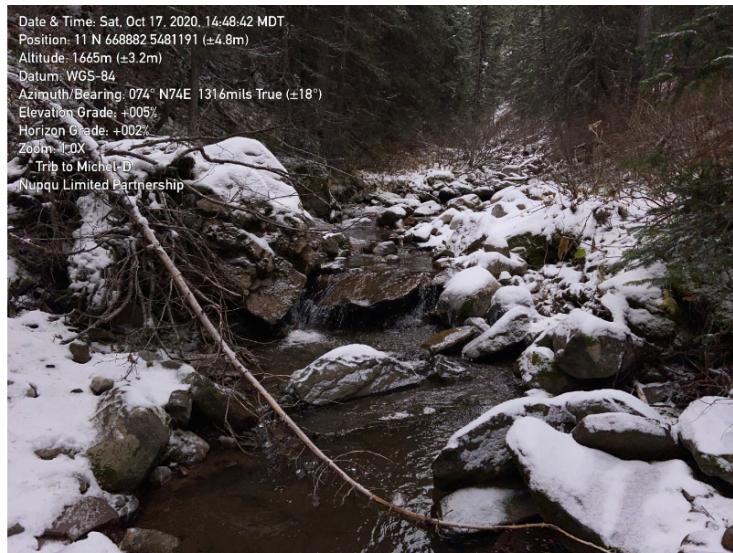
Figure 5.16: Habitat downstream of PSCIS crossing 50261.

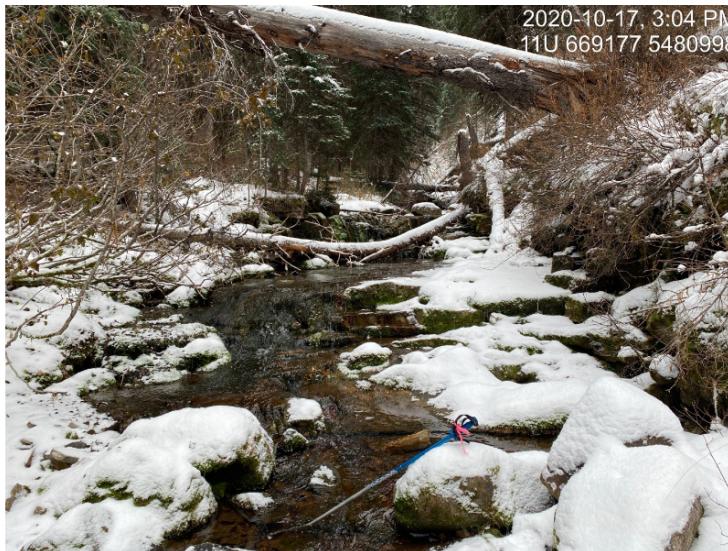
Figure 5.18: Habitat upstream of PSCIS crossing 50261.

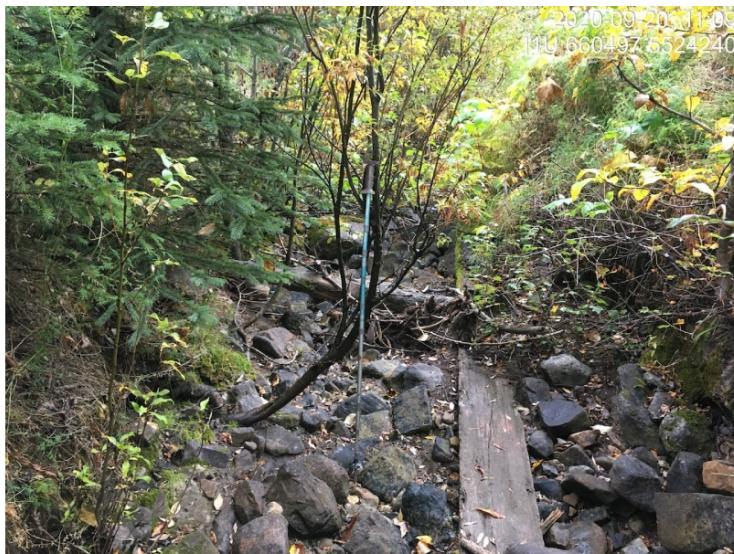
Figure 5.19: Typical habitat downstream of PSCIS crossing 62423.

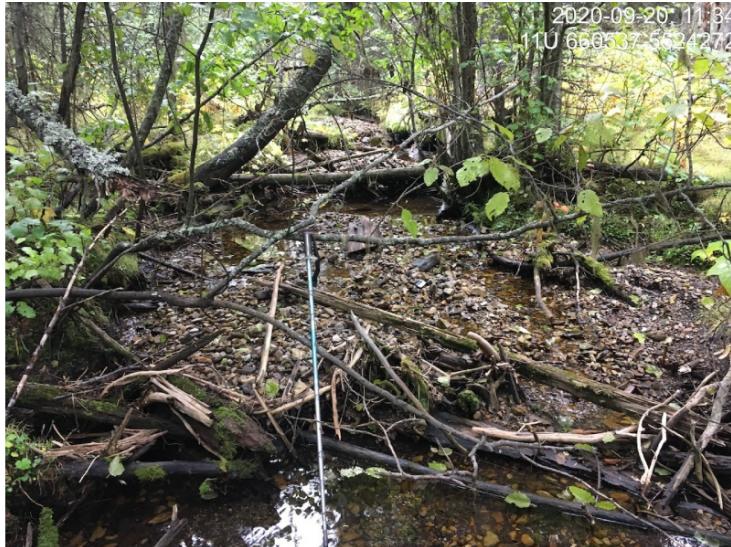
Figure 5.20: Typical habitat upstream of PSCIS crossing 62423.

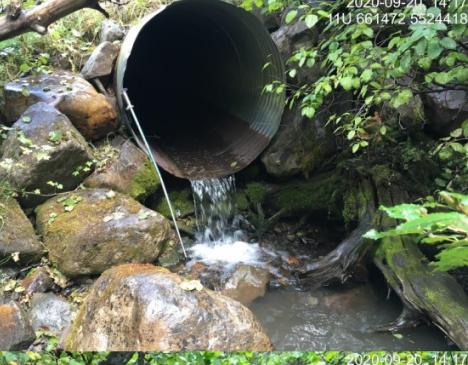
<b>Location and Stream Data</b>	•	<b>Crossing Characteristics –</b>	
Date	2020-09-20	Crossing Sub Type	Round Culvert
PSCIS ID	62425	Diameter (m)	1.2
External ID	NA	Length (m)	12
Crew	KP, AI	Embedded	No
UTM Zone	11	Depth Embedded (m)	NA
Easting	661486	Resemble Channel	No
Northing	5524426	Backwatered	No
Stream	Grave Creek	Percent Backwatered	NA
Road	Spur	Fill Depth (m)	1
Road Tenure	Canfor R08362	Outlet Drop (m)	0.47
Channel Width (m)	3.7	Outlet Pool Depth (m)	0.38
Stream Slope (%)	7.5	Inlet Drop	Yes
Beaver Activity	No	Slope (%)	7.5

Habitat Value	Medium	Valley Fill	Deep Fill
Photos: From top left clockwise: Road/Site Card, Barrel, Outlet, Downstream, Upstream, Inlet.			
	2020-09-20 14:16 11U 661487 5524433	2020-09-20 14:17 11U 661472 5524418

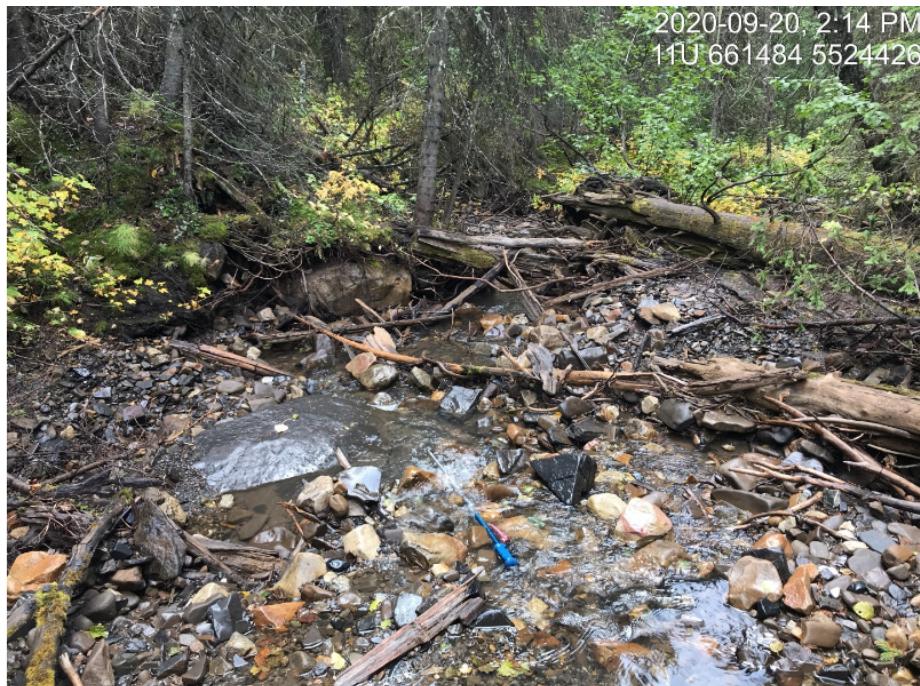
Figure 5.21: Typical habitat downstream of PSCIS crossing 62425.

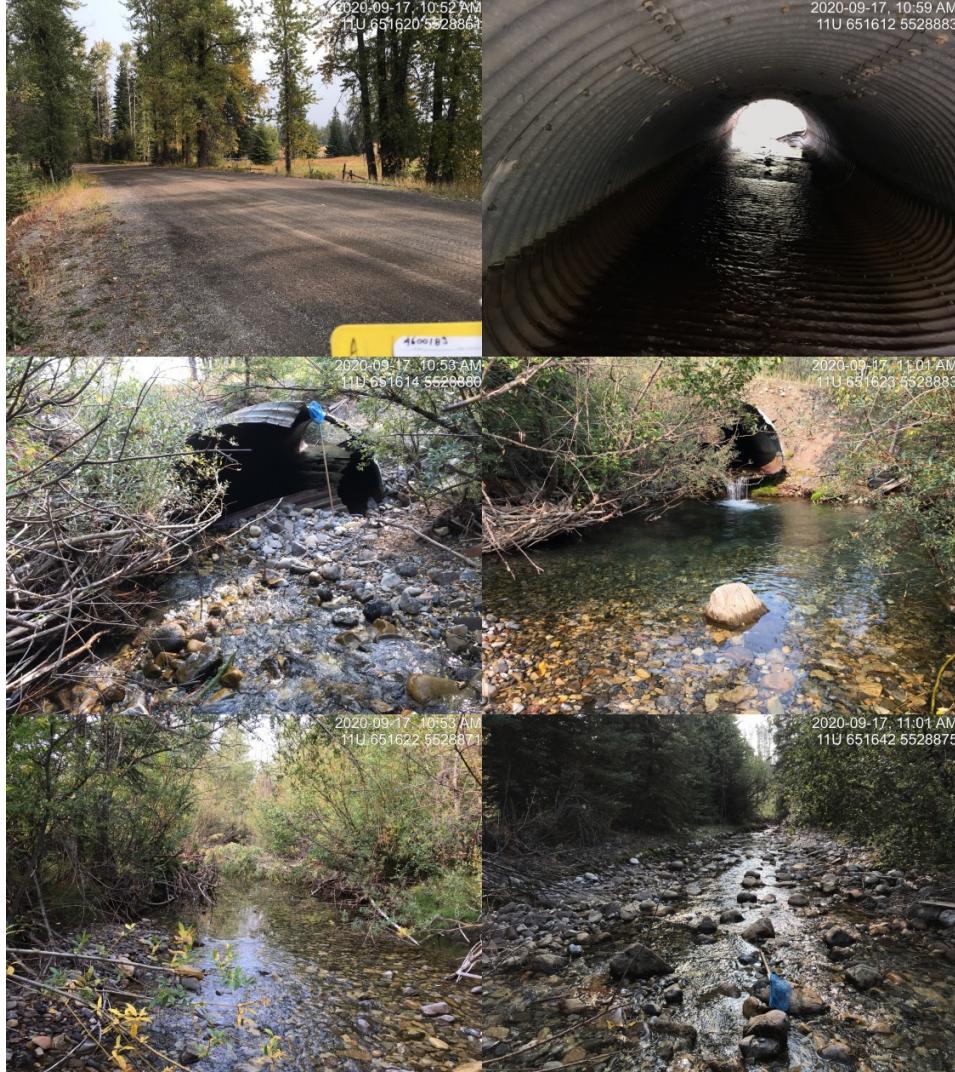
Photos: From top left clockwise: Road/Site Card, Barrel, Outlet, Downstream, Upstream, Inlet.

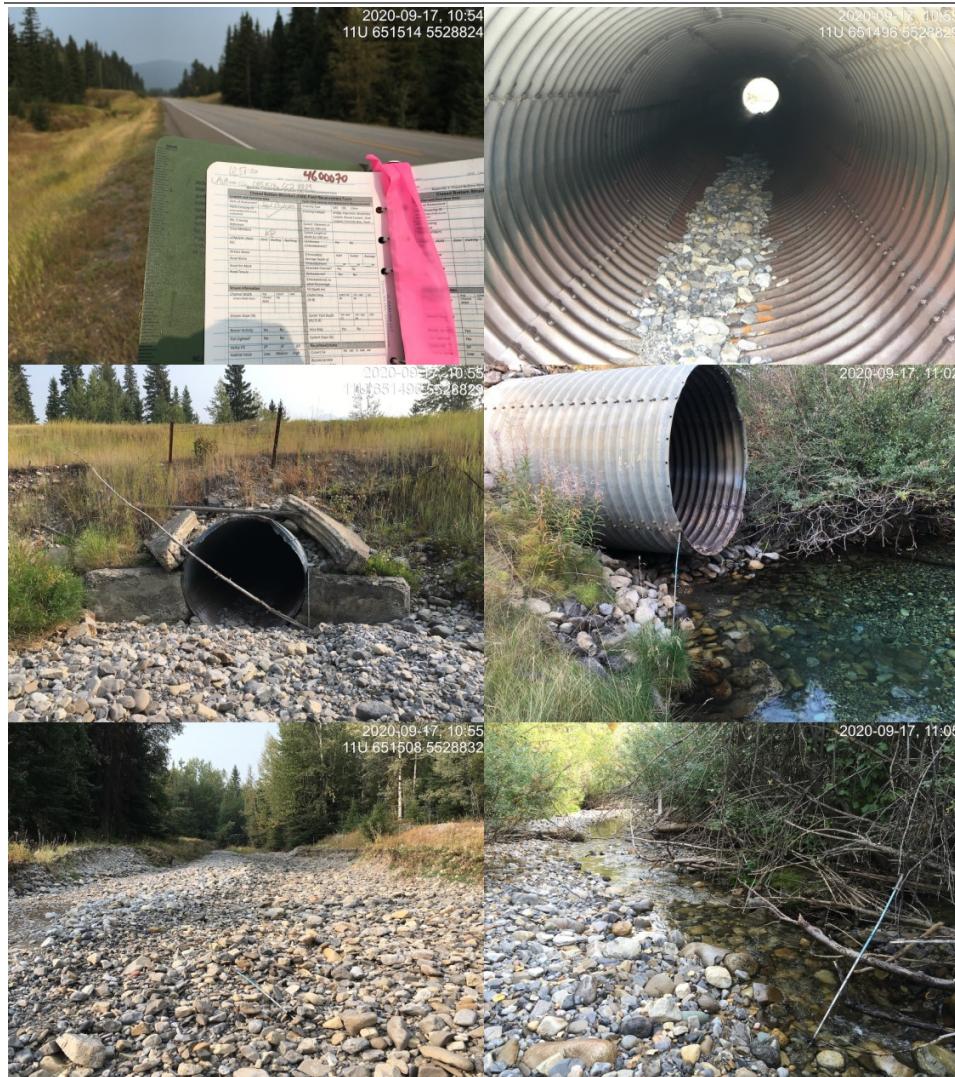
Photos: From top left clockwise: Road/Site Card, Barrel, Outlet, Downstream, Upstream, Inlet.

\$3050000 respectively. The combined cost benefit of replacements are estimated at \$7700/linear m and \$23600/m<sup>2</sup>.

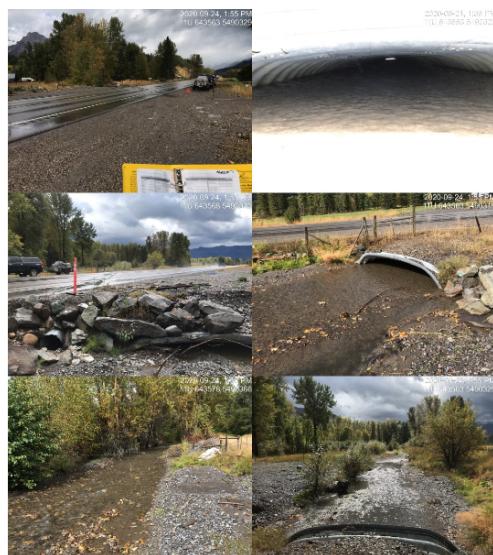
Figure 5.37: PSCIS crossing 197582.
