DRAFT - Bulkley River and Morice River Watershed Groups Fish Passage Restoration Planning

Prepared for
Habitat Conservation Trust Fund
BC Fish Passage Remediation Program
Canadian Wildlife Federation

Prepared by
Al Irvine, B.Sc., R.P.Bio.
New Graph Environment
6 Regent St
Nelson, BC V1L 2P1

DRaFT - Version 0.0.1
2021-02-26

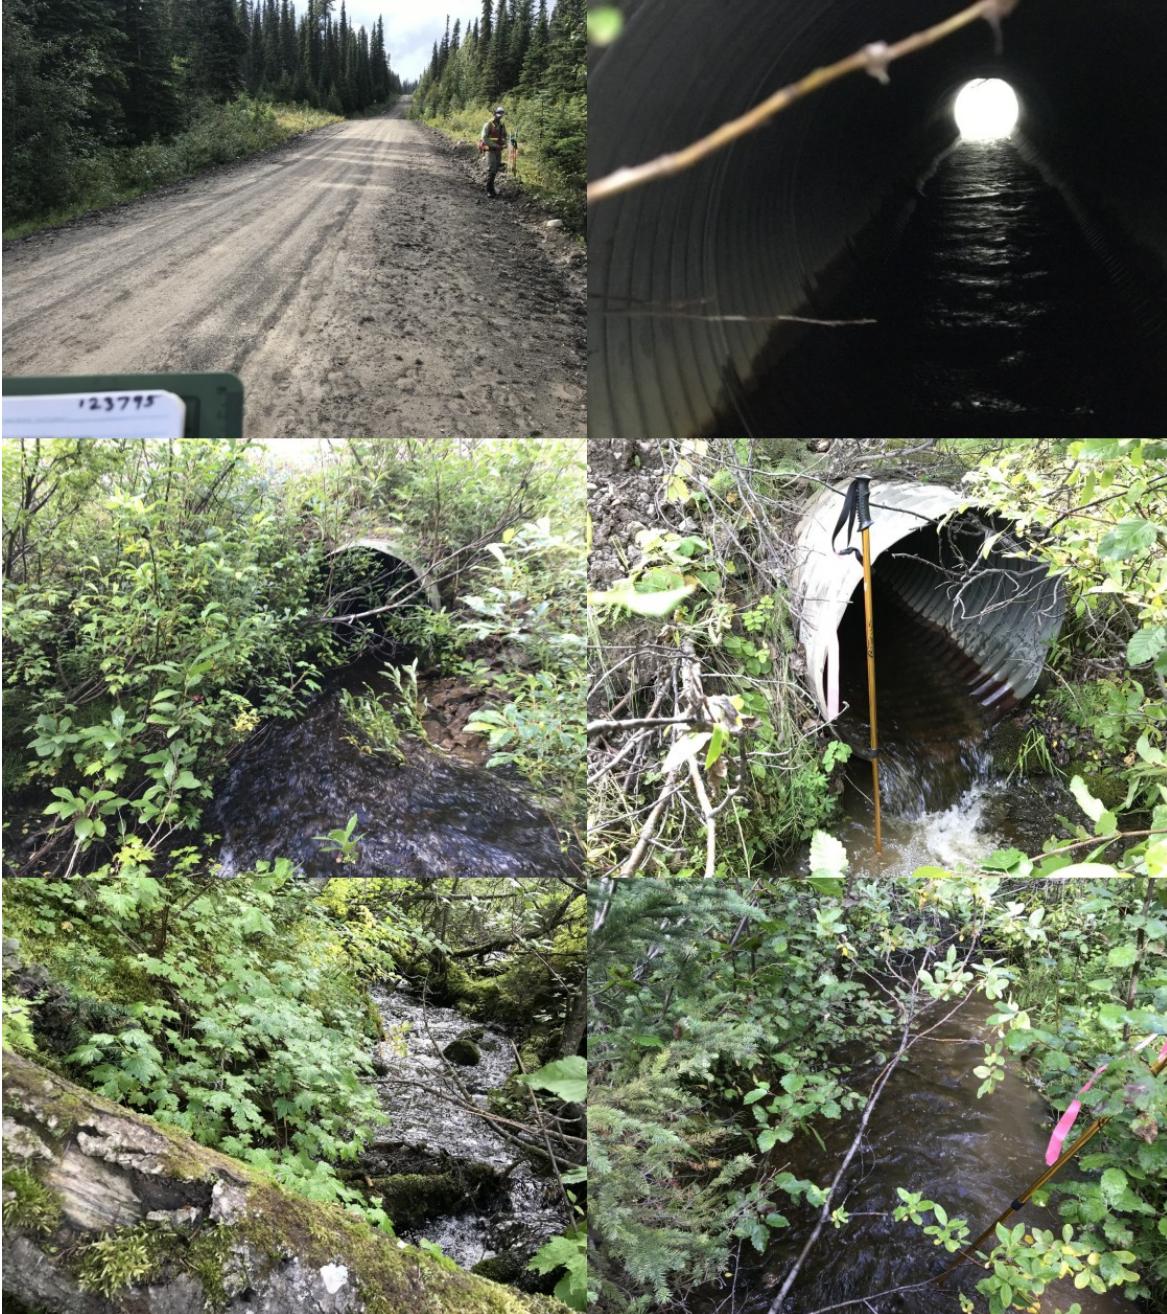
Comments: Smaller stream with good flow. Salmon point (juvenile) noted upstream. Recommend sampling upstream and downstream and habitat assessment of stream at associated PSCIS crossing 123785.

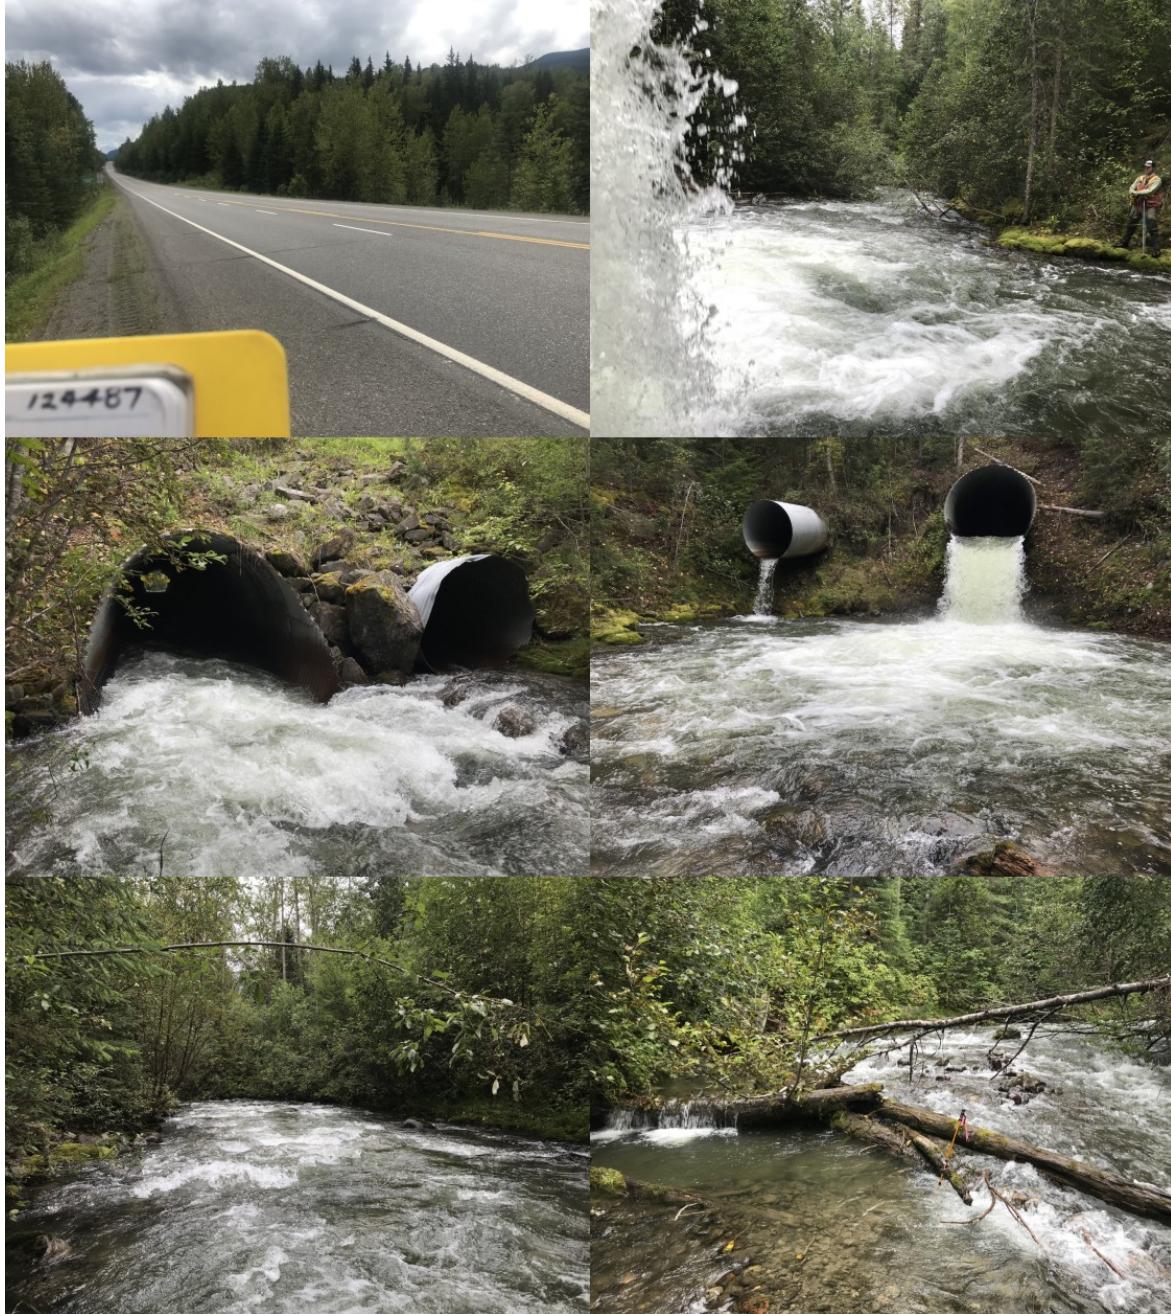
Comments: Unpassable to all life stages and species. Fill depth is approximately 35m. Salomid (50cm) observed trying to ascend to outlet of main pipe.

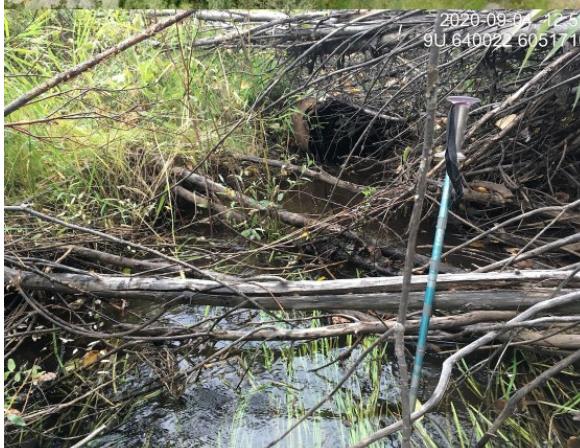
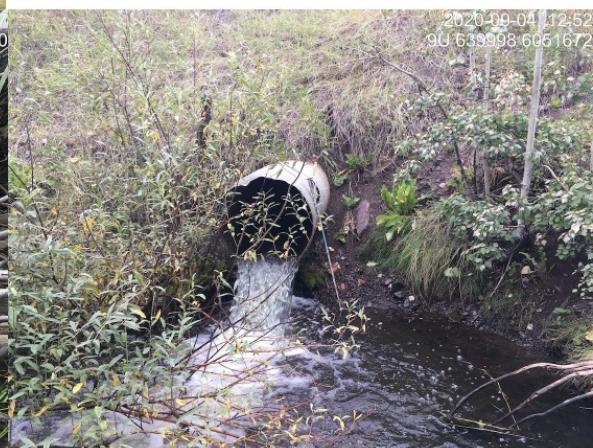
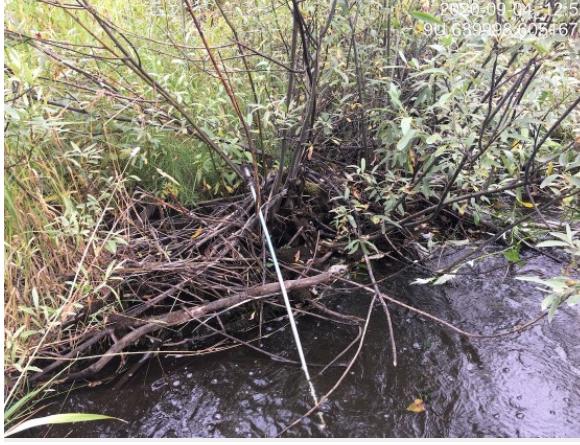
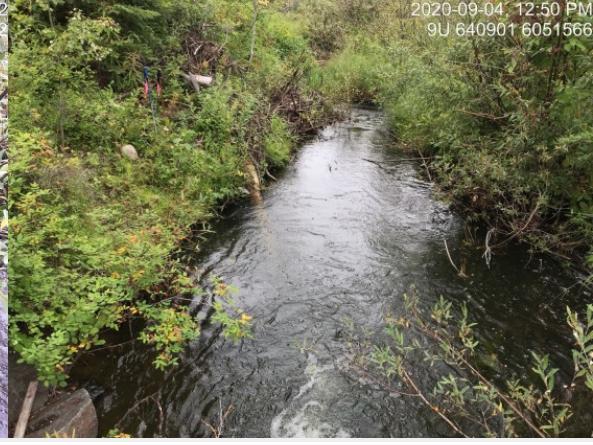
Comments: Flows into Deep Creek downstream. Electrofished upstream and downstream. Wetland type habitat upstream with CO captured below only. Candidate for backwatering?

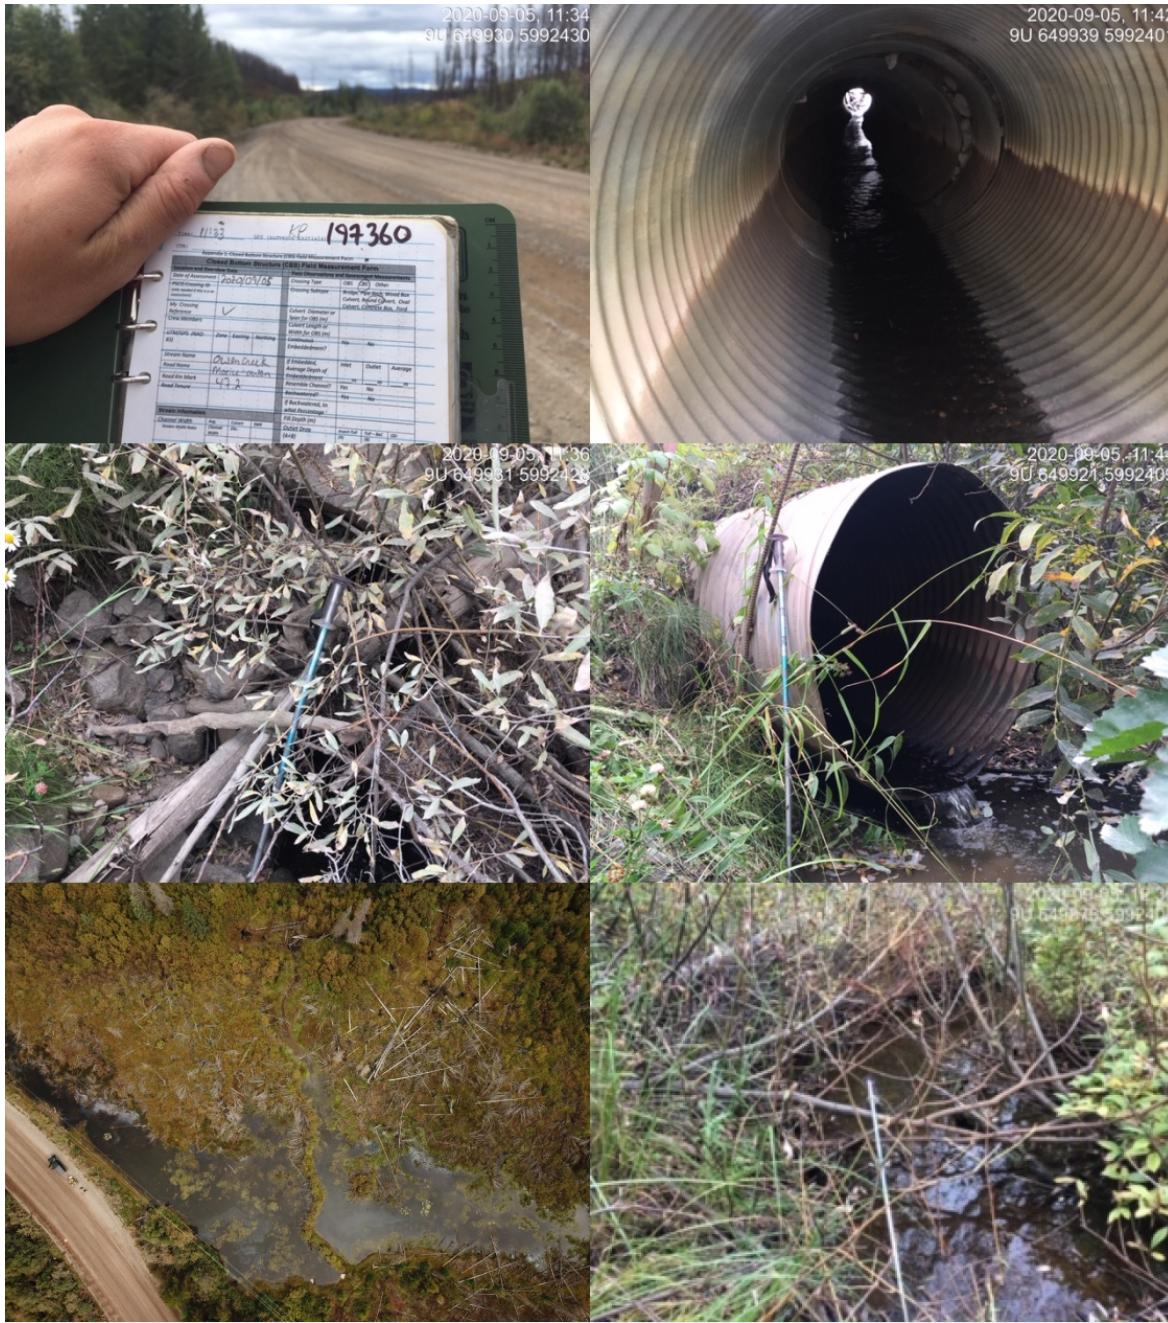
Comments: Wetland type habitat for first 300m upstream then 3m wide channel with cover available in all forms with pools suitable for juvenile RB and CO overwintering. Abundant gravels and small cobbles throughout suitable for CO or RB/ST spawning.

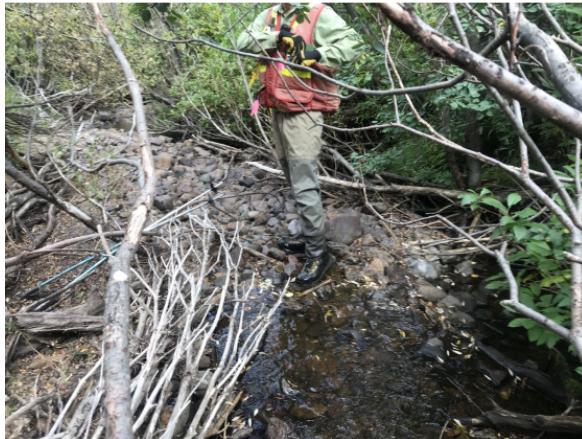
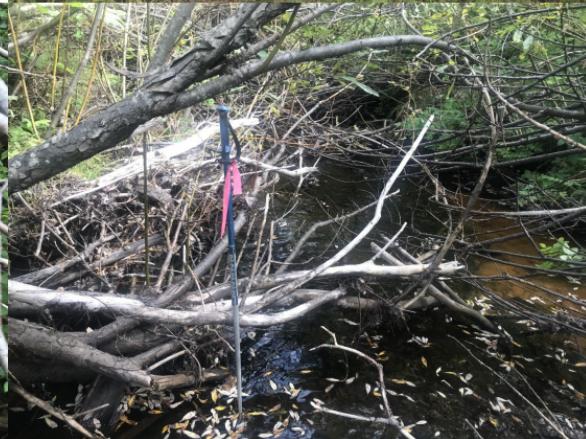
Table 5.33: Summary of fish passage assessment for PSCIS crossing 197647.

Location and Stream Data	•	Crossing Characteristics	-
Date	2020-08-26	Crossing Sub Type	Round Culvert
PSCIS ID	197647	Diameter (m)	1
External ID	1804986	Length (m)	16
Crew	KP, AI	Embedded	No
UTM Zone	9	Depth Embedded (m)	-
Easting	651263.5	Resemble Channel	No
Northing	6012508	Backwatered	No
Stream	Tributary to Buck Creek	Percent Backwatered	-
Road	Carrier FSR	Fill Depth (m)	1.8
Road Tenure	FLNR Nadina 9772	Outlet Drop (m)	0.3
Channel Width (m)	1.5	Outlet Pool Depth (m)	0
Stream Slope (%)	2	Inlet Drop	No
Beaver Activity	No	Slope (%)	1.5
Habitat Value	Low	Valley Fill	Deep Fill
Final score	34	Barrier Result	Barrier
Fix type	Replace Structure with Streambed Simulation CBS	Fix Span / Diameter	3

Comments: Suspect no fish. Multiple fish survey sites located downstream. Dry at time of survey.

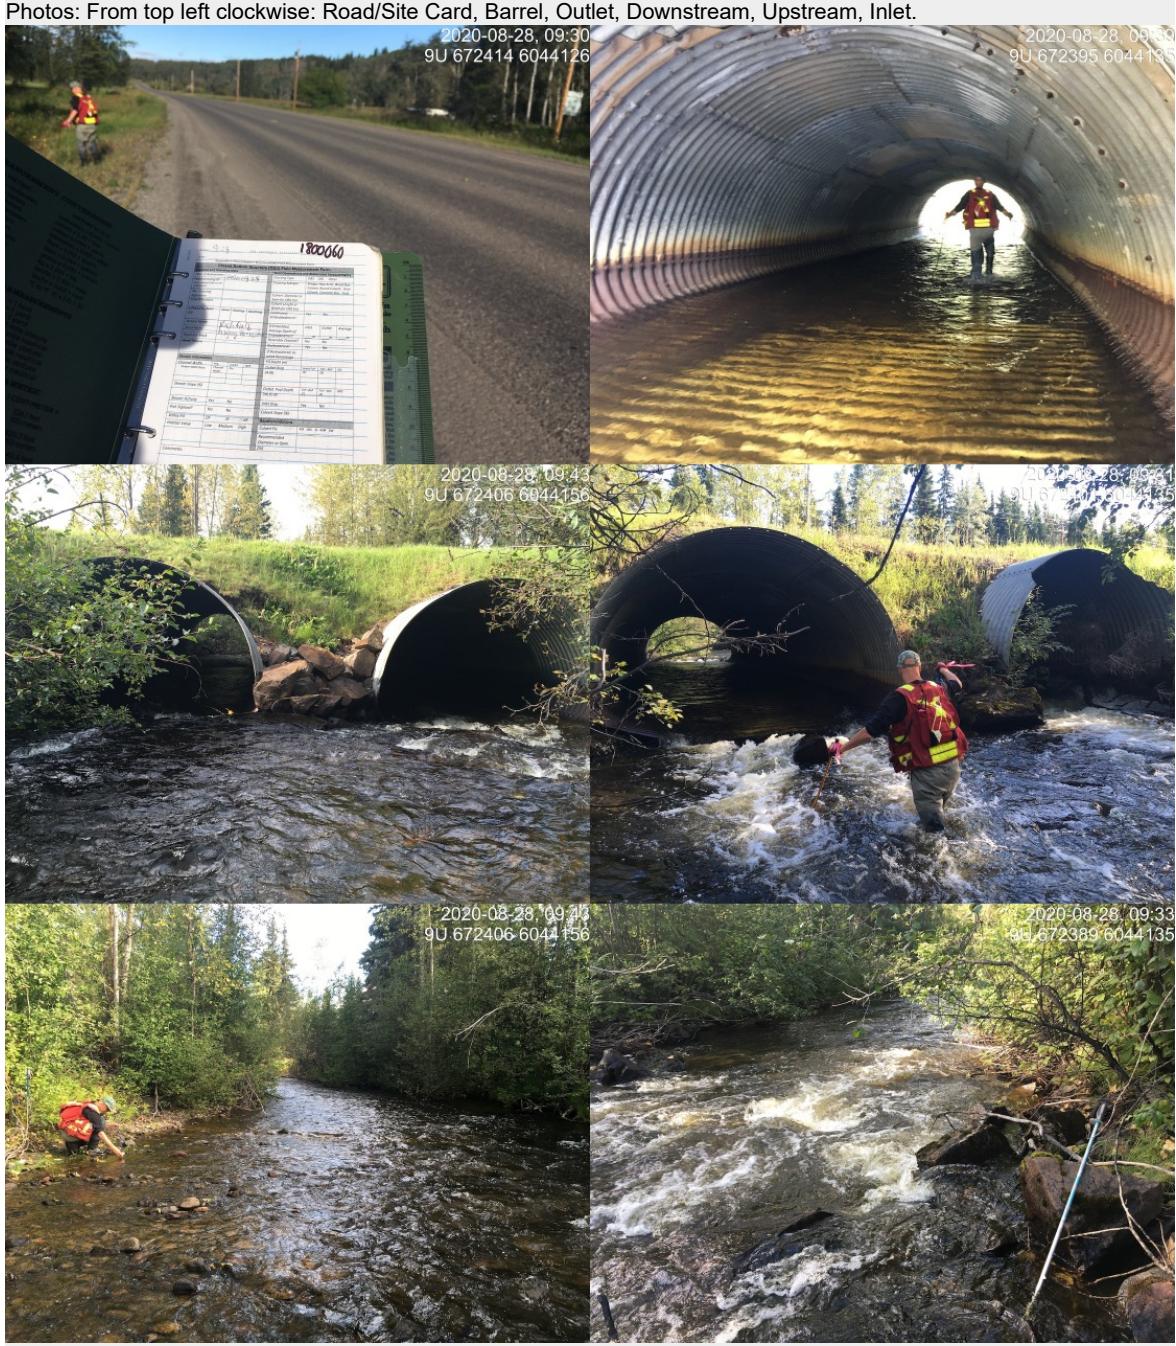
The crossing at the highway presents a barrier not only to some fry and juvenile salmonids due to the small outlet drop and high flow velocities within the pipes but also to adult salmon migrating upstream to spawn during low flows due to shallow water depths in the pipes. Future electrofishing surveys upstream and downstream of the crossing are recommended to provide presence/absence as well as density data for chinook salmon, coho salmon and other species. Highway 16 is the responsibility of the Ministry of Transportation and Infrastructure and was ranked as a high priority for proceeding to design for replacement. Restoration of riparian forests, cattle exclusion, bank stabilization and habitat complexing as per NCFDC (1998) could be considered alongside fish passage restoration activities and an assessment of the passability of the debris jam just upstream of the crossing is recommended when fish passage restoration works at the highway are initiated.

Stream Slope (%)	1.5	Inlet Drop	No
Beaver Activity	No	Slope (%)	2
Habitat Value	High	Valley Fill	Deep Fill
Final score	29	Barrier Result	Barrier
Fix type	Replace with New Open Bottom Structure		Fix Span / Diameter
Comments:	Habitat confirmation and minnowtrapping completed.		
Photos:	From top left clockwise: Road/Site Card, Barrel, Outlet, Downstream, Upstream, Inlet.

Structure replacement with a bridge (16.5m span) is recommended to provide access to the habitat located upstream of PSCIS crossing 197662. The cost of the work is estimated at \$8,250,000 for a

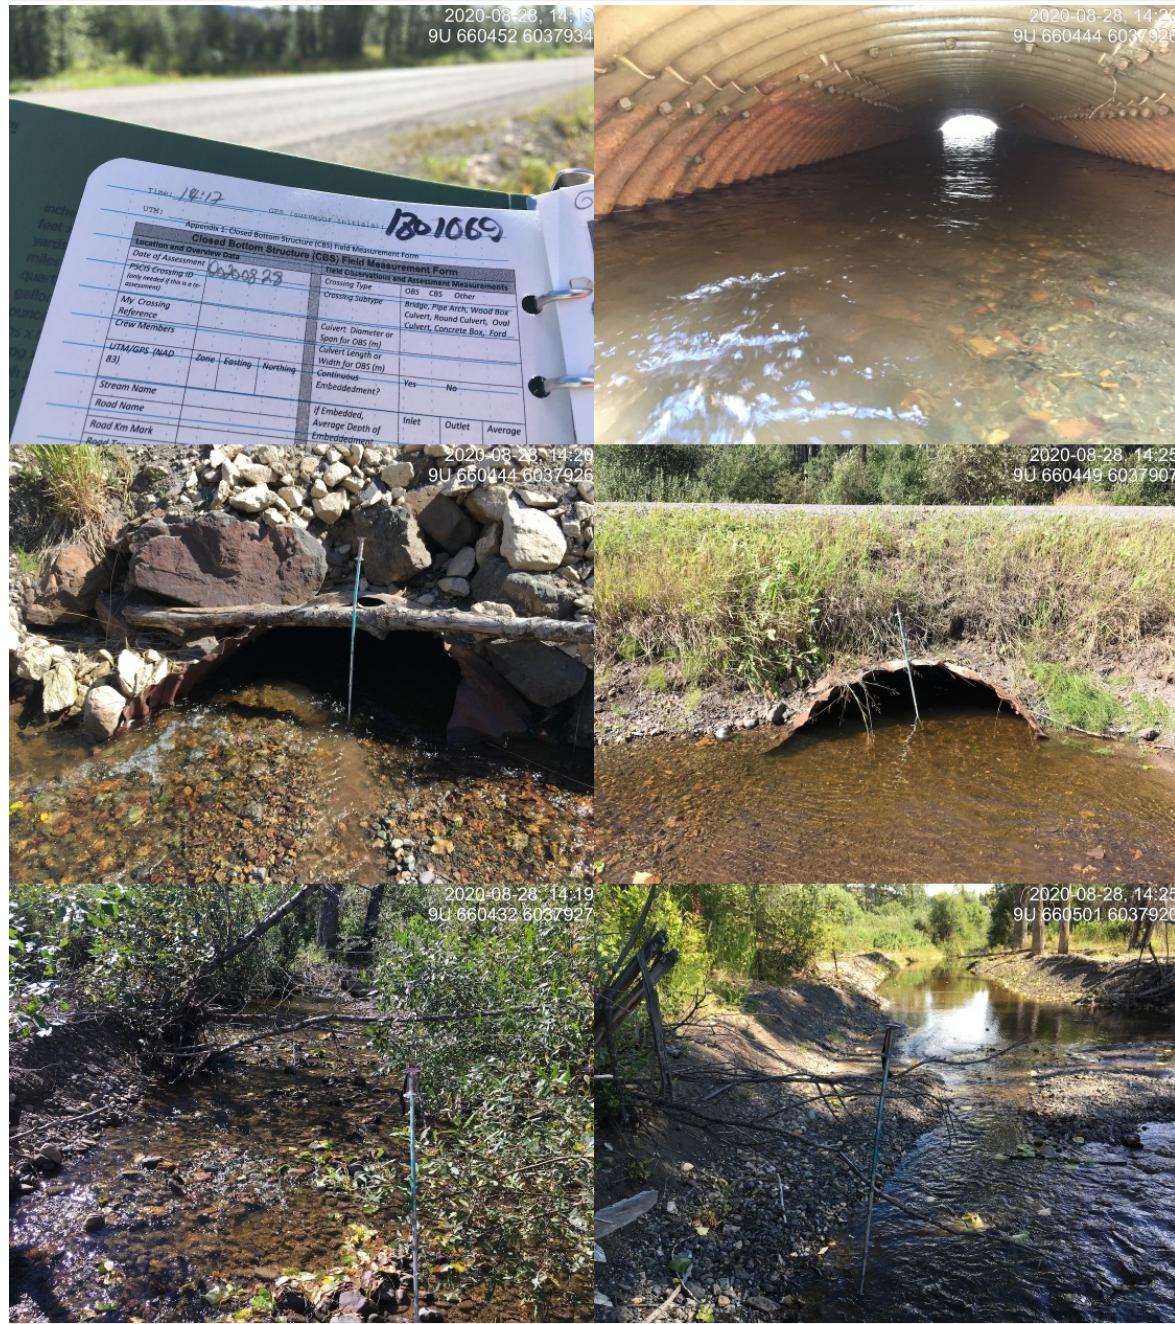
Table 5.48: Summary of fish passage assessment for PSCIS crossing 197664.

Comments: Habitat confirmation completed.

Comments: Targeted for habitat confirmation due to aggradation and dredging associated impacts on coho.

Costs to replace 197665 and 197664 with bridges are estimated at \$5,000,000 per crossing. Structure replacement with an embedded culvert is recommended for 3042 (streambed simulation - 3m span) with an estimated cost of \$25,000 resulting in cost benefits of 68 linear m/\$1000 and $156.4\text{m}^2/\$1000$.

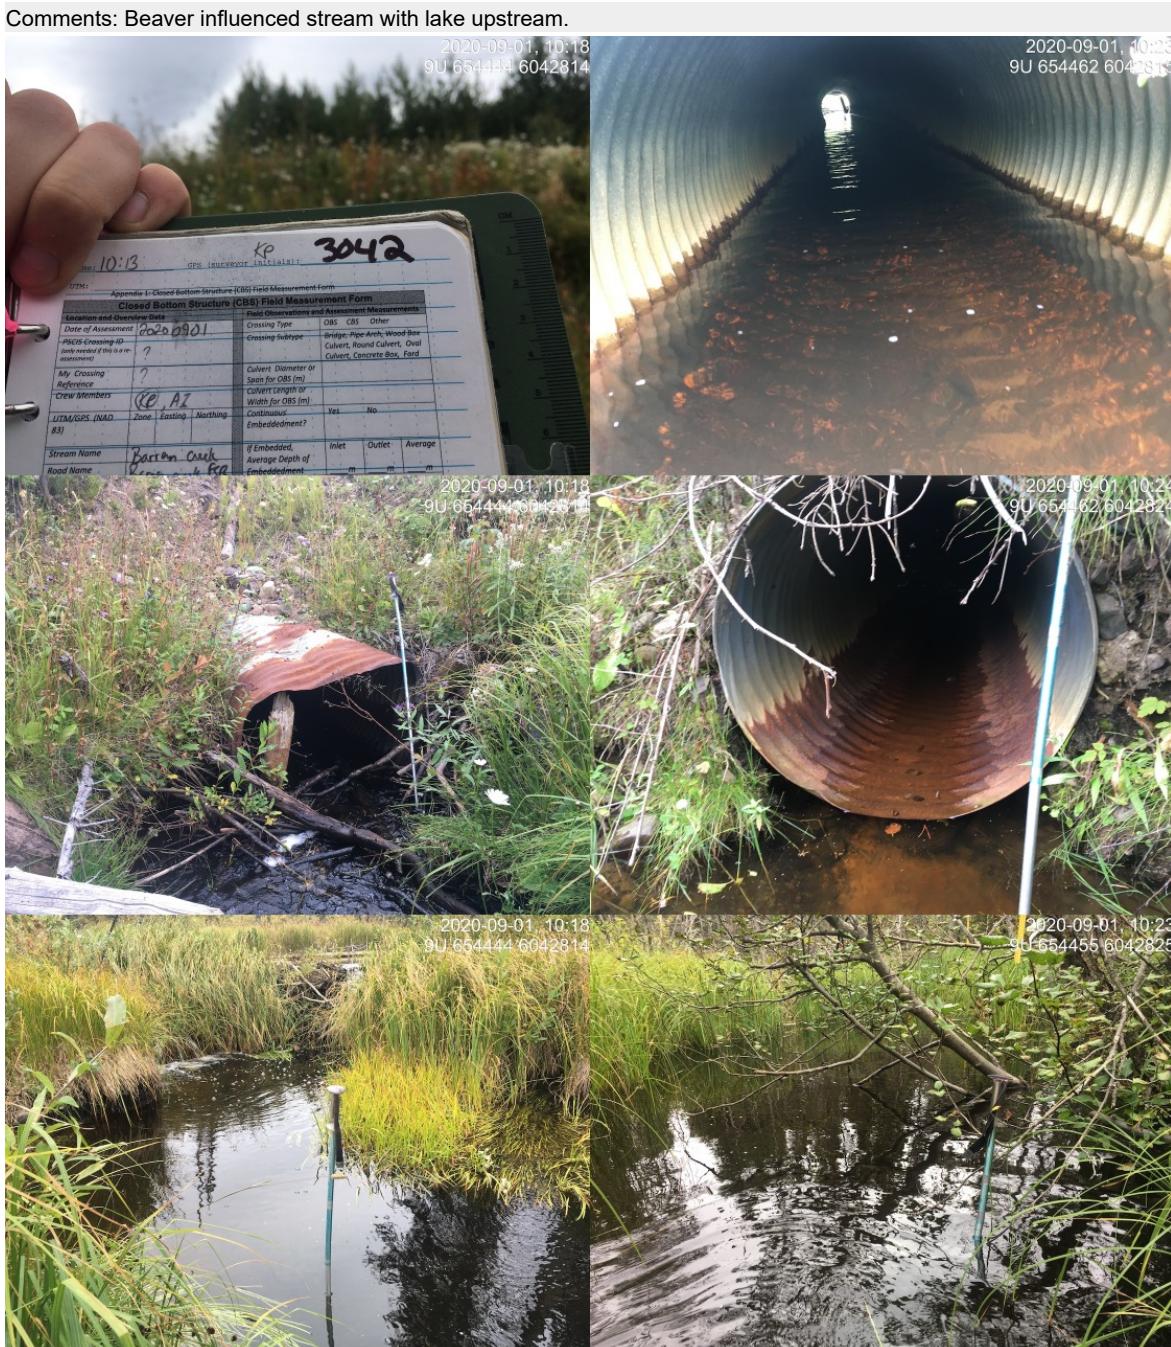
Table 5.49: Summary of fish passage assessment for PSCIS crossing 3042.

Date	2020-09-01	Crossing Sub Type	Round Culvert
PSCIS ID	3042	Diameter (m)	1
External ID	–	Length (m)	23
Crew	KP, AI	Embedded	No
UTM Zone	9	Depth Embedded (m)	–
Easting	654451	Resemble Channel	No
Northing	6042827	Backwatered	No
Stream	Barren Creek	Percent Backwatered	–
Road	Barren Creek FSR	Fill Depth (m)	2
Road Tenure	MoTi highway	Outlet Drop (m)	0
Channel Width (m)	1	Outlet Pool Depth (m)	0.5
Stream Slope (%)	0.5	Inlet Drop	Yes
Beaver Activity	Yes	Slope (%)	1.5
Habitat Value	Medium	Valley Fill	Deep Fill
Final score	21	Barrier Result	Barrier
Fix type	Replace Structure with Streambed Simulation CBS	Fix Span / Diameter	3
Photos: From top left clockwise: Road/Site Card, Barrel, Outlet, Downstream, Upstream, Inlet.

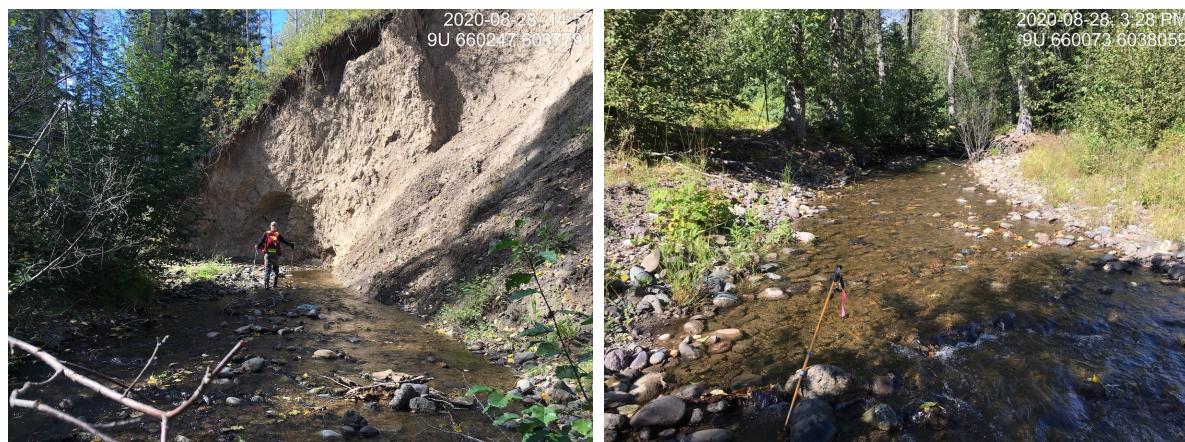
Figure 5.40: Left: Habitat upstream of PSCIS crossing 197664 and location of cutslope. Right: Habitat upstream of PSCIS crossing 197664.

active cut was noted approximately 100m upstream of culvert. It is suspected that this area is constantly depositing gravels into stream. There extensive areas of gravels suitable for CO spawning. Riparian vegetation consisted of a mature cottonwood forest with right bank armouring and riparian removal along the adjacent private road. Habitat was rated as high value for resident and anadromous salmonid rearing and spawning.

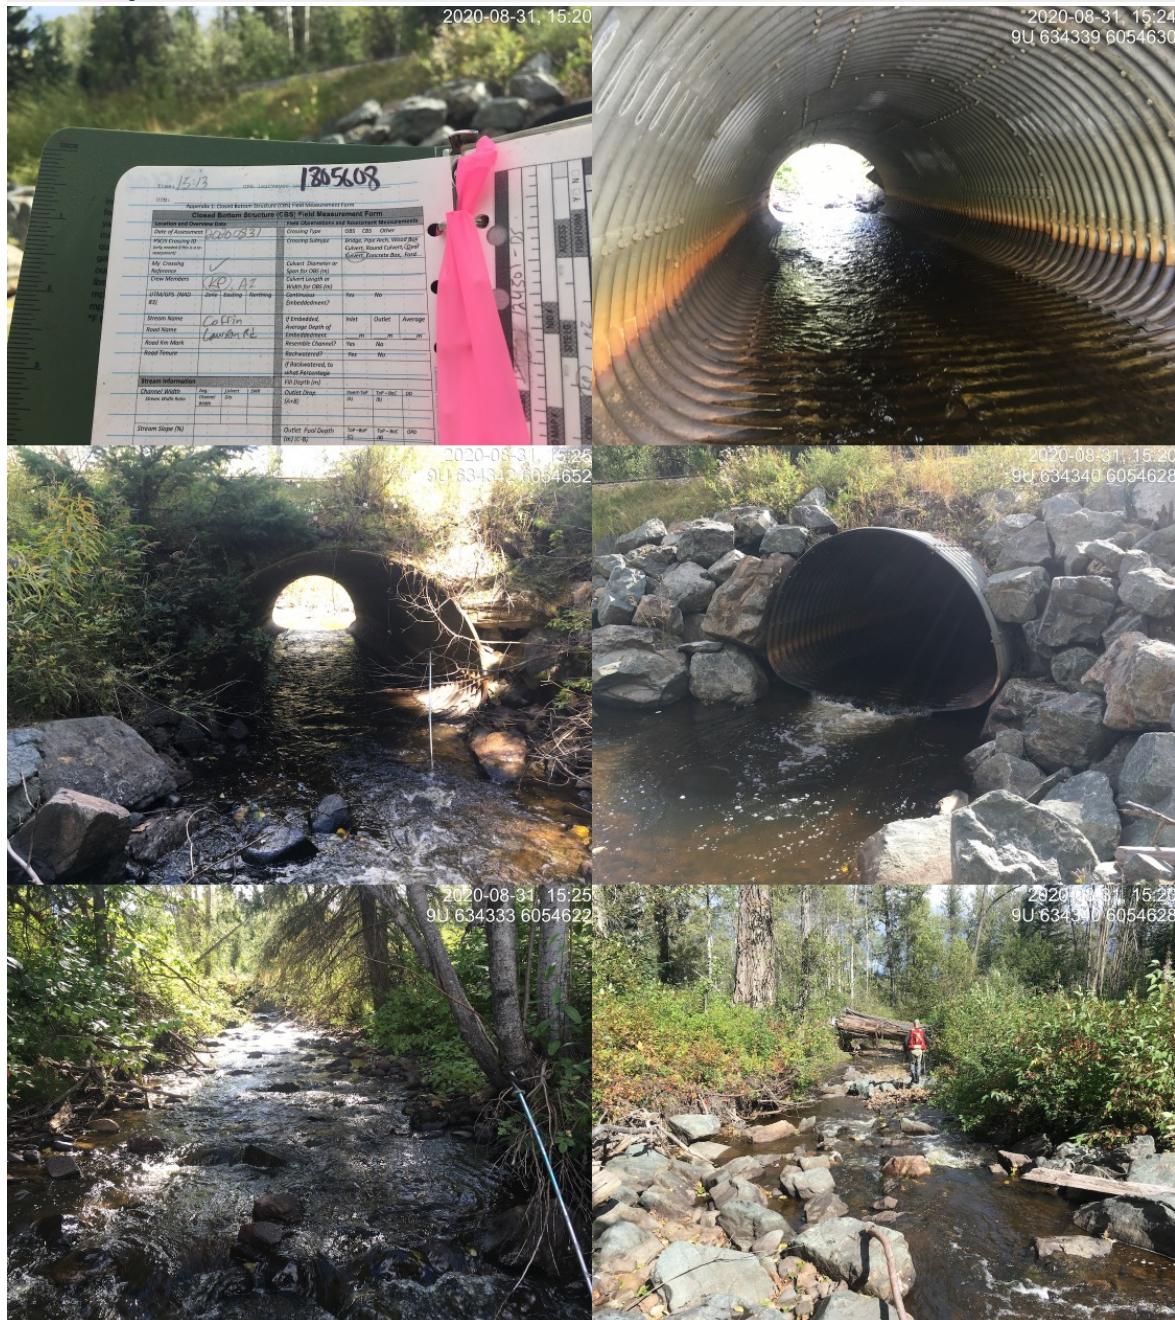
Comments: CN crossing has had Newbury riffles constructed to decrease the size of the outlet drop but drop still present. Abundant gravels suitable for spawning chinook and coho present. Some deep pools available for fry/parr overwintering.
