Elk River Fish Passage

Al Irvine, R.P.Bio.

2020-12-14

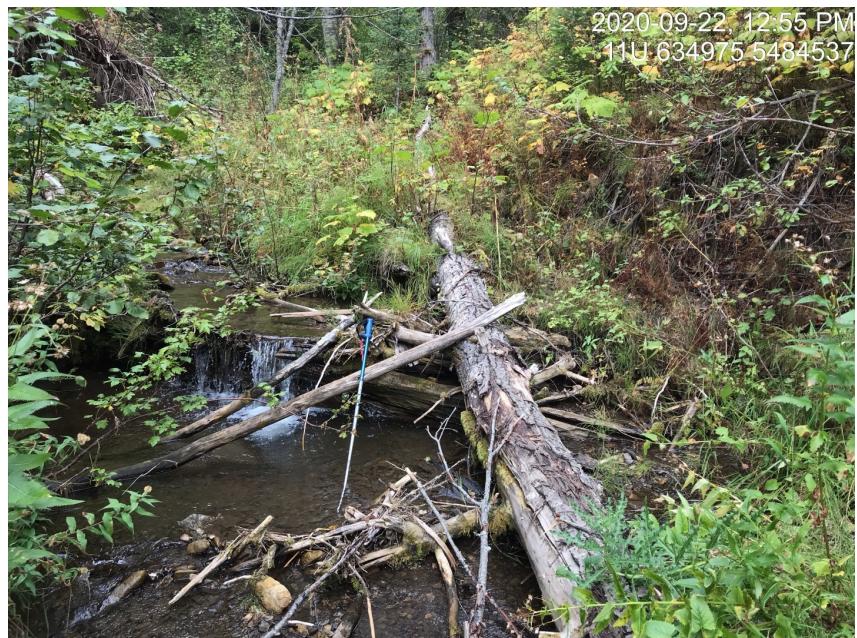
Figure 5.2: Typical habitat upstream of PSCIS crossing 50155.

There is an estimated NAKm of mainstem habitat upstream of crossing 50155 with habitat in the areas surveyed upstream of the crossing rated as high value for fry and juvenile salmonid rearing. Although it could be partially attributed to the lower gradient habitat downstream and the proximity to the Lizard Creek mainstem, fish sampling results indicated that the crossing is potentially negatively impacting habitat capacity upstream of the crossing as higher densities of westslope cutthroat trout were captured downstream of the crossing than above. It is unclear whether the road is part of the Island Lake Recreational tenure or solely the responsibility of the Ministry of Forests, Lands, Natural Resource Operations & Rural Development. The crossing was ranked as a moderate priority for proceeding to design for an open bottomed replacement structure.
