# Elk River Fish Passage Restoration Planning

Al Irvine, B.Sc., R.P.Bio.

2020-12-15

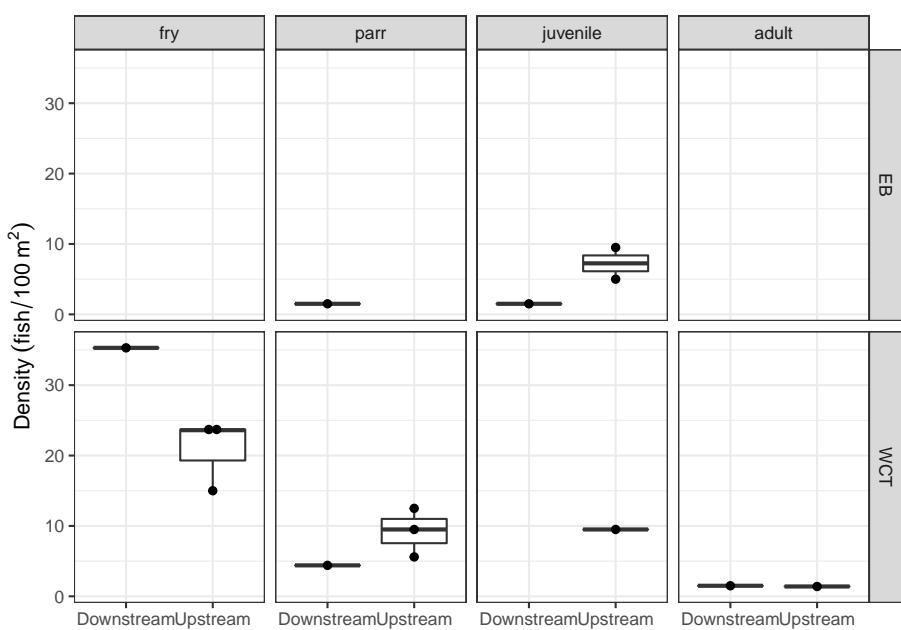
Table 5.3: Westslope cutthroat trout densities (fish/100m<sup>2</sup>) for PSCIS crossing 50155.

Figure 5.1: Fish densities (fish/100m<sup>2</sup>) for PSCIS crossing 50155.

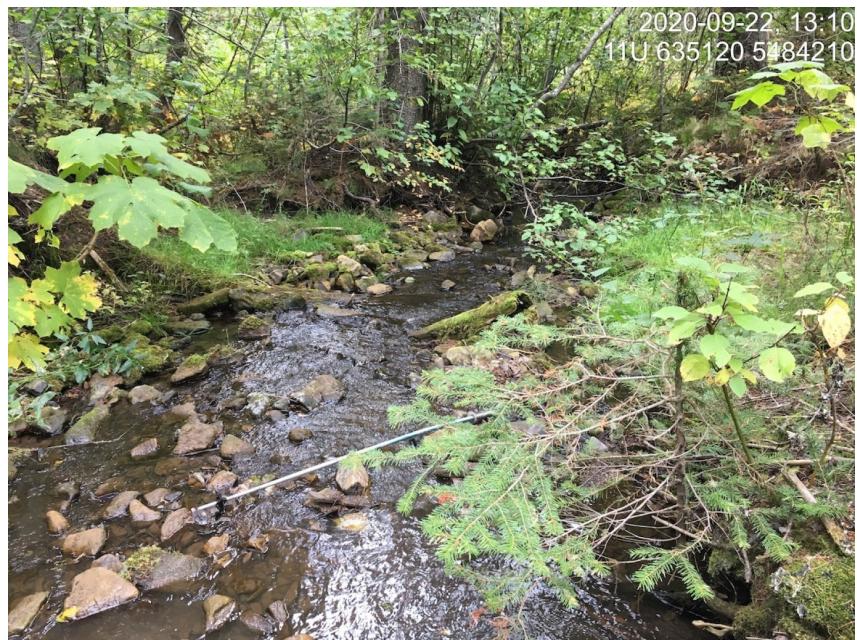
Figure 5.2: Typical habitat downstream of PSCIS crossing 50155.

Structure replacement with an open bottomed culvert is recommended to provide unconstrained access to the habitat located upstream of PSCIS crossing 50155. The cost for work is estimated at \$125000 for a cost benefit of \$8700/linear m and \$9700/m<sup>2</sup>.

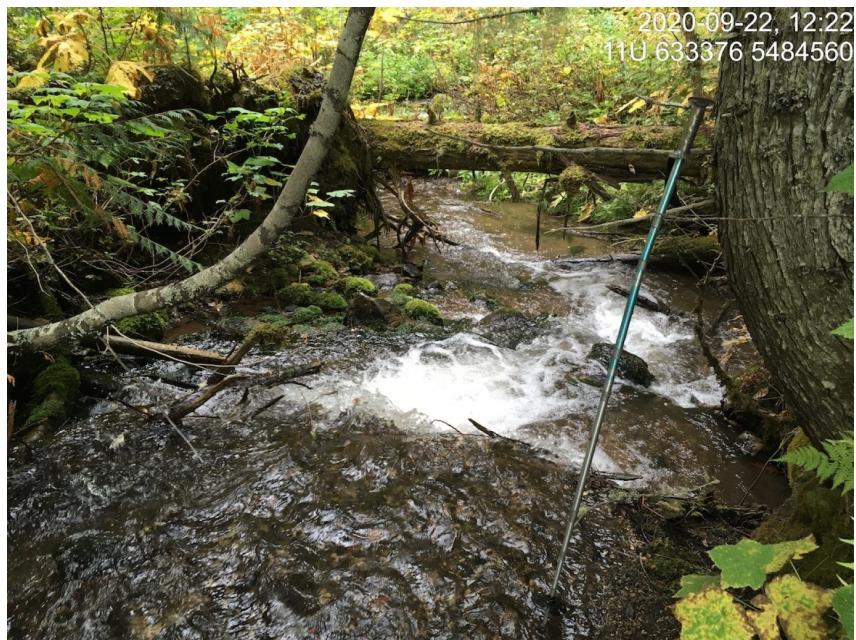
Figure 5.4: Typical habitat downstream of PSCIS crossing 50159.

Structure replacement with an open bottomed culvert is recommended to provide unconstrained access to the habitat located upstream of PSCIS crossing 50159. The cost for work is estimated at \$125000 for a cost benefit of \$0/linear m and \$0/m<sup>2</sup>.

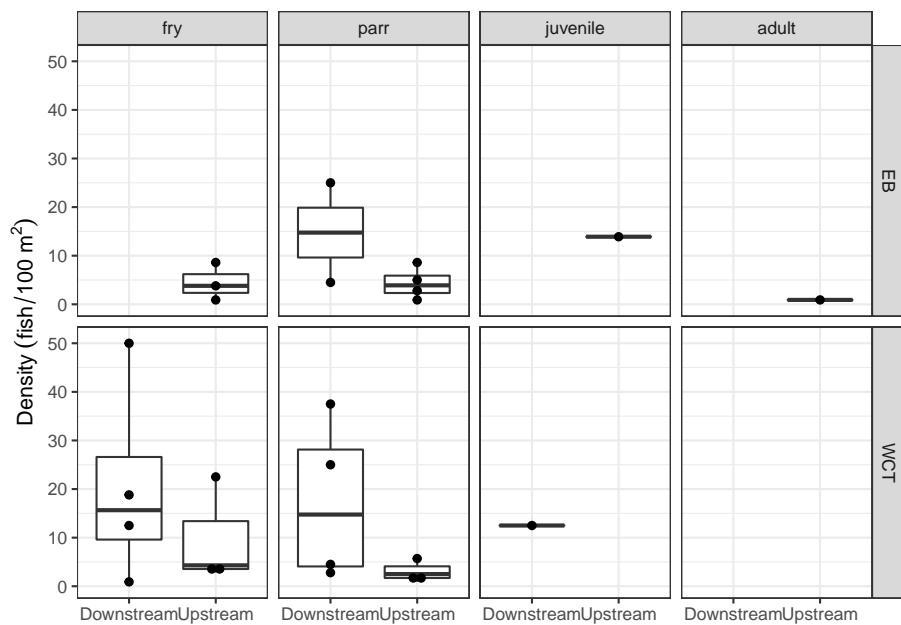
Table 5.7: Westslope cutthroat trout densities (fish/100m<sup>2</sup>) for PSCIS crossing 50185.

Figure 5.6: Fish densities (fish/100m<sup>2</sup>) for PSCIS crossing 50185.

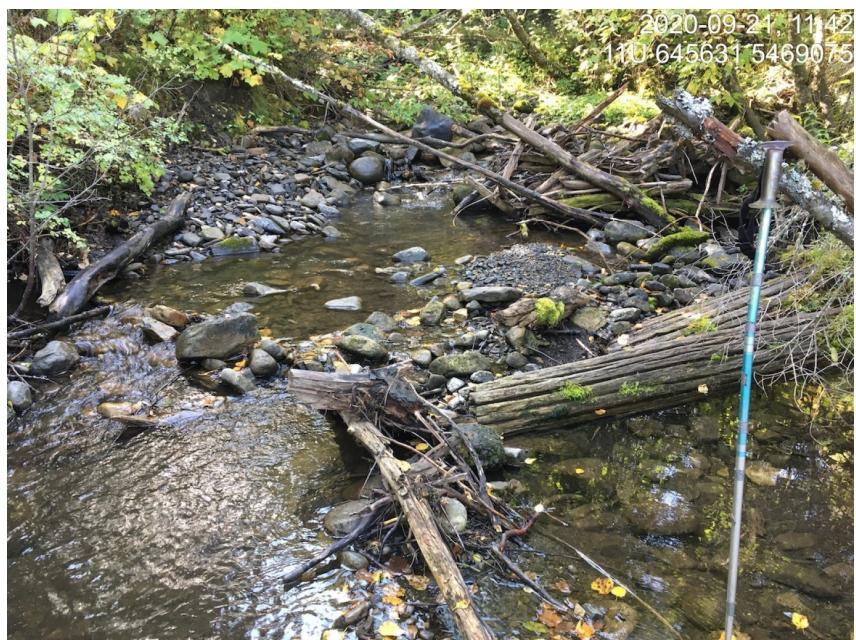
The stream was surveyed downstream from the culvert for 255m to the confluence with Morrissey Creek. The mouth of the stream is located approximately 500m upstream from the confluence of Morrissey Creek and the Elk River. Overall, total cover amount was rated as moderate with small woody debris dominant. Cover was also present as large woody debris, undercut banks, deep pools, and overhanging vegetation (Figure ??). The average channel width was 4.3m, the average wetted width was 2.7m and the average gradient was 4.2%. The dominant substrate was cobbles with gravels subdominant. There were frequent pools formed by small and large woody debris ranging from 0.3 - 0.75m in depth (average residual depth = 0.4m). Pockets of small gravels suitable for resident salmonid spawning were also present. Habitat value was rated as high with good potential for fry/juvenile salmonid rearing.

Figure 5.7: Typical habitat downstream of PSCIS crossing 50185.

Structure replacement with an open bottomed culvert is recommended to provide unconstrained access to the habitat located upstream of PSCIS crossing 50185. The cost for work is estimated at \$125000 for a cost benefit of \$14400/linear m and \$30900/m<sup>2</sup>.

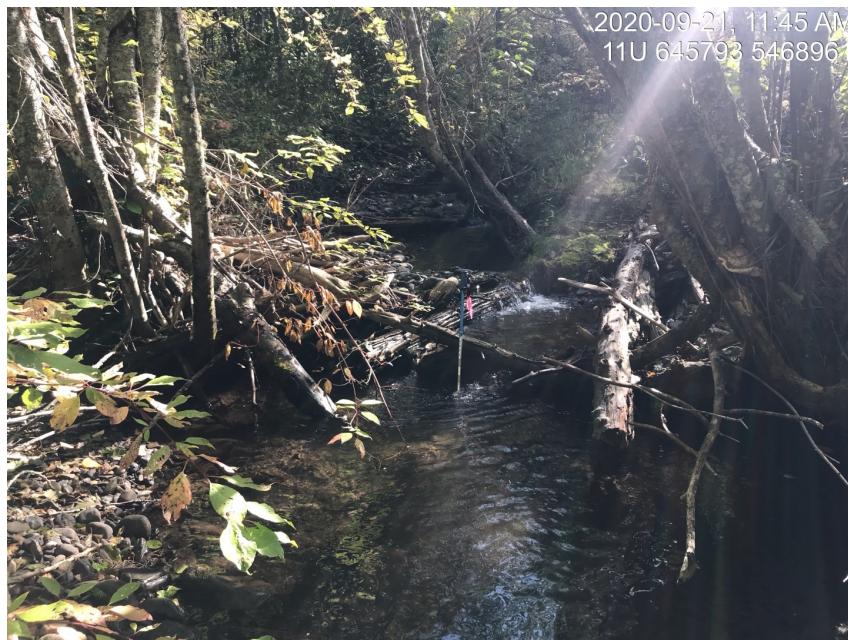
The stream was surveyed upstream from the culvert for 740m. Overall, total cover amount was rated as moderate with small woody debris dominant. Cover was also present as large woody debris, undercut banks, deep pools, and overhanging vegetation (Figure 5.3). The average channel width was 4m, the average wetted width was 2.8m and the average gradient was 6.2%. The dominant substrate was cobbles with gravels subdominant. The stream had good flows with fry observed throughout the area surveyed. Pools to 0.6m deep (average residual depth = 0.4m) were present with pockets of gravel suitable for spawning throughout. Infrequent large woody debris jams to 0.5m high were also observed. There were frequent areas of gravels suitable for resident westslope cutthroat trout spawning. Habitat value was rated as high for fry and juvenile westslope cutthroat trout rearing.

Figure 5.8: Typical habitat upstream of PSCIS crossing 50185.

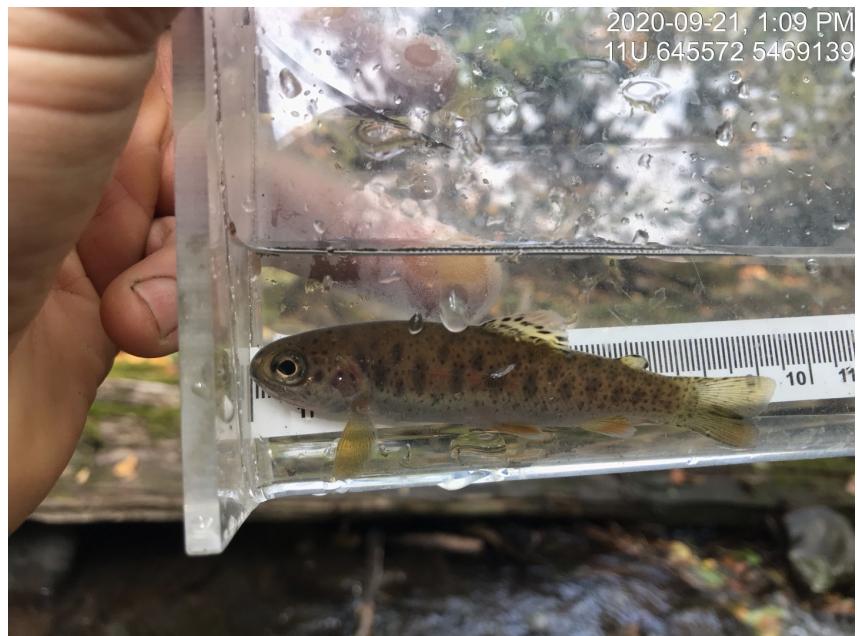
Figure 5.9: Westslope cutthroat trout captured upstream of PSCIS crossing 50185.

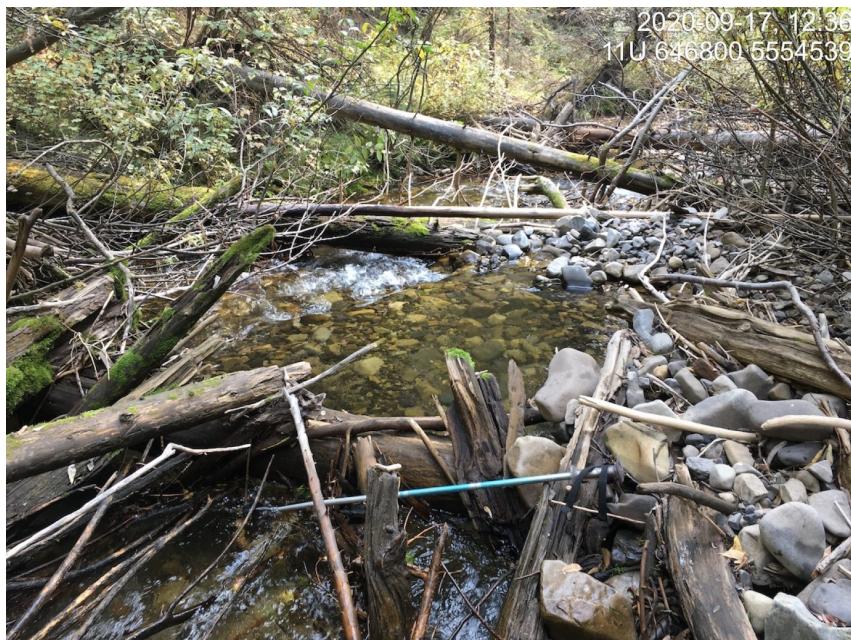
Figure 5.10: Typical habitat downstream of PSCIS crossing 197555.

Structure replacement with an open bottomed culvert is recommended to provide access to the habitat located upstream of PSCIS crossing 197555. Due to the large amount of fill on the road (8) the size of a replacement bridge was estimated at 25m. The cost for work is estimated at \$312000 for a cost benefit of \$21900/linear m and \$38400/m<sup>2</sup>.

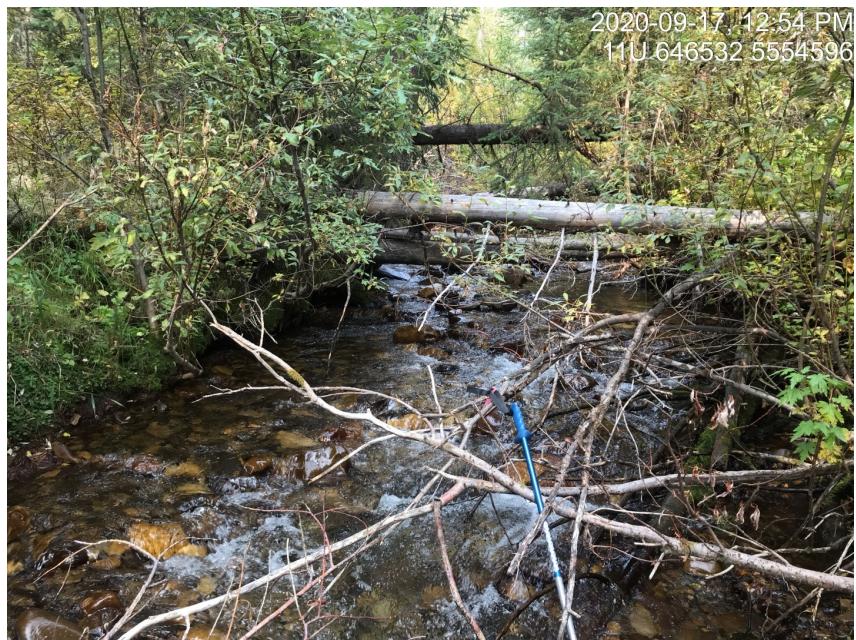
The stream was surveyed upstream from the culvert for 675m. Overall, total cover amount was rated as abundant with boulders as the dominant type. Cover was also present as small woody debris, large woody debris, undercut banks, deep pools, and overhanging vegetation (Figure 5.11). The average channel width was 5.9m, the average wetted width was 3.8m and the average gradient was 5.9%. The dominant substrate was cobbles with boulders subdominant. The stream had good flows with fry observed throughout the area surveyed. Pools to 0.6m deep (average residual depth = 0.4m) were present with pockets of gravel suitable for spawning throughout. Infrequent large woody debris jams to 0.5m high were also observed. Pockets of gravel suitable for resident and fluvial salmonid spawning were present throughout the area surveyed. Habitat value was rated as high for fry and juvenile westslope cutthroat trout and bull trout rearing.

Figure 5.11: Typical habitat upstream of PSCIS crossing 197555.

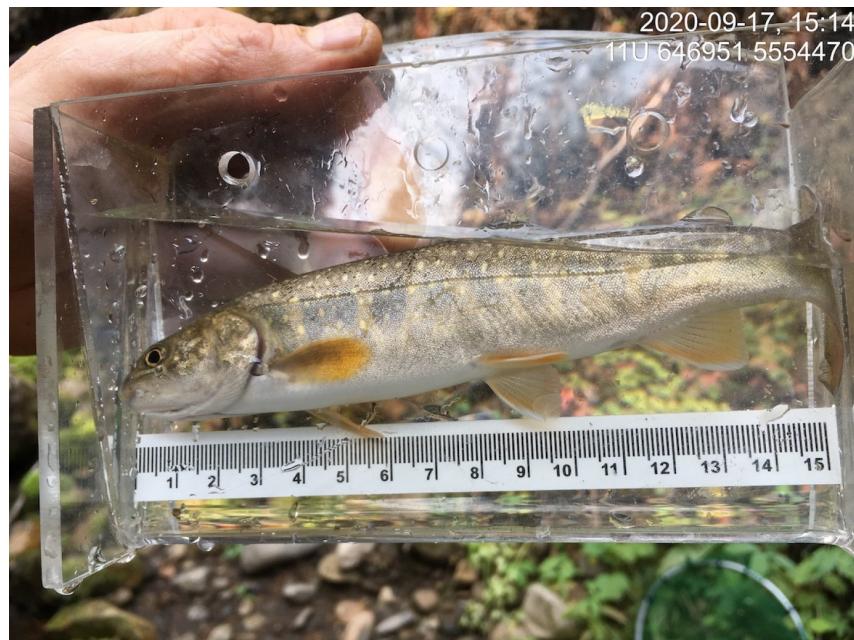
Figure 5.12: Bull trout captured downstream of PSCIS crossing 197555.
