DRAFT - Bulkley River and Morice River Watershed Groups Fish Passage Restoration Planning

Prepared for
Habitat Conservation Trust Fund
BC Fish Passage Remediation Program
Canadian Wildlife Federation

Prepared by
Al Irvine, B.Sc., R.P.Bio.
New Graph Environment
6 Regent St
Nelson, BC V1L 2P1

DRaFT - Version 0.0.8
2021-03-23

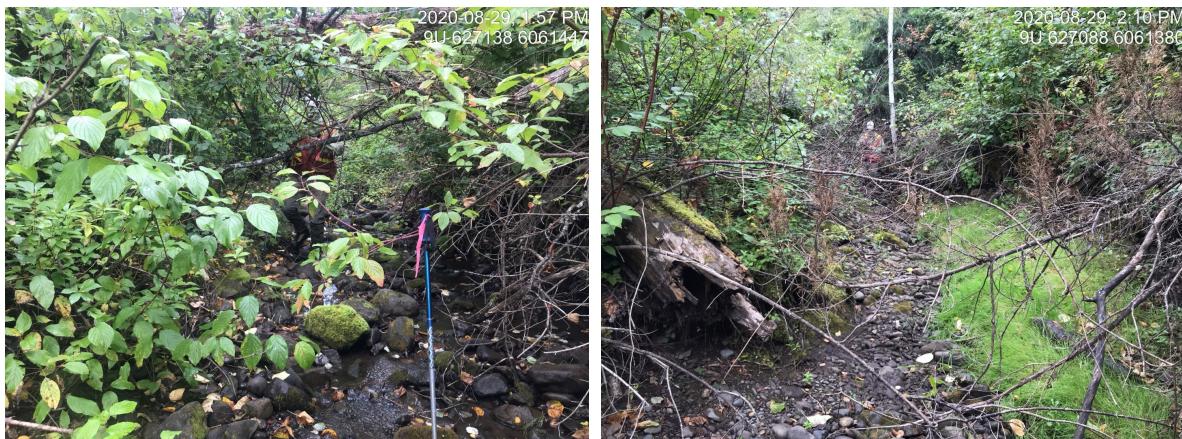
Figure 5.6: Left: Typical habitat downstream of PSCIS crossing 123445. Right: Typical habitat downstream of PSCIS crossing 123445.

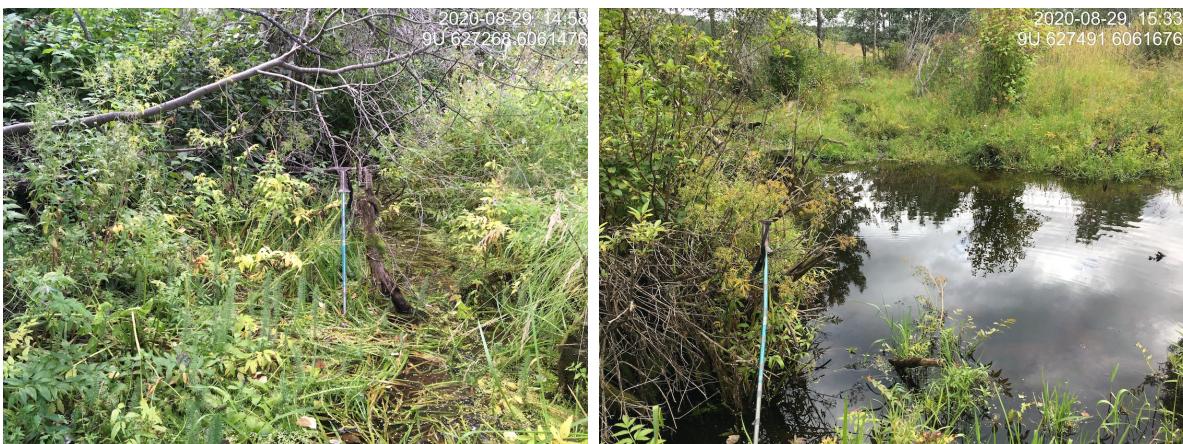
Figure 5.7: Left: Habitat upstream of PSCIS crossing 123445. Right: Habitat upstream of PSCIS crossing 123445.

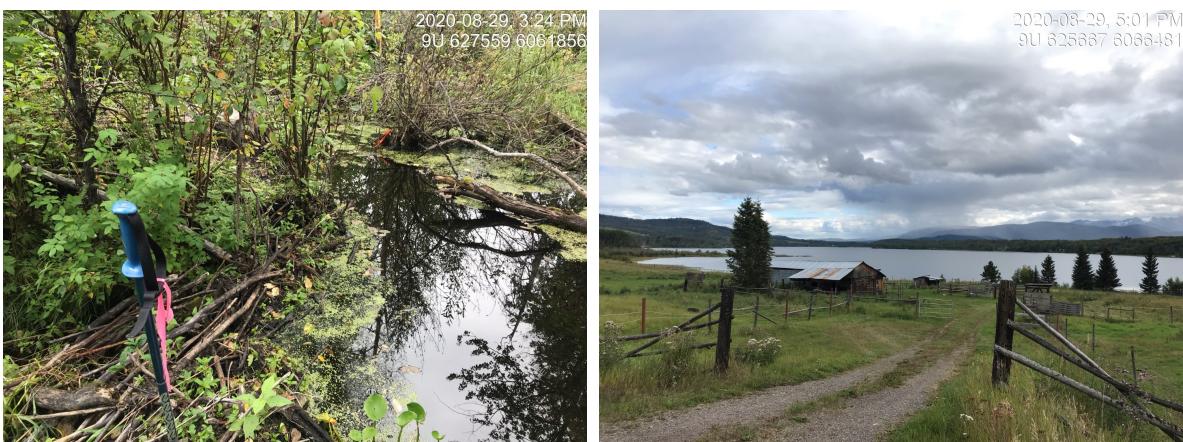
(Figure 5.8). Within the area surveyed, total cover amount was rated as abundant with overhanging vegetation dominant. Cover was also present as small woody debris, large woody debris, deep pools, and instream vegetation (Table 5.12). The average channel width was 8.5m, the average wetted width was 7.5m and the average gradient was 0.2%. Beaver activity was prevalent in the area surveyed and there was a large agricultural field located on the right bank of the stream. Habitat value was rated as moderate as it was considered an important migration corridor providing access to the lake.

Figure 5.8: Left: Habitat upstream of PSCIS crossing 123446. Right: Habitat upstream of PSCIS crossing 123446.

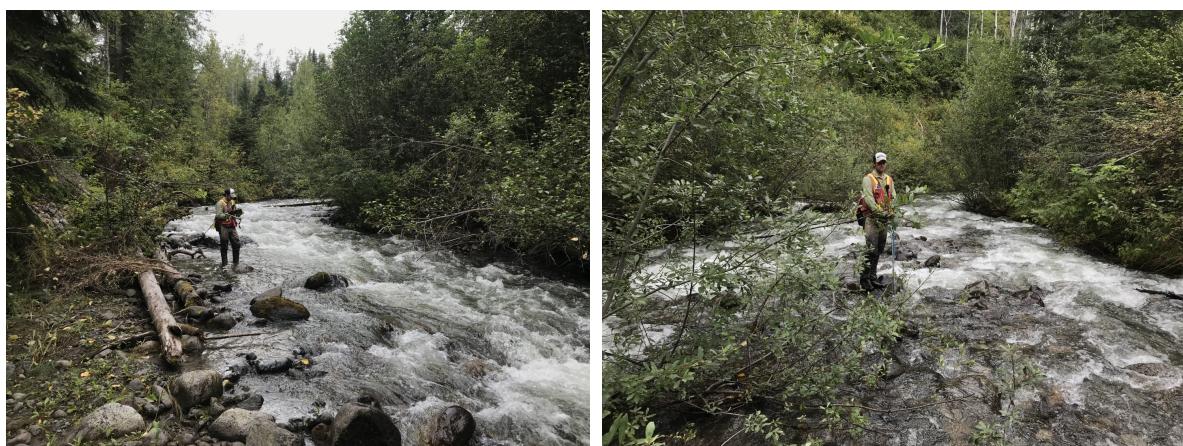
Figure 5.14: Left: habitat upstream of PSCIS crossing 124487. Right: Habitat upstream of PSCIS crossing 124487.

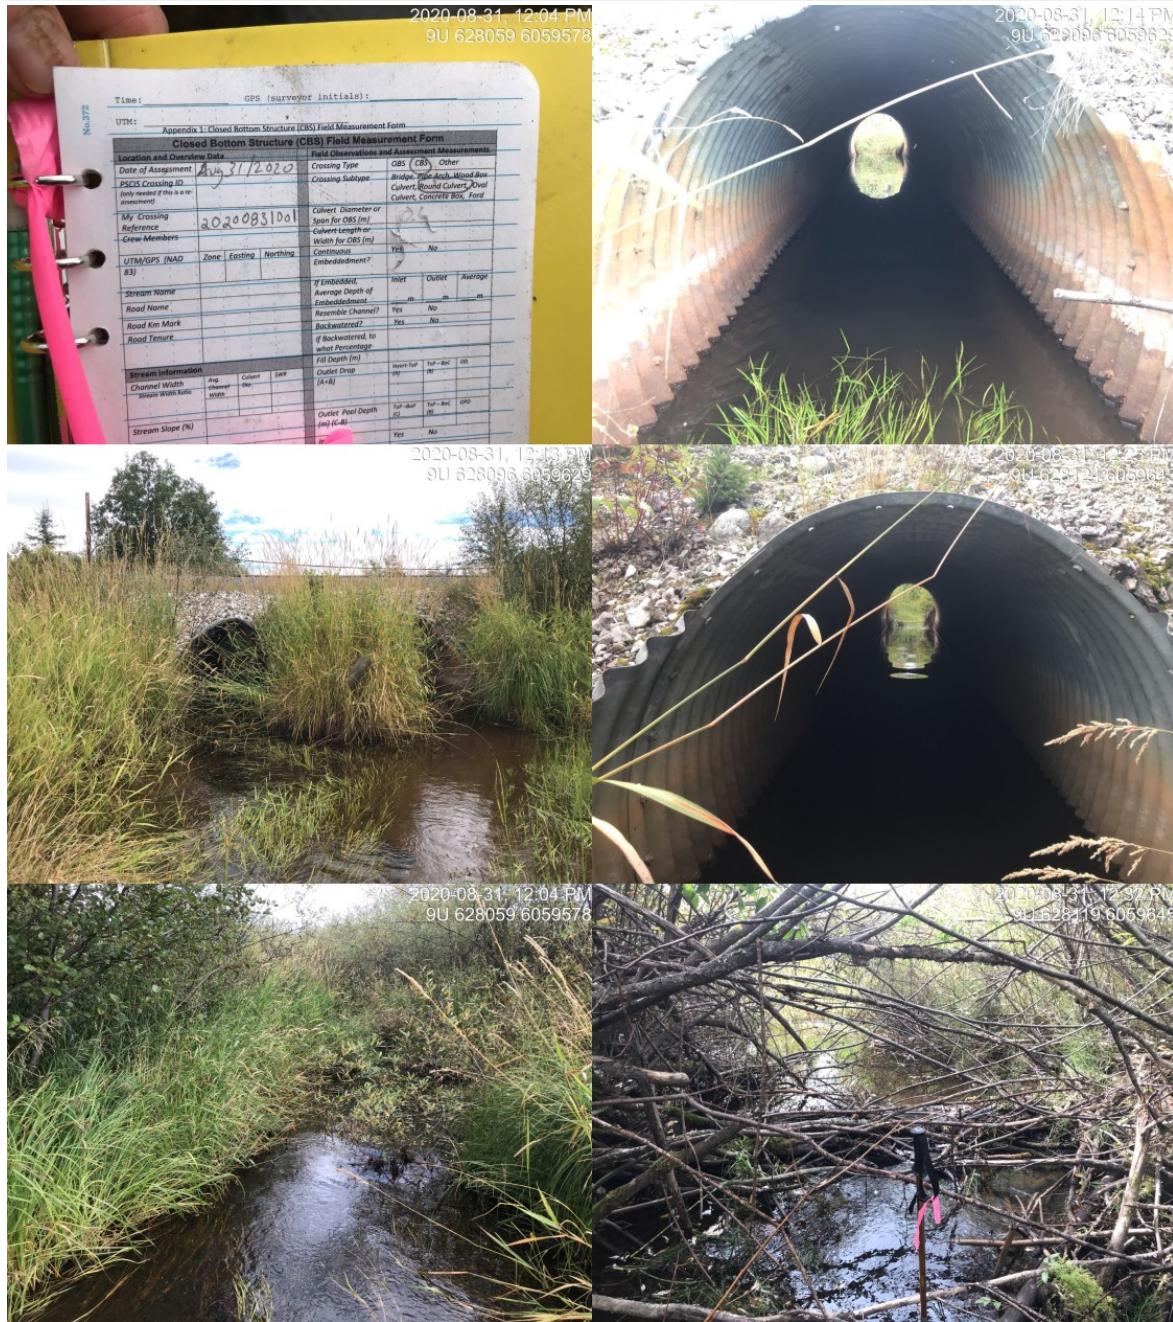
Table 5.26: Summary of habitat details for PSCIS crossing 124500.

Comments: Passable and fully backwatered structure. Landowner reports that lamprey (~40cm x 20) at crossing inside of the culvert in the past.

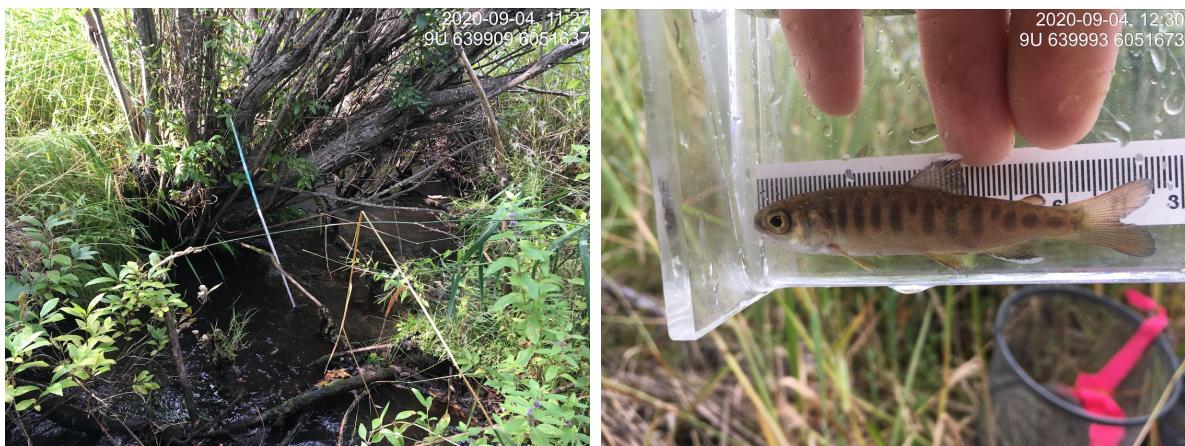
Figure 5.18: Left: Typical habitat downstream of PSCIS crossing 195290. Right: Coho captured downstream of PSCIS crossing 195290.

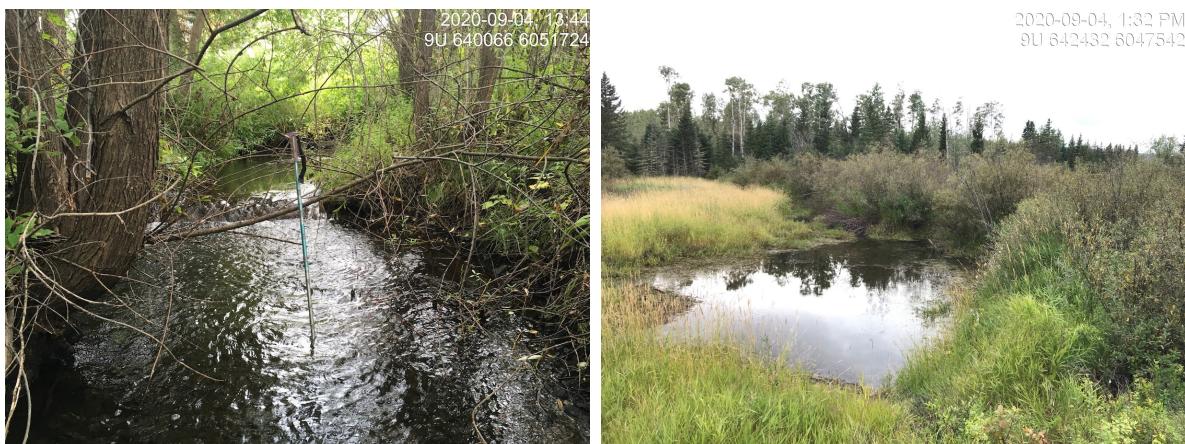
Figure 5.19: Left: Typical habitat upstream of PSCIS crossing 195290. Right: Wetland habitat upstream of PSCIS crossing 195290.

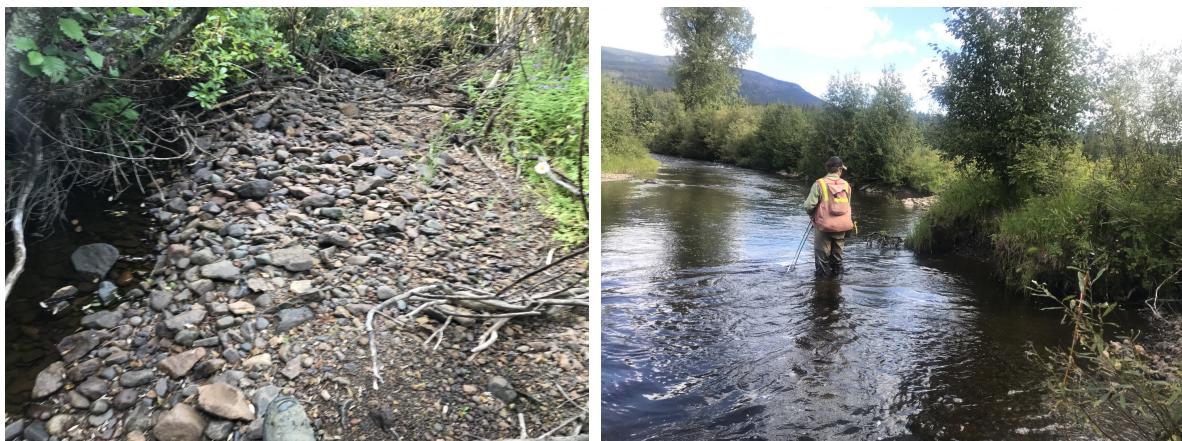
The stream was surveyed downstream from the culvert for 70m to the confluence with Buck Creek (Figure [??](#)). Total cover amount was rated as moderate with undercut banks dominant. Cover was also present as small woody debris, large woody debris, and overhanging vegetation (Table [5.44](#)). The average channel width was 4.6m, the average wetted width was 2.5m and the average gradient was 3%. The dominant substrate was gravels with cobbles subdominant. A fish (130mm) was observed in the culvert outlet pool and a substance suspected to be didymo was noted on the substrate. The habitat was rated as moderate value as it was considered an important migration corridor with habitat of moderate rearing potential for fry and juvenile salmonids.

Figure 5.24: Left: Habitat downstream of PSCIS crossing 197640. Right: Habitat downstream of crossing 197640 at the confluence with Buck Creek.

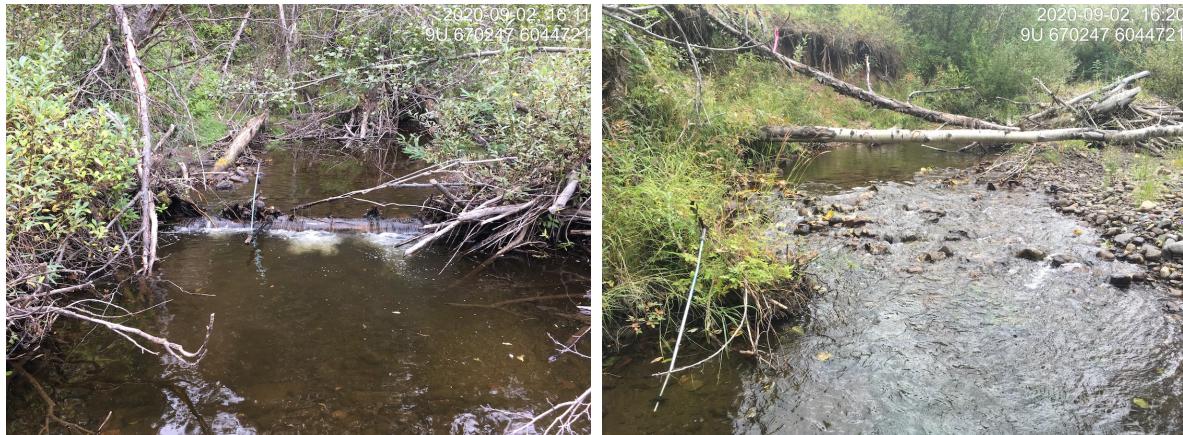
Figure 5.33: Left: Typical habitat downstream of PSCIS crossing 197663. Right: Typical habitat downstream of PSCIS crossing 197663.

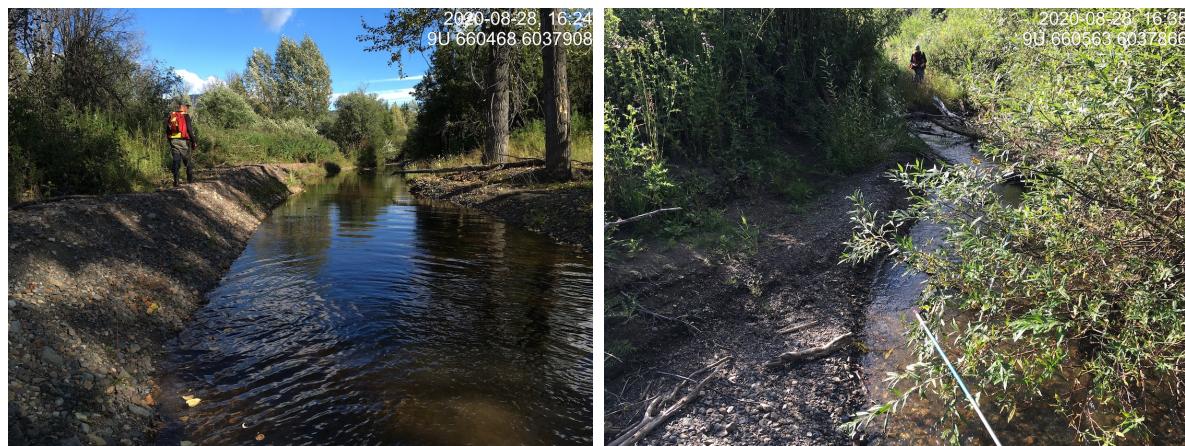
The stream was surveyed upstream from 197665 for 100m to Highway 16 (Figure 5.37). Within the area surveyed, total cover amount was rated as moderate with overhanging vegetation dominant. Cover was also present as small woody debris (Table 5.65). The average channel width was 4.7m, the average wetted width was 2.7m and the average gradient was 1.8%. Abundant gravels and small cobbles suitable for resident, fluvial, adfluvial and anadromous salmonid spawning were present throughout the area surveyed. Habitat was rated as moderate value with habitat present suitable for resident and anadromous fry/juvenile salmonid rearing and spawning.

Figure 5.37: Left: Typical habitat downstream of PSCIS crossing 197664. Right: Typical habitat downstream of PSCIS crossing 197664.

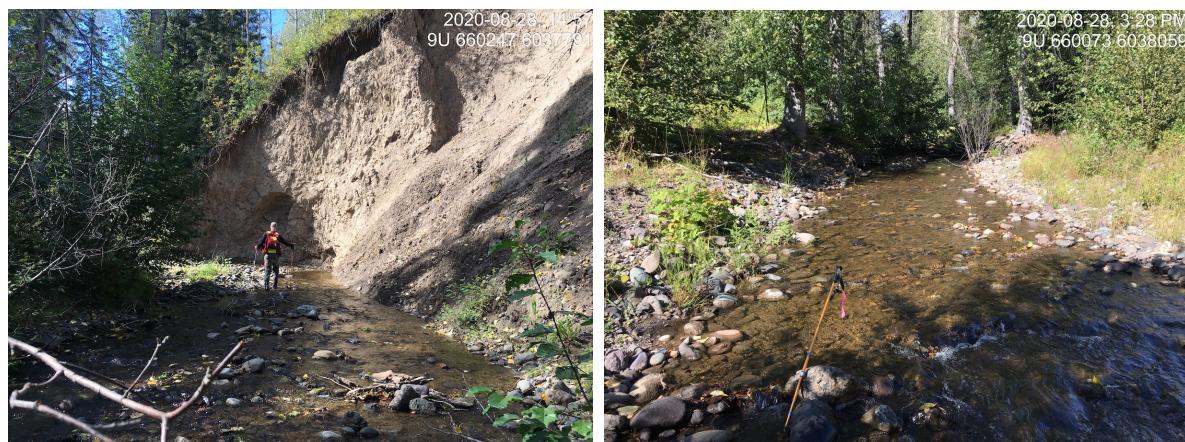
Barren Creek was surveyed upstream from 197664 for 800m (Figure 5.38). Within the area surveyed, total cover amount was rated as moderate with undercut banks dominant. Cover was also present as small woody debris, large woody debris, and overhanging vegetation (Table 5.65). The average channel width was 7.2m, the average wetted width was 4.7m and the average gradient

Figure 5.38: Left: Habitat upstream of PSCIS crossing 197664 and location of cutslope. Right: Habitat upstream of PSCIS crossing 197664.

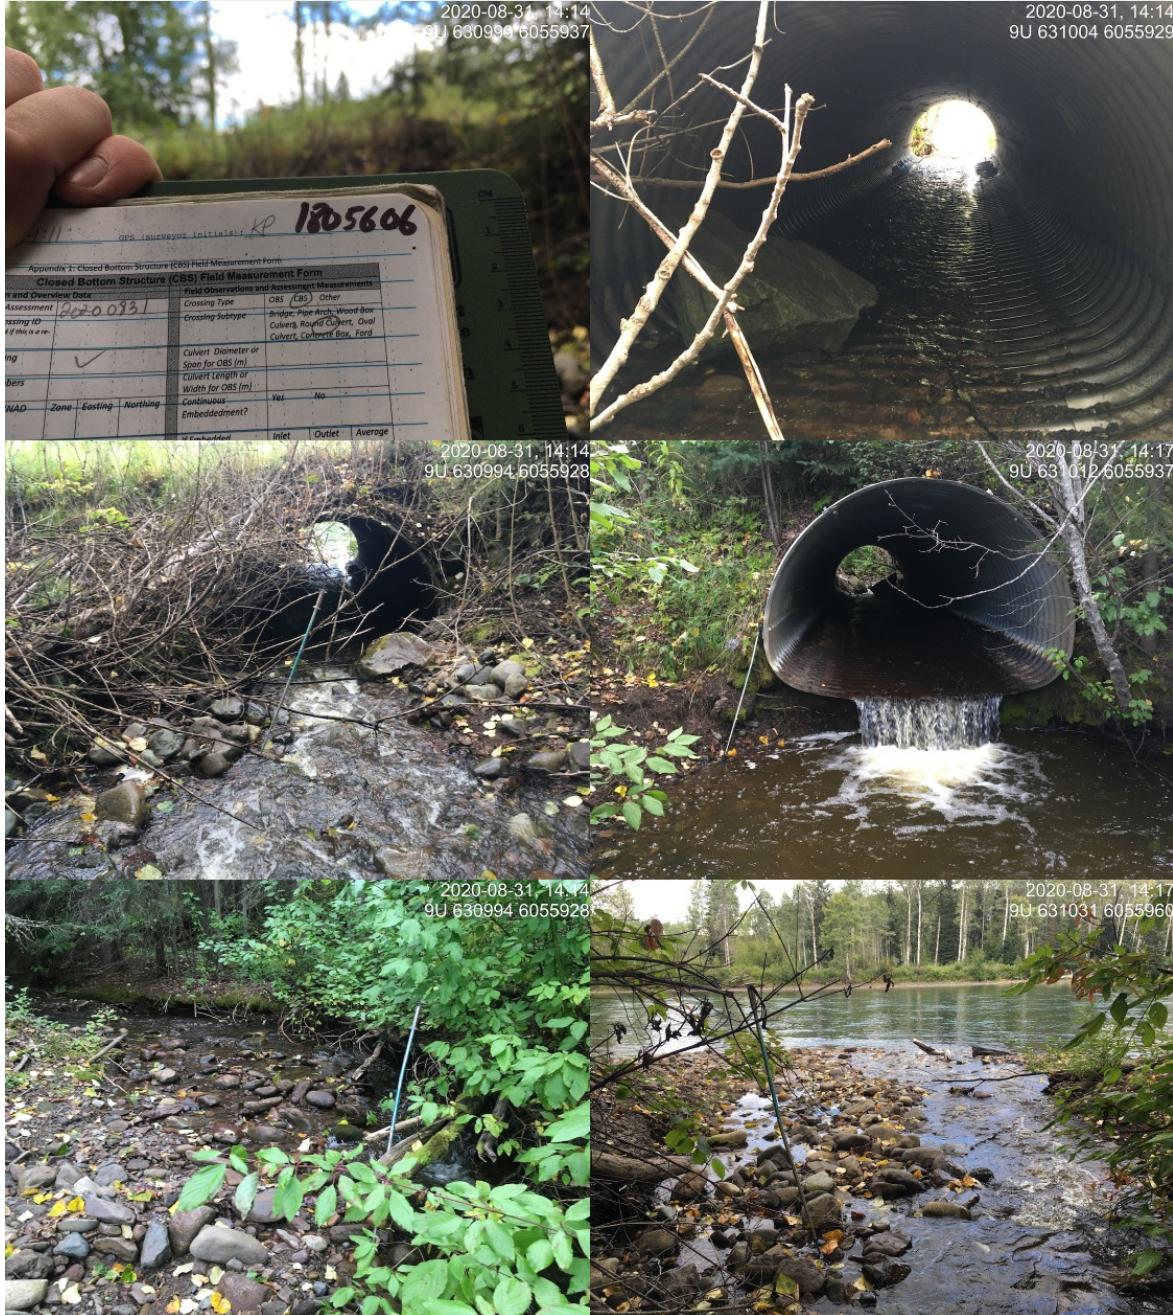
Photos: From top left clockwise: Road/Site Card, Barrel, Outlet, Downstream, Upstream, Inlet.

Road Tenure	Canadian National	Outlet Drop (m)	0.58
Channel Width (m)	3.8	Outlet Pool Depth (m)	0.57
Stream Slope (%)	4.5	Inlet Drop	No
Beaver Activity	No	Slope (%)	4
Habitat Value	High	Valley Fill	Deep Fill
Final score	39	Barrier Result	Barrier
Fix type	Replace with New Open Bottom Structure	Fix Span / Diameter	10

Comments: Approximately 17m from the outlet to the Bulkley River.

A cost estimate for replacing 197667 with a bridge (10m span) is \$5,000,000, resulting in cost benefits of 0.7 linear m/\$1000 and $3m^2/\$1000$. Although 124501 on Lawson Road was considered passable for most species/life stages during most flows, an estimate of cost for replacement (10m span) is \$500,000 resulting in cost benefits of 5.6 linear m/\$1000 and $26.9m^2/\$1000$.

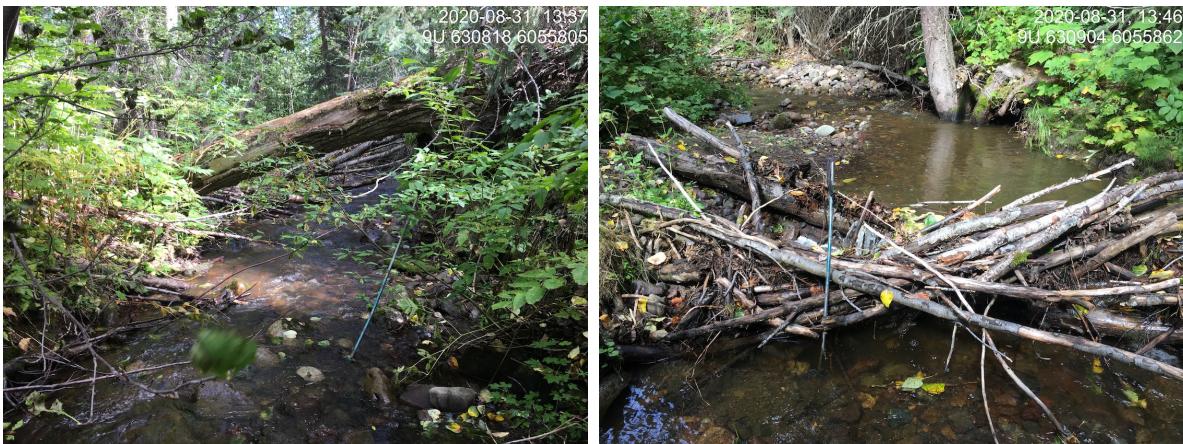
Figure 5.41: Left: Typical habitat upstream of PSCIS crossing 197667. Right: Typical habitat upstream of PSCIS crossing 197667.

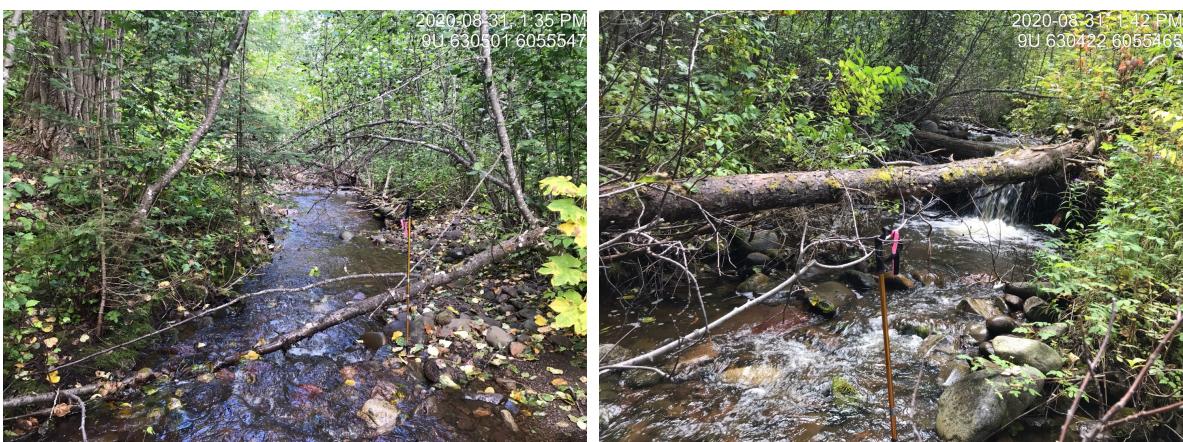
Moan Creek was surveyed upstream from 124501 for 520m (Figure [5.42](#)). Within the area surveyed, total cover amount was rated as moderate with deep pools dominant. Cover was also present as small woody debris, large woody debris, boulders, undercut banks, and overhanging vegetation (Table [5.69](#)). The average channel width was 4.8m, the average wetted width was 3.1m and the average gradient was 6.3%. There were multiple debris jams present upstream from 350m above Larson Road with heights ranging from 0.4 - 1m high. Habitat was noted as complex with abundant gravels suitable for resident, fluvial and anadromous salmonid spawning. Habitat was rated as high value.

Figure 5.42: Left: Habitat upstream of PSCIS crossing 124501. Right: Habitat upstream of PSCIS crossing 124501.

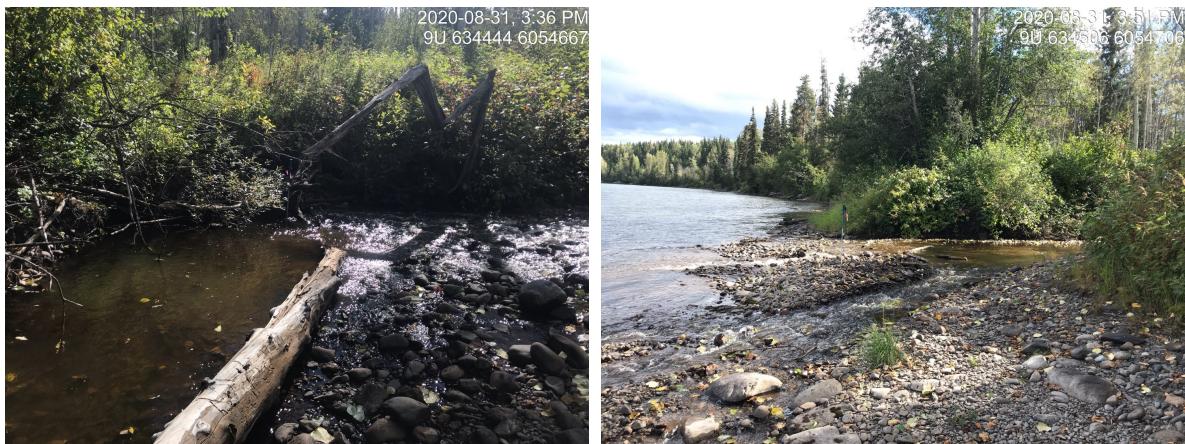
Figure 5.43: Left: Typical habitat downstream of PSCIS crossing 197668. Right: Coffin Creek downstream of PSCIS crossing 197668 at confluence with the Bulkley River.

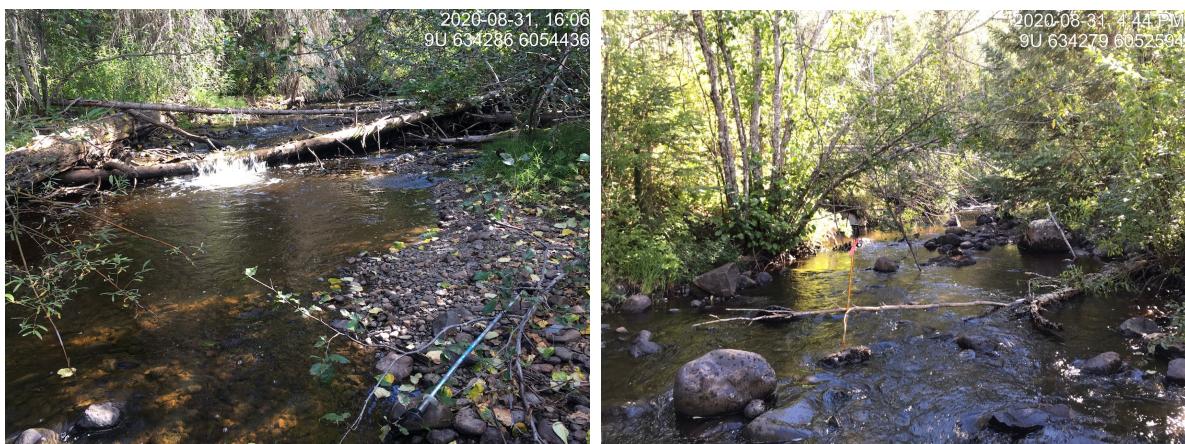
Coffin Creek was surveyed upstream from 124504 for 415m and again upstream approximately 2.2km at a powerline ford crossing (Figure 5.44). Within the area surveyed, total cover amount was rated as moderate with undercut banks dominant. Cover was also present as small woody debris, large woody debris, boulders, deep pools, and overhanging vegetation (Table 5.75). The average channel width was 5.8m, the average wetted width was 3.5m and the average gradient was 2.3%. The stream in the areas surveyed was noted as having high complexity with occasional patches of gravels suitable for spawning present. Habitat value was rated as high for younger life stages of resident and anadromous salmonid rearing and resident adult salmonid spawning.

Figure 5.44: Left: Habitat upstream of PSCIS crossing 124504. Right: Habitat 2.1km upstream of PSCIS crossing 124504.
