## Bulkley Watershed Fish Passage Restoration Planning 2022

Prepared for  
Canadian Wildlife Federation  
Habitat Conservation Trust Foundation - CAT23-6-288  
BC Fish Passage Remediation Program  
Ministry of Transportation and Infrastructure

Prepared by  
Al Irvine, B.Sc., R.P.Bio., Mateo Wintersheidt, B.Sc. and Lucy Schick, B.Sc.  
New Graph Environment Ltd.  
on behalf of  
Society for Ecosystem Restoration in Northern British Columbia

Version 0.1.8 2024-04-23

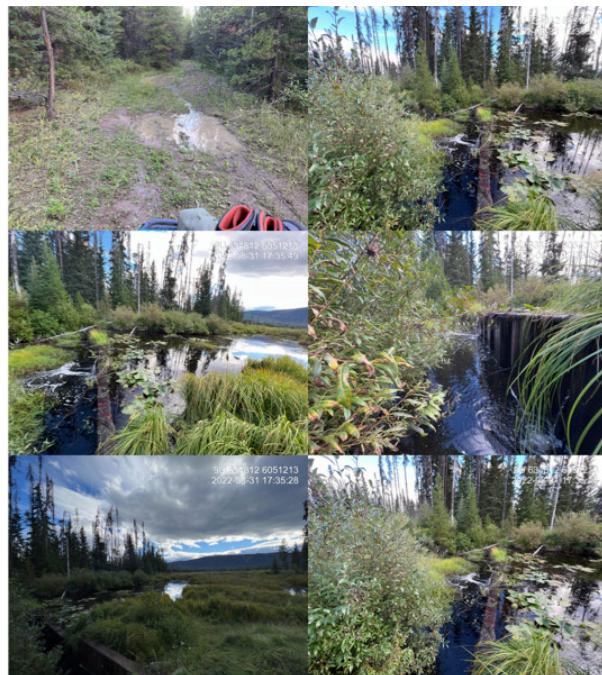
Site	Stream	Easting	Northing	Mapsheet	Barrier	Notes
1f365462-063c-491e-9fb3-bfac004d9183	Coffin Creek	634763	6051171	093L.113	T	Aerial imagery aquired. Complete barrier. 1.2m high steel structure within wetland complex downstream of Coffin Lake. Extremely difficult access via all terrain vehicle due to muddy conditions

Figure 4.1: Photos of Dam 1f365462-063c-491e-9fb3-bfac004d9183 on Coffin Creek

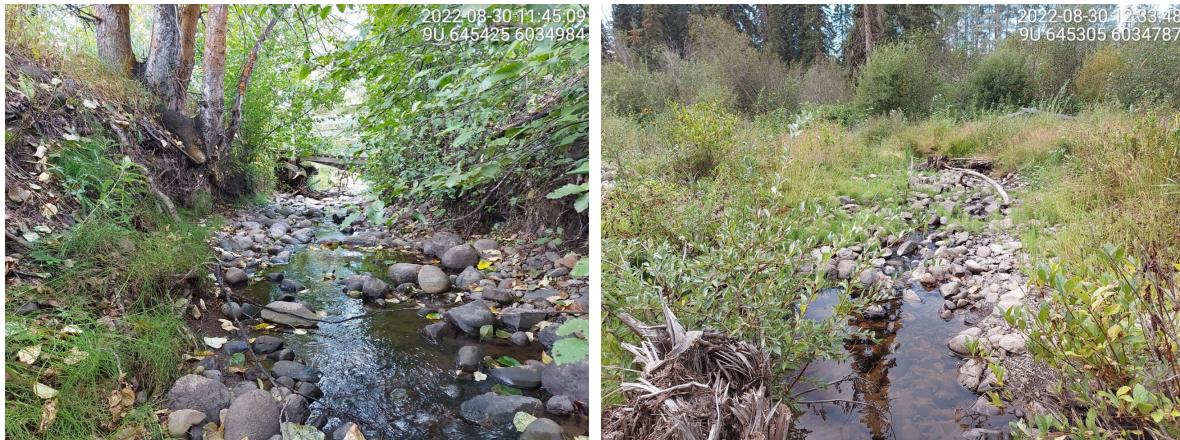
Figure 5.2: Left: Habitat downstream of PSCIS crossing 195943. Right: Habitat downstream of PSCIS crossing 195943.

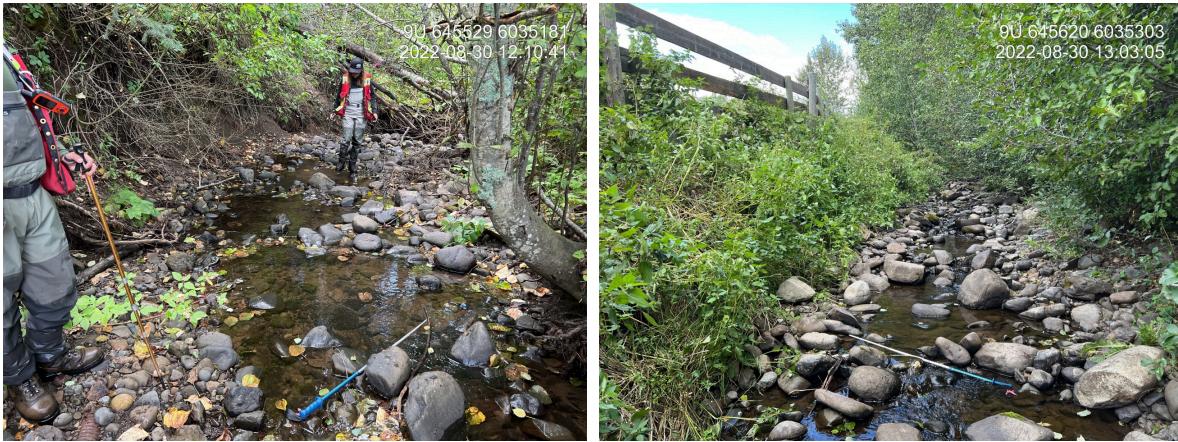
The stream was surveyed upstream from crossing 195943 for 330m (Figure 5.3). The average channel width was 3.1m, the average wetted width was 1.8m, and the average gradient was 2.1%. The dominant substrate was cobbles with boulders sub-dominant. Total cover amount was rated as abundant with boulders dominant. Cover was also present as undercut banks. Good flow volumes were noted along with a decent amount of complexity due to boulders and

Figure 5.3: Left: Habitat upstream of PSCIS crossing 195943. Right: Habitat upstream of PSCIS crossing 195943.

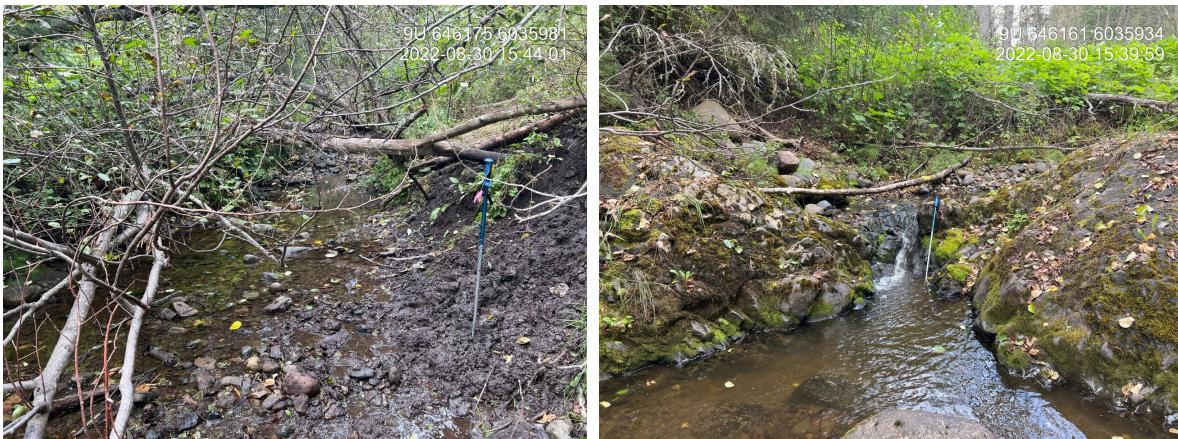
Figure 5.4: Left: Habitat upstream of PSCIS crossing 195944. Right: A 0.65m high rock drop located 365m upstream of PSCIS crossing 195944.

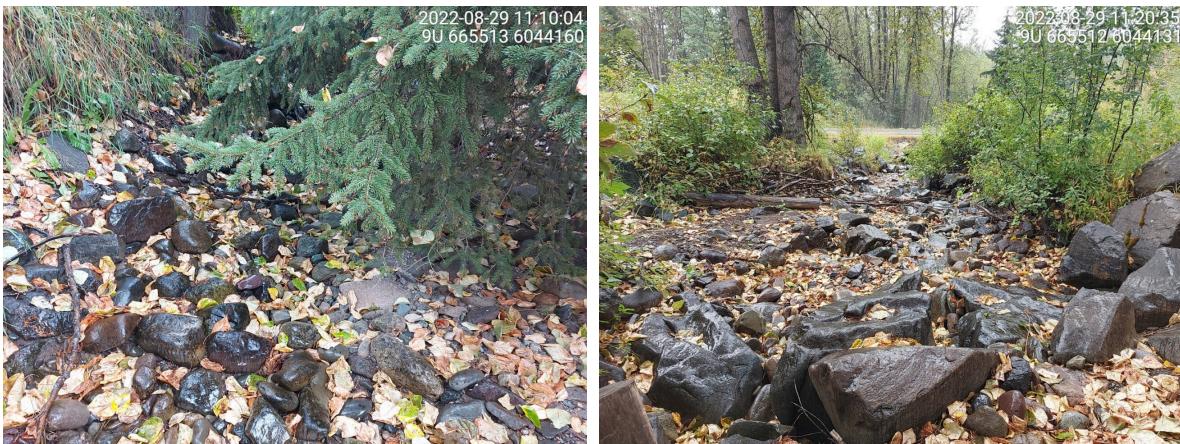
The stream was surveyed downstream from crossing 197653 for 100m to the culvert (PSCIS 197657) located on Highway 16, then an additional 25m downstream from the highway. The entire area assessed downstream of the crossing was dry at the time of the survey (Figure 5.5). Total cover amount was rated as moderate with boulders dominant. Cover was also present as overhanging vegetation. The average channel width was 4.3m, and the average gradient was 2%. The dominant substrate was boulders with cobbles sub-dominant. PSCIS crossing 197657 on the highway, approximately 50m downstream from crossing 197653 was reassessed and ranked as passable as it was low gradient, fully embedded and with no outlet drop. It appeared passable to all species and life stages at the time of assessment (Table 5.20). This crossing was previously assessed in 2020 by Irvine (2021), but it was mistakenly input as modelled crossing ID 1800064, when it should have been 1800067. The stream from Perow Loop Rd to the highway flowed through private property and appeared to be channelized and confined with concrete slabs used as stream bank armoring just downstream of the outlet. Downstream of the highway crossing two bridges are documented in the PSCIS database (197660 and 197659). Although habitat downstream had limited complexity resulting from impacts related to the adjacent road infrastructure and residential properties, the habitat was rated as medium value as it was considered an important migration corridor.

Figure 5.5: Left: Habitat downstream of PSCIS crossing 197653. Right: Habitat downstream of PSCIS crossing 197653.

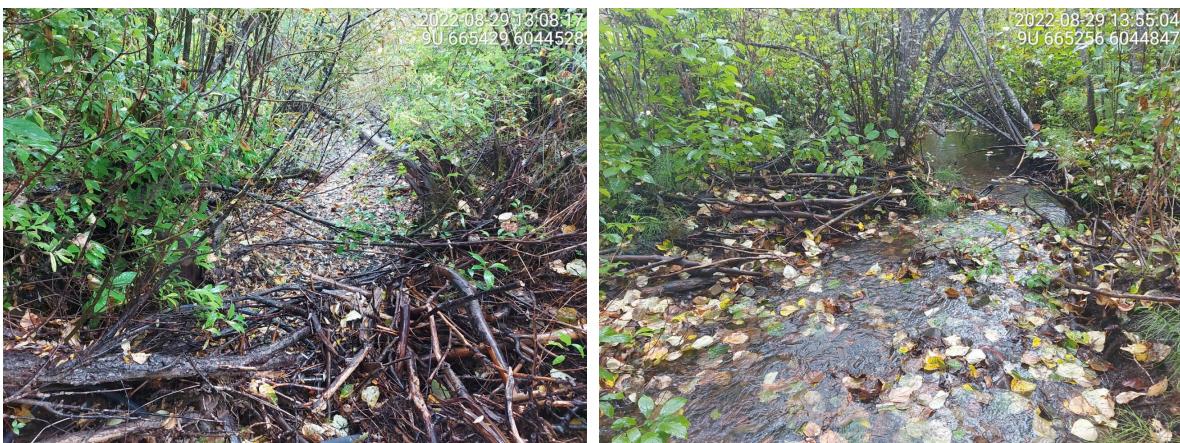
The stream was surveyed upstream from crossing 197653 for 500m (Figure 5.6). Two sections of stream upstream of the crossing were assessed. As residential buildings and yards were situated immediately adjacent to the stream upstream of the crossing, the stream was accessed from a ford located on the transmission line ~325m upstream of Perow Loop Road. The first section surveyed included ~350m of channel upstream of the ford and was dewatered at the time of survey. The average channel width was 3.2m, the average wetted width was 1.9m, and the average gradient was 3%. The dominant substrate was cobbles with gravels sub-dominant. Total cover amount was rated as moderate with overhanging vegetation dominant. Cover was also present as small woody debris.

Figure 5.6: Left: Habitat upstream of PSCIS crossing 197653. Right: Habitat upstream of PSCIS crossing 197653.

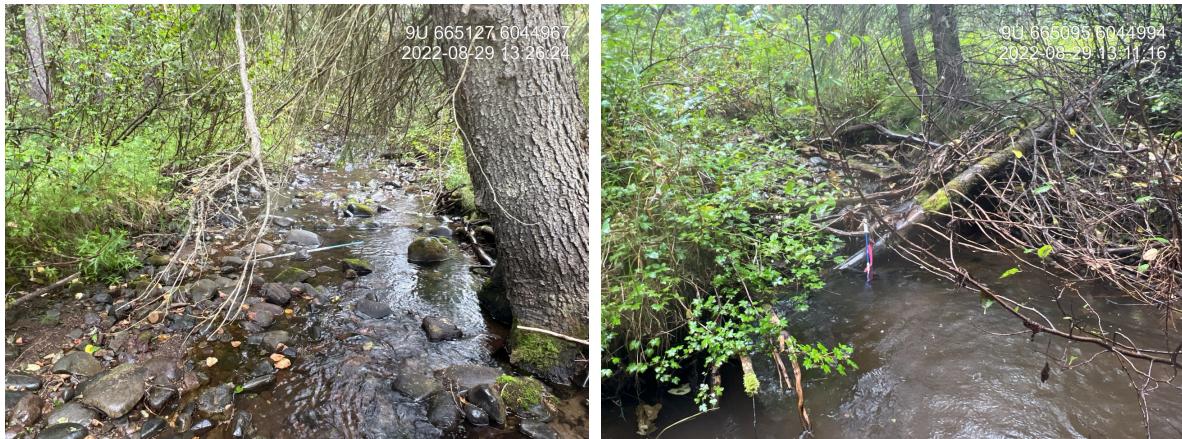
Figure 5.7: Left: Habitat upstream of PSCIS crossing 197653. Right: Habitat upstream of PSCIS crossing 197653.

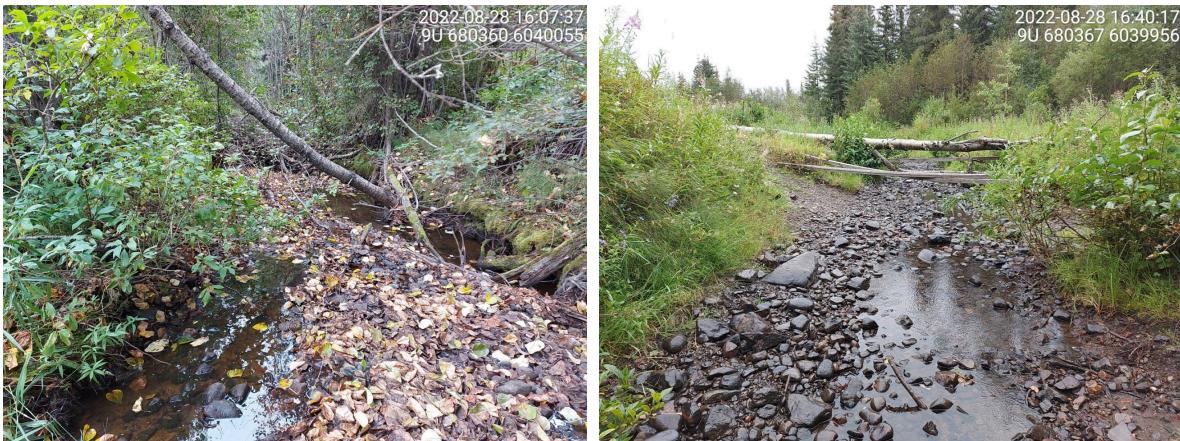
The stream was surveyed downstream from crossing 197974 for 350m to the confluence with Airport Creek (Figure 5.8). The average channel width was 3.5m, the average wetted width was 1.4m, and the average gradient was 2.2%. Total cover amount was rated as trace with small woody debris dominant. Cover was also present as undercut banks and deep pools. The dominant substrate was gravels with cobbles sub-dominant. Immediately downstream of the culvert stream flows were noted as very minimal however, at approximately 50m downstream the volume of water increased substantially. There were occasional deep pools and undercut banks but cover and complexity was notably lacking in most areas. At approximately 100m downstream of the highway riparian forests have been removed to accommodate pasture with notably less cover present and a channel confined by steep banks. Abundant gravels suitable for resident and anadromous salmonid spawning were present throughout the area surveyed. The habitat was rated as medium value for salmonid rearing and spawning.

Figure 5.8: Left: Typical habitat downstream of PSCIS crossing 197974. Right: Typical habitat downstream of PSCIS crossing 197974.

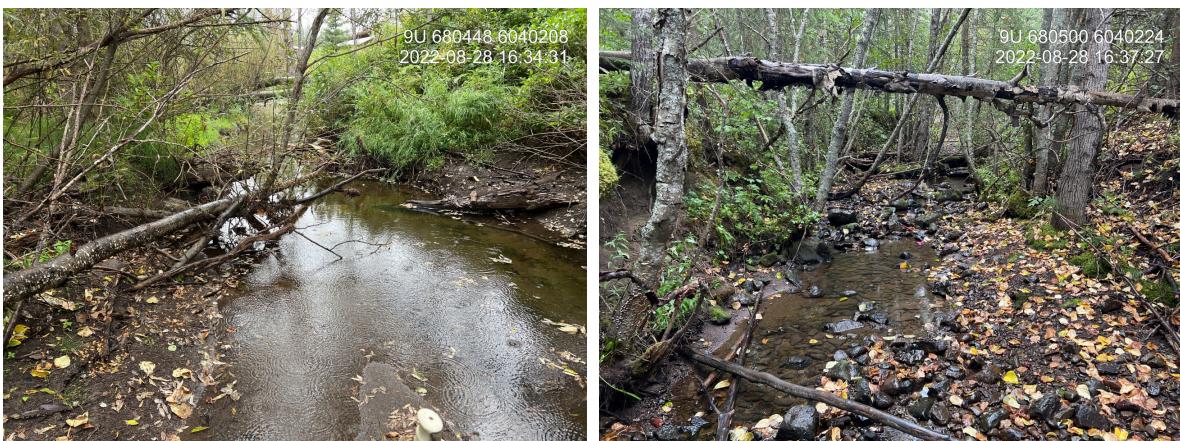
The stream was surveyed upstream from crossing 197974 for 600m (Figure 5.9). The dominant substrate was gravels with fines sub-dominant. The average channel width was 3.4m, the average wetted width was 1.8m, and the average gradient was 1.8%. Total cover amount was rated as moderate with undercut banks dominant. Cover was also present as small woody debris, large woody debris, deep pools, and overhanging vegetation. Numerous salmonid fry were noted throughout the area surveyed along with abundant gravels suitable for resident and anadromous salmonid spawning. Immediately upstream of the crossing for approximately 150-200m stream banks and riparian areas were heavily impacted by cattle with beaver activity also noted in this

Figure 5.9: Left: Typical habitat upstream of PSCIS crossing 197974. Right: Typical habitat upstream of PSCIS crossing 197974.

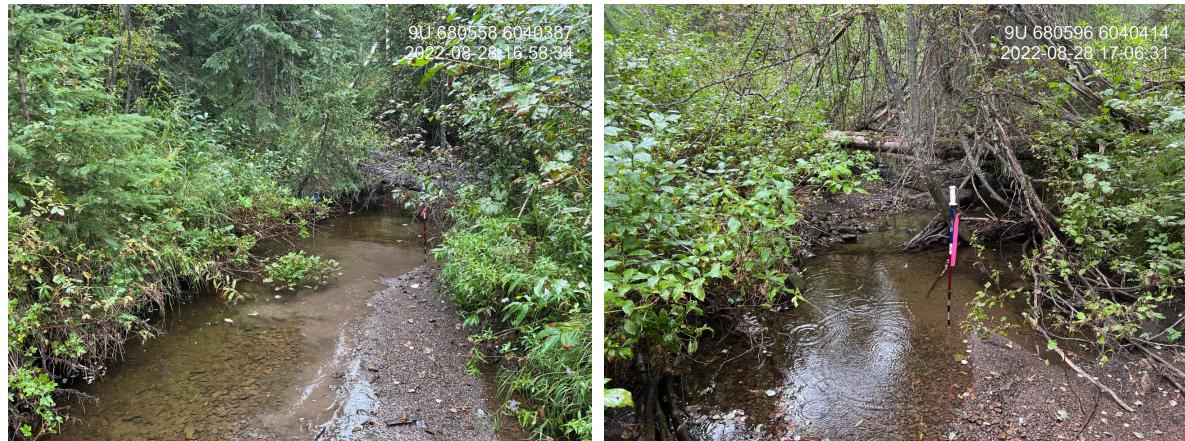
Figure 5.10: Left: Typical habitat upstream of PSCIS crossing 197974. Right: Typical habitat upstream of PSCIS crossing 197974.

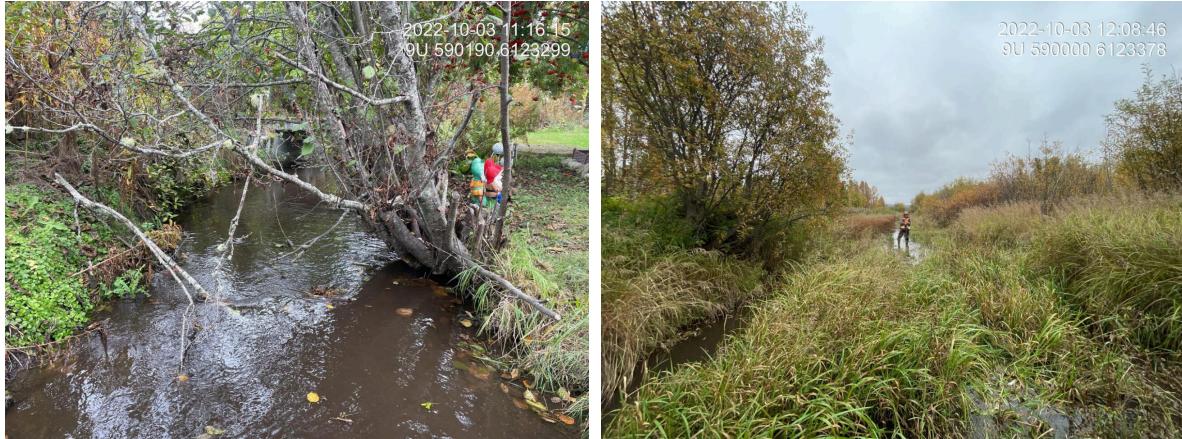
The stream was surveyed downstream from crossing 198116 for 450m past PSCIS crossing 198177 (9th avenue) to approximately 220m upstream of PSCIS crossing 124423 on the CN railway (Figure 5.13). The average channel width was 3m, the average wetted width was 2.8m, and the average gradient was 1%. Total cover amount was rated as abundant with overhanging vegetation dominant. Cover was also present as instream vegetation. The dominant substrate was fines with gravels sub-dominant. PSCIS crossing 198117 on 9th avenue was also assessed for fish passage and at the time of survey, the crossing was un-embedded, non-backwatered, and ranked as a barrier to upstream fish passage (Table 5.34). The stream flows through the town of New Hazelton. There was low flow at the time of survey and the stream contained a lot of waste and debris. There was a lot of cover from vegetation. The stream hits the railway and is drained into a tributary that flows west until it joins Station Creek. The habitat was rated as high value for salmonid rearing and spawning.

Figure 5.13: Left: Typical habitat downstream of PSCIS crossing 198116. Right: Typical habitat downstream of PSCIS crossing 198116.

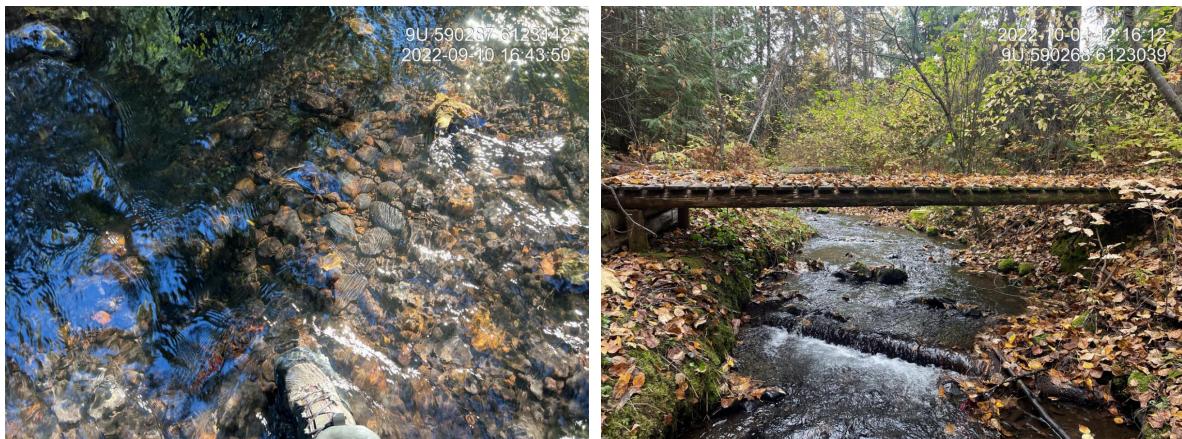
Figure 5.14: Left: Gravel and cobble substrate immediately upstream of PSCIS crossing 198116. Right: Footbridge located upstream of PSCIS crossing 198116.

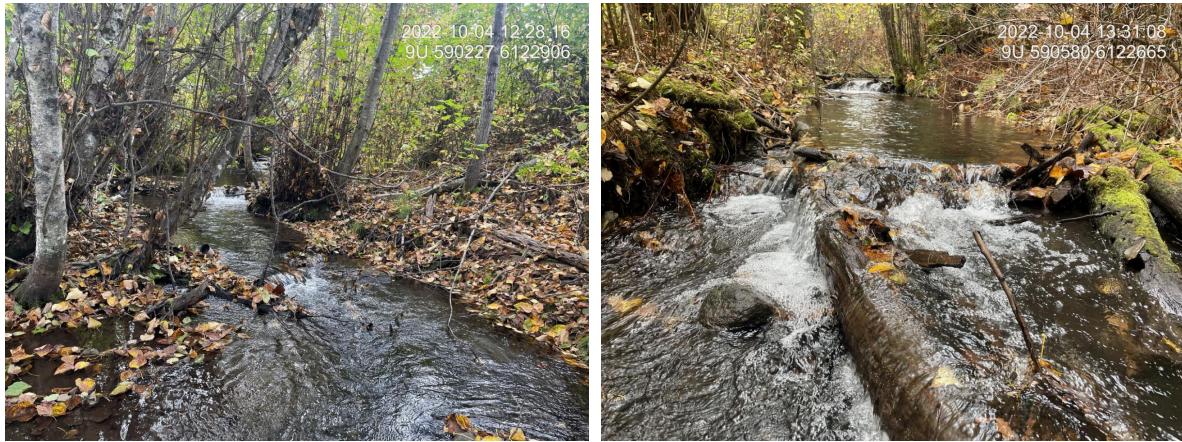
Figure 5.15: Left: Typical habitat upstream of PSCIS crossing 198116. Right: Typical habitat upstream of PSCIS crossing 198116.

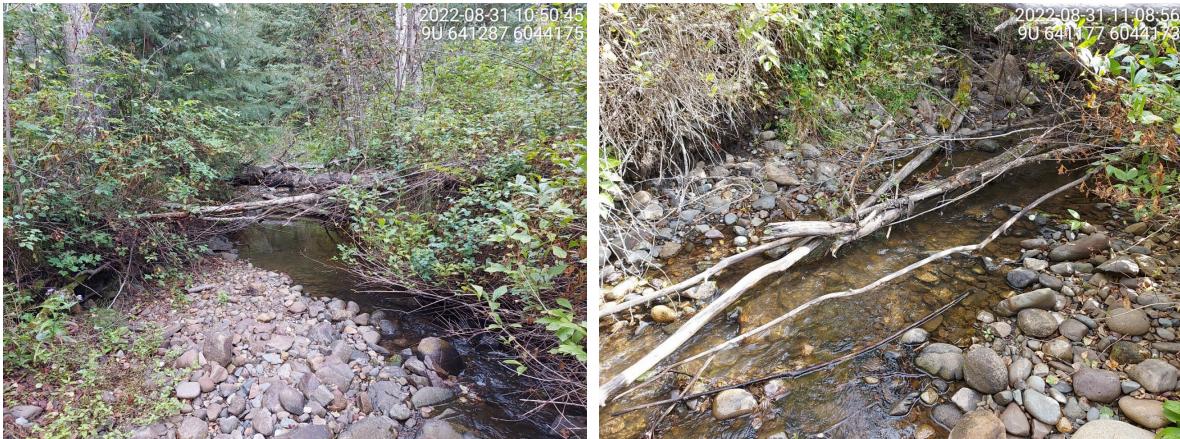
The stream was surveyed downstream from crossing 57793 for 300m (Figure 5.17). The average channel width was 4.1m, the average wetted width was 2.4m, and the average gradient was 2%. The dominant substrate was gravels with cobbles sub-dominant. Total cover amount was rated as abundant with undercut banks dominant. Cover was also present as small woody debris, large woody debris, and overhanging vegetation. There were undercut banks and abundant riparian vegetation throughout providing good cover for fish. Some gravels were present that could be suitable for spawning. Functional large woody debris was present throughout the stream. The habitat was rated as high value for salmonid rearing and spawning.

**Figure 5.17:** Left: Typical habitat downstream of PSCIS crossing 57793. Right: Typical habitat downstream of PSCIS crossing 57793.

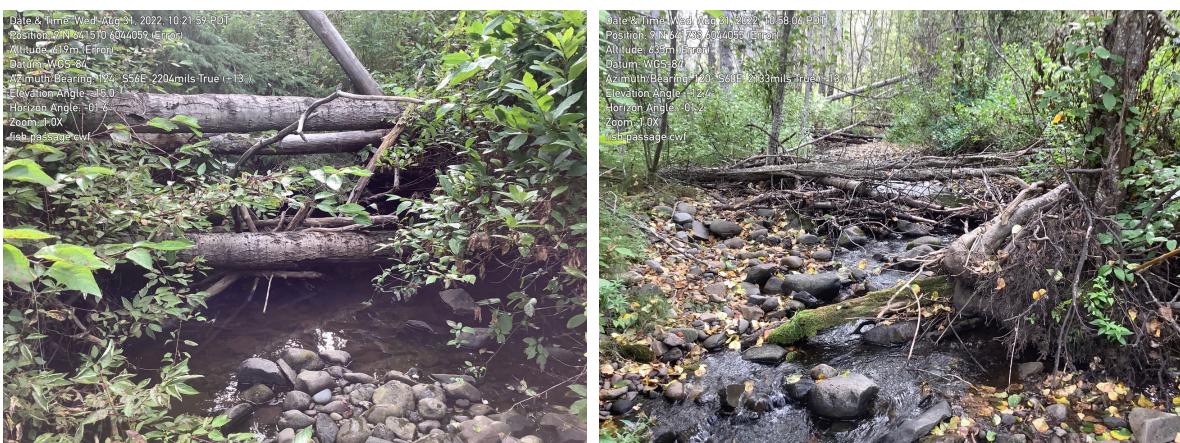
The stream was surveyed upstream from crossing 57793 for 600m (Figure 5.18). The dominant substrate was cobbles with gravels sub-dominant. Total cover amount was rated as abundant with large woody debris dominant. Cover was also present as small woody debris, undercut banks, and overhanging vegetation. The average channel width was 4.1m, the average wetted width was 2m, and the average gradient was 2%. The data for the upstream survey was misplaced and stream characteristics and measurements were obtained by reviewing photos. The habitat quality was excellent. There were abundant undercut banks and healthy mixed riparian vegetation throughout. The stream was wide and contained some pockets of gravel suitable for spawning resident species. The habitat was rated as high value as an important migration corridor containing suitable spawning habitat and having moderate rearing potential.

**Figure 5.18:** Left: Typical habitat upstream of PSCIS crossing 57793. Right: Typical habitat upstream of PSCIS crossing 57793.

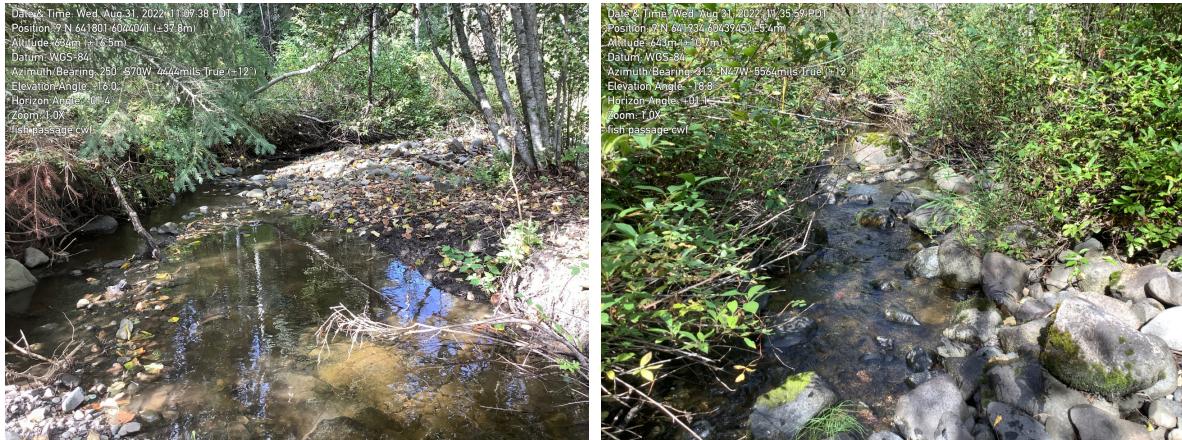
Figure 5.19: Left: Typical habitat upstream of PSCIS crossing 57793. Right: Typical habitat upstream of PSCIS crossing 57793.

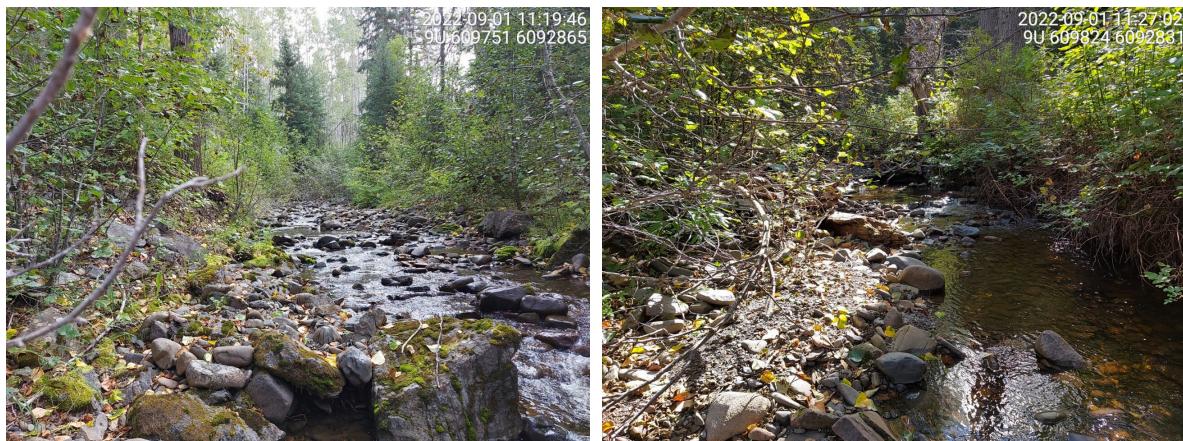
Figure 5.23: Left: Typical habitat upstream of PSCIS crossing 58067. Right: Typical habitat upstream of PSCIS crossing 58067.

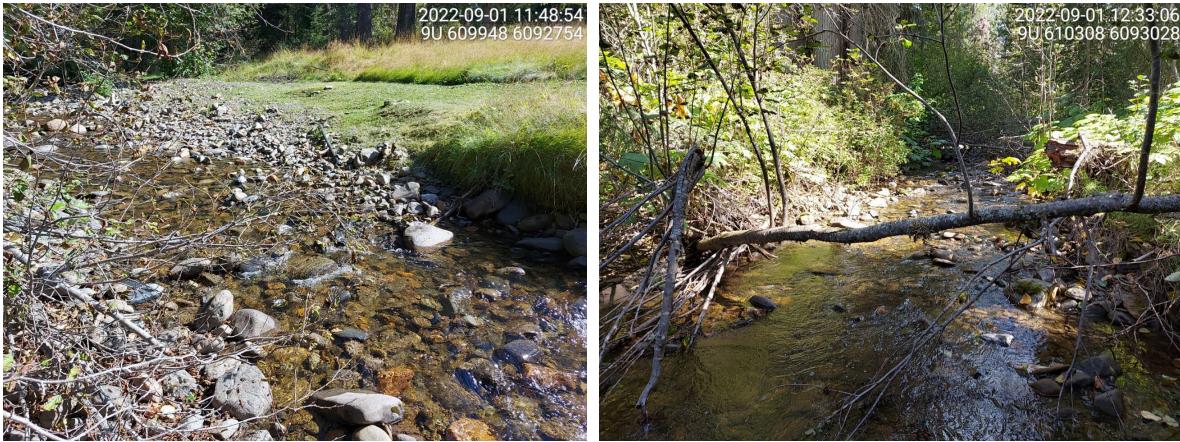
Figure 5.24: Left: Typical habitat upstream of PSCIS crossing 58067. Right: Typical habitat upstream of PSCIS crossing 58067.

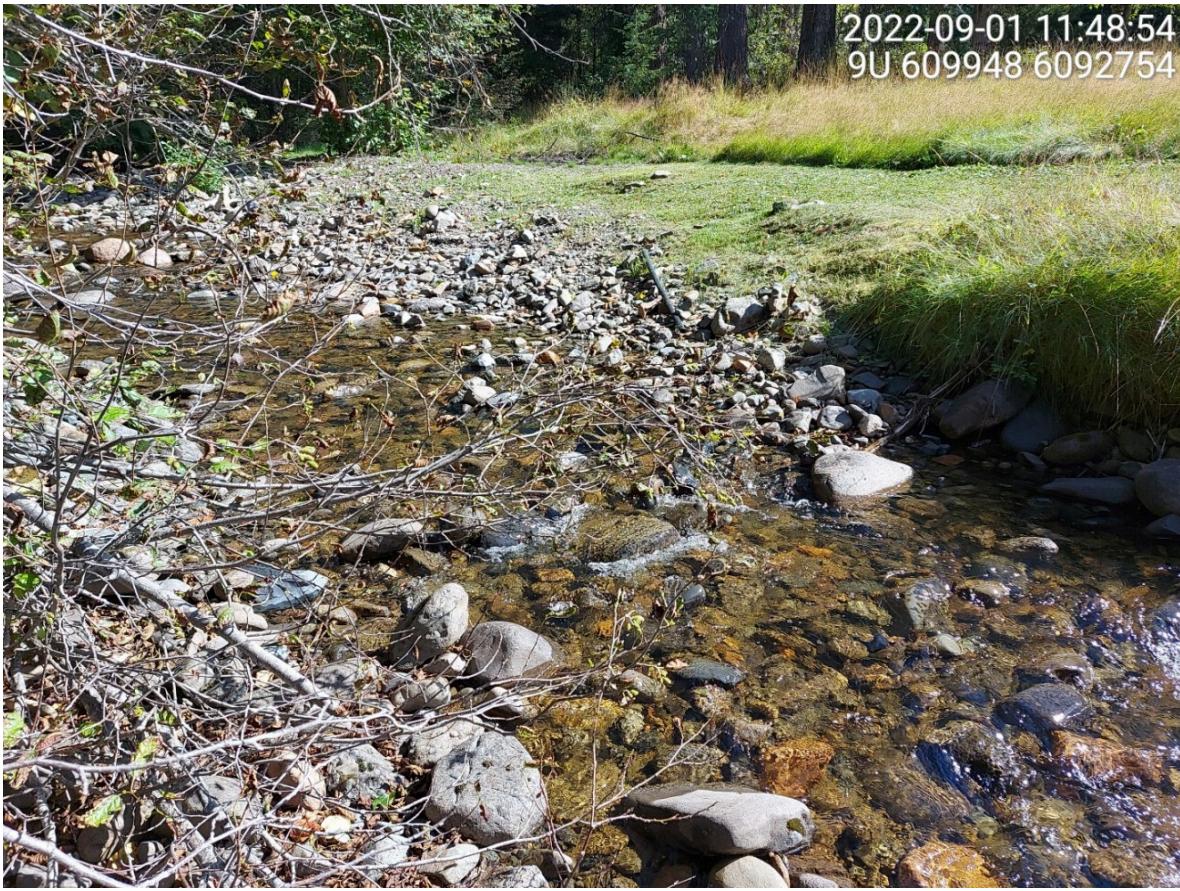
Figure 5.25: Canyon with 1.5m high rock outcrop located ~600m upstream from the confluence with the Bulkley River.

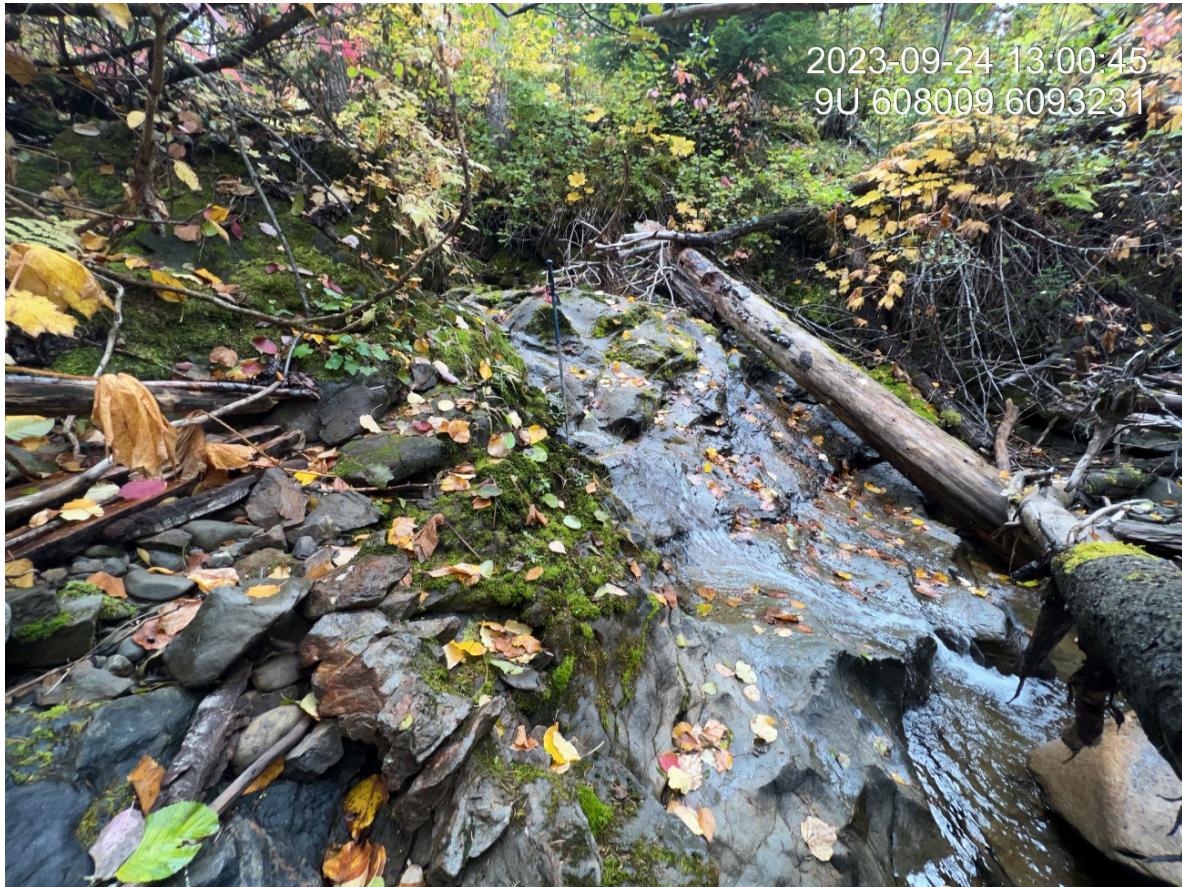
Figure 5.26: 25 meter rock chute located in the canyon

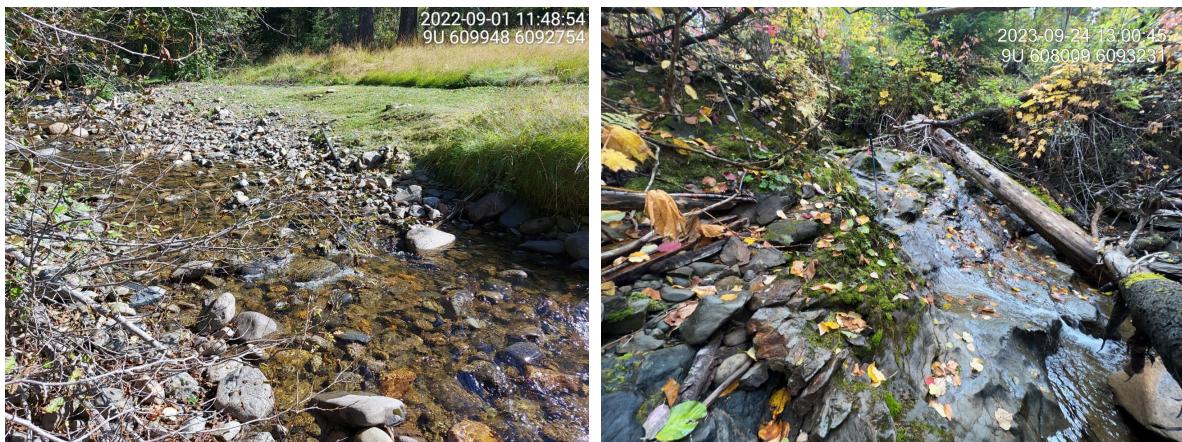
Figure 5.27: Left: Canyon with 1.5m high rock outcrop located ~600m upstream from the confluence with the Bulkley River. Right: 25 meter rock chute located in the canyon

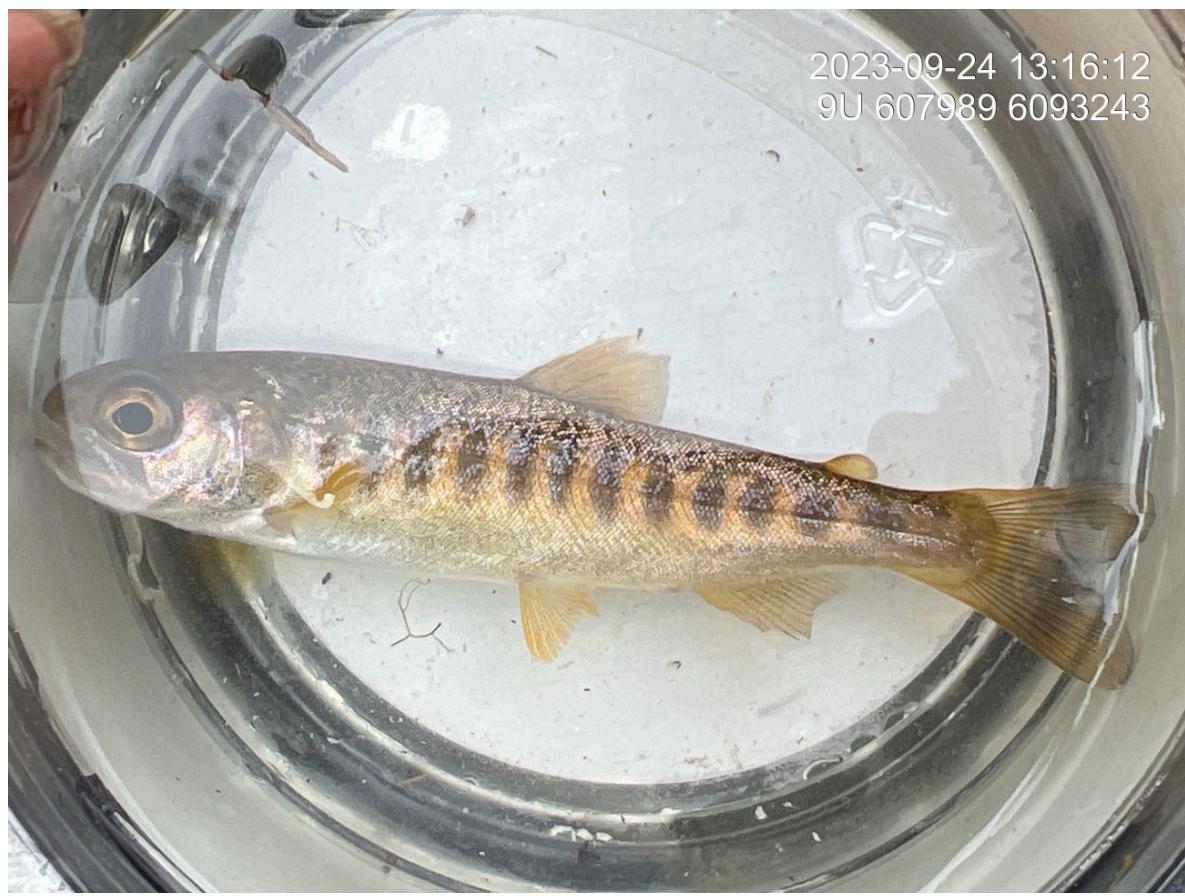
Figure 5.28: Coho parr captured below the lower rock outcrop and rock chute with dip nets during 2023 sampling.

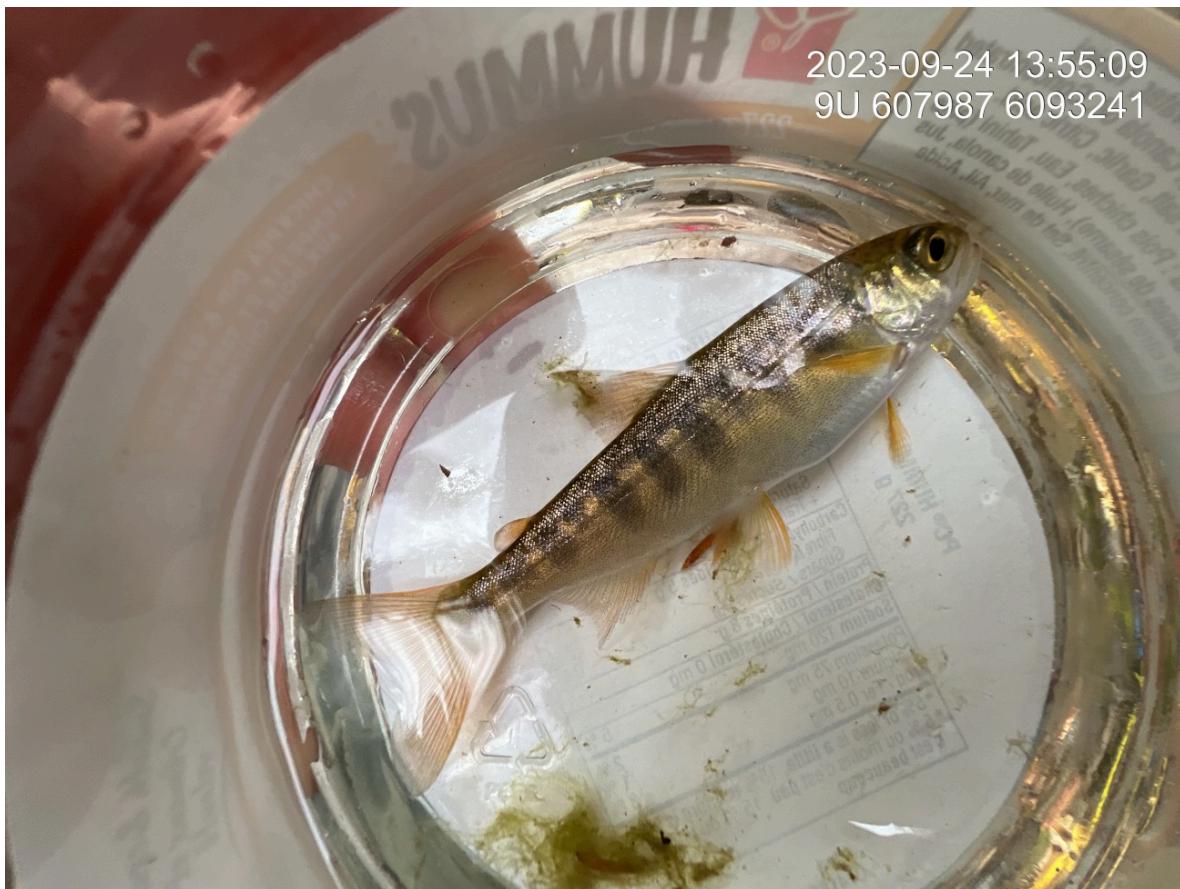
Figure 5.29: Coho parr captured below the lower rock outcrop and rock chute with dip nets during 2023 sampling.

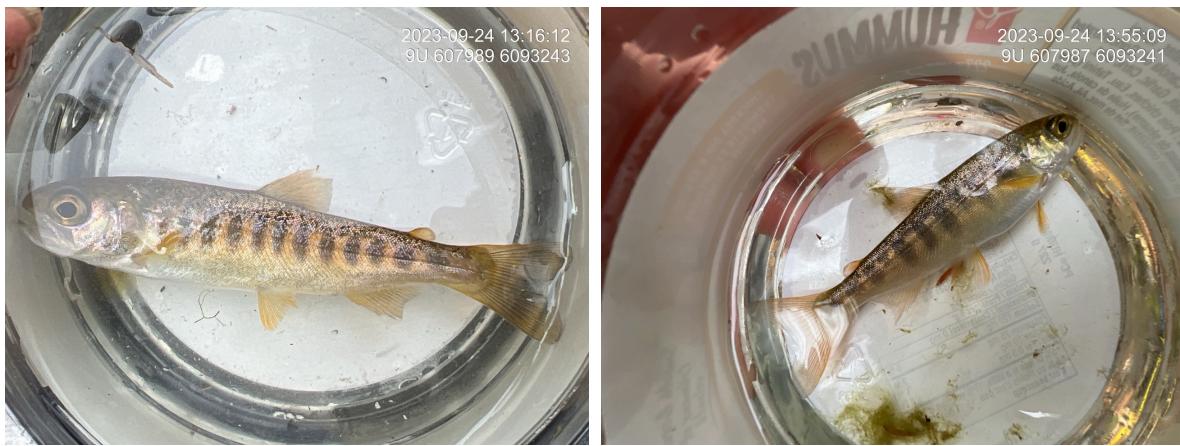
Figure 5.30: Left: Coho parr captured below the lower rock outcrop and rock chute with dip nets during 2023 sampling. Right: Coho parr captured below the lower rock outcrop and rock chute with dip nets during 2023 sampling.
