## Appendix - Phase 1 Fish Passage Assessment Data and Photos

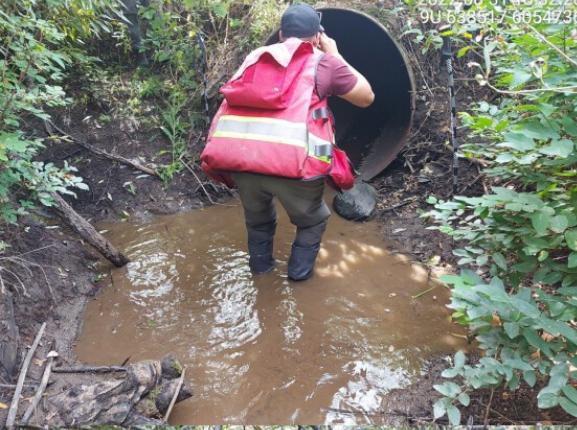
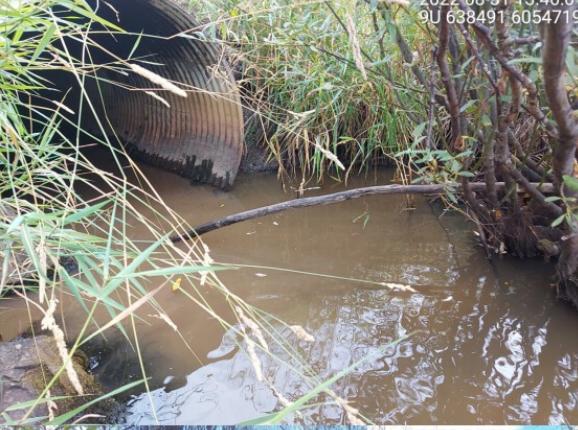
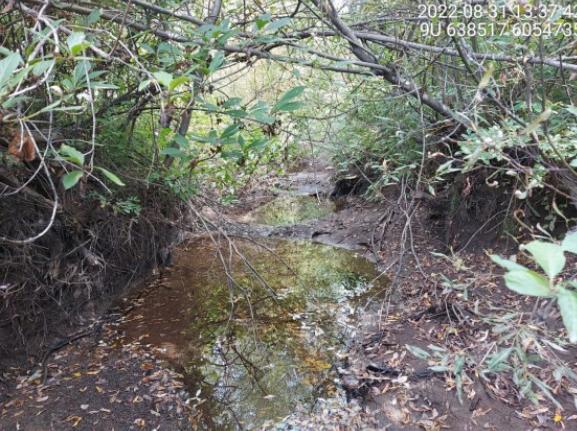
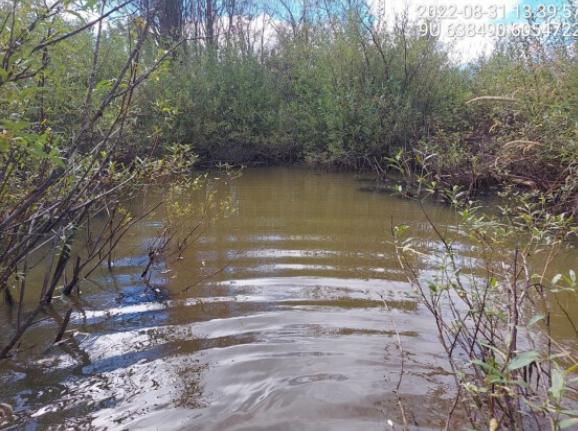
Location and Stream Data	•	Crossing Characteristics	-
Comments: Very deep outlet pool. Wetland downstream, beaver activity upstream. Almost fully backwatered, very little flow through the culvert. 13:32			
Photos: PSCIS ID 123393. From top left clockwise: Road/Site Card, Barrel, Outlet, Downstream, Upstream, Inlet.

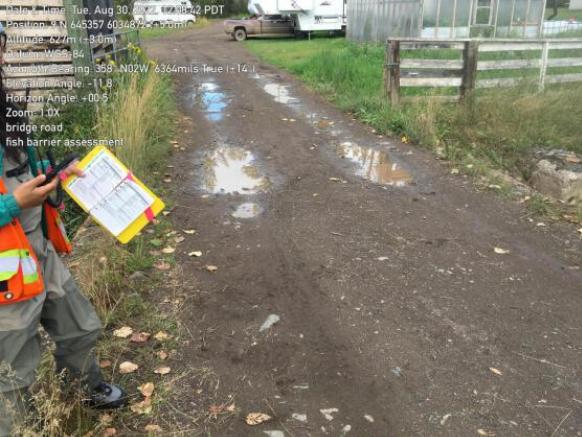
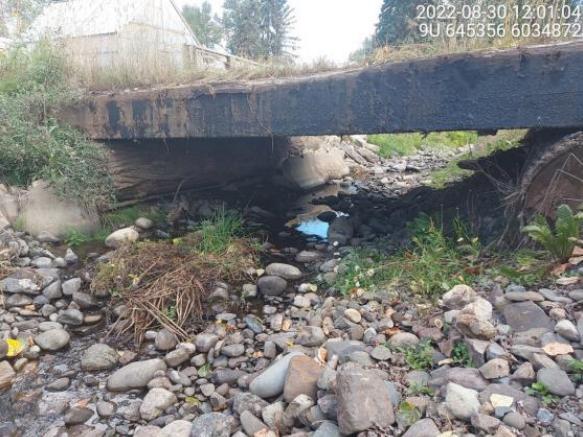
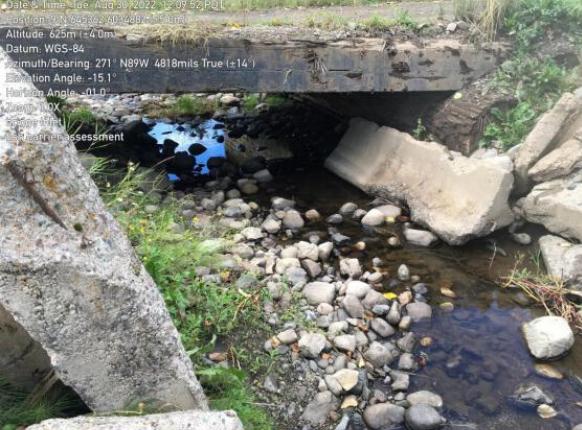
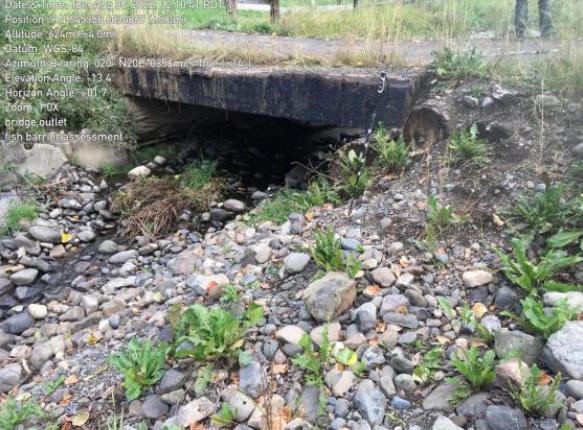
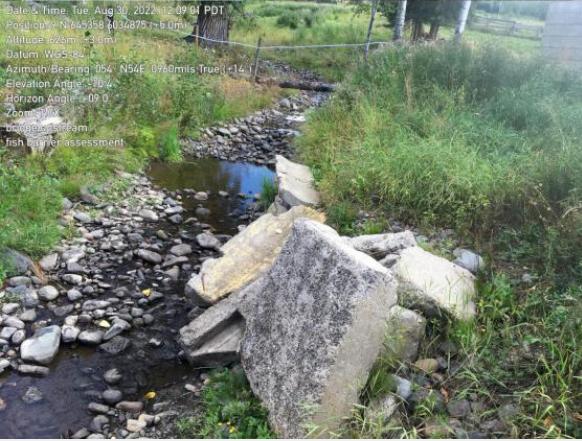
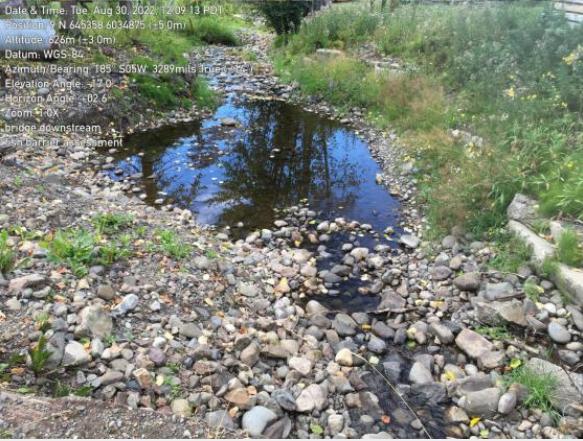
Location and Stream Data	•	Crossing Characteristics	-
Comments: Private property, farm bridge, concrete slabs on both banks upstream of culvert. 12:02			
Photos: PSCIS ID 198111. From top left clockwise: Road/Site Card, Barrel, Outlet, Downstream, Upstream, Inlet.

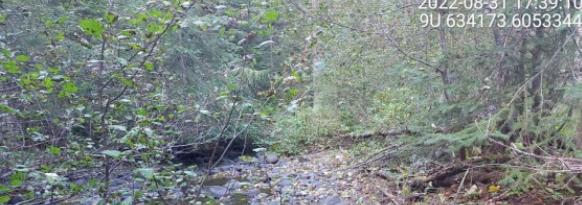
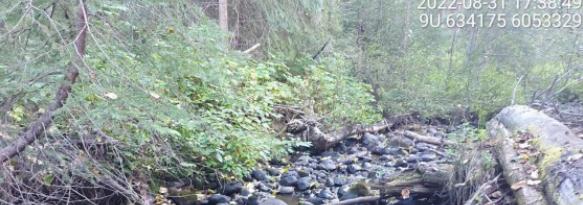
Location and Stream Data	•	Crossing Characteristics	-
Comments: Walked in. No crossing present. Road is more like a hiking trail than a road. 17:34			
Photos: PSCIS ID 198112. From top left clockwise: Road/Site Card, Barrel, Outlet, Downstream, Upstream, Inlet.

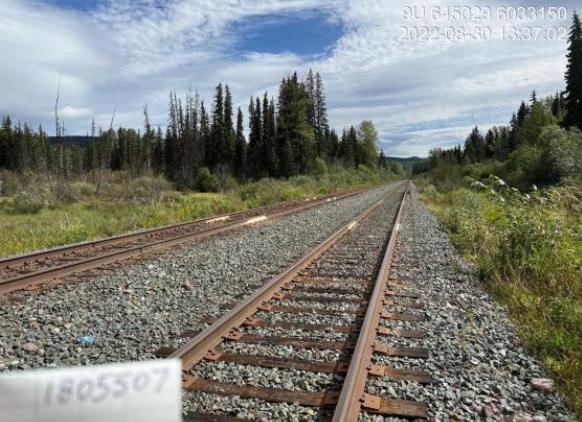
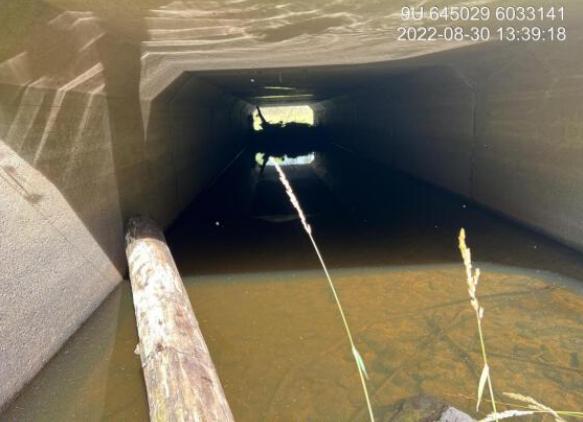
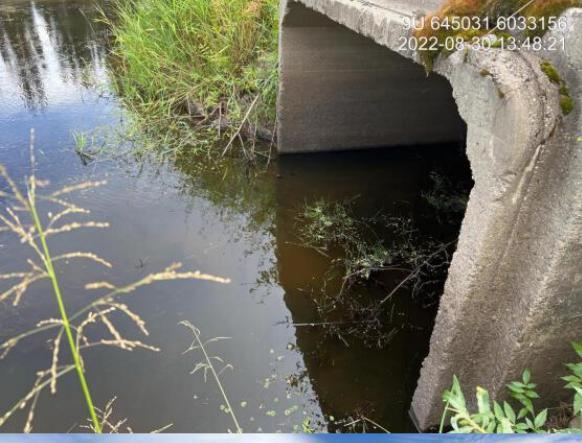
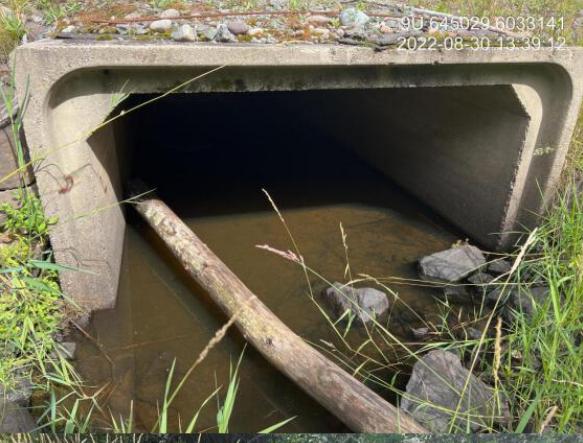
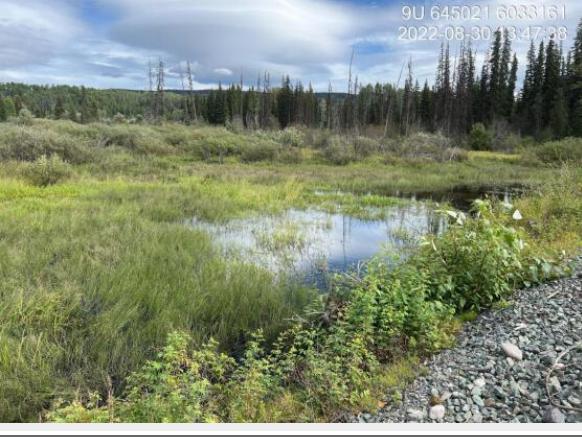
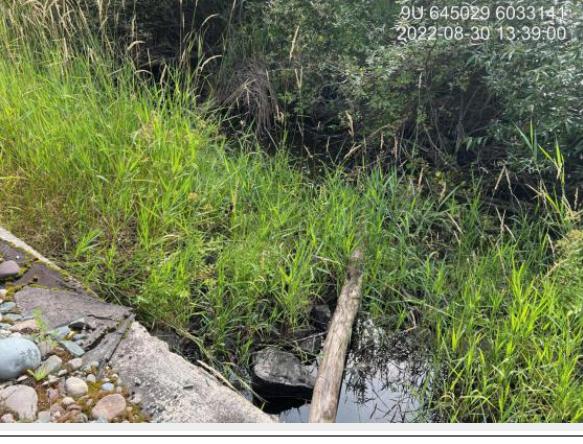
Location and Stream Data	•	Crossing Characteristics	-
Comments: Fully backwatered and embedded concrete box structure on the Railway. Not a fish passage issue at this time. 13:37			
Photos: PSCIS ID 198113. From top left clockwise: Road/Site Card, Barrel, Outlet, Downstream, Upstream, Inlet.

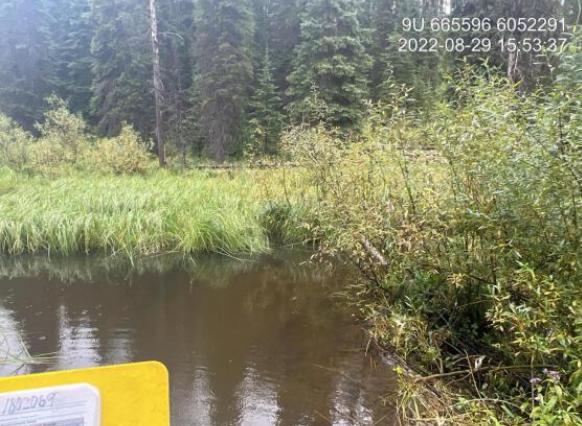
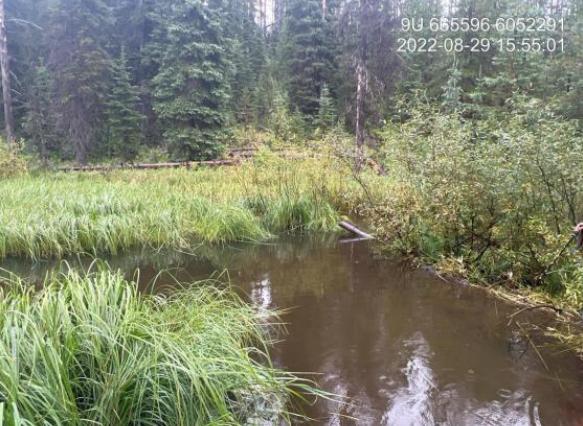
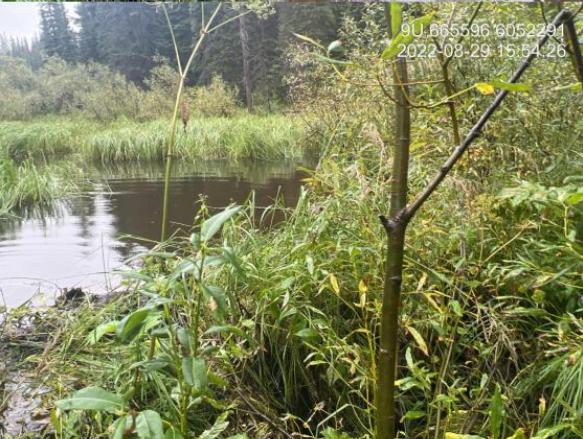
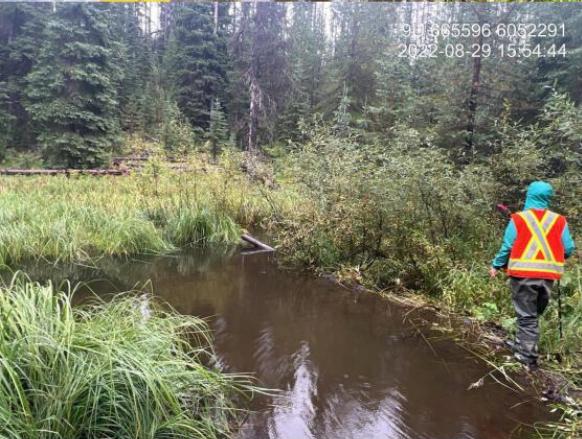
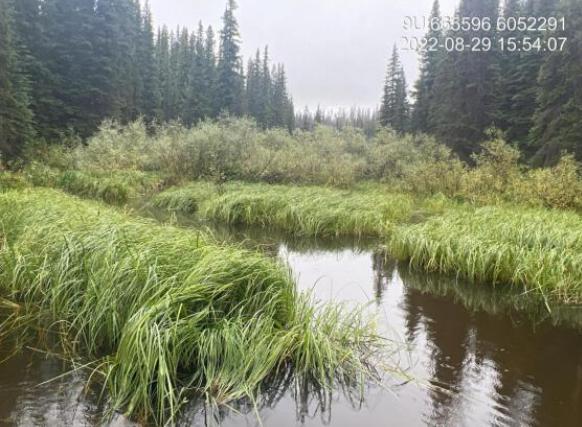
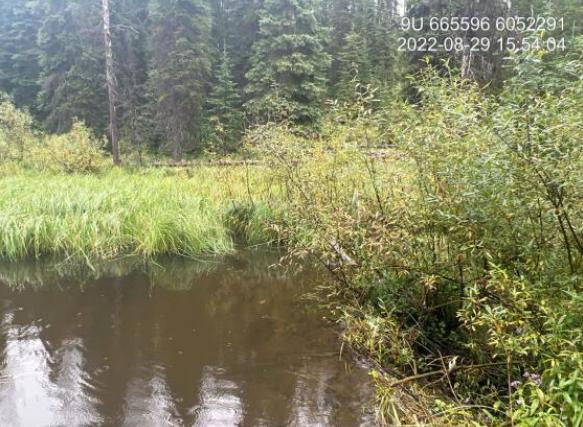
Location and Stream Data	•	Crossing Characteristics	-
Comments: Beaver dam in historic road location. 15:47			
Photos: PSCIS ID 198114. From top left clockwise: Road/Site Card, Barrel, Outlet, Downstream, Upstream, Inlet.

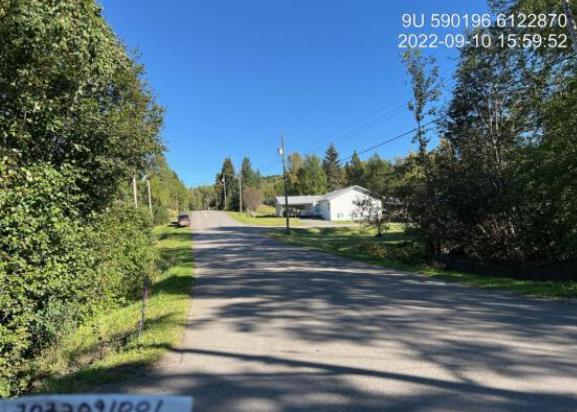
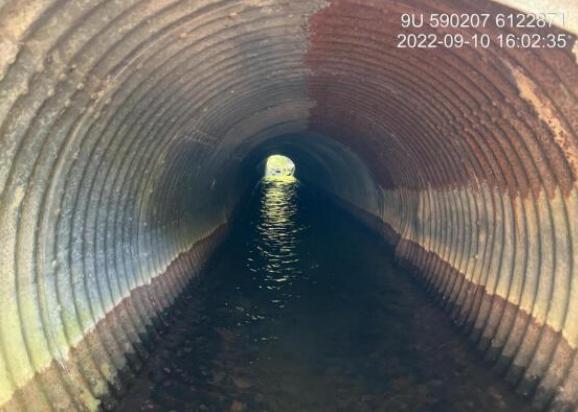
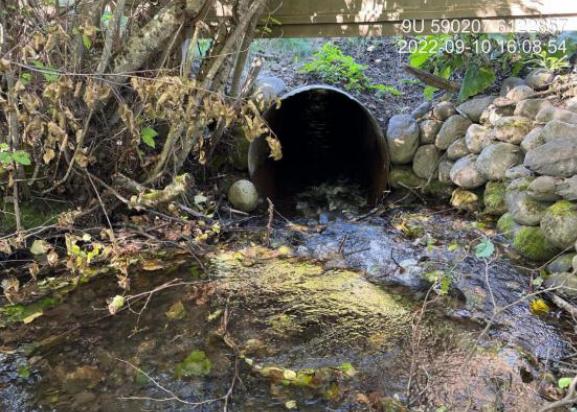
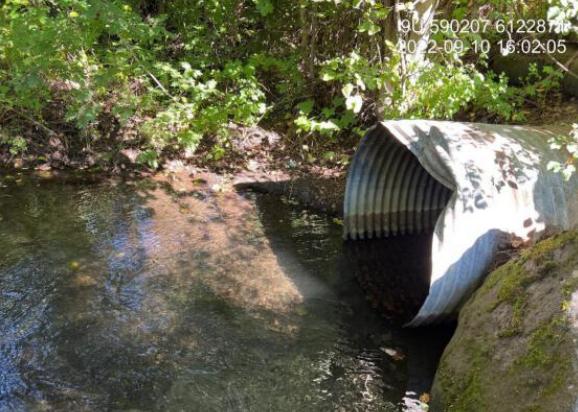
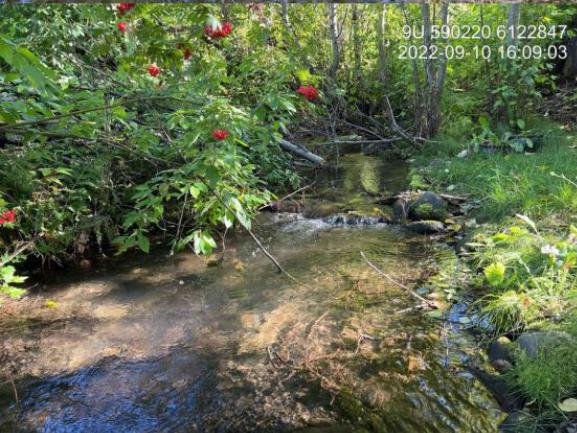
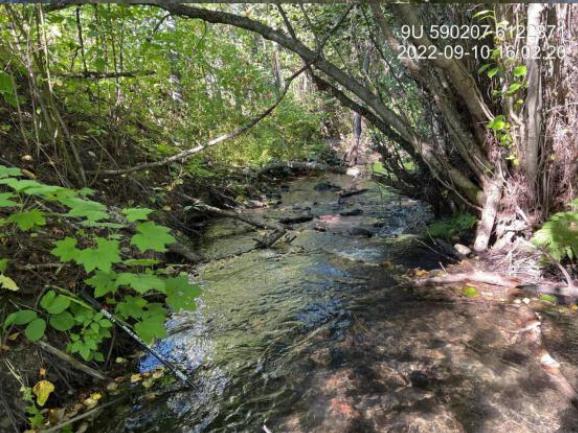
Location and Stream Data	•	Crossing Characteristics	-
Comments: This is waterfall Creek. It does not show up in the freshwater atlas as here, however this is the main flow. Numerous fry and parr observed upstream of the crossing. No paper card for site. 16:03			
Photos: PSCIS ID 198116. From top left clockwise: Road/Site Card, Barrel, Outlet, Downstream, Upstream, Inlet.

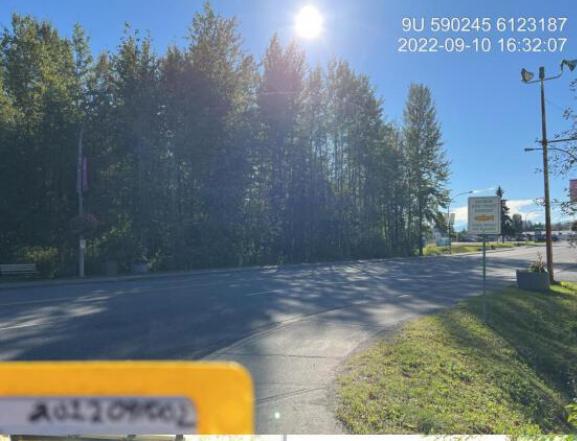
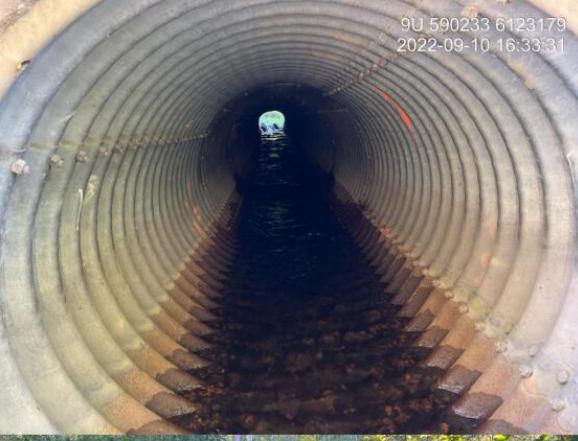
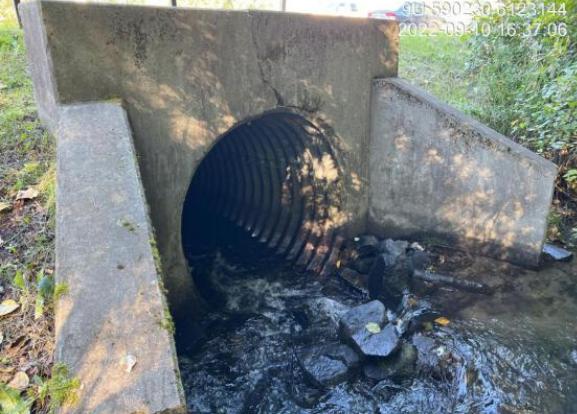
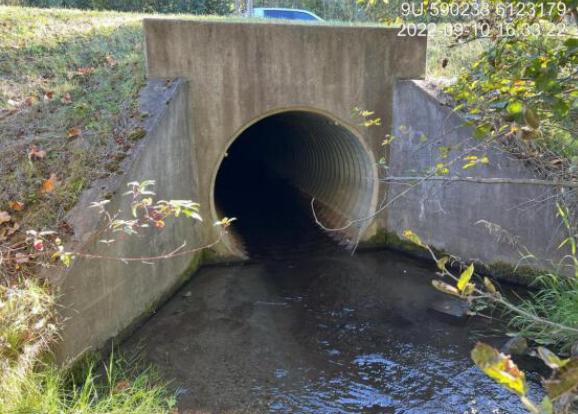
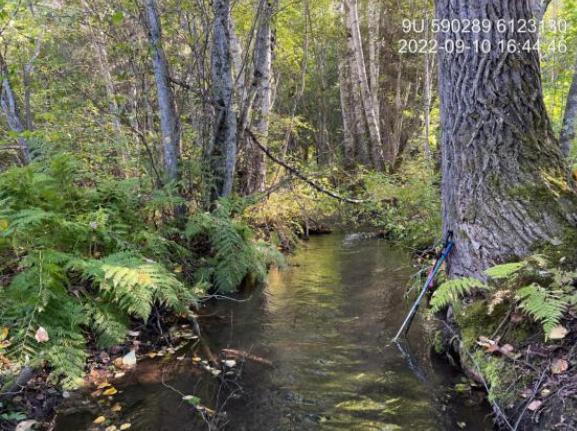
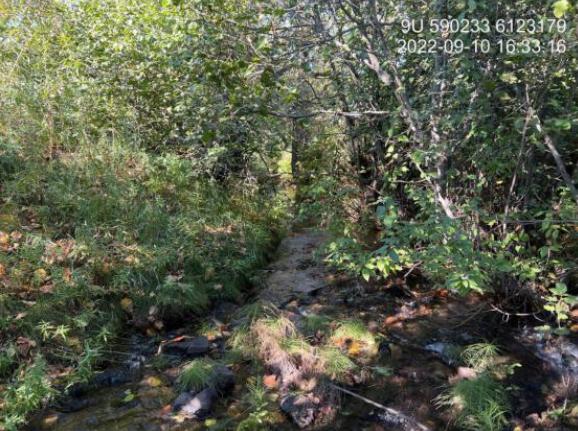
Location and Stream Data	•	Crossing Characteristics
Comments: Stream is not mapped correctly in the freshwater atlas. This is waterfall creek. Great flow, patches of gravel suitable for coho spawning. Right within the town of New Hazelton. Trap and truck coho operation conducted by Chicago Creek Restoration Society with spawners transplanted just downstream of the railway. 16:34		
Photos: PSCIS ID 198117. From top left clockwise: Road/Site Card, Barrel, Outlet, Downstream, Upstream, Inlet.

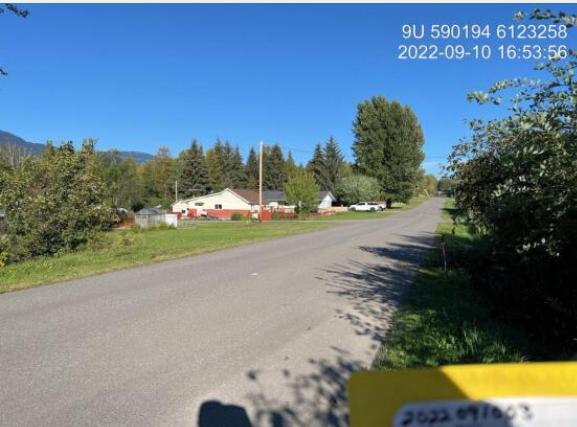
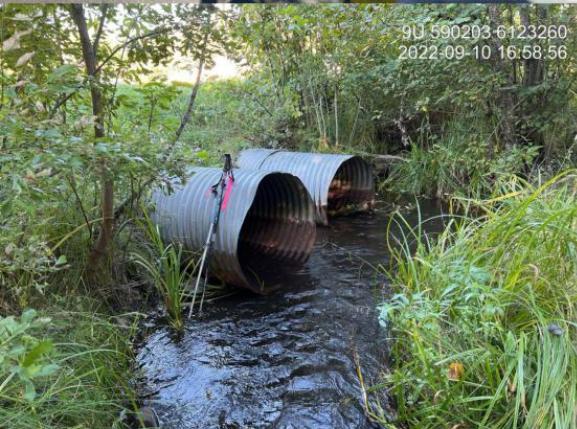
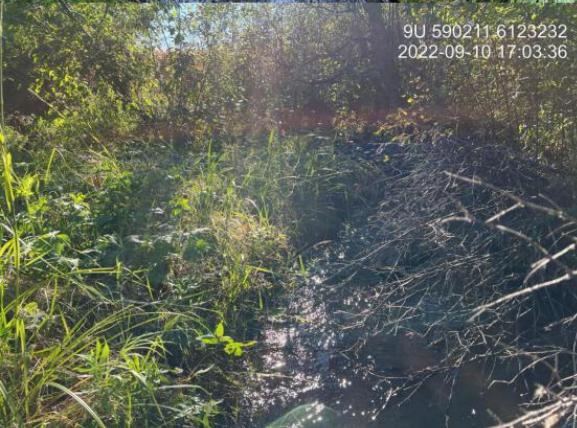
Location and Stream Data	•	Crossing Characteristics	-
Comments: Two 0.9 pipe added together for width. Left pipe has significant blockage 1/3 of the way through the pipe. Right Bank of the stream has an empty lot with only grass and invasive weed riparian. 16:52			
Photos: PSCIS ID 123392. From top left clockwise: Road/Site Card, Barrel, Outlet, Downstream, Upstream, Inlet.
