## Bulkley Watershed Fish Passage Restoration Planning 2022

Prepared for  
Canadian Wildlife Federation  
Habitat Conservation Trust Foundation - CAT23-6-288  
BC Fish Passage Remediation Program  
Ministry of Transportation and Infrastructure

Version 0.1.0 DRAFT 2023-01-16

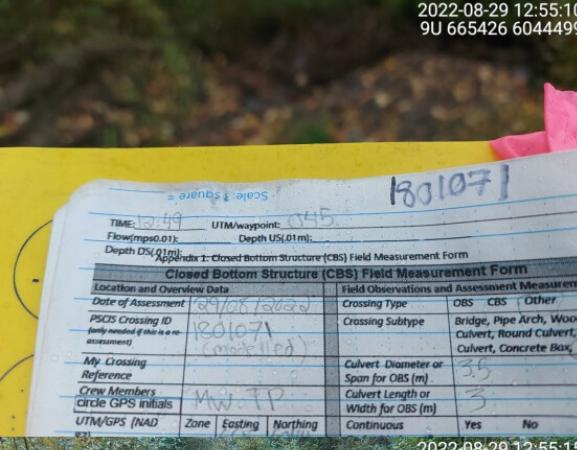
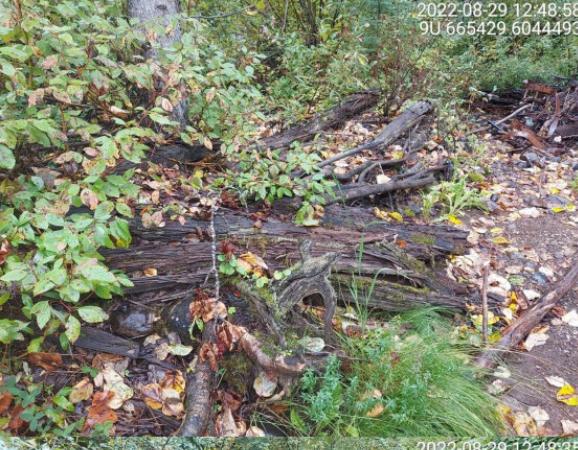
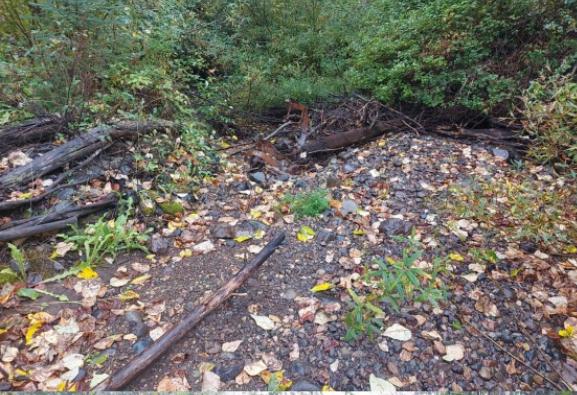
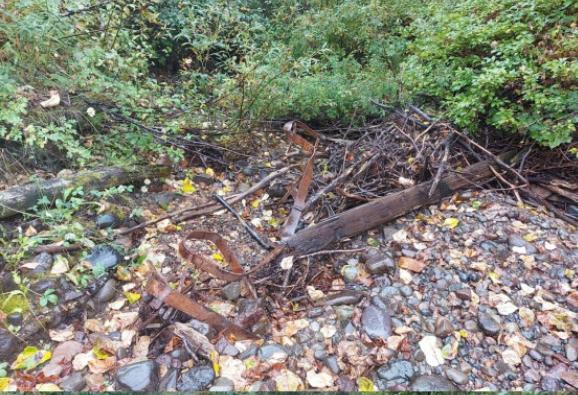
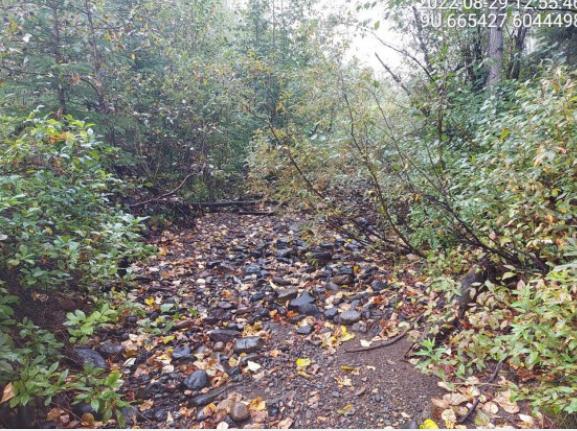
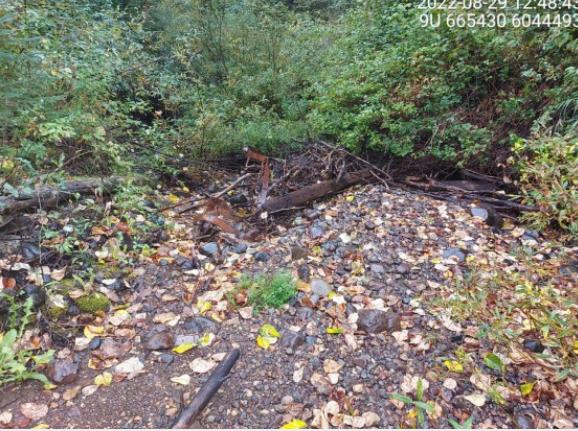
Location and Stream Data	•	Crossing Characteristics
Comments: No crossing. Transmission line. 12:49		
Photos: PSCIS ID 198109. From top left clockwise: Road/Site Card, Barrel, Outlet, Downstream, Upstream, Inlet.

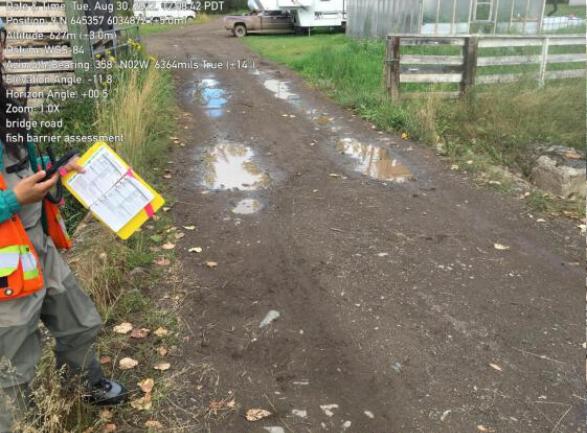
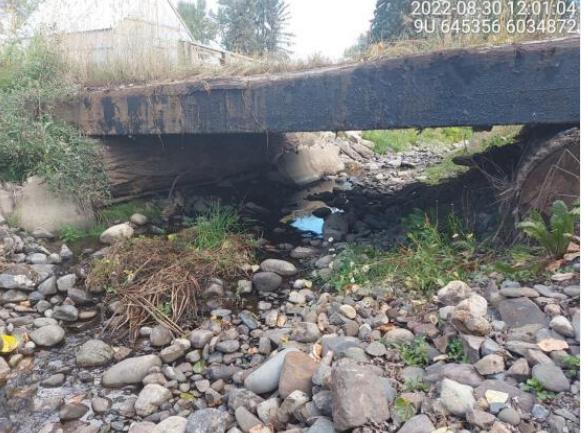
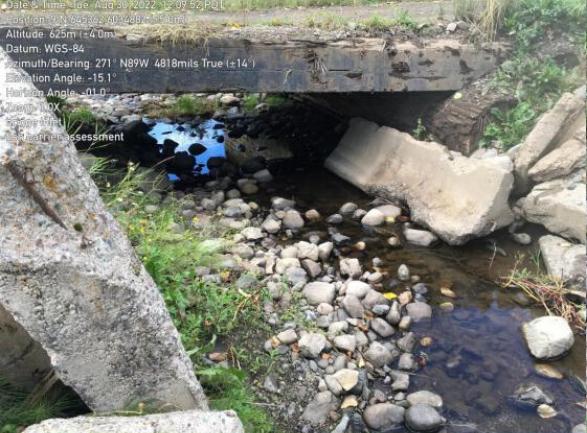
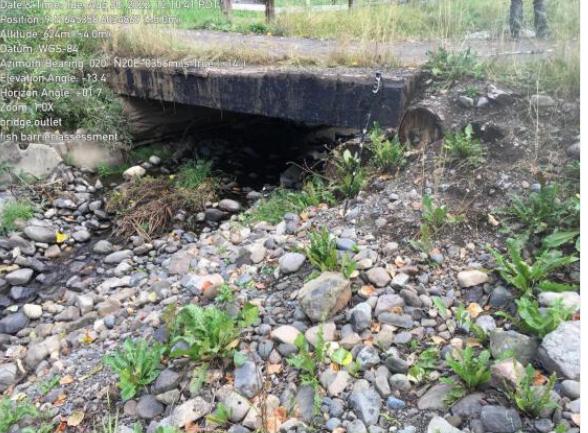
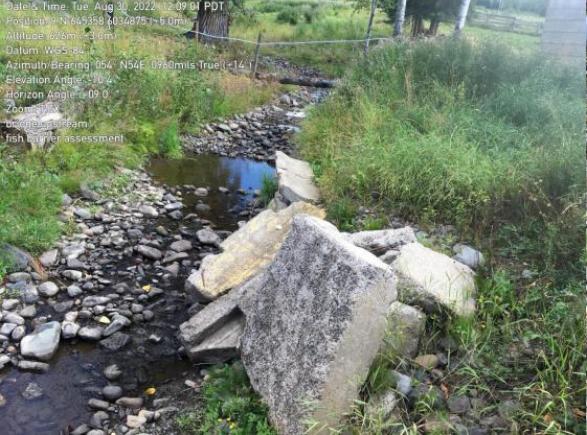
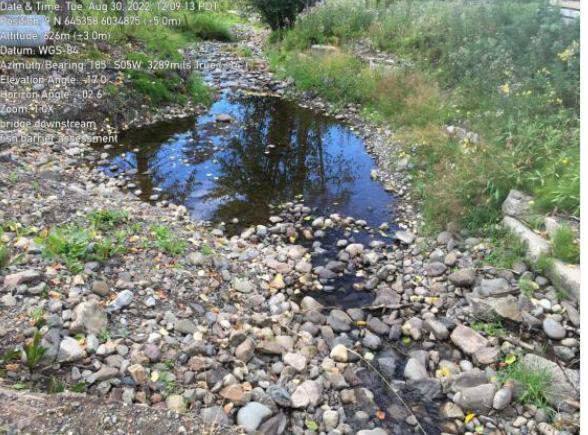
Location and Stream Data	•	Crossing Characteristics
Comments: Private property, farm bridge, concrete slabs on both banks upstream of culvert. 12:02		
Photos: PSCIS ID 198110. From top left clockwise: Road/Site Card, Barrel, Outlet, Downstream, Upstream, Inlet.

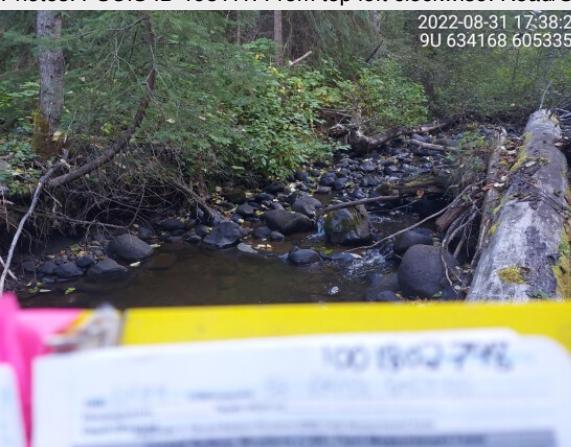
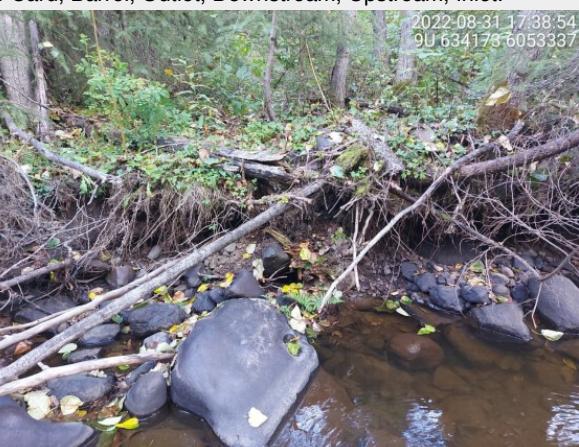
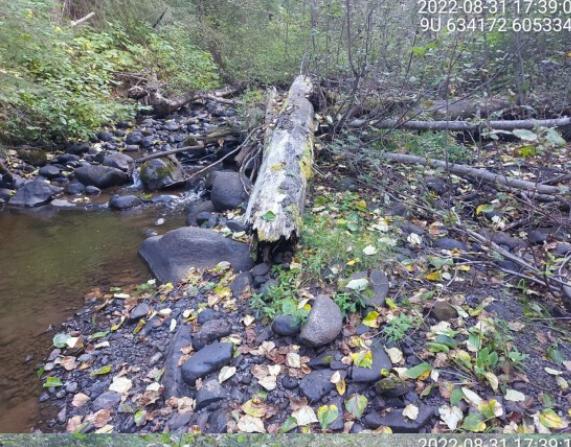
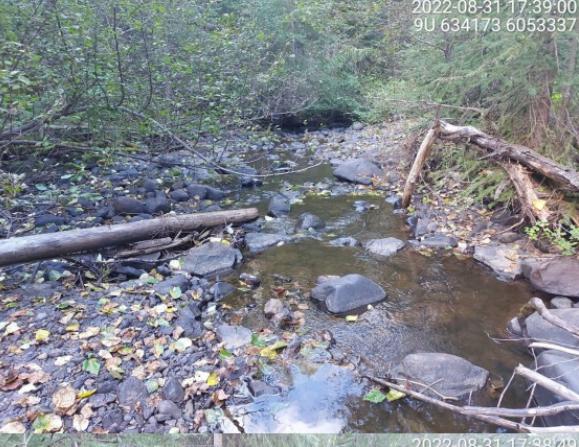
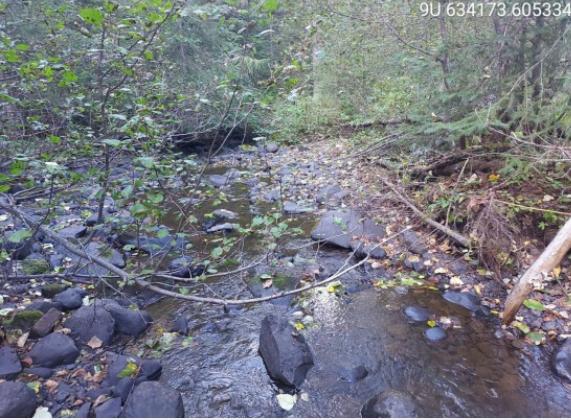
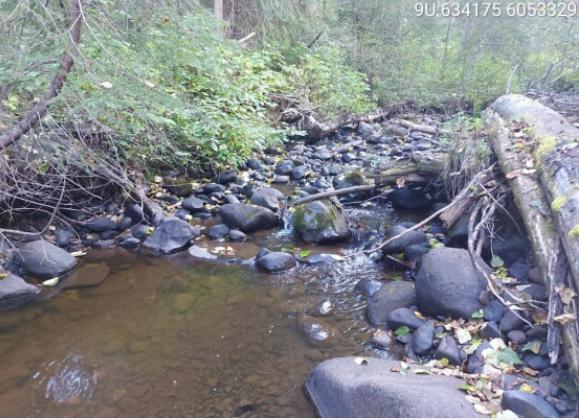
Location and Stream Data	•	Crossing Characteristics
Comments: Walked in. No crossing present. Road is more like a hiking trail than a road. 17:34		
Photos: PSCIS ID 198111. From top left clockwise: Road/Site Card, Barrel, Outlet, Downstream, Upstream, Inlet.

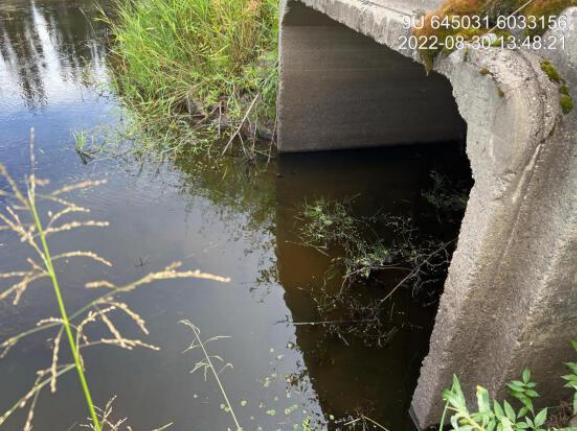
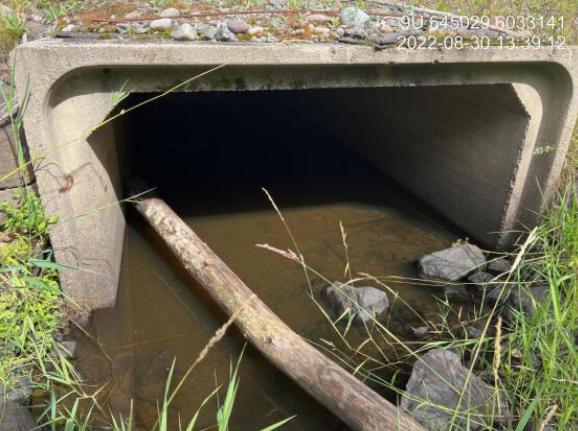
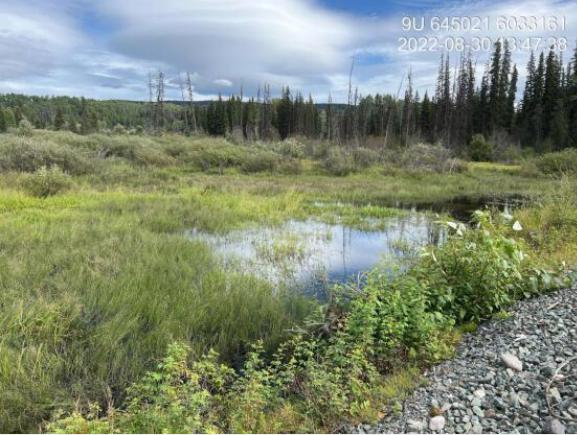
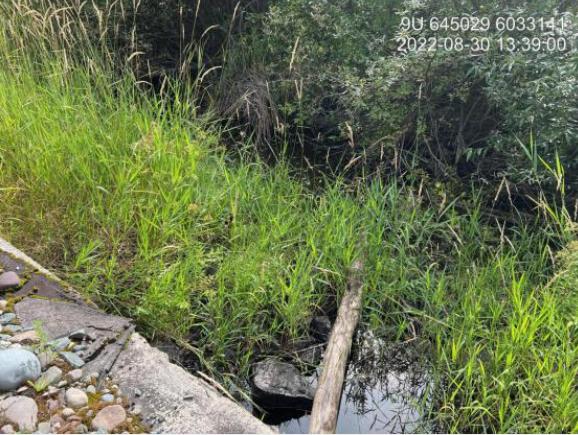
Location and Stream Data	•	Crossing Characteristics	-
Comments: Fully backwatered and embedded concrete box structure on the Railway. Not a fish passage issue at this time. 13:37			
Photos: PSCIS ID 198112. From top left clockwise: Road/Site Card, Barrel, Outlet, Downstream, Upstream, Inlet.

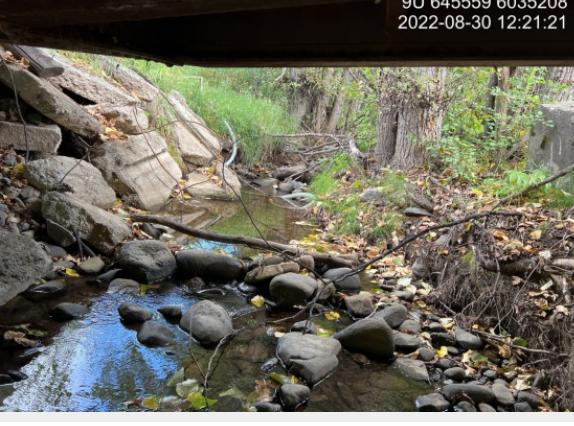
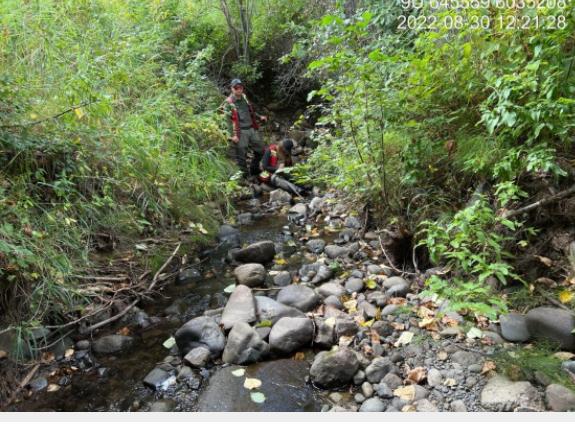
Location and Stream Data	•	Crossing Characteristics	-
Comments: Bridge is old CN railway metal structure and there is extensive concrete slabs in the stream used as rip rap. Private bridge within farmland. 12:20			
Photos: PSCIS ID 198114. From top left clockwise: Road/Site Card, Barrel, Outlet, Downstream, Upstream, Inlet.

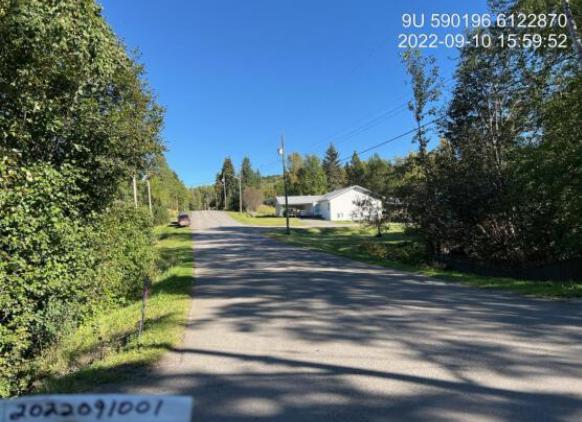
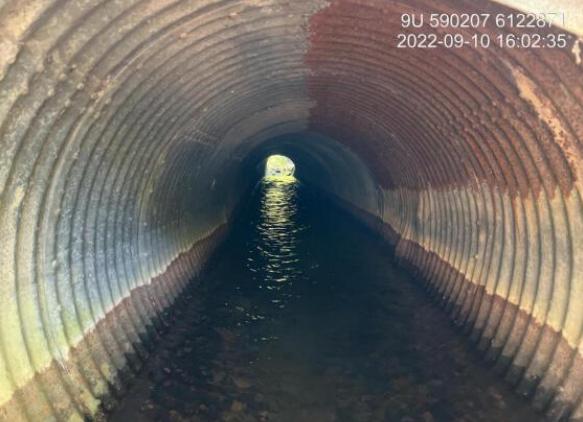
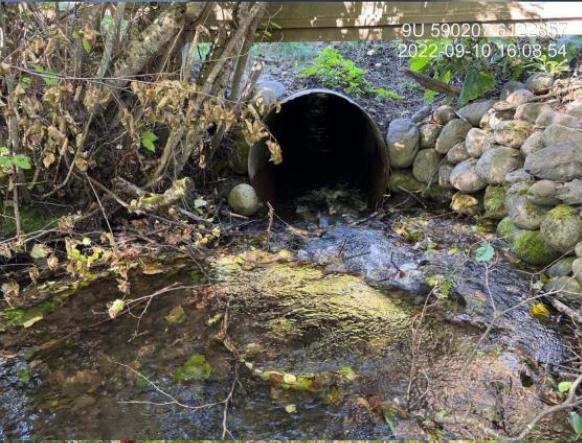
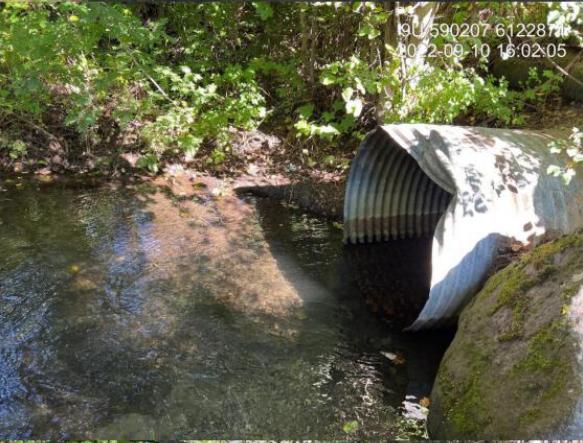
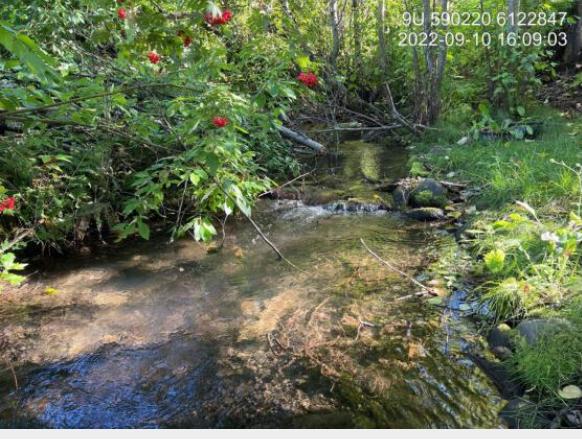
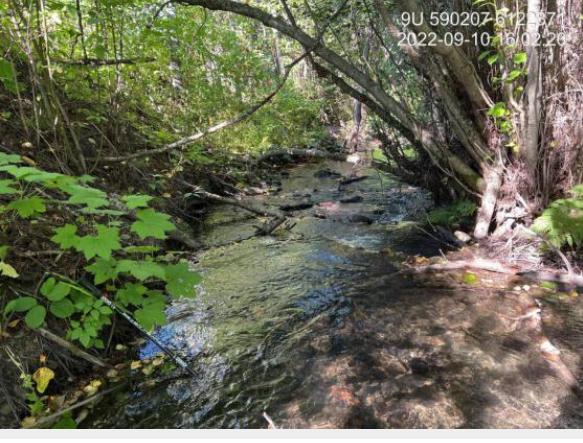
Location and Stream Data		Crossing Characteristics –	
Date	2022-09-10	Crossing Sub Type	Round Culvert
PSCIS ID	198115	Diameter (m)	1.25
External ID	2022091001	Length (m)	22
Crew	AI	Embedded	No
UTM Zone	9	Depth Embedded (m)	–
Easting	590210.7	Resemble Channel	No
Northing	6122882	Backwatered	No
Stream	Tributary to Waterfall Creek	Percent Backwatered	–
Road	13 Avenue	Fill Depth (m)	1.5
Road Tenure	New Hazelton	Outlet Drop (m)	0
Channel Width (m)	2.8	Outlet Pool Depth (m)	0.4
Stream Slope (%)	3	Inlet Drop	Yes
Beaver Activity	No	Slope (%)	1
Habitat Value	High	Valley Fill	Deep Fill
Final score	24	Barrier Result	Barrier
Fix type	Replace with New Open Bottom Structure	Fix Span / Diameter	10

Location and Stream Data	•	Crossing Characteristics	-
Comments: This is waterfall Creek. It does not show up in the freshwater atlas as here, however this is the main flow. Numerous fry and parr observed upstream of the crossing. No paper card for site. 16:03			
Photos: PSCIS ID 198115. From top left clockwise: Road/Site Card, Barrel, Outlet, Downstream, Upstream, Inlet.

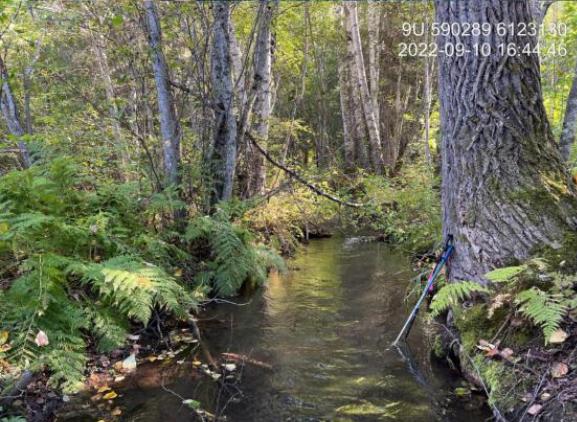
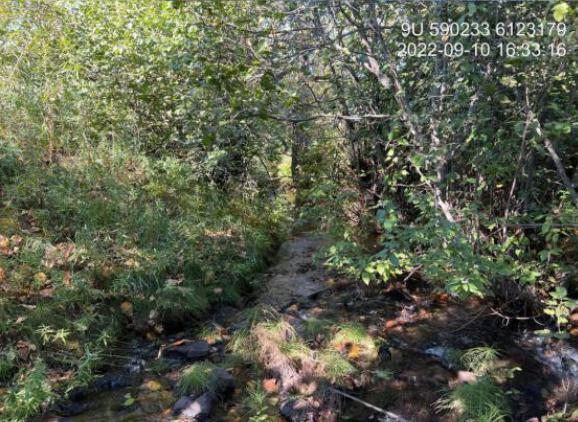
Location and Stream Data		Crossing Characteristics –	
Date	2022-09-10	Crossing Sub Type	Round Culvert
PSCIS ID	198116	Diameter (m)	1.5
External ID	2022091002	Length (m)	27
Crew	AI	Embedded	No
UTM Zone	9	Depth Embedded (m)	–
Easting	590233.2	Resemble Channel	No
Northing	6123183	Backwatered	No
Stream	Tributary to Waterfall Creek	Percent Backwatered	–
Road	Highway 16	Fill Depth (m)	1
Road Tenure	MoTi	Outlet Drop (m)	0
Channel Width (m)	3.9	Outlet Pool Depth (m)	0.2
Stream Slope (%)	2.5	Inlet Drop	Yes
Beaver Activity	No	Slope (%)	2.5
Habitat Value	High	Valley Fill	Deep Fill
Final score	24	Barrier Result	Barrier
Fix type	Replace with New Open Bottom Structure	Fix Span / Diameter	10

Location and Stream Data	Crossing Characteristics
Comments: Stream is not mapped correctly in the freshwater atlas. This is waterfall creek. Great flow, patches of gravel suitable for coho spawning. Right within the town of New Hazelton. Trap and truck coho operation conducted by Chicago Creek Restoration Society with spawners transplanted just downstream of the railway. 16:34	
Photos: PSCIS ID 198116. From top left clockwise: Road/Site Card, Barrel, Outlet, Downstream, Upstream, Inlet.

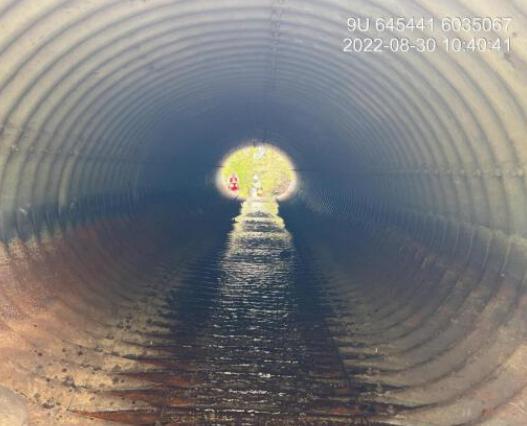
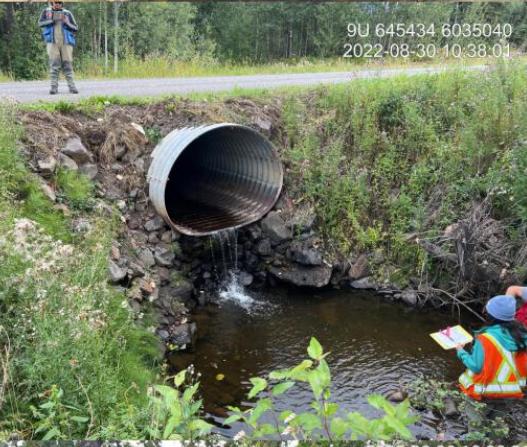
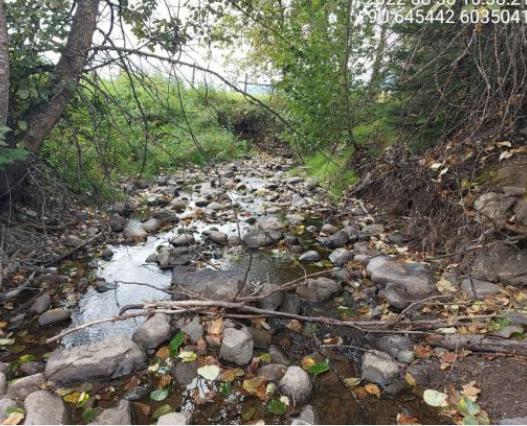
At the time of the survey, PSCIS crossing 195943 was un-embedded, non-backwatered and ranked as a barrier to upstream fish passage according to the provincial protocol (MoE 2011b) (Table 5.3). The culvert outlet drop was significant at 1.1m. Water temperature was 14°C, pH was 8.1 and conductivity was 343uS/cm. A beaver dam was noted just upstream of the culvert inlet (~1.5m high).

Location and Stream Data	•	Crossing Characteristics	-
Comments: Very large outlet drop, but creates nice pool for fish. Erosion on LB/RB on outlet side. Agricultural fields, minimal municipality population ds. Road is paved, detour available. 10:25			
Photos: From top left clockwise: Road/Site Card, Barrel, Outlet, Downstream, Upstream, Inlet.

Should restoration/maintenance activities proceed, replacement of PSCIS crossing 195943 with a bridge (10m span) is recommended. The cost of the work is estimated at \$2,000,000 for a cost benefit of 0.4 linear m/\$1000 and 0.6 m<sup>2</sup>/\$1000.

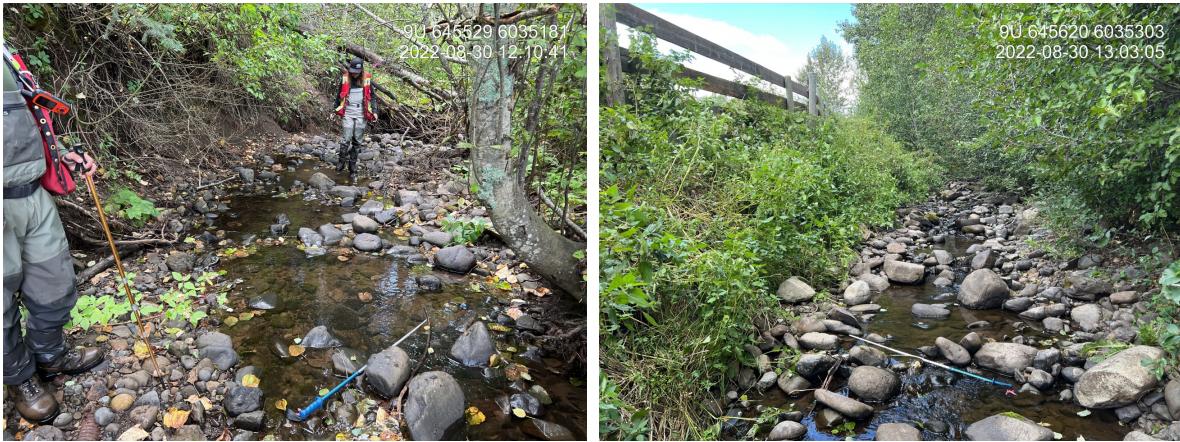
Figure 5.2: Left: Habitat upstream of PSCIS crossing 195943. Right: Habitat upstream of PSCIS crossing 195943.

Cover was also present as undercut banks. Good flow volumes were noted along with a decent amount of complexity due to boulders and undercut banks. There were small pockets of gravel suitable for resident rainbow as well as coho and steelhead spawning. The channel appeared to be constricted with riparian vegetation removed on both sides of the stream, likely due to agricultural development. Irrigation pipes in the channel indicated water withdrawal was occurring. The habitat was rated as medium value as an important migration corridor containing suitable spawning habitat and having moderate rearing potential for juvenile coho, steelhead and other salmonids.

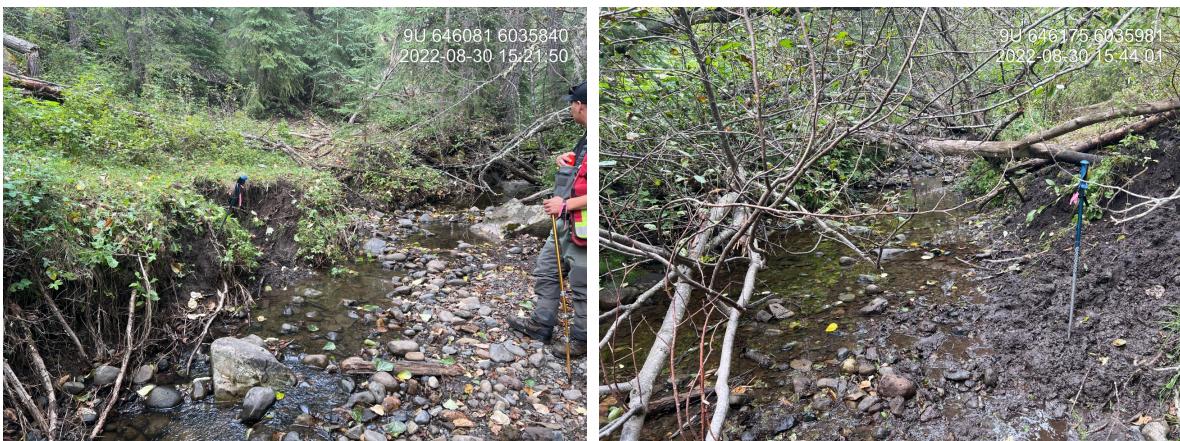
Figure 5.3: Left: Habitat upstream of PSCIS crossing 195944. Right: Habitat upstream of PSCIS crossing 195944.

The stream was surveyed upstream from crossing 195944 for 640m (Figure [??](#)). The dominant substrate was boulders with cobbles sub-dominant.Total cover amount was rated as moderate with boulders dominant. Cover was also present as small woody debris and undercut banks.The average channel width was 4.2m, the average wetted width was 1.8m, and the average gradient was 2%. Within the areas surveyed, the stream was noted heavily impacted by cattle activity with significant amounts of manure in the stream, degraded/removed riparian vegetation and extensive areas of trampled banks. There were occasional pockets of gravel suitable for resident rainbow spawning. Field notes indicate, occasional pools with depths suitable for juvenile salmon and adult resident salmonid overwintering. A rock drop of 65cm was located 365m upstream of the top end of the culvert.

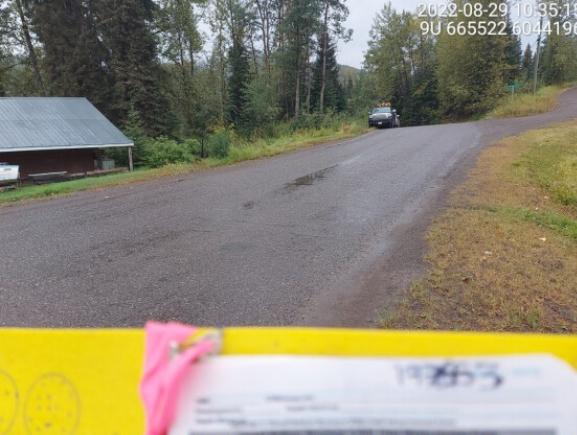
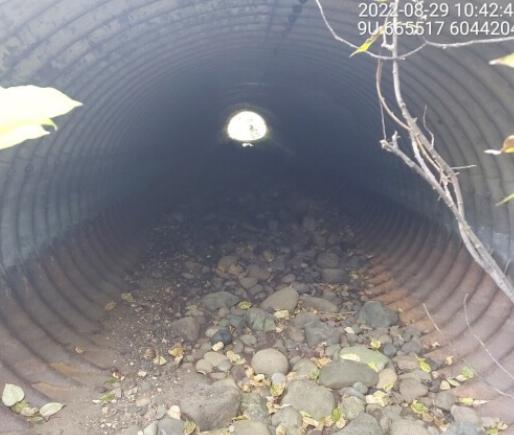
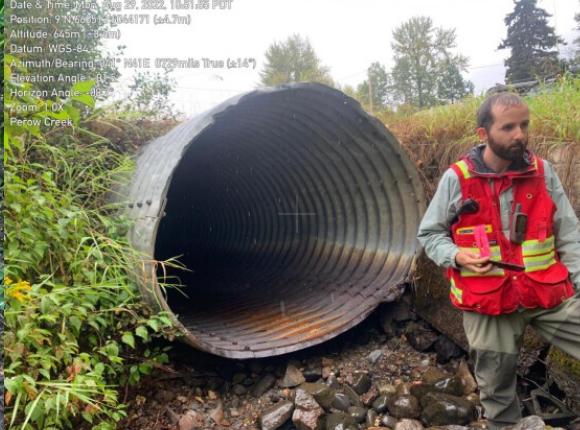
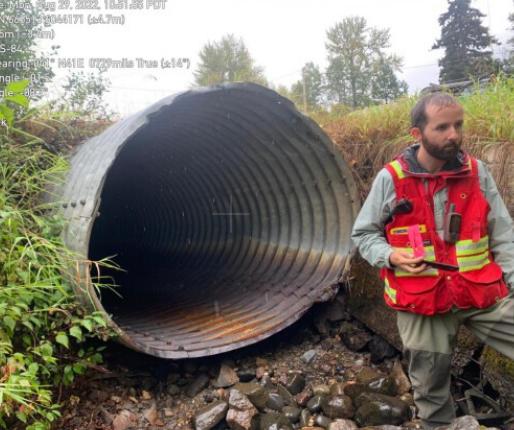
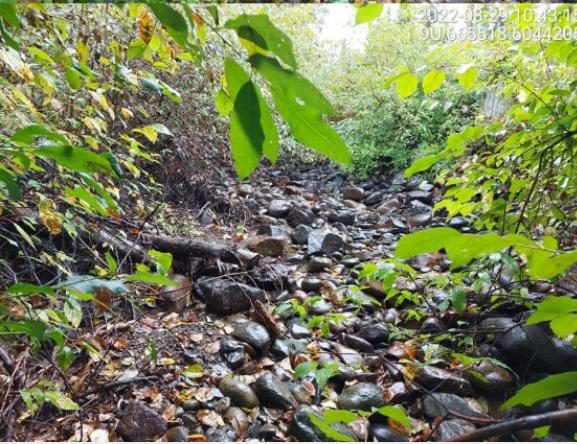
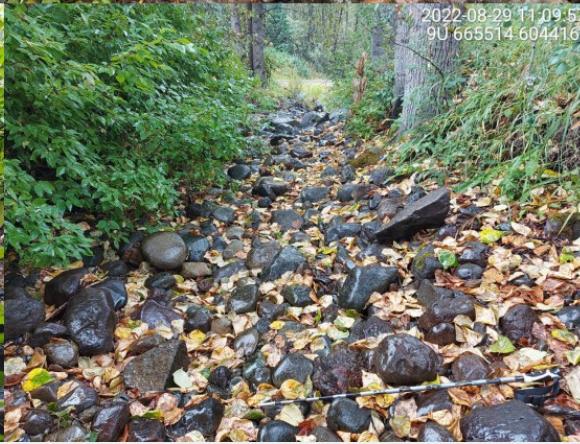
Location and Stream Data	•	Crossing Characteristics	-
Comments: Stream is dry. Private yards u/s and d/s. Rip rap and cement in channel. 10:48			
Photos: From top left clockwise: Road/Site Card, Barrel, Outlet, Downstream, Upstream, Inlet.

Should restoration/maintenance activities proceed, replacement of PSCIS crossing 197653 with a streambed simulation (3m span) is recommended. The cost of the work is estimated at \$400,000 for a cost benefit of 0.8 linear m/\$1000 and 1.8 m<sup>2</sup>/\$1000.

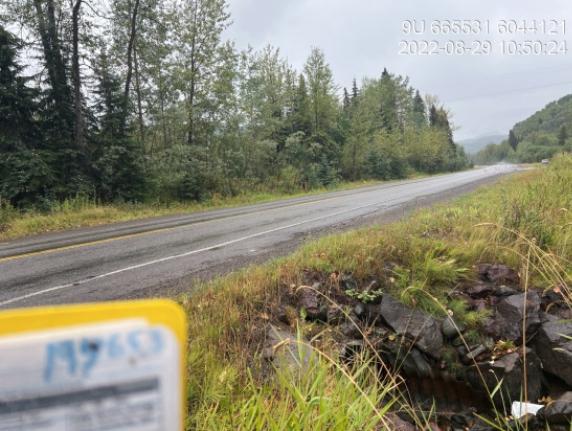
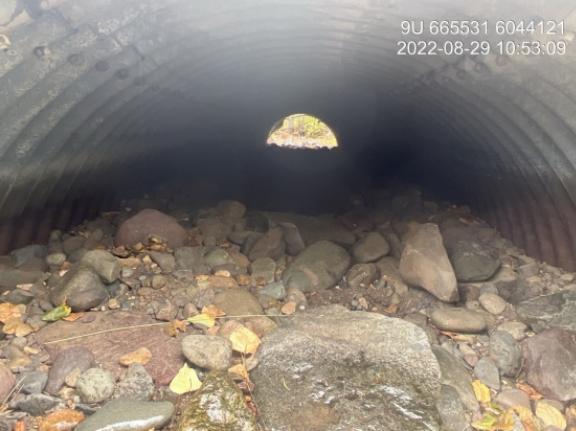
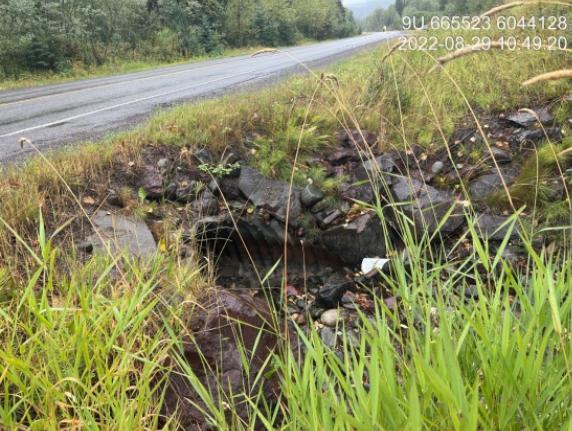
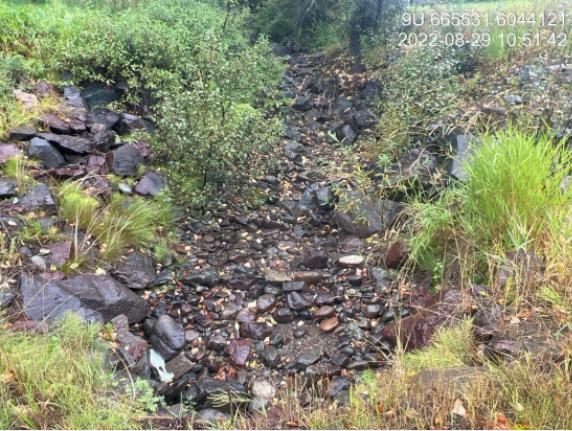
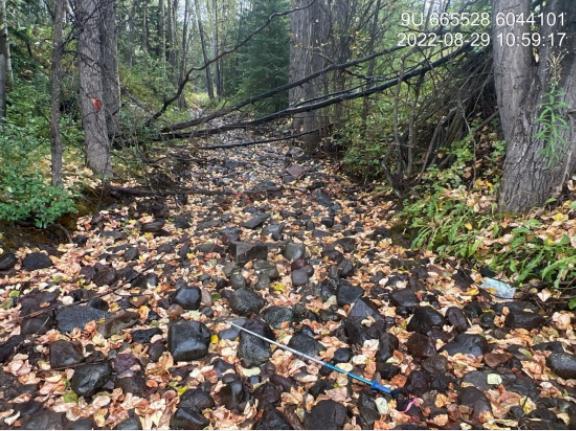
Location and Stream Data	•	Crossing Characteristics
<p>Comments: Stream was dry at time of survey but had water last year during extremely dry ear. Culvert appears passable for all life stages. There is private land residential development impacting the stream with the constricted channel with a large chunks of coffee just as rip rap throughout. 10:45</p>		
<p>Photos: From top left clockwise: Road/Site Card, Barrel, Outlet, Downstream, Upstream, Inlet.</p>

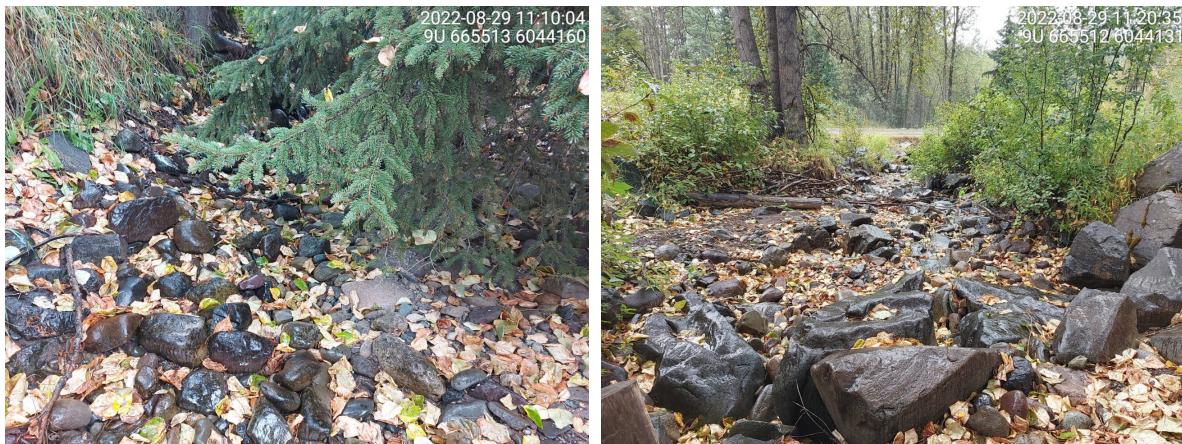
area assessed downstream of the crossing was dry at the time of the survey (Figure 5.4). The average channel width was 4.3m, the average wetted width was NAm, and the average gradient was 2%. Total cover amount was rated as moderate with boulders dominant. Cover was also present as overhanging vegetation. The dominant substrate was boulders with cobbles sub-dominant. PSCIS crossing 197657 on the highway, approximately 50m downstream from crossing 197653 was reassessed and ranked as passable as it was low gradient, fully embedded and with no outlet drop. It appeared passable to all species and life stages at the time of assessment (Table 5.10). This crossing was previously assessed in 2020 by Irvine (2021), but it was mistakenly input as modelled crossing ID 1800064, when it should have been 1800067. The stream from Perow Loop Road to the highway flowed through private property and appeared to be channelized and confined with concrete slabs used as stream bank armoring just downstream of the outlet. Downstream of the highway crossing two bridges are documented in the PSCIS database (197660 and 197659). Although habitat downstream had limited complexity resulting from impacts related to the adjacent road infrastructure and residential properties, the habitat was rated as medium value as it was considered an important migration corridor.

Figure 5.4: Left: Habitat downstream of PSCIS crossing 197653. Right: Habitat downstream of PSCIS crossing 197653.

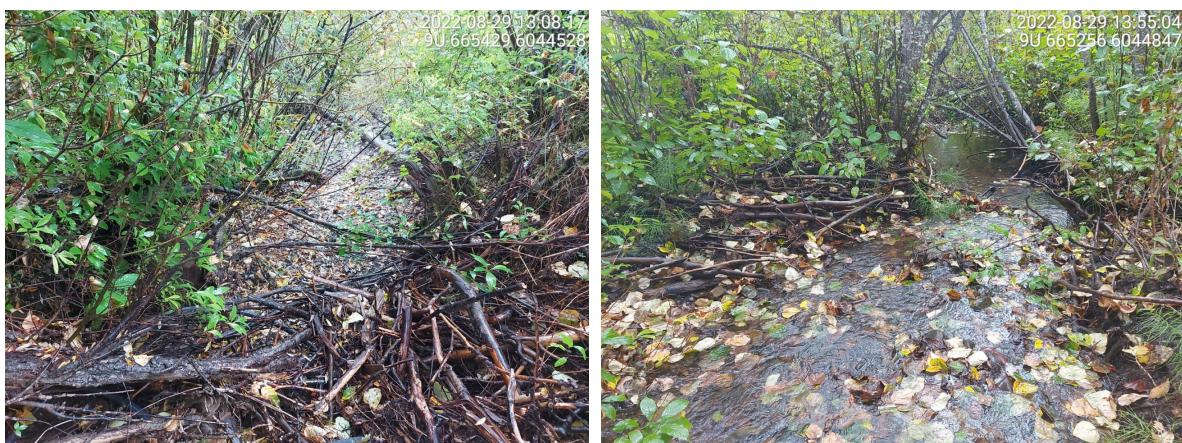
The stream was surveyed upstream from crossing 197653 for 500m (Figure 5.5). Two sections of stream upstream of the crossing were assessed. As residential buildings and yards were situated immediately adjacent to the stream upstream of the crossing, the stream was accessed from a ford located on the transmission line ~325m upstream of Perow Loop Road. The first section surveyed included ~350m of channel upstream of the ford and was dewatered at the time of survey. The dominant substrate was cobbles with gravels sub-dominant. Total cover amount was rated as moderate with overhanging vegetation dominant. Cover was also present as small woody debris. The average channel width was 3.2m, the average wetted width was 1.9m, and the average gradient was 3%.

Figure 5.5: Left: Habitat upstream of PSCIS crossing 197653. Right: Habitat upstream of PSCIS crossing 197653.

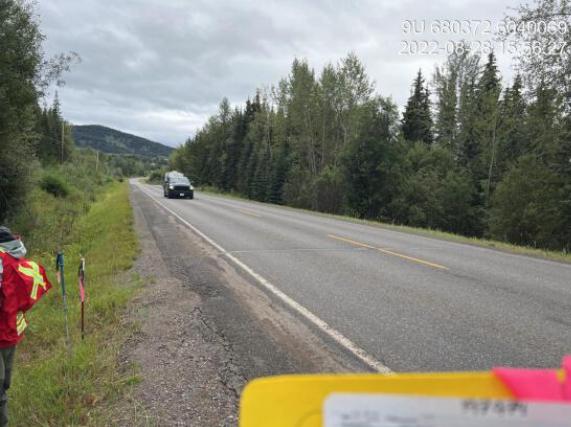
Location and Stream Data	•	Crossing Characteristics	-
Comments: Deep and large outlet pool indicate culvert is significantly undersized. Condition of the pipe is poor with corrosion and some collapsing in the middle of the pipe. 0.6m diameter overflow pipe located adjacent to the main culvert. Some decent gravels downstream. 15:52			
Photos: From top left clockwise: Road/Site Card, Barrel, Outlet, Downstream, Upstream, Inlet.

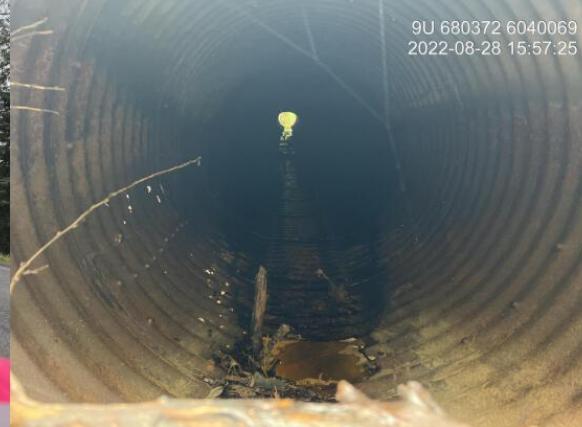
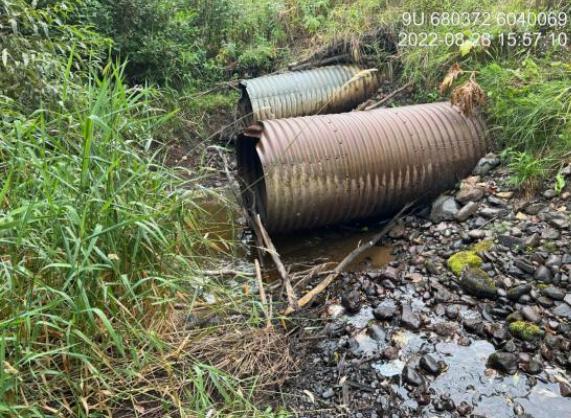
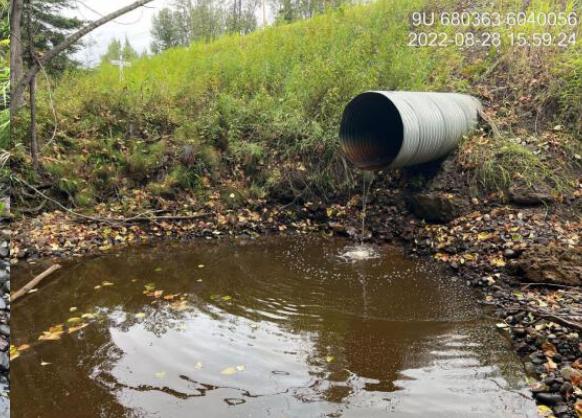
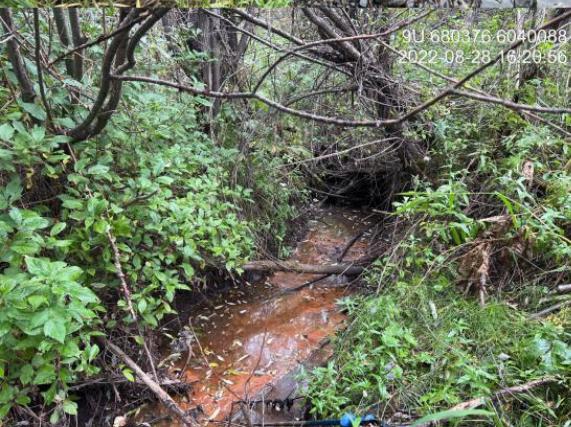
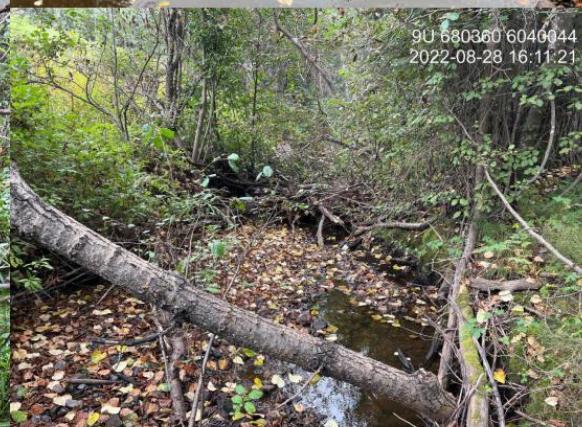
At the time of the survey, PSCIS crossing 197974 was un-embedded, non-backwatered and ranked as a barrier to upstream fish passage according to the provincial protocol (MoE 2011b) (Table 5.15). The culvert was considered a complete barrier to all species and all life stages at all flows due to an outlet drop measured at 1m high. The deep and large outlet pool indicated that the culvert was significantly undersized. Condition of the pipe was noted as poor with extensive corrosion present and some collapsing in the middle of the pipe. Water temperature was 13°C, pH was 7.8 and conductivity was 199uS/cm.

Should restoration/maintenance activities proceed, replacement of PSCIS crossing 197974 with a streambed simulation (3m span) is recommended. The cost of the work is estimated at \$1,500,000 for a cost benefit of 1.6 linear m/\$1000 and 2.8 m<sup>2</sup>/\$1000.

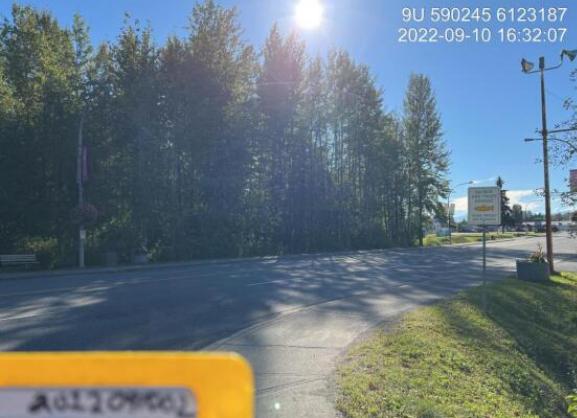
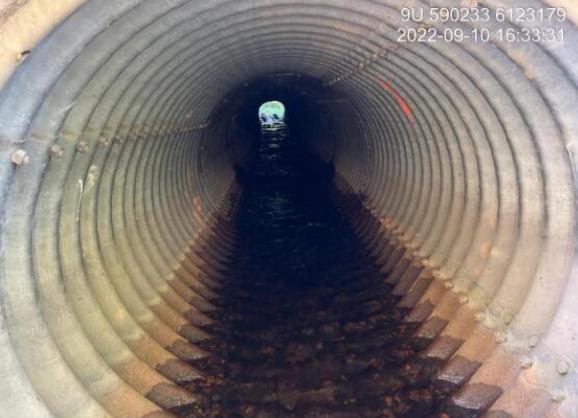
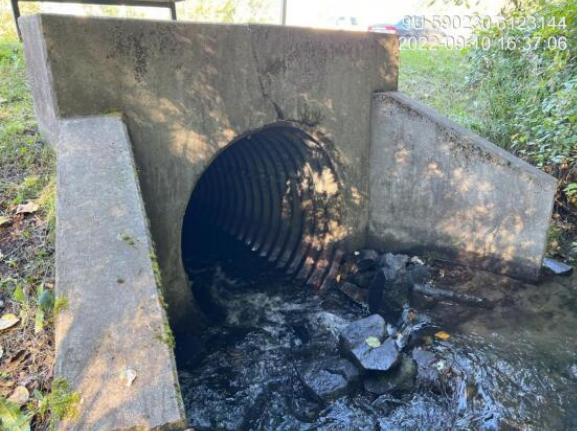
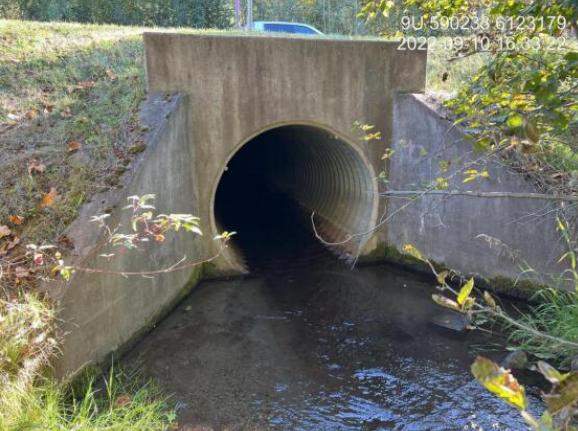
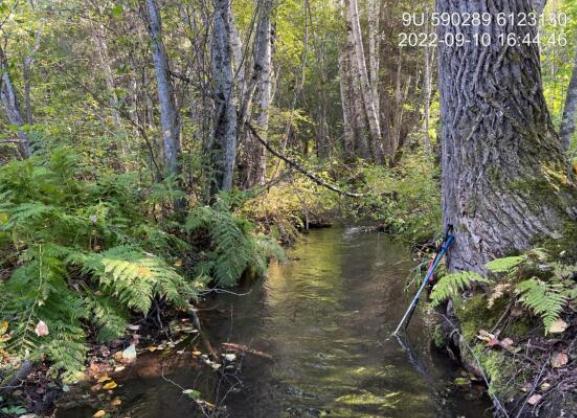
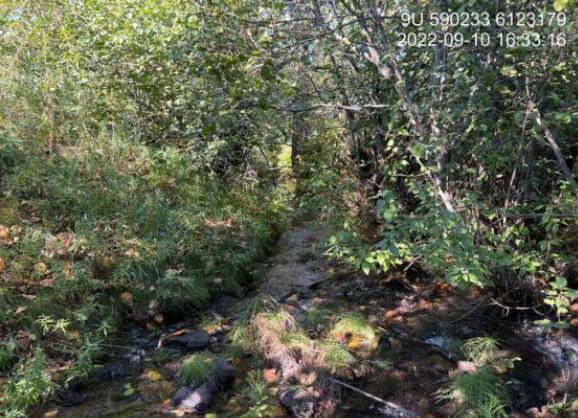
Location and Stream Data	•	Crossing Characteristics	-
<p>Comments: Stream is not mapped correctly in the freshwater atlas as it actually flows in a north direction through town. Great flow, patches of gravel suitable for cohost Bonnie. Right within the town of New Hazelton. Trap and truck coho operation occurring with spawners transplanted upstream of the railway and 14th avenue. 16:34</p>			
Photos: From top left clockwise: Road/Site Card, Barrel, Outlet, Downstream, Upstream, Inlet.

Should restoration/maintenance activities proceed, replacement of PSCIS crossing 198116 with a bridge (10m span) is recommended. The cost of the work is estimated at \$7,500,000 for a cost benefit of NA linear m/\$1000 and NA m<sup>2</sup>/\$1000.

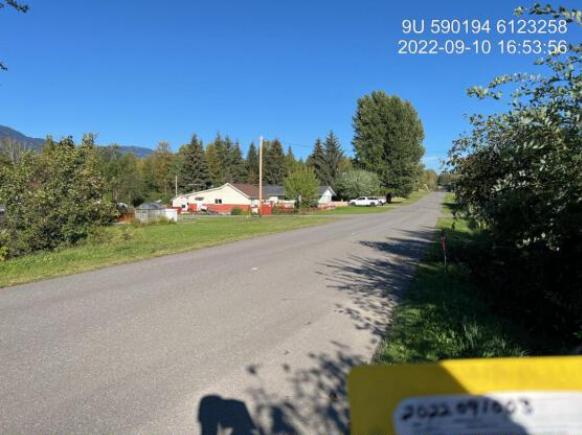
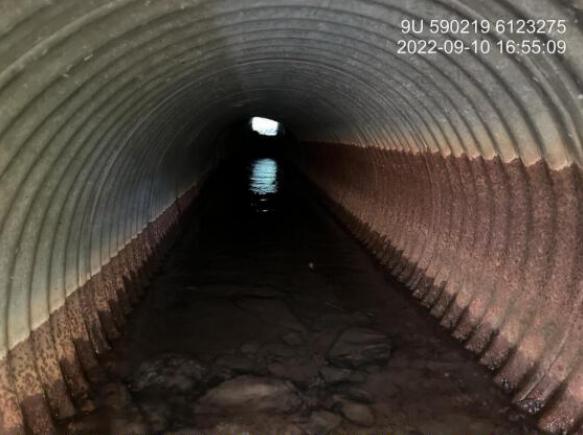
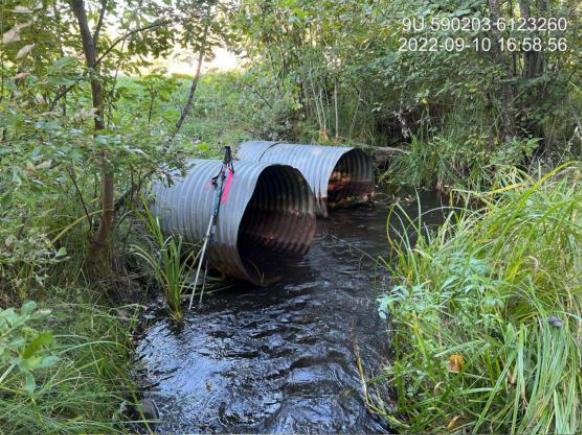
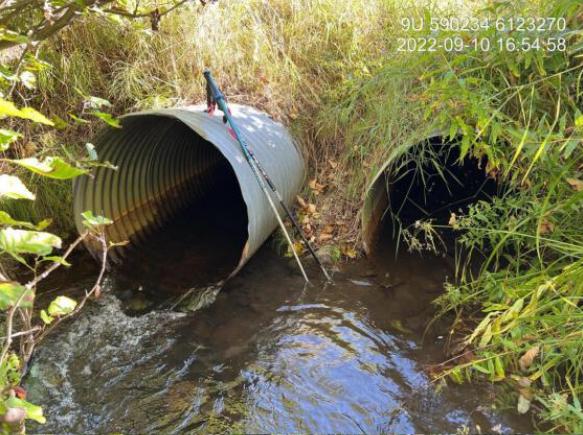
Location and Stream Data	•	Crossing Characteristics	-
Comments: Two 0.9 pipe added together for width. Left pipe has significant blockage 1/3 of the way through the pipe. Right Bank of the stream has an empty lot with only grass and invasive weed riparian. 16:52			
Photos: From top left clockwise: Road/Site Card, Barrel, Outlet, Downstream, Upstream, Inlet.

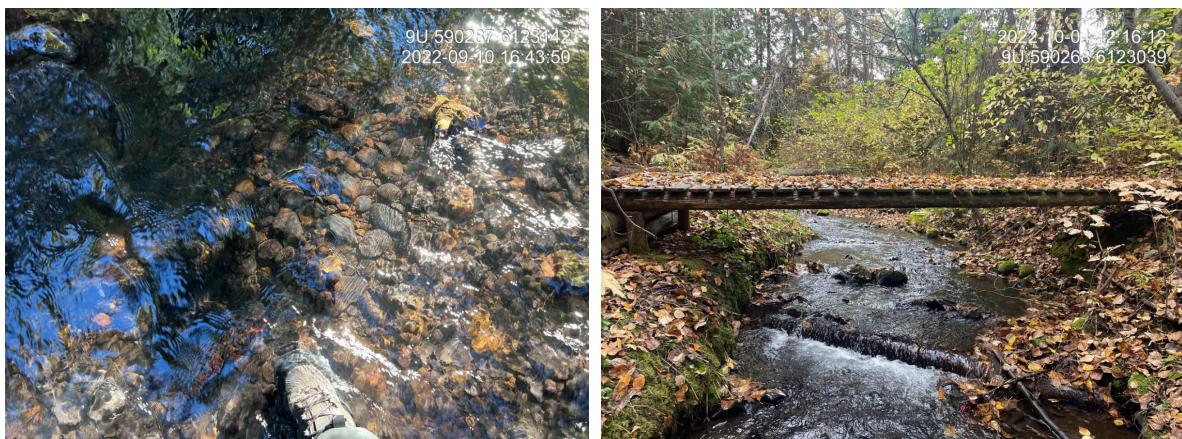
Figure 5.12: Left: Gravel and cobble substrate immediately upstream of PSCIS crossing 198116. Right: Footbridge located upstream of PSCIS crossing 198116.

The stream was surveyed upstream from crossing 198116 for 1200m to the location of a waterfall that blocks upstream migration for all life stages and species (Figure 5.12). Total cover amount was rated as abundant with overhanging vegetation dominant. Cover was also present as undercut banks. Total cover amount was rated as abundant with small woody debris dominant. Cover was also present as undercut banks. The average channel width was 3.7m, the average wetted width was 3.5m, and the average gradient was 1.5%. The dominant substrate was fines with gravels sub-dominant. There was a culvert approximately 400m upstream of PSCIS crossing 198116 that was also assessed. At the time of survey, this crossing was un-embedded, non-backwatered, and ranked as a barrier to upstream fish passage (Table 5.19). The habitat quality was excellent. The stream flow was moderate and there were fish spotted all the way up to the waterfall where the survey ended. An adult coho was seen upstream of crossing 198115. Cover from vegetation and undercut banks was noted as abundant. The habitat was rated as high value as an important migration corridor containing suitable spawning habitat and having high rearing potential for juvenile coho, rainbow trout, cutthroat trout and dolly varden.
