## Bulkley Watershed Fish Passage Restoration Planning 2022

Prepared for  
Canadian Wildlife Federation  
Habitat Conservation Trust Foundation - CAT23-6-288  
BC Fish Passage Remediation Program  
Ministry of Transportation and Infrastructure

Version 0.1.0 DRAFT 2023-01-16

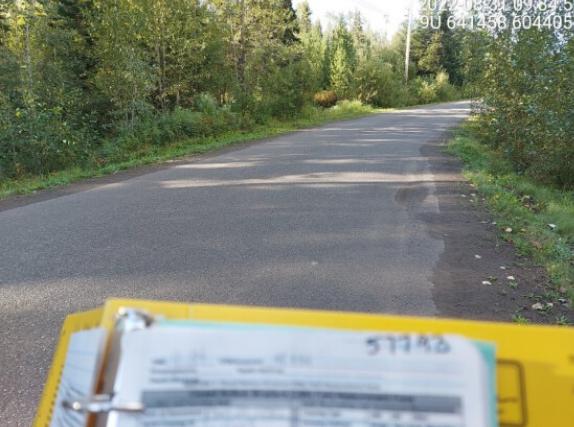
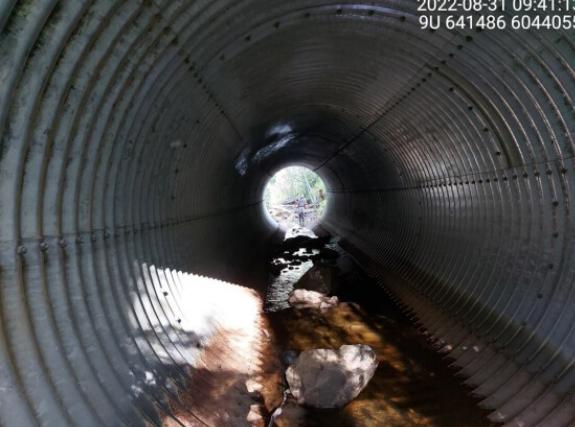
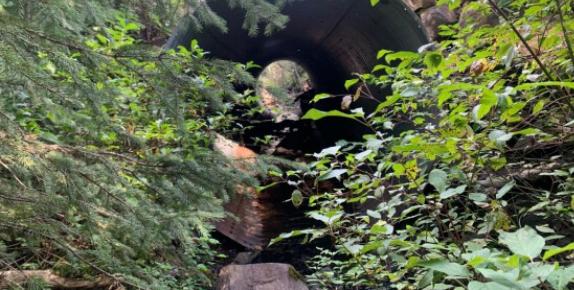
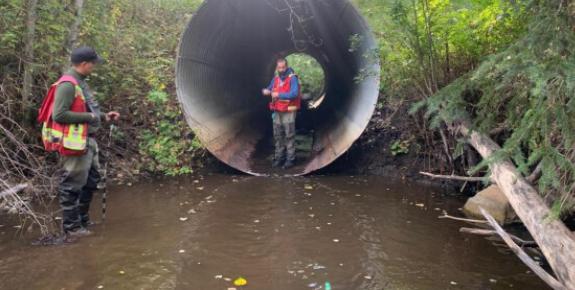
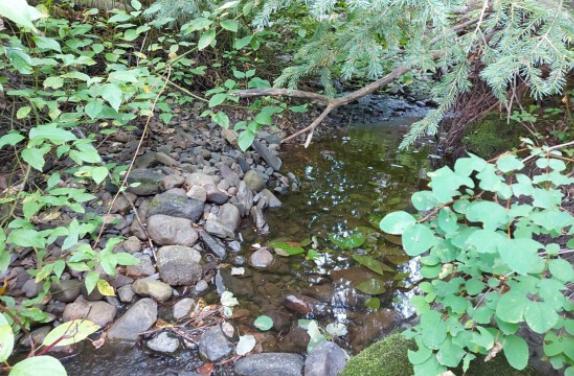
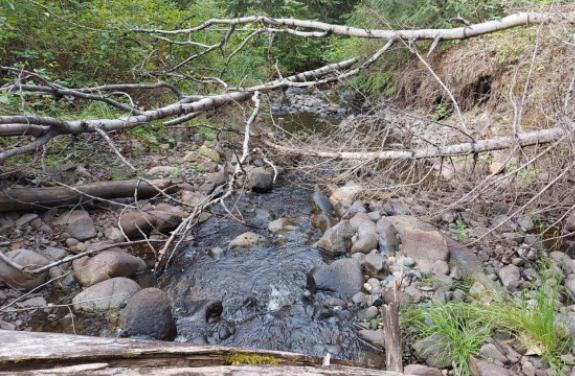
Location and Stream Data	•	Crossing Characteristics
Comments: Slight outlet drop, low water levels would be a fish passage issue. Little amount of water running through culvert. Deep pool at outlet of culvert, good for fish. Boulders in culvert, which are obstacles to fish. 9:34		
Photos: From top left clockwise: Road/Site Card, Barrel, Outlet, Downstream, Upstream, Inlet.

Should restoration/maintenance activities proceed, replacement of PSCIS crossing 57793 with a bridge (10m span) is recommended. The cost of the work is estimated at \$2,000,000 for a cost benefit of 8 linear m/\$1000 and 18.8 m<sup>2</sup>/\$1000.

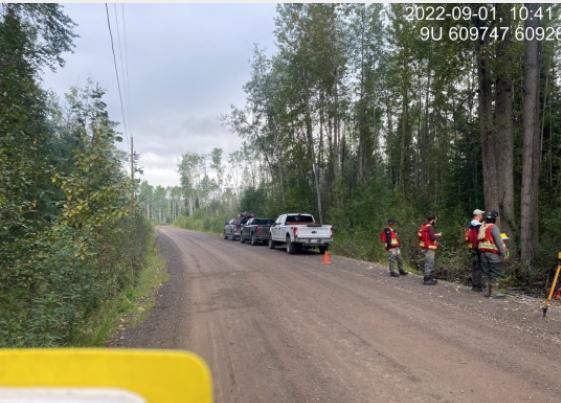
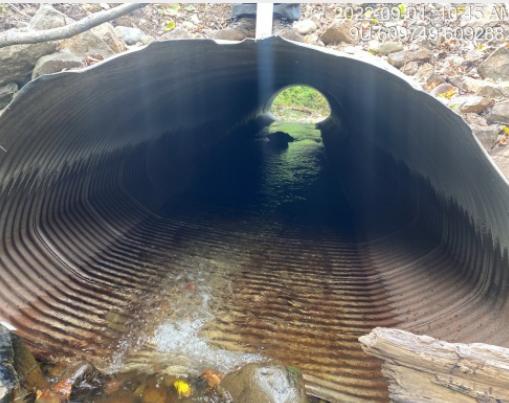
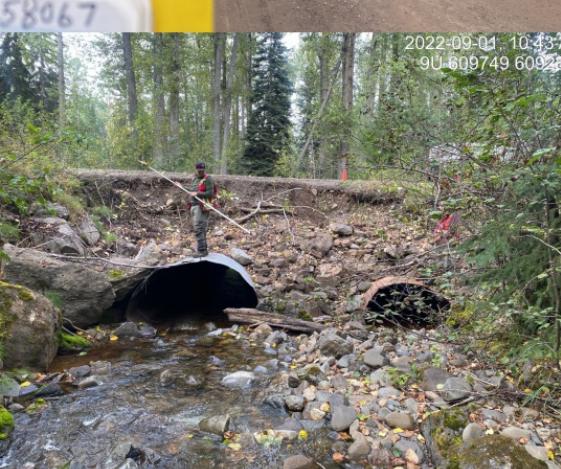
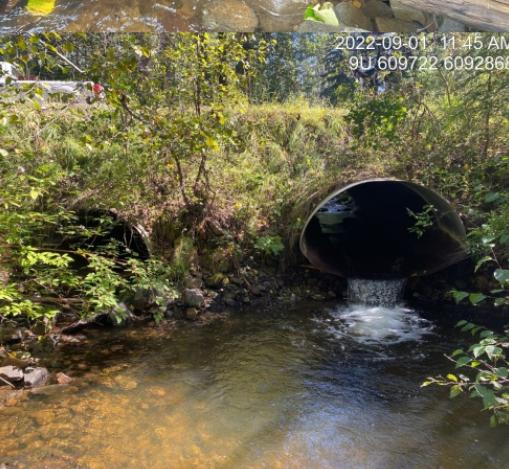
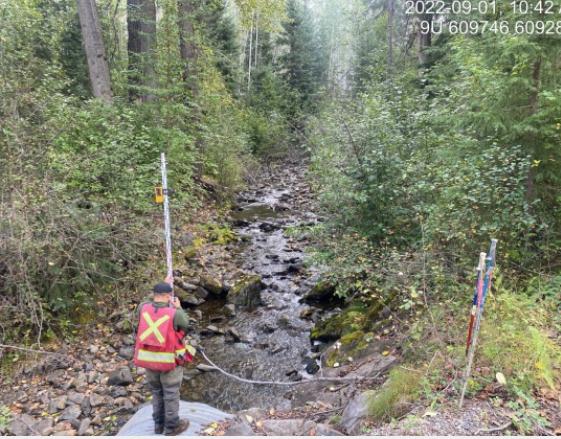
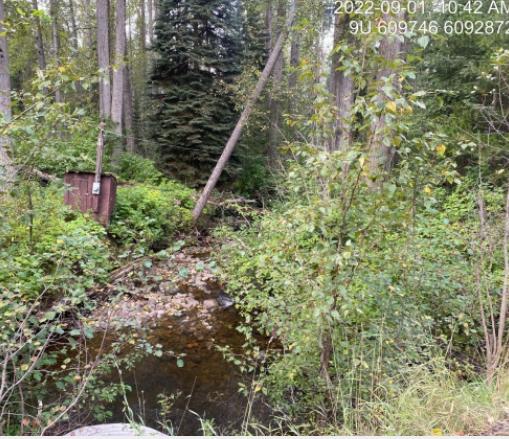
At the time of the survey, PSCIS crossing 58067 was un-embedded, non-backwatered, had an outlet drop of 0.49m and ranked as a barrier to upstream fish passage according to the provincial protocol (MoE 2011b) (Table 5.27). The crossing consisted of two pipes, with a very big outlet pool indicating the crossing was undersized. The pipes were noted as in poor condition due to corrosion and the road prism at the site had indications of significant erosion adjacent to the crossing. Water temperature was 12°C, pH was 8.2 and conductivity was 93uS/cm.

Location and Stream Data	•	Crossing Characteristics	-
Comments: Gradient of culvert shot with laser level. Inside of pipe is bent downward at the outlet. Upstream side of the road is eroding. Enormous outlet pool indicates pricing is undersized. Water flowing under overflow. Just outside of Whitsett community. Seems like a really good candidate for replacement. 10:26			
Photos: From top left clockwise: Road/Site Card, Barrel, Outlet, Downstream, Upstream, Inlet.

Should restoration/maintenance activities proceed, replacement of PSCIS crossing 58067 with a bridge (11.5m span) is recommended. The cost of the work is estimated at \$1,150,000 for a cost benefit of 12.2 linear m/\$1000 and 40.2 m<sup>2</sup>/\$1000.

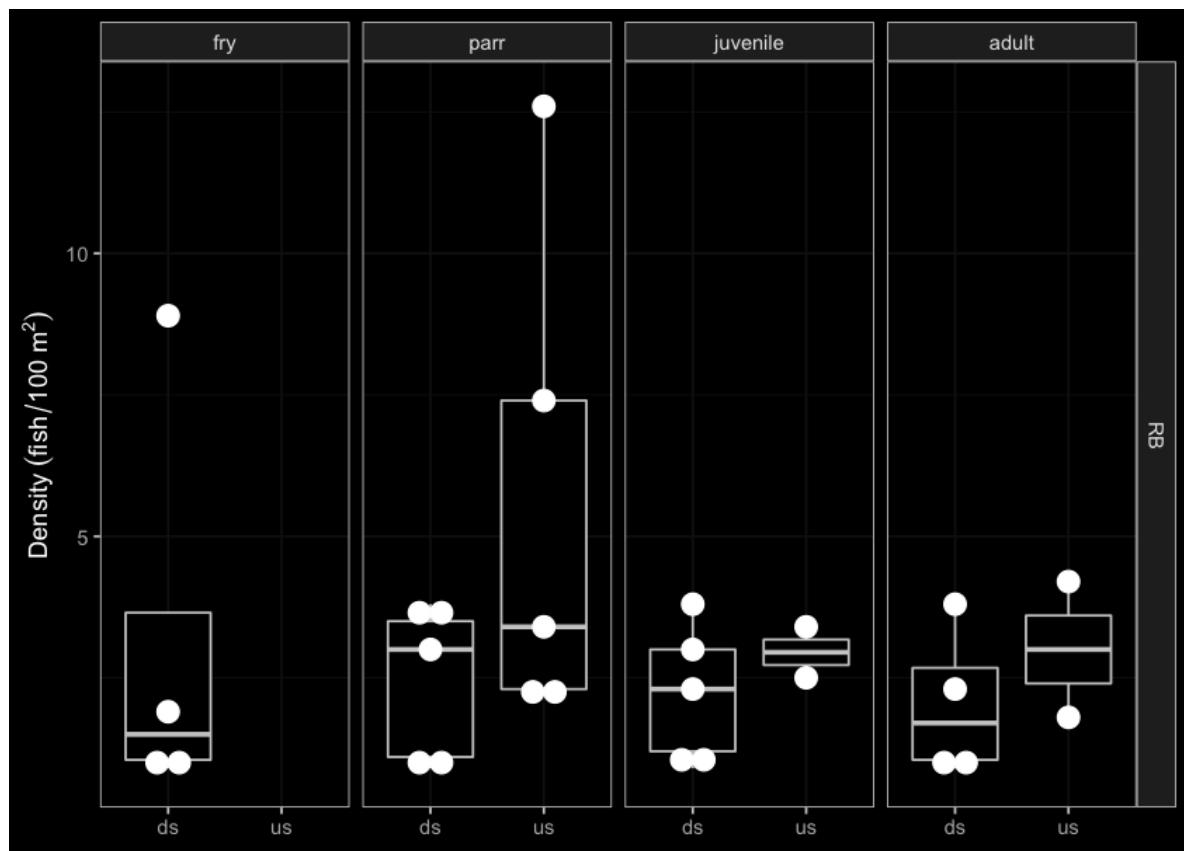
Figure 5.19: Densities of fish (fish/100m<sup>2</sup>) captured upstream of PSCIS crossing 58067.

local_name	species_code	life_stage	catch	density_100m2	nfc_pass
58067_us_ef2	RB	adult	1	1.8	FALSE
58067_us_ef3	RB	parr	2	2.3	FALSE
58067_us_ef4	RB	parr	2	2.2	FALSE
58067_us_ef5	RB	parr	3	7.4	FALSE
58067_us_ef5	RB	juvenile	1	2.5	FALSE
58067_us_ef6	RB	adult	1	4.2	FALSE

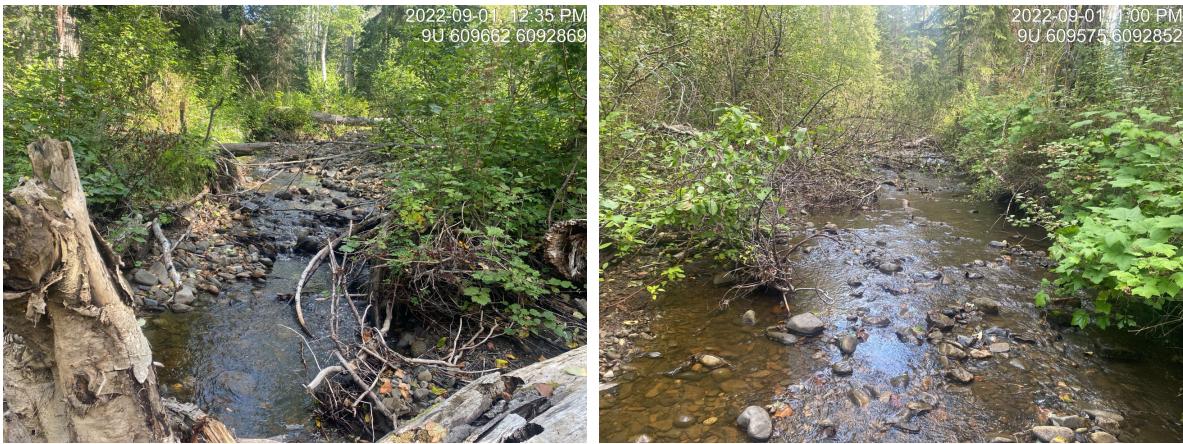
Figure 5.20: Left: Typical habitat downstream of PSCIS crossing 58067. Right: Typical habitat downstream of PSCIS crossing 58067.

The stream was surveyed downstream from crossing 58067 for 300m to the confluence with the Bulkley River (Figure [5.20](#)). The average channel width was 5.1m, the average wetted width was 3m, and the average gradient was 3%. Total cover amount was rated as moderate with undercut banks dominant. Cover was also present as small woody debris, boulders, deep pools, and overhanging vegetation. The dominant substrate was cobbles with boulders sub-dominant. There were abundant undercut banks available for cover. Some patches of gravel were present that would be suitable for rainbow, steelhead and coho spawning. Occasional deep pools were present that would serve as good habitat suitable for fish rearing and overwintering. Riparian vegetation was mixed deciduous and conifer old growth forest. The habitat was rated as high value for salmonid rearing and spawning.
