## Bulkley Watershed Fish Passage Restoration Planning 2022

Prepared for  
Canadian Wildlife Federation  
Habitat Conservation Trust Foundation - CAT23-6-288  
BC Fish Passage Remediation Program  
Ministry of Transportation and Infrastructure

Prepared by  
Al Irvine, B.Sc., R.P.Bio. and Mateo Wintersheidt, B.Sc.  
New Graph Environment Ltd.  
on behalf of  
Society for Ecosystem Restoration in Northern British Columbia

Version 0.1.6 DRAFT 2023-05-30

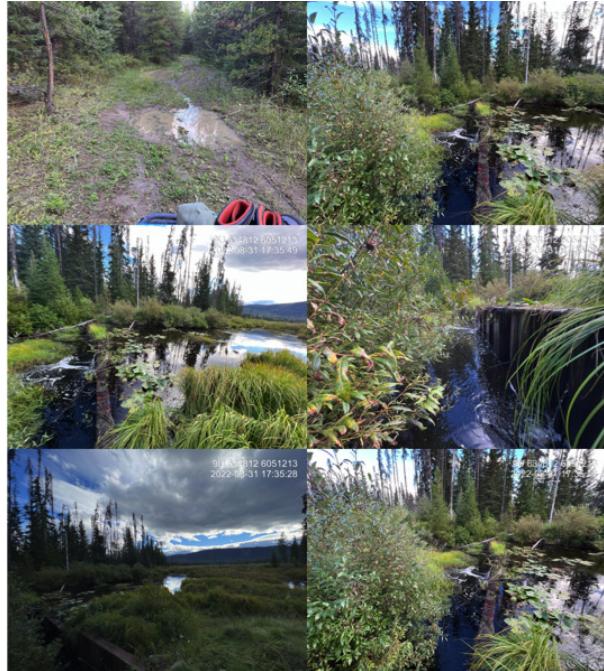
Site	Stream	Easting	Northing	Mapsheet	Barrier	Notes
1f365462-063c-491e-9fb3-bfac004d9183	Coffin Creek	634763	6051171	093L.113	T	Aerial imagery aquired. Complete barrier. 1.2m high steel structure within wetland complex downstream of Coffin Lake. Extremely difficult access via all terrain vehicle due to muddy conditions

Figure 4.1: Photos of Dam 1f365462-063c-491e-9fb3-bfac004d9183 on Coffin Creek

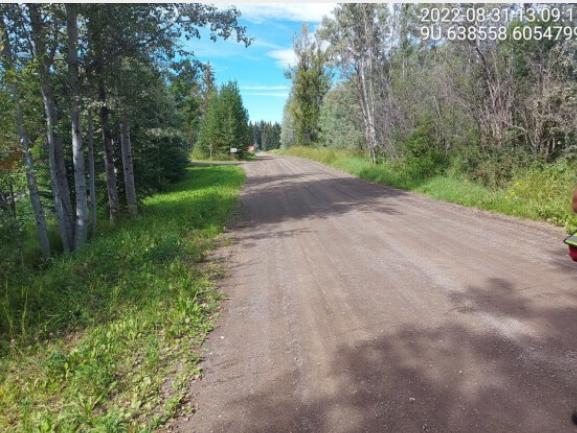
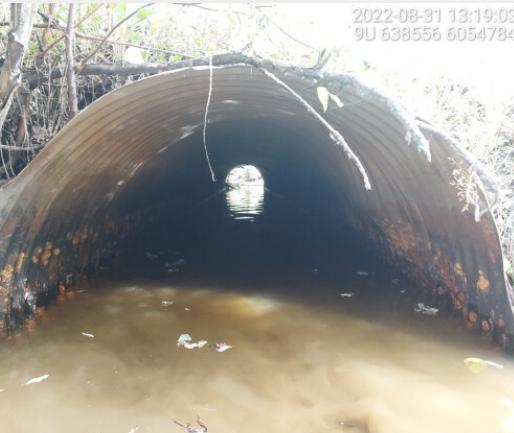
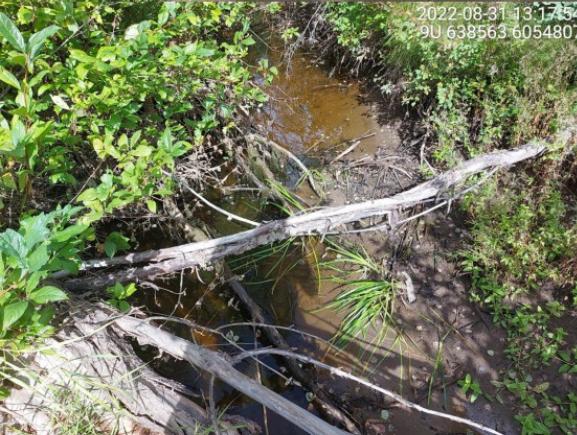
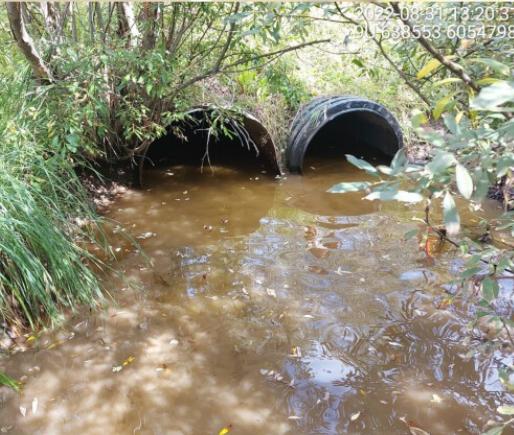
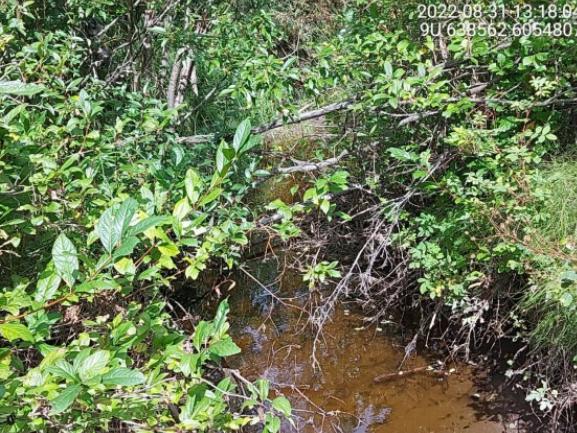
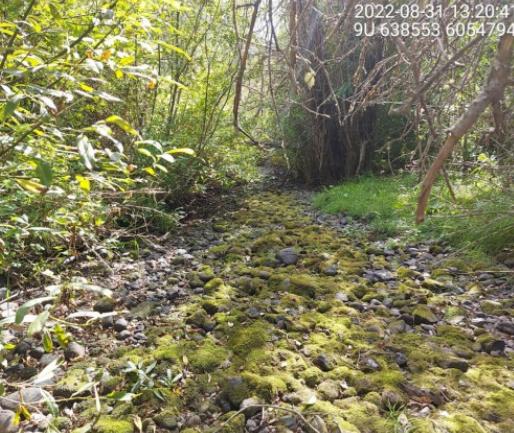
Location and Stream Data	•	Crossing Characteristics	-
Comments: Adjacent landowner reports culvert was replaced last year. Some dewatering downstream of outlet pool. Passable crossing, deep outlet pool but the stream deters after the pool. 13:14			
Photos: PSCIS ID 123392. From top left clockwise: Road/Site Card, Barrel, Outlet, Downstream, Upstream, Inlet.

Location and Stream Data		Crossing Characteristics	
Date	2022-08-31	Crossing Sub Type	Round Culvert
PSCIS ID	123392	Diameter (m)	1.15
External ID	–	Length (m)	12
Crew	MW, TP, DN, AN	Embedded	Yes
UTM Zone	9	Depth Embedded (m)	0.05
Easting	638553.4	Resemble Channel	No
Northing	6054802	Backwatered	Yes
Stream	Lemieux Creek	Percent Backwatered	100
Road	Quick school road	Fill Depth (m)	0.75
Road Tenure	–	Outlet Drop (m)	0
Channel Width (m)	3.6	Outlet Pool Depth (m)	0.5
Stream Slope (%)	1.5	Inlet Drop	No
Beaver Activity	No	Slope (%)	1
Habitat Value	Low	Valley Fill	Deep Fill
Final score	16	Barrier Result	Potential
Fix type	Replace with New Open Bottom Structure	Fix Span / Diameter	10

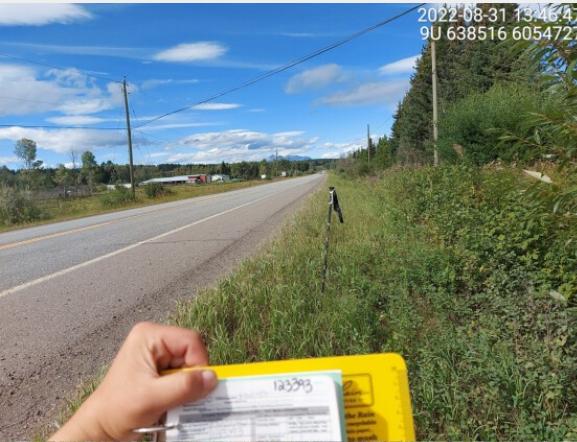
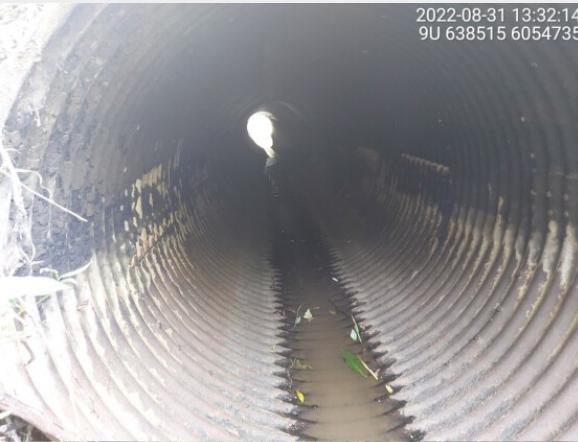
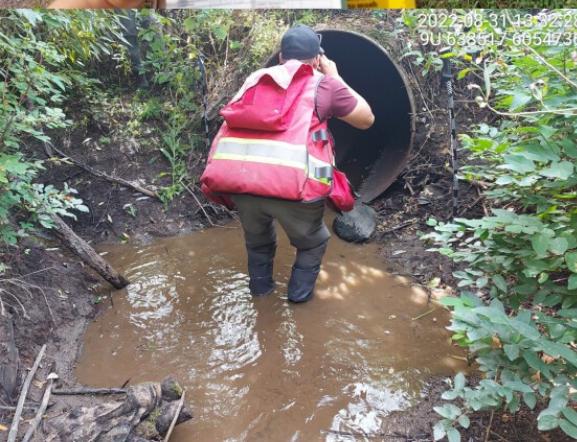
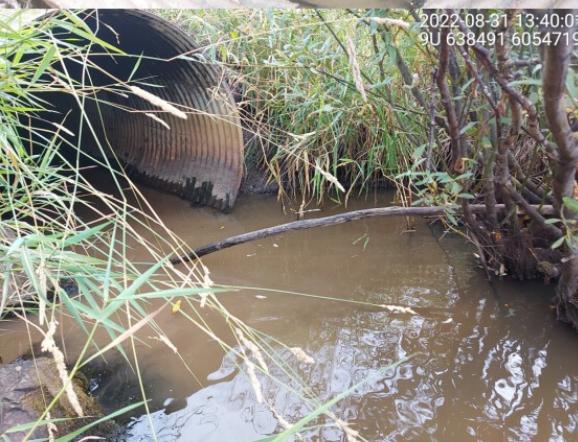
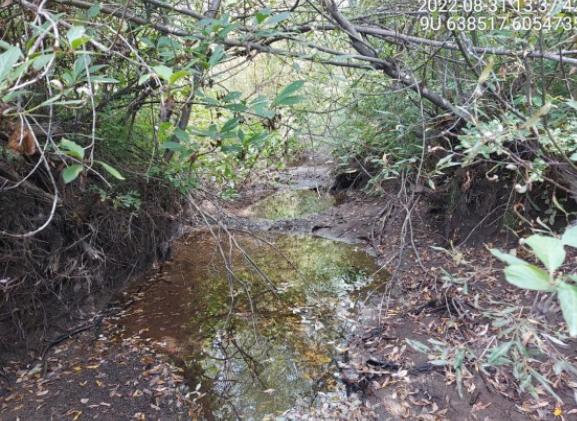
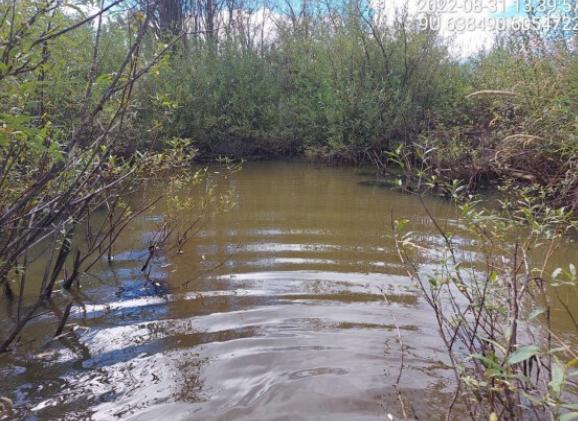
Location and Stream Data	•	Crossing Characteristics	-
Comments: Very deep outlet pool. Wetland downstream, beaver activity upstream. Almost fully backwatered, a little bit of flow through the culvert. 13:32			
Photos: PSCIS ID 123393. From top left clockwise: Road/Site Card, Barrel, Outlet, Downstream, Upstream, Inlet.

Location and Stream Data		Crossing Characteristics	
Date	2022-08-31	Crossing Sub Type	Round Culvert
PSCIS ID	123393	Diameter (m)	1.3
External ID	–	Length (m)	21
Crew	MW, TP, DN, AN	Embedded	No
UTM Zone	9	Depth Embedded (m)	–
Easting	638516	Resemble Channel	No
Northing	6054722	Backwatered	Yes
Stream	Lemieux creek	Percent Backwatered	90
Road	Highway 16	Fill Depth (m)	1.5
Road Tenure	Moti	Outlet Drop (m)	0
Channel Width (m)	2.8	Outlet Pool Depth (m)	0.9
Stream Slope (%)	1.5	Inlet Drop	No
Beaver Activity	Yes	Slope (%)	1
Habitat Value	Low	Valley Fill	Deep Fill
Final score	24	Barrier Result	Barrier
Fix type	Replace with New Open Bottom Structure	Fix Span / Diameter	10

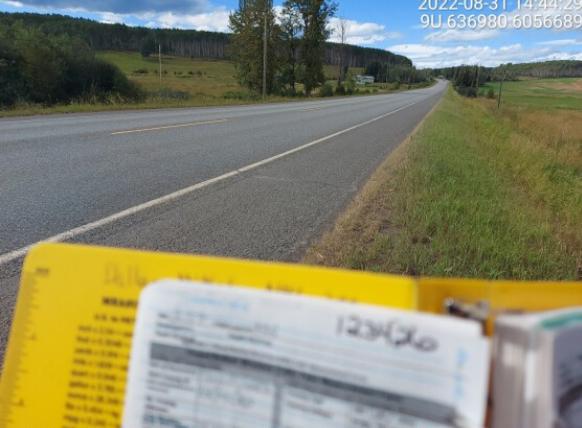
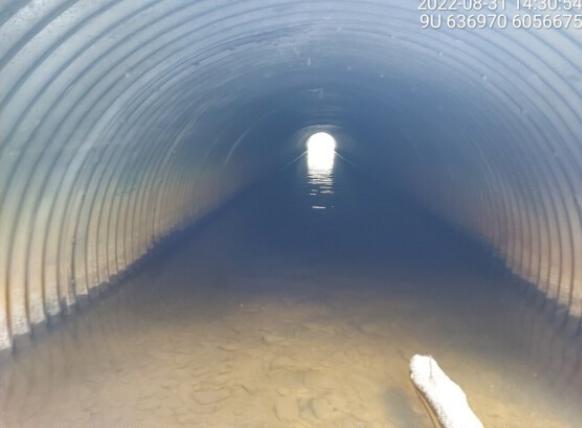
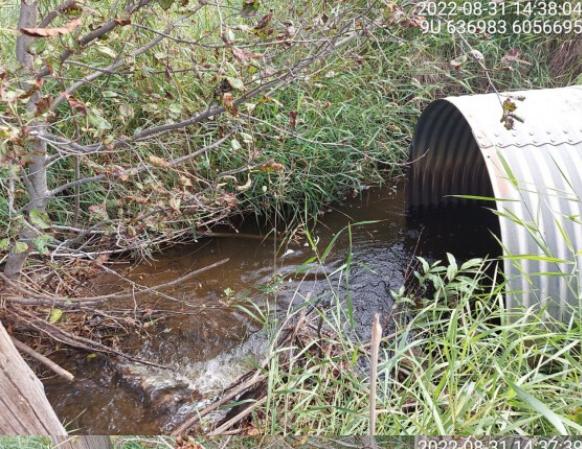
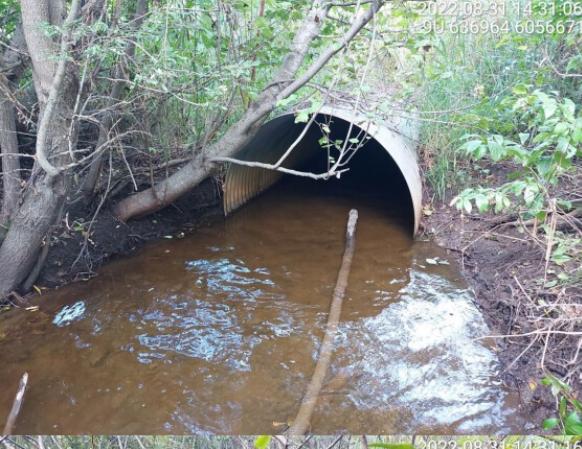
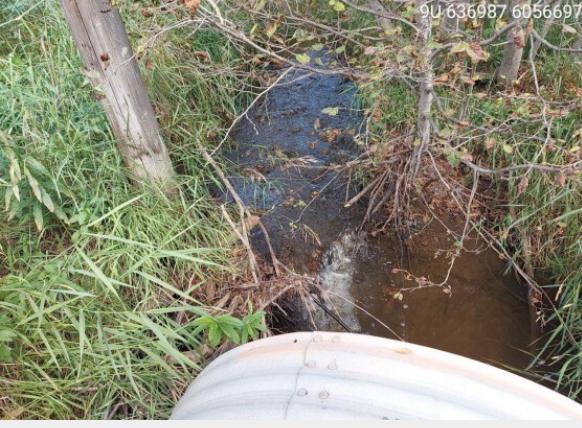
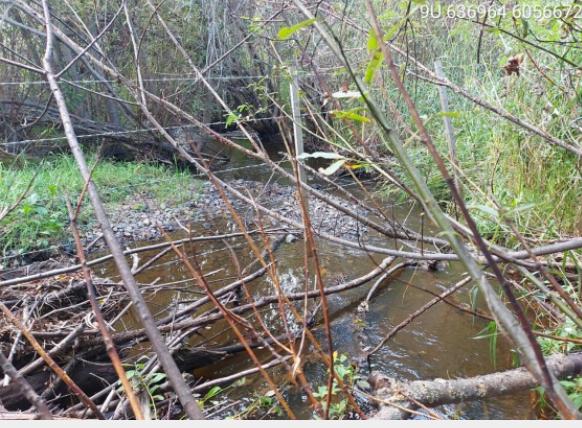
Location and Stream Data	•	Crossing Characteristics	-
Comments: Embedded culvert with high flow. 14:37			
Photos: PSCIS ID 123426. From top left clockwise: Road/Site Card, Barrel, Outlet, Downstream, Upstream, Inlet.

Location and Stream Data		Crossing Characteristics	
Date	2022-08-31	Crossing Sub Type	Round Culvert
PSCIS ID	123426	Diameter (m)	1.4
External ID	–	Length (m)	22
Crew	MW, TP, DN, AN	Embedded	Yes
UTM Zone	9	Depth Embedded (m)	0.2
Easting	636971	Resemble Channel	Yes
Northing	6056680	Backwatered	No
Stream	Robin Creek	Percent Backwatered	–
Road	Highway 16	Fill Depth (m)	2.2
Road Tenure	Moti	Outlet Drop (m)	0
Channel Width (m)	2.3	Outlet Pool Depth (m)	0.05
Stream Slope (%)	2	Inlet Drop	No
Beaver Activity	No	Slope (%)	1.5
Habitat Value	High	Valley Fill	Deep Fill
Final score	19	Barrier Result	Potential
Fix type	Replace with New Open Bottom Structure	Fix Span / Diameter	10

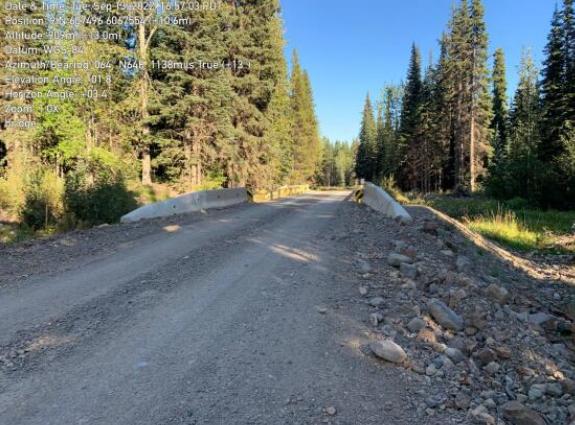
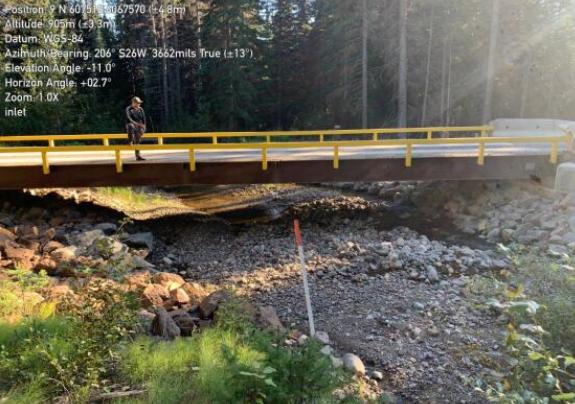
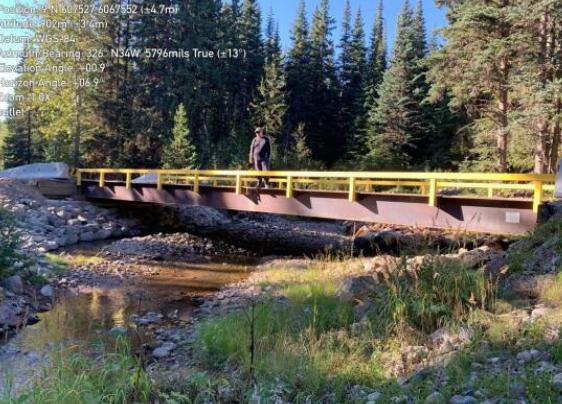
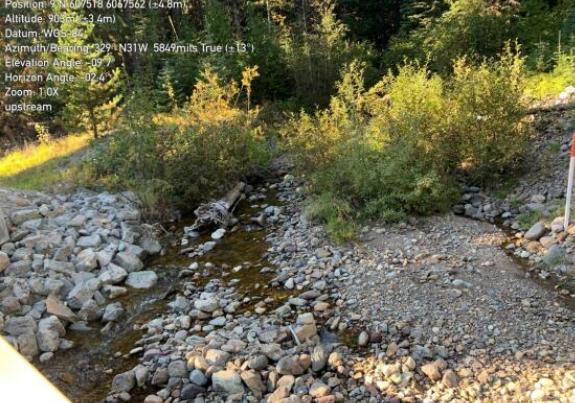
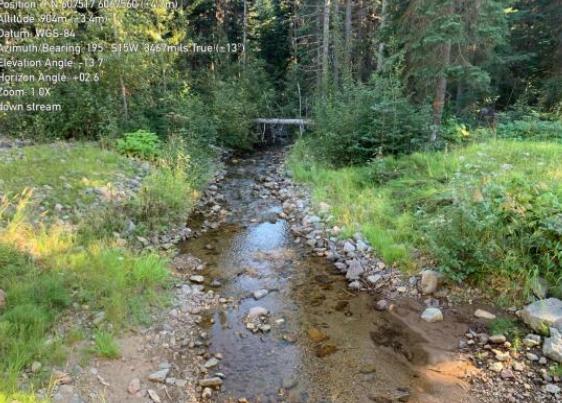
Location and Stream Data	Crossing Characteristics
Comments: New bridge, well built. Room on both banks for freshet melt. 16:57:00	
Photos: PSCIS ID 123750. From top left clockwise: Road/Site Card, Barrel, Outlet, Downstream, Upstream, Inlet.

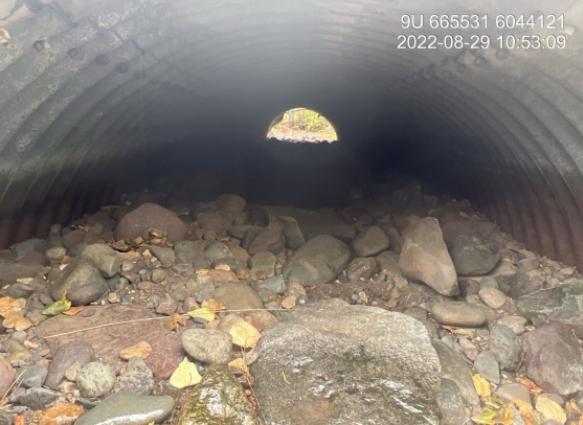
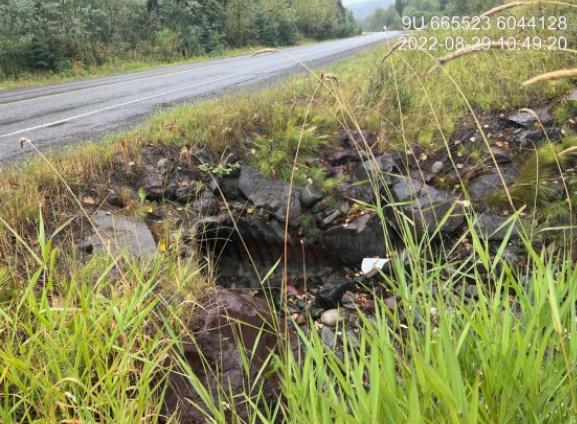
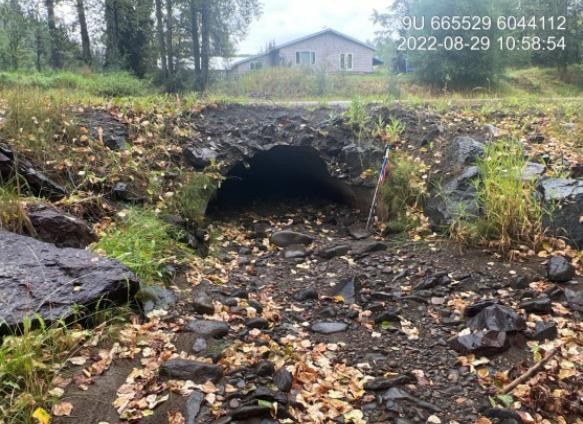
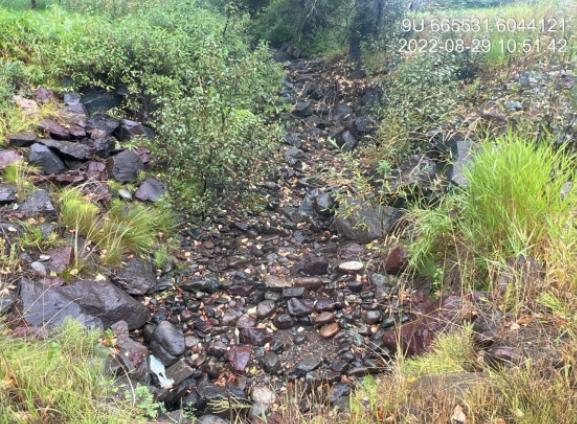
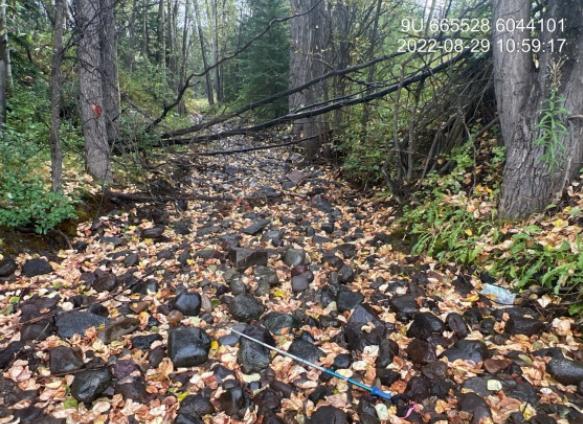
Location and Stream Data	•	Crossing Characteristics	-
Comments: Stream was dry at the time of survey but had water last year during extremely dry ear. Culvert appears passable for all life stages. There is a private land residential development impacting the stream. The channel is constricted and has large chunks of riprap throughout. 10:45			
Photos: PSCIS ID 197657. From top left clockwise: Road/Site Card, Barrel, Outlet, Downstream, Upstream, Inlet.

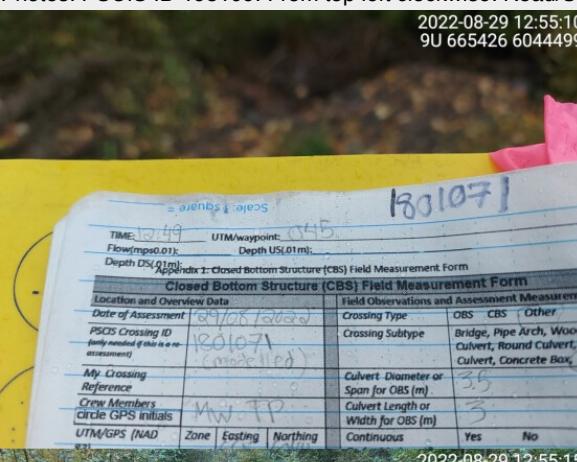
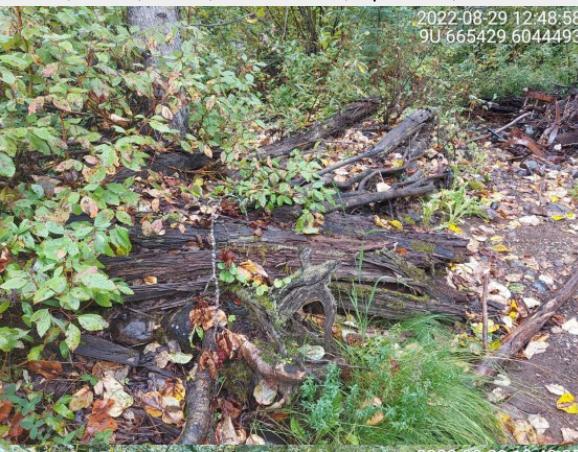
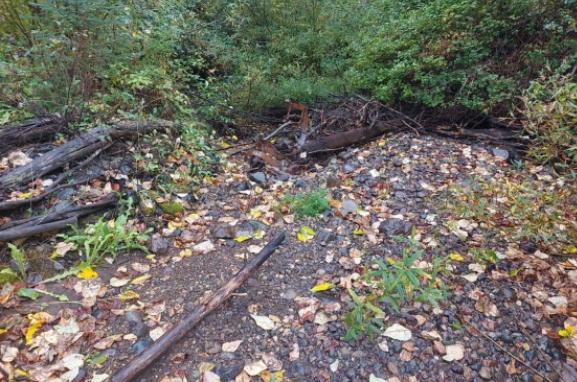
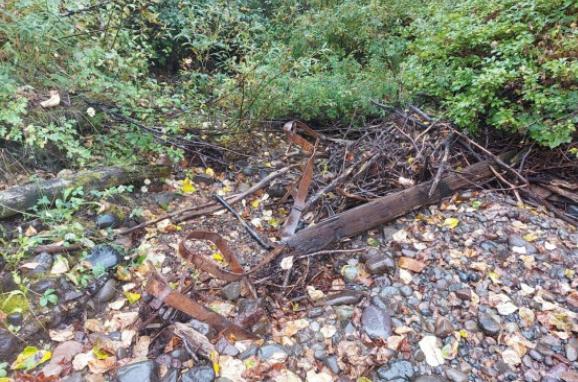
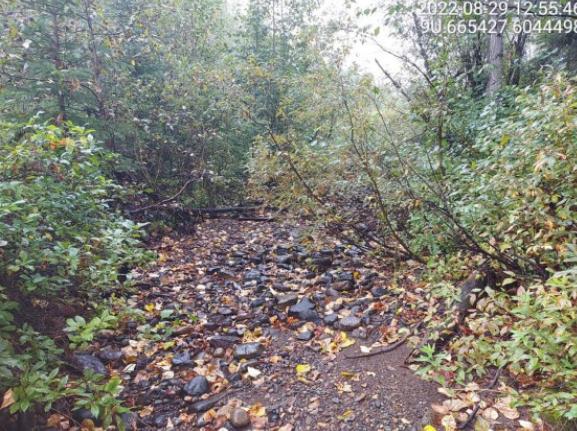
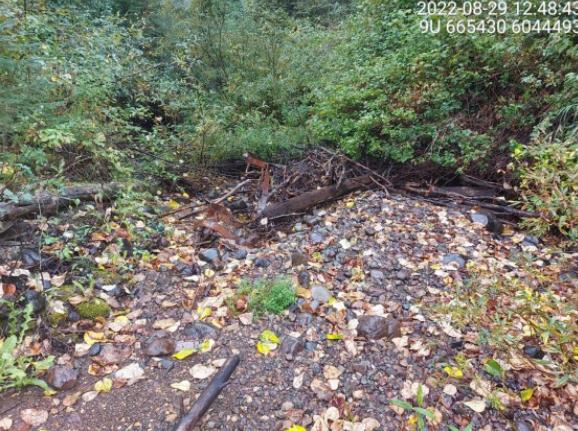
Location and Stream Data	•	Crossing Characteristics
Comments: No crossing. Transmission line. 12:49		
Photos: PSCIS ID 198109. From top left clockwise: Road/Site Card, Barrel, Outlet, Downstream, Upstream, Inlet.

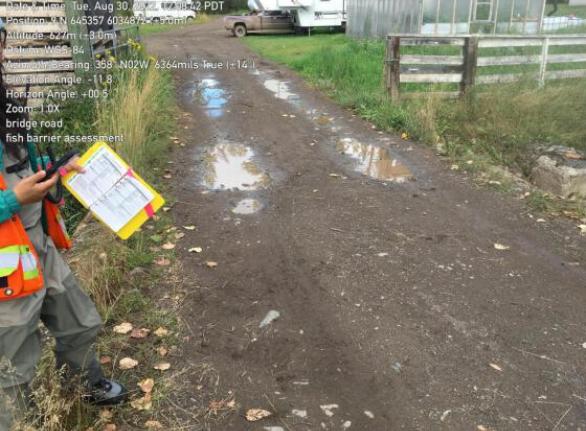
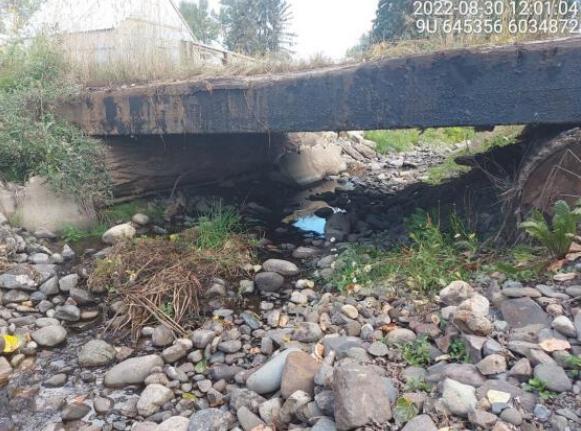
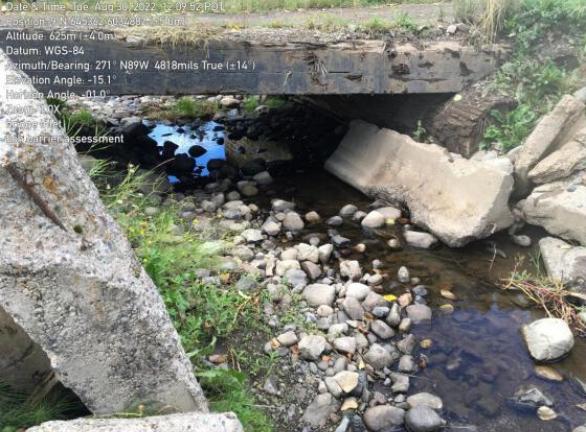
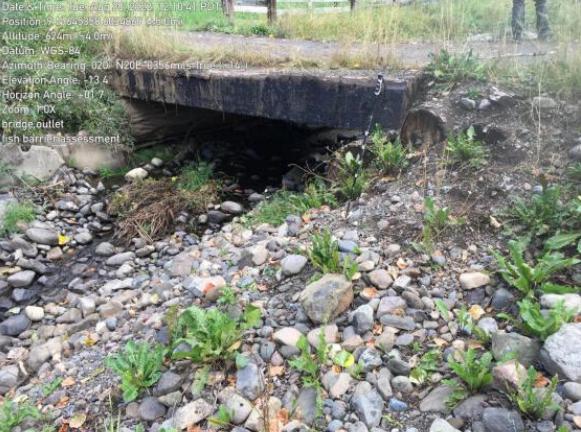
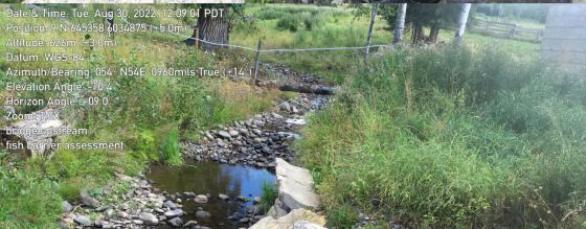
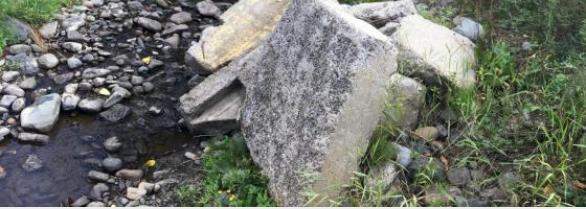
Location and Stream Data	•	Crossing Characteristics
Comments: Private property, farm bridge, concrete slabs on both banks upstream of culvert. 12:02		
Photos: PSCIS ID 198110. From top left clockwise: Road/Site Card, Barrel, Outlet, Downstream, Upstream, Inlet.

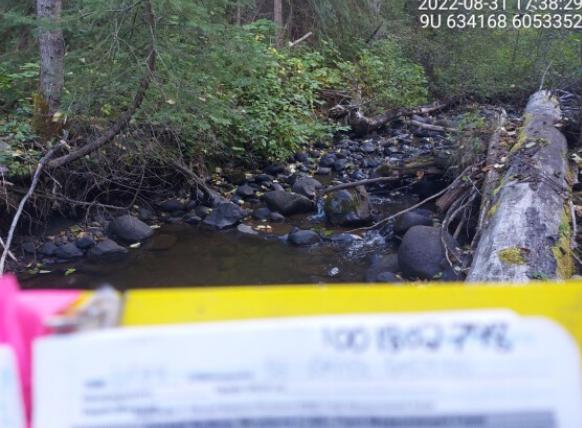
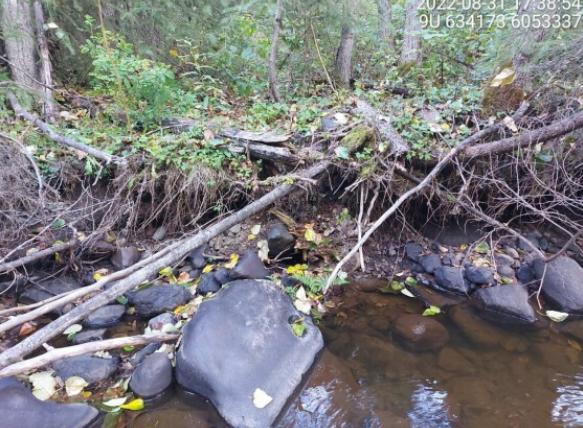
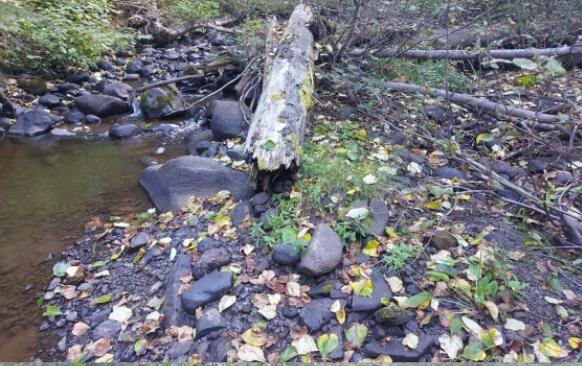
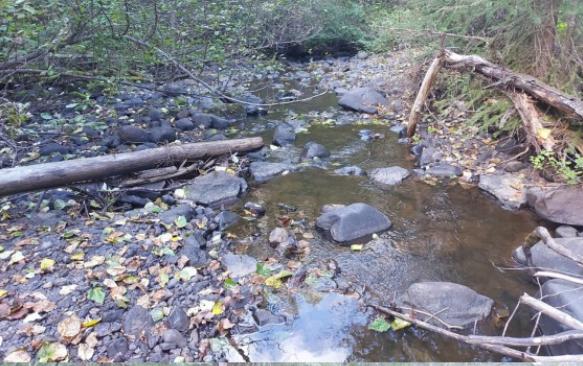
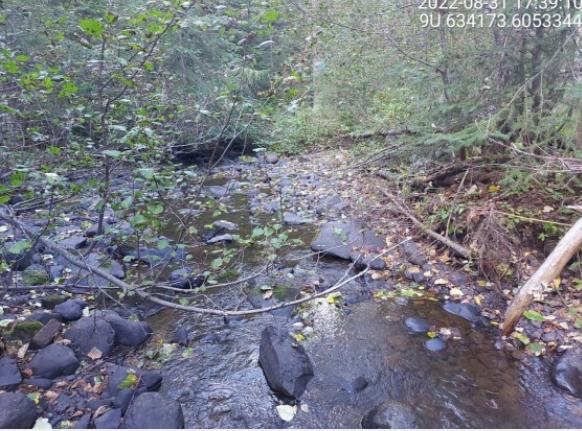
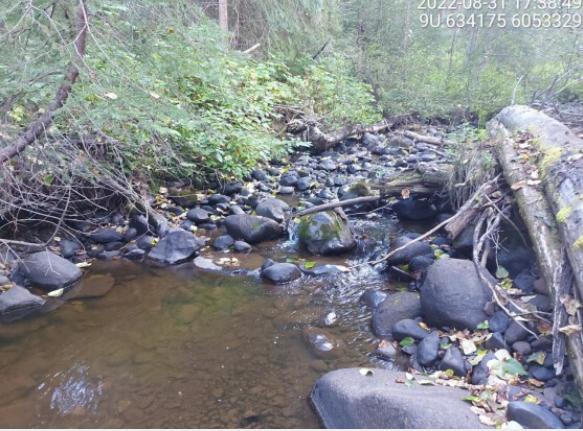
Location and Stream Data	•	Crossing Characteristics	-
Comments: Walked in. No crossing present. Road is more like a hiking trail than a road. 17:34			
Photos: PSCIS ID 198111. From top left clockwise: Road/Site Card, Barrel, Outlet, Downstream, Upstream, Inlet.

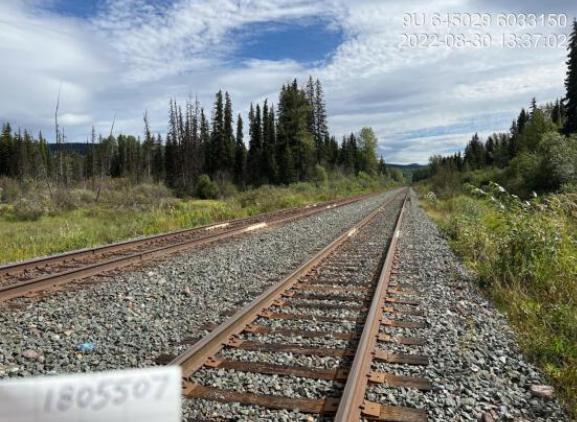
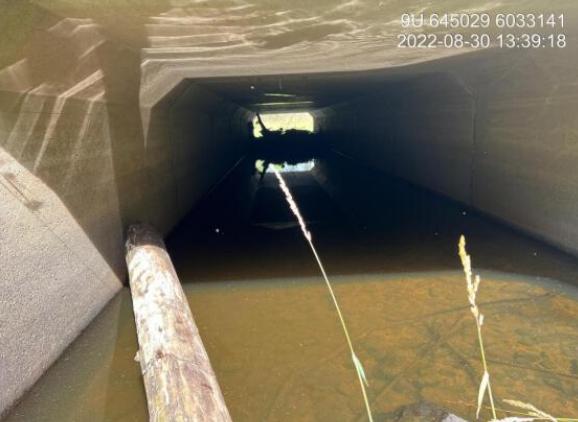
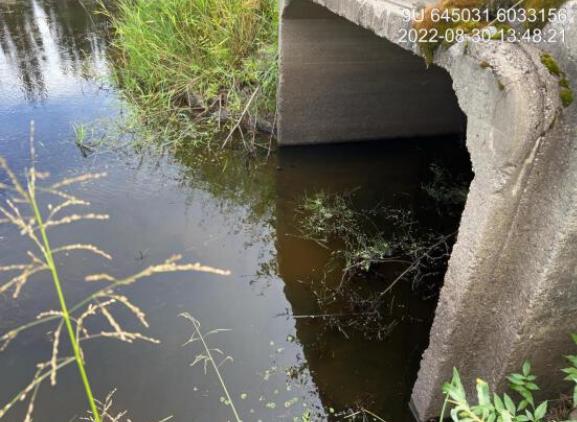
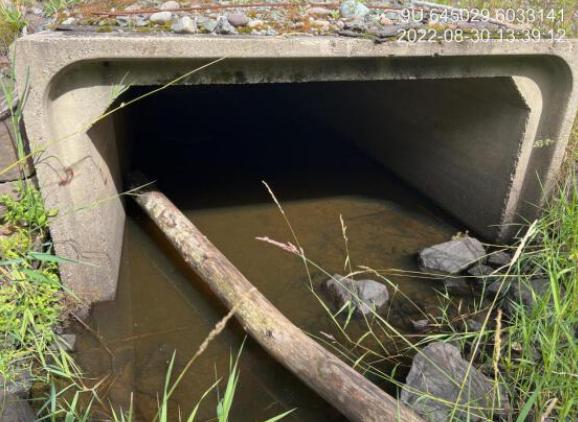
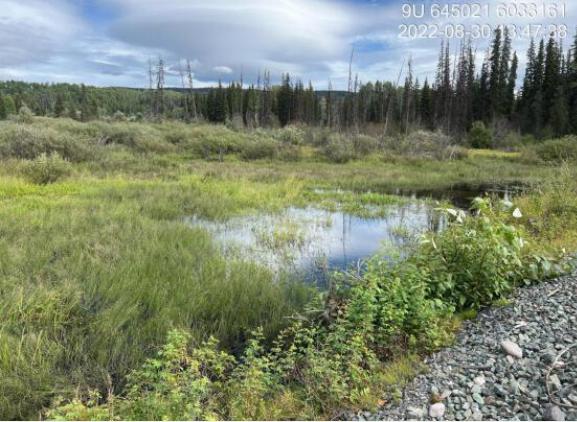
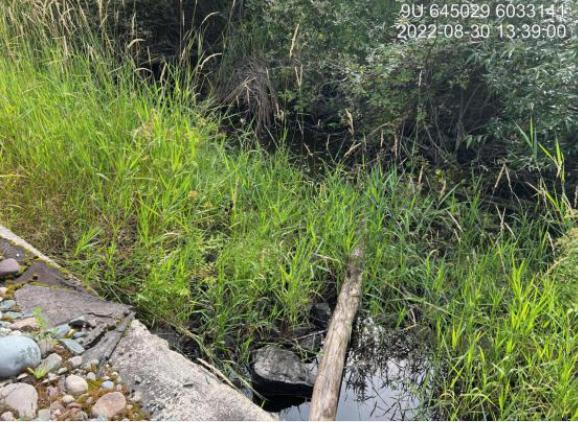
Location and Stream Data	•	Crossing Characteristics	-
Comments: Fully backwatered and embedded concrete box structure on the Railway. Not a fish passage issue at this time. 13:37			
Photos: PSCIS ID 198112. From top left clockwise: Road/Site Card, Barrel, Outlet, Downstream, Upstream, Inlet.

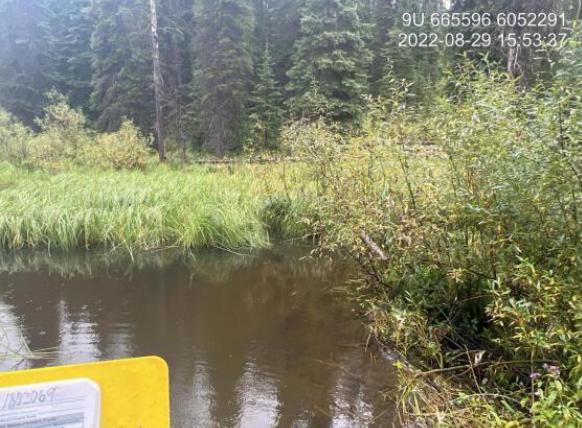
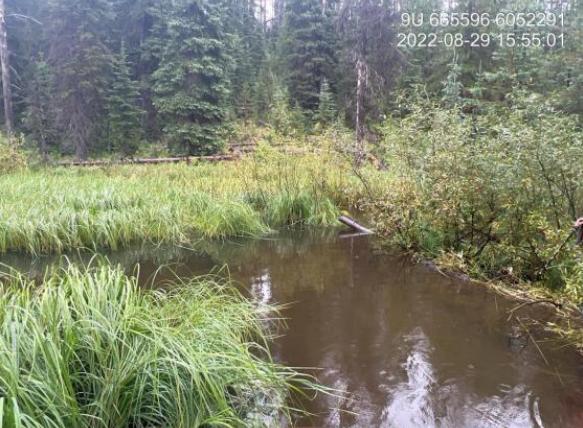
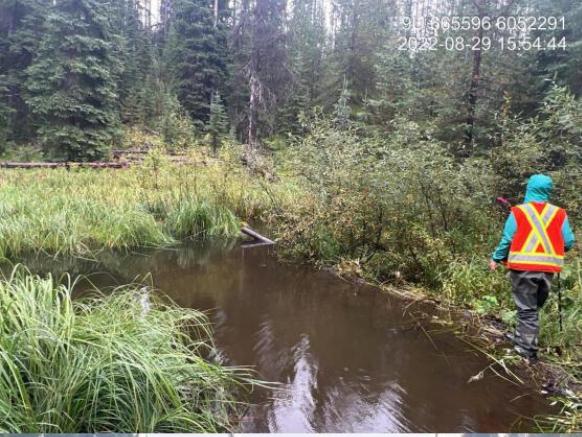
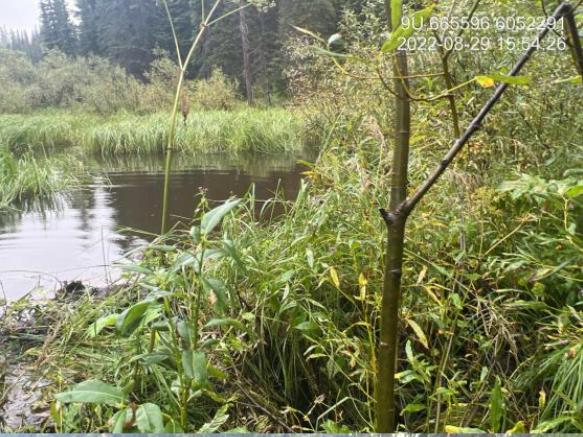
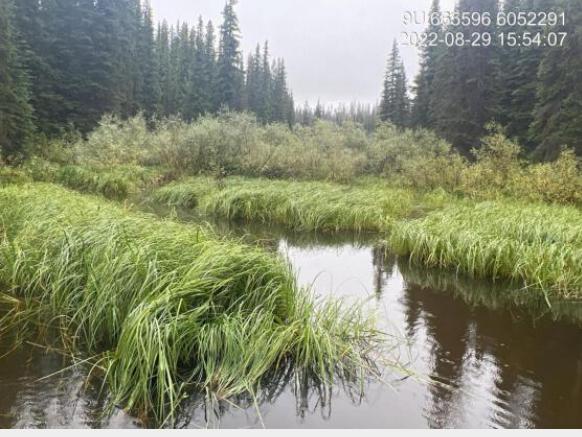
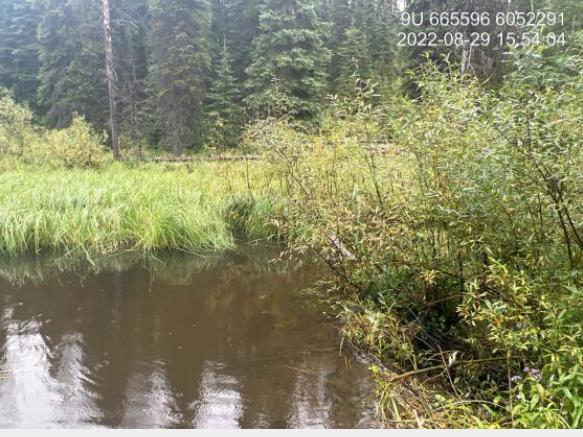
Location and Stream Data	•	Crossing Characteristics	-
Comments: Beaver dam in historic road location. 15:47			
Photos: PSCIS ID 198113. From top left clockwise: Road/Site Card, Barrel, Outlet, Downstream, Upstream, Inlet.

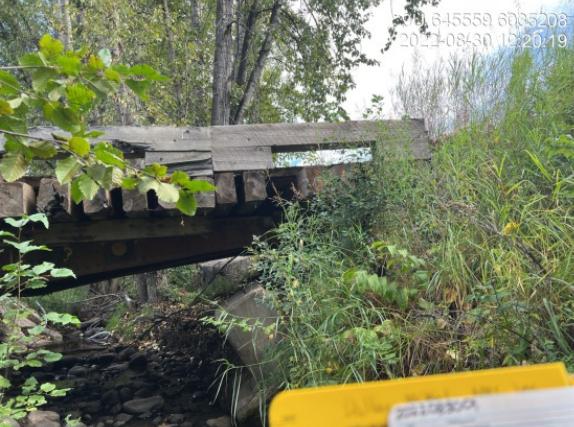
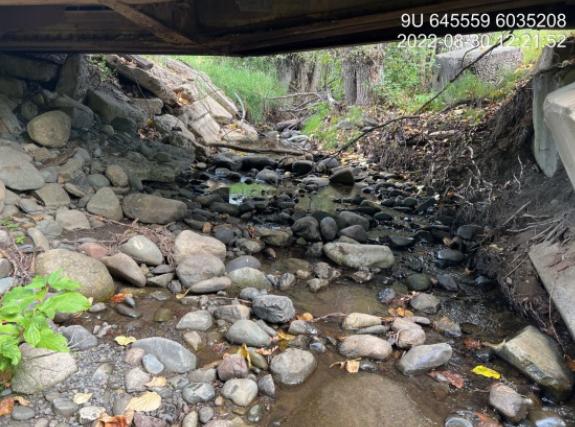
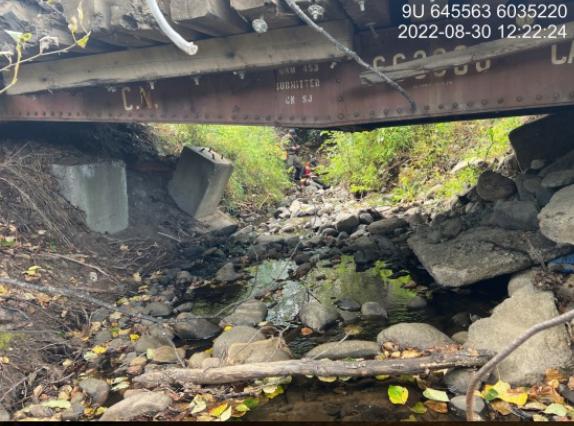
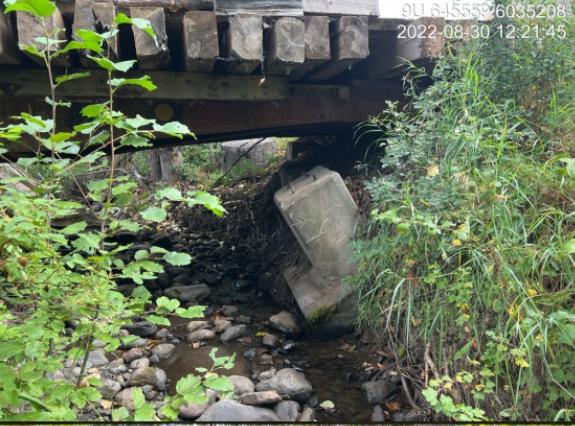
Location and Stream Data	•	Crossing Characteristics	-
Comments: Bridge is old CN railway metal structure and there is extensive concrete slabs in the stream used as rip rap. Private bridge within farmland. 12:20			
Photos: PSCIS ID 198114. From top left clockwise: Road/Site Card, Barrel, Outlet, Downstream, Upstream, Inlet.

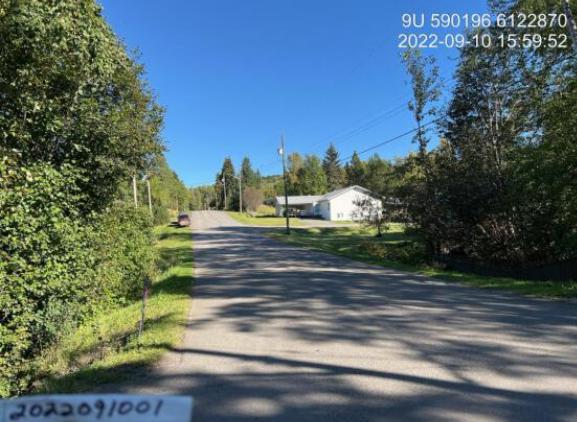
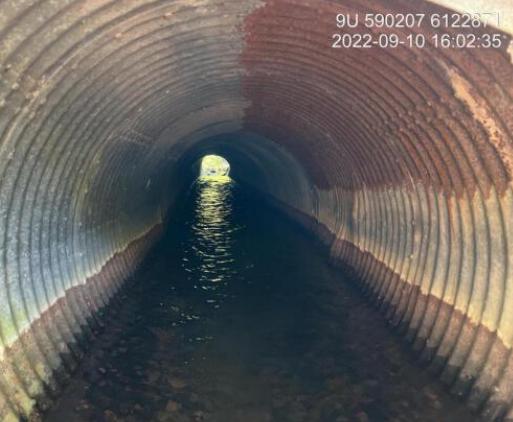
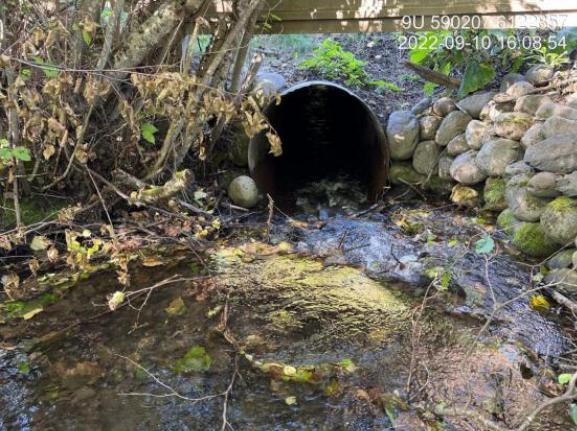
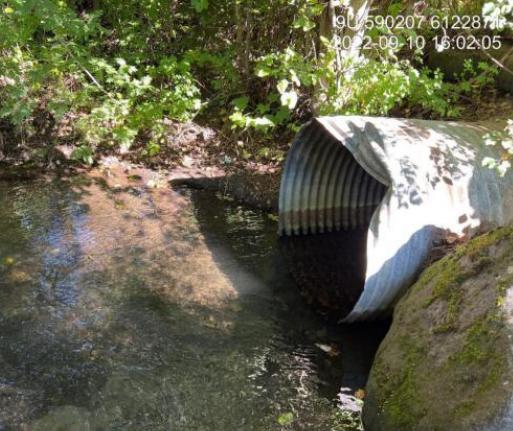
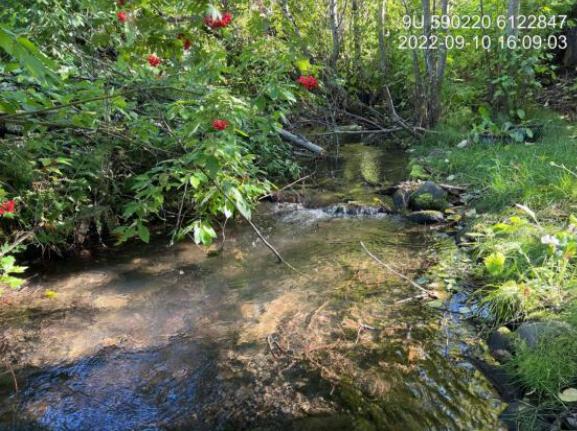
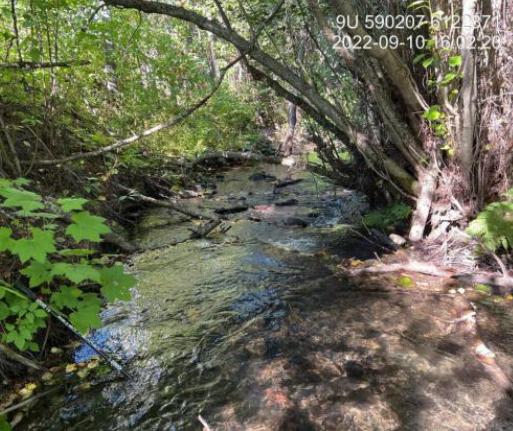
Location and Stream Data		Crossing Characteristics –	
Date	2022-09-10	Crossing Sub Type	Round Culvert
PSCIS ID	198115	Diameter (m)	1.25
External ID	2022091001	Length (m)	22
Crew	AI	Embedded	No
UTM Zone	9	Depth Embedded (m)	–
Easting	590210.7	Resemble Channel	No
Northing	6122882	Backwatered	No
Stream	Tributary to Waterfall Creek	Percent Backwatered	–
Road	13 Avenue	Fill Depth (m)	1.5
Road Tenure	New Hazelton	Outlet Drop (m)	0
Channel Width (m)	2.8	Outlet Pool Depth (m)	0.4
Stream Slope (%)	3	Inlet Drop	Yes
Beaver Activity	No	Slope (%)	1
Habitat Value	High	Valley Fill	Deep Fill
Final score	24	Barrier Result	Barrier
Fix type	Replace with New Open Bottom Structure	Fix Span / Diameter	10

Location and Stream Data	•	Crossing Characteristics	-
Comments: This is waterfall Creek. It does not show up in the freshwater atlas as here, however this is the main flow. Numerous fry and parr observed upstream of the crossing. No paper card for site. 16:03			
Photos: PSCIS ID 198115. From top left clockwise: Road/Site Card, Barrel, Outlet, Downstream, Upstream, Inlet.

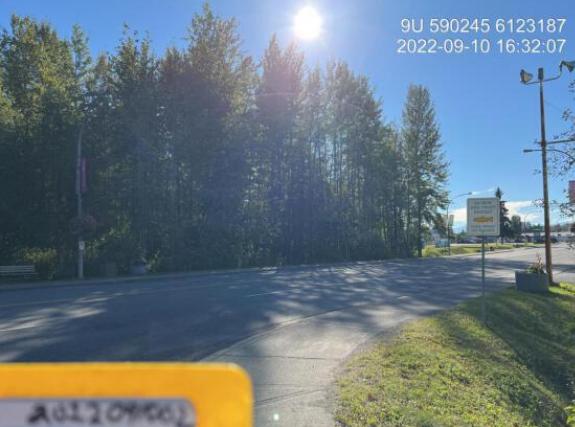
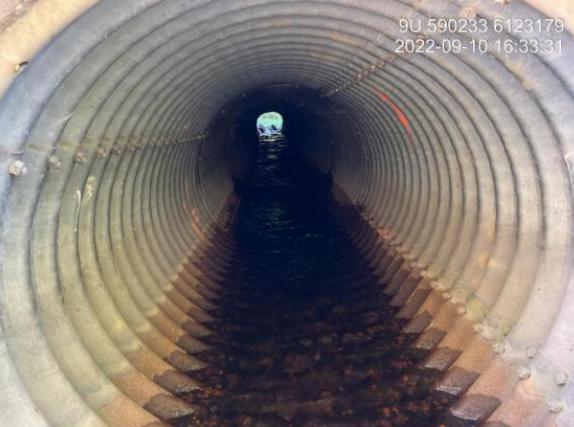
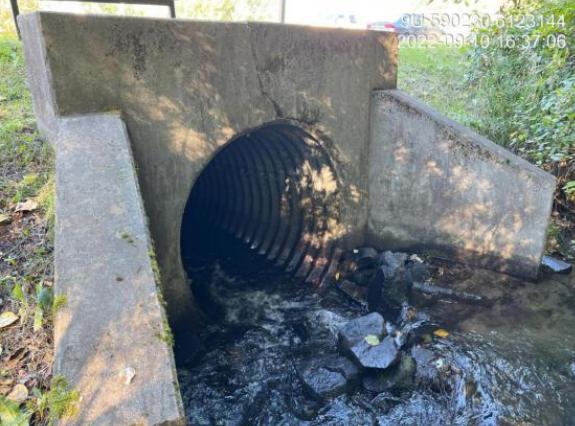
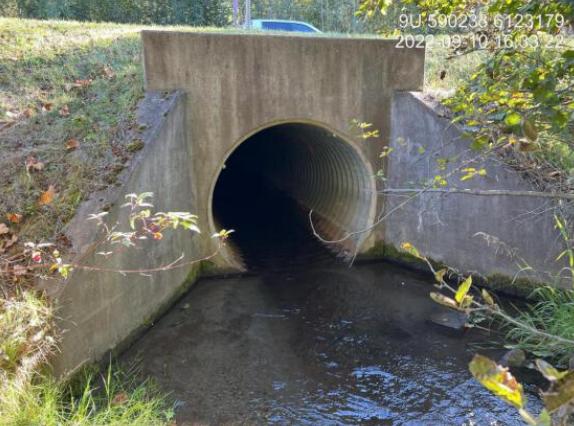
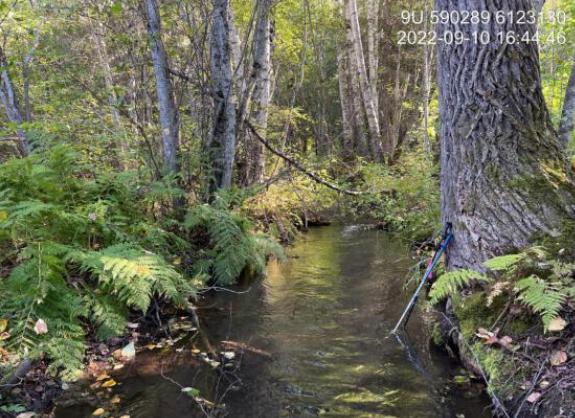
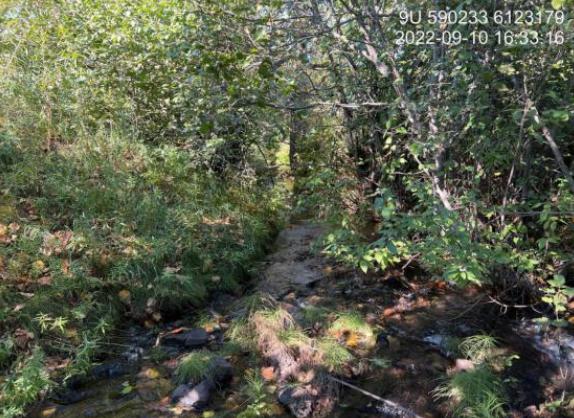
Location and Stream Data		Crossing Characteristics –	
Date	2022-09-10	Crossing Sub Type	Round Culvert
PSCIS ID	198116	Diameter (m)	1.5
External ID	2022091002	Length (m)	27
Crew	AI	Embedded	No
UTM Zone	9	Depth Embedded (m)	–
Easting	590233.2	Resemble Channel	No
Northing	6123183	Backwatered	No
Stream	Tributary to Waterfall Creek	Percent Backwatered	–
Road	Highway 16	Fill Depth (m)	1
Road Tenure	MoTi	Outlet Drop (m)	0
Channel Width (m)	3.9	Outlet Pool Depth (m)	0.2
Stream Slope (%)	2.5	Inlet Drop	Yes
Beaver Activity	No	Slope (%)	2.5
Habitat Value	High	Valley Fill	Deep Fill
Final score	24	Barrier Result	Barrier
Fix type	Replace with New Open Bottom Structure	Fix Span / Diameter	10

Location and Stream Data	Crossing Characteristics
Comments: Stream is not mapped correctly in the freshwater atlas. This is waterfall creek. Great flow, patches of gravel suitable for coho spawning. Right within the town of New Hazelton. Trap and truck coho operation conducted by Chicago Creek Restoration Society with spawners transplanted just downstream of the railway. 16:34	
Photos: PSCIS ID 198116. From top left clockwise: Road/Site Card, Barrel, Outlet, Downstream, Upstream, Inlet.

Should restoration/maintenance activities proceed, replacement of PSCIS crossing 198116 with a bridge (10m span) is recommended. The cost of the work is estimated at \$7,500,000 for a cost benefit of 160 linear m/\$1000 and 312 m<sup>2</sup>/\$1000.

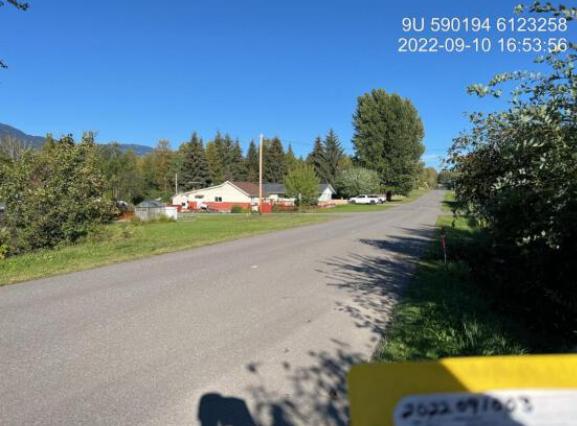
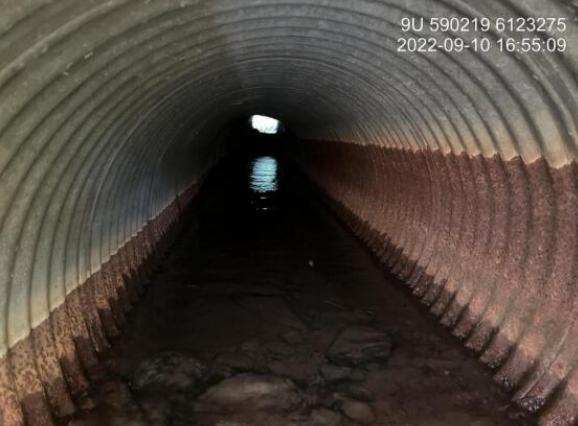
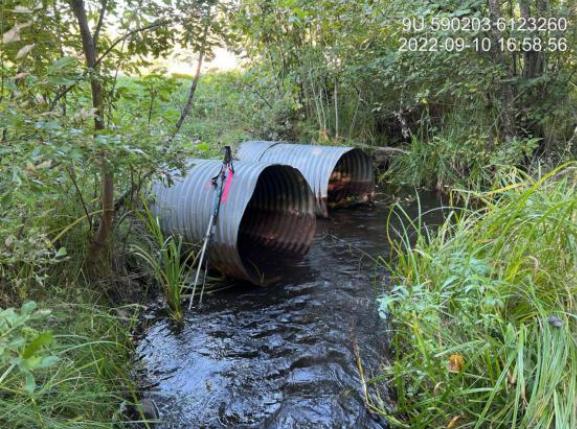
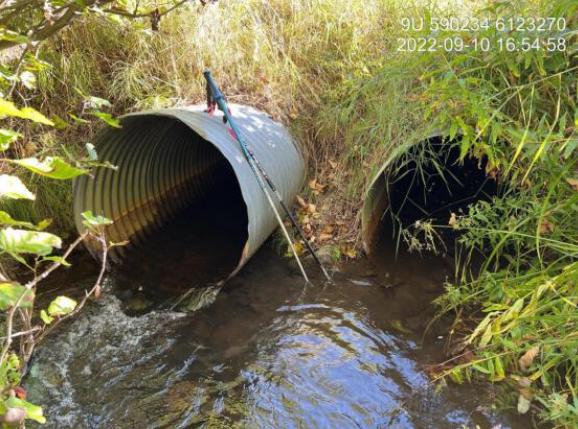
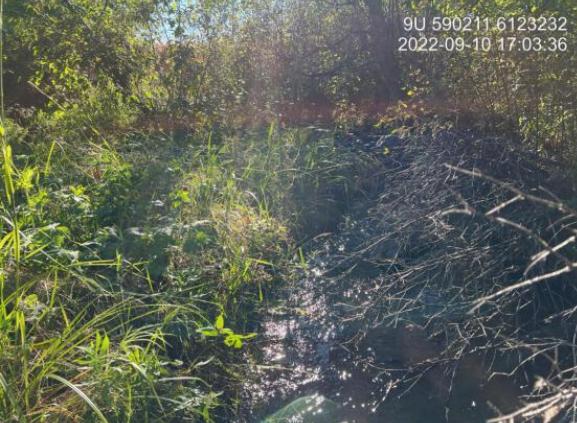
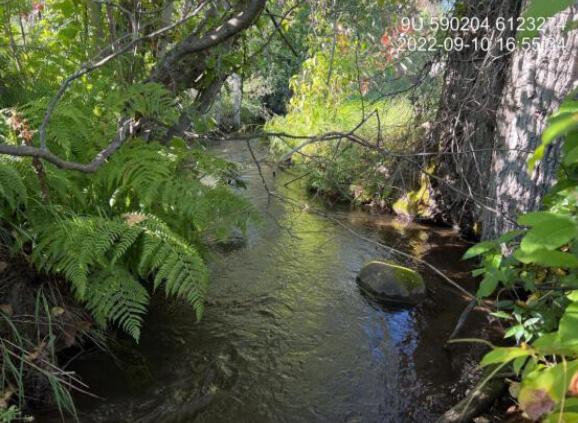
Location and Stream Data		Crossing Characteristics –	
Date	2022-09-10	Crossing Sub Type	Round Culvert
PSCIS ID	198117	Diameter (m)	1.8
External ID	2022091003	Length (m)	19
Crew	AI	Embedded	No
UTM Zone	9	Depth Embedded (m)	–
Easting	590200.9	Resemble Channel	No
Northing	6123262	Backwatered	No
Stream	Tributary to Waterfall Creek	Percent Backwatered	–
Road	9th Avenue	Fill Depth (m)	1
Road Tenure	New Hazelton	Outlet Drop (m)	0.2
Channel Width (m)	2.6	Outlet Pool Depth (m)	0.1
Stream Slope (%)	1	Inlet Drop	Yes
Beaver Activity	No	Slope (%)	1
Habitat Value	High	Valley Fill	Deep Fill
Final score	29	Barrier Result	Barrier
Fix type	Replace with New Open Bottom Structure	Fix Span / Diameter	10

Location and Stream Data	•	Crossing Characteristics	-
Comments: Two 0.9 pipe added together for width. Left pipe has significant blockage 1/3 of the way through the pipe. Right Bank of the stream has an empty lot with only grass and invasive weed riparian. 16:52			
Photos: PSCIS ID 198117. From top left clockwise: Road/Site Card, Barrel, Outlet, Downstream, Upstream, Inlet.
