## Bulkley Watershed Fish Passage Restoration Planning 2022

Prepared for  
Canadian Wildlife Federation  
Habitat Conservation Trust Foundation - CAT23-6-288  
BC Fish Passage Remediation Program  
Ministry of Transportation and Infrastructure

Prepared by  
Al Irvine, B.Sc., R.P.Bio. and Mateo Wintersheidt, B.Sc.  
New Graph Environment Ltd.  
on behalf of  
Society for Ecosystem Restoration in Northern British Columbia

Version 0.1.6 DRAFT 2023-05-30

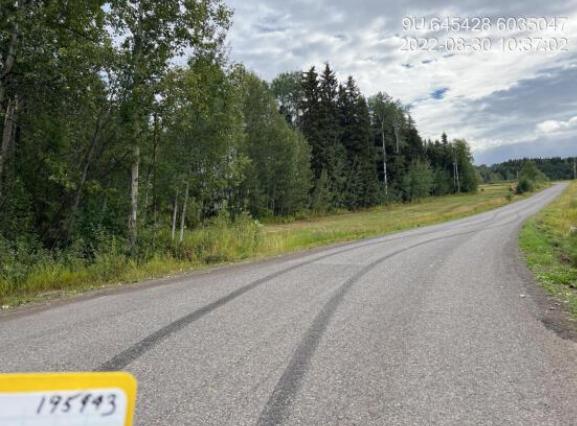
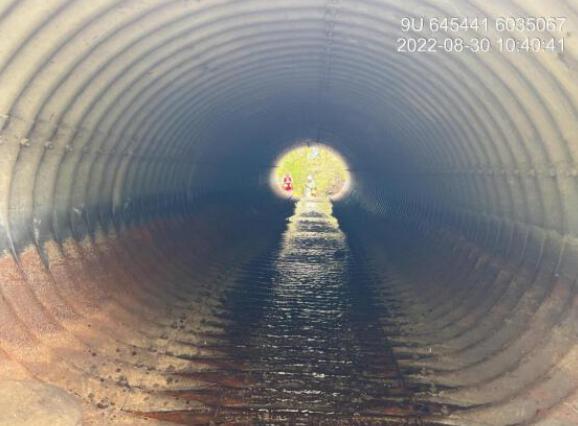
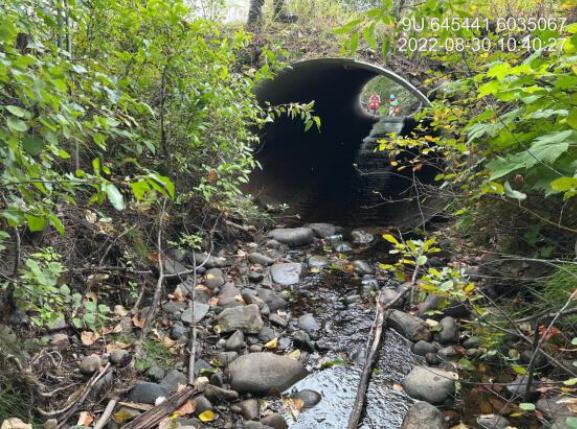
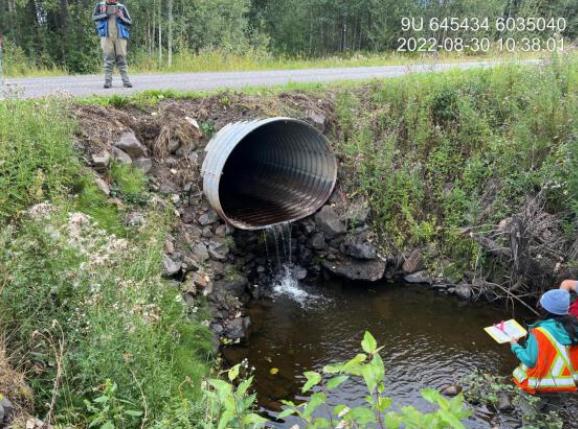
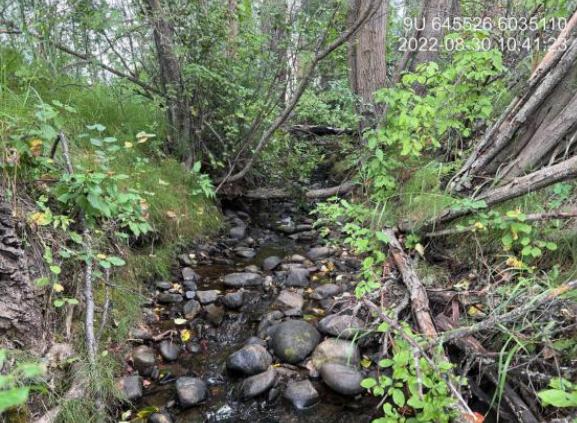
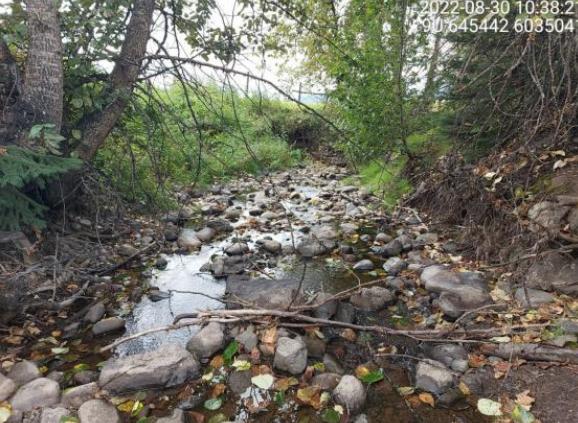
Location and Stream Data		Crossing Characteristics –	
Date	2022-08-30	Crossing Sub Type	Oval Culvert
PSCIS ID	195943	Diameter (m)	2
External ID	–	Length (m)	14
Crew	MW, TP, AI, VJ, AN, DN	Embedded	No
UTM Zone	9	Depth Embedded (m)	–
Easting	645434	Resemble Channel	No
Northing	6035035	Backwatered	No
Stream	Stock Creek	Percent Backwatered	–
Road	Barrett Station Road	Fill Depth (m)	0.6
Road Tenure	MoTi	Outlet Drop (m)	1.1
Channel Width (m)	3	Outlet Pool Depth (m)	0.71
Stream Slope (%)	3	Inlet Drop	No
Beaver Activity	No	Slope (%)	1.5
Habitat Value	Medium	Valley Fill	Deep Fill
Final score	31	Barrier Result	Barrier
Fix type	Replace with New Open Bottom Structure	Fix Span / Diameter	10

Location and Stream Data	•	Crossing Characteristics	-
Comments: Very large outlet drop, but creates nice pool for fish. Erosion on LB/RB on outlet side. Agricultural fields, minimal municipality population ds. Road is paved, detour available. 10:25			
Photos: From top left clockwise: Road/Site Card, Barrel, Outlet, Downstream, Upstream, Inlet.

Replacement of PSCIS crossing 195943 with a bridge (10m span) is recommended. The cost of the work was estimated at \$2,000,000 for a cost benefit of 370 linear m/\$1000 and 555 m<sup>2</sup>/\$1000.

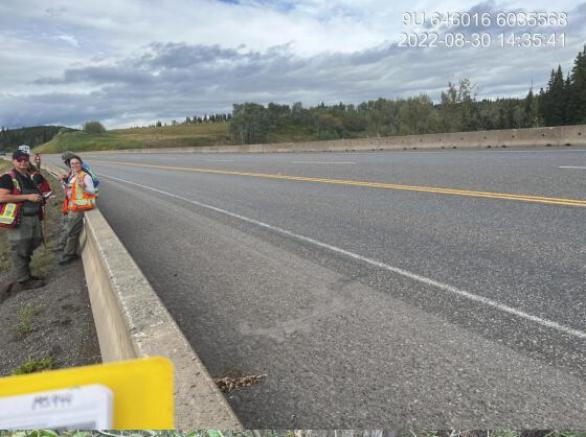
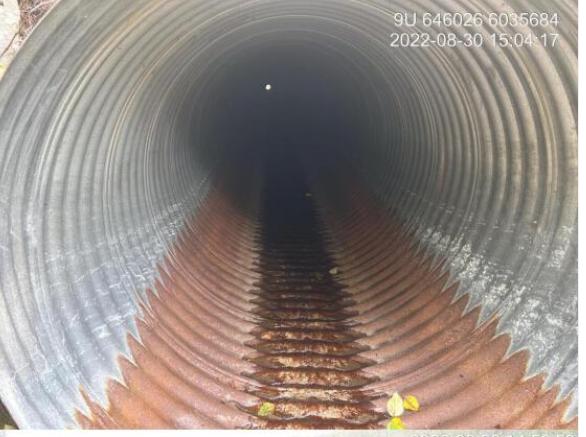
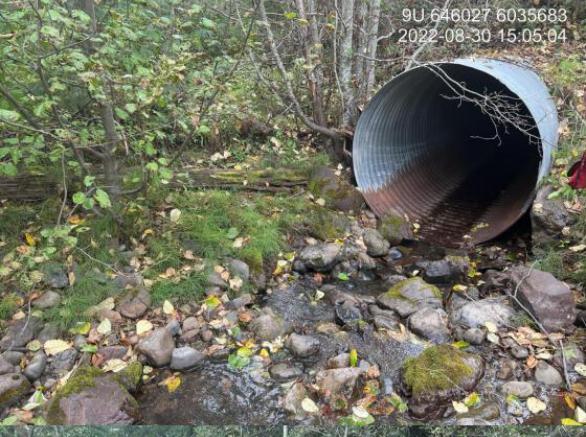
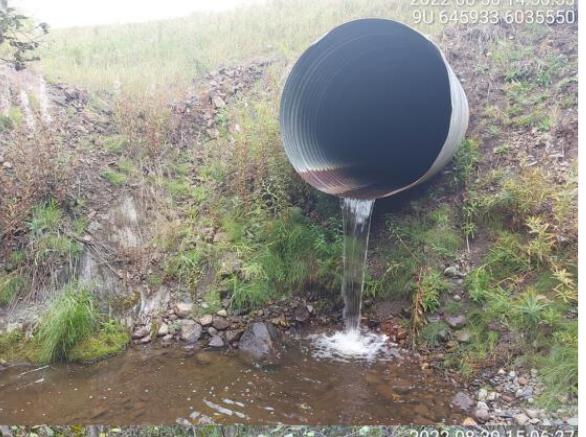
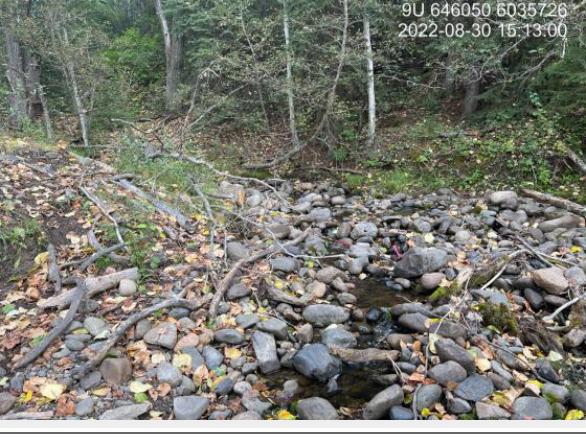
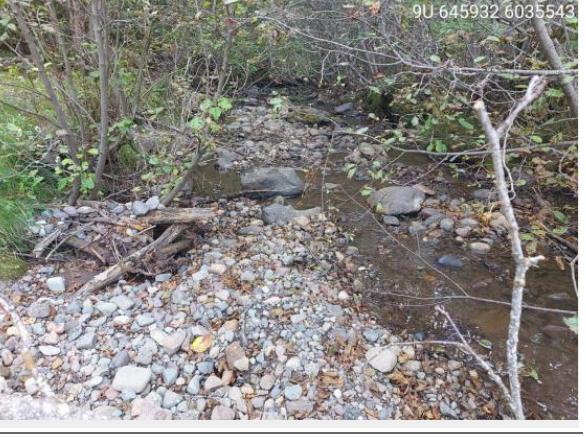
Location and Stream Data	•	Crossing Characteristics	-
Comments: Length 167 m. Fill depth estimated at approximately 35 m. 14:35			
Photos: From top left clockwise: Road/Site Card, Barrel, Outlet, Downstream, Upstream, Inlet.

Replacement of PSCIS crossing 195944 with a bridge (10m span) will have significant costs (\$1,500,000) due to the length of the structure and depth of fill. A cost benefit is estimated 4786.7 linear m/\$1000 and 6222.7 m<sup>2</sup>/\$1000.

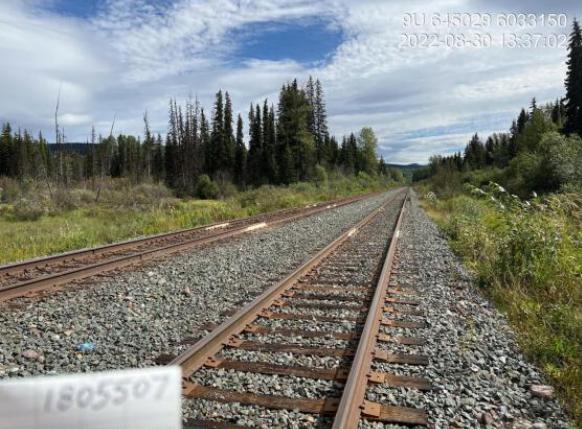
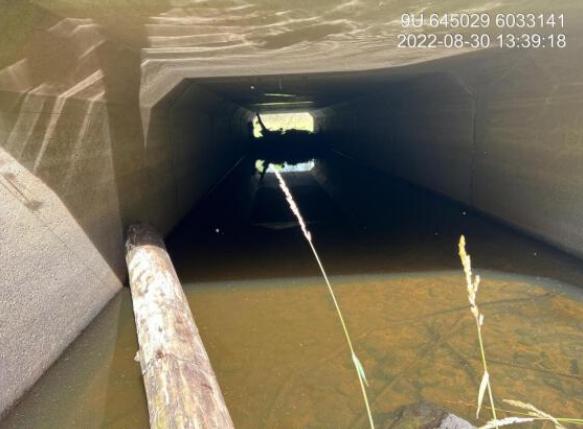
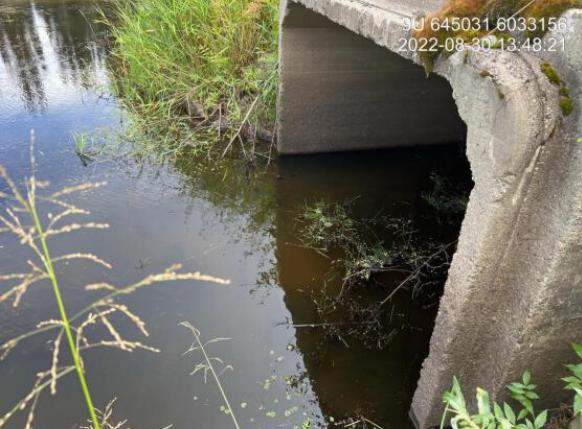
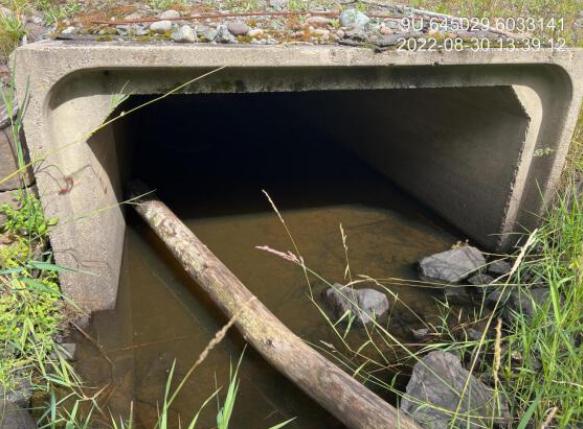
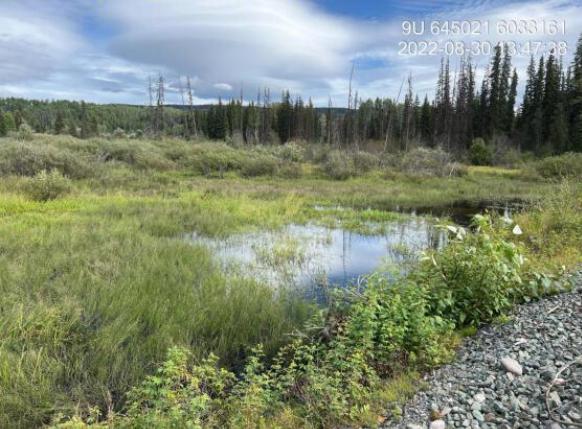
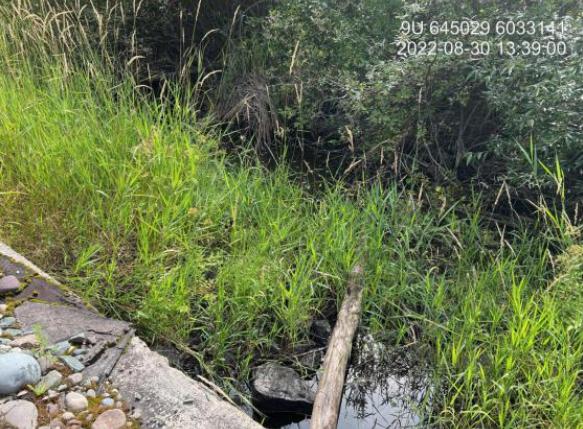
Location and Stream Data	.	Crossing Characteristics –	
Date	2022-08-30	Crossing Sub Type	Concrete Box
PSCIS ID	198112	Diameter (m)	2.5
External ID	1805507	Length (m)	14
Crew	AI, DN, AN	Embedded	Yes
UTM Zone	9	Depth Embedded (m)	0.4
Easting	645034	Resemble Channel	Yes
Northing	6033148	Backwatered	Yes
Stream	Stock Creek	Percent Backwatered	100
Road	CN Railway	Fill Depth (m)	0.5
Road Tenure	CN Rail	Outlet Drop (m)	0
Channel Width (m)	2.5	Outlet Pool Depth (m)	0.2
Stream Slope (%)	0	Inlet Drop	No
Beaver Activity	Yes	Slope (%)	0
Habitat Value	Medium	Valley Fill	Deep Fill
Final score	8	Barrier Result	Passable
Fix type	–	Fix Span / Diameter	–

Location and Stream Data	•	Crossing Characteristics	-
Comments: Fully backwatered and embedded concrete box structure on the Railway. Not a fish passage issue at this time. 13:37			
Photos: From top left clockwise: Road/Site Card, Barrel, Outlet, Downstream, Upstream, Inlet.

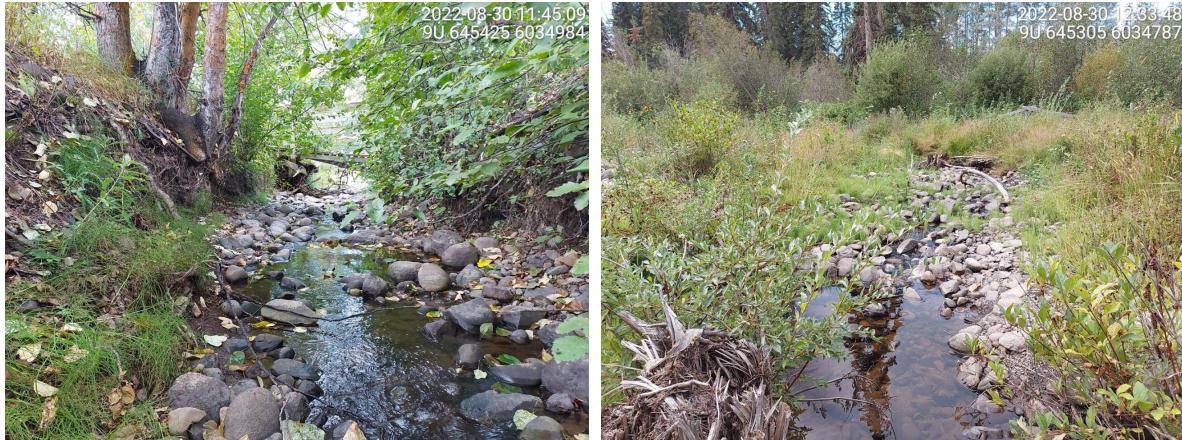
The stream was surveyed downstream from crossing 195943 for 300m (Figure 5.2). The average channel width was 3.8m, the average wetted width was 1.8m, and the average gradient was 2.7%. The dominant substrate was gravels with cobbles sub-dominant. Total cover amount was rated as moderate with small woody debris dominant. Cover was also present as boulders. A footbridge was present approximately 200m downstream with concrete slabs on both adjacent banks upstream. Multiple fish up to 10cm in length were observed in a pool near the bridge. The stream had minimal overhanging and riparian vegetation in the area surveyed due to adjacent agricultural use. Some areas of stream had pools formed by small dams likely built for livestock waterholes. The habitat was rated as medium value for salmonid rearing and spawning.

Figure 5.2: Left: Habitat downstream of PSCIS crossing 195943. Right: Habitat downstream of PSCIS crossing 195943.

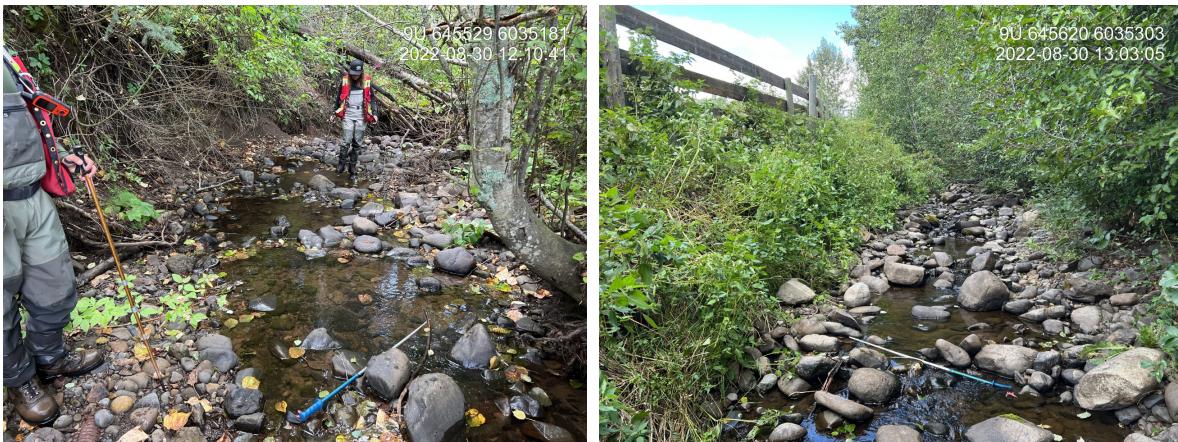
The dominant substrate was cobbles with boulders sub-dominant. Total cover amount was rated as abundant with boulders dominant. Cover was also present as undercut banks. The average channel width was 3.1m, the average wetted width was 1.8m, and the average gradient was 2.1%. Good flow volumes were noted along with a decent amount of complexity due to boulders and undercut banks. There were small pockets of gravel suitable for resident rainbow as well as coho and steelhead spawning. The channel appeared to be constricted with riparian vegetation removed on both sides of the stream, likely due to agricultural development. Irrigation pipes in the channel indicated water withdrawal was occurring. The habitat was rated as medium value as an important migration corridor containing suitable spawning habitat and having moderate rearing potential for juvenile coho, steelhead and other salmonids.

Figure 5.3: Left: Habitat upstream of PSCIS crossing 195943. Right: Habitat upstream of PSCIS crossing 195943.

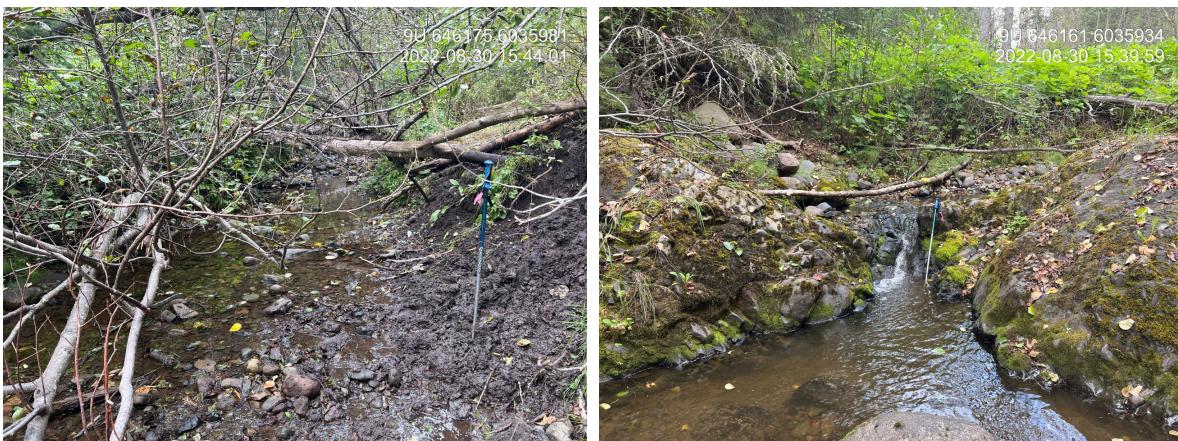
The stream was surveyed upstream from crossing 195944 for 640m (Figure 5.4). Total cover amount was rated as moderate with boulders dominant. Cover was also present as small woody debris and undercut banks. The dominant substrate was boulders with cobbles sub-dominant. The average channel width was 4.2m, the average wetted width was 1.8m, and the average gradient was 2%. Within the areas surveyed, the stream was noted as heavily impacted by cattle activity with significant amounts of manure in the stream, degraded/removed riparian vegetation and extensive areas of trampled banks. There were occasional pockets of gravel suitable for resident rainbow spawning. Field notes indicate, occasional pools with depths suitable for juvenile salmon and adult resident salmonid overwintering. A rock drop of 65cm was located 365m upstream of the top end of the culvert (Figure 5.4). This drop would likely be passable for adult salmonids but dependent on flow conditions, could prevent upstream migration for younger life stages of anadromous fish as well as non-adult resident species.

Figure 5.4: Left: Habitat upstream of PSCIS crossing 195944. Right: A 0.65m high rock drop located 365m upstream of PSCIS crossing 195944.

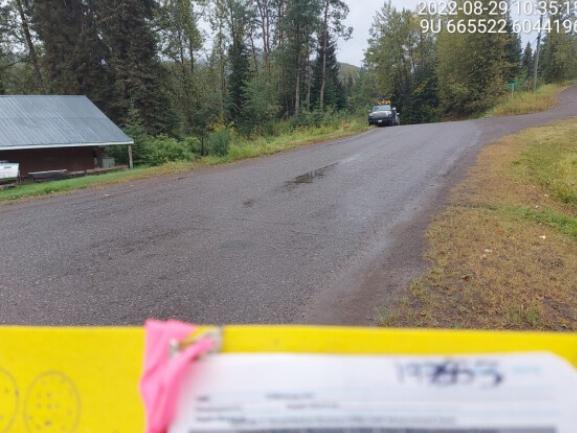
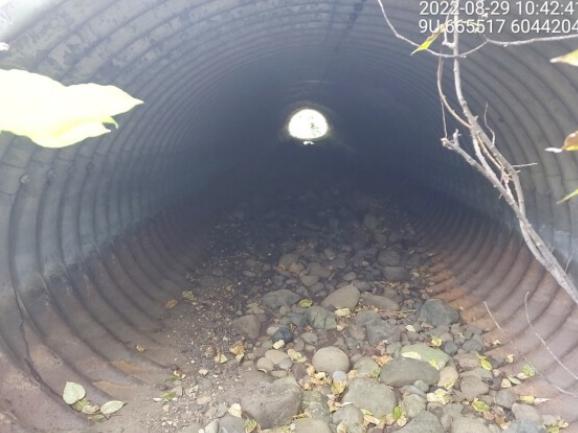
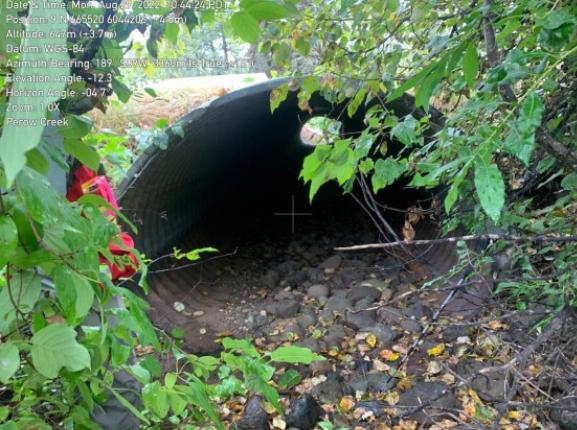
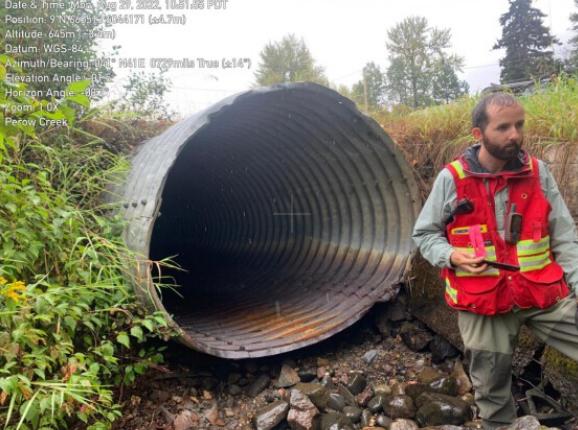
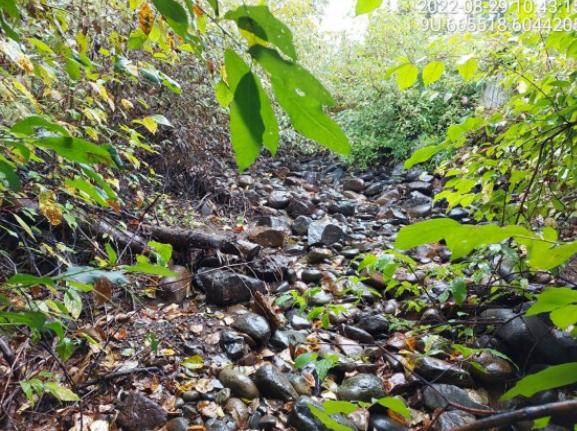
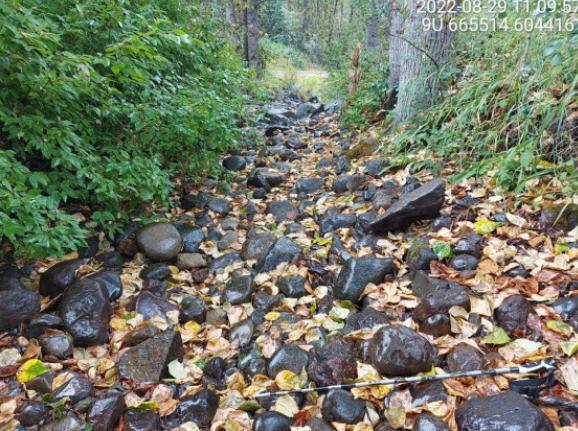
Location and Stream Data	.	Crossing Characteristics –	
Date	2022-08-29	Crossing Sub Type	Round Culvert
PSCIS ID	197653	Diameter (m)	2.3
External ID	–	Length (m)	28
Crew	MW, TP	Embedded	No
UTM Zone	9	Depth Embedded (m)	–
Easting	665520	Resemble Channel	No
Northing	6044200	Backwatered	No
Stream	Perow Creek	Percent Backwatered	–
Road	Perow Loop Road	Fill Depth (m)	0.5
Road Tenure	MoTi	Outlet Drop (m)	0.3
Channel Width (m)	4.3	Outlet Pool Depth (m)	0
Stream Slope (%)	4	Inlet Drop	No
Beaver Activity	No	Slope (%)	1.5
Habitat Value	Low	Valley Fill	Deep Fill
Final score	34	Barrier Result	Barrier
Fix type	Replace with New Open Bottom Structure	Fix Span / Diameter	10

Location and Stream Data	•	Crossing Characteristics
Comments: Stream is dry. Private yards u/s and d/s. Riprap and cement in channel. 10:48		
Photos: From top left clockwise: Road/Site Card, Barrel, Outlet, Downstream, Upstream, Inlet.

Should restoration/maintenance activities proceed, replacement of PSCIS crossing 197653 with a bridge (10m span) is recommended. The cost of the work is estimated at \$400,000 for a cost benefit of 18475 linear m/\$1000 and 39721.2 m<sup>2</sup>/\$1000.

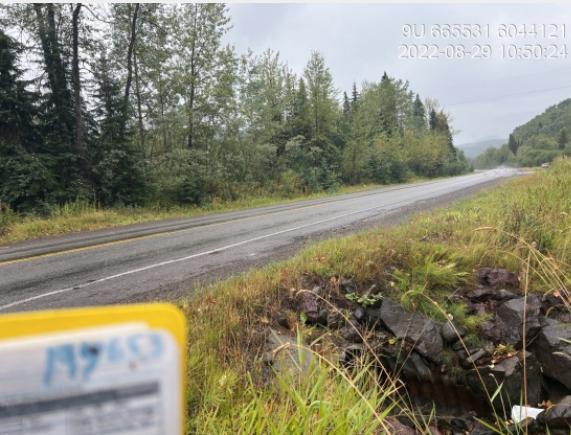
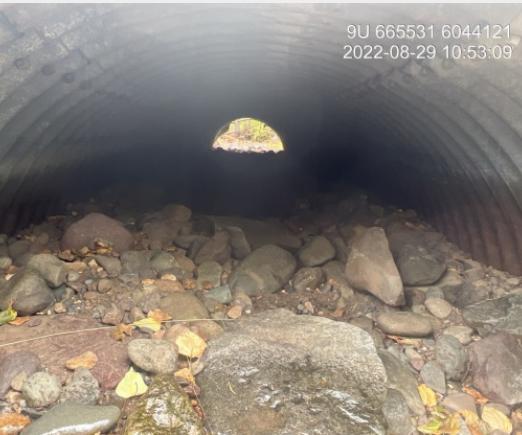
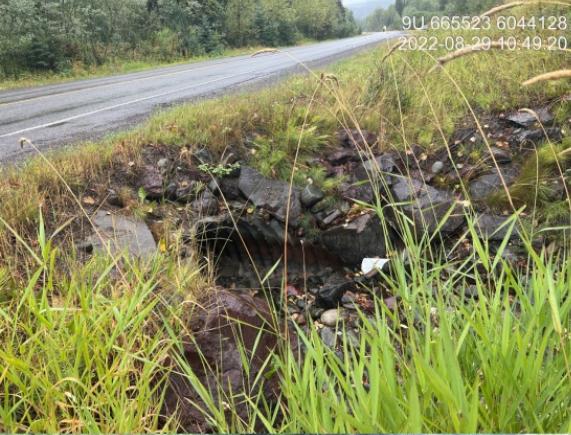
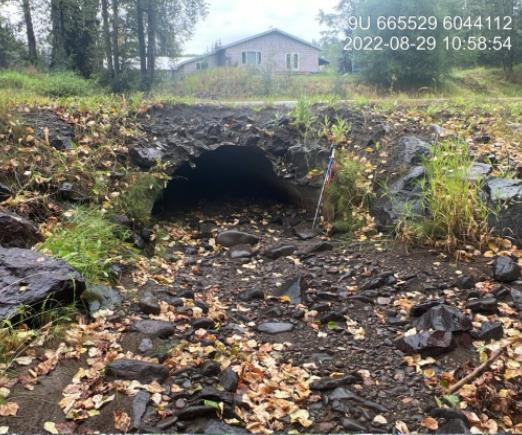
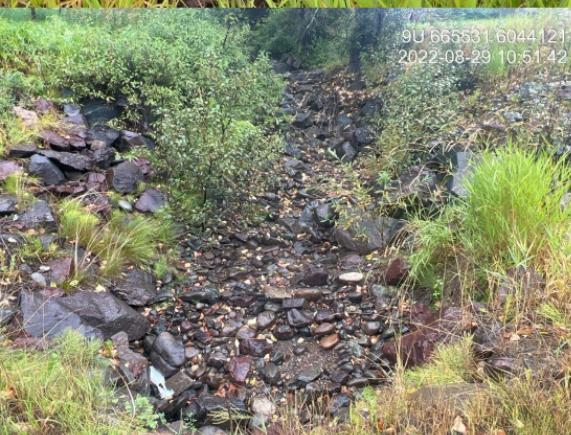
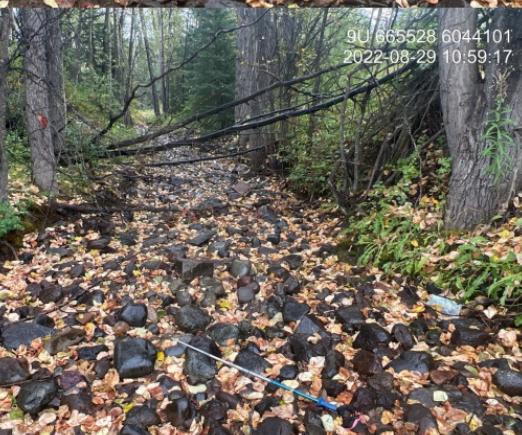
Location and Stream Data	.	Crossing Characteristics –	
Date	2022-08-29	Crossing Sub Type	Oval Culvert
PSCIS ID	197657	Diameter (m)	2.3
External ID	–	Length (m)	18
Crew	AI, TP	Embedded	Yes
UTM Zone	9	Depth Embedded (m)	1
Easting	665525.1	Resemble Channel	Yes
Northing	6044126	Backwatered	No
Stream	Perow Creek	Percent Backwatered	–
Road	Highway 16	Fill Depth (m)	0.5
Road Tenure	–	Outlet Drop (m)	0
Channel Width (m)	4.6	Outlet Pool Depth (m)	0
Stream Slope (%)	3	Inlet Drop	No
Beaver Activity	No	Slope (%)	1.5
Habitat Value	Medium	Valley Fill	Deep Fill
Final score	14	Barrier Result	Passable
Fix type	–	Fix Span / Diameter	–

Location and Stream Data	•	Crossing Characteristics	-
Comments: Stream was dry at the time of survey but had water last year during extremely dry ear. Culvert appears passable for all life stages. There is a private land residential development impacting the stream. The channel is constricted and has large chunks of riprap throughout. 10:45			
Photos: From top left clockwise: Road/Site Card, Barrel, Outlet, Downstream, Upstream, Inlet.

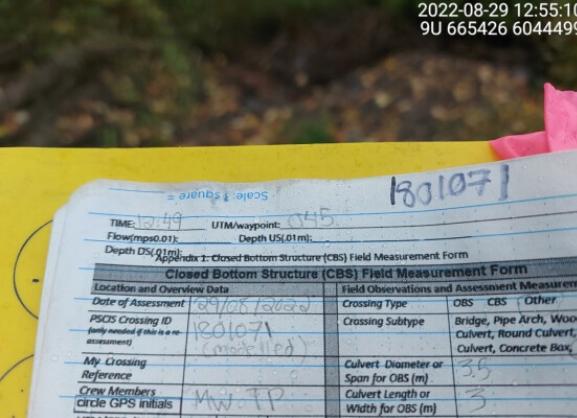
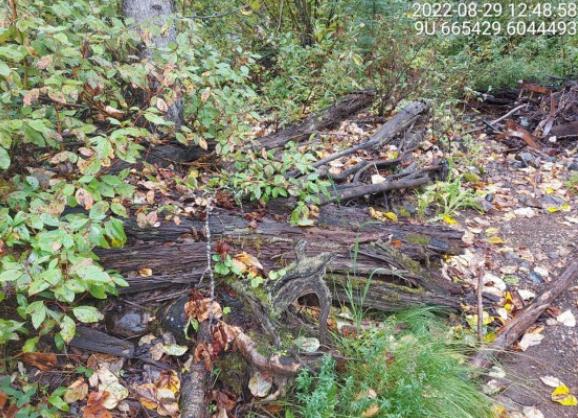
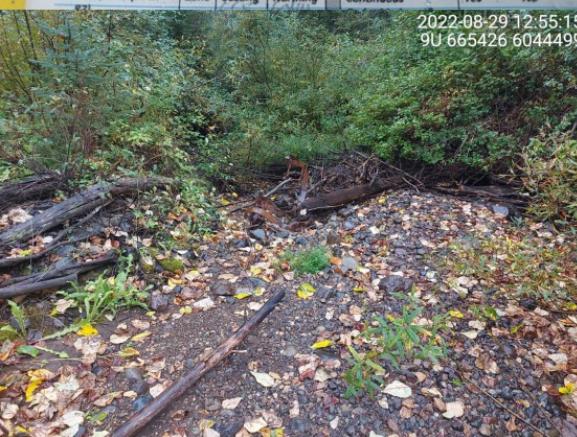
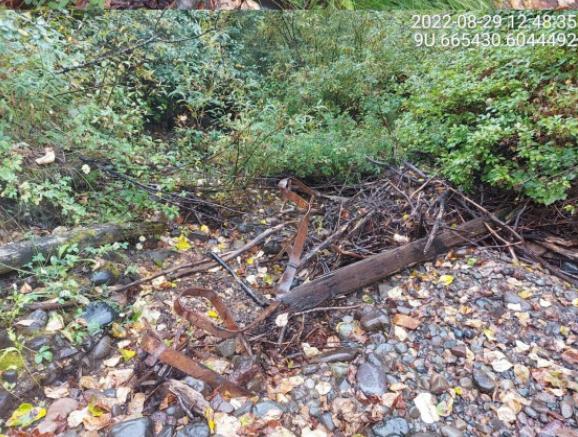
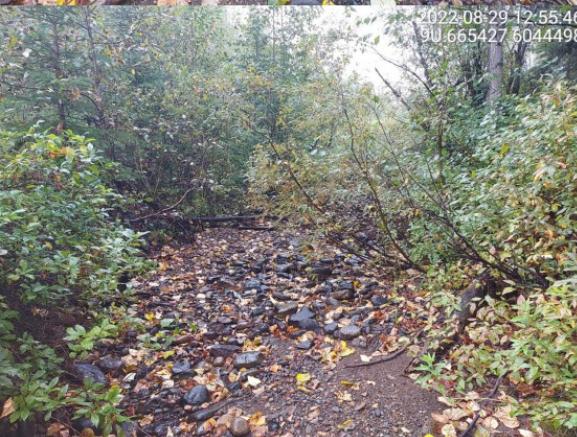
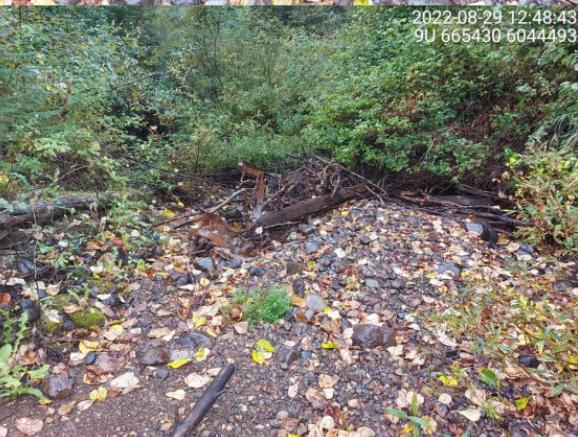
Perow Creek - 197653 - Appendix

Location and Stream Data	•	Crossing Characteristics	-
Fix type	-	Fix Span / Diameter	-
Comments: No crossing. Transmission line. 12:49			
Photos: From top left clockwise: Road/Site Card, Barrel, Outlet, Downstream, Upstream, Inlet.

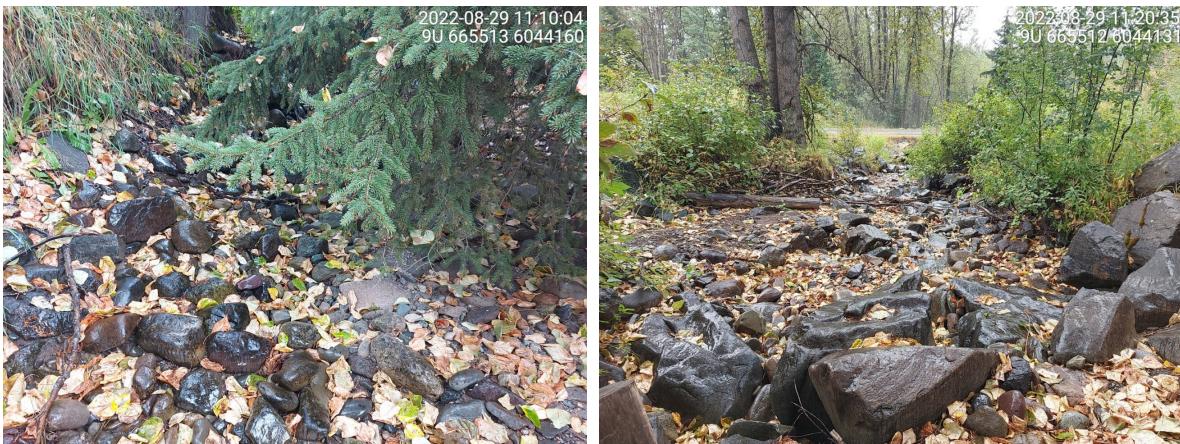
Figure 5.5: Left: Habitat downstream of PSCIS crossing 197653. Right: Habitat downstream of PSCIS crossing 197653.

area assessed downstream of the crossing was dry at the time of the survey (Figure 5.5). Total cover amount was rated as moderate with boulders dominant. Cover was also present as overhanging vegetation. The average channel width was 4.3m, and the average gradient was 2%. The dominant substrate was boulders with cobbles sub-dominant. PSCIS crossing 197657 on the highway, approximately 50m downstream from crossing 197653 was reassessed and ranked as passable as it was low gradient, fully embedded and with no outlet drop. It appeared passable to all species and life stages at the time of assessment (Table 5.10). This crossing was previously assessed in 2020 by Irvine (2021), but it was mistakenly input as modelled crossing ID 1800064, when it should have been 1800067. The stream from Perow Loop Road to the highway flowed through private property and appeared to be channelized and confined with concrete slabs used as stream bank armoring just downstream of the outlet. Downstream of the highway crossing two bridges are documented in the PSCIS database (197660 and 197659). Although habitat downstream had limited complexity resulting from impacts related to the adjacent road infrastructure and residential properties, the habitat was rated as medium value as it was considered an important migration corridor.

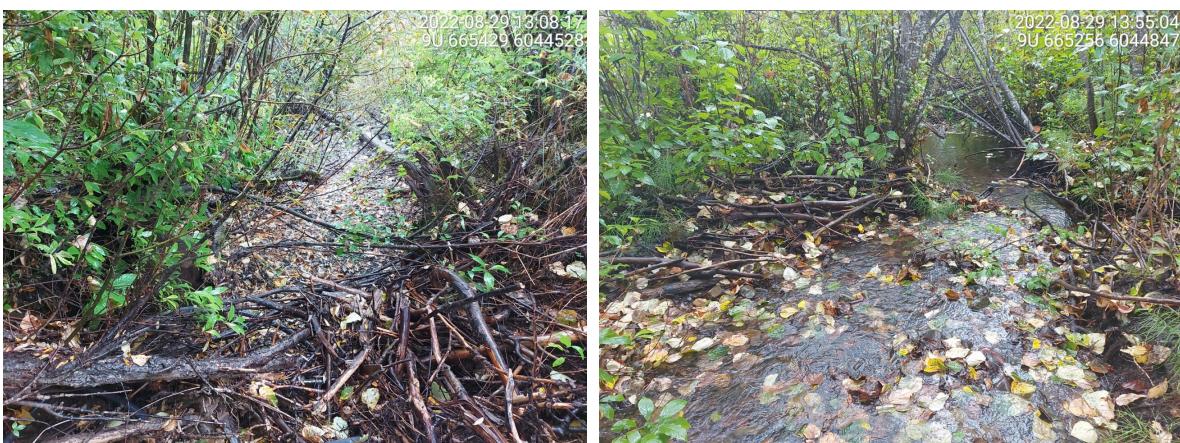
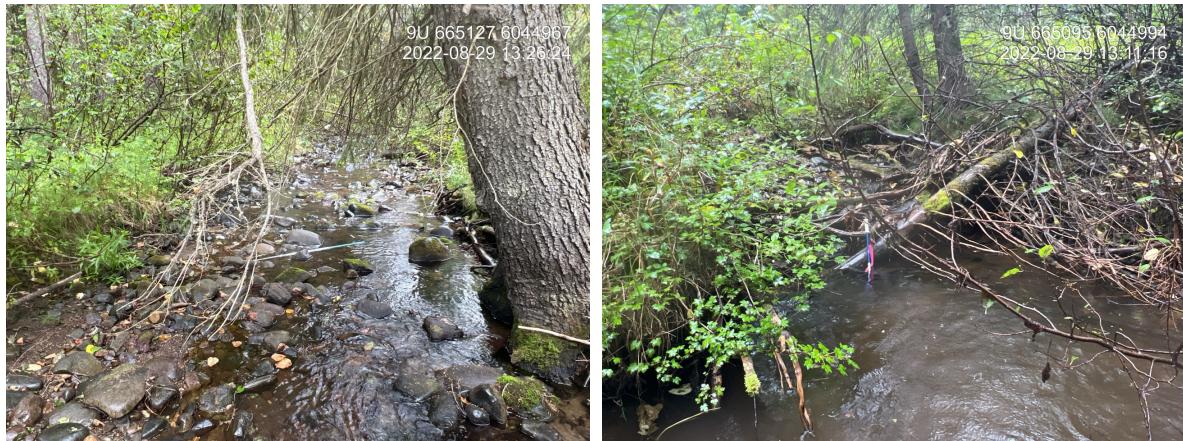
Figure 5.6: Left: Habitat upstream of PSCIS crossing 197653. Right: Habitat upstream of PSCIS crossing 197653.

The stream was surveyed upstream from crossing 197653 for 500m (Figure 5.6). Two sections of stream upstream of the crossing were assessed. As residential buildings and yards were situated immediately adjacent to the stream upstream of the crossing, the stream was accessed from a ford located on the transmission line ~325m upstream of Perow Loop Road. The first section surveyed included ~350m of channel upstream of the ford and was dewatered at the time of survey. Total cover amount was rated as moderate with overhanging vegetation dominant. Cover was also present as small woody debris. The average channel width was 3.2m, the average wetted width was 1.9m, and the average gradient was 3%. The dominant substrate was cobbles with gravels sub-dominant.

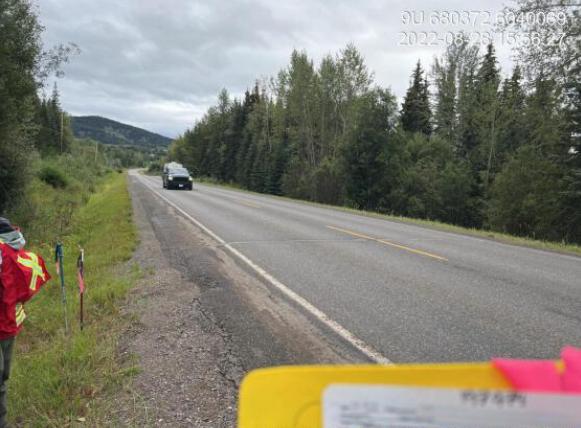
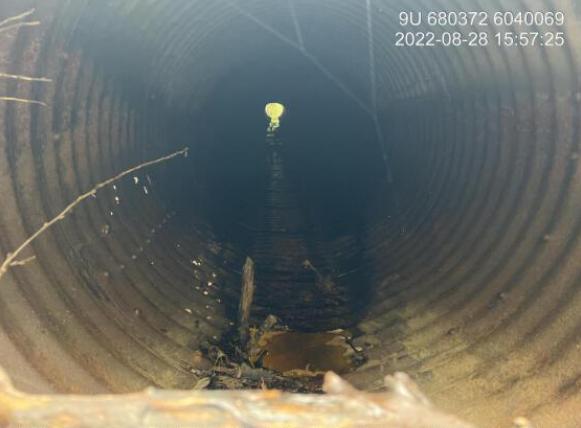
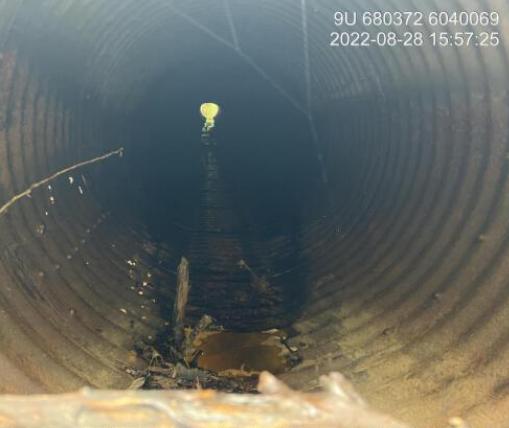
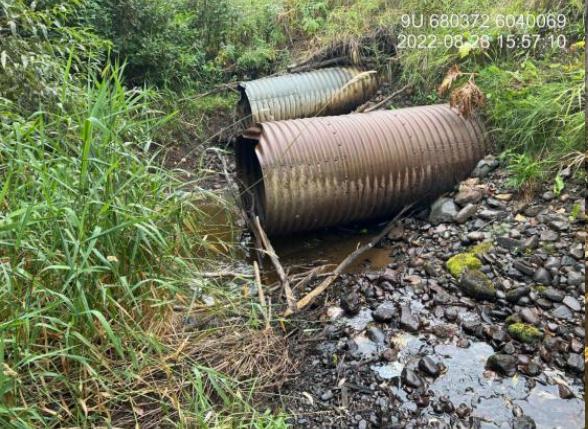
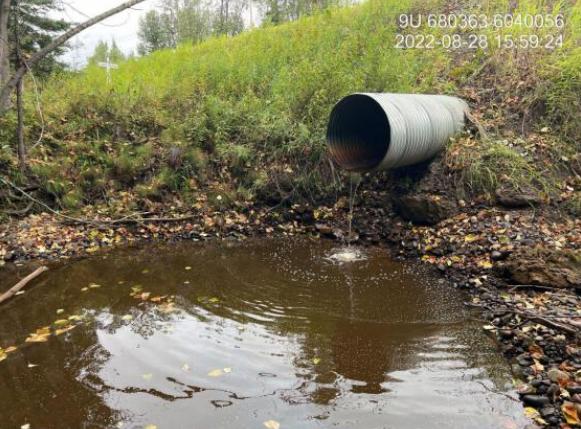
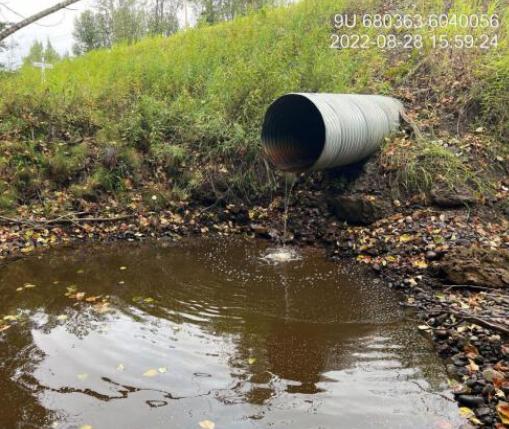
Location and Stream Data	•	Crossing Characteristics	-
<p>Comments: Deep and large outlet pool indicate culvert is significantly undersized. Condition of the pipe is poor with corrosion and some collapsing in the middle of the pipe. 0.6m diameter overflow pipe located adjacent to the main culvert. Some decent gravels downstream. 15:52</p>			
<p>Photos: From top left clockwise: Road/Site Card, Barrel, Outlet, Downstream, Upstream, Inlet.</p>

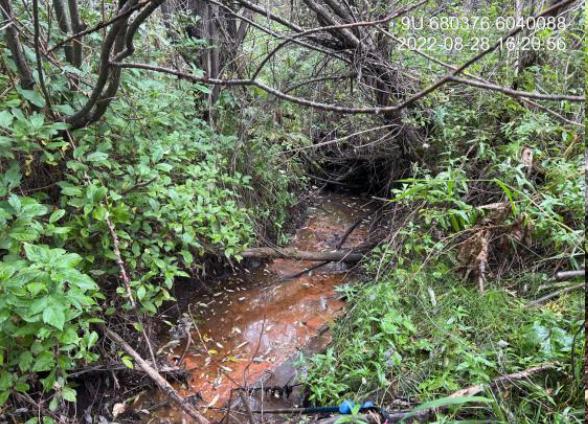
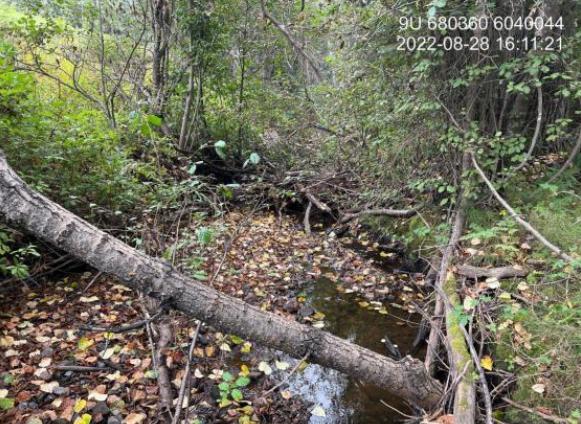
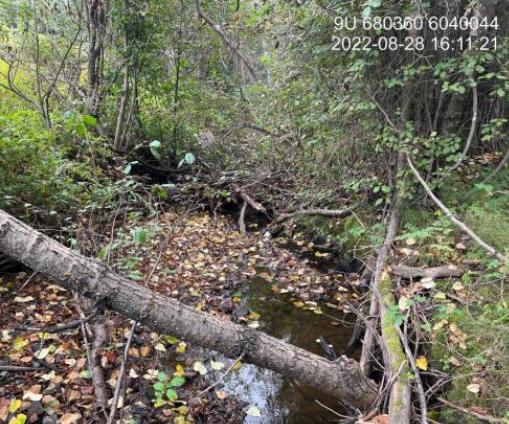
At the time of the survey, PSCIS crossing 197974 was un-embedded, non-backwatered and ranked as a barrier to upstream fish passage according to the provincial protocol (MoE 2011b) (Table 5.15). The culvert was considered a complete barrier to all species and all life stages at all flows due to an outlet drop measured at 1m high. The deep and large outlet pool indicated that the culvert was significantly undersized. Condition of the pipe was noted as poor with extensive corrosion present and some collapsing in the middle of the pipe. Water temperature was 13°C, pH was 7.8 and conductivity was 199uS/cm.

Location and Stream Data		Crossing Characteristics –	
Date	2022-08-28	Crossing Sub Type	Round Culvert
PSCIS ID	197974	Diameter (m)	0.9
External ID	–	Length (m)	26
Crew	MW, AI	Embedded	No
UTM Zone	9	Depth Embedded (m)	–
Easting	680379	Resemble Channel	No
Northing	6040073	Backwatered	No
Stream	Watson Creek	Percent Backwatered	–
Road	Highway 16	Fill Depth (m)	3
Road Tenure	MoTi	Outlet Drop (m)	1
Channel Width (m)	3.4	Outlet Pool Depth (m)	1.2
Stream Slope (%)	2	Inlet Drop	No
Beaver Activity	No	Slope (%)	3.5
Habitat Value	Medium	Valley Fill	Deep Fill
Final score	39	Barrier Result	Barrier
Fix type	Replace with New Open Bottom Structure	Fix Span / Diameter	10

Should restoration/maintenance activities proceed, replacement of PSCIS crossing 197974 with a bridge (10m span) is recommended. The cost of the work is estimated at \$1,500,000 for a cost benefit of 9300 linear m/\$1000 and 15810 m<sup>2</sup>/\$1000.

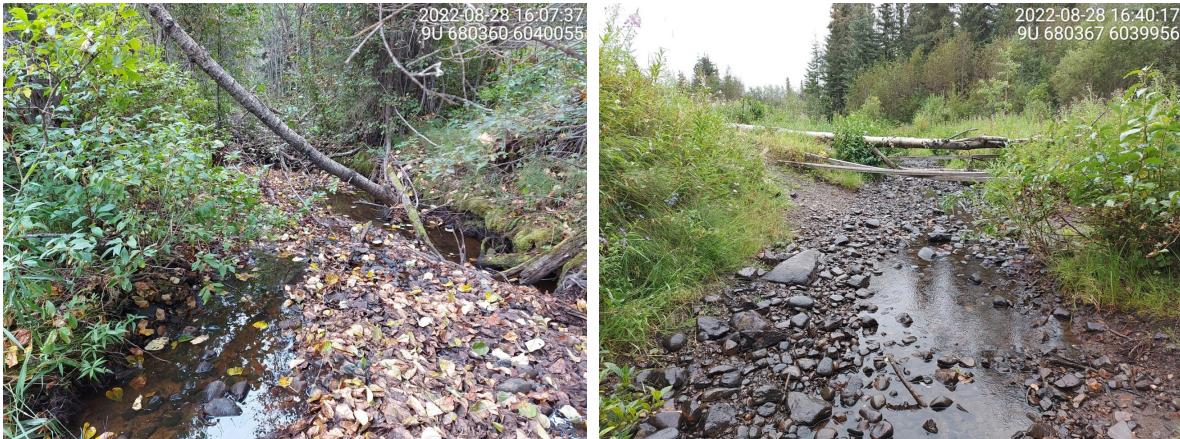
Figure 5.8: Left: Typical habitat downstream of PSCIS crossing 197974. Right: Typical habitat downstream of PSCIS crossing 197974.

The stream was surveyed downstream from crossing 197974 for 350m to the confluence with Ailport Creek (Figure 5.8). Total cover amount was rated as trace with small woody debris dominant. Cover was also present as undercut banks and deep pools. The dominant substrate was gravels with cobbles sub-dominant. The average channel width was 3.5m, the average wetted width was 1.4m, and the average gradient was 2.2%. Immediately downstream of the culvert stream flows were noted as very minimal however, at approximately 50m downstream the volume of water increased substantially. There were occasional deep pools and undercut banks but cover and complexity was notably lacking in most areas. At approximately 100m downstream of the highway riparian forests have been removed to accommodate pasture with notably less cover present and a channel confined by steep banks. Abundant gravels suitable for resident and anadromous salmonid spawning were present throughout the area surveyed. The habitat was rated as medium value for salmonid rearing and spawning.

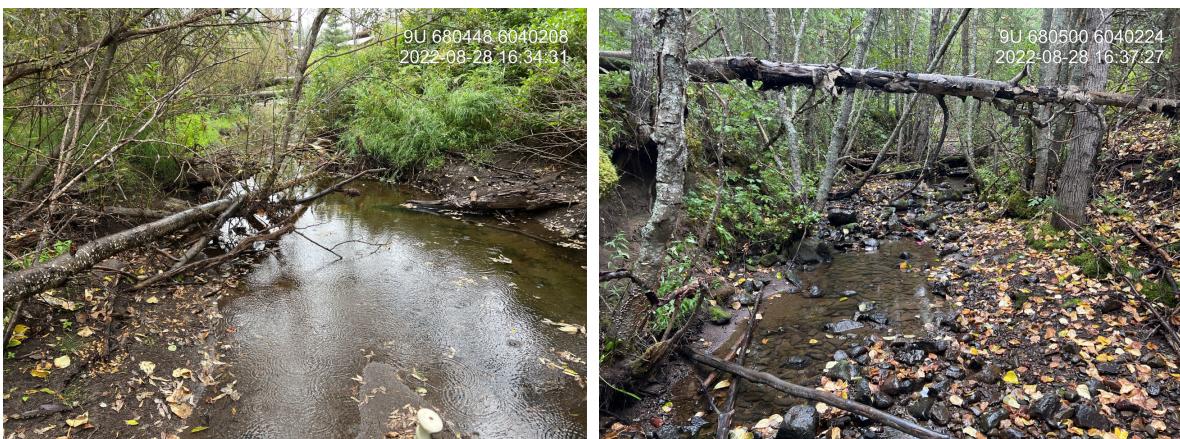
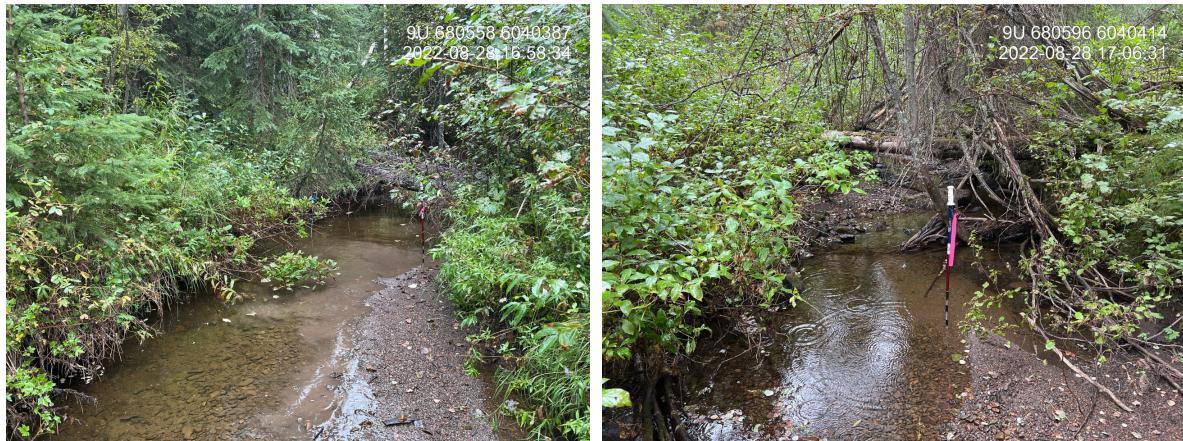
Figure 5.9: Left: Typical habitat upstream of PSCIS crossing 197974. Right: Typical habitat upstream of PSCIS crossing 197974.

The stream was surveyed upstream from crossing 197974 for 600m (Figure 5.9). Total cover amount was rated as moderate with undercut banks dominant. Cover was also present as small woody debris, large woody debris, deep pools, and overhanging vegetation. The dominant substrate was gravels with fines sub-dominant. The average channel width was 3.4m, the average wetted width was 1.8m, and the average gradient was 1.8%. Numerous salmonid fry were noted throughout the area surveyed along with abundant gravels suitable for resident and anadromous salmonid spawning. Immediately upstream of the crossing for approximately 150-200m stream banks and riparian areas were heavily impacted by cattle with beaver activity also noted in this area. Some pools to 0.7m deep were present and suitable for salmonid juvenile rearing and overwintering. Survey notes indicate that at the time of the survey cattle appeared to be accessing the stream intermittently throughout the entire area surveyed. Overall, the habitat surveyed upstream of the crossing rated as medium value as an important migration corridor containing habitat suitable for rainbow and coho spawning with moderate rearing potential for juvenile salmonids.

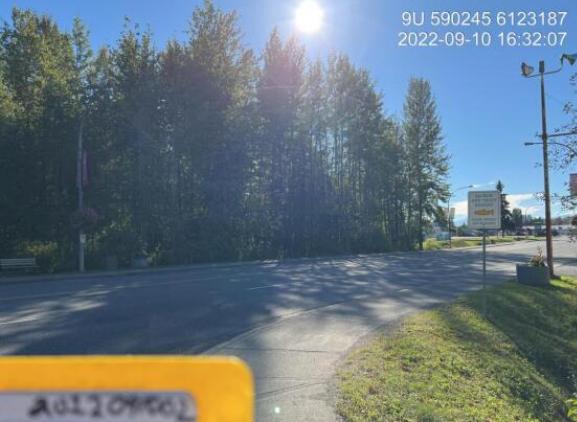
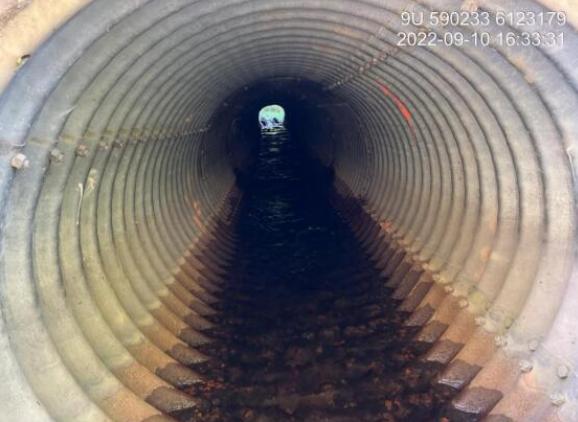
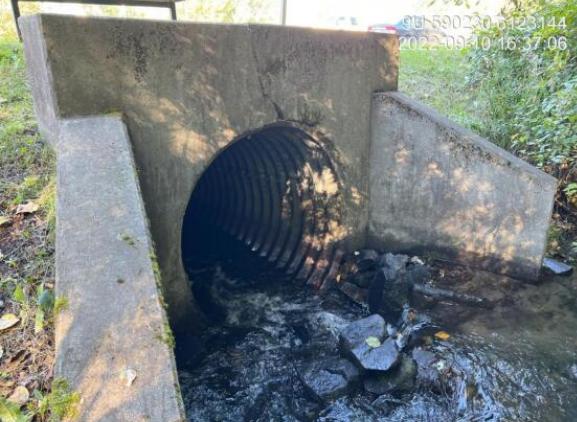
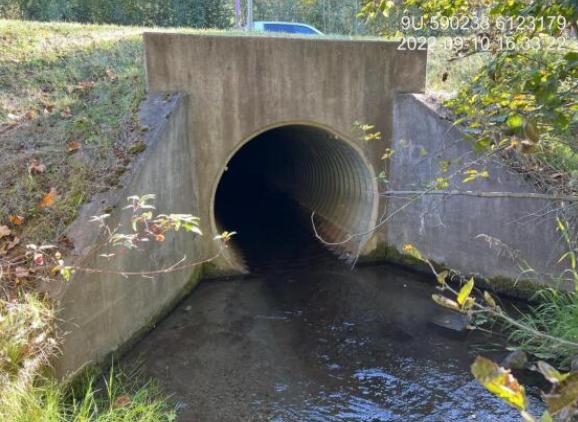
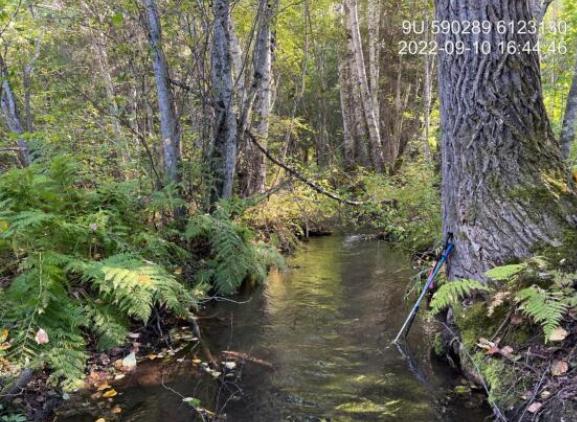
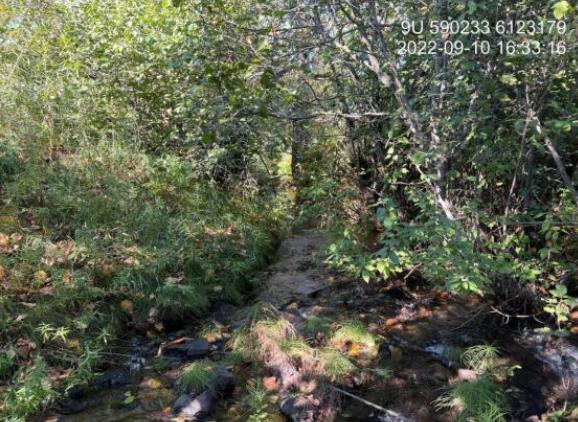
Tributary to Waterfall Creek - 198116 -...

Location and Stream Data	•	Crossing Characteristics	-
<p>Comments: Stream is not mapped correctly in the freshwater atlas as it actually flows in a north direction through town. Great flow, patches of gravel suitable for coho spawning. Located right within the town of New Hazelton. Trap and truck coho operation occurring with spawners transplanted upstream of the railway and 14th avenue. 16:34</p>			
Photos: From top left clockwise: Road/Site Card, Barrel, Outlet, Downstream, Upstream, Inlet.

Should restoration/maintenance activities proceed, replacement of PSCIS crossing 198116 with a bridge (10m span) is recommended. The cost of the work is estimated at \$7,500,000 for a cost benefit of 160 linear m/\$1000 and 312 m<sup>2</sup>/\$1000.
