## Bulkley Watershed Fish Passage Restoration Planning 2022

Prepared for  
Canadian Wildlife Federation  
Habitat Conservation Trust Foundation - CAT23-6-288  
BC Fish Passage Remediation Program  
Ministry of Transportation and Infrastructure

Prepared by  
Al Irvine, B.Sc., R.P.Bio. and Mateo Wintersheidt, B.Sc.  
New Graph Environment Ltd.  
on behalf of  
Society for Ecosystem Restoration in Northern British Columbia

Version 0.1.6 DRAFT 2023-05-30

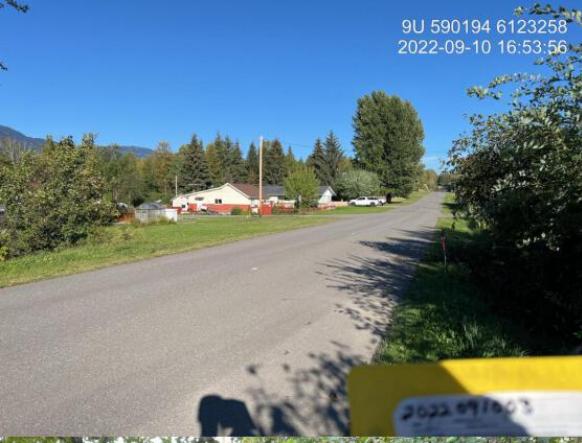
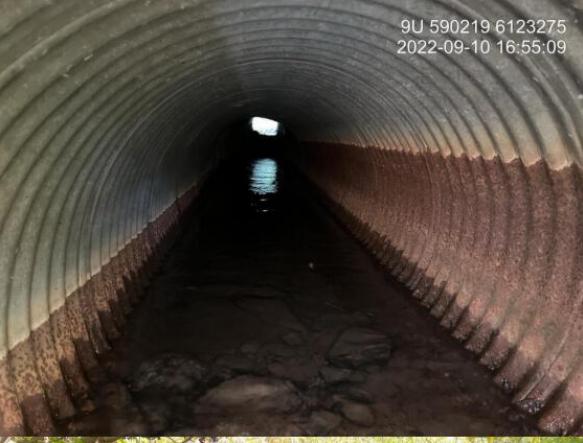
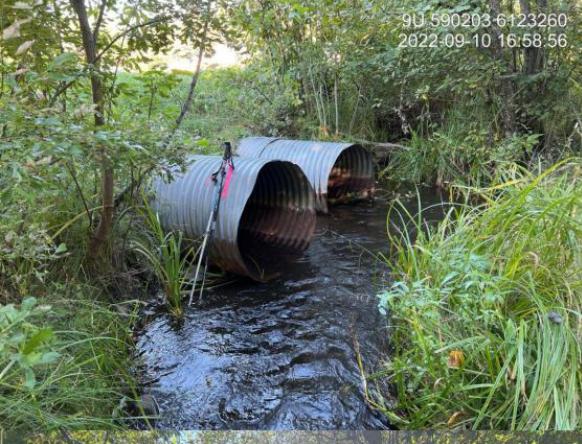
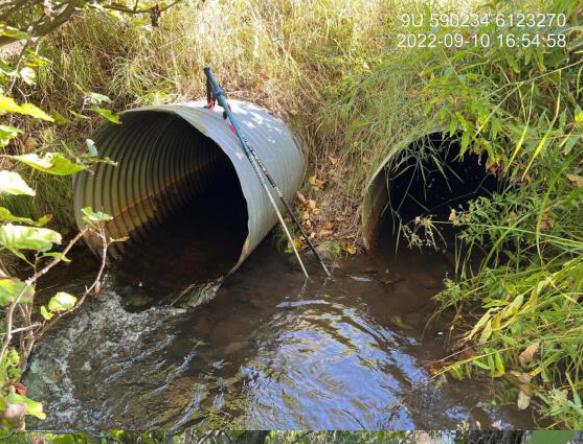
Location and Stream Data	•	Crossing Characteristics	-
Comments: Two 0.9 pipe added together for width. Left pipe has significant blockage 1/3 of the way through the pipe. Right Bank of the stream has an empty lot with only grass and invasive weed riparian. 16:52			
Photos: From top left clockwise: Road/Site Card, Barrel, Outlet, Downstream, Upstream, Inlet.

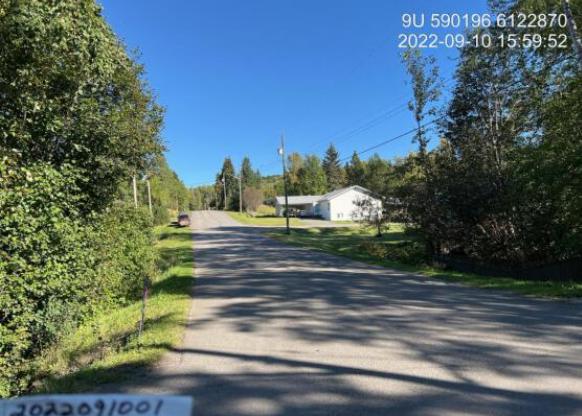
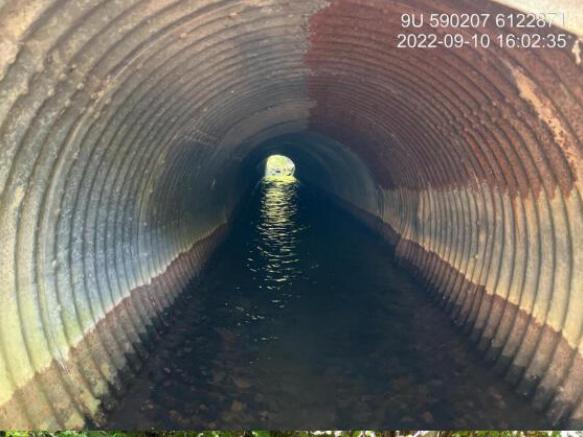
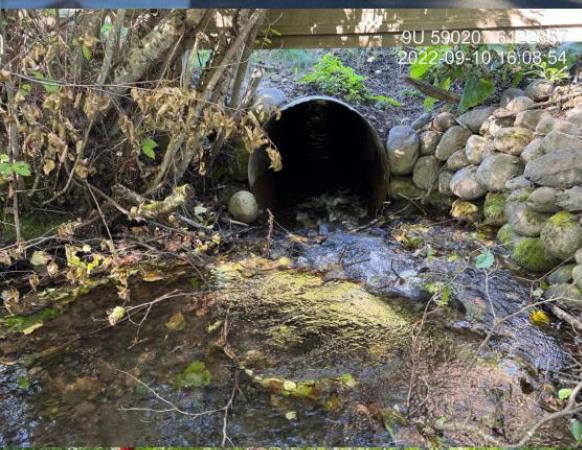
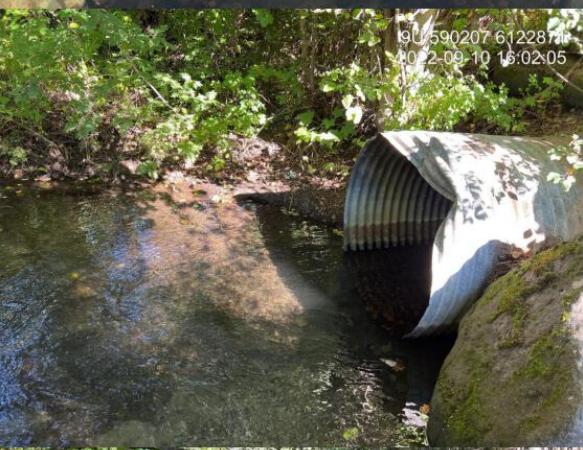
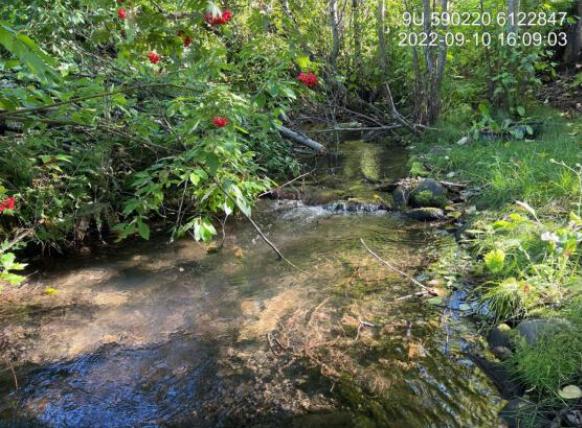
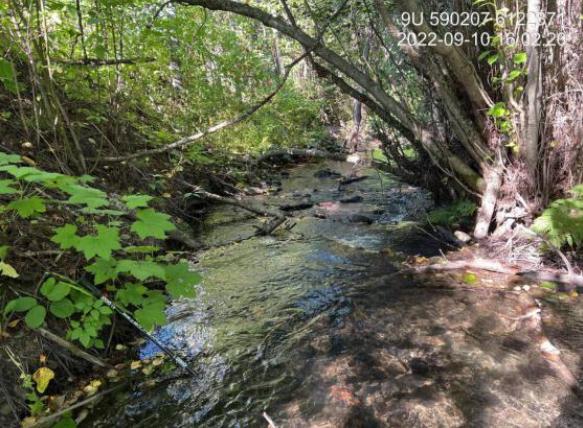
Tributary to Waterfall Creek - 198116 -...

Location and Stream Data	•	Crossing Characteristics	-
Comments: This is waterfall Creek. It does not show up in the freshwater atlas as here, however this is the main flow. Numerous fry and parr observed upstream of the crossing. No paper card for site. 16:03			
Photos: From top left clockwise: Road/Site Card, Barrel, Outlet, Downstream, Upstream, Inlet.

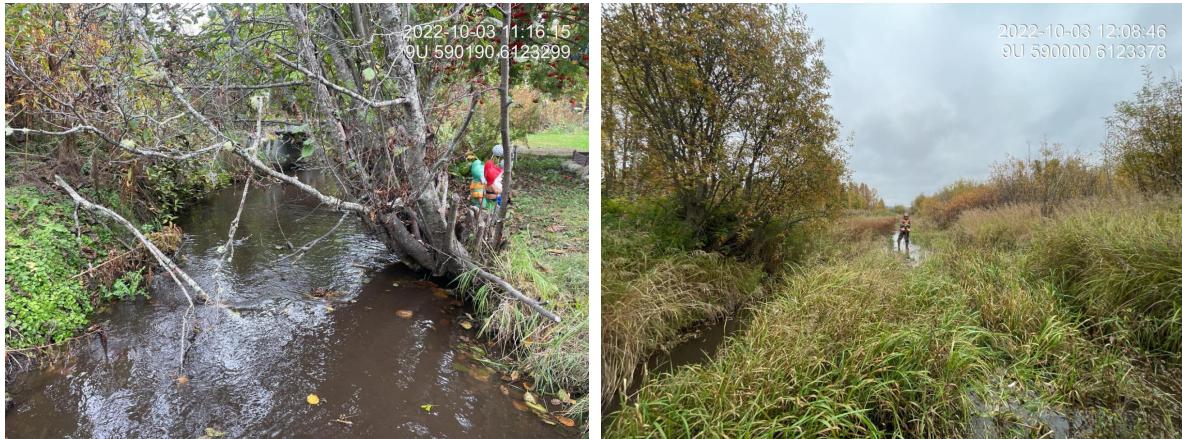
Figure 5.13: Left: Typical habitat downstream of PSCIS crossing 198116. Right: Typical habitat downstream of PSCIS crossing 198116.

The stream was surveyed downstream from crossing 198116 for 450m past PSCIS crossing 198177 to adjacent to the CN railway approximately 220m upstream of PSCIS crossing 124423 (Figure 5.13). The average channel width was 3m, the average wetted width was 2.8m, and the average gradient was 1%. Total cover amount was rated as abundant with overhanging vegetation dominant. Cover was also present as instream vegetation. The dominant substrate was fines with gravels sub-dominant. There is a culvert approximately 100m downstream (PSCIS crossing 198117) that was also assessed. At the time of survey, this crossing was un-embedded, non-backwatered, and ranked as a barrier to upstream fish passage (Table 5.18). The stream flows through the town of New Hazelton. There was low flow at the time of survey and the stream contained a lot of waste and debris. There was a lot of cover from vegetation. The stream hits the railway and is drained into a tributary that flows west until it joins Station Creek. The habitat was rated as high value for salmonid rearing and spawning.

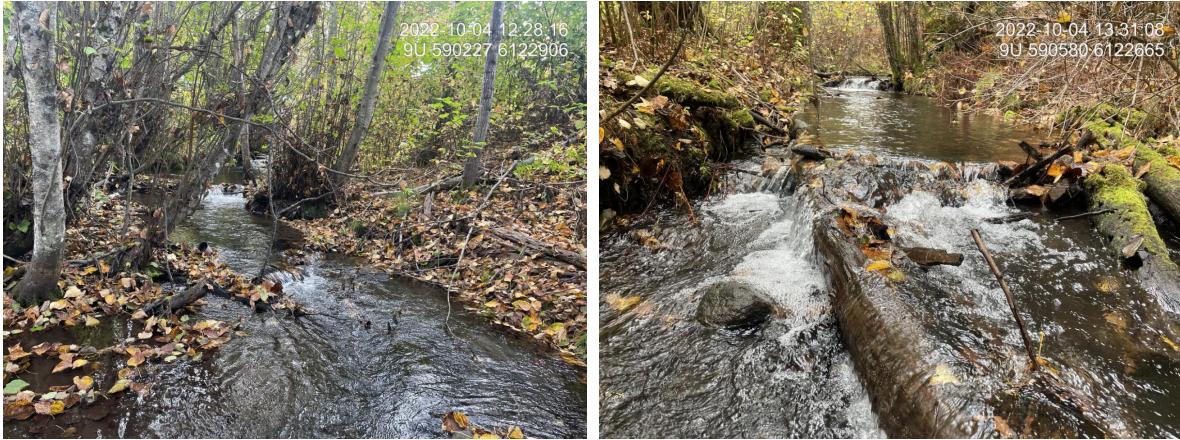
Figure 5.14: Left: Gravel and cobble substrate immediately upstream of PSCIS crossing 198116. Right: Footbridge located upstream of PSCIS crossing 198116.

The stream was surveyed upstream from crossing 198116 for 1200m to the location of a waterfall that blocks upstream migration for all life stages and species. (Figure 5.14). The waterfall was estimated to be approximately 7m in height. Total cover amount was rated as abundant with small woody debris dominant. Cover was also present as undercut banks. The average channel width was 3.7m, the average wetted width was 3.5m, and the average gradient was 1.5%. The dominant substrate was fines with gravels sub-dominant. Total cover amount was rated as abundant with overhanging vegetation dominant. Cover was also present as undercut banks. There was a culvert approximately 400m upstream of PSCIS crossing 198116 that was also assessed. At the time of survey, this crossing was un-embedded, non-backwatered, and ranked as a barrier to upstream fish passage (Table 5.19). The habitat quality was excellent. The stream flow was moderate and there were fish spotted all the way up to the waterfall where the survey ended. An adult coho was seen upstream of crossing 198115. Cover from vegetation and undercut banks was noted as abundant. The habitat was rated as high value as an important migration corridor containing suitable spawning habitat and having high rearing potential for juvenile coho, rainbow trout, cutthroat trout and dolly varden.

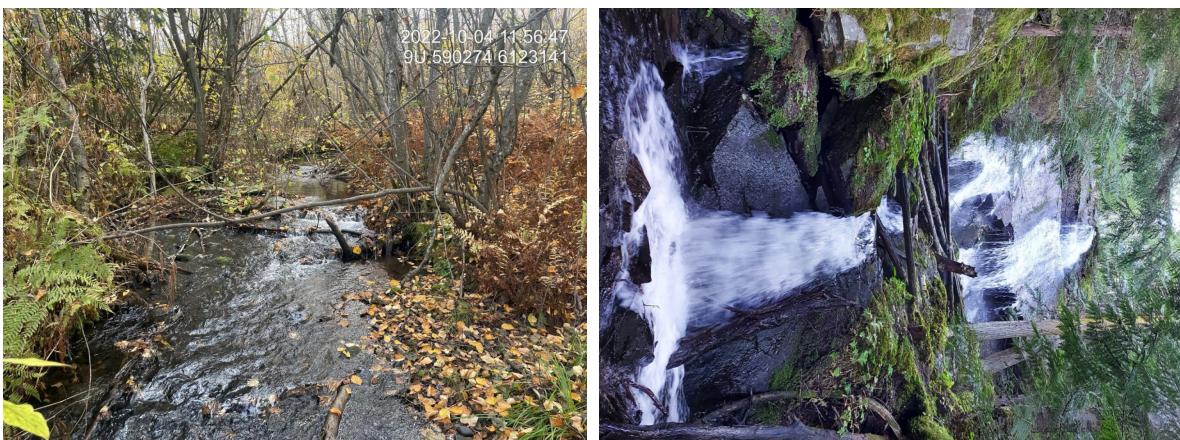
Figure 5.16: Left: Typical habitat upstream of PSCIS crossing 198116. Right: Waterfall at the end of survey, upstream of PSCIS crossing 198115.

Should restoration/maintenance activities proceed, replacement of PSCIS crossing 198116 with a bridge (10m span) is recommended. The cost of the work is estimated at \$7,500,000 for a cost benefit of 160 linear m/\$1000 and 312 m<sup>2</sup>/\$1000.

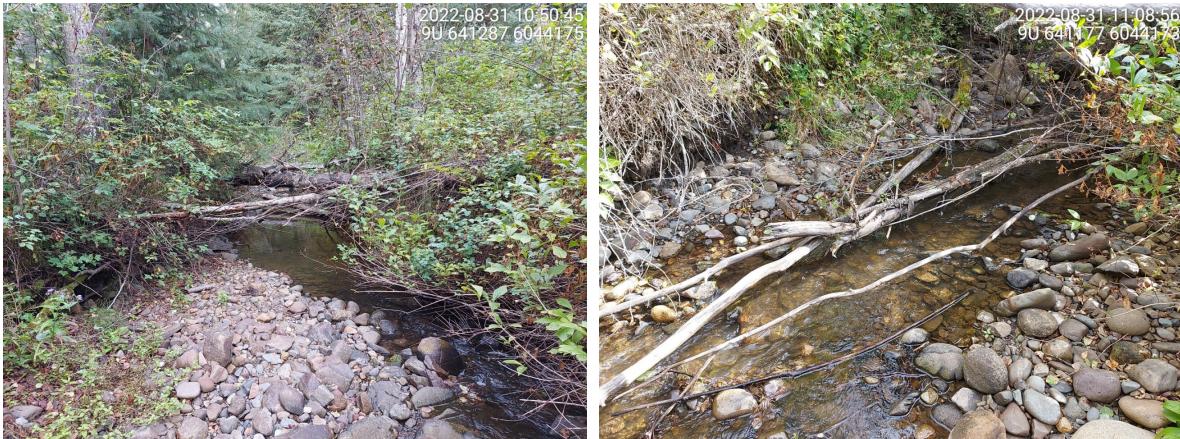
The stream was surveyed downstream from crossing 57793 for 300m (Figure 5.17). The dominant substrate was gravels with cobbles sub-dominant. The average channel width was 4.1m, the average wetted width was 2.4m, and the average gradient was 2%. Total cover amount was rated as abundant with undercut banks dominant. Cover was also present as small woody debris, large woody debris, and overhanging vegetation. There were undercut banks and abundant riparian vegetation throughout providing good cover for fish. Some gravels were present that could be suitable for spawning. Functional large woody debris was present throughout the stream. The habitat was rated as high value for salmonid rearing and spawning.

Figure 5.17: Left: Typical habitat downstream of PSCIS crossing 57793. Right: Typical habitat downstream of PSCIS crossing 57793.

Should restoration/maintenance activities proceed, replacement of PSCIS crossing 57793 with a bridge (10m span) is recommended. The cost of the work is estimated at \$2,000,000 for a cost benefit of 1720 linear m/\$1000 and 4042 m<sup>2</sup>/\$1000.

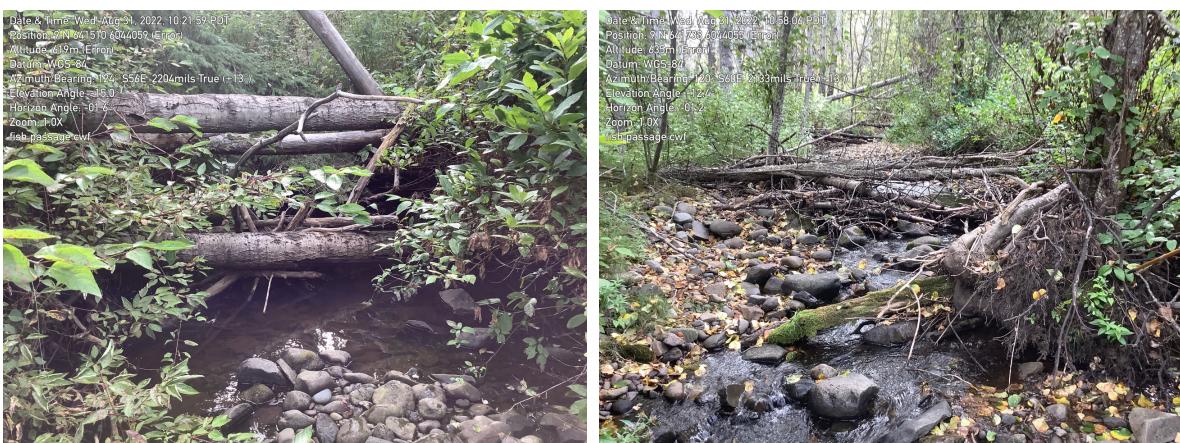
The stream was surveyed upstream from crossing 57793 for 600m (Figure 5.18). Total cover amount was rated as abundant with large woody debris dominant. Cover was also present as small woody debris, undercut banks, and overhanging vegetation. The average channel width was 4.1m, the average wetted width was 2m, and the average gradient was 2%. The dominant substrate was cobbles with gravels sub-dominant. The data for the upstream survey was misplaced and stream characteristics and measurements were obtained by reviewing photos. The habitat quality was excellent. There were abundant undercut banks and healthy mixed riparian vegetation throughout. The stream was wide and contained some pockets of gravel suitable for spawning resident species. The habitat was rated as high value as an important migration corridor containing suitable spawning habitat and having moderate rearing potential.

Figure 5.18: Left: Typical habitat upstream of PSCIS crossing 57793. Right: Typical habitat upstream of PSCIS crossing 57793.

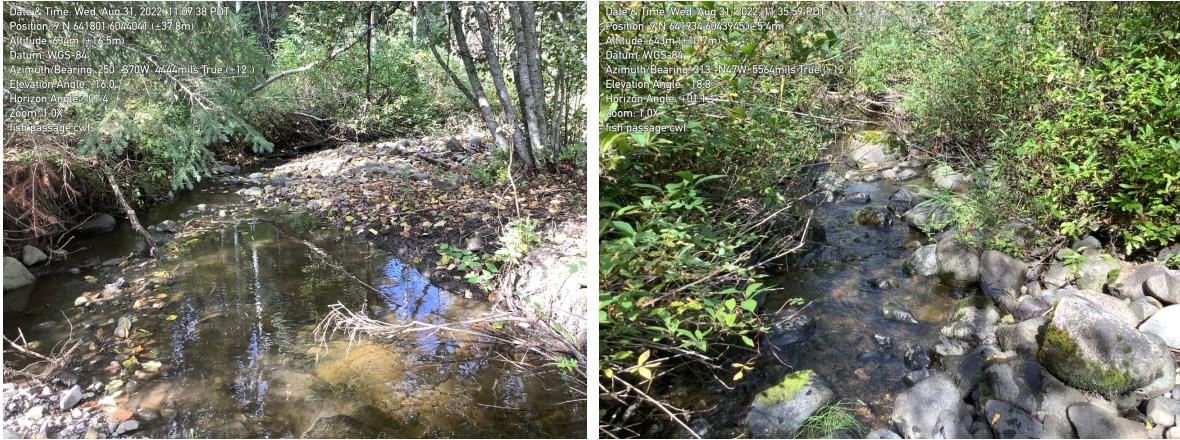
Figure 5.19: Left: Typical habitat upstream of PSCIS crossing 57793. Right: Typical habitat upstream of PSCIS crossing 57793.

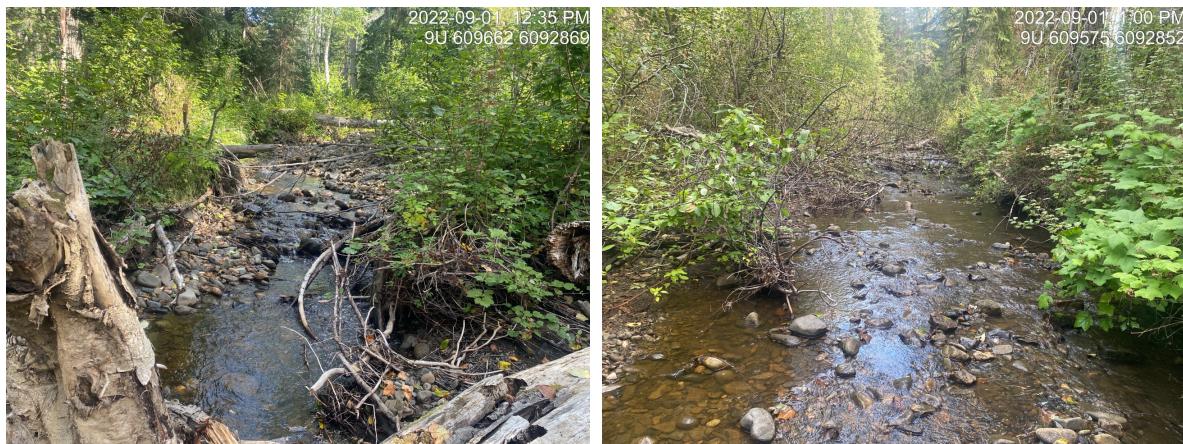
Figure 5.22: Left: Typical habitat downstream of PSCIS crossing 58067. Right: Typical habitat downstream of PSCIS crossing 58067.

Should restoration/maintenance activities proceed, replacement of PSCIS crossing 58067 with a bridge (11.5m span) is recommended. The cost of the work is estimated at \$1,150,000 for a cost benefit of 2982.6 linear m/\$1000 and 9842.6 m<sup>2</sup>/\$1000.

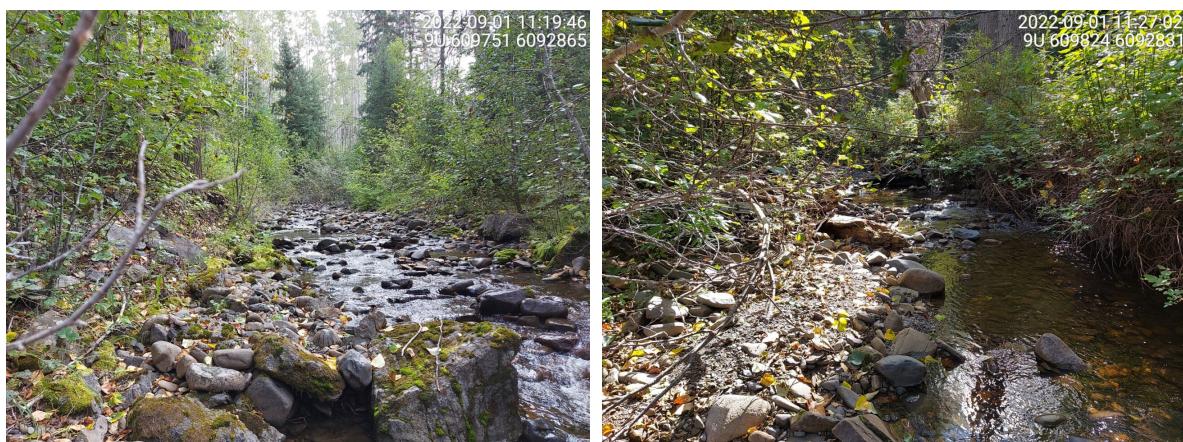
Figure 5.23: Left: Typical habitat upstream of PSCIS crossing 58067. Right: Typical habitat upstream of PSCIS crossing 58067.

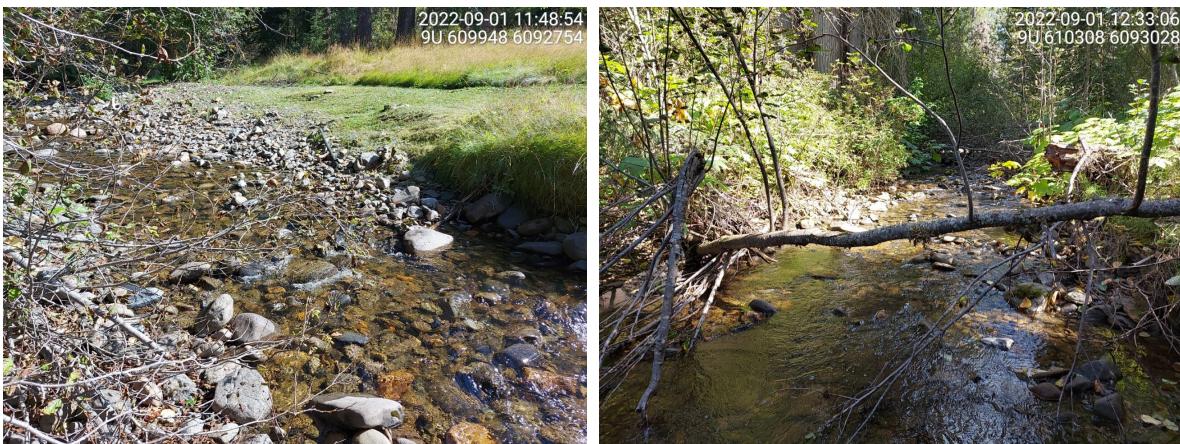
Figure 5.24: Left: Typical habitat upstream of PSCIS crossing 58067. Right: Typical habitat upstream of PSCIS crossing 58067.
