Bulkley Watershed Fish Passage Restoration Planning 2022

Prepared for
Canadian Wildlife Federation
Habitat Conservation Trust Foundation - CAT23-6-288
BC Fish Passage Remediation Program
Ministry of Transportation and Infrastructure

Prepared by
Al Irvine, B.Sc., R.P.Bio. and Mateo Wintersheidt, B.Sc.
New Graph Environment Ltd.
on behalf of
Society for Ecosystem Restoration in Northern British Columbia

Version 0.1.0 DRAFT 2023-01-13

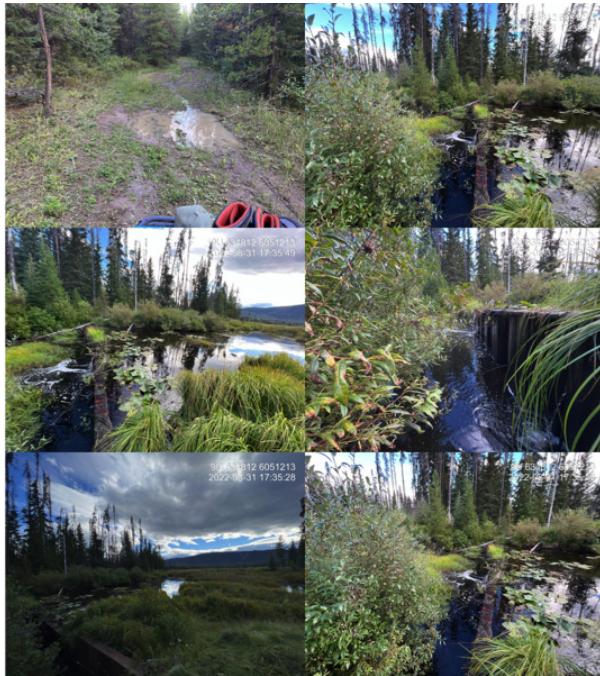
Figure 4.1: Photos of Dam 1f365462-063c-491e-9fb3-bfac004d9183 on Coffin Creek

Site	Stream	Easting	Northing	Mapsheet	Barrier	Notes
1f365462-063c-491e-9fb3-bfac004d9183	Coffin Creek	634763	6051171	093L.113	T	Aerial imagery aquired. Complete barrier. 1.2m high steel structure within wetland complex downstream of Coffin Lake. Extremely difficult access via all terrain vehicle due to muddy conditions
* UTM Zone 9

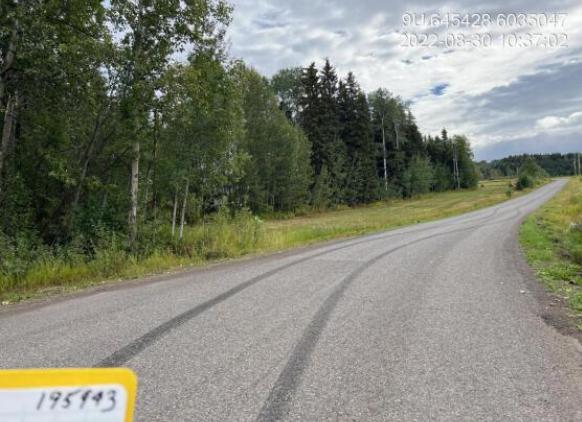
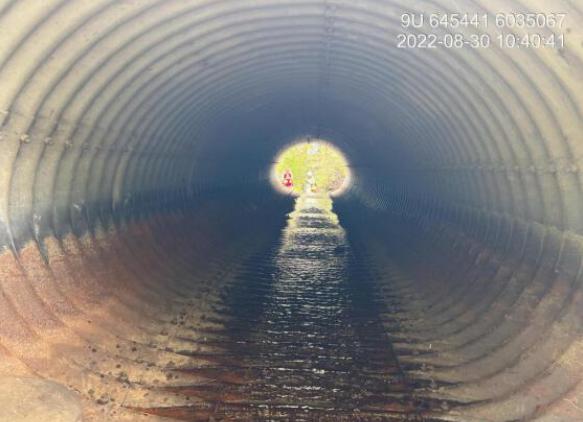
At the time of the survey, PSCIS crossing 195943 was un-embedded, non-backwatered and ranked as a barrier to upstream fish passage according to the provincial protocol (MoE 2011b) (Table 5.3). The culvert outlet drop was significant at 1.1m. Water temperature was 14°C, pH was 8.1 and conductivity was 343uS/cm. A beaver dam was noted just upstream of the culvert inlet (~1.5m high).

Location and Stream Data	•	Crossing Characteristics	-
Comments: Very large outlet drop, but creates nice pool for fish. Erosion on LB/RB on outlet side. Agricultural fields, minimal municipality population ds. Road is paved, detour available. 10:25			
Photos: From top left clockwise: Road/Site Card, Barrel, Outlet, Downstream, Upstream, Inlet.

Should restoration/maintenance activities proceed, replacement of PSCIS crossing 195943 with a bridge (10m span) is recommended. The cost of the work is estimated at \$2,000,000 for a cost benefit of 0.4 linear m/\$1000 and 0.6 m²/\$1000.

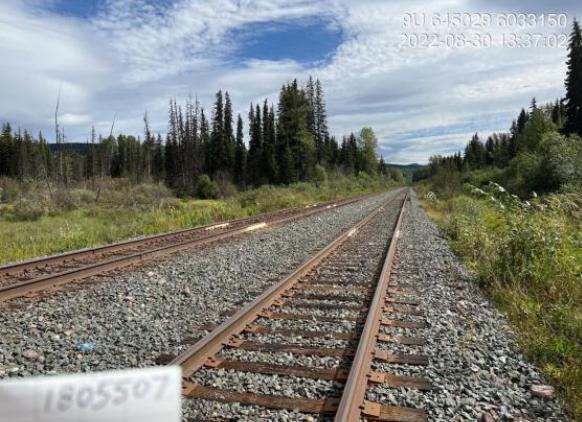
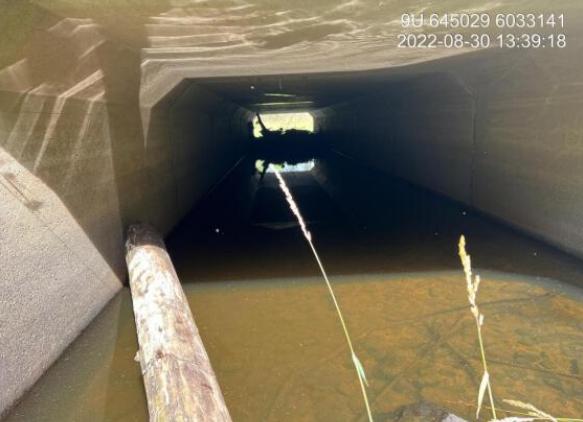
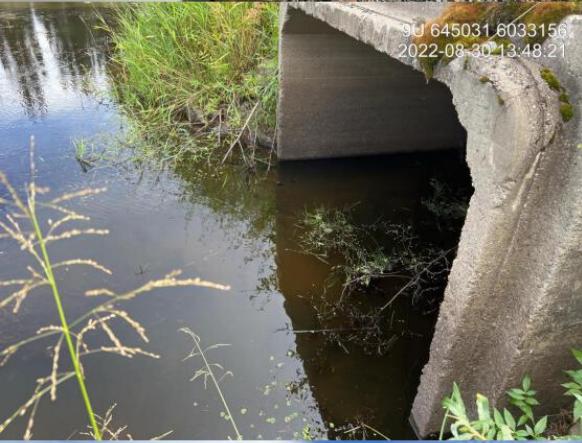
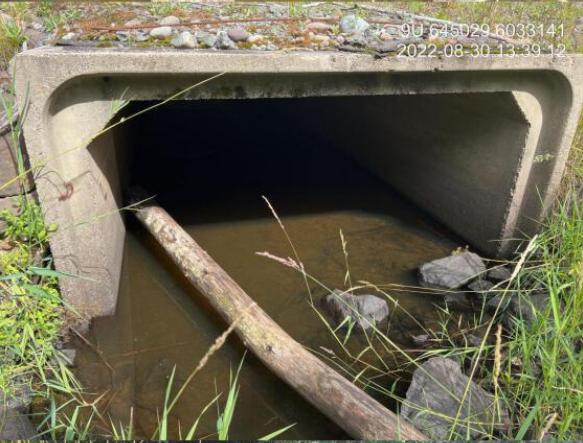
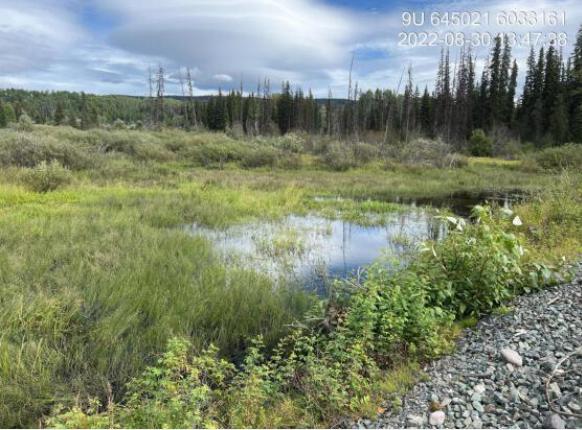
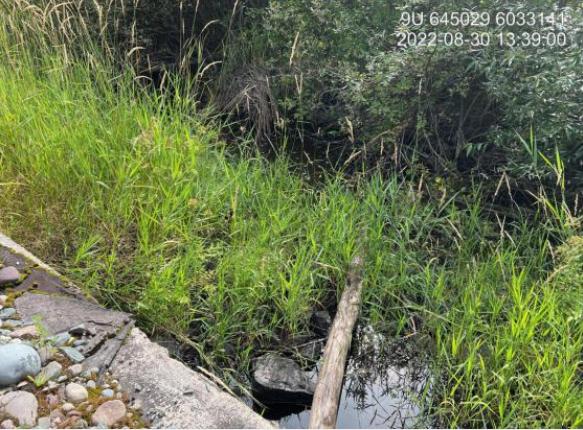
Location and Stream Data	•	Crossing Characteristics	-
Comments: Fully backwatered and embedded concrete box structure on the Railway. Not a fish passage issue at this time. 13:37			
Photos: From top left clockwise: Road/Site Card, Barrel, Outlet, Downstream, Upstream, Inlet.

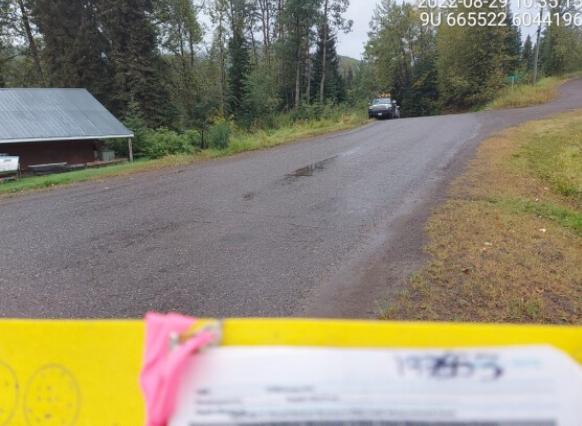
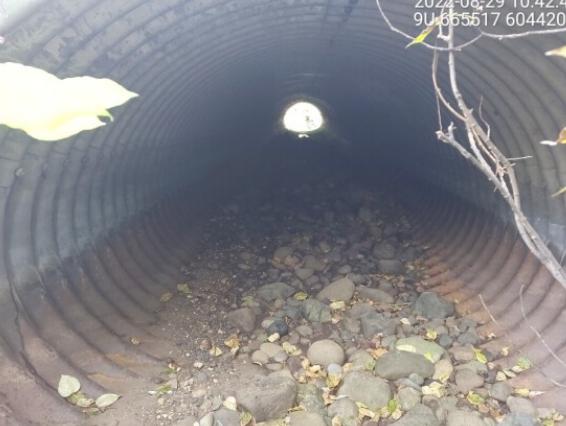
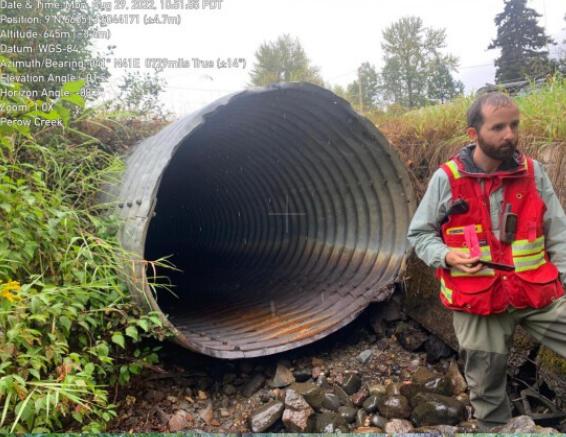
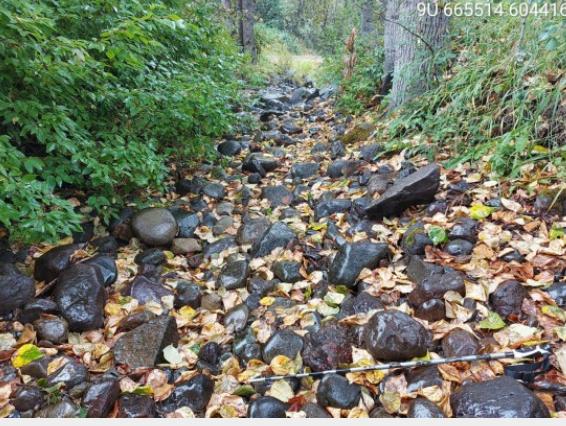
Location and Stream Data	.	Crossing Characteristics	-
Date	2022-08-29	Crossing Sub Type	Round Culvert
PSCIS ID	197653	Diameter (m)	2.3
External ID	-	Length (m)	28
Crew	MW, TP	Embedded	No
UTM Zone	9	Depth Embedded (m)	-
Easting	665520	Resemble Channel	No
Northing	6044200	Backwatered	No
Stream	Perow Creek	Percent Backwatered	-
Road	Perow Loop Road	Fill Depth (m)	0.5
Road Tenure	MoTi	Outlet Drop (m)	0.3
Channel Width (m)	4.3	Outlet Pool Depth (m)	0
Stream Slope (%)	4	Inlet Drop	No
Beaver Activity	No	Slope (%)	1.5
Habitat Value	Low	Valley Fill	Deep Fill
Final score	34	Barrier Result	Barrier
Fix type	Replace Structure with Streambed Simulation CBS	Fix Span / Diameter	3

Location and Stream Data	•	Crossing Characteristics	-
Comments: Stream is dry. Private yards u/s and d/s. Rip rap and cement in channel. 10:48			
Photos: From top left clockwise: Road/Site Card, Barrel, Outlet, Downstream, Upstream, Inlet.

Should restoration/maintenance activities proceed, replacement of PSCIS crossing 197653 with a streambed simulation (3m span) is recommended. The cost of the work is estimated at \$400,000 for a cost benefit of 0.8 linear m/\$1000 and 1.8 m²/\$1000.

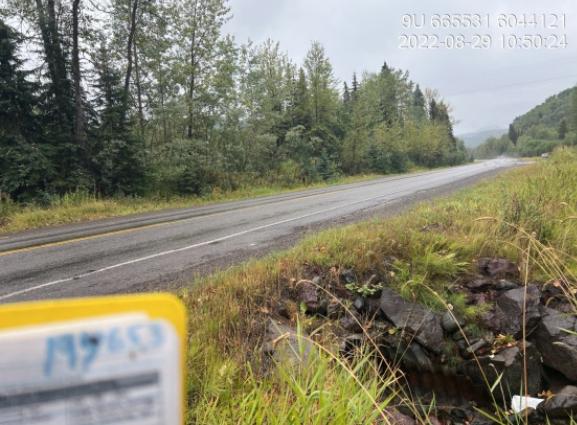
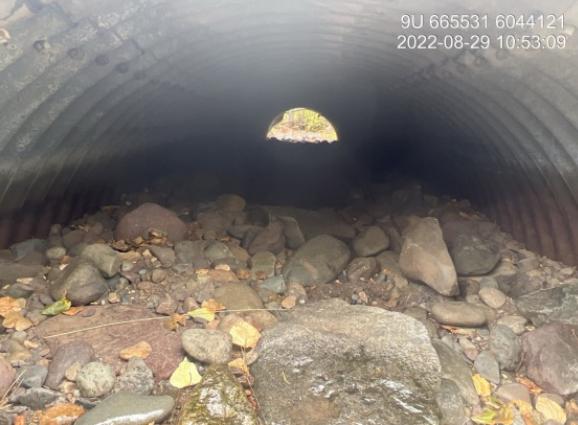
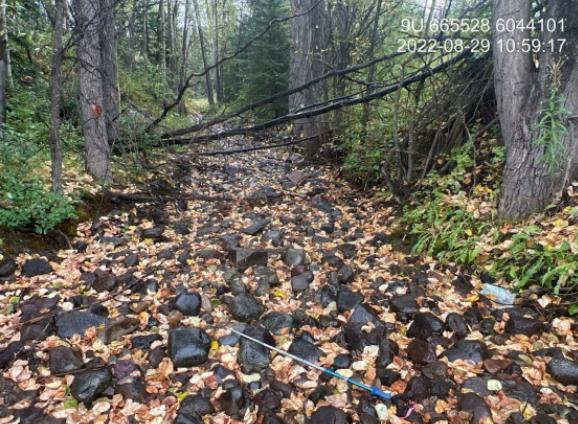
Location and Stream Data	.	Crossing Characteristics –	
Date	2022-08-29	Crossing Sub Type	Oval Culvert
PSCIS ID	197657	Diameter (m)	2.3
External ID	–	Length (m)	18
Crew	AI, TP	Embedded	Yes
UTM Zone	9	Depth Embedded (m)	1
Easting	665525.1	Resemble Channel	Yes
Northing	6044126	Backwatered	No
Stream	Perow Creek	Percent Backwatered	–
Road	Highway 16	Fill Depth (m)	0.5
Road Tenure	–	Outlet Drop (m)	0
Channel Width (m)	4.6	Outlet Pool Depth (m)	0
Stream Slope (%)	3	Inlet Drop	No
Beaver Activity	No	Slope (%)	1.5
Habitat Value	Medium	Valley Fill	Deep Fill
Final score	14	Barrier Result	Passable
Fix type	–	Fix Span / Diameter	–

Location and Stream Data	•	Crossing Characteristics
<p>Comments: Stream was dry at time of survey but had water last year during extremely dry ear. Culvert appears passable for all life stages. There is private land residential development impacting the stream with the constricted channel with a large chunks of coffee just as rip rap throughout. 10:45</p>		
<p>Photos: From top left clockwise: Road/Site Card, Barrel, Outlet, Downstream, Upstream, Inlet.</p>

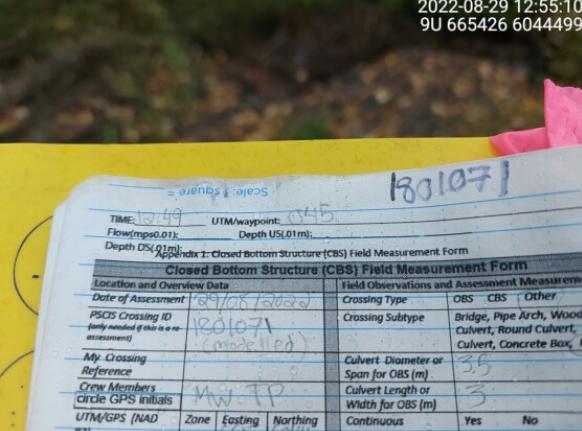
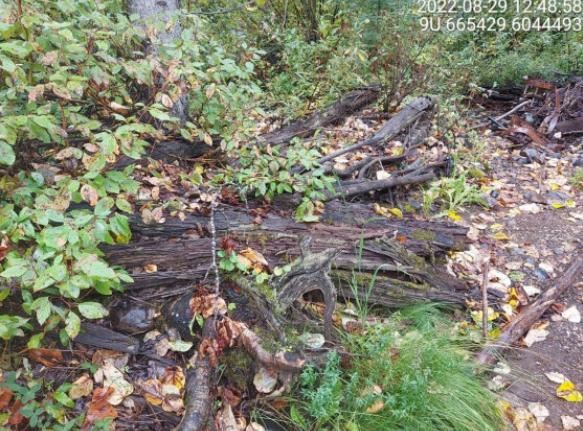
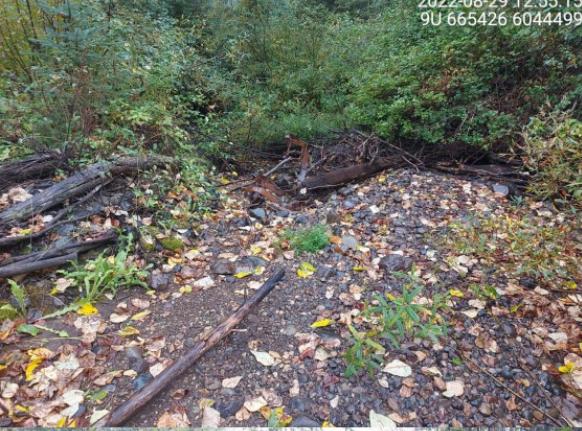
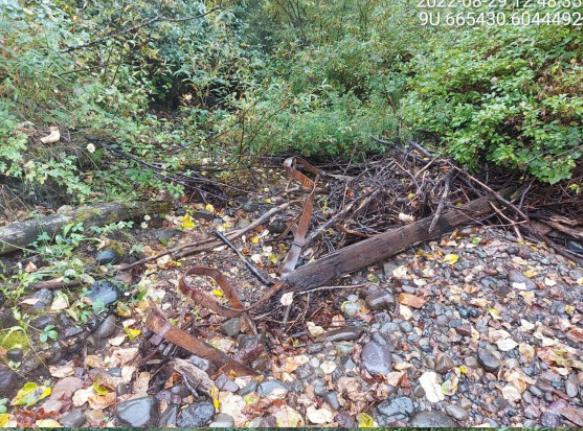
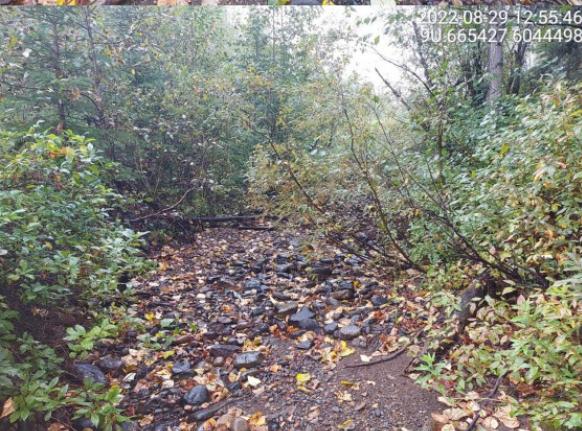
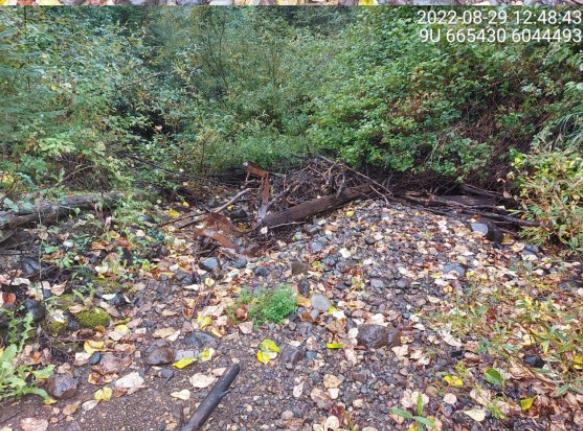
Location and Stream Data	•	Crossing Characteristics	-
Fix type	-	Fix Span / Diameter	-
Comments: No crossing. Transmission line. 12:49			
Photos: From top left clockwise: Road/Site Card, Barrel, Outlet, Downstream, Upstream, Inlet.

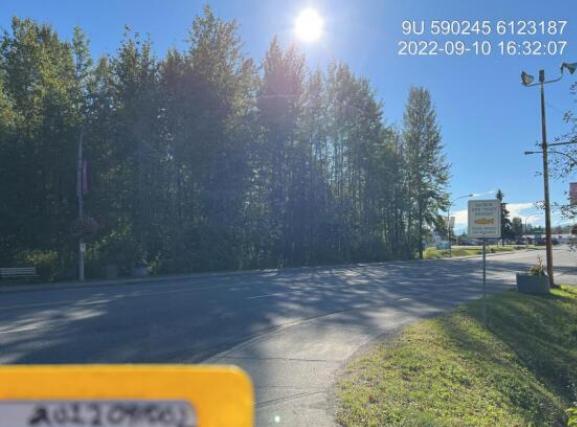
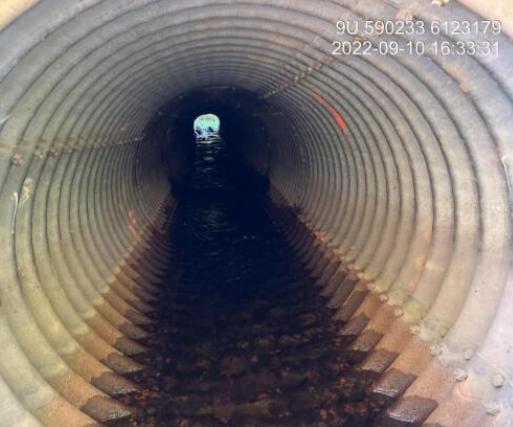
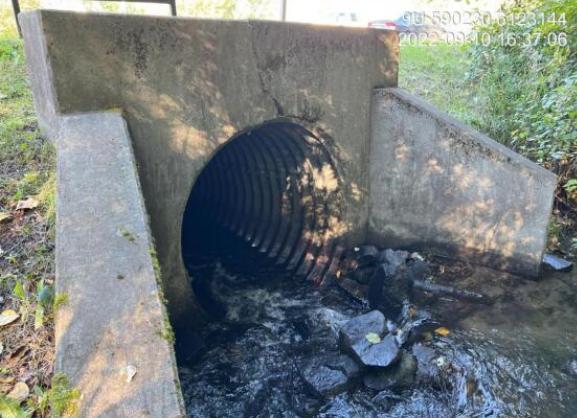
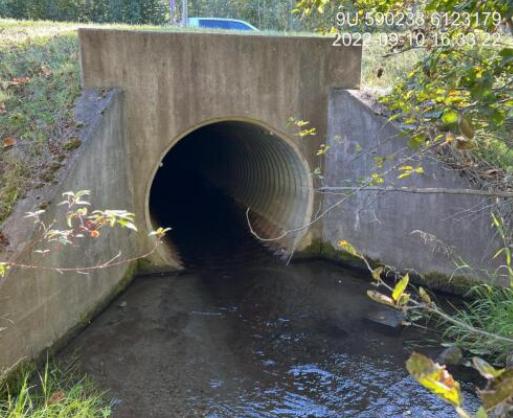
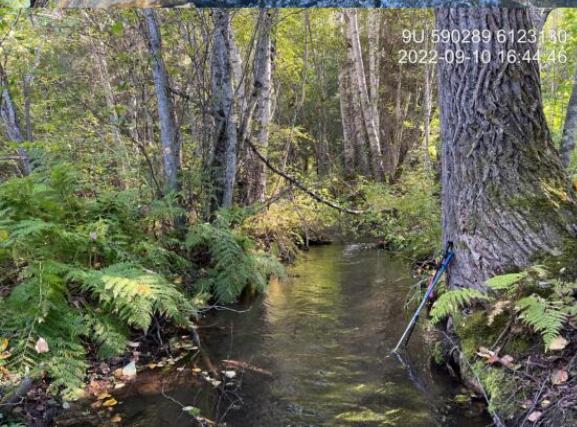
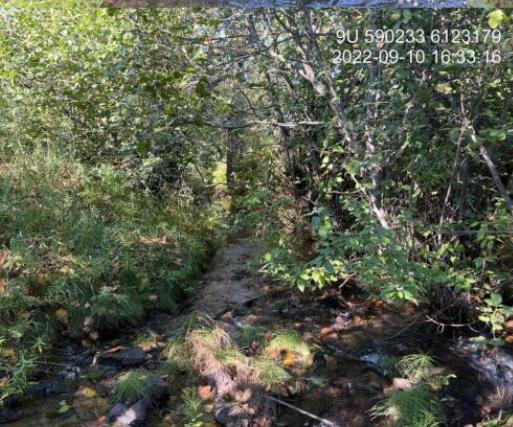
Location and Stream Data	•	Crossing Characteristics	-
<p>Comments: Stream is not mapped correctly in the freshwater atlas as it actually flows in a north direction through town. Great flow, patches of gravel suitable for cohost Bonnie. Right within the town of New Hazelton. Trap and truck coho operation occurring with spawners transplanted upstream of the railway and 14th avenue. 16:34</p>			
<p>Photos: From top left clockwise: Road/Site Card, Barrel, Outlet, Downstream, Upstream, Inlet.</p>

Should restoration/maintenance activities proceed, replacement of PSCIS crossing 198116 with a bridge (10m span) is recommended. The cost of the work is estimated at \$7,500,000 for a cost benefit of NA linear m/\$1000 and NA m²/\$1000.

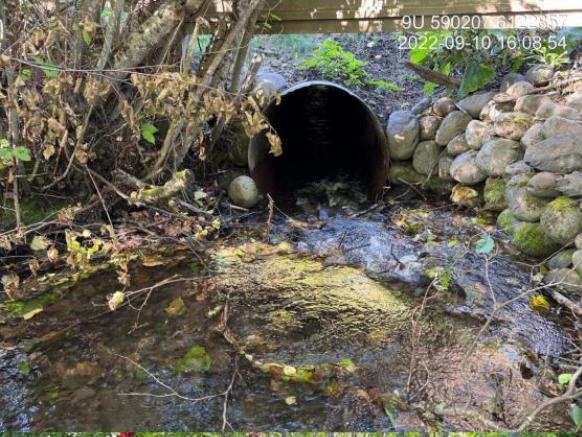
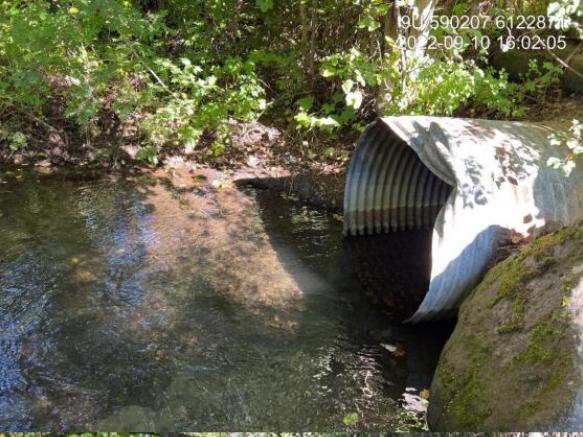
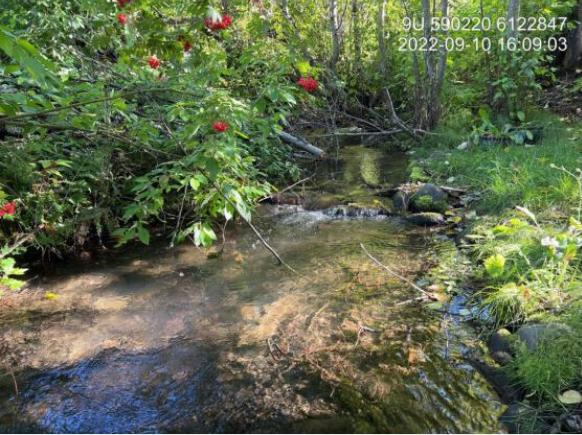
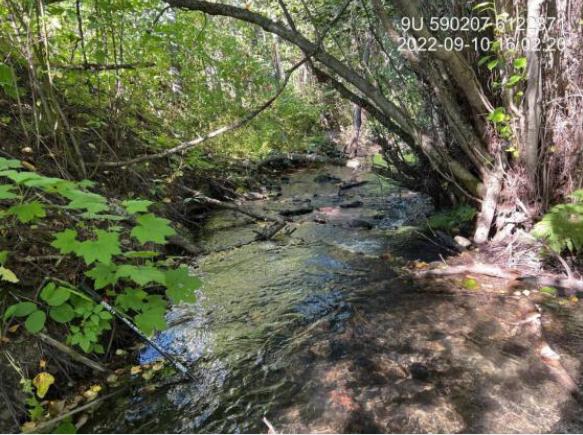
Location and Stream Data	•	Crossing Characteristics	-
Comments: This is waterfall Creek. It does not show up in the freshwater atlas as here, however this is the main flow. Numerous fry and parr observed upstream of the crossing. No paper card for site. 16:03			
Photos: From top left clockwise: Road/Site Card, Barrel, Outlet, Downstream, Upstream, Inlet.

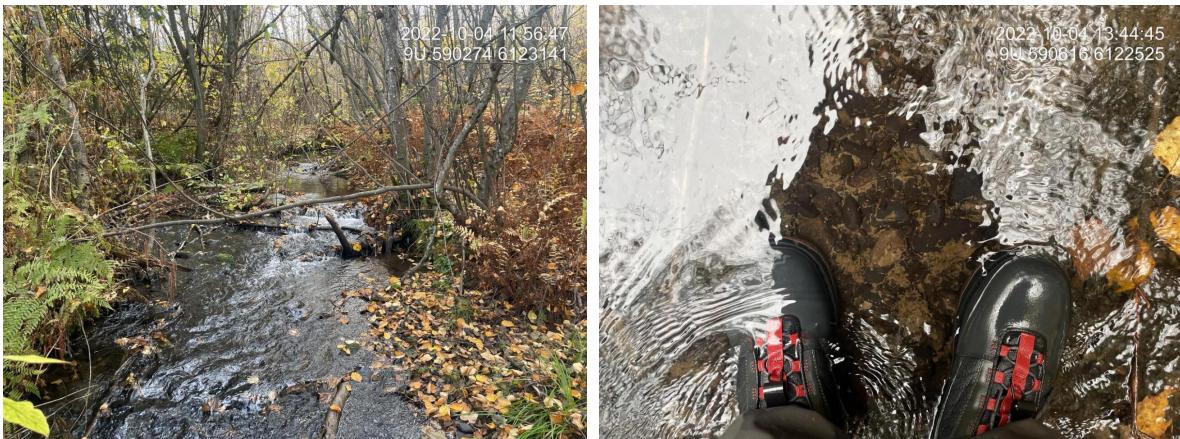
Figure 5.14: Left: Typical habitat upstream of PSCIS crossing 198116. Right: Gravel and cobble substrate immediately downstream of waterfall, upstream of PSCIS crossing 198115.

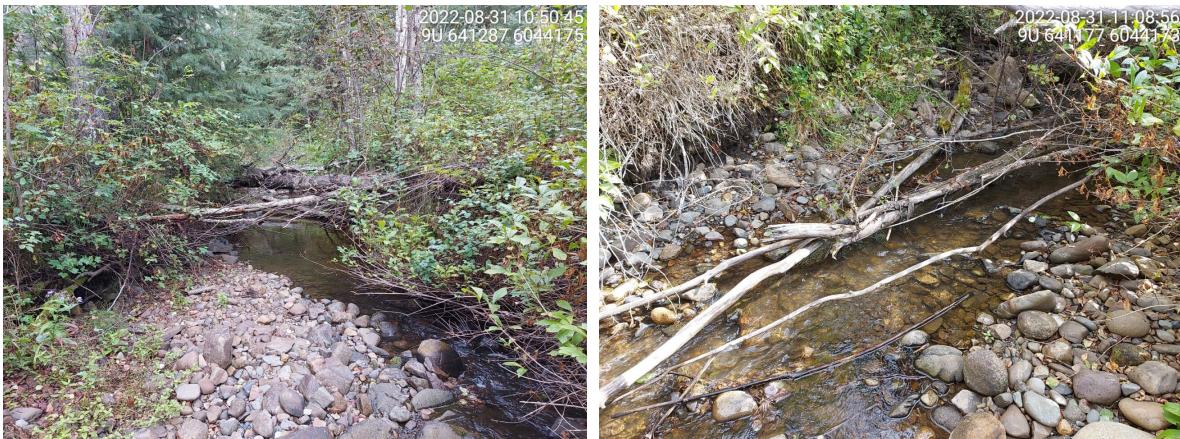
Figure 5.15: Left: Typical habitat downstream of PSCIS crossing 57793. Right: Typical habitat downstream of PSCIS crossing 57793.

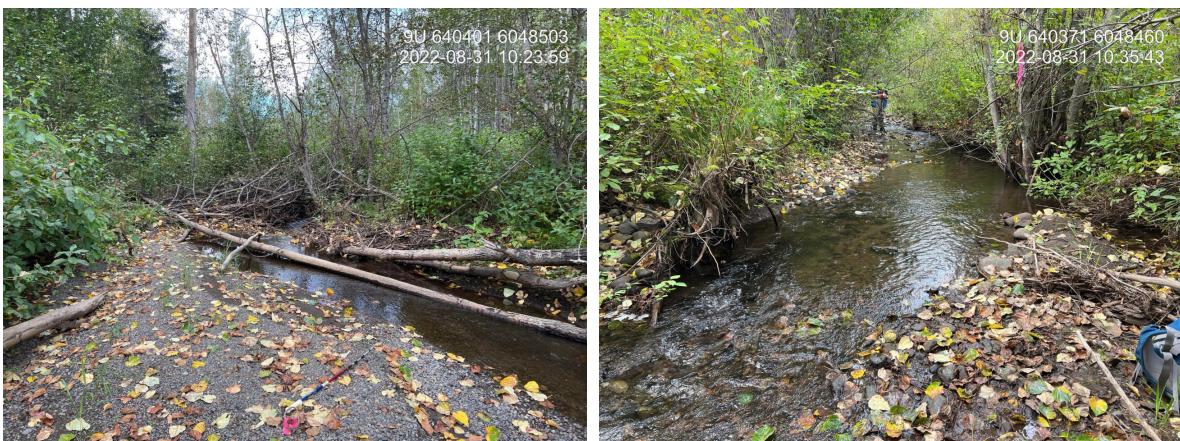
Figure 5.16: Left: Typical habitat upstream of PSCIS crossing 57793. Right: Typical habitat upstream of PSCIS crossing 57793.

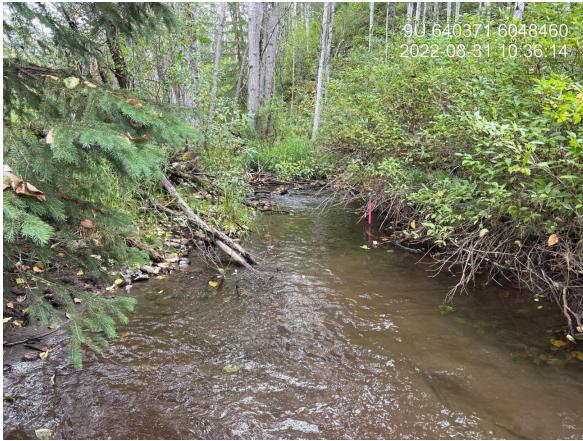
Figure 5.17: Left: Typical habitat upstream of PSCIS crossing 57793. Right: Typical habitat upstream of PSCIS crossing 57793.

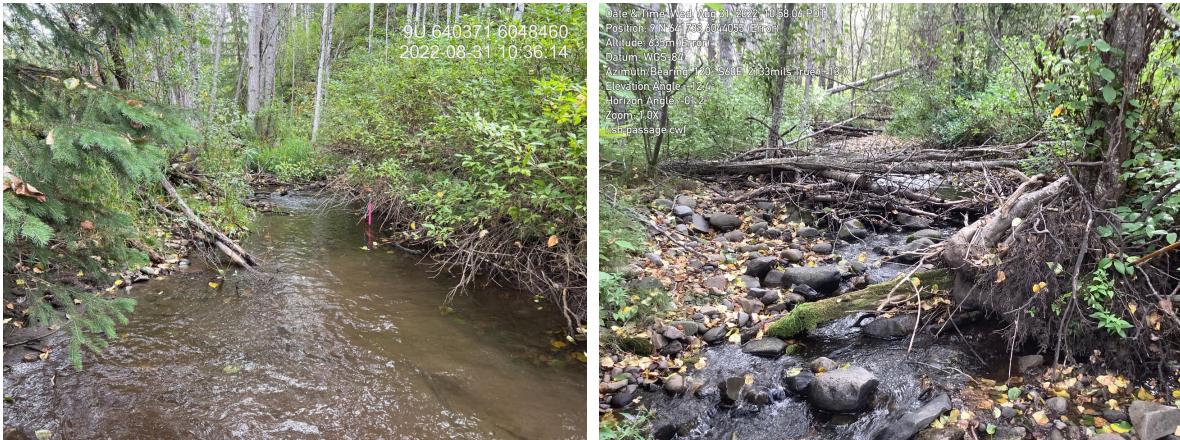
Figure 5.18: Left: Typical habitat upstream of PSCIS crossing 57793. Right: Habitat upstream of PSCIS crossing 57793.

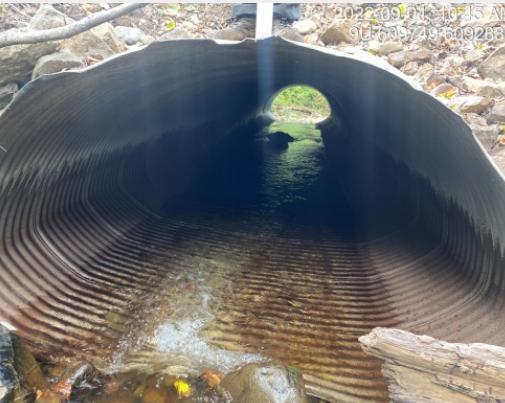
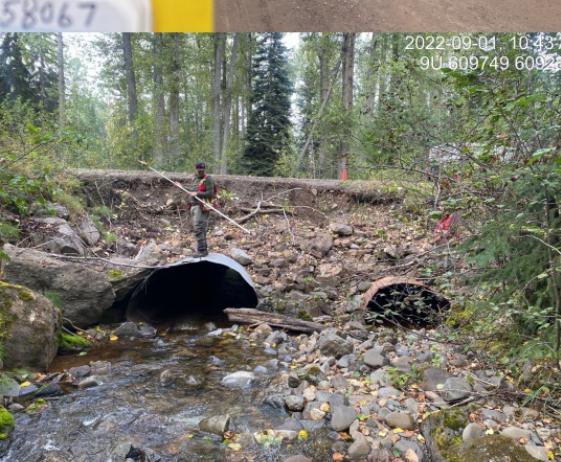
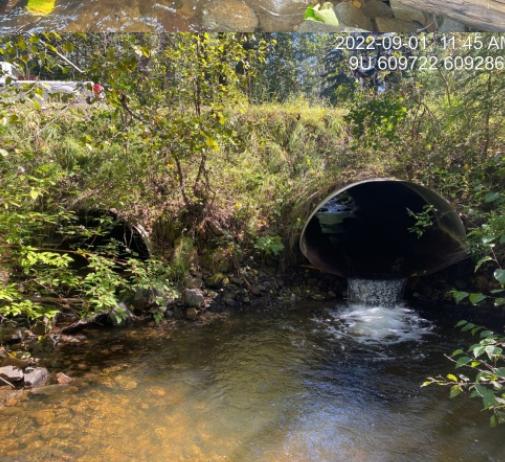
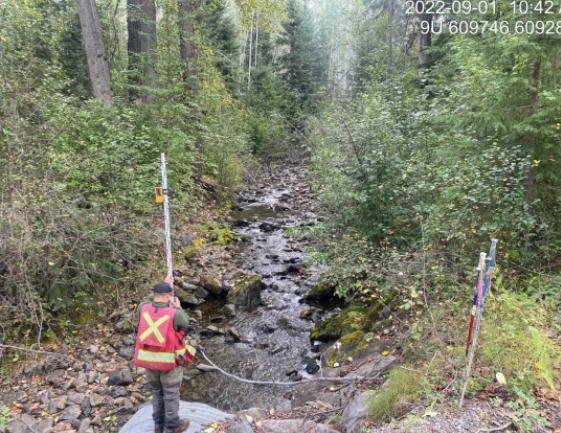
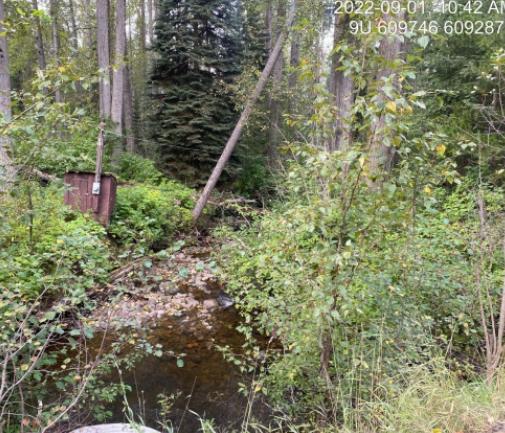
At the time of the survey, PSCIS crossing 58067 was un-embedded, non-backwatered, had an outlet drop of 0.49m and ranked as a barrier to upstream fish passage according to the provincial protocol (MoE 2011b) (Table 5.27). The crossing consisted of two pipes, with a very big outlet pool indicating the crossing was undersized. The pipes were noted as in poor condition due to corrosion and the road prism at the site had indications of significant erosion adjacent to the crossing. Water temperature was 12°C, pH was 8.2 and conductivity was 93uS/cm.

Location and Stream Data	•	Crossing Characteristics	-
Comments: Gradient of culvert shot with laser level. Inside of pipe is bent downward at the outlet. Upstream side of the road is eroding. Enormous outlet pool indicates pricing is undersized. Water flowing under overflow. Just outside of Whitsett community. Seems like a really good candidate for replacement. 10:26			
Photos: From top left clockwise: Road/Site Card, Barrel, Outlet, Downstream, Upstream, Inlet.

Should restoration/maintenance activities proceed, replacement of PSCIS crossing 58067 with a bridge (11.5m span) is recommended. The cost of the work is estimated at \$1,150,000 for a cost benefit of 12.2 linear m/\$1000 and 40.2 m²/\$1000.
