## Bulkley Watershed Fish Passage Restoration Planning 2022

Prepared for  
Canadian Wildlife Federation  
Habitat Conservation Trust Foundation - CAT23-6-288  
BC Fish Passage Remediation Program  
Ministry of Transportation and Infrastructure

Prepared by  
Al Irvine, B.Sc., R.P.Bio. and Mateo Wintersheidt, B.Sc.  
New Graph Environment Ltd.  
on behalf of  
Society for Ecosystem Restoration in Northern British Columbia

Version 0.1.3 DRAFT 2023-03-01

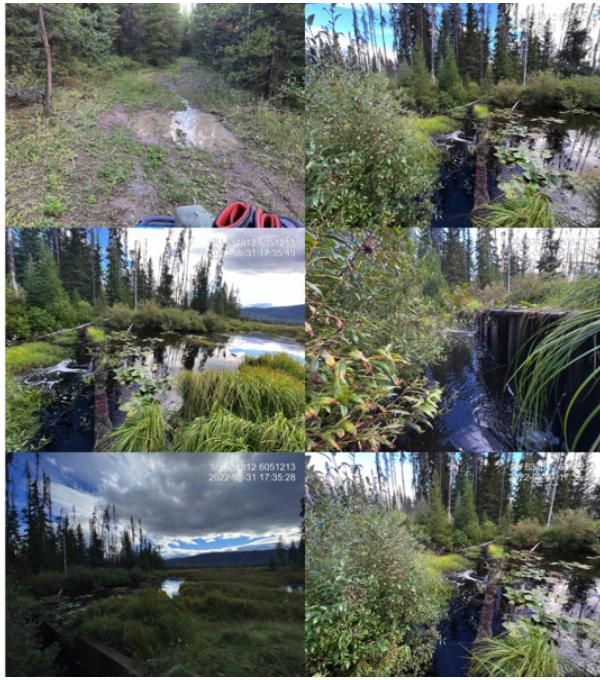
Site	Stream	Easting	Northing	Mapsheet	Barrier	Notes
1f365462-063c-491e-9fb3-bfac004d9183	Coffin Creek	634763	6051171	093L.113	T	Aerial imagery aquired. Complete barrier. 1.2m high steel structure within wetland complex downstream of Coffin Lake. Extremely difficult access via all terrain vehicle due to muddy conditions
* UTM Zone 9

Figure 4.1: Photos of Dam 1f365462-063c-491e-9fb3-bfac004d9183 on Coffin Creek

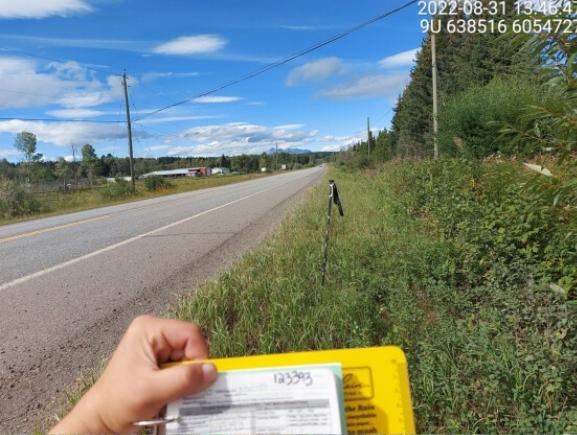
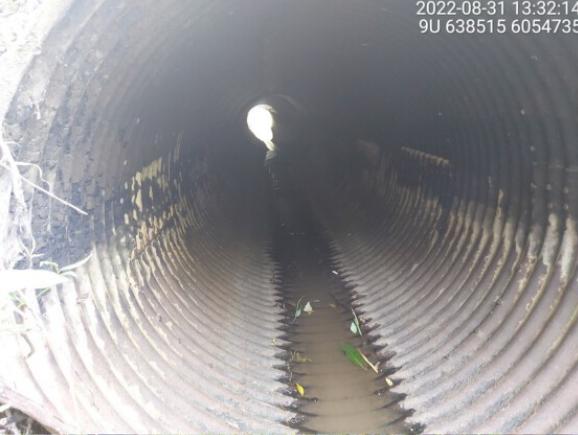
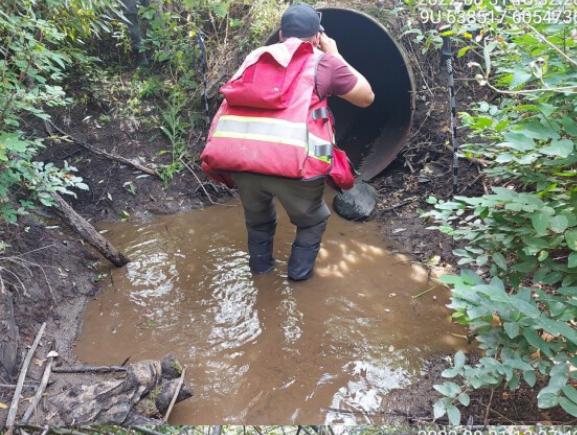
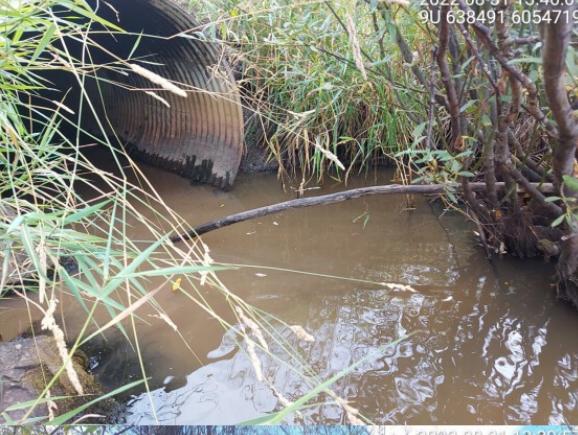
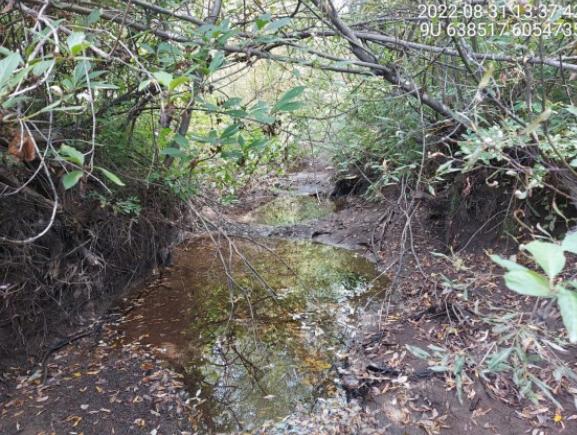
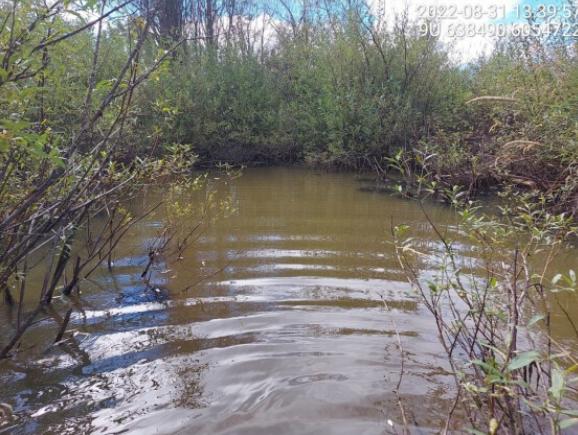
Location and Stream Data		Crossing Characteristics	
Date	2022-08-31	Crossing Sub Type	Round Culvert
PSCIS ID	123393	Diameter (m)	1.3
External ID	–	Length (m)	21
Crew	MW, TP, DN, AN	Embedded	No
UTM Zone	9	Depth Embedded (m)	–
Easting	638516	Resemble Channel	No
Northing	6054722	Backwatered	Yes
Stream	Lemieux creek	Percent Backwatered	90
Road	Highway 16	Fill Depth (m)	1.5
Road Tenure	Moti	Outlet Drop (m)	0
Channel Width (m)	2.8	Outlet Pool Depth (m)	0.9
Stream Slope (%)	1.5	Inlet Drop	No
Beaver Activity	Yes	Slope (%)	1
Habitat Value	Low	Valley Fill	Deep Fill
Final score	24	Barrier Result	Barrier
Fix type	Replace with New Open Bottom Structure	Fix Span / Diameter	10

Location and Stream Data	•	Crossing Characteristics	-
Comments: Very deep outlet pool. Wetland downstream, beaver activity upstream. Almost fully backwatered, a little bit of flow through the culvert. 13:32			
Photos: PSCIS ID 123393. From top left clockwise: Road/Site Card, Barrel, Outlet, Downstream, Upstream, Inlet.

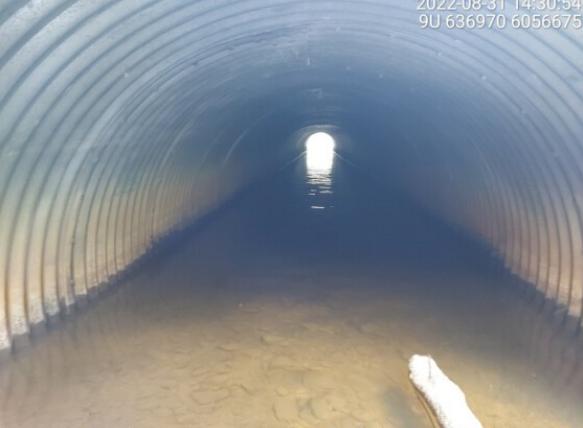
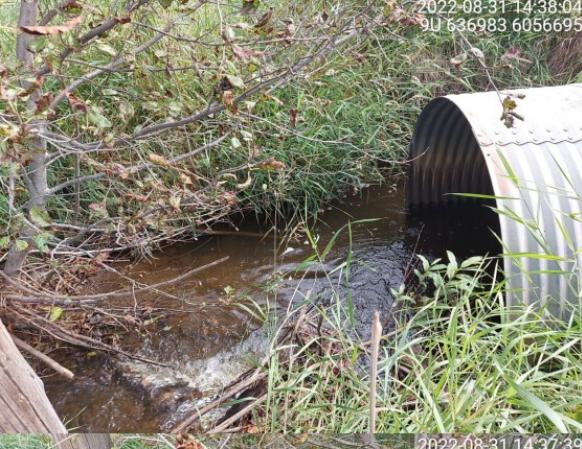
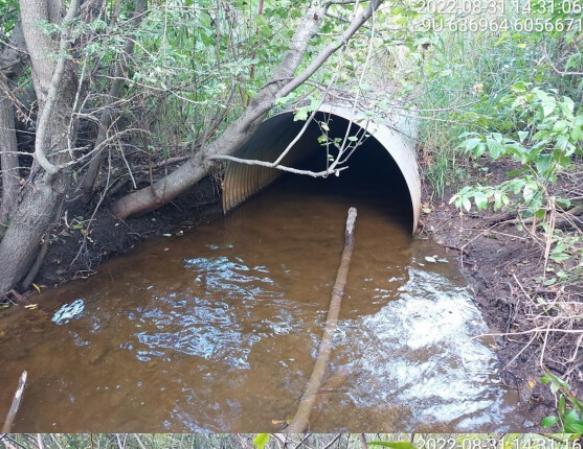
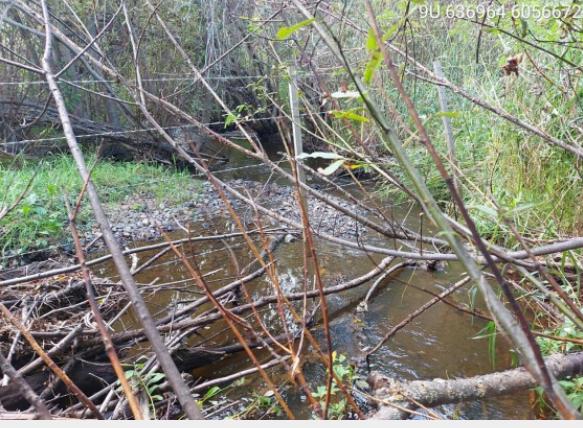
Location and Stream Data		Crossing Characteristics	
Date	2022-08-31	Crossing Sub Type	Round Culvert
PSCIS ID	123426	Diameter (m)	1.4
External ID	–	Length (m)	22
Crew	MW, TP, DN, AN	Embedded	Yes
UTM Zone	9	Depth Embedded (m)	0.2
Easting	636971	Resemble Channel	Yes
Northing	6056680	Backwatered	No
Stream	Robin Creek	Percent Backwatered	–
Road	Highway 16	Fill Depth (m)	2.2
Road Tenure	Moti	Outlet Drop (m)	0
Channel Width (m)	2.3	Outlet Pool Depth (m)	0.05
Stream Slope (%)	2	Inlet Drop	No
Beaver Activity	No	Slope (%)	1.5
Habitat Value	High	Valley Fill	Deep Fill
Final score	19	Barrier Result	Potential
Fix type	Replace with New Open Bottom Structure	Fix Span / Diameter	10

Location and Stream Data	•	Crossing Characteristics	-
Comments: Embedded culvert with high flow. 14:37			
Photos: PSCIS ID 123426. From top left clockwise: Road/Site Card, Barrel, Outlet, Downstream, Upstream, Inlet.

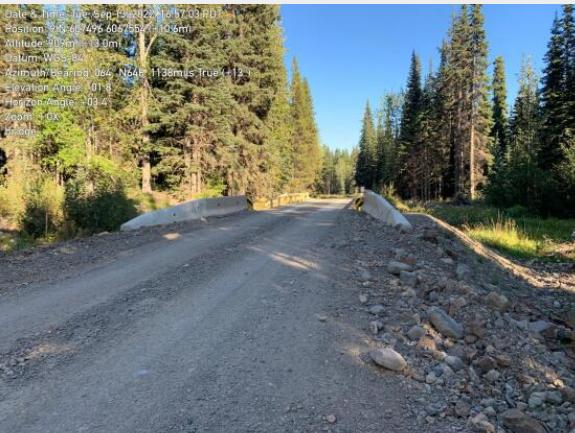
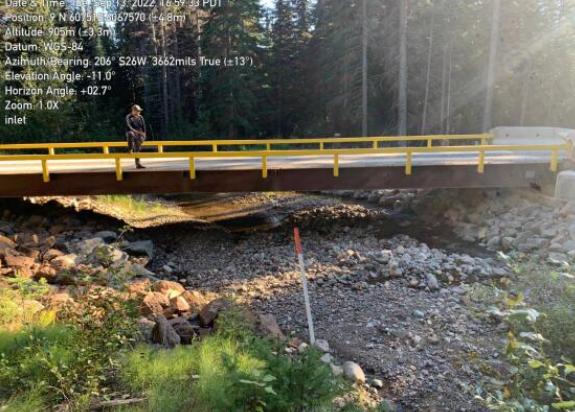
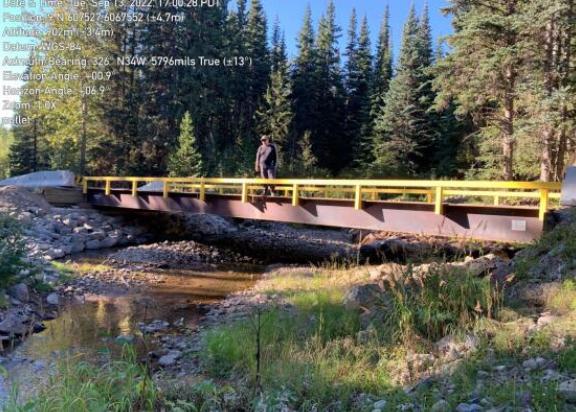
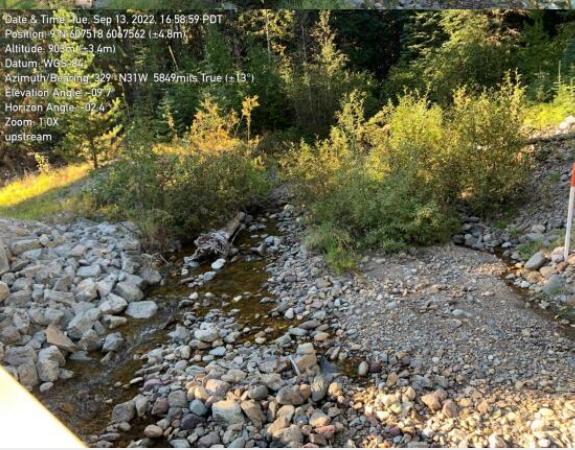
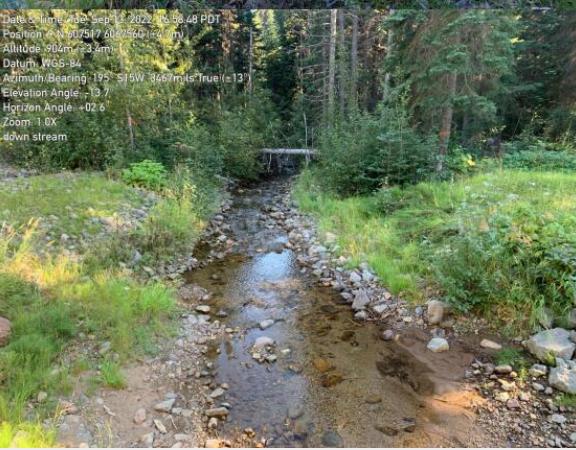
Location and Stream Data	•	Crossing Characteristics
Comments: New bridge, well built. Room on both banks for freshet melt. 16:57:00		
Photos: PSCIS ID 123750. From top left clockwise: Road/Site Card, Barrel, Outlet, Downstream, Upstream, Inlet.

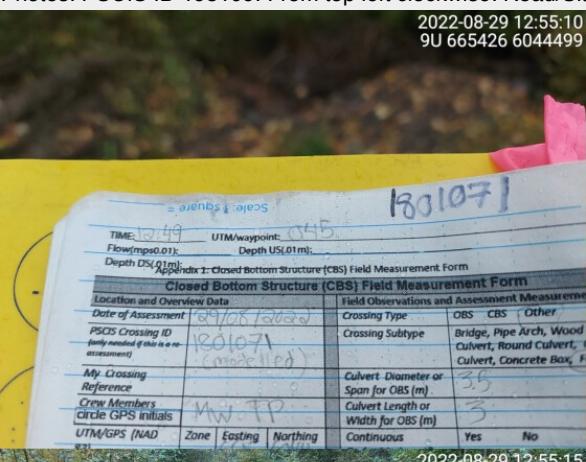
Location and Stream Data	•	Crossing Characteristics																																
Comments: No crossing. Transmission line. 12:49																																		
Photos: PSCIS ID 198109. From top left clockwise: Road/Site Card, Barrel, Outlet, Downstream, Upstream, Inlet.

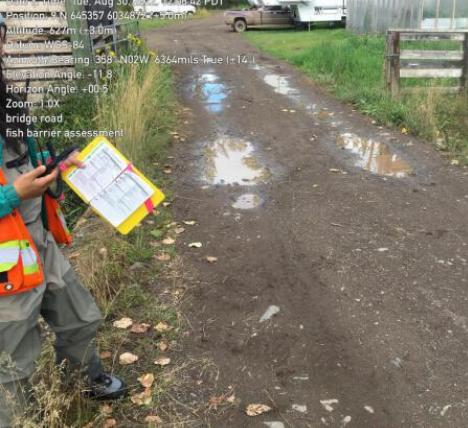
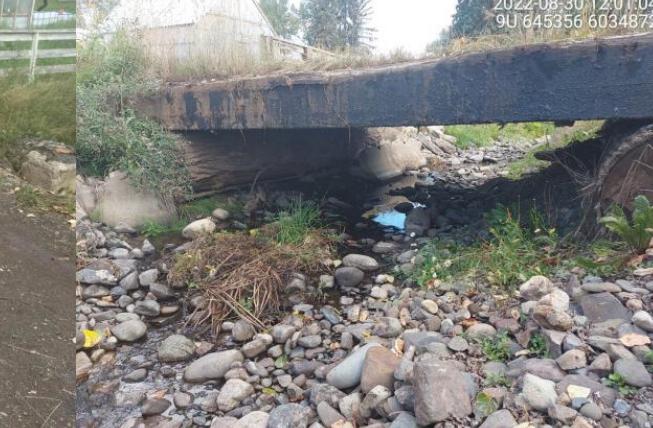
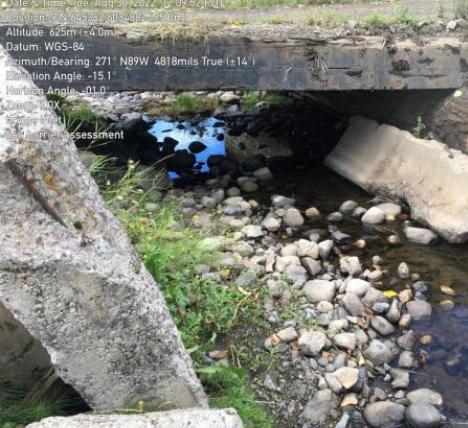
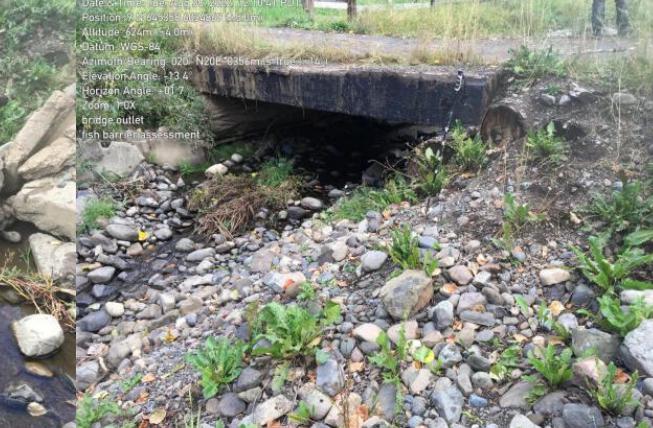
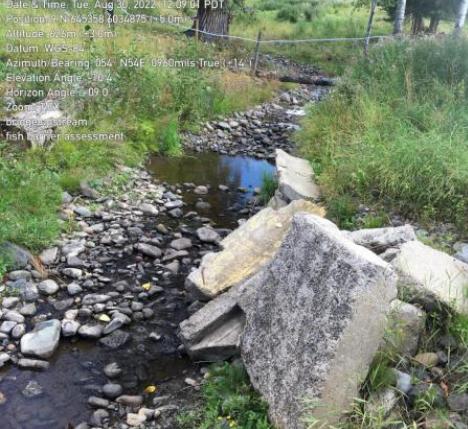
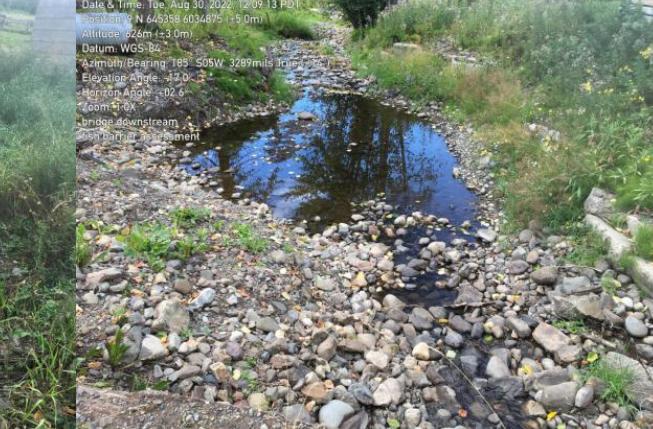
Location and Stream Data	Crossing Characteristics
Comments: Private property, farm bridge, concrete slabs on both banks upstream of culvert. 12:02	
Photos: PSCIS ID 198110. From top left clockwise: Road/Site Card, Barrel, Outlet, Downstream, Upstream, Inlet.	
<p>Date &amp; Time: Tue Aug 30, 2022 12:09:52 PDT  Position: N 64°33'57" 60°34'87" E 000  Altitude: 527m (+/-0m)  Datum: WGS-84  Azimuth/Bearing: 359° N02W 6364mils True (+14°)  Elevation Angle: -11.8°  Horizon Angle: +0.5°  Zoom: 10x  bridge road  fish barrier assessment</p>

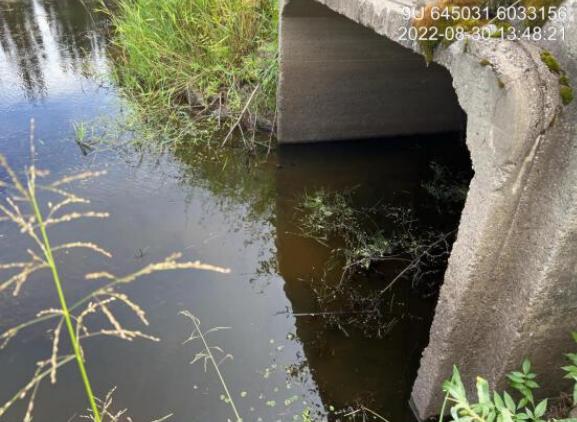
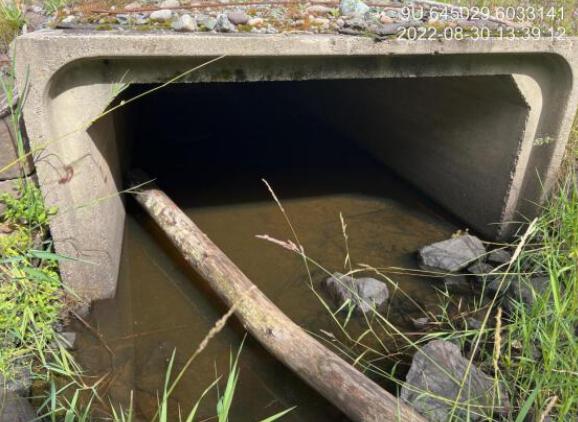
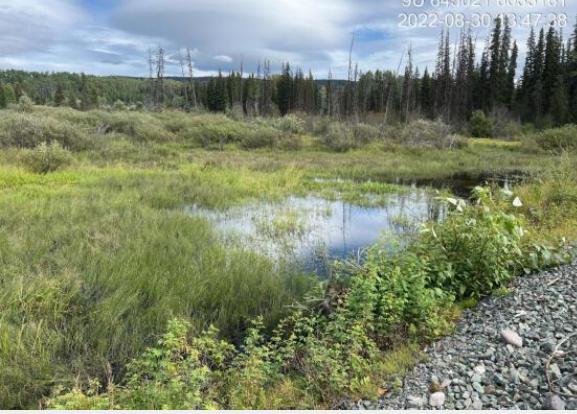
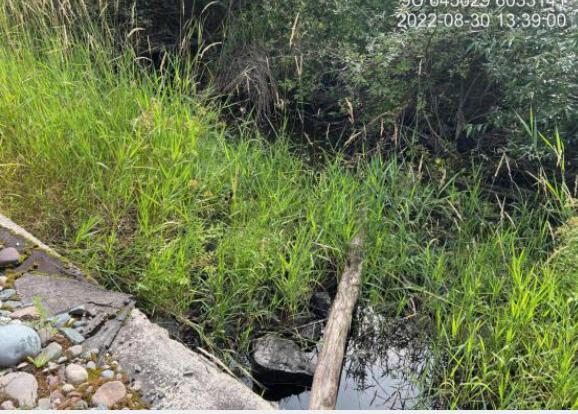
Location and Stream Data	•	Crossing Characteristics	-
Comments: Fully backwatered and embedded concrete box structure on the Railway. Not a fish passage issue at this time. 13:37			
Photos: PSCIS ID 198112. From top left clockwise: Road/Site Card, Barrel, Outlet, Downstream, Upstream, Inlet.

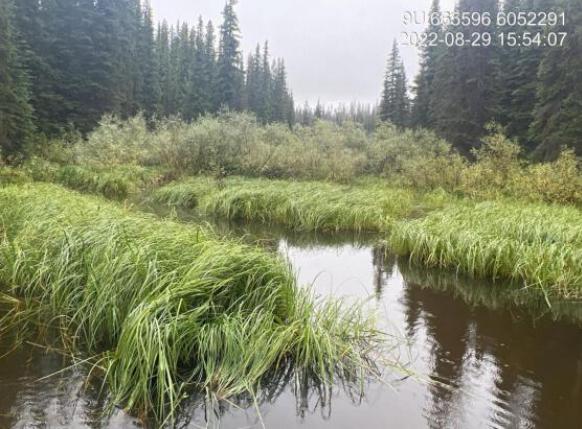
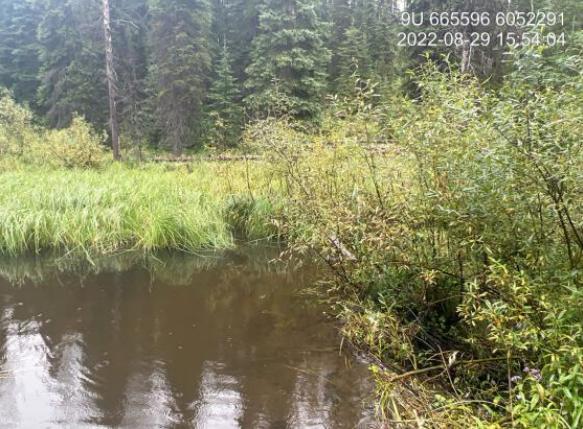
Location and Stream Data	•	Crossing Characteristics	-
Comments: Beaver dam in historic road location. 15:47			
Photos: PSCIS ID 198113. From top left clockwise: Road/Site Card, Barrel, Outlet, Downstream, Upstream, Inlet.

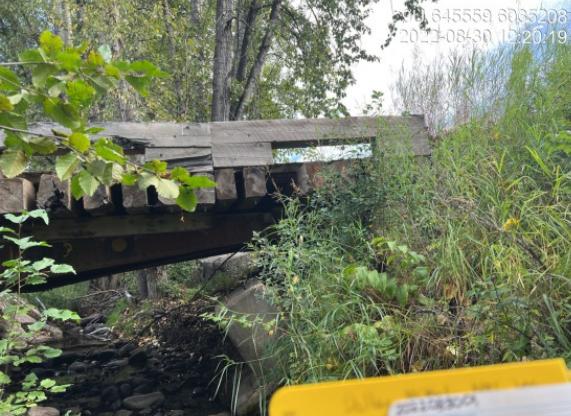
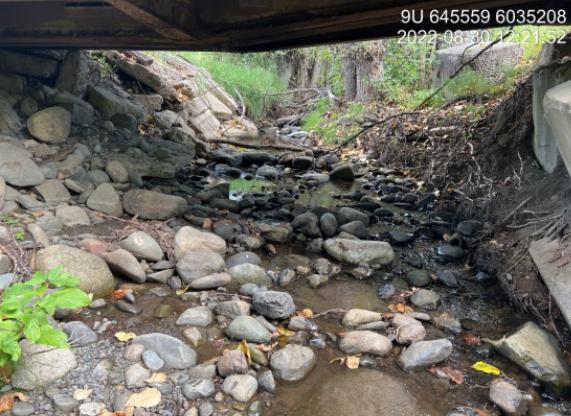
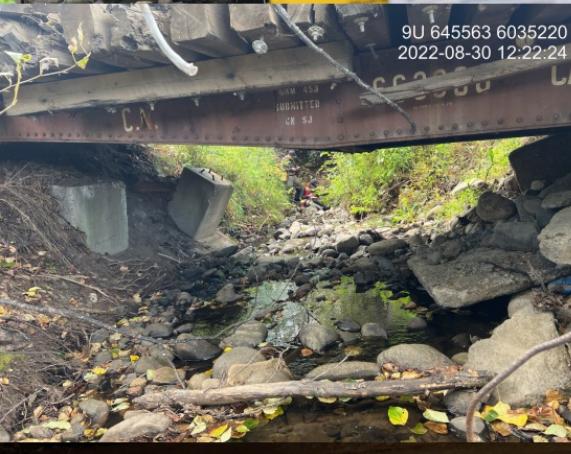
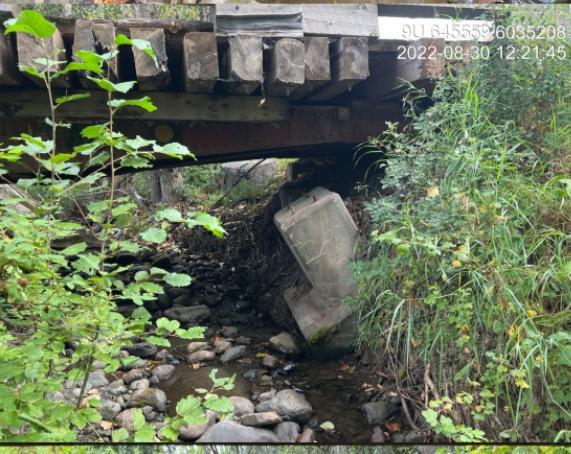
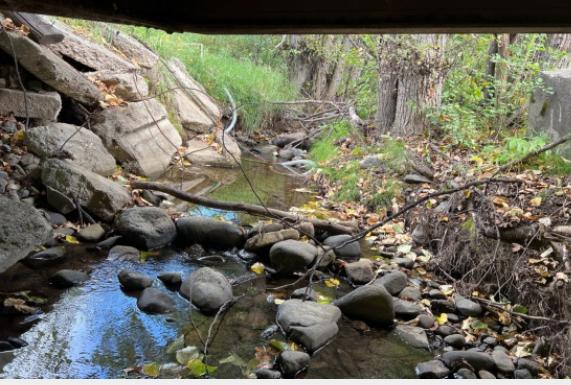
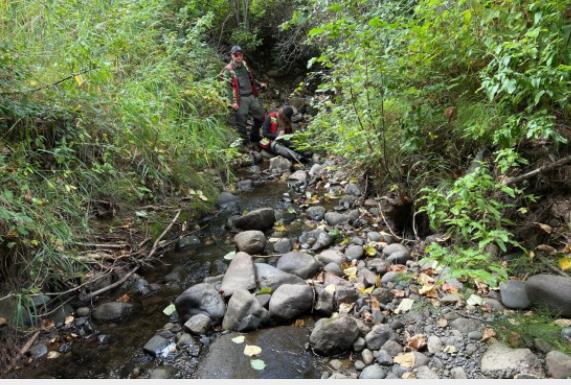
Location and Stream Data	•	Crossing Characteristics	-
Comments: Bridge is old CN railway metal structure and there is extensive concrete slabs in the stream used as rip rap. Private bridge within farmland. 12:20			
Photos: PSCIS ID 198114. From top left clockwise: Road/Site Card, Barrel, Outlet, Downstream, Upstream, Inlet.

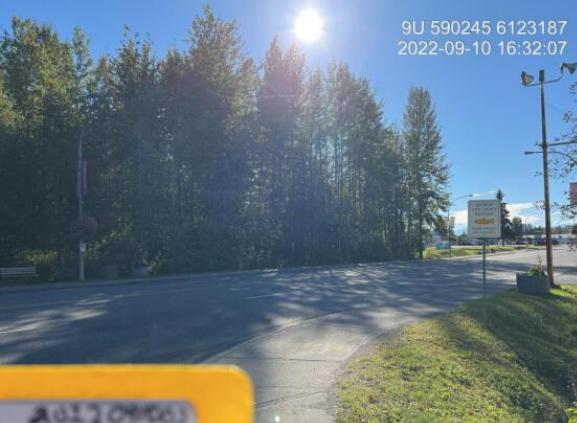
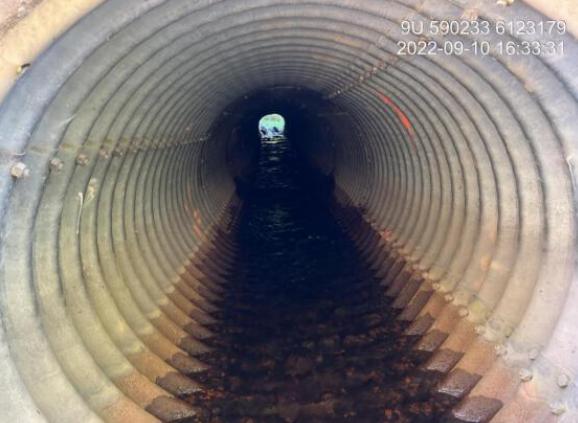
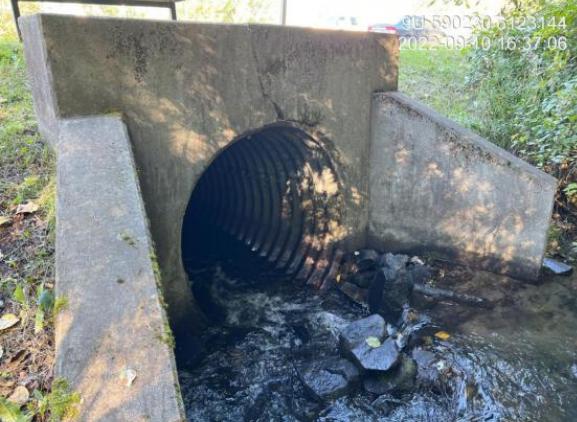
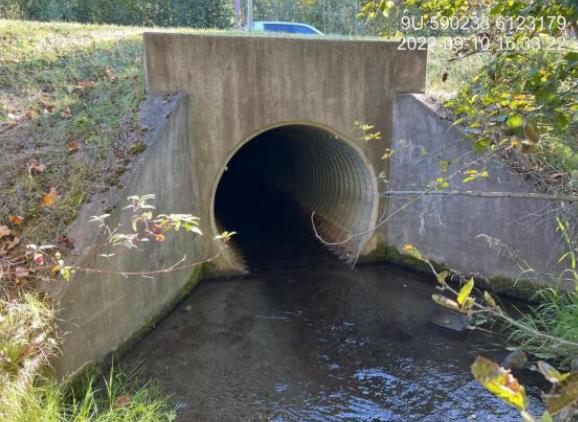
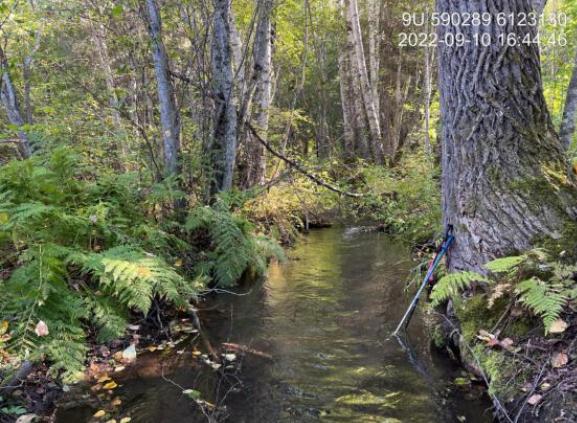
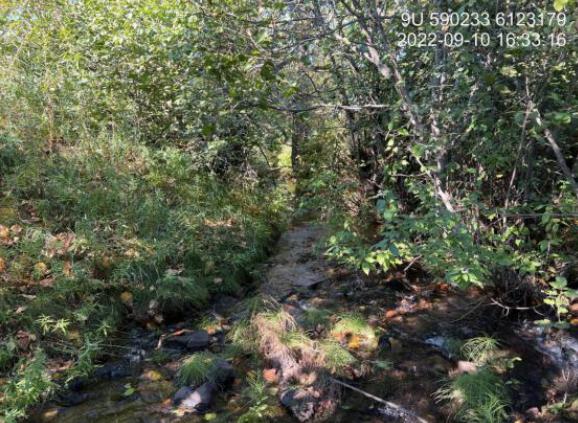
Location and Stream Data		Crossing Characteristics –	
Date	2022-09-10	Crossing Sub Type	Round Culvert
PSCIS ID	198116	Diameter (m)	1.5
External ID	2022091002	Length (m)	27
Crew	AI	Embedded	No
UTM Zone	9	Depth Embedded (m)	–
Easting	590233.2	Resemble Channel	No
Northing	6123183	Backwatered	No
Stream	Tributary to Waterfall Creek	Percent Backwatered	–
Road	Highway 16	Fill Depth (m)	1
Road Tenure	MoTi	Outlet Drop (m)	0
Channel Width (m)	3.9	Outlet Pool Depth (m)	0.2
Stream Slope (%)	2.5	Inlet Drop	Yes
Beaver Activity	No	Slope (%)	2.5
Habitat Value	High	Valley Fill	Deep Fill
Final score	24	Barrier Result	Barrier
Fix type	Replace with New Open Bottom Structure	Fix Span / Diameter	10

Location and Stream Data	Crossing Characteristics
Comments: Stream is not mapped correctly in the freshwater atlas. This is waterfall creek. Great flow, patches of gravel suitable for coho spawning. Right within the town of New Hazelton. Trap and truck coho operation conducted by Chicago Creek Restoration Society with spawners transplanted just downstream of the railway. 16:34	
Photos: PSCIS ID 198116. From top left clockwise: Road/Site Card, Barrel, Outlet, Downstream, Upstream, Inlet.

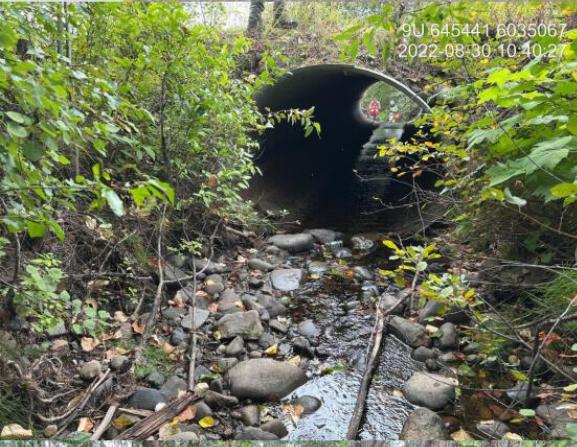
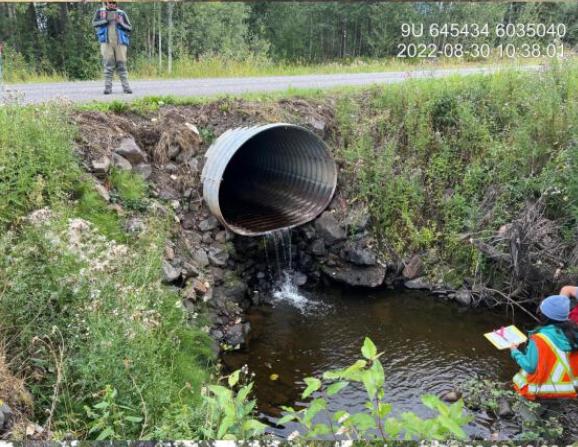
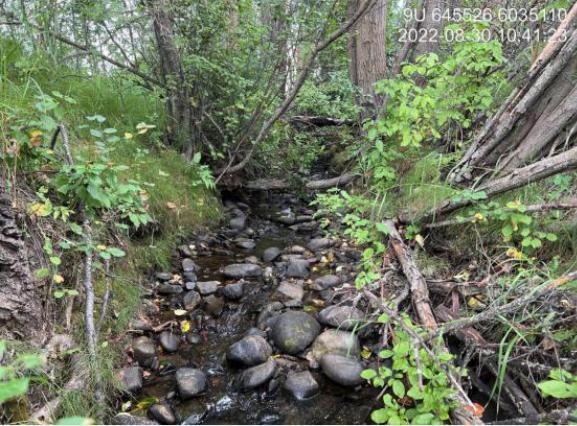
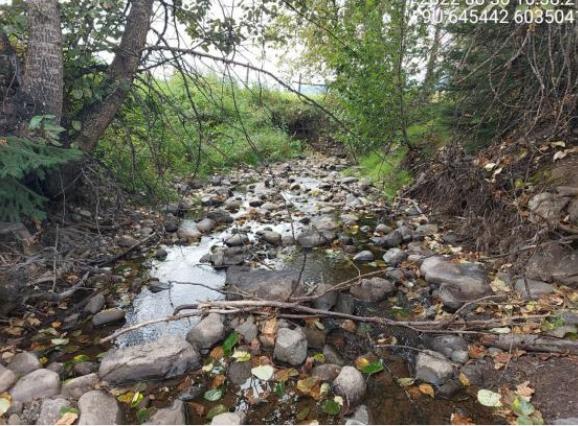
Location and Stream Data	•	Crossing Characteristics
Comments: Very large outlet drop, but creates nice pool for fish. Erosion on LB/RB on outlet side. Agricultural fields, minimal municipality population ds. Road is paved, detour available. 10:25		
Photos: From top left clockwise: Road/Site Card, Barrel, Outlet, Downstream, Upstream, Inlet.

Replacement of PSCIS crossing 195943 with a bridge (10m span) is recommended. The cost of the work was estimated at \$2,000,000 for a cost benefit of 370 linear m/\$1000 and 555 m<sup>2</sup>/\$1000.

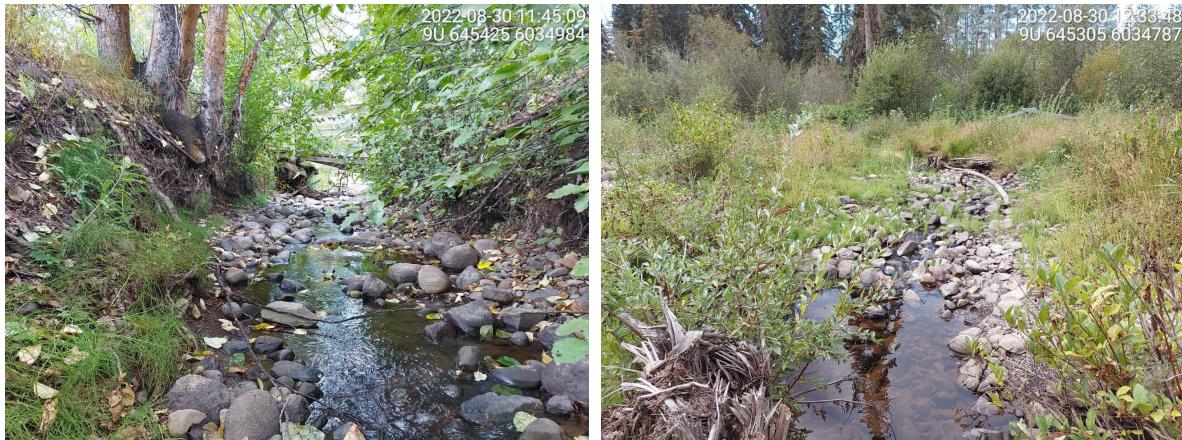
The stream was surveyed downstream from crossing 195943 for 300m (Figure 5.1). Total cover amount was rated as moderate with small woody debris dominant. Cover was also present as boulders. The average channel width was 3.8m, the average wetted width was 1.8m, and the average gradient was 2.7%. The dominant substrate was gravels with cobbles sub-dominant. A footbridge was present approximately 200m downstream with concrete slabs on both adjacent banks upstream. Multiple fish up to 10cm in length were observed in a pool near the bridge. The stream had minimal overhanging and riparian vegetation in the area surveyed due to adjacent agricultural use. Some areas of stream had pools formed by small dams likely built for livestock waterholes. The habitat was rated as medium value for salmonid rearing and spawning.

Figure 5.1: Left: Habitat downstream of PSCIS crossing 195943. Right: Habitat downstream of PSCIS crossing 195943.

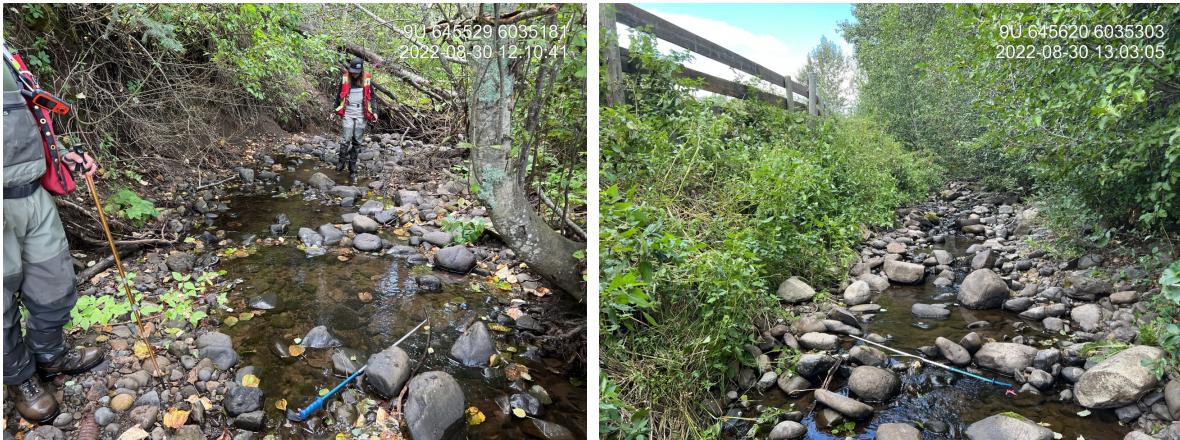
The stream was surveyed upstream from crossing 195943 for 330m (Figure 5.2). The dominant substrate was cobbles with boulders sub-dominant. Total cover amount was rated as abundant with boulders dominant. Cover was also present as undercut banks. The average channel width was 3.1m, the average wetted width was 1.8m, and the average gradient was 2.1%. Good flow volumes were noted along with a decent amount of complexity due to boulders and undercut banks. There were small pockets of gravel suitable for resident rainbow as well as coho and steelhead spawning. The channel appeared to be constricted with riparian vegetation removed on both sides of the stream, likely due to agricultural development. Irrigation pipes in the channel indicated water withdrawal was occurring. The habitat was rated as medium value as an important migration corridor containing suitable spawning habitat and having moderate rearing potential for juvenile coho, steelhead and other salmonids.

Figure 5.2: Left: Habitat upstream of PSCIS crossing 195943. Right: Habitat upstream of PSCIS crossing 195943.

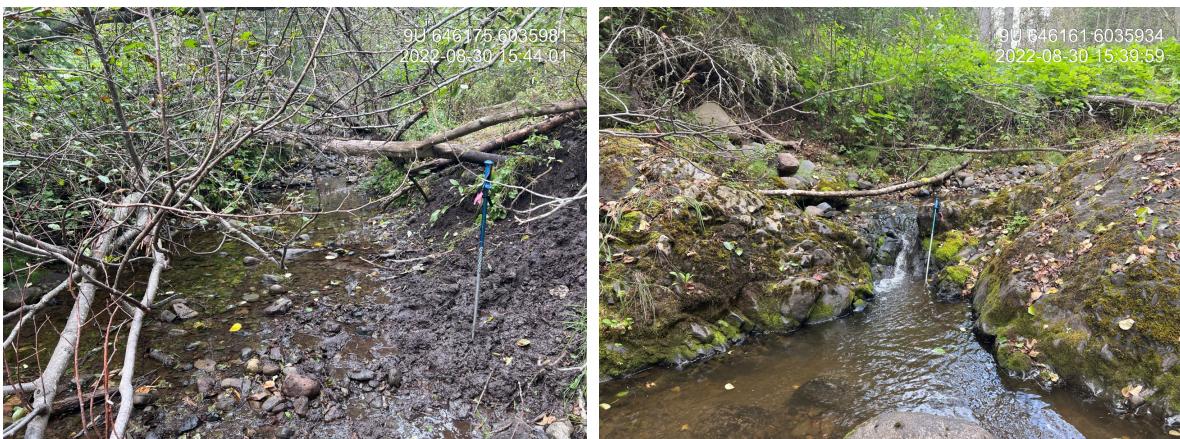
The stream was surveyed upstream from crossing 195944 for 640m (Figure 5.3). The average channel width was 4.2m, the average wetted width was 1.8m, and the average gradient was 2%. The dominant substrate was boulders with cobbles sub-dominant. Total cover amount was rated as moderate with boulders dominant. Cover was also present as small woody debris and undercut banks. Within the areas surveyed, the stream was noted as heavily impacted by cattle activity with significant amounts of manure in the stream, degraded/removed riparian vegetation and extensive areas of trampled banks. There were occasional pockets of gravel suitable for resident rainbow spawning. Field notes indicate, occasional pools with depths suitable for juvenile salmon and adult resident salmonid overwintering. A rock drop of 65cm was located 365m upstream of the top end of the culvert (Figure 5.3). This drop would likely be passable for adult salmonids but dependent on flow conditions, could prevent upstream migration for younger life stages of anadromous fish as well as non-adult resident species.

Figure 5.3: Left: Habitat upstream of PSCIS crossing 195944. Right: A 0.65m high rock drop located 365m upstream of PSCIS crossing 195944.

Replacement of PSCIS crossing 195944 with a bridge (10m span) will have significant costs (\$1,500,000) due to the length of the structure and depth of fill. A cost benefit is estimated 4786.7 linear m/\$1000 and 6222.7 m<sup>2</sup>/\$1000.

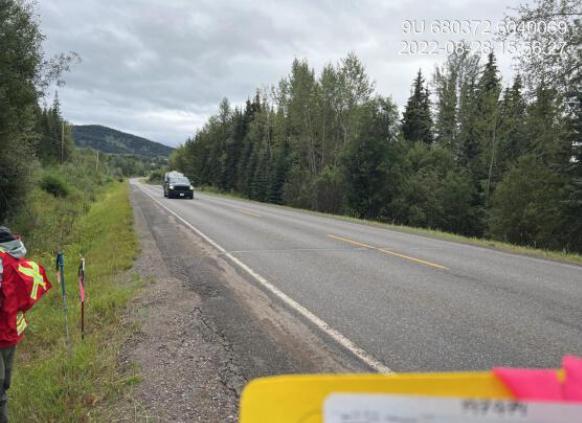
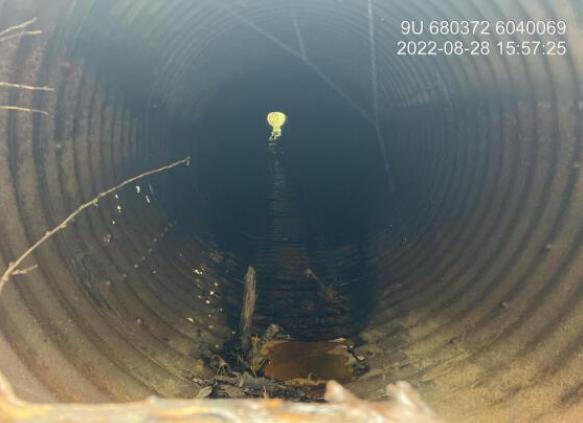
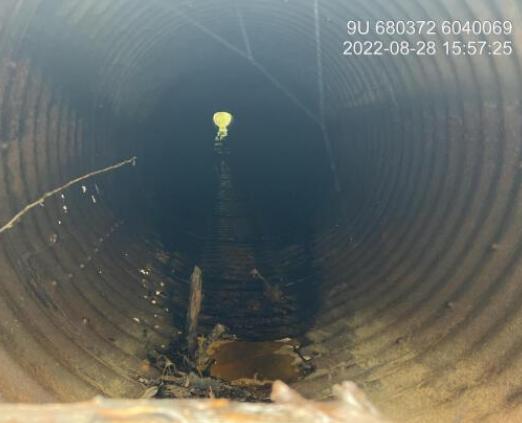
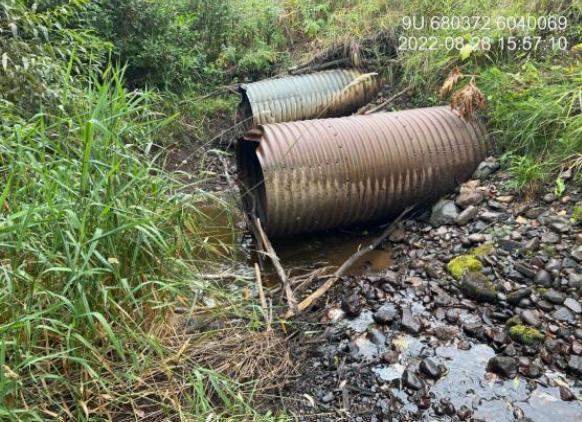
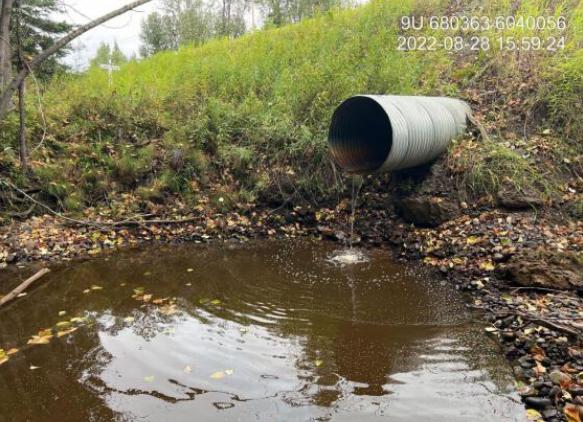
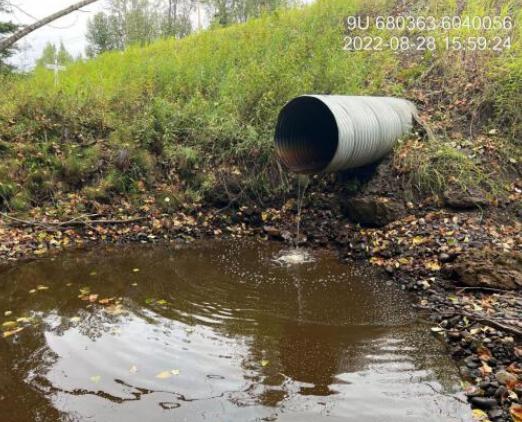
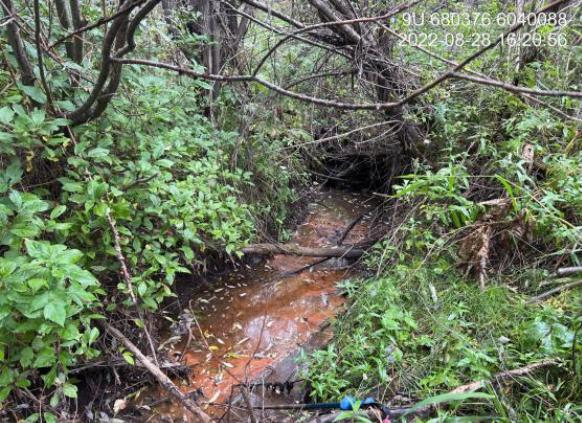
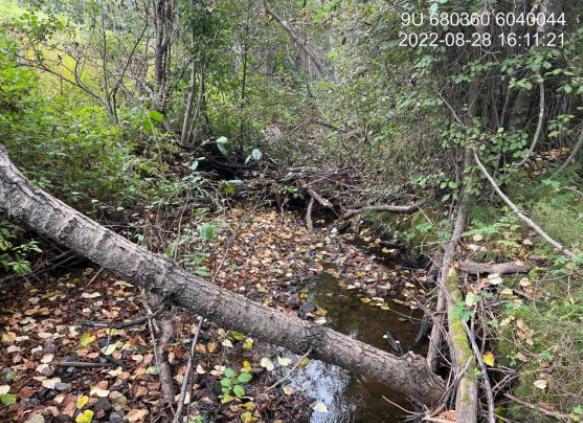
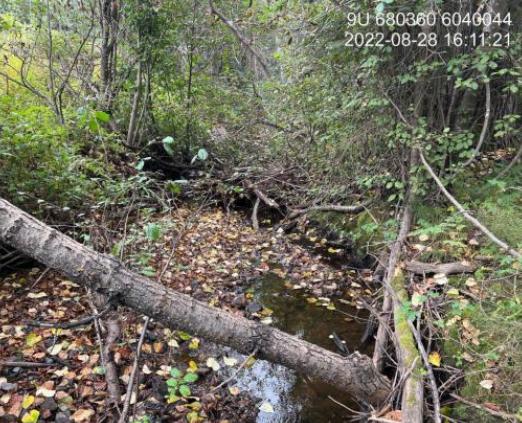
Location and Stream Data	•	Crossing Characteristics	-
Comments: Deep and large outlet pool indicate culvert is significantly undersized. Condition of the pipe is poor with corrosion and some collapsing in the middle of the pipe. 0.6m diameter overflow pipe located adjacent to the main culvert. Some decent gravels downstream. 15:52			
Photos: From top left clockwise: Road/Site Card, Barrel, Outlet, Downstream, Upstream, Inlet.

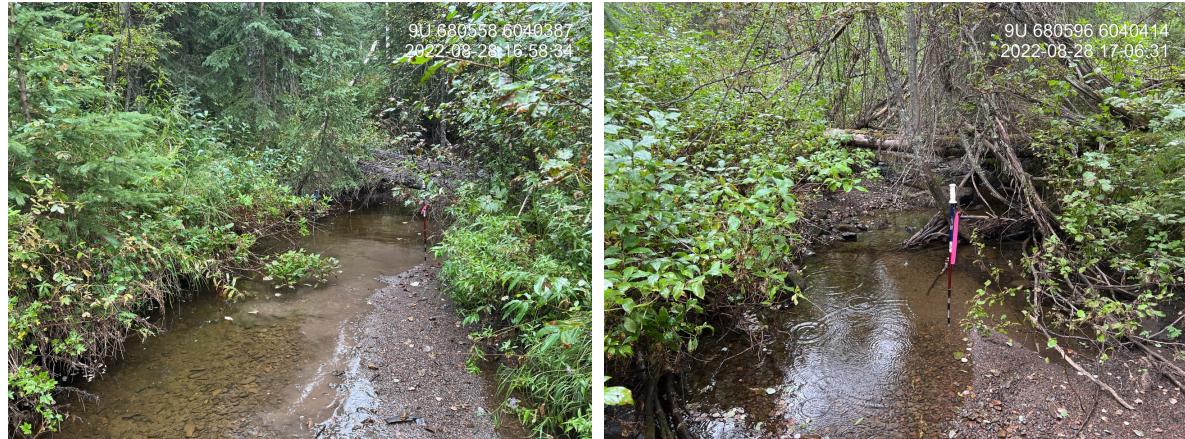
Figure 5.9: Left: Typical habitat upstream of PSCIS crossing 197974. Right: Typical habitat upstream of PSCIS crossing 197974.

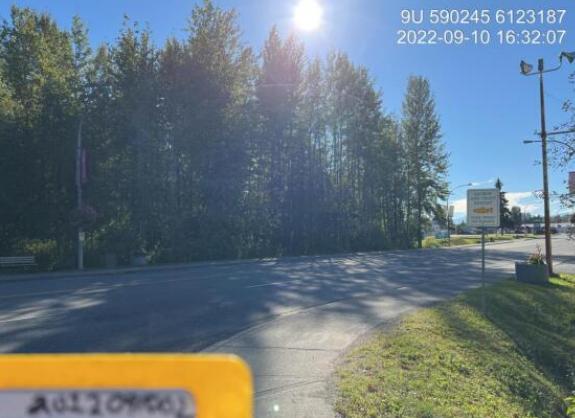
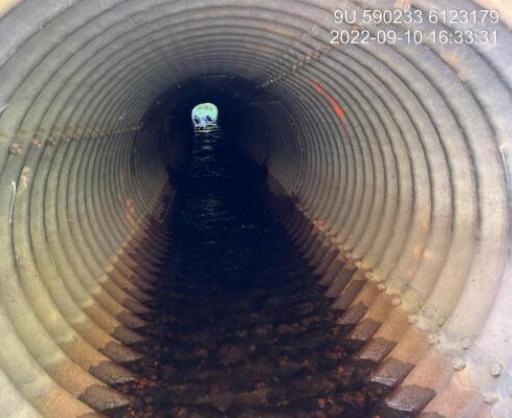
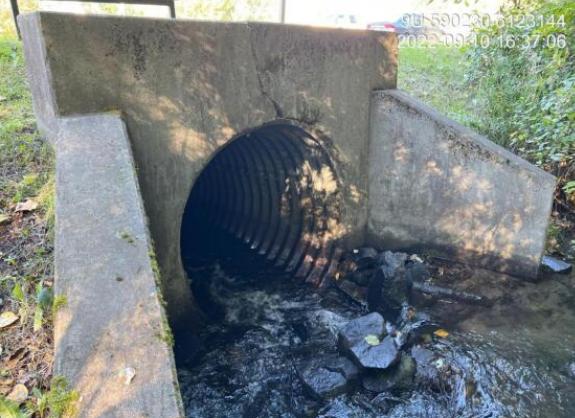
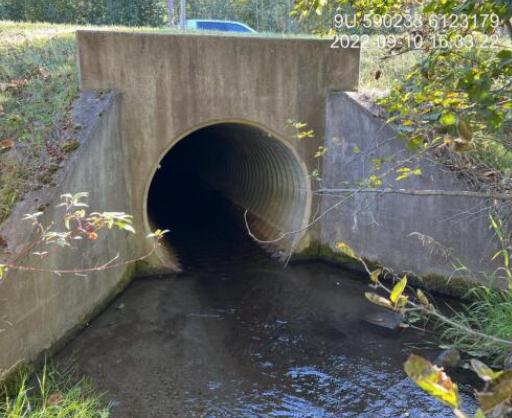
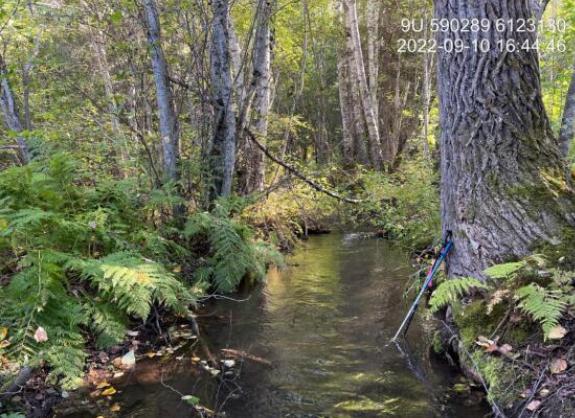
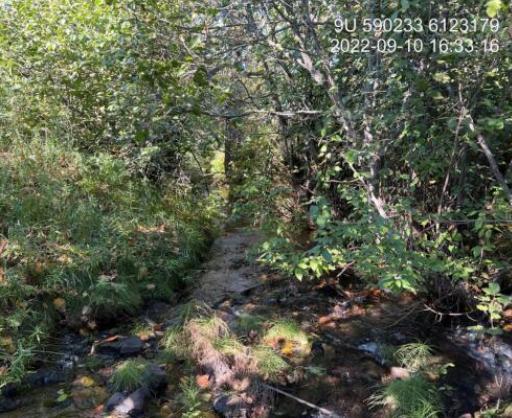
Location and Stream Data	•	Crossing Characteristics	-
<p>Comments: Stream is not mapped correctly in the freshwater atlas as it actually flows in a north direction through town. Great flow, patches of gravel suitable for coho spawning. Located right within the town of New Hazelton. Trap and truck coho operation occurring with spawners transplanted upstream of the railway and 14th avenue. 16:34</p>			
Photos: From top left clockwise: Road/Site Card, Barrel, Outlet, Downstream, Upstream, Inlet.

Should restoration/maintenance activities proceed, replacement of PSCIS crossing 198116 with a bridge (10m span) is recommended. The cost of the work is estimated at \$7,500,000 for a cost benefit of 160 linear m/\$1000 and 312 m<sup>2</sup>/\$1000.

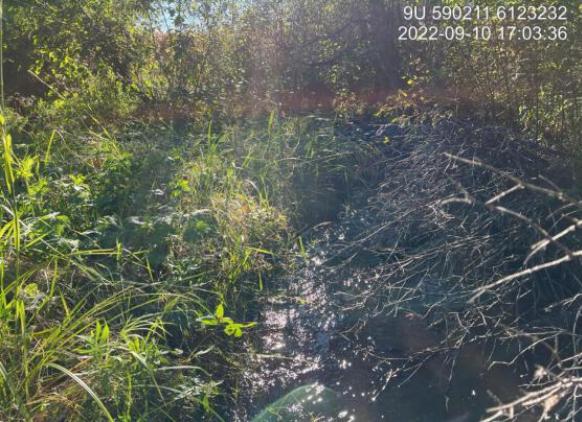
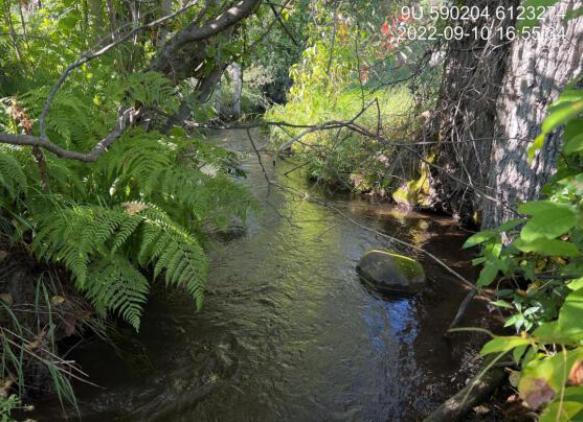
Location and Stream Data	•	Crossing Characteristics	-
Comments: Two 0.9 pipe added together for width. Left pipe has significant blockage 1/3 of the way through the pipe. Right Bank of the stream has an empty lot with only grass and invasive weed riparian. 16:52			
Photos: From top left clockwise: Road/Site Card, Barrel, Outlet, Downstream, Upstream, Inlet.

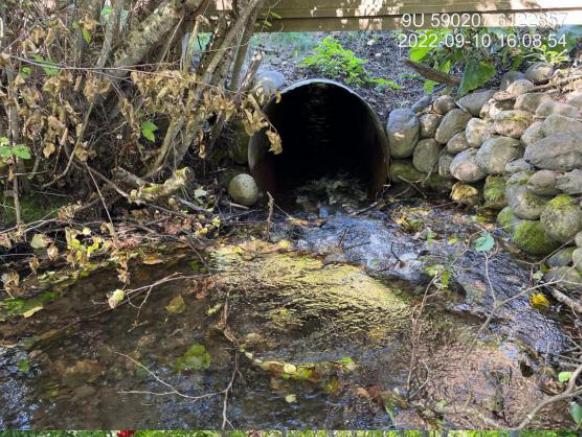
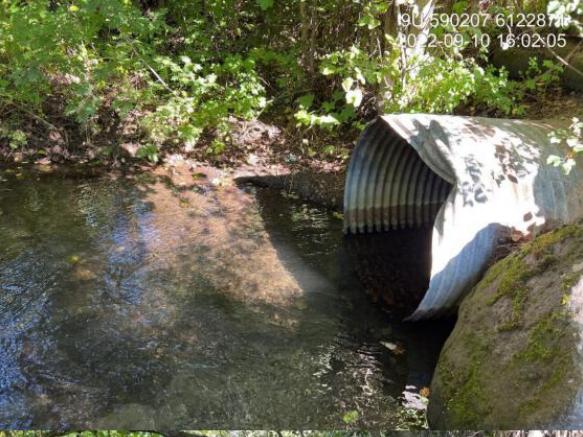
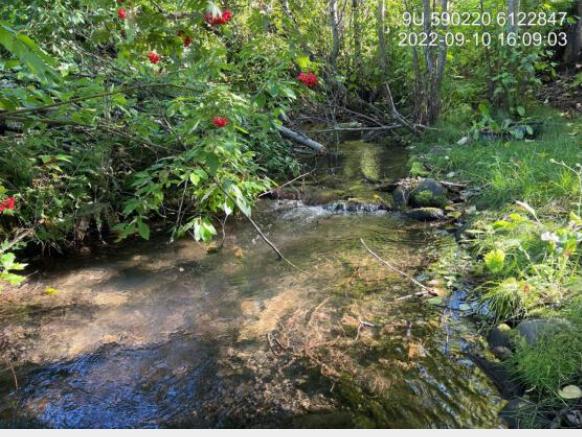
Location and Stream Data	•	Crossing Characteristics	-
Comments: This is waterfall Creek. It does not show up in the freshwater atlas as here, however this is the main flow. Numerous fry and parr observed upstream of the crossing. No paper card for site. 16:03			
Photos: From top left clockwise: Road/Site Card, Barrel, Outlet, Downstream, Upstream, Inlet.

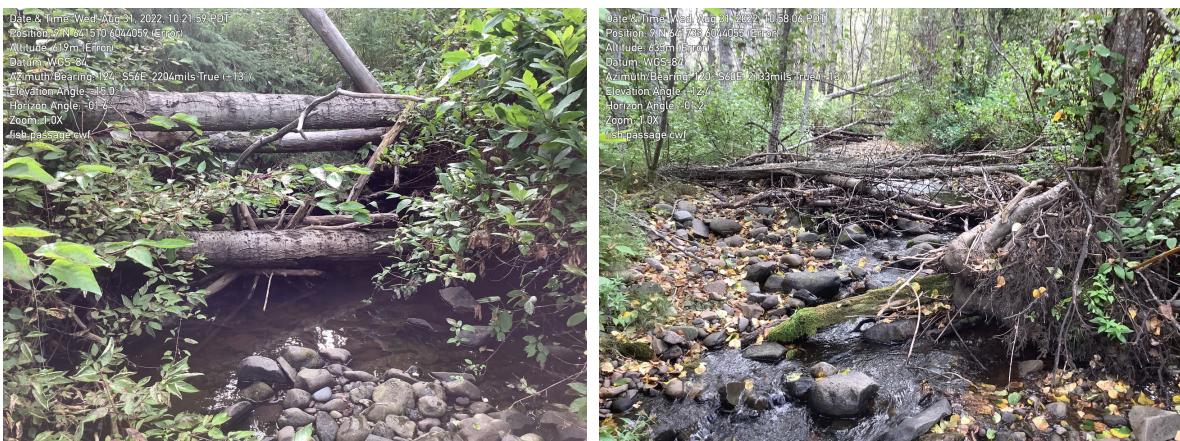
The stream was surveyed upstream from crossing 57793 for 600m (Figure 5.16). The average channel width was 4.1m, the average wetted width was 2m, and the average gradient was 2%. Total cover amount was rated as abundant with large woody debris dominant. Cover was also present as small woody debris, undercut banks, and overhanging vegetation. The dominant substrate was cobbles with gravels sub-dominant. The data for the upstream survey was misplaced and stream characteristics and measurements were obtained by reviewing photos. The habitat quality was excellent. There were abundant undercut banks and healthy mixed riparian vegetation throughout. The stream was wide and contained some pockets of gravel suitable for spawning resident species. The habitat was rated as high value as an important migration corridor containing suitable spawning habitat and having moderate rearing potential.

Figure 5.16: Left: Typical habitat upstream of PSCIS crossing 57793. Right: Typical habitat upstream of PSCIS crossing 57793.
