## Bulkley Watershed Fish Passage Restoration Planning 2022

Prepared for  
Canadian Wildlife Federation  
Habitat Conservation Trust Foundation - CAT23-6-288  
BC Fish Passage Remediation Program  
Ministry of Transportation and Infrastructure

Prepared by  
Al Irvine, B.Sc., R.P.Bio. and Mateo Wintersheidt, B.Sc.  
New Graph Environment Ltd.  
on behalf of  
Society for Ecosystem Restoration in Northern British Columbia

Version 0.1.3 DRAFT 2023-03-01

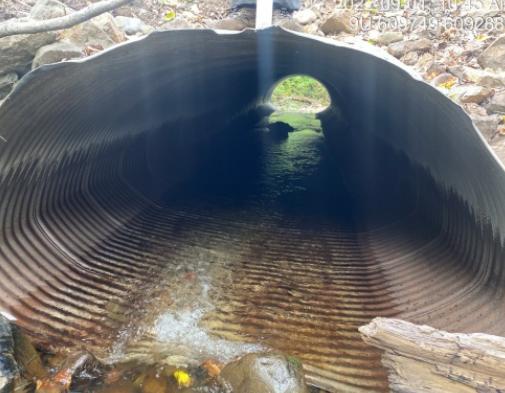
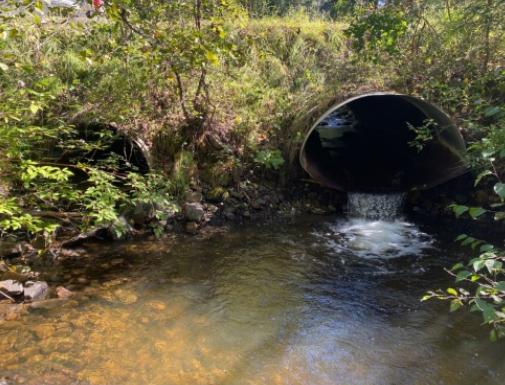
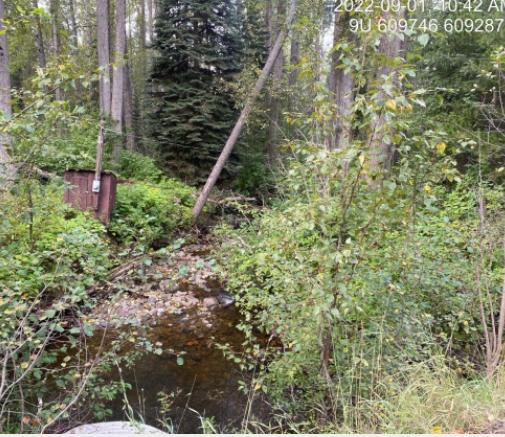
At the time of the survey, PSCIS crossing 58067 was un-embedded, non-backwatered, had an outlet drop of 0.49m and ranked as a barrier to upstream fish passage according to the provincial protocol (MoE 2011b) (Table 5.27). The crossing consisted of two pipes, with a very big outlet pool indicating the crossing was undersized. The pipes were noted as in poor condition due to corrosion and the road prism at the site had indications of significant erosion adjacent to the crossing. Water temperature was 12°C, pH was 8.2 and conductivity was 93uS/cm.

Location and Stream Data	•	Crossing Characteristics	-
<p>Comments: Gradient of culvert shot with laser level. Inside of pipe is bent downward at the outlet. Upstream side of the road is eroding. Enormous outlet pool indicates culvert is undersized. Water flowing under overflow. Just outside of Witset community. Seems like a really good candidate for replacement. 10:26</p>			
<p>Photos: From top left clockwise: Road/Site Card, Barrel, Outlet, Downstream, Upstream, Inlet.</p>

Should restoration/maintenance activities proceed, replacement of PSCIS crossing 58067 with a bridge (11.5m span) is recommended. The cost of the work is estimated at \$1,150,000 for a cost benefit of 2982.6 linear m/\$1000 and 9842.6 m<sup>2</sup>/\$1000.

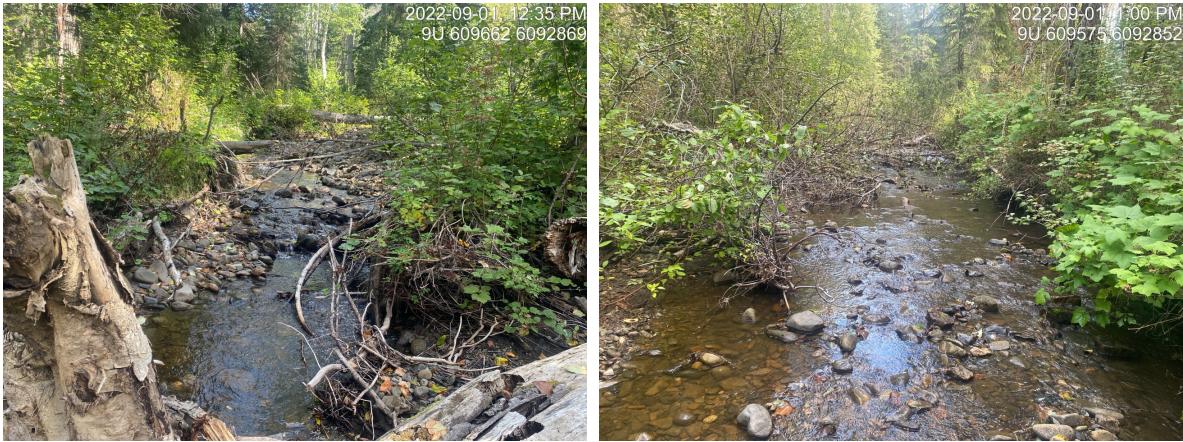
The stream was surveyed downstream from crossing 58067 for 300m (Figure [5.19](#)). The average channel width was 5.1m, the average wetted width was 3m, and the average gradient was 3%. The dominant substrate was cobbles with boulders sub-dominant. Total cover amount was rated as moderate with undercut banks dominant. Cover was also present as small woody debris, boulders, deep pools, and overhanging vegetation. There were abundant undercut banks available for cover. Some patches of gravel were present that would be suitable for rainbow, steelhead and coho spawning. Occasional deep pools were present that would serve as good habitat suitable for fish rearing and overwintering. Riparian vegetation was mixed deciduous and conifer old growth forest. The habitat was rated as high value for salmonid rearing and spawning.

Figure 5.19: Left: Typical habitat downstream of PSCIS crossing 58067. Right: Typical habitat downstream of PSCIS crossing 58067.

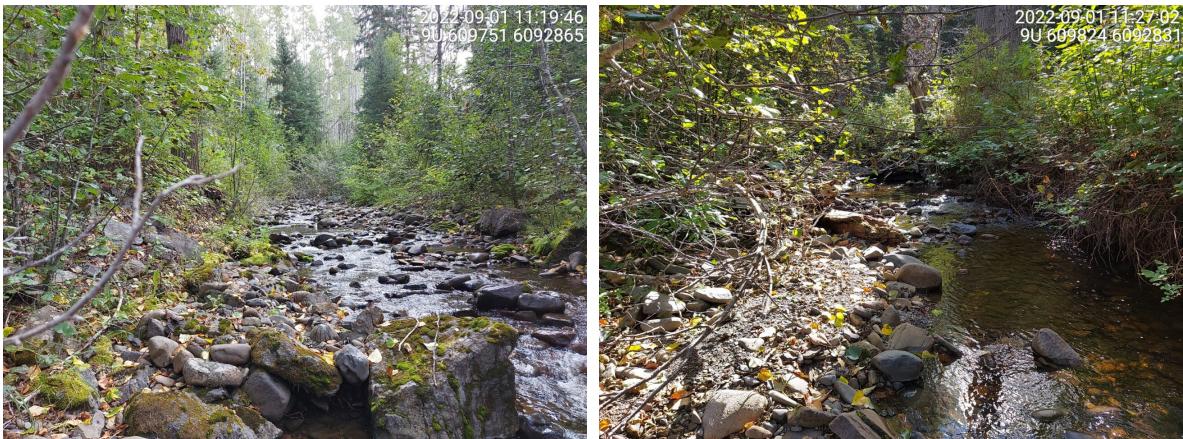
Figure 5.20: Left: Typical habitat upstream of PSCIS crossing 58067. Right: Typical habitat upstream of PSCIS crossing 58067.

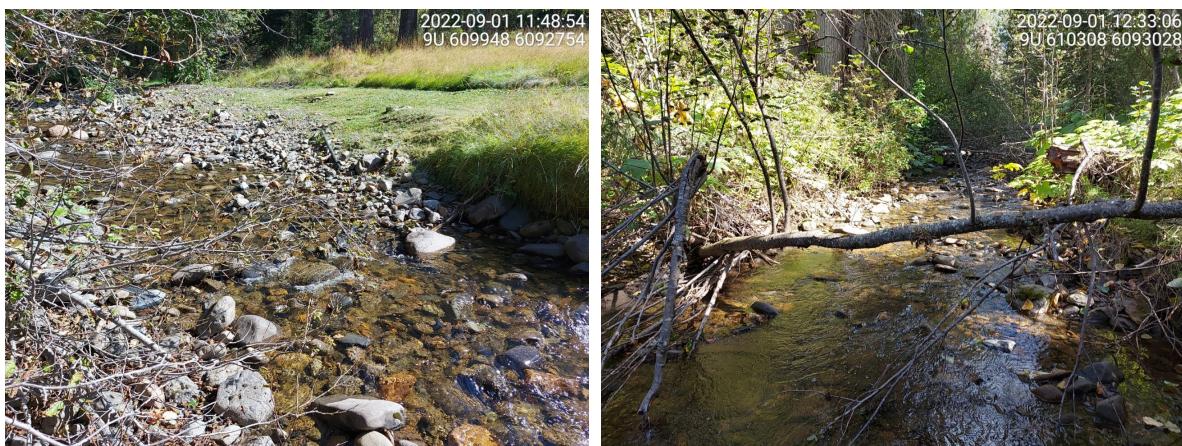
Figure 5.21: Left: Typical habitat upstream of PSCIS crossing 58067. Right: Typical habitat upstream of PSCIS crossing 58067.
