Bulkley Watershed Fish Passage Restoration Planning 2022

Prepared for
Canadian Wildlife Federation
Habitat Conservation Trust Foundation - CAT23-6-288
BC Fish Passage Remediation Program
Ministry of Transportation and Infrastructure

Prepared by
Al Irvine, B.Sc., R.P.Bio., Mateo Wintersheidt, B.Sc. and Lucy Schick, B.Sc.
New Graph Environment Ltd.
on behalf of
Society for Ecosystem Restoration in Northern British Columbia

Version 0.1.8 2024-04-24

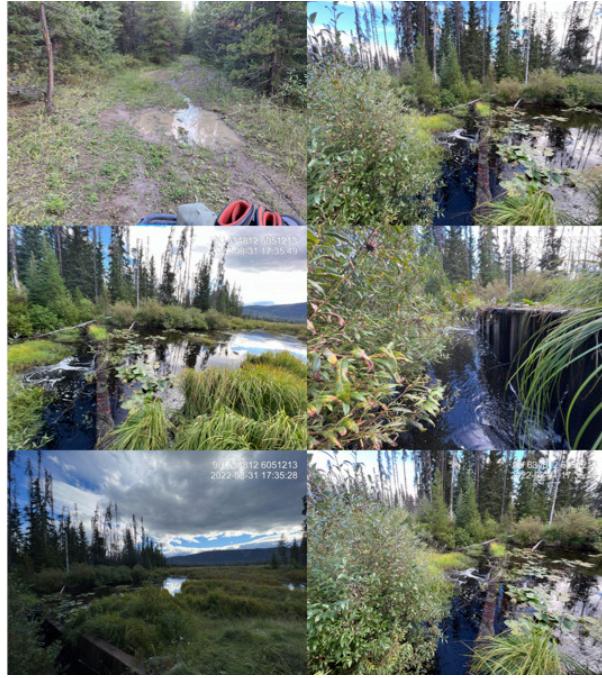
Figure 4.1: Photos of Dam 1f365462-063c-491e-9fb3-bfac004d9183 on Coffin Creek

Site	Stream	Easting	Northing	Mapsheet	Barrier	Notes
1f365462-063c-491e-9fb3-bfac004d9183	Coffin Creek	634763	6051171	093L.113	T	Aerial imagery aquired. Complete barrier. 1.2m high steel structure within wetland complex downstream of Coffin Lake. Extremely difficult access via all terrain vehicle due to muddy conditions

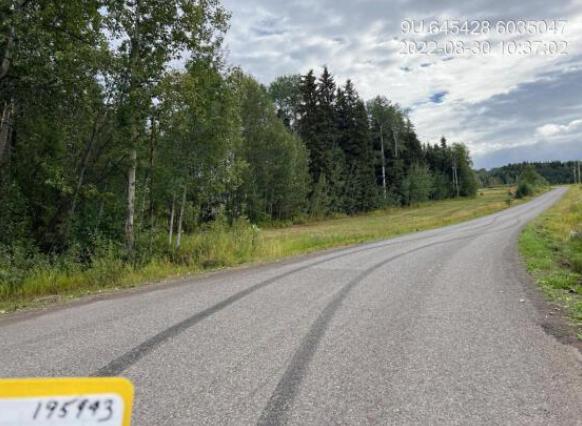
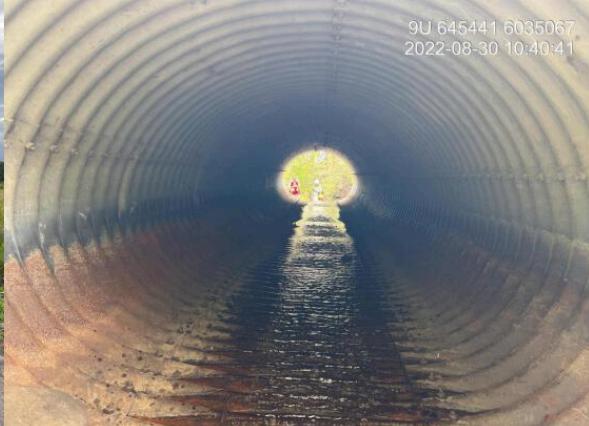
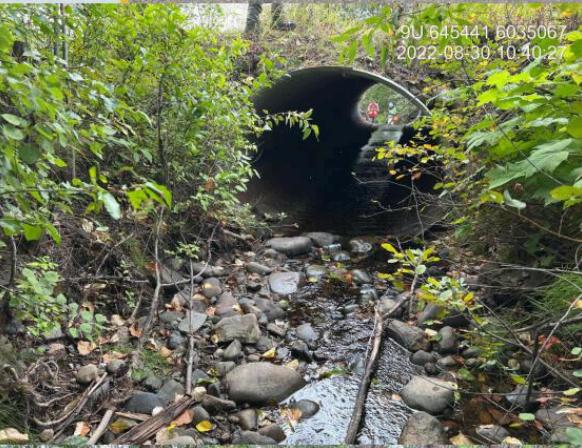
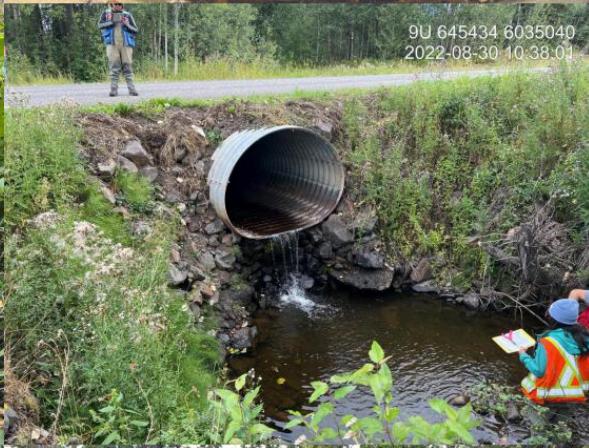
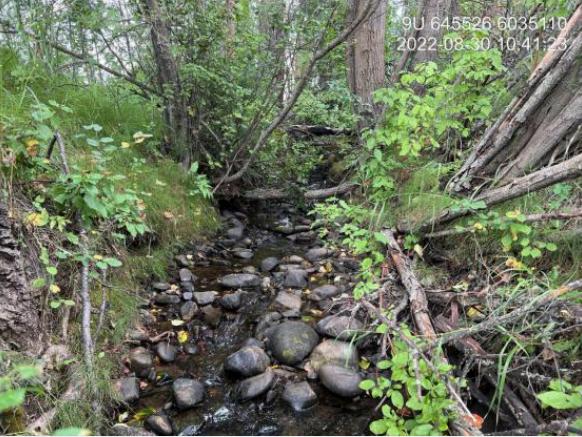
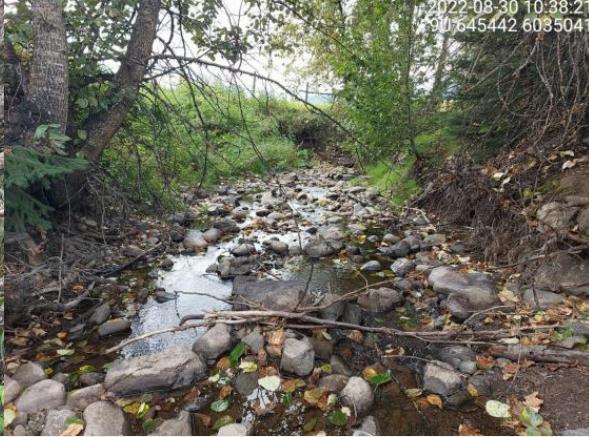
Category	Comments
Condition	Extensive erosion is present on the right bank on the downstream side. Very large outlet drop and deep outlet pool indicates culvert is undersized. Very little corrosion on the pipe. Pipe shape is good and not deformed.
Climate	Only one house visible downstream of the crossing. Road appears to have some traffic volume. Agricultural fields and minimal housing upstream and downstream.
Priority	Appears as though Hagaman Road could be used as alternative access to the community, so impact on traffic is not high.

Location and Stream Data	Crossing Characteristics
Comments: Very large outlet drop, but creates nice pool for fish. Erosion on left and right bank on outlet side. Agricultural fields, minimal municipality population downstream. Road is paved, detour available. 10:25	
Photos: From top left clockwise: Road/Site Card, Barrel, Outlet, Downstream, Upstream, Inlet.

Location and Stream Data		Crossing Characteristics	
Date	2022-08-30	Crossing Sub Type	Oval Culvert
PSCIS ID	195943	Diameter (m)	2
External ID	–	Length (m)	14
Crew	MW TP AI VJ AN DN	Embedded	No
UTM Zone	9	Depth Embedded (m)	–
Easting	645434	Resemble Channel	No
Northing	6035035	Backwatered	No
Stream	Stock Creek	Percent Backwatered	–
Road	Barrett Station Rd	Fill Depth (m)	0.6
Road Tenure	MoTi	Outlet Drop (m)	1.1
Channel Width (m)	3	Outlet Pool Depth (m)	0.71
Stream Slope (%)	3	Inlet Drop	No
Beaver Activity	No	Slope (%)	1.5
Habitat Value	Medium	Valley Fill	Deep Fill
Final score	31	Barrier Result	Barrier
Fix type	Replace with New Open Bottom Structure	Fix Span / Diameter	15

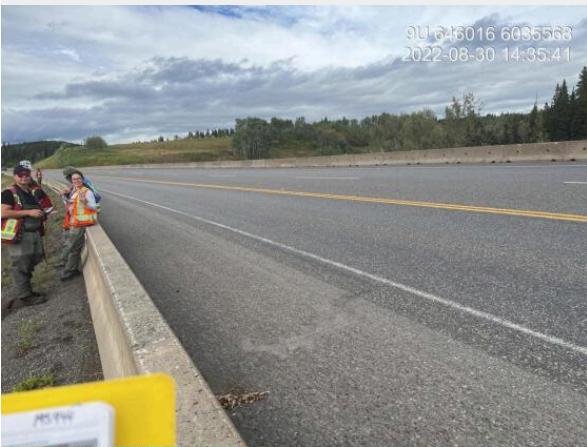
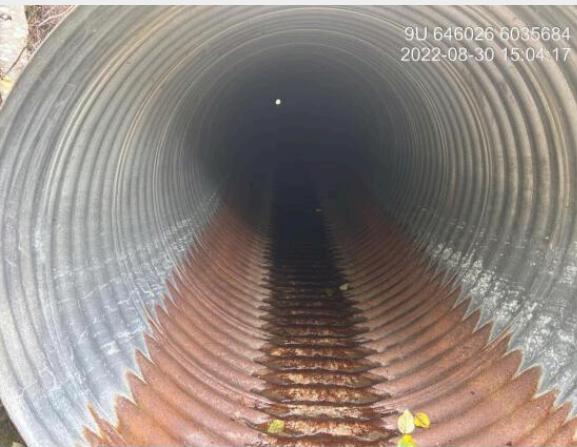
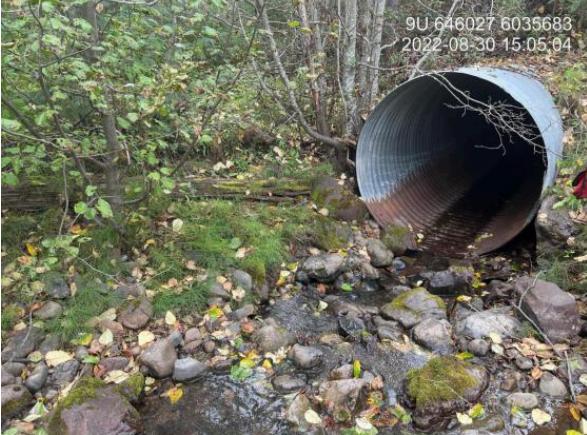
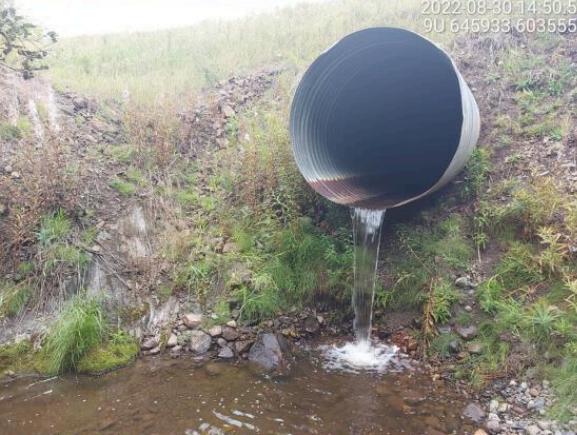
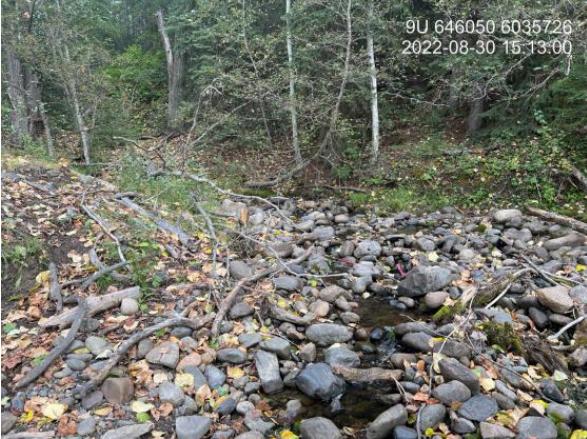
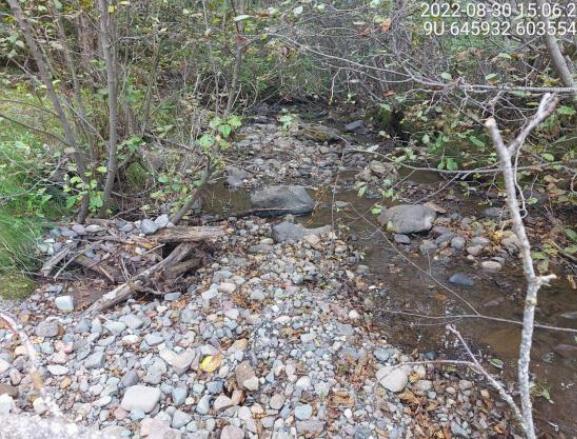
Location and Stream Data	Crossing Characteristics	-
<p>Comments: Length 167 m. Fill depth estimated at approximately 35 m. 14:35 Photos: From top left clockwise: Road/Site Card, Barrel, Outlet, Downstream, Upstream, Inlet.</p>

Location and Stream Data		Crossing Characteristics	
Date	2022-08-30	Crossing Sub Type	Round Culvert
PSCIS ID	195944	Diameter (m)	1.8
External ID	–	Length (m)	99
Crew	MW TP AI VJ AN DN	Embedded	No
UTM Zone	9	Depth Embedded (m)	–
Easting	646015.2	Resemble Channel	No
Northing	6035570	Backwatered	No
Stream	Stock Creek	Percent Backwatered	–
Road	Highway 16	Fill Depth (m)	9.99
Road Tenure	MoTi	Outlet Drop (m)	1.5
Channel Width (m)	2.6	Outlet Pool Depth (m)	0.25
Stream Slope (%)	2	Inlet Drop	No
Beaver Activity	No	Slope (%)	3.5
Habitat Value	Medium	Valley Fill	Deep Fill
Final score	42	Barrier Result	Barrier
Fix type	Replace with New Open Bottom Structure	Fix Span / Diameter	15

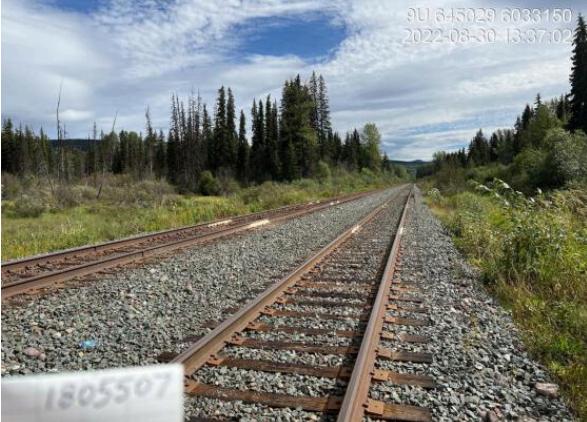
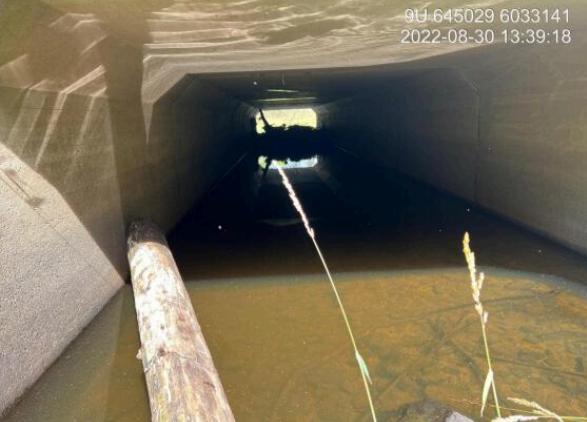
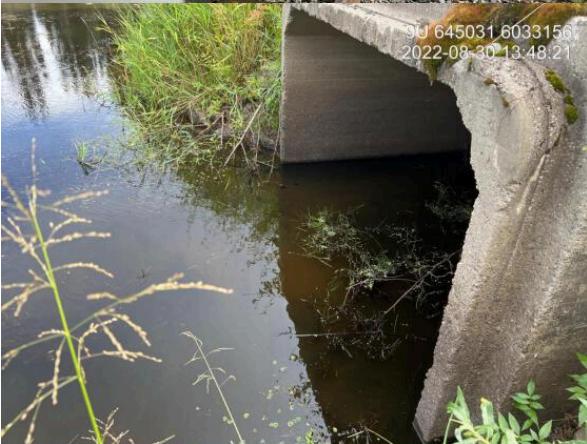
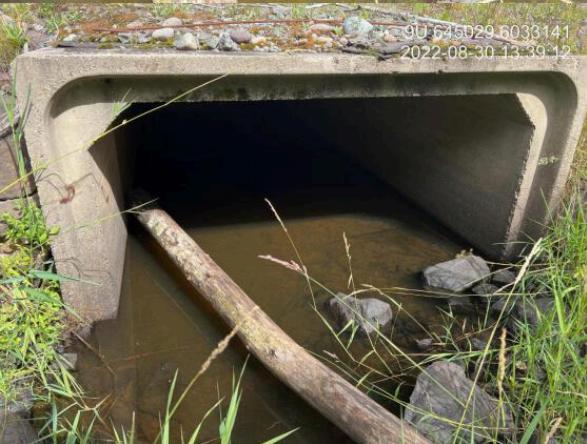
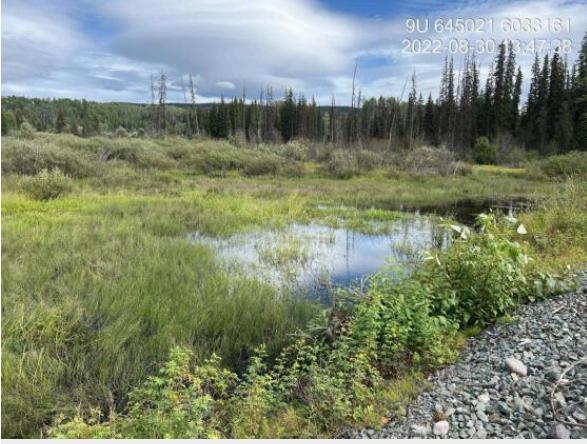
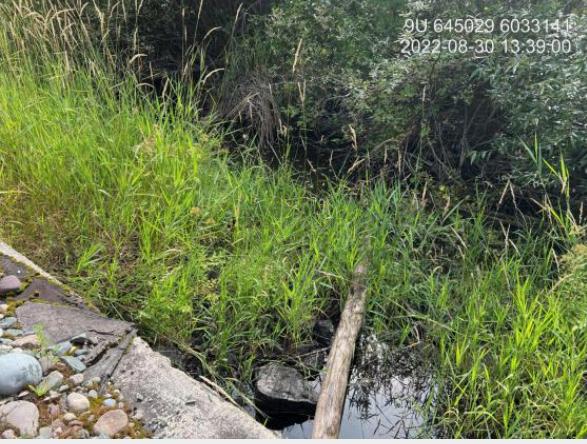
Location and Stream Data		Crossing Characteristics	
Final score	8	Barrier Result	Passable
Fix type	-	Fix Span / Diameter	-
Comments: Fully backwatered and embedded concrete box structure on the Railway. Not a fish passage issue at this time. 13:37			
Photos: From top left clockwise: Road/Site Card, Barrel, Outlet, Downstream, Upstream, Inlet.

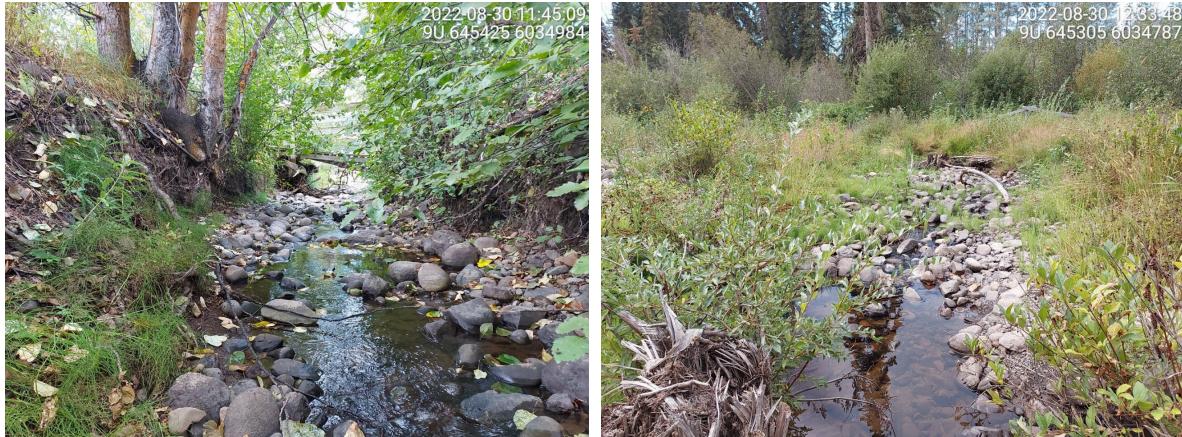
Figure 5.2: Left: Habitat downstream of PSCIS crossing 195943. Right: Habitat downstream of PSCIS crossing 195943.

The stream was surveyed downstream from crossing 195943 for 300m (Figure 5.2). Total cover amount was rated as moderate with small woody debris dominant. Cover was also present as boulders. The dominant substrate was gravels with cobbles sub-dominant. The average channel width was 3.8m, the average wetted width was 1.8m, and the average gradient was 2.7%. A footbridge was present approximately 200m downstream with concrete slabs on both adjacent banks upstream. Multiple fish up to 10cm in length were observed in a pool near the bridge. The stream had minimal overhanging and riparian vegetation in the area surveyed due to adjacent agricultural use. Some areas of stream had pools formed by small dams likely built for livestock waterholes. The habitat was rated as medium value for salmonid rearing and spawning.

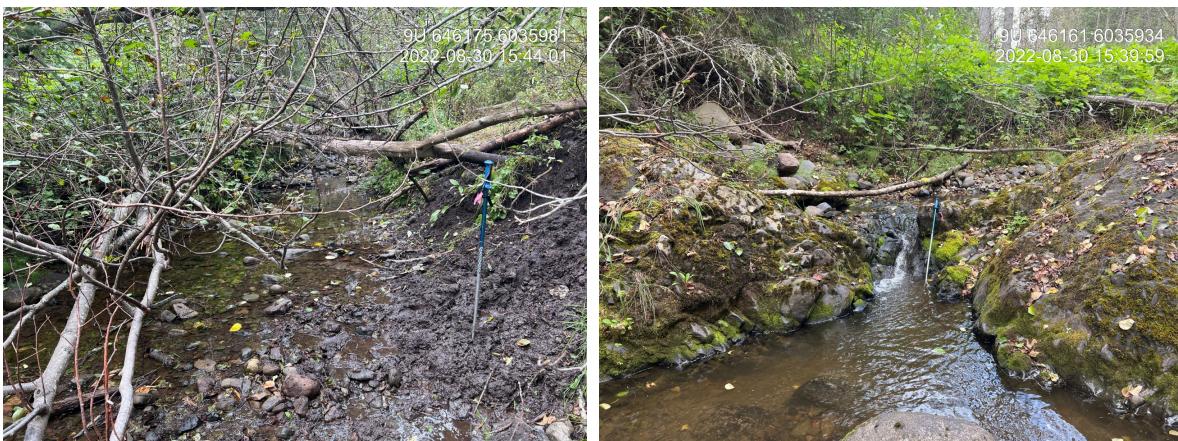
Figure 5.4: Left: Habitat upstream of PSCIS crossing 195944. Right: A 0.65m high rock drop located 365m upstream of PSCIS crossing 195944.

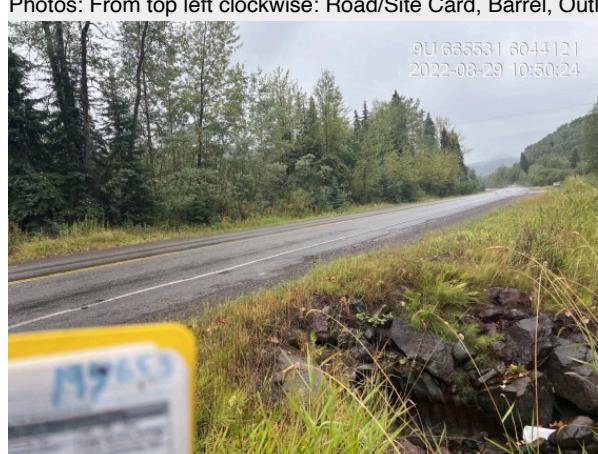
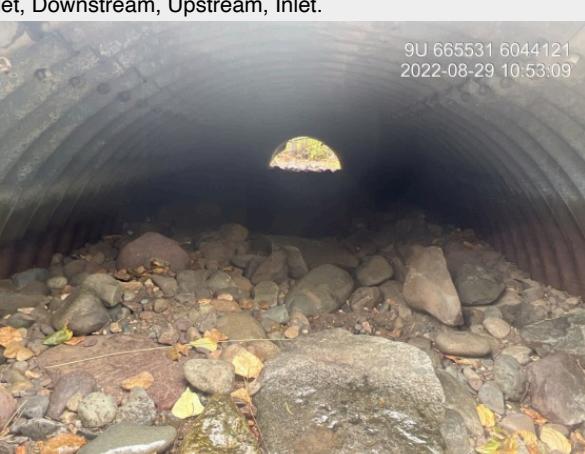
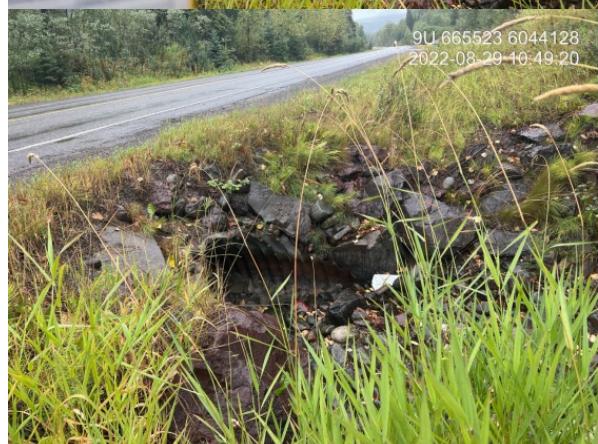
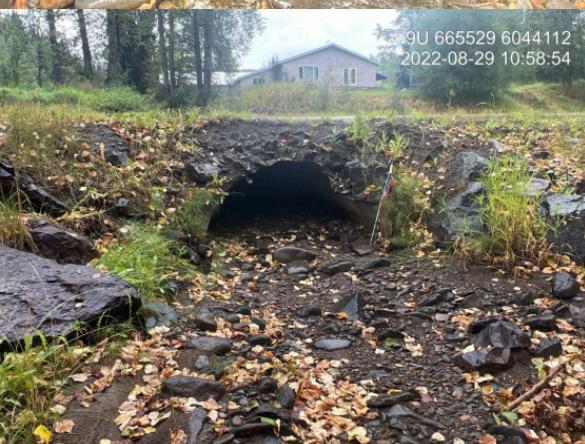
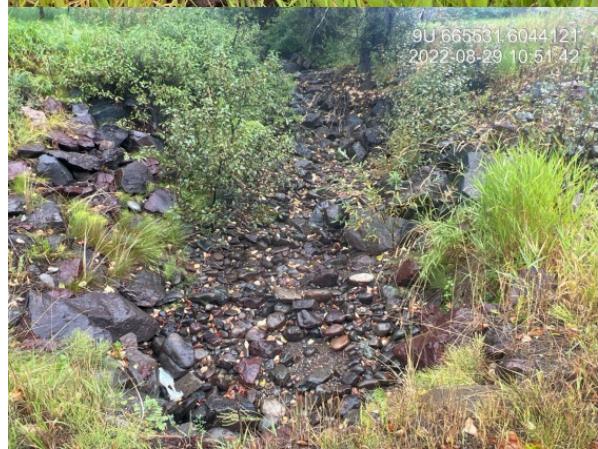
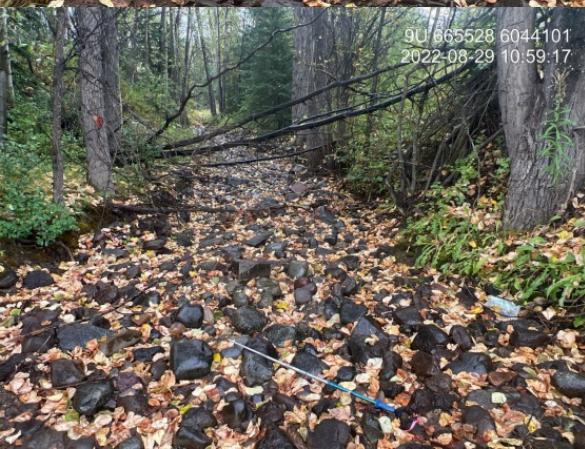
Location and Stream Data	Crossing Characteristics
<p>Comments: Stream was dry at the time of survey but had water last year during extremely dry ear. Culvert appears passable for all life stages. There is a private land residential development upstream that's impacting the stream. The channel is constricted upstream and has large chunks of riprap throughout. 10:45</p> <p>Photos: From top left clockwise: Road/Site Card, Barrel, Outlet, Downstream, Upstream, Inlet.</p>

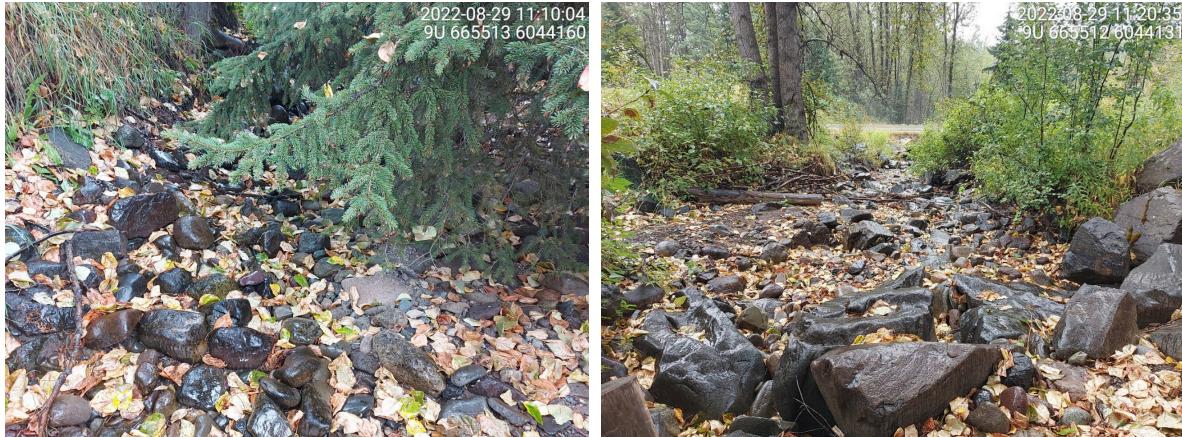
The stream was surveyed downstream from crossing 197653 for 100m to the culvert (PSCIS 197657) located on Highway 16, then an additional 25m downstream from the highway. The entire area assessed downstream of the crossing was dry at the time of the survey (Figure 5.5). Total cover amount was rated as moderate with boulders dominant. Cover was also present as overhanging vegetation. The average channel width was 4.3m, and the average gradient was 2%. The dominant substrate was boulders with cobbles sub-dominant. PSCIS crossing 197657 on the highway, approximately 50m downstream from crossing 197653 was reassessed and ranked as passable as it was low gradient, fully embedded and with no outlet drop. It appeared passable to all species and life stages at the time of assessment (Table 5.16). This crossing was previously assessed in 2020 by Irvine (2021), but it was mistakenly input as modelled crossing ID 1800064, when it should have been 1800067. The stream from Perow Loop Rd to the highway flowed through private property and appeared to be channelized and confined with concrete slabs used as stream bank armoring just downstream of the outlet. Downstream of the highway crossing two bridges are documented in the PSCIS database (197660 and 197659). Although habitat downstream had limited complexity resulting from impacts related to the adjacent road infrastructure and residential properties, the habitat was rated as medium value as it was considered an important migration corridor.

Figure 5.5: Left: Habitat downstream of PSCIS crossing 197653. Right: Habitat downstream of PSCIS crossing 197653.

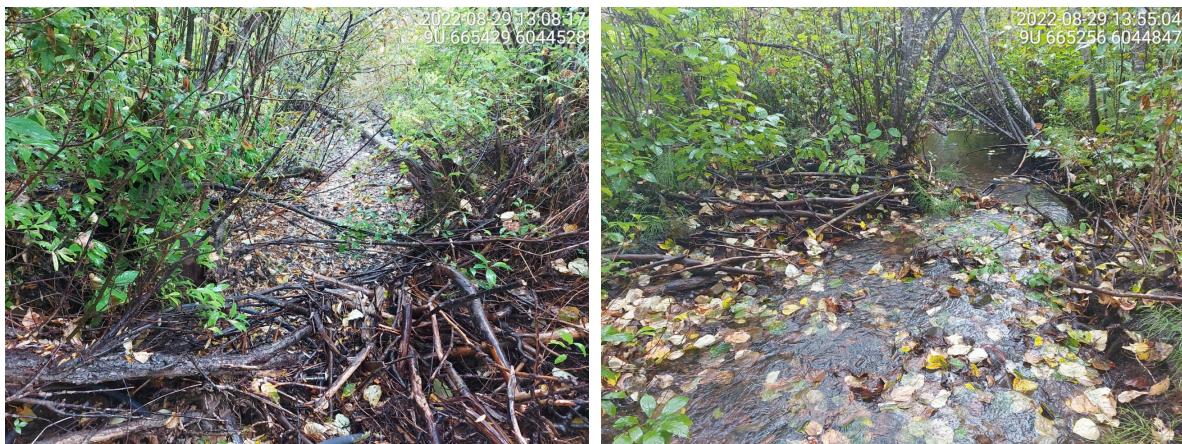
The stream was surveyed upstream from crossing 197653 for 500m (Figure 5.6). Two sections of stream upstream of the crossing were assessed. As residential buildings and yards were situated immediately adjacent to the stream upstream of the crossing, the stream was accessed from a ford located on the transmission line ~325m upstream of Perow Loop Road. The first section surveyed included ~350m of channel upstream of the ford and was dewatered at the time of survey. The average channel width was 3.2m, the average wetted width was 1.9m, and the average gradient was 3%. Total cover amount was rated as moderate with overhanging vegetation dominant. Cover was also present as small woody debris. The dominant substrate was cobbles with gravels sub-dominant.

Figure 5.6: Left: Habitat upstream of PSCIS crossing 197653. Right: Habitat upstream of PSCIS crossing 197653.

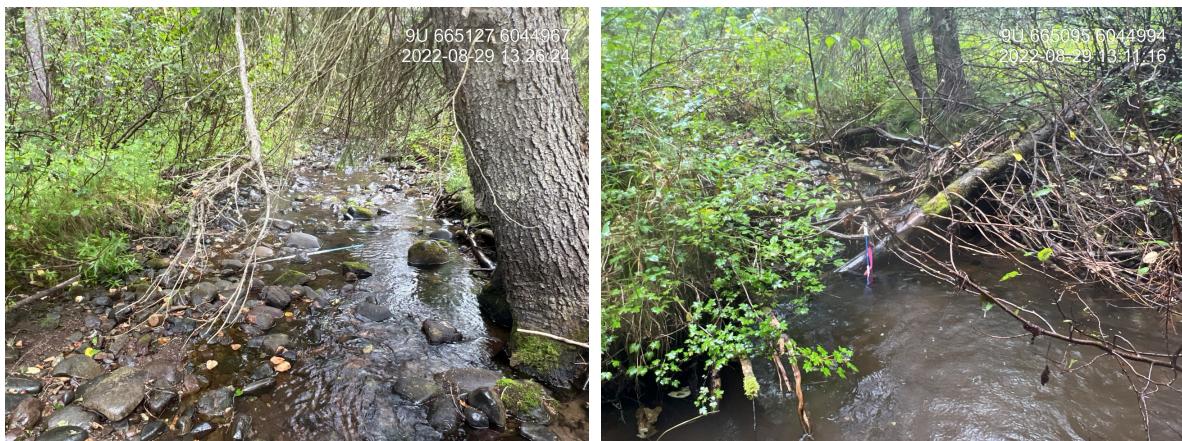
Figure 5.7: Left: Habitat upstream of PSCIS crossing 197653. Right: Habitat upstream of PSCIS crossing 197653.

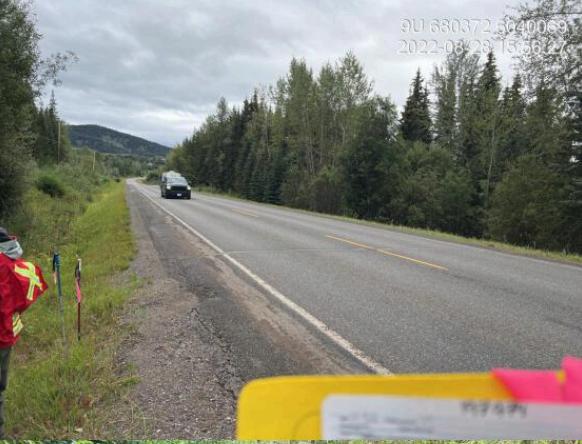
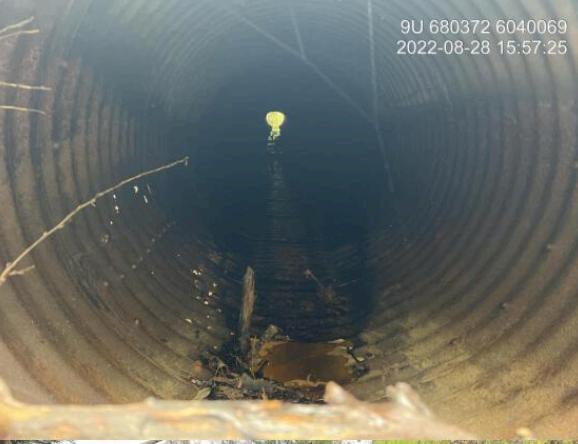
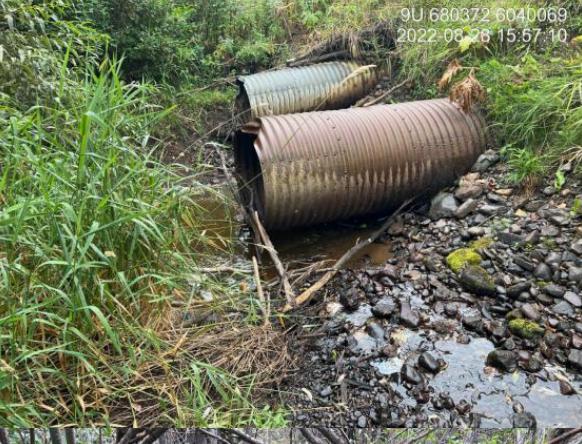
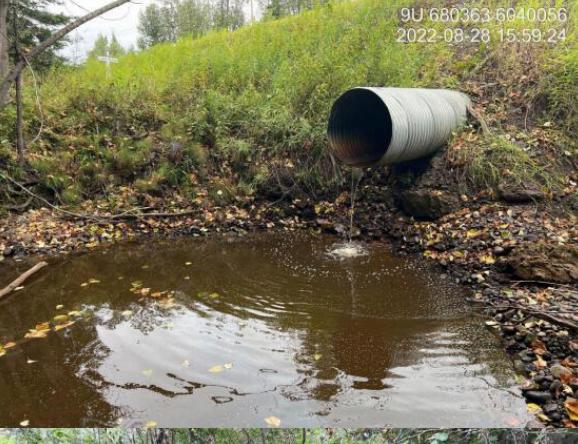
Location and Stream Data	Crossing Characteristics
Comments: Deep and large outlet pool indicate the culvert is significantly undersized. Condition of the pipe is poor with corrosion and some collapsing in the middle of the pipe. 0.6m diameter overflow pipe located adjacent to the main culvert. Some decent gravels downstream. 15:52	
Photos: From top left clockwise: Road/Site Card, Barrel, Outlet, Downstream, Upstream, Inlet.

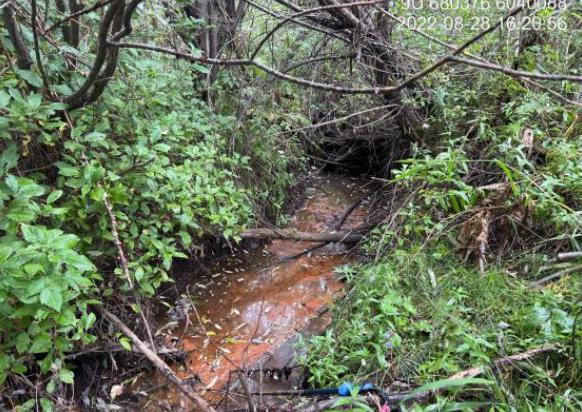
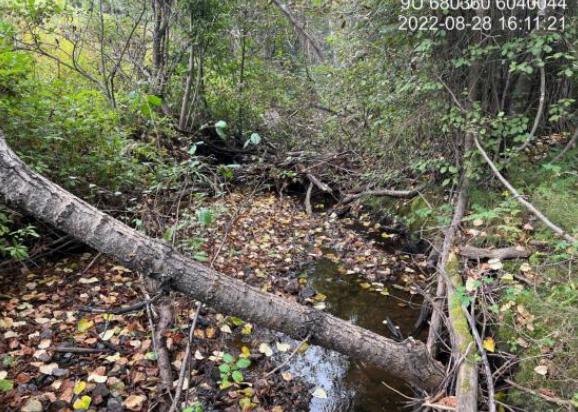
Category	Comments
Condition	Culvert is collapsing in the middle and is extensively eroded. Top end of the pipe is elevated from the stream bed at the inlet.
Climate	The large size and depth of the outlet pool indicates that there is major flow that comes through here that is not well-accommodated by the 0.9 m pipe, along with the 0.6 m overflow which is adjacent to it.
Priority	Although it would be an extremely expensive fix, this culvert looks to be a threat and closer investigation is warranted.

Should restoration/maintenance activities proceed, replacement of PSCIS crossing 197974 with a bridge (15m span) is recommended. The cost of the work is estimated at \$1,500,000 for a cost benefit of 9300 linear m/\$1000 and 15810 m²/\$1000.

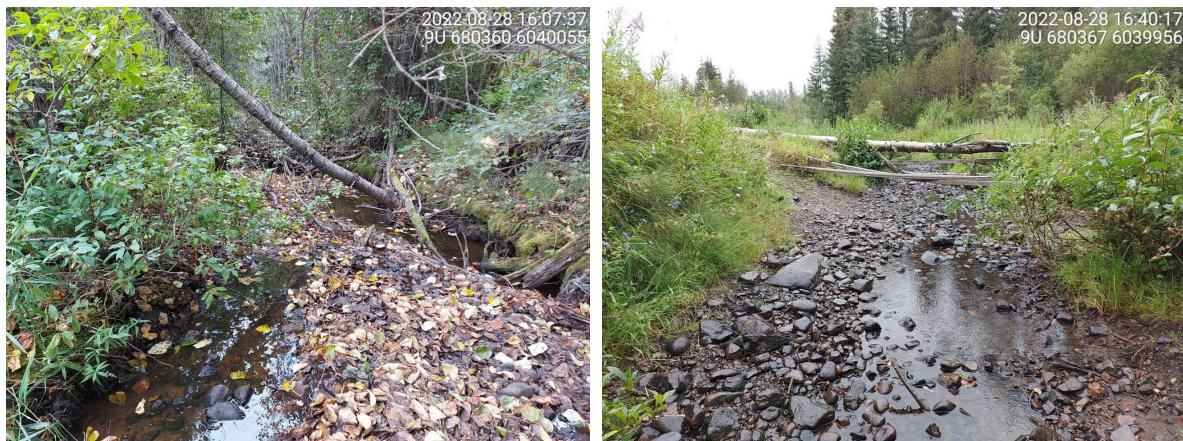
The stream was surveyed downstream from crossing 197974 for 350m to the confluence with Ailport Creek (Figure [5.8](#)). The average channel width was 3.5m, the average wetted width was 1.4m, and the average gradient was 2.2%. The dominant substrate was gravels with cobbles sub-dominant. Total cover amount was rated as trace with small woody debris dominant. Cover was also present as undercut banks and deep pools. Immediately downstream of the culvert stream flows were noted as very minimal however, at approximately 50m downstream the volume of water increased substantially. There were occasional deep pools and undercut banks but cover and complexity was notably lacking in most areas. At approximately 100m downstream of the highway riparian forests have been removed to accommodate pasture with notably less cover present and a channel confined by steep banks. Abundant gravels suitable for resident and anadromous salmonid spawning were present throughout the area surveyed. The habitat was rated as medium value for salmonid rearing and spawning.

Figure 5.8: Left: Typical habitat downstream of PSCIS crossing 197974. Right: Typical habitat downstream of PSCIS crossing 197974.

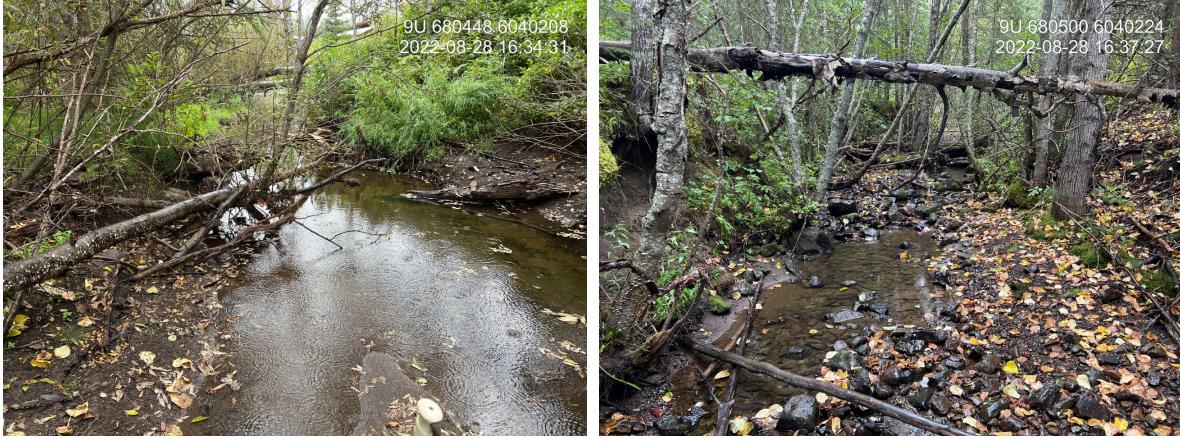
The stream was surveyed upstream from crossing 197974 for 600m (Figure [5.9](#)). Total cover amount was rated as moderate with undercut banks dominant. Cover was also present as small woody debris, large woody debris, deep pools, and overhanging vegetation. The dominant substrate was gravels with fines sub-dominant. The average channel width was 3.4m, the average wetted width was 1.8m, and the average gradient was 1.8%. Numerous salmonid fry were noted throughout the area surveyed along with abundant gravels suitable for resident and anadromous salmonid spawning. Immediately upstream of the crossing for approximately 150-200m stream banks and riparian areas were heavily impacted by cattle with beaver activity also noted in this area. Some pools to 0.7m deep were present and suitable for salmonid juvenile rearing and overwintering. Survey notes indicate that at the time of the survey cattle appeared to be accessing the stream intermittently throughout the entire area surveyed. Overall, the habitat surveyed upstream of the crossing rated as medium value as an important migration corridor containing habitat suitable for rainbow and coho spawning with moderate rearing potential for juvenile salmonids.

Figure 5.9: Left: Typical habitat upstream of PSCIS crossing 197974. Right: Typical habitat upstream of PSCIS crossing 197974.

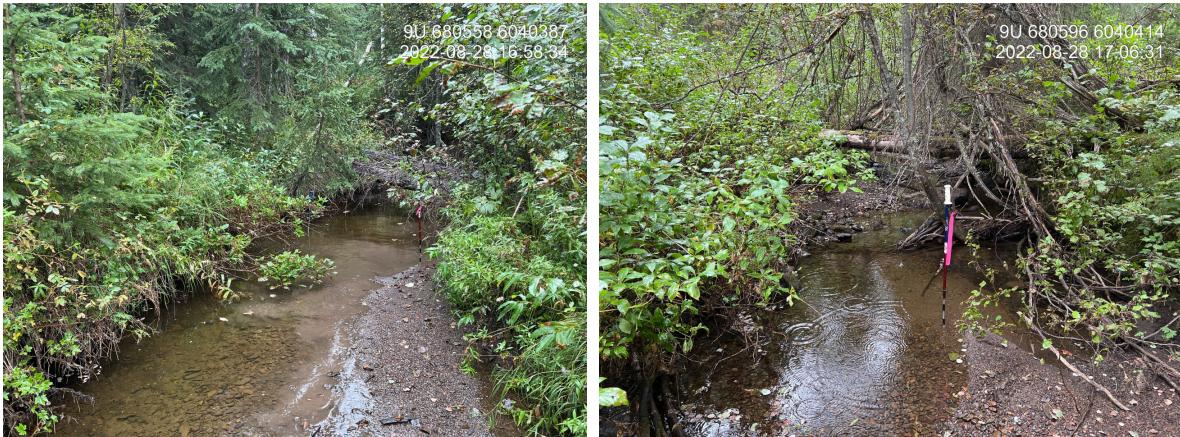
Figure 5.10: Left: Typical habitat upstream of PSCIS crossing 197974. Right: Typical habitat upstream of PSCIS crossing 197974.

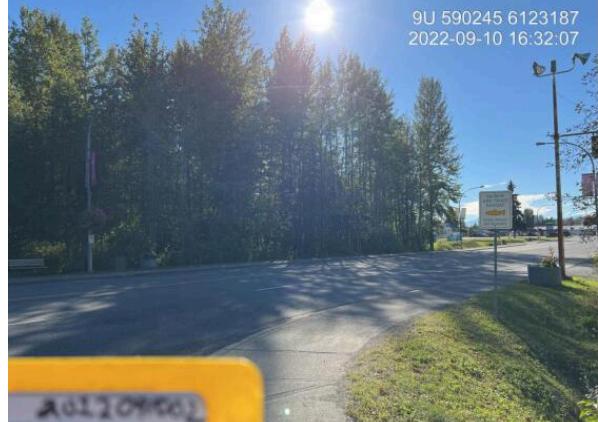
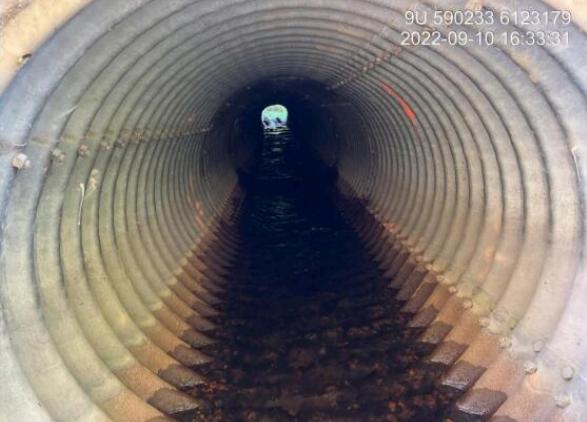
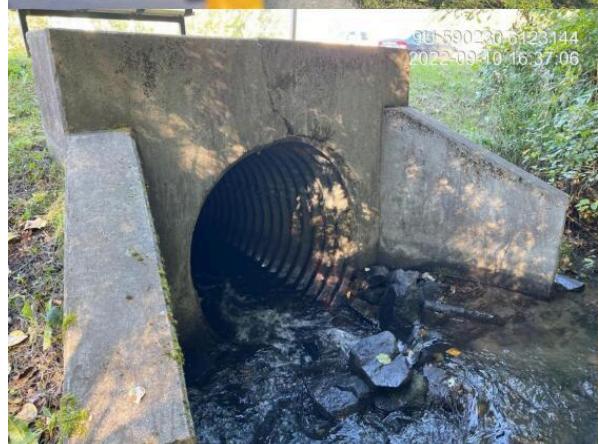
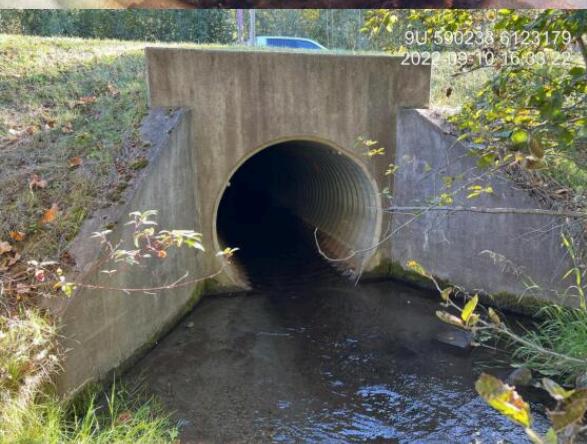
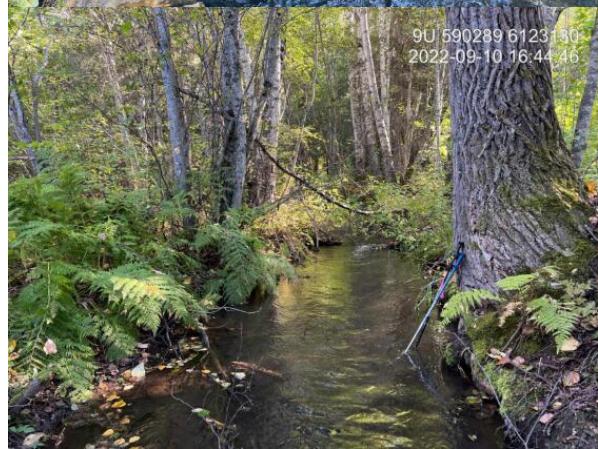
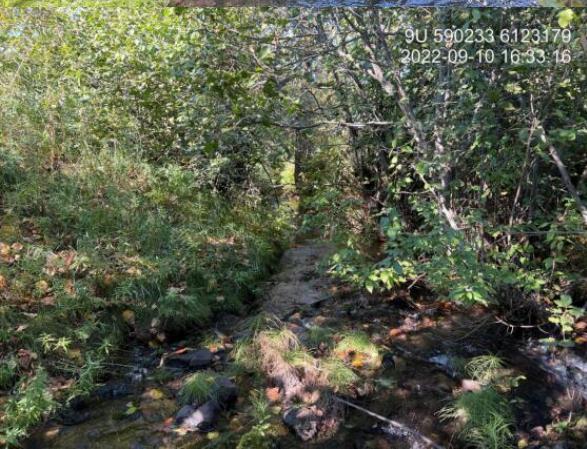
Location and Stream Data		Crossing Characteristics	
Date	2022-09-10	Crossing Sub Type	Round Culvert
PSCIS ID	198116	Diameter (m)	1.5
External ID	–	Length (m)	27
Crew	AI	Embedded	No
UTM Zone	9	Depth Embedded (m)	–
Easting	590233.2	Resemble Channel	No
Northing	6123183	Backwatered	No
Stream	Waterfall Creek	Percent Backwatered	–
Road	Highway 16	Fill Depth (m)	1
Road Tenure	MoTi	Outlet Drop (m)	0
Channel Width (m)	3.9	Outlet Pool Depth (m)	0.2
Stream Slope (%)	2.5	Inlet Drop	Yes
Beaver Activity	No	Slope (%)	2.5
Habitat Value	High	Valley Fill	Deep Fill
Final score	24	Barrier Result	Barrier
Fix type	Replace with New Open Bottom Structure	Fix Span / Diameter	15

Location and Stream Data	Crossing Characteristics
<p>Comments: Stream is not mapped correctly in the freshwater atlas as it actually flows north through town. Great flow, patches of gravel suitable for coho spawning. Located right within the town of New Hazelton. Trap and truck coho operation occurring with spawners transplanted upstream of the railway and 14th avenue. 16:34</p>	
<p>Photos: From top left clockwise: Road/Site Card, Barrel, Outlet, Downstream, Upstream, Inlet.</p>

Should restoration/maintenance activities proceed, replacement of PSCIS crossing 198116 on Highway 16 with a bridge (15m span) is recommended. The cost of the work is estimated at \$7,500,000 for a cost benefit of 160 linear m/\$1000 and 312 m²/\$1000. Costs for replacement of the sites assessed on 9th avenue and 13th avenue with bridges are roughly estimated at /\$2,000,000 dollars each.

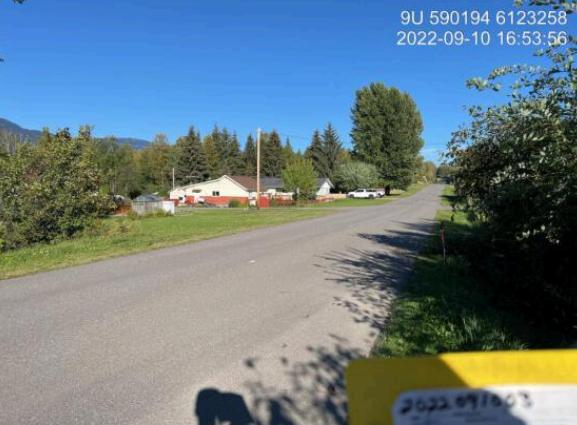
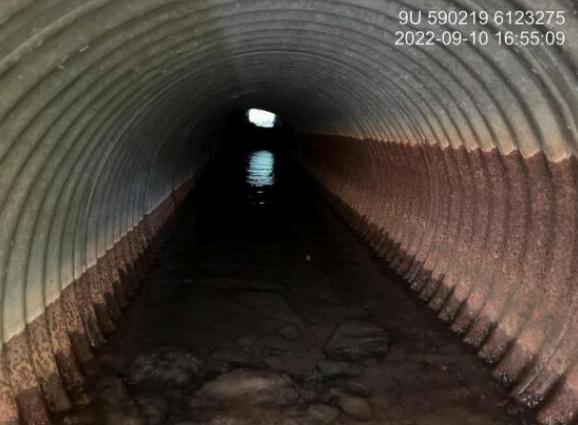
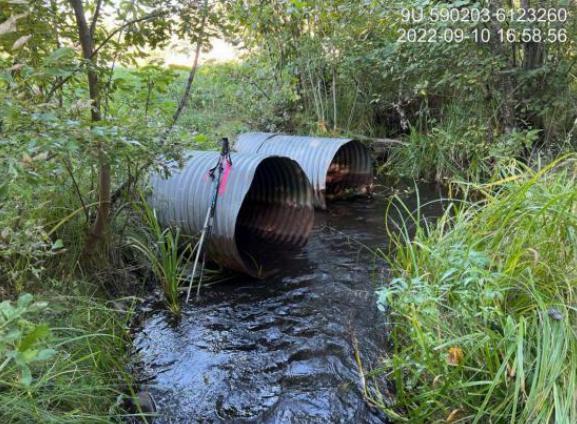
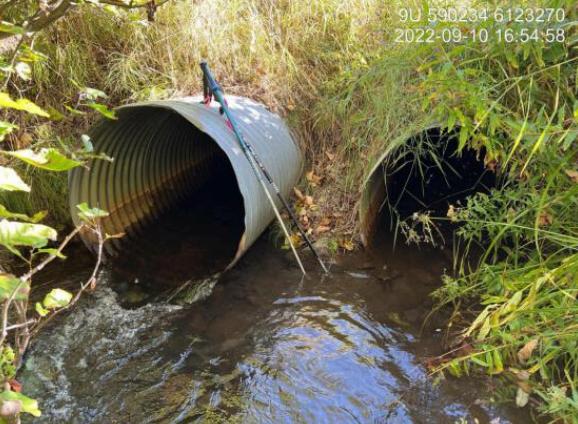
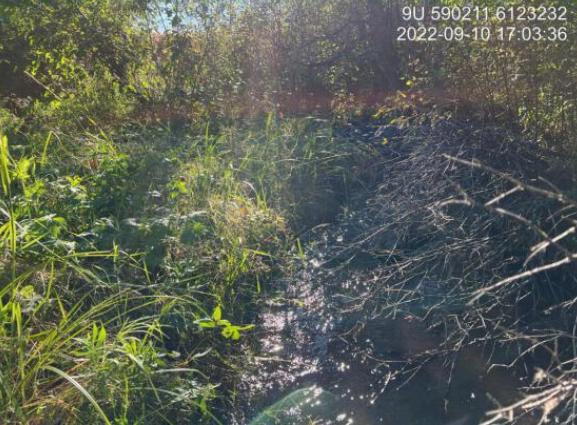
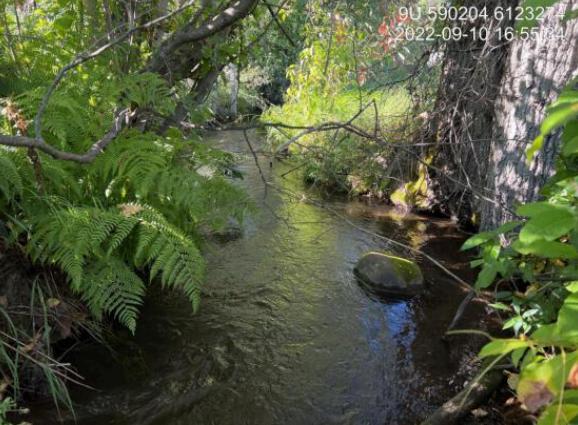
Location and Stream Data		Crossing Characteristics	
Date	2022-09-10	Crossing Sub Type	Round Culvert
PSCIS ID	198117	Diameter (m)	1.8
External ID	2022091003	Length (m)	19
Crew	AI	Embedded	No
UTM Zone	9	Depth Embedded (m)	–
Easting	590200.9	Resemble Channel	No
Northing	6123262	Backwatered	No
Stream	Waterfall Creek	Percent Backwatered	–
Road	9th Avenue	Fill Depth (m)	1
Road Tenure	New Hazelton	Outlet Drop (m)	0.2
Channel Width (m)	2.6	Outlet Pool Depth (m)	0.1
Stream Slope (%)	1	Inlet Drop	Yes
Beaver Activity	No	Slope (%)	1
Habitat Value	High	Valley Fill	Deep Fill
Final score	29	Barrier Result	Barrier
Fix type	Replace with New Open Bottom Structure	Fix Span / Diameter	10

Location and Stream Data	Crossing Characteristics
Comments: Two 0.9 pipe added together for width. Left pipe has significant blockage 1/3 of the way through the pipe. Right Bank of the stream has an empty lot with only grass and invasive weed riparian. 16:52	
Photos: From top left clockwise: Road/Site Card, Barrel, Outlet, Downstream, Upstream, Inlet.

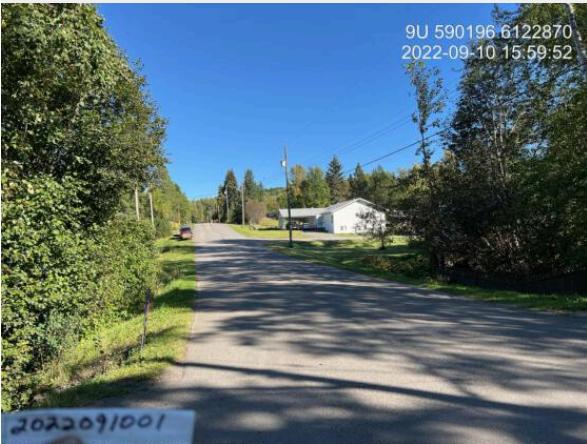
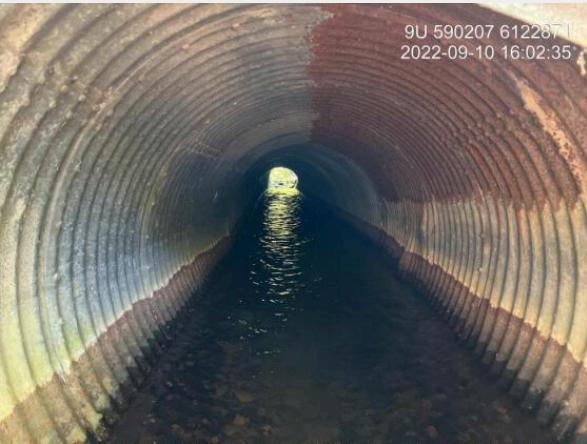
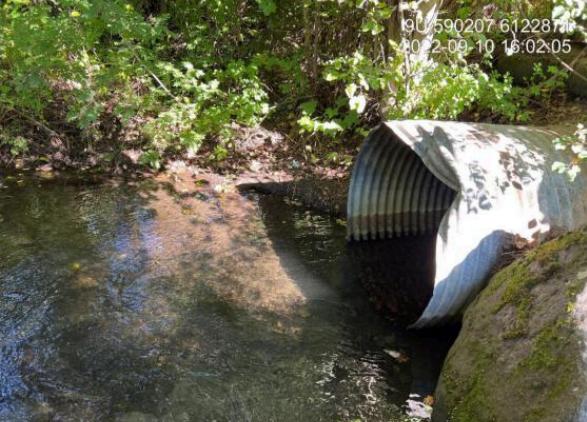
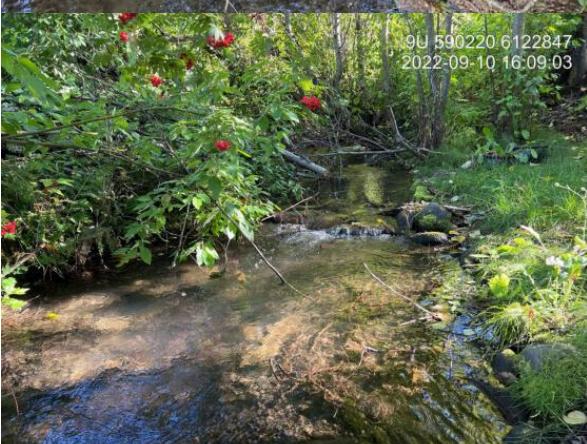
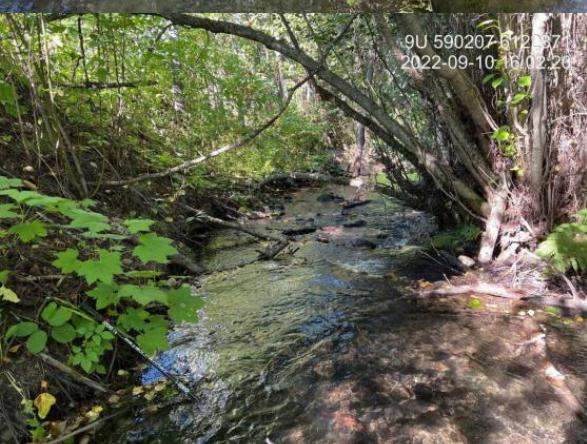
Location and Stream Data		Crossing Characteristics	
Date	2022-09-10	Crossing Sub Type	Round Culvert
PSCIS ID	198115	Diameter (m)	1.25
External ID	2022091001	Length (m)	22
Crew	AI	Embedded	No
UTM Zone	9	Depth Embedded (m)	–
Easting	590210.7	Resemble Channel	No
Northing	6122882	Backwatered	No
Stream	Waterfall Creek	Percent Backwatered	–
Road	13 Avenue	Fill Depth (m)	1.5
Road Tenure	New Hazelton	Outlet Drop (m)	0
Channel Width (m)	2.8	Outlet Pool Depth (m)	0.4
Stream Slope (%)	3	Inlet Drop	Yes
Beaver Activity	No	Slope (%)	1
Habitat Value	High	Valley Fill	Deep Fill

Location and Stream Data		Crossing Characteristics	-
Fix type	Replace with New Open Bottom Structure	Fix Span / Diameter	10
Comments: This is waterfall Creek. It does not show up in the freshwater atlas as here, however this is the main flow. Numerous fry and parr observed upstream of the crossing. No paper card for site. 16:03			
Photos: From top left clockwise: Road/Site Card, Barrel, Outlet, Downstream, Upstream, Inlet.

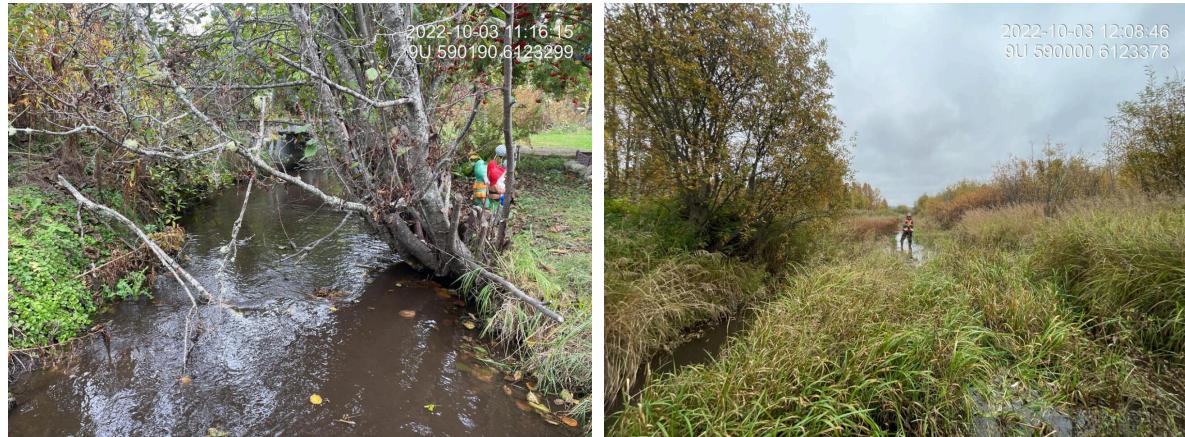
The stream was surveyed downstream from crossing 198116 for 450m past PSCIS crossing 198177 (9th avenue) to approximately 220m upstream of PSCIS crossing 124423 on the CN railway (Figure 5.13). The average channel width was 3m, the average wetted width was 2.8m, and the average gradient was 1%. The dominant substrate was fines with gravels sub-dominant. Total cover amount was rated as abundant with overhanging vegetation dominant. Cover was also present as instream vegetation. PSCIS crossing 198117 on 9th avenue was also assessed for fish passage and at the time of survey, the crossing was un-embedded, non-backwatered, and ranked as a barrier to upstream fish passage (Table 5.26). The stream flows through the town of New Hazelton. There was low flow at the time of survey and the stream contained a lot of waste and debris. There was a lot of cover from vegetation. The stream hits the railway and is drained into a tributary that flows west until it joins Station Creek. The habitat was rated as high value for salmonid rearing and spawning.

Figure 5.13: Left: Typical habitat downstream of PSCIS crossing 198116. Right: Typical habitat downstream of PSCIS crossing 198116.

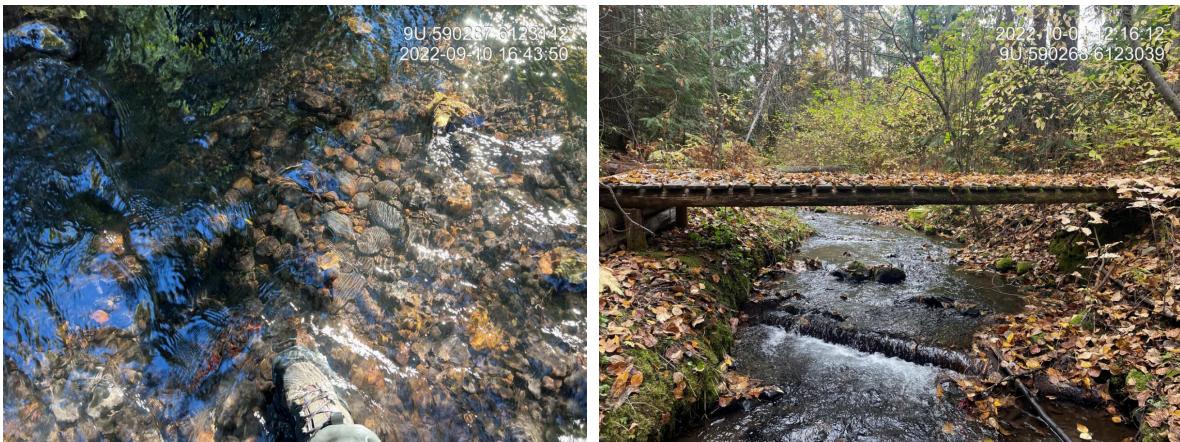
The stream was surveyed upstream from crossing 198116 for 1200m to the location of a waterfall that blocks upstream migration for all life stages and species. (Figure 5.14). The waterfall was estimated to be approximately 7m in height. Total cover amount was rated as abundant with small woody debris dominant. Cover was also present as undercut banks. The average channel width was 3.7m, the average wetted width was 3.5m, and the average gradient was 1.5%. Total cover amount was rated as abundant with overhanging vegetation dominant. Cover was also present as undercut banks. The dominant substrate was fines with gravels sub-dominant. There was a culvert approximately 400m upstream of PSCIS crossing 198116 that was also assessed. At the time of survey, this crossing was un-embedded, non-backwatered, and ranked as a barrier to upstream fish passage (Table 5.27). The habitat quality was excellent. The stream flow was moderate and there were fish spotted all the way up to the waterfall where the survey ended. An adult coho was seen upstream of crossing 198115. Cover from vegetation and undercut banks was noted as abundant. The habitat was rated as high value as an important migration corridor containing suitable spawning habitat and having high rearing potential for juvenile coho, rainbow trout, cutthroat trout and dolly varden.

Figure 5.14: Left: Gravel and cobble substrate immediately upstream of PSCIS crossing 198116. Right: Footbridge located upstream of PSCIS crossing 198116.
