Bulkley Watershed Fish Passage Restoration Planning 2022

Prepared for
Canadian Wildlife Federation
Habitat Conservation Trust Foundation - CAT23-6-288
BC Fish Passage Remediation Program
Ministry of Transportation and Infrastructure

Prepared by
Al Irvine, B.Sc., R.P.Bio., Mateo Wintersheidt, B.Sc. and Lucy Schick, B.Sc.
New Graph Environment Ltd.
on behalf of
Society for Ecosystem Restoration in Northern British Columbia

Version 0.1.8 2024-04-24

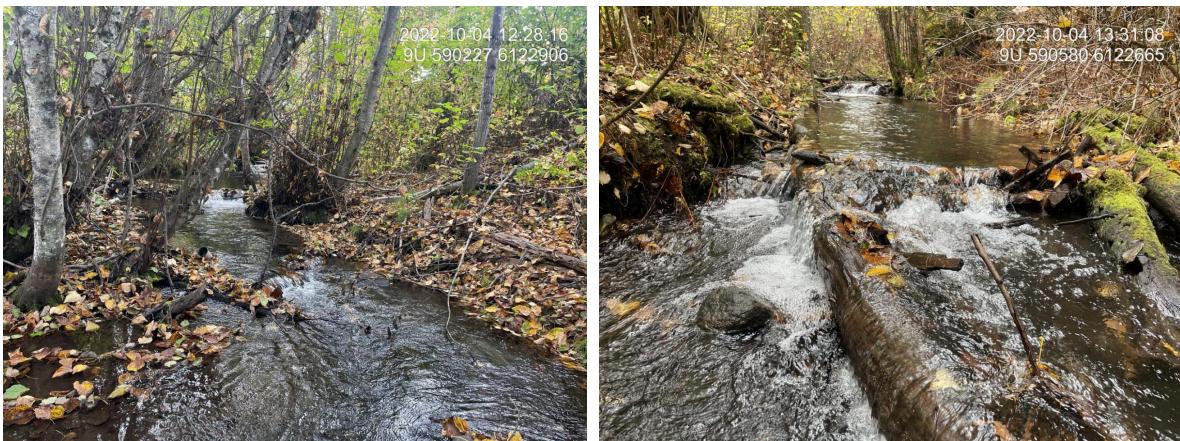
Figure 5.15: Left: Typical habitat upstream of PSCIS crossing 198116. Right: Typical habitat upstream of PSCIS crossing 198116.

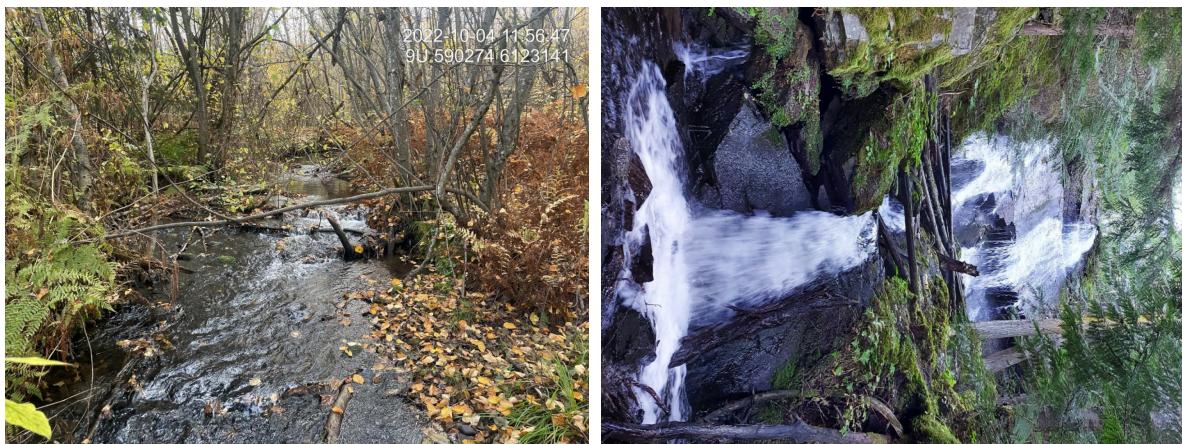
Figure 5.16: Left: Typical habitat upstream of PSCIS crossing 198116. Right: Waterfall at the end of survey, upstream of PSCIS crossing 198115.

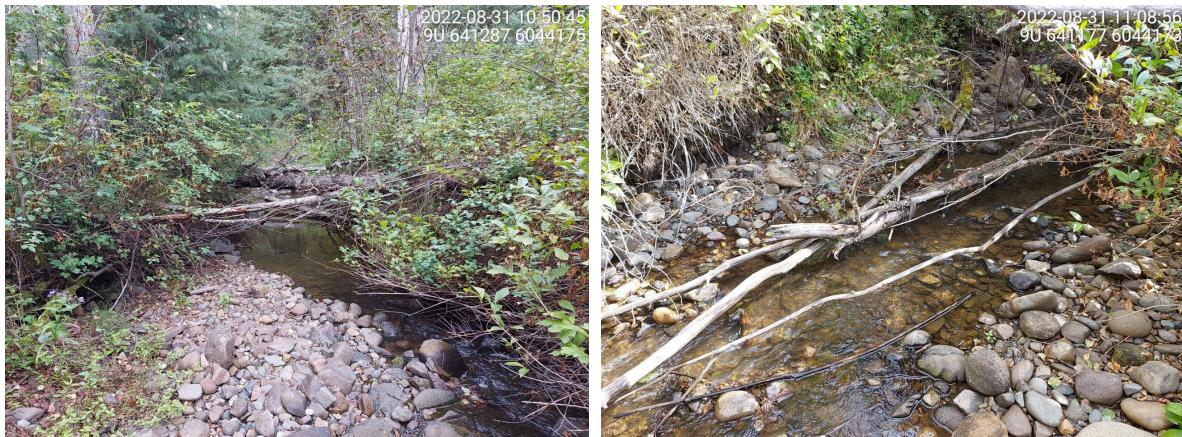
The stream was surveyed downstream from crossing 57793 for 300m (Figure [5.17](#)). Total cover amount was rated as abundant with undercut banks dominant. Cover was also present as small woody debris, large woody debris, and overhanging vegetation. The dominant substrate was gravels with cobbles sub-dominant. The average channel width was 4.1m, the average wetted width was 2.4m, and the average gradient was 2%. There were undercut banks and abundant riparian vegetation throughout providing good cover for fish. Some gravels were present that could be suitable for spawning. Functional large woody debris was present throughout the stream. The habitat was rated as high value for salmonid rearing and spawning.

Figure 5.17: Left: Typical habitat downstream of PSCIS crossing 57793. Right: Typical habitat downstream of PSCIS crossing 57793.

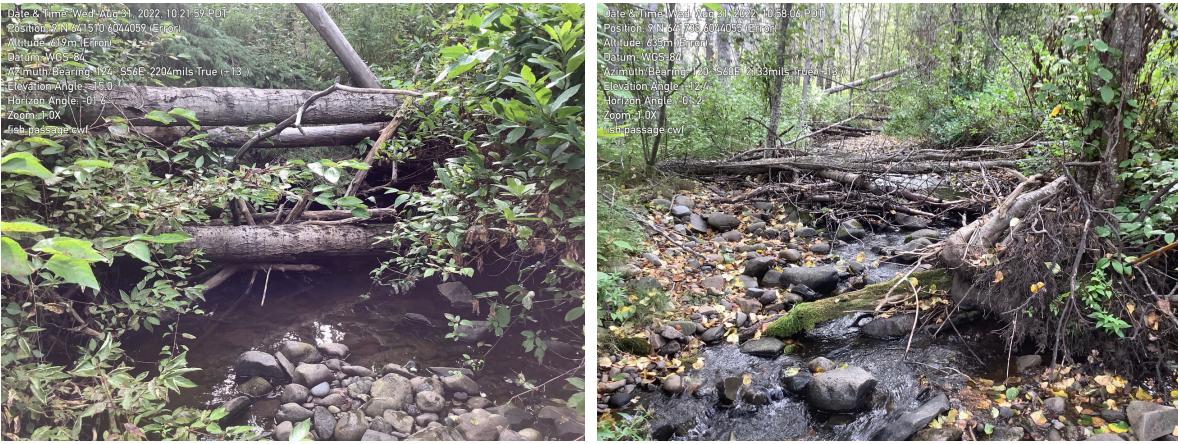
Figure 5.18: Left: Typical habitat upstream of PSCIS crossing 57793. Right: Typical habitat upstream of PSCIS crossing 57793.

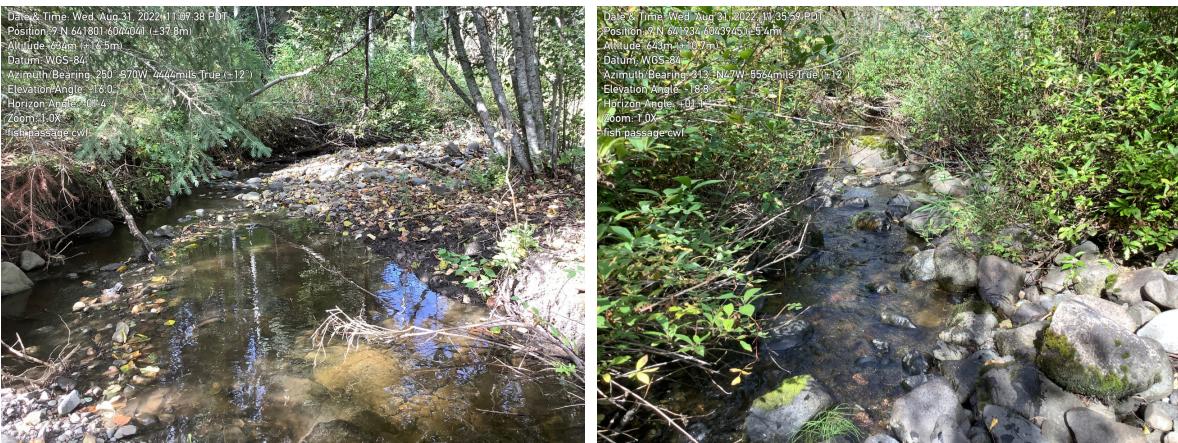
Figure 5.19: Left: Typical habitat upstream of PSCIS crossing 57793. Right: Typical habitat upstream of PSCIS crossing 57793.

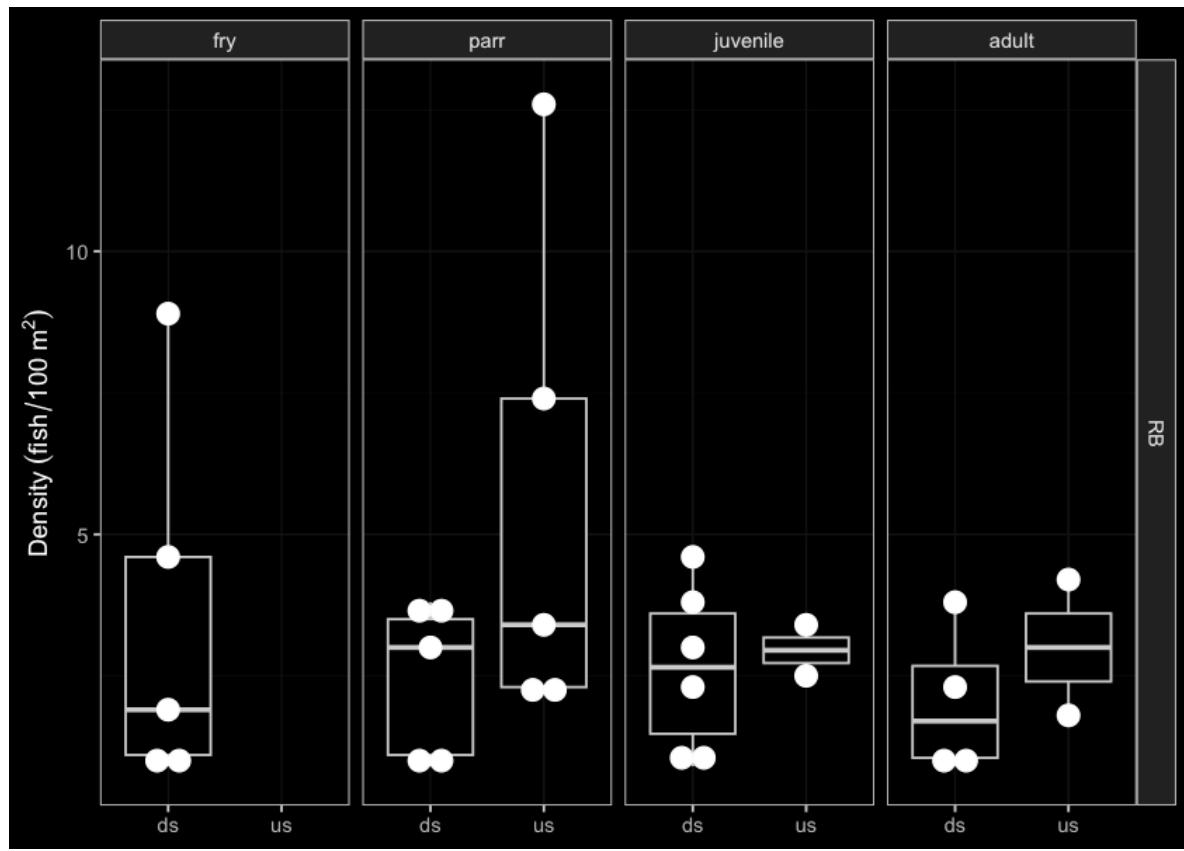
Figure 5.21: Densities of fish (fish/100m²) captured upstream of PSCIS crossing 58067.

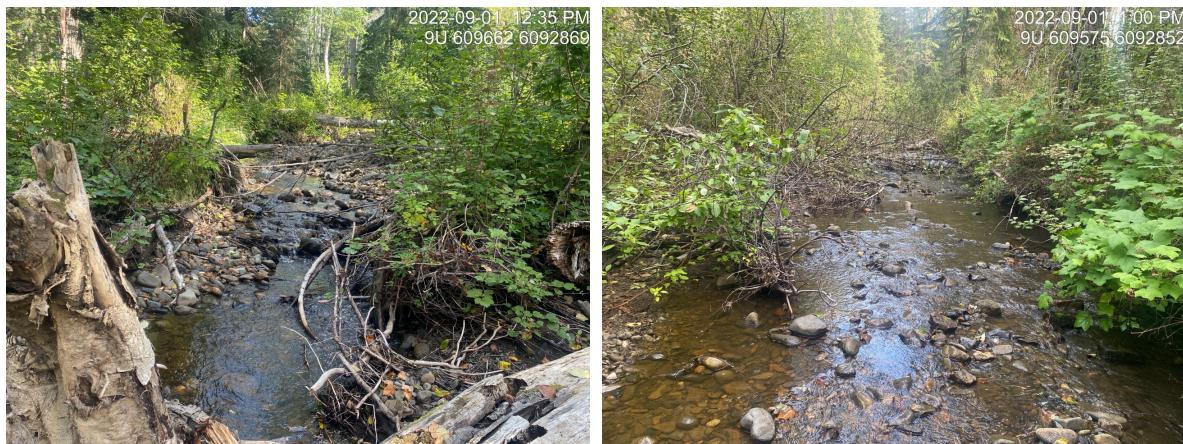
The stream was surveyed downstream from crossing 58067 for 300m in 2022 (Figure 5.22). Total cover amount was rated as moderate with undercut banks dominant. Cover was also present as small woody debris, boulders, deep pools, and overhanging vegetation. The average channel width was 5.1m, the average wetted width was 3m, and the average gradient was 3%. The dominant substrate was cobbles with boulders sub-dominant. There were abundant undercut banks available for cover. Some patches of gravel were present suitable for rainbow, steelhead and coho spawning. Occasional deep pools were present suitable for juvenile rearing and overwintering. Riparian vegetation was mixed deciduous and conifer old growth forest. The habitat was rated as high value for salmonid rearing and spawning.

Figure 5.22: Left: Typical habitat downstream of PSCIS crossing 58067. Right: Typical habitat downstream of PSCIS crossing 58067.

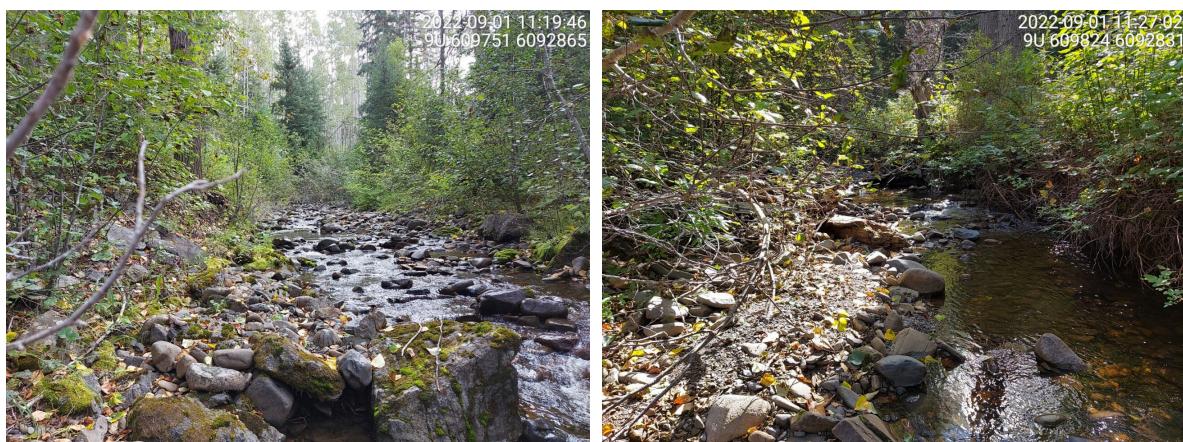
The stream was surveyed upstream from crossing 58067 for 600m (Figure 5.23 - 5.24). The dominant substrate was cobbles with gravels sub-dominant. The average channel width was 5.7m, the average wetted width was 4m, and the average gradient was 3%. Total cover amount was rated as moderate with boulders dominant. Cover was also present as small woody debris and undercut

Figure 5.23: Left: Typical habitat upstream of PSCIS crossing 58067. Right: Typical habitat upstream of PSCIS crossing 58067.

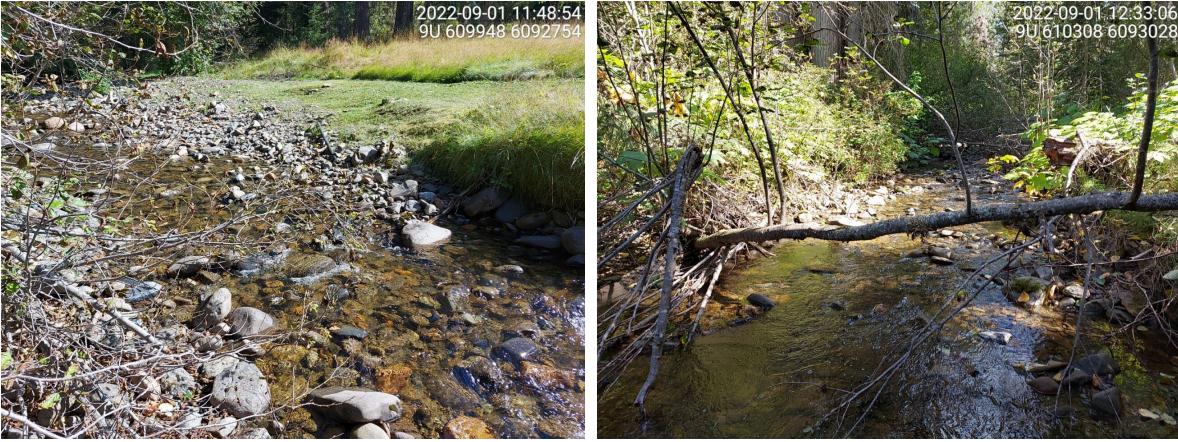
Figure 5.24: Left: Typical habitat upstream of PSCIS crossing 58067. Right: Typical habitat upstream of PSCIS crossing 58067.

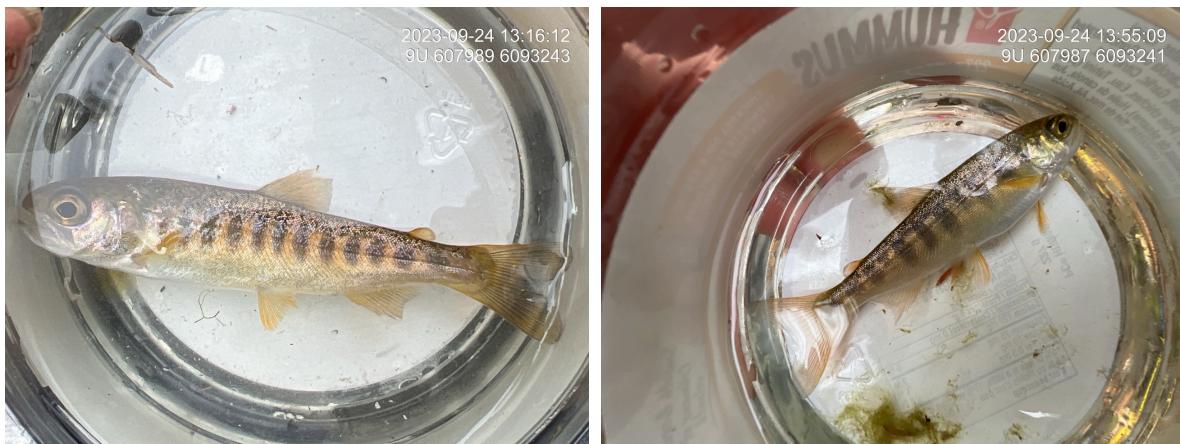
Figure 5.26: Left: Coho parr captured below the lower rock outcrop and rock chute with dip nets during 2023 sampling. Right: Coho parr captured below the lower rock outcrop and rock chute with dip nets during 2023 sampling.
