# **Upper Elk River and Flathead River Fish Passage Restoration Planning**

**Prepared for  
Canadian Wildlife Federation  
350 Michael Cowpland Dr  
Kanata, ON K2M 2W1**

**Version 1.4**

**2021-02-02**

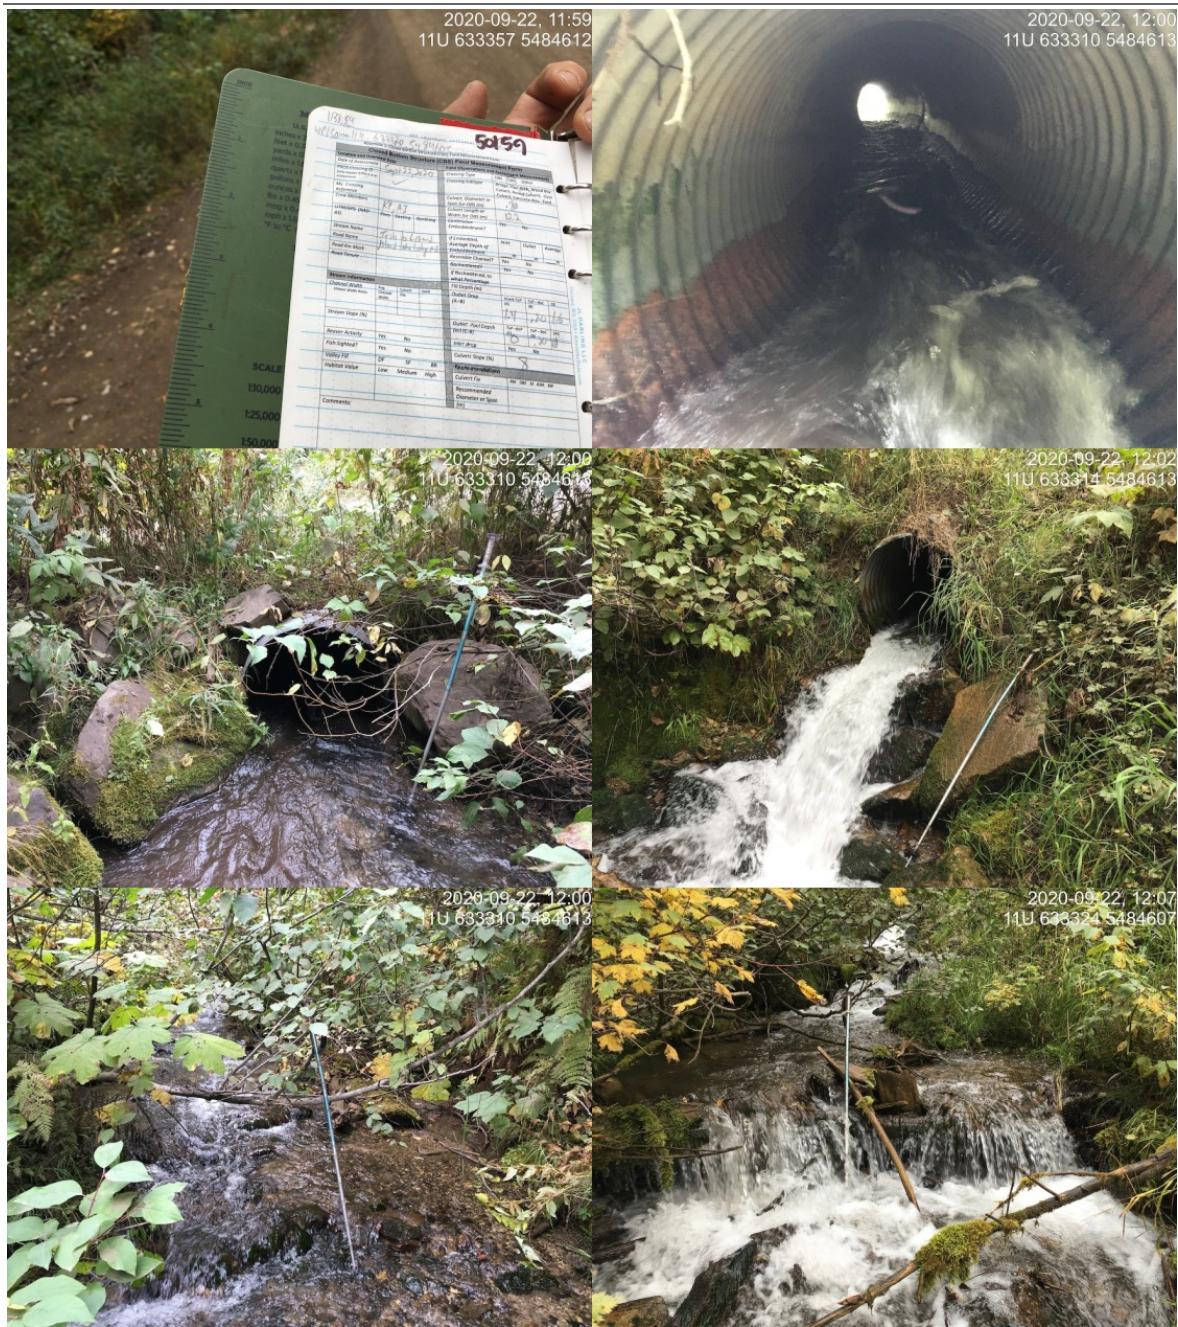
Table 5.8: Summary of habitat details for PSCIS crossing 50159.

At the crossing location, the stream had good flow and is located within an area of old growth cedar adjacent to a recreation trail. At the time of the survey the stream was the highest volume tributary to Lizard Creek located on the east side of the valley. No fisheries information was available for the stream (MoE 2020d), however, Lizard Creek supports westslope cutthroat trout, bull trout, mountain whitefish, brook trout, longnose sucker and longnose dace (MoE 2020b). Elk River Alliance (2020) conducted redd surveys in Lizard Creek in 2019 along with Morrissey Creek, Coal Creek and Forsyth Creek. A total of 55 redds were observed within a 2.4km section of Lizard Creek comprising the largest densities of redds of the four tributaries surveyed (22.9 redds/km).

Structure replacement with a bridge is recommended to provide access to the habitat located upstream of PSCIS crossing 50159. The cost of the work is estimated at \$125,000 for a cost benefit of 2.8 linear m/\$1000 and 8.4m<sup>2</sup>/\$1000.

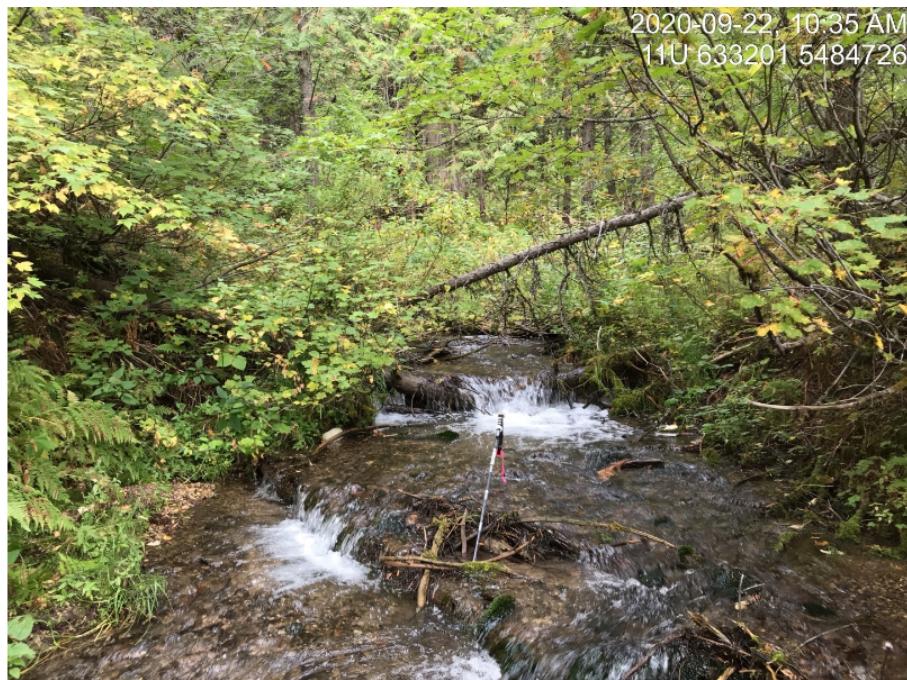
The stream was surveyed upstream from the culvert for 400m. Overall, total cover amount was rated as moderate with undercut banks dominant. Cover was also present as small woody debris, large woody debris, and deep pools (Table 5.4, Figure 5.5). The average channel width was 3m, the average wetted width was 2.6m and the average gradient was 11.2%. There were abundant gravels suitable for resident and fluvial westslope cutthroat trout spawning. Frequent pools to 40cm deep were present and associated with small and large woody debris. The stream contained relatively flatter sections from 3 - 8% and steeper sections of 15 - 18% for first 350m above culvert where the stream becomes too steep for upstream salmonid passage (35% - UTM: 11 U 632810 5484842). Habitat was rated as high value for salmonid rearing and spawning.

Figure 5.7: Typical habitat upstream of PSCIS crossing 50159.

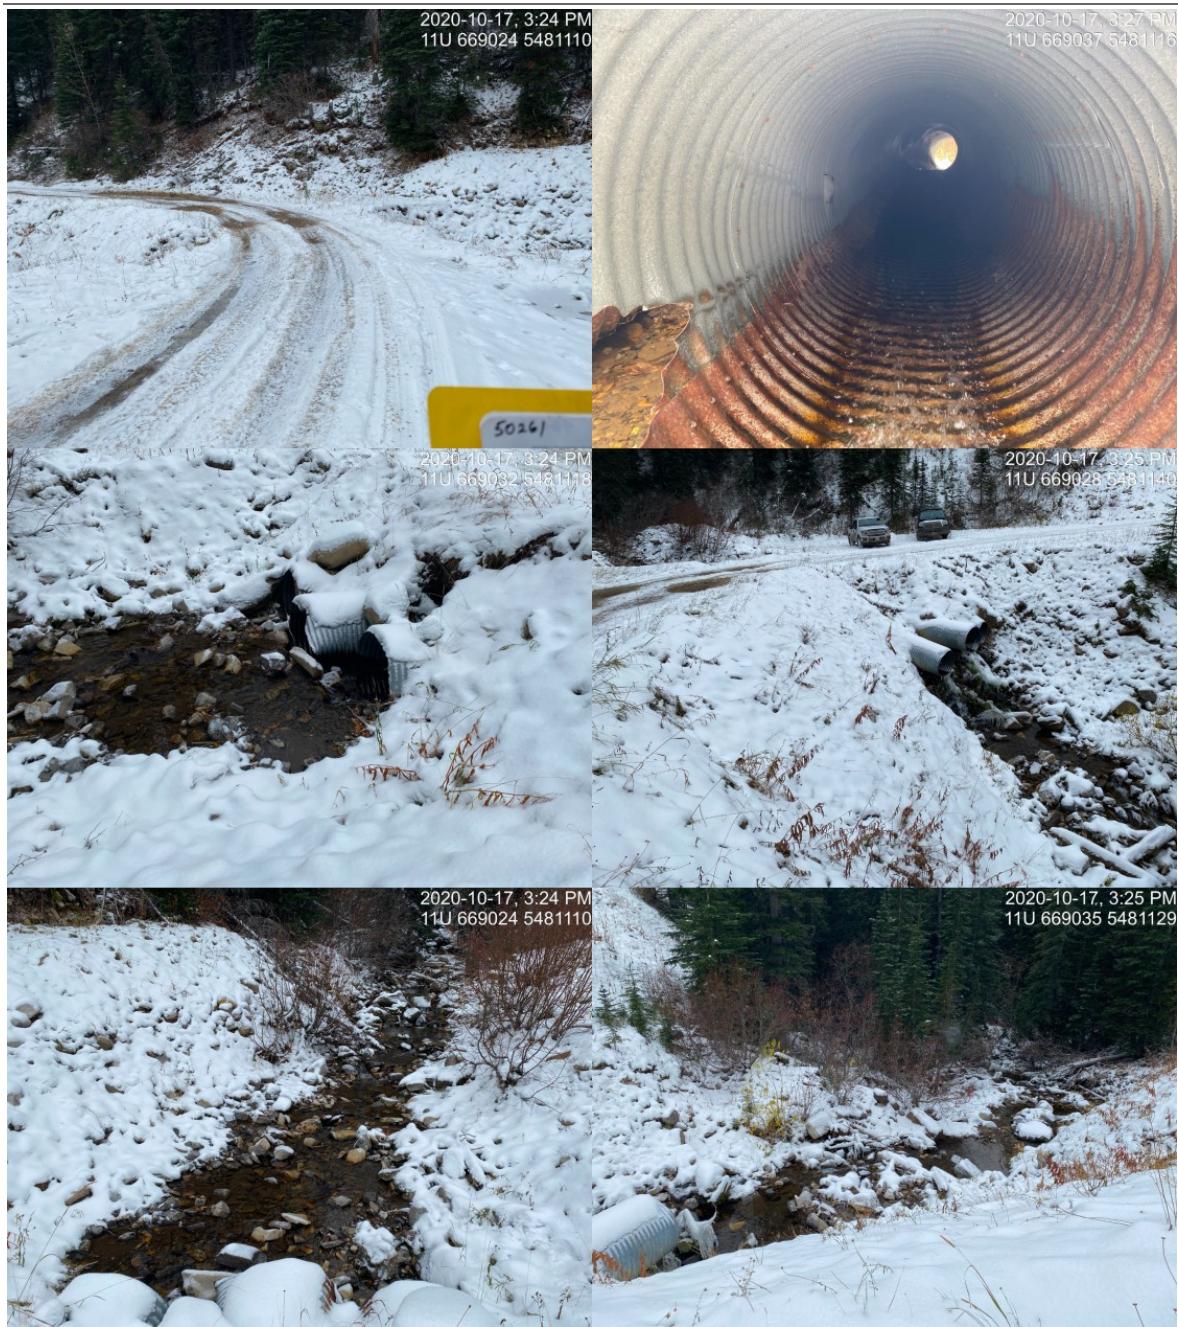
Location and Stream Data		Crossing Characteristics –	
Date	2020-10-17	Crossing Sub Type	Round Culvert
PSCIS ID	50261	Diameter (m)	2.7
External ID	–	Length (m)	19
Crew	AI, MF	Embedded	No
UTM Zone	11	Depth Embedded (m)	–
Easting	669027	Resemble Channel	No
Northing	5481115	Backwatered	No
Stream	Tributary to Michel Creek	Percent Backwatered	–
Road	Flathead FSR	Fill Depth (m)	3
Road Tenure	–	Outlet Drop (m)	1.8
Channel Width (m)	4.6	Outlet Pool Depth (m)	0
Stream Slope (%)	12	Inlet Drop	Yes
Beaver Activity	No	Slope (%)	12
Habitat Value	Low	Valley Fill	Deep Fill
Photos: From top left clockwise: Road/Site Card, Barrel, Outlet, Downstream, Upstream, Inlet.

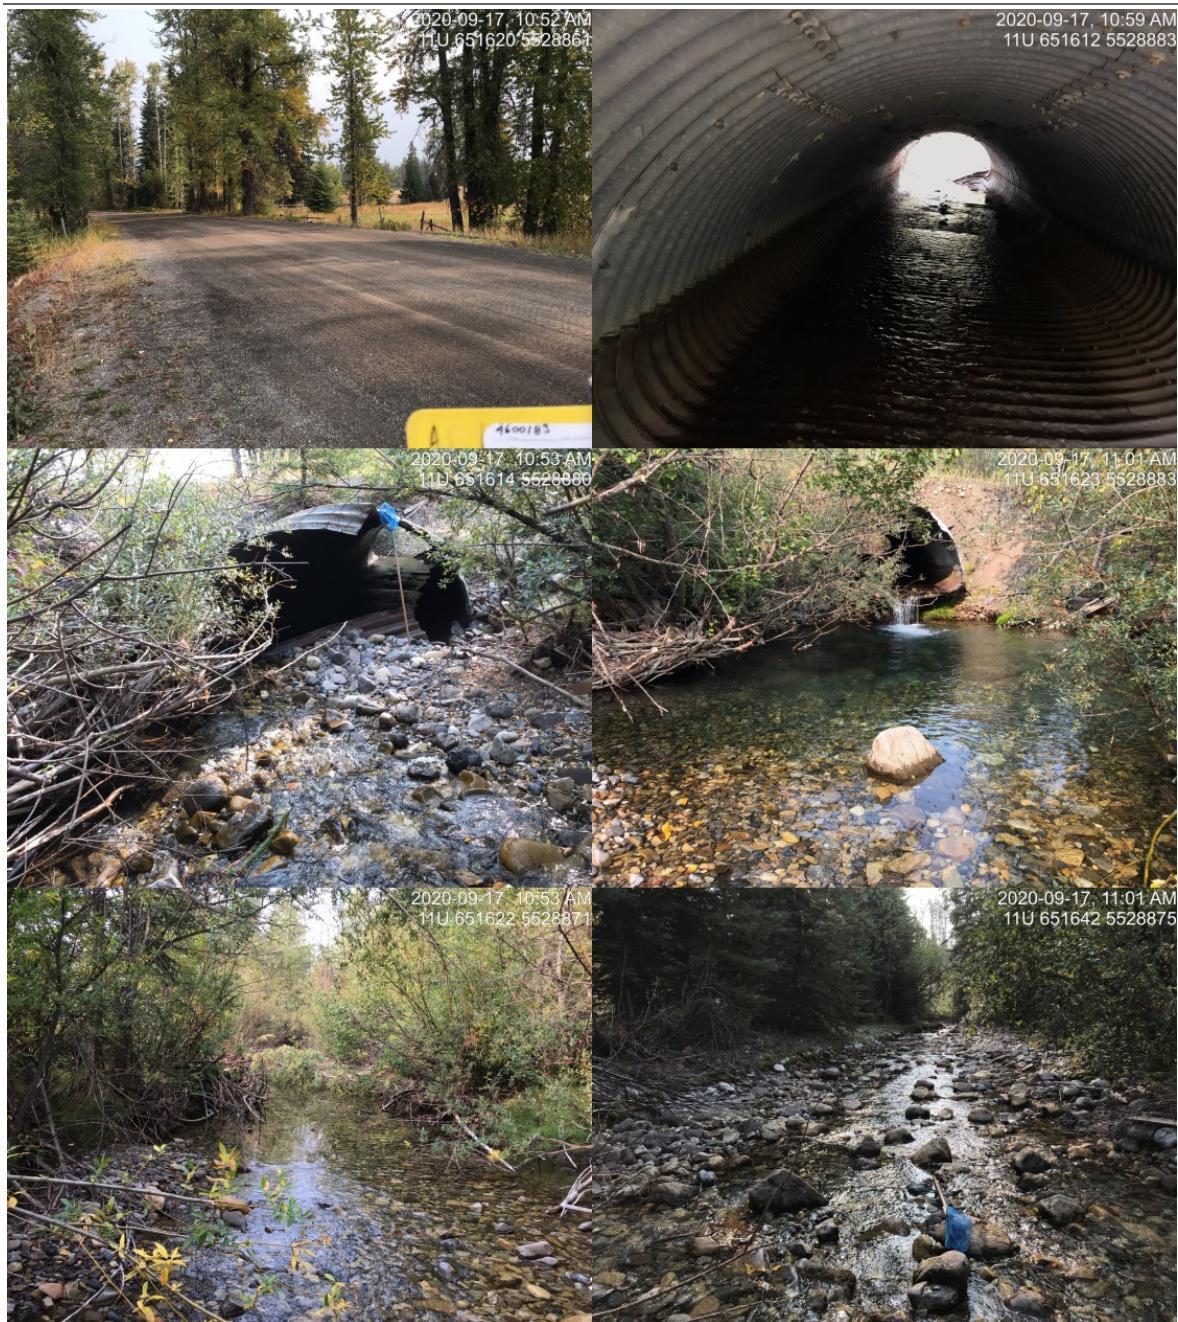
**Table 5.26: Summary of fish passage reassessment for PSCIS crossing 197533.**

Location and Stream Data	.	Crossing Characteristics	-
Date	2020-09-17	Crossing Sub Type	Oval Culvert
PSCIS ID	197533	Diameter (m)	3.3
External ID	-	Length (m)	20
Crew	AI, KP	Embedded	No
UTM Zone	11	Depth Embedded (m)	-
Easting	651626	Resemble Channel	No
Northing	5528888	Backwatered	No
Stream	Brule Creek	Percent Backwatered	-
Road	Busato Rd	Fill Depth (m)	1
Road Tenure	MoTi local	Outlet Drop (m)	0.7
Channel Width (m)	7.1	Outlet Pool Depth (m)	1.5
Stream Slope (%)	2	Inlet Drop	Yes
Beaver Activity	No	Slope (%)	4
Habitat Value	High	Valley Fill	Deep Fill
Photos: From top left clockwise: Road/Site Card, Barrel, Outlet, Downstream, Upstream, Inlet.

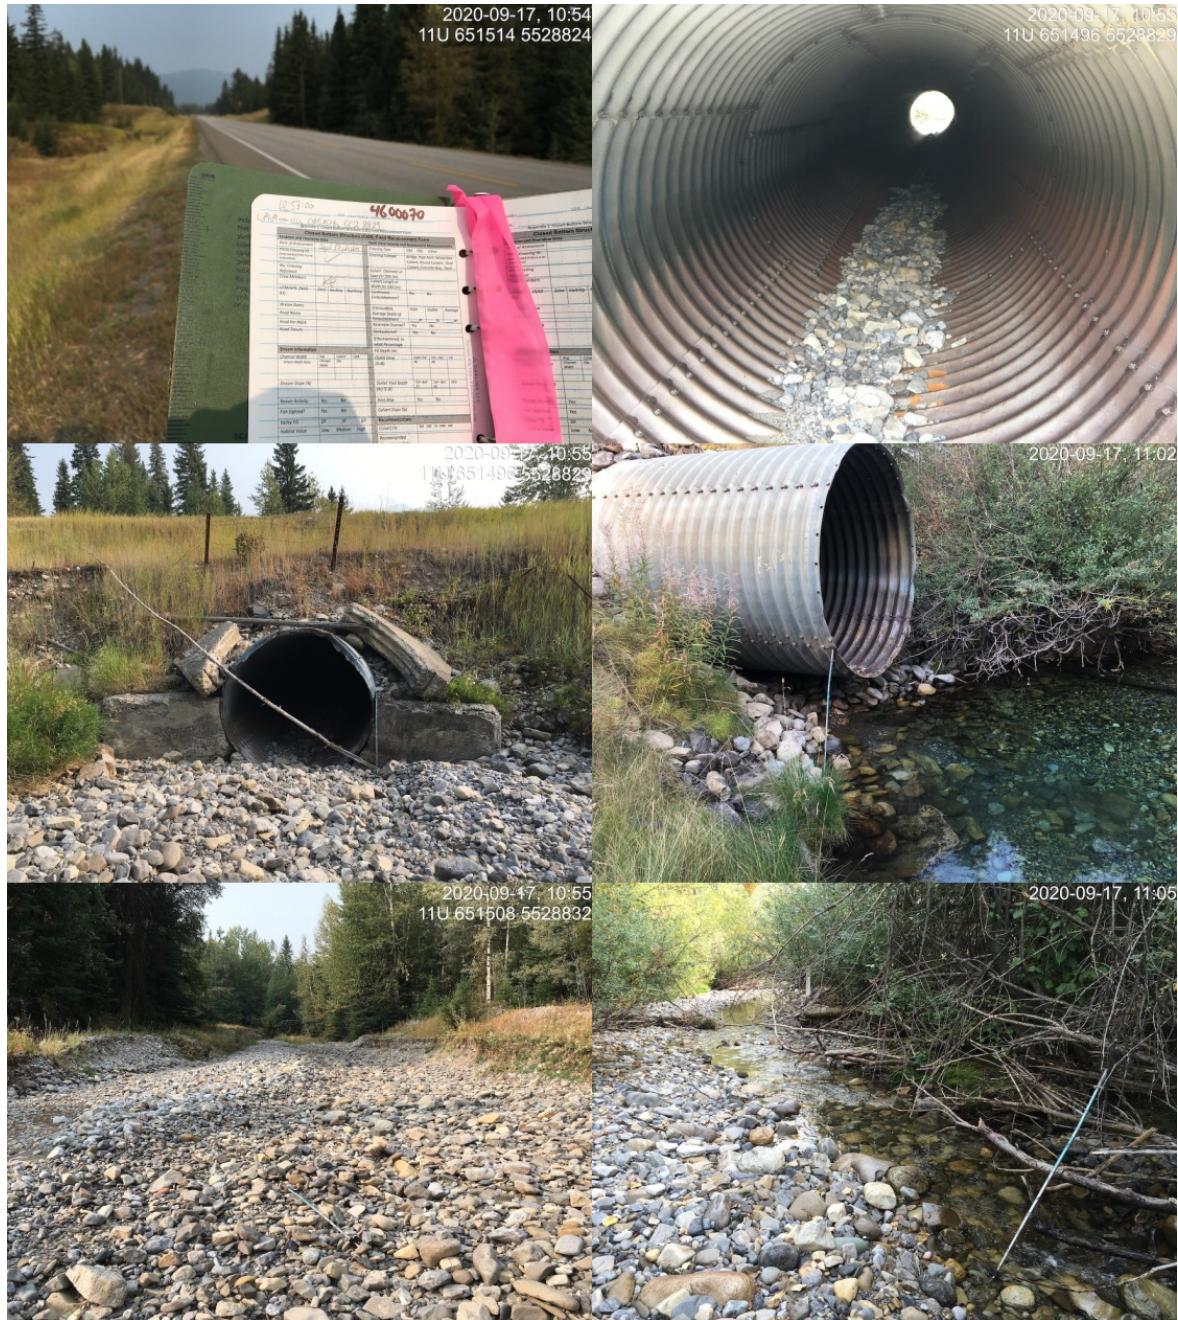
**Table 5.27: Summary of fish passage reassessment for PSCIS crossing 197559.**

Location and Stream Data	.	Crossing Characteristics	-
Date	2020-09-17	Crossing Sub Type	Round Culvert
PSCIS ID	197559	Diameter (m)	2.5
External ID	-	Length (m)	35
Crew	KP, AI	Embedded	Yes
UTM Zone	11	Depth Embedded (m)	0.05
Easting	651516	Resemble Channel	Yes
Northing	5528829	Backwatered	No
Stream	Brule Creek	Percent Backwatered	-
Road	Highway 43	Fill Depth (m)	3
Road Tenure	MoTi highway	Outlet Drop (m)	0
Channel Width (m)	6.1	Outlet Pool Depth (m)	1.7
Stream Slope (%)	1.5	Inlet Drop	No
Beaver Activity	No	Slope (%)	2.5
Habitat Value	Medium	Valley Fill	Deep Fill

Photos: From top left clockwise: Road/Site Card, Barrel, Outlet, Downstream, Upstream, Inlet.

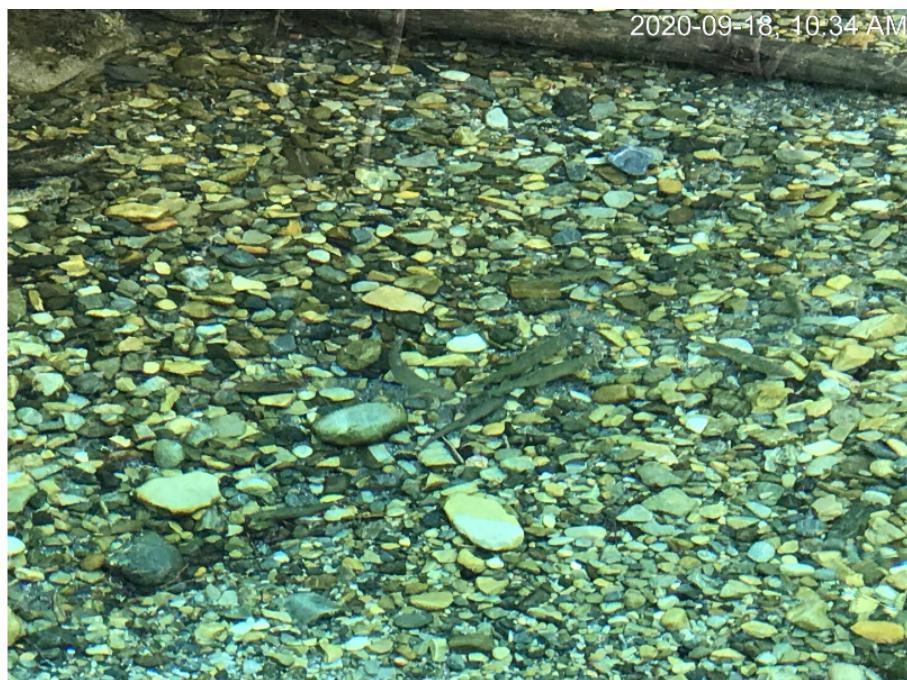
Figure 5.29: Westslope cutthroat trout in outlet pool downstream of PSCIS crossing 197559.

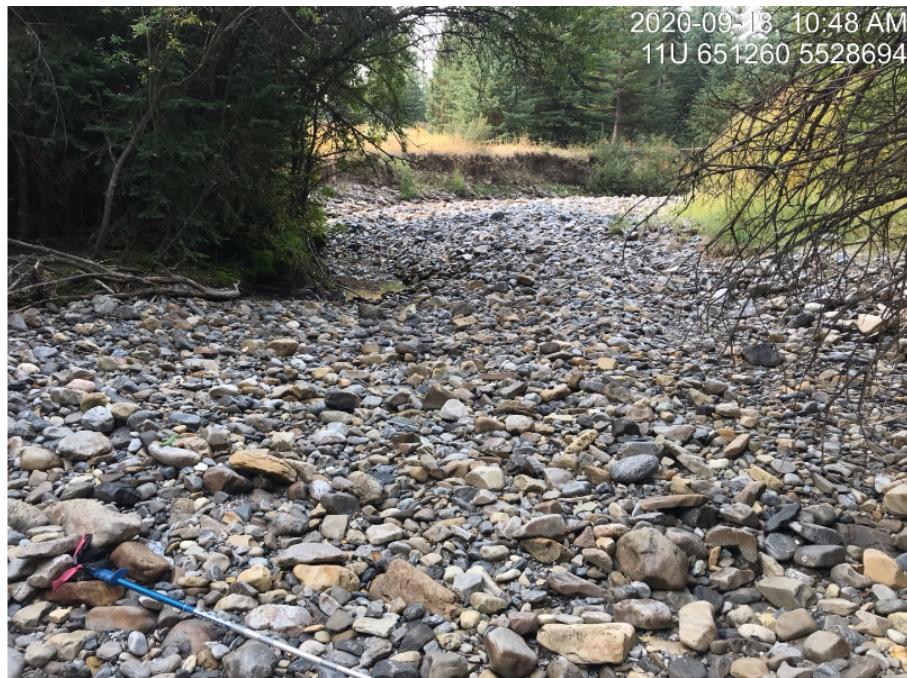
Figure 5.30: Subsurface flow area upstream of PSCIS crossing 197559.

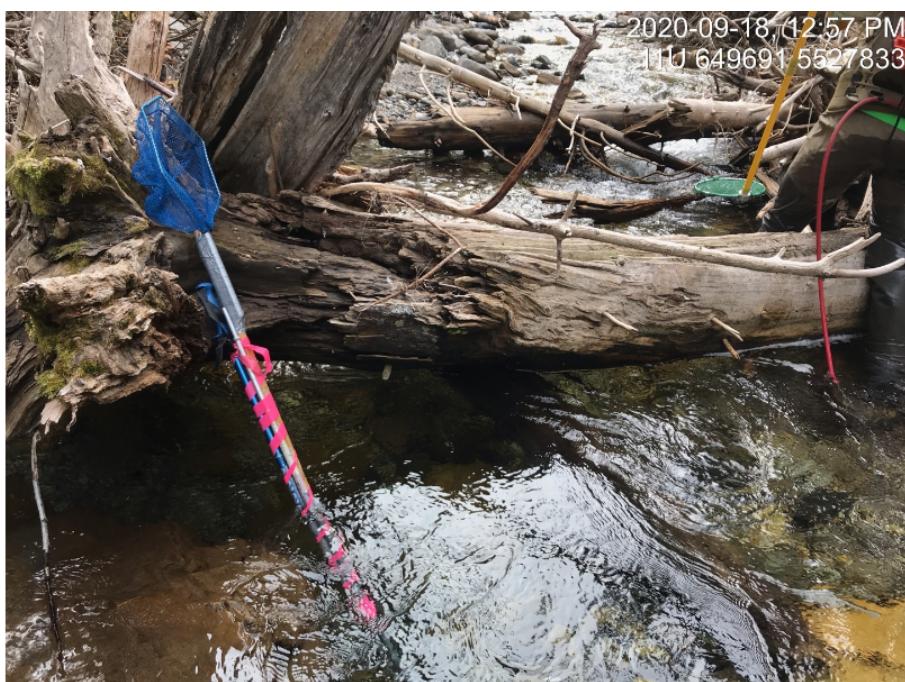
Figure 5.32: Habitat within electrofishing site upstream of PSCIS crossing 197533.

As properties on Busato Road could be accessed from either side of the road, removal of PSCIS 197533 could be explored as an option for providing access to the 125m of habitat located upstream and below PSCIS 197533. However, conservative cost estimates for replacements are \$710,000 for 197533 and \$6,100,000 for 197559. The cost benefits are estimated at 0.2 linear m/\$1000 and 1m<sup>2</sup>/\$1000 for 197533, and 3.8 linear m/\$1000 and 29m<sup>2</sup>/\$1000 for 197559.

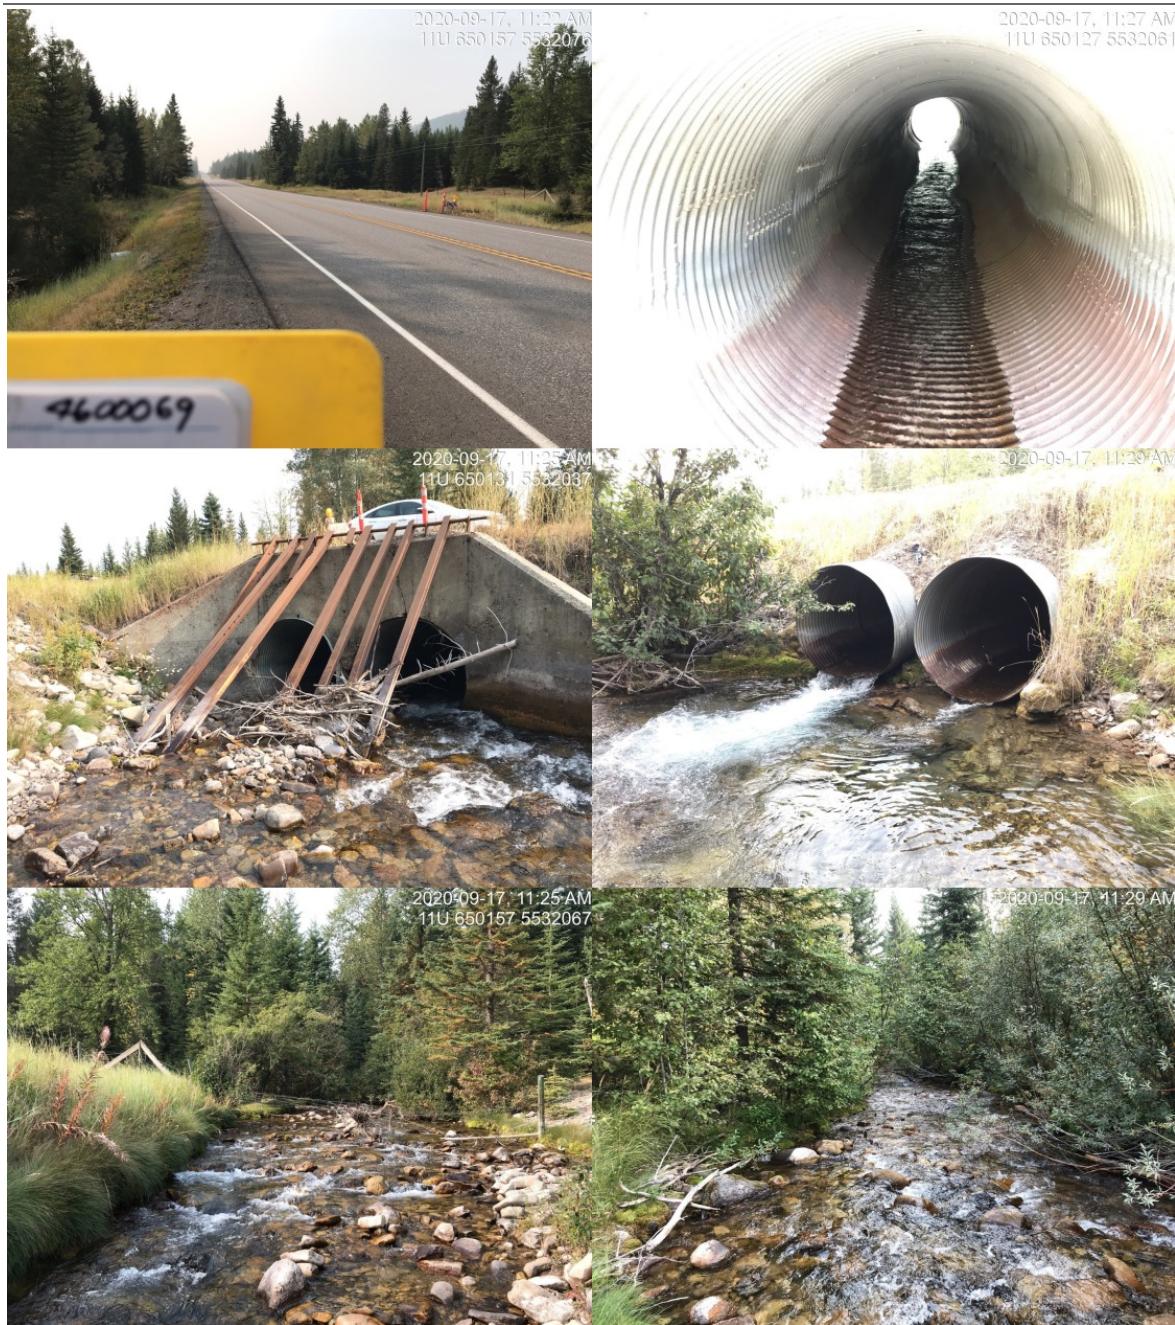
Appendix - 197534 - Weigert Creek

Photos: From top left clockwise: Road/Site Card, Barrel, Outlet, Downstream, Upstream, Inlet.

Structure replacement with a bridge is recommended to provide access to the habitat located upstream of PSCIS crossing 197534. The cost of the work is estimated at \$5,000,000 for a cost benefit of 2.3 linear m/\$1000 and  $15.3\text{m}^2/\$1000$ .

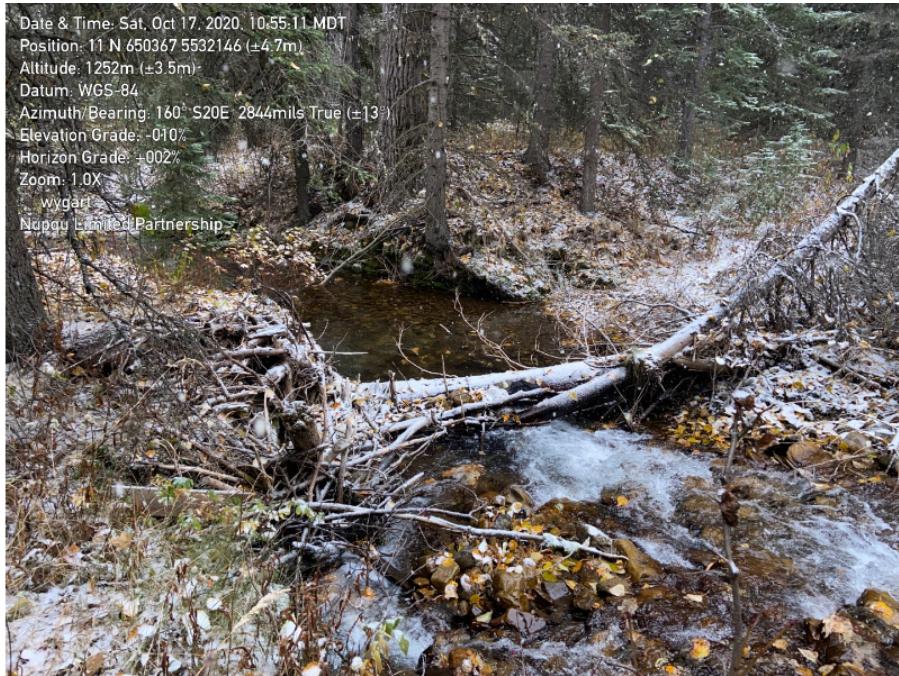
Figure 5.33: Habitat downstream of PSCIS crossing 197534.

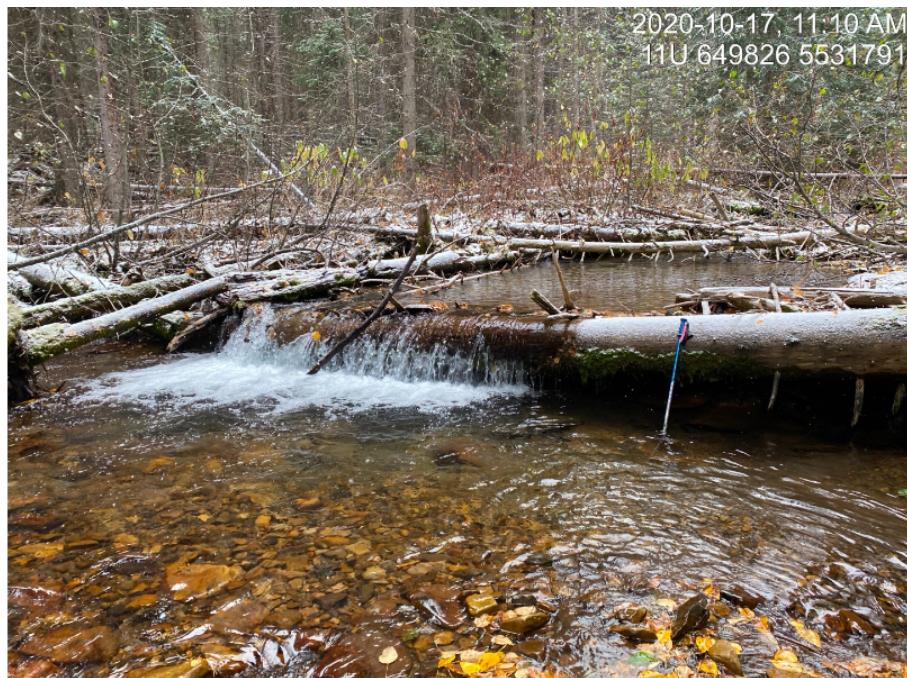
There is an estimated 11.6km of mainstem Weigert Creek habitat available upstream of PSCIS 197534 with habitat in areas surveyed rated as high value, representing an important migration corridor with high rearing and spawning potential for resident and fluvial salmonids. Highway 43 is the responsibility of the Ministry of Transportation and Infrastructure. The crossing was ranked as a high priority for proceeding to design for replacement with an open bottomed structure.

Figure 5.34: Habitat upstream of PSCIS crossing 197534.

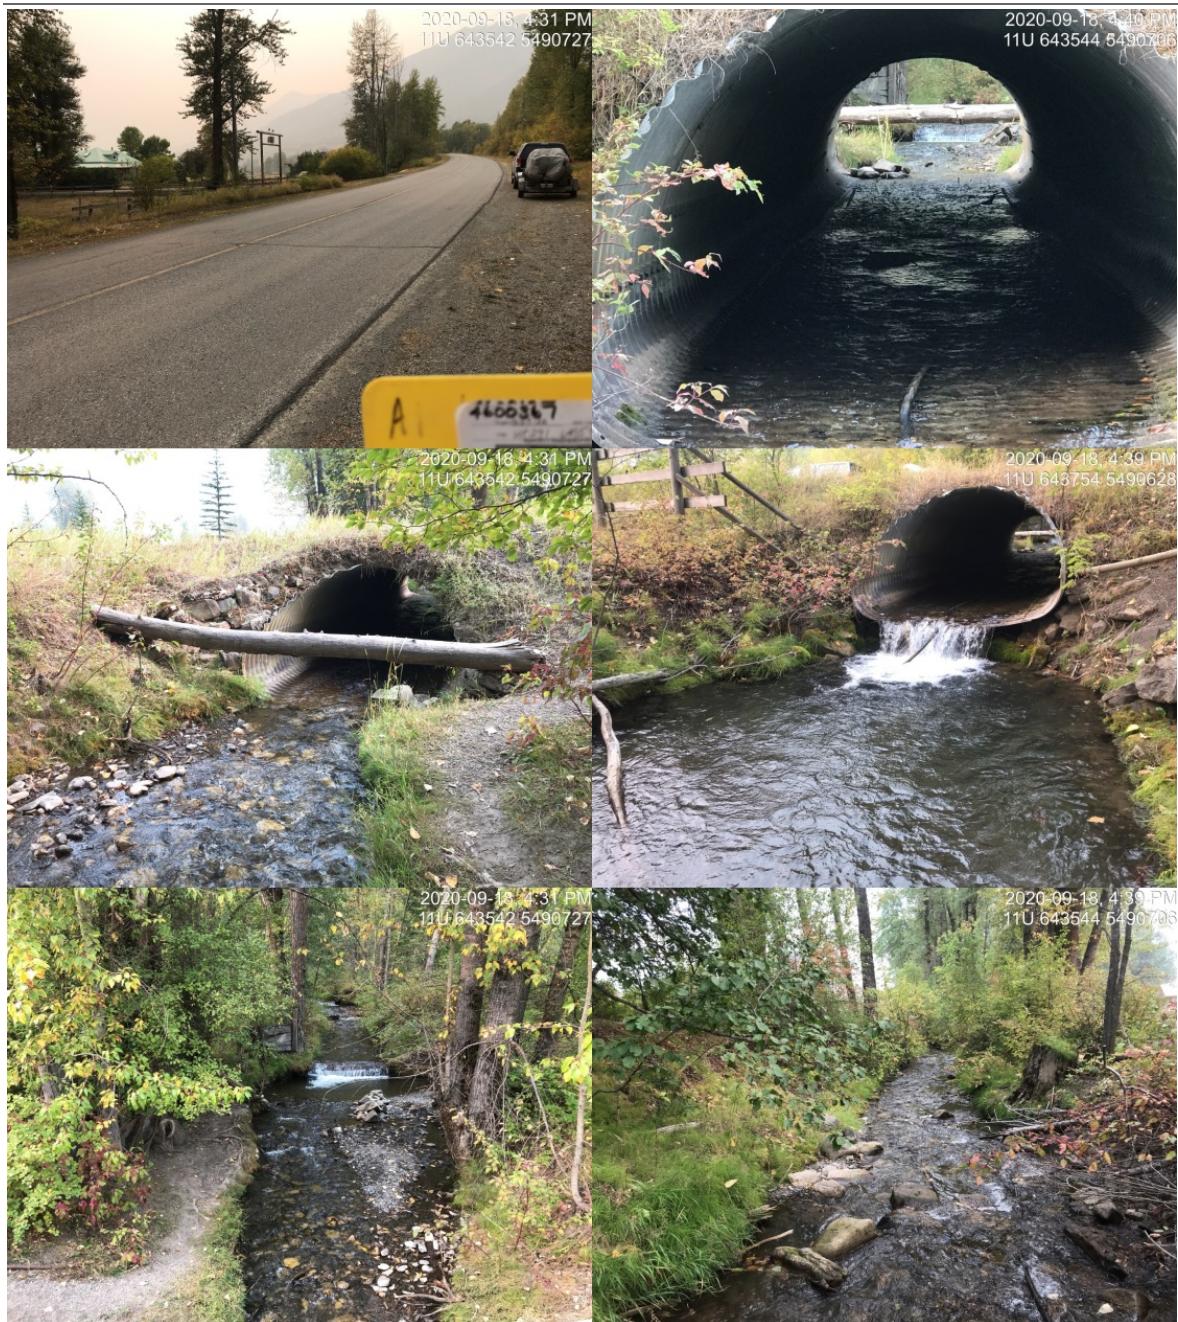
Location and Stream Data	.	Crossing Characteristics	-
Date	2020-09-18	Crossing Sub Type	Oval Culvert
PSCIS ID	197542	Diameter (m)	2.6
External ID	-	Length (m)	20
Crew	AI, KP	Embedded	No
UTM Zone	11	Depth Embedded (m)	-
Easting	643534	Resemble Channel	No
Northing	5490723	Backwatered	No
Stream	Hartley Creek	Percent Backwatered	-
Road	Dicken Road	Fill Depth (m)	0.4
Road Tenure	MoTi collector	Outlet Drop (m)	0.4
Channel Width (m)	3.5	Outlet Pool Depth (m)	0.8
Stream Slope (%)	1	Inlet Drop	No
Beaver Activity	No	Slope (%)	2
Habitat Value	High	Valley Fill	Deep Fill
Photos: From top left clockwise: Road/Site Card, Barrel, Outlet, Downstream, Upstream, Inlet.

Structure replacement with an open bottomed structure is recommended to provide access to the habitat located upstream of PSCIS crossing 197542. The cost of the work is estimated at \$1,000,000 for a cost benefit of 7.2 linear m/\$1000 and  $43.9\text{m}^2/\$1000$ .

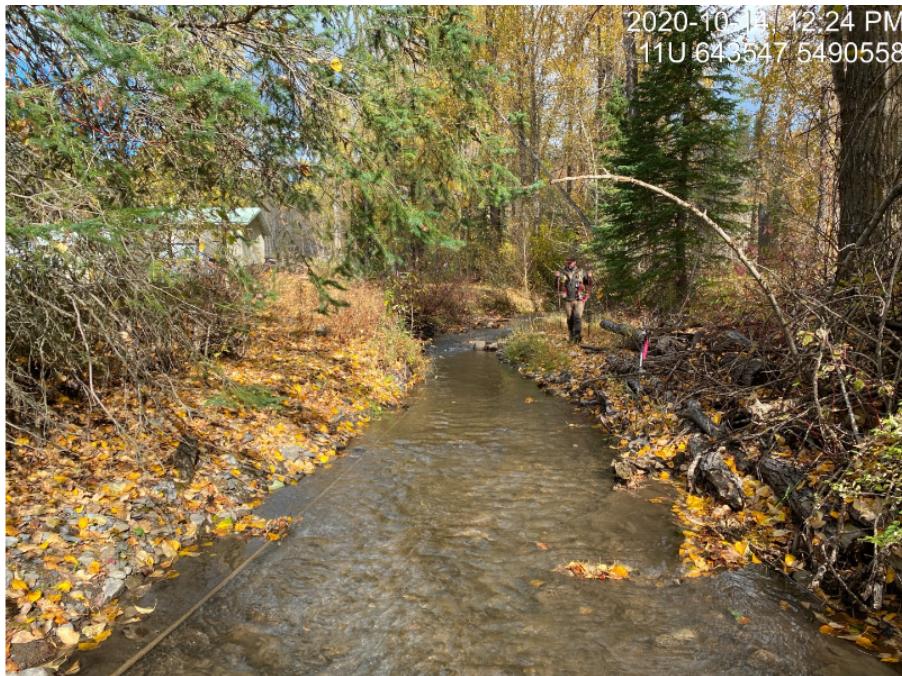
Figure 5.35: Typical habitat downstream of PSCIS crossing 197542.

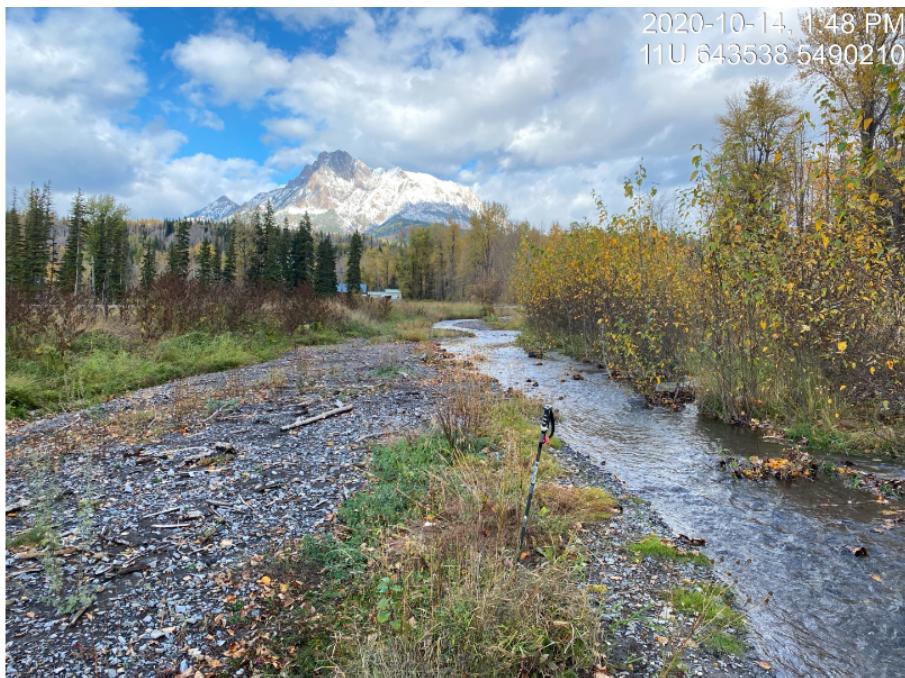
Figure 5.36: Typical habitat downstream of PSCIS crossing 197582.

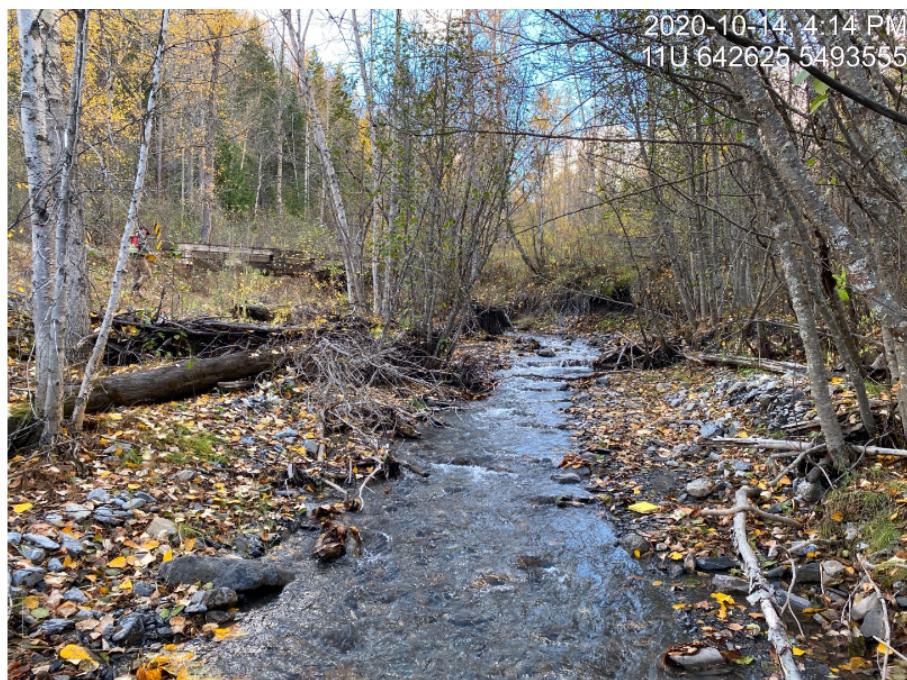
Within the 75m section of stream surveyed 2.5km upstream of Dicken Road, stream conditions were similiar to those observed downstream with an average channel width of 4.6m and gravel dominated substrate (Figure [5.39](#)). Overall, upstream of PSCIS 197542 was rated as high habitat value, containing habitat with moderate rearing and spawning potential for resident and fluvial salmonids.

Figure 5.39: Habitat upstream of PSCIS crossing 197542 approximatley 2.5km.

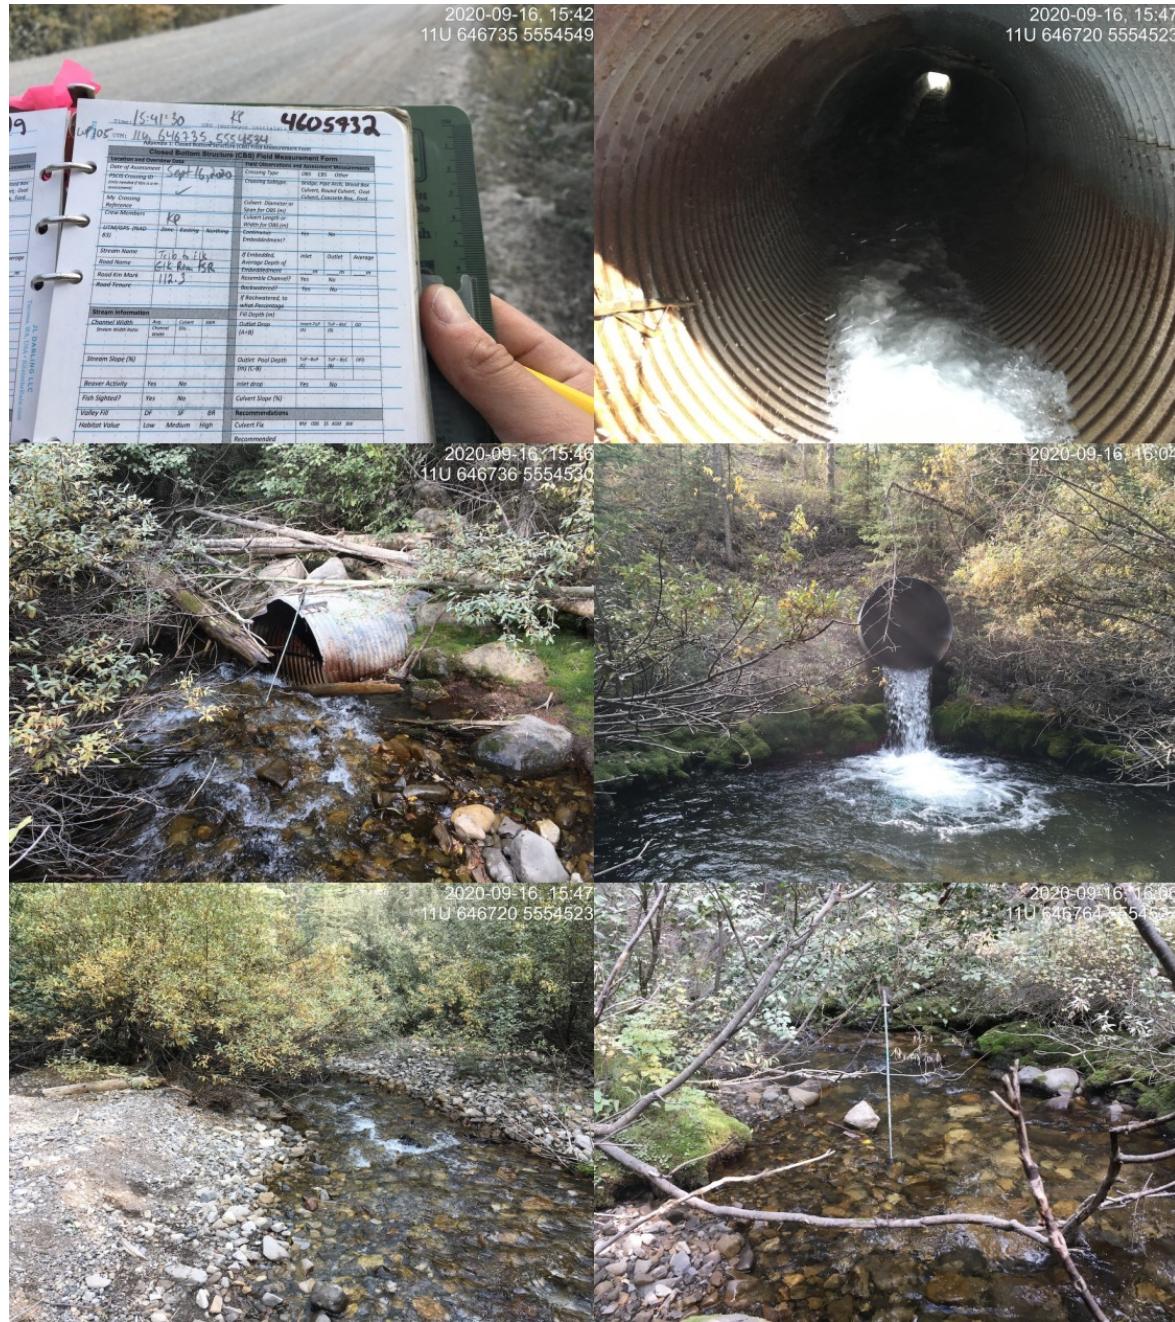
Appendix - 197555 - Tributary to Elk R...

Location and Stream Data		Crossing Characteristics –	
Date	2020-09-16	Crossing Sub Type	Round Culvert
PSCIS ID	197555	Diameter (m)	1.5
External ID	–	Length (m)	49
Crew	KP, AI	Embedded	No
UTM Zone	11	Depth Embedded (m)	–
Easting	646735	Resemble Channel	No
Northing	5554534	Backwatered	No
Stream	Tributary to Elk River	Percent Backwatered	–
Road	Elk River FSR	Fill Depth (m)	8
Road Tenure	FLNR 0103	Outlet Drop (m)	1.48
Channel Width (m)	3.5	Outlet Pool Depth (m)	1.3
Stream Slope (%)	1.5	Inlet Drop	Yes
Beaver Activity	No	Slope (%)	3.5
Habitat Value	High	Valley Fill	Deep Fill
Photos: From top left clockwise: Road/Site Card, Barrel, Outlet, Downstream, Upstream, Inlet.

Structure replacement with an open bottomed culvert is recommended to provide access to the habitat located upstream of PSCIS crossing 197555. Due to the large amount of fill on the road (8m) the size of a replacement bridge was estimated at 25m. The cost for work is estimated at \$312,000 for a cost benefit of 19.2linear m/\$1000 and 113.5m<sup>2</sup>/\$1000.

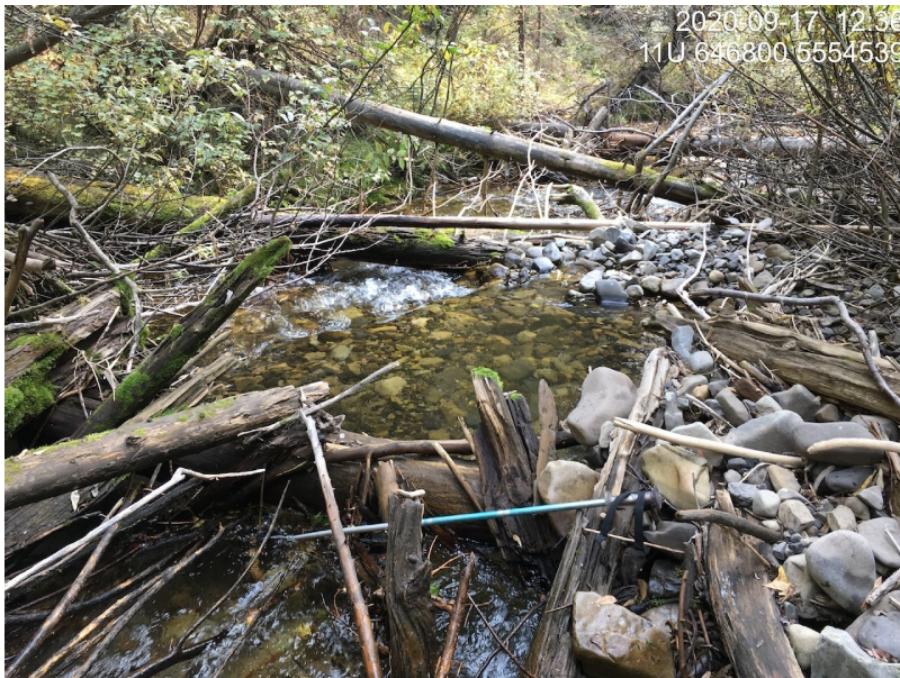
Figure 5.40: Typical habitat downstream of PSCIS crossing 197555.

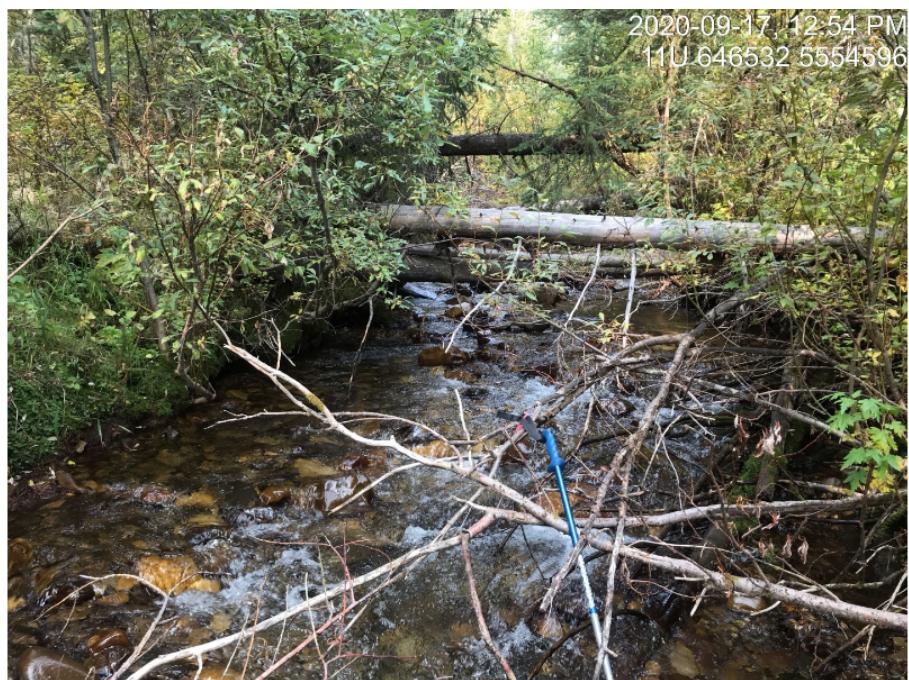
There is an estimated 6km of mainstem habitat upstream of crossing 197555 with habitat in the areas surveyed rated as high value for fry and juvenile salmonid rearing. However, fish sampling results indicate that westslope cutthroat trout are not currently utilizing the stream and densities of bull trout are very low. This could be the result of the cold water conditions due to the positioning of the watershed at high elevation in the generally cold Rocky Mountain setting. Elk River FSR is a forest tenure licensee road of the Ministry of Forests, Lands, Natural Resource Operations & Rural Development. The crossing was ranked as a moderate priority for proceeding to design for replacement with an open bottomed structure.

Figure 5.41: Typical habitat upstream of PSCIS crossing 197555.

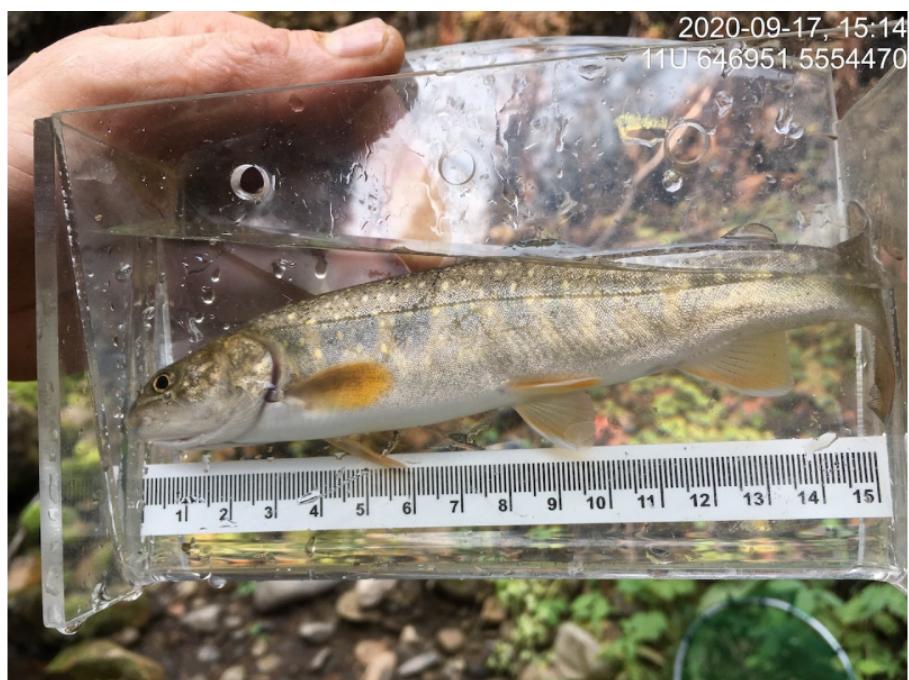
Figure 5.42: Bull trout captured downstream of PSCIS crossing 197555.
