# **Upper Elk River and Flathead River Fish Passage Restoration Planning**

**Version 1.2**

**2021-01-30**

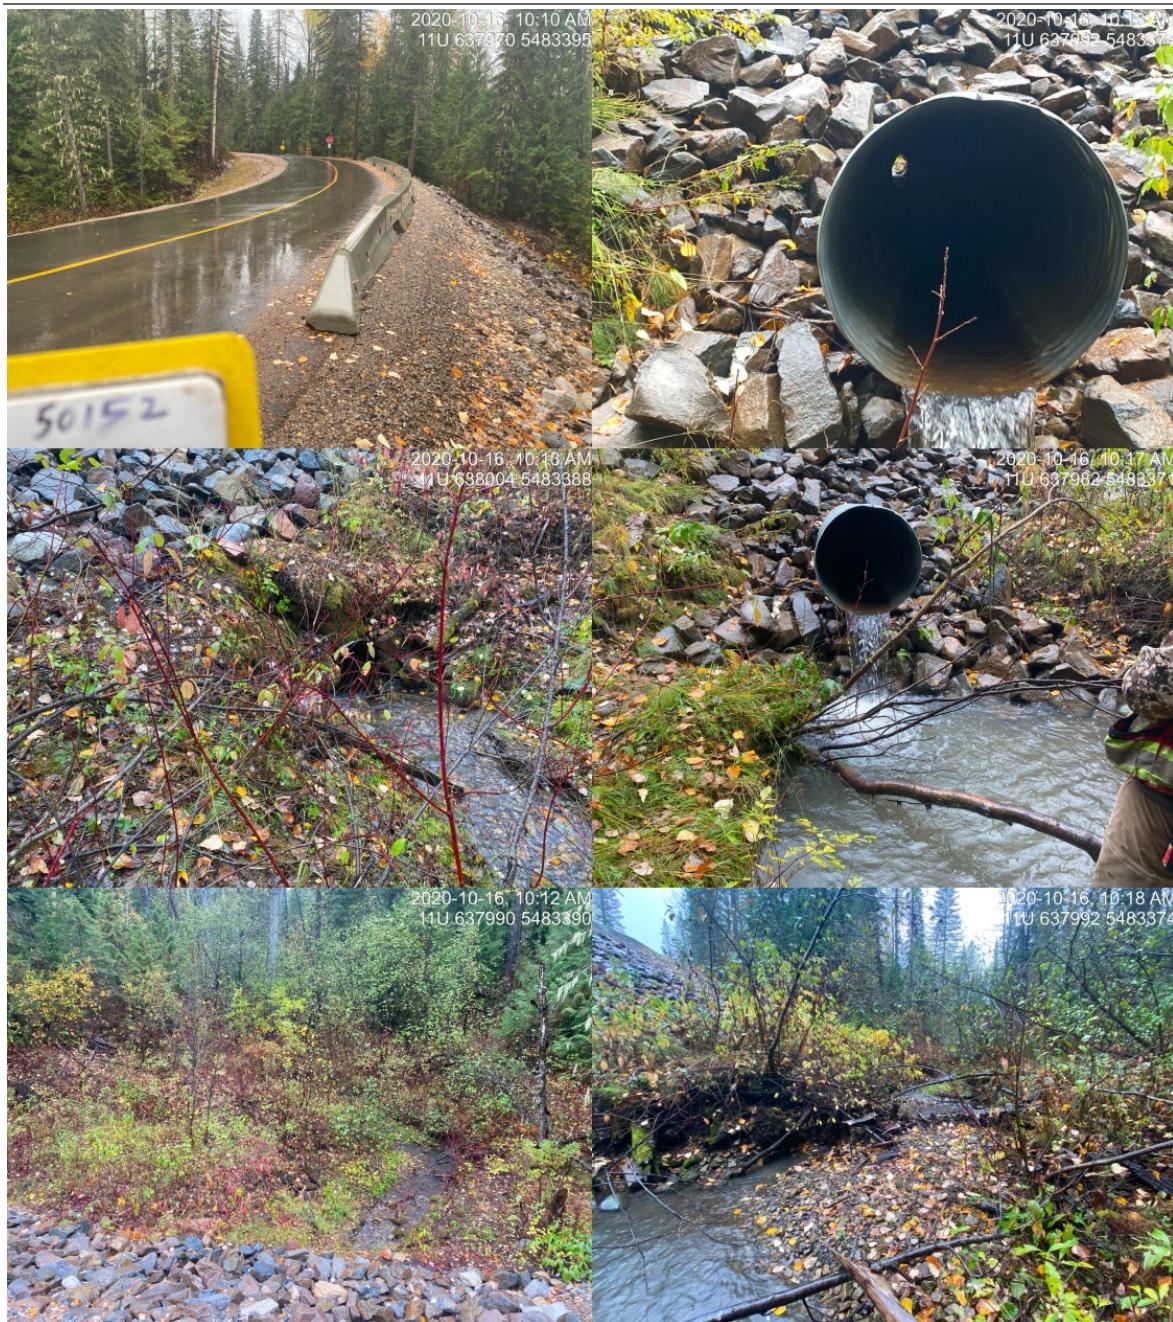
As noted, the culvert located at PSCIS 50152 appeared to have been replaced in 2020 with fresh rock, road fill and pavement present. At the time of the survey, the un-embedded and non-backwatered 0.9m diameter crossing was considered a barrier to upstream fish passage with a pipe length of 30m, a culvert slope of 1.5%, a stream width ratio of 2.9 and an outlet drop of 0.9m (Table 5.1). Water temperature was 5°C, pH was 8.5 and conductivity was 286uS/cm.

The stream was surveyed downstream from the culvert for 140m to Lizard Creek. Overall, total cover amount was rated as moderate with undercut banks dominant. Cover was also present as small woody debris, large woody debris, and overhanging vegetation (Table [5.2](#), Figure [5.1](#)). The average channel width was 2.7m, the average wetted width was 2.1m and the average gradient was 4%. The dominant substrate was cobbles with gravels subdominant. Downstream of the crossing, numerous fry were observed, there were frequent sections of gravels suitable for salmonid spawning and there were no barriers or obstacles to fish passage. Habitat was rated as high value for fry/juvenile salmonid rearing.

The stream was surveyed upstream from the culvert for 675m. Overall, total cover amount was rated as moderate with undercut banks dominant. Cover was also present as small woody debris, large woody debris, deep pools, and overhanging vegetation (Table [5.2](#), Figure [5.2](#)). The average channel width was 2.6m, the average wetted width was 2m and the average gradient was 3%. There were numerous fry observed throughout the area surveyed and abundant gravels suitable for resident westslope cutthroat trout spawning were noted. Habitat value was rated as high for salmonid rearing and spawning.

Structure replacement with a bridge is recommended to provide access to the habitat located upstream of PSCIS crossing 50152. The cost of the work is estimated at \$438,000 for a cost benefit of 6.2 linear m/\$1000 and 16m<sup>2</sup>/\$1000.

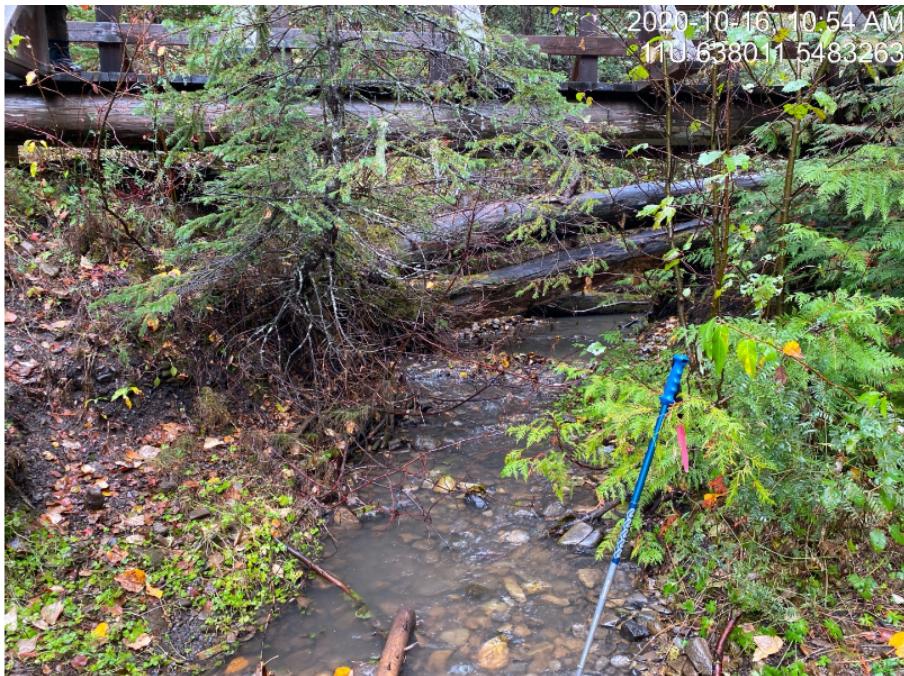
Figure 5.1: Typical habitat downstream of PSCIS crossing 50152.

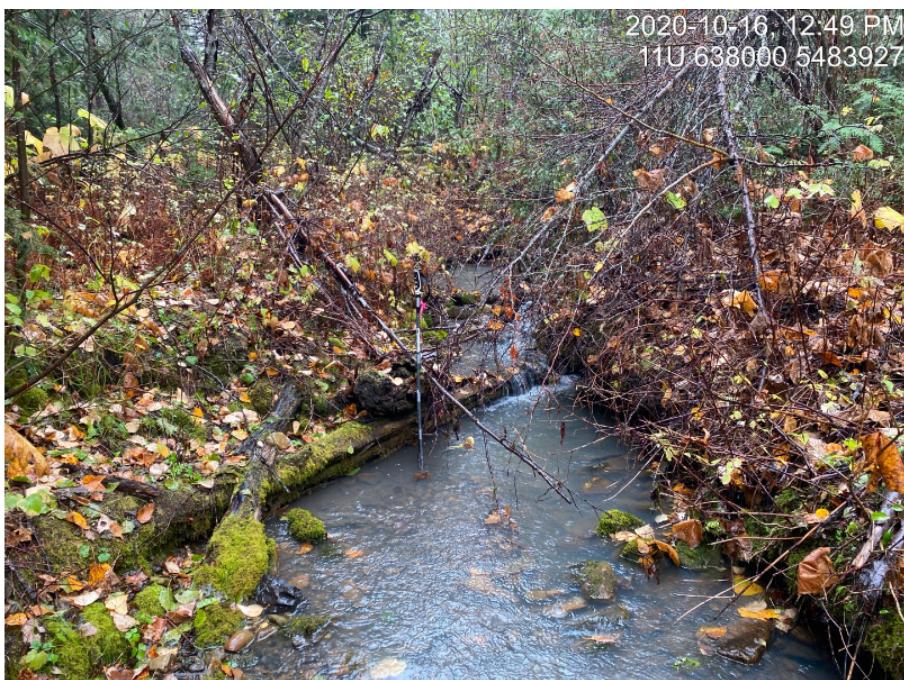
Figure 5.2: Typical habitat upstream of PSCIS crossing 50152.

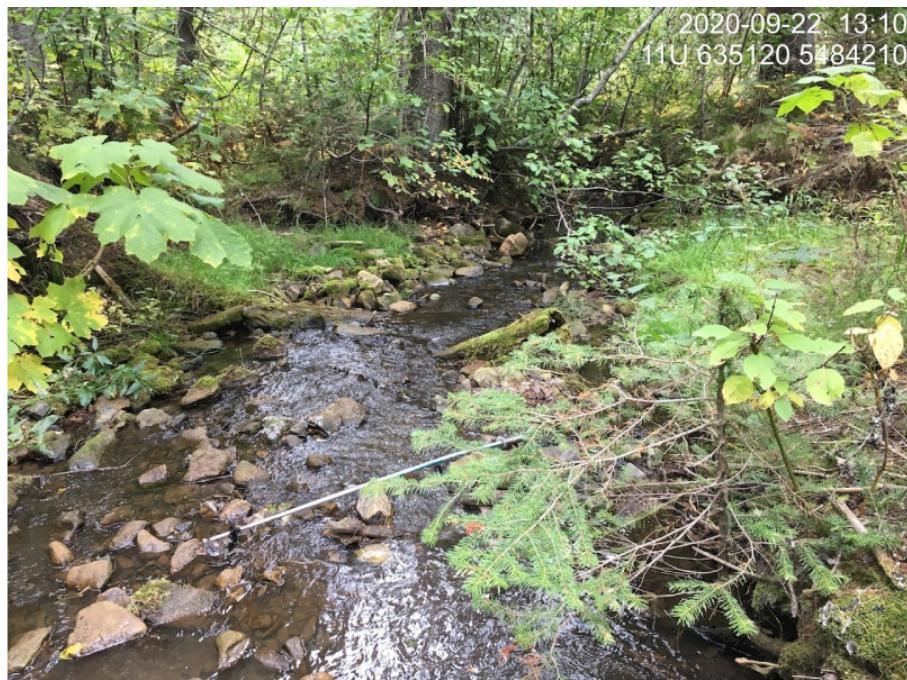
Figure 5.4: Typical habitat downstream of PSCIS crossing 50155.

Structure replacement with a bridge is recommended to provide unconstrained access to the habitat located upstream of PSCIS crossing 50155. The cost of the work is estimated at \$125,000 for a cost benefit of 14.4 linear m/\$1000 and 31.7m<sup>2</sup>/\$1000.

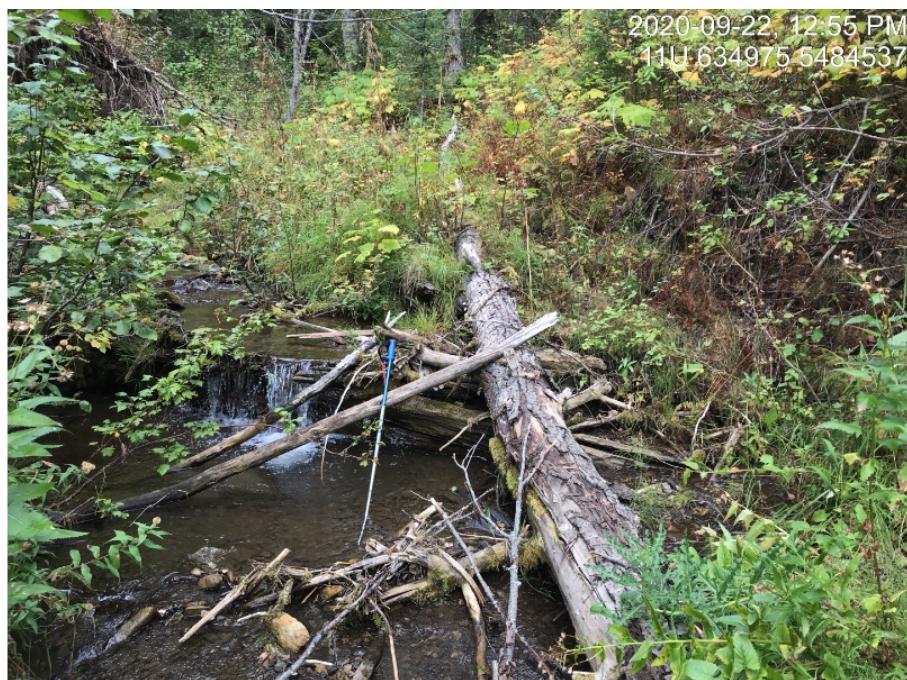
Figure 5.5: Typical habitat upstream of PSCIS crossing 50155.

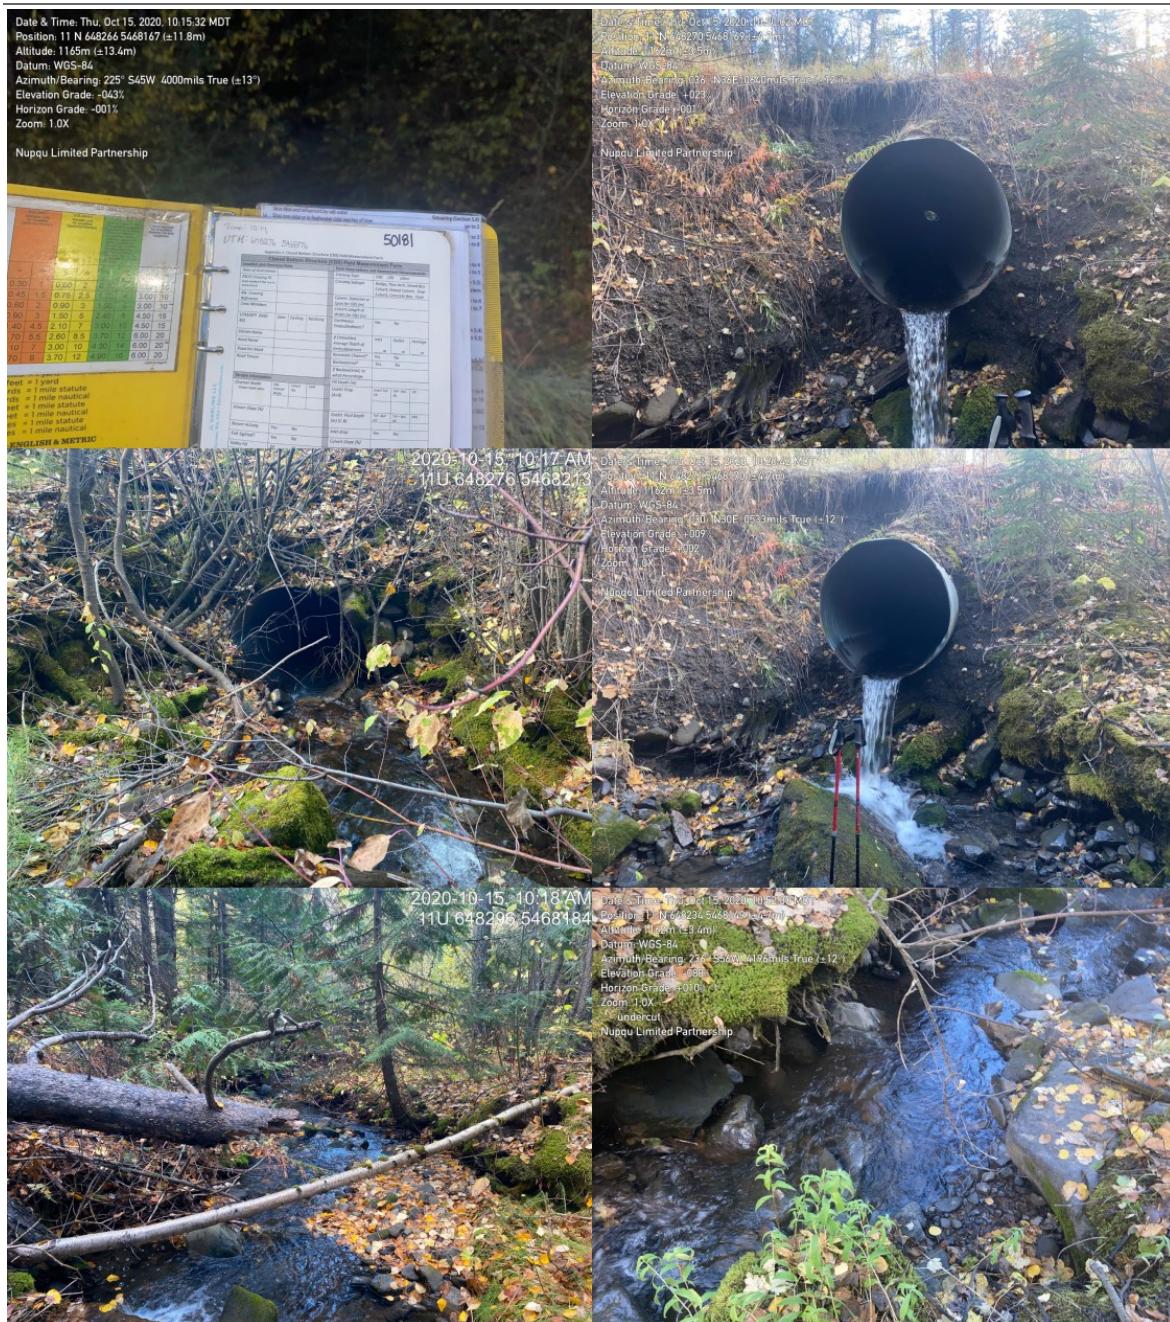
<b>Location and Stream Data</b>	.	<b>Crossing Characteristics –</b>	
Date	2020-10-15	Crossing Sub Type	Round Culvert
PSCIS ID	50181	Diameter (m)	1.2
External ID	–	Length (m)	30
Crew	MF, AI	Embedded	No
UTM Zone	11	Depth Embedded (m)	–
Easting	648276	Resemble Channel	No
Northing	5468176	Backwatered	No
Stream	Tributary to Morrissey Creek	Percent Backwatered	–
Road	Lodgepole FSR	Fill Depth (m)	3
Road Tenure	–	Outlet Drop (m)	0.95
Channel Width (m)	2.6	Outlet Pool Depth (m)	0.18
Stream Slope (%)	7	Inlet Drop	No
Beaver Activity	No	Slope (%)	7
Habitat Value	Medium	Valley Fill	Deep Fill
Photos: From top left clockwise: Road/Site Card, Barrel, Outlet, Downstream, Upstream, Inlet.

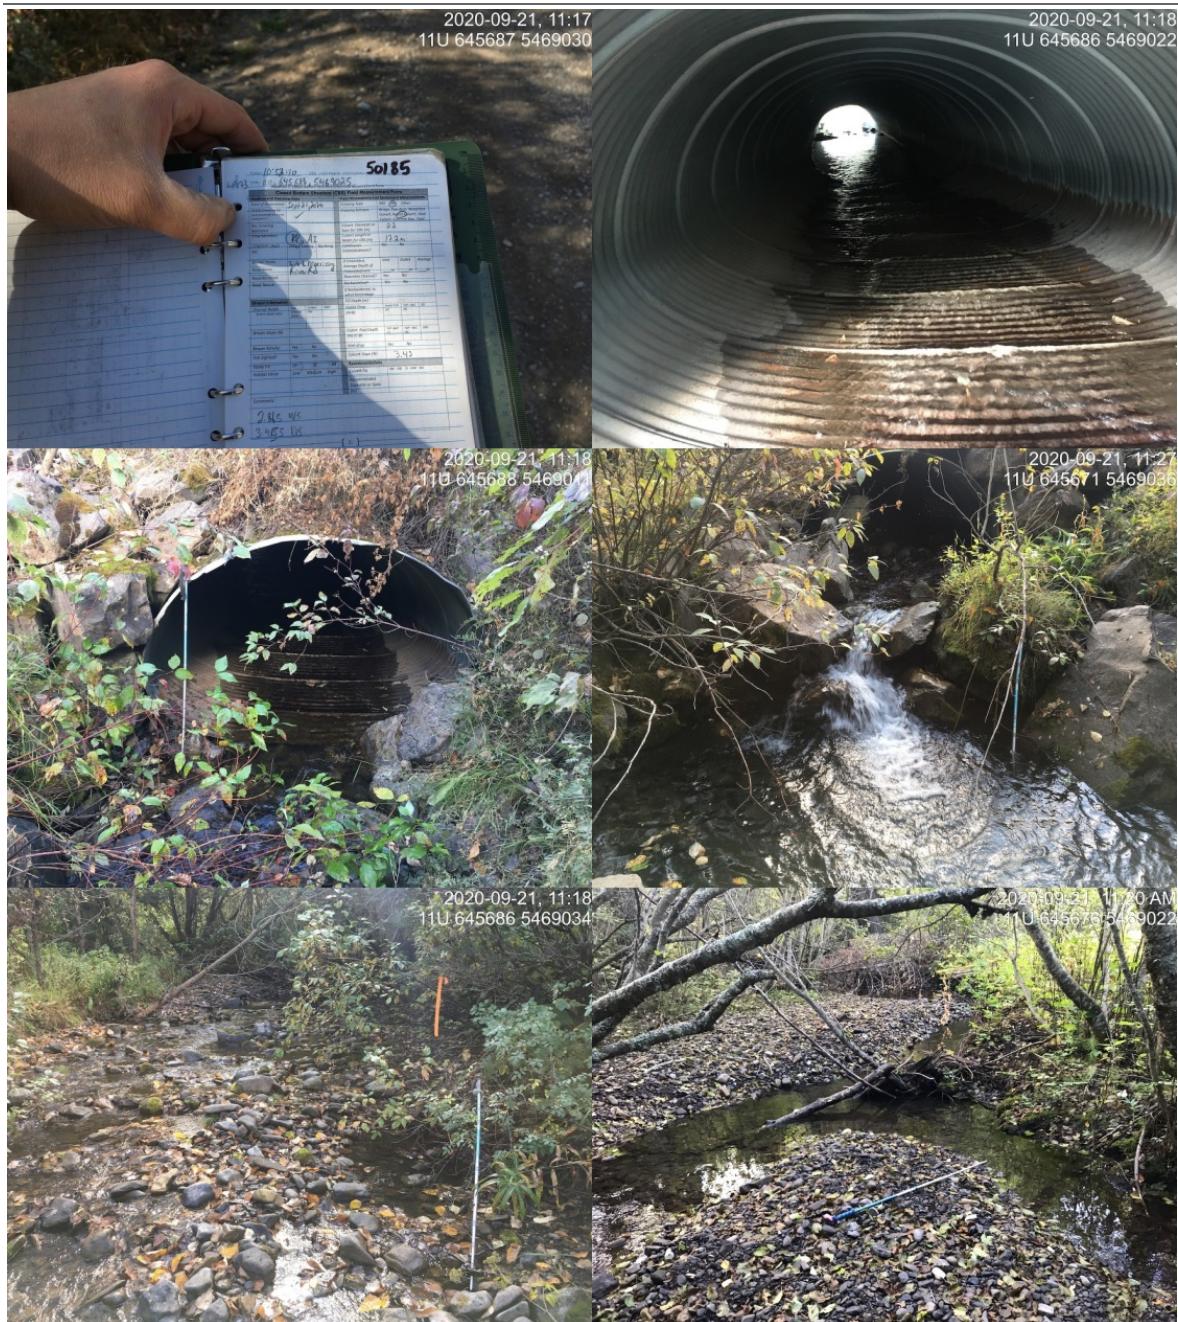
<b>Location and Stream Data</b>		<b>Crossing Characteristics –</b>	
Date	2020-09-21	Crossing Sub Type	Round Culvert
PSCIS ID	50185	Diameter (m)	2.2
External ID	–	Length (m)	17
Crew	KP, AI	Embedded	No
UTM Zone	11	Depth Embedded (m)	–
Easting	645683	Resemble Channel	No
Northing	5469025	Backwatered	No
Stream	Tributary to Morrisey Creek	Percent Backwatered	–
Road	River Rd	Fill Depth (m)	1.4
Road Tenure	FLNR 5466	Outlet Drop (m)	0
Channel Width (m)	4.3	Outlet Pool Depth (m)	0
Stream Slope (%)	4.3	Inlet Drop	No
Beaver Activity	No	Slope (%)	3.4
Habitat Value	High	Valley Fill	Deep Fill
Photos: From top left clockwise: Road/Site Card, Barrel, Outlet, Downstream, Upstream, Inlet.

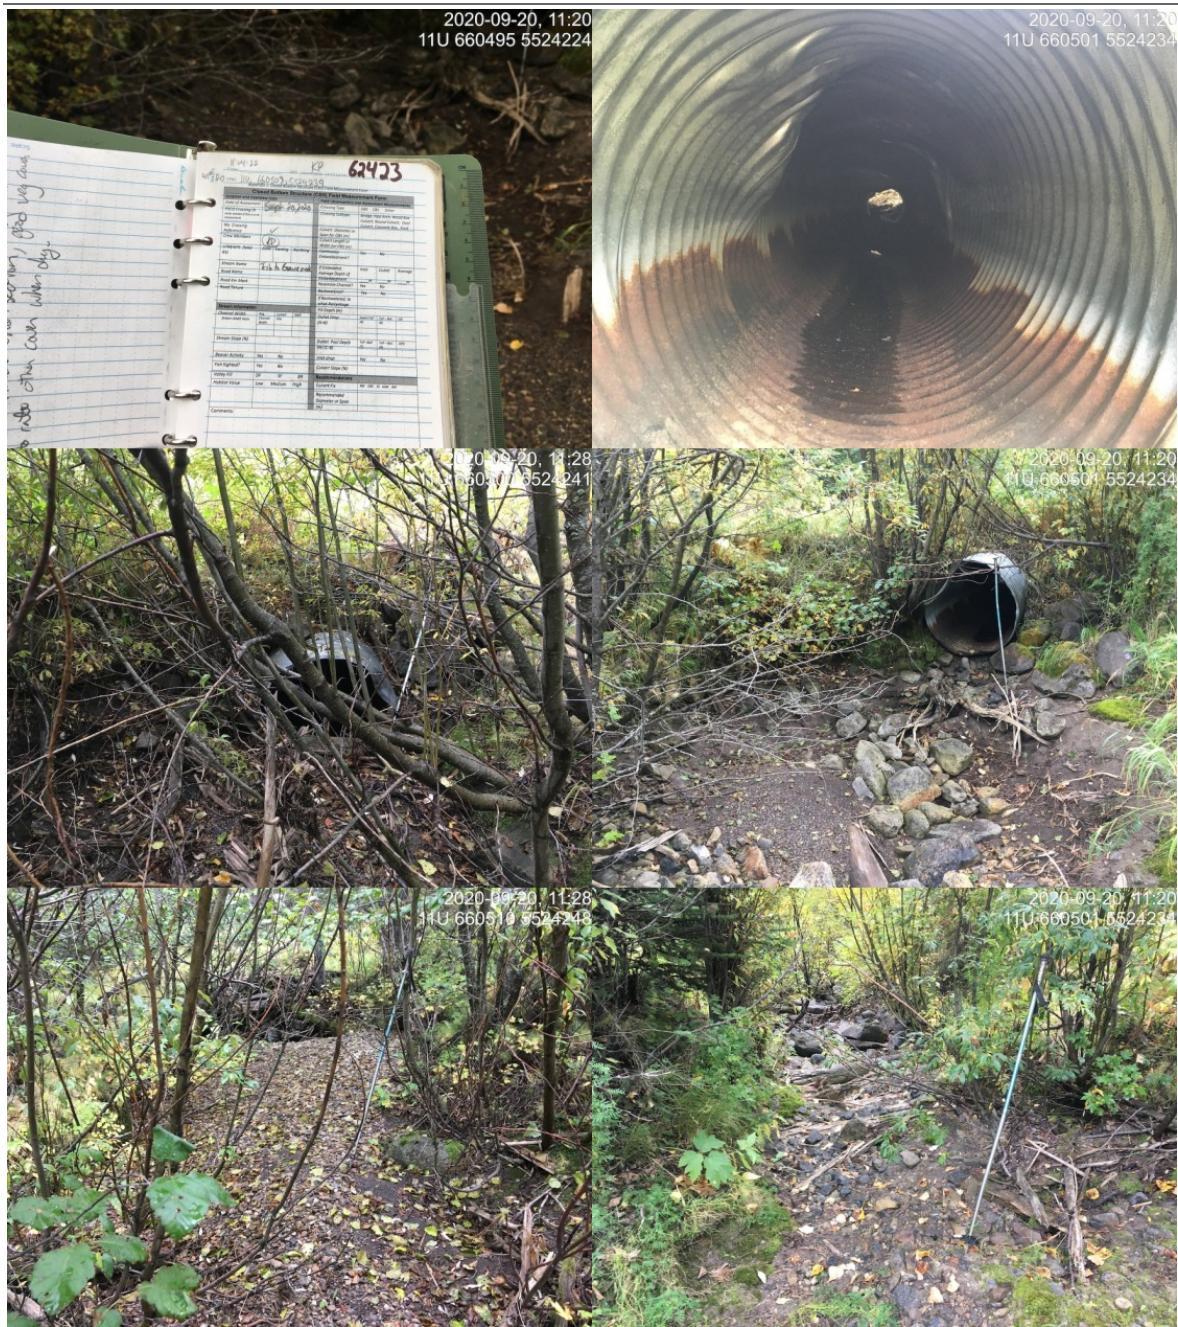
Location and Stream Data		.	Crossing Characteristics	-
Date	2020-09-20	Crossing Sub Type	Round Culvert	
PSCIS ID	62423	Diameter (m)	0.9	
External ID	-	Length (m)	12	
Crew	KP, AI	Embedded	No	
UTM Zone	11	Depth Embedded (m)	-	
Easting	660508	Resemble Channel	No	
Northing	5524239	Backwatered	No	
Stream	Harriet Lake Creek	Percent Backwatered	-	
Road	Grave Creek FSR	Fill Depth (m)	0.3	
Road Tenure	Unknown	Outlet Drop (m)	0.18	
Channel Width (m)	1.44	Outlet Pool Depth (m)	0.6	
Stream Slope (%)	4	Inlet Drop	Yes	
Beaver Activity	No	Slope (%)	0.5	
Habitat Value	Low	Valley Fill	Deep Fill	
Photos: From top left clockwise: Road/Site Card, Barrel, Outlet, Downstream, Upstream, Inlet.

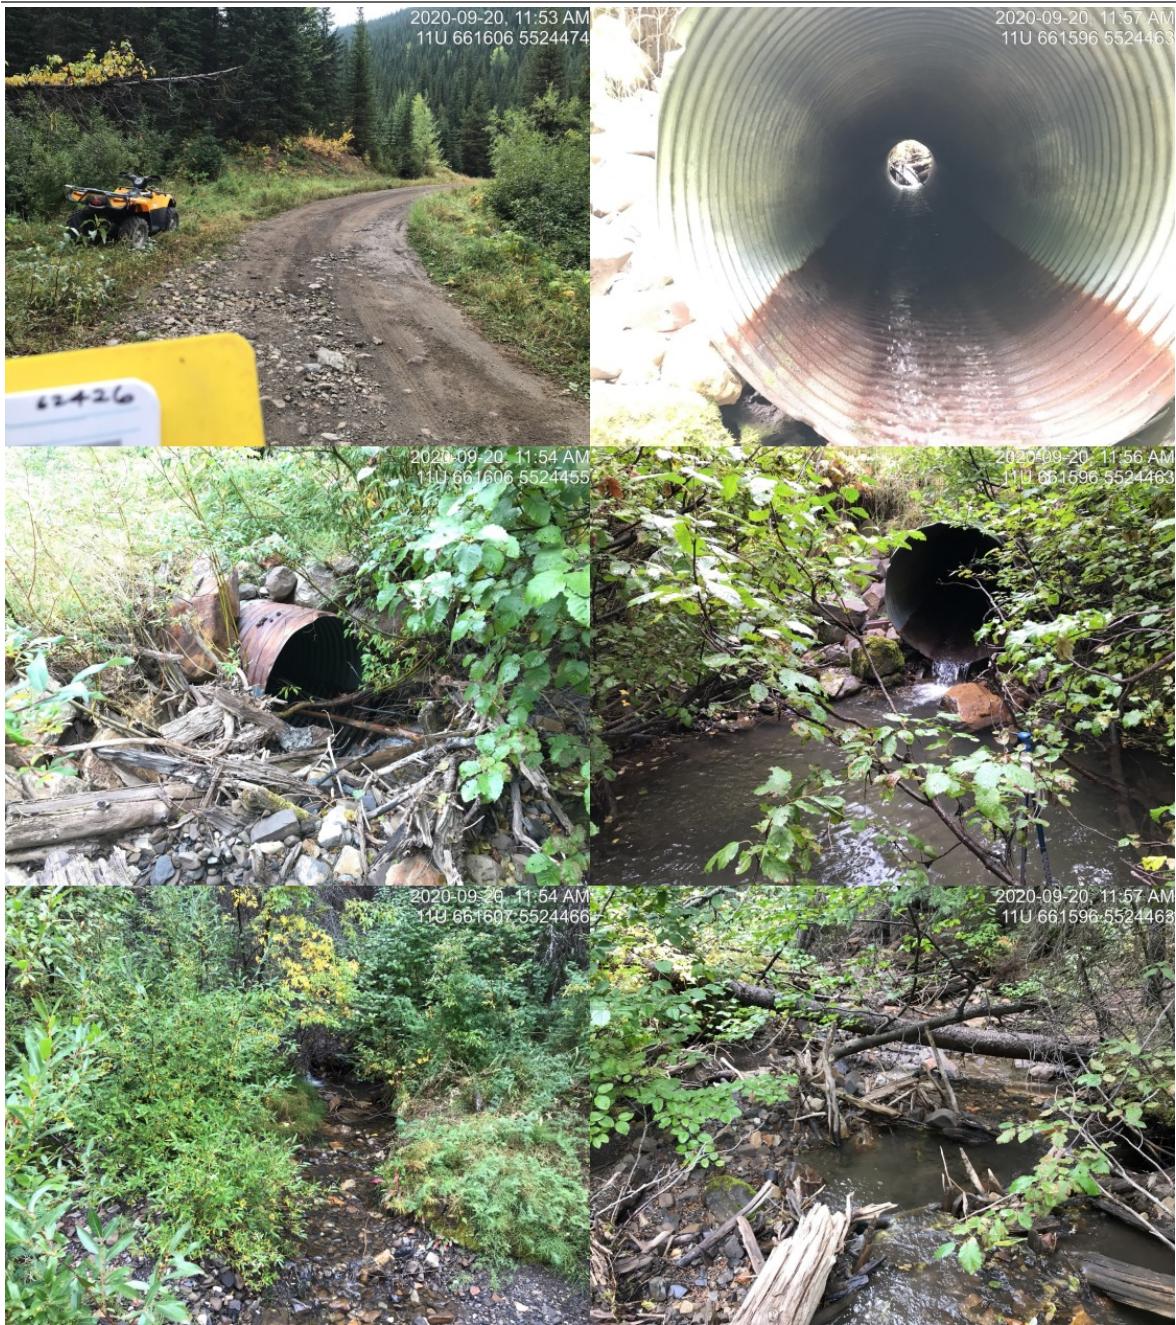
External ID	-	Length (m)	12
Crew	KP, AI	Embedded	No
UTM Zone	11	Depth Embedded (m)	-
Easting	661611	Resemble Channel	No
Northing	5524460	Backwatered	No
Stream	Grave Creek	Percent Backwatered	-
Road	Spur	Fill Depth (m)	1
Road Tenure	Canfor R08362	Outlet Drop (m)	0.25
Channel Width (m)	3.5	Outlet Pool Depth (m)	0.65
Stream Slope (%)	6	Inlet Drop	Yes
Beaver Activity	No	Slope (%)	5
Habitat Value	Medium	Valley Fill	Deep Fill

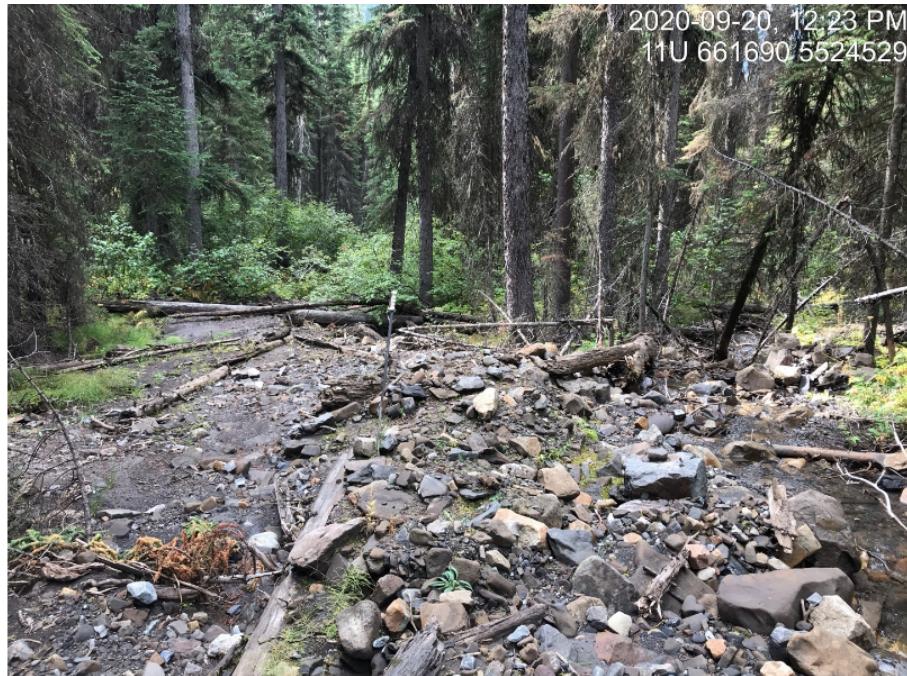
Figure 5.23: Grave Creek redirection out of historic channel located upstream of PSCIS crossing 62426.

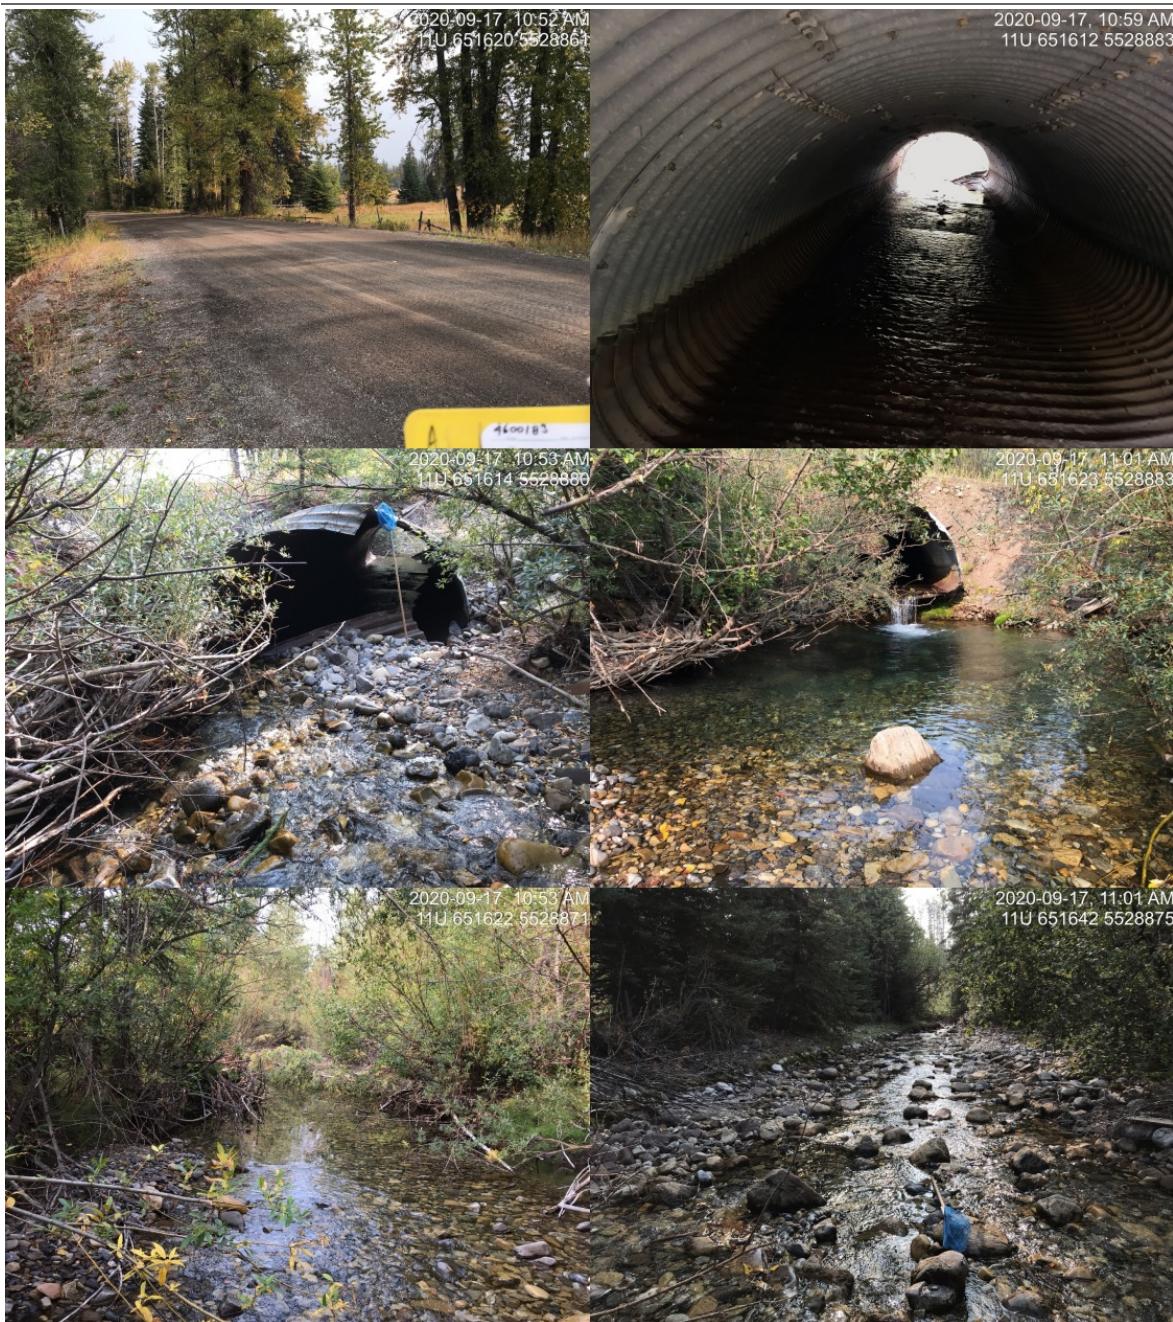
Location and Stream Data	•	Crossing Characteristics	-
Date	2020-09-17	Crossing Sub Type	Oval Culvert
PSCIS ID	197533	Diameter (m)	3.3
External ID	–	Length (m)	20
Crew	AI, KP	Embedded	No
UTM Zone	11	Depth Embedded (m)	–
Easting	651626	Resemble Channel	No
Northing	5528888	Backwatered	No
Stream	Brule Creek	Percent Backwatered	–
Road	Busato Rd	Fill Depth (m)	1
Road Tenure	MoTi local	Outlet Drop (m)	0.7
Channel Width (m)	7.1	Outlet Pool Depth (m)	1.5
Stream Slope (%)	2	Inlet Drop	Yes
Beaver Activity	No	Slope (%)	4
Habitat Value	High	Valley Fill	Deep Fill

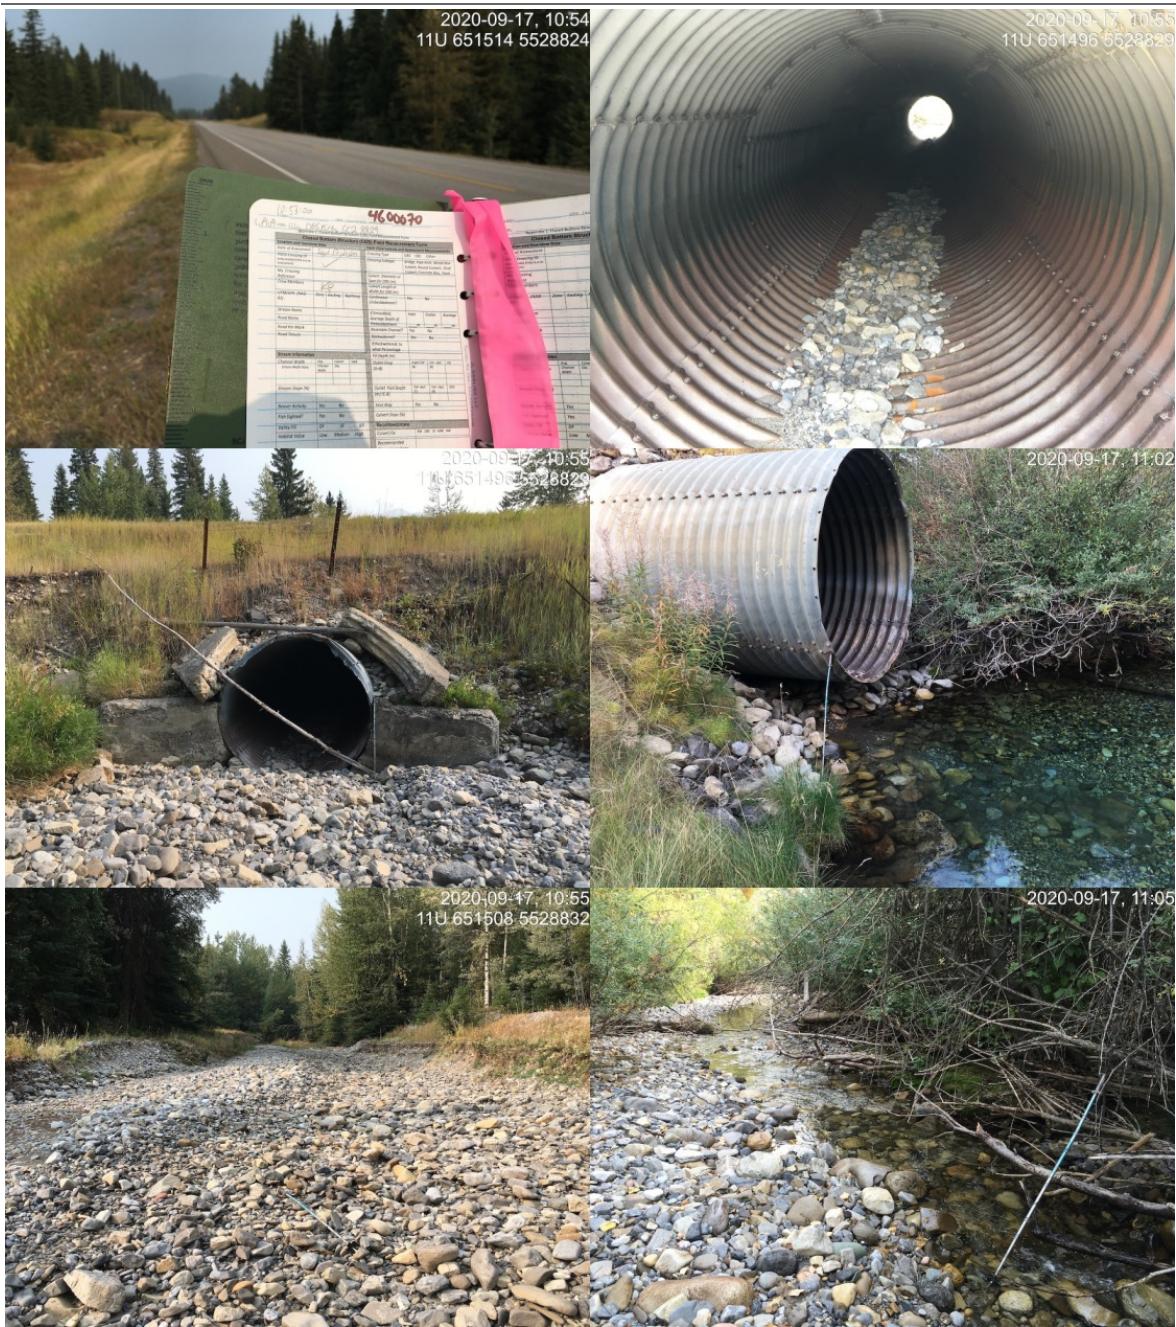
External ID	–	Length (m)	35
Crew	KP, AI	Embedded	Yes
UTM Zone	11	Depth Embedded (m)	0.05
Easting	651516	Resemble Channel	Yes
Northing	5528829	Backwatered	No
Stream	Brule Creek	Percent Backwatered	–
Road	Highway 43	Fill Depth (m)	3
Road Tenure	MoTi highway	Outlet Drop (m)	0
Channel Width (m)	6.1	Outlet Pool Depth (m)	1.7
Stream Slope (%)	1.5	Inlet Drop	No
Beaver Activity	No	Slope (%)	2.5
Habitat Value	Medium	Valley Fill	Deep Fill

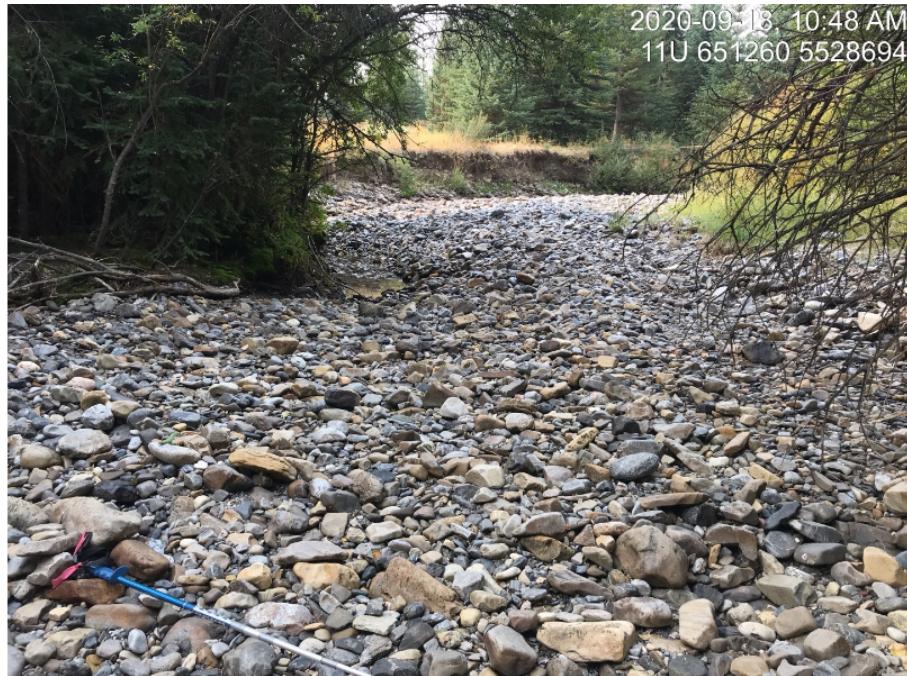
Figure 5.30: Subsurface flow area upstream of PSCIS crossing 197559.

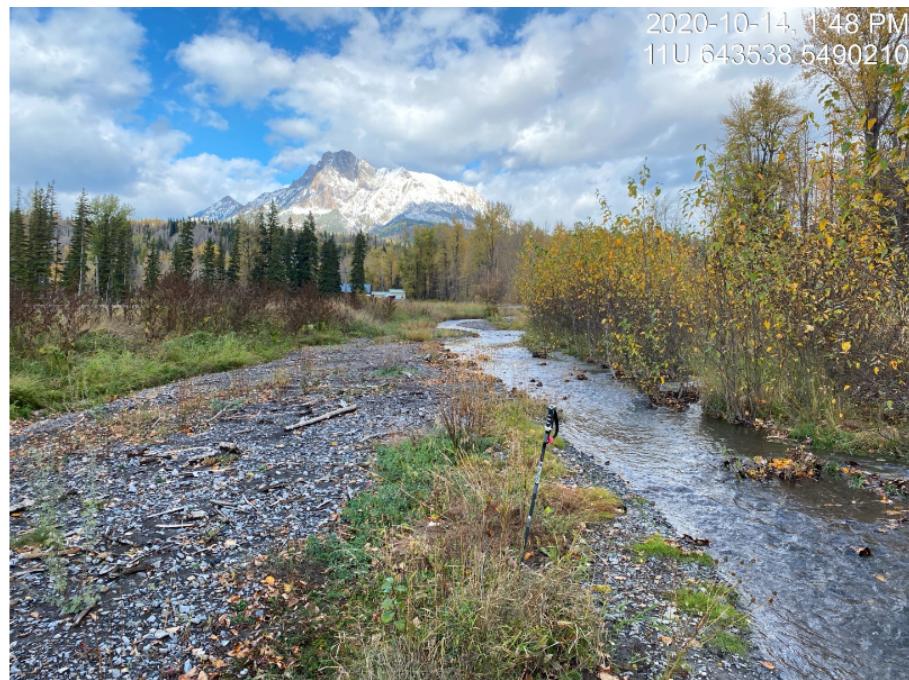
Figure 5.36: Typical habitat downstream of PSCIS crossing 197582.

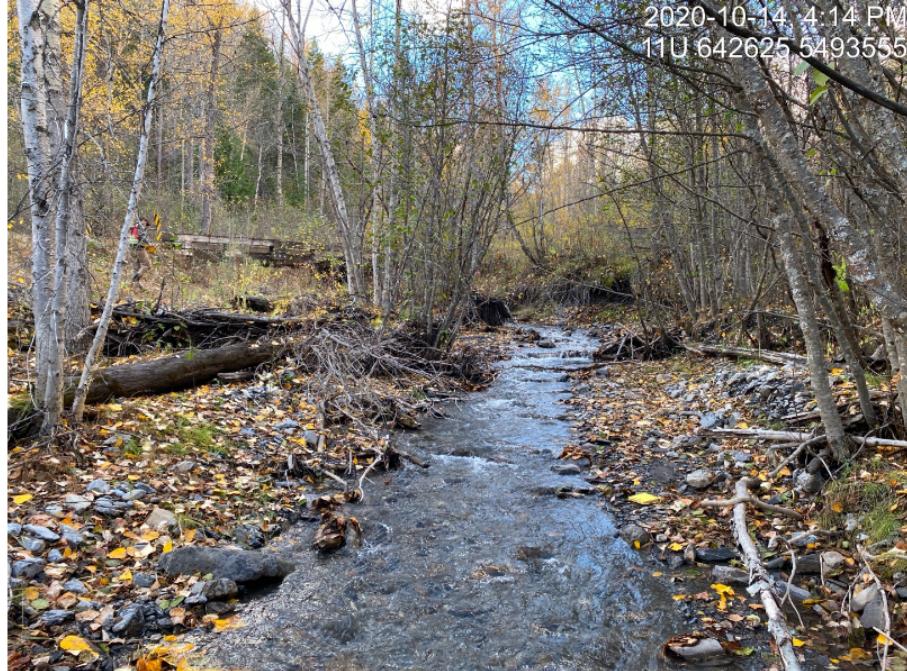
Within the 75m section of stream surveyed 2.5km upstream of Dicken Road, stream conditions were similiar to those observed downstream with an average channel width of 4.6m and gravel dominated substrate (Figure [5.39](#)). Overall, upstream of PSCIS 197542 was rated as high habitat value, containing habitat with moderate rearing and spawning potential for resident and fluvial salmonids.

Figure 5.39: Habitat upstream of PSCIS crossing 197542 approximatley 2.5km.

Structure replacement with an open bottomed structure is recommended to provide access to the habitat located upstream of PSCIS crossing 197542. The cost of the work is estimated at \$1,000,000 for a cost benefit of 7.2 linear m/\$1000 and  $43.9\text{m}^2/\$1000$ .
