Upper Elk River and Flathead River Fish Passage Restoration Planning

**Prepared by
AI Irvine, B.Sc., R.P.Bio.
New Graph Environment
6 Regent St
Nelson, BC V1L 2P1**

Version 1.0

2021-01-28

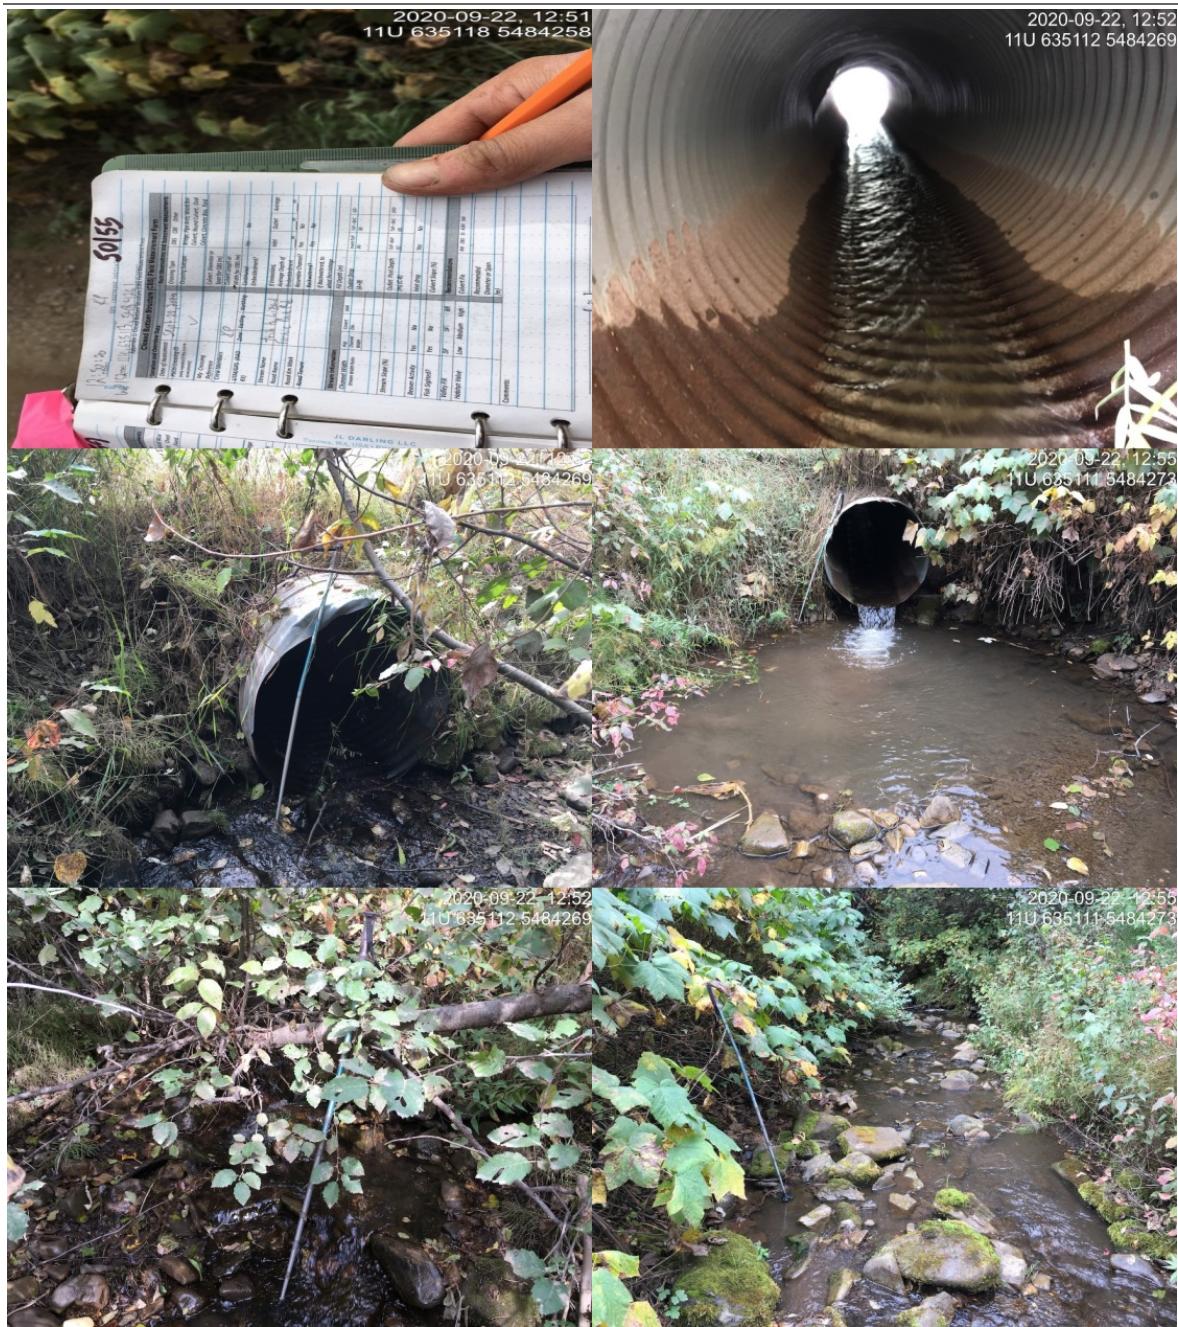
Table 5.4: Summary of habitat details for PSCIS crossing 50155.

The crossing was ranked as a moderate priority for proceeding to design for replacement with an open bottomed structure.

Structure replacement with a bridge is recommended to provide unconstrained access to the habitat located upstream of PSCIS crossing 50155. The cost of the work is estimated at \$125,000 for a cost benefit of 14.4 linear m/\$1000 and 31.7m²/\$1000.

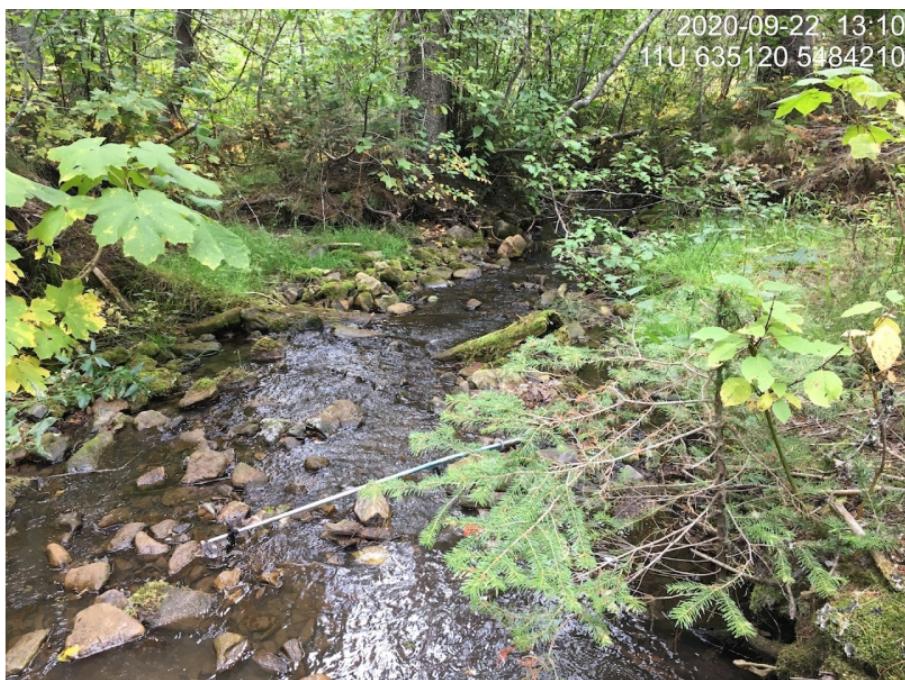
Figure 5.4: Typical habitat downstream of PSCIS crossing 50155.

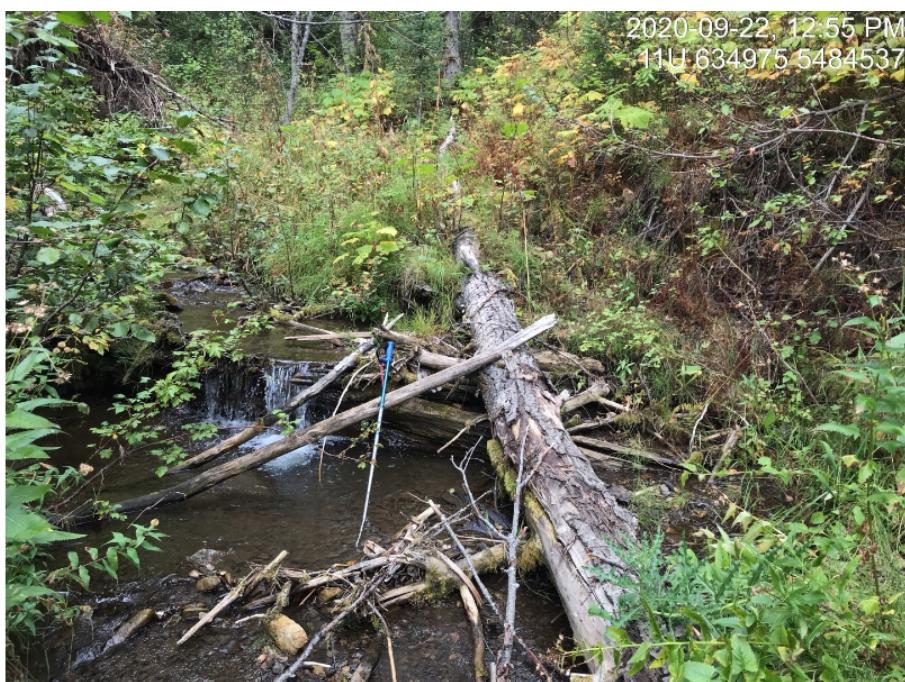
Figure 5.5: Typical habitat upstream of PSCIS crossing 50155.

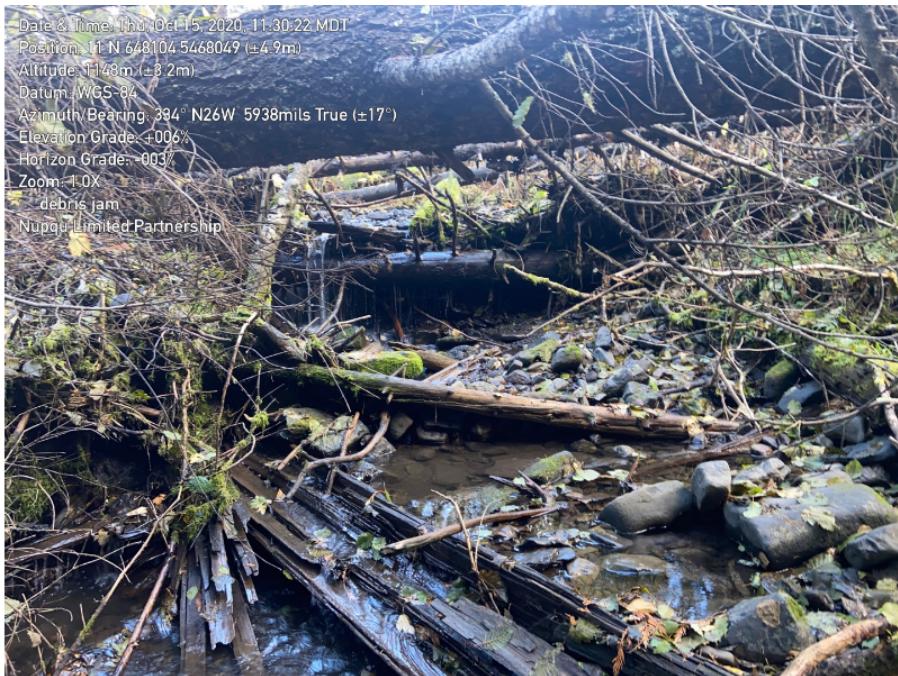
Figure 5.9: Typical habitat downstream of PSCIS crossing 50181.

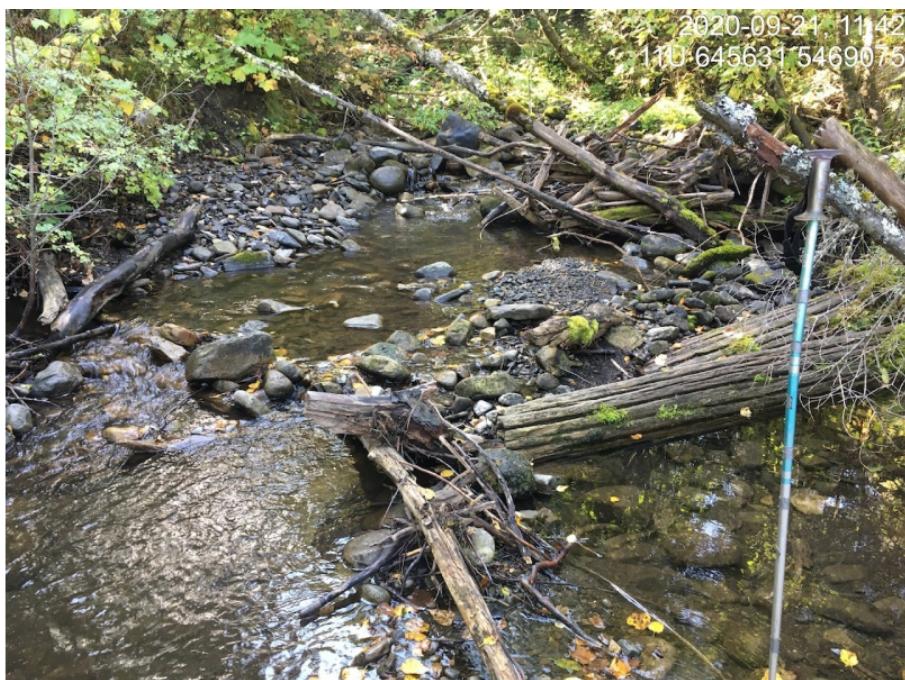
Figure 5.13: Typical habitat downstream of PSCIS crossing 50185.

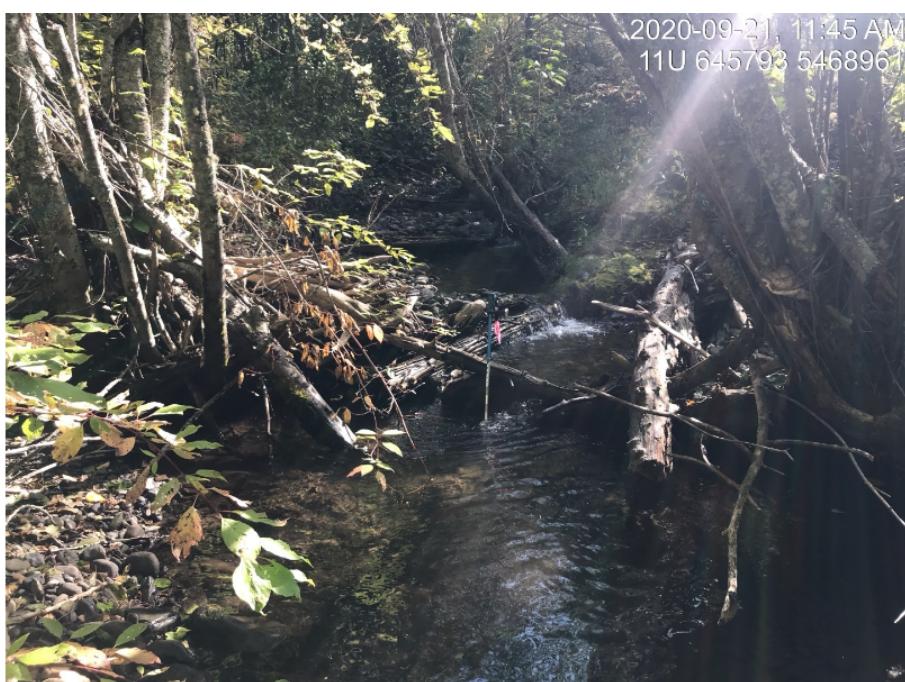
Figure 5.14: Typical habitat upstream of PSCIS crossing 50185.

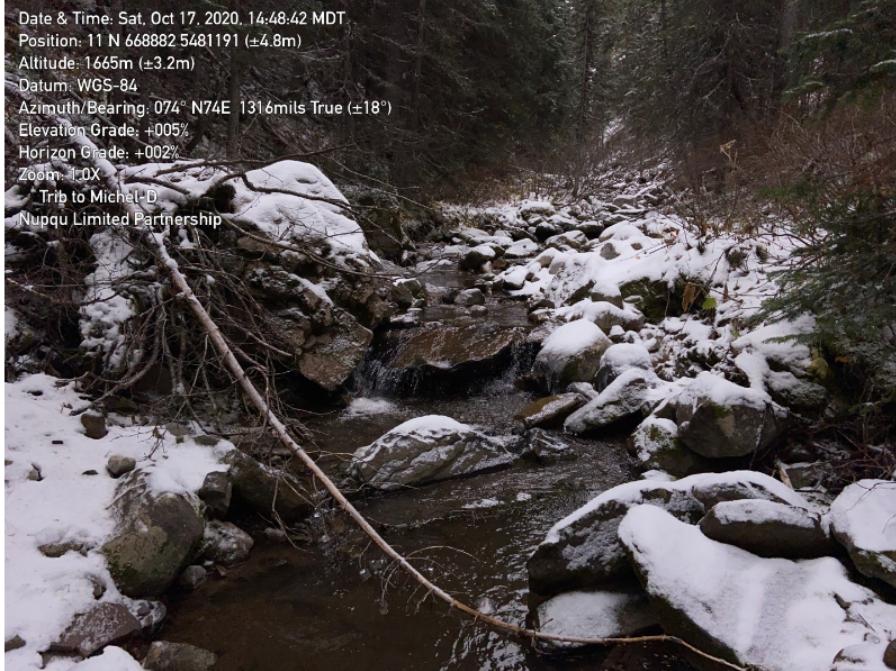
Figure 5.16: Habitat downstream of PSCIS crossing 50261.

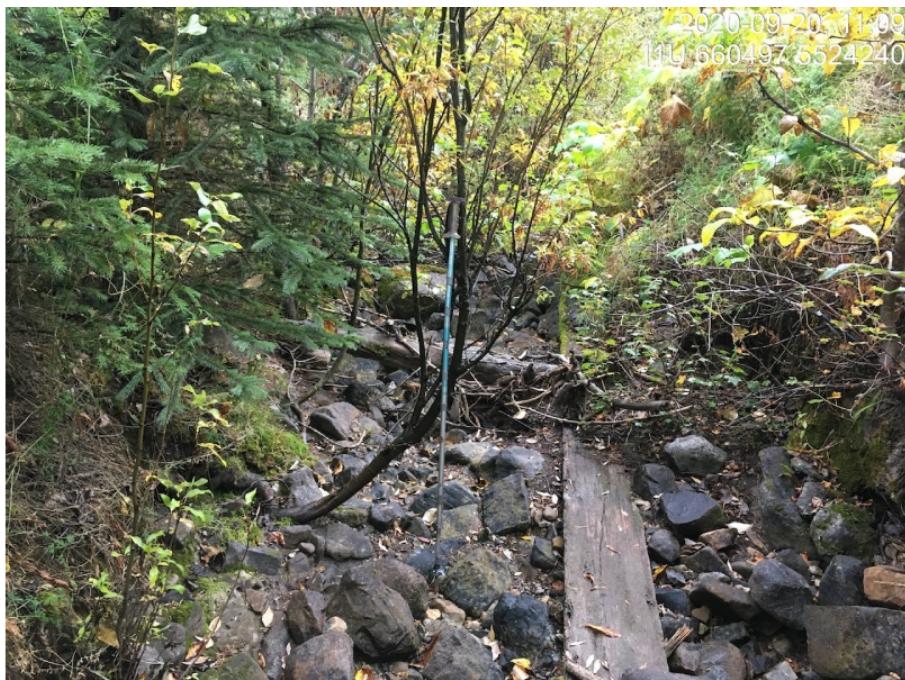
Figure 5.19: Typical habitat downstream of PSCIS crossing 62423.

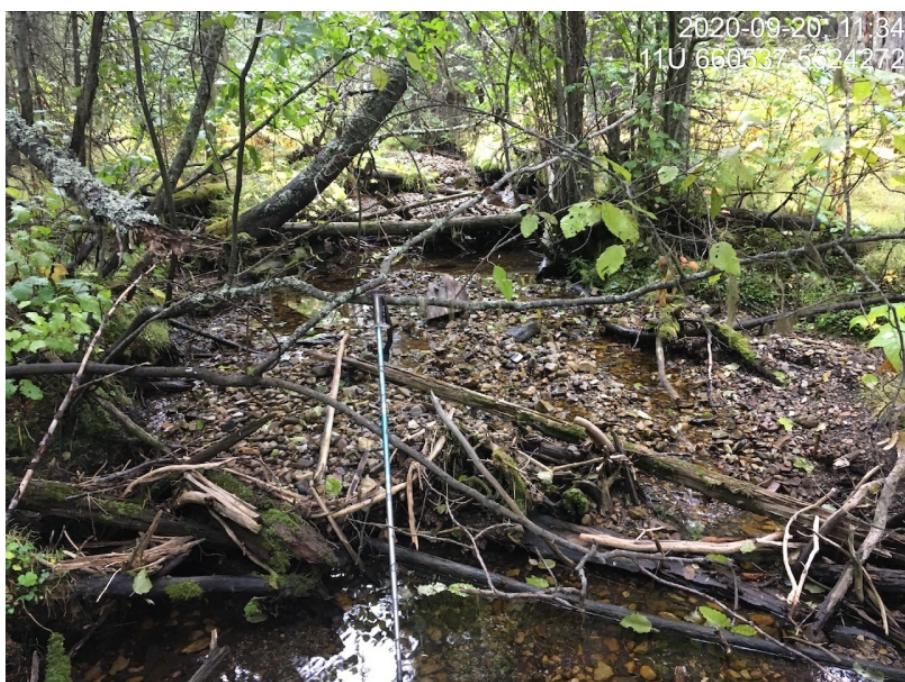
Figure 5.20: Typical habitat upstream of PSCIS crossing 62423.

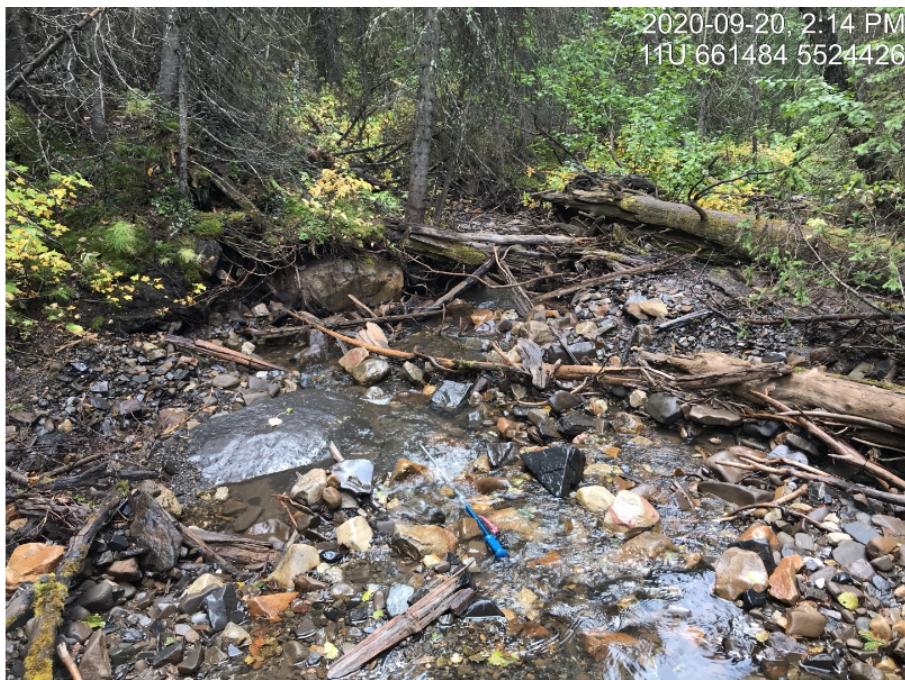
The stream was surveyed downstream from the culvert for 75m to where the stream joins the flow entering the valley from the south. Overall, total cover amount was rated as moderate with deep pools dominant. Cover was also present as small woody debris, large woody debris, boulders, undercut banks, and overhanging vegetation (Table 5.23, Figure 5.21). The average channel width was 3.7m, the average wetted width was 1.8m and the average gradient was 7.5%. The dominant substrate was cobbles with boulders subdominant. Downstream of the crossing there were frequent sections of gravels suitable for salmonid spawning and no barriers or obstacles to fish passage. Habitat was rated as high value for fry/juvenile salmonid rearing.

Figure 5.21: Typical habitat downstream of PSCIS crossing 62425.

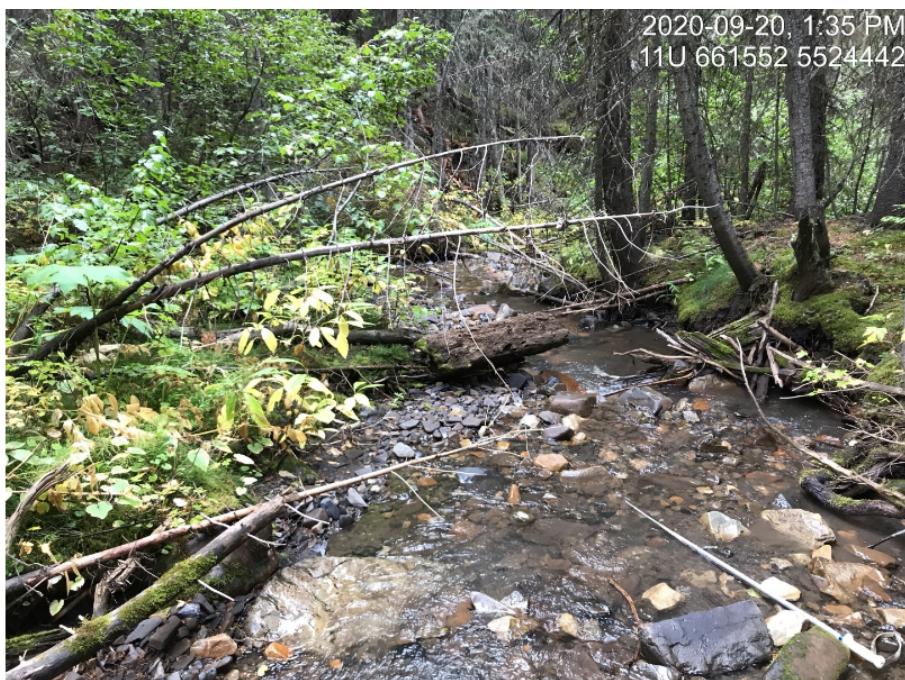
The stream was surveyed upstream from 62425 for 170m to 62426. Overall, total cover amount was rated as moderate with deep pools dominant. Cover was also present as large woody debris and boulders (Table 5.23, Figure 5.22). The average channel width was 3.5m, the average wetted width was 2.1m and the average gradient was 5%. There were abundant gravels suitable for resident westslope cutthroat trout spawning throughout (Figure 5.23). Some debris jam steps to 0.8m in height were observed and there were approximately 15 westslope cutthroat trout (approximately 170mm long) in the outlet pool for crossing 62426. Habitat value was rated as high for fry/juvenile salmonid rearing.

The stream was surveyed upstream from 62426 for 650m. Overall, total cover amount was rated as moderate with deep pools dominant. Cover was also present as boulders (Table 5.23, Figure 5.22). The average channel width was 3.5m, the average wetted width was 1.6m and the average gradient was 11.9%. This stream channel showed evidence of recent disturbance with eroding banks, multiple channels and aggraded sections throughout. Steps (0.6 - 0.9m in height) due to large woody debris debris jams were frequent throughout surveyed area and at a point approximately 200 m upstream of the road-stream crossing to the top end of the area surveyed, cover was limited to sporadic pools up to 0.3m deep. As mentioned previously, the historic channel was abandoned at 175m upstream of 62426 (UTM: 11 U 661748 5524558, Figure 5.23) with no flow observed within its banks. One of the tributaries that enters Grave Creek approximately 250m upstream of 62426

Figure 5.22: Typical habitat upstream of PSCIS crossing 62425 and downstream of PSCIS crossing 62426.

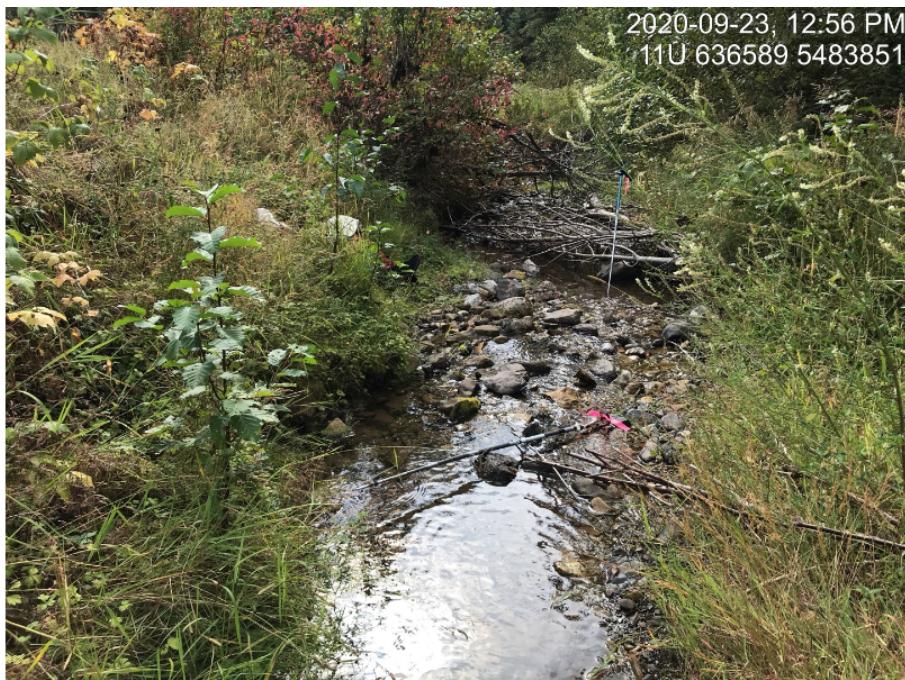
Figure 5.24: Typical habitat downstream of PSCIS crossing 62516.

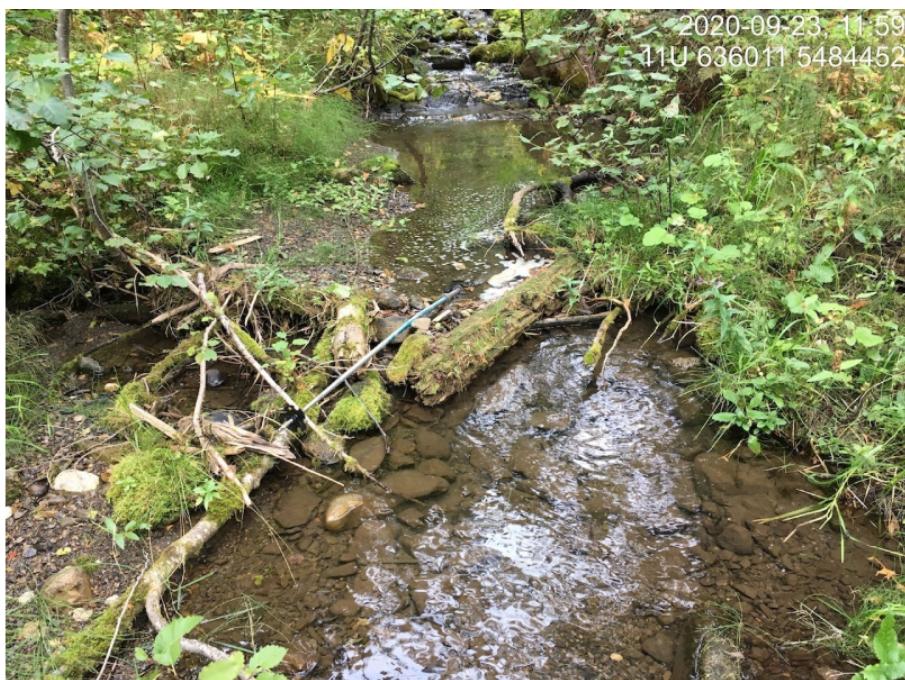
Figure 5.25: Typical habitat upstream of PSCIS crossing 62516.

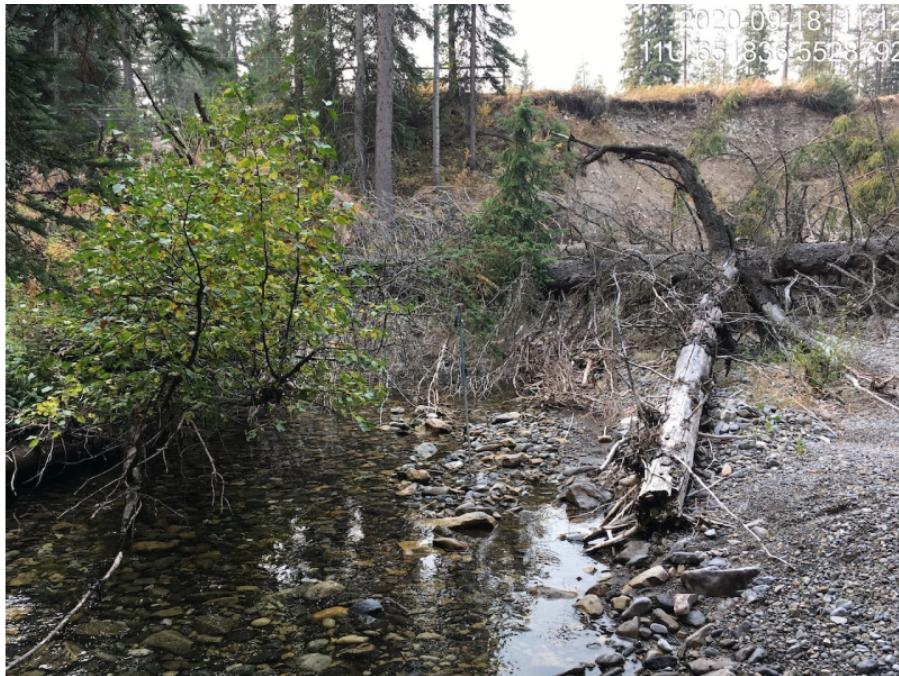
Figure 5.27: Typical habitat downstream of PSCIS crossing 197533.

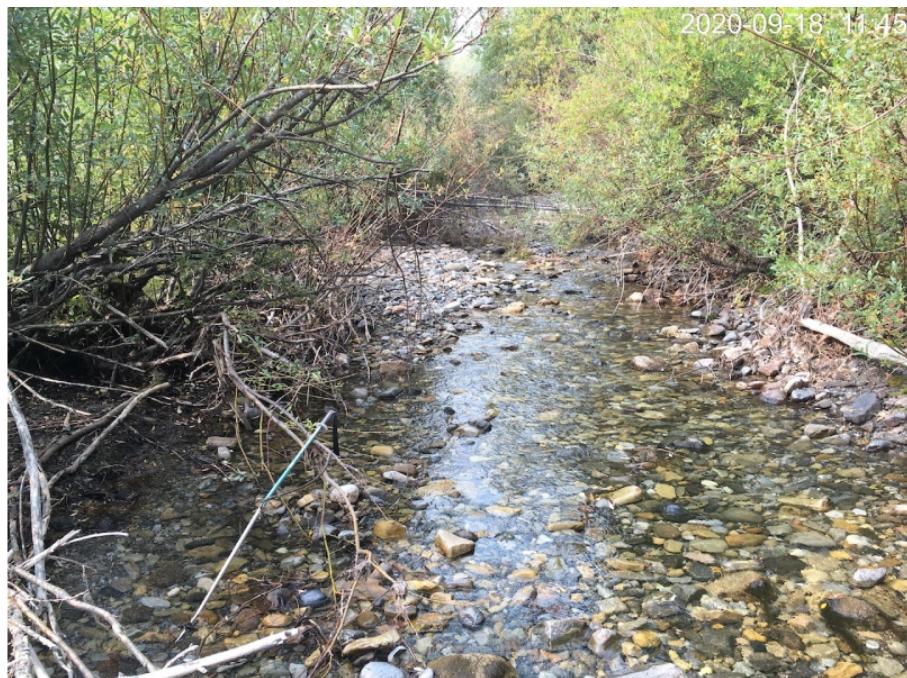
Figure 5.28: Typical habitat upstream of PSCIS crossing 197533 and downstream of PSCIS crossing 197533.

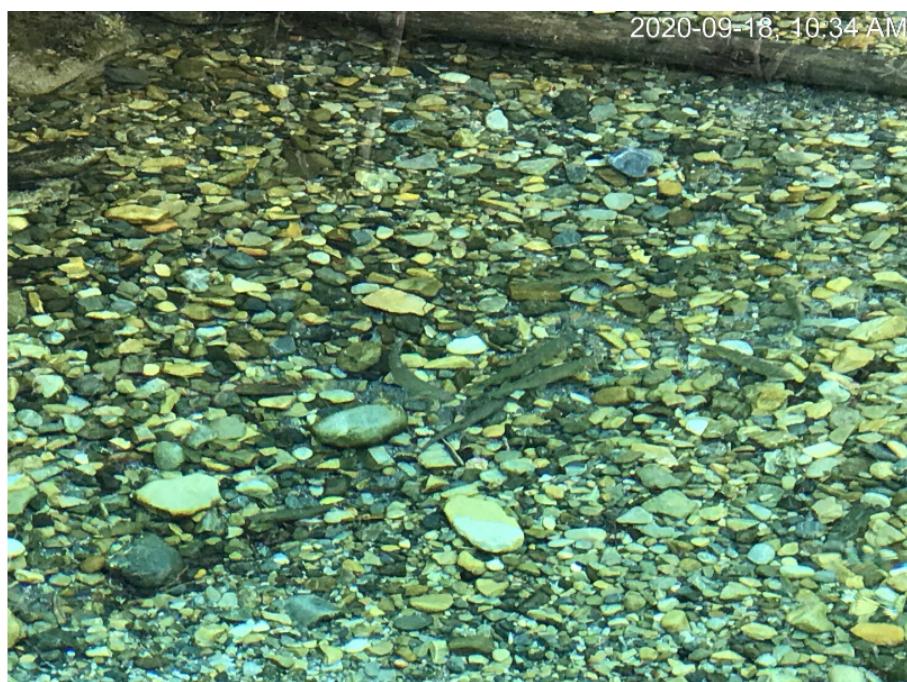
Figure 5.29: Westslope cutthroat trout in outlet pool downstream of PSCIS crossing 197559.

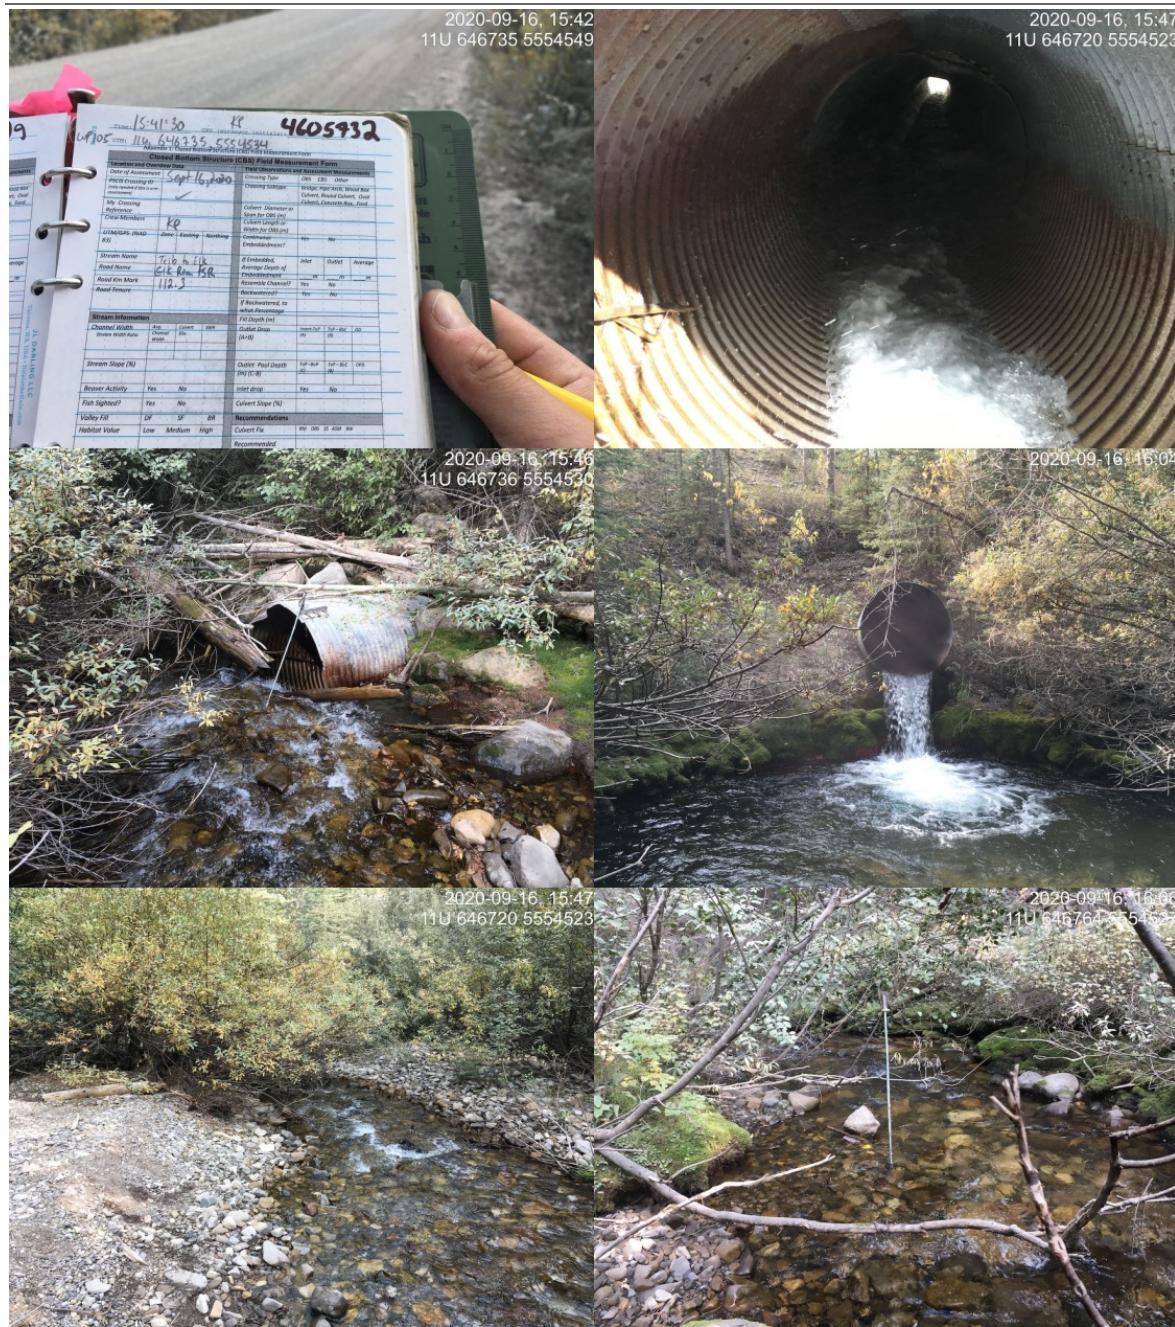
Photos: From top left clockwise: Road/Site Card, Barrel, Outlet, Downstream, Upstream, Inlet.

Structure replacement with an open bottomed culvert is recommended to provide access to the habitat located upstream of PSCIS crossing 197555. Due to the large amount of fill on the road (8m) the size of a replacement bridge was estimated at 25m. The cost for work is estimated at \$312,000 for a cost benefit of 19200linear m/\$1000 and 113500m²/\$1000.

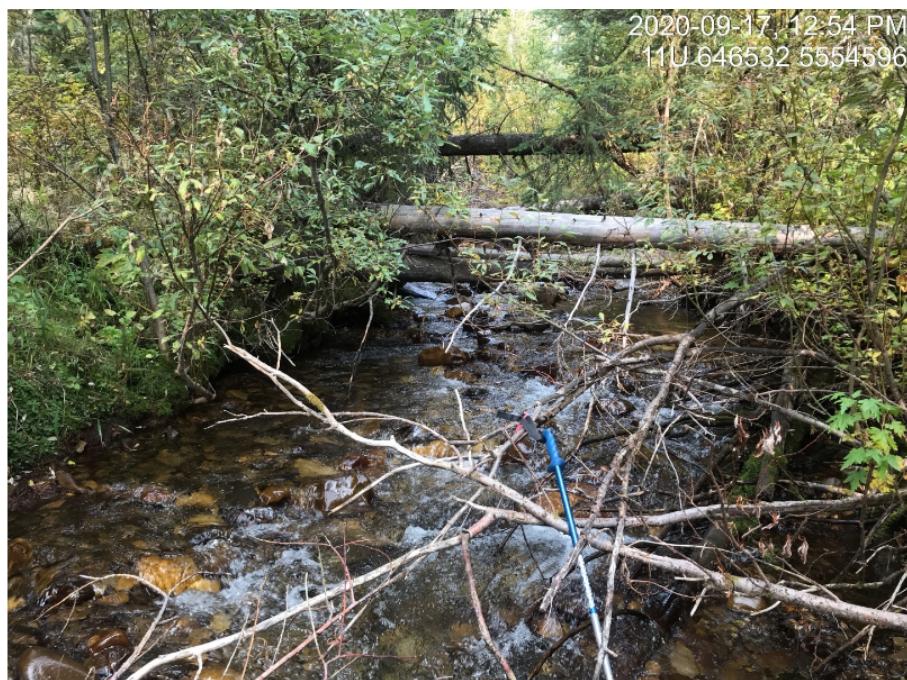
Figure 5.41: Typical habitat upstream of PSCIS crossing 197555.

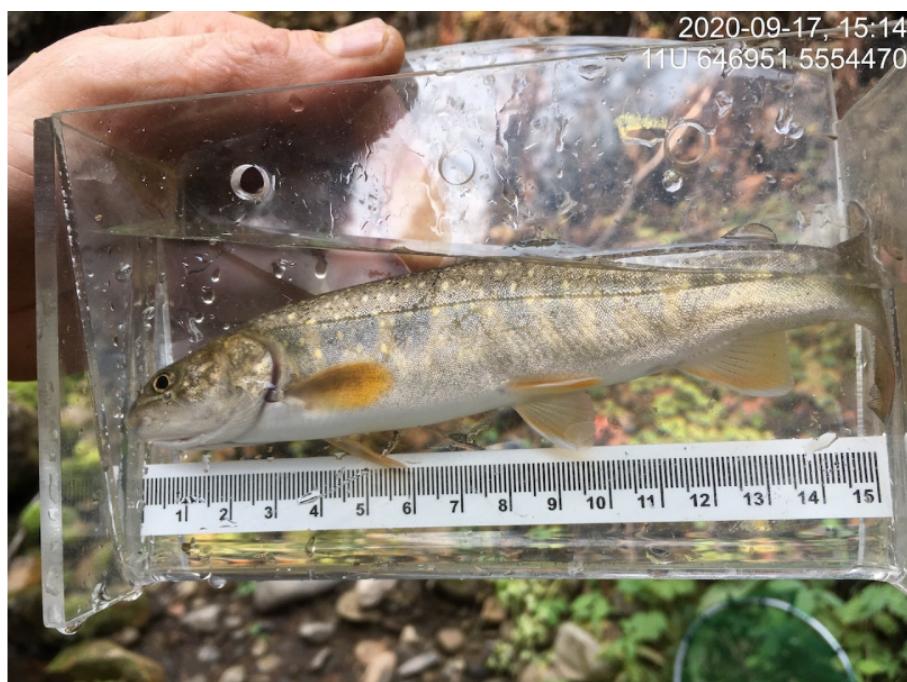
Figure 5.42: Bull trout captured downstream of PSCIS crossing 197555.
