Upper Elk River and Flathead River Fish Passage Restoration Planning

Version 1.2

2021-01-31

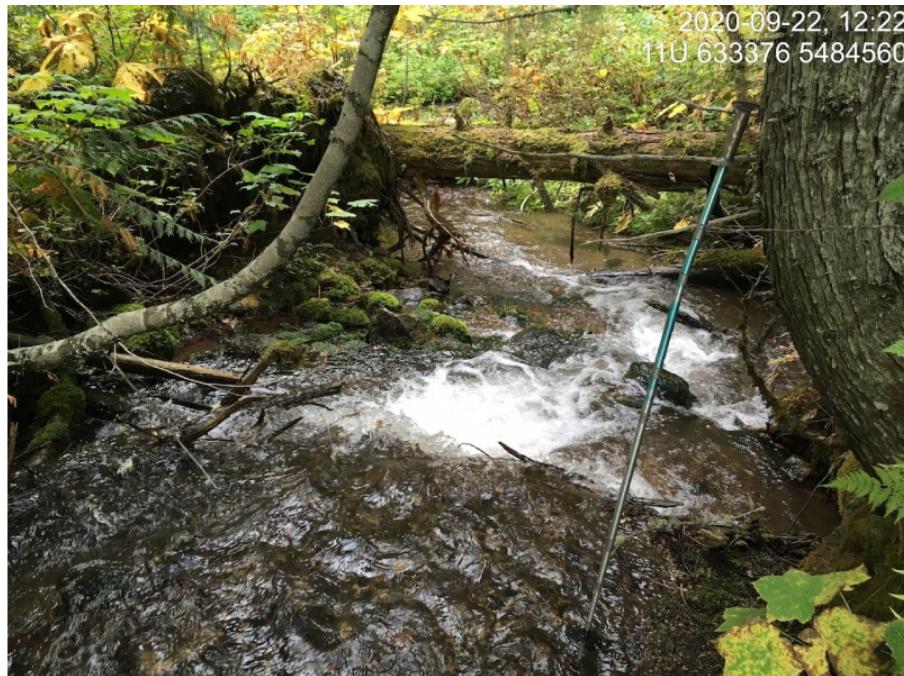
Figure 5.6: Typical habitat downstream of PSCIS crossing 50159.

The stream was surveyed downstream from the culvert for 150m to Lizard Creek. Overall, total cover amount was rated as moderate with large woody debris dominant. Cover was also present as small woody debris, deep pools, and overhanging vegetation (Table 5.4, Figure 5.4). The average channel width was 2.5m, the average wetted width was 2.3m and the average gradient was 8.8%. The dominant substrate was gravels with cobbles subdominant. Some small pools and steps of 0.2 - 0.6m in height were present throughout the area surveyed. Large woody debris steps ranging from 0.4 - 0.8m high were spaced sporadically throughout area surveyed. Habitat value was rated as moderate for salmonid fry/juvenile rearing and high value habitat for spawning.

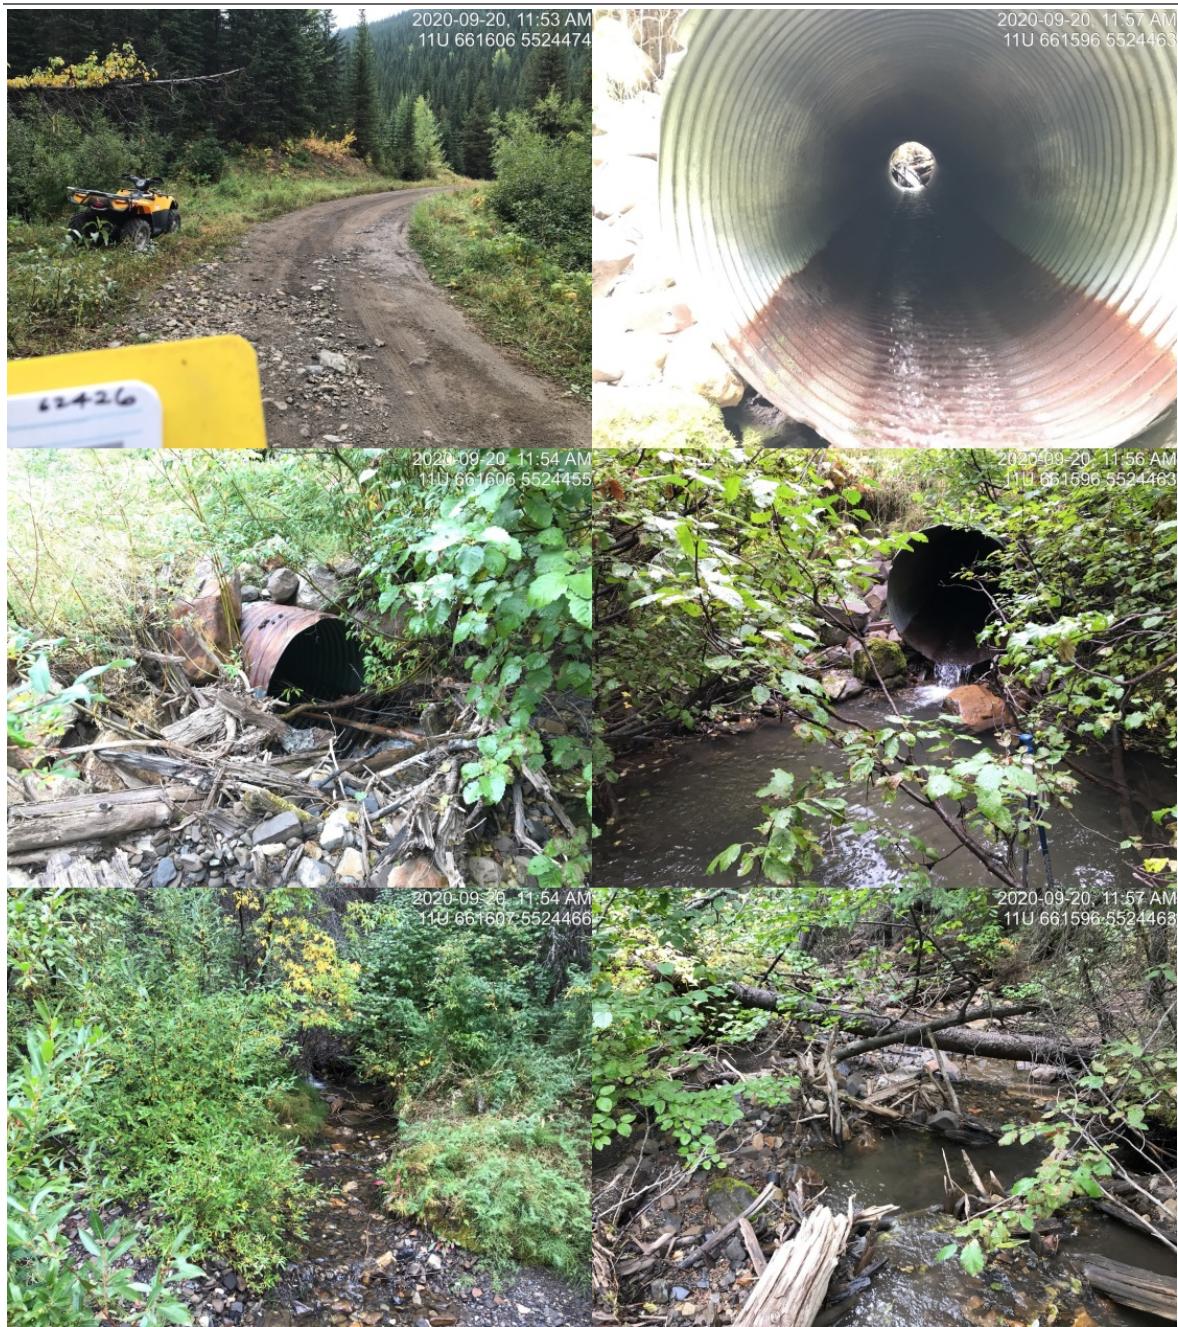
External ID	-	Length (m)	12
Crew	KP, AI	Embedded	No
UTM Zone	11	Depth Embedded (m)	-
Easting	661611	Resemble Channel	No
Northing	5524460	Backwatered	No
Stream	Grave Creek	Percent Backwatered	-
Road	Spur	Fill Depth (m)	1
Road Tenure	Canfor R08362	Outlet Drop (m)	0.25
Channel Width (m)	3.5	Outlet Pool Depth (m)	0.65
Stream Slope (%)	6	Inlet Drop	Yes
Beaver Activity	No	Slope (%)	5
Habitat Value	Medium	Valley Fill	Deep Fill

Photos: From top left clockwise: Road/Site Card, Barrel, Outlet, Downstream, Upstream, Inlet.

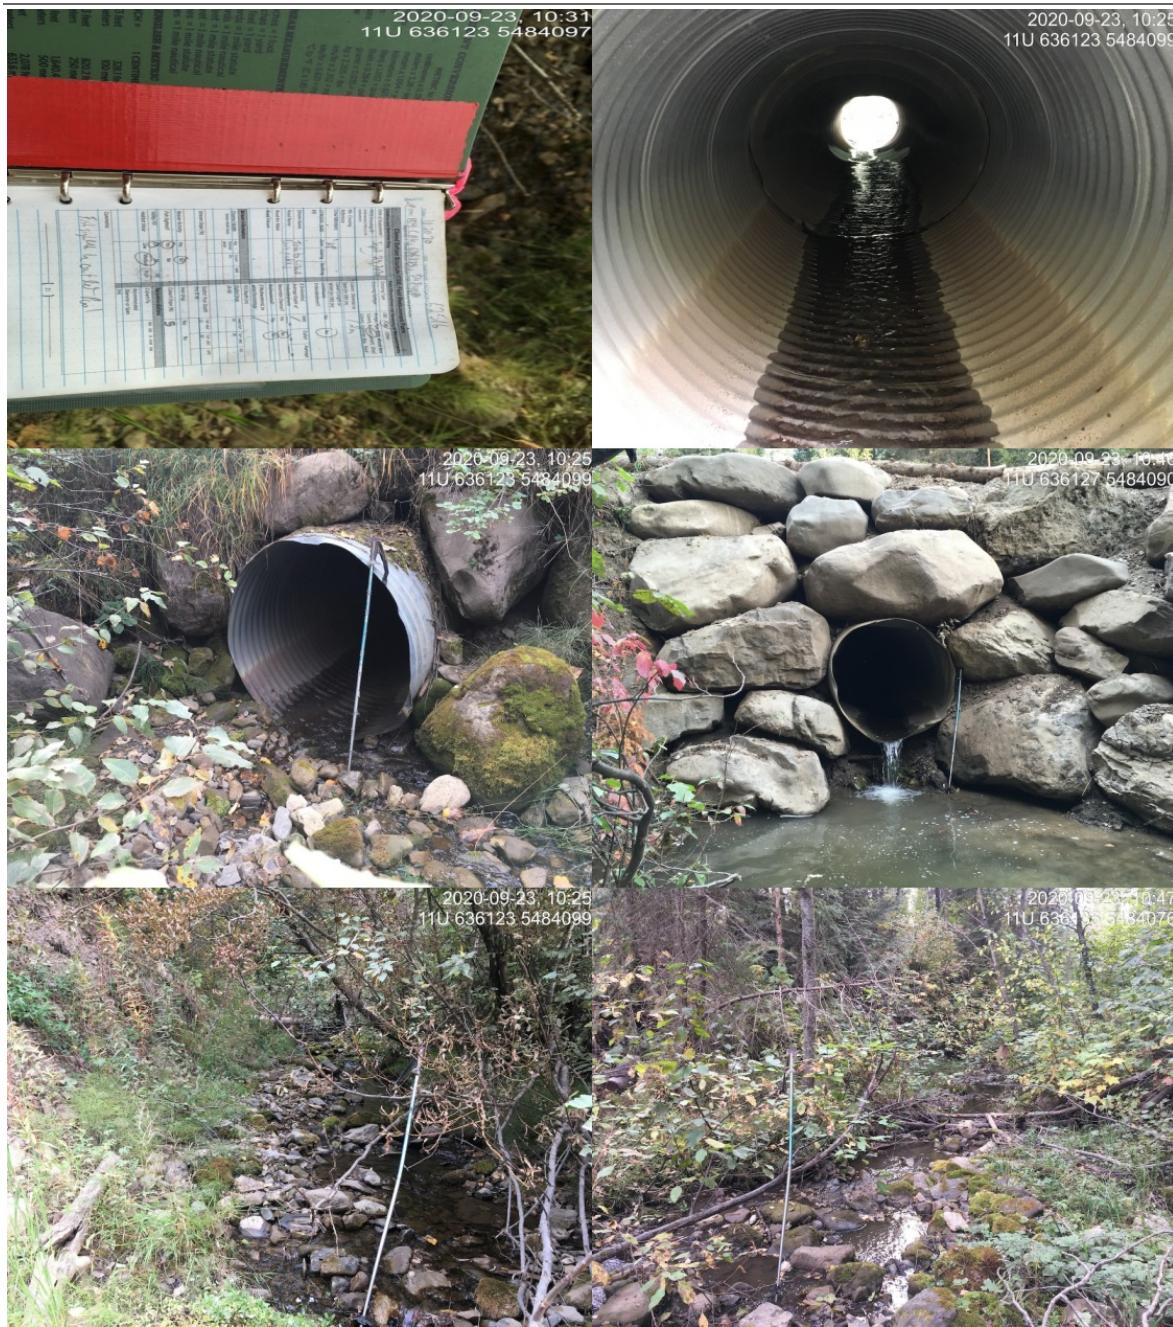
Photos: From top left clockwise: Road/Site Card, Barrel, Outlet, Downstream, Upstream, Inlet.

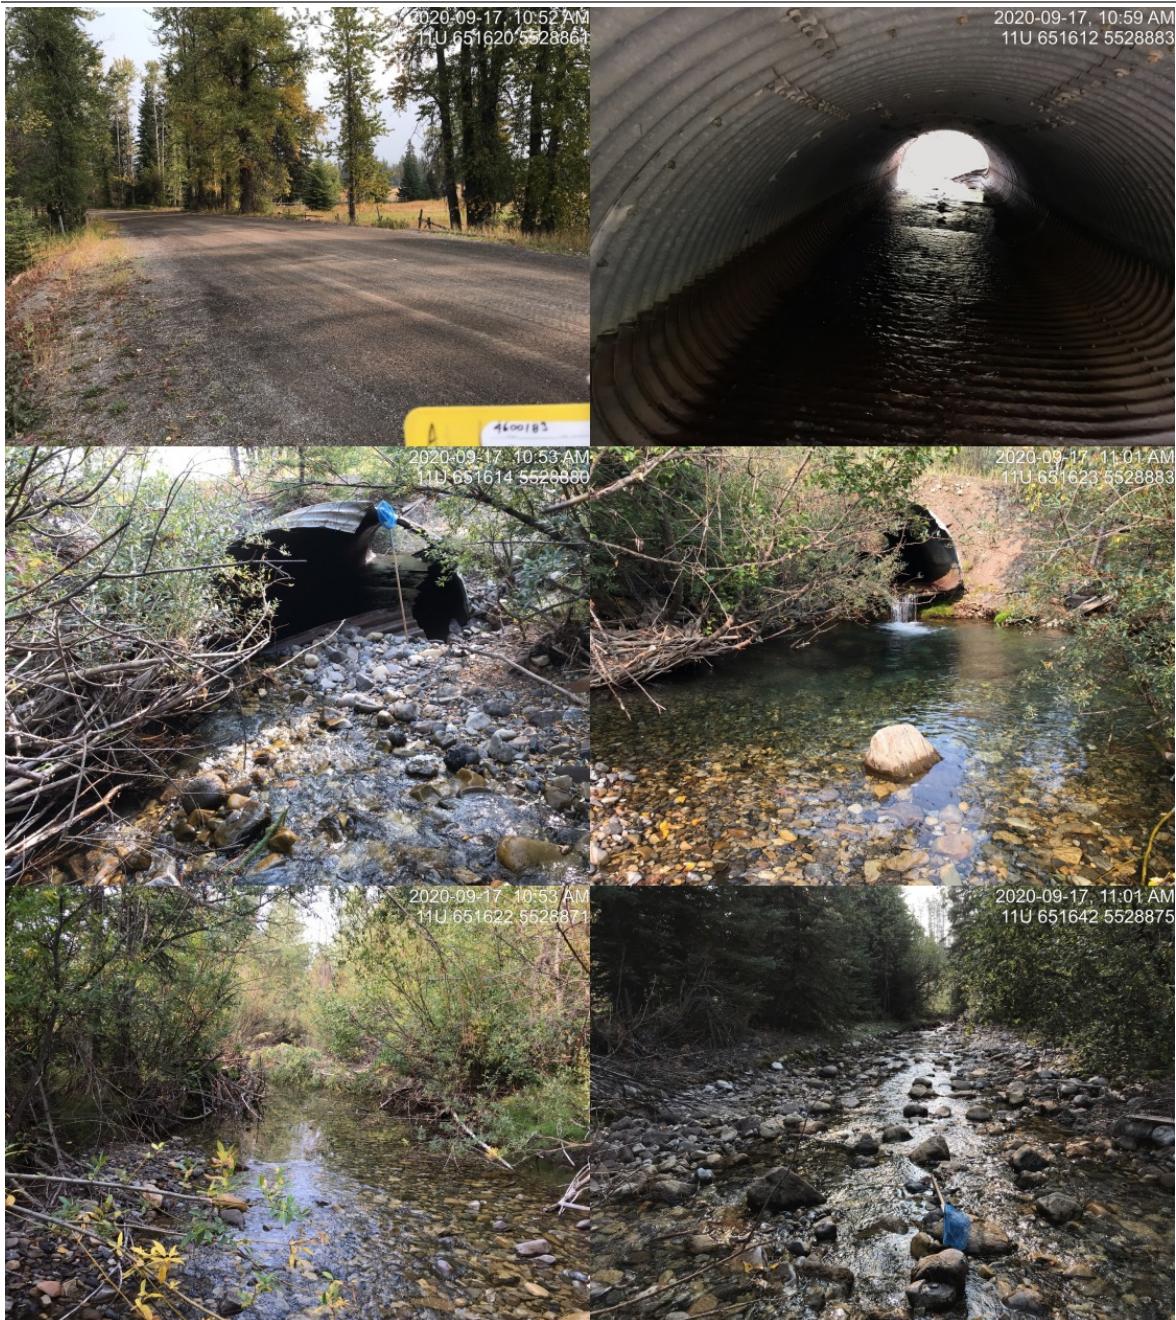
Location and Stream Data	.	Crossing Characteristics	-
Date	2020-09-17	Crossing Sub Type	Oval Culvert
PSCIS ID	197533	Diameter (m)	3.3
External ID	-	Length (m)	20
Crew	AI, KP	Embedded	No
UTM Zone	11	Depth Embedded (m)	-
Easting	651626	Resemble Channel	No
Northing	5528888	Backwatered	No
Stream	Brule Creek	Percent Backwatered	-
Road	Busato Rd	Fill Depth (m)	1
Road Tenure	MoTi local	Outlet Drop (m)	0.7
Channel Width (m)	7.1	Outlet Pool Depth (m)	1.5
Stream Slope (%)	2	Inlet Drop	Yes
Beaver Activity	No	Slope (%)	4
Habitat Value	High	Valley Fill	Deep Fill
Photos: From top left clockwise: Road/Site Card, Barrel, Outlet, Downstream, Upstream, Inlet.

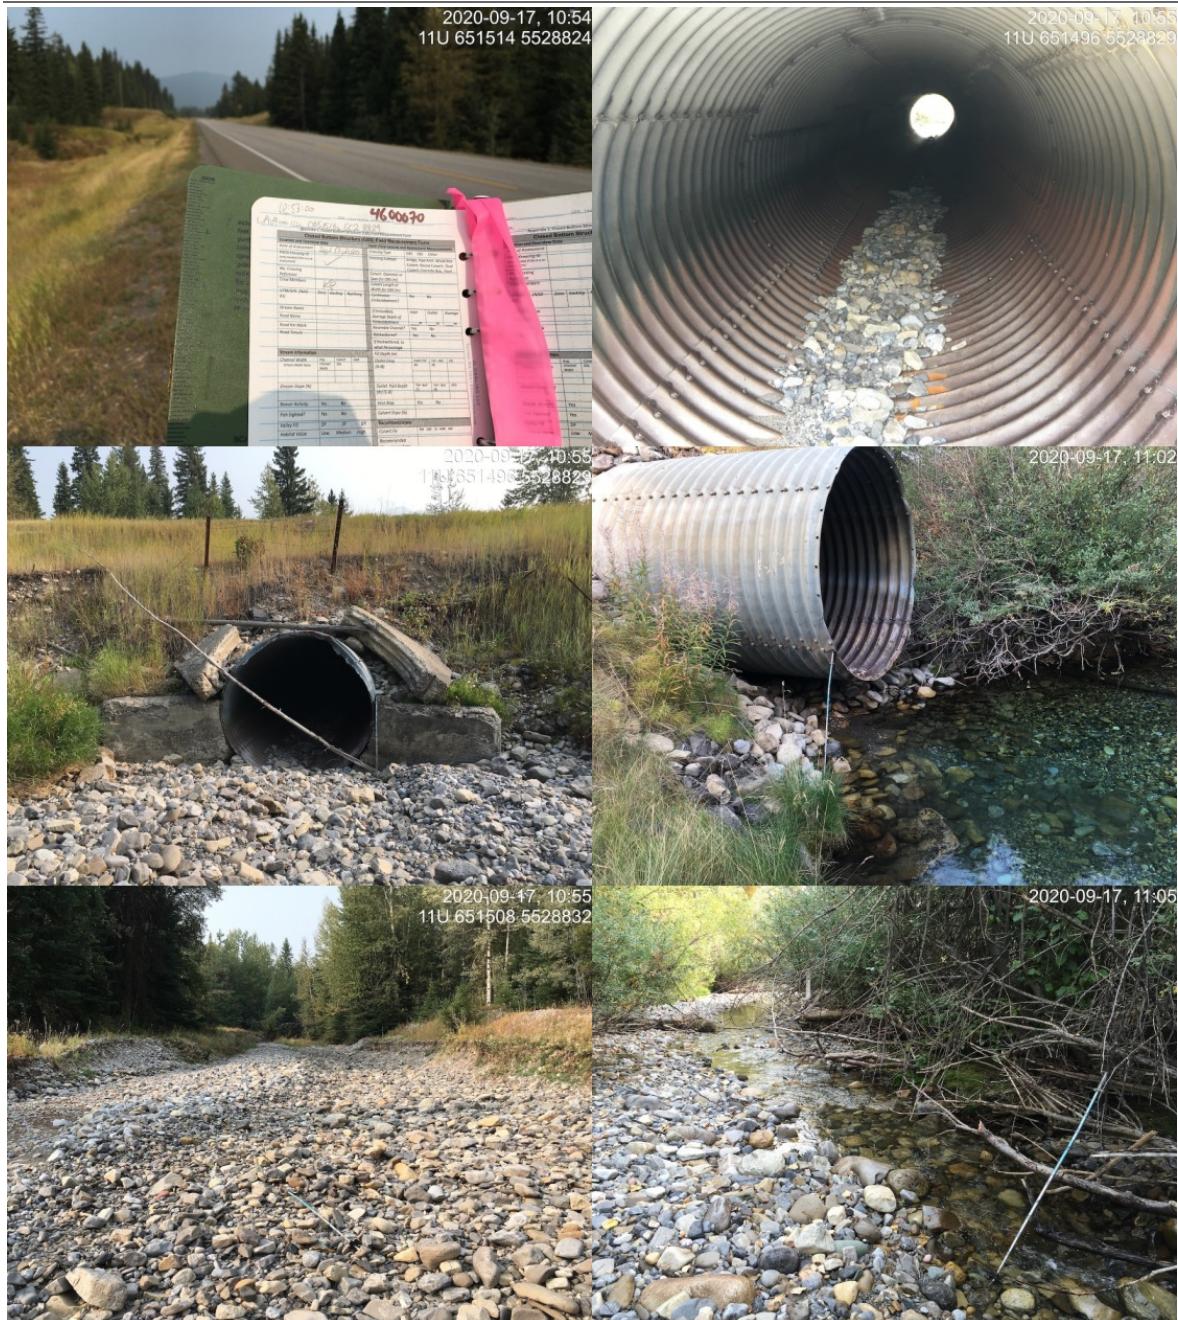
External ID	–	Length (m)	35
Crew	KP, AI	Embedded	Yes
UTM Zone	11	Depth Embedded (m)	0.05
Easting	651516	Resemble Channel	Yes
Northing	5528829	Backwatered	No
Stream	Brule Creek	Percent Backwatered	–
Road	Highway 43	Fill Depth (m)	3
Road Tenure	MoTi highway	Outlet Drop (m)	0
Channel Width (m)	6.1	Outlet Pool Depth (m)	1.7
Stream Slope (%)	1.5	Inlet Drop	No
Beaver Activity	No	Slope (%)	2.5
Habitat Value	Medium	Valley Fill	Deep Fill

Photos: From top left clockwise: Road/Site Card, Barrel, Outlet, Downstream, Upstream, Inlet.

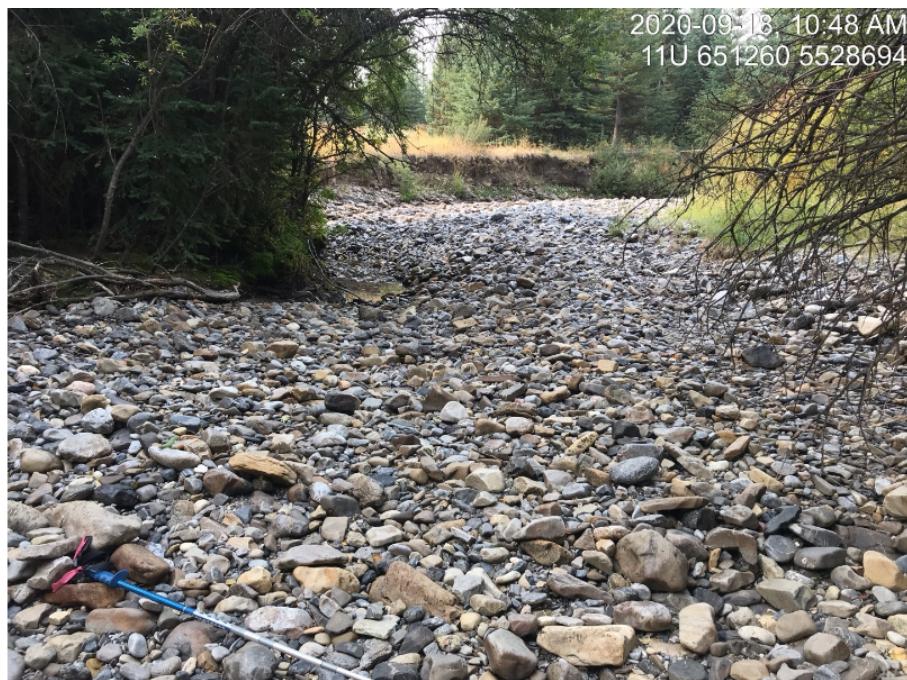
Figure 5.30: Subsurface flow area upstream of PSCIS crossing 197559.

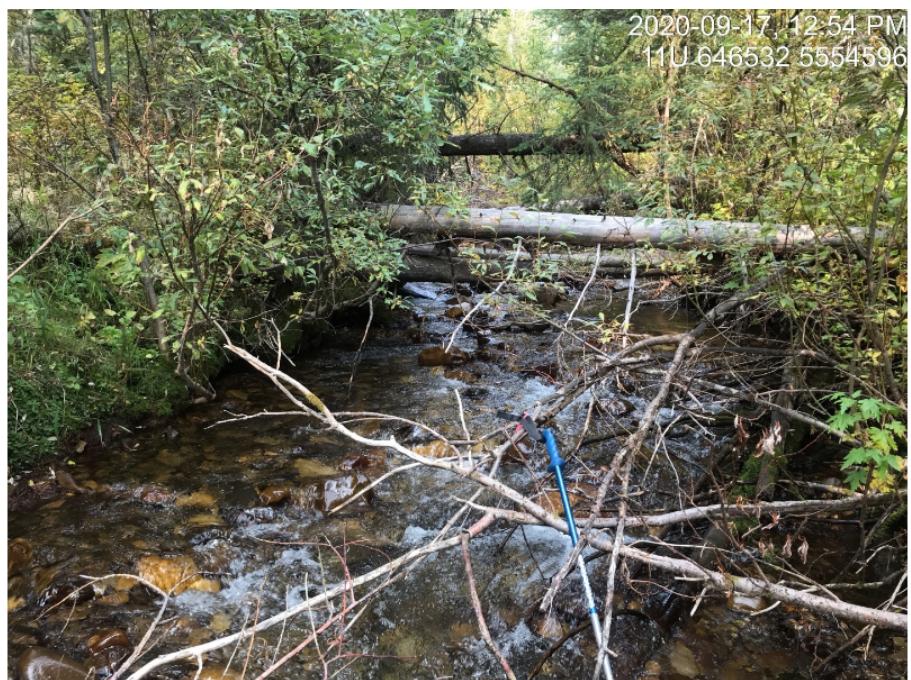
Figure 5.41: Typical habitat upstream of PSCIS crossing 197555.

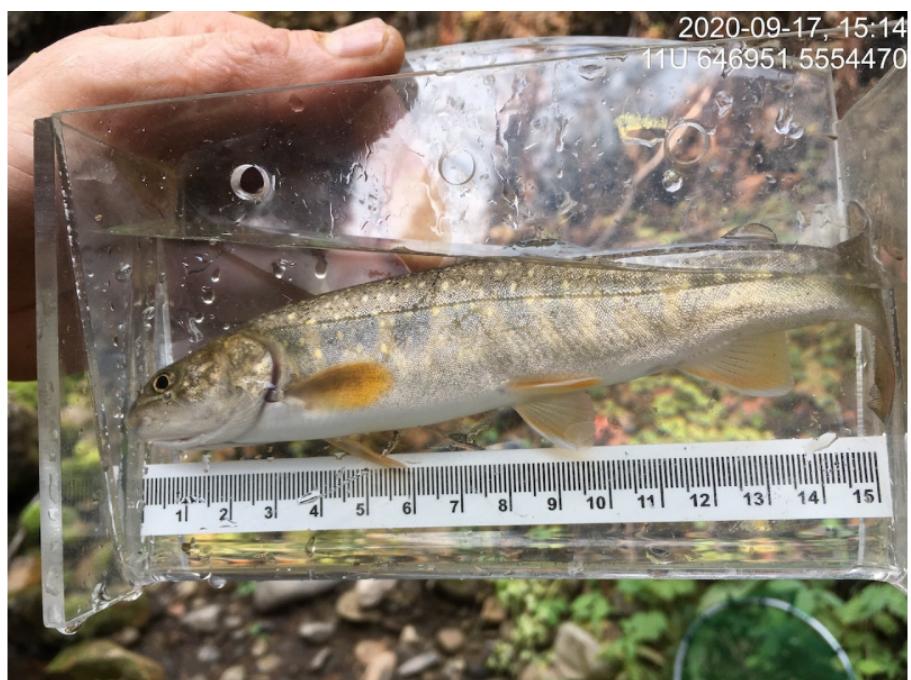
Figure 5.42: Bull trout captured downstream of PSCIS crossing 197555.
