Appendix - Phase 1 Fish Passage Assessment Data and Photos

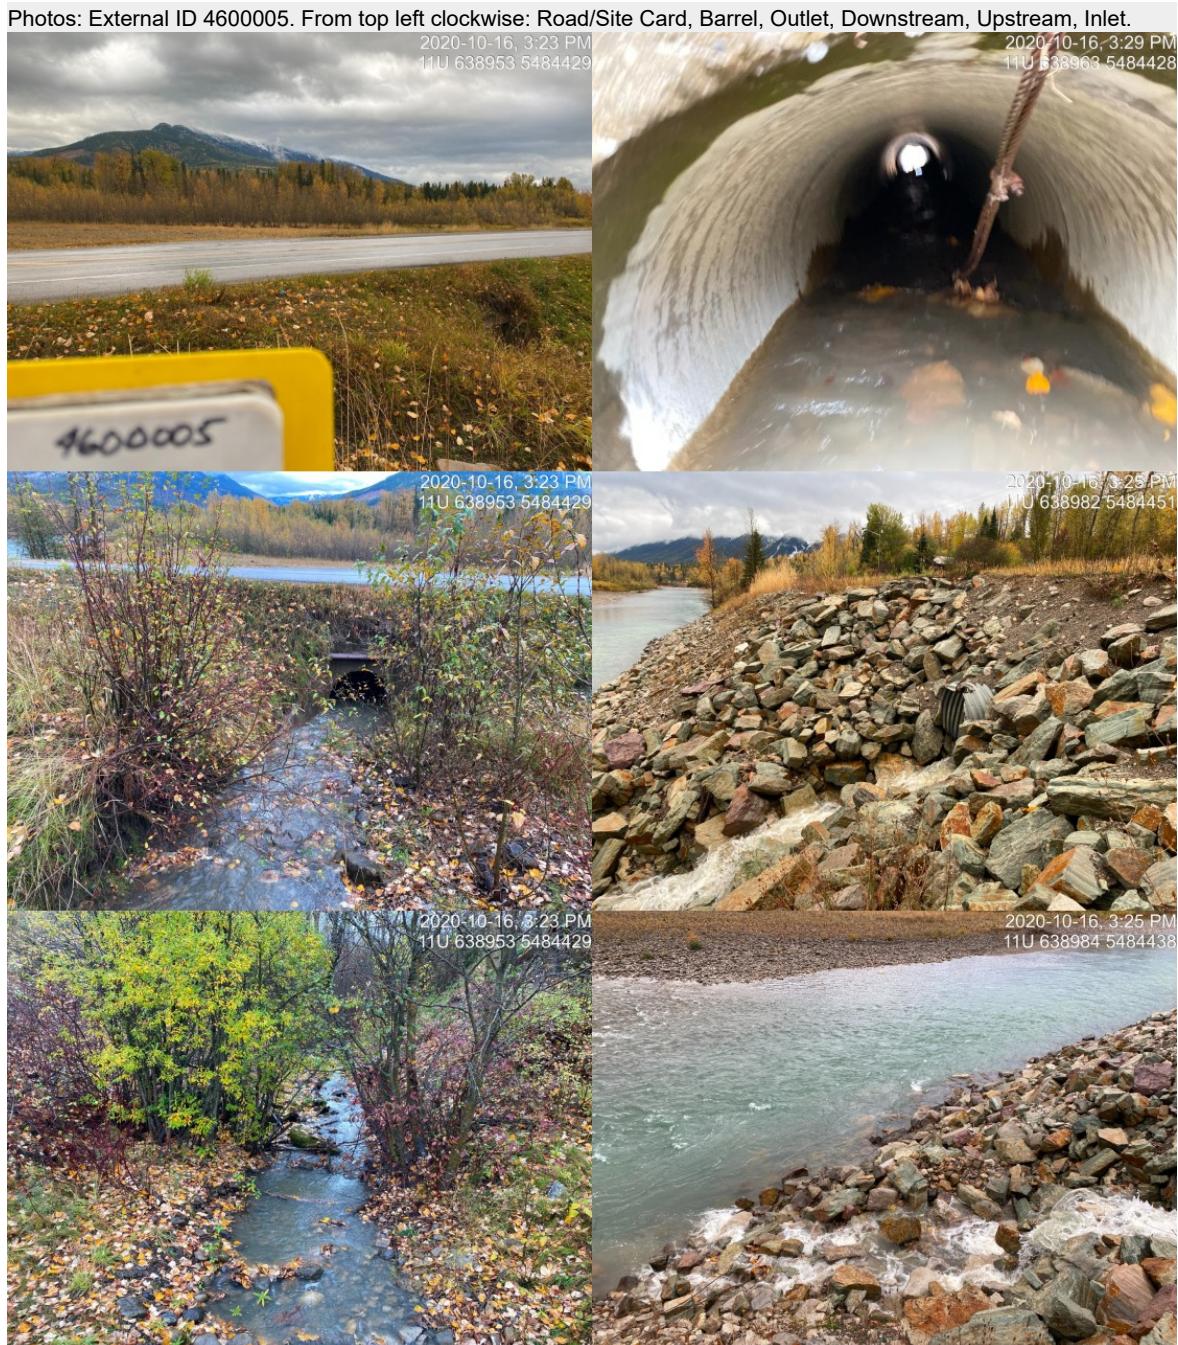
Comments: Difficult to discern if slope (>60%) downstream between the highway and the Elk River is due to highway fill or was naturally occurring before highway installation.

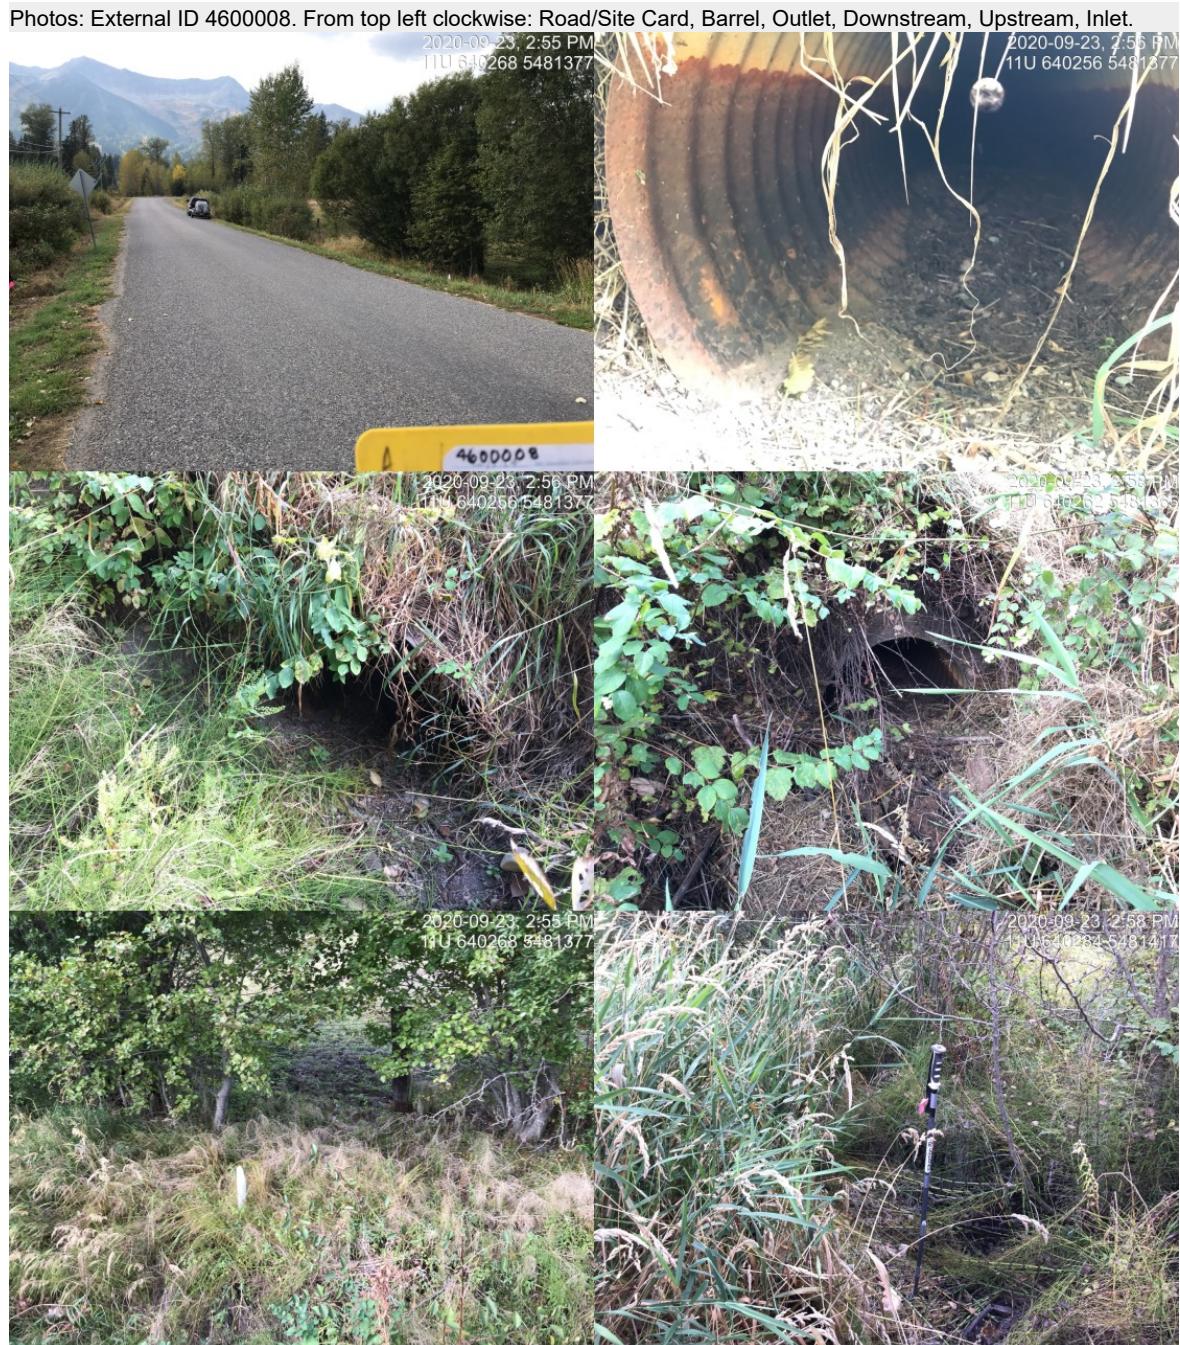
Comments: Dry mostly vegetated channel. Not likely fish habitat.

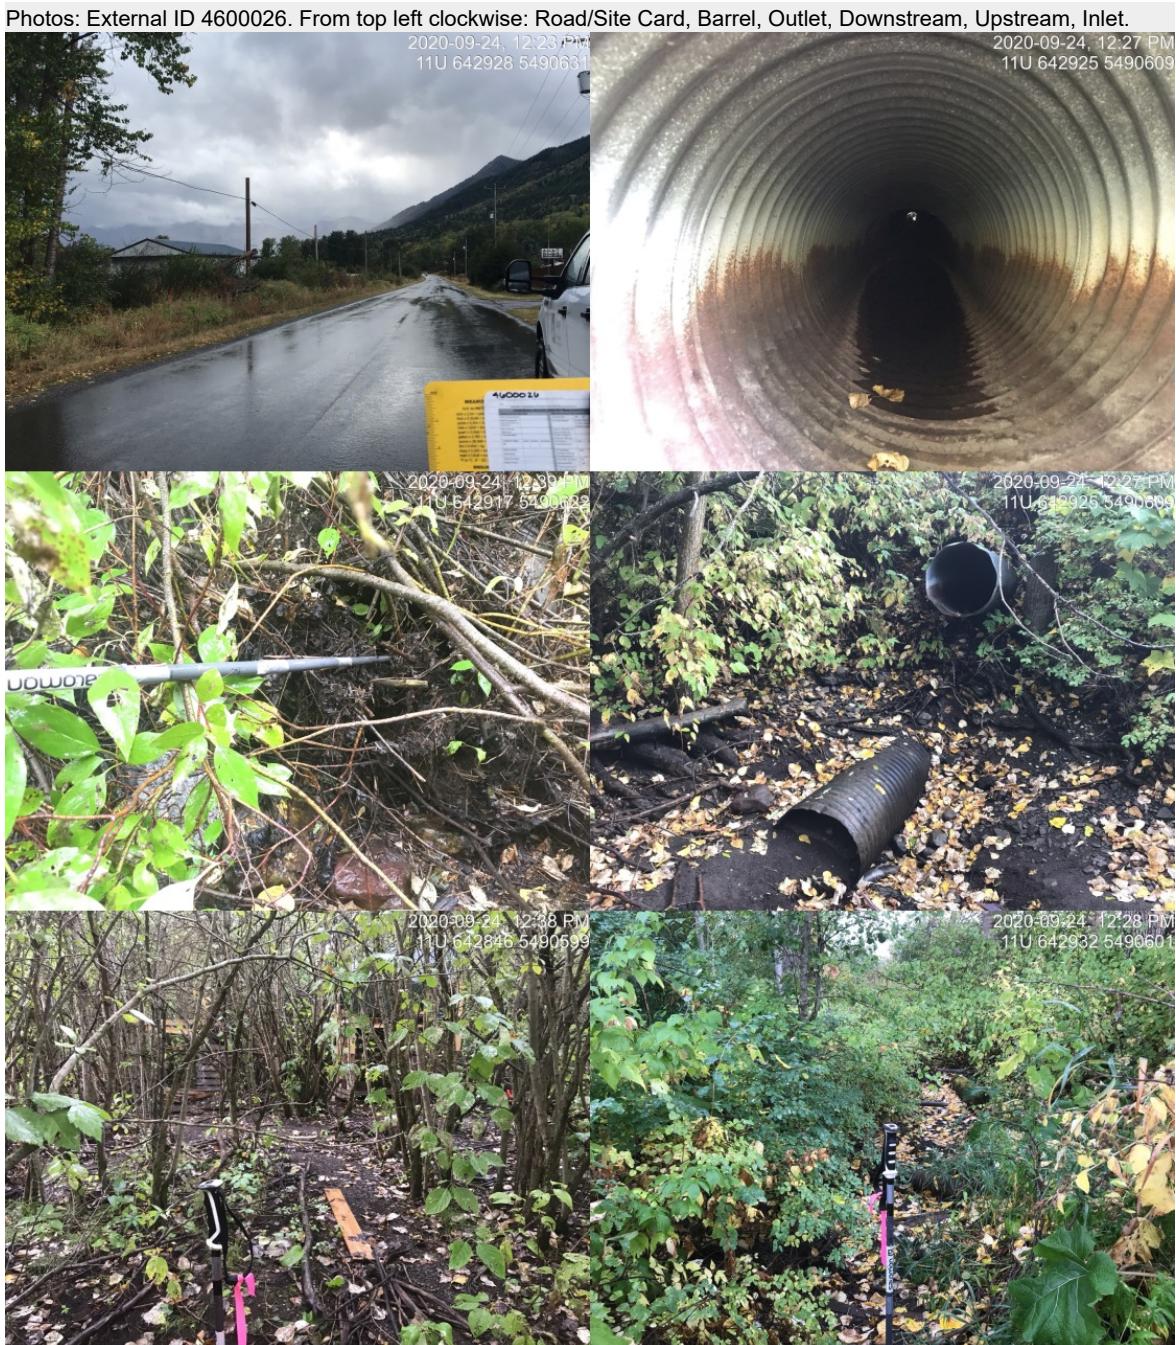
Comments: Stream dry at time of survey. Children's fort in upstream channel indicating that flows are likely very minimal year round.

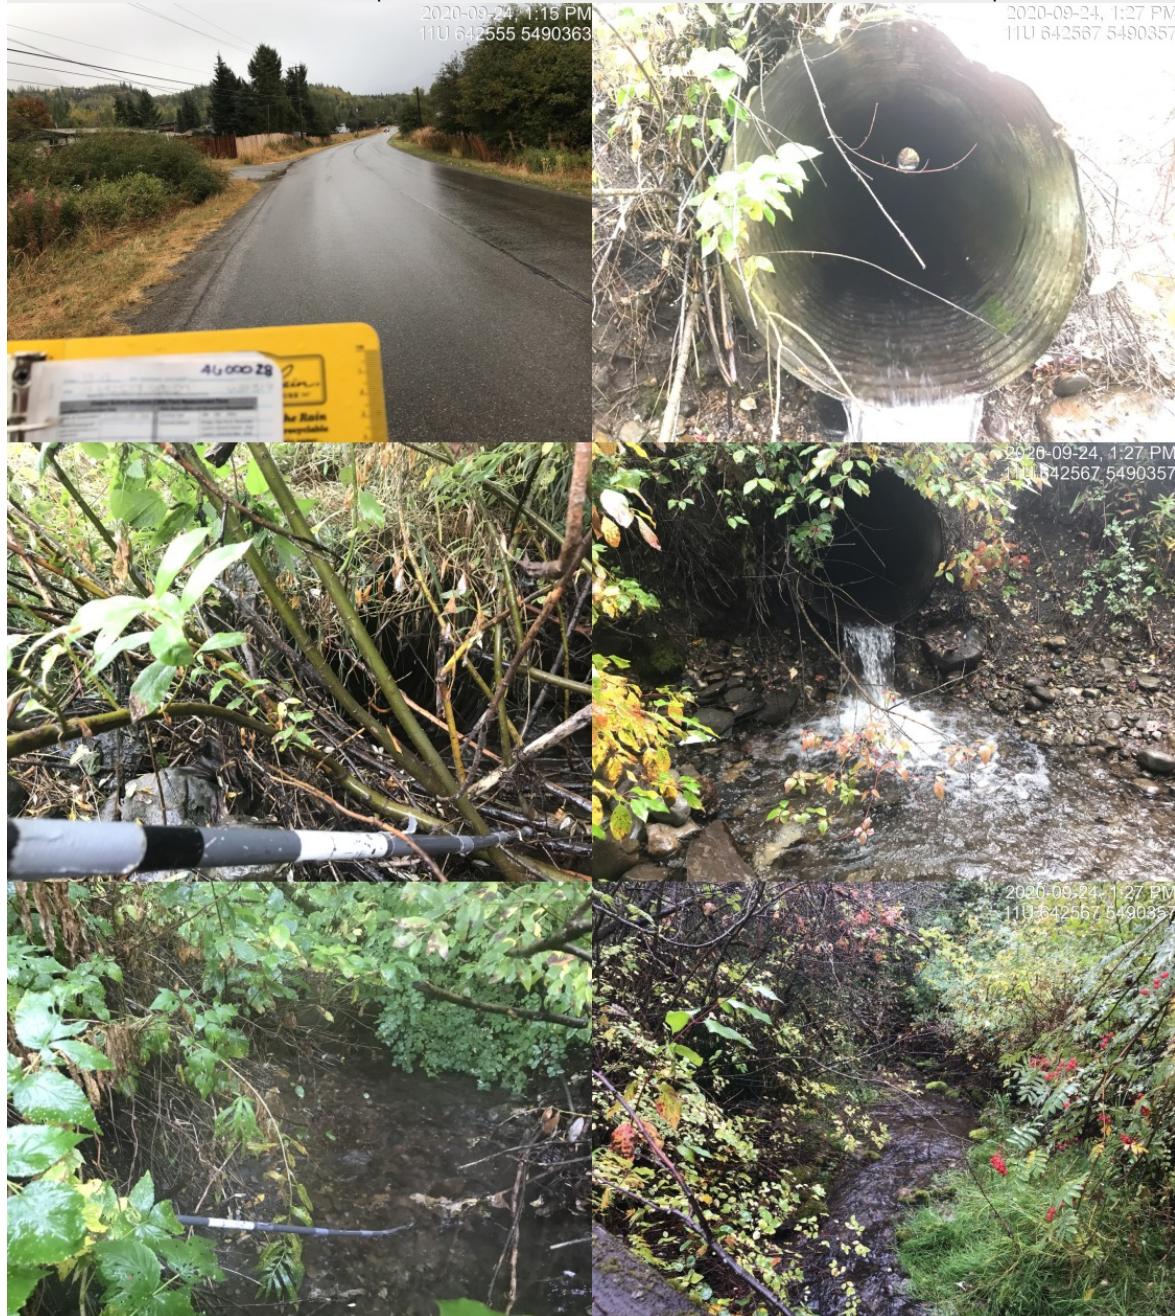
Photos: External ID 4600028. From top left clockwise: Road/Site Card, Barrel, Outlet, Downstream, Upstream, Inlet.

Comments: Multiple fish observed in outlet pool (~190mm). Some gravels suitable for spawning located upstream.

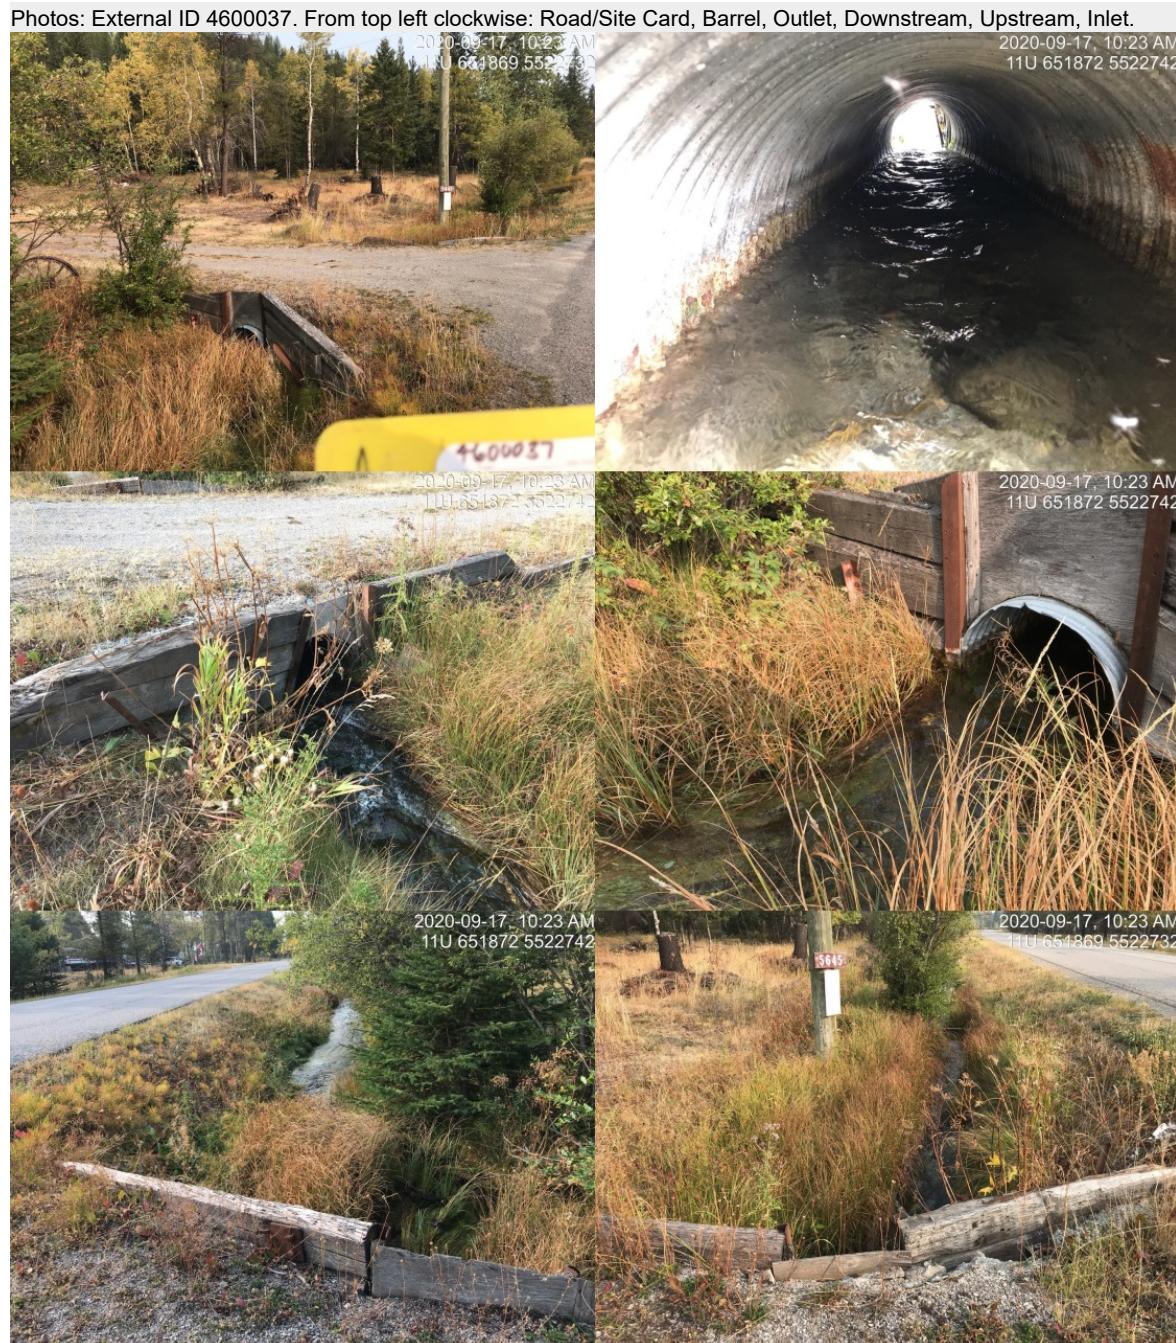
Comments: Embedded culvert on private driveway. EB known upstream. Culvert does not appear likely to be significantly impacting upstream fish passage for juvenile or adult WCT at time of survey.

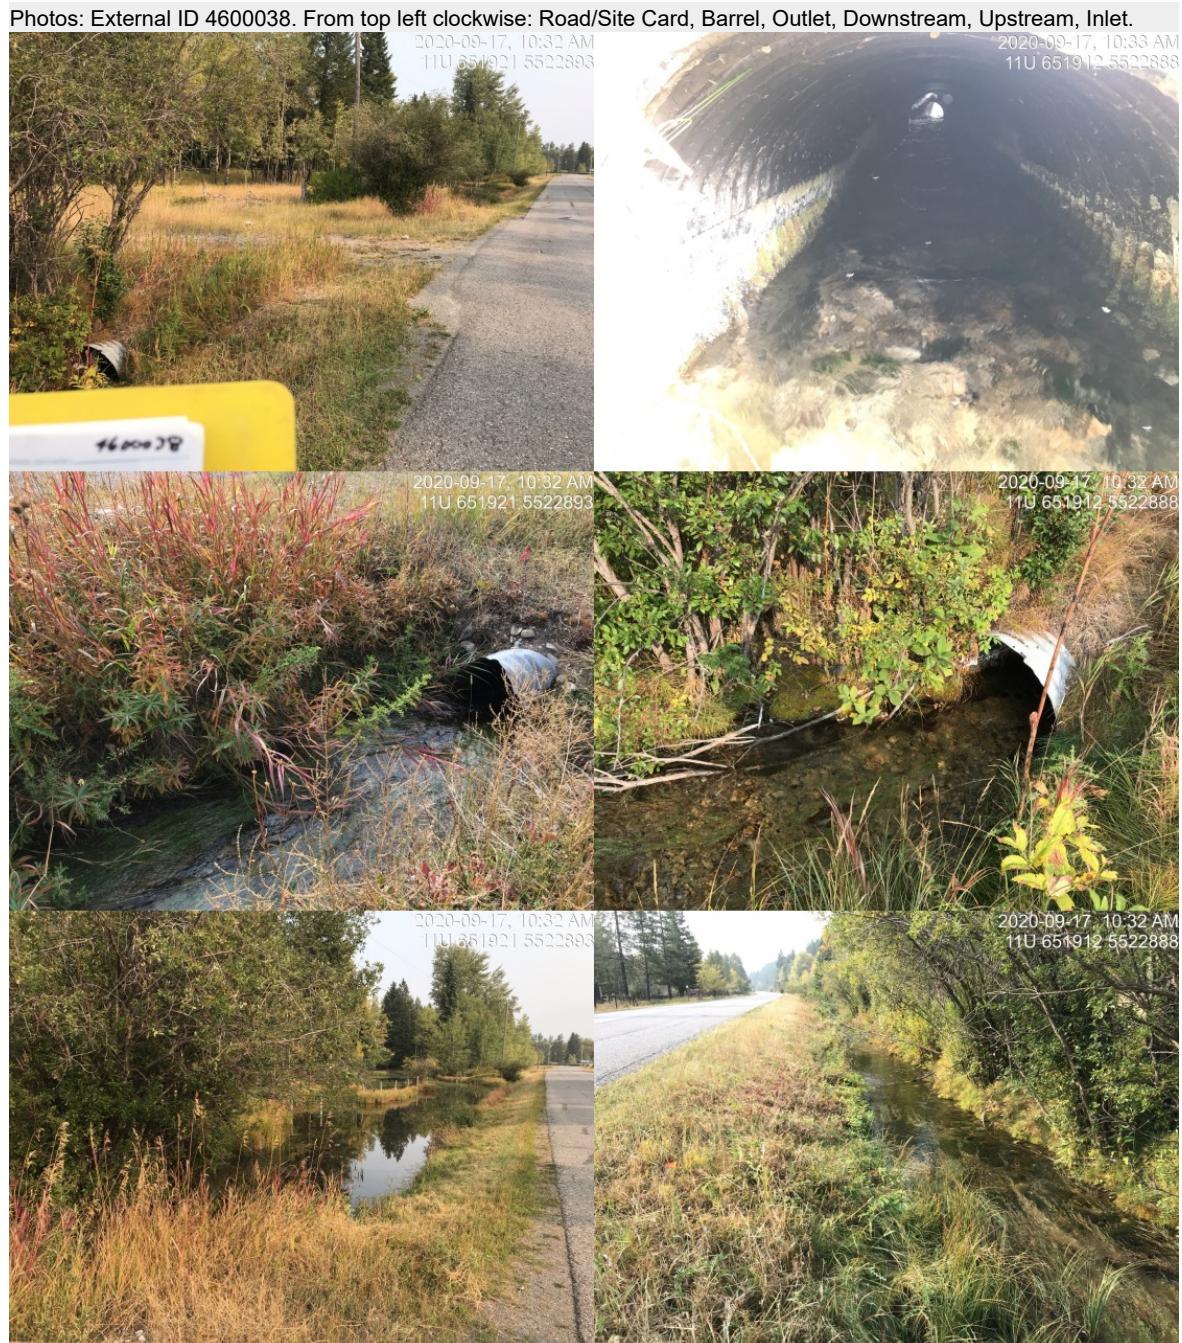
Comments: Culvert collapsing in the middle. Private residence driveway. Wetland type habitat upstream. Culvert does not appear likely to be significantly impacting upstream fish passage for juvenile or adult WCT at time of survey.

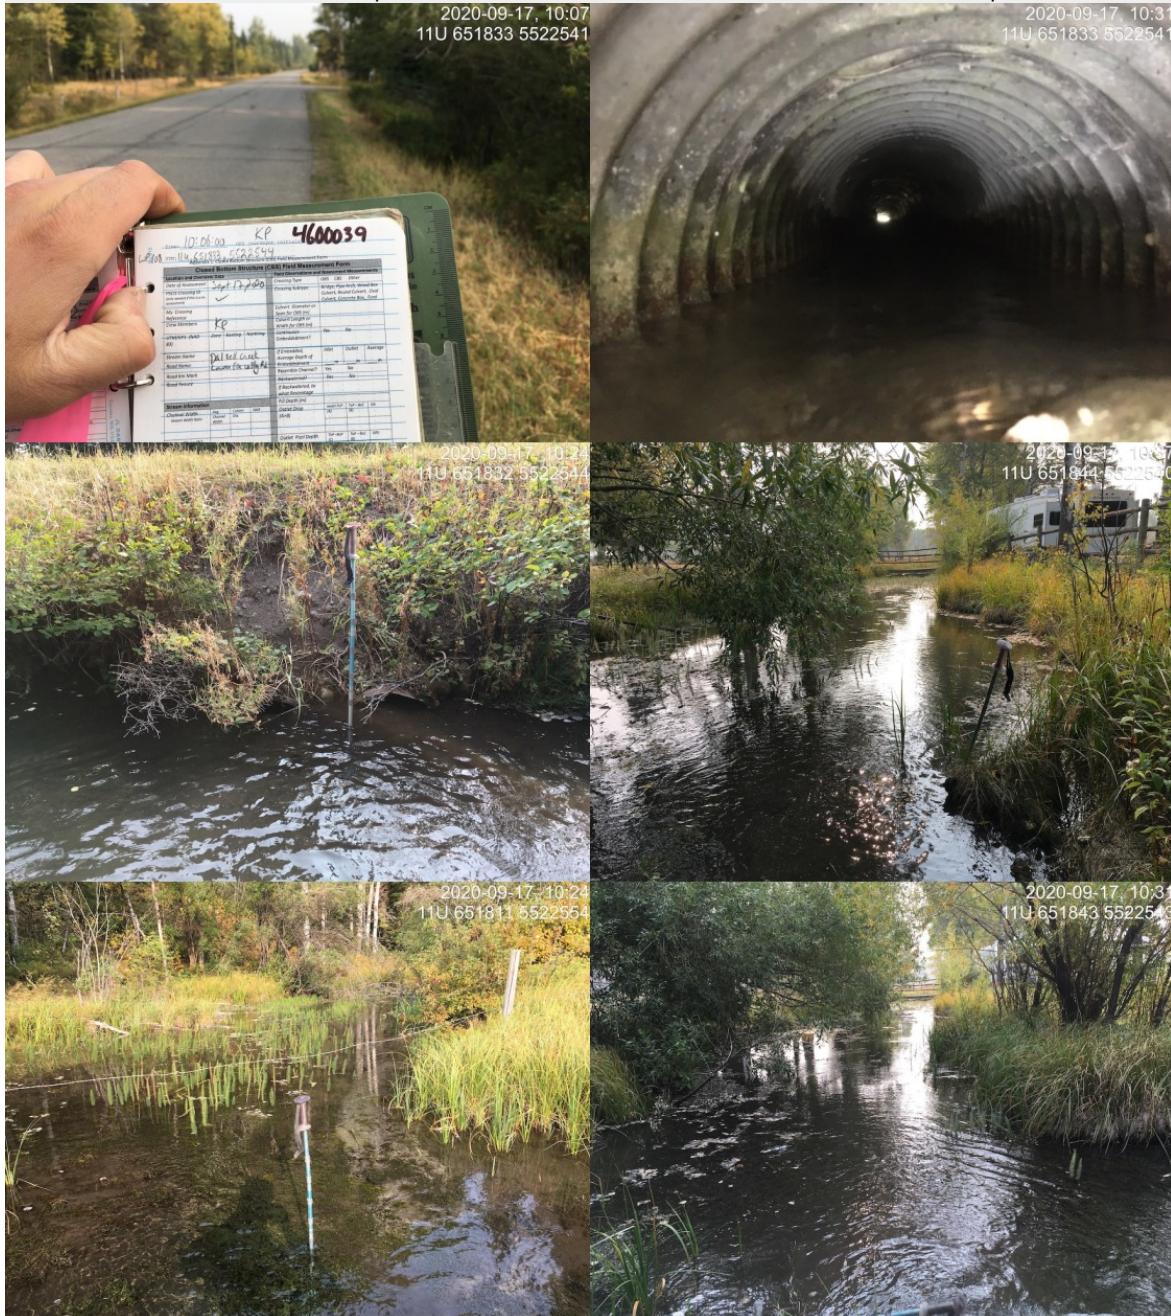
Photos: External ID 4600039. From top left clockwise: Road/Site Card, Barrel, Outlet, Downstream, Upstream, Inlet.

Comments: Three barrels (.45m each). Two of the three have water flowing through them. Upstream and downstream channel widens out, slow flow through vegetated channel. Highly manipulated banks. Deep fine substrate on both sides of crossing. Upstream resembles a wetland. Crossing does not appear likely to be significantly impacting upstream fish passage for juvenile or adult WCT at time of survey.

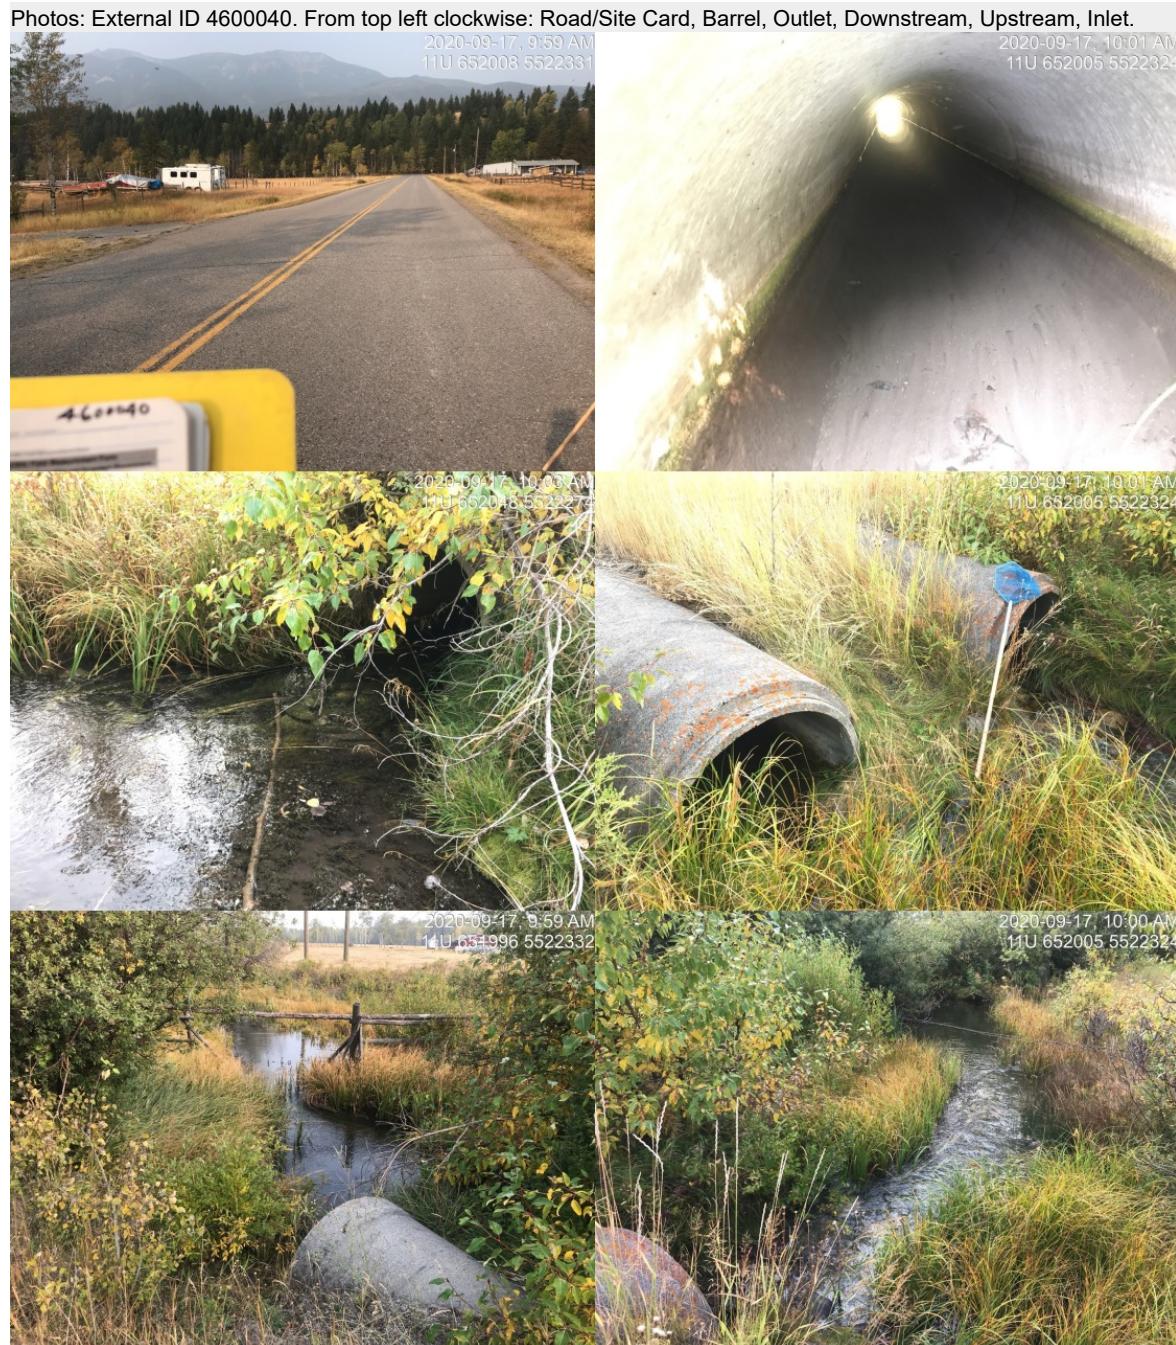
Comments: Fenced private land upstream and downstream. Wetland area downstream. Culvert does not appear likely to be significantly impacting upstream fish passage for juvenile or adult WCT at time of survey.

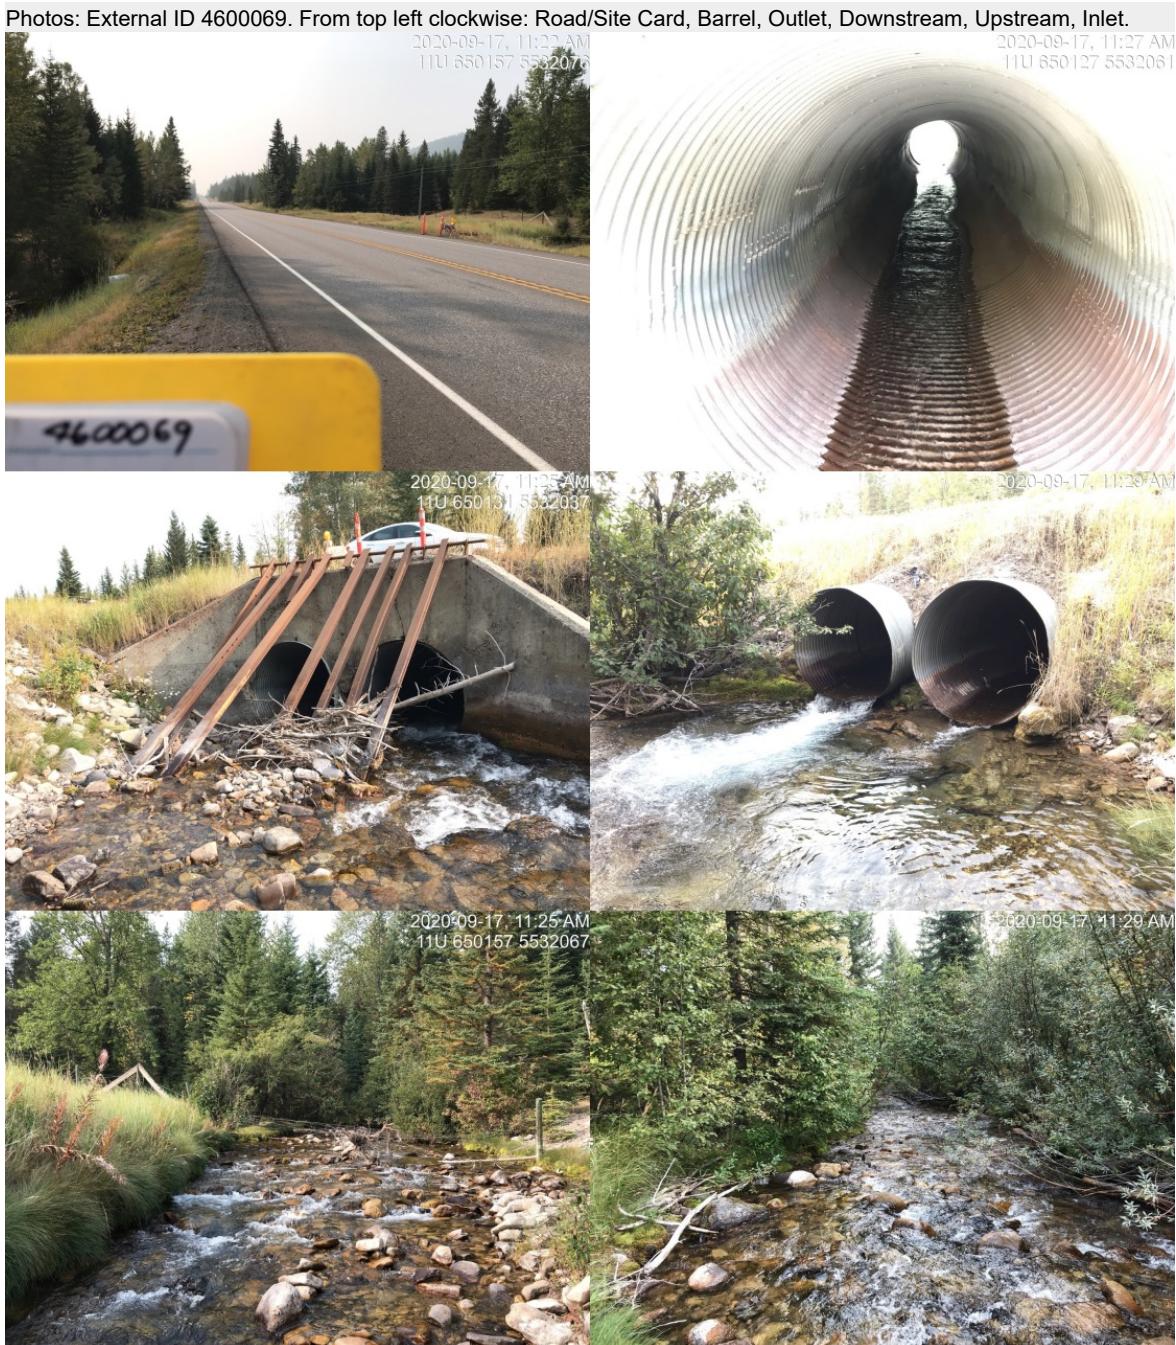
Comments: Large stream with good flow. Flows currently mostly through south culvert which has slightly higher outlet drop. Similar elevation outlets so added together for width. Lazer level used for culvert slope. Cobble/boulder substrate. Boulder cover.

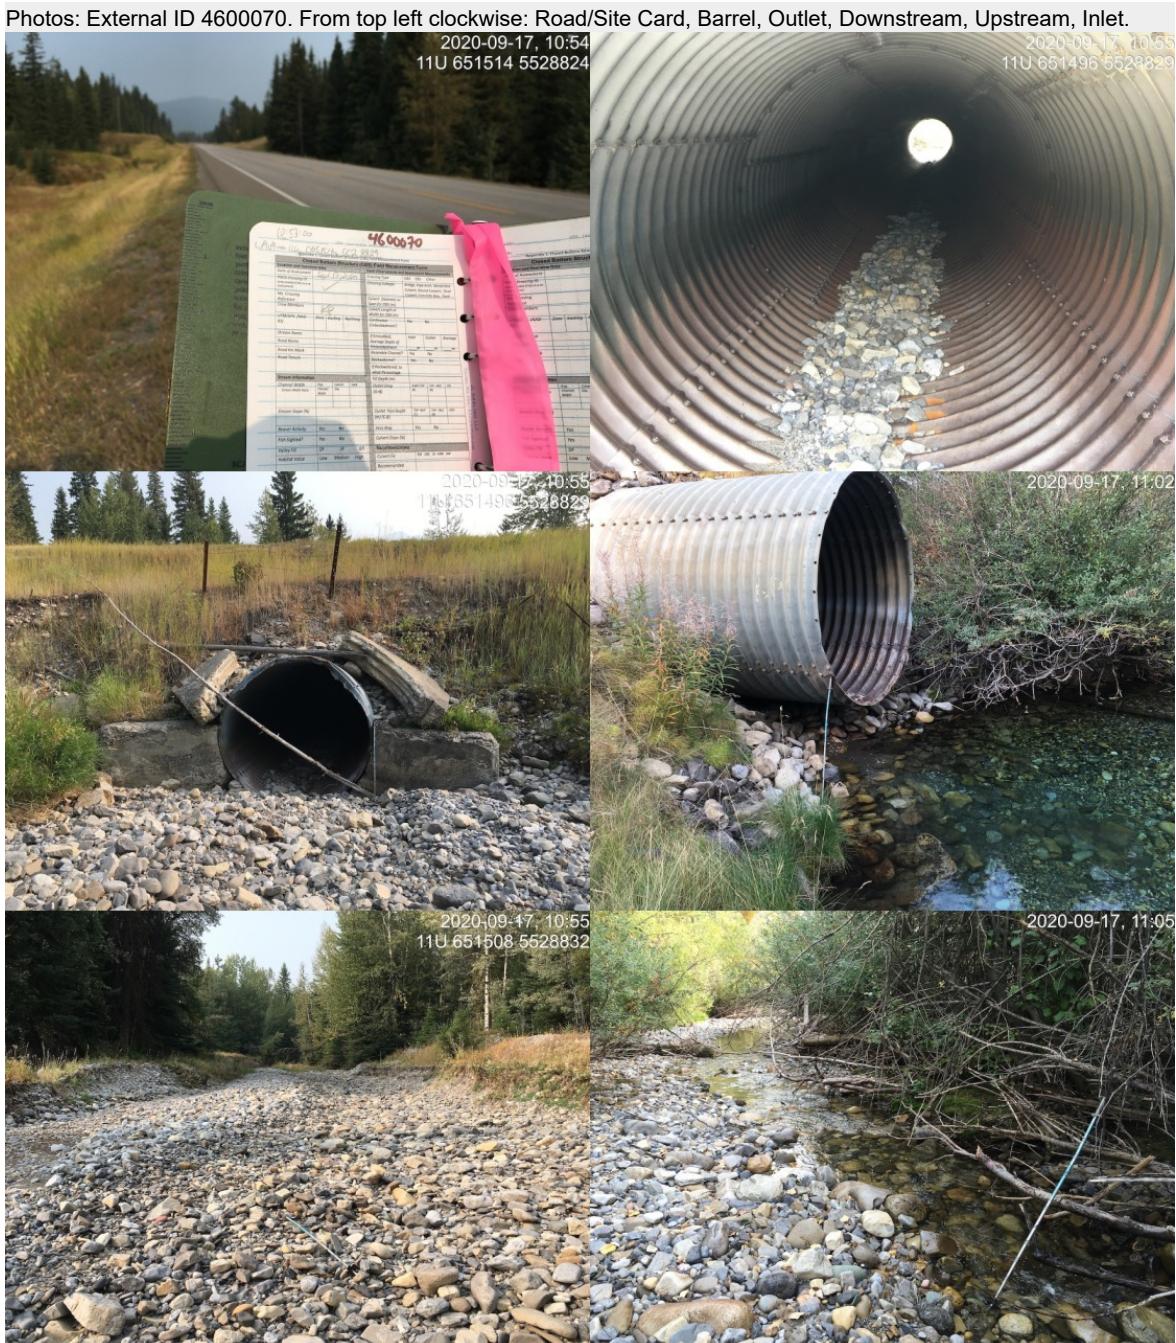
Comments: Dewatered upstream of highway for 600m. Deep pool present downstream fed subsurface from northside of culvert. Approximately 9 WCT in outlet pool. Four fish ~300mm and 5 fish ~200 mm. High confidence that the larger fish were WCT as easy to recognize spotted backs from bank.

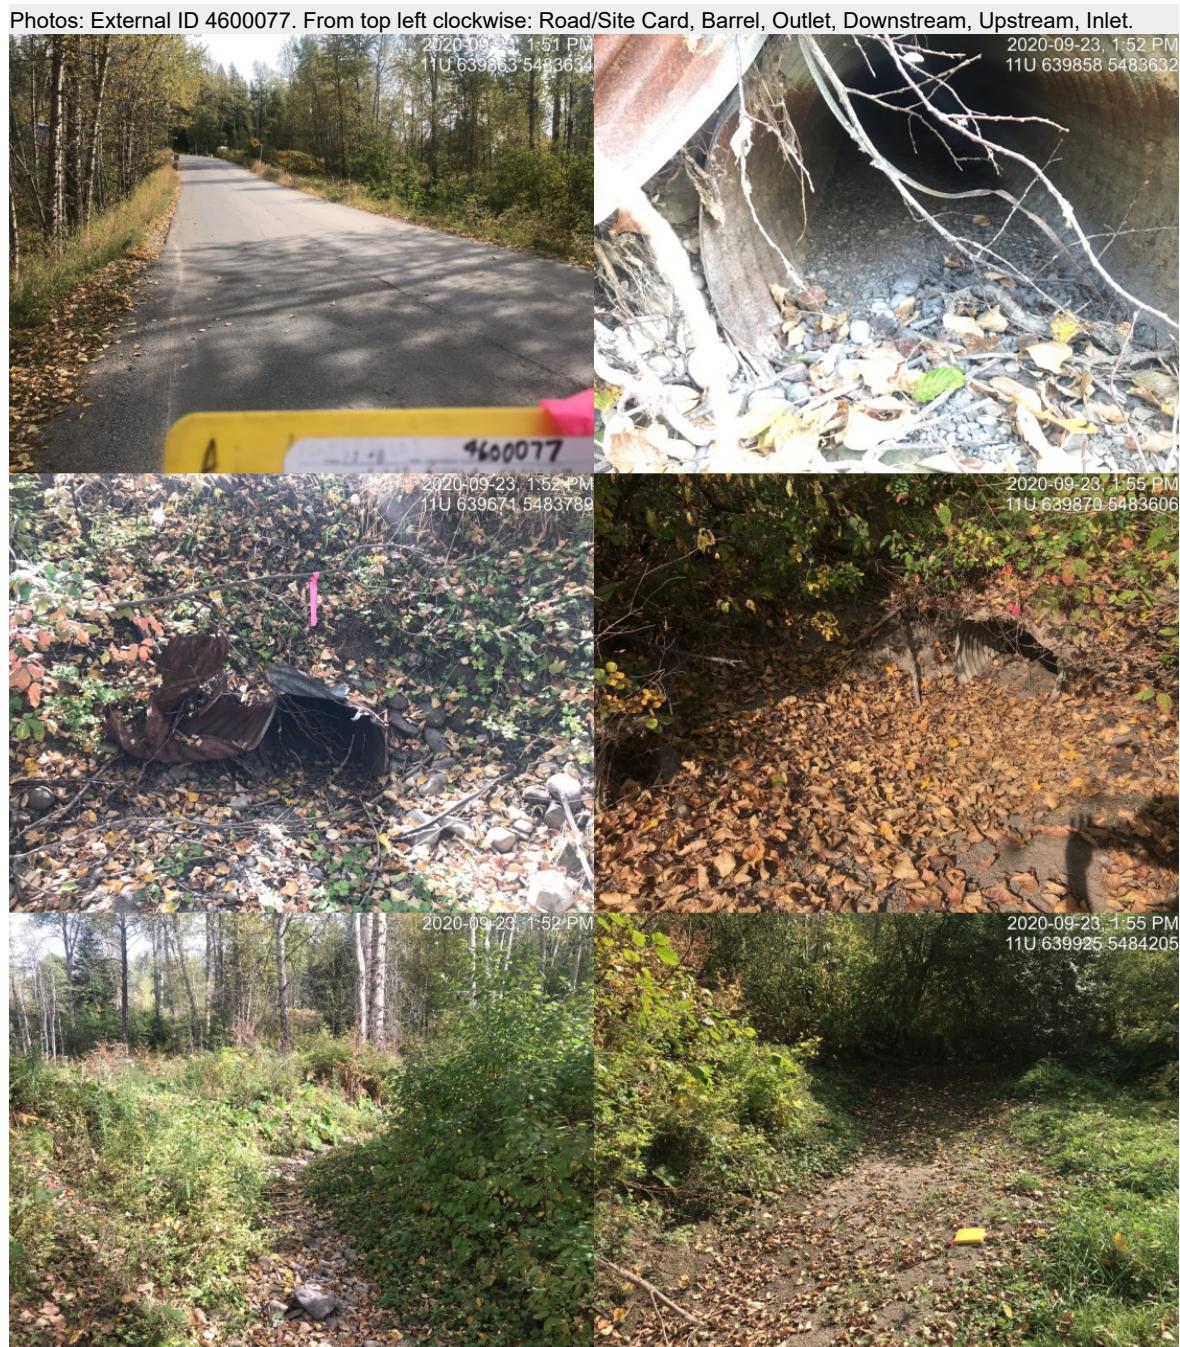
Comments: Dry channel. Culvert is embedded.

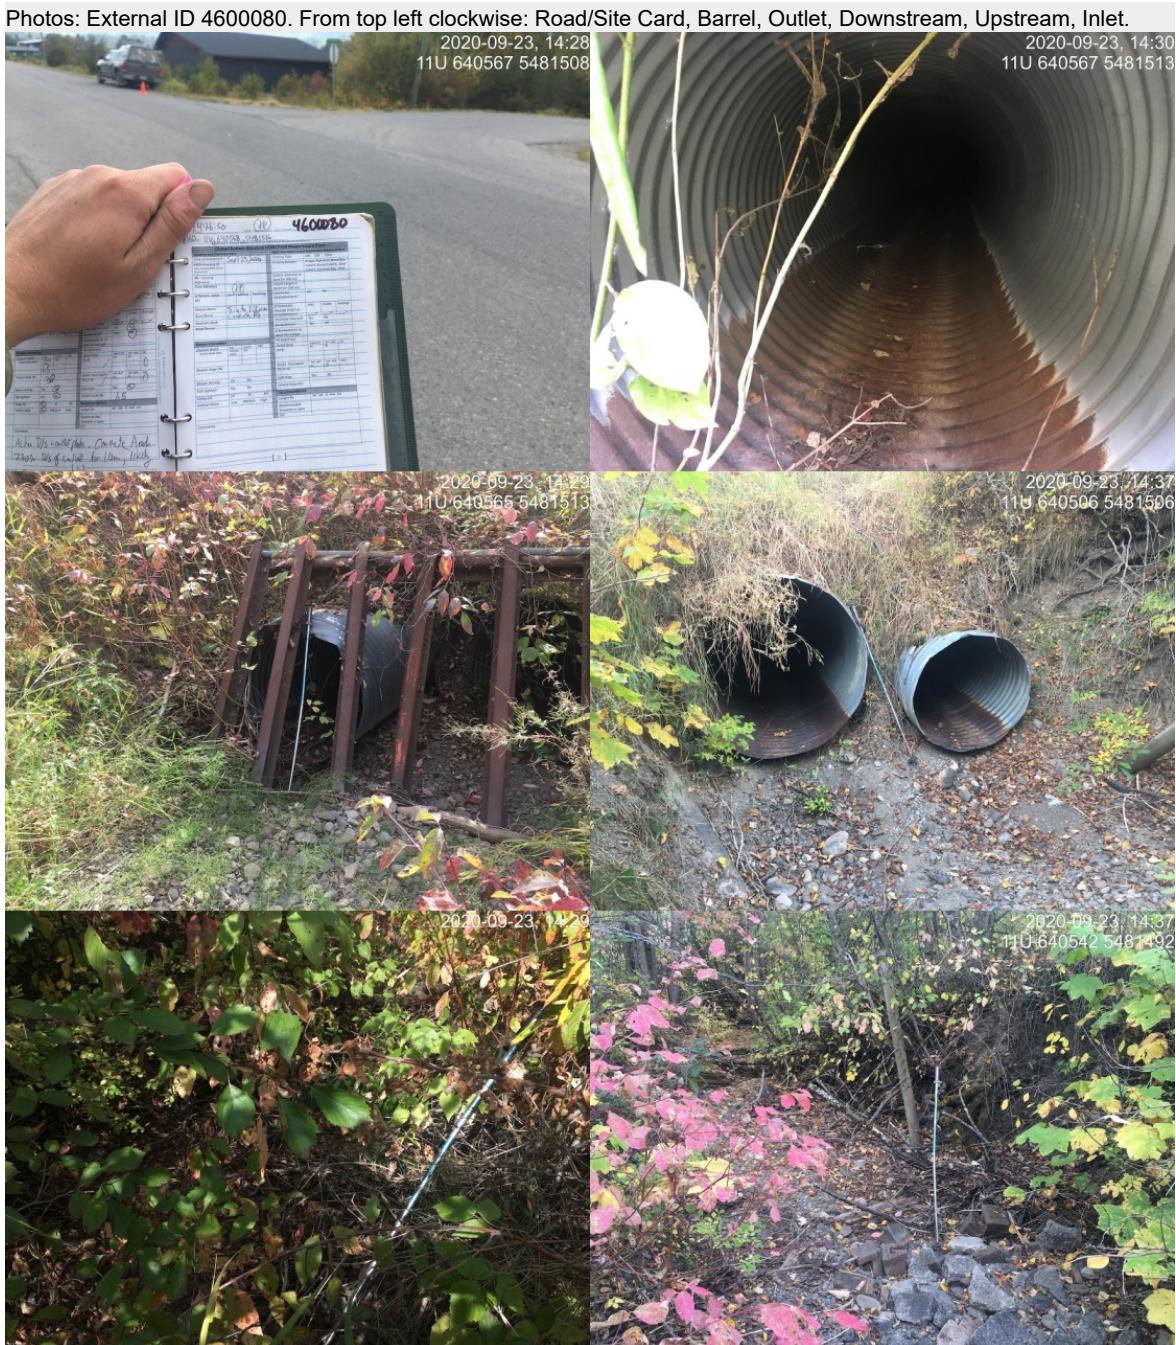
Comments: 2 barrels, 0.90 and 1.1m. Debris rack on inlet. Stream dry at time of survey.

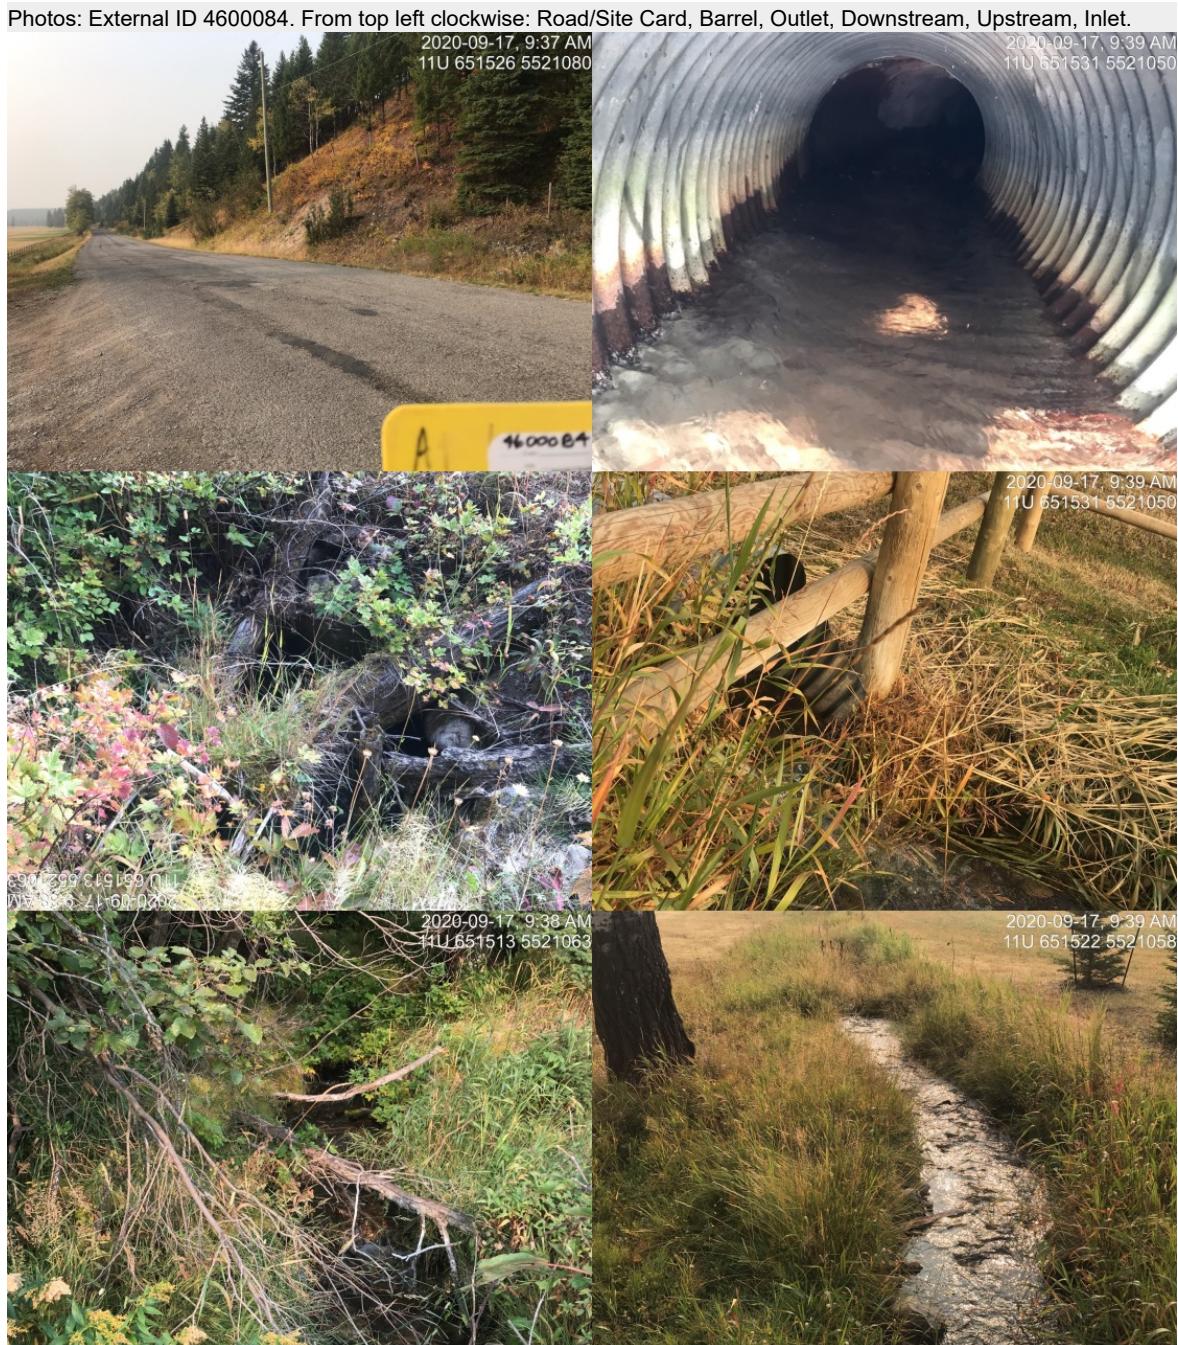
Comments: Flows through fenced private land upstream and downstream. Inlet has quite a bit of debris on it. Upstream is much steeper than downstream with gradient estimated at 12%. Small stream with good flow.

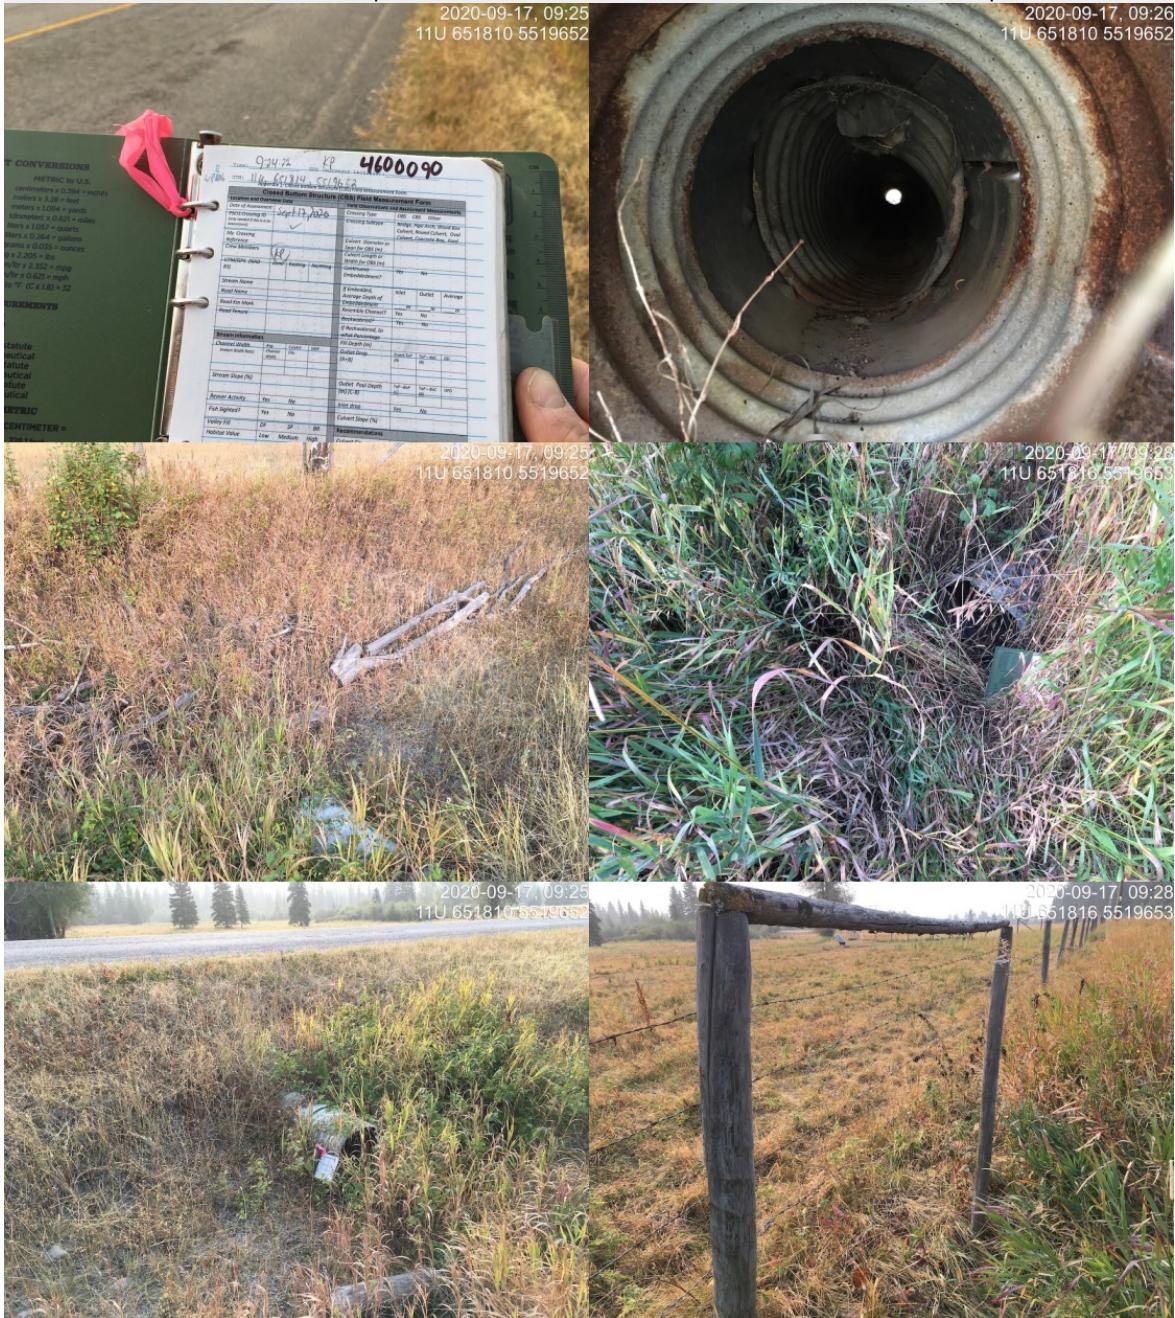
Photos: External ID 4600090. From top left clockwise: Road/Site Card, Barrel, Outlet, Downstream, Upstream, Inlet.

Comments: No visible channel. Not likely fish habitat. Agricultural area.
