Appendix - Phase 1 Fish Passage Assessment Data and Photos

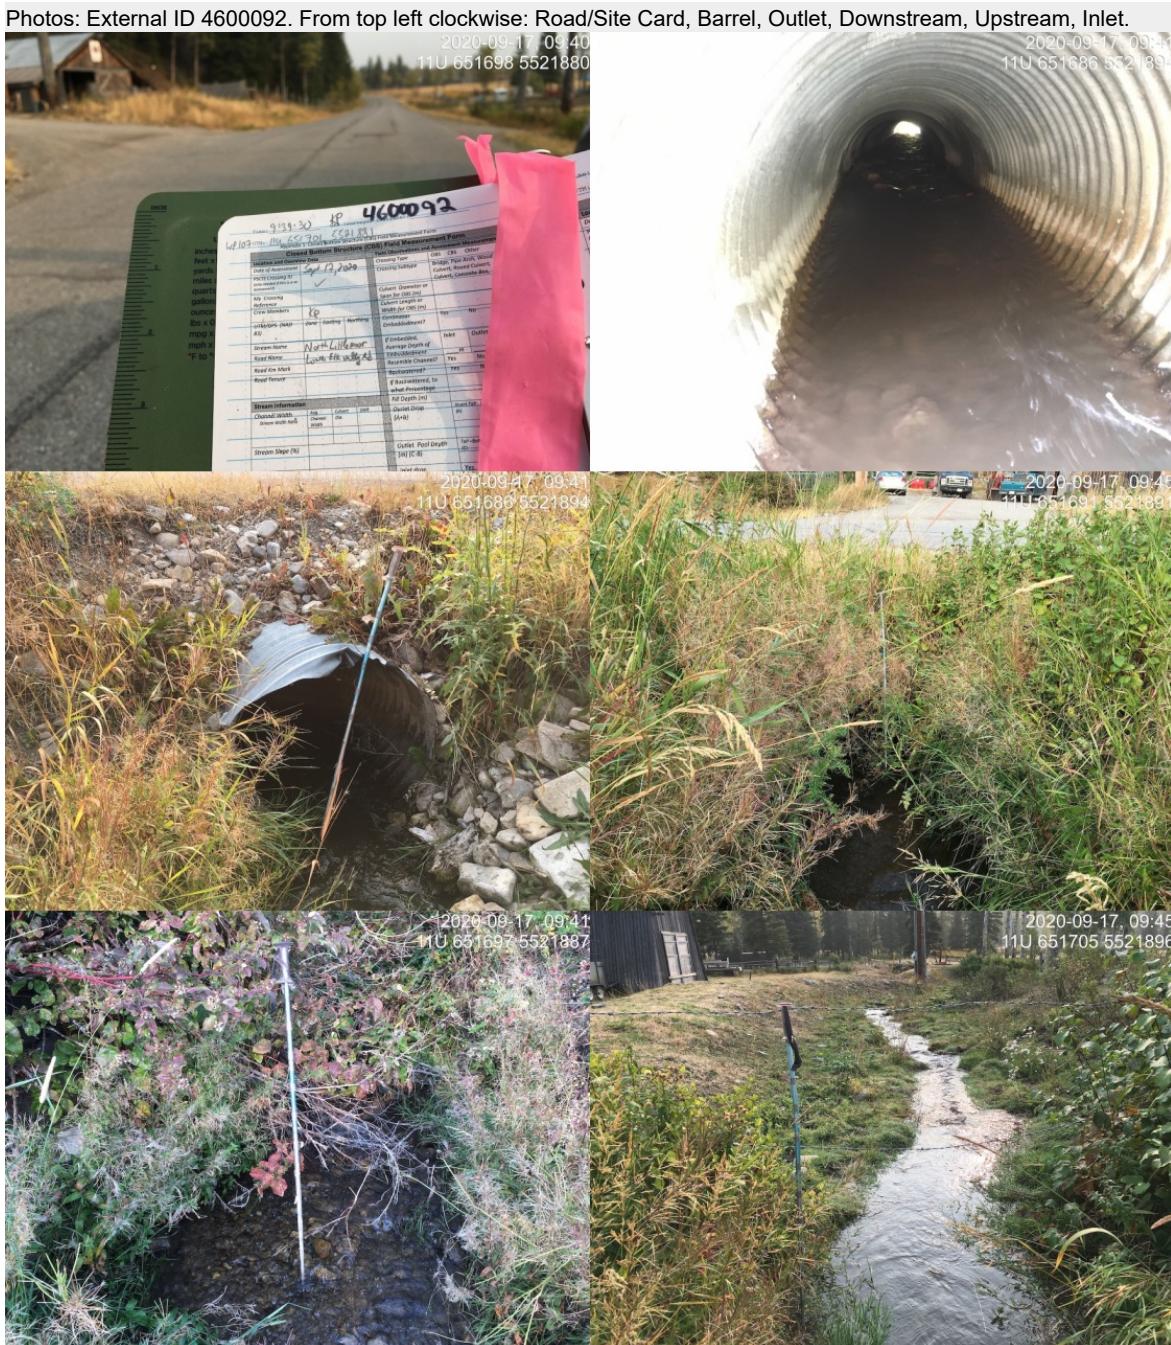
Comments: Stream slope estimated due to fenced private land.

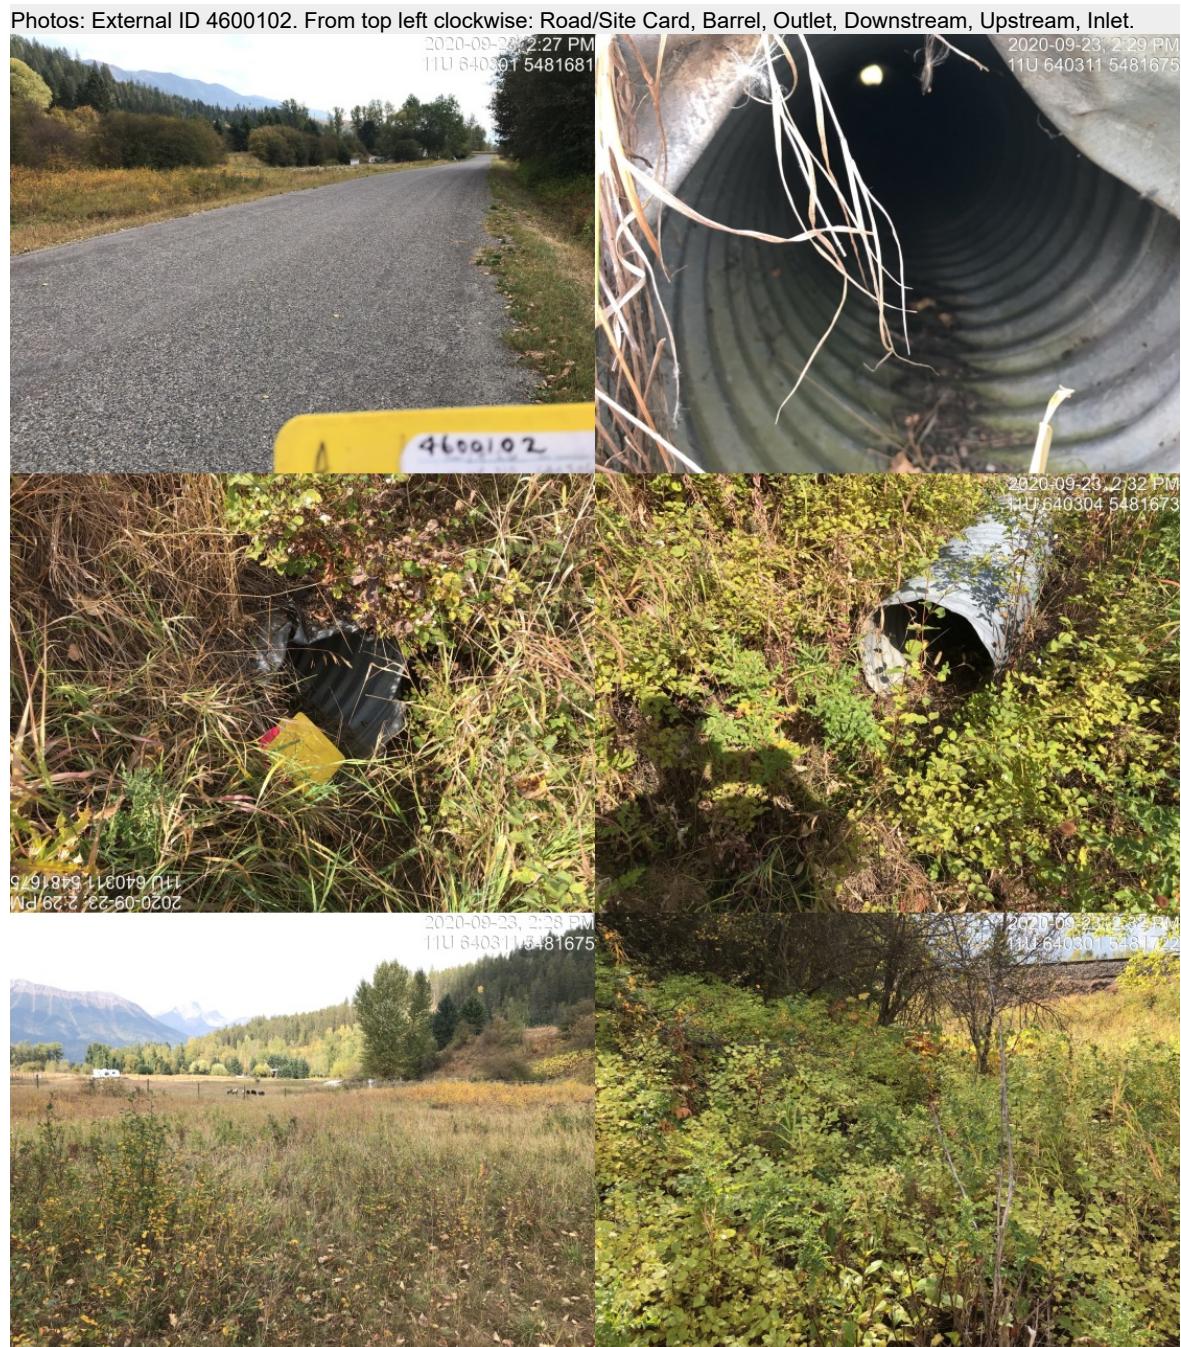
Comments: Vegetated channel. Not likely fish habitat.

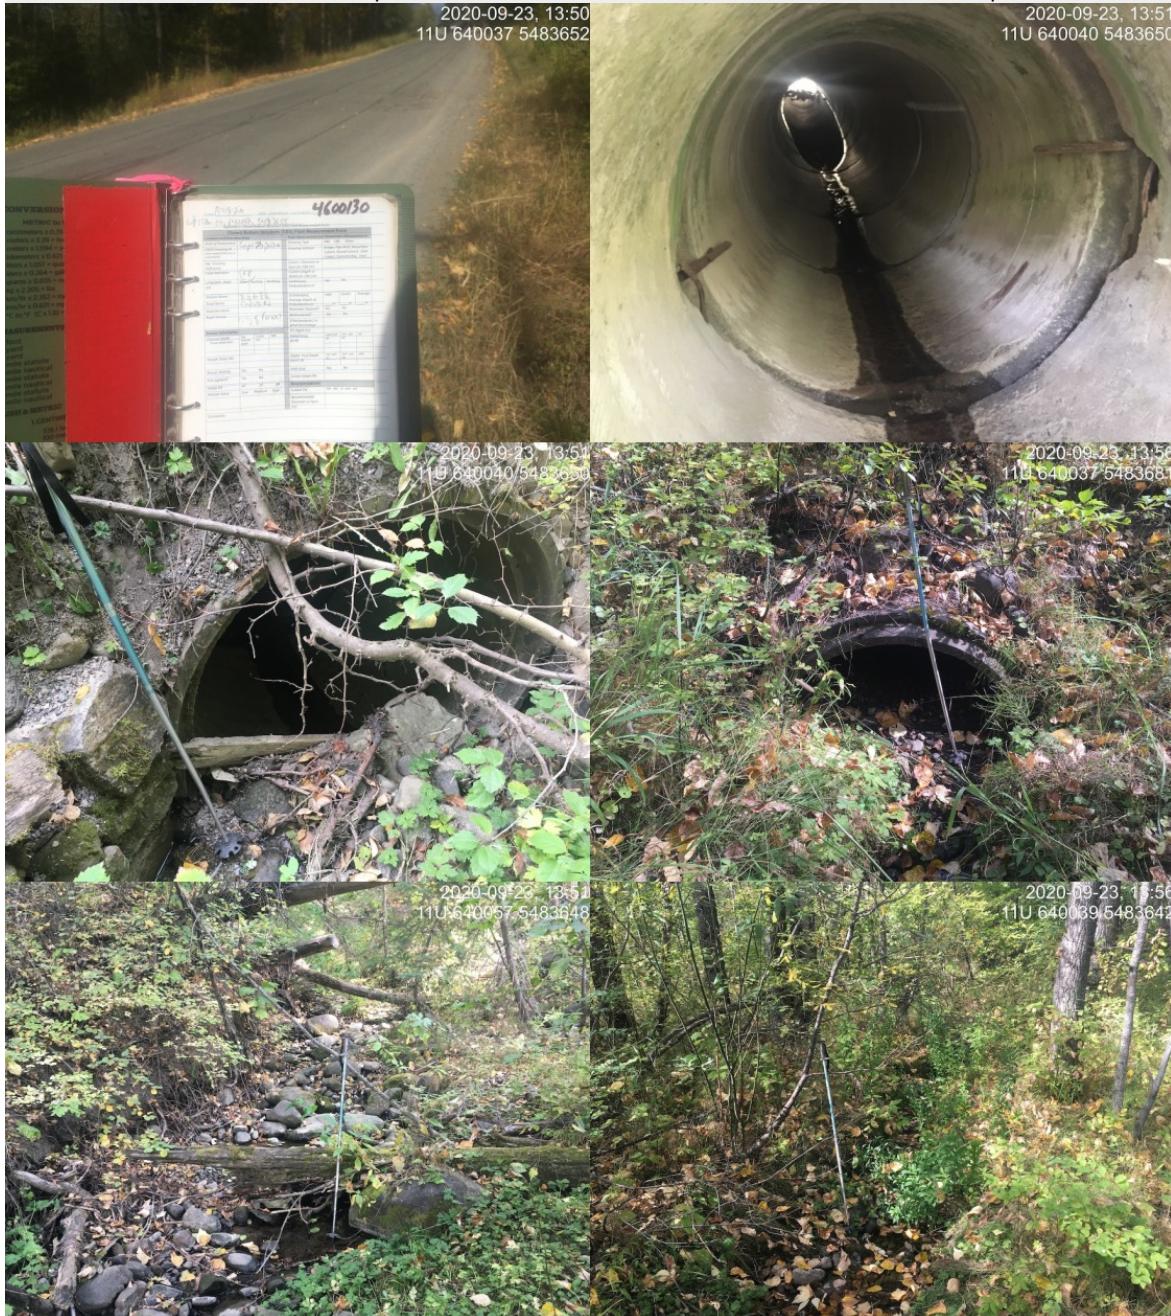
Photos: External ID 4600130. From top left clockwise: Road/Site Card, Barrel, Outlet, Downstream, Upstream, Inlet.

Comments: Very low flow at time of survey and 0.5m inlet drop from debris. Very steep culvert, possibly 2 sections with further upstream section being much steeper.

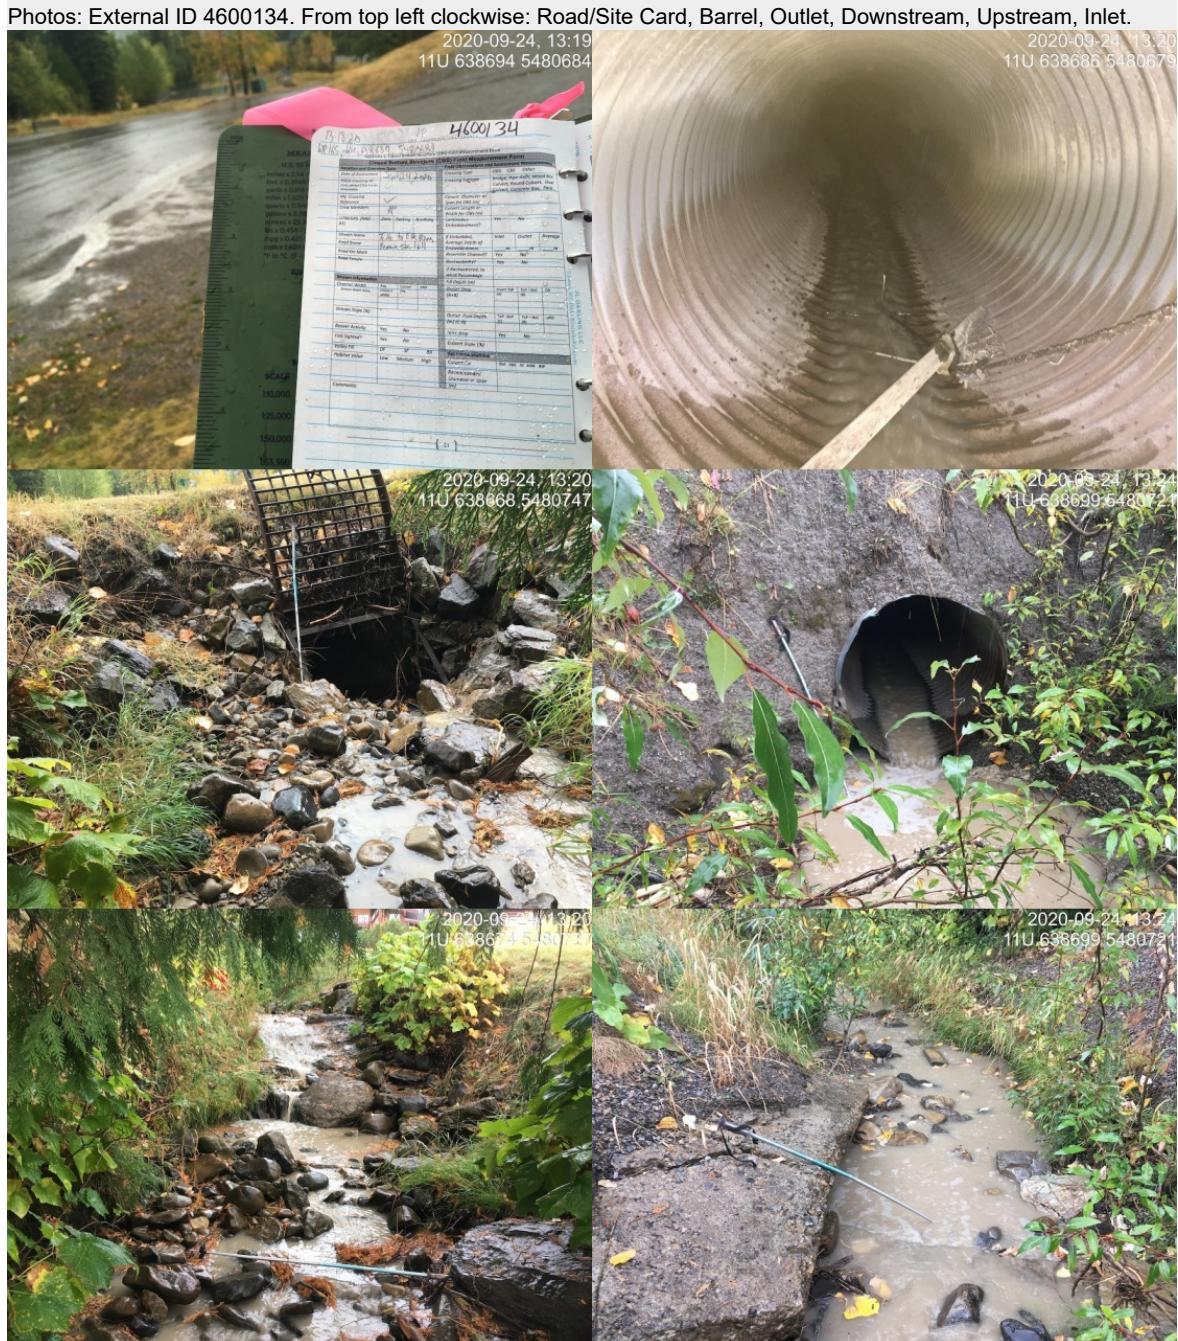
Comments: Debris guard on inlet. Unable to see through the culvert to other end. Highly manipulated banks, drains large parking area and ski hill. Steep with placed rocks (rip rap) in spots upstream. Stream goes under large turn around, paved area. Culvert likely >1 piece with slight angle. Armoured banks downstream, lots of sediment (sand) form pavement and parking area.

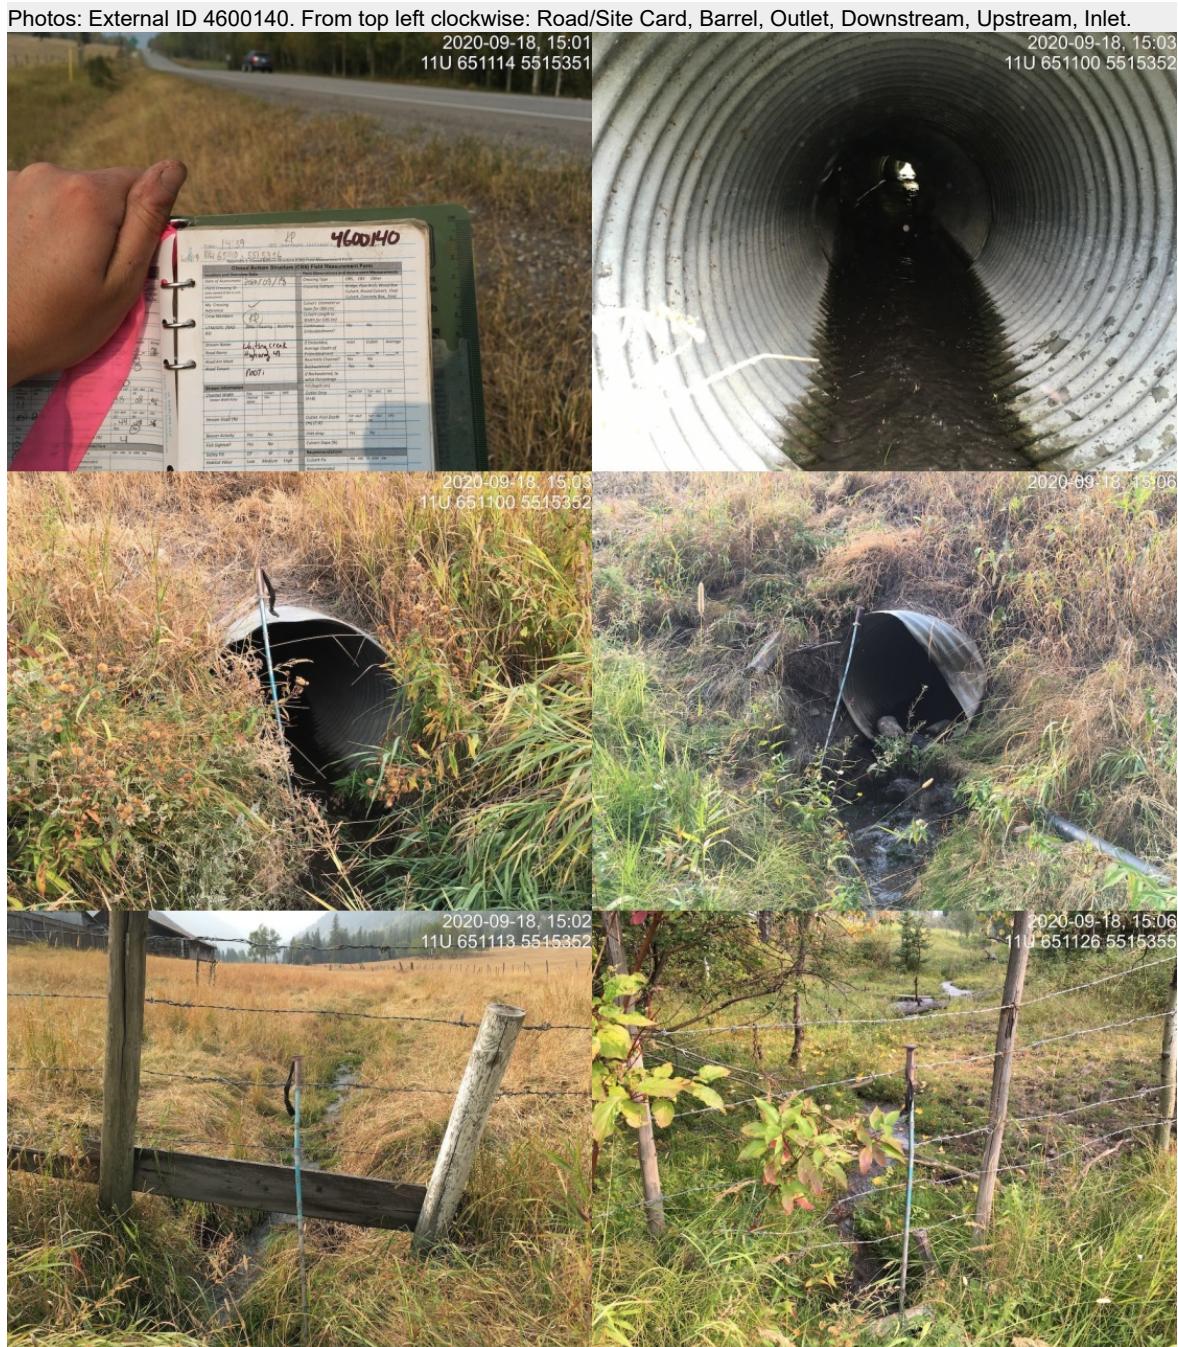
Comments: No access up or downstream due to fenced private land. Stream slope estimated. Water pipe intake at the outlet.

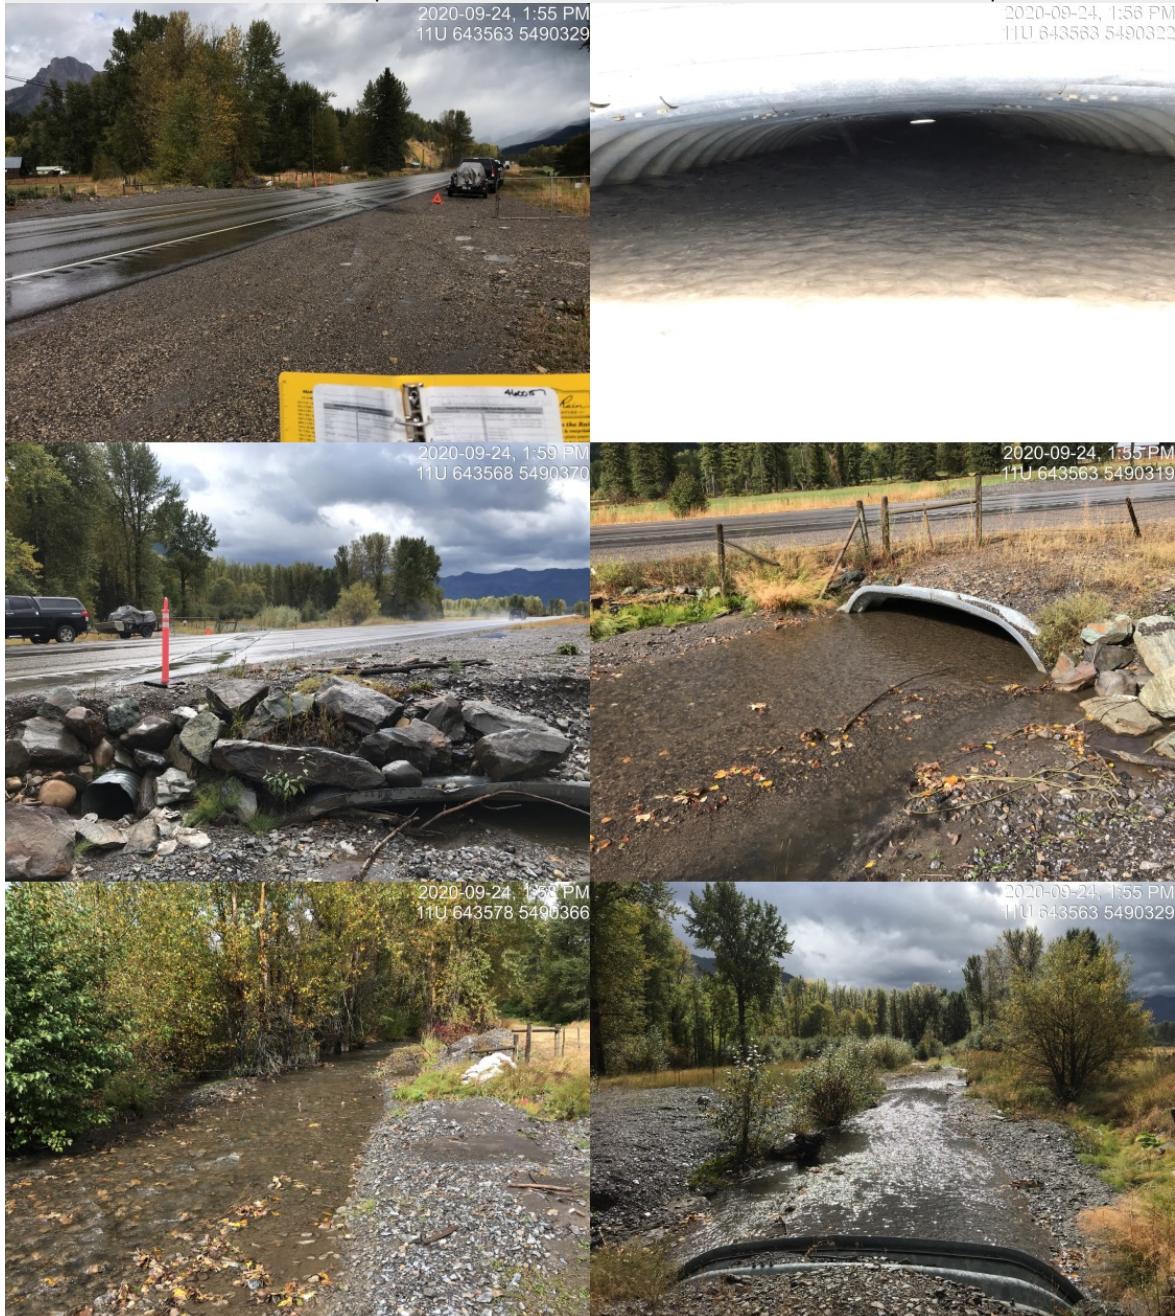
Photos: External ID 4600157. From top left clockwise: Road/Site Card, Barrel, Outlet, Downstream, Upstream, Inlet.

Comments: This crossing is very full of debris and has been recently dredges. Less than 30cm freeboard from top of aggregated gravels at inlet and top of pipe arch. Newly installed overflow pipe (0.55 diameter) on left bank.

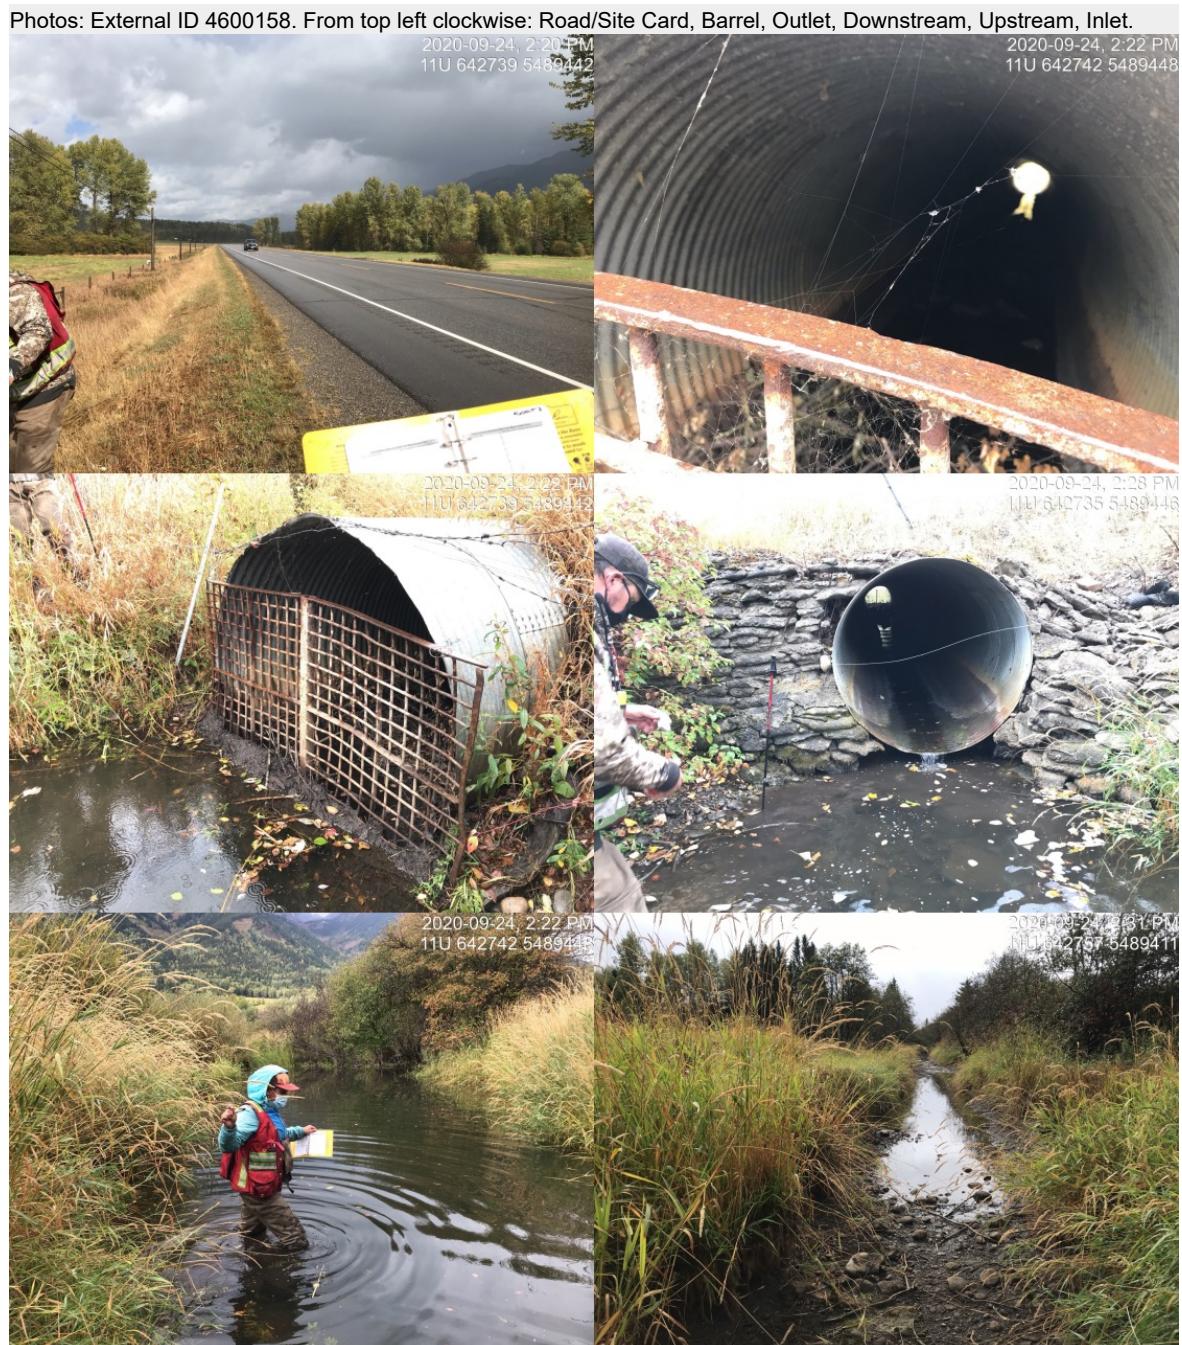
Comments: Fish observed at upstream crossing on Bean Rd. Grate on inlet may prevent passage off adult fish. Fill depth estimated from photos.

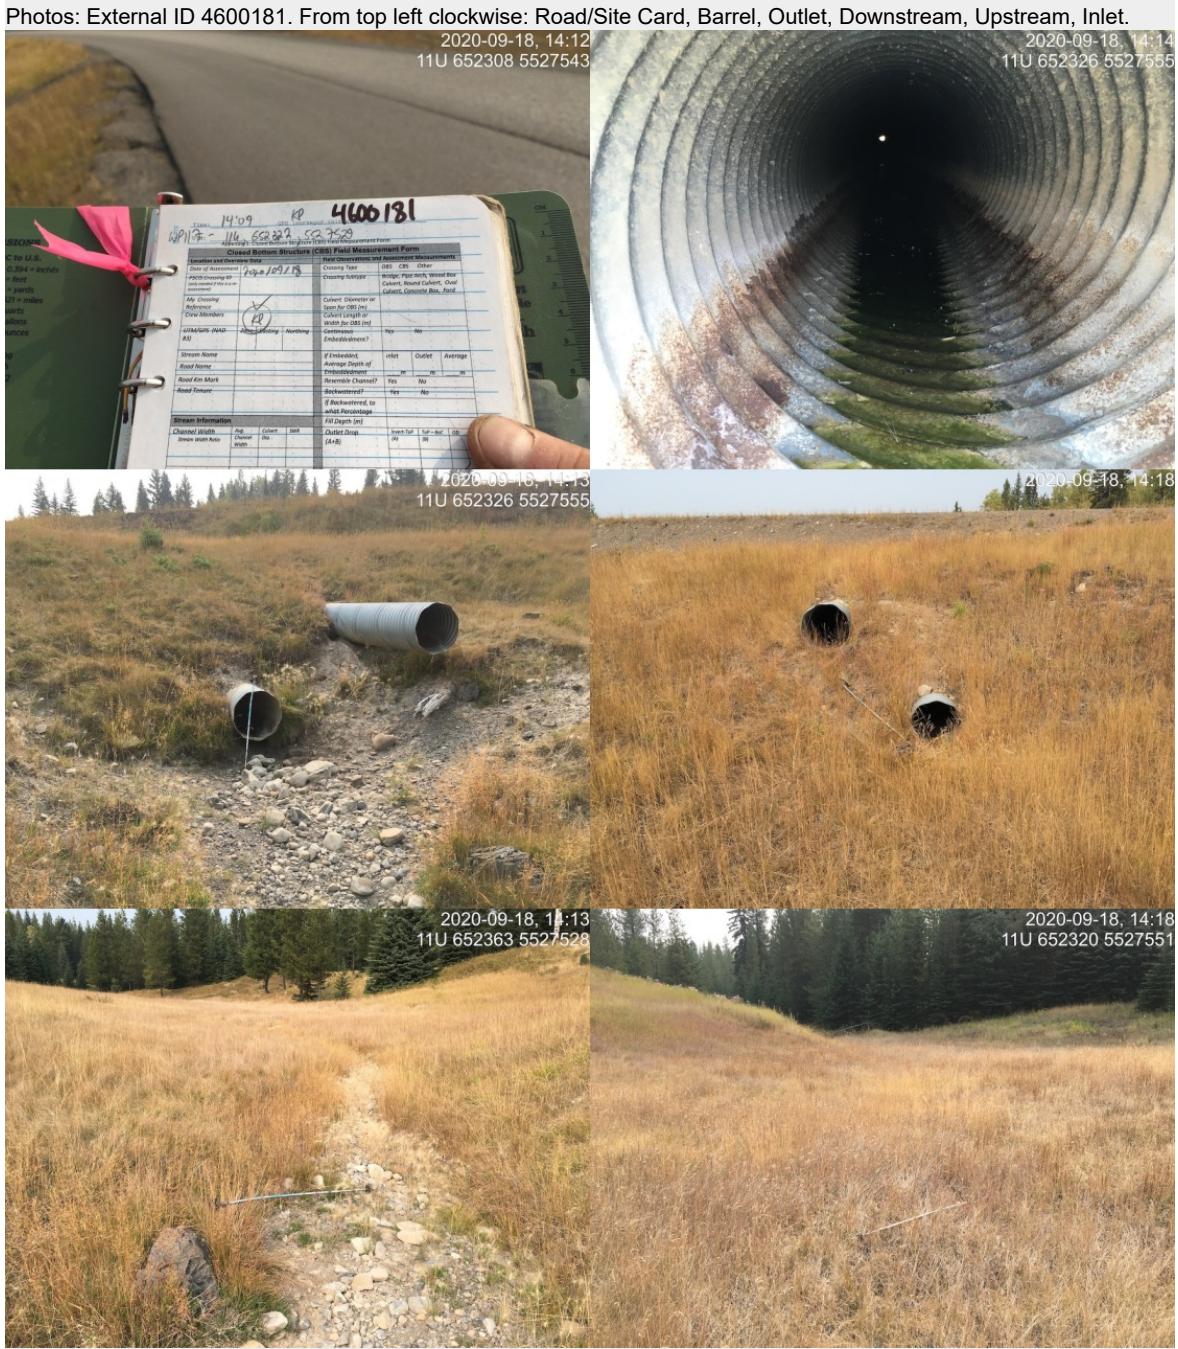
Comments: Dry at time of survey, no channel present, area vegetated grassland. Two culverts, 0.60m in diameter. Top culvert 0.5m higher than the lower.

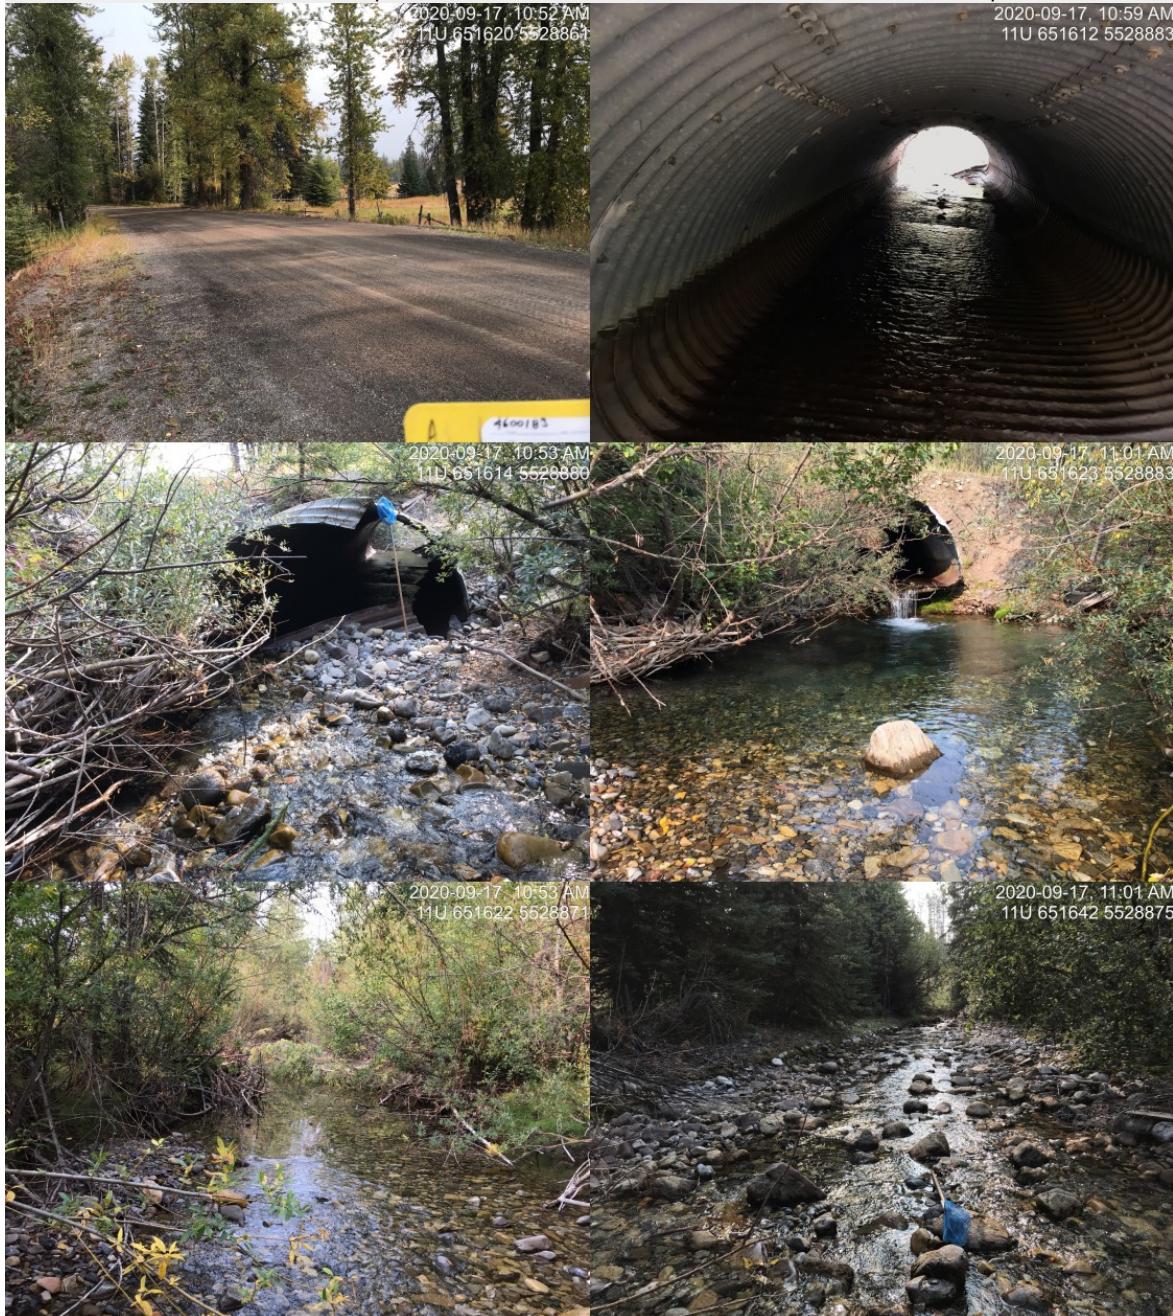
Photos: External ID 4600183. From top left clockwise: Road/Site Card, Barrel, Outlet, Downstream, Upstream, Inlet.

Comments: Large stream with good flow at this crossing. Culvert inlet is damaged and there is a large outlet drop. Upstream of highway the stream is subsurface for ~600m.

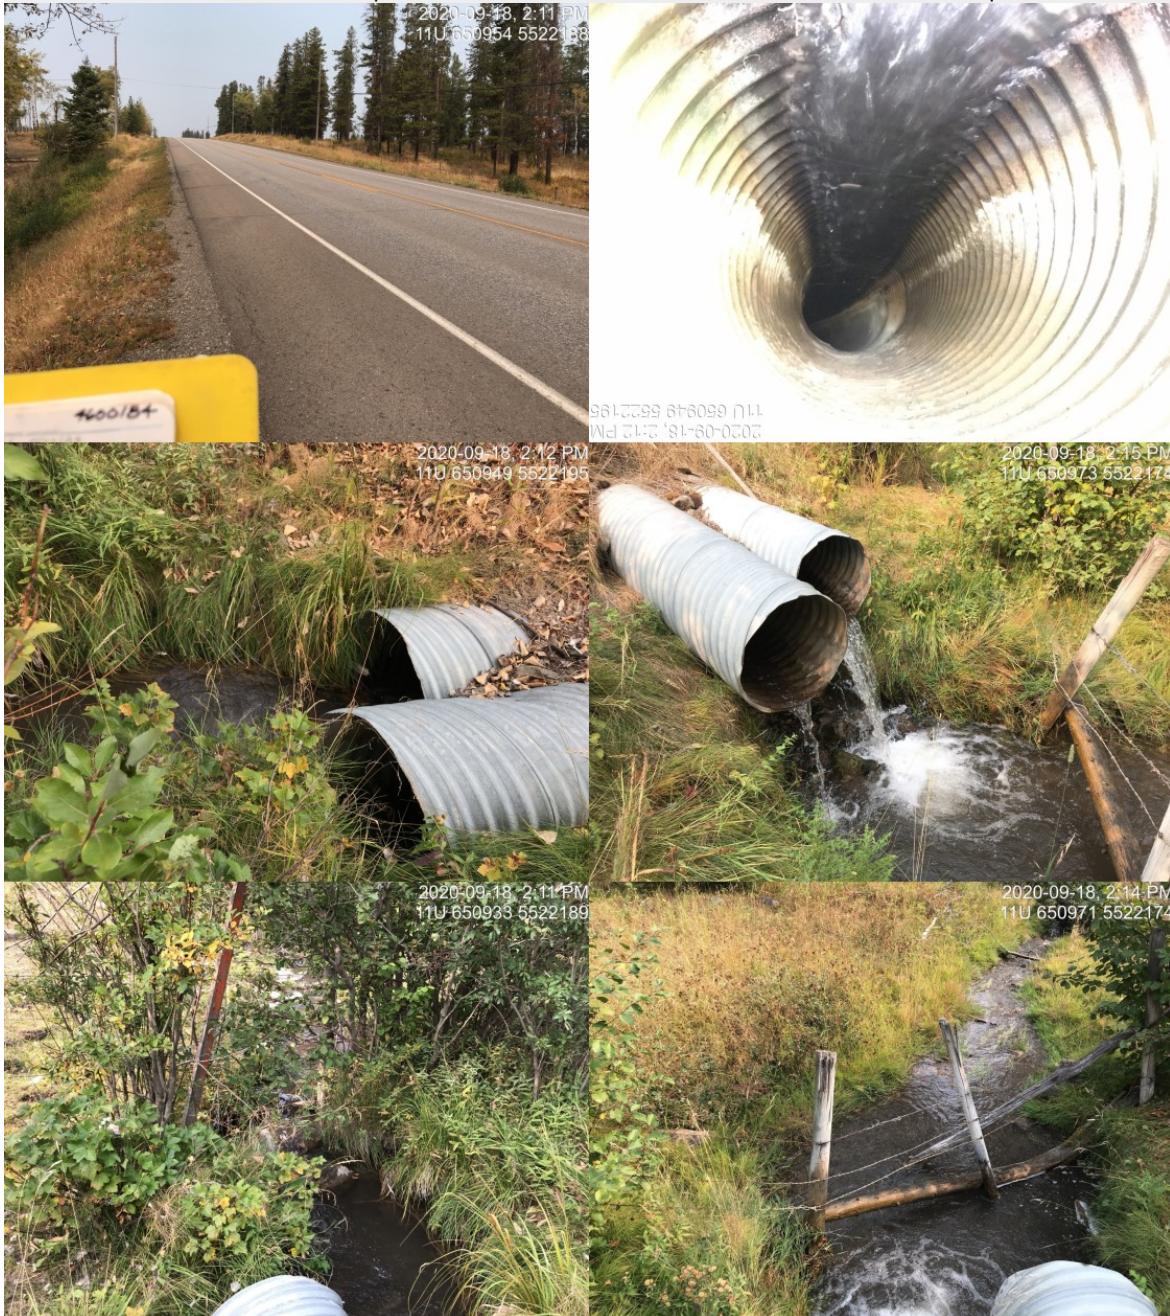
Photos: External ID 4600184. From top left clockwise: Road/Site Card, Barrel, Outlet, Downstream, Upstream, Inlet.

Comments: Small stream with good flow, EB known upstream. Fenced private land upstream and downstream. Stream measurements estimated due to fenced private land. Large outlet drop.

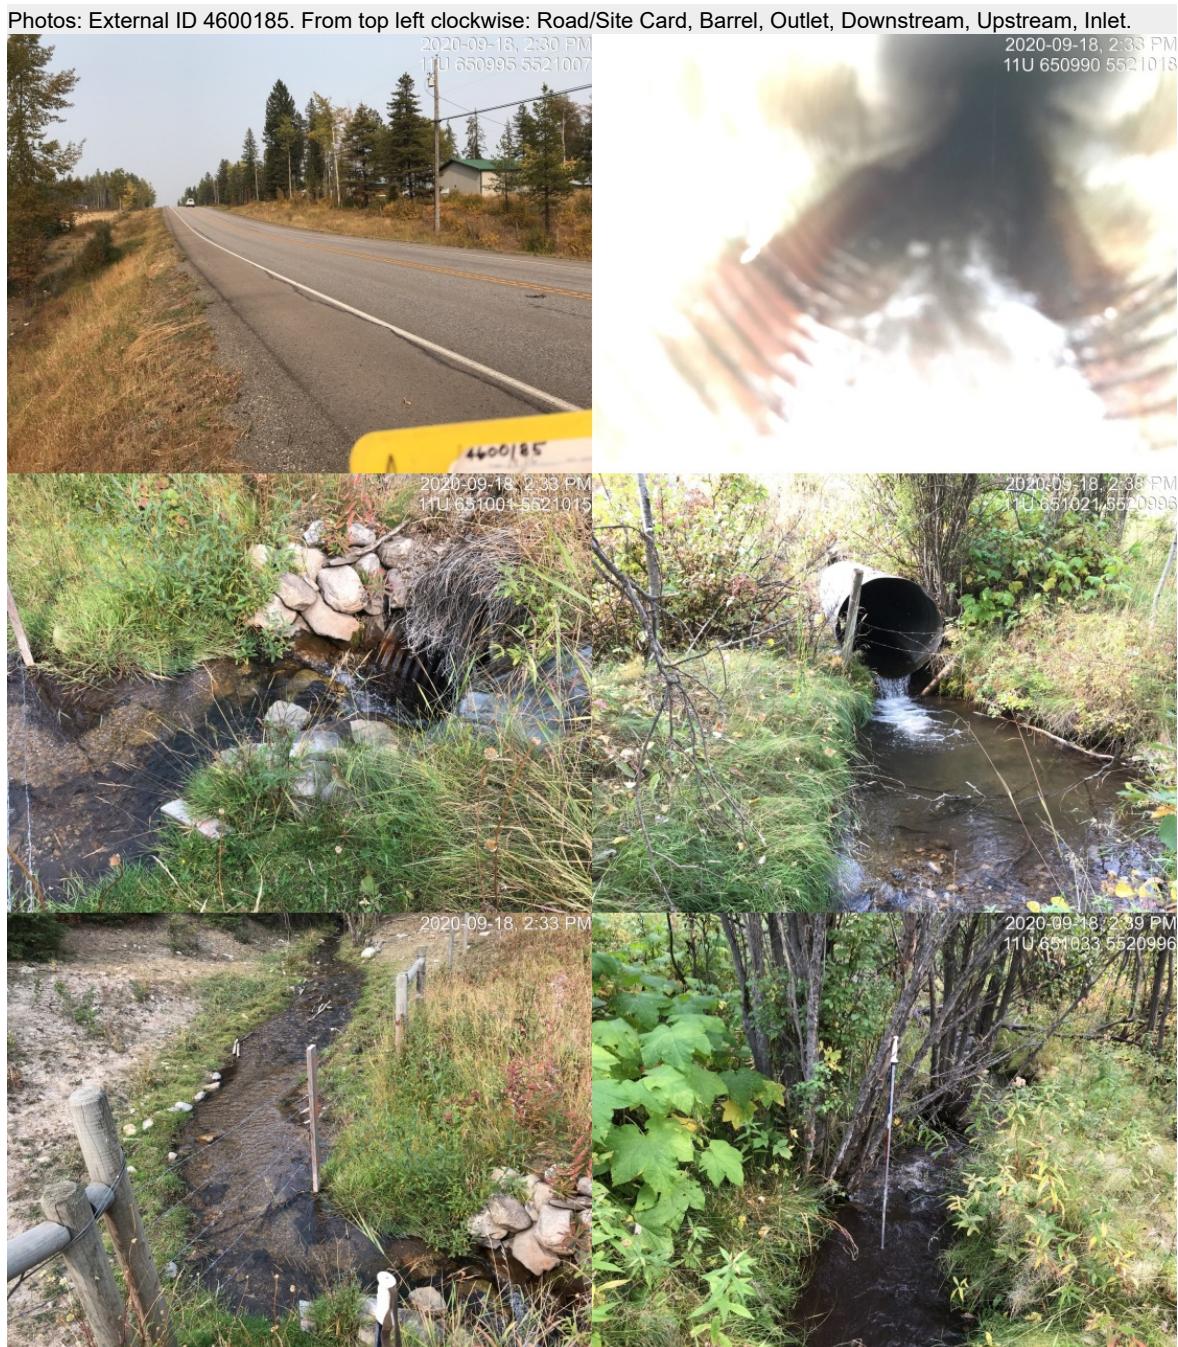
Comments: Culvert has extension with corner, small stream with good flow. WCT and EB documented upstream. Gravels present suitable for WCT and EB spawning.

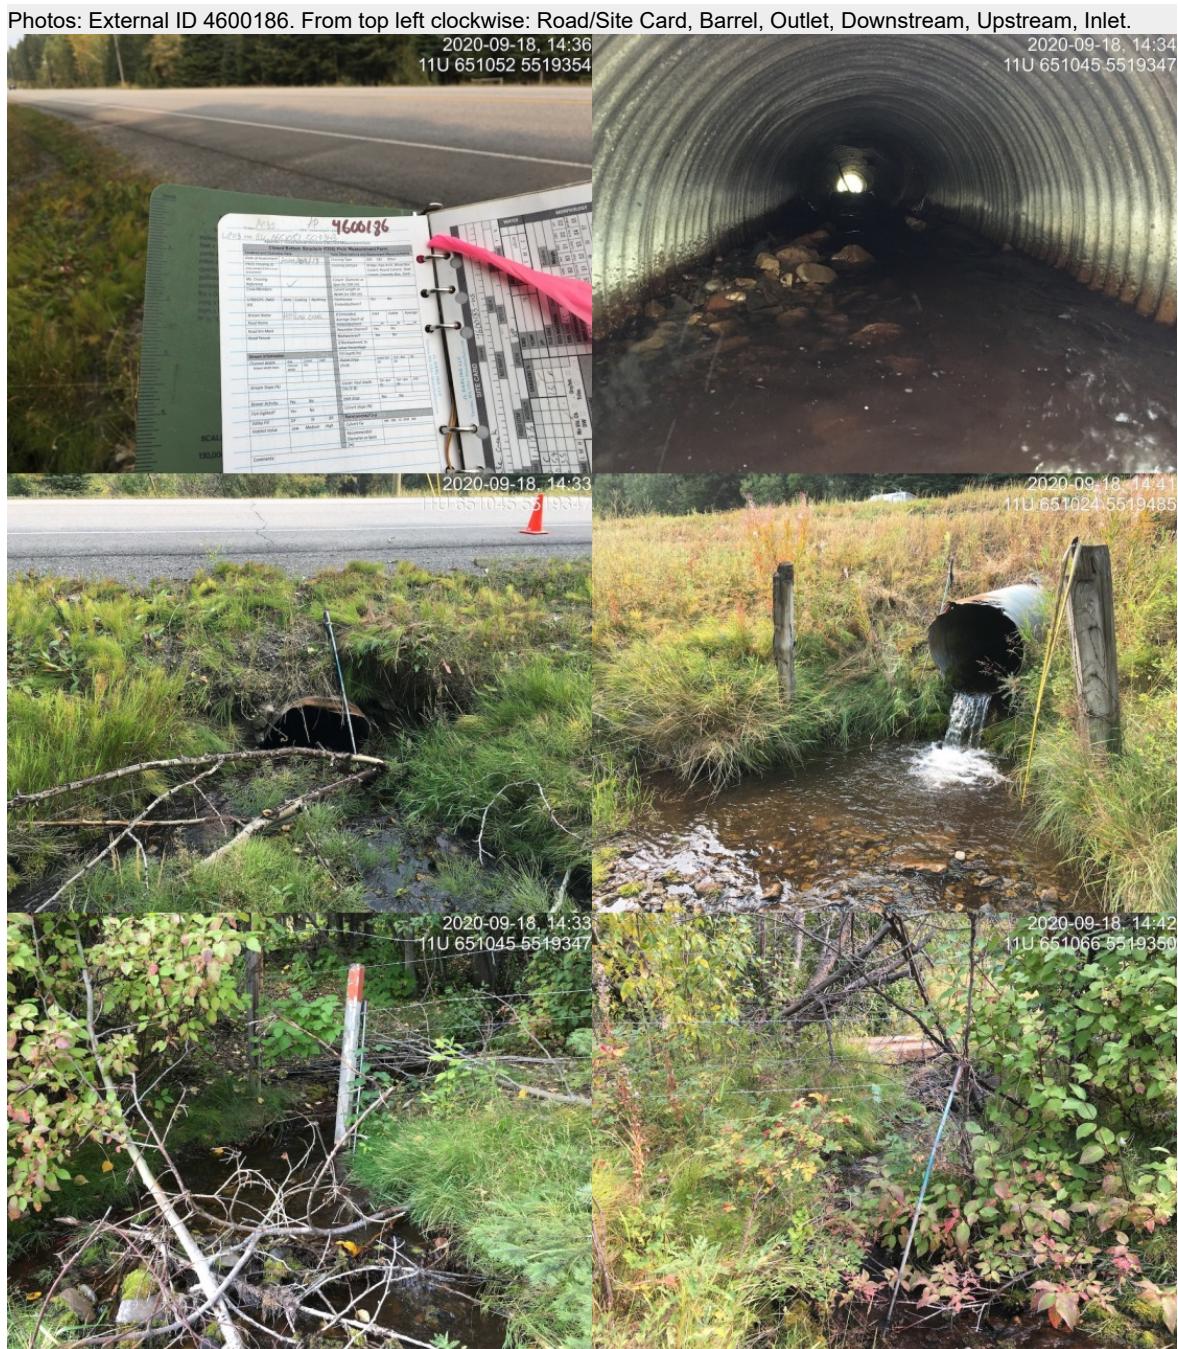
Comments: No access up or downstream due to fenced private land. Stream slope estimated.

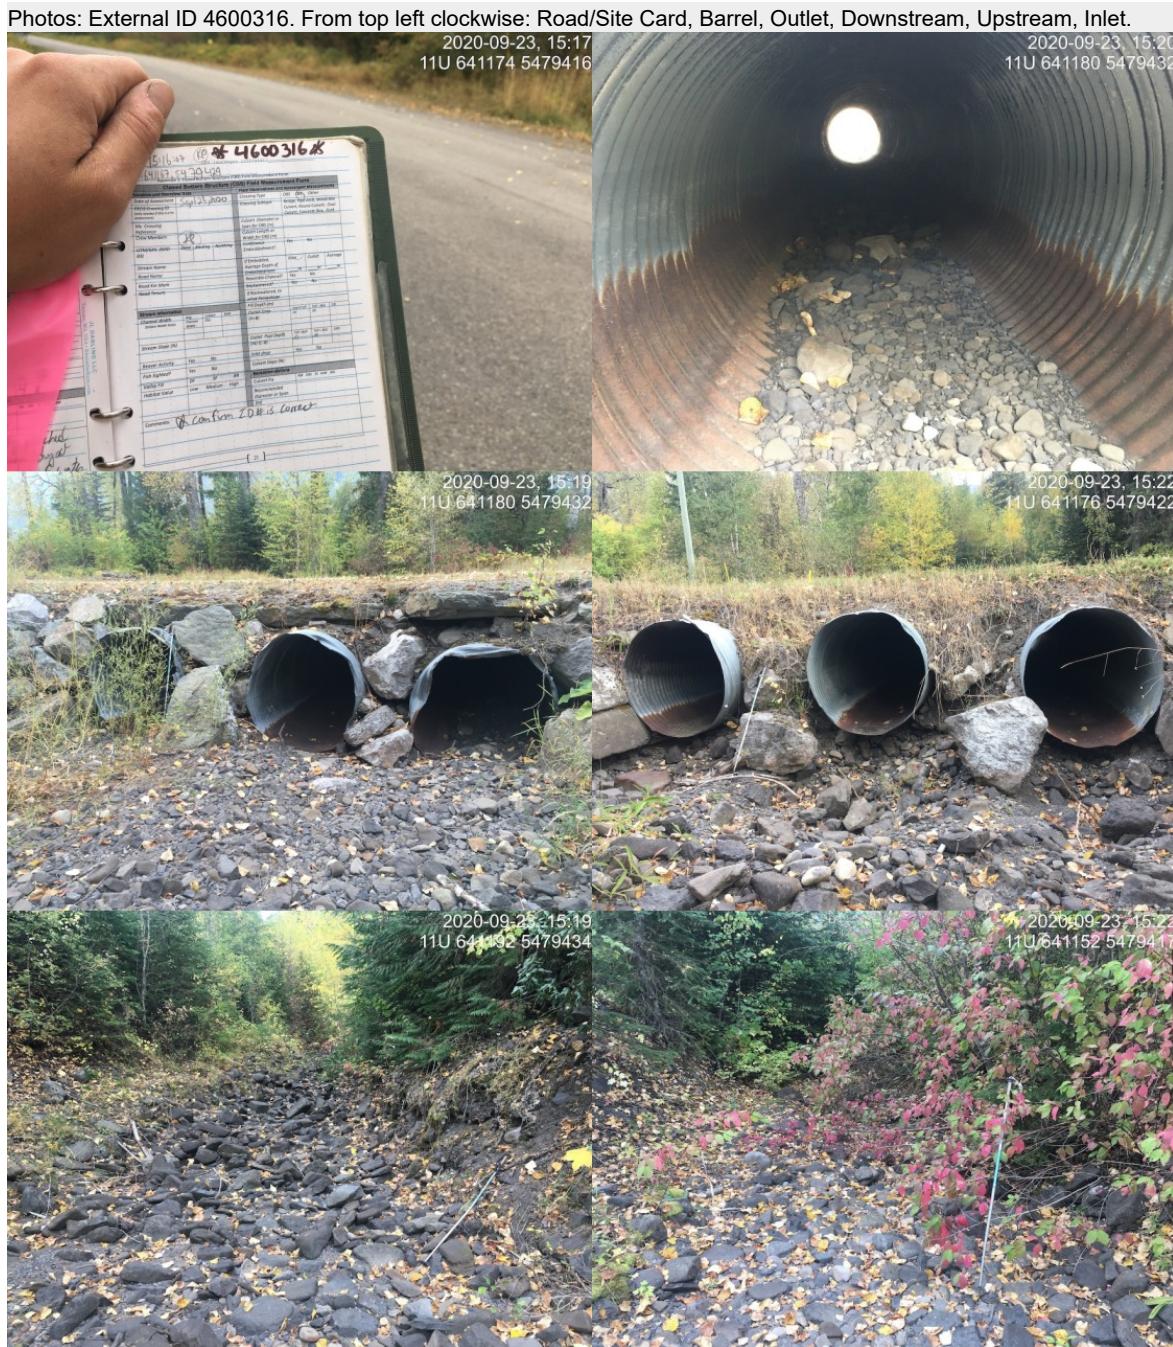
Comments: Stream dry at time of survey. Three barrels, 1.2m in diameter. All three very similar elevation, all perched .2-.50m above substrate.

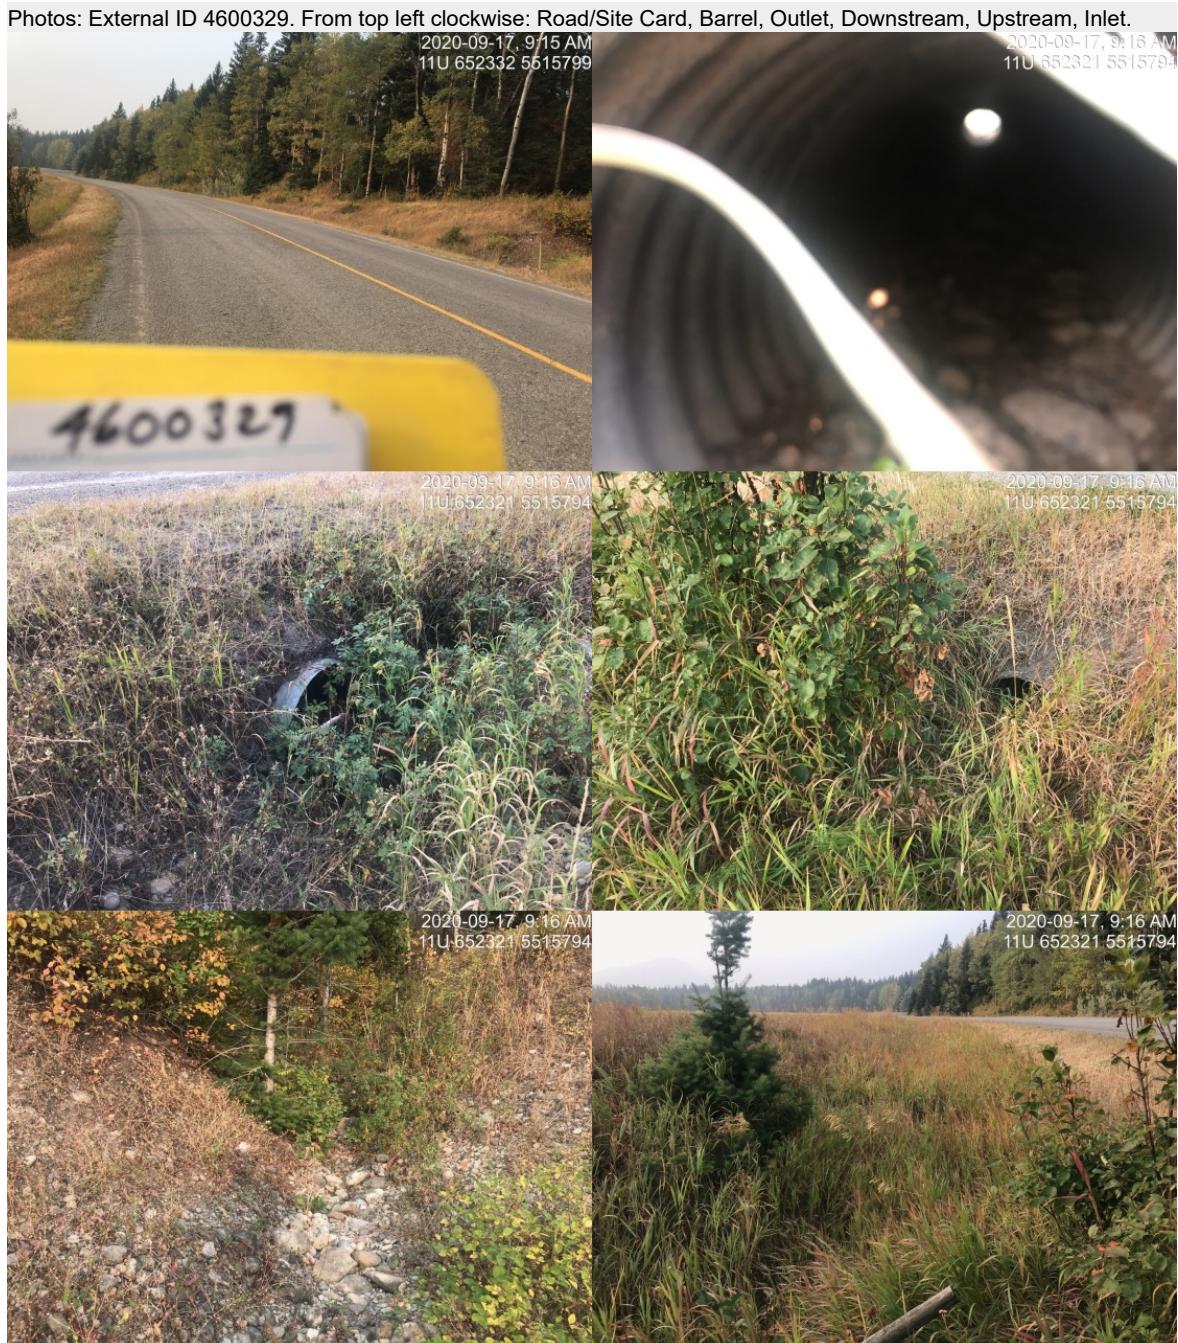
Comments: Whiting creek appeared to not be present through agricultural field downstream. This appeared to be only channel present for Whiting crossing this road although the main Whiting channel is present upstream. Dry, heavily vegetated channel downstream. Defined channel upstream but seems unlikely to be fish bearing.
