Appendix - Phase 1 Fish Passage Assessment Data and Photos

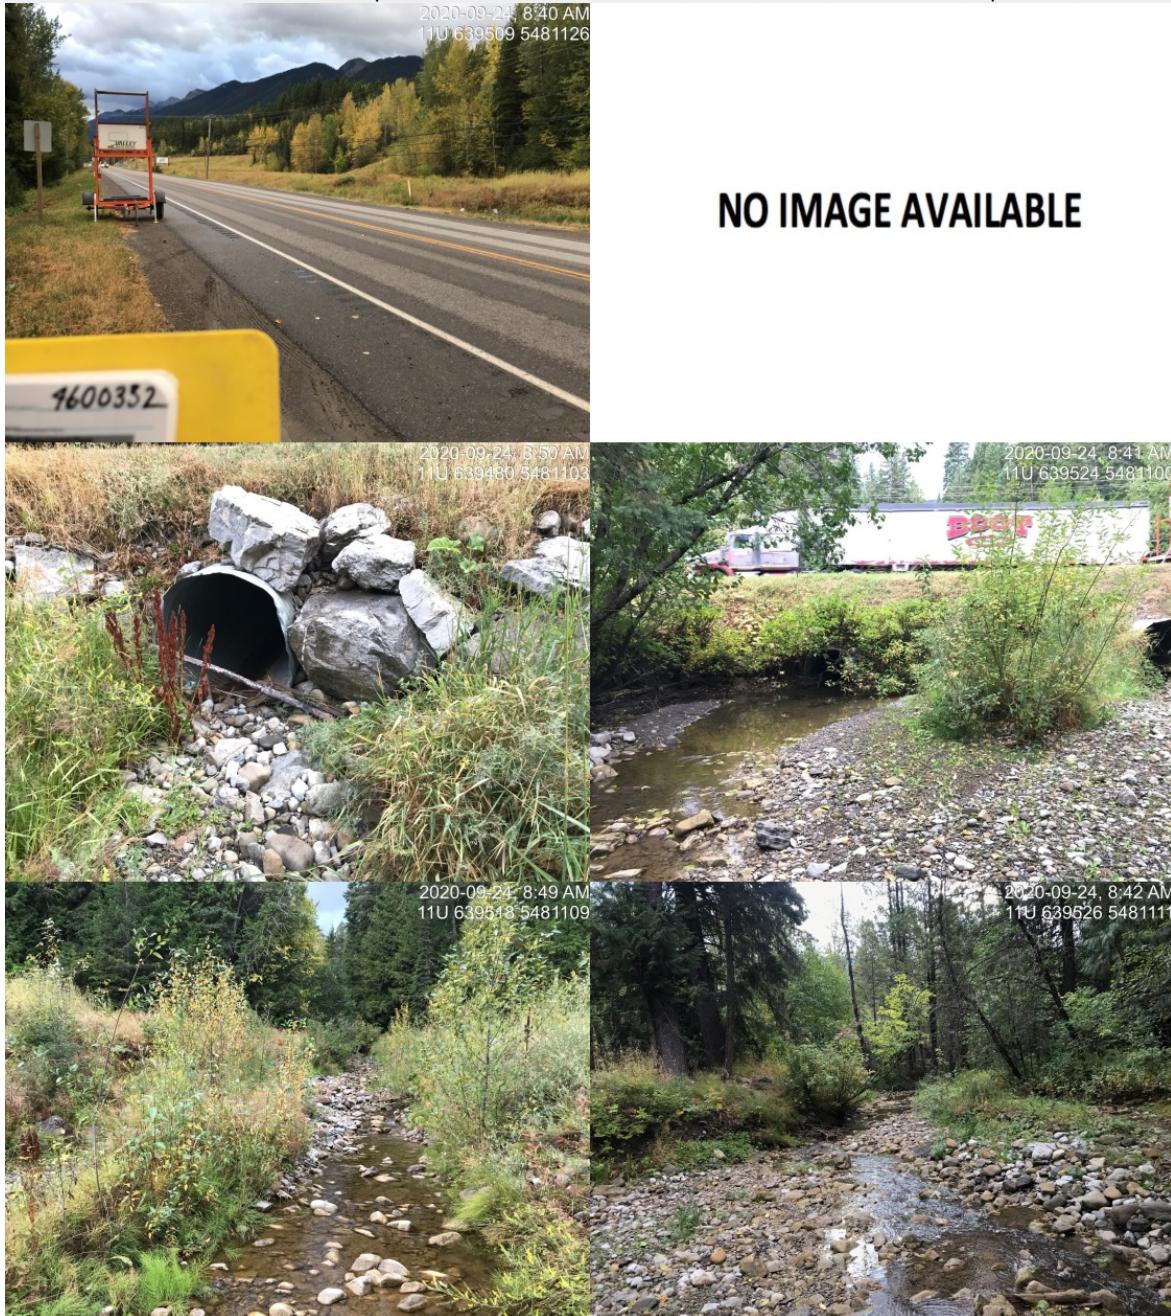
Photos: External ID 4600332. From top left clockwise: Road/Site Card, Barrel, Outlet, Downstream, Upstream, Inlet.

Comments: Fry observed at outlet pool. Inlet of active pipe mostly plugged with debris. Overflow pipe is 0.8m outlet drop with fry/juveniles stranded in outlet pool. Flows out of Fernie Ski Hill Road development area.

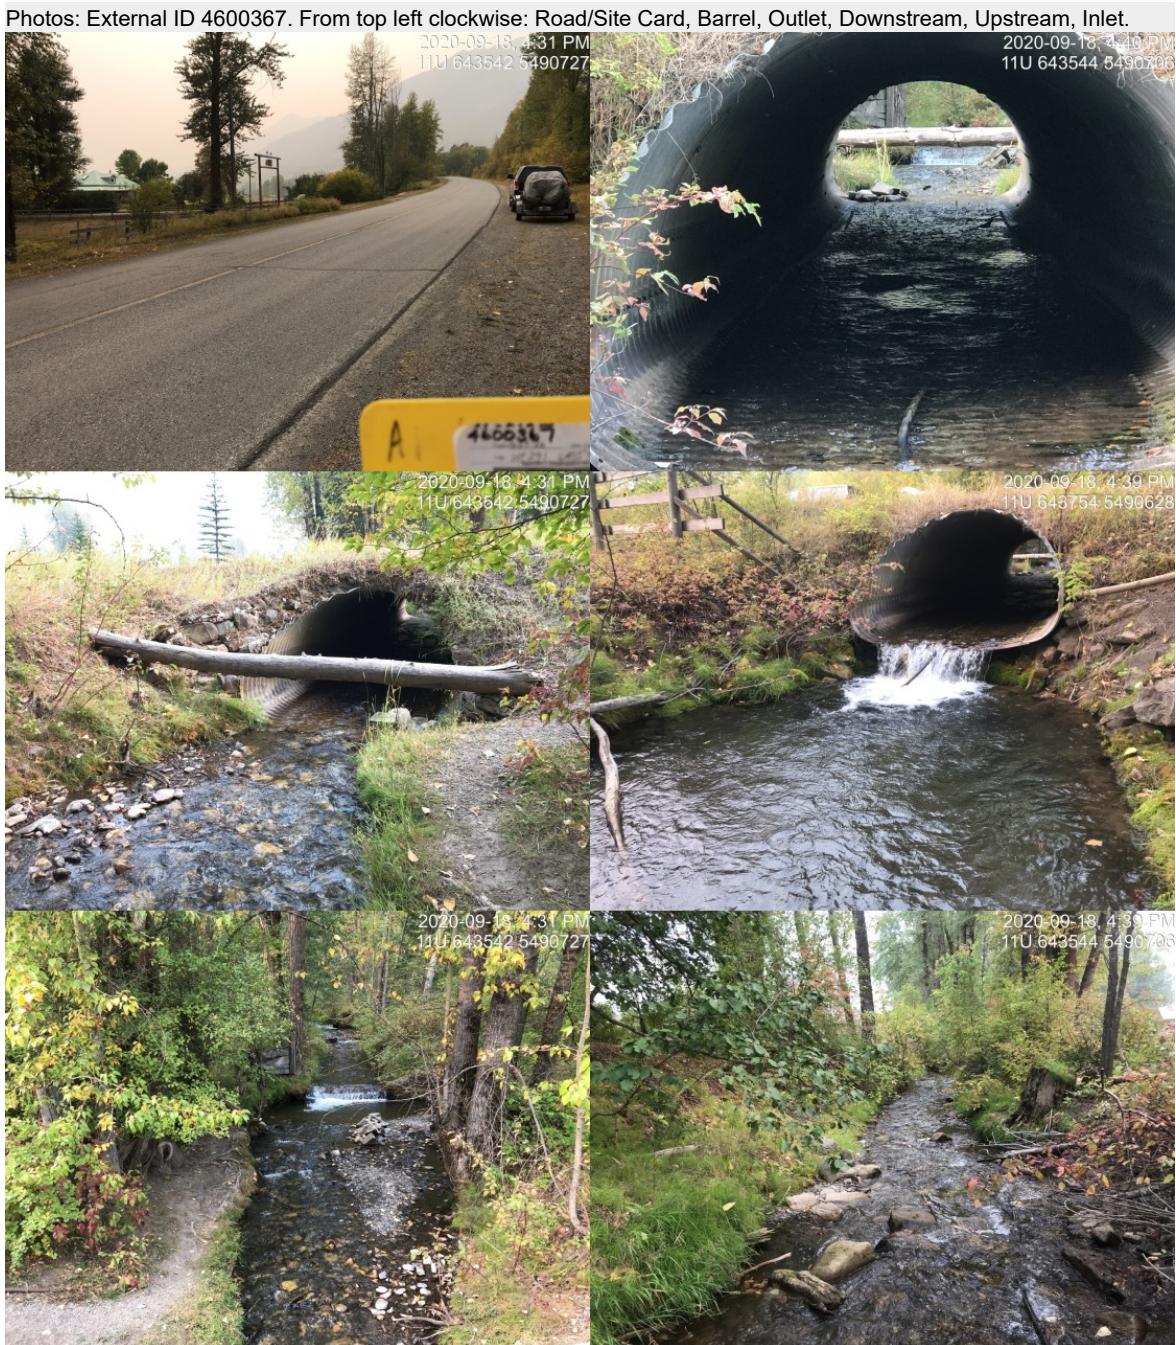
Comments: Laser level used for culvert slope. WCT spawning system. See Management Plan for the Westslope Cutthroat Trout (*Oncorhynchus clarkii lewisi*) in British Columbia 2014

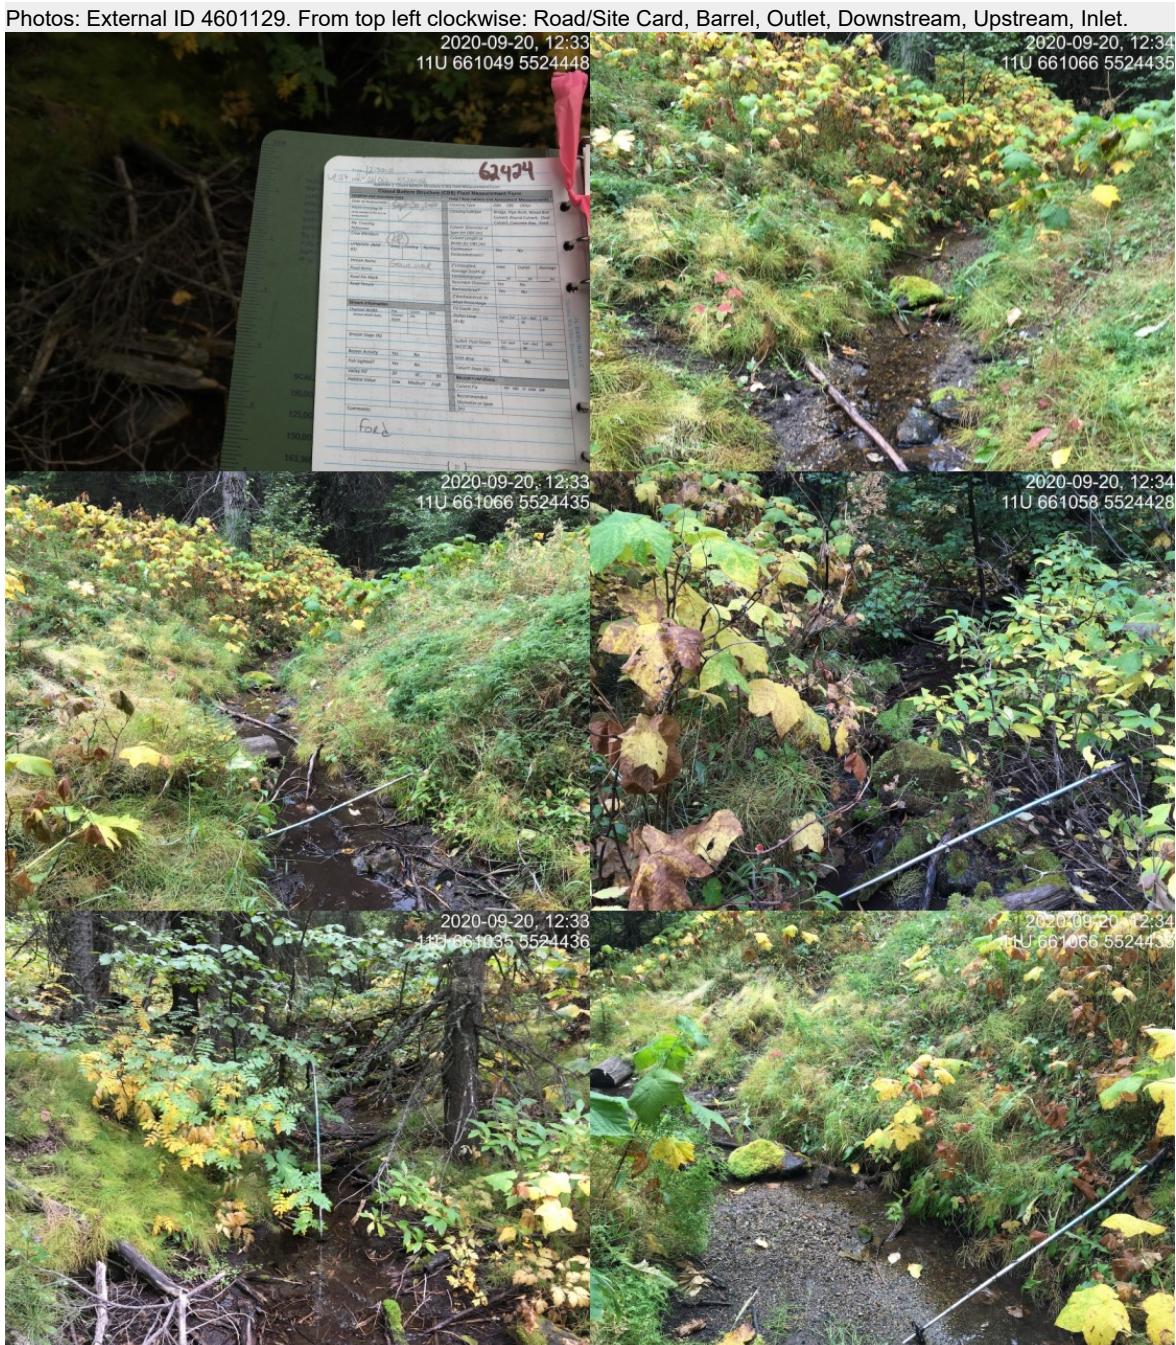
Comments: Deactivated road. Ford.
