# **Upper Elk River and Flathead River Fish Passage Restoration Planning**

**Prepared by  
Al Irvine, B.Sc., R.P.Bio.  
New Graph Environment  
6 Regent St  
Nelson, BC V1L 2P1**

**Version 1.0  
2021-01-27**

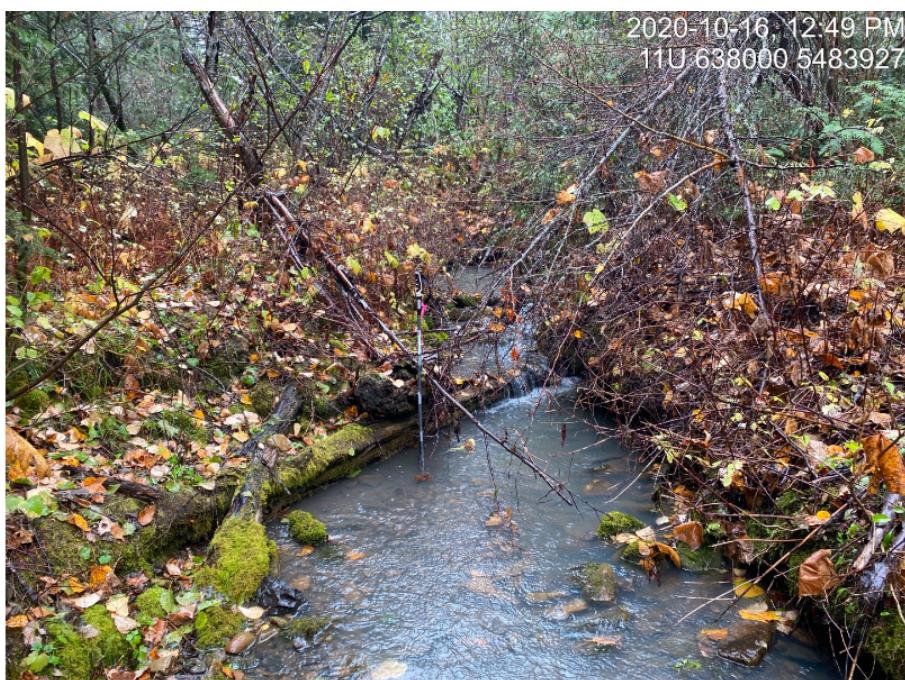
The stream was surveyed upstream from the culvert for 675m. Overall, total cover amount was rated as moderate with undercut banks dominant. Cover was also present as small woody debris, large woody debris, deep pools, and overhanging vegetation (Table [5.2](#), Figure [5.2](#)). The average channel width was 2.6m, the average wetted width was 2m and the average gradient was 3%. There were numerous fry observed throughout the area surveyed and abundant gravels suitable for resident westslope cutthroat trout spawning were noted. Habitat value was rated as high for salmonid rearing and spawning.

Figure 5.2: Typical habitat upstream of PSCIS crossing 50152.

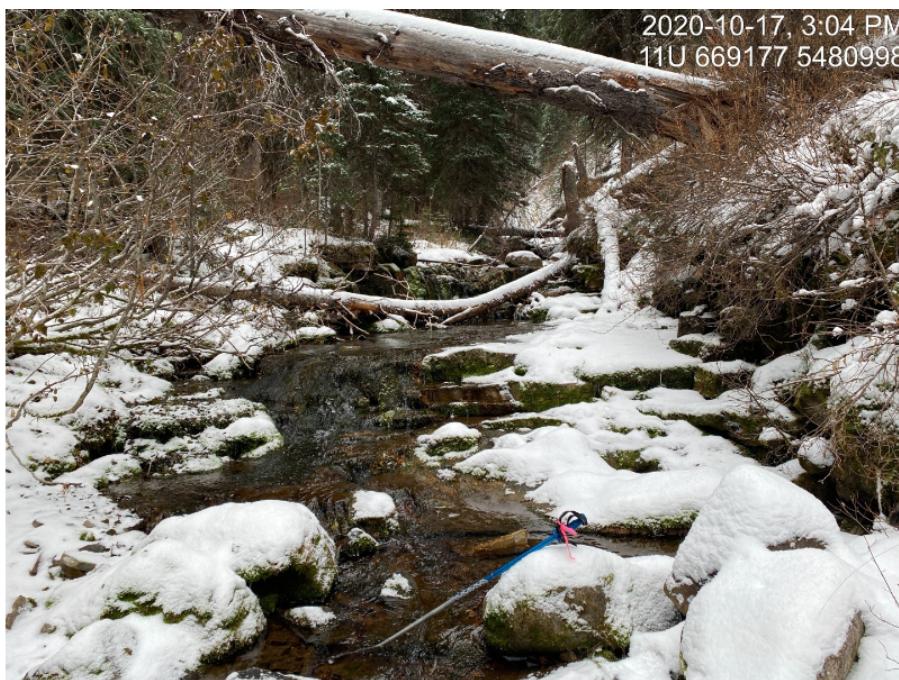
Figure 5.18: Habitat upstream of PSCIS crossing 50261.

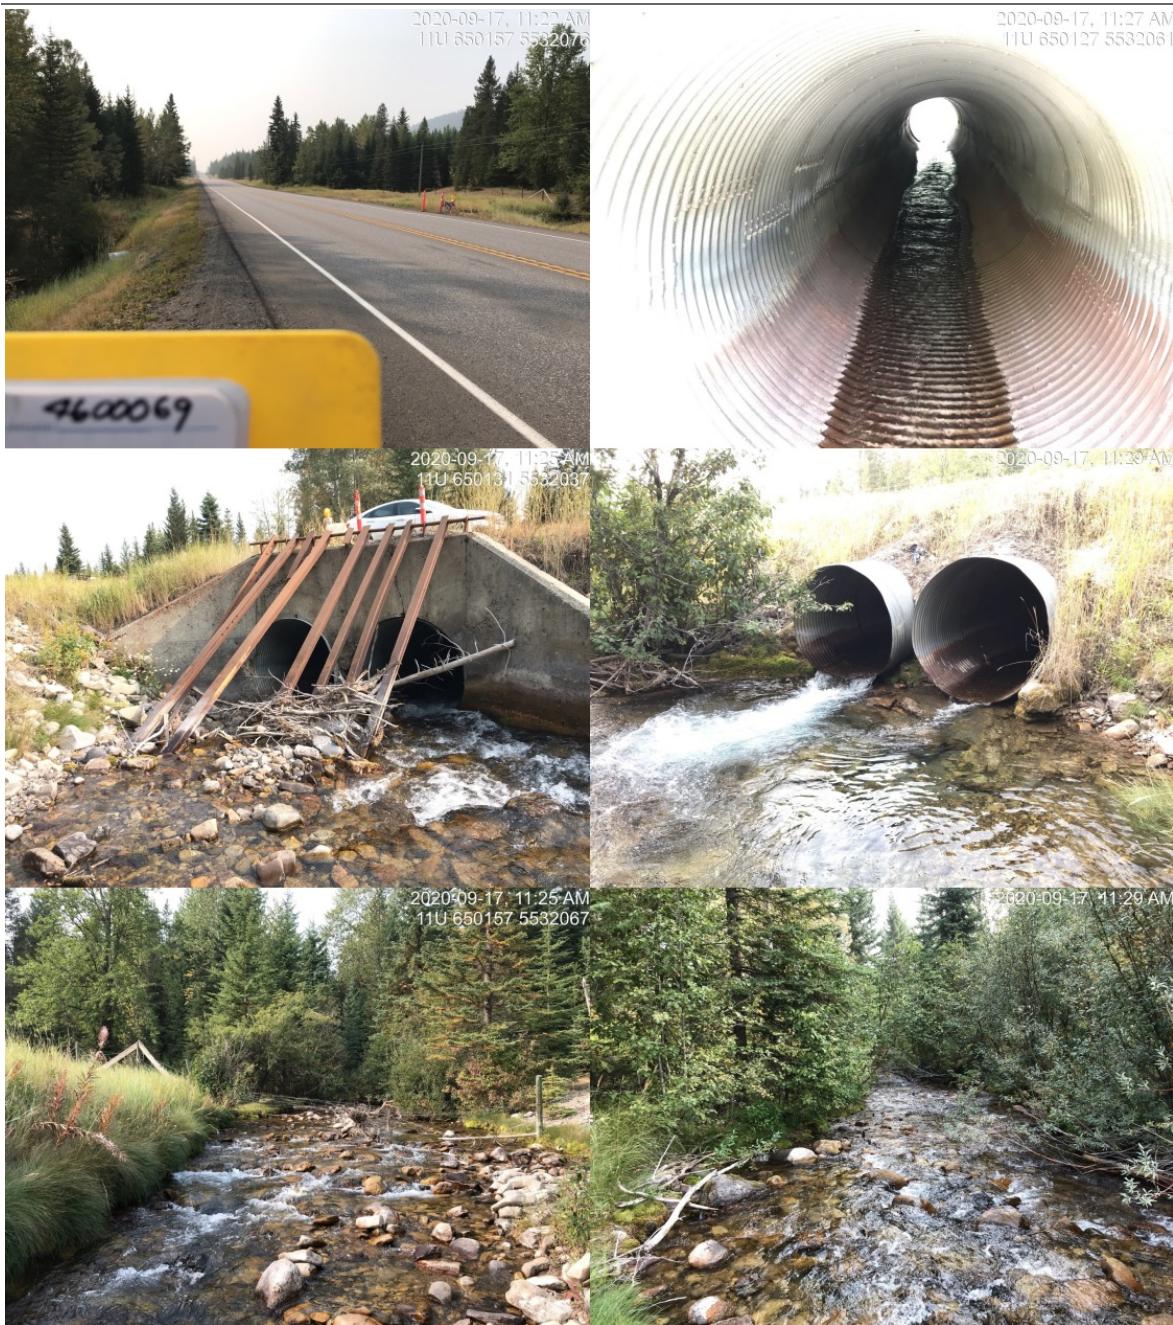
Photos: From top left clockwise: Road/Site Card, Barrel, Outlet, Downstream, Upstream, Inlet.

Structure replacement with a bridge is recommended to provide access to the habitat located upstream of PSCIS crossing 197534. The cost of the work is estimated at \$5,000,000 for a cost benefit of 2.3 linear m/\$1000 and 15.3m<sup>2</sup>/\$1000.

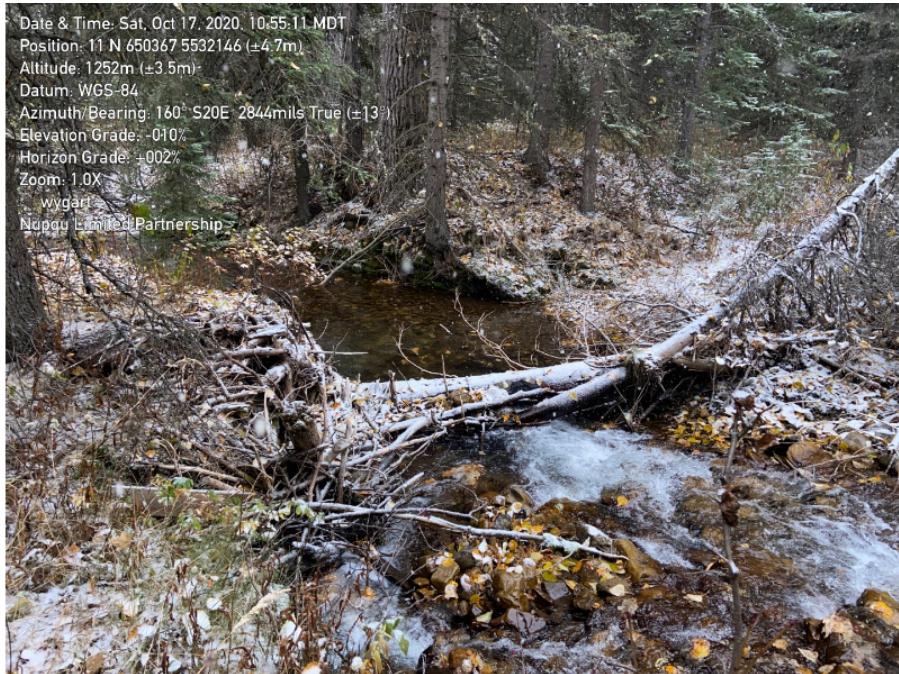
large woody debris, boulders, deep pools, and overhanging vegetation (Table 5.31, Figure 5.33). The average channel width was 4.7m, the average wetted width was 3.6m and the average gradient was 3.7%. The dominant substrate was cobbles with gravels subdominant. Pools were present to 0.8m deep and gravels/cobbles suitable for resident and fluvial spawning were present. A ford crosses the stream at the Fortis gasline located approximately 115m downstream of the highway. Overall, habitat was rated as medium value providing an important migration corridor and habitat suitable for resident and fluvial salmonid rearing and spawning.

Figure 5.33: Habitat downstream of PSCIS crossing 197534.

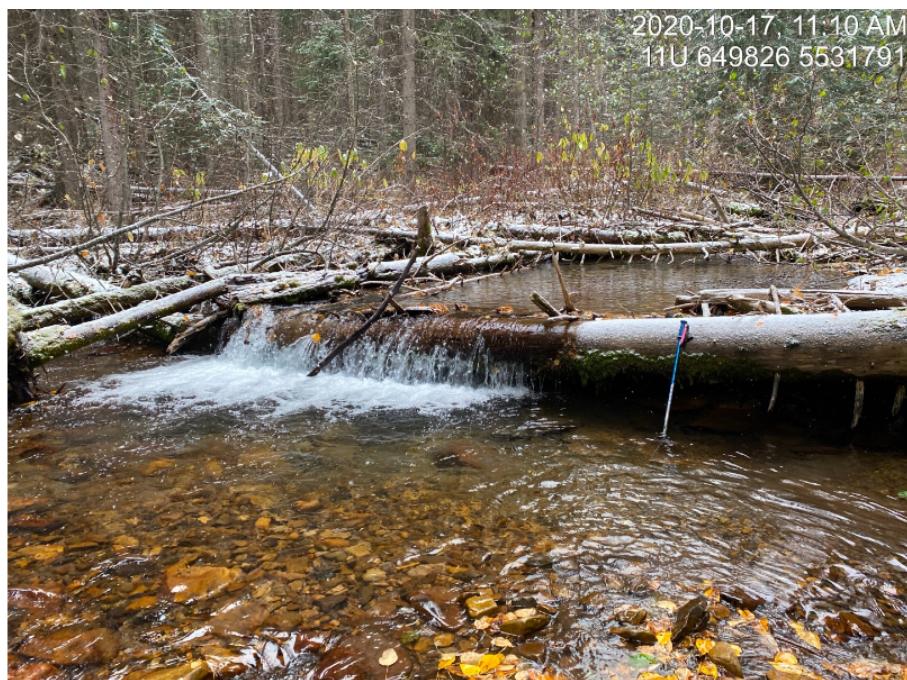
The stream was surveyed immediately upstream from the culvert for 675m. Overall, total cover amount was rated as moderate with undercut banks dominant. Cover was also present as small woody debris, large woody debris, boulders, deep pools, and overhanging vegetation (Table 5.31, Figure 5.34). The average channel width was 6.6m, the average wetted width was 4.6m and the average gradient was 4.5%. The dominant substrate was cobbles with boulders subdominant. Habitat became increasingly complex with increased distance upstream. Throughout the area surveyed there were occasional pools available with depths suitable for juvenile/adult salmonid overwintering and rearing and frequent sections of gravels available for resident and fluvial salmonid spawning. Overall, habitat was rated as medium value.

Figure 5.34: Habitat upstream of PSCIS crossing 197534.

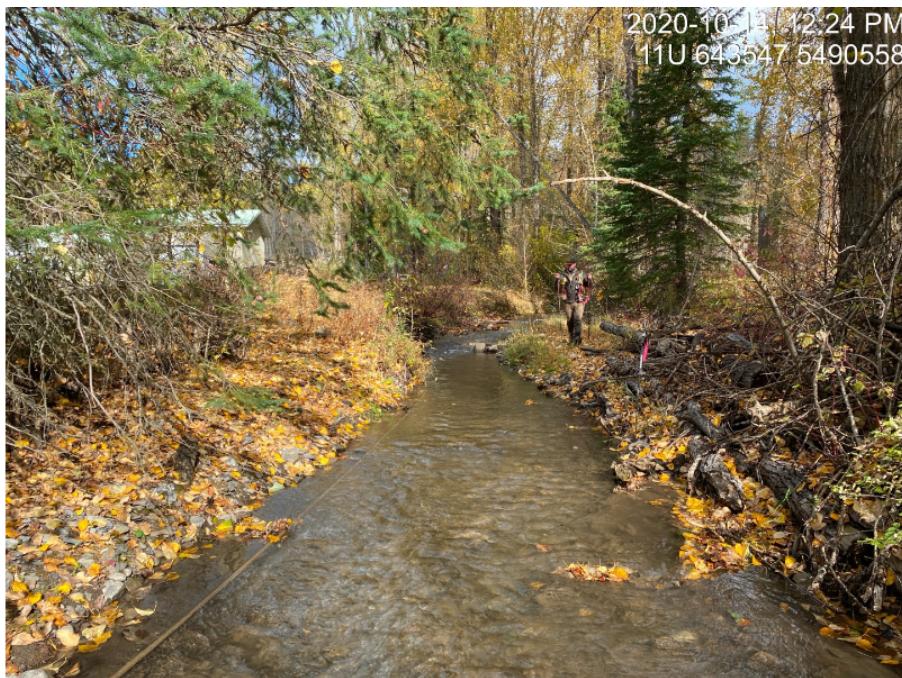
Figure 5.35: Typical habitat downstream of PSCIS crossing 197542.

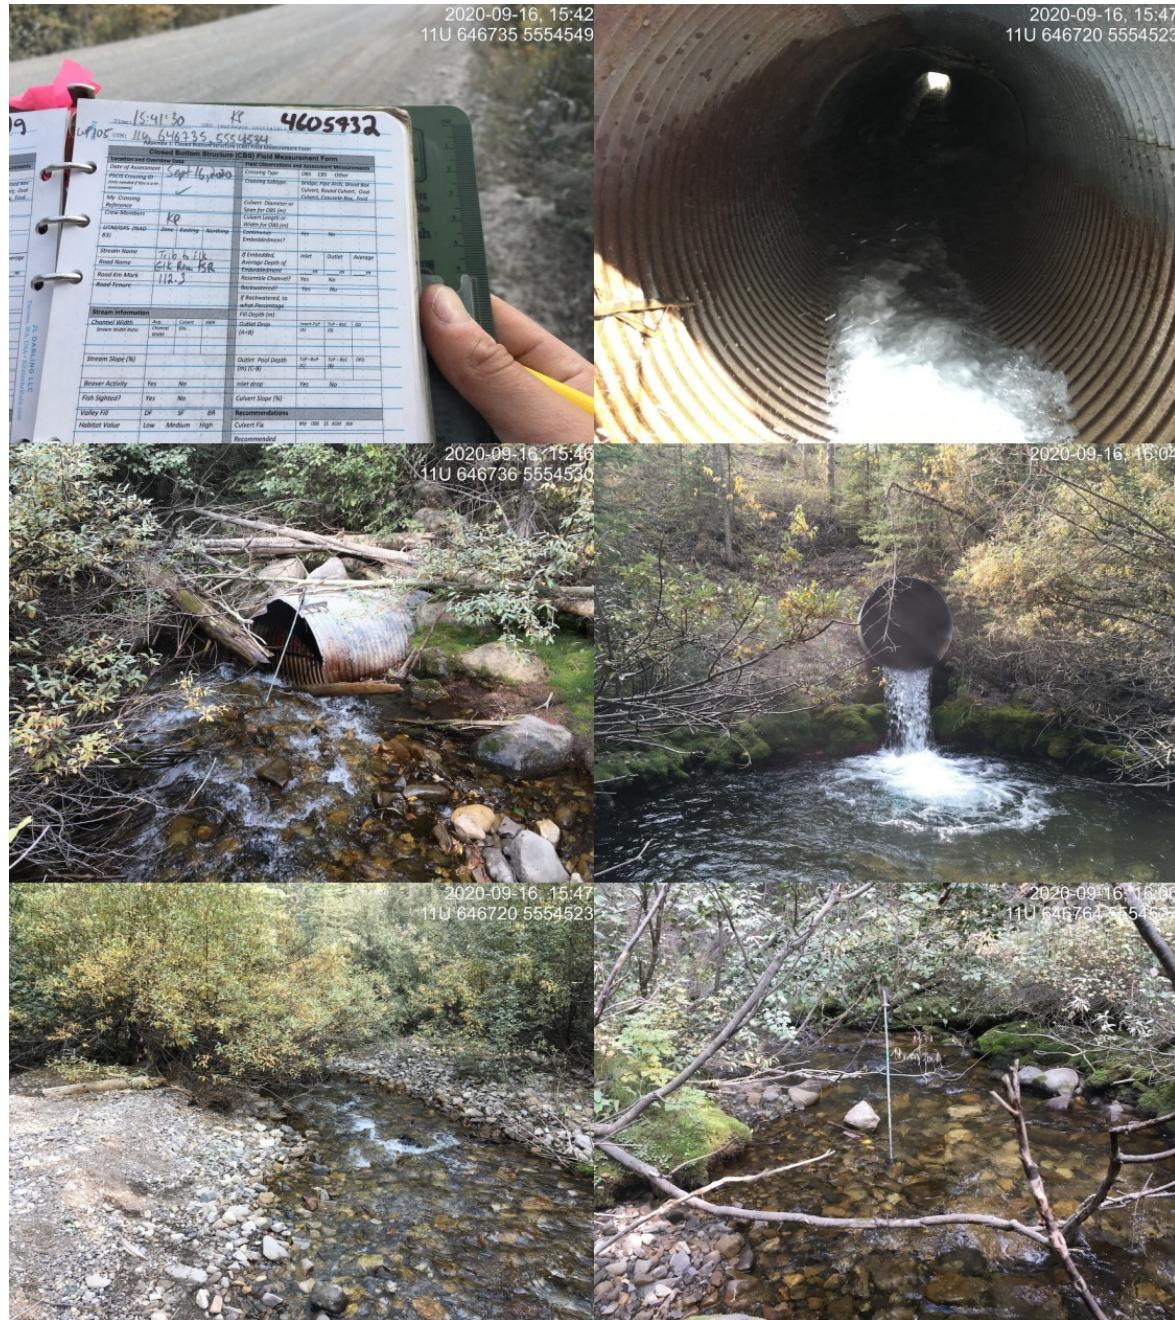
Photos: From top left clockwise: Road/Site Card, Barrel, Outlet, Downstream, Upstream, Inlet.

Structure replacement with an open bottomed culvert is recommended to provide access to the habitat located upstream of PSCIS crossing 197555. Due to the large amount of fill on the road (8m) the size of a replacement bridge was estimated at 25m. The cost for work is estimated at \$312,000 for a cost benefit of 19200linear m/\$1000 and 113500m<sup>2</sup>/\$1000.

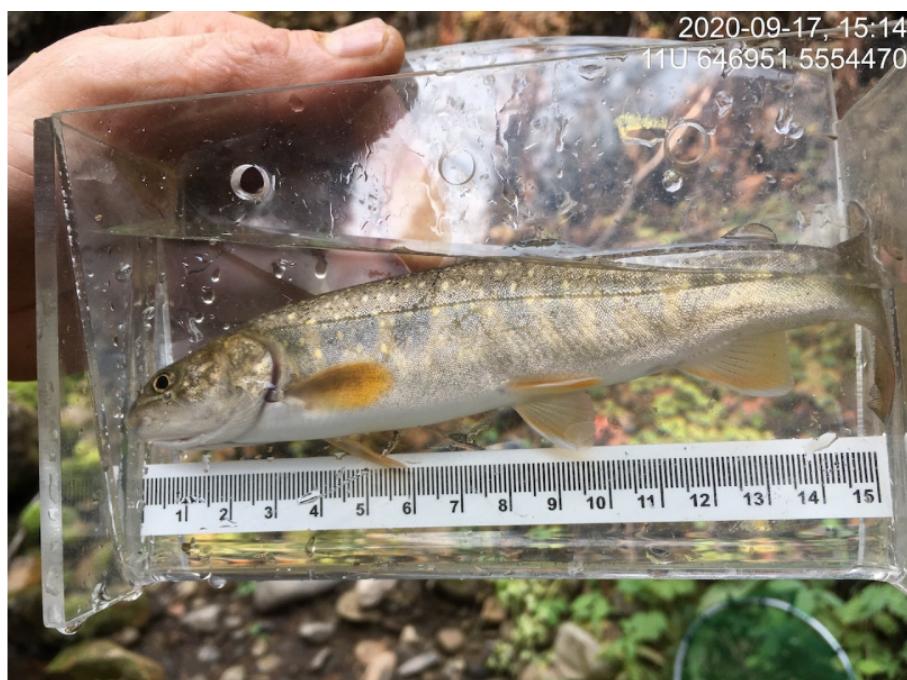
Figure 5.42: Bull trout captured downstream of PSCIS crossing 197555.
