Upper Elk River and Flathead River Fish Passage Restoration Planning

Version 1.2

2021-01-31

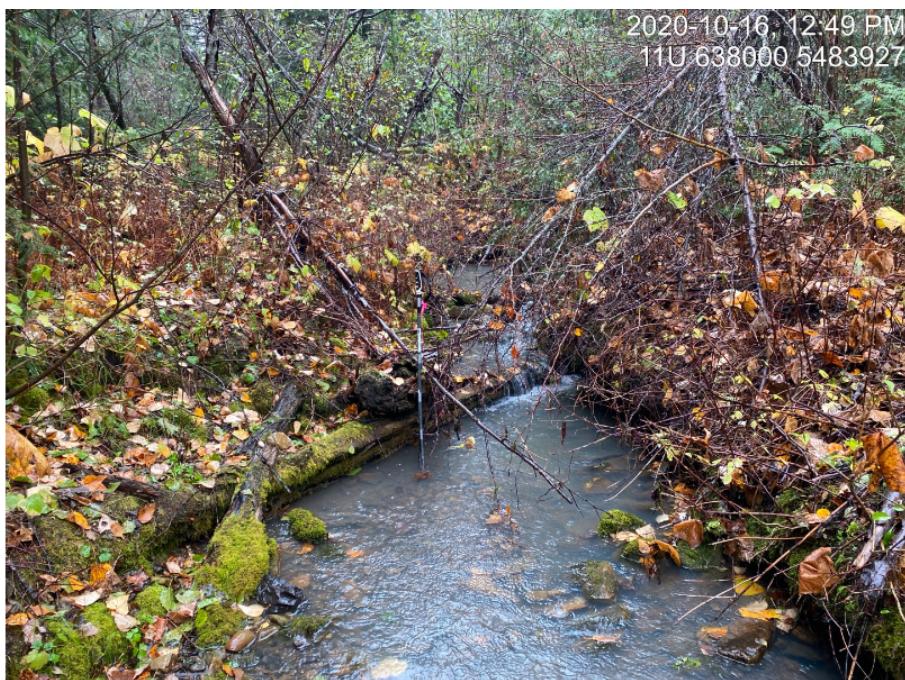
The stream was surveyed upstream from the culvert for 675m. Overall, total cover amount was rated as moderate with undercut banks dominant. Cover was also present as small woody debris, large woody debris, deep pools, and overhanging vegetation (Table [5.2](#), Figure [5.2](#)). The average channel width was 2.6m, the average wetted width was 2m and the average gradient was 3%. There were numerous fry observed throughout the area surveyed and abundant gravels suitable for resident westslope cutthroat trout spawning were noted. Habitat value was rated as high for salmonid rearing and spawning.

Figure 5.2: Typical habitat upstream of PSCIS crossing 50152.

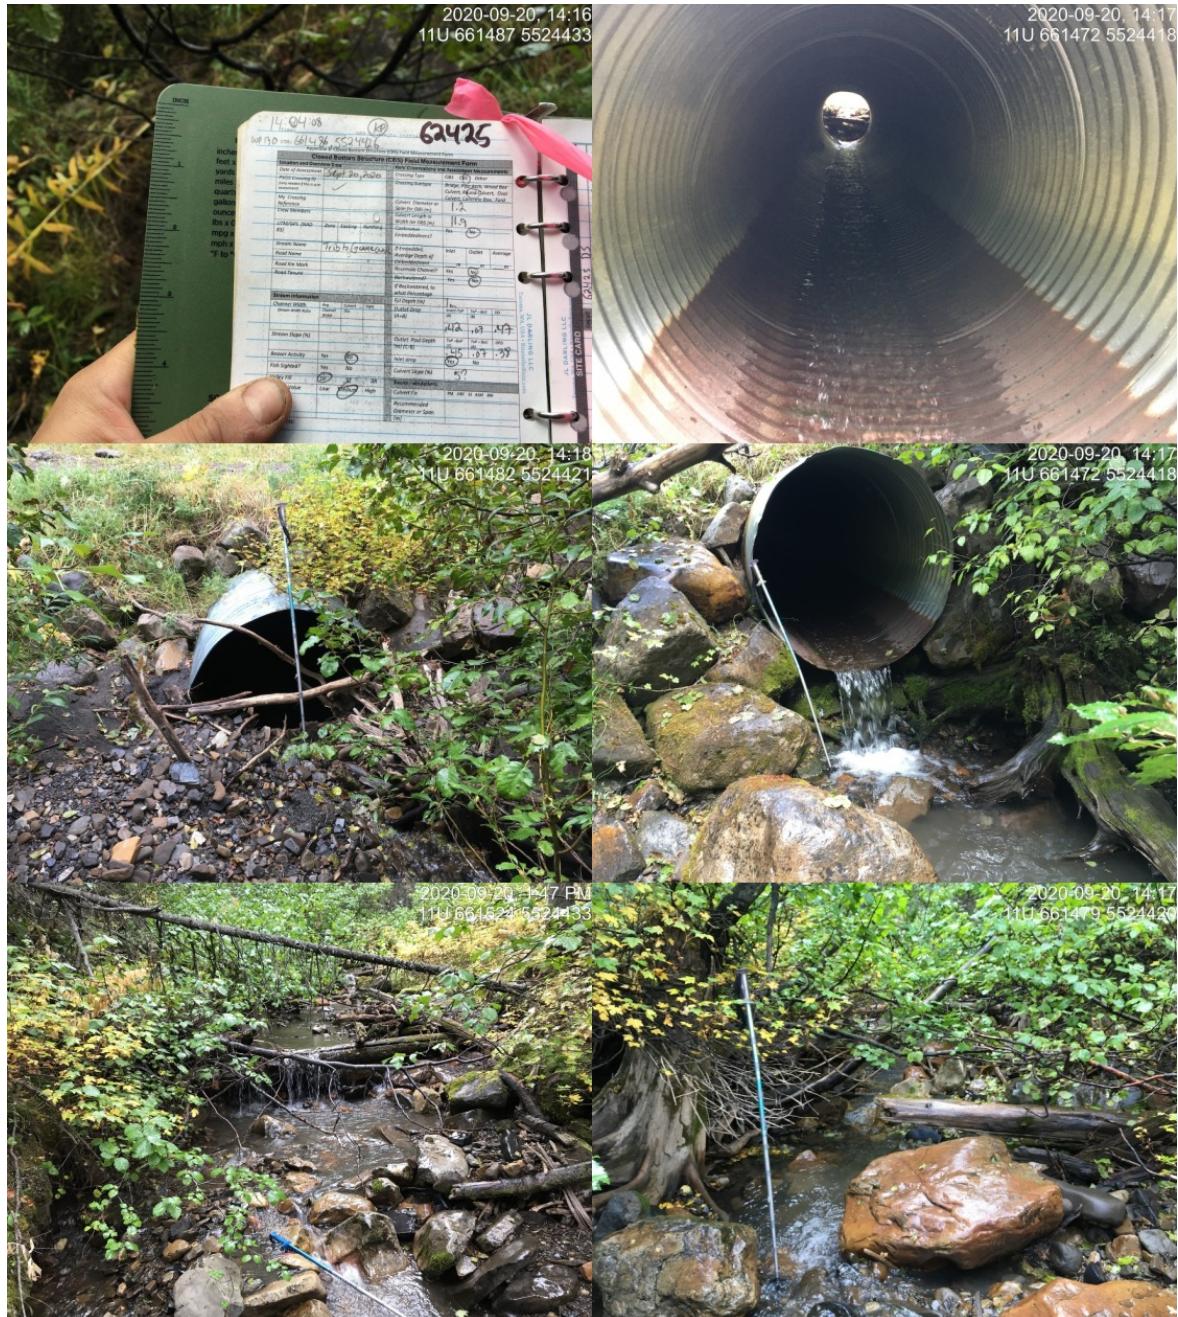
Location and Stream Data	.	Crossing Characteristics	-
Date	2020-09-20	Crossing Sub Type	Round Culvert
PSCIS ID	62425	Diameter (m)	1.2
External ID	-	Length (m)	12
Crew	KP, AI	Embedded	No
UTM Zone	11	Depth Embedded (m)	-
Easting	661486	Resemble Channel	No
Northing	5524426	Backwatered	No
Stream	Grave Creek	Percent Backwatered	-
Road	Spur	Fill Depth (m)	1
Road Tenure	Canfor R08362	Outlet Drop (m)	0.47
Channel Width (m)	3.7	Outlet Pool Depth (m)	0.38
Stream Slope (%)	7.5	Inlet Drop	Yes
Beaver Activity	No	Slope (%)	7.5
Habitat Value	Medium	Valley Fill	Deep Fill
