Upper Elk River and Flathead River Fish Passage Restoration Planning

**Prepared by
AI Irvine, B.Sc., R.P.Bio.
New Graph Environment
6 Regent St
Nelson, BC V1L 2P1**

Version 1.1

2021-01-28

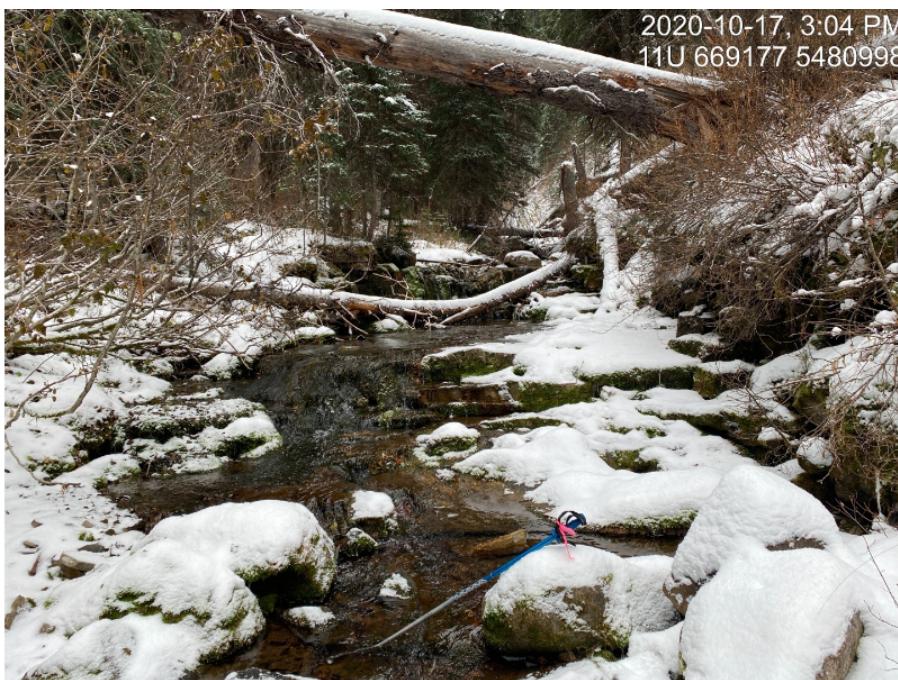
Figure 5.18: Habitat upstream of PSCIS crossing 50261.

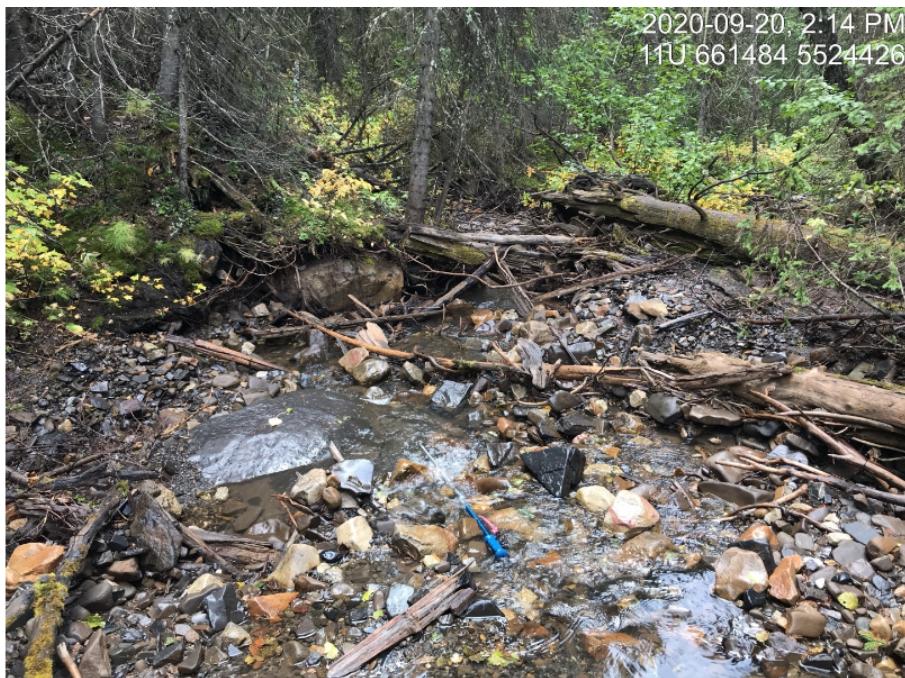
Figure 5.21: Typical habitat downstream of PSCIS crossing 62425.

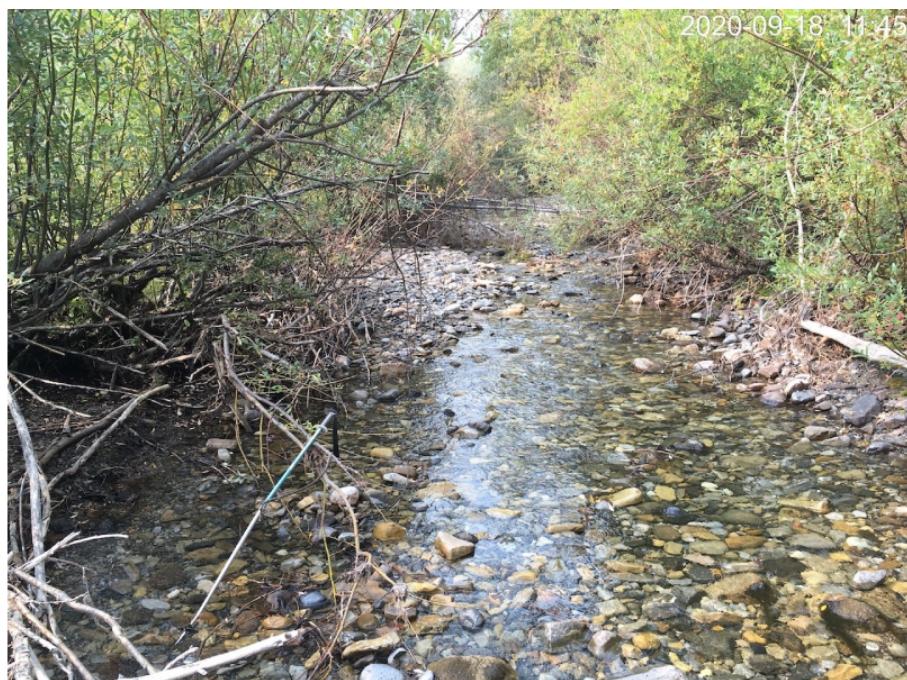
Figure 5.28: Typical habitat upstream of PSCIS crossing 197533 and downstream of PSCIS crossing 197533.

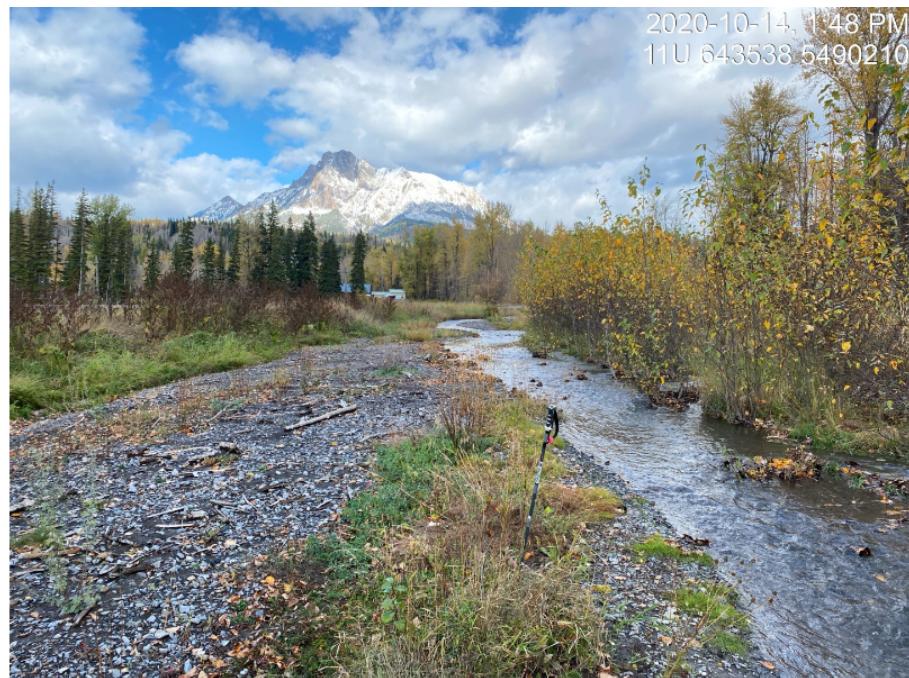
Figure 5.36: Typical habitat downstream of PSCIS crossing 197582.

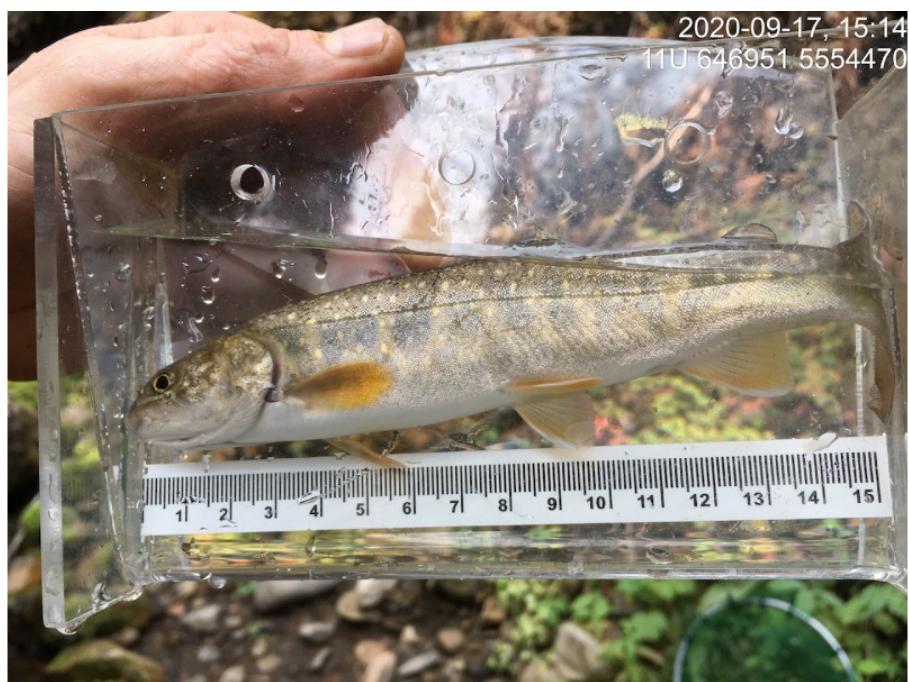
Figure 5.42: Bull trout captured downstream of PSCIS crossing 197555.
