Upper Elk River and Flathead River Fish Passage Restoration Planning

Version 1.2

2021-01-30

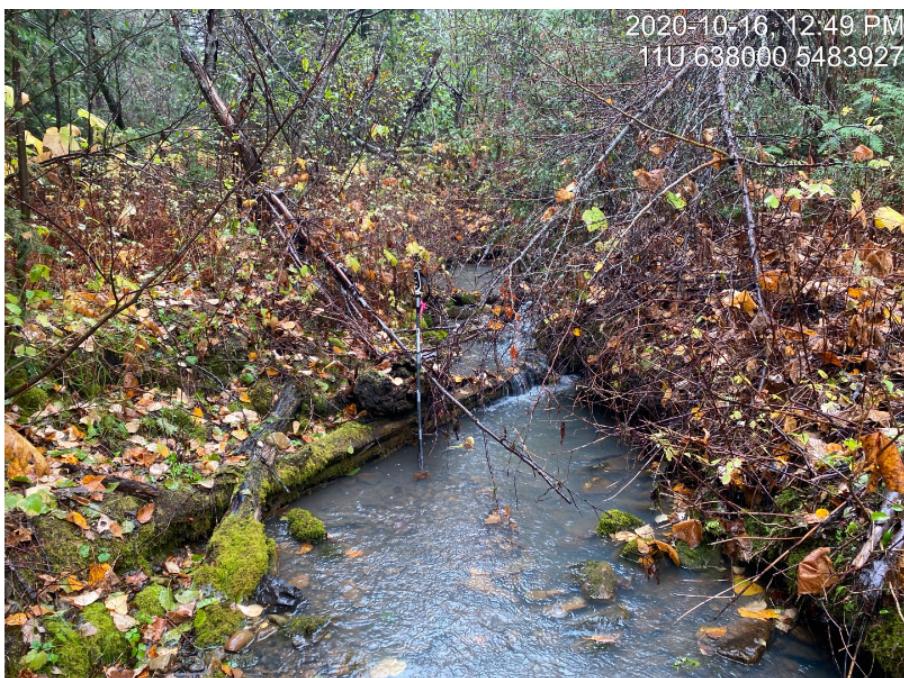
The stream was surveyed upstream from the culvert for 675m. Overall, total cover amount was rated as moderate with undercut banks dominant. Cover was also present as small woody debris, large woody debris, deep pools, and overhanging vegetation (Table [5.2](#), Figure [5.2](#)). The average channel width was 2.6m, the average wetted width was 2m and the average gradient was 3%. There were numerous fry observed throughout the area surveyed and abundant gravels suitable for resident westslope cutthroat trout spawning were noted. Habitat value was rated as high for salmonid rearing and spawning.

Figure 5.2: Typical habitat upstream of PSCIS crossing 50152.

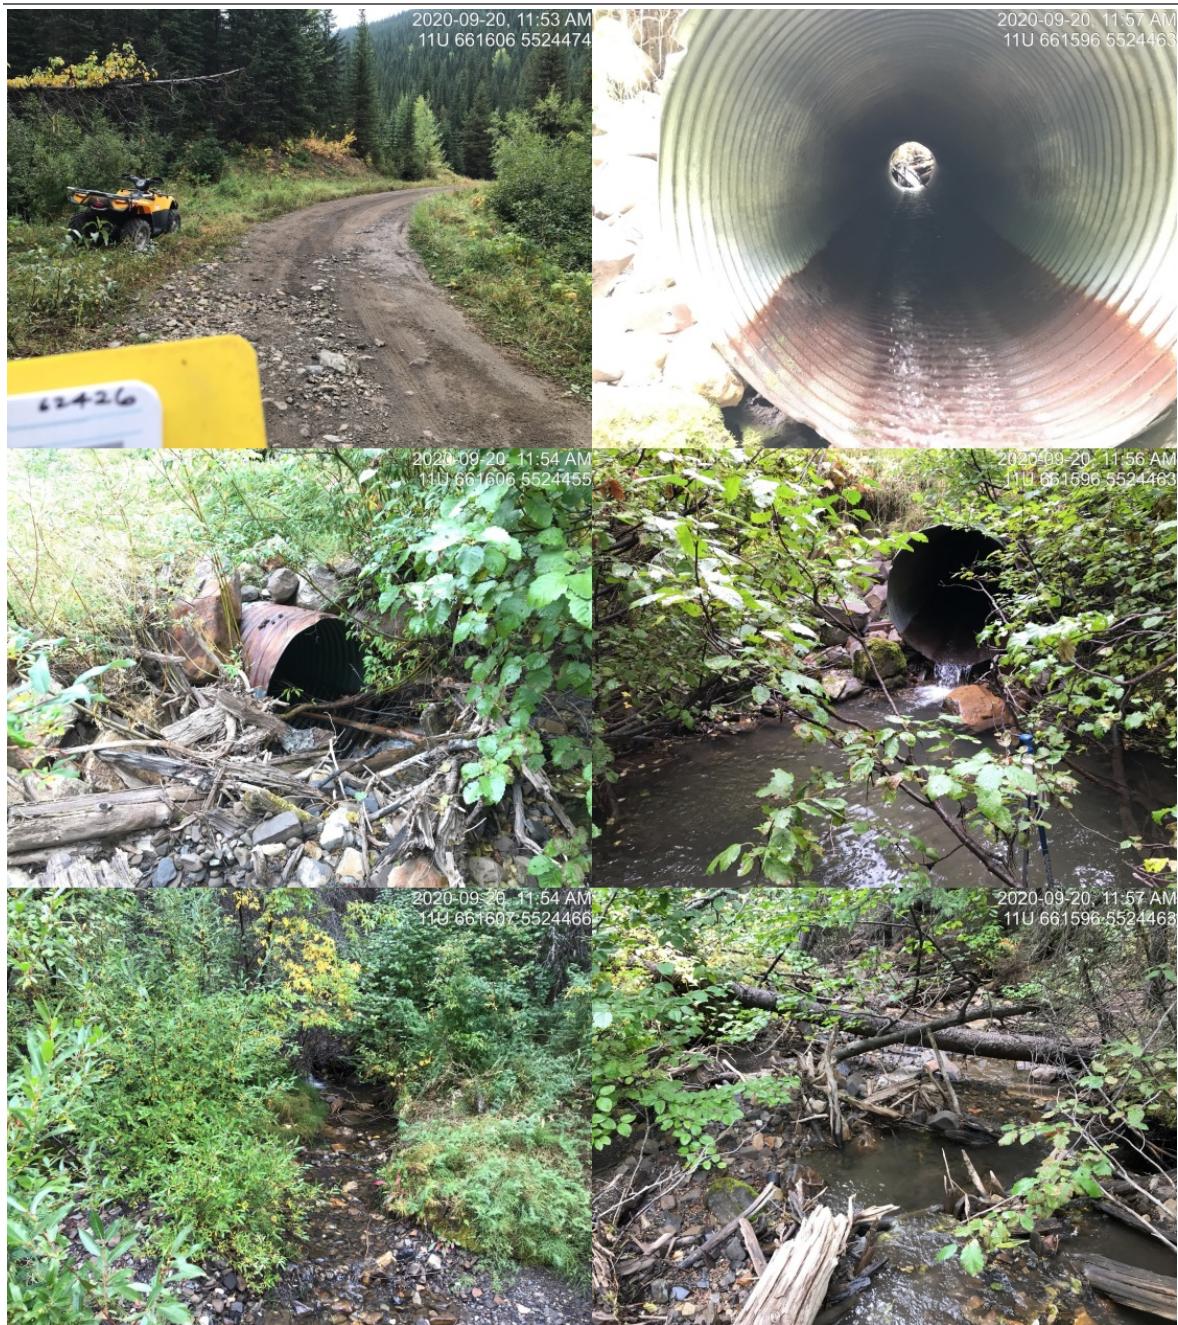
Photos: From top left clockwise: Road/Site Card, Barrel, Outlet, Downstream, Upstream, Inlet.

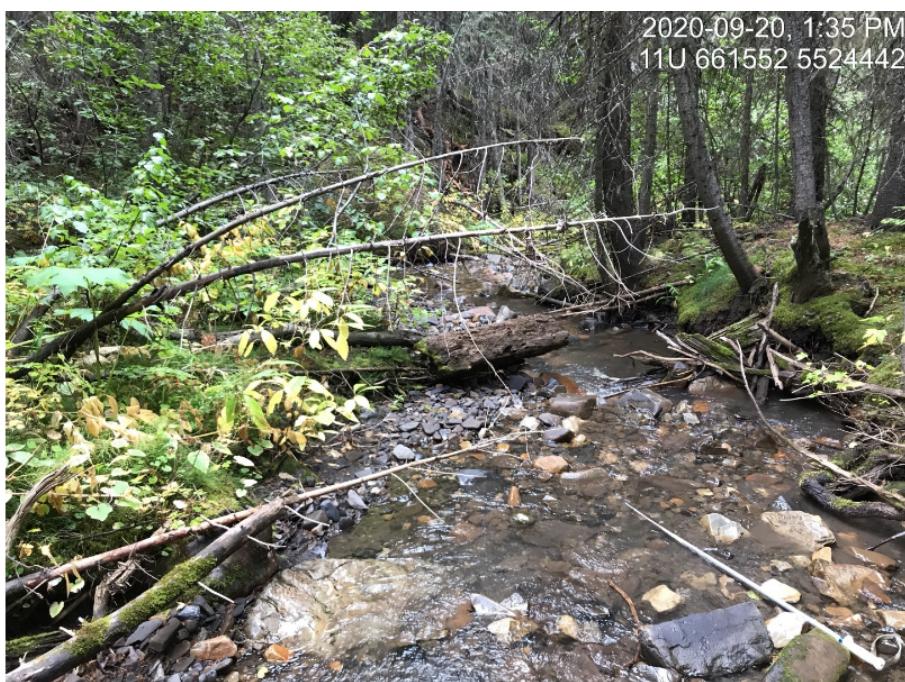
Figure 5.22: Typical habitat upstream of PSCIS crossing 62425 and downstream of PSCIS crossing 62426.

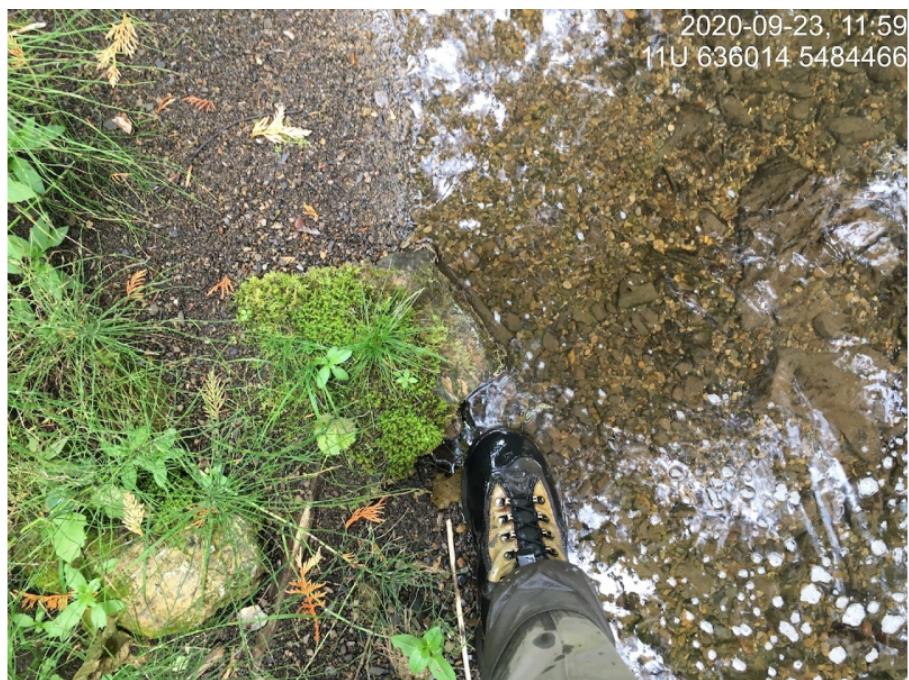
Figure 5.26: Gravels suitable for spawning upstream of PSCIS crossing 62516.

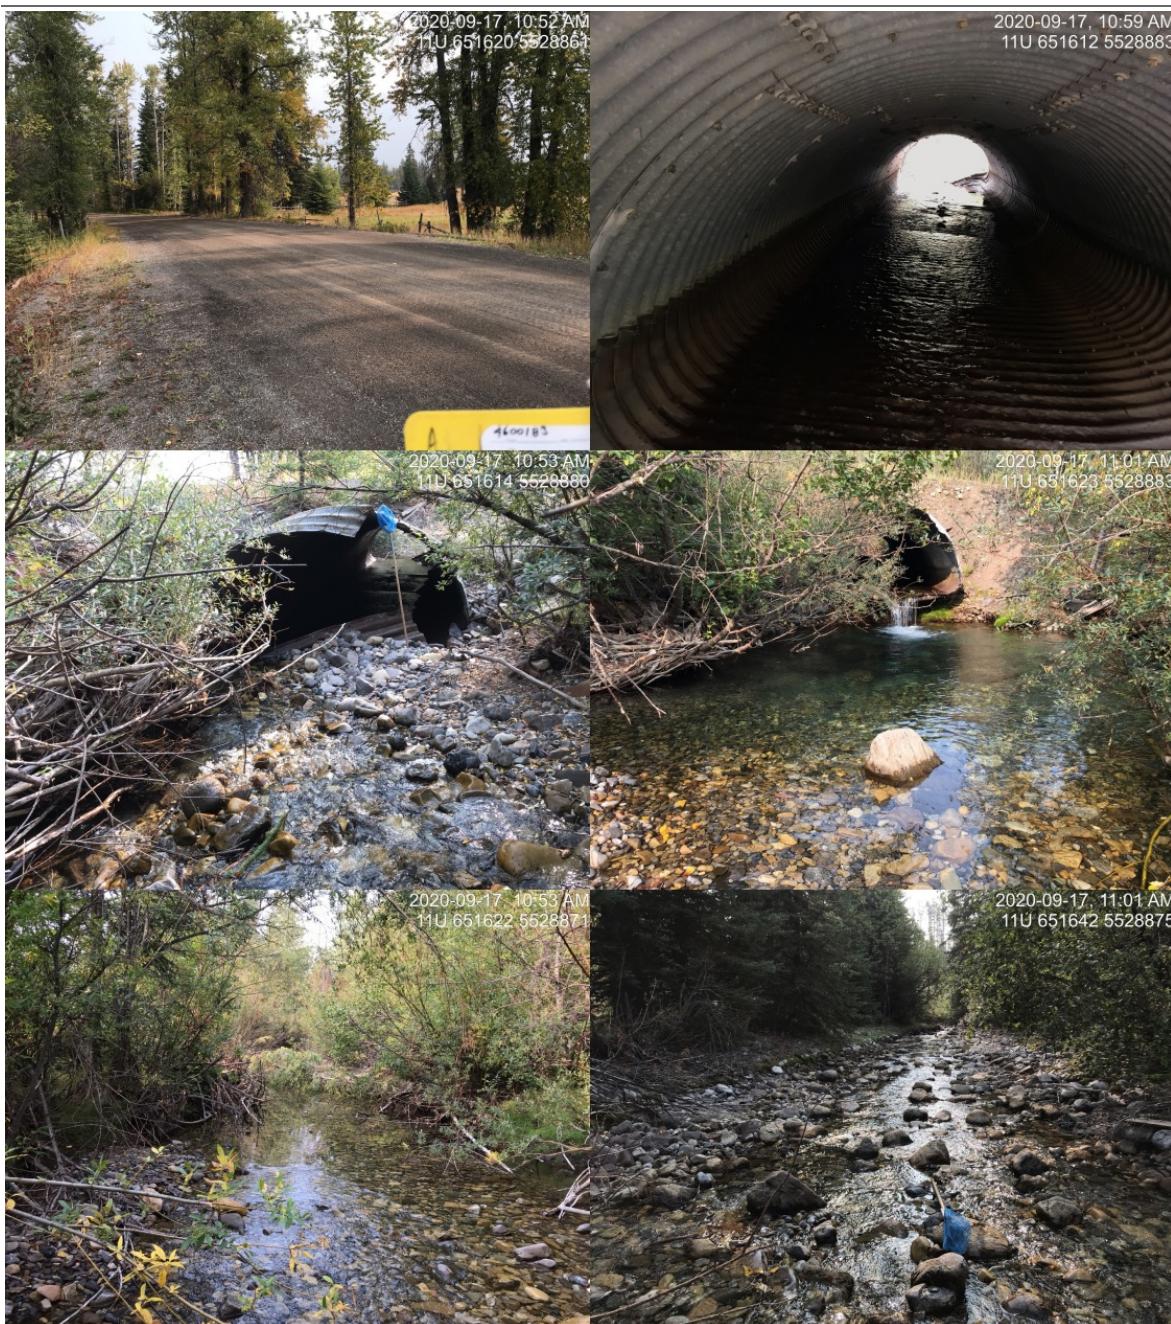
Photos: From top left clockwise: Road/Site Card, Barrel, Outlet, Downstream, Upstream, Inlet.

Table 5.27: Summary of fish passage reassessment for PSCIS crossing 197559.

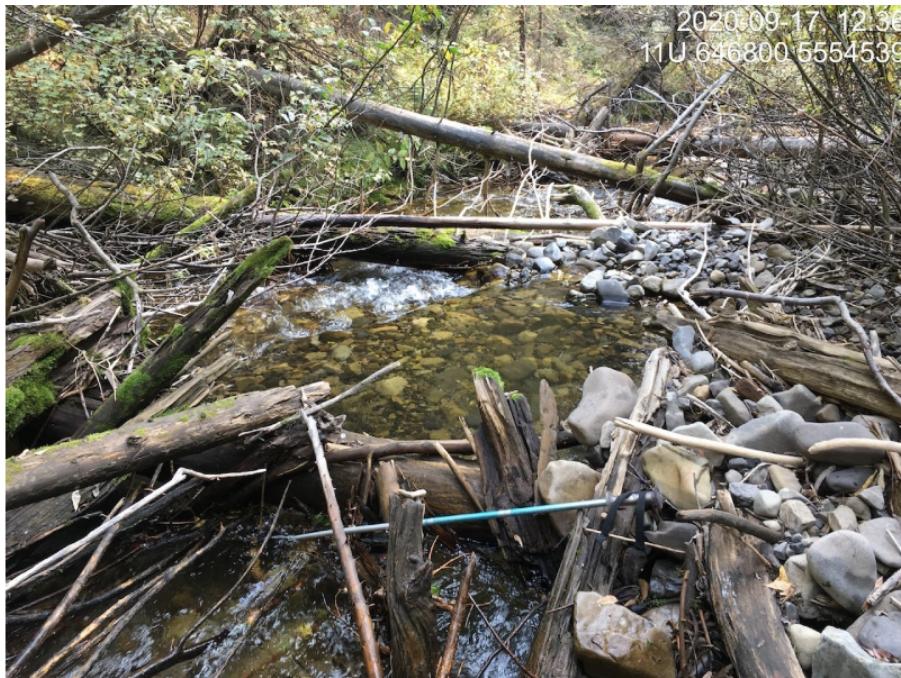
Figure 5.40: Typical habitat downstream of PSCIS crossing 197555.
