Upper Elk River and Flathead River Fish Passage Restoration Planning

**Prepared for
Canadian Wildlife Federation
350 Michael Cowpland Dr
Kanata, ON K2M 2W1**

**Prepared by
Al Irvine, B.Sc., R.P.Bio.
New Graph Environment
6 Regent St
Nelson, BC V1L 2P1**

Version 1.3

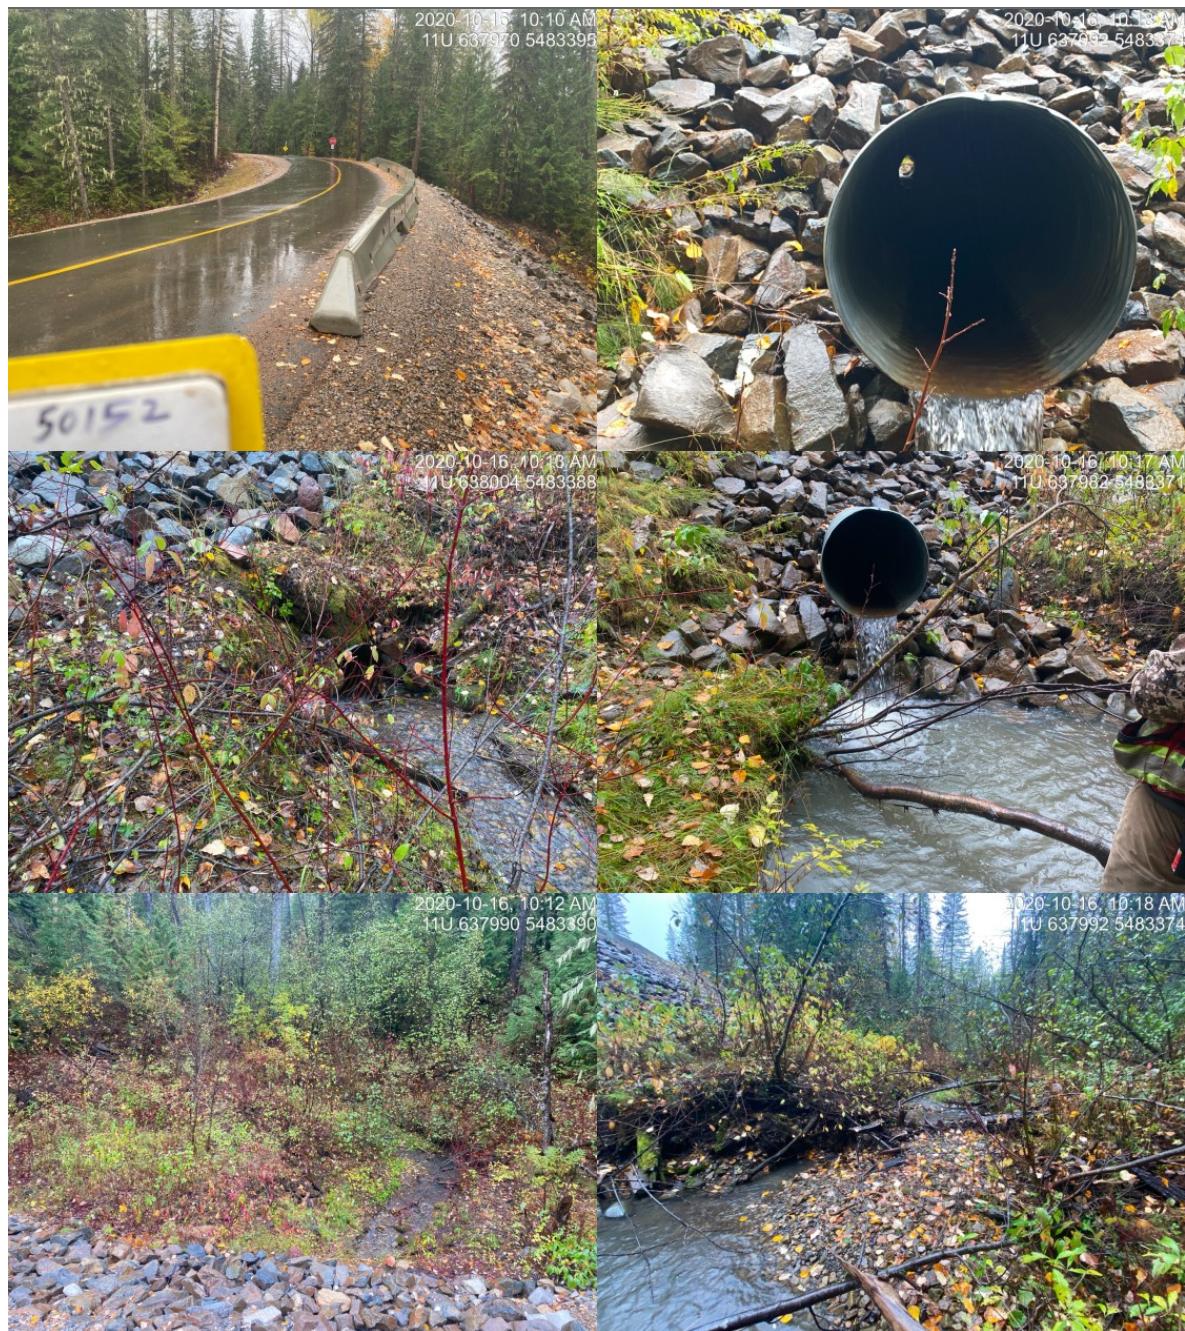
As noted, the culvert located at PSCIS 50152 appeared to have been replaced in 2020 with fresh rock, road fill and pavement present. At the time of the survey, the un-embedded and non-backwatered 0.9m diameter crossing was considered a barrier to upstream fish passage with a pipe length of 30m, a culvert slope of 1.5%, a stream width ratio of 2.9 and an outlet drop of 0.9m (Table 5.1). Water temperature was 5°C, pH was 8.5 and conductivity was 286uS/cm.

Structure replacement with a bridge is recommended to provide access to the habitat located upstream of PSCIS crossing 50152. The cost of the work is estimated at \$438,000 for a cost benefit of 6.2 linear m/\$1000 and 16m²/\$1000.

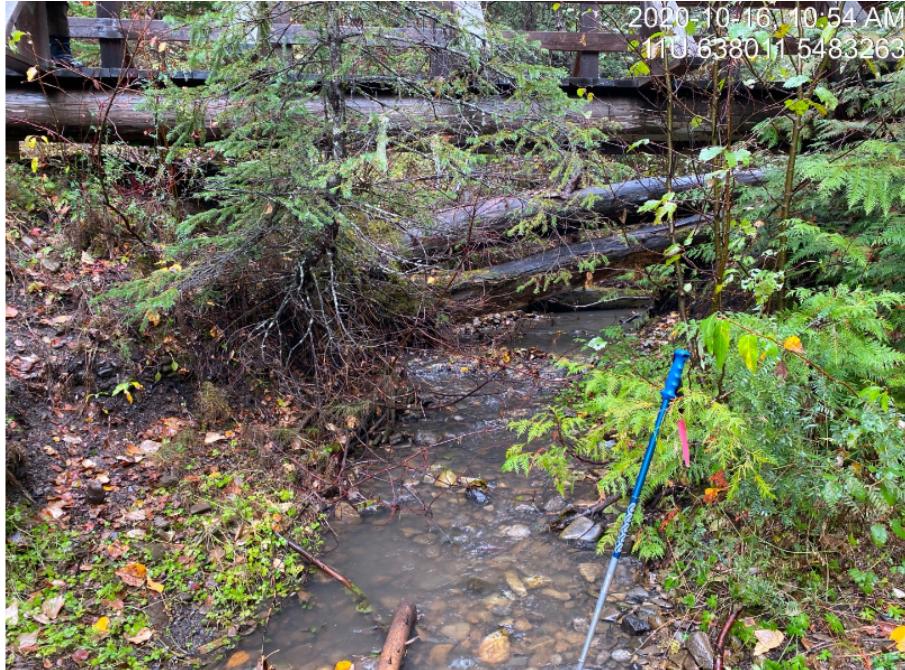
The stream was surveyed downstream from the culvert for 140m to Lizard Creek. Overall, total cover amount was rated as moderate with undercut banks dominant. Cover was also present as small woody debris, large woody debris, and overhanging vegetation (Table 5.2, Figure 5.1). The average channel width was 2.7m, the average wetted width was 2.1m and the average gradient was 4%. The dominant substrate was cobbles with gravels subdominant. Downstream of the crossing, numerous fry were observed, there were frequent sections of gravels suitable for salmonid spawning and there were no barriers or obstacles to fish passage. Habitat was rated as high value for fry/juvenile salmonid rearing.

Figure 5.1: Typical habitat downstream of PSCIS crossing 50152.

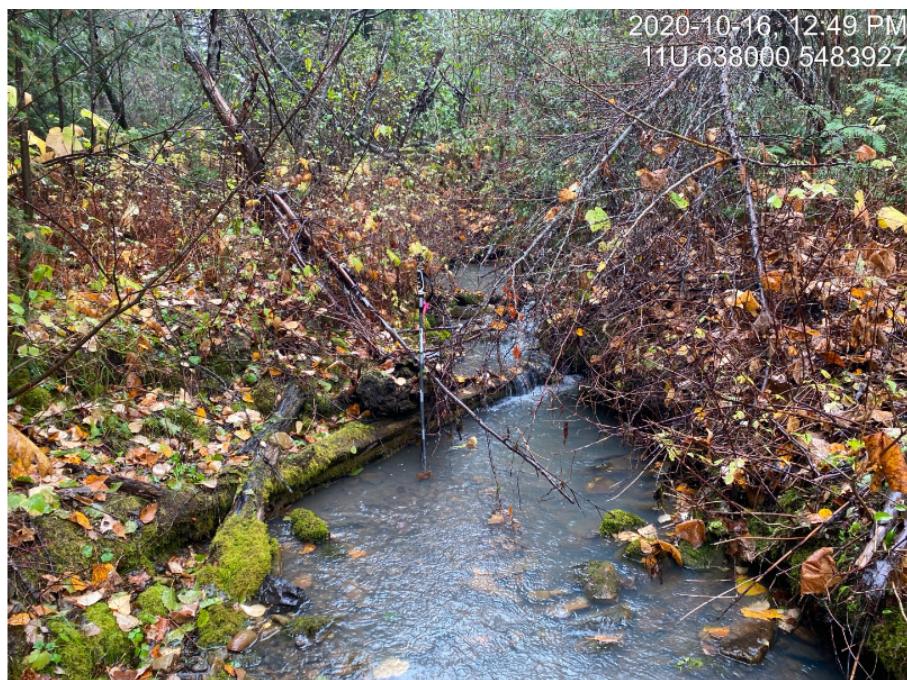
The stream was surveyed upstream from the culvert for 675m. Overall, total cover amount was rated as moderate with undercut banks dominant. Cover was also present as small woody debris, large woody debris, deep pools, and overhanging vegetation (Table 5.2, Figure 5.2). The average channel width was 2.6m, the average wetted width was 2m and the average gradient was 3%. There were numerous fry observed throughout the area surveyed and abundant gravels suitable for resident westslope cutthroat trout spawning were noted. Habitat value was rated as high for salmonid rearing and spawning.

Figure 5.2: Typical habitat upstream of PSCIS crossing 50152.

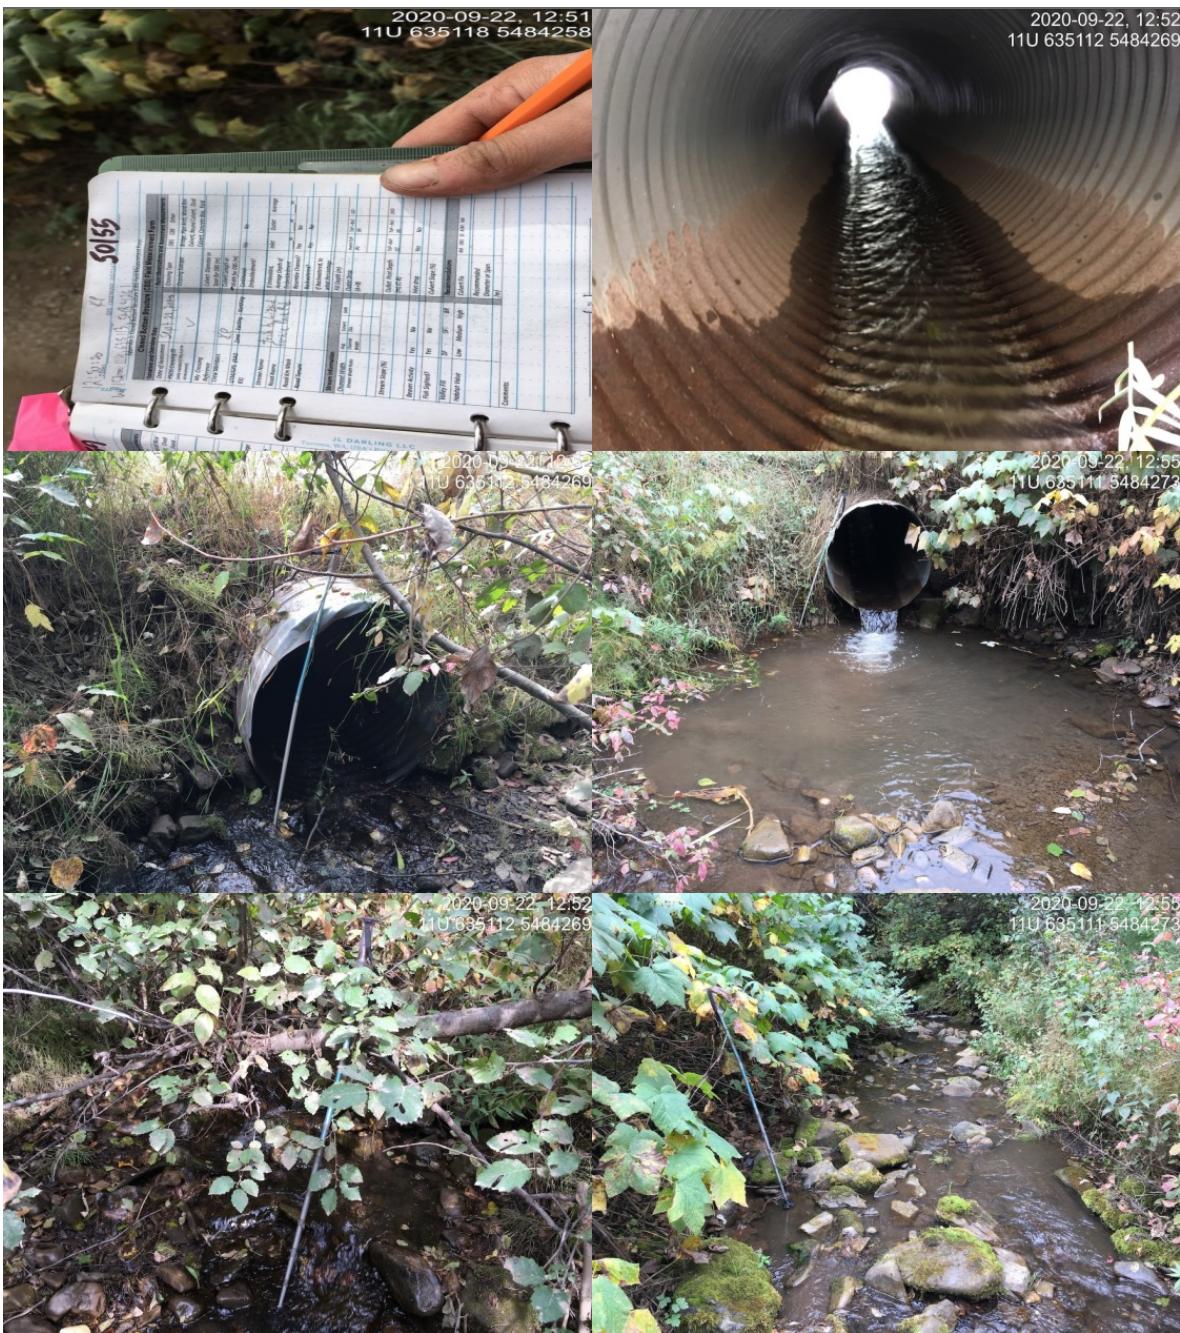
Photos: From top left clockwise: Road/Site Card, Barrel, Outlet, Downstream, Upstream, Inlet.

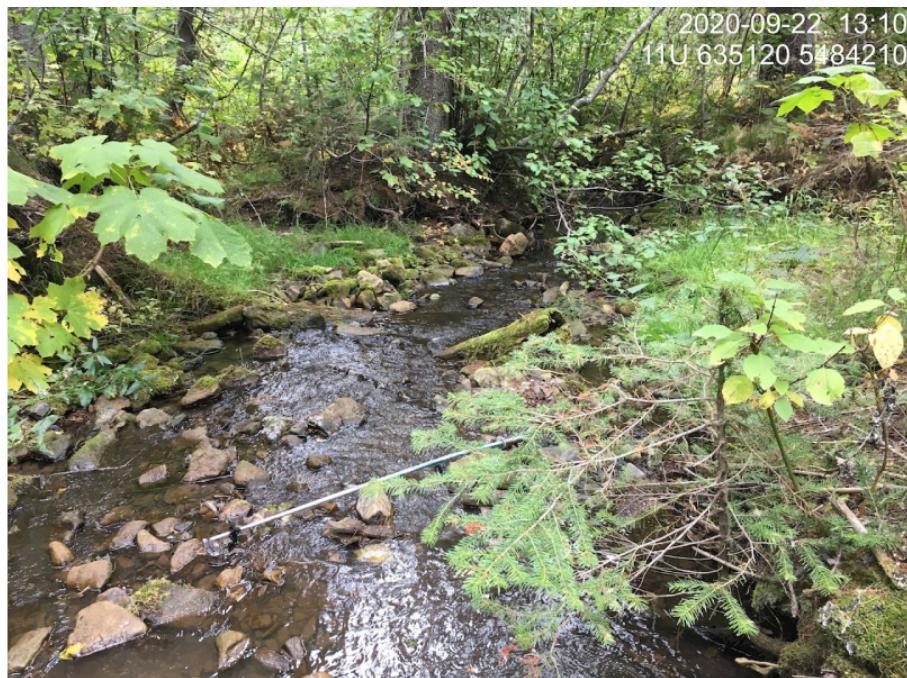
Figure 5.4: Typical habitat downstream of PSCIS crossing 50155.

Structure replacement with a bridge is recommended to provide unconstrained access to the habitat located upstream of PSCIS crossing 50155. The cost of the work is estimated at \$125,000 for a cost benefit of 14.4 linear m/\$1000 and 31.7m²/\$1000.

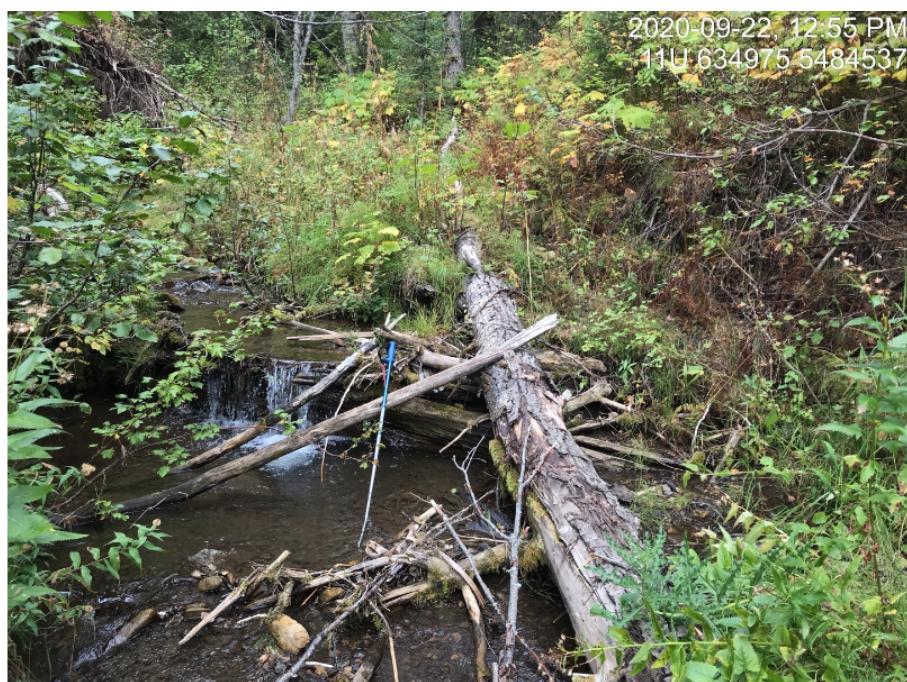
Figure 5.5: Typical habitat upstream of PSCIS crossing 50155.

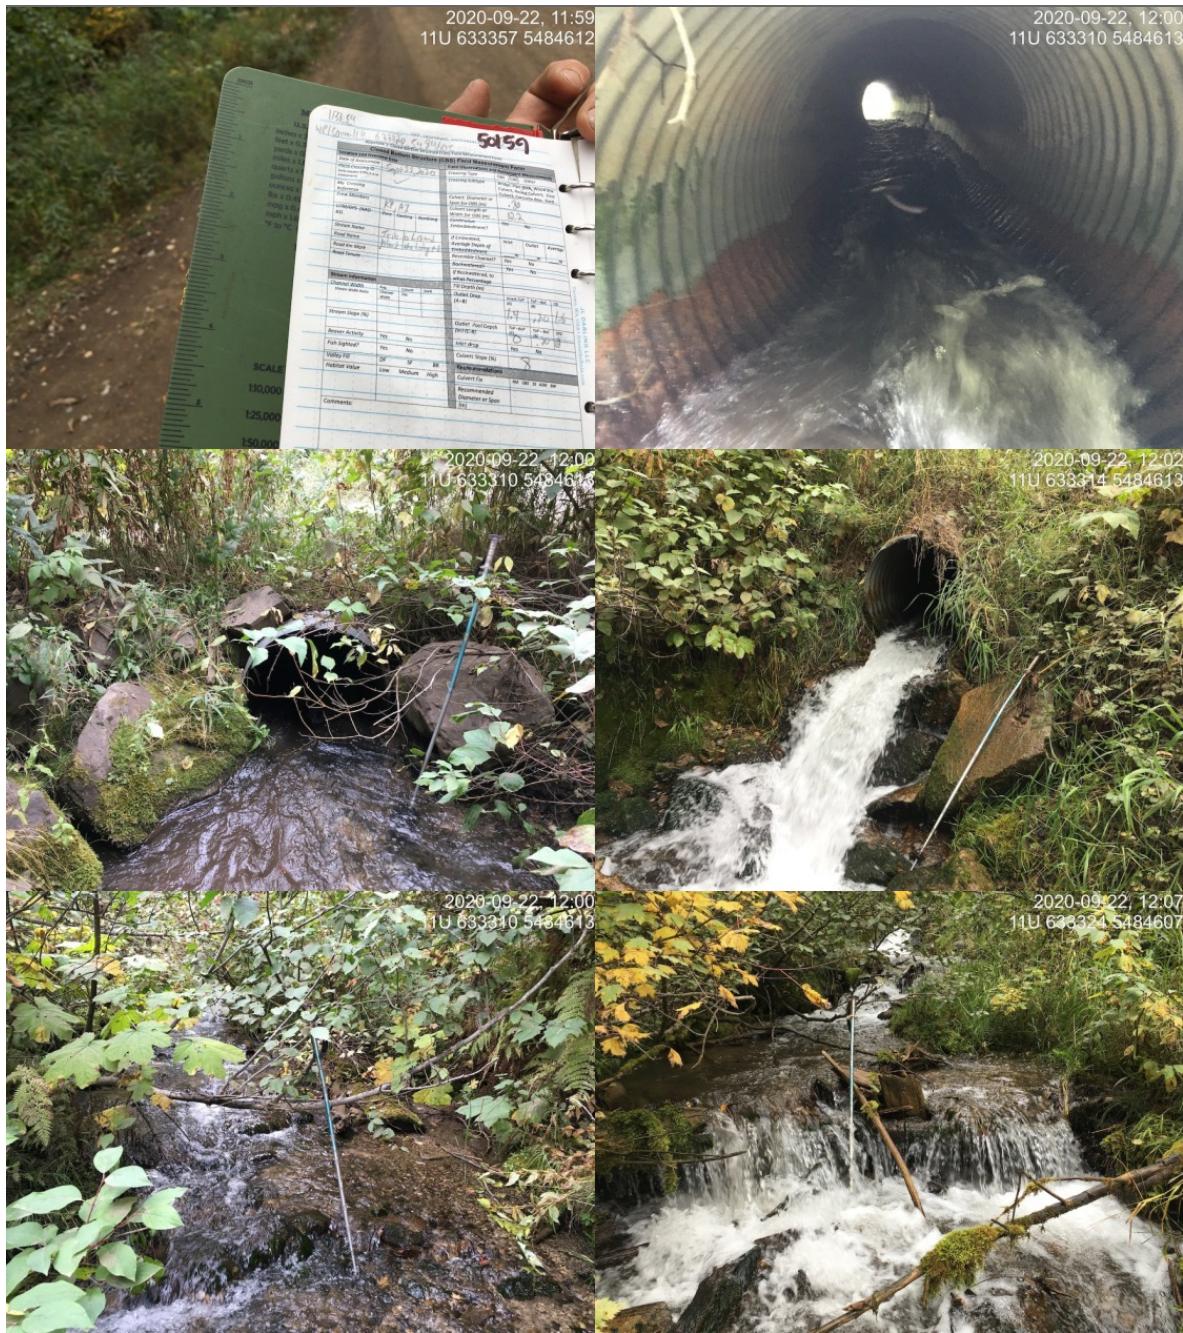
Photos: From top left clockwise: Road/Site Card, Barrel, Outlet, Downstream, Upstream, Inlet.

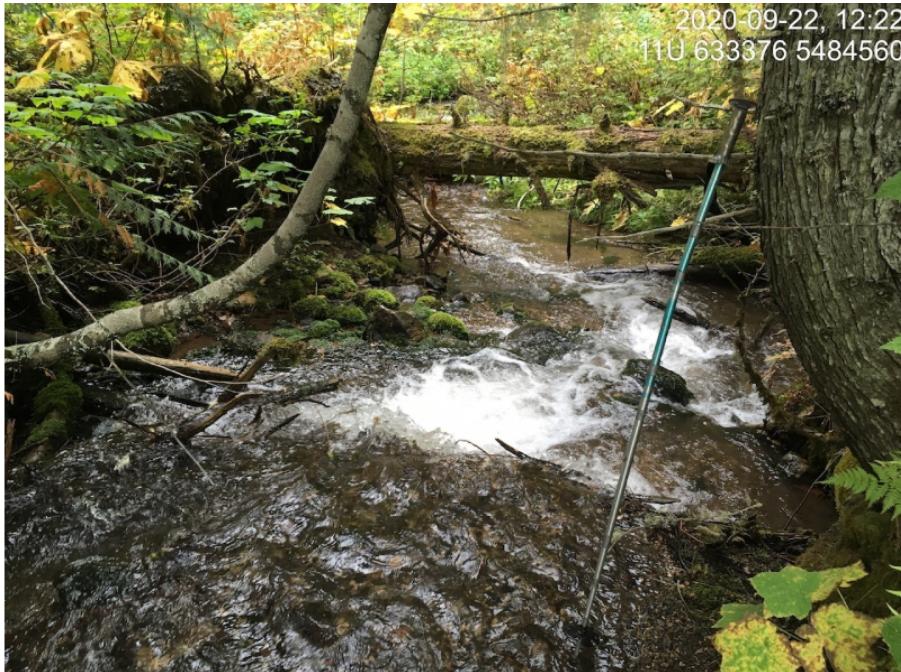
Figure 5.6: Typical habitat downstream of PSCIS crossing 50159.

Structure replacement with a bridge is recommended to provide access to the habitat located upstream of PSCIS crossing 50159. The cost of the work is estimated at \$125,000 for a cost benefit of 2.8 linear m/\$1000 and 8.4m²/\$1000.

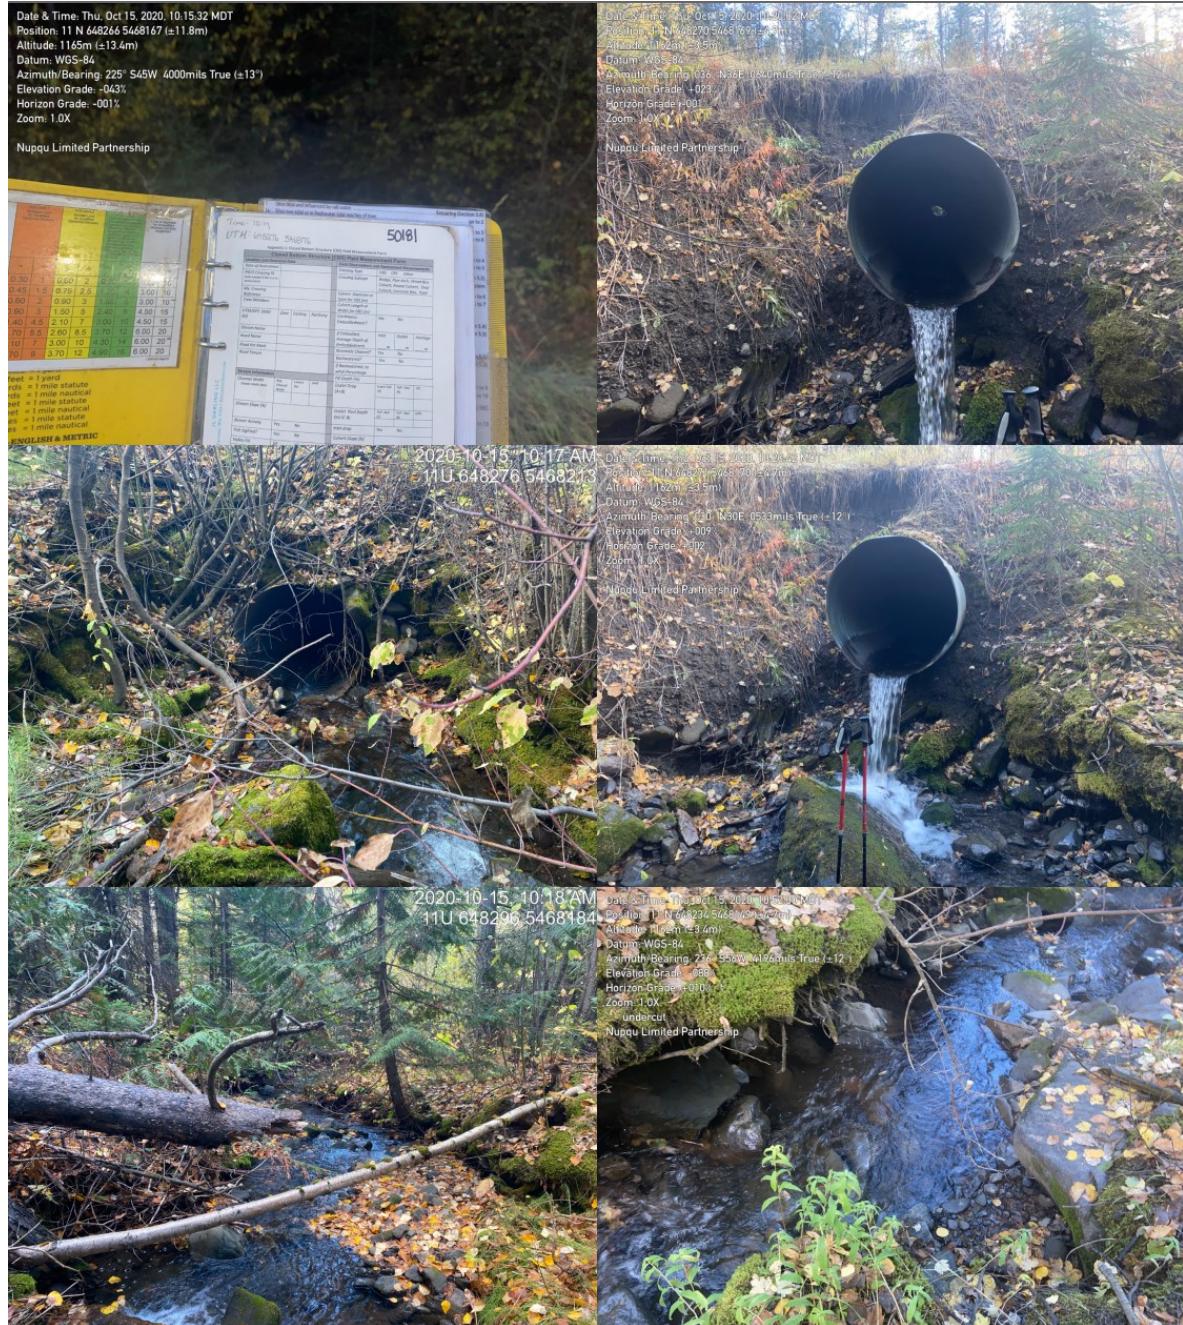
Photos: From top left clockwise: Road/Site Card, Barrel, Outlet, Downstream, Upstream, Inlet.

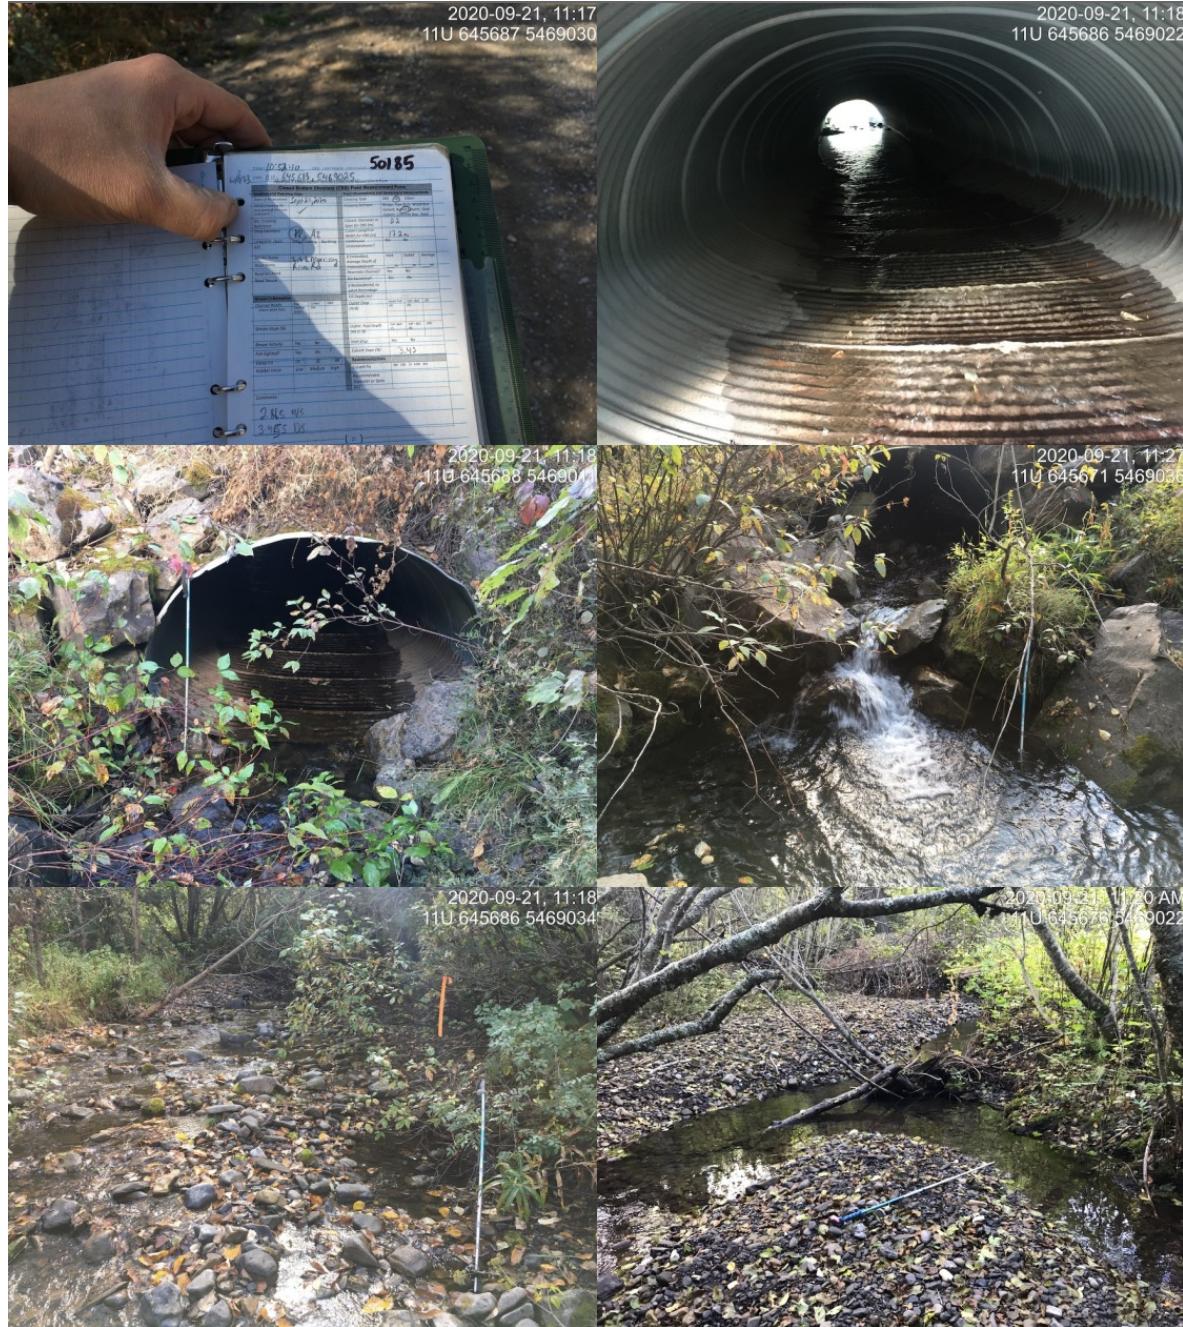
Photos: From top left clockwise: Road/Site Card, Barrel, Outlet, Downstream, Upstream, Inlet.

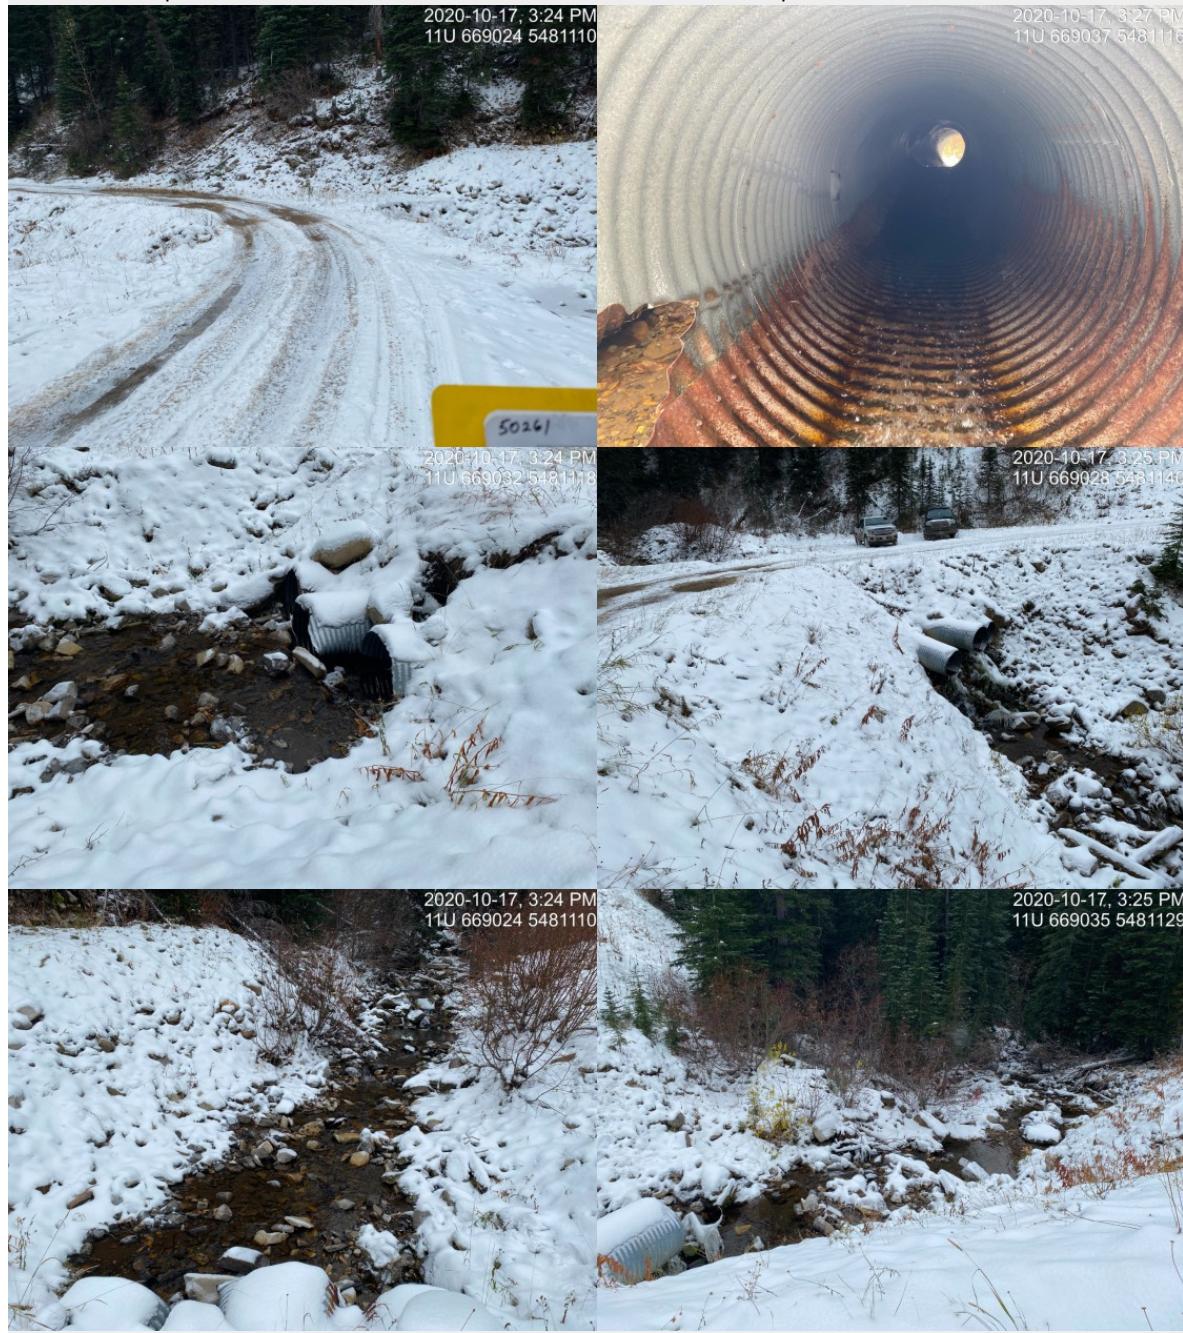
Photos: From top left clockwise: Road/Site Card, Barrel, Outlet, Downstream, Upstream, Inlet.

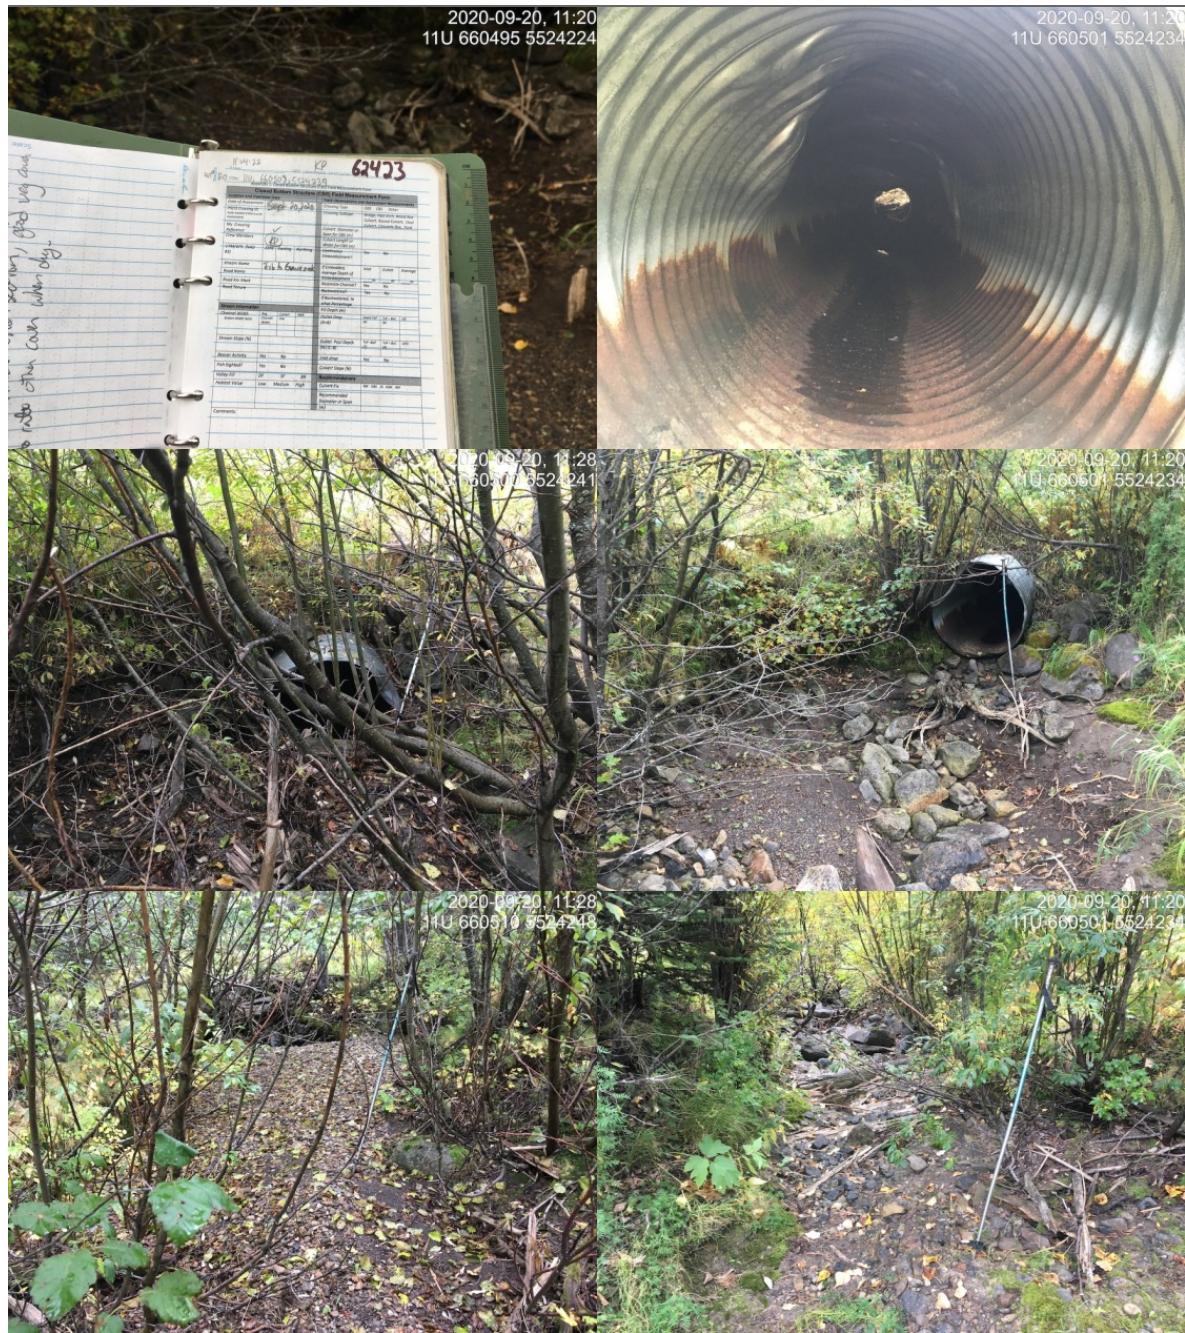
Date	2020-09-20	Crossing Sub Type	Round Culvert
PSCIS ID	62423	Diameter (m)	0.9
External ID	–	Length (m)	12
Crew	KP, AI	Embedded	No
UTM Zone	11	Depth Embedded (m)	–
Easting	660508	Resemble Channel	No
Northing	5524239	Backwatered	No
Stream	Harriet Lake Creek	Percent Backwatered	–
Road	Grave Creek FSR	Fill Depth (m)	0.3
Road Tenure	Unknown	Outlet Drop (m)	0.18
Channel Width (m)	1.44	Outlet Pool Depth (m)	0.6
Stream Slope (%)	4	Inlet Drop	Yes
Beaver Activity	No	Slope (%)	0.5
Habitat Value	Low	Valley Fill	Deep Fill
Photos: From top left clockwise: Road/Site Card, Barrel, Outlet, Downstream, Upstream, Inlet.

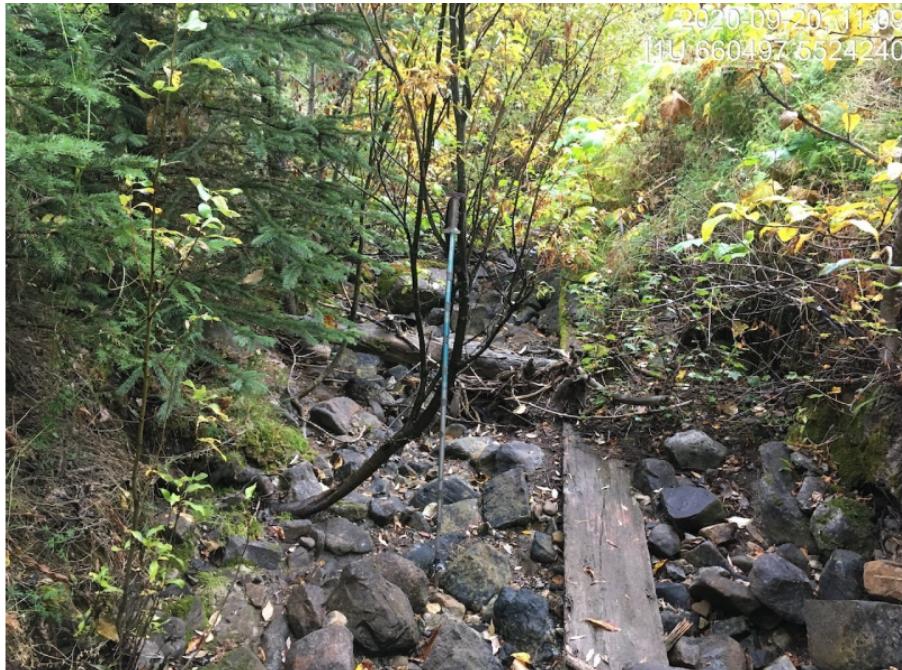
The stream was surveyed downstream from the culvert for 30m to Grave Creek. Overall, total cover amount was rated as moderate with overhanging vegetation dominant. Cover was also present as small woody debris and boulders (Table 5.20, Figure 5.20). The average channel width was 1.3m, and the average gradient was 4%. The dominant substrate was cobbles with boulders subdominant. Habitat value was rated as low value due to a lack of flow.

Figure 5.19: Typical habitat downstream of PSCIS crossing 62423.

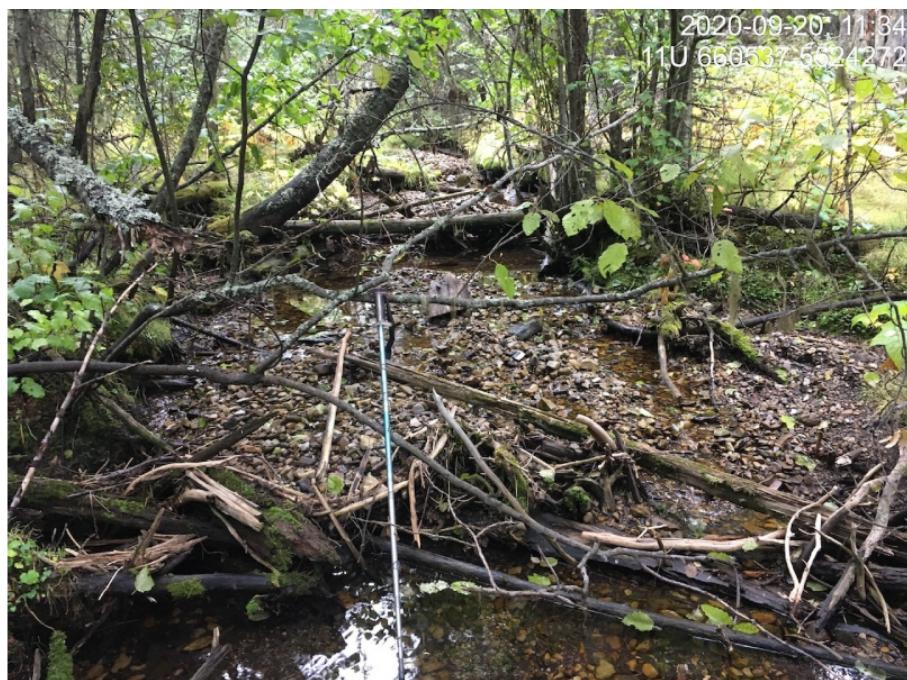
The stream was surveyed upstream from the culvert in the general location of the mapped Grave Creek streamline for 725m. As Harriet Lake Creek was the primary source of flow for the area and enters the surveyed tributary 150m upstream of the crossing location, flows were very minimal and substrate was primarily fines above its confluence. There was however, a visible channel in this location with a ford (PSCIS 197563) located approximately 600m upstream of PSCIS 62423. Overall, total cover amount was rated as moderate with undercut banks dominant. Cover was also present as small woody debris, large woody debris, and boulders (Table 5.20, Figure 5.19). The average channel width was 1.2m, the average wetted width was 0.8m and the average gradient was 4.4%. Harriet Lake Creek gradients modelled at 19% just upstream of the bridge located 1km upstream and too steep for upstream westslope cutthroat passage (>20%) at 2.2km. Habitat value was rated as medium for fry and juvenile westslope cutthroat rearing in Harriet Creek and low in the unnamed tributary mapped as Grave Creek due to a lack of flow.

Figure 5.20: Typical habitat upstream of PSCIS crossing 62423.

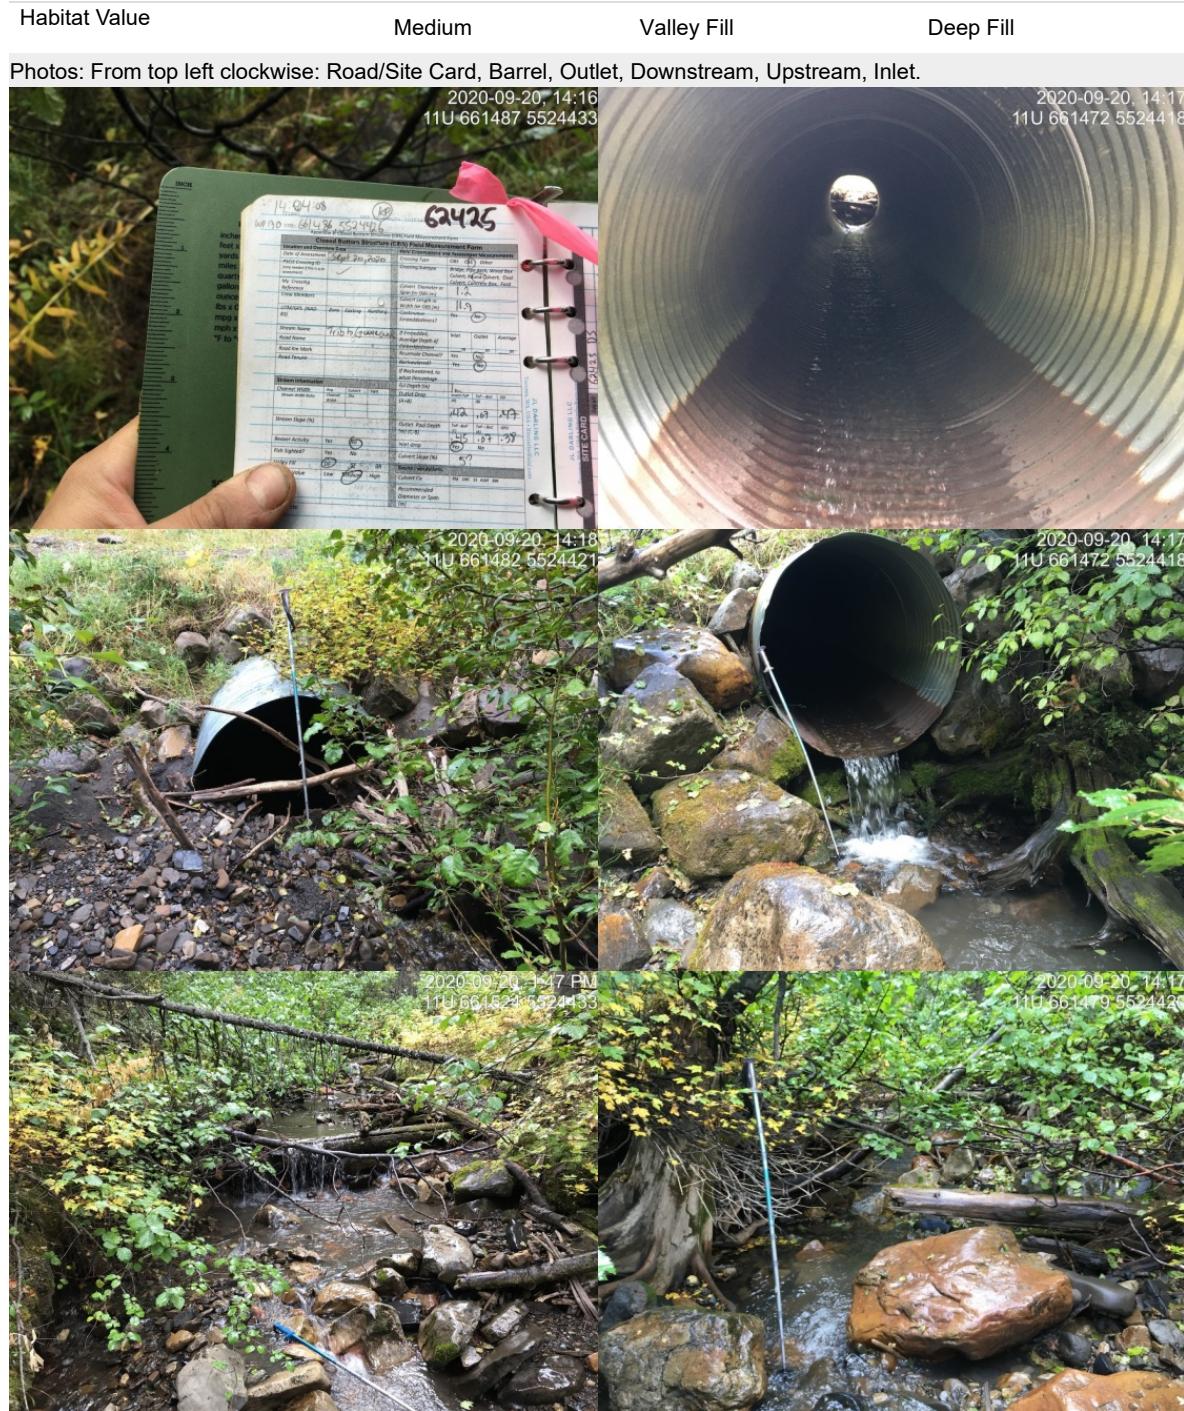
Photos: From top left clockwise: Road/Site Card, Barrel, Outlet, Downstream, Upstream, Inlet.

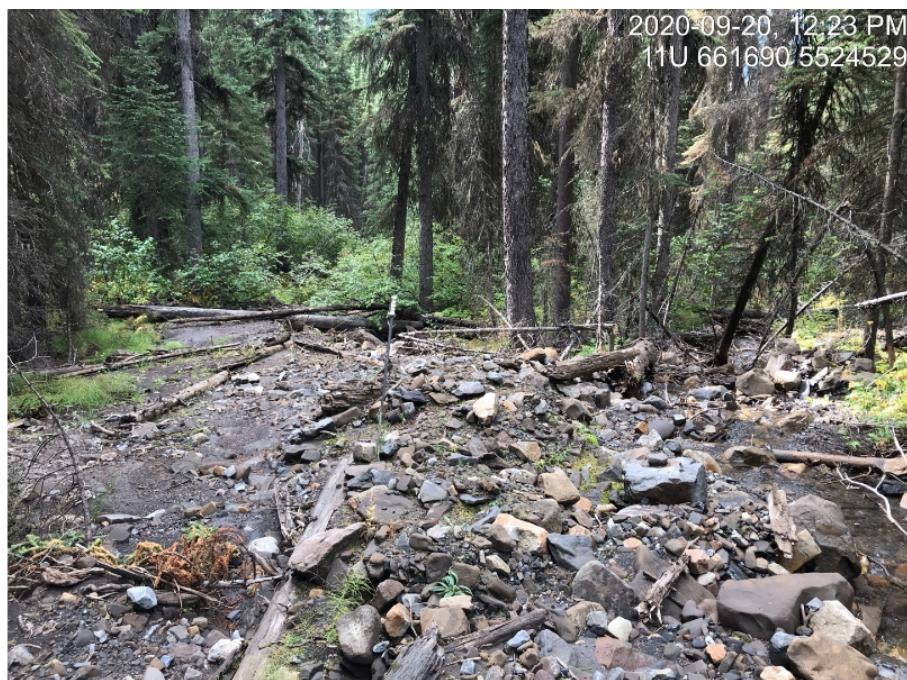
Figure 5.23: Grave Creek redirection out of historic channel located upstream of PSCIS crossing 62426.

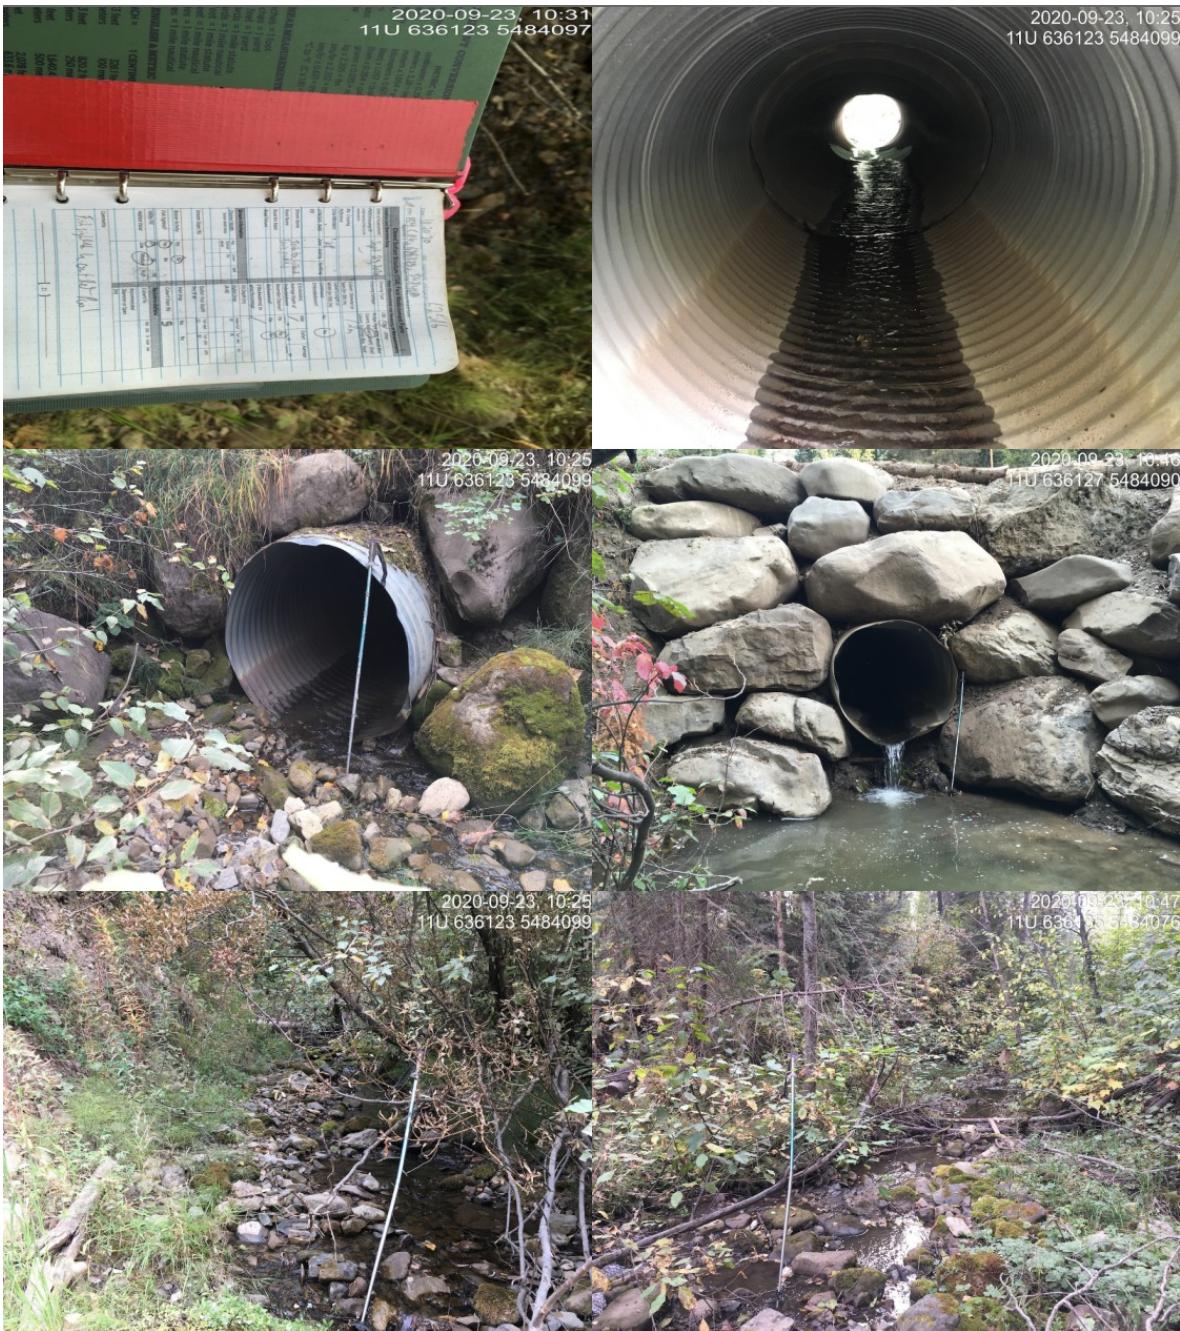
Date	2020-09-23	Crossing Sub Type	Round Culvert
PSCIS ID	62516	Diameter (m)	1.2
External ID	–	Length (m)	11
Crew	KP, AI	Embedded	No
UTM Zone	11	Depth Embedded (m)	–
Easting	636123	Resemble Channel	No
Northing	5484087	Backwatered	No
Stream	Tributary to Lizard Creek	Percent Backwatered	–
Road	Island Lake Lodge Road	Fill Depth (m)	1.3
Road Tenure	MoTi recreation	Outlet Drop (m)	0.49
Channel Width (m)	2.47	Outlet Pool Depth (m)	0.8
Stream Slope (%)	2.67	Inlet Drop	No
Beaver Activity	No	Slope (%)	5
Habitat Value	Medium	Valley Fill	Deep Fill
Photos: From top left clockwise: Road/Site Card, Barrel, Outlet, Downstream, Upstream, Inlet.

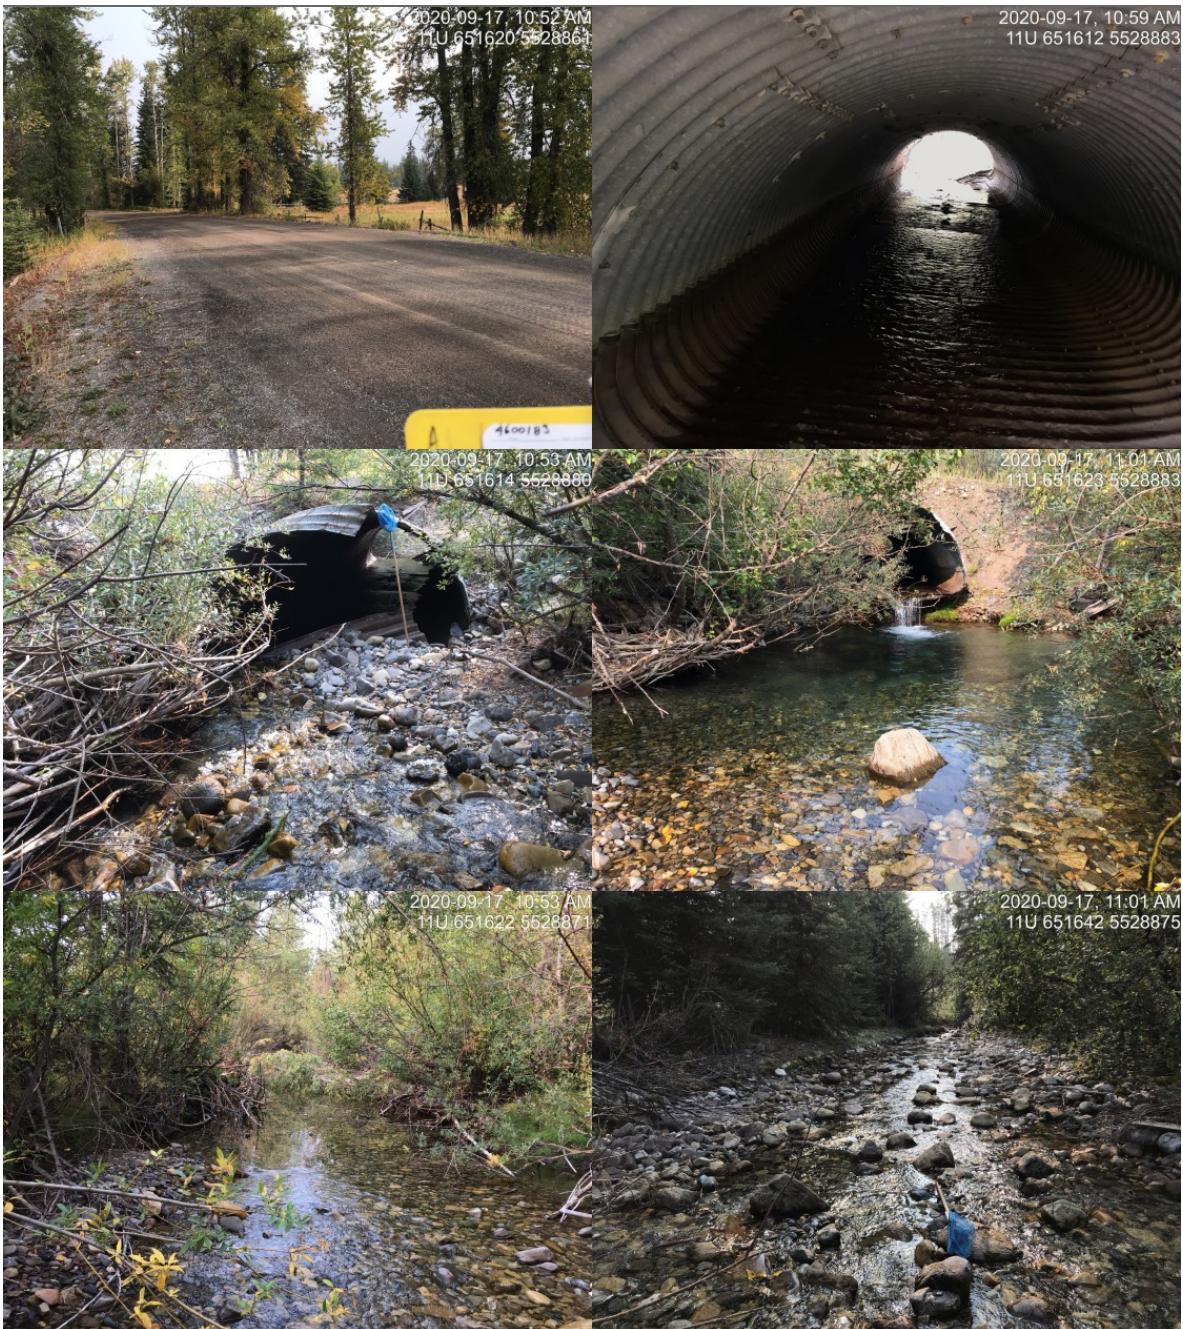
Photos: From top left clockwise: Road/Site Card, Barrel, Outlet, Downstream, Upstream, Inlet.
