Upper Elk River and Flathead River Fish Passage Restoration Planning

**Prepared for
Canadian Wildlife Federation
350 Michael Cowpland Dr
Kanata, ON K2M 2W1**

**Prepared by
Al Irvine, B.Sc., R.P.Bio.
New Graph Environment
6 Regent St
Nelson, BC V1L 2P1**

Version 1.3

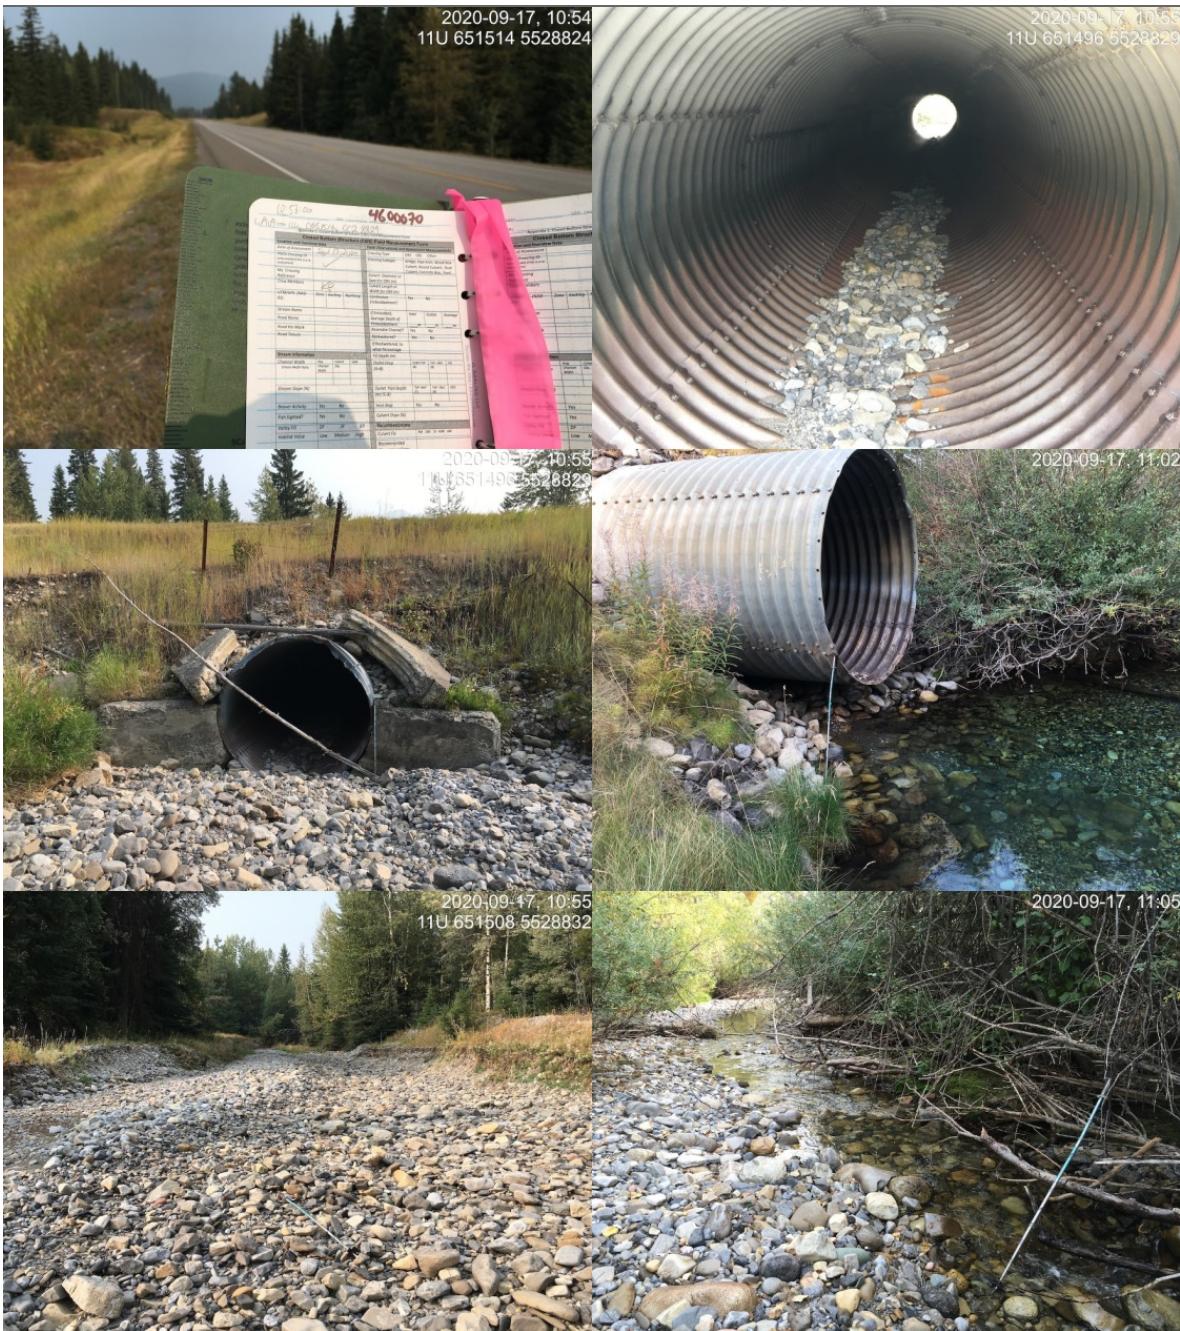
Photos: From top left clockwise: Road/Site Card, Barrel, Outlet, Downstream, Upstream, Inlet.

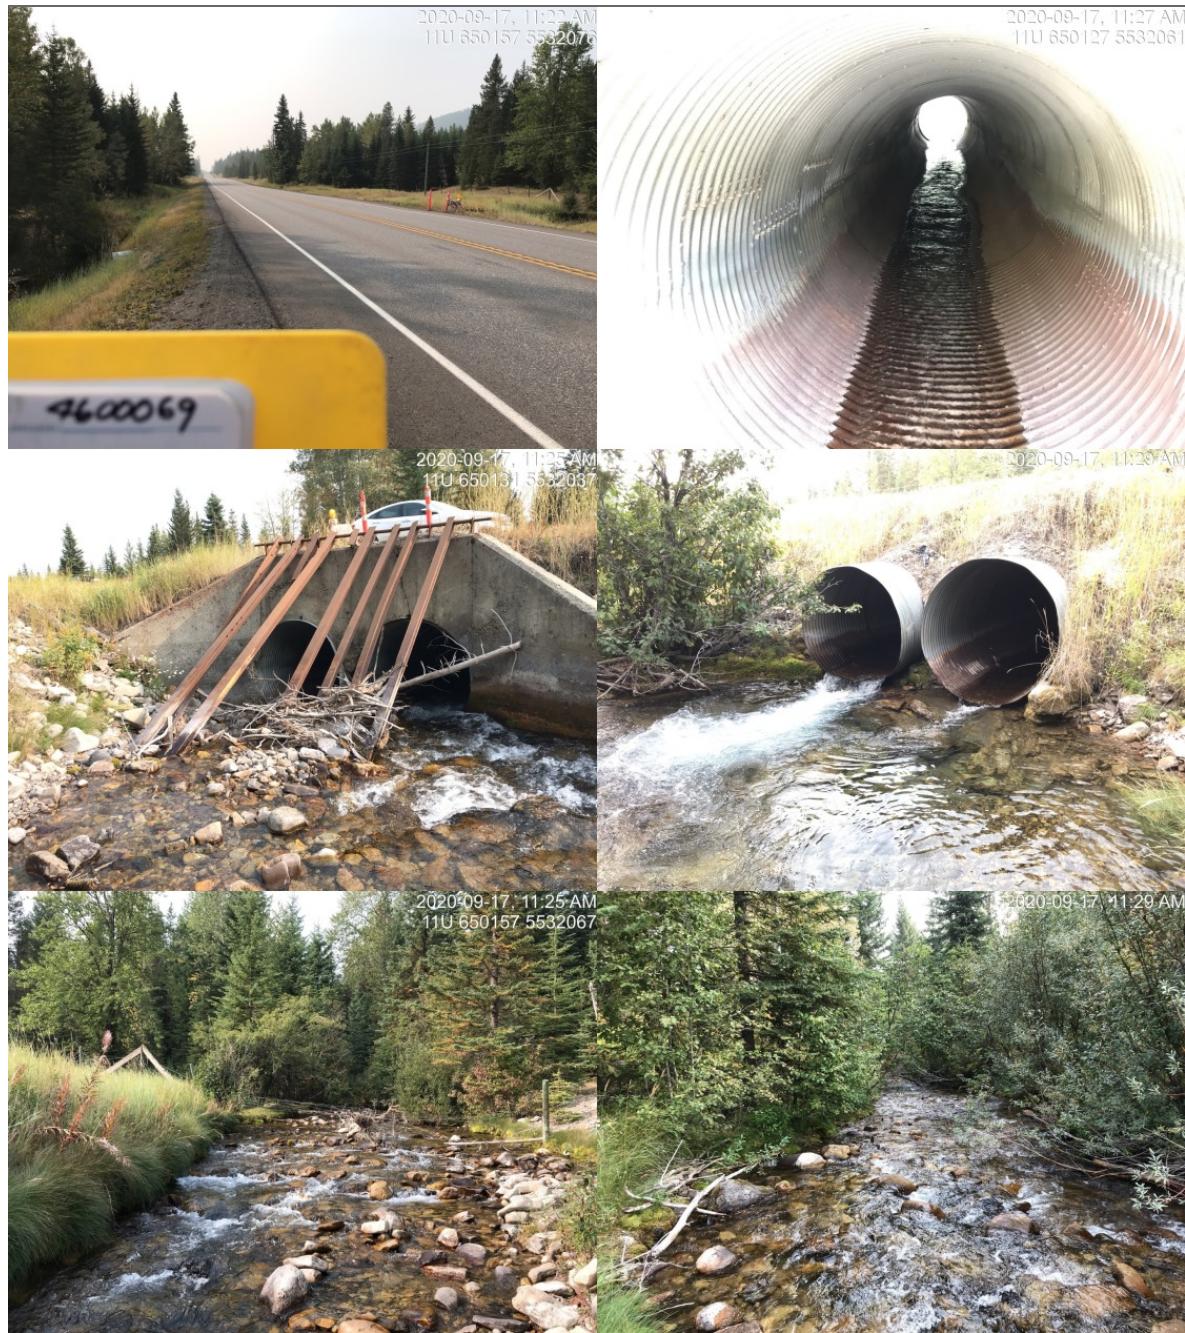
Location and Stream Data		Crossing Characteristics	
Date	2020-09-17	Crossing Sub Type	Round Culvert
PSCIS ID	197534	Diameter (m)	3.2
External ID	–	Length (m)	18
Crew	AI, KP	Embedded	No
UTM Zone	11	Depth Embedded (m)	–
Easting	650144	Resemble Channel	No
Northing	5532055	Backwatered	No
Stream	Weigert Creek	Percent Backwatered	–
Road	Highway 43	Fill Depth (m)	1.3
Road Tenure	MoTi highway	Outlet Drop (m)	0.15
Channel Width (m)	4.3	Outlet Pool Depth (m)	0.6
Stream Slope (%)	2	Inlet Drop	Yes
Beaver Activity	No	Slope (%)	3.4
Habitat Value	High	Valley Fill	Deep Fill
Photos: From top left clockwise: Road/Site Card, Barrel, Outlet, Downstream, Upstream, Inlet.

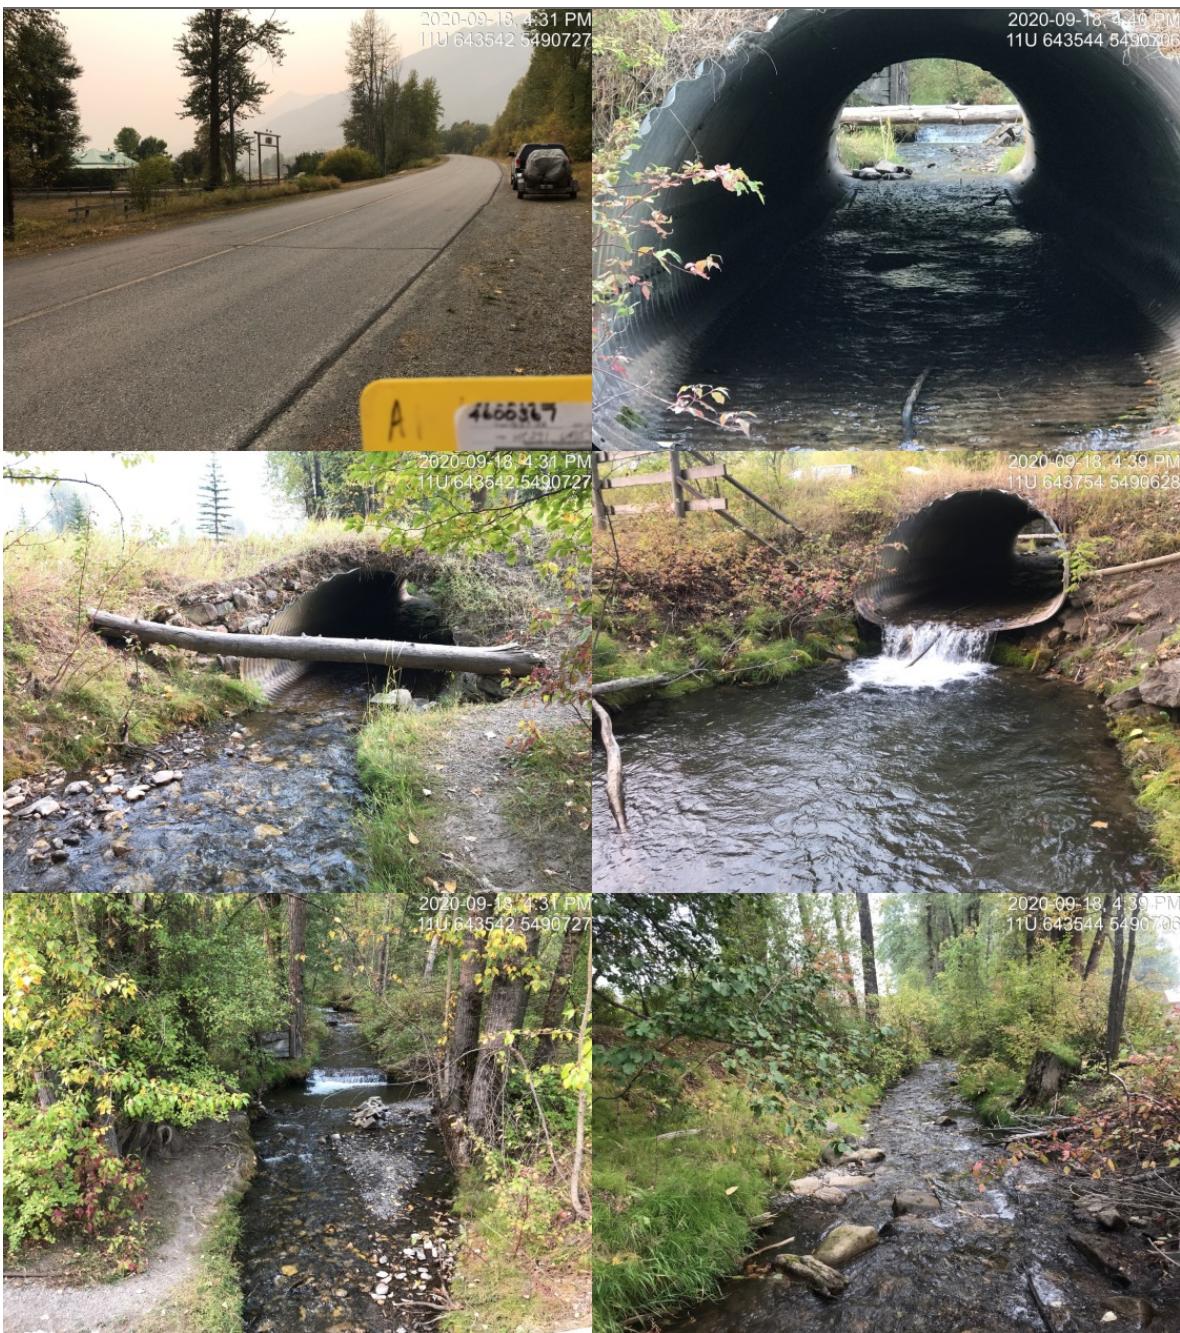
Photos: From top left clockwise: Road/Site Card, Barrel, Outlet, Downstream, Upstream, Inlet.

Structure replacement with an open bottomed structure is recommended to provide access to the habitat located upstream of PSCIS crossing 197542. The cost of the work is estimated at \$1,000,000 for a cost benefit of 7.2 linear m/\$1000 and $43.9\text{m}^2/\$1000$.

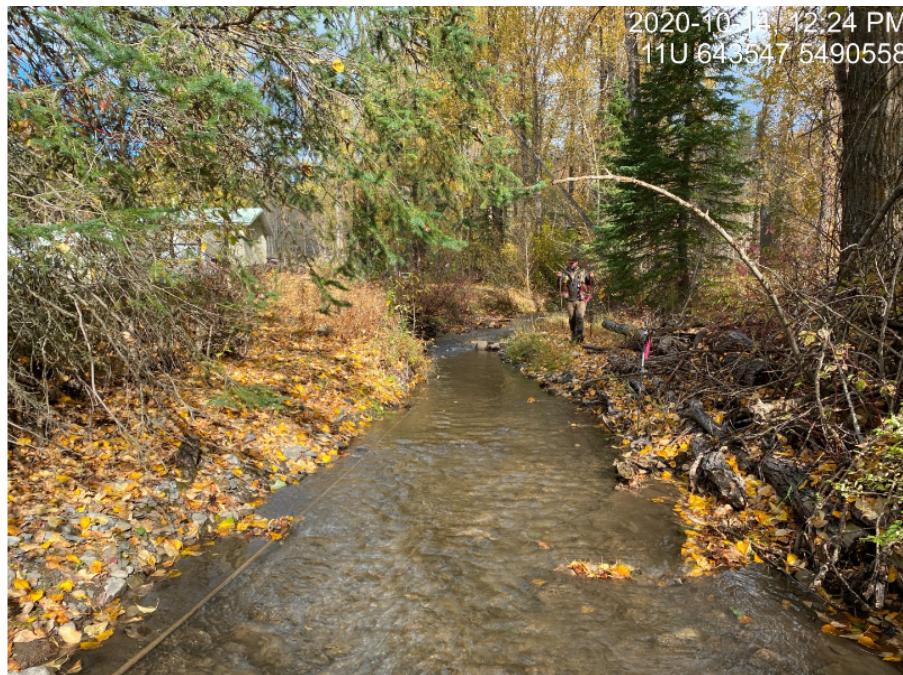
Figure 5.35: Typical habitat downstream of PSCIS crossing 197542.

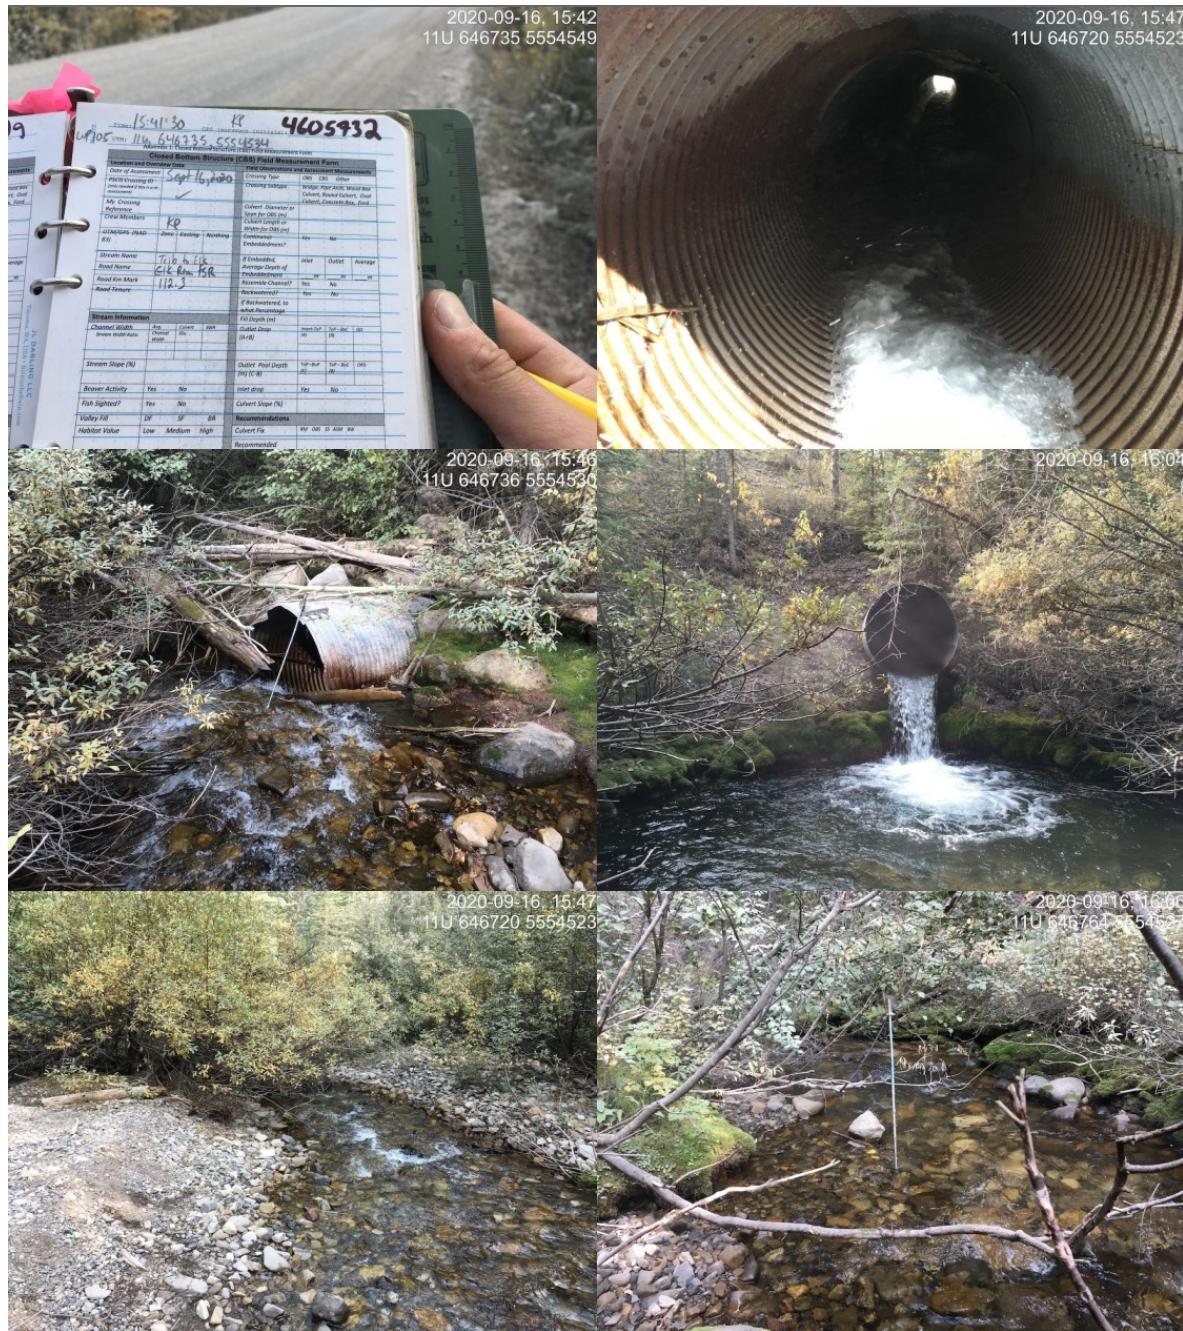
Location and Stream Data		Crossing Characteristics	
Date	2020-09-16	Crossing Sub Type	Round Culvert
PSCIS ID	197555	Diameter (m)	1.5
External ID	–	Length (m)	49
Crew	KP, AI	Embedded	No
UTM Zone	11	Depth Embedded (m)	–
Easting	646735	Resemble Channel	No
Northing	5554534	Backwatered	No
Stream	Tributary to Elk River	Percent Backwatered	–
Road	Elk River FSR	Fill Depth (m)	8
Road Tenure	FLNR 0103	Outlet Drop (m)	1.48
Channel Width (m)	3.5	Outlet Pool Depth (m)	1.3
Stream Slope (%)	1.5	Inlet Drop	Yes
Beaver Activity	No	Slope (%)	3.5
Habitat Value	High	Valley Fill	Deep Fill
Photos: From top left clockwise: Road/Site Card, Barrel, Outlet, Downstream, Upstream, Inlet.

Structure replacement with an open bottomed culvert is recommended to provide access to the habitat located upstream of PSCIS crossing 197555. Due to the large amount of fill on the road (8m) the size of a replacement bridge was estimated at 25m. The cost for work is estimated at \$312,000 for a cost benefit of 19.2linear m/\$1000 and 113.5m²/\$1000.

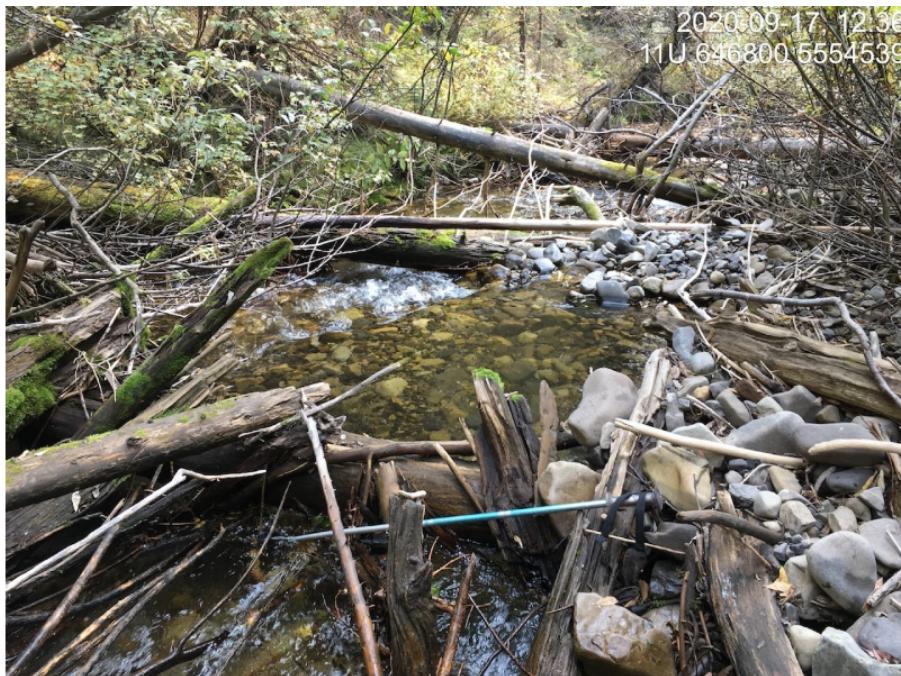
Figure 5.40: Typical habitat downstream of PSCIS crossing 197555.
