# **Upper Elk River and Flathead River Fish Passage Restoration Planning**

**Prepared by  
AI Irvine, B.Sc., R.P.Bio.  
New Graph Environment  
6 Regent St  
Nelson, BC V1L 2P1**

**Version 1.0**

**2021-01-27**

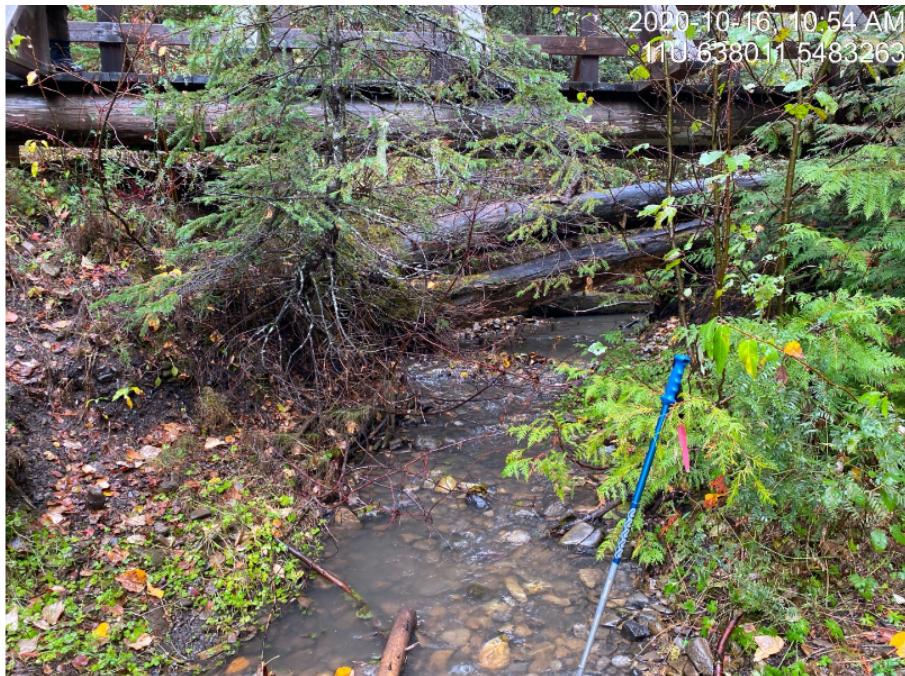
The stream was surveyed downstream from the culvert for 140m to Lizard Creek. Overall, total cover amount was rated as moderate with undercut banks dominant. Cover was also present as small woody debris, large woody debris, and overhanging vegetation (Table [5.2](#), Figure [5.1](#)). The average channel width was 2.7m, the average wetted width was 2.1m and the average gradient was 4%. The dominant substrate was cobbles with gravels subdominant. Downstream of the crossing, numerous fry were observed, there were frequent sections of gravels suitable for salmonid spawning and there were no barriers or obstacles to fish passage. Habitat was rated as high value for fry/juvenile salmonid rearing.

Figure 5.1: Typical habitat downstream of PSCIS crossing 50152.

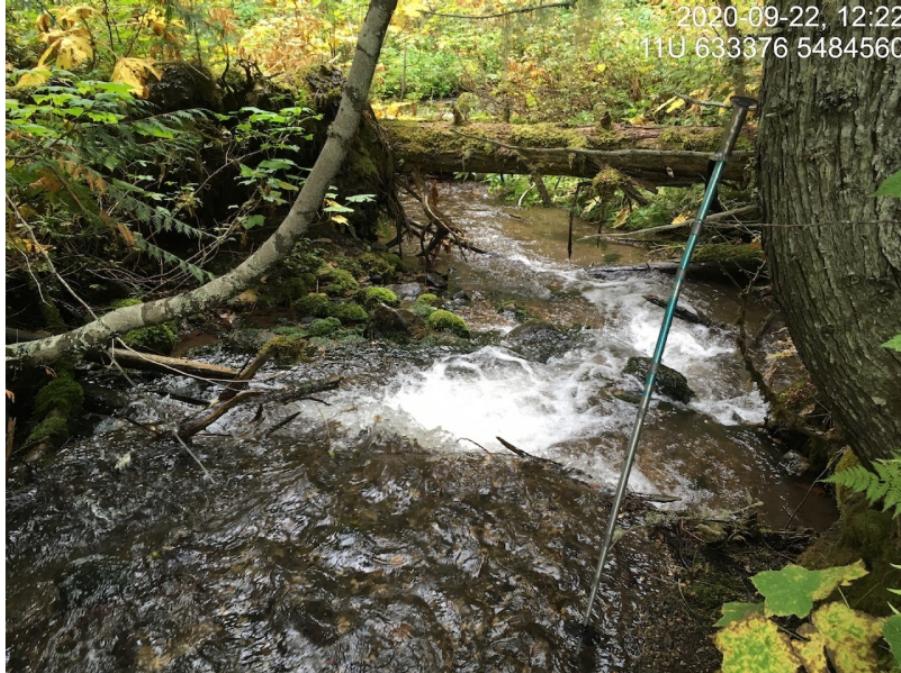
Figure 5.6: Typical habitat downstream of PSCIS crossing 50159.

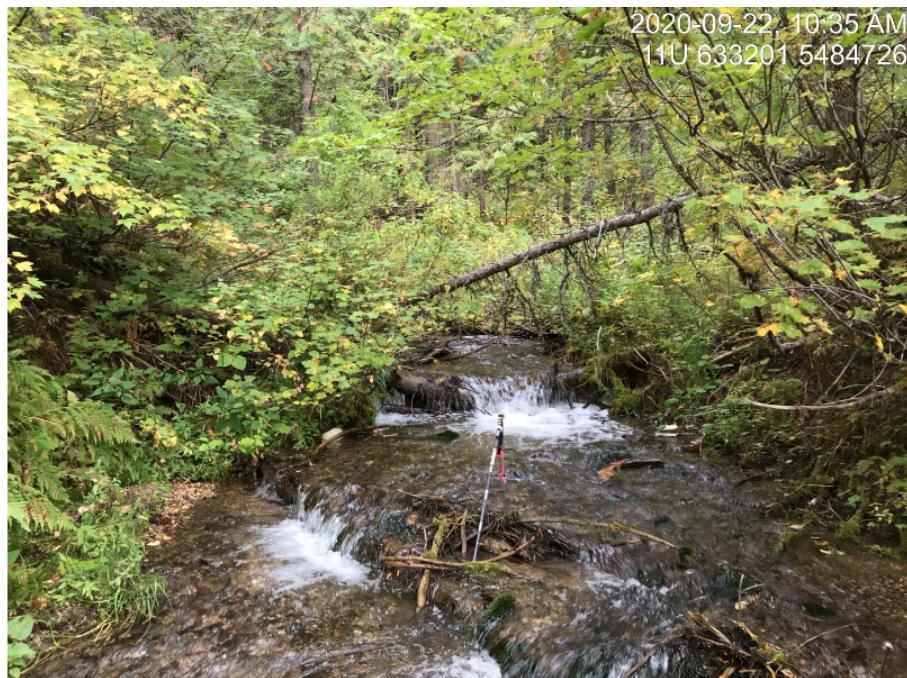
Figure 5.7: Typical habitat upstream of PSCIS crossing 50159.

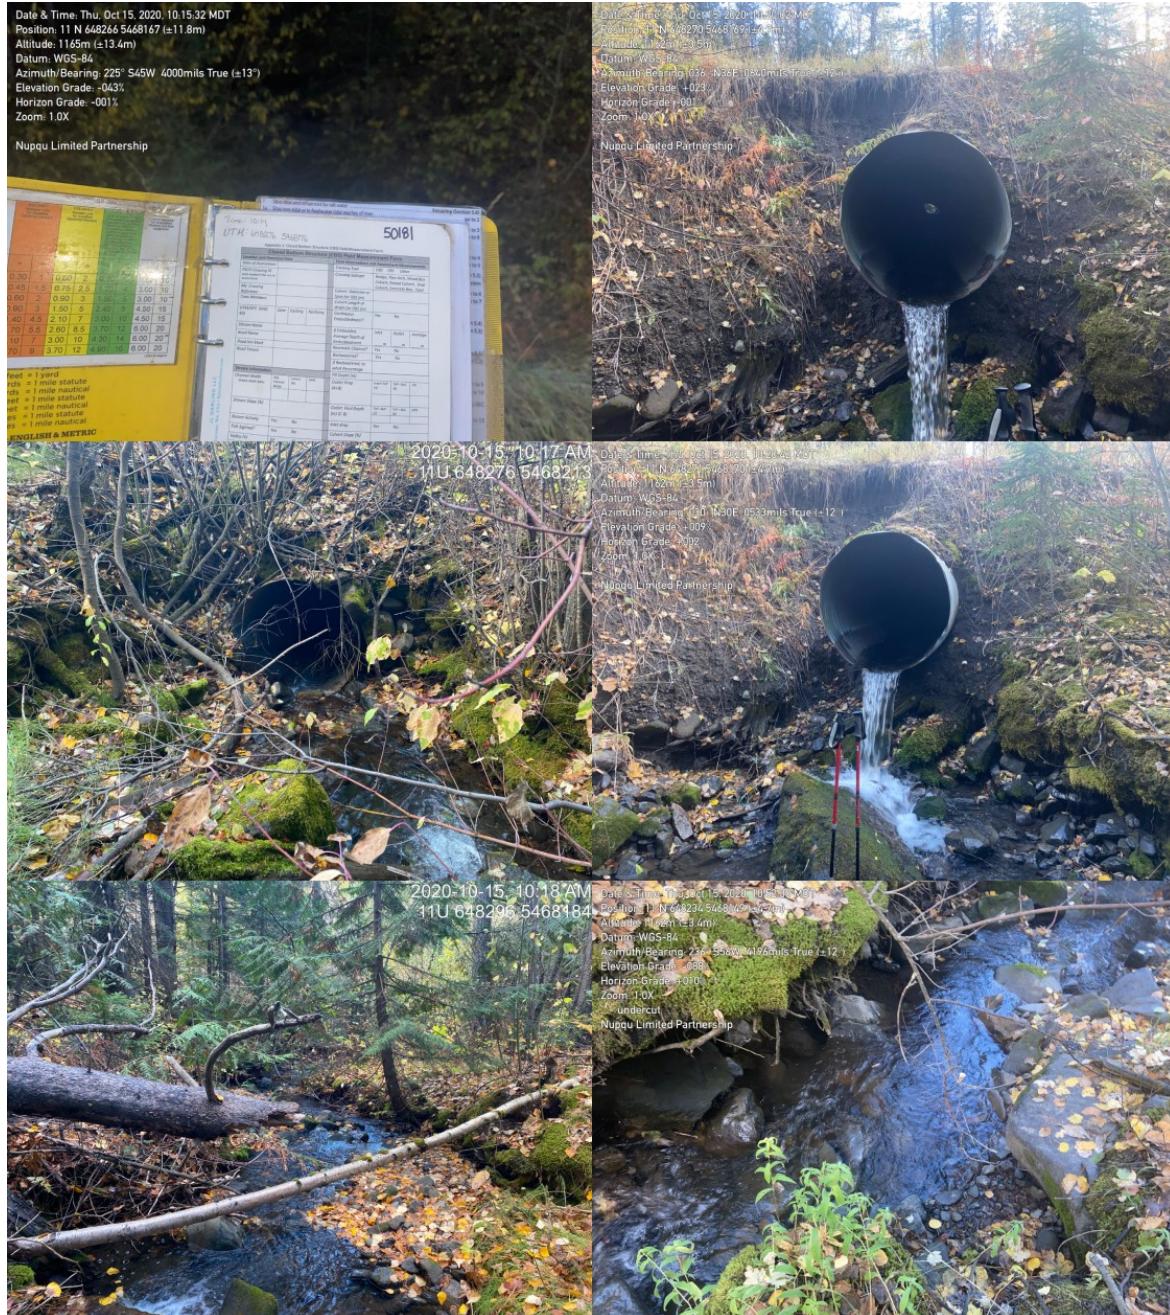
Location and Stream Data	.	Crossing Characteristics –	
Date	2020-10-15	Crossing Sub Type	Round Culvert
PSCIS ID	50181	Diameter (m)	1.2
External ID	NA	Length (m)	30
Crew	MF, AI	Embedded	No
UTM Zone	11	Depth Embedded (m)	NA
Easting	648276	Resemble Channel	No
Northing	5468176	Backwatered	No
Stream	Tributary to Morrissey Creek	Percent Backwatered	NA
Road	Lodgepole FSR	Fill Depth (m)	3
Road Tenure	NA	Outlet Drop (m)	0.95
Channel Width (m)	2.6	Outlet Pool Depth (m)	0.18
Stream Slope (%)	7	Inlet Drop	No
Beaver Activity	No	Slope (%)	7
Habitat Value	Medium	Valley Fill	Deep Fill
Photos: From top left clockwise: Road/Site Card, Barrel, Outlet, Downstream, Upstream, Inlet.

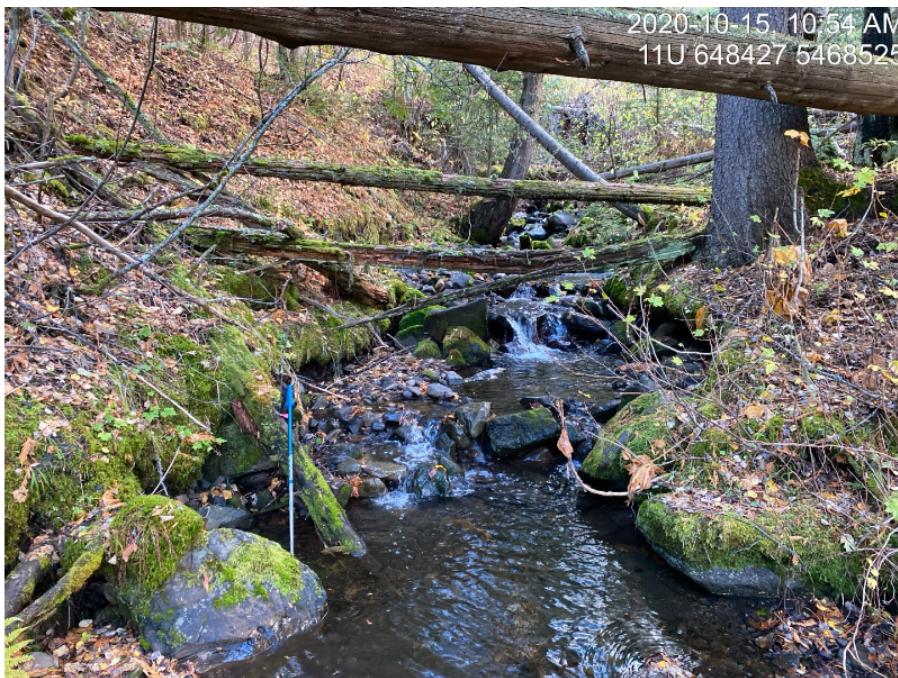
Figure 5.10: Typical habitat upstream of PSCIS crossing 50181.

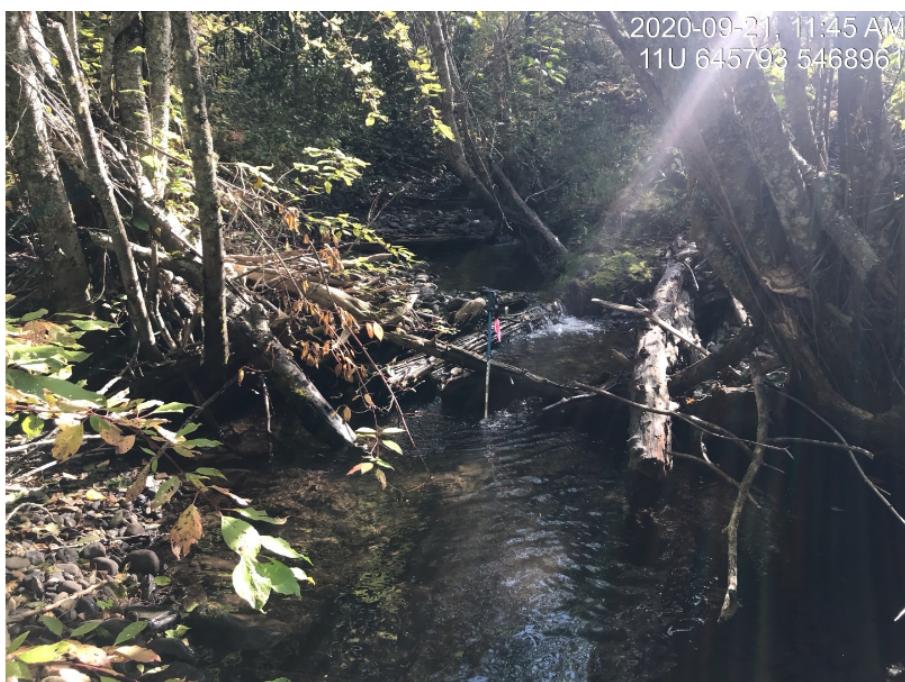
Figure 5.14: Typical habitat upstream of PSCIS crossing 50185.

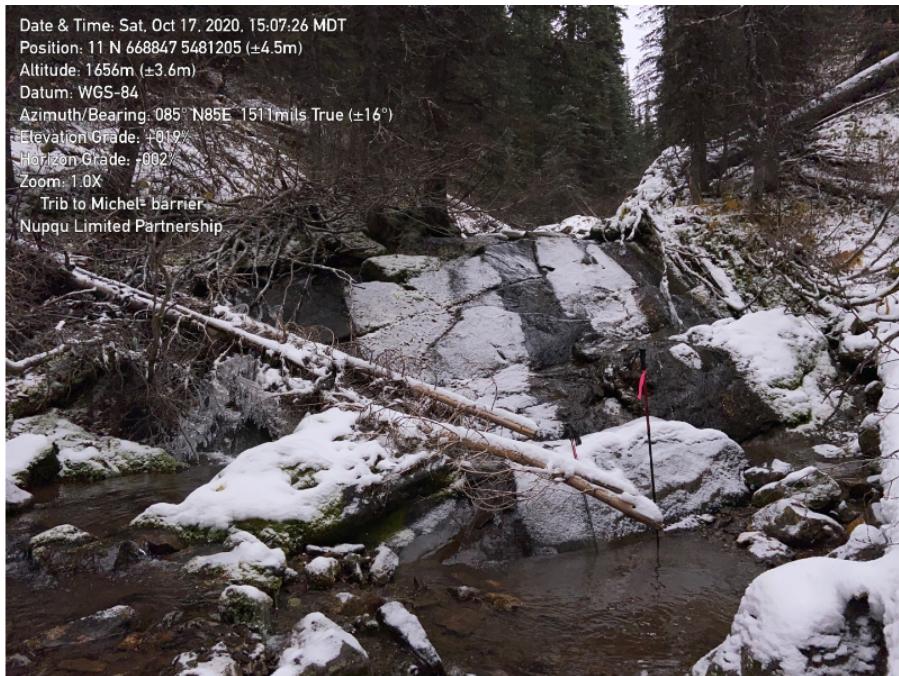
Figure 5.17: Chute barrier located 200 downstream of PSCIS crossing 50261.

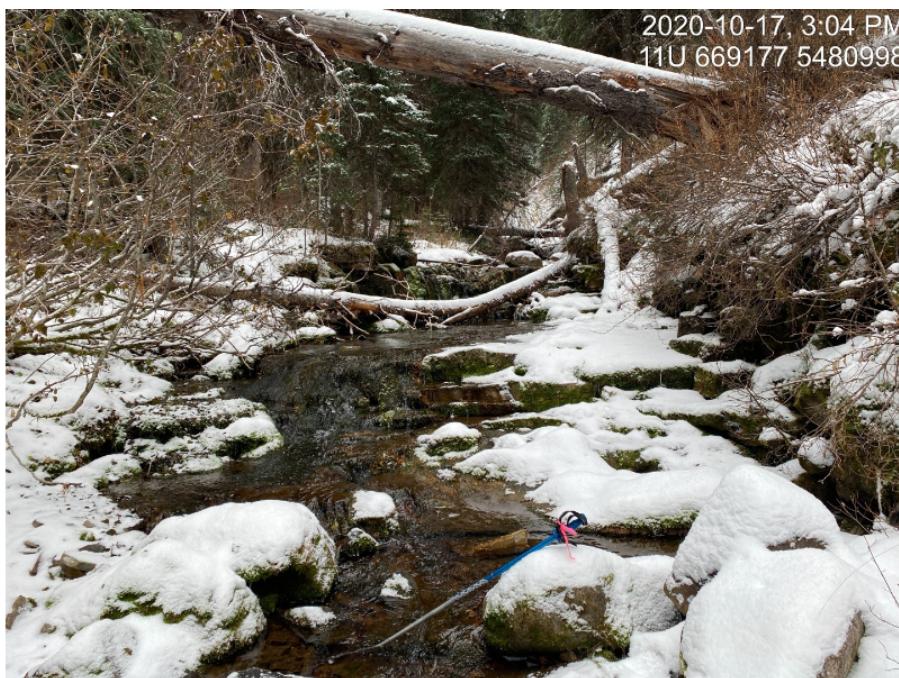
Figure 5.18: Habitat upstream of PSCIS crossing 50261.

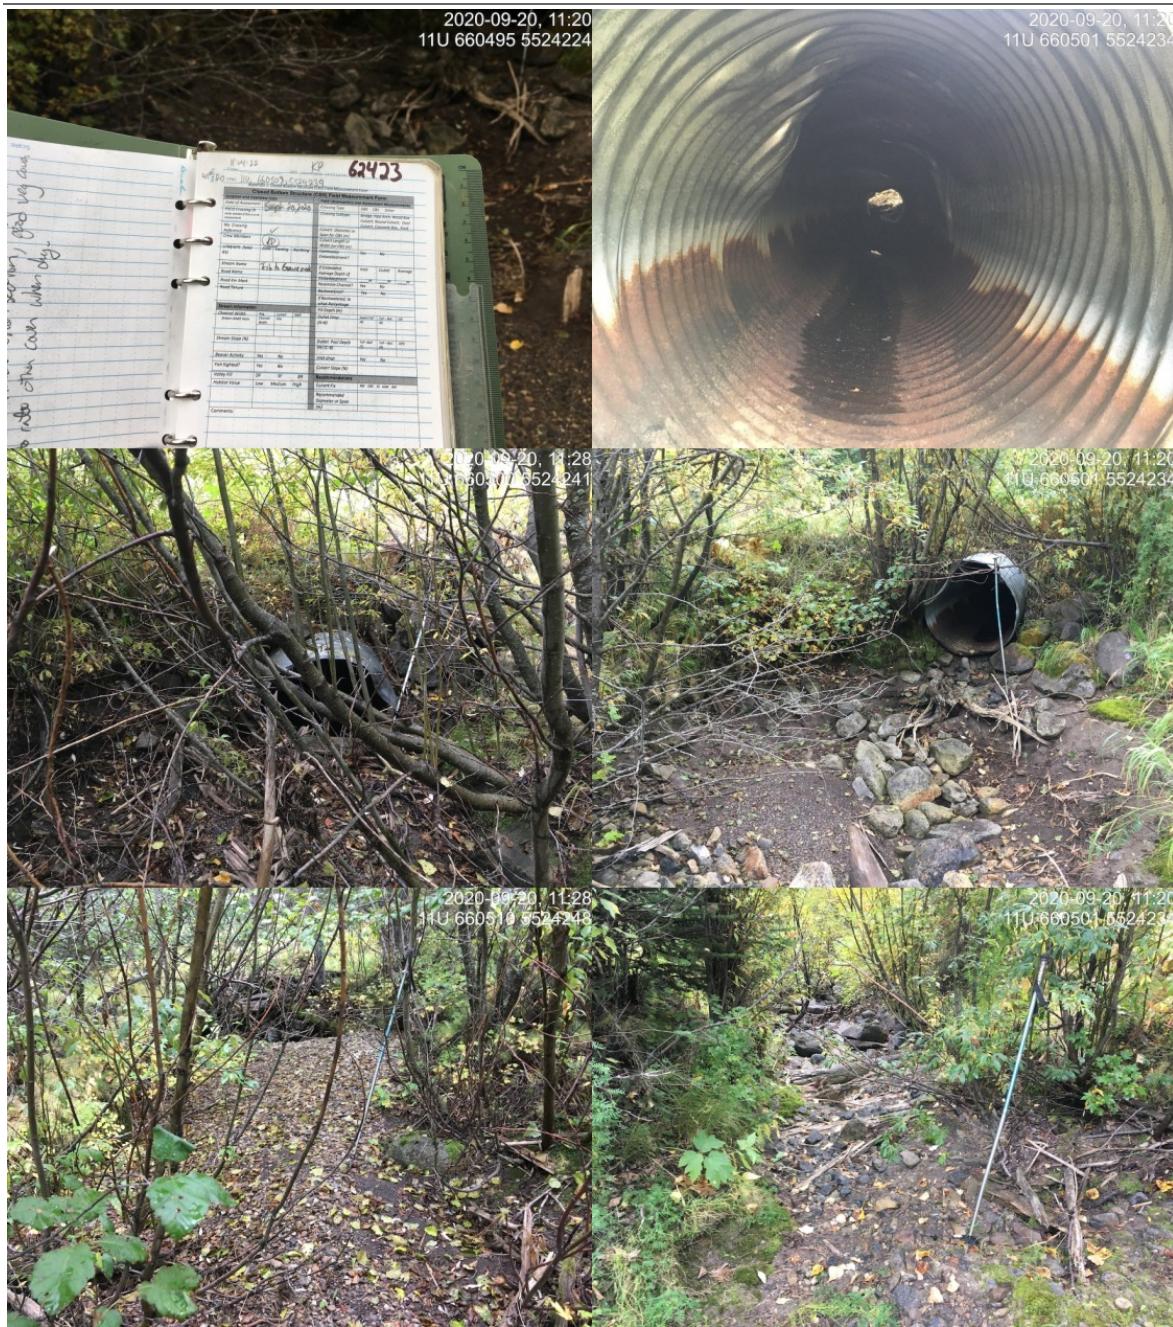
Location and Stream Data		.	Crossing Characteristics	-
Date	2020-09-20	Crossing Sub Type	Round Culvert	
PSCIS ID	62423	Diameter (m)	0.9	
External ID	NA	Length (m)	12	
Crew	KP, AI	Embedded	No	
UTM Zone	11	Depth Embedded (m)	NA	
Easting	660508	Resemble Channel	No	
Northing	5524239	Backwatered	No	
Stream	Harriet Lake Creek	Percent Backwatered	NA	
Road	Grave Creek FSR	Fill Depth (m)	0.3	
Road Tenure	Unknown	Outlet Drop (m)	0.18	
Channel Width (m)	1.44	Outlet Pool Depth (m)	0.6	
Stream Slope (%)	4	Inlet Drop	Yes	
Beaver Activity	No	Slope (%)	0.5	
Habitat Value	Low	Valley Fill	Deep Fill	
Photos: From top left clockwise: Road/Site Card, Barrel, Outlet, Downstream, Upstream, Inlet.

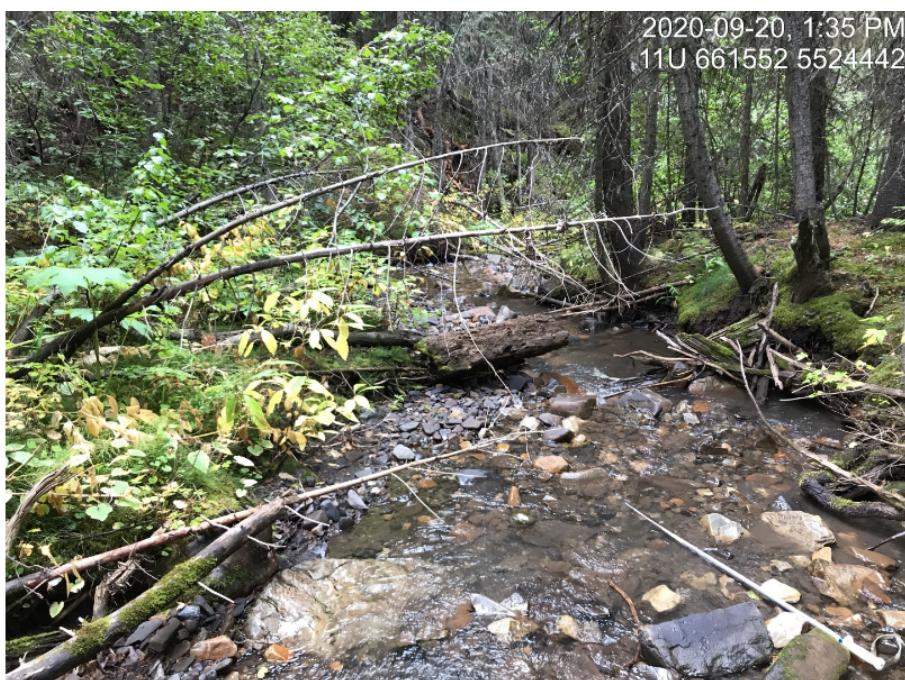
Figure 5.22: Typical habitat upstream of PSCIS crossing 62425 and downstream of PSCIS crossing 62426.

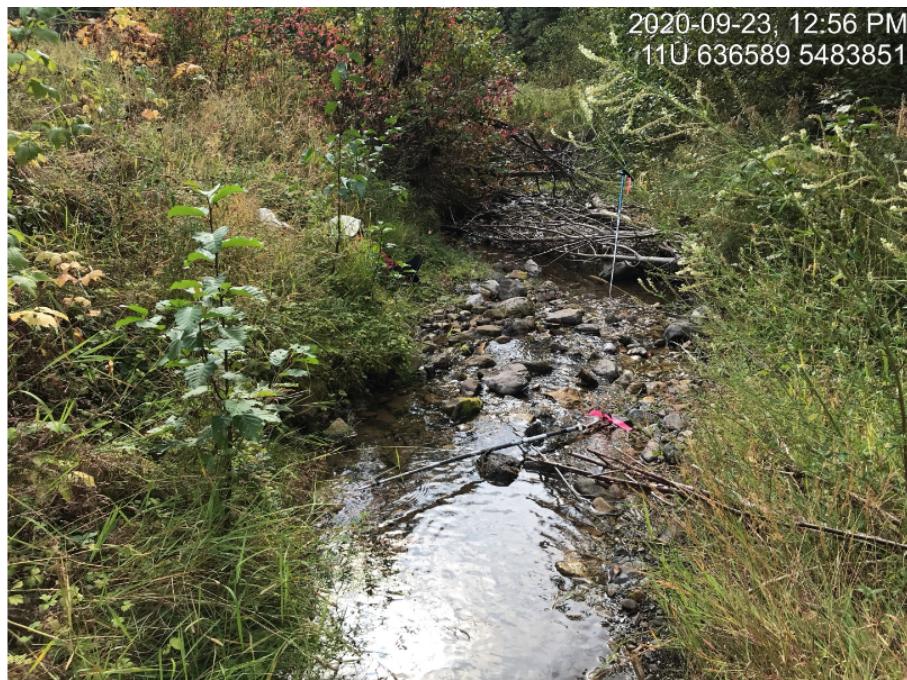
Figure 5.24: Typical habitat downstream of PSCIS crossing 62516.

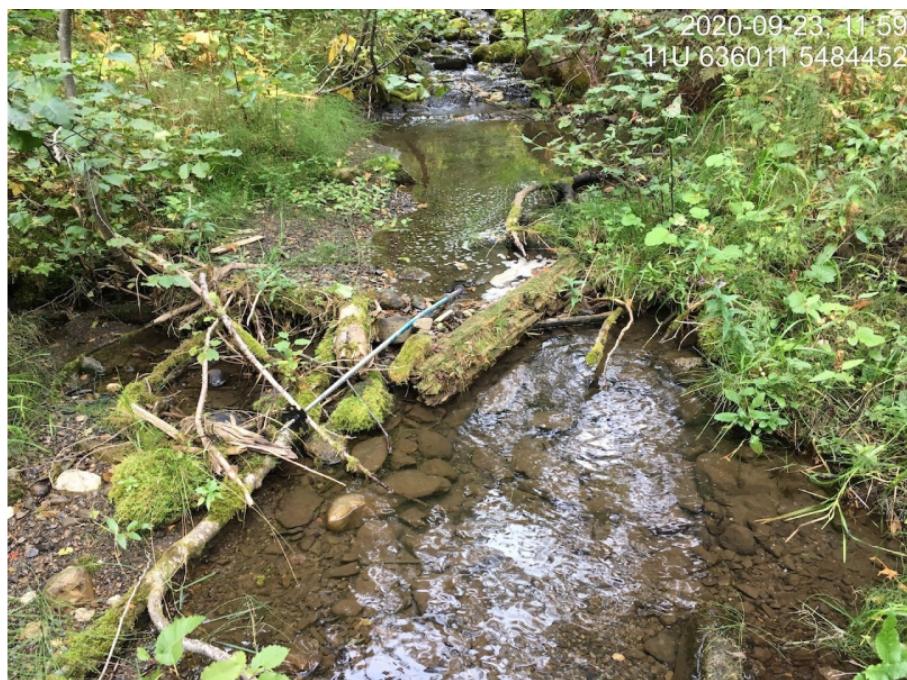
Figure 5.25: Typical habitat upstream of PSCIS crossing 62516.

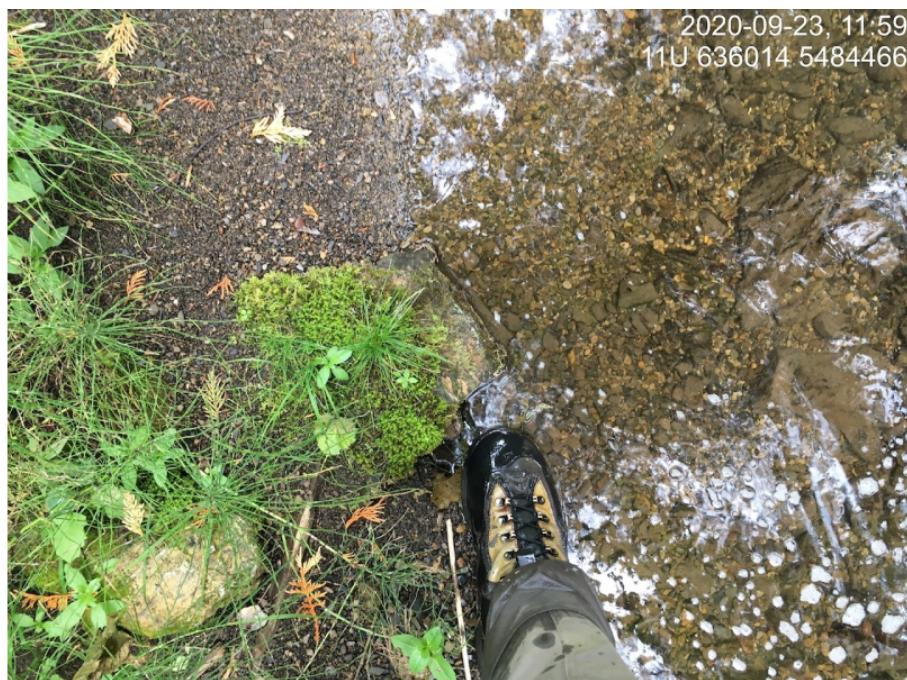
Figure 5.26: Gravels suitable for spawning upstream of PSCIS crossing 62516.

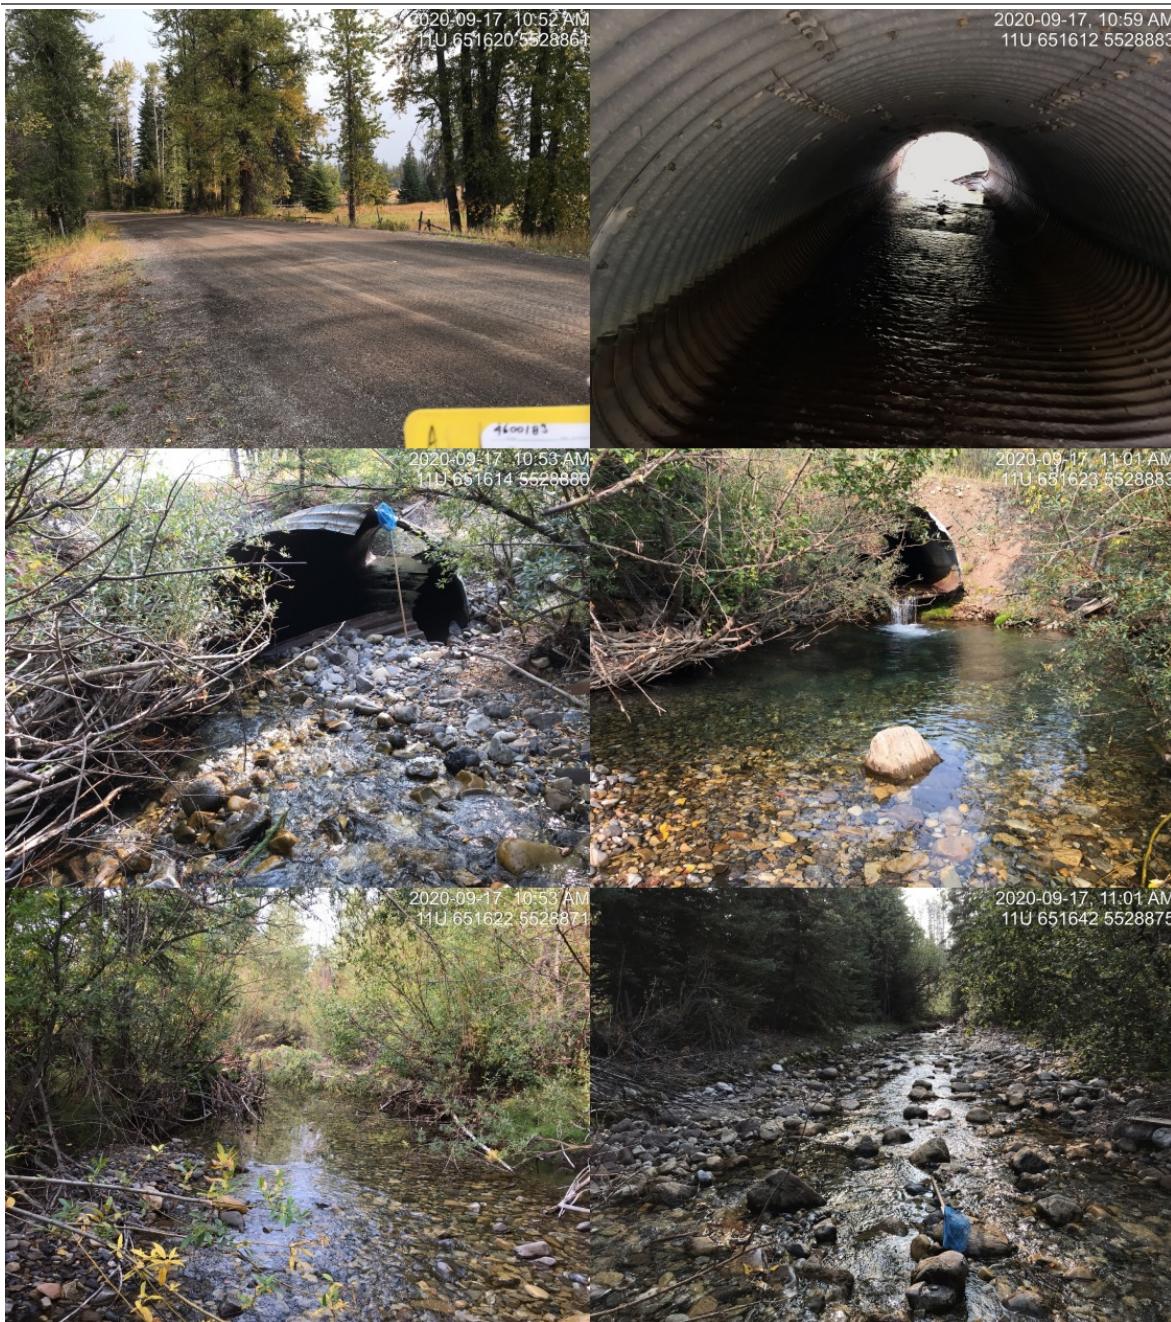
Table 5.27: Summary of fish passage reassessment for PSCIS crossing 197559.

Location and Stream Data	.	Crossing Characteristics –	
Date	2020-09-17	Crossing Sub Type	Round Culvert
PSCIS ID	197559	Diameter (m)	2.5

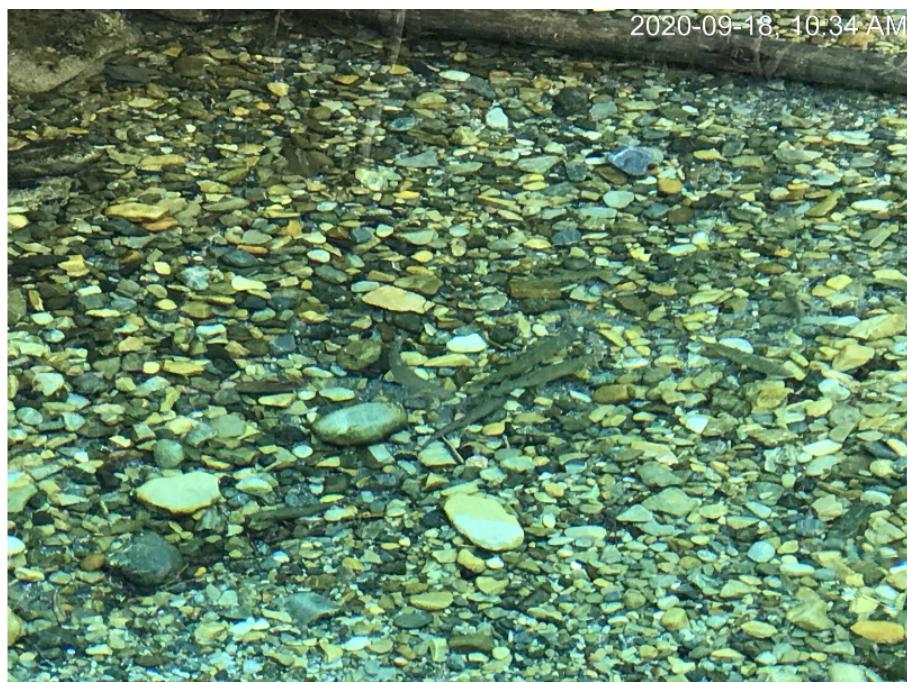
Figure 5.29: Westslope cutthroat trout in outlet pool downstream of PSCIS crossing 197559.

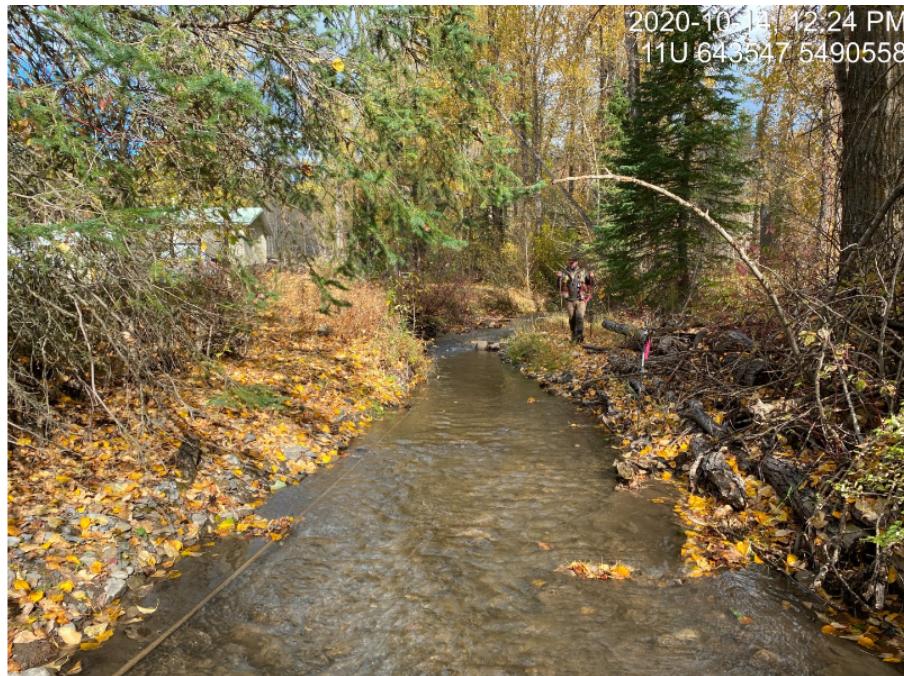
Figure 5.35: Typical habitat downstream of PSCIS crossing 197542.
