Upper Elk River and Flathead River Fish Passage Restoration Planning

**Prepared for
Canadian Wildlife Federation
350 Michael Cowpland Dr
Kanata, ON K2M 2W1**

**Prepared by
Al Irvine, B.Sc., R.P.Bio.
New Graph Environment
6 Regent St
Nelson, BC V1L 2P1**

Version 1.5

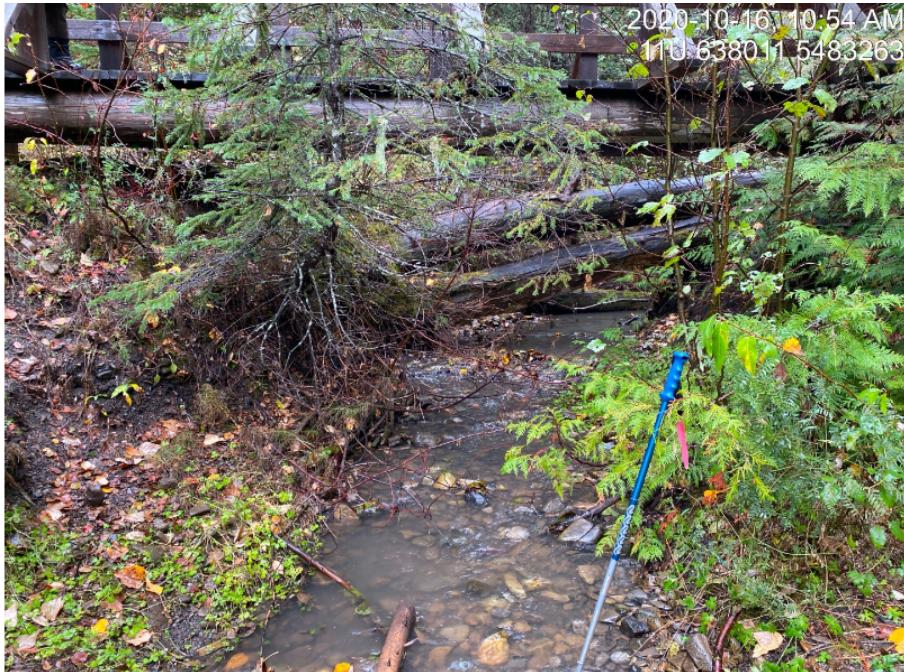
The stream was surveyed downstream from the culvert for 140m to Lizard Creek. Overall, total cover amount was rated as moderate with undercut banks dominant. Cover was also present as small woody debris, large woody debris, and overhanging vegetation (Table [5.2](#), Figure [5.1](#)). The average channel width was 2.7m, the average wetted width was 2.1m and the average gradient was 4%. The dominant substrate was cobbles with gravels subdominant. Downstream of the crossing, numerous fry were observed, there were frequent sections of gravels suitable for salmonid spawning and there were no barriers or obstacles to fish passage. Habitat was rated as high value for fry/juvenile salmonid rearing.

Figure 5.1: Typical habitat downstream of PSCIS crossing 50152.

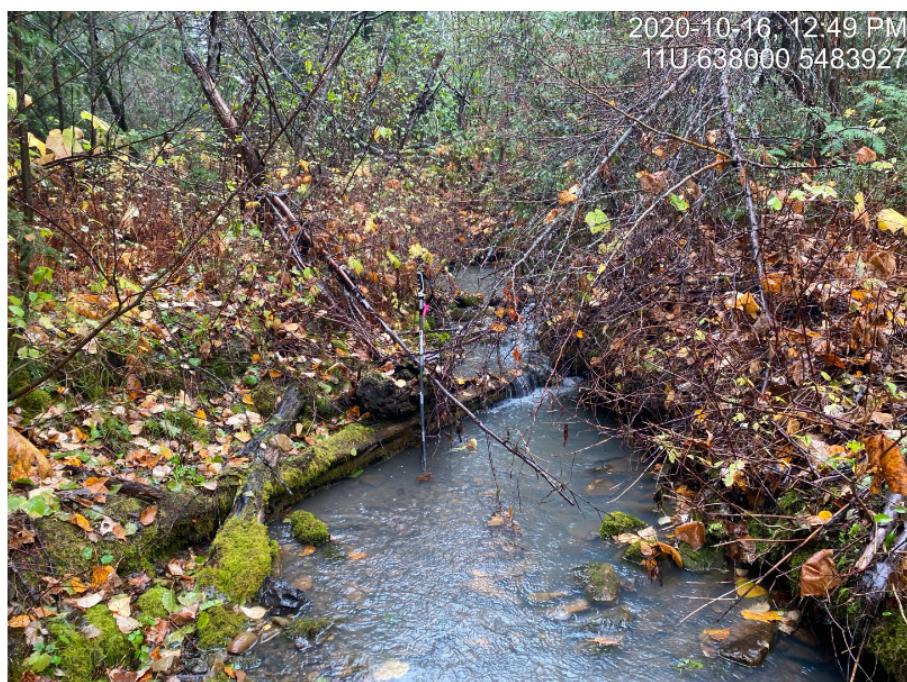
The stream was surveyed upstream from the culvert for 675m. Overall, total cover amount was rated as moderate with undercut banks dominant. Cover was also present as small woody debris, large woody debris, deep pools, and overhanging vegetation (Table [5.2](#), Figure [5.2](#)). The average channel width was 2.6m, the average wetted width was 2m and the average gradient was 3%. There were numerous fry observed throughout the area surveyed and abundant gravels suitable for resident westslope cutthroat trout spawning were noted. Habitat value was rated as high for salmonid rearing and spawning.

Figure 5.2: Typical habitat upstream of PSCIS crossing 50152.

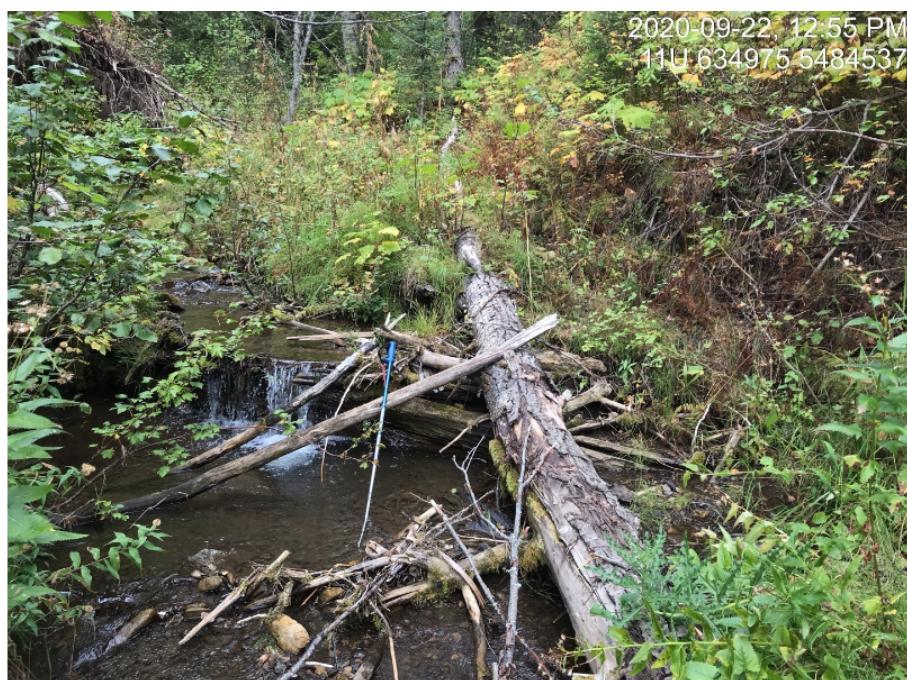
Figure 5.5: Typical habitat upstream of PSCIS crossing 50155.

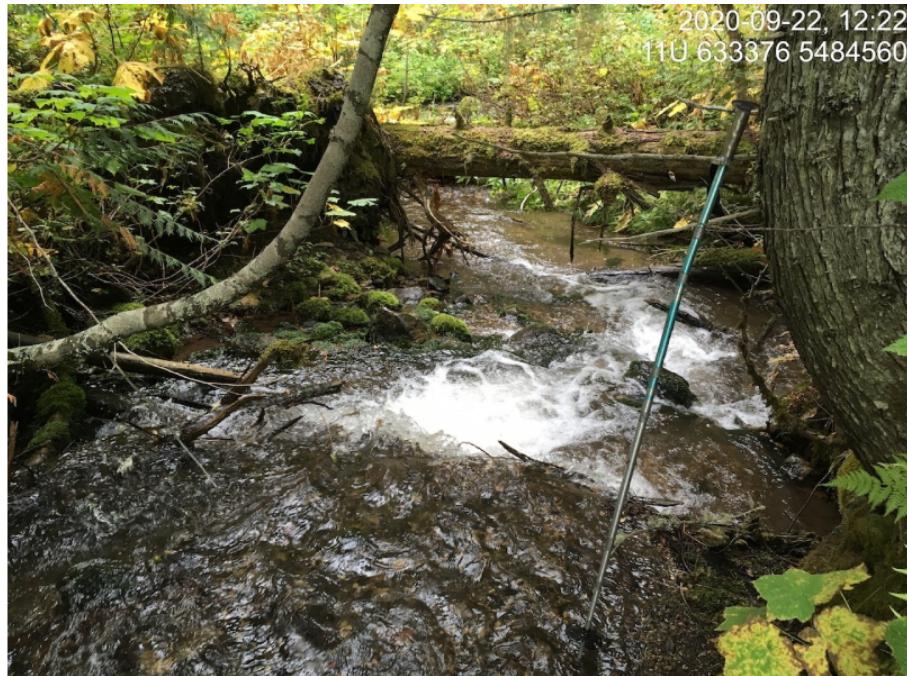
The stream was surveyed downstream from the culvert for 150m to Lizard Creek. Overall, total cover amount was rated as moderate with large woody debris dominant. Cover was also present as small woody debris, deep pools, and overhanging vegetation (Table 5.4, Figure 5.4). The average channel width was 2.5m, the average wetted width was 2.3m and the average gradient was 8.8%. The dominant substrate was gravels with cobbles subdominant. Some small pools and steps of 0.2 - 0.6m in height were present throughout the area surveyed. Large woody debris steps ranging from 0.4 - 0.8m high were spaced sporadically throughout area surveyed. Habitat value was rated as moderate for salmonid fry/juvenile rearing and high value habitat for spawning.

Figure 5.6: Typical habitat downstream of PSCIS crossing 50159.

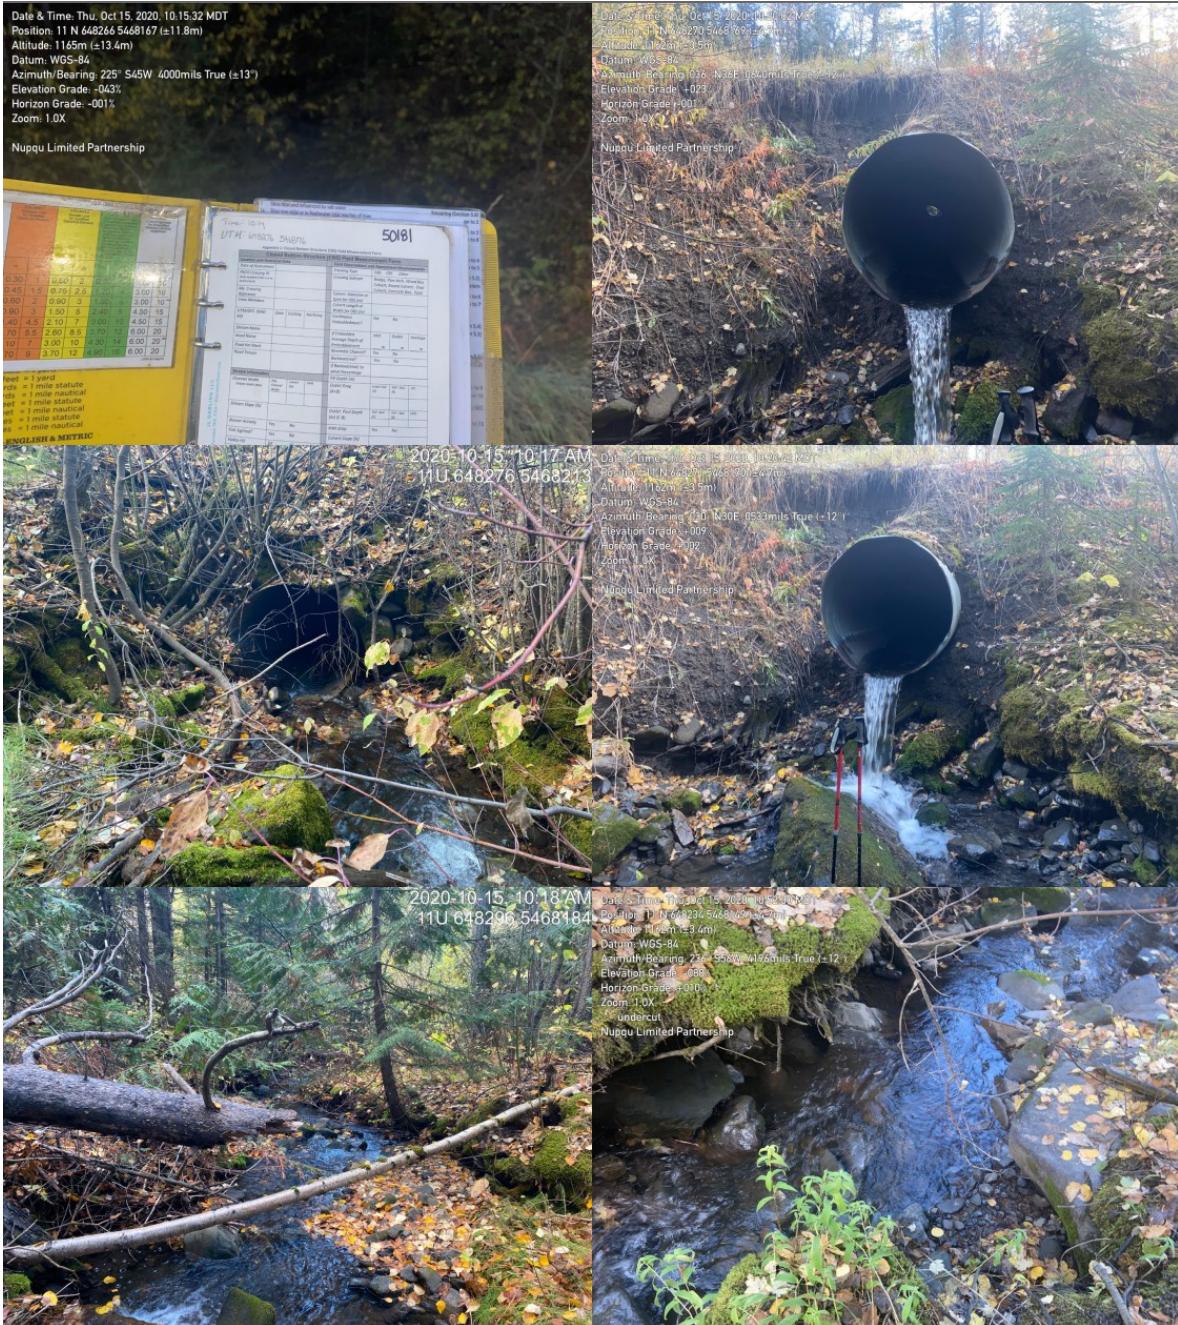
Photos: From top left clockwise: Road/Site Card, Barrel, Outlet, Downstream, Upstream, Inlet.

Structure replacement with a bridge is recommended to provide access to the habitat located upstream of PSCIS crossing 50181. The cost of the work is estimated at \$125,000 for a cost benefit of 4.1 linear m/\$1000 and 11.9m²/\$1000.

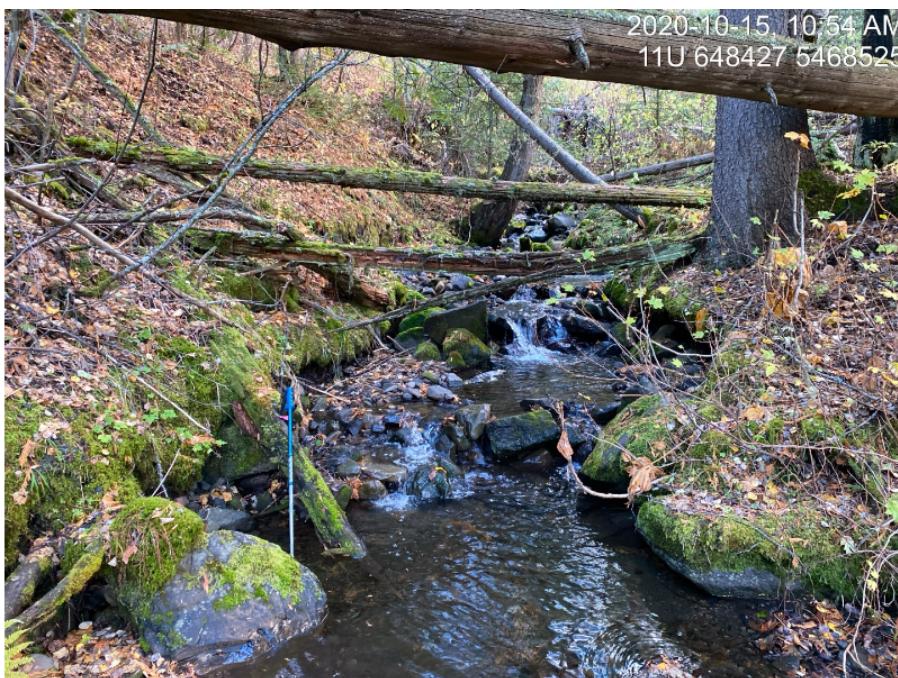
Figure 5.10: Typical habitat upstream of PSCIS crossing 50181.

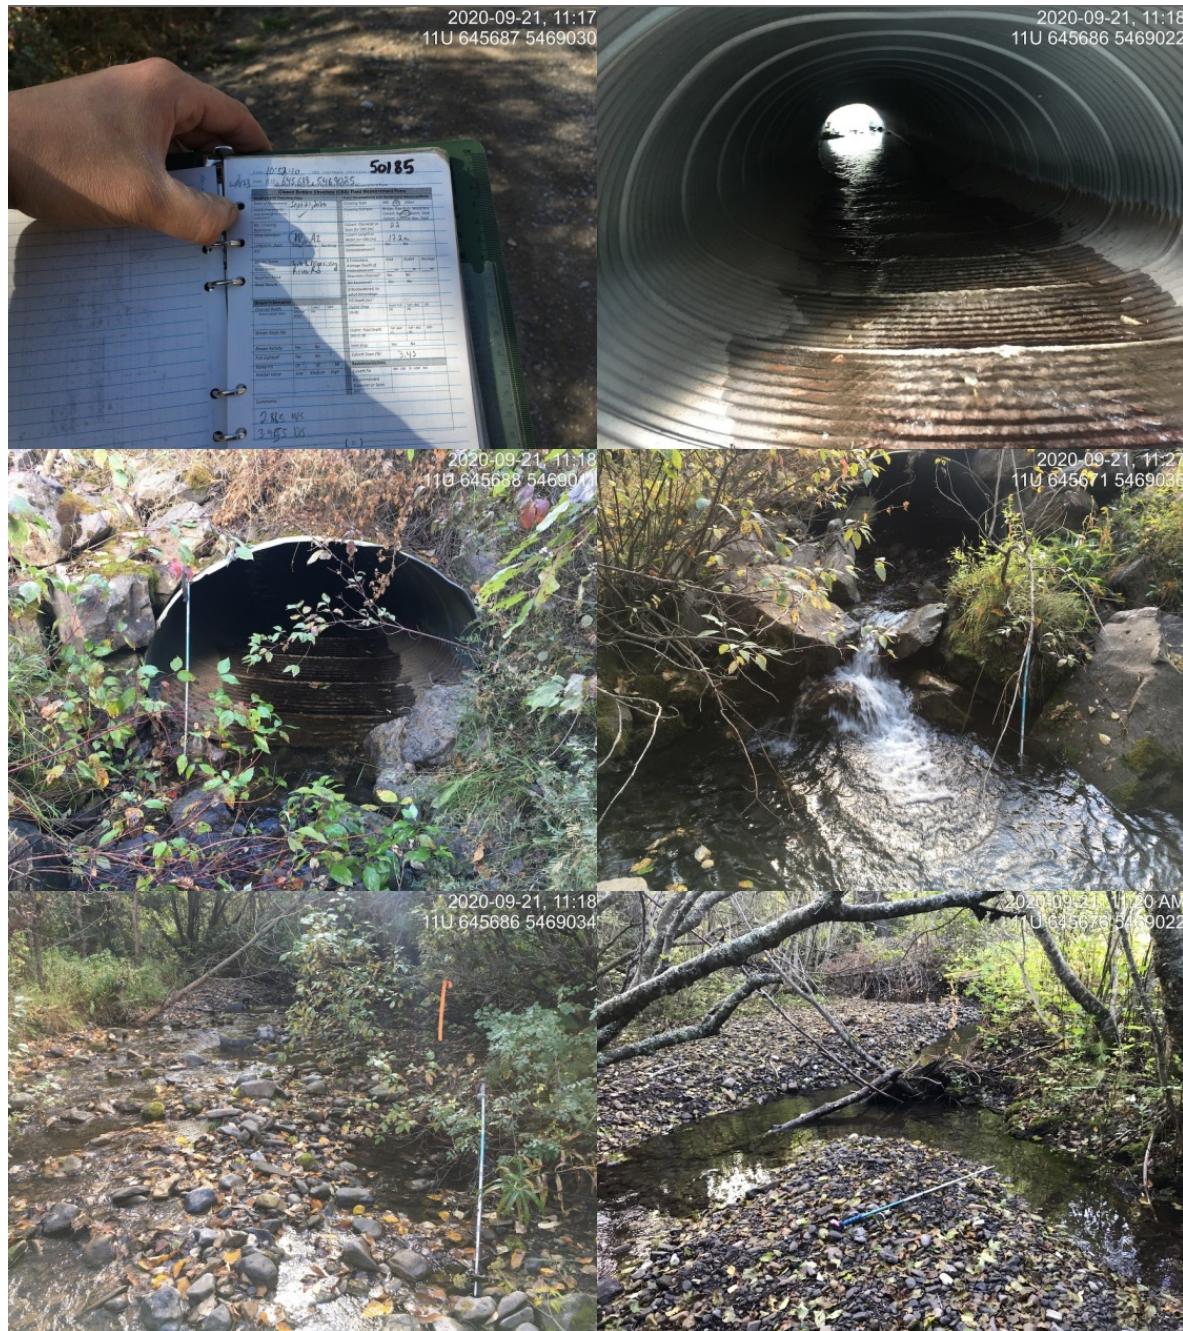
Photos: From top left clockwise: Road/Site Card, Barrel, Outlet, Downstream, Upstream, Inlet.

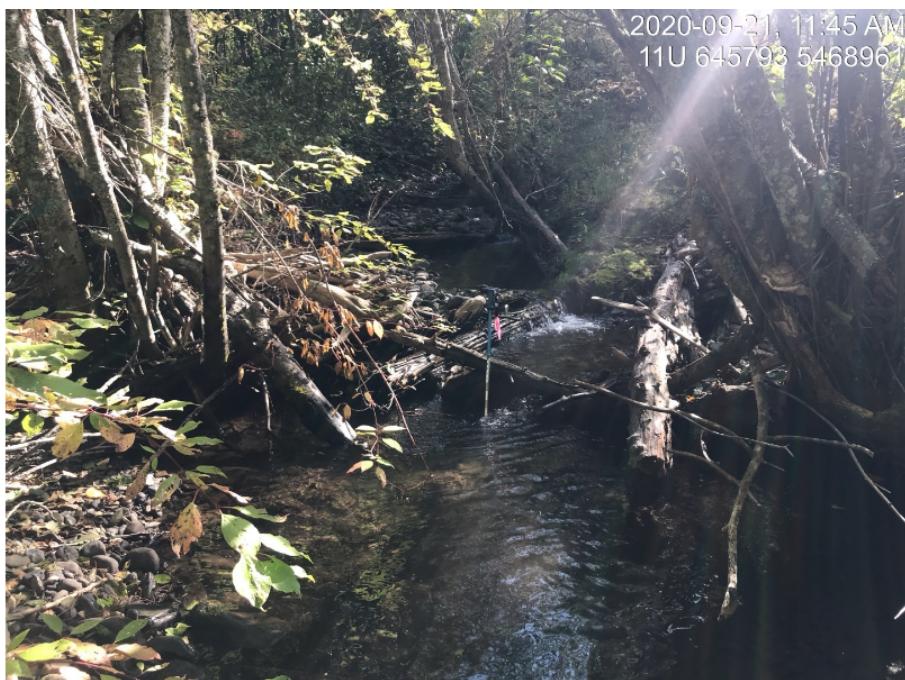
Figure 5.14: Typical habitat upstream of PSCIS crossing 50185.

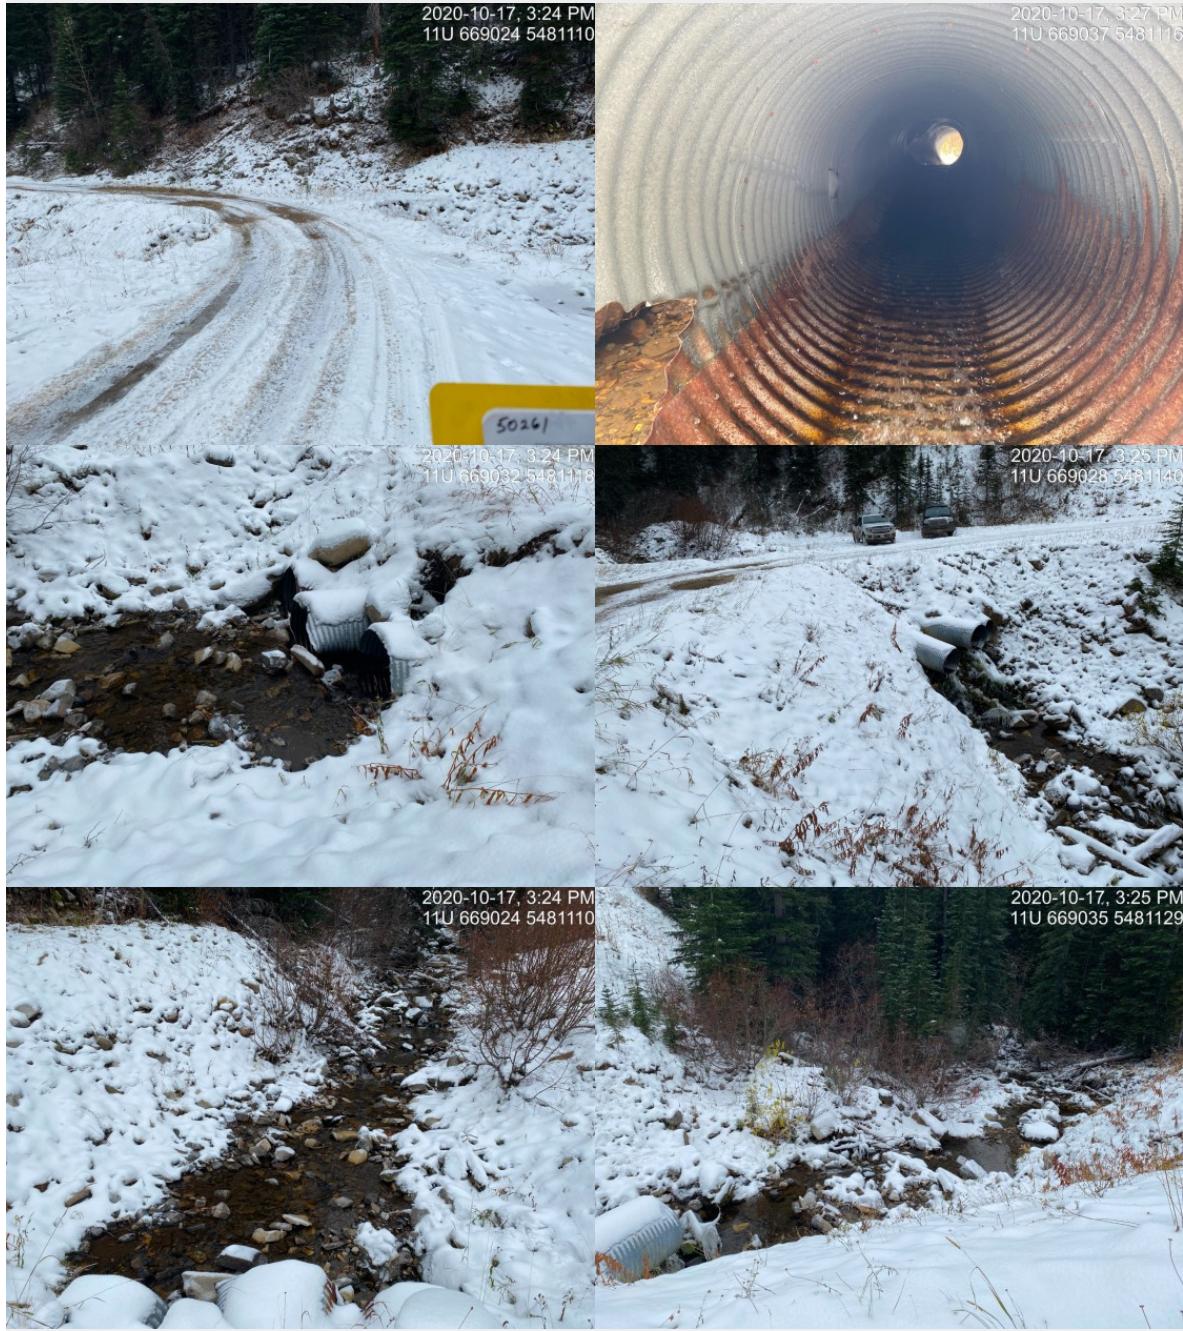
Photos: From top left clockwise: Road/Site Card, Barrel, Outlet, Downstream, Upstream, Inlet.

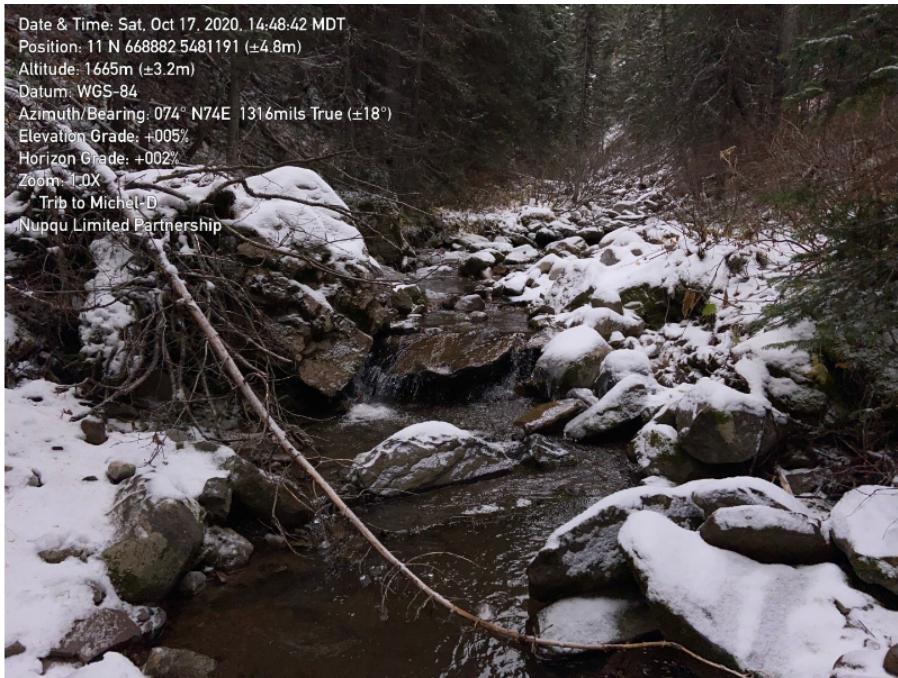
Figure 5.16: Habitat downstream of PSCIS crossing 50261.

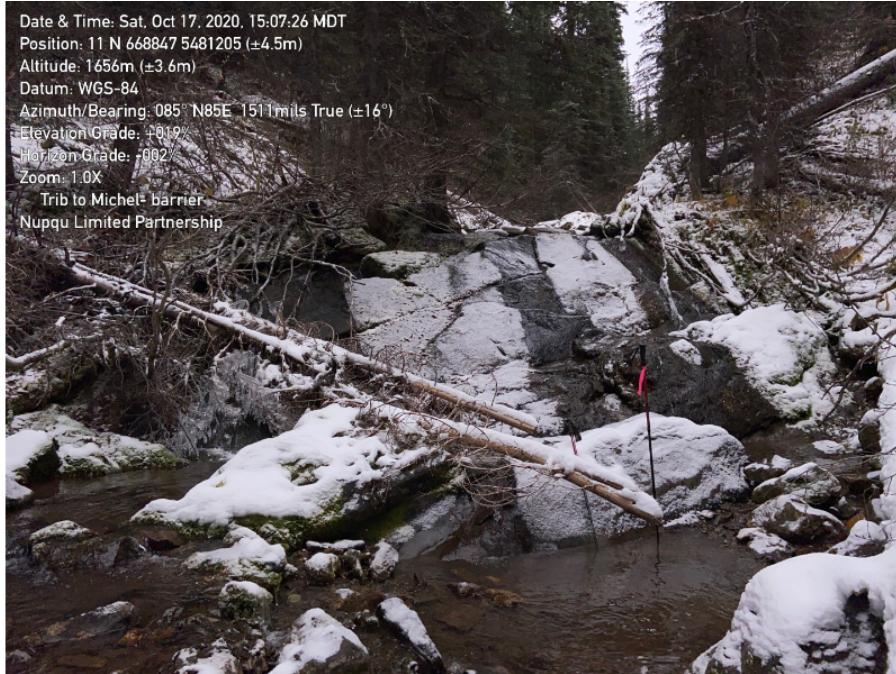
Figure 5.17: Chute barrier located 200 downstream of PSCIS crossing 50261.

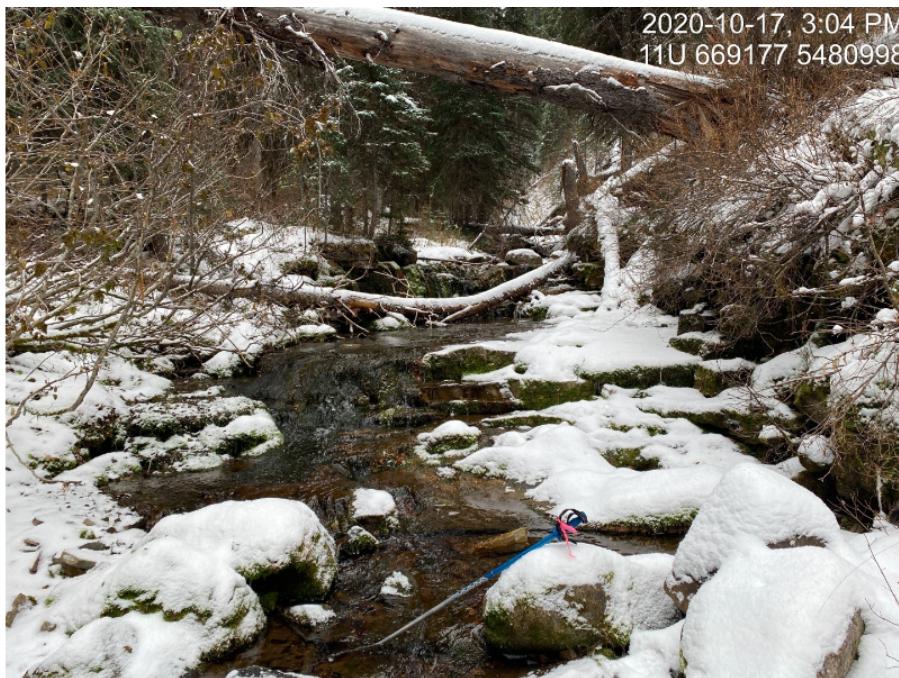
The stream was surveyed immediately upstream from the culvert for 210m. Overall, total cover amount was rated as moderate with deep pools dominant. Cover was also present as small woody debris, large woody debris, boulders, undercut banks, and overhanging vegetation (Table 5.18, Figure 5.18). The average channel width was 5.2m, the average wetted width was 3.6m and the average gradient was 12%. The dominant substrate was large rock/bedrock with boulders subdominant. Overall, habitat was rated as medium value. There were multiple natural barriers to upstream fish passage within the area surveyed that were considered too steep for upstream migration by any species.

Figure 5.18: Habitat upstream of PSCIS crossing 50261.

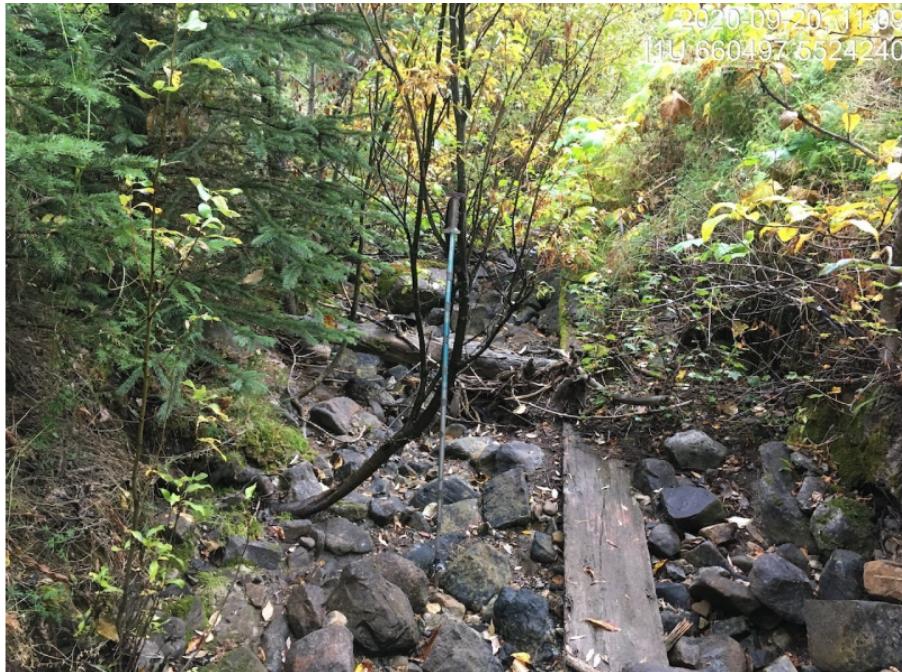
Figure 5.19: Typical habitat downstream of PSCIS crossing 62423.

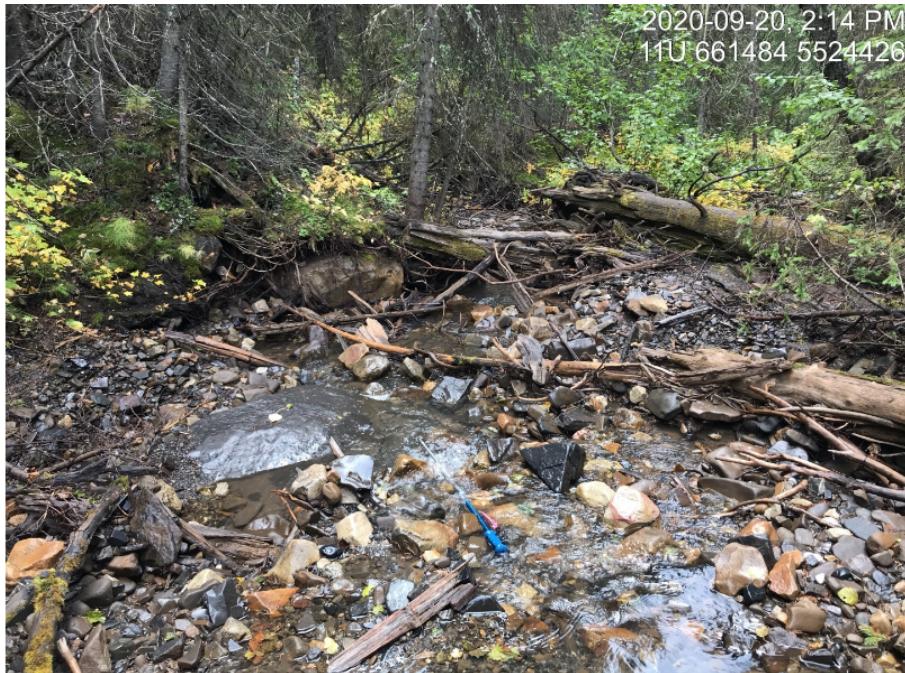
Figure 5.21: Typical habitat downstream of PSCIS crossing 62425.

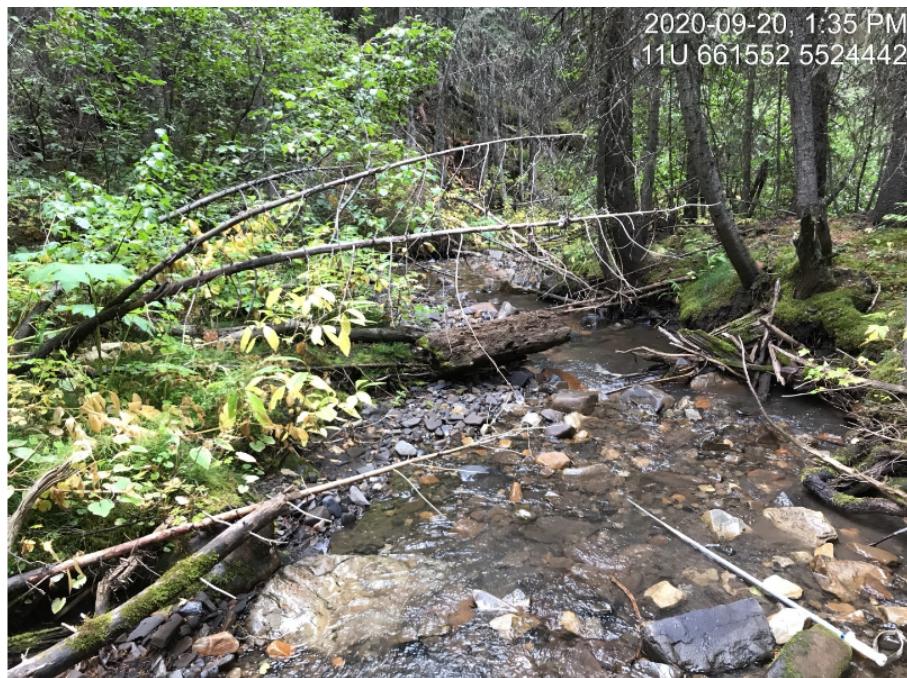
Figure 5.22: Typical habitat upstream of PSCIS crossing 62425 and downstream of PSCIS crossing 62426.

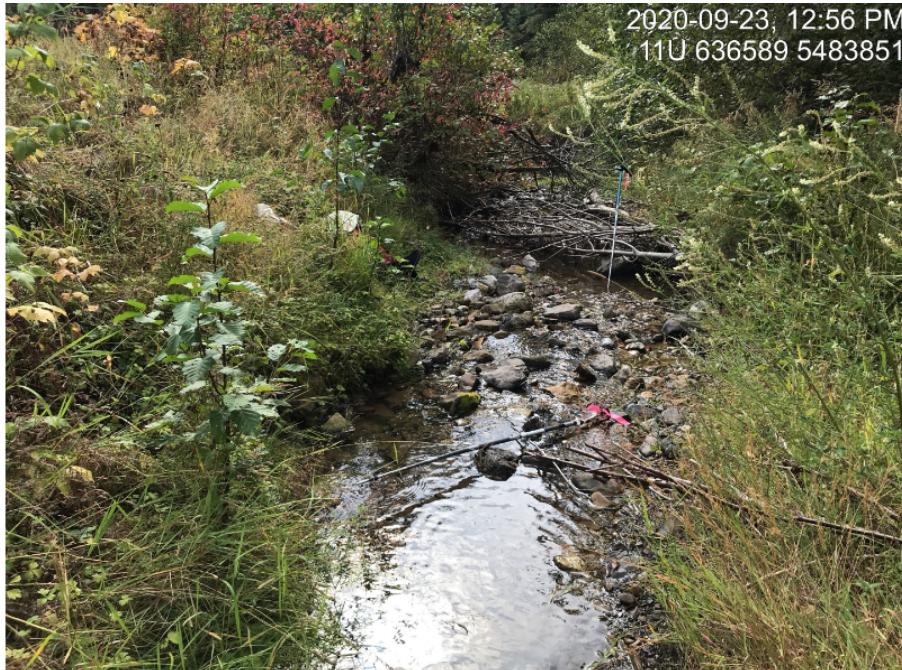
Figure 5.24: Typical habitat downstream of PSCIS crossing 62516.

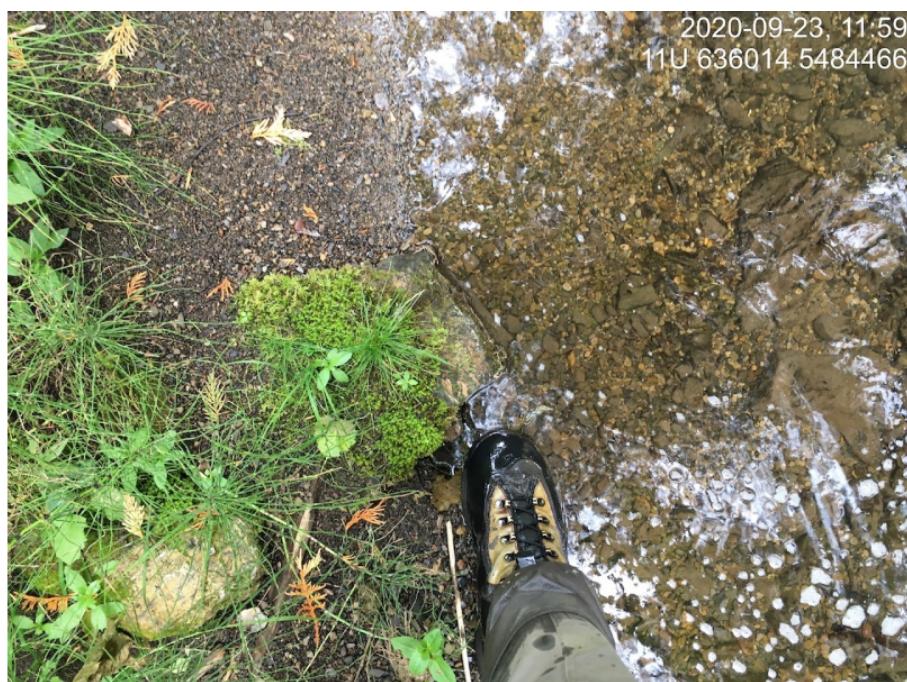
Figure 5.26: Gravels suitable for spawning upstream of PSCIS crossing 62516.

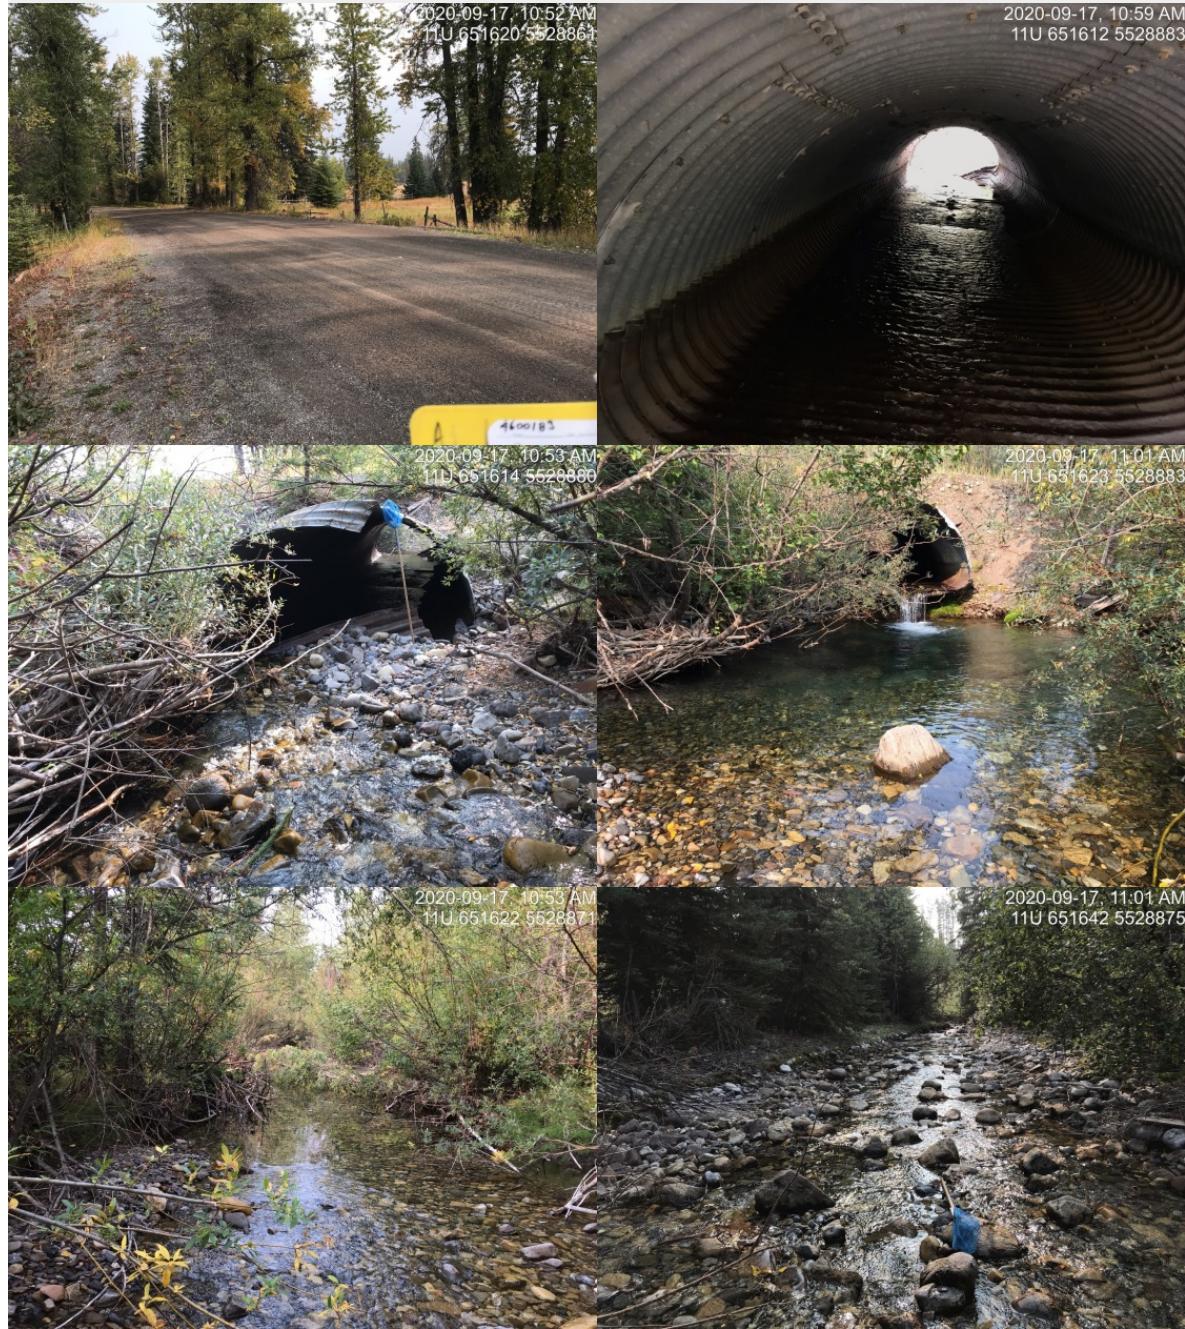
Photos: From top left clockwise: Road/Site Card, Barrel, Outlet, Downstream, Upstream, Inlet.

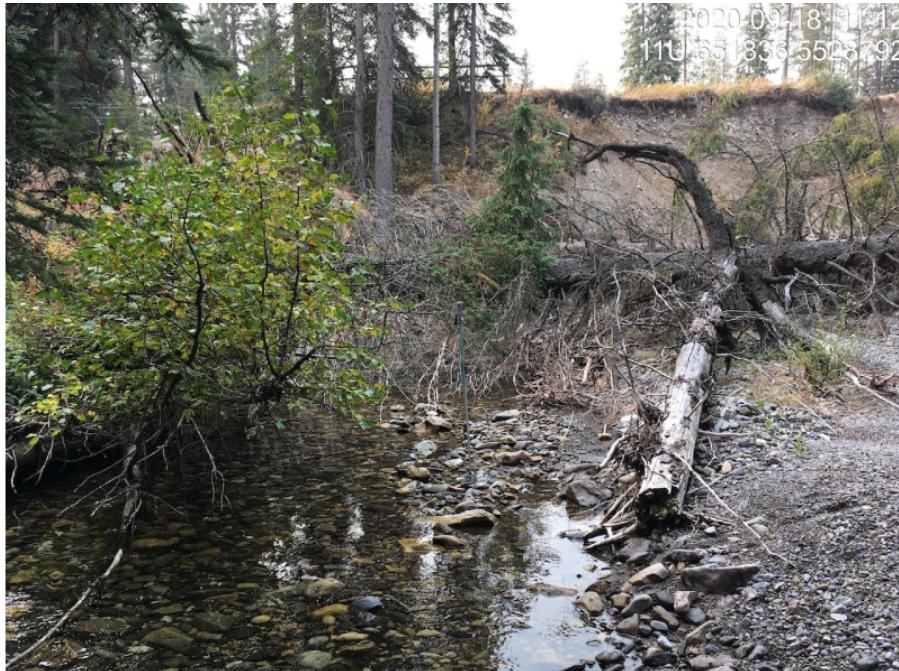
Figure 5.27: Typical habitat downstream of PSCIS crossing 197533.

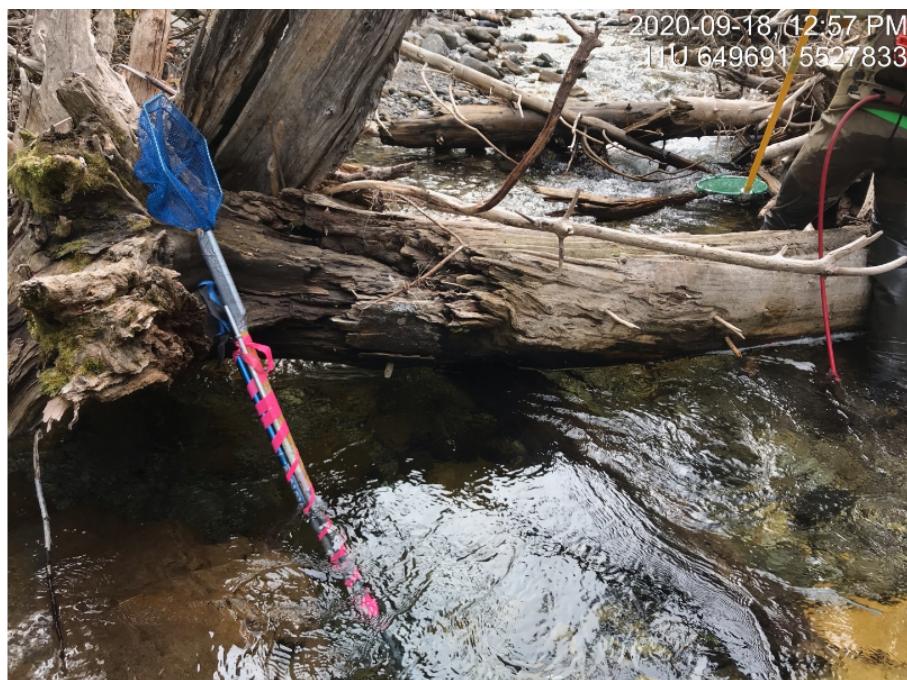
Figure 5.32: Habitat within electrofishing site upstream of PSCIS crossing 197533.

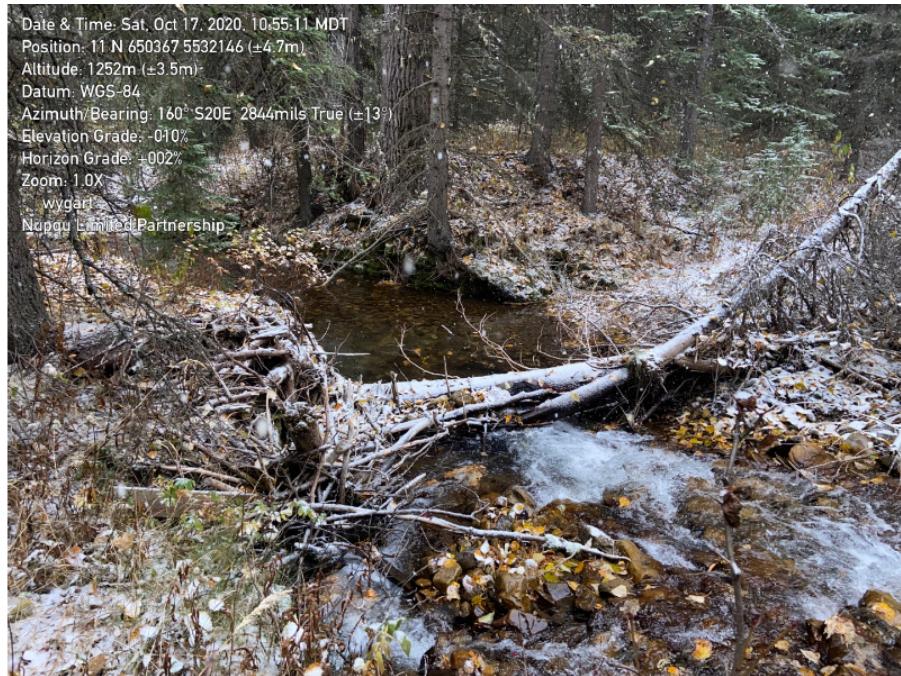
Figure 5.33: Habitat downstream of PSCIS crossing 197534.

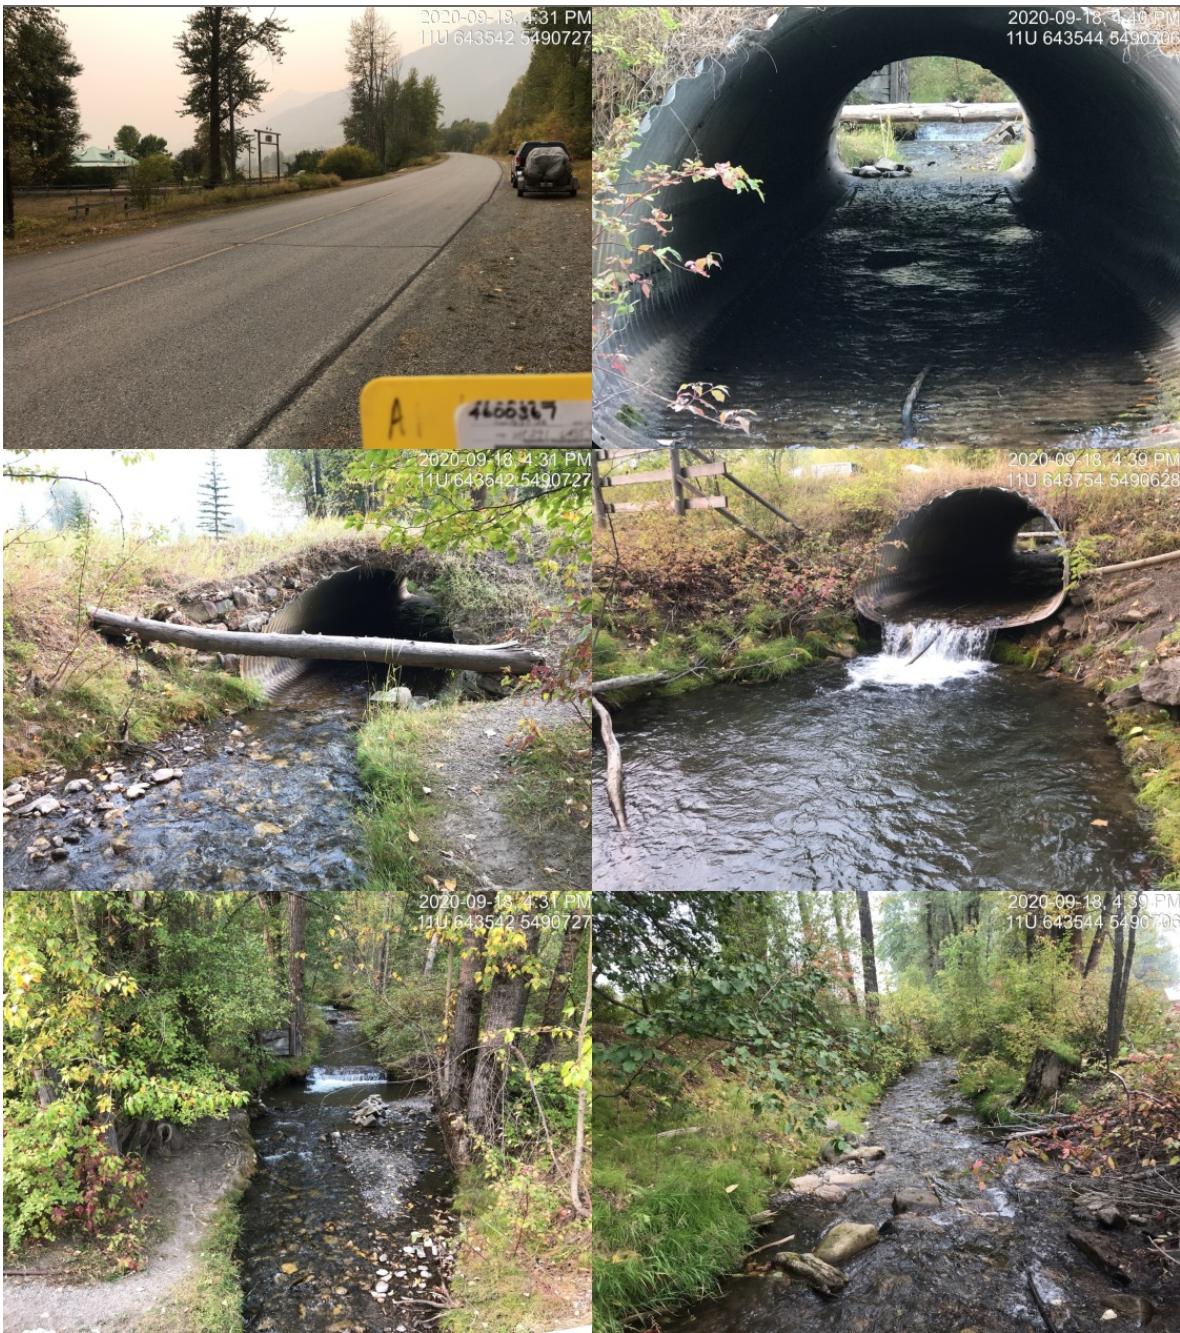
There is an estimated 7.2km of mainstem habitat available upstream of crossing 197542 with habitat in areas surveyed rated as high value, representing an important migration corridor with moderate rearing and spawning potential for resident and fluvial salmonids. Dicken Road is the responsibility of the Ministry of Transportation and Infrastructure. We recommend fish collection data from Lotic Environmental Ltd. (2012) be analyzed to calculate baseline fish densities upstream of the crossing in 2012. The crossing was ranked as a high priority for proceeding to design for replacement with an open bottomed structure. The private land adjacent to Hartley Creek in the vicinity of Dicken Road and Highway 3 may represent valuable opportunities for channel and riparian restoration activities as it is located within an area of intensive fish habitat impacts resulting from dredging to protect highway infrastructure as well as other historic land use activities (i.e. log transport and processing).

Photos: From top left clockwise: Road/Site Card, Barrel, Outlet, Downstream, Upstream, Inlet.

Structure replacement with an open bottomed structure is recommended to provide access to the habitat located upstream of PSCIS crossing 197542. The cost of the work is estimated at \$1,000,000 for a cost benefit of 7.2 linear m/\$1000 and $43.9\text{m}^2/\$1000$.

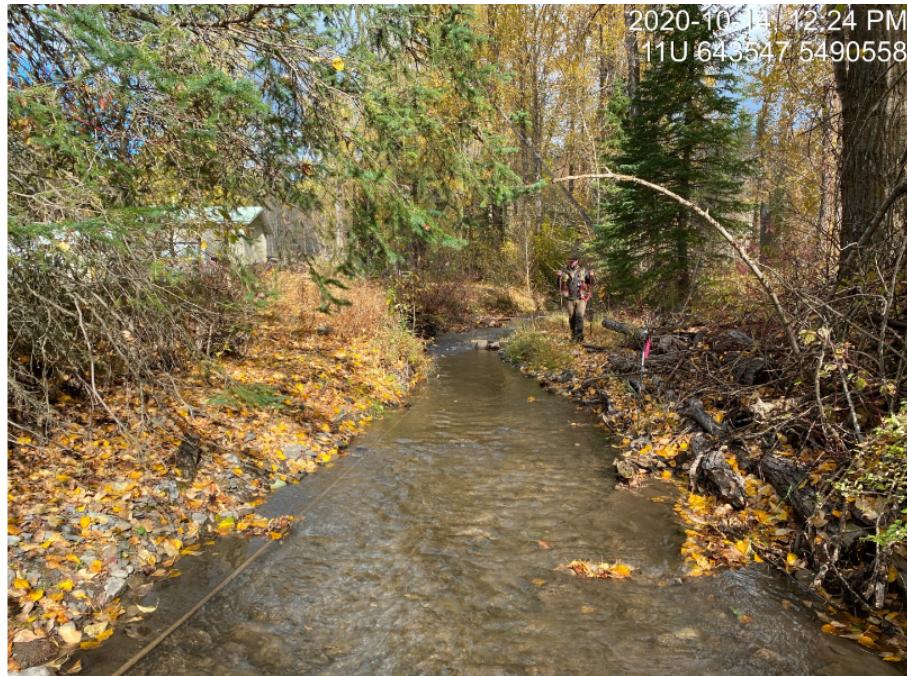
Figure 5.35: Typical habitat downstream of PSCIS crossing 197542.

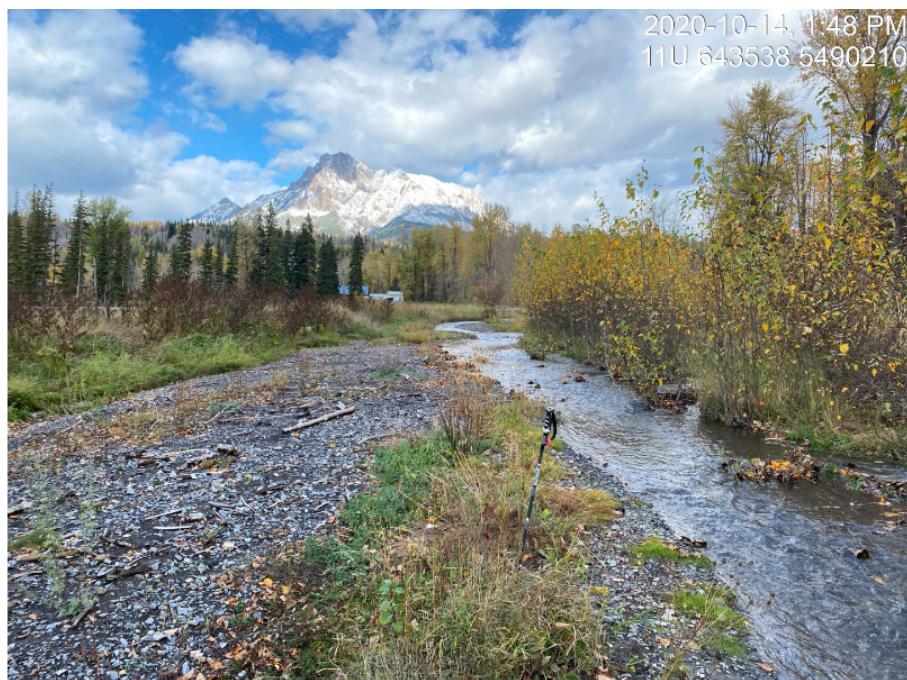
Figure 5.36: Typical habitat downstream of PSCIS crossing 197582.

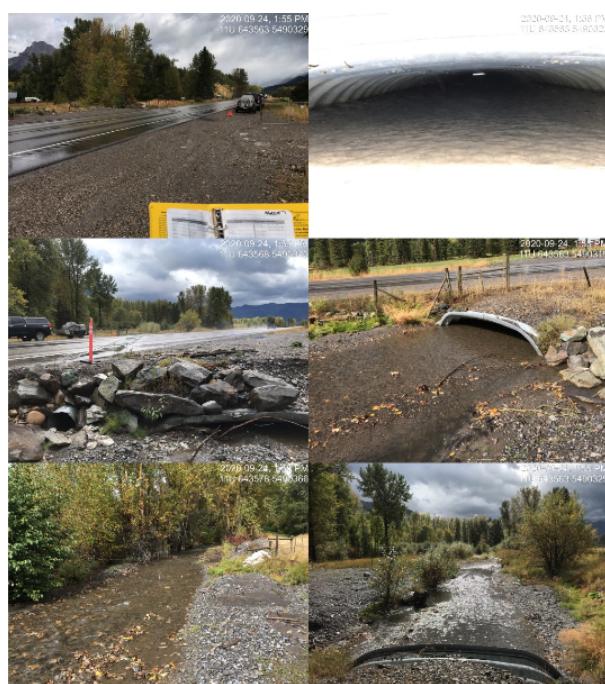
Figure 5.37: PSCIS crossing 197582.

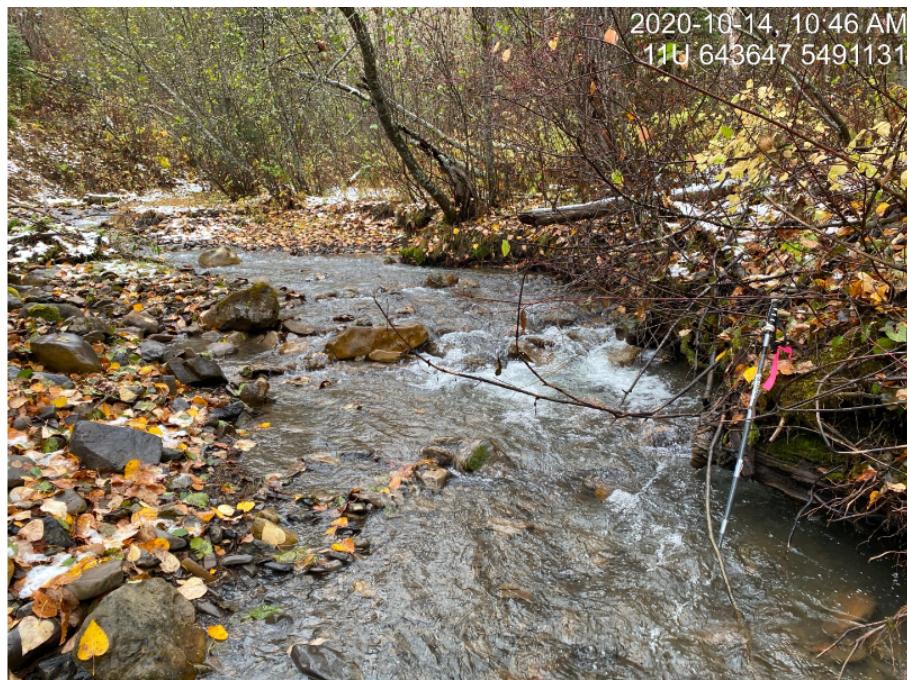
Figure 5.38: Typical habitat upstream of PSCIS crossing 197542.
