Upper Elk River and Flathead River Fish Passage Restoration Planning

**Prepared for
Canadian Wildlife Federation
350 Michael Cowpland Dr
Kanata, ON K2M 2W1**

**Prepared by
Al Irvine, B.Sc., R.P.Bio.
New Graph Environment
6 Regent St
Nelson, BC V1L 2P1**

Version 1.5

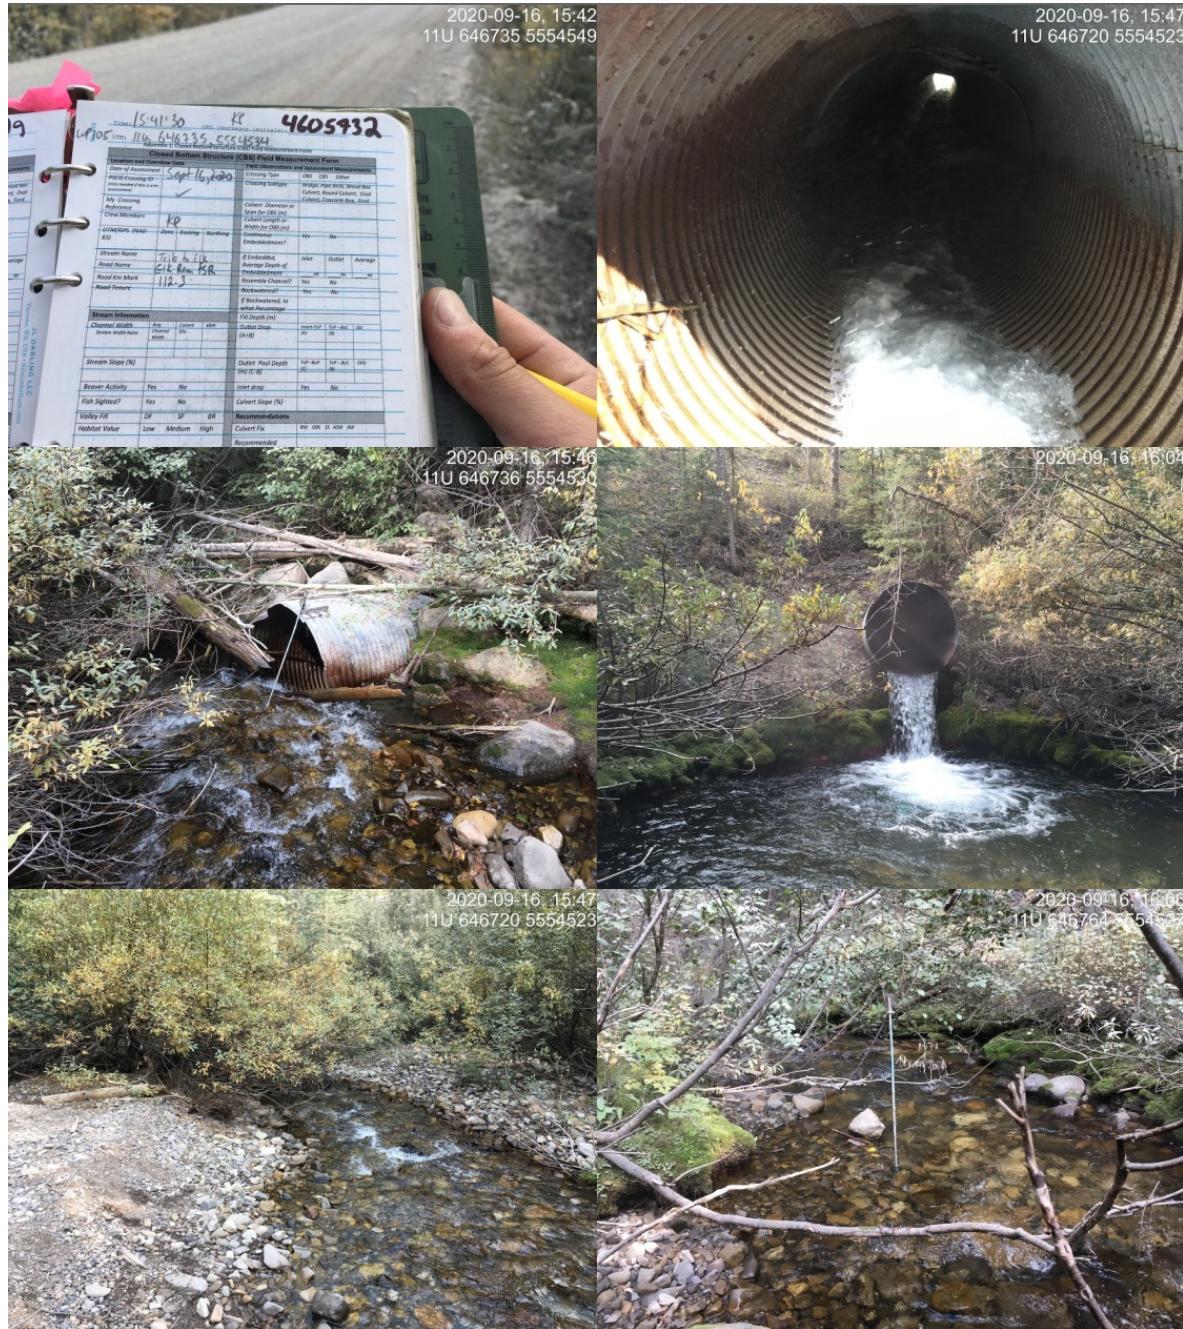
There is an estimated 6km of mainstem habitat upstream of crossing 197555 with habitat in the areas surveyed rated as high value for fry and juvenile salmonid rearing. However, fish sampling results indicate that westslope cutthroat trout are not currently utilizing the stream and densities of bull trout are very low. This could be the result of the cold water conditions due to the positioning of the watershed at high elevation in the generally cold Rocky Mountain setting. Elk River FSR is a forest tenure licensee road of the Ministry of Forests, Lands, Natural Resource Operations & Rural Development. The crossing was ranked as a moderate priority for proceeding to design for replacement with an open bottomed structure.

Location and Stream Data		Crossing Characteristics	
Date	2020-09-16	Crossing Sub Type	Round Culvert
PSCIS ID	197555	Diameter (m)	1.5
External ID	–	Length (m)	49
Crew	KP, AI	Embedded	No
UTM Zone	11	Depth Embedded (m)	–
Easting	646735	Resemble Channel	No
Northing	5554534	Backwatered	No
Stream	Tributary to Elk River	Percent Backwatered	–
Road	Elk River FSR	Fill Depth (m)	8
Road Tenure	FLNR 0103	Outlet Drop (m)	1.48
Channel Width (m)	3.5	Outlet Pool Depth (m)	1.3
Stream Slope (%)	1.5	Inlet Drop	Yes
Beaver Activity	No	Slope (%)	3.5
Habitat Value	High	Valley Fill	Deep Fill
Photos: From top left clockwise: Road/Site Card, Barrel, Outlet, Downstream, Upstream, Inlet.

Structure replacement with an open bottomed culvert is recommended to provide access to the habitat located upstream of PSCIS crossing 197555. Due to the large amount of fill on the road (8m) the size of a replacement bridge was estimated at 25m. The cost for work is estimated at \$312,000 for a cost benefit of 19.2linear m/\$1000 and 113.5m²/\$1000.

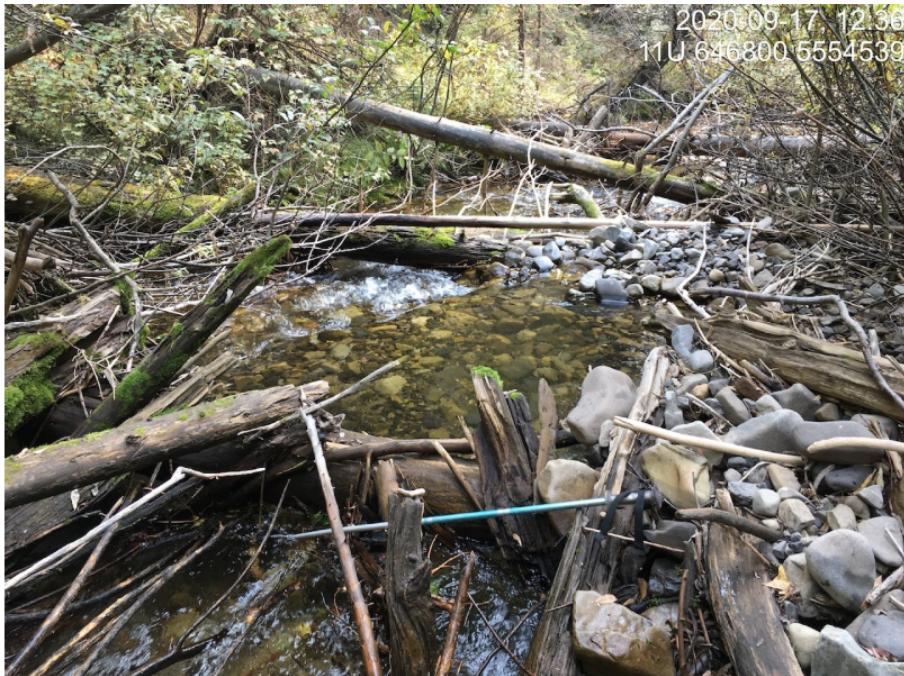
Figure 5.40: Typical habitat downstream of PSCIS crossing 197555.

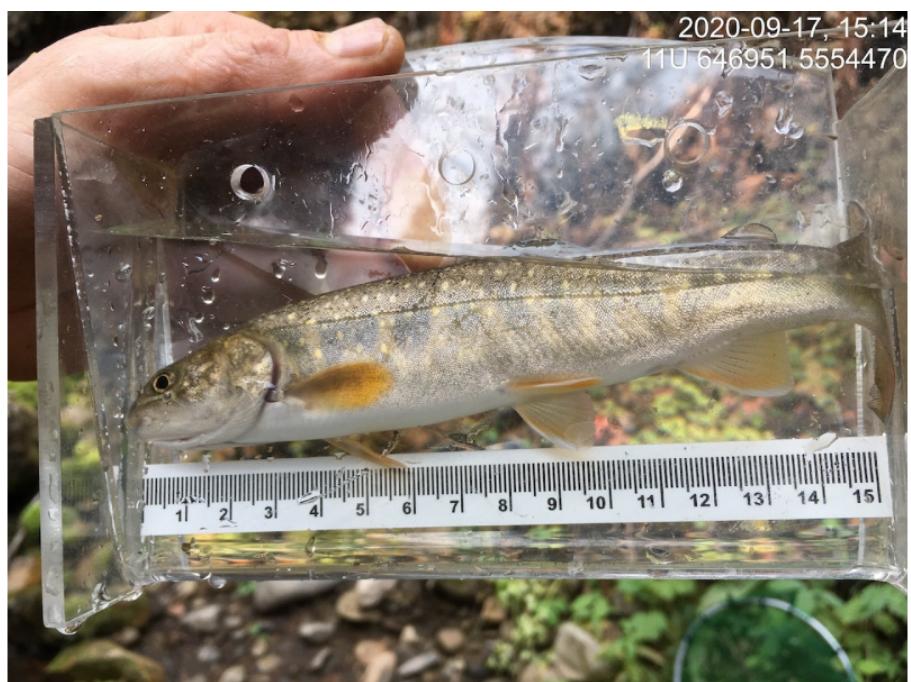
Figure 5.42: Bull trout captured downstream of PSCIS crossing 197555.
