DRAFT - Elk River Watershed Group Fish Passage Restoration Planning 2021

**Prepared for
Nupqua Limited Partnership**

**Prepared by
Al Irvine, B.Sc., R.P.Bio.
New Graph Environment Ltd.**

**Version 0.0.1 - DRAFT
2022-03-10**

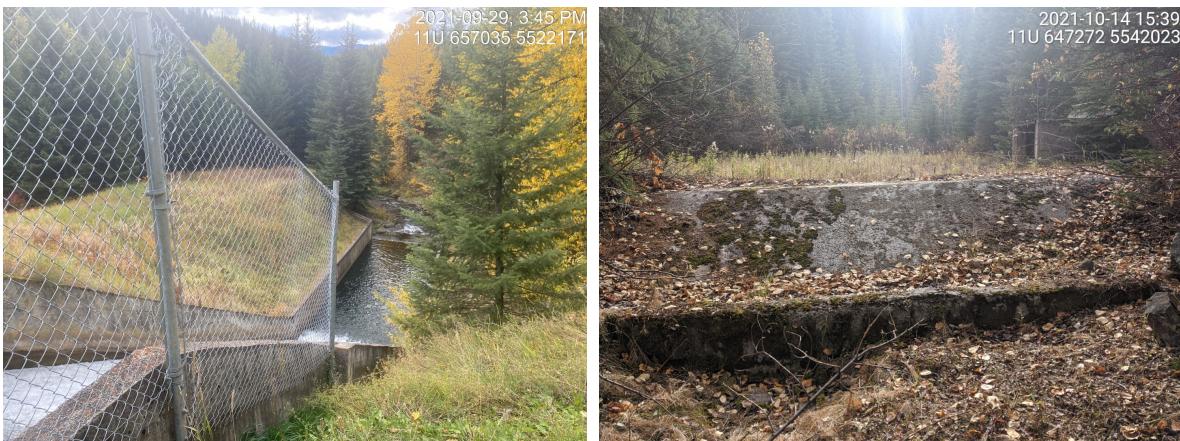
Figure 4.2: Left: Teck Coal Limited dam (15m high and 55% gradient) on Harmer Creek. Right: Historic dam structure adjacent to Boivin Creek.

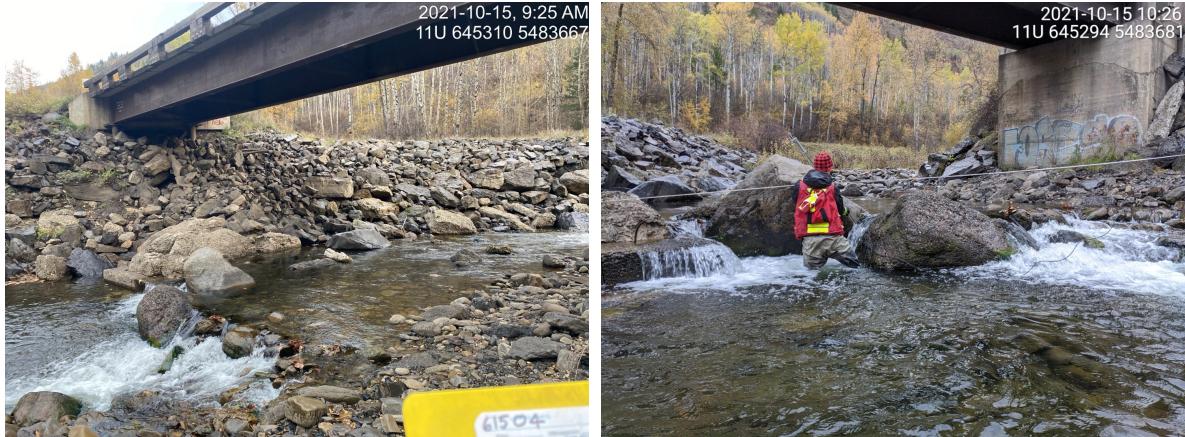
Location and Stream Data	Crossing Characteristics
Comments: Habitat confirmation conducted due to debris in stream that causes small drop across stream (0.2 - 0.6m high) just downstream of the bridge. 9:20

Figure 5.1: Left: Cascade adjacent to PSCIS crossing 61504. Right: Flow velocity measurement adjacent to PSCIS crossing 61504.

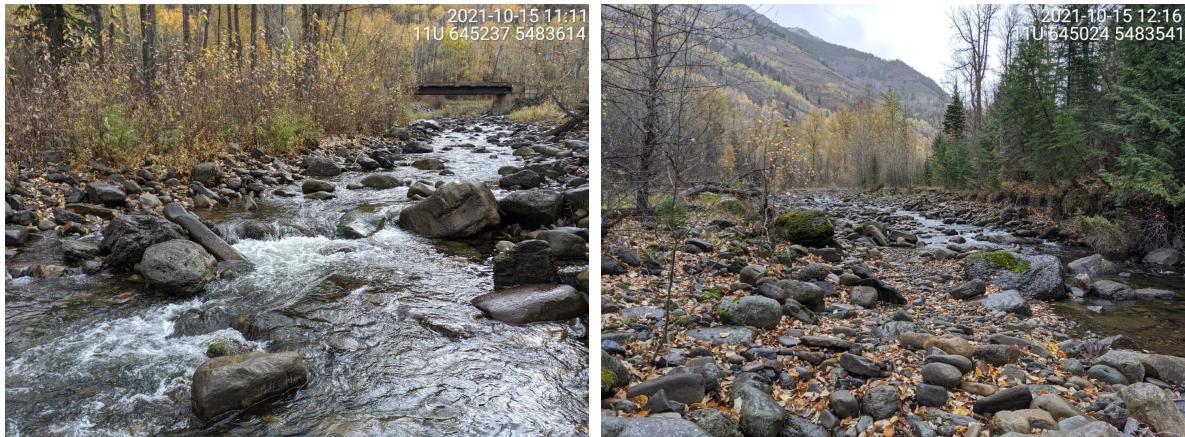
The stream was surveyed downstream from 61504 for 365m (Figure 5.1). Overall, total cover amount was rated as abundant with boulders dominant undercut banks subdominant (Table 5.4). The average channel width was 27.8m, the average wetted width was 10.5m and the average gradient was 2.8%. The dominant substrate was NA with NA subdominant. Some pockets of gravel suitable for westslope cutthroat trout spawning were observed. Habitat value was rated as high within the large system with abundant habitat available for fry/juvenile salmonid rearing.

Figure 5.2: Left: Typical habitat downstream of PSCIS crossing 61504. Right: Typical habitat downstream of PSCIS crossing 61504.

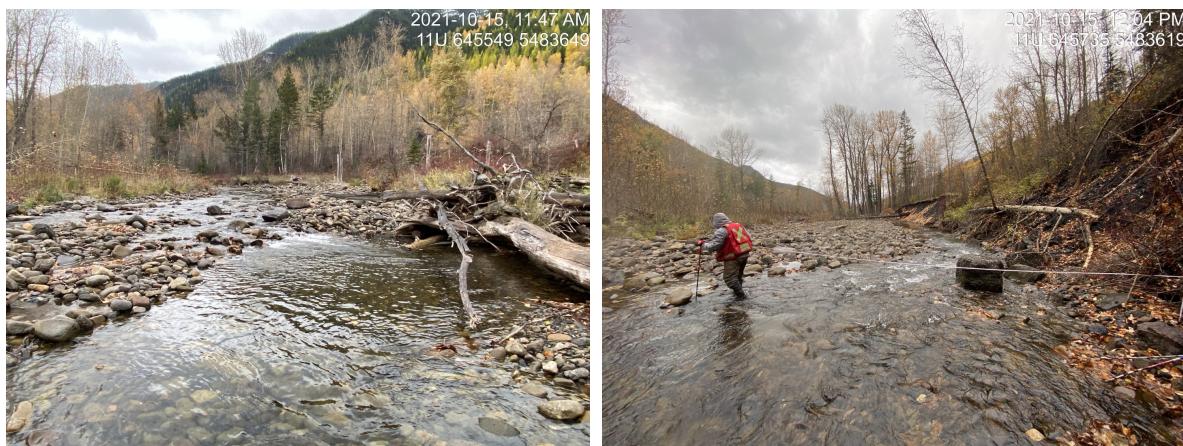
Figure 5.3: Left: Typical habitat upstream of PSCIS crossing 61504. Right: Typical habitat upstream of PSCIS crossing 61504.

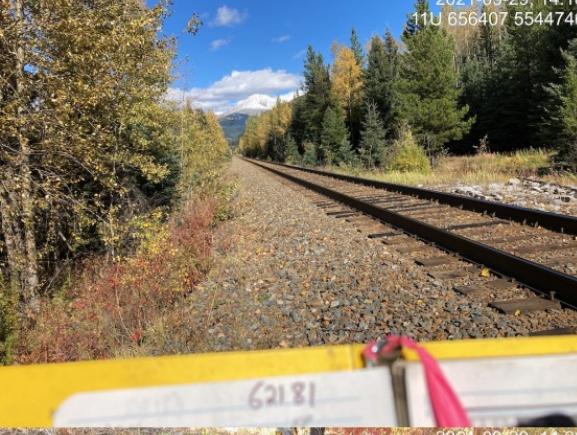
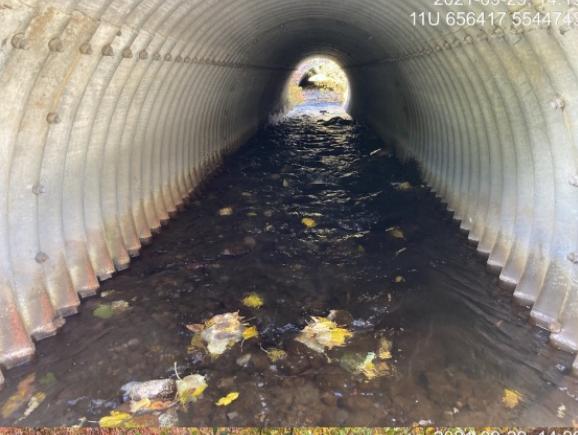
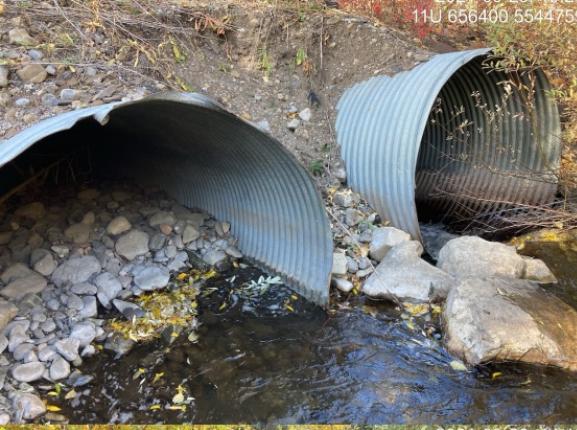
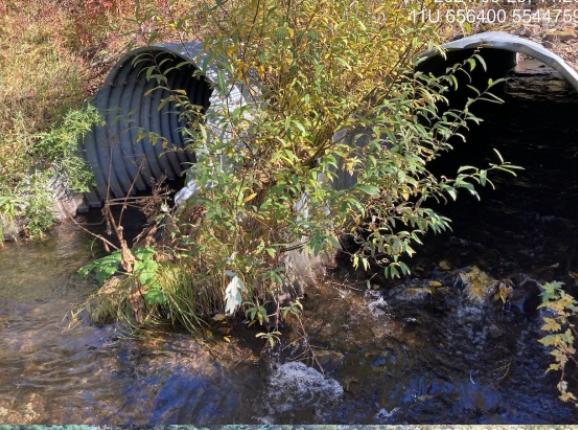
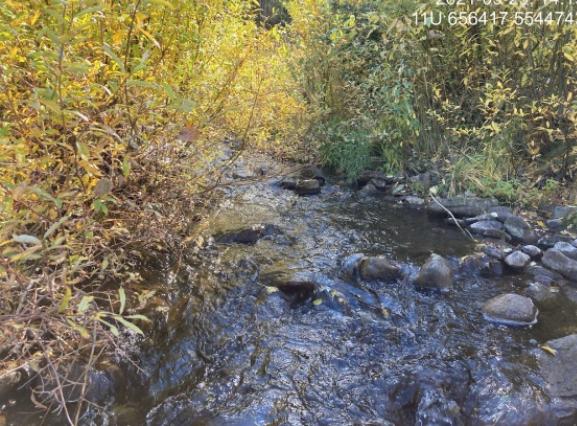
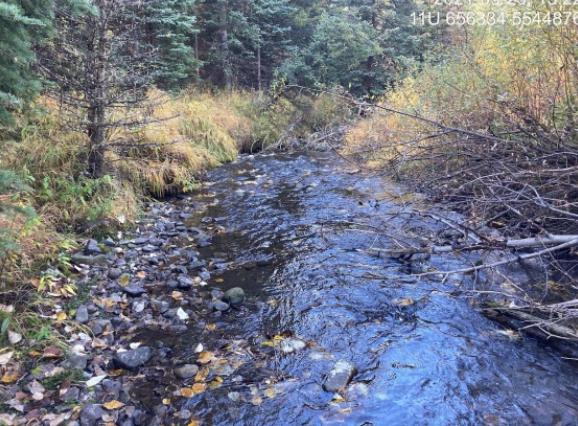
Location and Stream Data	Crossing Characteristics
Comments: Two pipes (1.8m x 1.8m). Left pipe was measured. Right pipe gradient ~3%. Right pipe partially embedded.

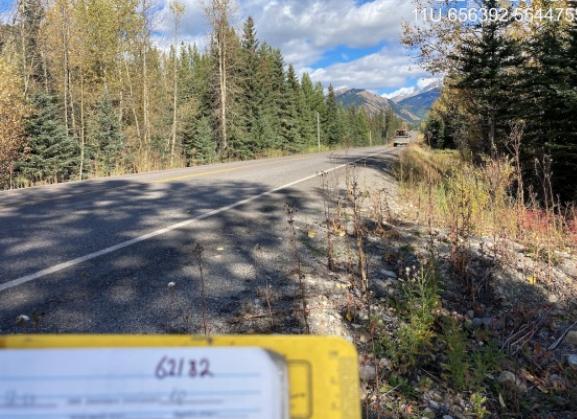
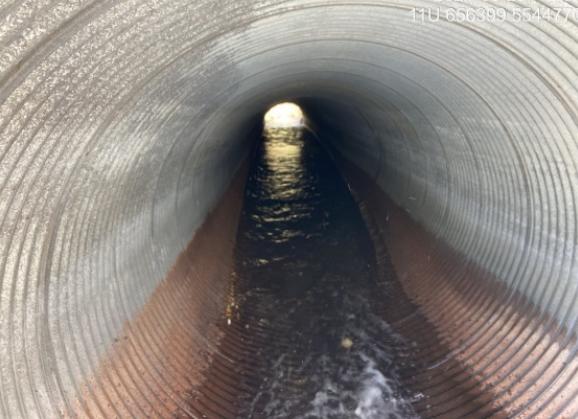
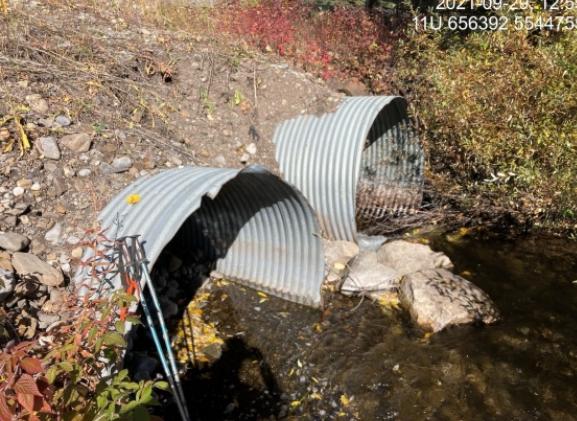
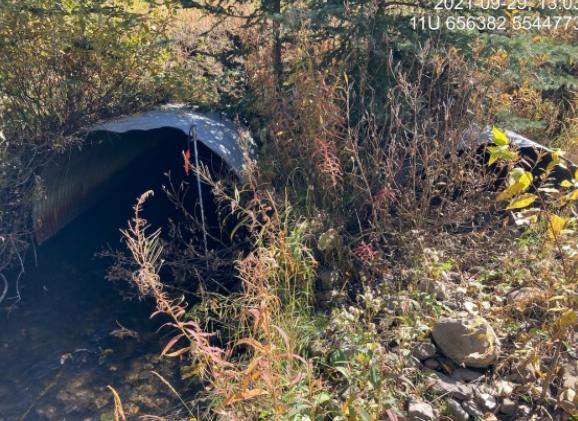
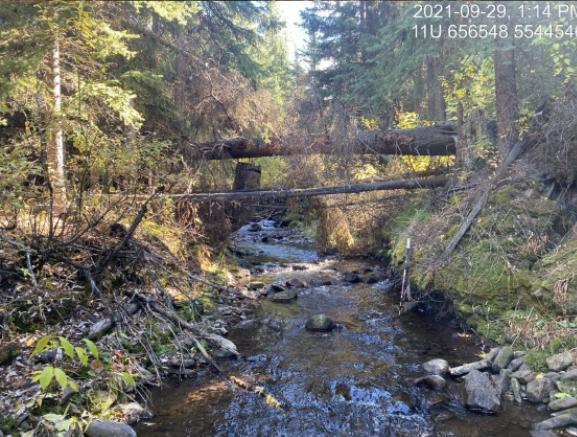
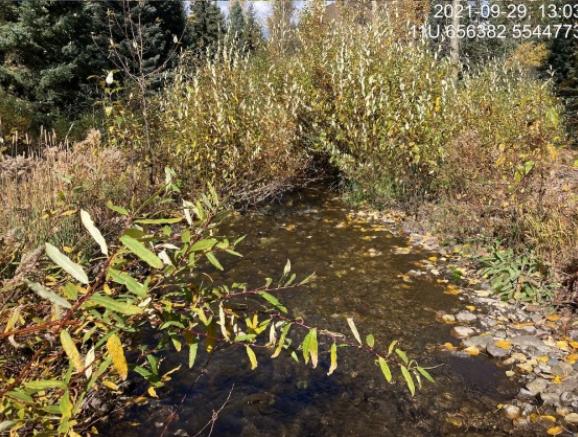
Location and Stream Data	• Crossing Characteristics	-
Comments: Two pipes (1.8m x 1.8m). Stream left pipe embedd at outlet 0.6m but not at inlet and there is a significant inlet drop. PSCIS crossing 62182 is located ~30m upstream of the crossing under the railway. 12:50

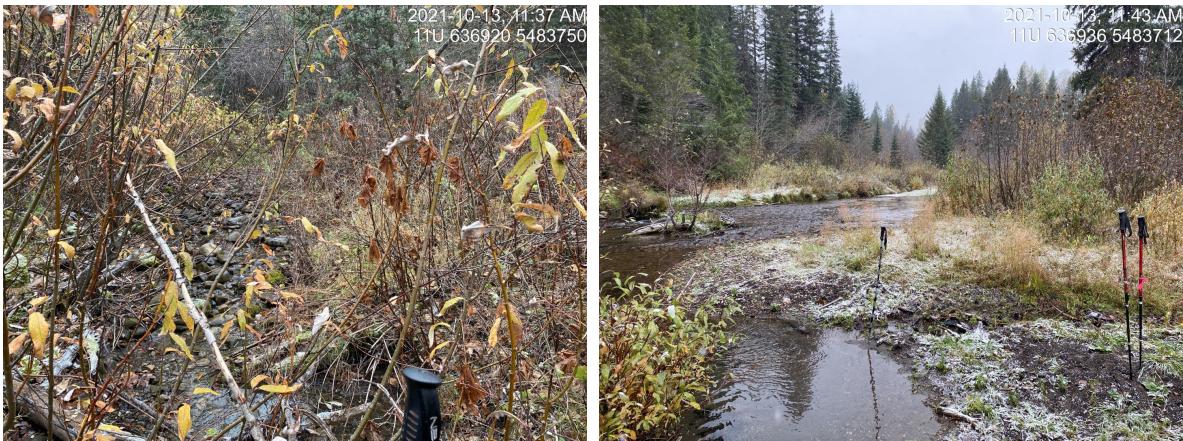
Figure 5.6: Left: Habitat downstream of crossing 62505. Right: Confluence with Lizard Creek located ~70m downstream of crossing 62505.

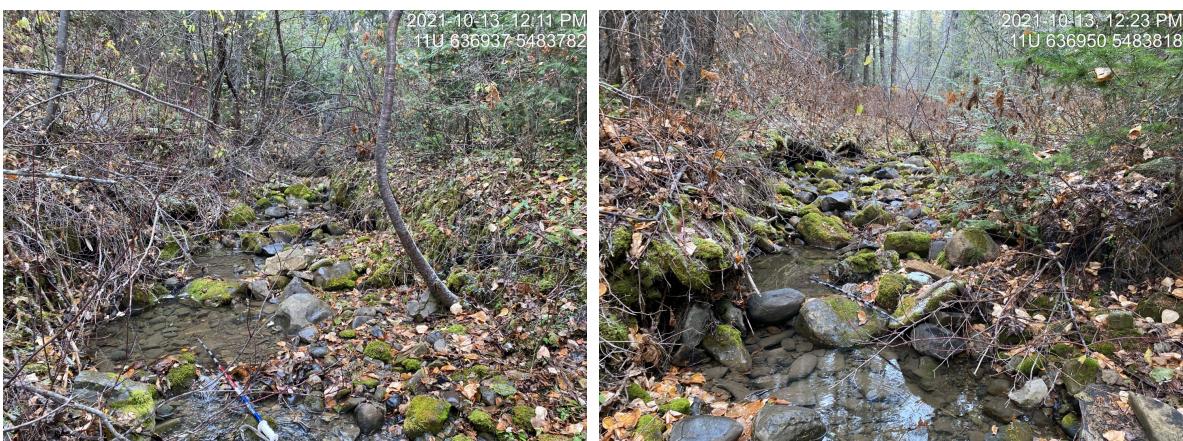
Figure 5.7: Left: Habitat upstream of PSCIS crossing 62505. Right: Habitat upstream of PSCIS crossing 62505.

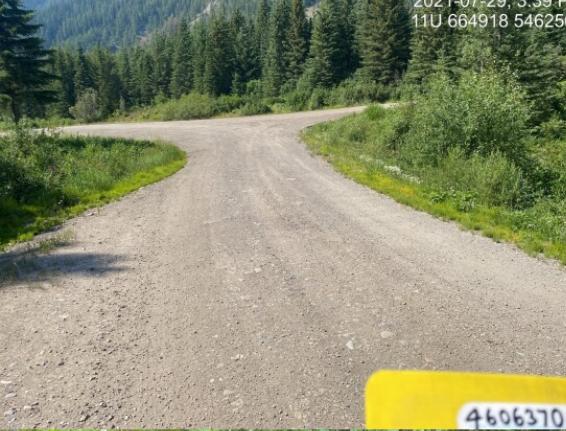
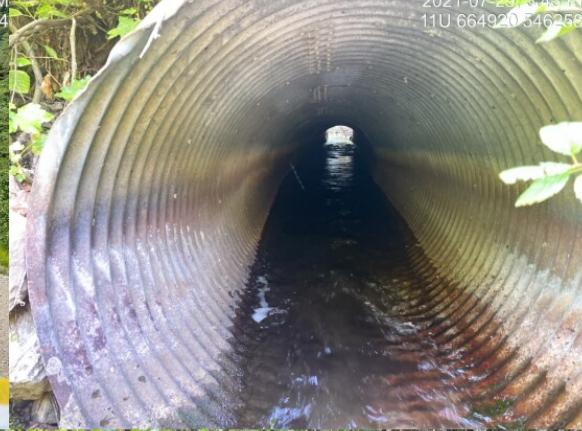
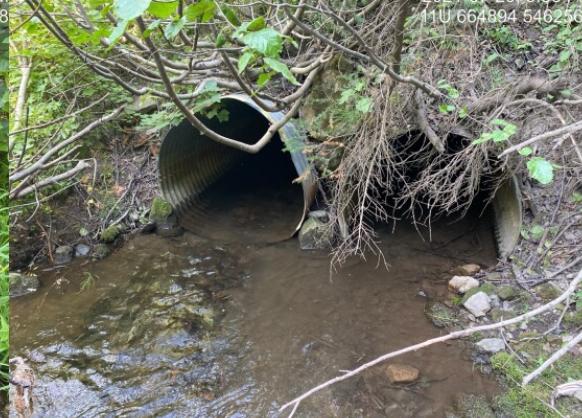
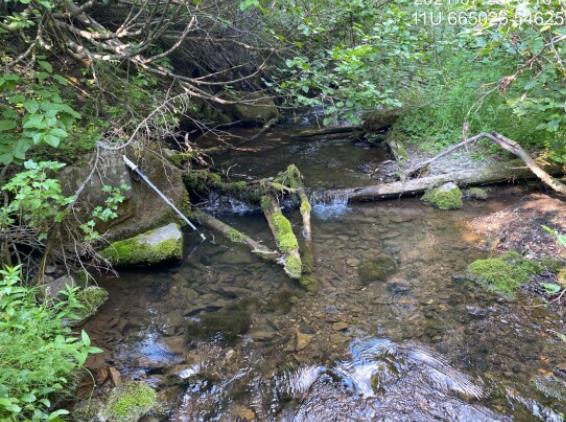
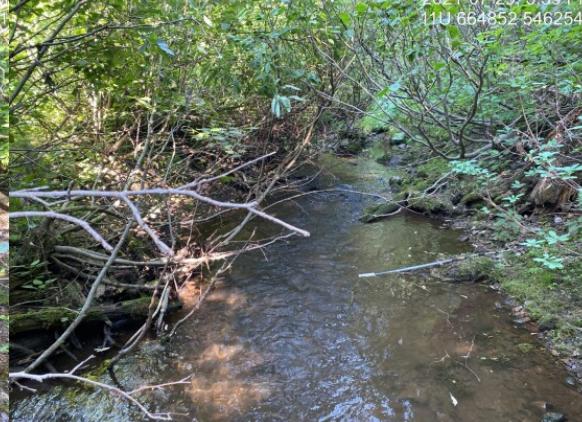
Location and Stream Data	• Crossing Characteristics	-
<p>Comments: Two pipes (1m each) but one blocked with debris. Because height of outlets equivalent widths were added together for input to stream width ratio. Large beaver dams upstream between culvert and Lodgepole Lake. 15:37</p>

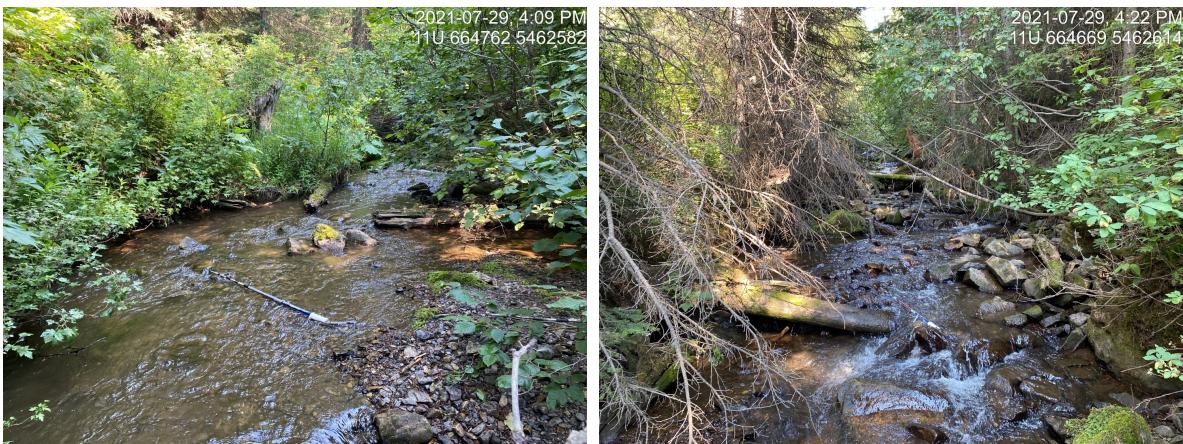
Figure 5.8: Left: Typical habitat downstream of PSCIS crossing 197787. Right: Typical habitat downstream of PSCIS crossing 197786.

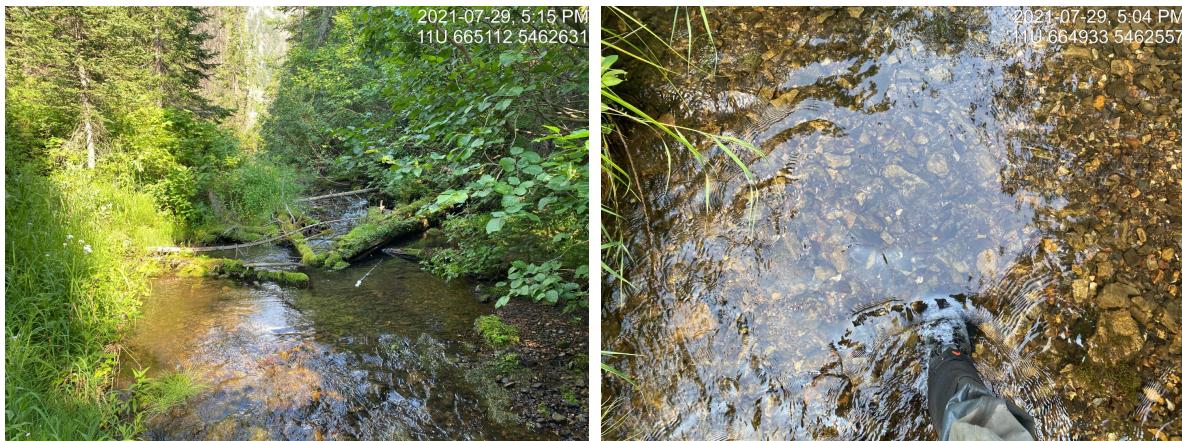
Figure 5.9: Left: Typical habitat upstream of PSCIS crossing 197787. Right: Gravels suitable for spawning located upstream of PSCIS crossing 197787.

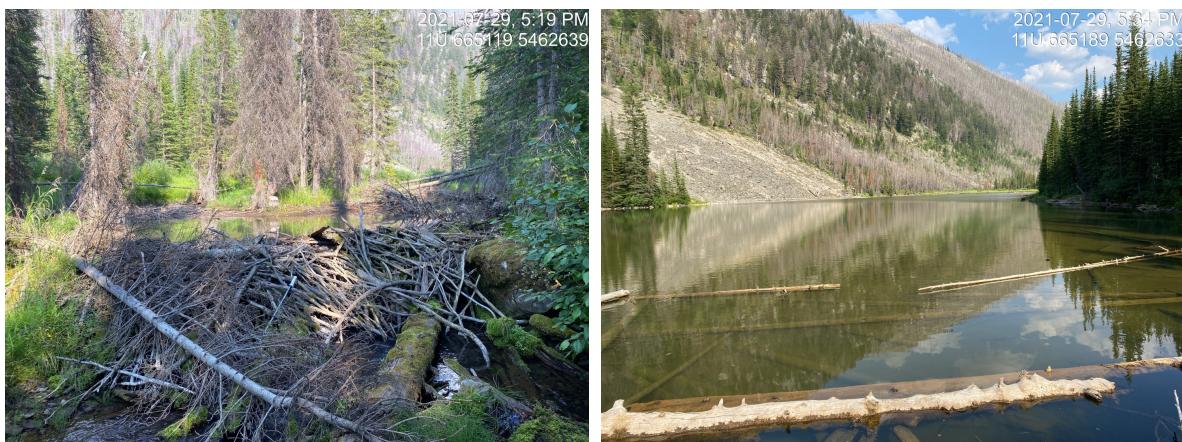
Figure 5.10: Left: Beaver dam located upstream of PSCIS crossing 197787 and just below Lodgepole Lake. Right: Lodgepole Lake located upstream of PSCIS crossing 197787.

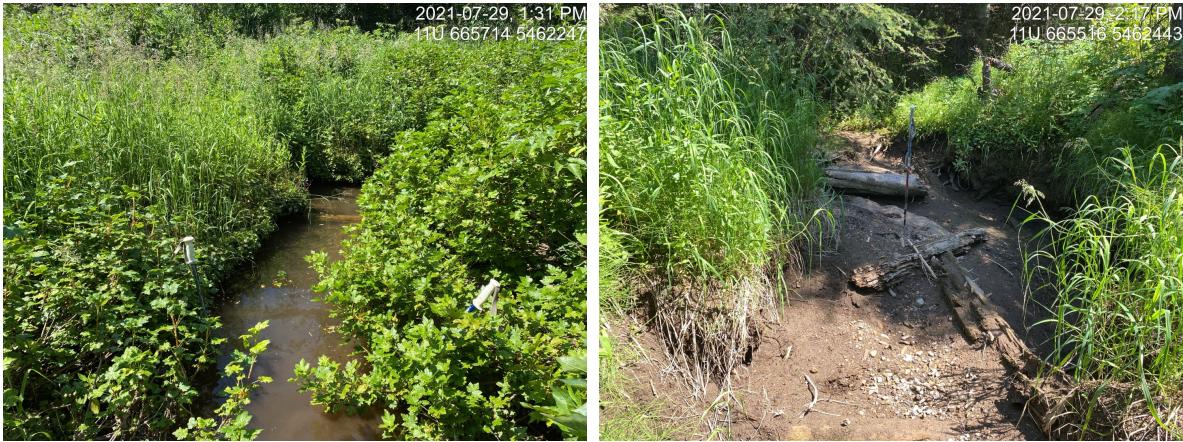
Figure 5.11: Left: Habitat downstream of PSCIS crossing 197786. Right: Dewatered habitat downstream of PSCIS crossing 197786.

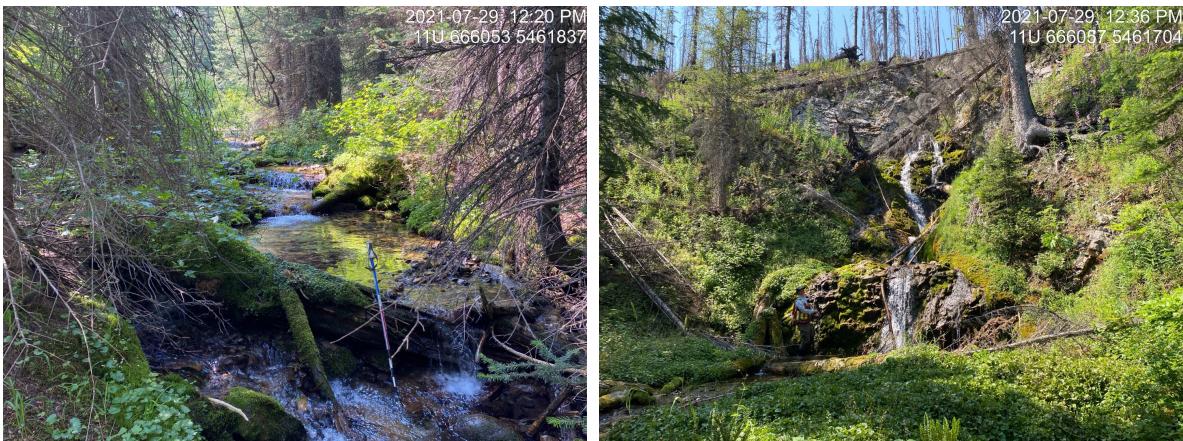
Figure 5.12: Left: Typical habitat upstream of PSCIS crossing 197786. Right: Large falls located ~550m upstream of PSCIS crossing 197786.

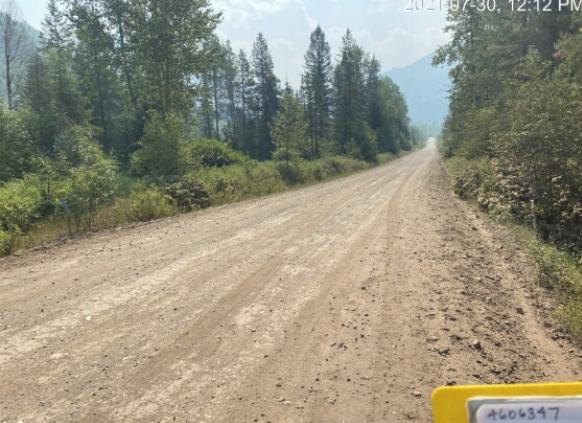
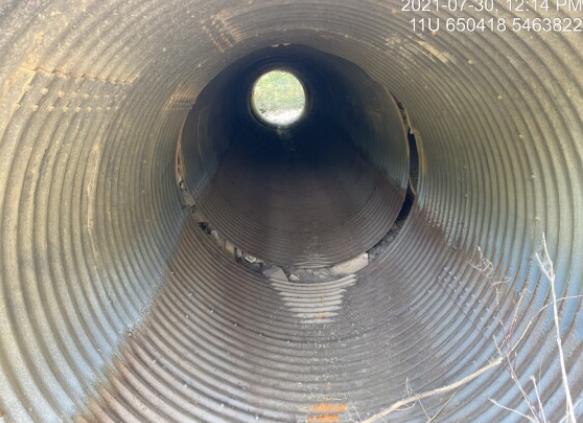
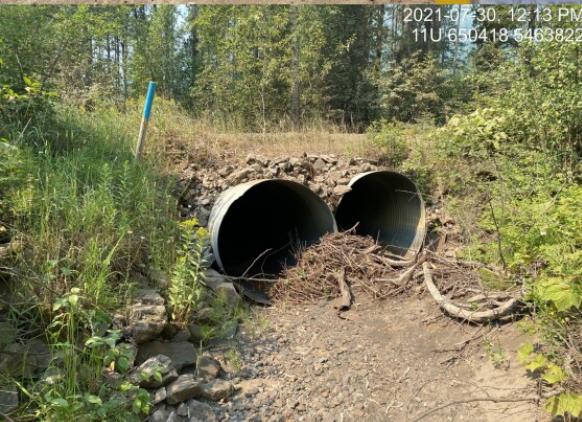
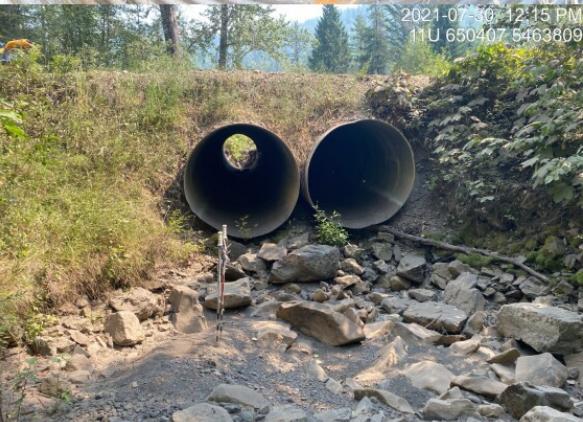
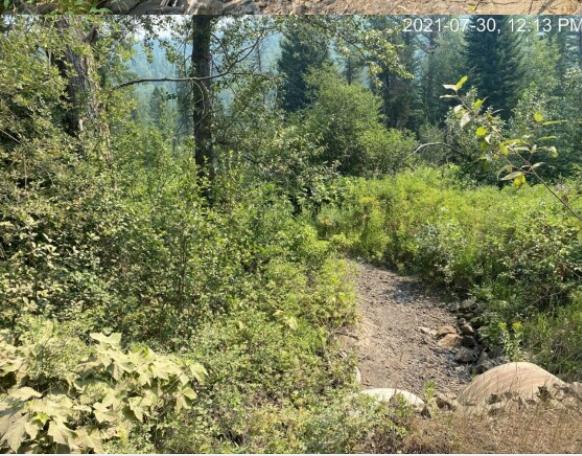
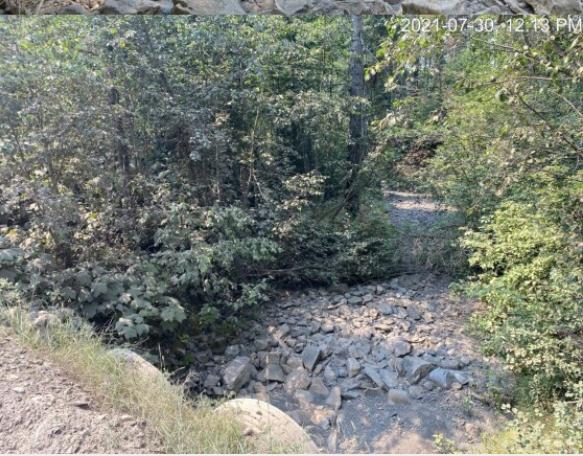
Location and Stream Data	•	Crossing Characteristics	-
Comments: Large channel but stream is completely dry. 12:11

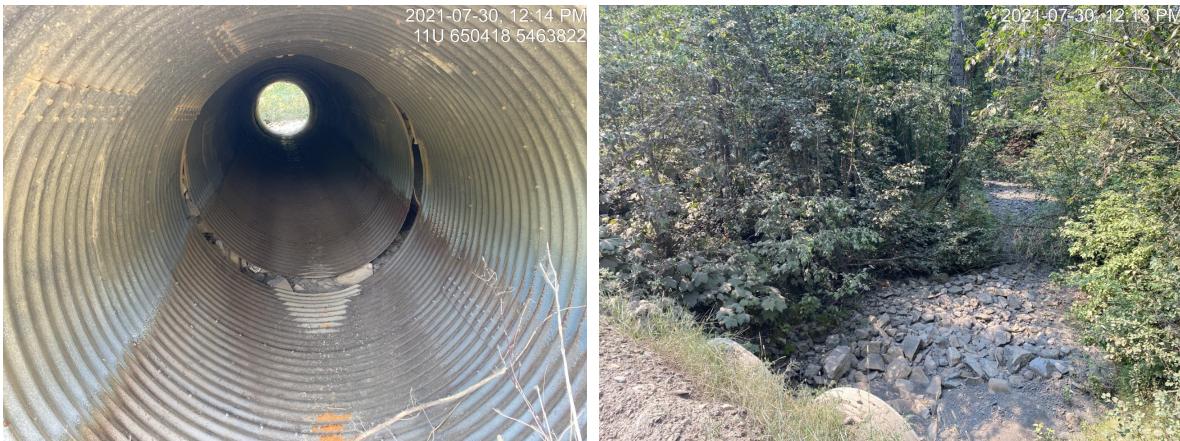
Figure 5.13: Left: Damage within PSCIS crossing 197793. Right: Habitat downstream of crossing 197793.

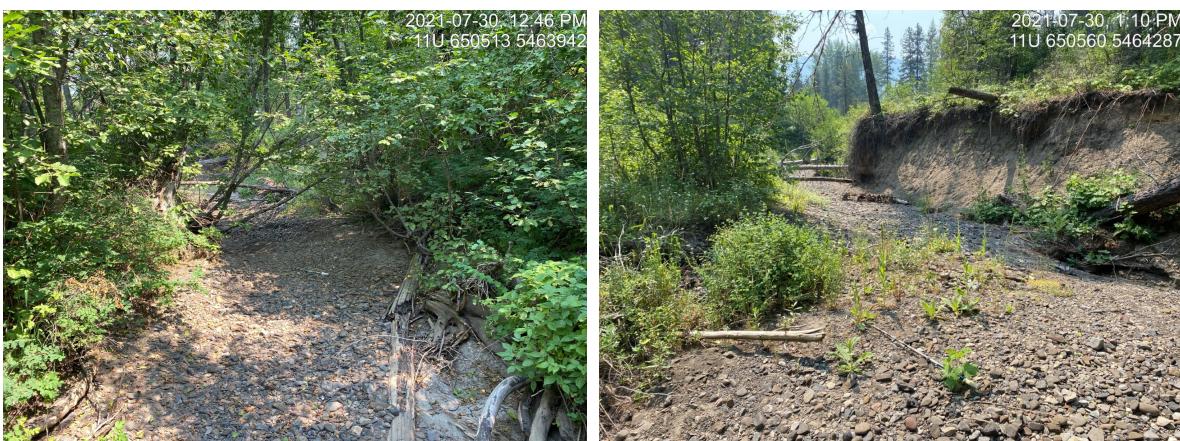
Figure 5.14: Left: Habitat upstream of PSCIS crossing 197793. Right: Habitat upstream of PSCIS crossing 197793.

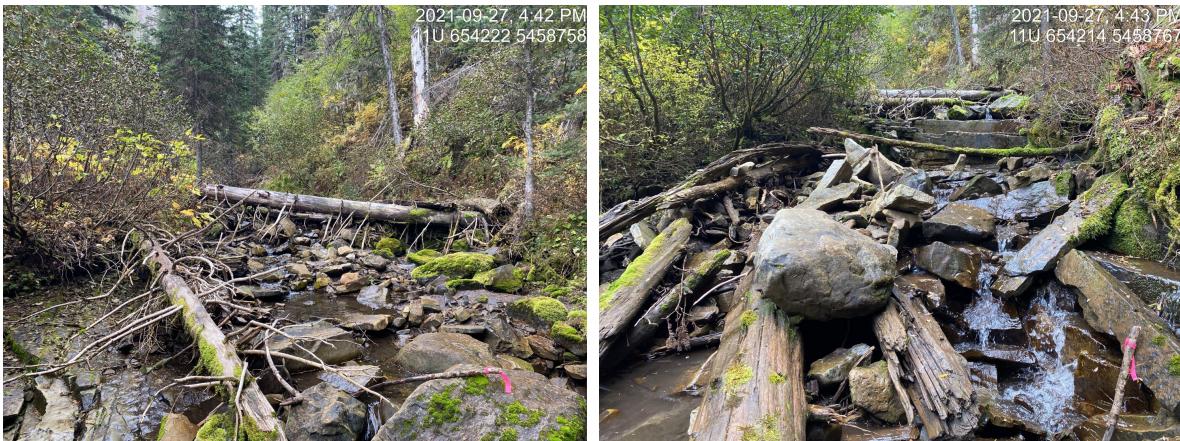
Figure 5.15: Left: Typical habitat downstream of PSCIS crossing 197796. Right: Habitat downstream of crossing 197796.

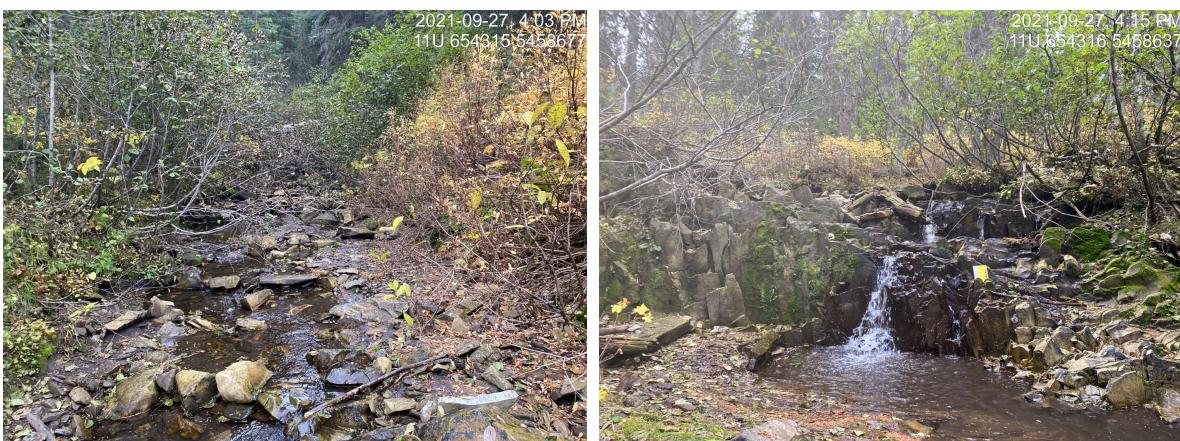
Figure 5.16: Left: Habitat upstream of PSCIS crossing 197796. Right: 2.4m high rock falls located ~60m upstream of PSCIS crossing 197796.

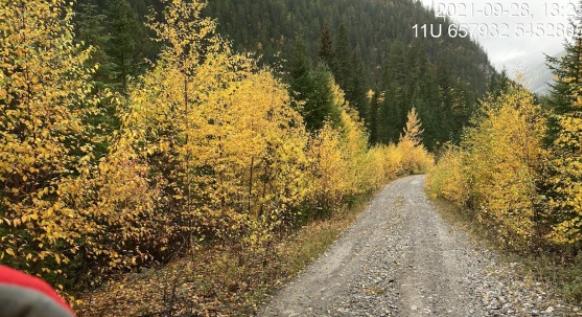
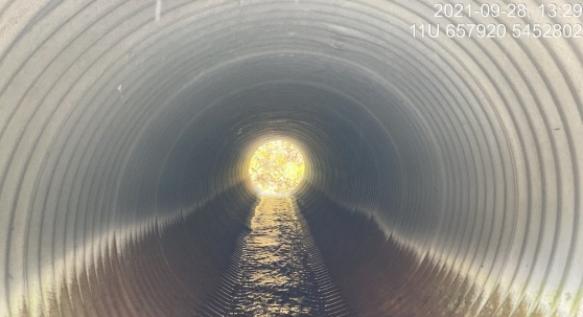
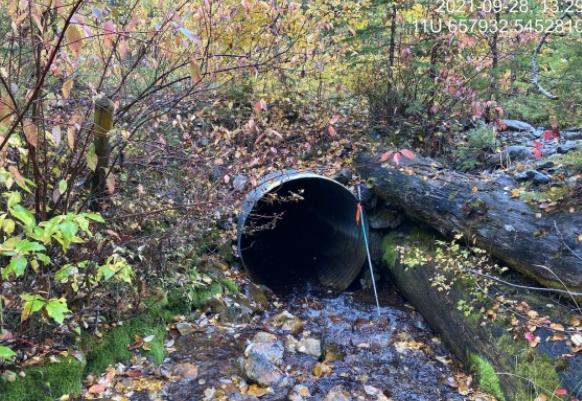
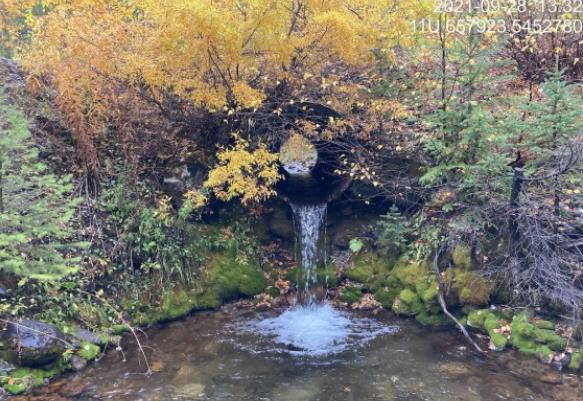
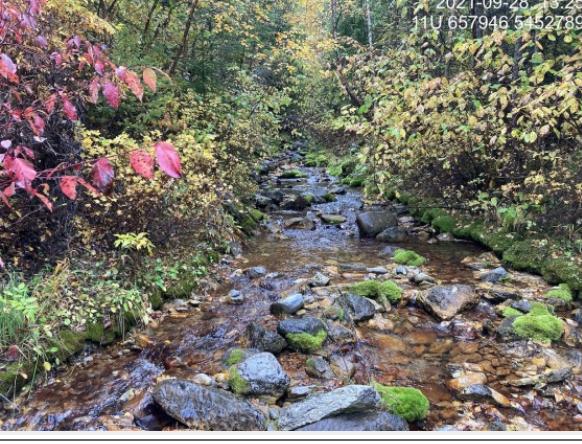
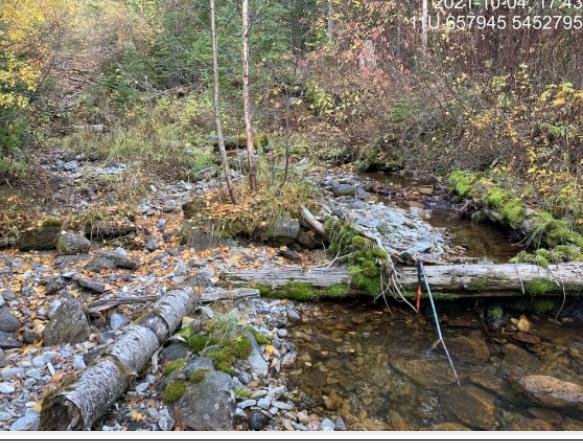
Location and Stream Data	Crossing Characteristics
Comments: Cobble substrate and abundant overhanging vegetation. Decent sized stream. 13:24

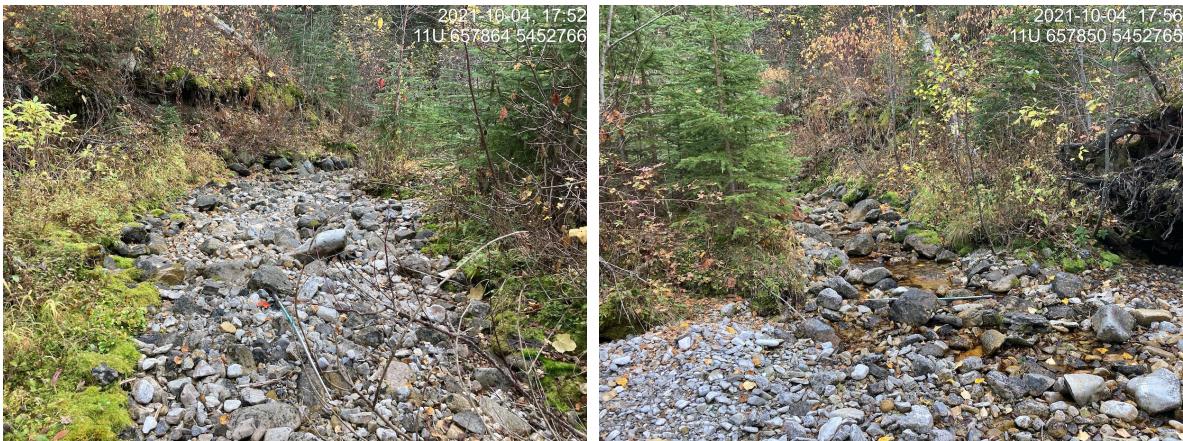
Figure 5.17: Left: Habitat downstream of crossing 197844. Right: Habitat downstream of crossing 197844.

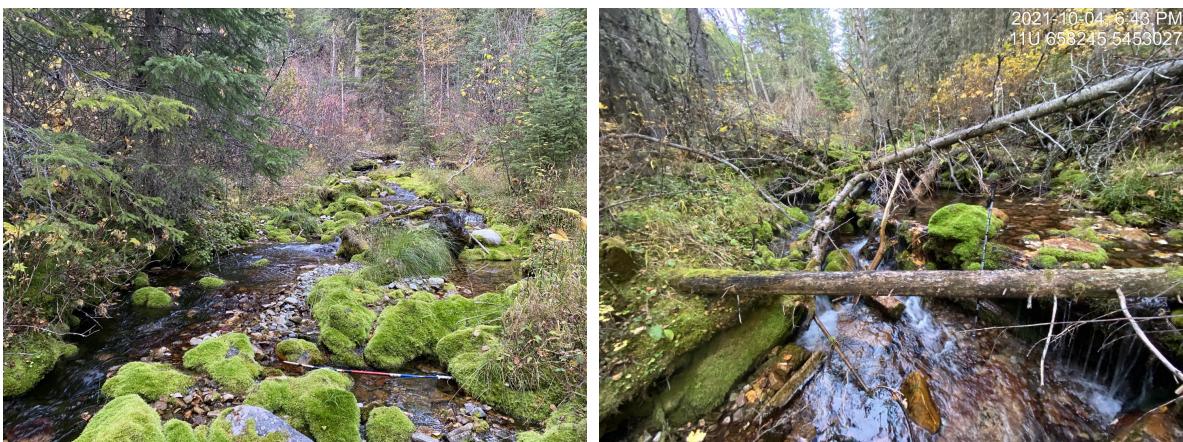
Figure 5.18: Left: Habitat upstream of PSCIS crossing 197844. Right: Habitat upstream of PSCIS crossing 197844.
