DRAFT - Elk River Watershed Group Fish Passage Restoration Planning 2021

**Prepared for
Nupqua Limited Partnership**

**Prepared by
Al Irvine, B.Sc., R.P.Bio.
New Graph Environment Ltd.**

**Version 0.1.0 - DRAFT
2022-03-11**

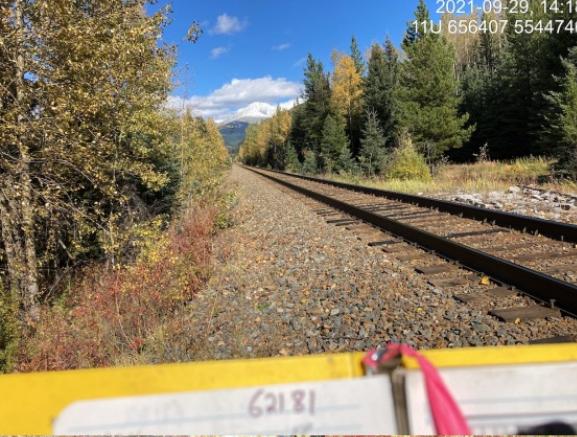
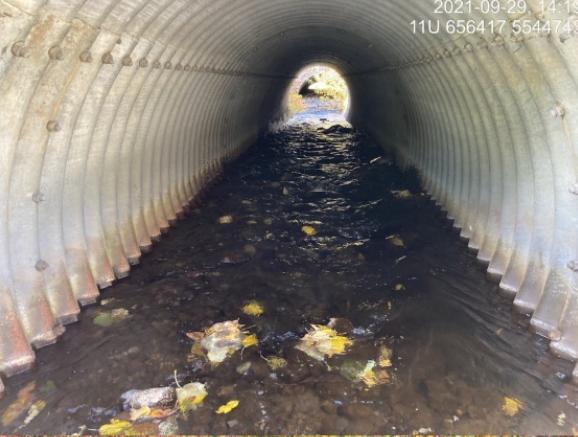
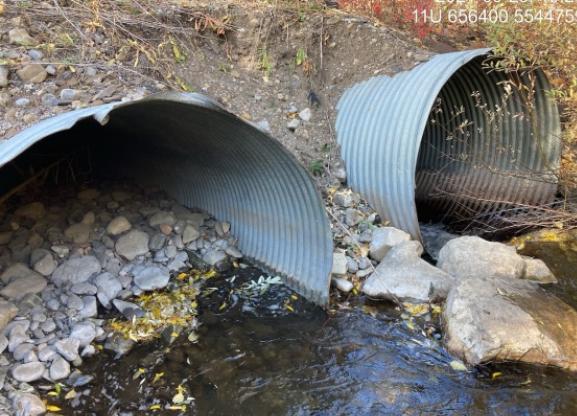
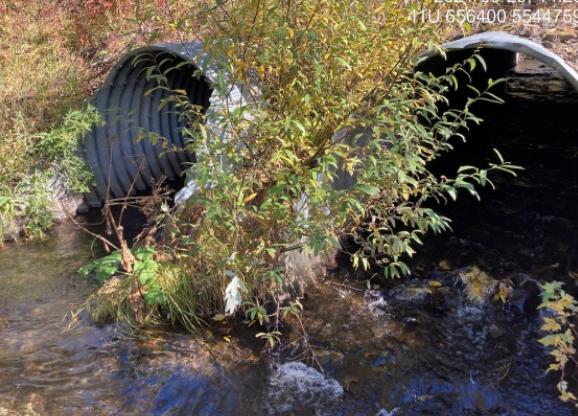
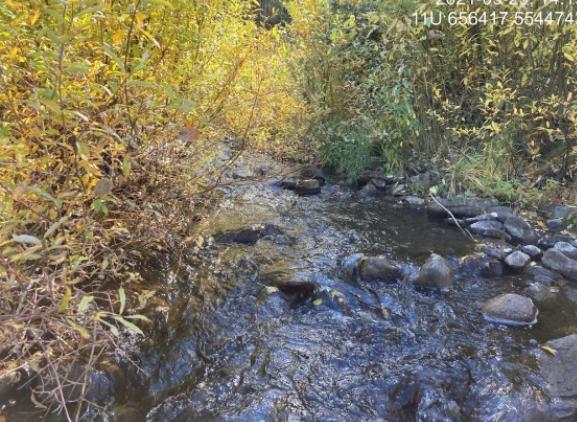
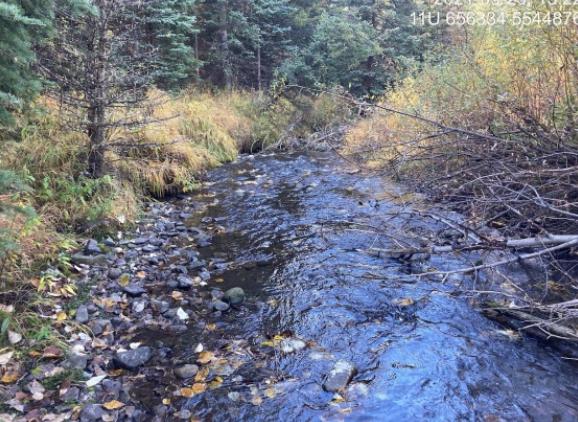
Location and Stream Data	Crossing Characteristics
Comments: Two pipes (1.8m x 1.8m). Left pipe was measured. Right pipe gradient ~3%. Right pipe partially embedded.

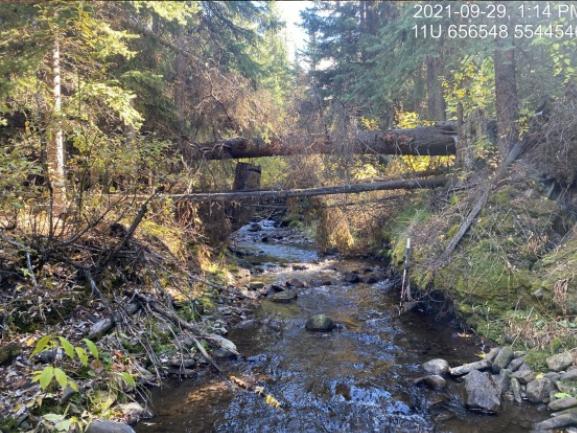
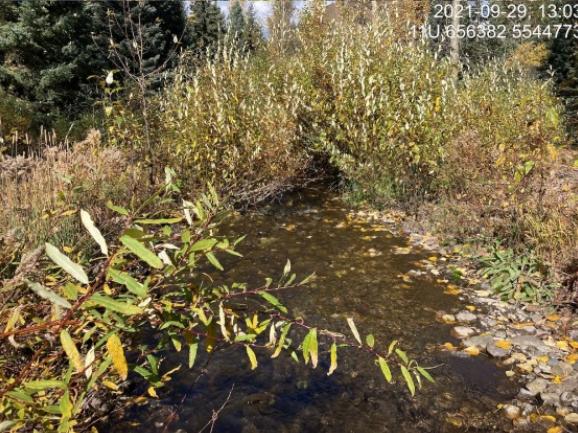
Location and Stream Data	• Crossing Characteristics	-
Comments: Two pipes (1.8m x 1.8m). Stream left pipe embedd at outlet 0.6m but not at inlet and there is a significant inlet drop. PSCIS crossing 62182 is located ~30m upstream of the crossing under the railway. 12:50

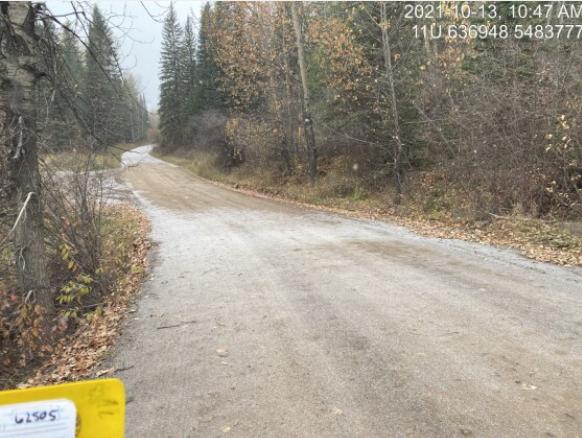
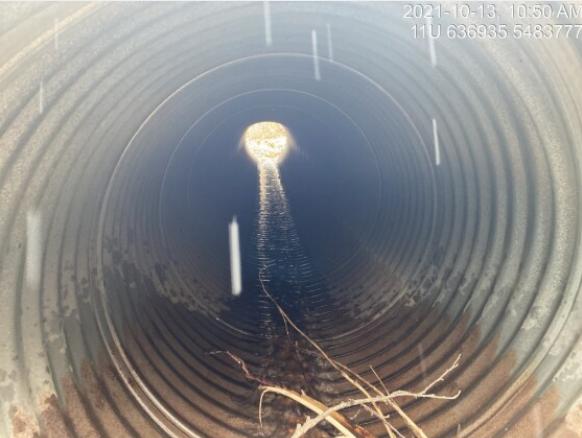
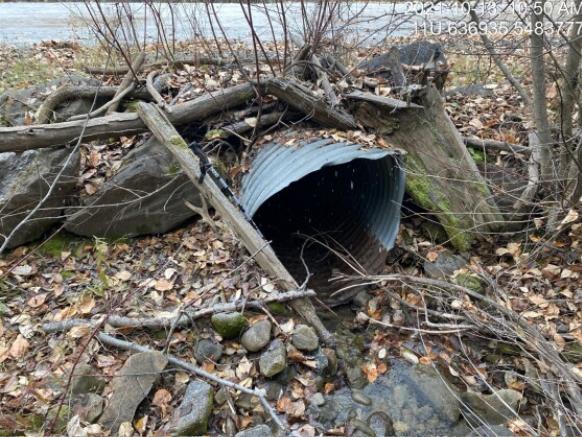
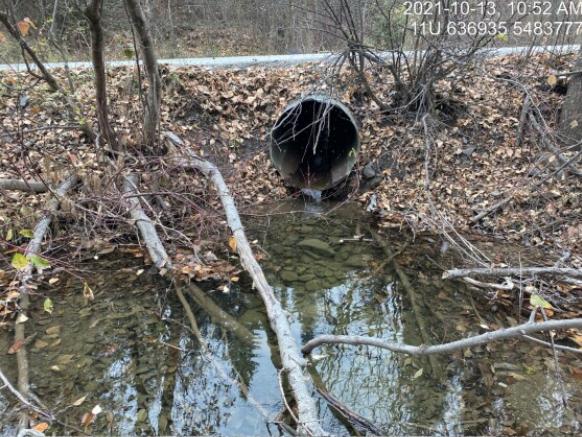
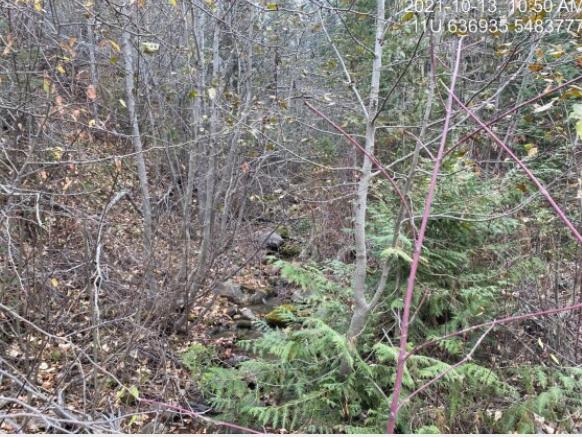
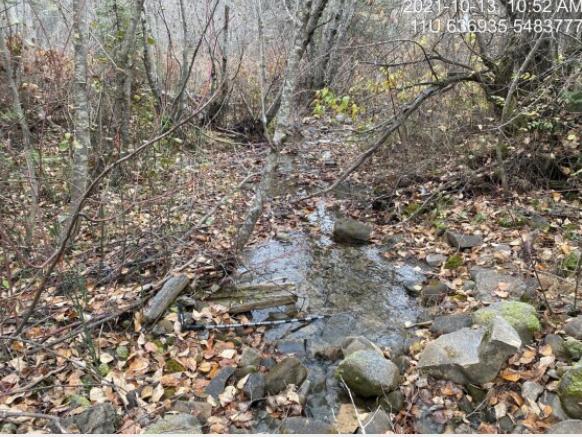
Location and Stream Data	.	Crossing Characteristics	-
Habitat Value	Medium	Valley Fill	Deep Fill
Final score	31	Barrier Result	Barrier
Fix type	Replace with New Open Bottom Structure	Fix Span / Diameter	12
Comments: Very close to Lizard Creek mainstem. 10:43			
Photos: From top left clockwise: Road/Site Card, Barrel, Outlet, Downstream, Upstream, Inlet.

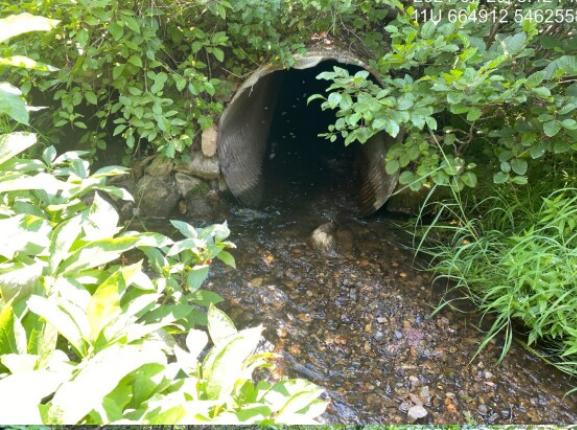
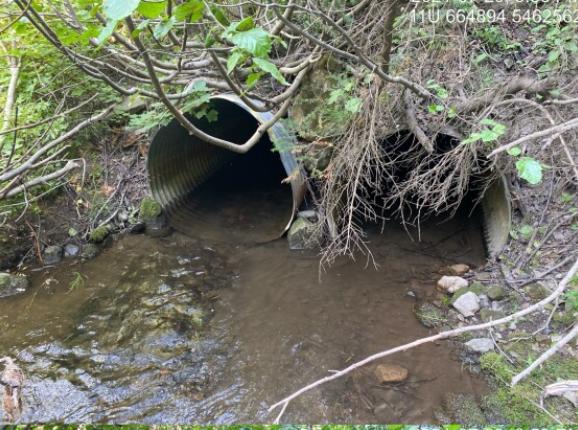
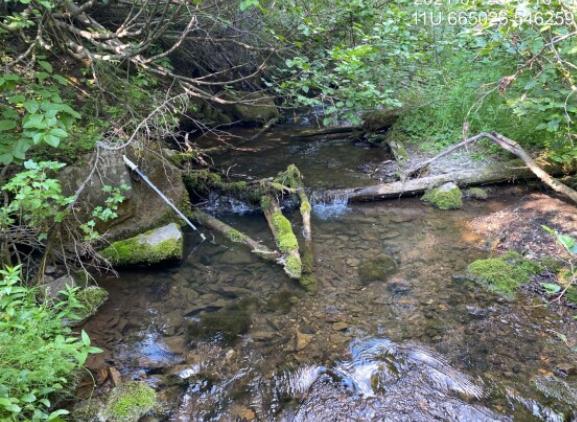
Location and Stream Data		Crossing Characteristics –	
Road	Harvey FSR	Fill Depth (m)	1.5
Road Tenure	FLNR DRM 5466	Outlet Drop (m)	0
Channel Width (m)	3.26	Outlet Pool Depth (m)	0.1
Stream Slope (%)	2.8	Inlet Drop	Yes
Beaver Activity	Yes	Slope (%)	0.5
Habitat Value	Medium	Valley Fill	Deep Fill
Final score	19	Barrier Result	Potential
Fix type	Replace with New Open Bottom Structure	Fix Span / Diameter	12
Photos: From top left clockwise: Road/Site Card, Barrel, Outlet, Downstream, Upstream, Inlet.

Location and Stream Data	Crossing Characteristics
Comments: Two pipes (1m each) but one blocked with debris. Because height of outlets equivalent widths were added together for input to stream width ratio. Large beaver dams upstream between culvert and Lodgepole Lake. 15:37

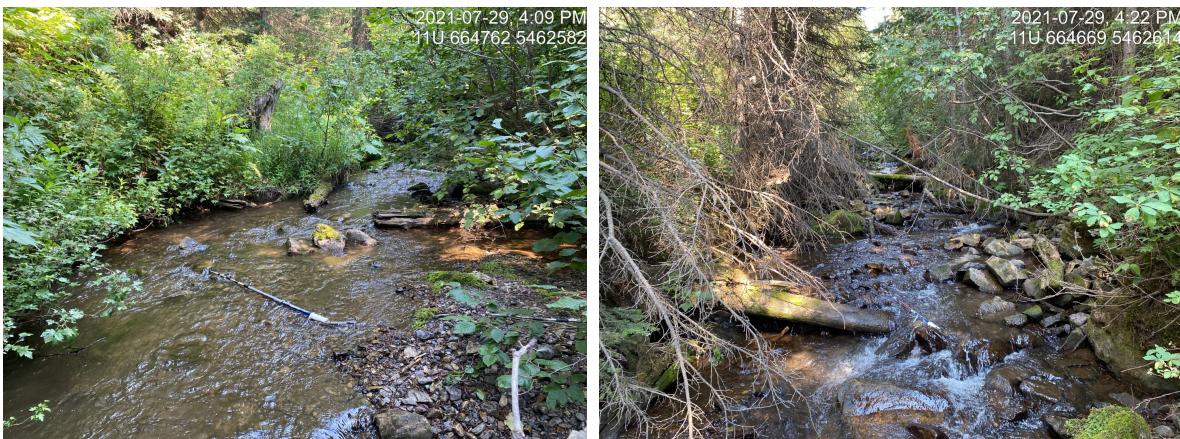
The stream was surveyed downstream from 197787 for 285m (Figure 5.8). Overall, total cover amount was rated as moderate with deep pools dominant. Cover was also present as small woody debris, large woody debris, boulders, undercut banks, and overhanging vegetation (Table 5.18). The average channel width was 4.4m, the average wetted width was 3.2m and the average gradient was 6.2%. The dominant substrate was boulders with gravels subdominant. Habitat value was rated

Figure 5.8: Left: Typical habitat downstream of PSCIS crossing 197787. Right: Typical habitat downstream of PSCIS crossing 197786.

Structure replacement with a bridge (12m span) was recommended to provide access to the habitat located upstream of PSCIS crossing 197786. The cost of the work was estimated at \$240,000 for a cost benefit of 2.4 linear m/\$1000 and 4.8m²/\$1000.

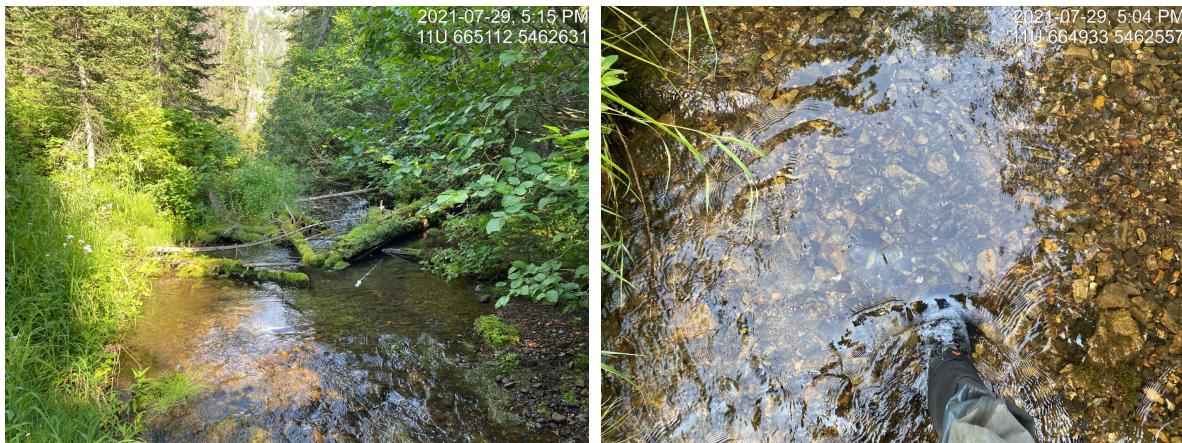
Figure 5.9: Left: Typical habitat upstream of PSCIS crossing 197787. Right: Gravels suitable for spawning located upstream of PSCIS crossing 197787.

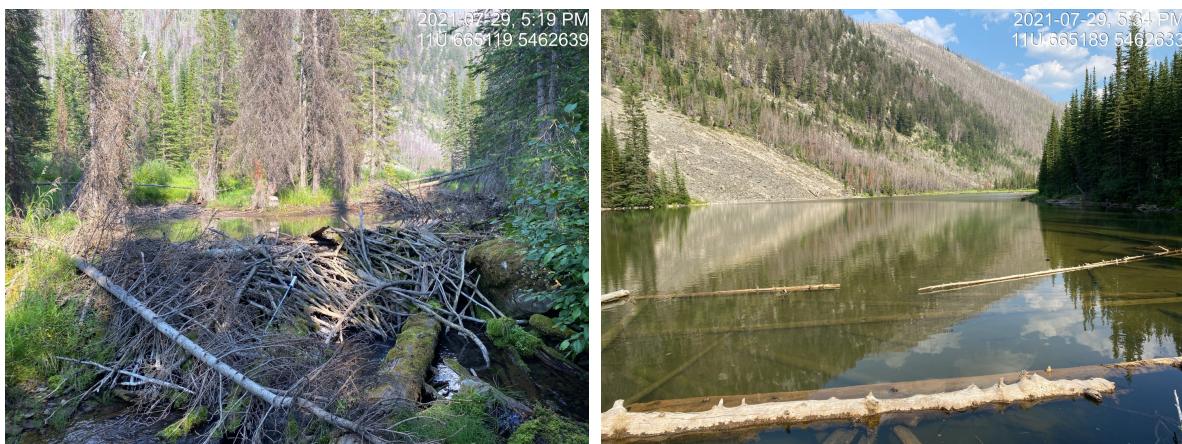
Figure 5.10: Left: Beaver dam located upstream of PSCIS crossing 197787 and just below Lodgepole Lake. Right: Lodgepole Lake located upstream of PSCIS crossing 197787.

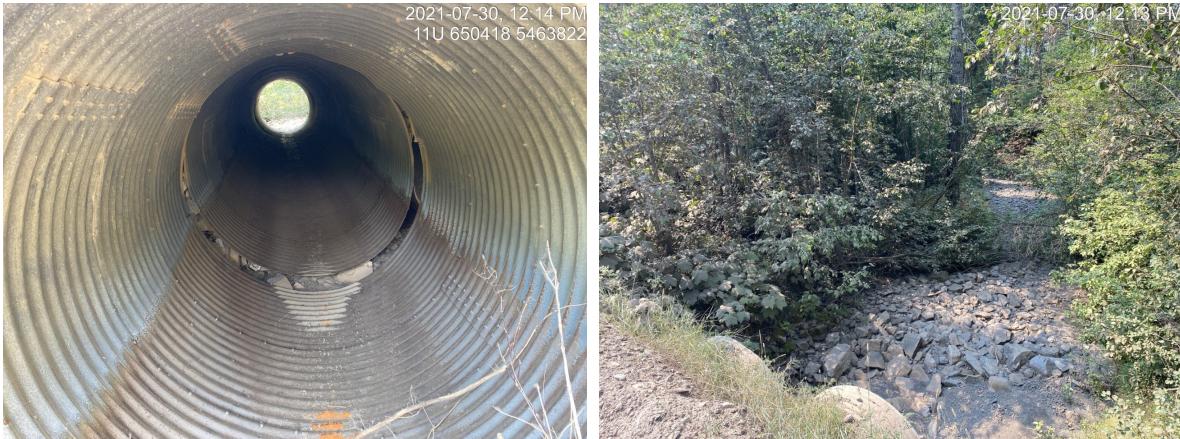
Figure 5.13: Left: Damage within PSCIS crossing 197793. Right: Habitat downstream of crossing 197793.

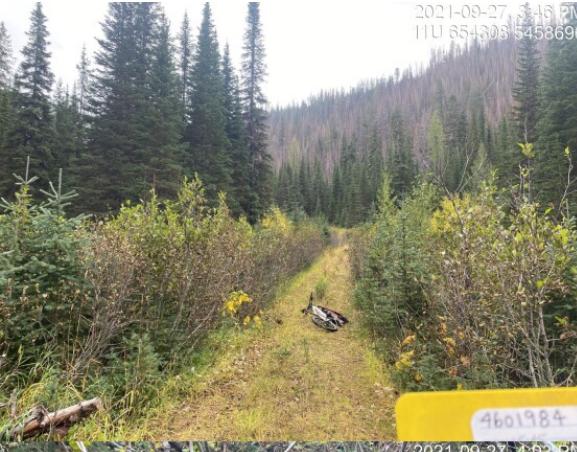
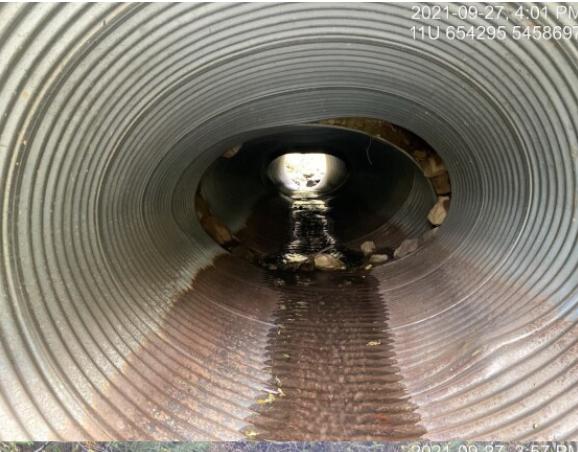
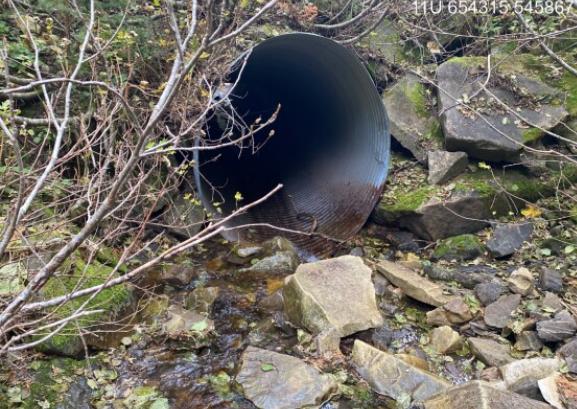
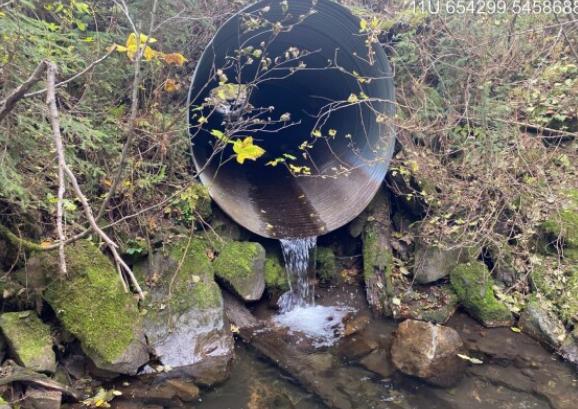
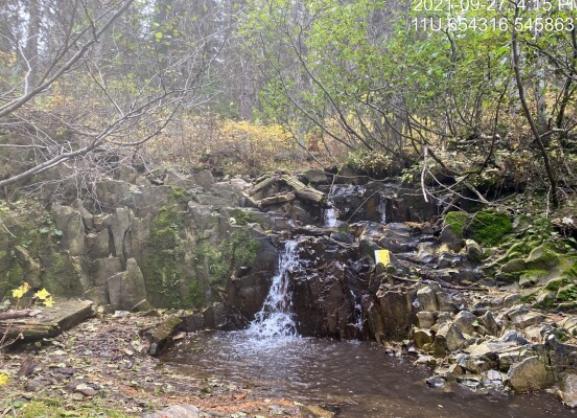
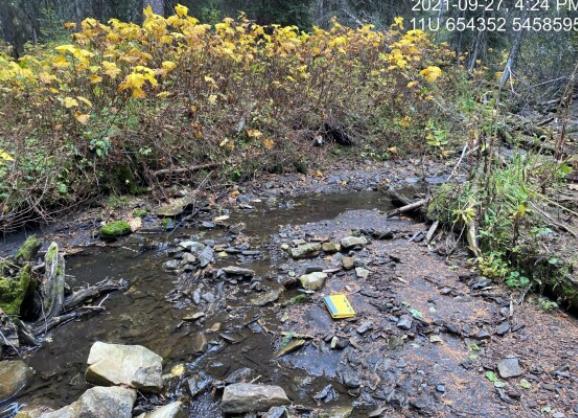
At the time of the survey, the culvert was un-embedded, non-backwatered and ranked as a barrier to upstream fish passage according to the provincial protocol (MoE 2011b). The pipe was extensively damaged (separating within the centre of the road), 1.6m in diameter with a length of 14m, a culvert slope of 5%, a stream width ratio of 2.4 and an outlet drop of 0.6m (Table 5.26).

Location and Stream Data	Crossing Characteristics
Comments: Gated access management area. Falls located ~60m upstream of the crossing. 15:45

Should restoration/maintenance activities proceed at the site, replacement of PSCIS crossing 197796 with a bridge (12m span) is recommended. The cost of the work is estimated at \$240,000 for a cost benefit of 0.2 linear m/\$1000 and 0.9m²/\$1000.

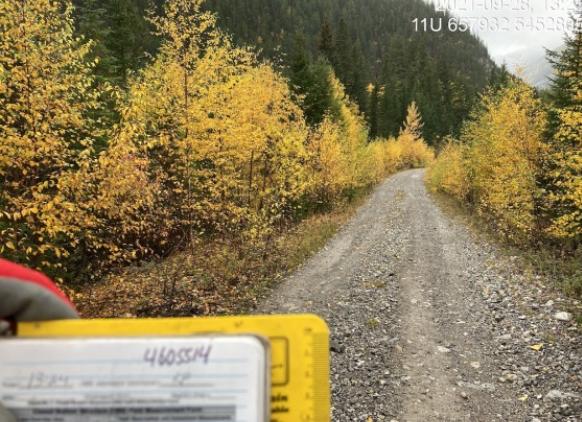
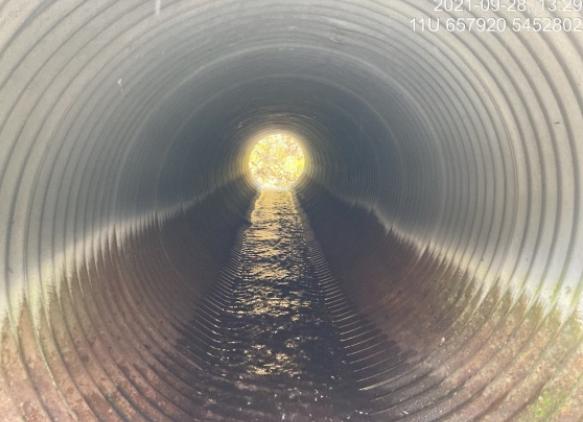
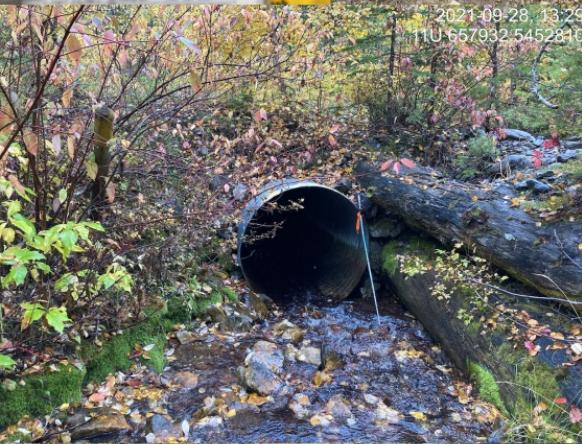
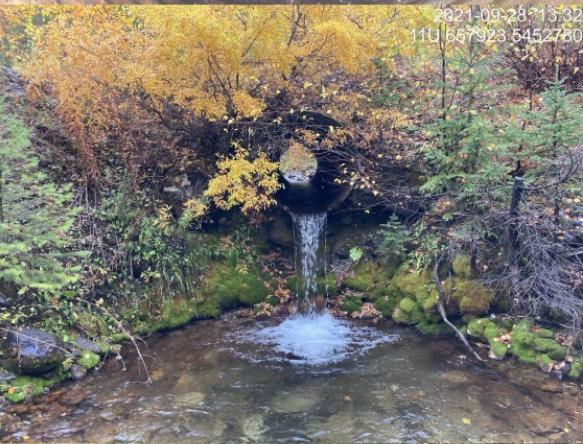
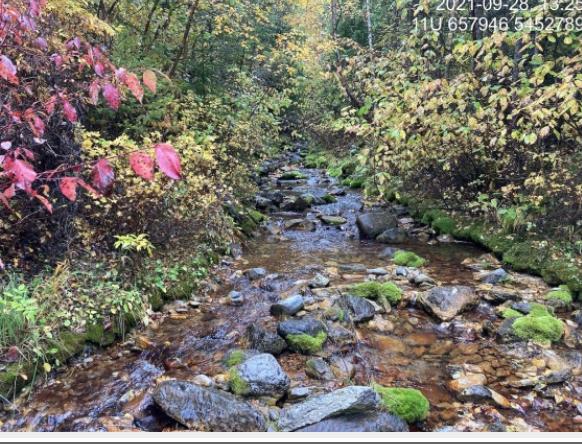
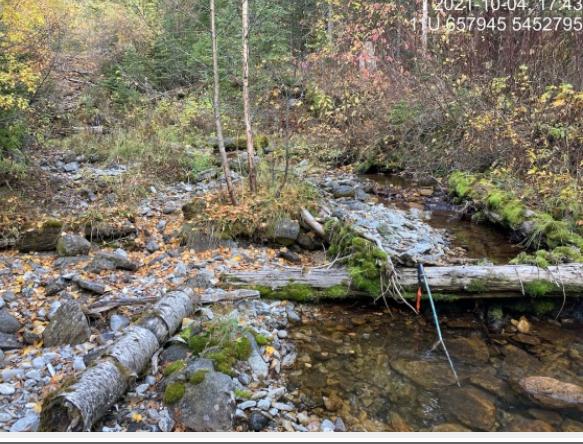
Location and Stream Data	.	Crossing Characteristics	-
Beaver Activity	No	Slope (%)	5
Habitat Value	Medium	Valley Fill	Deep Fill
Final score	36	Barrier Result	Barrier
Fix type	Replace with New Open Bottom Structure	Fix Span / Diameter	12
Comments:	Cobble substrate and abundant overhanging vegetation. Decent sized stream. 13:24		
Photos:	From top left clockwise: Road/Site Card, Barrel, Outlet, Downstream, Upstream, Inlet.

Should restoration/maintenance activities proceed at the site, replacement of PSCIS crossing 197844 with a bridge (12m span) is recommended. The cost of the work is estimated at \$240,000 for a cost benefit of 12.5 linear m/\$1000 and 41.2m²/\$1000.

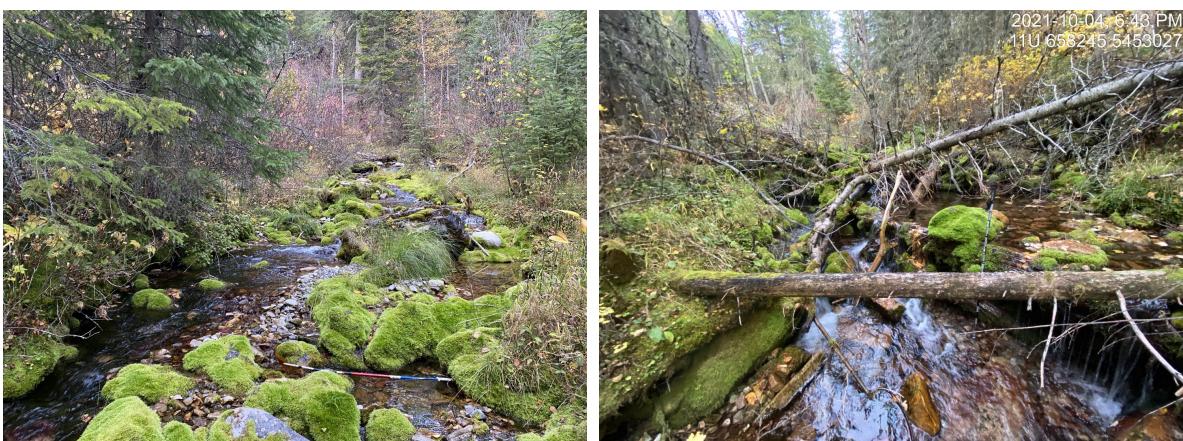
Figure 5.18: Left: Habitat upstream of PSCIS crossing 197844. Right: Habitat upstream of PSCIS crossing 197844.
