Elk River Watershed Group Fish Passage Restoration Planning 2021

**Prepared for
Nupqua Resource Limited Partnership**

**Prepared by
Al Irvine, B.Sc., R.P.Bio.
New Graph Environment Ltd.**

**Version 1.0.1
2022-03-25**

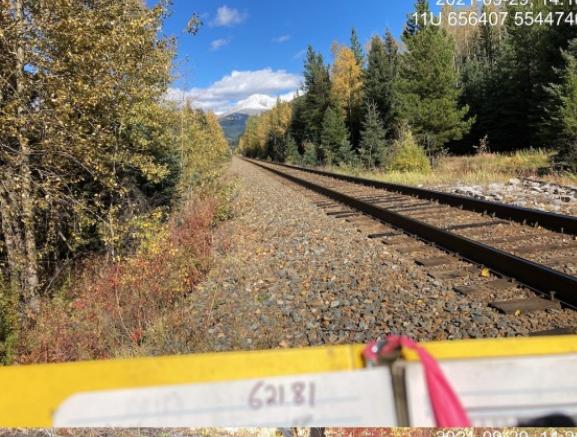
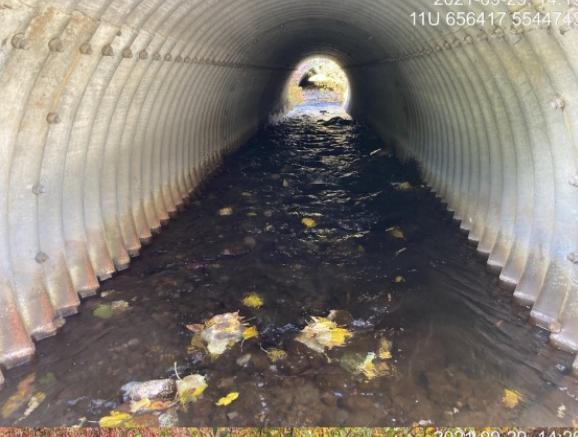
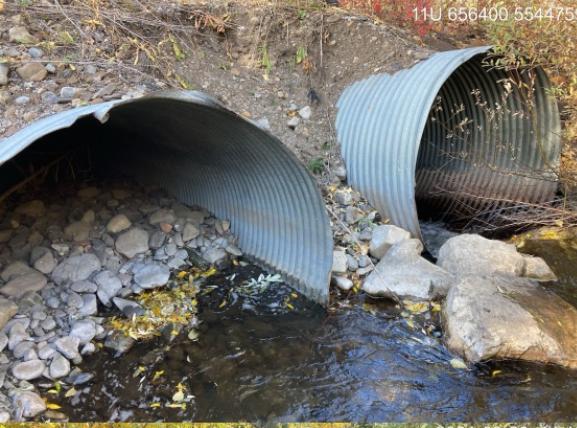
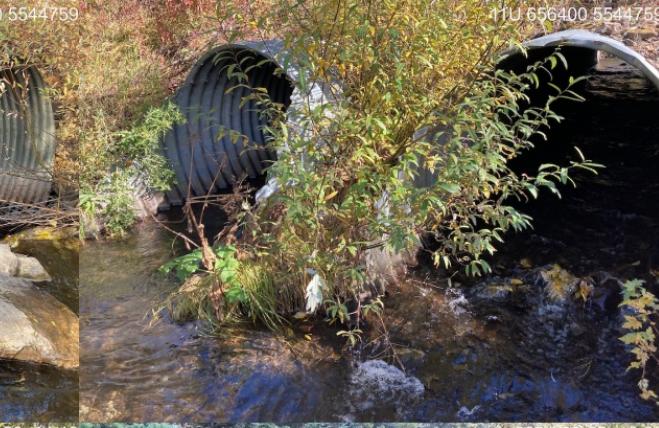
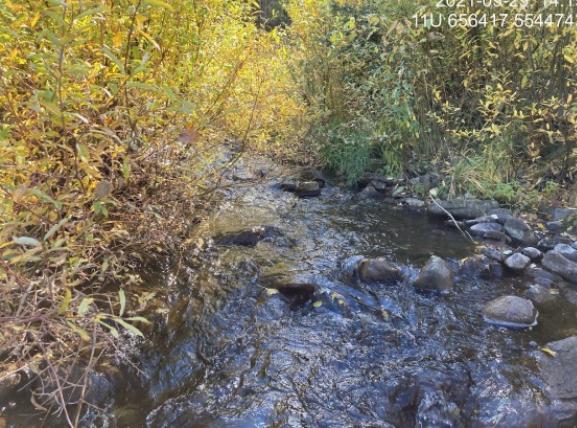
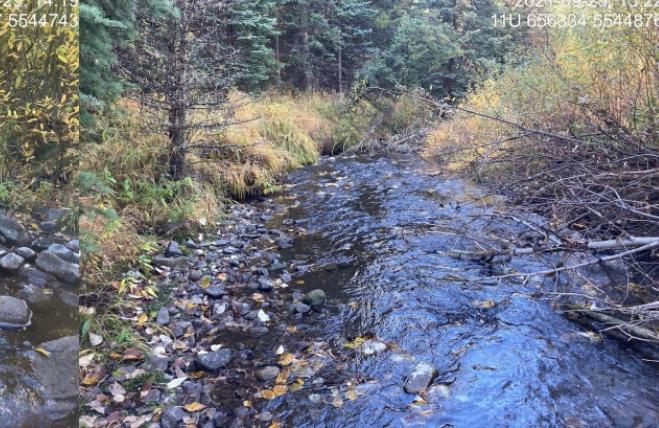
Location and Stream Data	Crossing Characteristics
Comments: Two pipes (1.8m x 1.8m). Left pipe was measured. Right pipe gradient ~3%. Right pipe partially embedded.

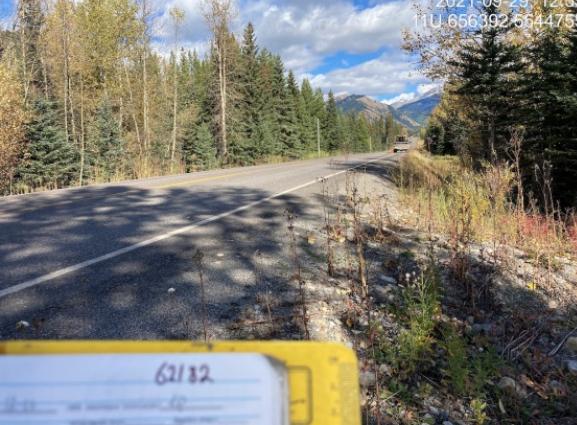
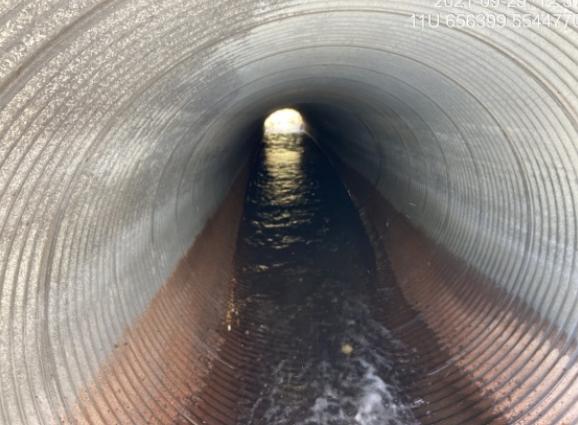
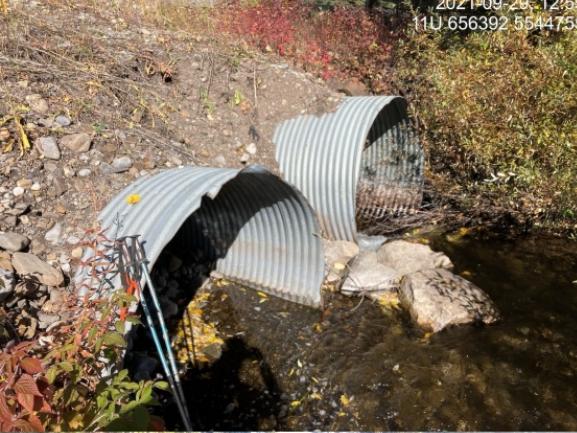
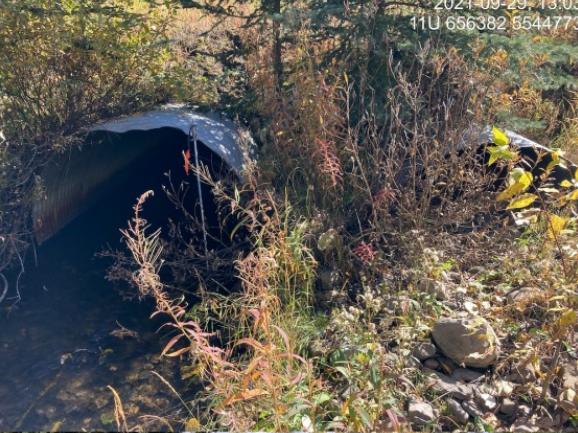
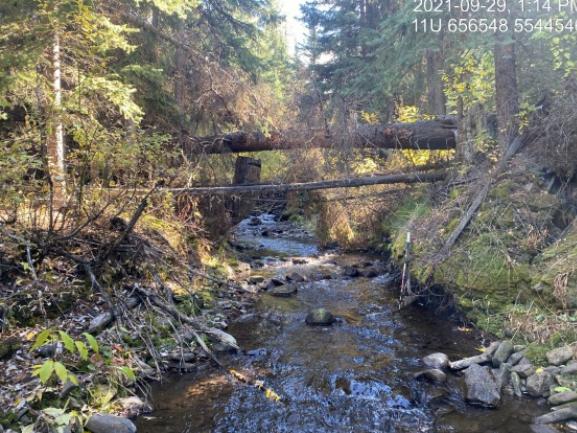
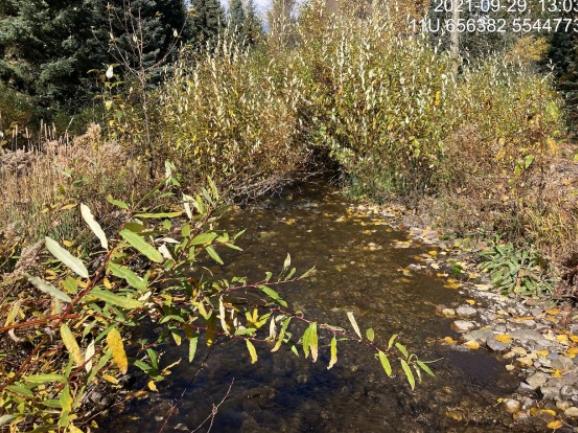
Location and Stream Data	• Crossing Characteristics	-
Comments: Two pipes (1.8m x 1.8m). Stream left pipe embedd at outlet 0.6m but not at inlet and there is a significant inlet drop. PSCIS crossing 62182 is located ~30m upstream of the crossing under the railway. 12:50

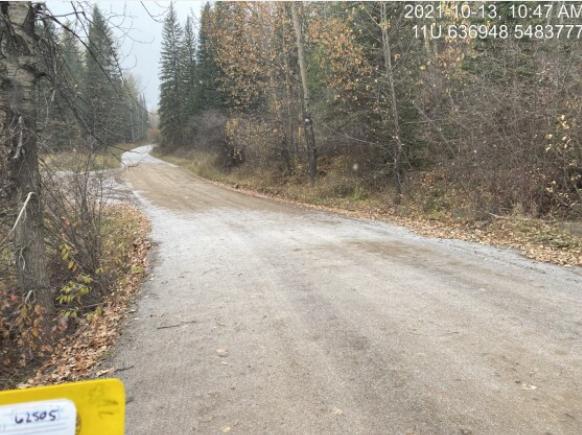
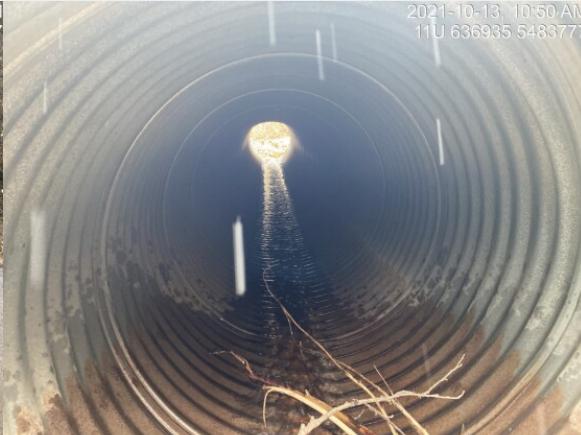
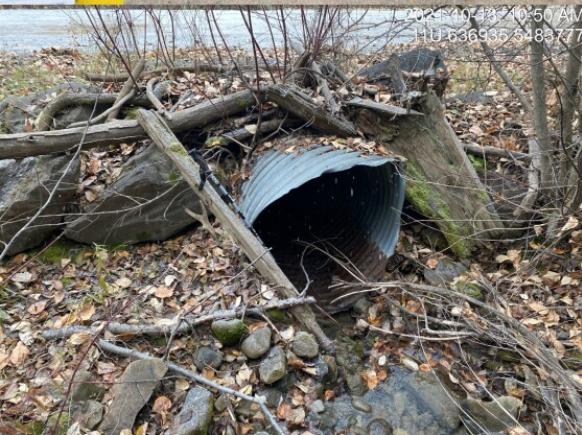
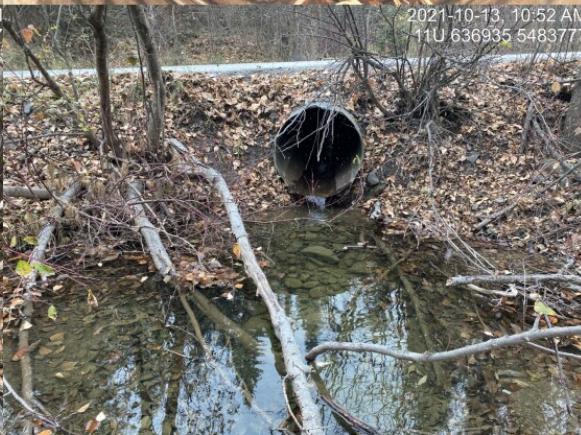
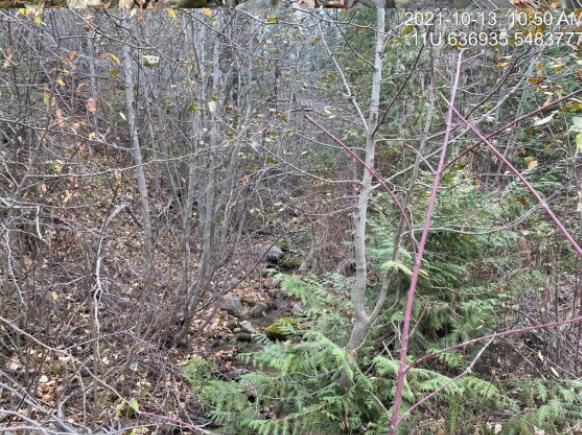
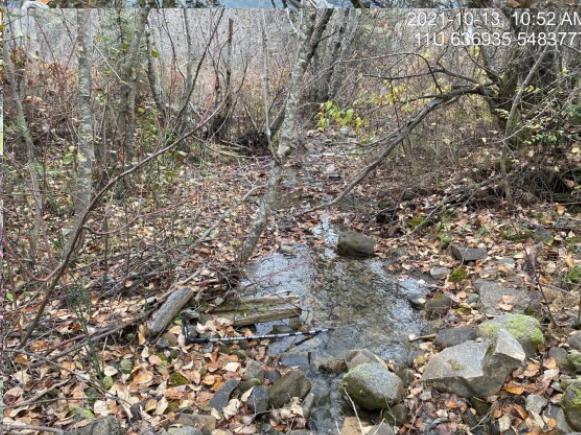
Location and Stream Data	.	Crossing Characteristics	-
Beaver Activity	No	Slope (%)	5
Habitat Value	Medium	Valley Fill	Deep Fill
Final score	31	Barrier Result	Barrier
Fix type	Replace with New Open Bottom Structure	Fix Span / Diameter	12
Comments:	Very close to Lizard Creek mainstem. 10:43		
Photos:	From top left clockwise: Road/Site Card, Barrel, Outlet, Downstream, Upstream, Inlet.

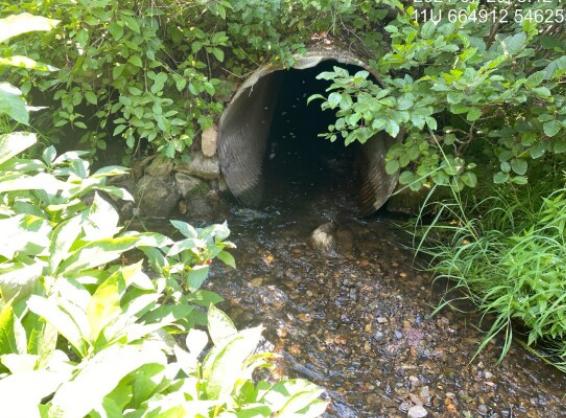
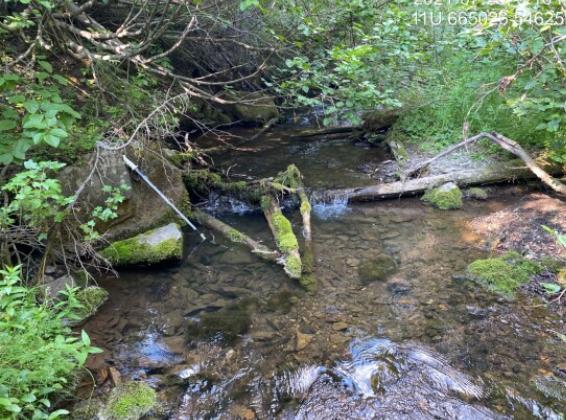
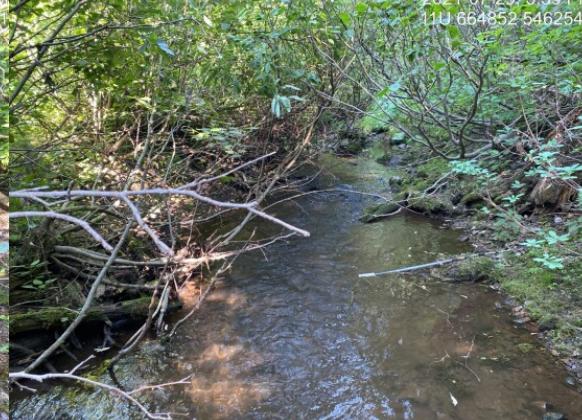
Location and Stream Data		Crossing Characteristics –	
Channel Width (m)	3.26	Outlet Pool Depth (m)	0.1
Stream Slope (%)	2.8	Inlet Drop	Yes
Beaver Activity	Yes	Slope (%)	0.5
Habitat Value	Medium	Valley Fill	Deep Fill
Final score	19	Barrier Result	Potential
Fix type	Replace with New Open Bottom Structure	Fix Span / Diameter	12
Photos: From top left clockwise: Road/Site Card, Barrel, Outlet, Downstream, Upstream, Inlet.

Location and Stream Data	• Crossing Characteristics	-
<p>Comments: Two pipes (1m each) but one blocked with debris. Because height of outlets equivalent widths were added together for input to stream width ratio. Large beaver dams upstream between culvert and Lodgepole Lake. 15:37</p>

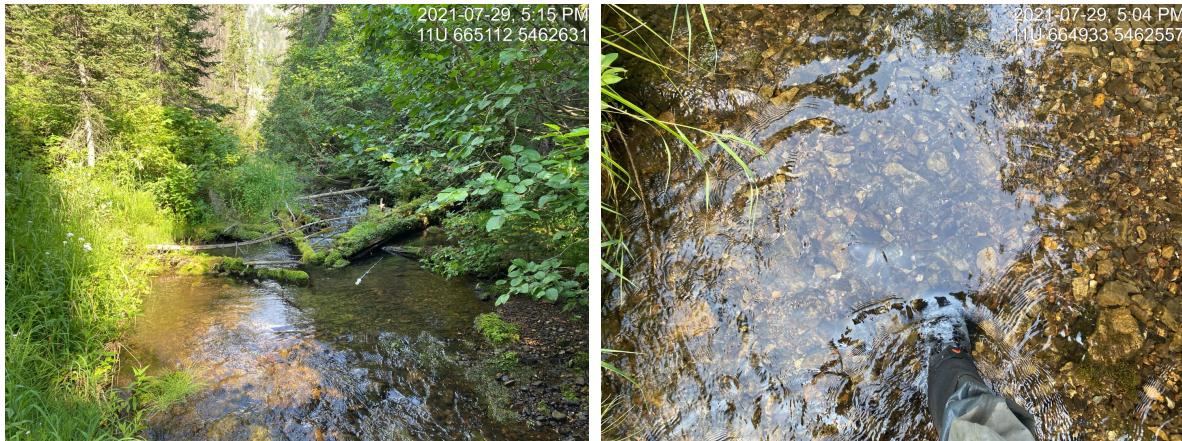
Figure 5.9: Left: Typical habitat upstream of PSCIS crossing 197787. Right: Gravels suitable for spawning located upstream of PSCIS crossing 197787.

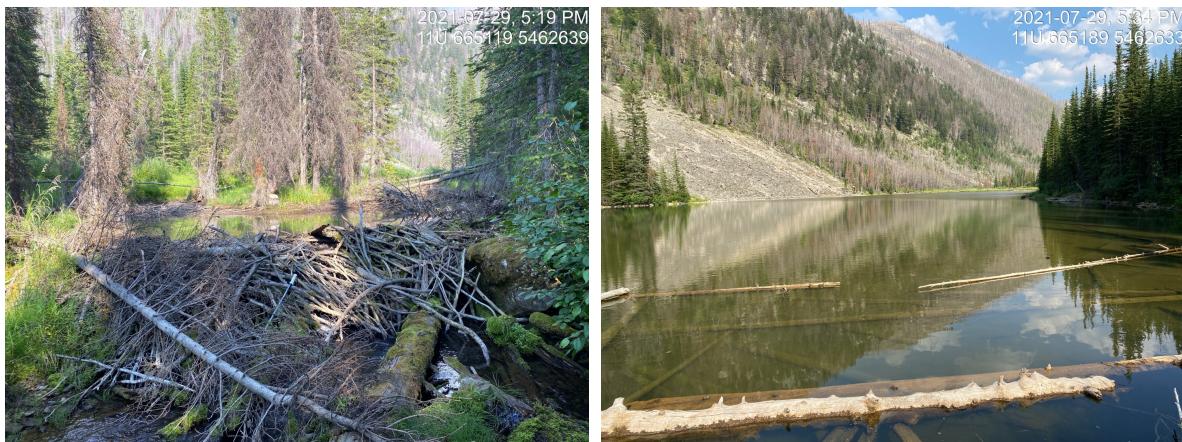
Figure 5.10: Left: Beaver dam located upstream of PSCIS crossing 197787 and just below Lodgepole Lake. Right: Lodgepole Lake located upstream of PSCIS crossing 197787.

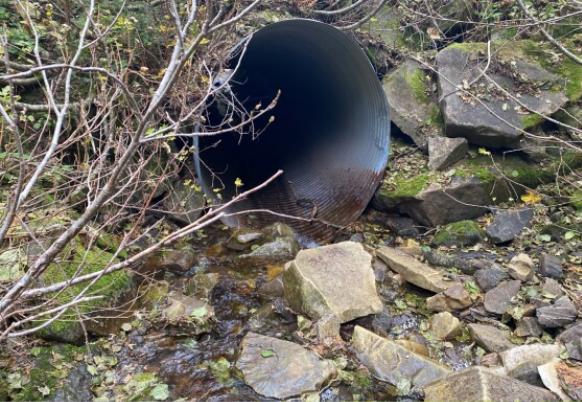
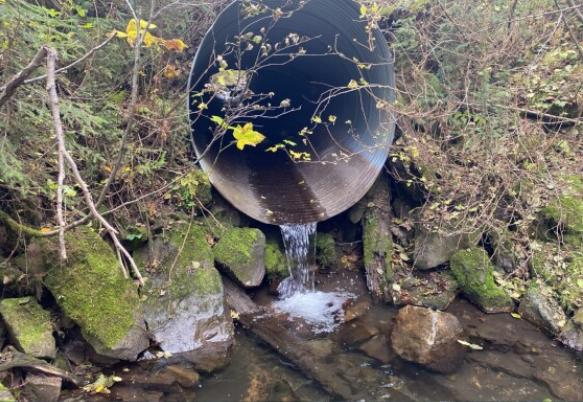
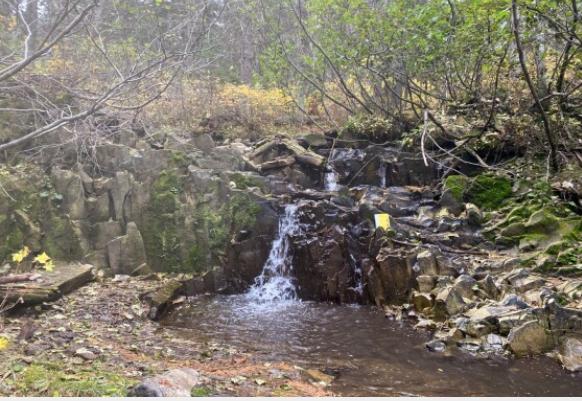
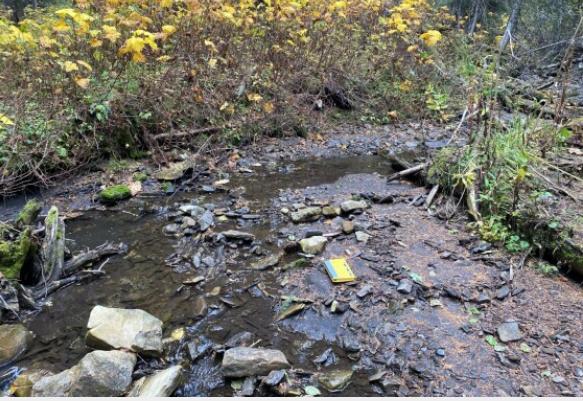
At the time of the survey, the culvert was un-embedded, non-backwatered and ranked as a barrier to upstream fish passage according to the provincial protocol (MoE 2011b). The pipe was extensively damaged (separating within the centre of the road), 1.6m in diameter with a length of 14m, a culvert slope of 5%, a stream width ratio of 2.4 and an outlet drop of 0.6m (Table 5.26).

Location and Stream Data	•	Crossing Characteristics	-
Comments: Gated access management area. Falls located ~60m upstream of the crossing. 15:45

Should restoration/maintenance activities proceed at the site, replacement of PSCIS crossing 197796 with a bridge (12m span) is recommended. The cost of the work is estimated at \$240,000 for a cost benefit of 0.2 linear m/\$1000 and 0.9m²/\$1000.
