DRAFT - Elk River Watershed Group Fish Passage Restoration Planning 2021

**Prepared for
Nupqua Resource Limited Partnership**

**Prepared by
Al Irvine, B.Sc., R.P.Bio.
New Graph Environment Ltd.**

**Version 0.1.3 - DRAFT
2022-03-12**

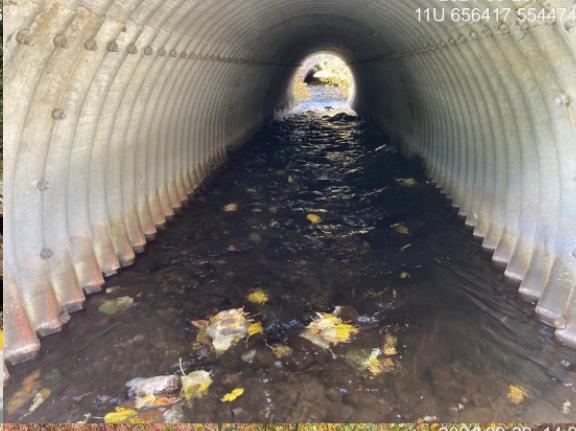
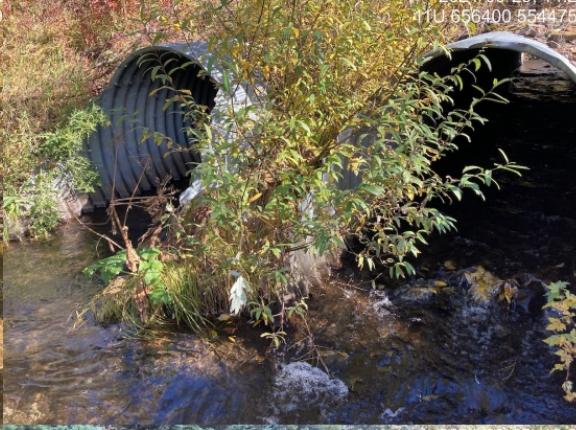
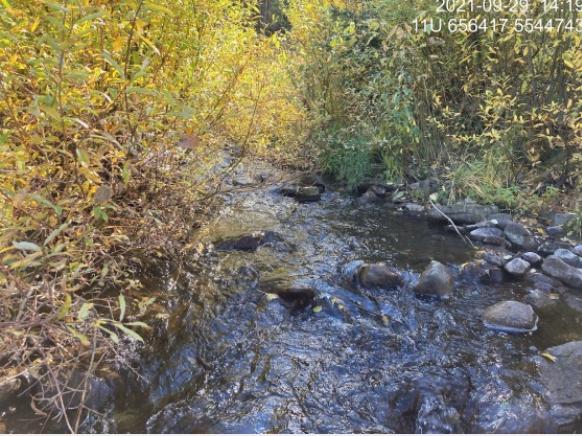
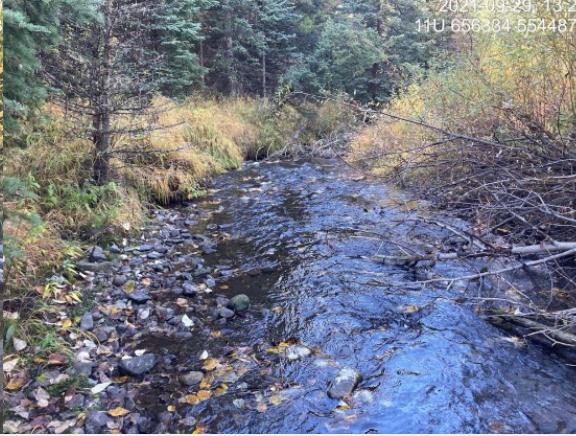
Location and Stream Data	Crossing Characteristics
<p>Comments: Two pipes (1.8m x 1.8m). Left pipe was measured. Right pipe gradient ~3%. Right pipe partially embedded.</p>	
<p>14:16</p>

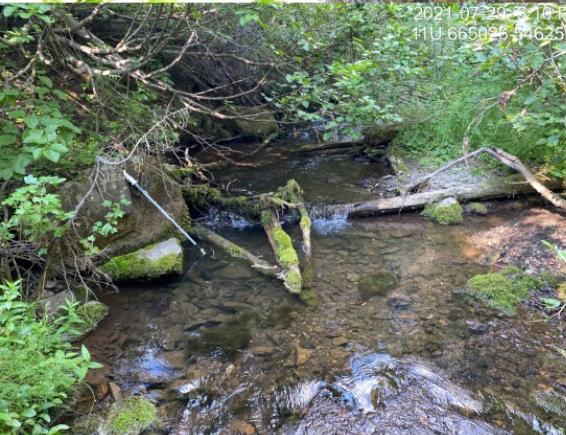
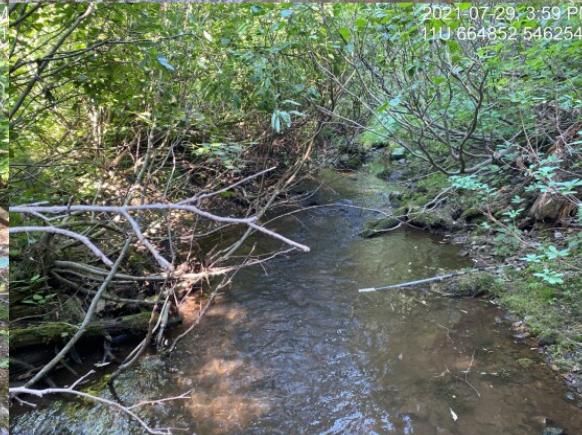
Location and Stream Data	• Crossing Characteristics	-
<p>Comments: Two pipes (1m each) but one blocked with debris. Because height of outlets equivalent widths were added together for input to stream width ratio. Large beaver dams upstream between culvert and Lodgepole Lake. 15:37</p>

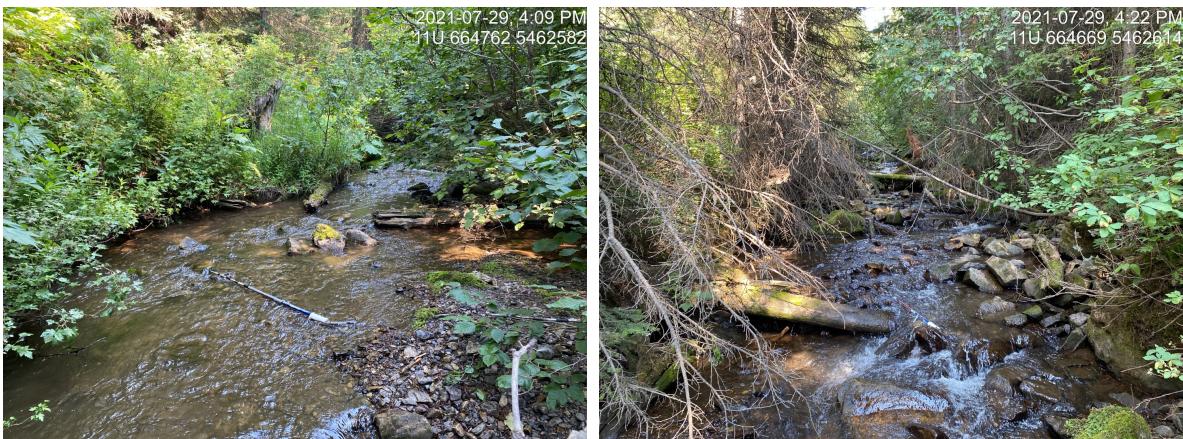
Figure 5.8: Left: Typical habitat downstream of PSCIS crossing 197787. Right: Typical habitat downstream of PSCIS crossing 197786.
