DRAFT - Elk River Watershed Group Fish Passage Restoration Planning 2021

**Prepared for
Nupqua Resource Limited Partnership**

**Prepared by
Al Irvine, B.Sc., R.P.Bio.
New Graph Environment Ltd.**

**Version 0.1.4 - DRAFT
2022-03-17**

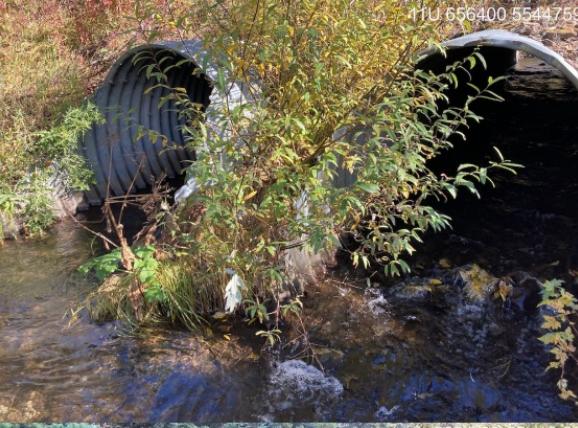
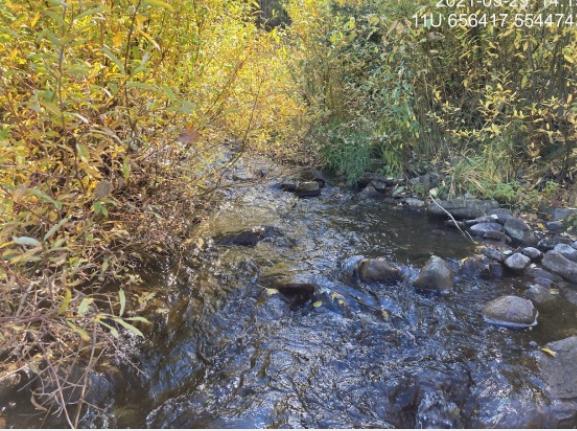
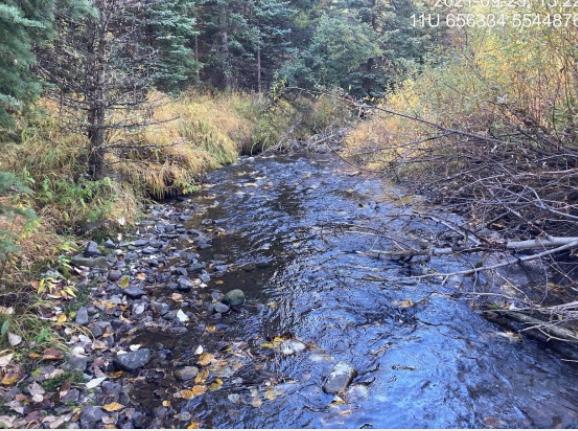
Location and Stream Data	Crossing Characteristics
Comments: Two pipes (1.8m x 1.8m). Left pipe was measured. Right pipe gradient ~3%. Right pipe partially embedded.	
14:16

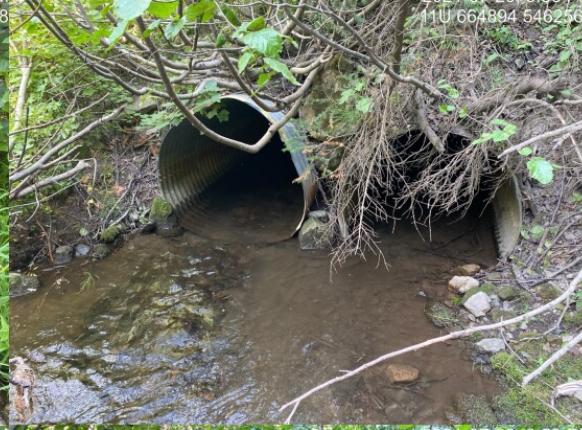
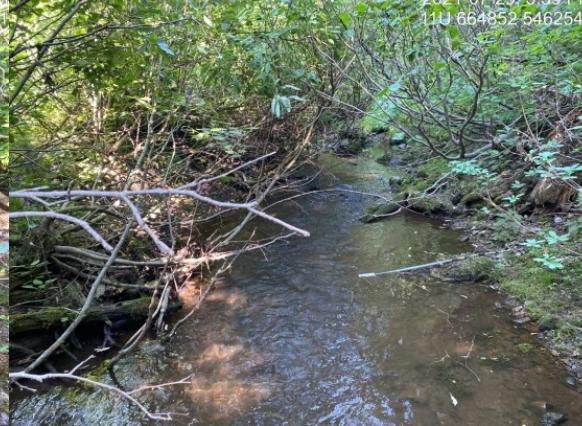
Location and Stream Data	• Crossing Characteristics	-
<p>Comments: Two pipes (1m each) but one blocked with debris. Because height of outlets equivalent widths were added together for input to stream width ratio. Large beaver dams upstream between culvert and Lodgepole Lake. 15:37</p>
