DRAFT - Elk River Watershed Group Fish Passage Restoration Planning 2021

**Prepared for
Nupqua Limited Partnership**

**Prepared by
Al Irvine, B.Sc., R.P.Bio.
New Graph Environment Ltd.**

**Version 0.1.1 - DRAFT
2022-03-11**

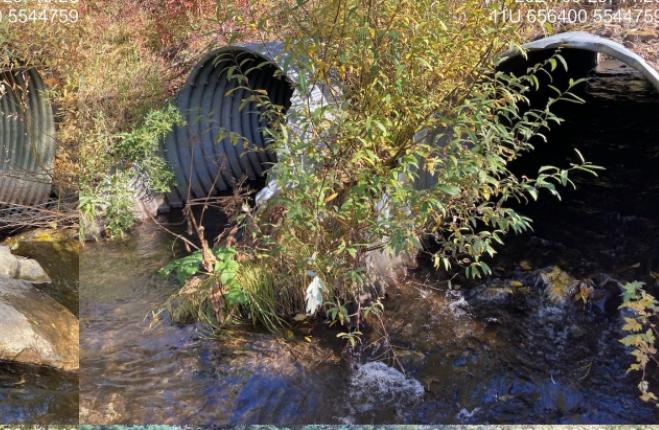
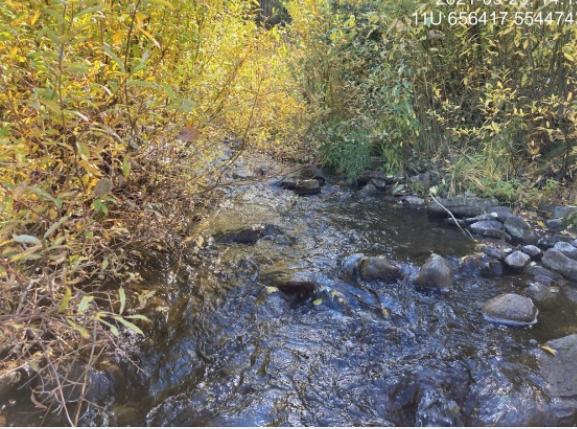
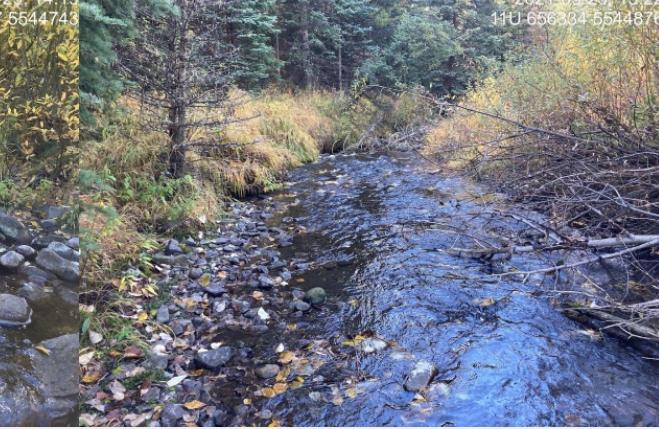
Location and Stream Data	Crossing Characteristics
Comments: Two pipes (1.8m x 1.8m). Left pipe was measured. Right pipe gradient ~3%. Right pipe partially embedded.

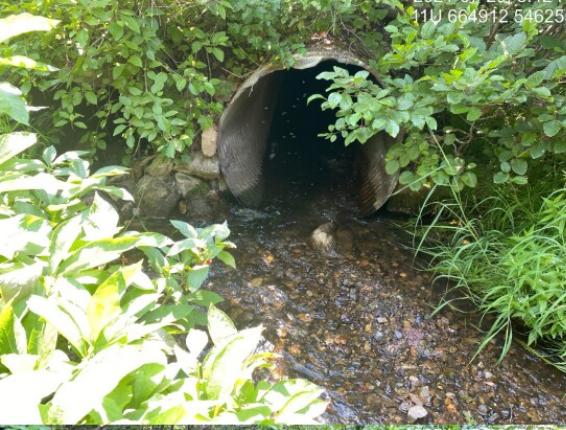
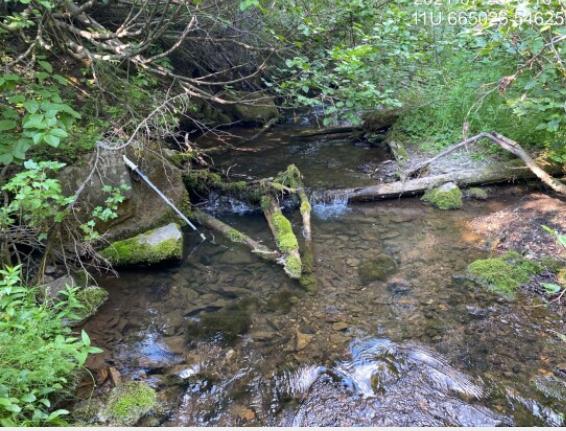
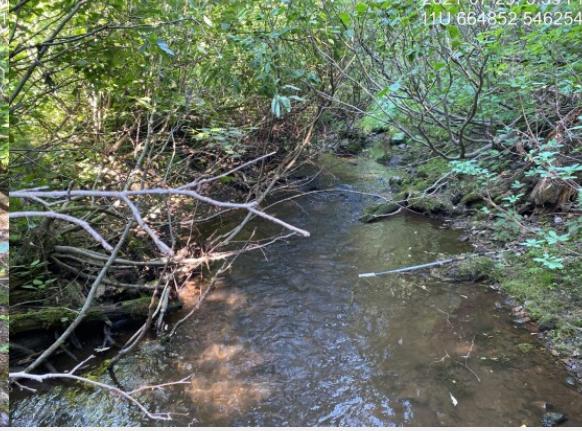
Location and Stream Data	• Crossing Characteristics	-
<p>Comments: Two pipes (1m each) but one blocked with debris. Because height of outlets equivalent widths were added together for input to stream width ratio. Large beaver dams upstream between culvert and Lodgepole Lake. 15:37</p>

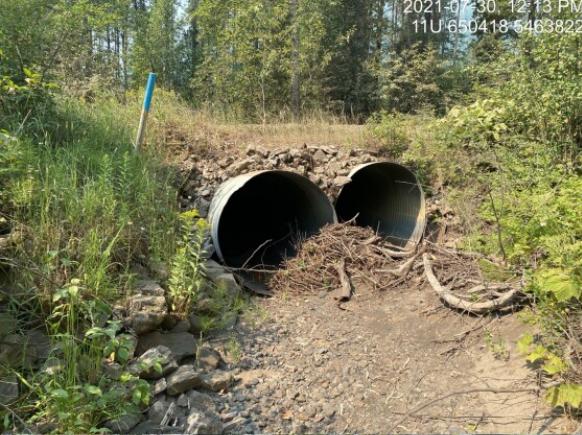
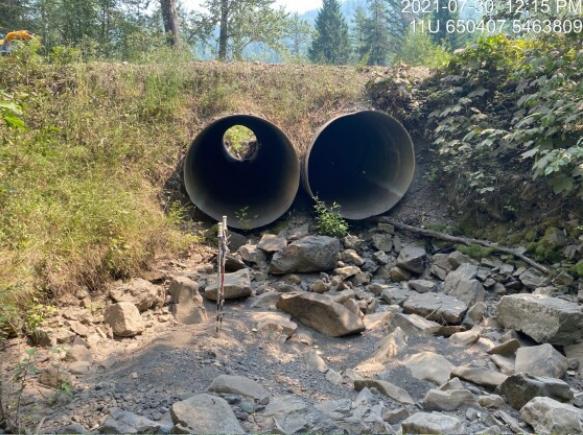
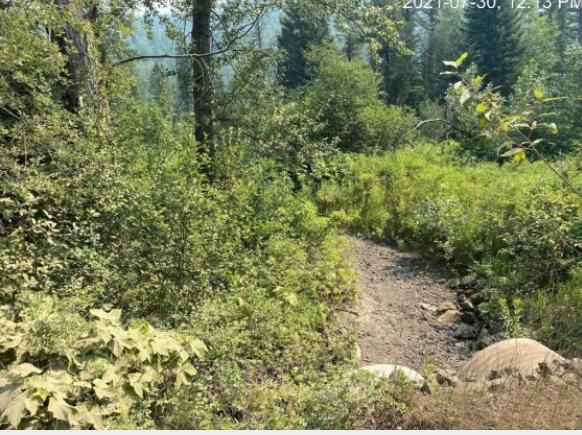
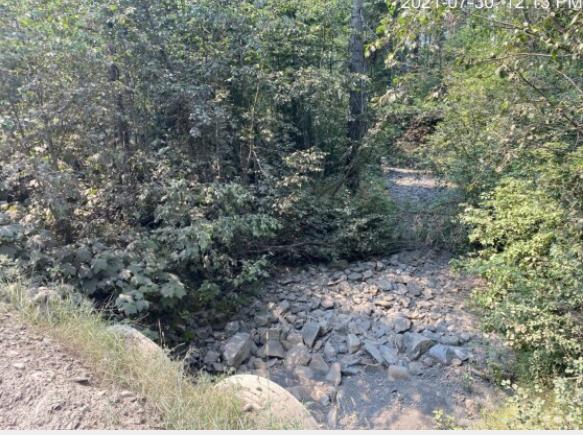
Appendix - 197793 - Bean Creek

At the time of the survey, the two culverts under Lodgepole FSR were un-embedded, non-backwatered and ranked as a barrier to upstream fish passage according to the provincial protocol (MoE 2011b). The pipes were 1.5m in diameter with lengths of 14m, a culvert slope of 2.5%, a stream width ratio of 3.5 and an outlet drop of 0m (Table 5.22). Significant damage to the crossing was apparent with the pipe split vertically through the entire culvert near the centre of the southern most pipe (Figure 5.13). The stream was completely dry at the time of the survey and the freshwater atlas stream layer indicates intermittent flow (FLNRORD 2021). Of note, the culverts are located approximately 840m upstream from the confluence with a tributary to Bean Creek and a bridge of stream of the confluence (PSCIS 197792) was assessed on this tributary. The tributary was flowing at the bridge site at the time of the survey (2021-07-30).

A conservative estimate of mainstem habitat upstream of crossing 197793 is 1.8km. Habitat in the areas surveyed upstream of the culvert were rated as low value for salmonid rearing and spawning due to likely annual seasonal dewatering within the rocky south-west facing watershed. Lodgepole FSR is the responsibility of the Ministry of Forests, Lands, Natural Resource Operations and Rural Development - Rocky Mountain Forest District. Crossing 197793 was ranked as a low priority for proceeding to design for replacement.

Location and Stream Data	.	Crossing Characteristics	-
Beaver Activity	No	Slope (%)	2.5
Habitat Value	Low	Valley Fill	Deep Fill
Final score	21	Barrier Result	Barrier
Fix type	Replace with New Open Bottom Structure	Fix Span / Diameter	12
Comments:	Large channel but stream is completely dry. 12:11		
Photos:	From top left clockwise: Road/Site Card, Barrel, Outlet, Downstream, Upstream, Inlet.

Should restoration/maintenance activities proceed at the site, replacement of PSCIS crossing 197793 with a bridge (12m span) is recommended. The cost of the work is estimated at \$240,000 for a cost benefit of 7.5 linear m/\$1000 and 39.8m²/\$1000.

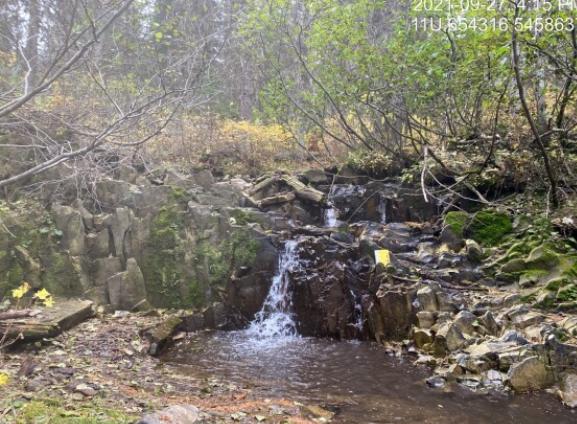
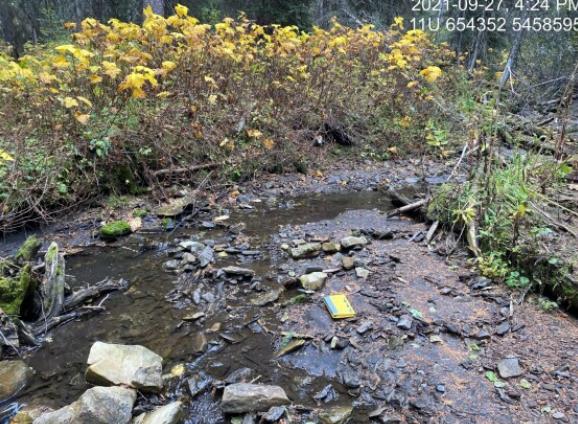
At the time of the survey, the culvert was un-embedded, non-backwatered and ranked as a barrier to upstream fish passage according to the provincial protocol (MoE 2011b). The pipe was extensively damaged (separating within the centre of the road), 1.6m in diameter with a length of 14m, a culvert slope of 5%, a stream width ratio of 2.4 and an outlet drop of 0.6m (Table 5.26).

There was 197796 is 0.1km of habitat upstream of crossing rated as low value for salmonid rearing and spawning. Although unconfirmed, this road within the Wigwam Flats - Mt. Broadwood/Sportsmans Ridge access management area is likely the responsibility of the Ministry of Forests, Lands, Natural Resource Operations and Rural Development - Rocky Mountain Forest District. Crossing 197796 was observed to have extensive damage within the structure and was ranked as a low priority for proceeding to design for replacement. The site could also be considered for removal and road deactivation once silviculture obligations have been met in the area.

Location and Stream Data	.	Crossing Characteristics –	
Date	2021-09-27	Crossing Sub Type	Round Culvert
PSCIS ID	197796	Diameter (m)	1.6
External ID	–	Length (m)	14
Crew	AI	Embedded	No
UTM Zone	11	Depth Embedded (m)	–
Easting	654301.7	Resemble Channel	No
Northing	5458678	Backwatered	No
Stream	Tributary to Lodgepole Creek	Percent Backwatered	–
Road	Spur	Fill Depth (m)	2
Road Tenure	Unclassified	Outlet Drop (m)	0.6
Channel Width (m)	3.8	Outlet Pool Depth (m)	0.8
Stream Slope (%)	8.5	Inlet Drop	Yes
Beaver Activity	No	Slope (%)	5
Habitat Value	Low	Valley Fill	Deep Fill
Final score	36	Barrier Result	Barrier
Fix type	Replace with New Open Bottom Structure	Fix Span / Diameter	12
Photos: From top left clockwise: Road/Site Card, Barrel, Outlet, Downstream, Upstream, Inlet.

Location and Stream Data	Crossing Characteristics
Comments: Gated access management area. Falls located ~60m upstream of the crossing. 15:45

Should restoration/maintenance activities proceed at the site, replacement of PSCIS crossing 197796 with a bridge (12m span) is recommended. The cost of the work is estimated at \$240,000 for a cost benefit of 0.2 linear m/\$1000 and 0.9m²/\$1000.
