## Appendix - Phase 1 Fish Passage Assessment Data and Photos

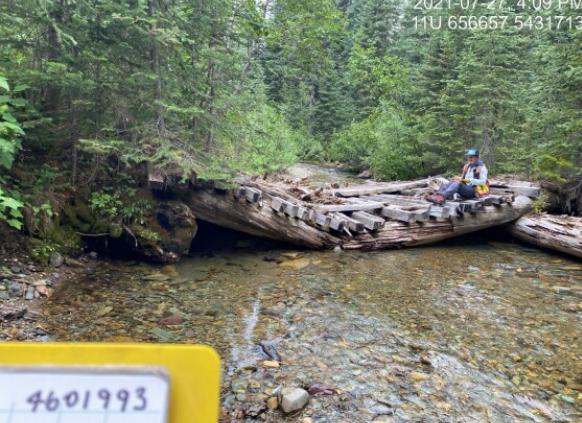
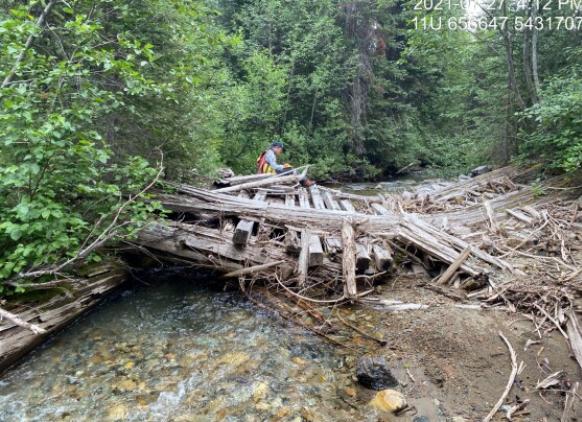
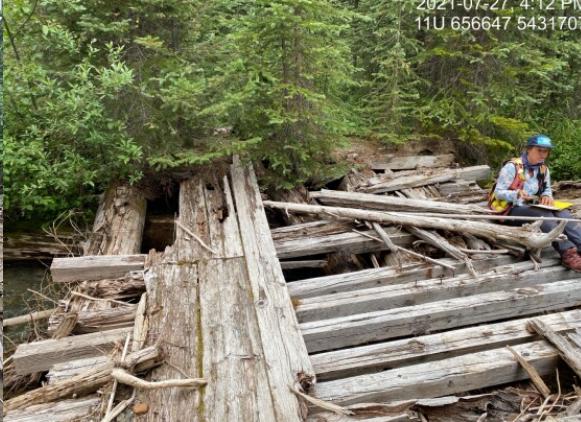
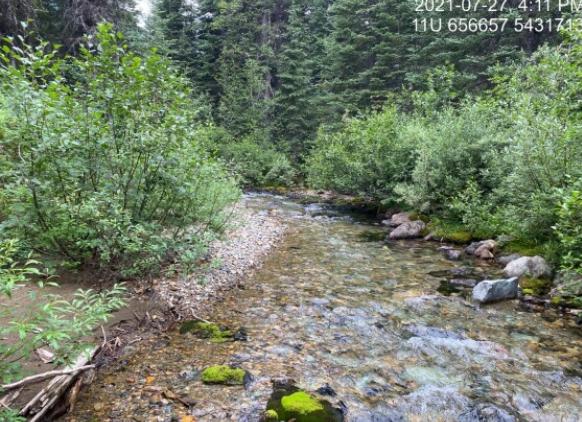
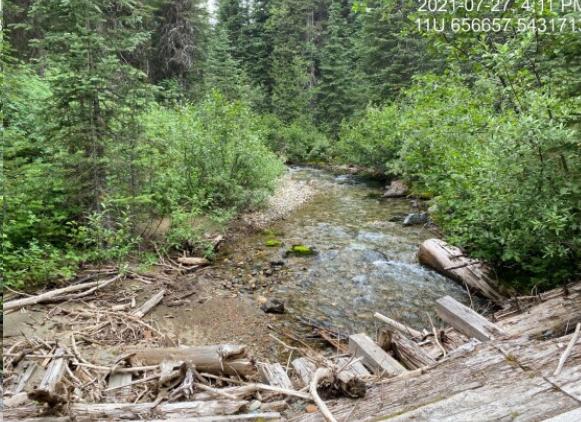
Location and Stream Data	•	Crossing Characteristics	-
Photos: PSCIS ID 197780. From top left clockwise: Road/Site Card, Barrel, Outlet, Downstream, Upstream, Inlet.

Comments: Bridge has collapsed but is not blocking channel. 16:08

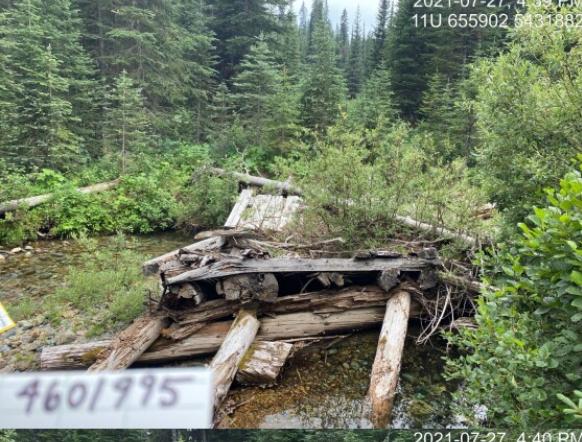
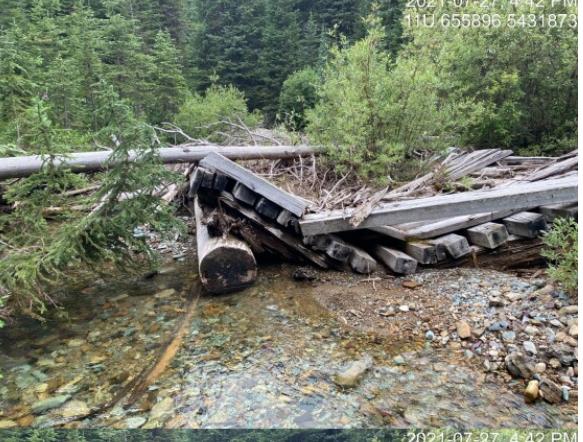
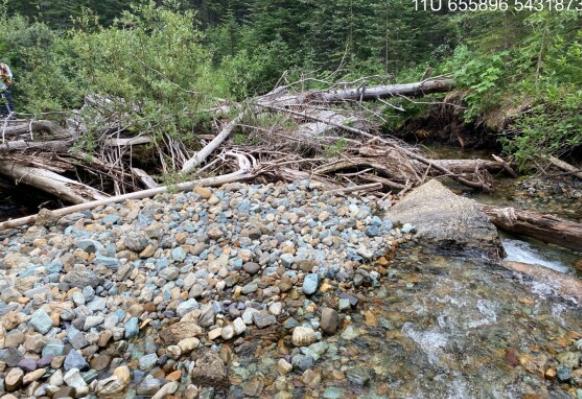
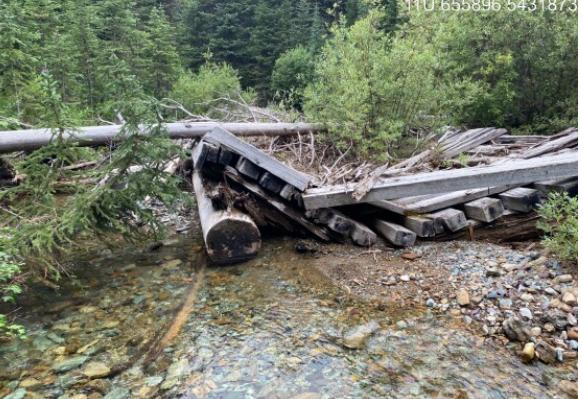
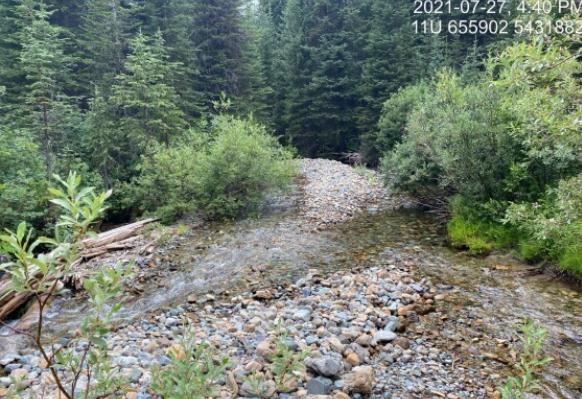
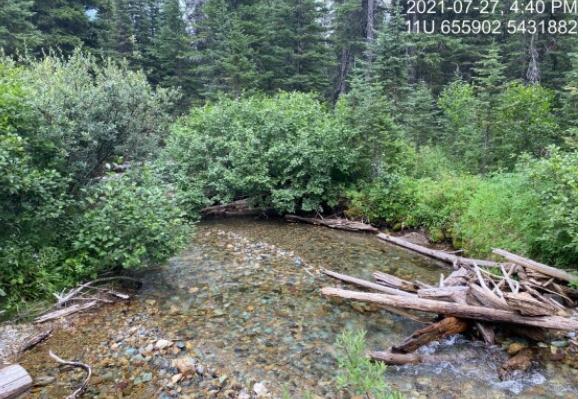
Location and Stream Data	Crossing Characteristics
Photos: PSCIS ID 197781. From top left clockwise: Road/Site Card, Barrel, Outlet, Downstream, Upstream, Inlet.

2021-07-27, 4:40 PM 11U 655902 5431882
Comments: Bridge has collapsed but is not blocking channel. 16:36

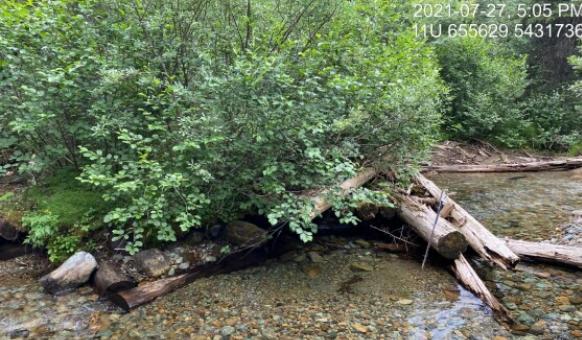
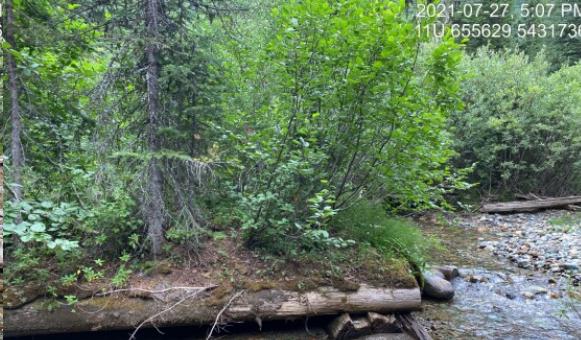
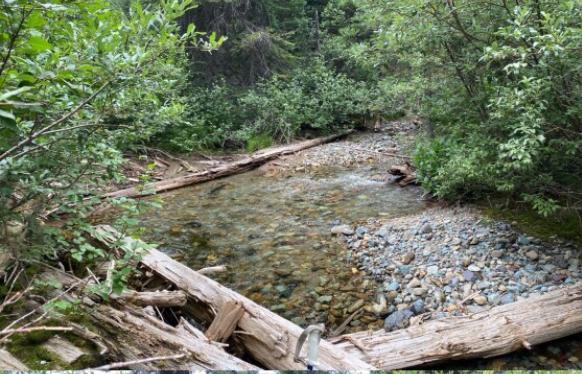
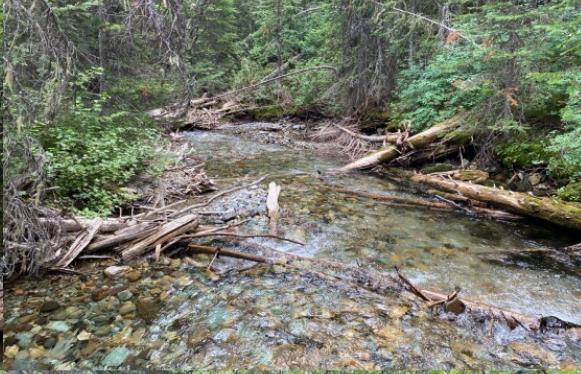
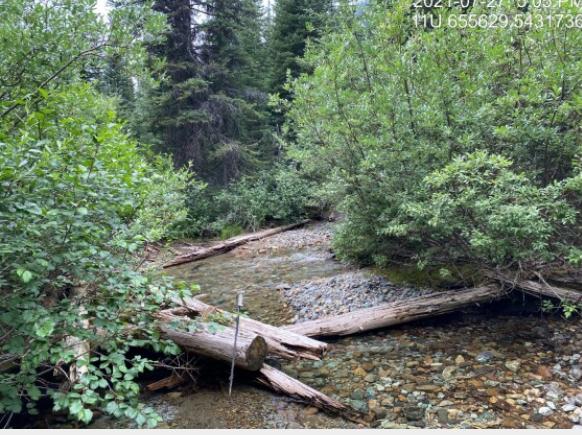
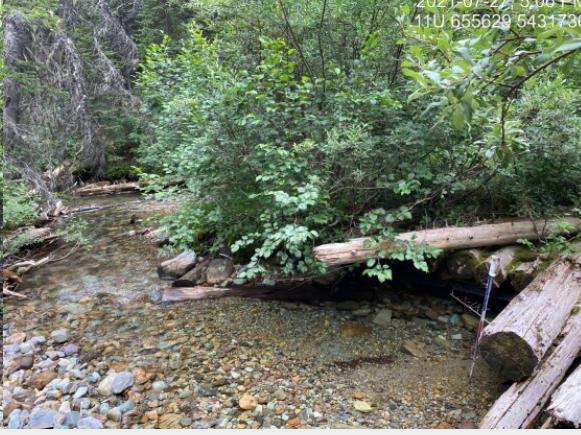
Location and Stream Data	Crossing Characteristics
Photos: PSCIS ID 197782. From top left clockwise: Road/Site Card, Barrel, Outlet, Downstream, Upstream, Inlet.

Comments: Bridge has collapsed but is not blocking channel. 16:59

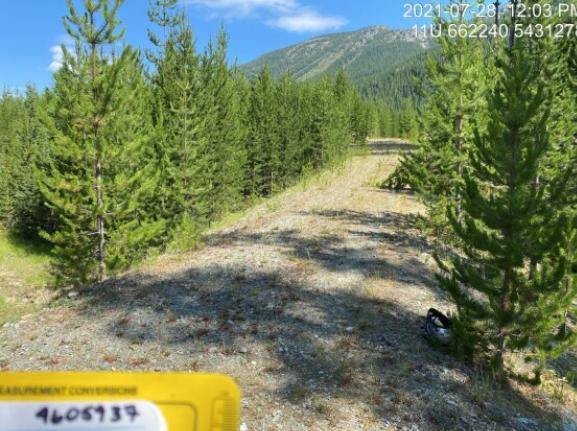
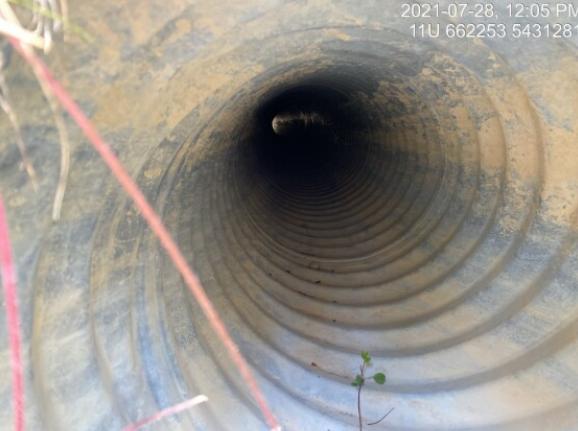
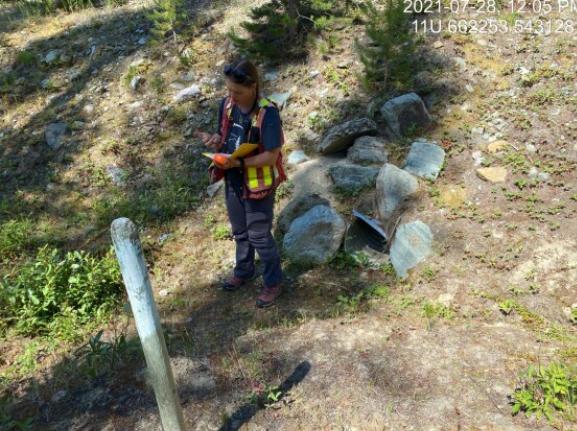
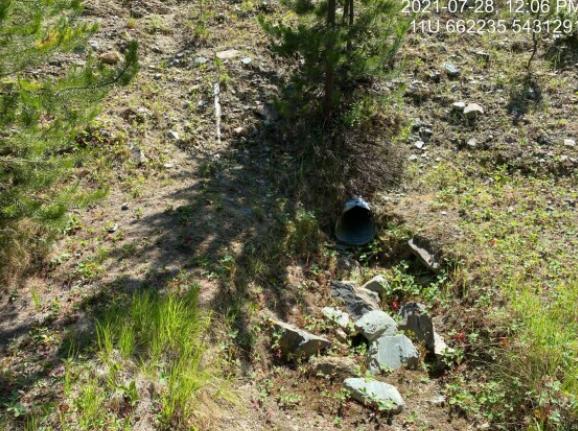
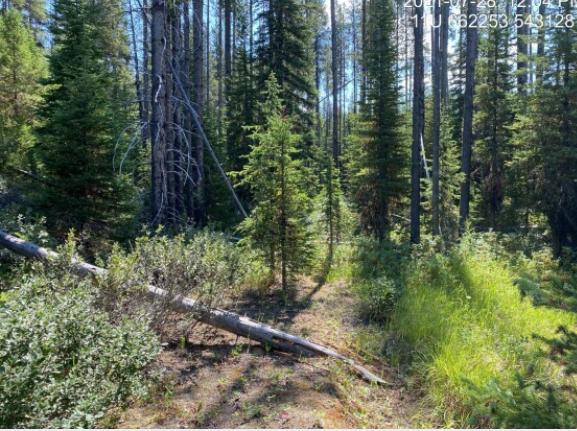
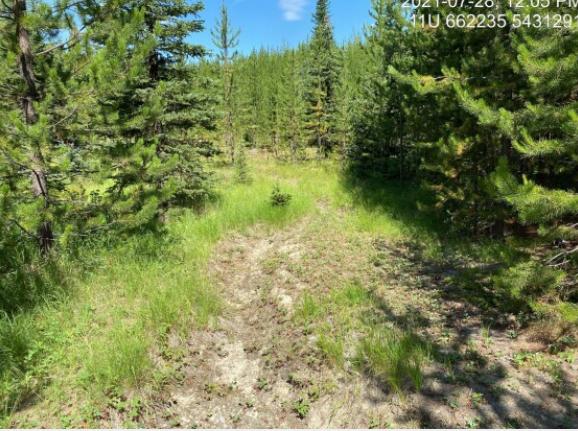
Location and Stream Data	Crossing Characteristics
Photos: PSCIS ID 197783. From top left clockwise: Road/Site Card, Barrel, Outlet, Downstream, Upstream, Inlet.

2021-07-28, 12:05 PM 11U 662235 5431291
Comments: Dry with poorly defined downstream channel. 12:03

Location and Stream Data		Crossing Characteristics	
Date	2021-07-28	Crossing Sub Type	Round Culvert
PSCIS ID	197783	Diameter (m)	0.4
External ID	4605937	Length (m)	12
Crew	AI TS	Embedded	No
UTM Zone	11	Depth Embedded (m)	–
Easting	662247	Resemble Channel	No
Northing	5431294	Backwatered	No
Stream	Tributary to Wigwam River	Percent Backwatered	–
Road	Wigwam FSR	Fill Depth (m)	2
Road Tenure	Canfor R08380	Outlet Drop (m)	0
Channel Width (m)	0.6	Outlet Pool Depth (m)	0
Stream Slope (%)	3.5	Inlet Drop	No
Beaver Activity	No	Slope (%)	1
Habitat Value	Low	Valley Fill	Deep Fill
Final score	21	Barrier Result	Barrier
Fix type	Replace Structure with Streambed Simulation CBS	Fix Span / Diameter	3

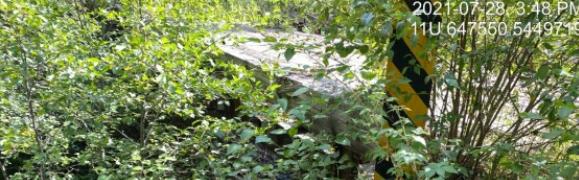
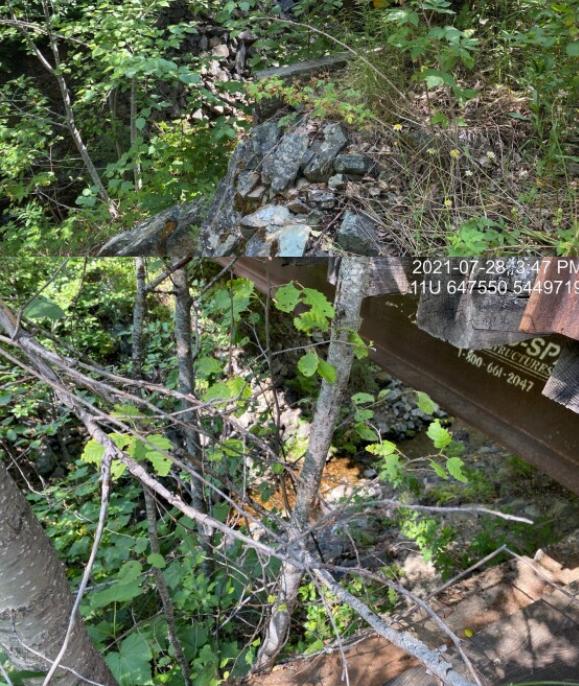
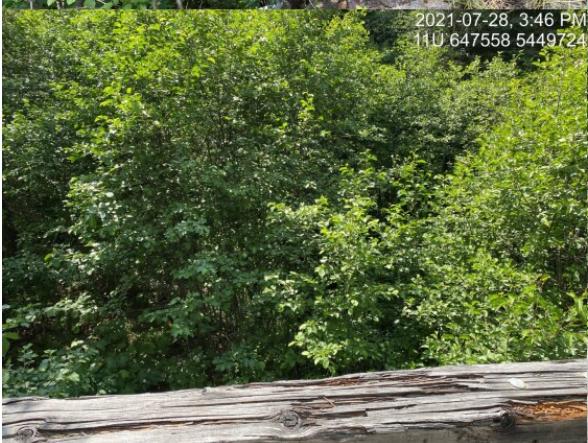
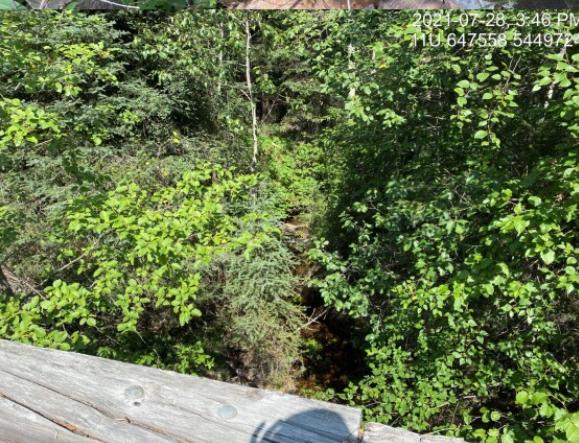
Location and Stream Data	•	Crossing Characteristics	-
Photos: PSCIS ID 197784. From top left clockwise: Road/Site Card, Barrel, Outlet, Downstream, Upstream, Inlet.

2021-07-28, 3:45 PM 11U 647558 5449724	
Comments: Suspect that this stream is mapped incorrectly. 15:41

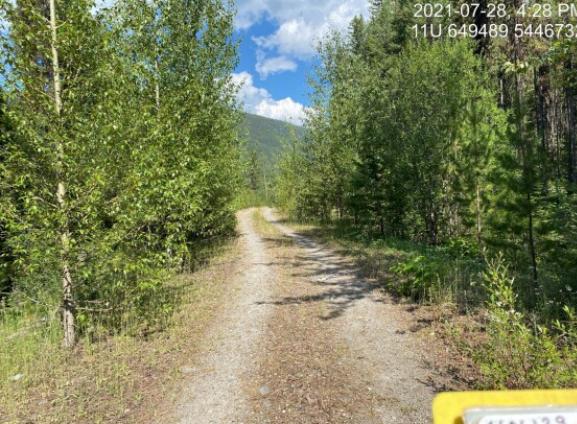
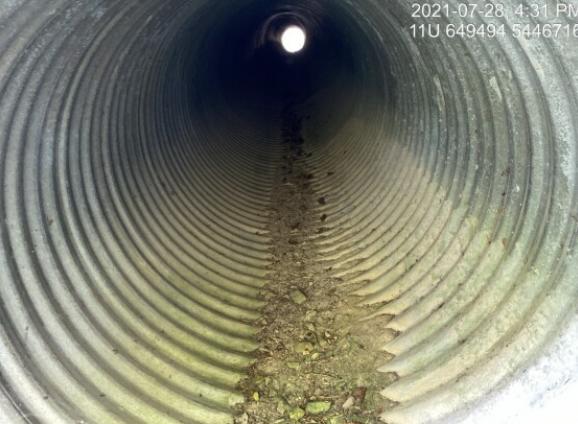
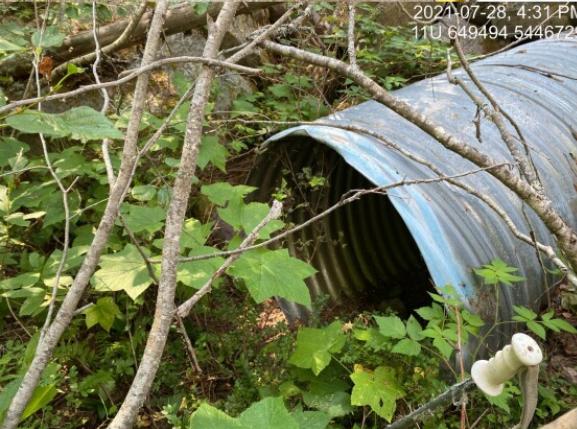
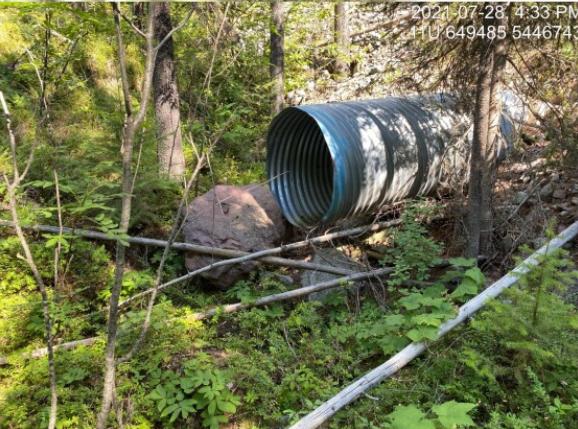
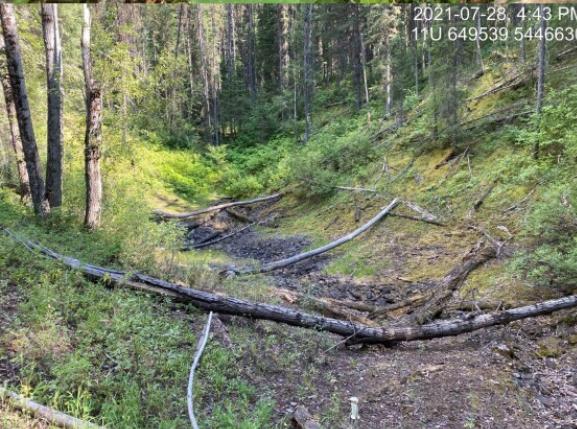
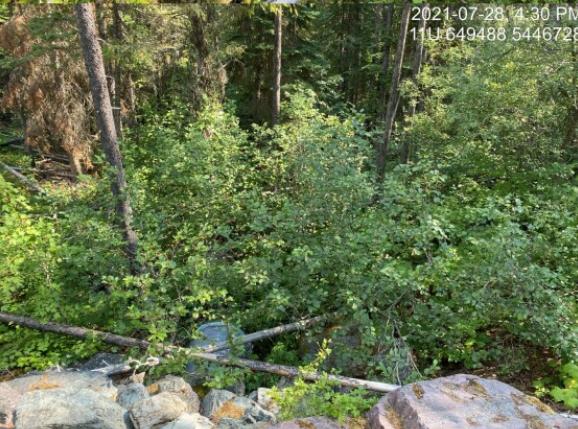
Location and Stream Data	Crossing Characteristics
Photos: PSCIS ID 197785. From top left clockwise: Road/Site Card, Barrel, Outlet, Downstream, Upstream, Inlet.

Location and Stream Data		Crossing Characteristics	
Date	2021-07-28	Crossing Sub Type	Round Culvert
PSCIS ID	197785	Diameter (m)	1
External ID	4606129	Length (m)	28
Crew	AI TS	Embedded	No
UTM Zone	11	Depth Embedded (m)	–
Easting	649481.2	Resemble Channel	No
Northing	5446732	Backwatered	No
Stream	Tributary to Wigwam River	Percent Backwatered	–
Road	–	Fill Depth (m)	4
Road Tenure	Canfor R08380	Outlet Drop (m)	0.4
Channel Width (m)	0	Outlet Pool Depth (m)	0
Stream Slope (%)	5	Inlet Drop	No
Beaver Activity	No	Slope (%)	1.5
Habitat Value	Low	Valley Fill	Deep Fill
Final score	28	Barrier Result	Barrier
Fix type	Replace Structure with Streambed Simulation CBS	Fix Span / Diameter	3

Comments: Drains Snowshoe Lake. No visible channel. No fish habitat present as the channel empties into large natural depression area ~60m upstream of the road. 16:25

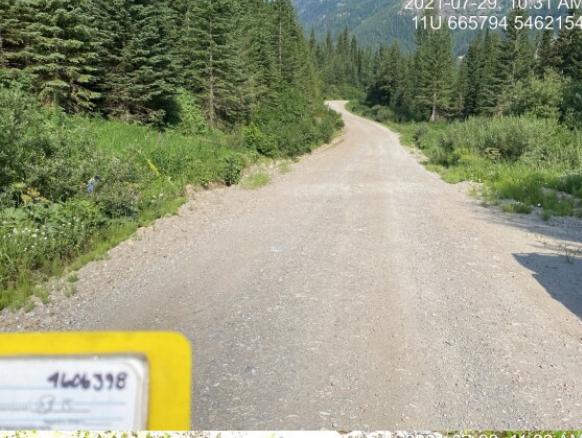
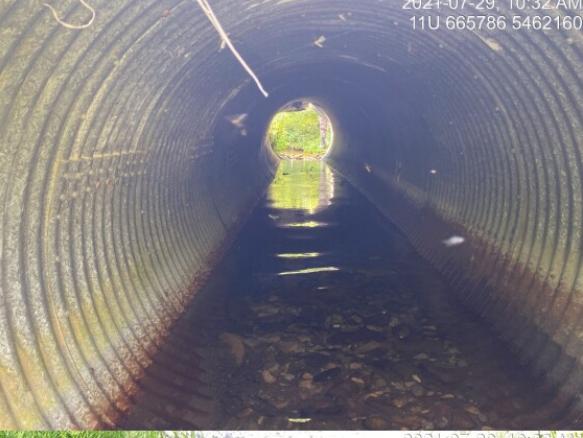
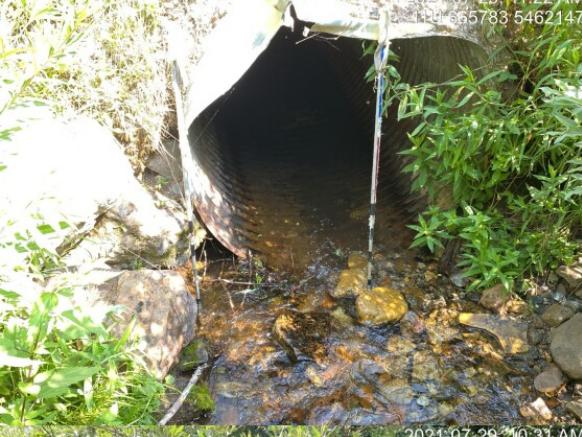
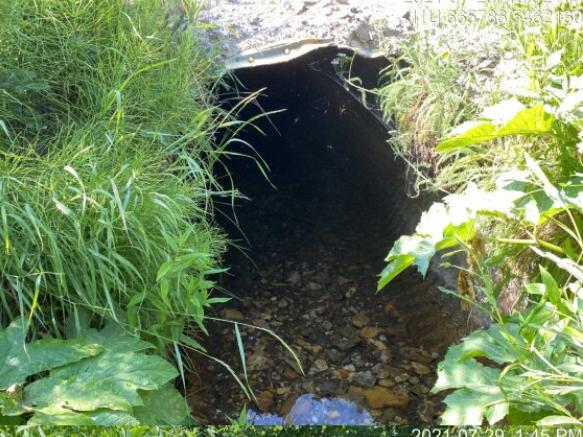
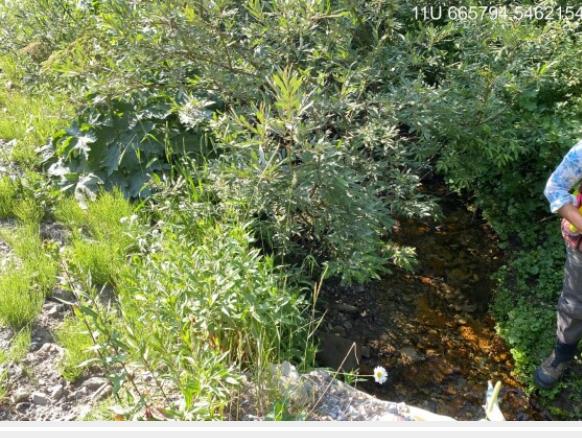
Location and Stream Data	•	Crossing Characteristics	-
Photos: PSCIS ID 197786. From top left clockwise: Road/Site Card, Barrel, Outlet, Downstream, Upstream, Inlet.

Comments: Small stream with good flow. Abundant gravels just upstream with gradients increasing to 6-7% near 540m upstream of culvert where large (~30m high) waterfall is located. 10:18

Location and Stream Data		Crossing Characteristics	
Date	2021-07-29	Crossing Sub Type	Round Culvert
PSCIS ID	197786	Diameter (m)	1.2
External ID	4606398	Length (m)	10
Crew	AI TS	Embedded	No
UTM Zone	11	Depth Embedded (m)	—
Easting	665796.1	Resemble Channel	No
Northing	5462152	Backwatered	No
Stream	Lodgepole Creek	Percent Backwatered	—
Road	Harvey FSR	Fill Depth (m)	0.1
Road Tenure	FLNR DRM 5466	Outlet Drop (m)	0
Channel Width (m)	2	Outlet Pool Depth (m)	0.1
Stream Slope (%)	3.8	Inlet Drop	Yes
Beaver Activity	No	Slope (%)	1.7
Habitat Value	Medium	Valley Fill	Deep Fill
Final score	21	Barrier Result	Barrier
Fix type	Replace with New Open Bottom Structure	Fix Span / Diameter	12

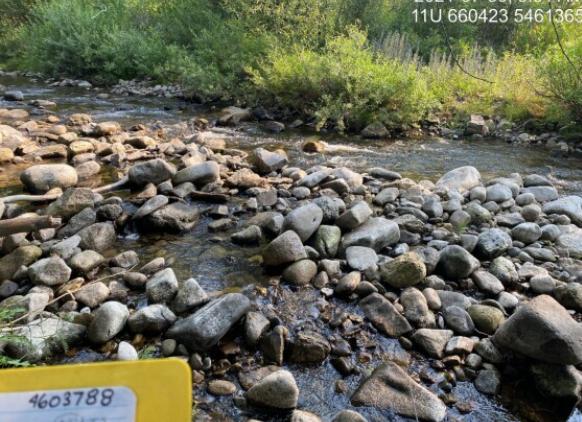
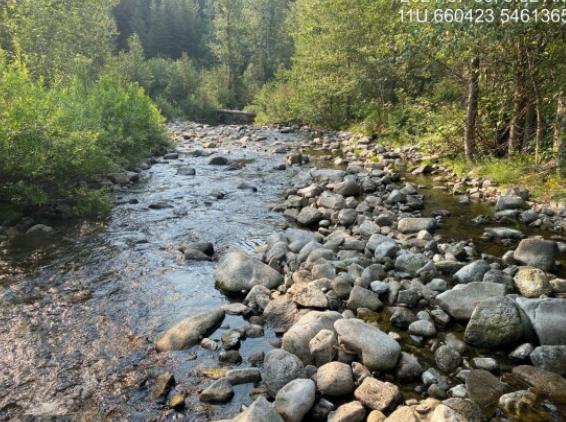
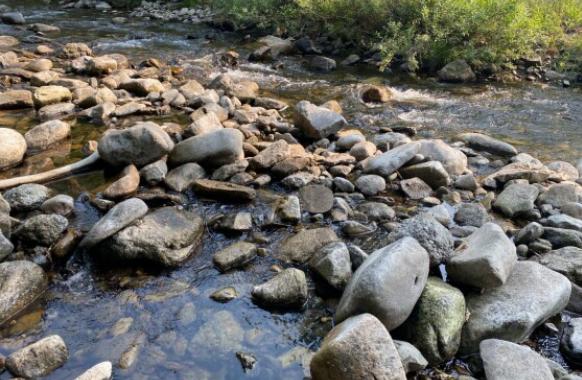
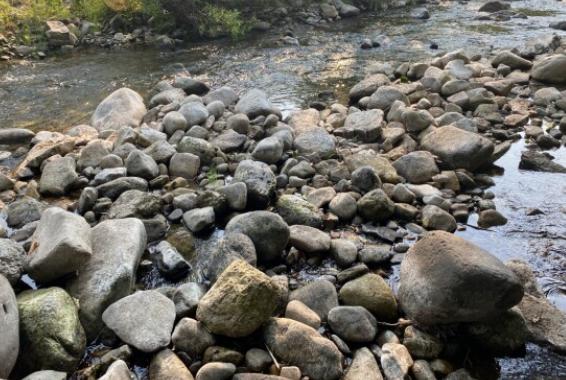
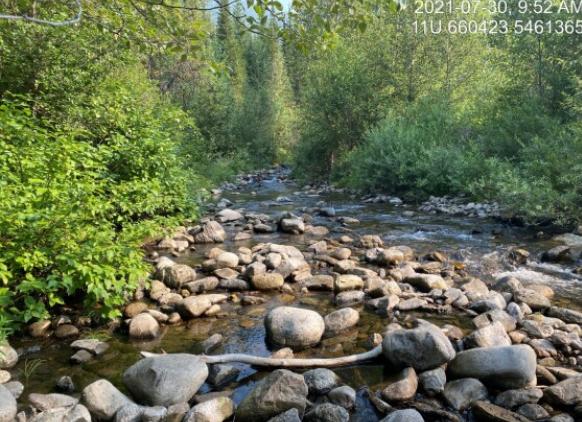
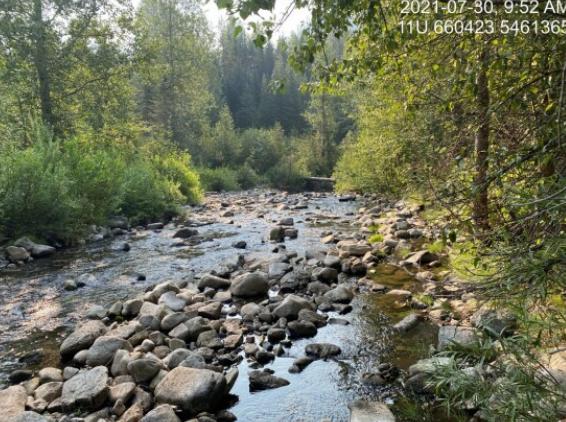
Location and Stream Data	•	Crossing Characteristics	-
Photos: PSCIS ID 197788. From top left clockwise: Road/Site Card, Barrel, Outlet, Downstream, Upstream, Inlet.

Comments: Bridge has been removed. No issues. 9:50

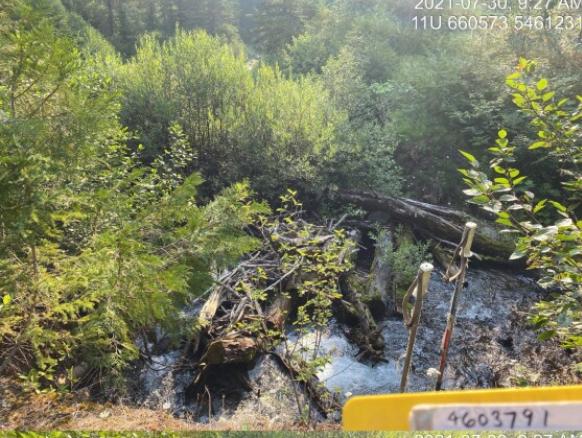
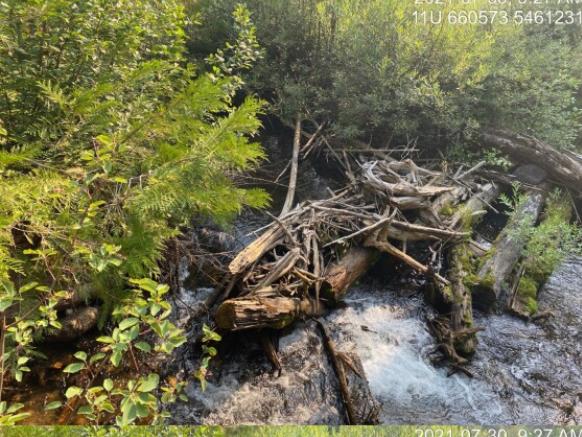
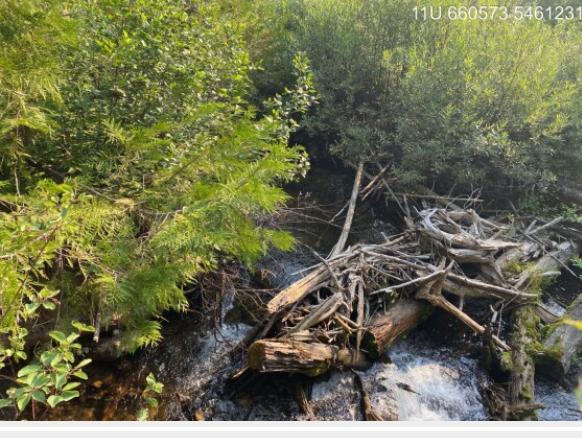
Location and Stream Data	•	Crossing Characteristics	-
Photos: PSCIS ID 197789. From top left clockwise: Road/Site Card, Barrel, Outlet, Downstream, Upstream, Inlet.

2021-07-30, 9:27 AM 11U 660573 5461231
Comments: Bridge has been removed. No issues. 9:25

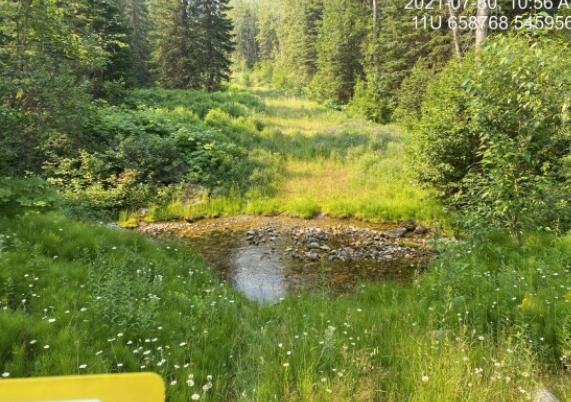
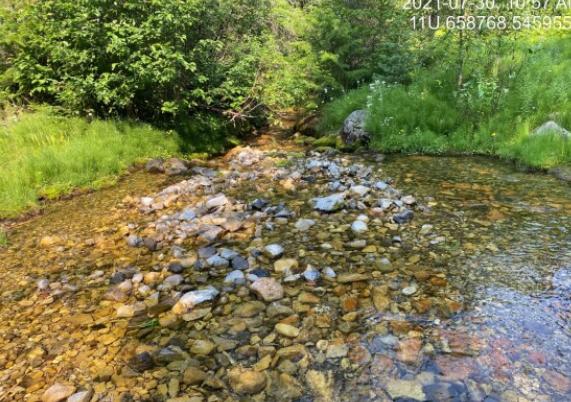
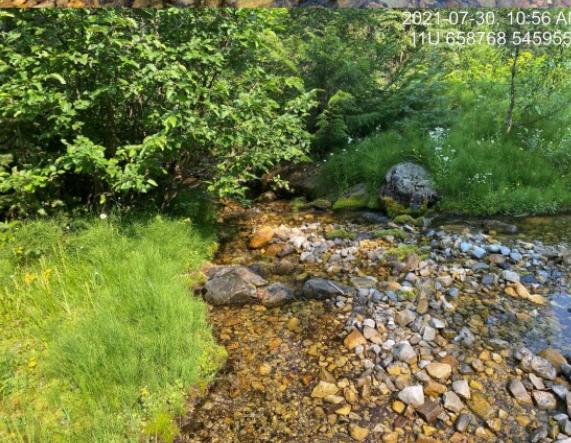
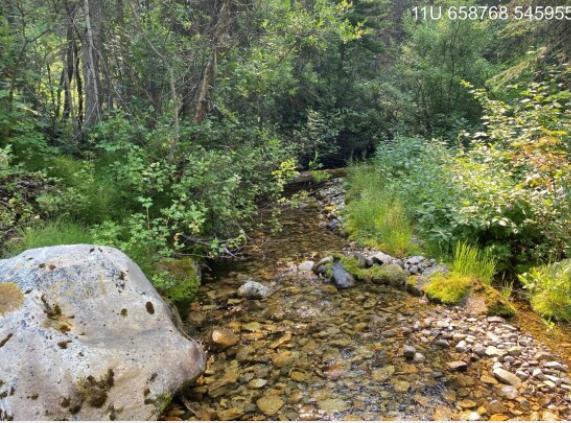
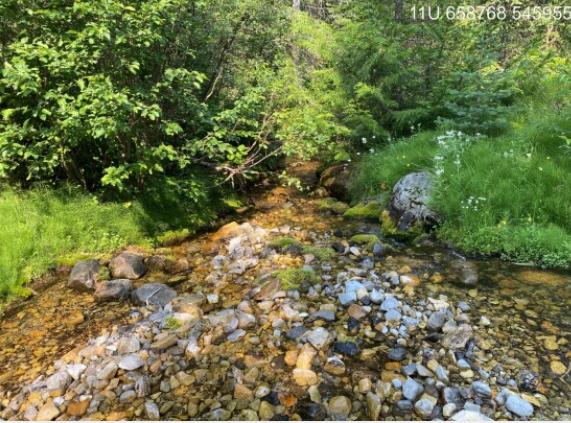
Location and Stream Data	•	Crossing Characteristics	-
Photos: PSCIS ID 197790. From top left clockwise: Road/Site Card, Barrel, Outlet, Downstream, Upstream, Inlet.

Comments: Ford. No fish passage issues. 10:55

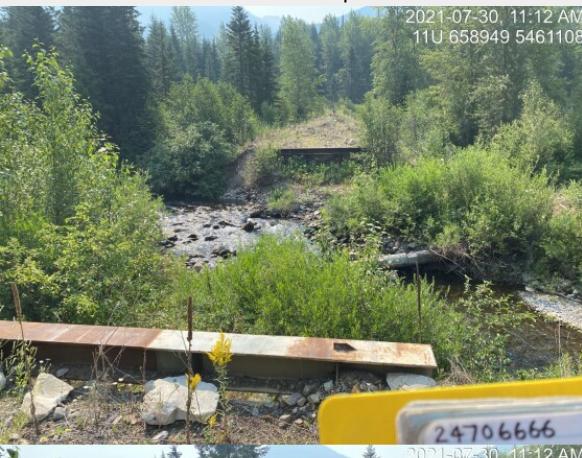
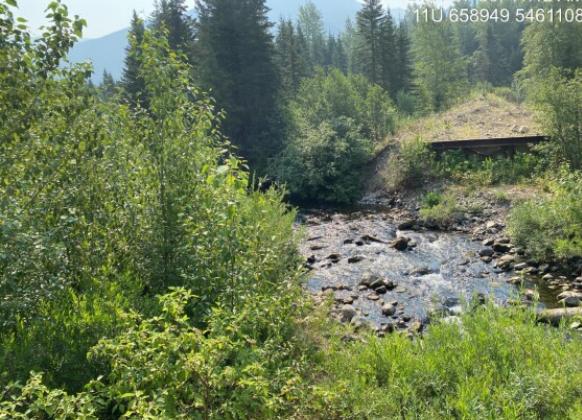
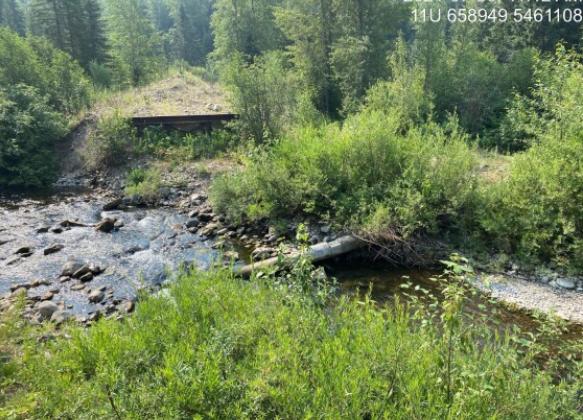
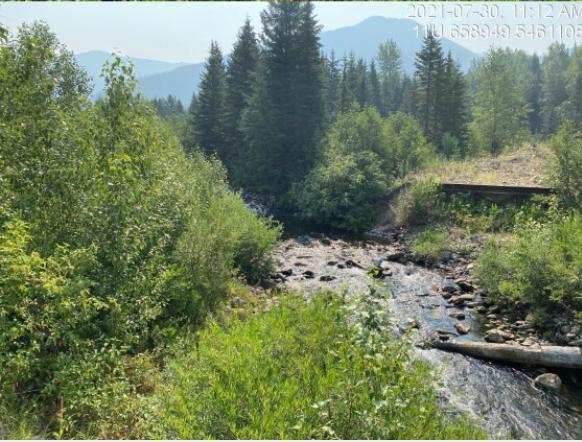
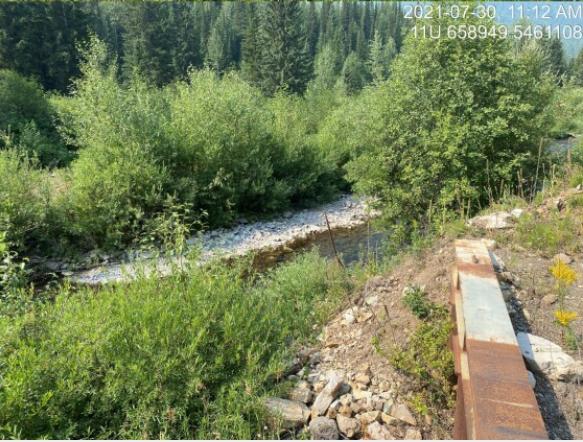
Location and Stream Data	•	Crossing Characteristics	-
Photos: PSCIS ID 197791. From top left clockwise: Road/Site Card, Barrel, Outlet, Downstream, Upstream, Inlet.

Comments: ATV ford. No fish passage issues. 11:10

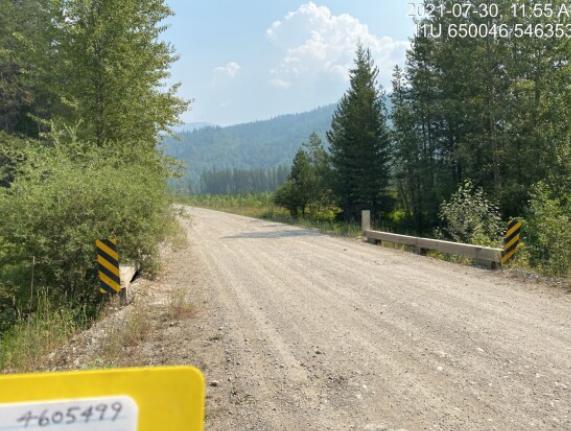
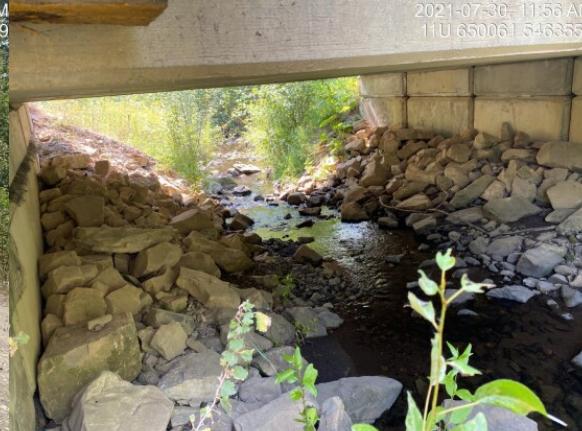
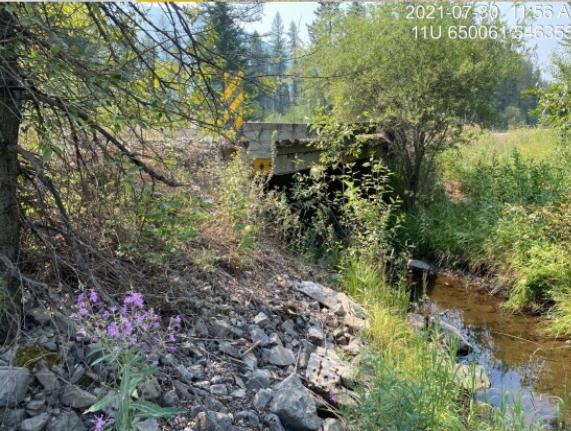
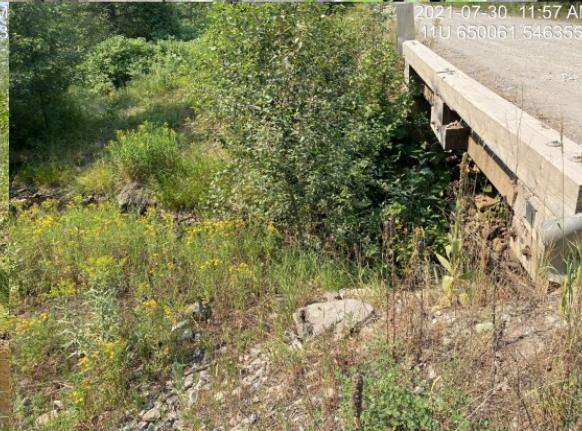
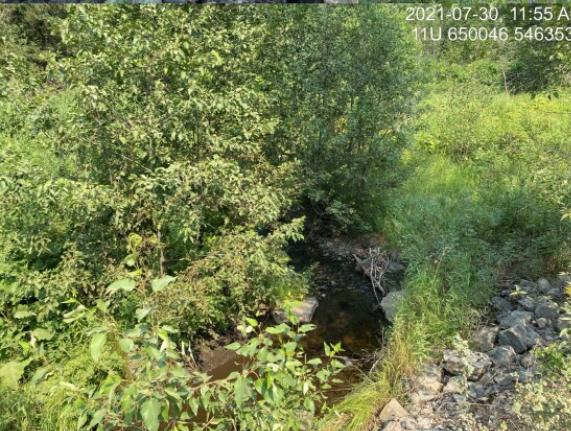
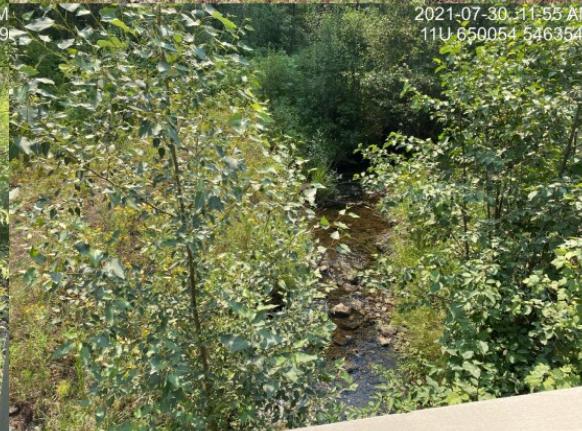
Location and Stream Data	Crossing Characteristics
Photos: PSCIS ID 197792. From top left clockwise: Road/Site Card, Barrel, Outlet, Downstream, Upstream, Inlet.

Comments: Bridge. 11:53

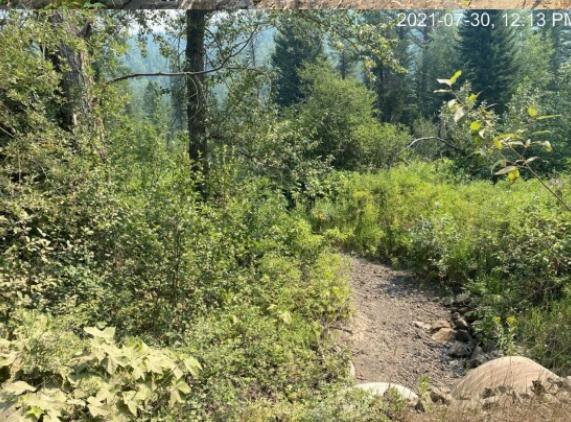
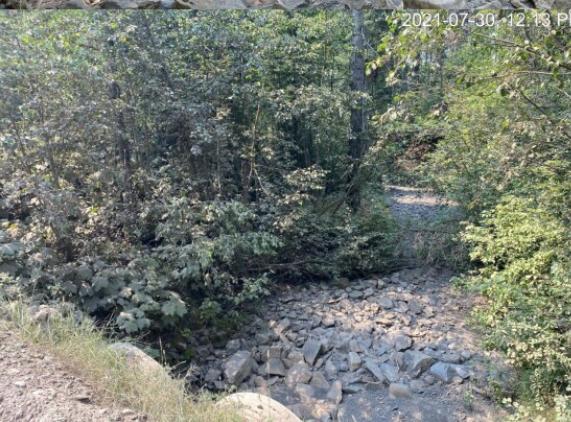
Comments: Large channel but stream is completely dry. 12:11

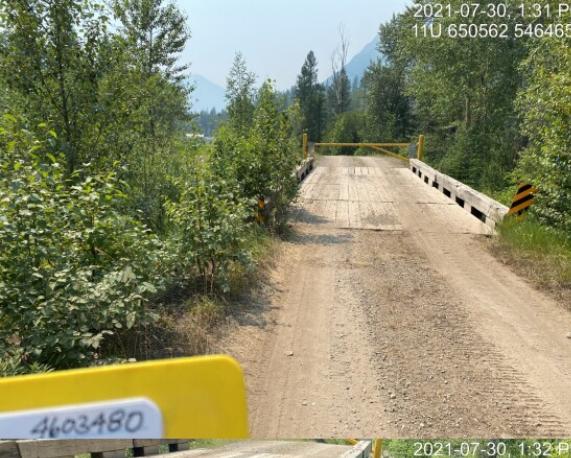
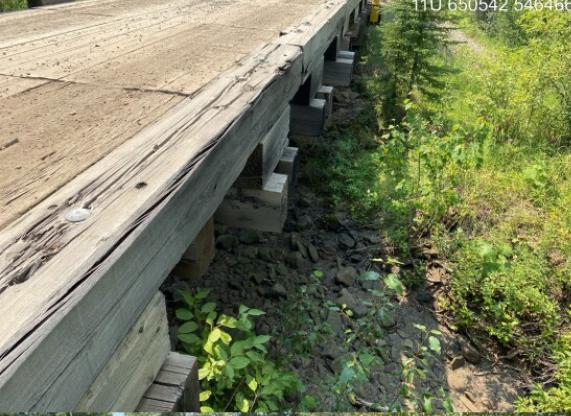
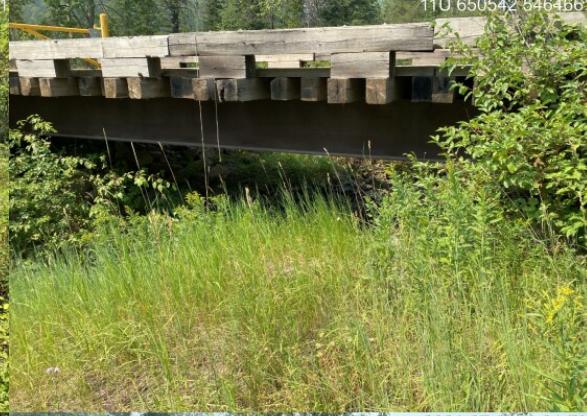
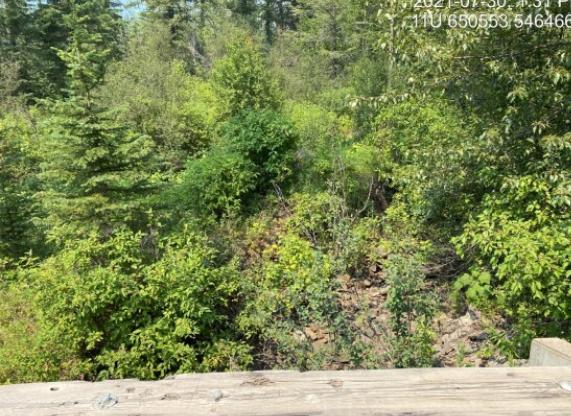
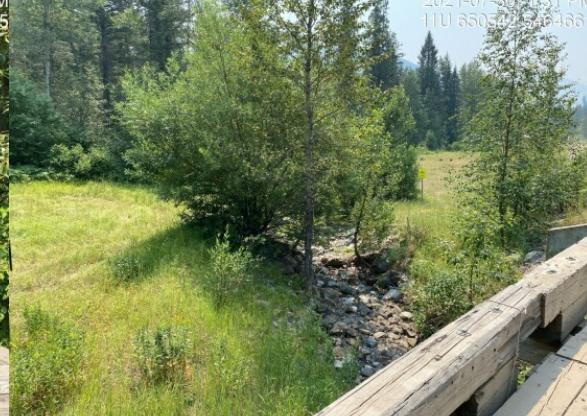
Location and Stream Data	Crossing Characteristics
Photos: PSCIS ID 197794. From top left clockwise: Road/Site Card, Barrel, Outlet, Downstream, Upstream, Inlet.

2021-07-30, 1:31 PM 11U 650529 5464661
Comments: Bridge on the pipeline right of way. 13:30

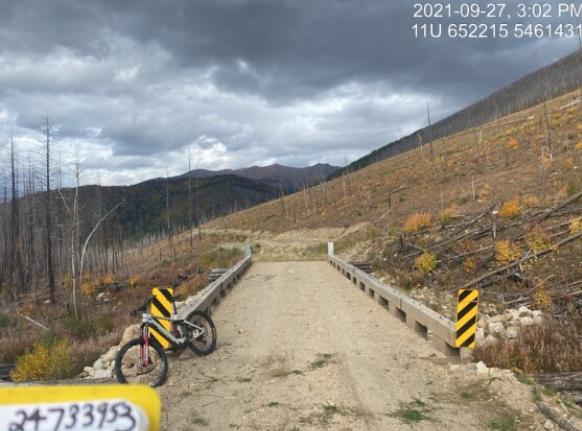
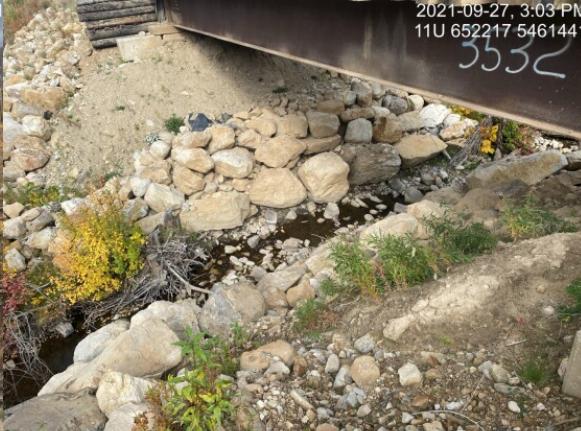
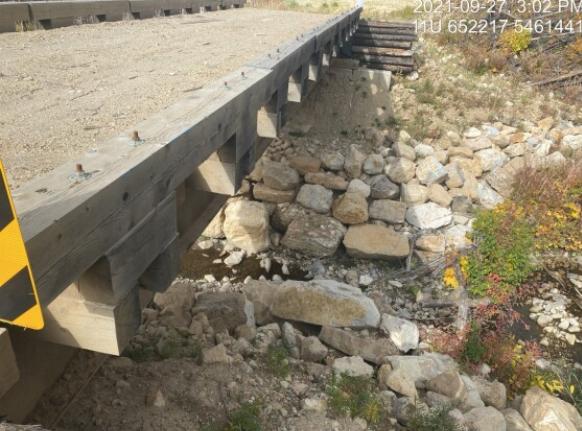
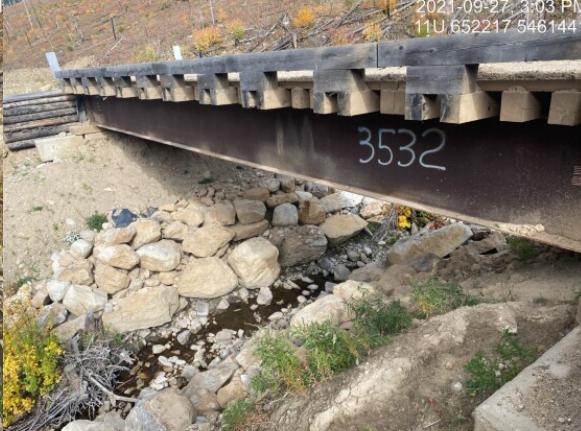
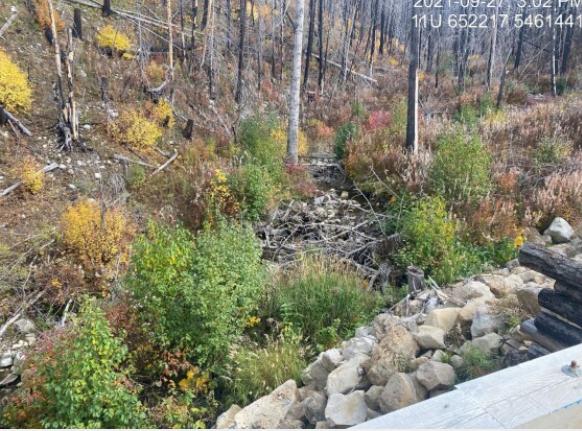
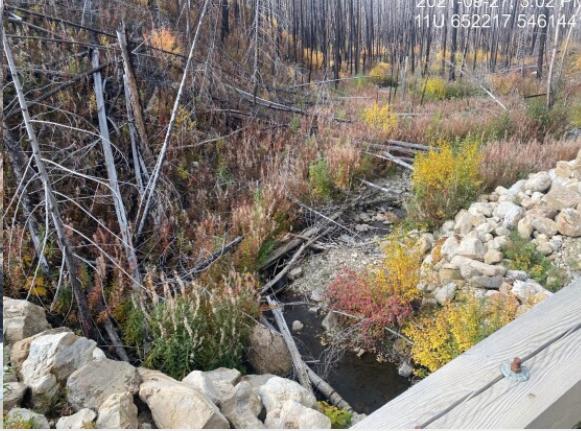
Location and Stream Data	Crossing Characteristics
Photos: PSCIS ID 197795. From top left clockwise: Road/Site Card, Barrel, Outlet, Downstream, Upstream, Inlet.

2021-09-27, 3:02 PM 11U 652217 5461441
Comments: Gated access management area. 15:00

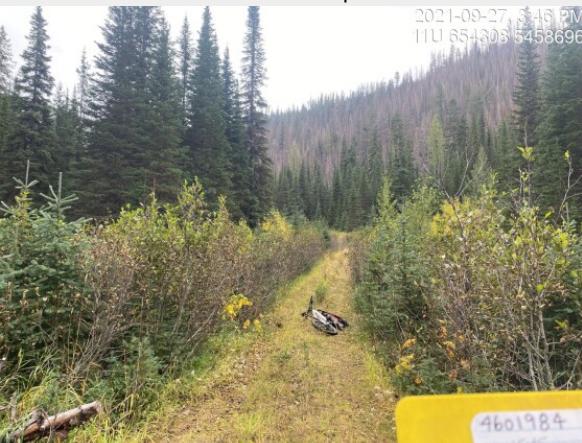
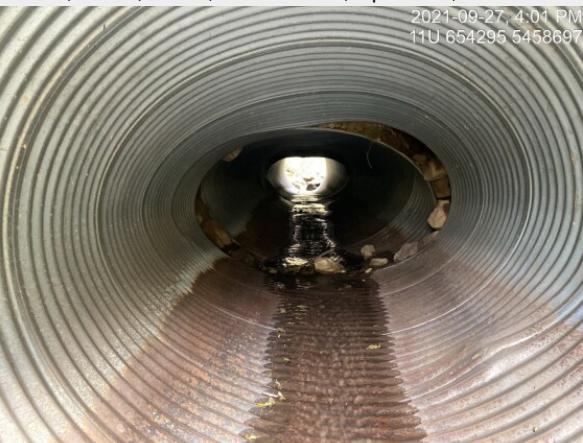
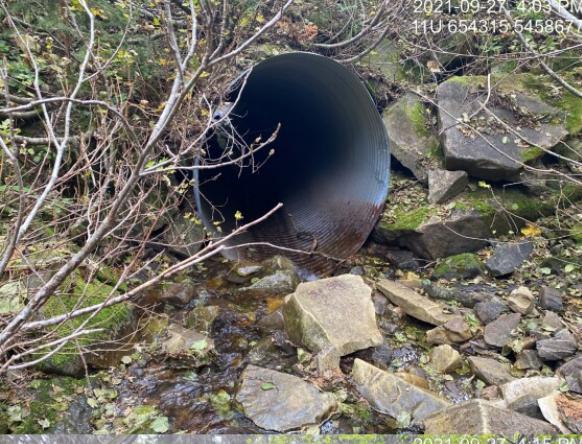
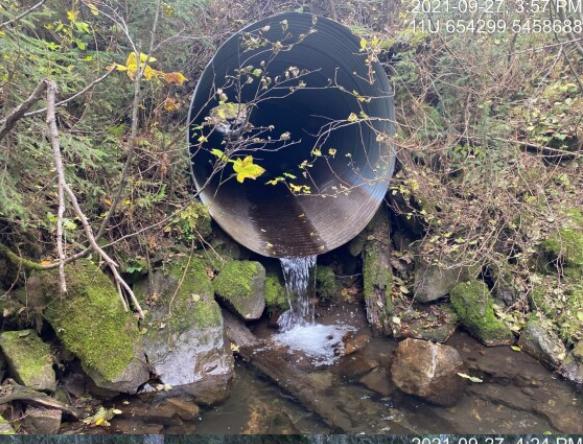
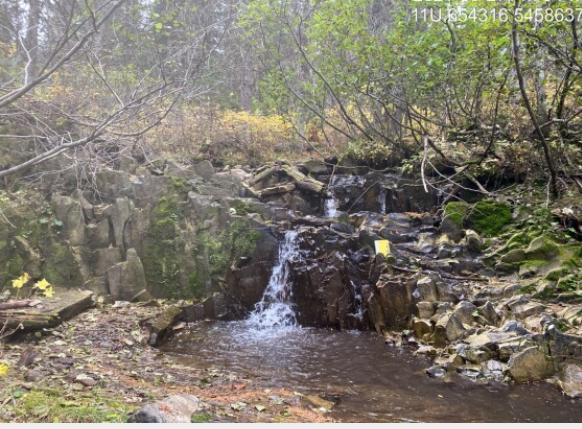
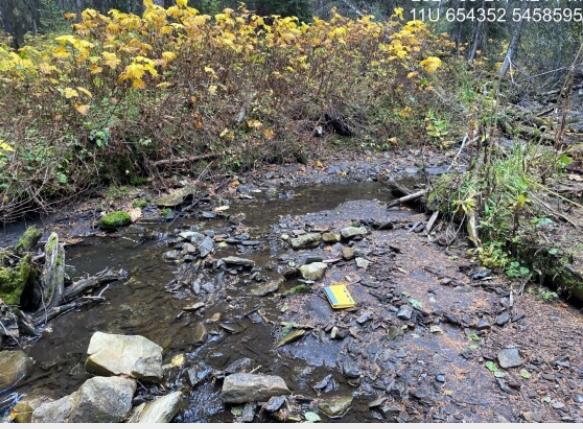
Location and Stream Data	Crossing Characteristics
Photos: PSCIS ID 197796. From top left clockwise: Road/Site Card, Barrel, Outlet, Downstream, Upstream, Inlet.

Location and Stream Data		Crossing Characteristics	
Date	2021-09-27	Crossing Sub Type	Round Culvert
PSCIS ID	197796	Diameter (m)	1.6
External ID	4601984	Length (m)	14
Crew	AI	Embedded	No
UTM Zone	11	Depth Embedded (m)	—
Easting	654301.7	Resemble Channel	No
Northing	5458678	Backwatered	No
Stream	Tributary to Lodgepole Creek	Percent Backwatered	—
Road	Spur	Fill Depth (m)	2
Road Tenure	Unclassified	Outlet Drop (m)	0.6
Channel Width (m)	3.8	Outlet Pool Depth (m)	0.8
Stream Slope (%)	8.5	Inlet Drop	Yes
Beaver Activity	No	Slope (%)	5
Habitat Value	Low	Valley Fill	Deep Fill
Final score	36	Barrier Result	Barrier
Fix type	Replace with New Open Bottom Structure	Fix Span / Diameter	12

Comments: Gated access management area. Falls located ~60m upstream of the crossing. 15:45
