## Appendix - Phase 1 Fish Passage Assessment Data and Photos

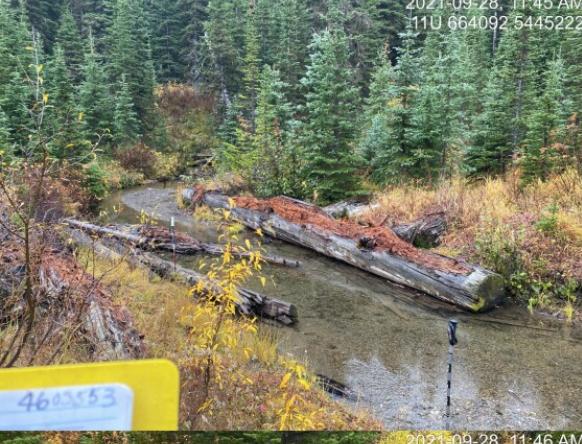
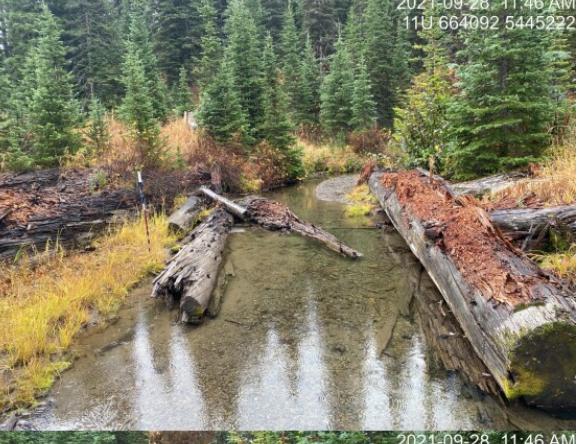
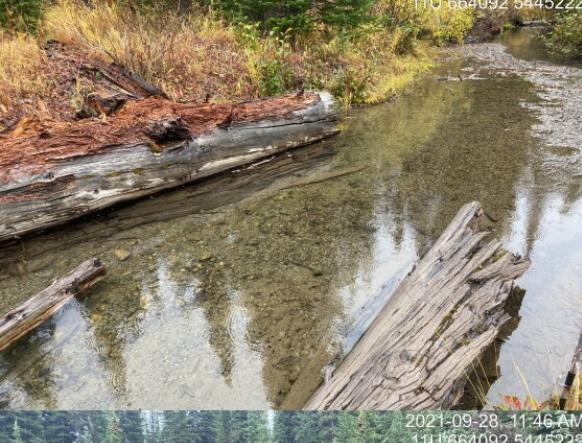
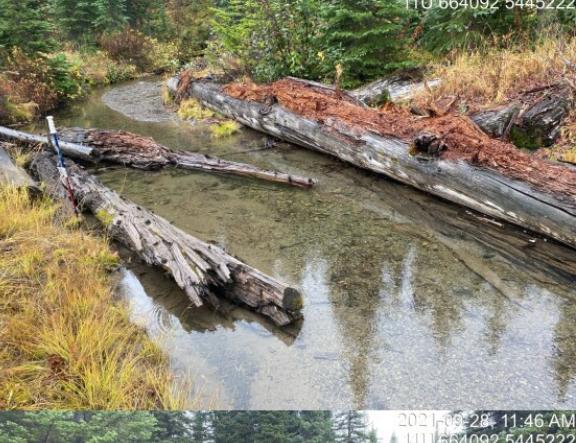
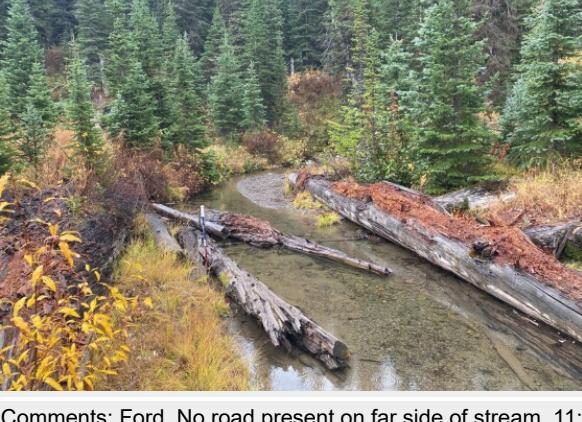
Location and Stream Data	•	Crossing Characteristics	-
Photos: PSCIS ID 197797. From top left clockwise: Road/Site Card, Barrel, Outlet, Downstream, Upstream, Inlet.

2021-09-28, 11:46 AM 11U 664092 5445222
Comments: Ford. No road present on far side of stream. 11:28

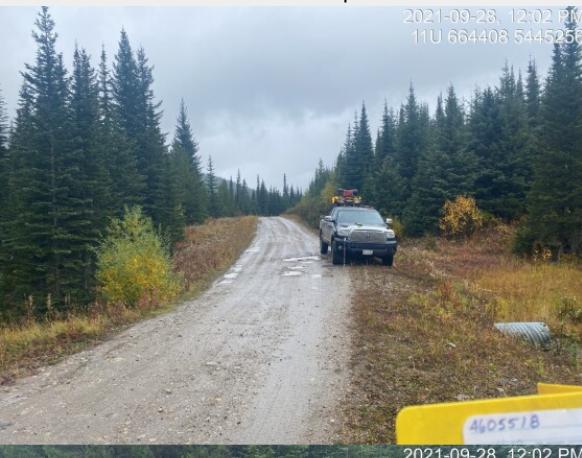
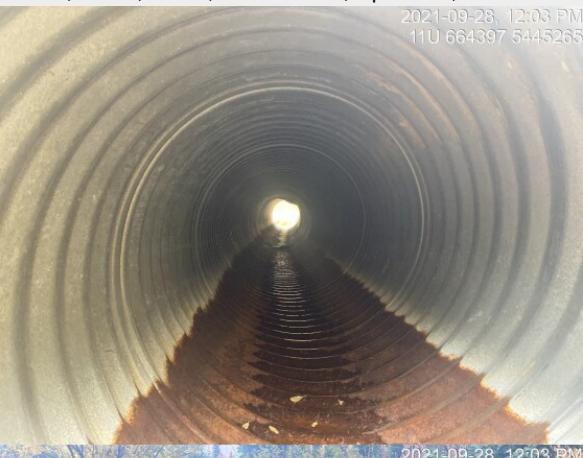
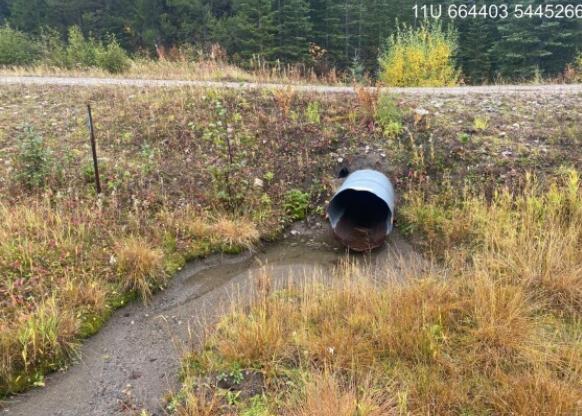
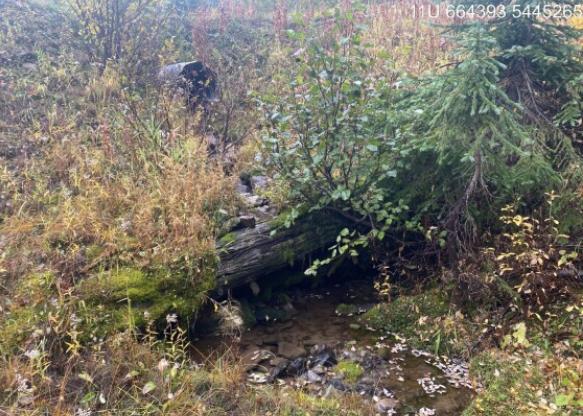
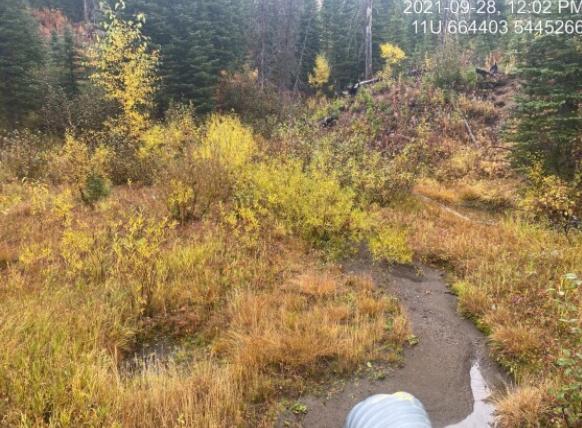
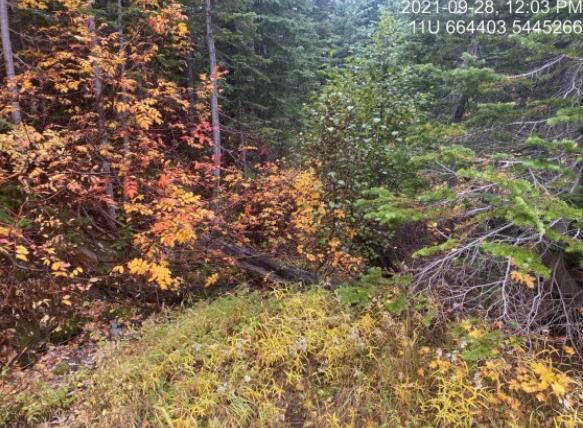
Location and Stream Data	•	Crossing Characteristics	-
Photos: PSCIS ID 197798. From top left clockwise: Road/Site Card, Barrel, Outlet, Downstream, Upstream, Inlet.

Location and Stream Data		Crossing Characteristics	
Date	2021-09-28	Crossing Sub Type	Round Culvert
PSCIS ID	197798	Diameter (m)	0.6
External ID	4605518	Length (m)	11
Crew	AI	Embedded	No
UTM Zone	11	Depth Embedded (m)	–
Easting	664404.6	Resemble Channel	No
Northing	5445263	Backwatered	No
Stream	Tributary to Bighorn Creek	Percent Backwatered	–
Road	Cabin FSR	Fill Depth (m)	1
Road Tenure	FLNR DRM 5466	Outlet Drop (m)	0.6
Channel Width (m)	1	Outlet Pool Depth (m)	0
Stream Slope (%)	4	Inlet Drop	No
Beaver Activity	No	Slope (%)	4
Habitat Value	Low	Valley Fill	Deep Fill
Final score	36	Barrier Result	Barrier
Fix type	Replace Structure with Streambed Simulation CBS	Fix Span / Diameter	3

Comments: Culvert installed in road prism which creates 1m step, steep gradients and outlet drop. Small system. 12:00

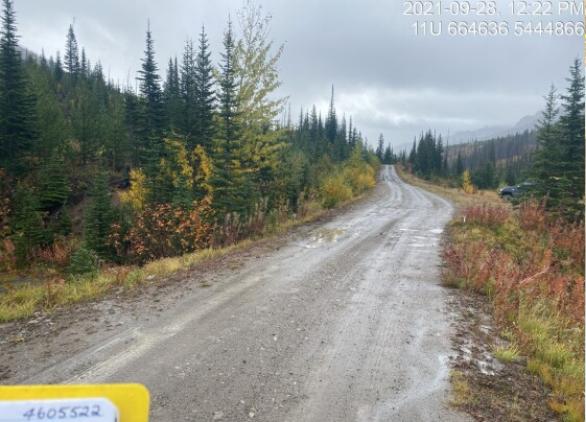
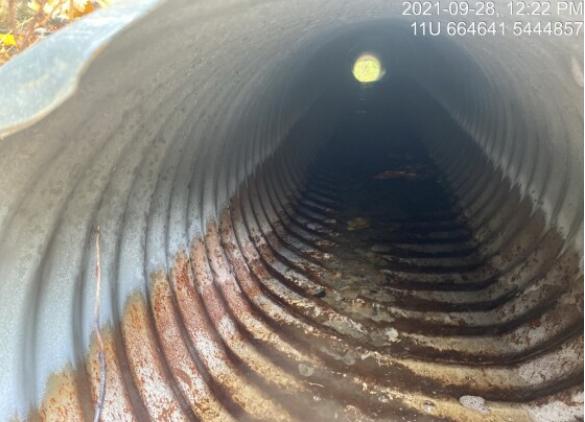
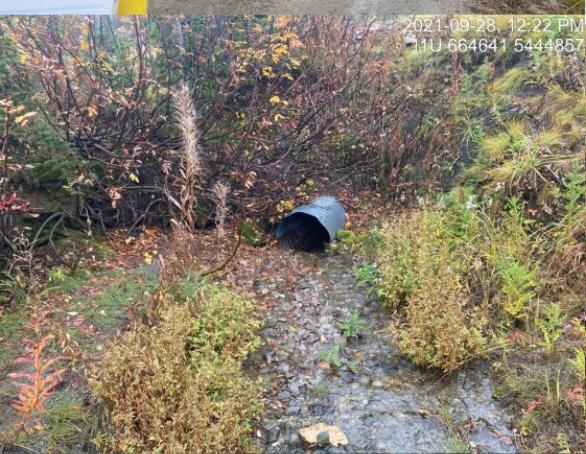
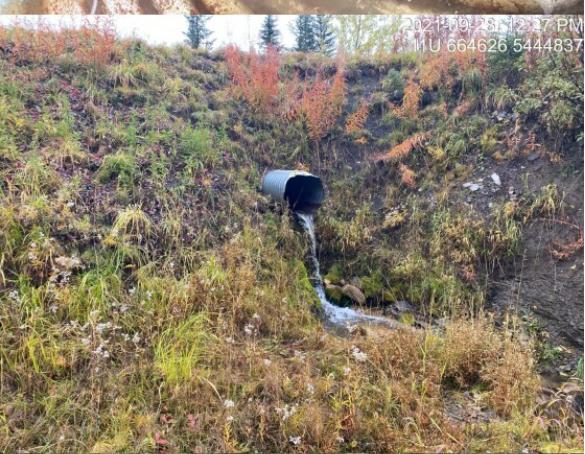
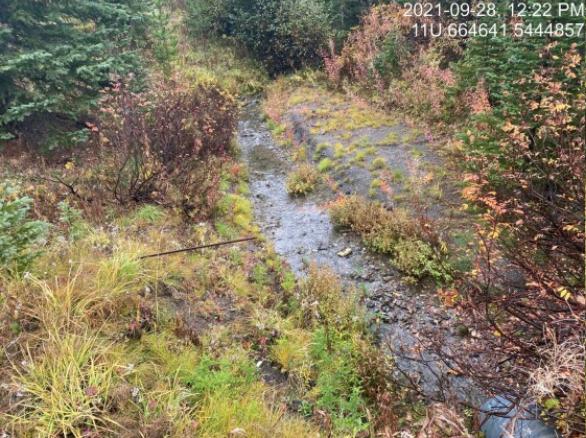
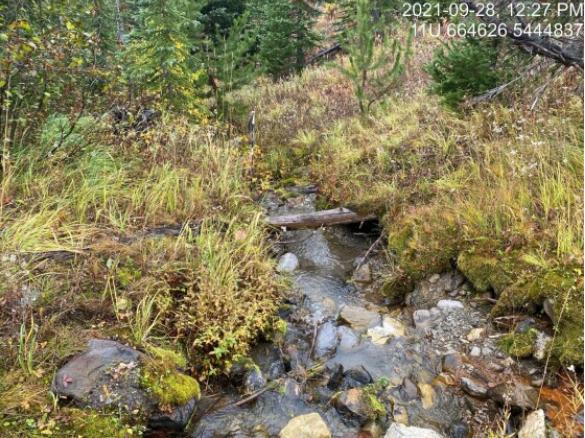
Location and Stream Data	•	Crossing Characteristics	-
Photos: PSCIS ID 197799. From top left clockwise: Road/Site Card, Barrel, Outlet, Downstream, Upstream, Inlet.

Location and Stream Data		Crossing Characteristics	
Date	2021-09-28	Crossing Sub Type	Round Culvert
PSCIS ID	197799	Diameter (m)	0.6
External ID	4605522	Length (m)	16
Crew	AI	Embedded	No
UTM Zone	11	Depth Embedded (m)	–
Easting	664642.1	Resemble Channel	No
Northing	5444852	Backwatered	No
Stream	Tributary to Bighorn Creek	Percent Backwatered	–
Road	Cabin FSR	Fill Depth (m)	3
Road Tenure	FLNR DRM 5466	Outlet Drop (m)	1.2
Channel Width (m)	1.3	Outlet Pool Depth (m)	0.2
Stream Slope (%)	9	Inlet Drop	No
Beaver Activity	No	Slope (%)	5
Habitat Value	Low	Valley Fill	Deep Fill
Final score	39	Barrier Result	Barrier
Fix type	Replace Structure with Streambed Simulation CBS	Fix Span / Diameter	3

Comments: Nice gravels with good flow but small stream with steeper grade for size of channel. LWD drop of ~90cm located at ~55m upstream. Borderline moderate habitat value. 12:20

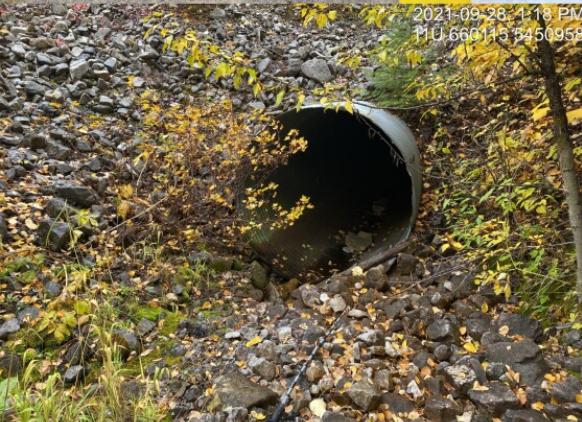
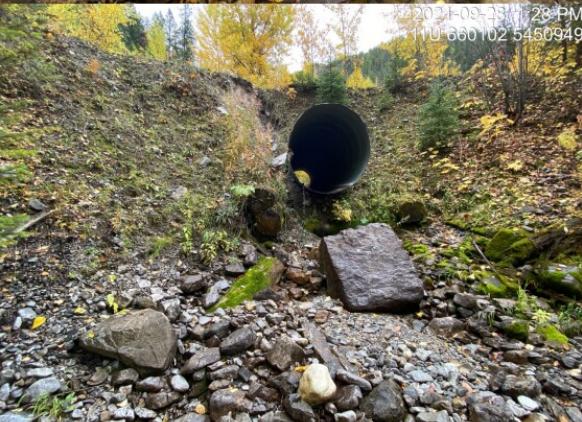
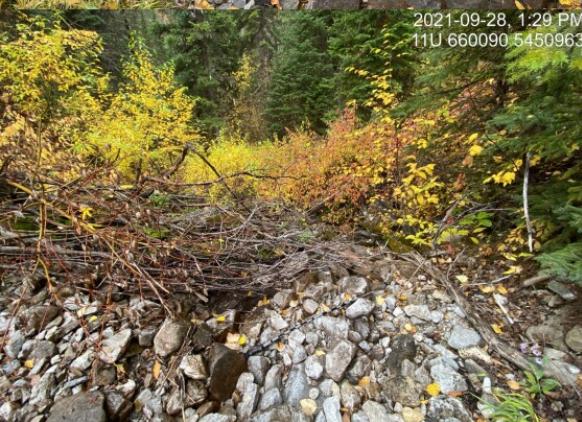
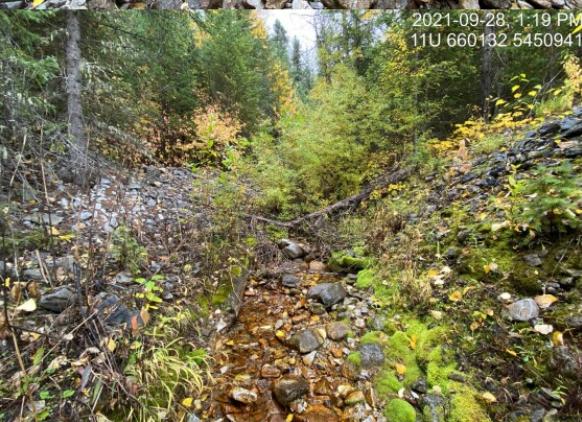
Comments: Dredged upstream. Nice stream with boulder habitat but very steep. 13:15

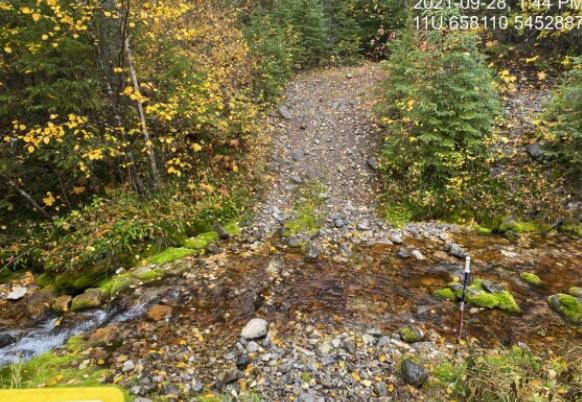
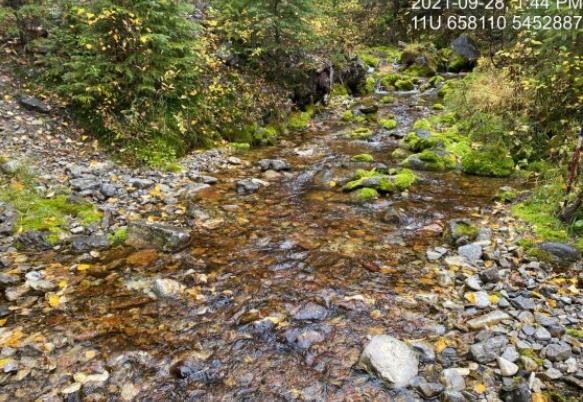
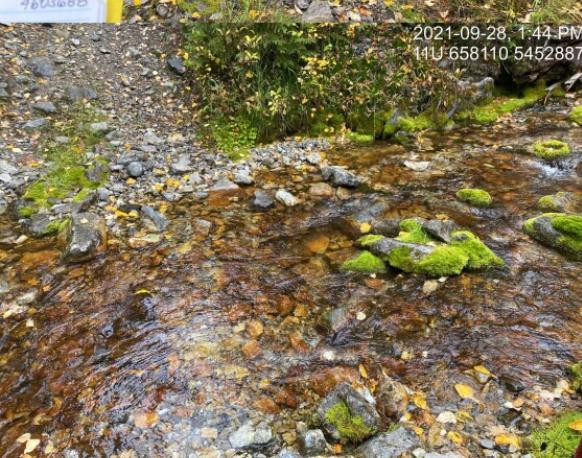
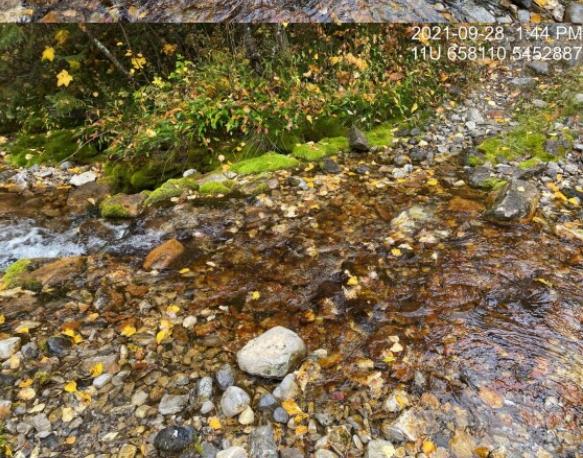
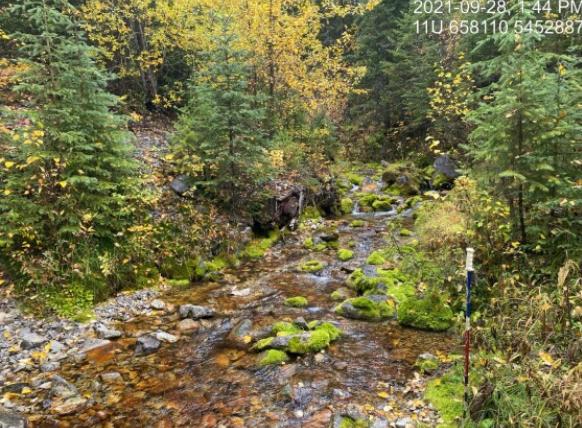
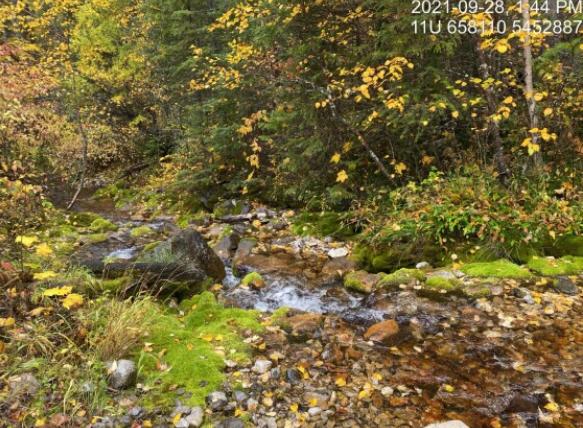
Location and Stream Data	•	Crossing Characteristics	-
Photos: PSCIS ID 197801. From top left clockwise: Road/Site Card, Barrel, Outlet, Downstream, Upstream, Inlet.

Comments: Ford. 13:43

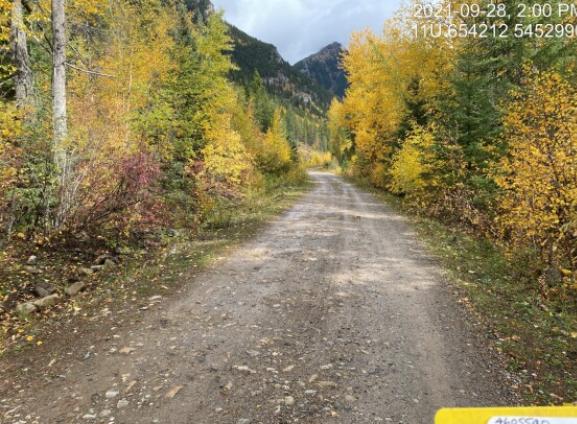
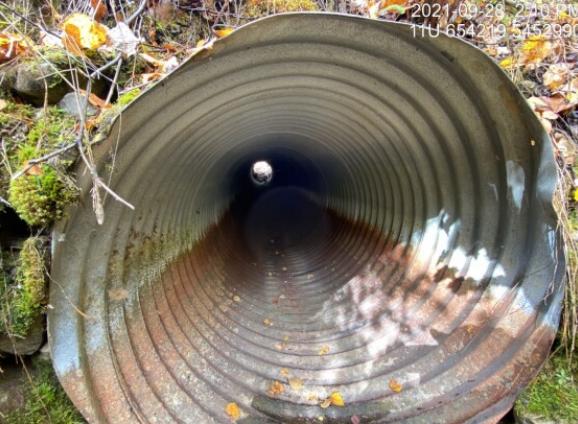
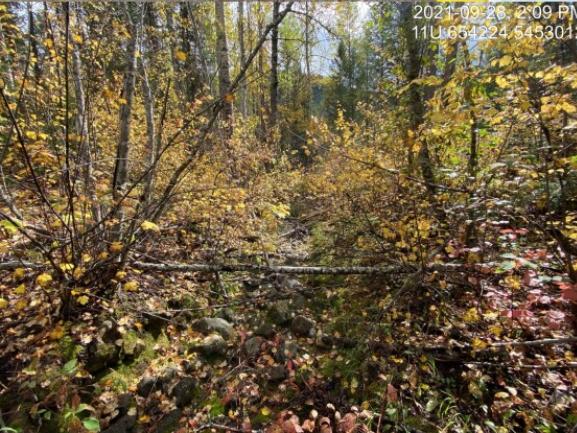
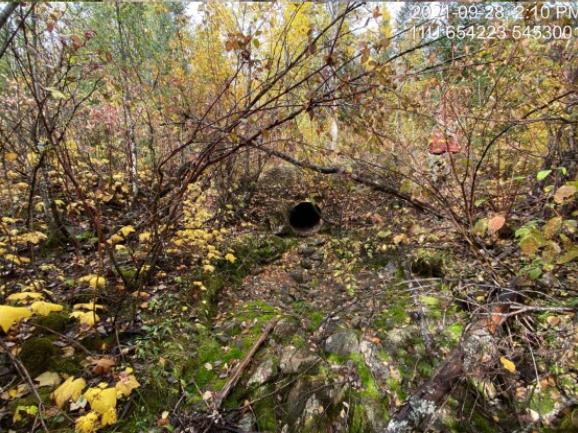
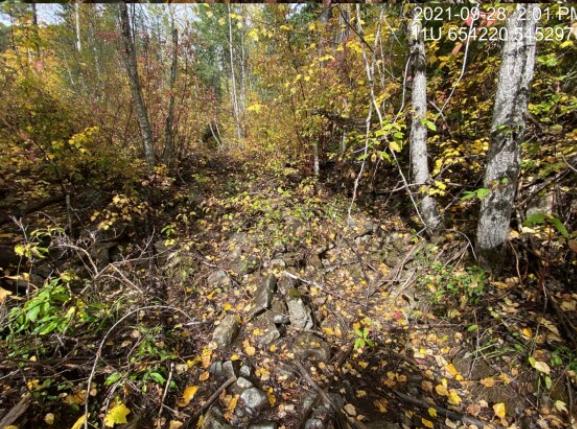
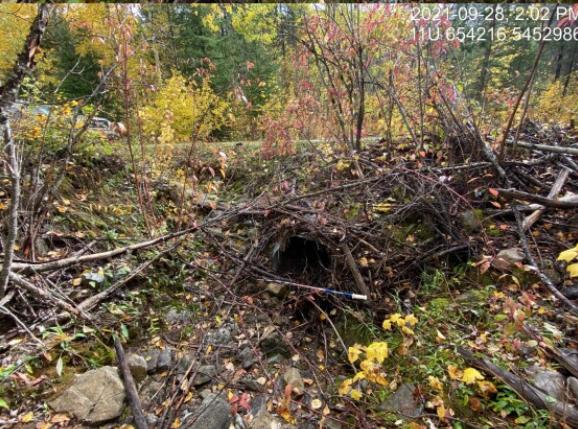
Location and Stream Data	Crossing Characteristics
Photos: PSCIS ID 197802. From top left clockwise: Road/Site Card, Barrel, Outlet, Downstream, Upstream, Inlet.

Comments: Dry with partially vegetated channel. 14:00

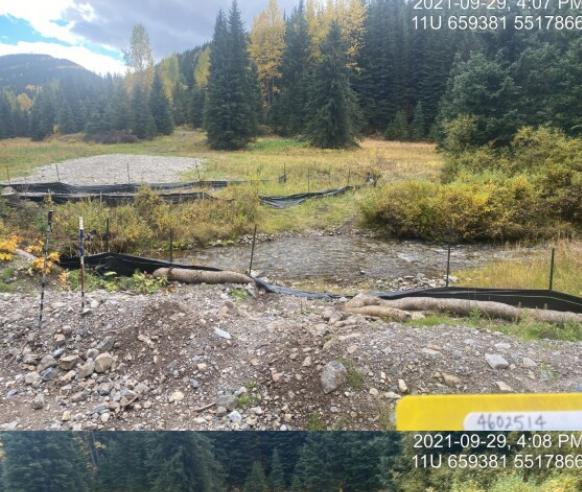
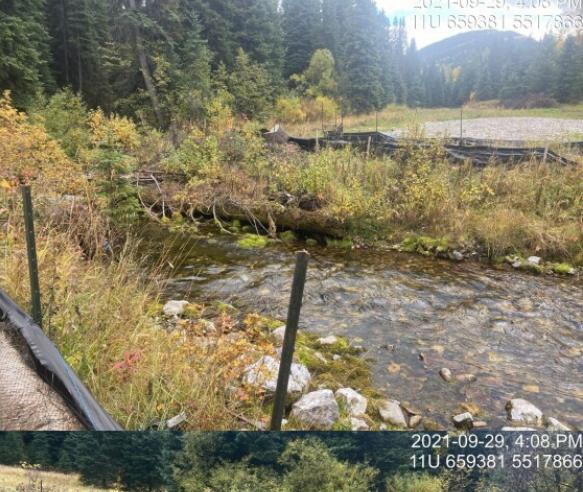
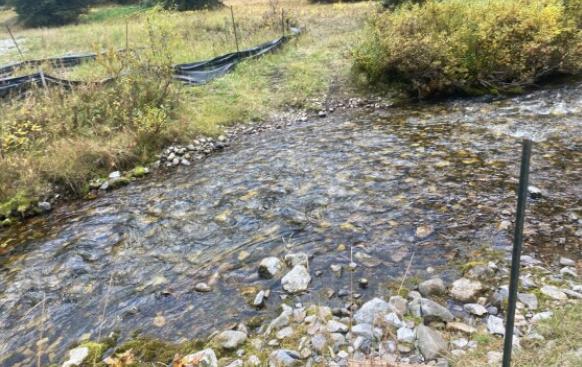
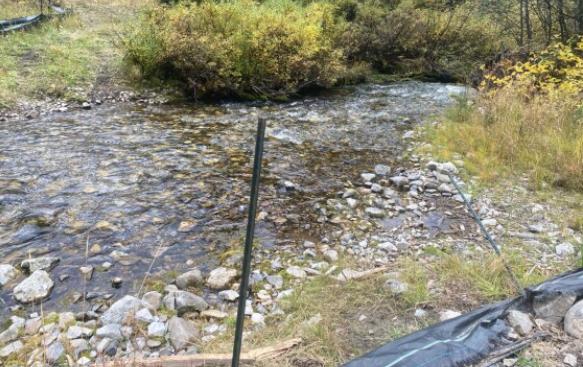
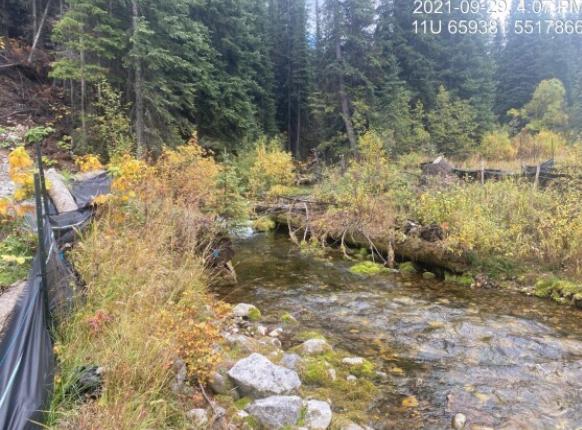
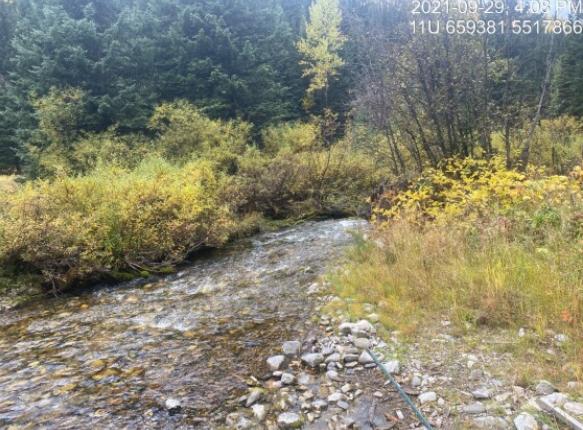
Location and Stream Data	•	Crossing Characteristics	-
Photos: PSCIS ID 197803. From top left clockwise: Road/Site Card, Barrel, Outlet, Downstream, Upstream, Inlet.

Comments: Appears that bridge may have been removed recently. 16:06

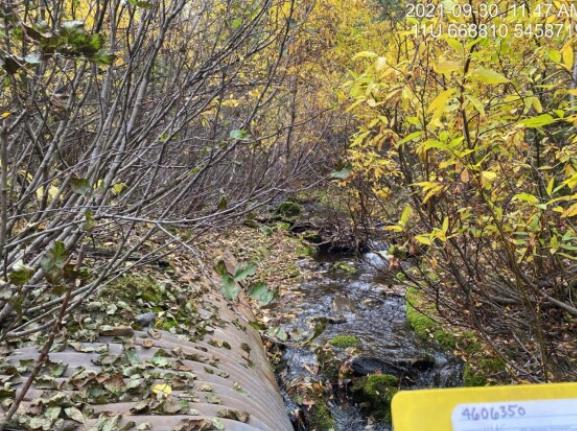
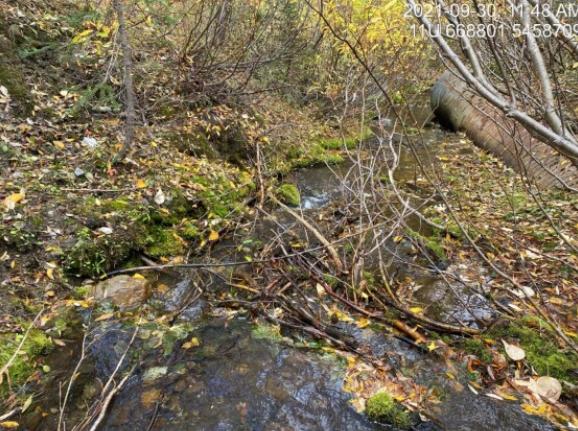
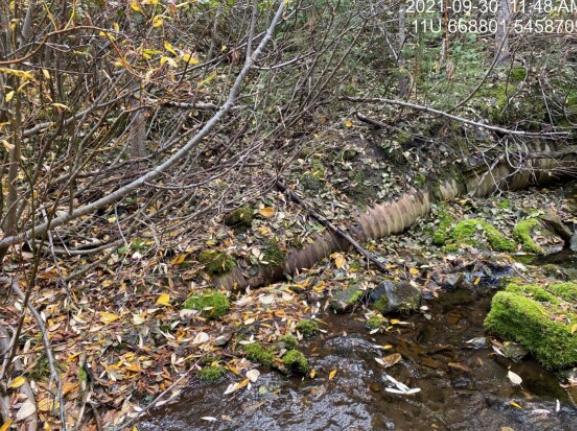
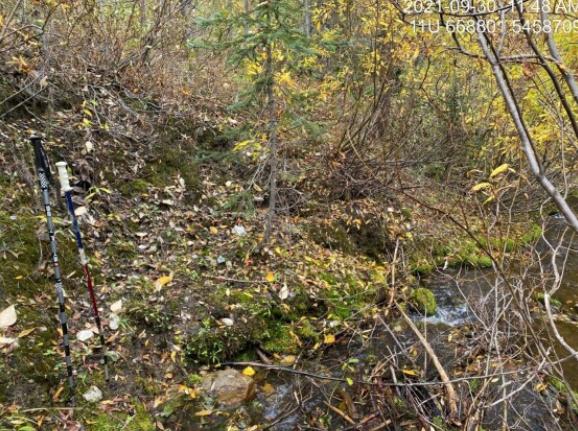
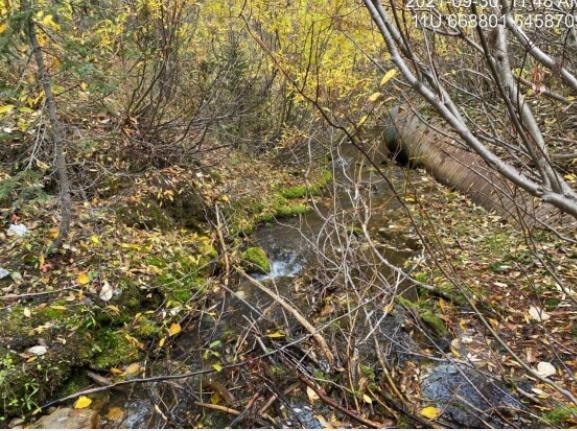
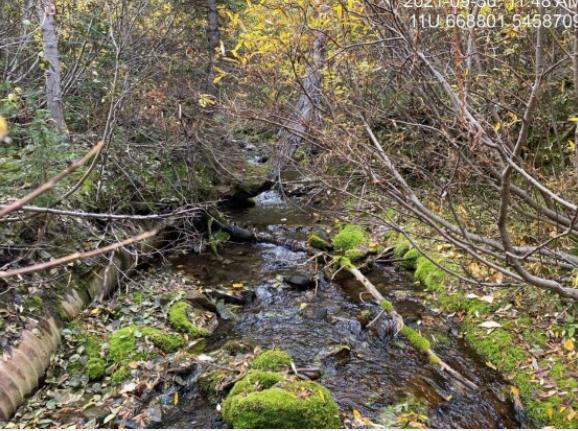
Location and Stream Data	Crossing Characteristics
Photos: PSCIS ID 197804. From top left clockwise: Road/Site Card, Barrel, Outlet, Downstream, Upstream, Inlet.

2021-09-30 11:48 AM 11U 668801 5458709
Comments: Crossing removed. 11:45

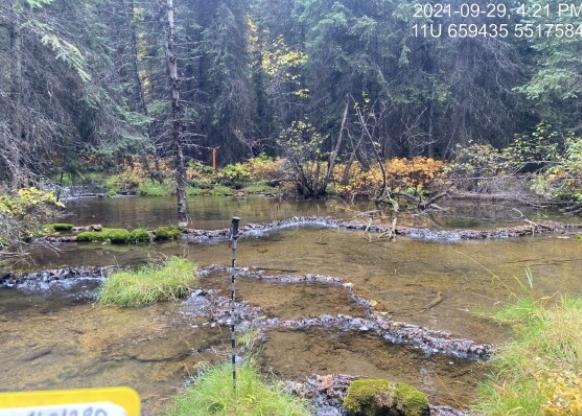
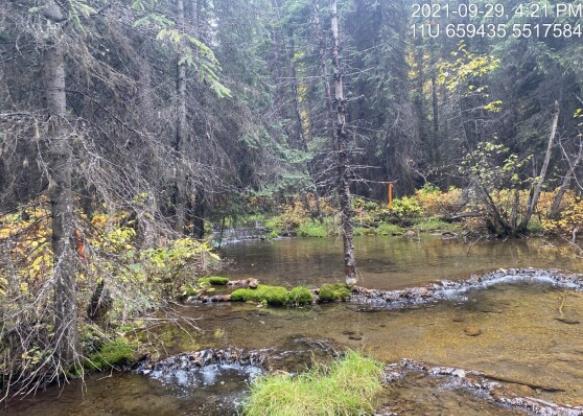
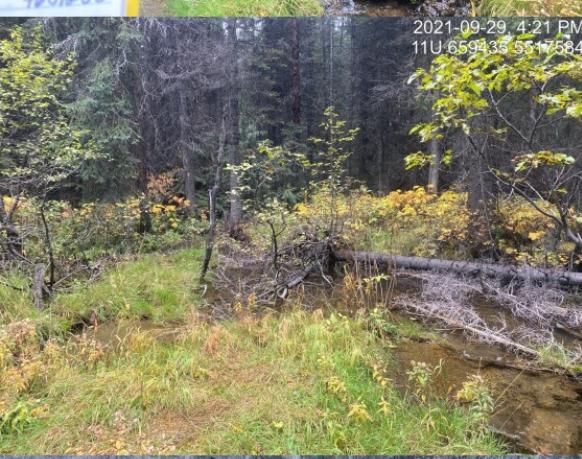
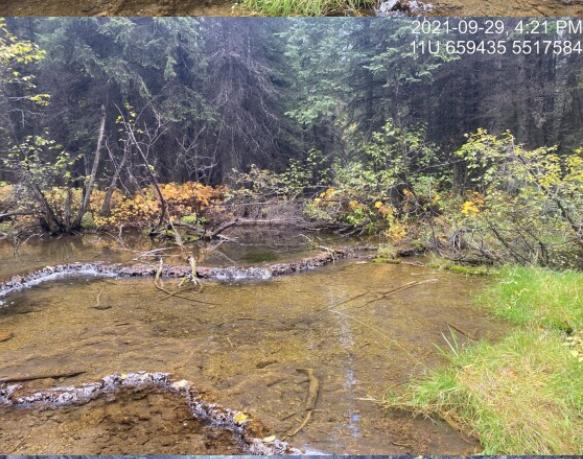
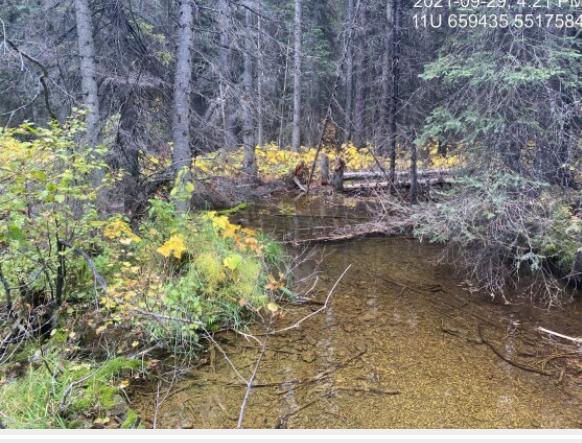
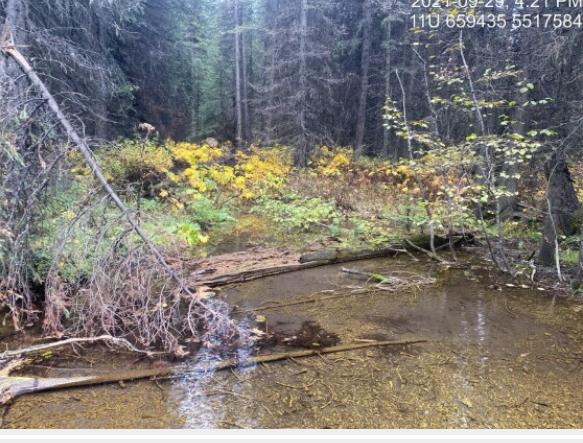
Location and Stream Data	Crossing Characteristics
Photos: PSCIS ID 197805. From top left clockwise: Road/Site Card, Barrel, Outlet, Downstream, Upstream, Inlet.

Comments: No crossing present. 16:20

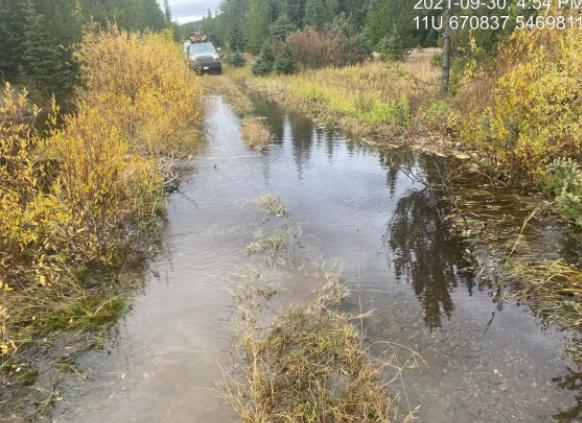
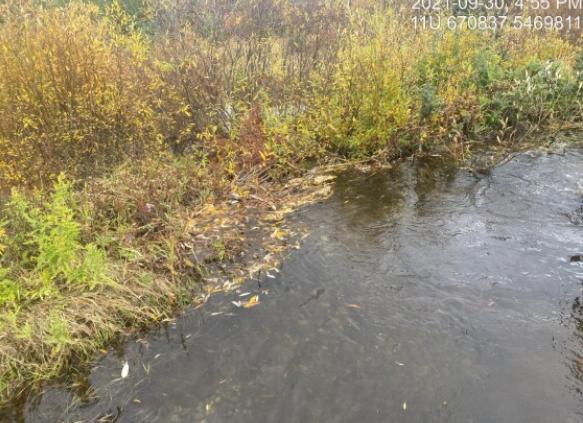
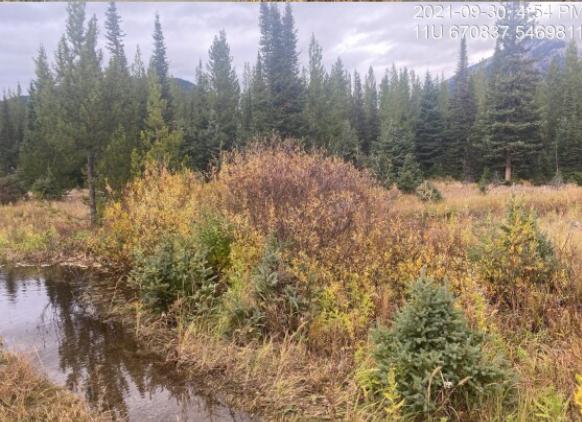
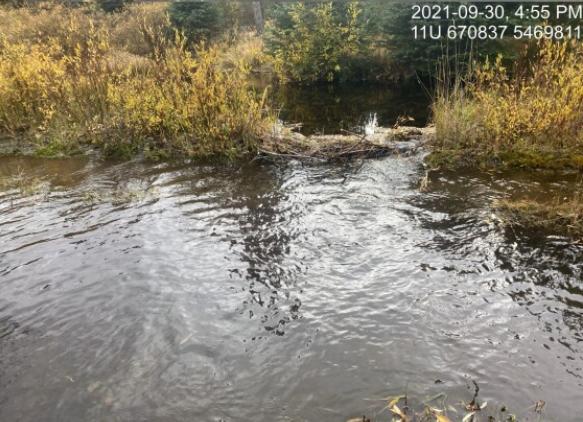
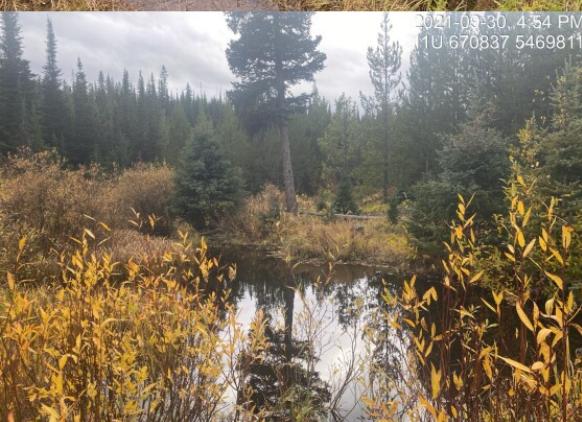
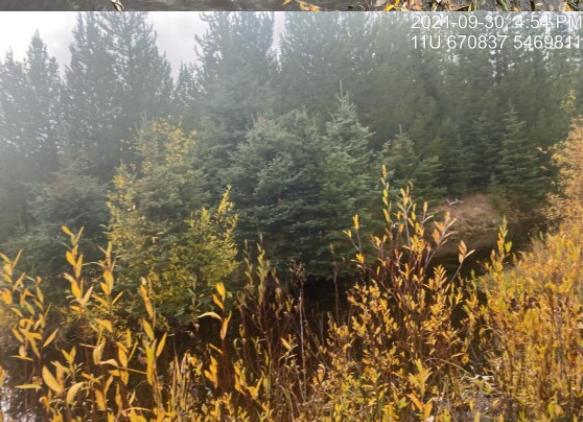
Location and Stream Data	•	Crossing Characteristics	-
Photos: PSCIS ID 197806. From top left clockwise: Road/Site Card, Barrel, Outlet, Downstream, Upstream, Inlet.

Comments: Ford. 16:52

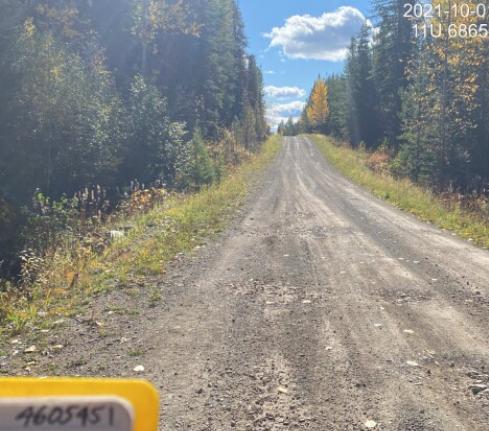
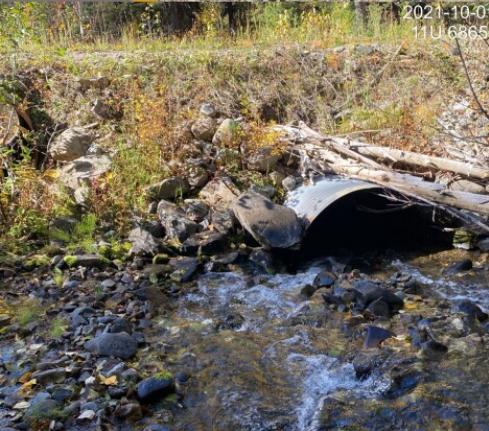
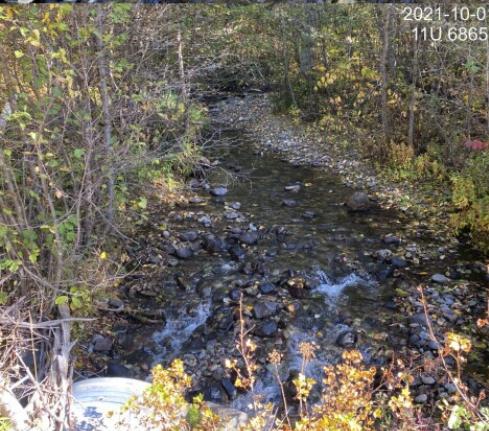
Location and Stream Data	Crossing Characteristics
Photos: PSCIS ID 197807. From top left clockwise: Road/Site Card, Barrel, Outlet, Downstream, Upstream, Inlet.

Comments: Overflow pipe on river left is ~1.4m diameter. Aggrading happening upstream of structure because undersized. Aggrading is 8-9% gradient for rise of 0.55m over a distance of 2.3m. Channel width is 4.0m. 12:32

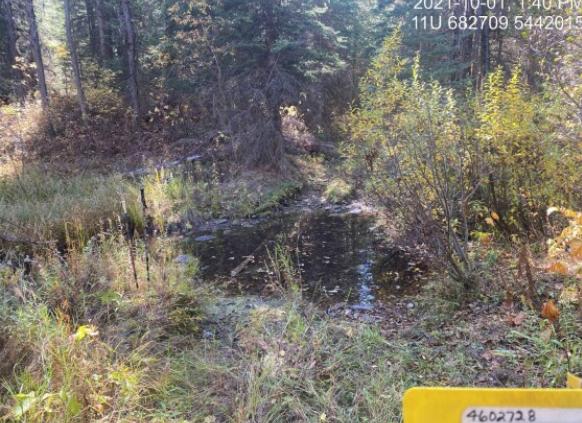
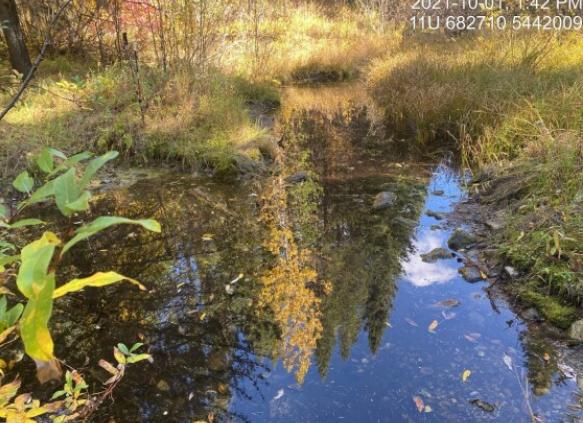
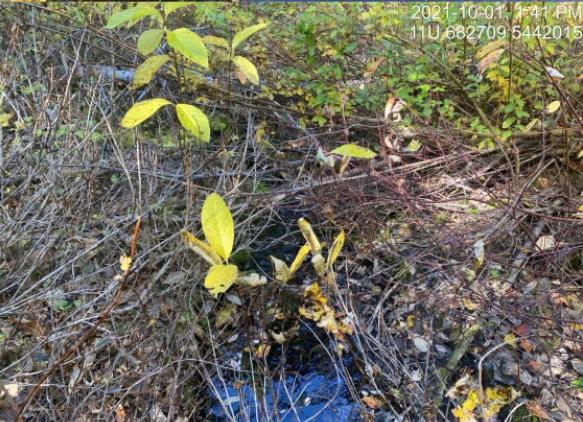
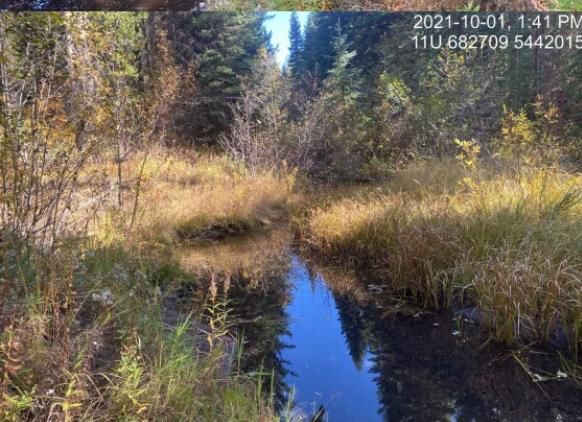
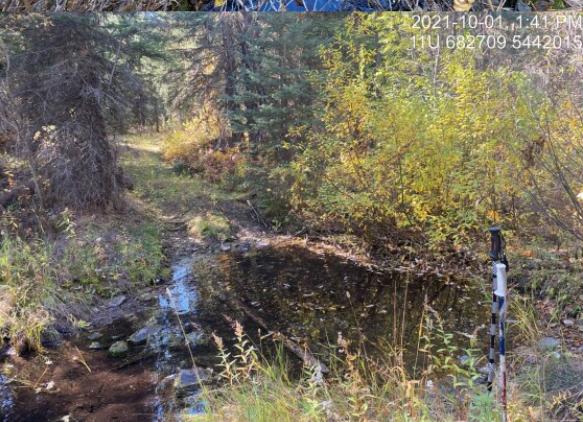
Location and Stream Data	Crossing Characteristics
Photos: PSCIS ID 197808. From top left clockwise: Road/Site Card, Barrel, Outlet, Downstream, Upstream, Inlet.

Comments: ATV access road. Small beaver dam along road. Good flow but very small channel. 13:39

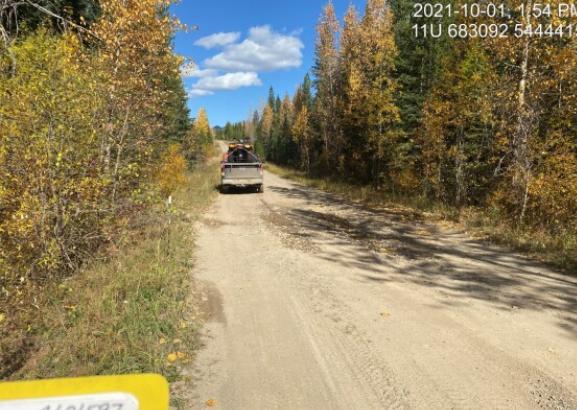
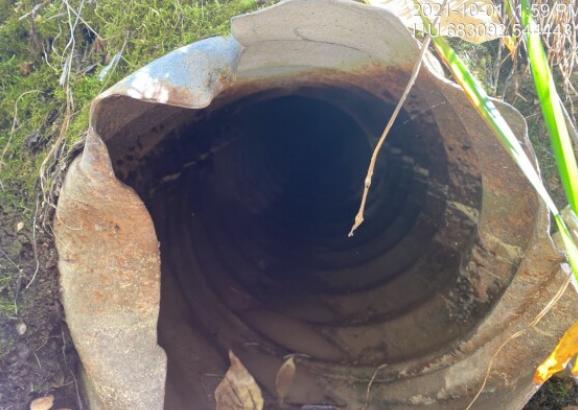
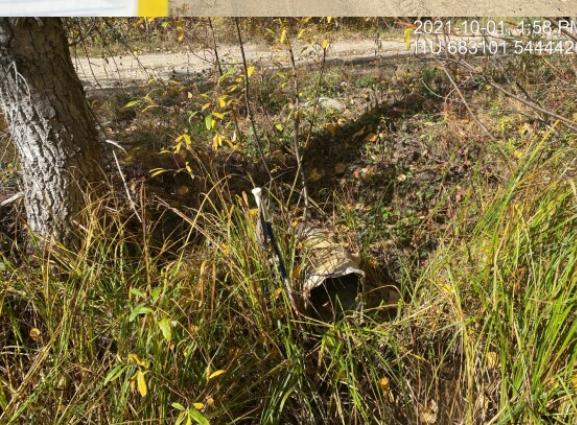
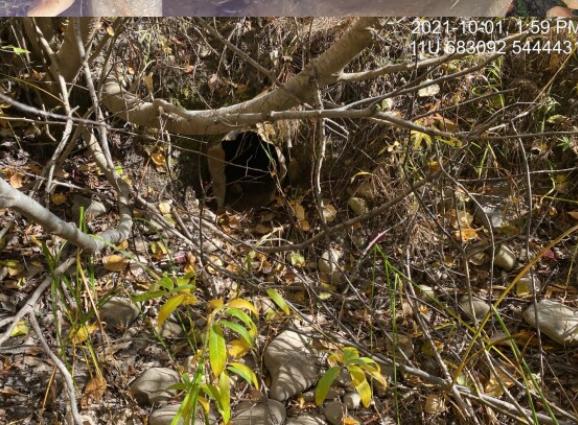
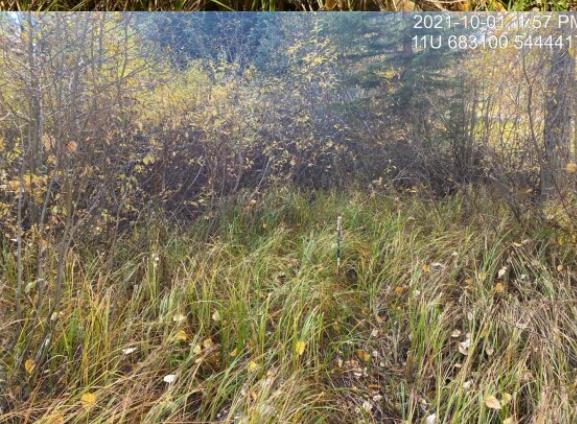
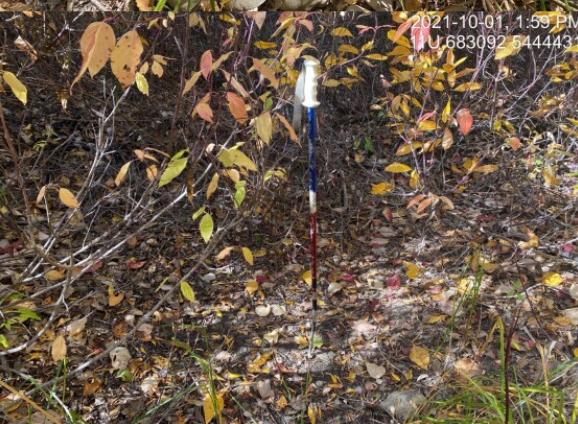
Location and Stream Data	Crossing Characteristics
Photos: PSCIS ID 197809. From top left clockwise: Road/Site Card, Barrel, Outlet, Downstream, Upstream, Inlet.

Comments: Dry channel. Very poorly defined channel upstream. Inlet perched. Unlikely fish habitat. 13:53

Location and Stream Data		Crossing Characteristics	
Date	2021-10-01	Crossing Sub Type	Round Culvert
PSCIS ID	197809	Diameter (m)	0.3
External ID	4606597	Length (m)	12
Crew	AI	Embedded	No
UTM Zone	11	Depth Embedded (m)	–
Easting	683097	Resemble Channel	No
Northing	5444416	Backwatered	No
Stream	Tributary to Flathead River	Percent Backwatered	–
Road	Commerce FSR	Fill Depth (m)	1
Road Tenure	FLNR DRM 0030	Outlet Drop (m)	0
Channel Width (m)	0.9	Outlet Pool Depth (m)	0
Stream Slope (%)	1	Inlet Drop	No
Beaver Activity	No	Slope (%)	3
Habitat Value	Low	Valley Fill	Deep Fill
Final score	26	Barrier Result	Barrier
Fix type	Replace Structure with Streambed Simulation CBS	Fix Span / Diameter	3

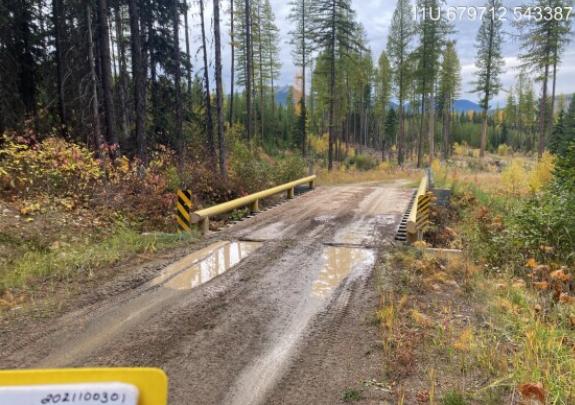
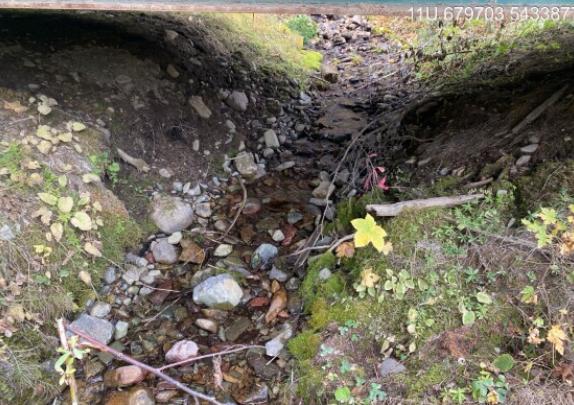
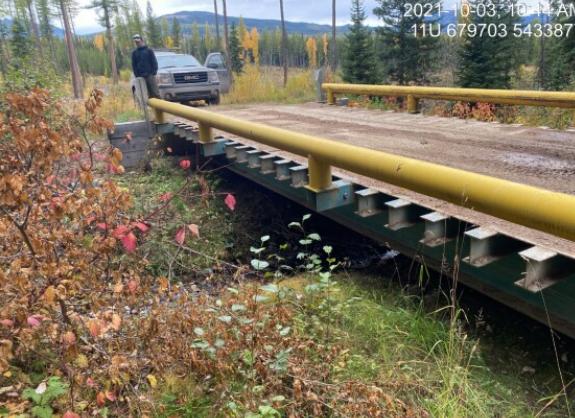
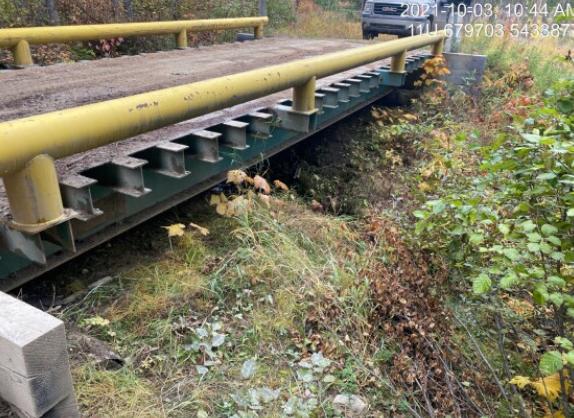
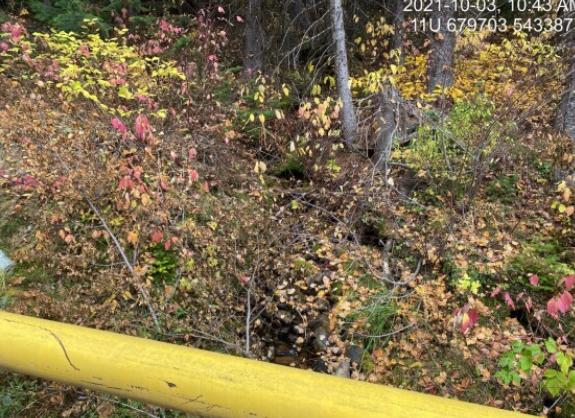
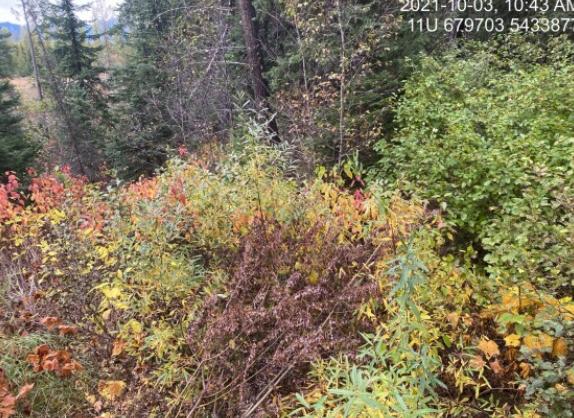
Location and Stream Data	Crossing Characteristics
Photos: PSCIS ID 197810. From top left clockwise: Road/Site Card, Barrel, Outlet, Downstream, Upstream, Inlet.

Comments: WCT captured just upstream of this site in 2014 <https://a100.gov.bc.ca/pub/acat/public/viewReport.do?reportId=50581> . 10:40

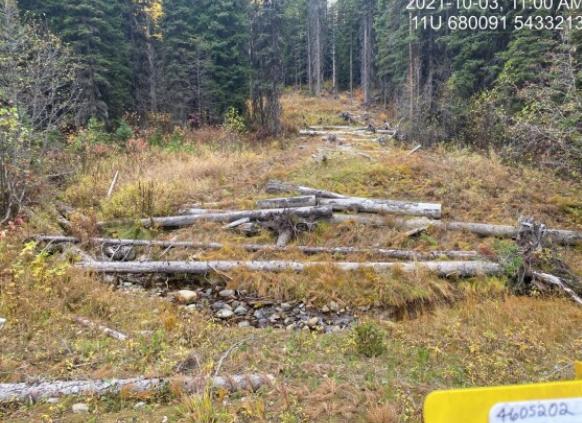
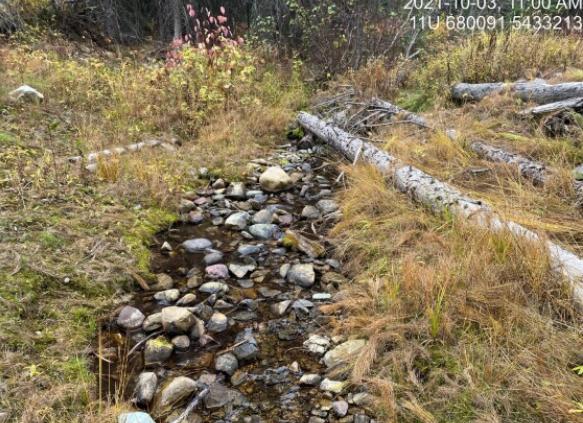
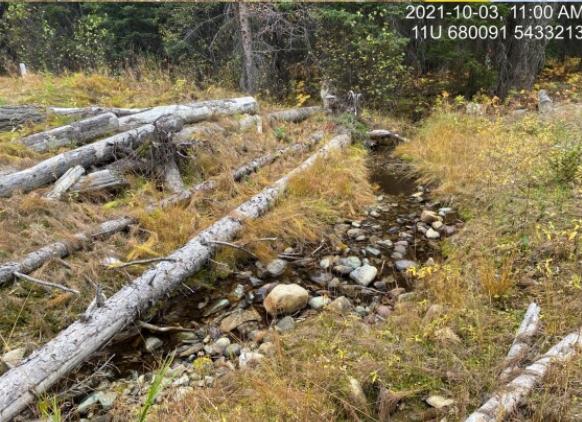
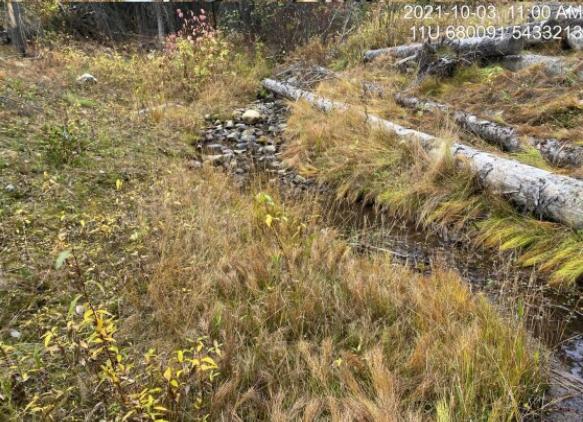
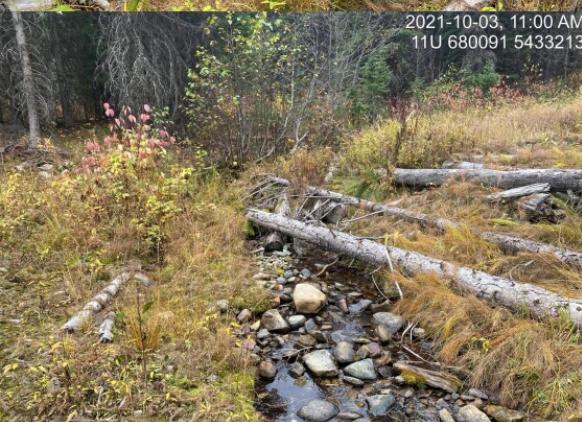
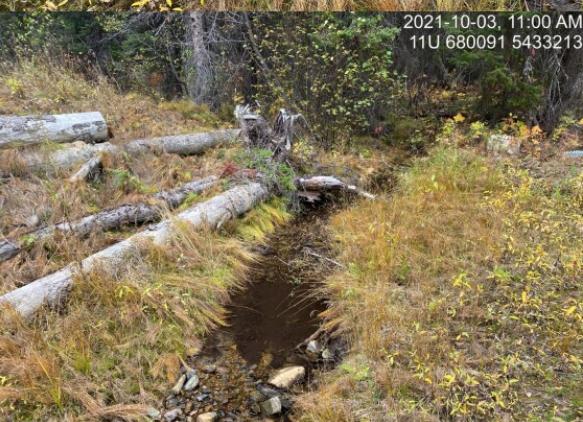
Location and Stream Data	•	Crossing Characteristics	-
Photos: PSCIS ID 197811. From top left clockwise: Road/Site Card, Barrel, Outlet, Downstream, Upstream, Inlet.

Comments: Road deactivated. Full rehab. No ATV access. 10:58
