## Appendix - Phase 1 Fish Passage Assessment Data and Photos

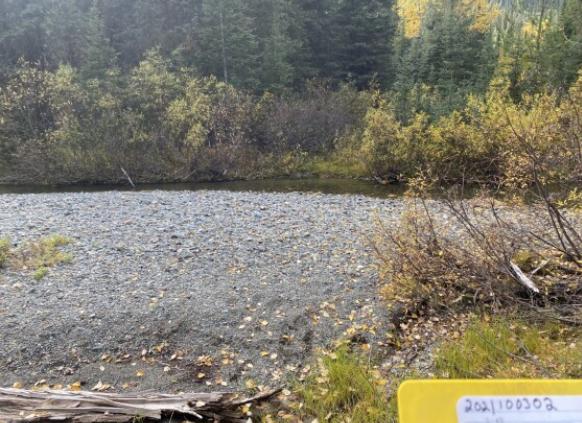
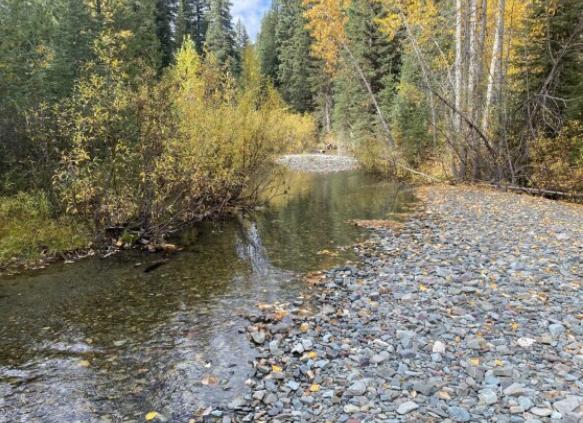
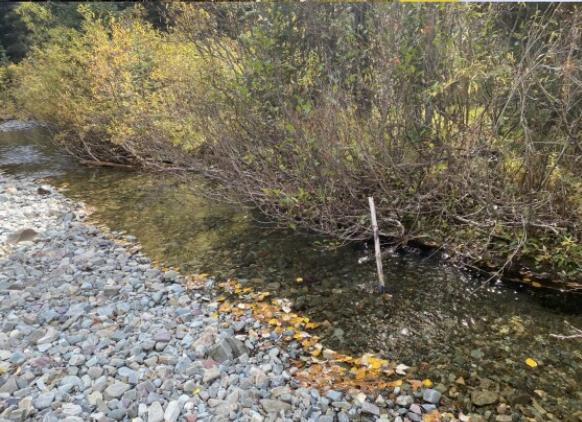
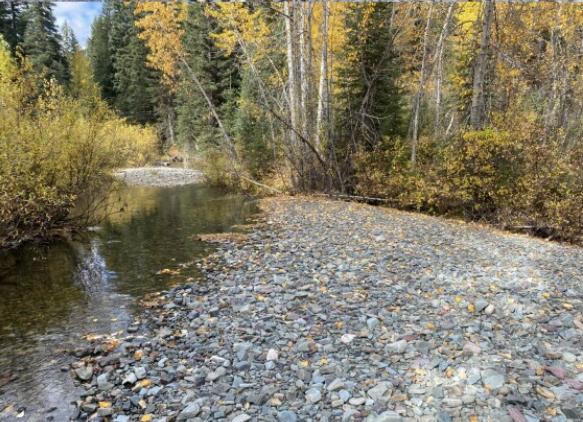
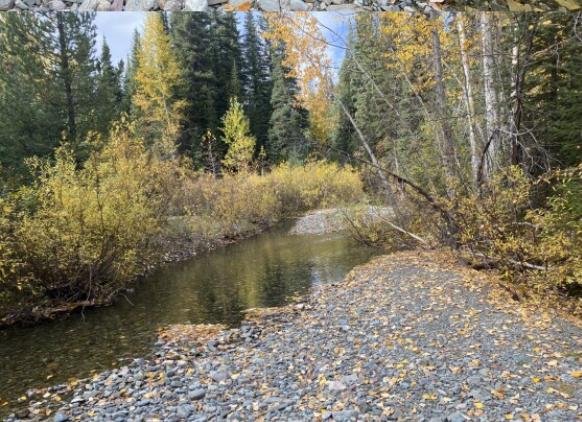
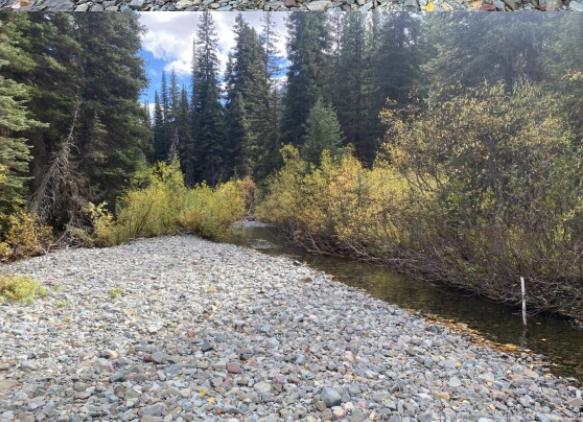
Location and Stream Data	•	Crossing Characteristics	-
Photos: PSCIS ID 197812. From top left clockwise: Road/Site Card, Barrel, Outlet, Downstream, Upstream, Inlet.

Comments: No modelled crossing on maps. 14:28

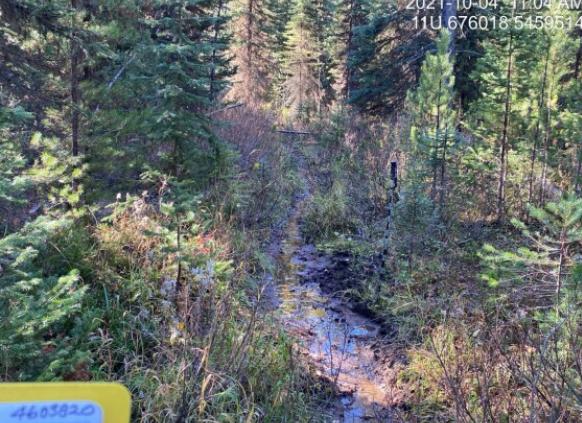
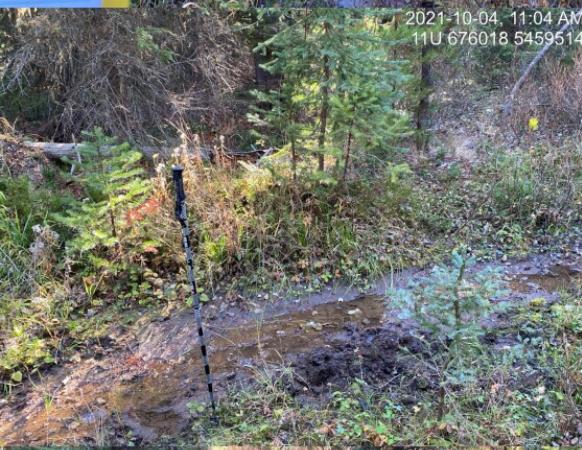
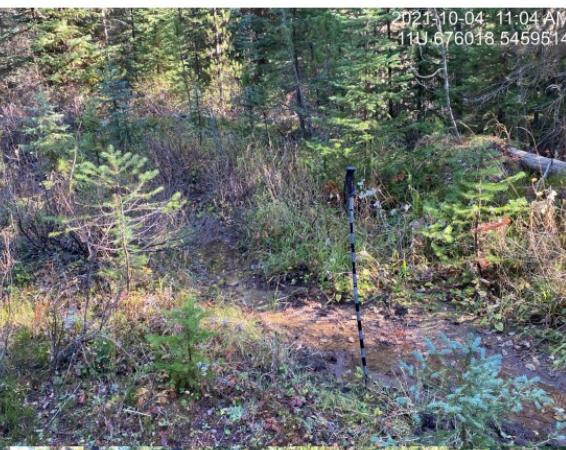
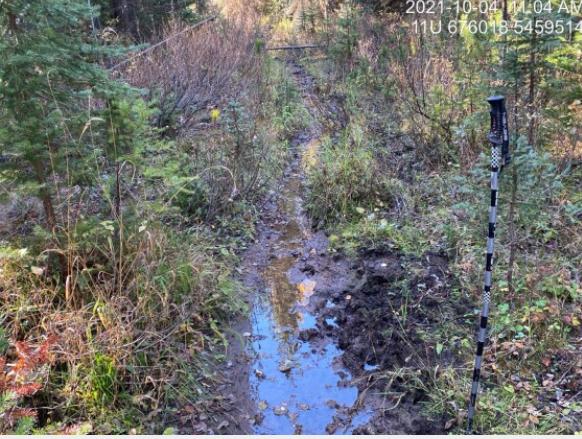
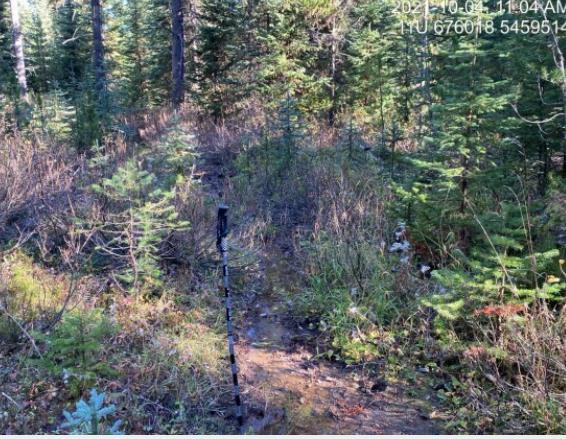
Location and Stream Data	•	Crossing Characteristics	-
Photos: PSCIS ID 197813. From top left clockwise: Road/Site Card, Barrel, Outlet, Downstream, Upstream, Inlet.

Comments: Wildlife trail. No structure. Road does not appear to be used by ATVs. Main flow of Morris Creek is actually north of here and flows in from the north. Small amount of flow on trail. No indication of channel. 11:02

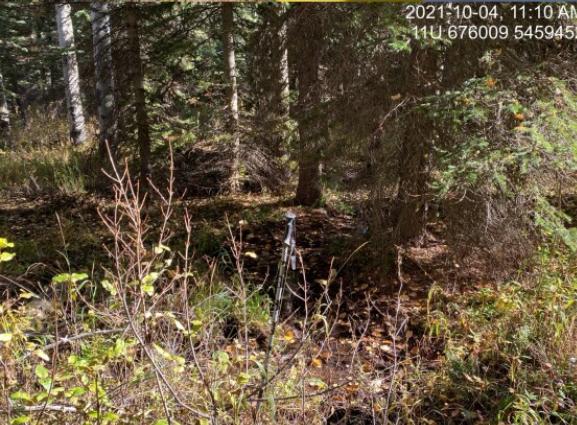
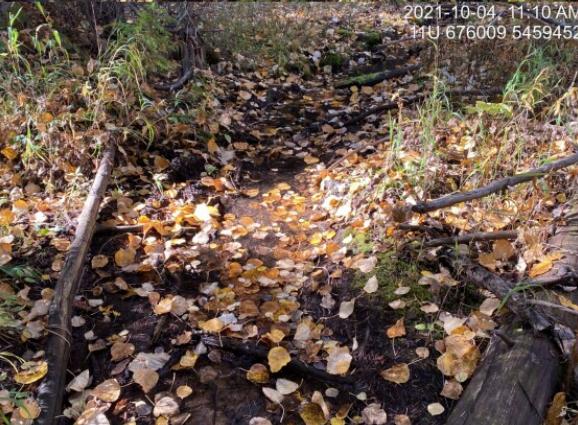
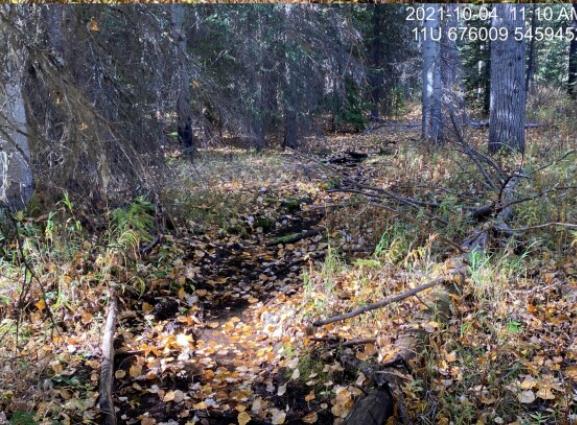
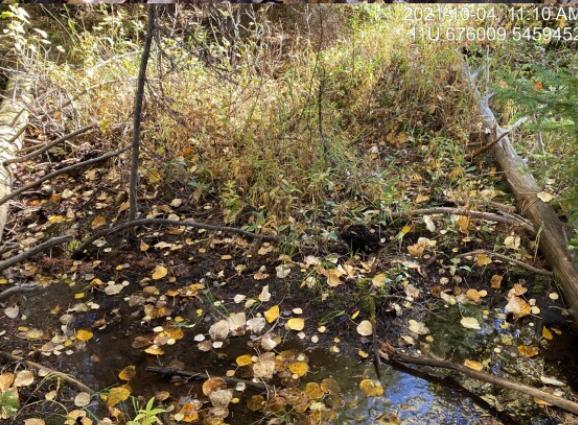
Comments: Wildlife trail. No structure. Road does not appear to be used by ATVs. Main flow of Morris Creek is actually north of here and flows in from the north. Small amount of flow on trail. No indication of channel. 11:07

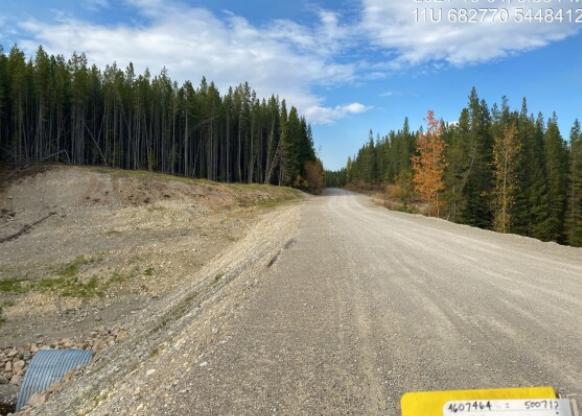
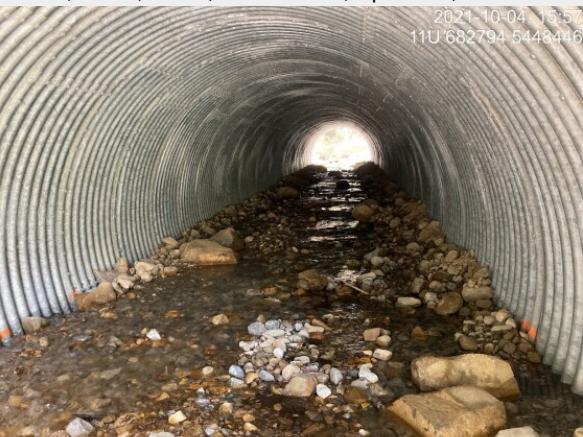
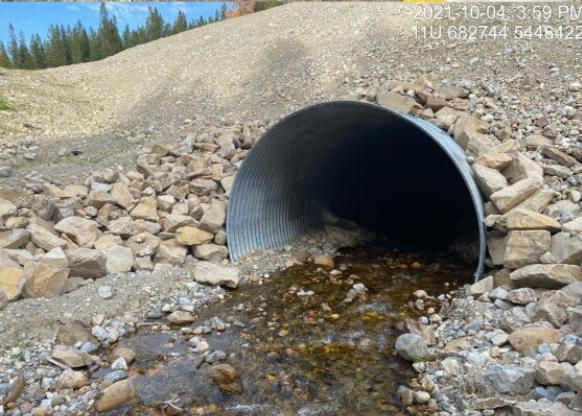
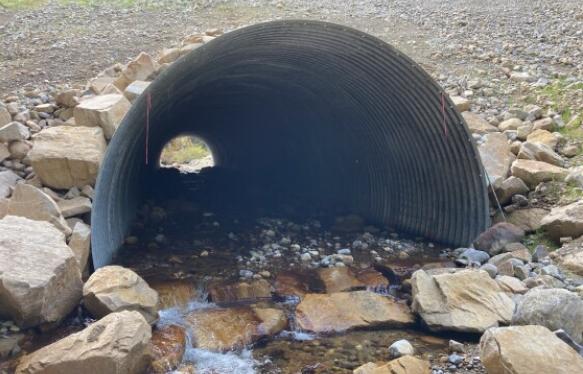
Location and Stream Data	Crossing Characteristics
Photos: PSCIS ID 197815. From top left clockwise: Road/Site Card, Barrel, Outlet, Downstream, Upstream, Inlet.	
2021-10-04, 3:56 PM 11U 682770 5448412	2021-10-04, 15:57 11U 682794 5448446

Comments: Newly replaced culvert with natural embedded substrate. Likely PSCIS point 50071 however the coordinates for that site appear to be input incorrectly. 15:55

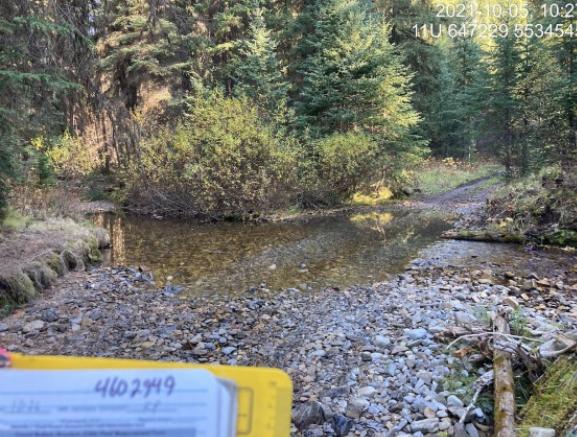
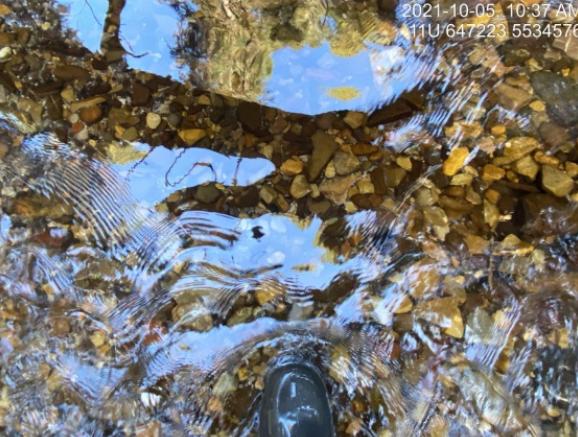
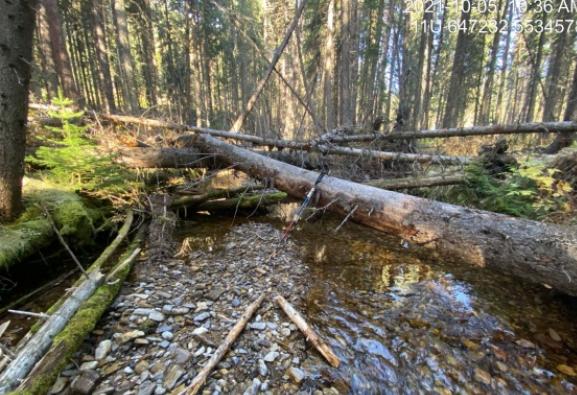
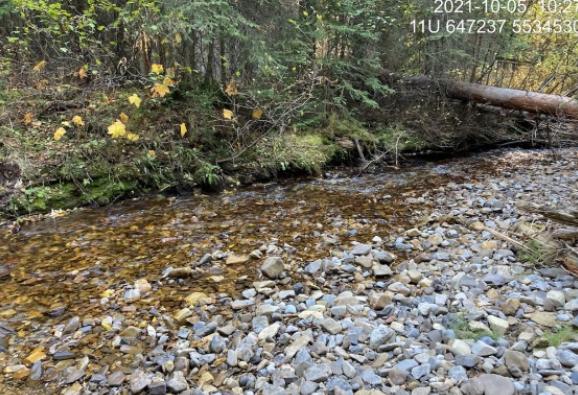
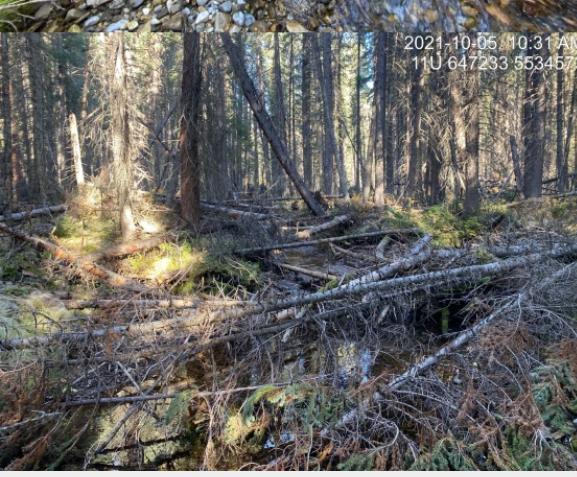
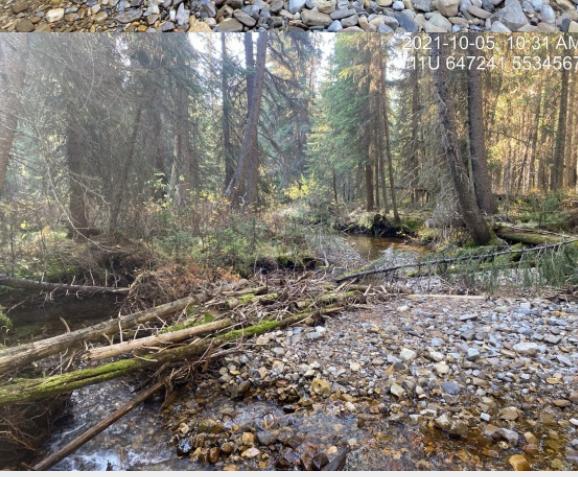
Location and Stream Data	Crossing Characteristics
Photos: PSCIS ID 197816. From top left clockwise: Road/Site Card, Barrel, Outlet, Downstream, Upstream, Inlet.

Comments: Ford within access management area. 10:26

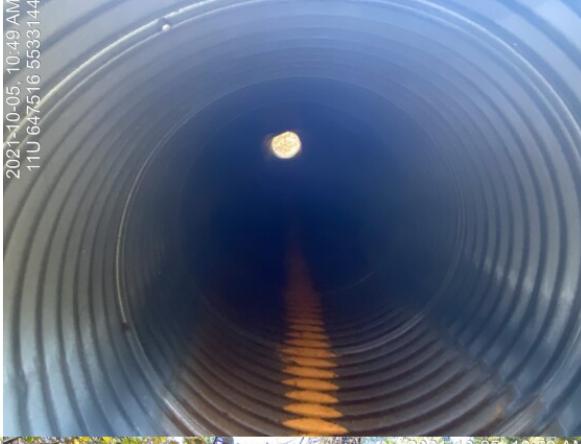
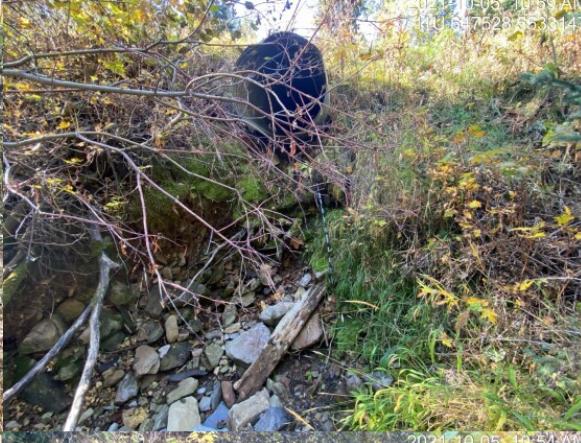
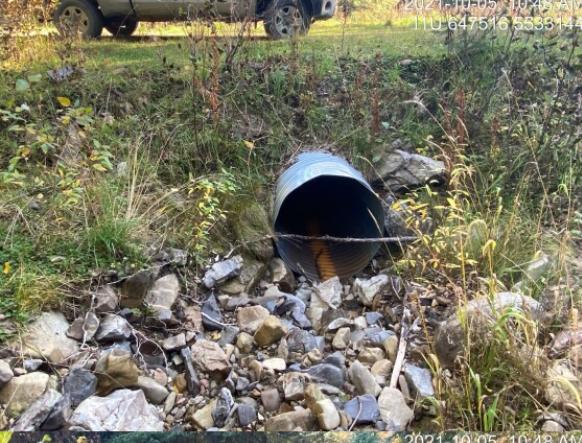
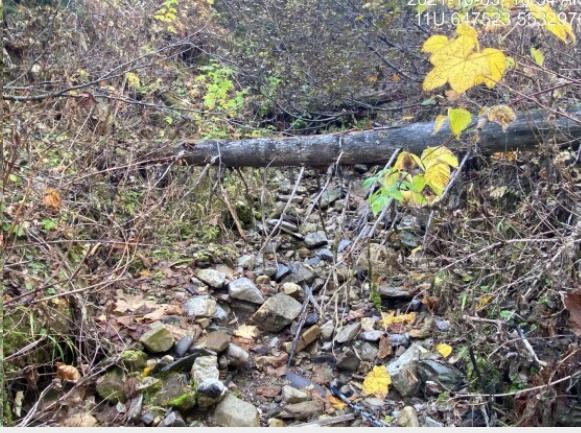
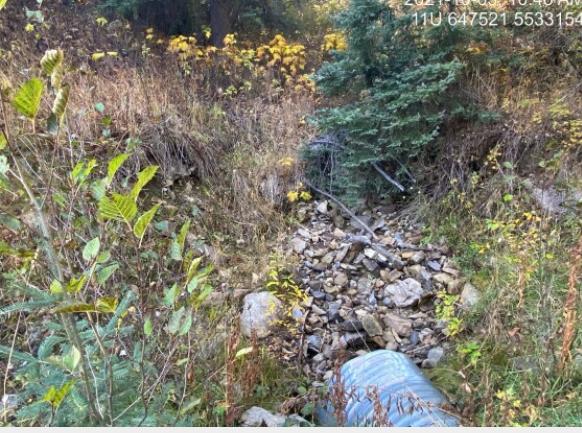
Location and Stream Data	•	Crossing Characteristics	-
Photos: PSCIS ID 197817. From top left clockwise: Road/Site Card, Barrel, Outlet, Downstream, Upstream, Inlet.

Location and Stream Data		CROSSING CHARACTERISTICS	
Date	2021-10-05	Crossing Sub Type	Round Culvert
PSCIS ID	197817	Diameter (m)	1
External ID	4605995	Length (m)	15
Crew	AI	Embedded	No
UTM Zone	11	Depth Embedded (m)	—
Easting	647526	Resemble Channel	No
Northing	5533149	Backwatered	No
Stream	Tributary to Weigert Creek	Percent Backwatered	—
Road	Weigert FSR	Fill Depth (m)	1
Road Tenure	FLNR DRM 8633	Outlet Drop (m)	1.7
Channel Width (m)	2.4	Outlet Pool Depth (m)	0.3
Stream Slope (%)	17	Inlet Drop	Yes
Beaver Activity	No	Slope (%)	5
Habitat Value	Low	Valley Fill	Deep Fill
Final score	39	Barrier Result	Barrier
Fix type	Replace with New Open Bottom Structure	Fix Span / Diameter	12

Comments: Dry and very steep stream channel. Likely to steep for WCT. 10:47

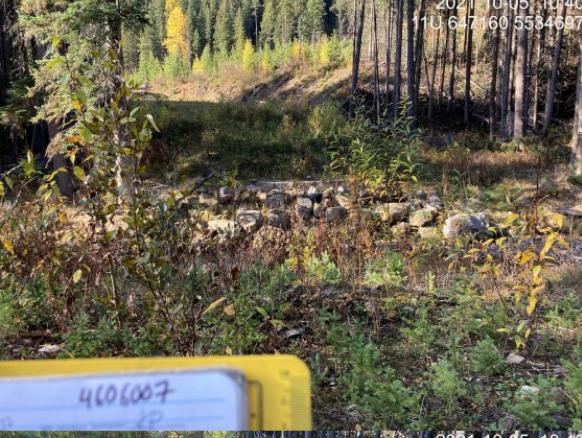
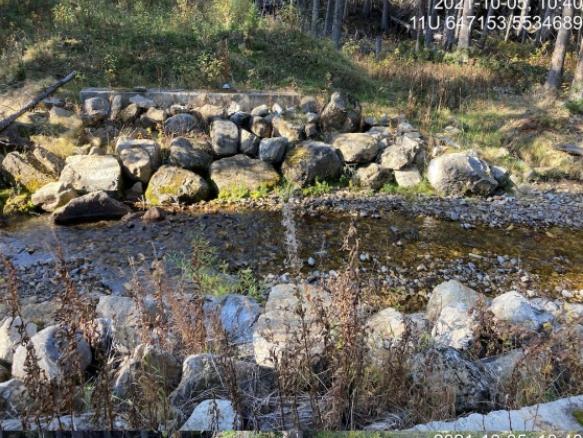
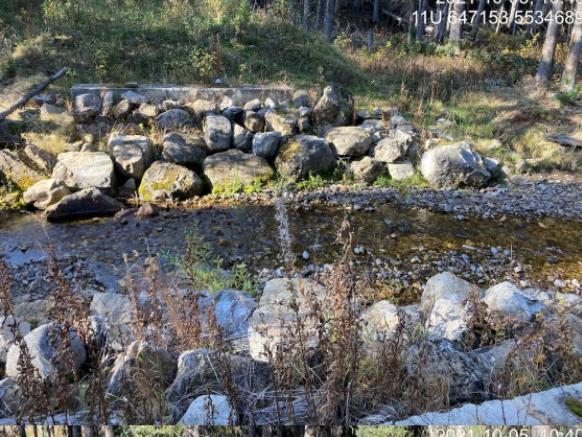
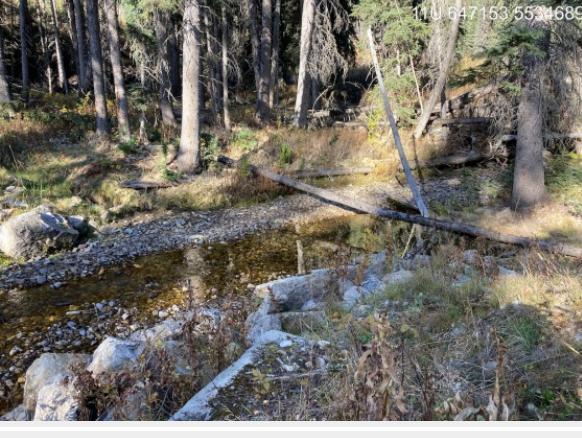
Location and Stream Data	Crossing Characteristics
Photos: PSCIS ID 197818. From top left clockwise: Road/Site Card, Barrel, Outlet, Downstream, Upstream, Inlet.

2021-10-05, 10:40 11U 647153 5534689
Comments: Road deactivated at entrance and crossings pulled. 10:37

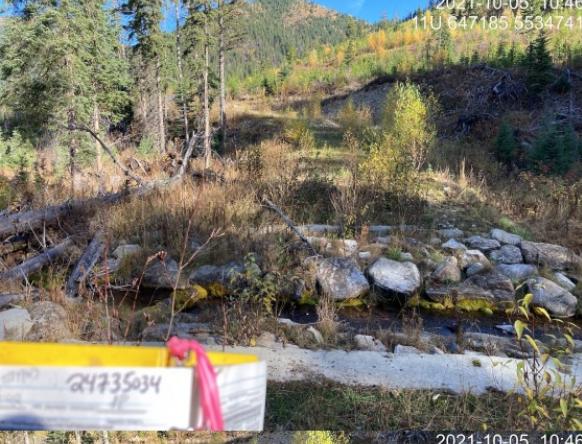
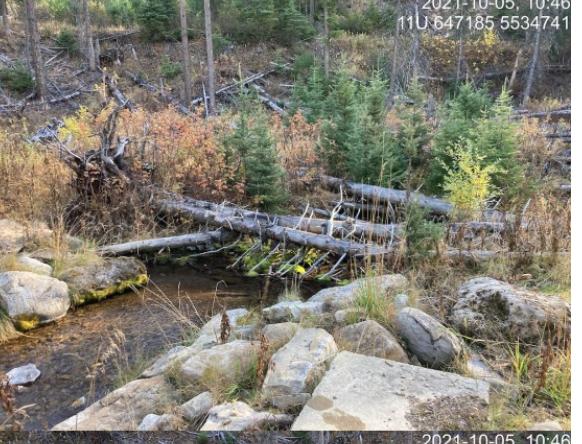
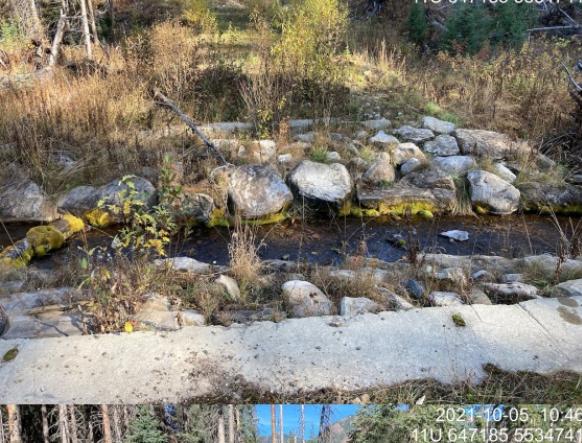
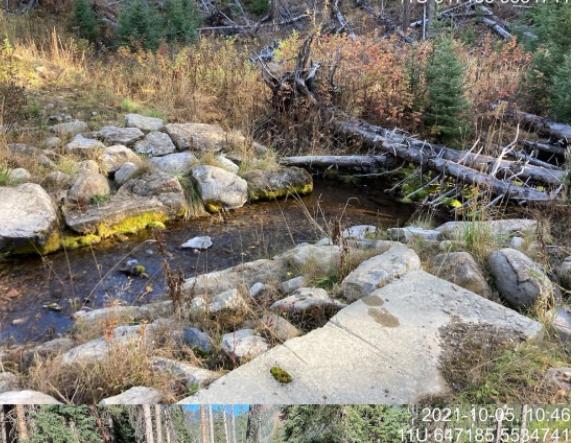
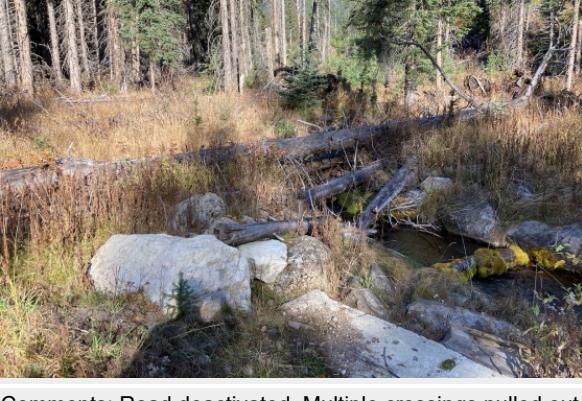
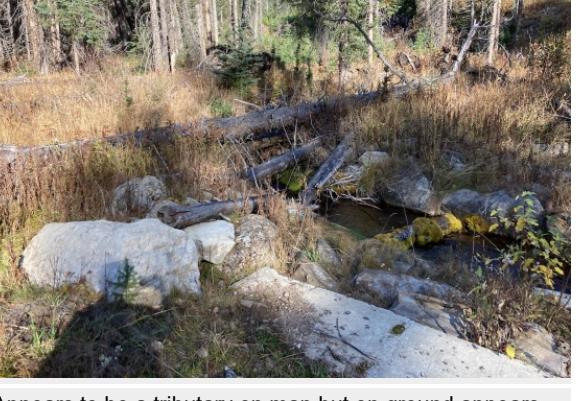
Location and Stream Data	•	Crossing Characteristics	-
Photos: PSCIS ID 197819. From top left clockwise: Road/Site Card, Barrel, Outlet, Downstream, Upstream, Inlet.

Comments: Road deactivated. Multiple crossings pulled out. Appears to be a tributary on map but on ground appears that it is possibly a side channel to Weigert. 10:42

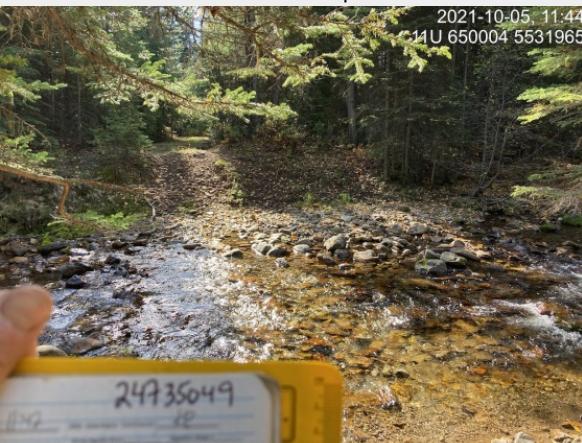
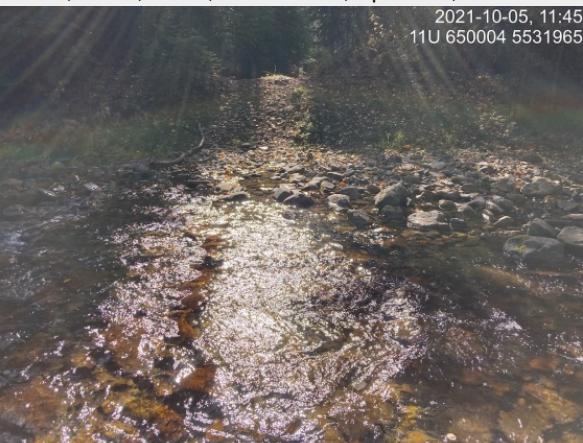
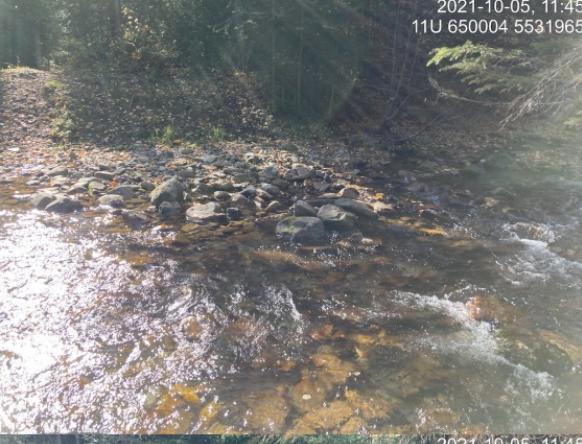
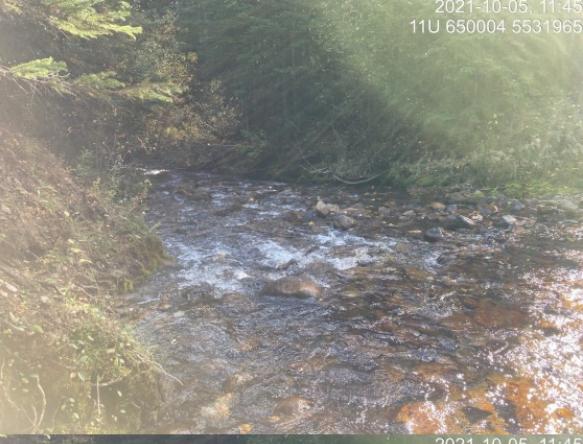
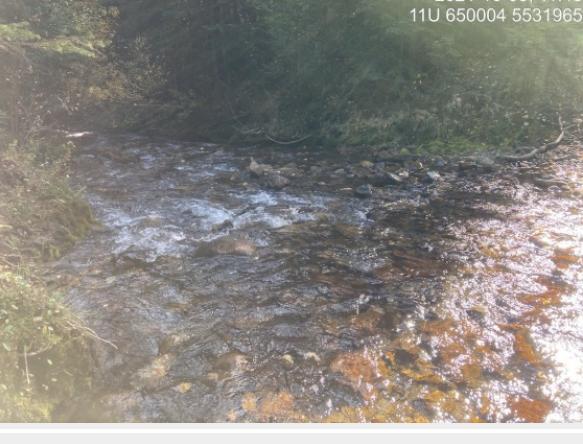
Location and Stream Data	•	Crossing Characteristics	-
Photos: PSCIS ID 197820. From top left clockwise: Road/Site Card, Barrel, Outlet, Downstream, Upstream, Inlet.

Comments: ATV Trail. 11:42

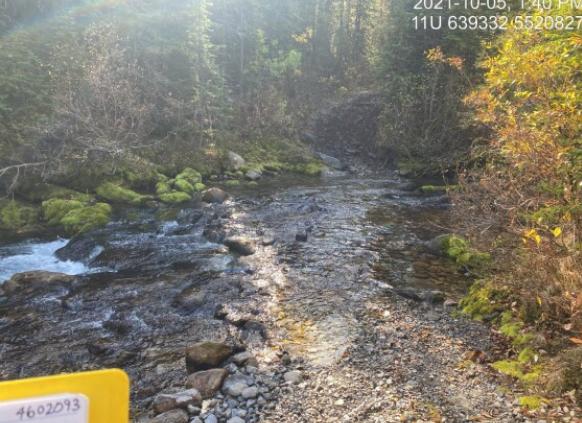
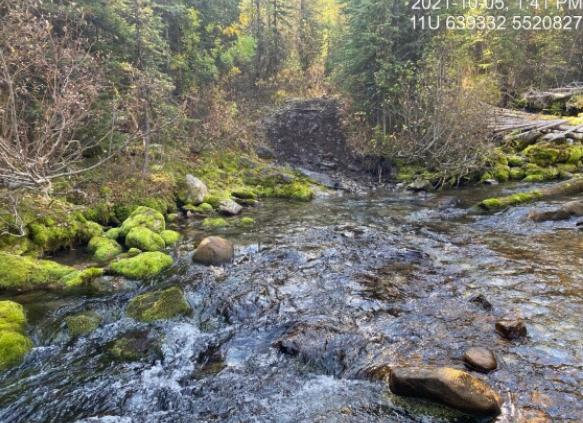
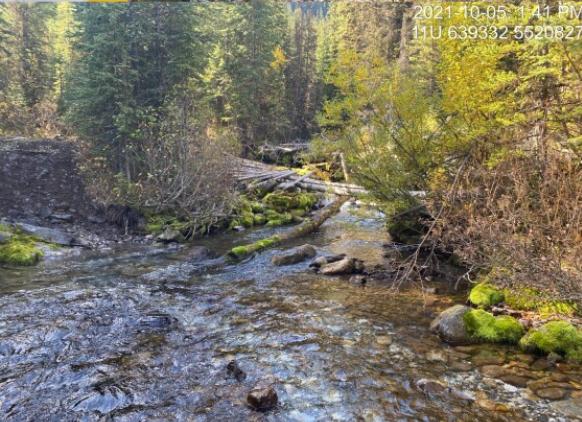
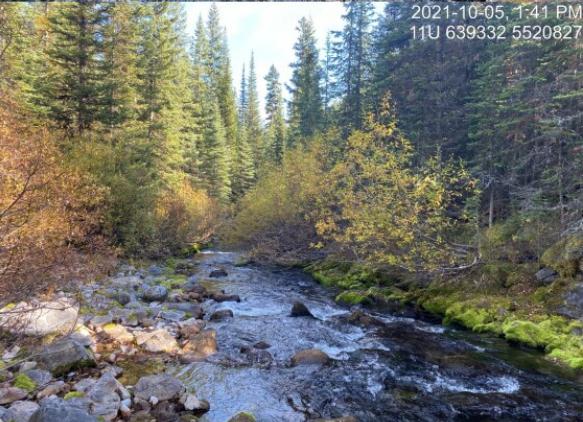
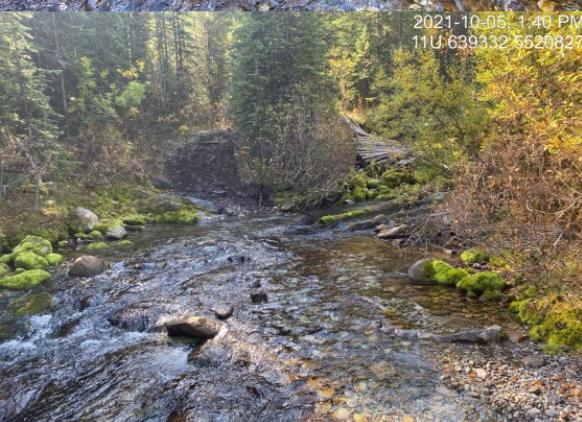
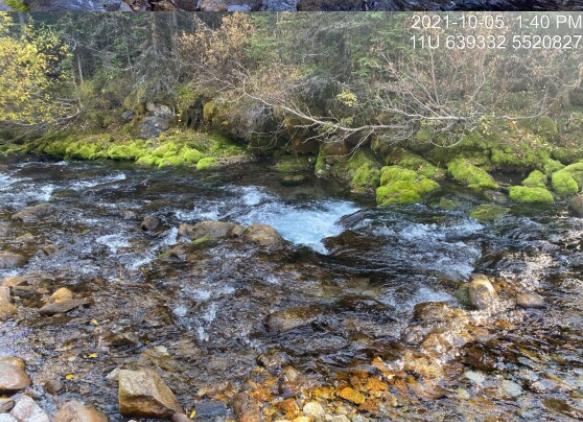
Location and Stream Data	•	Crossing Characteristics	-
Photos: PSCIS ID 197822. From top left clockwise: Road/Site Card, Barrel, Outlet, Downstream, Upstream, Inlet.

Comments: Sporty ATV access only ;). 13:40

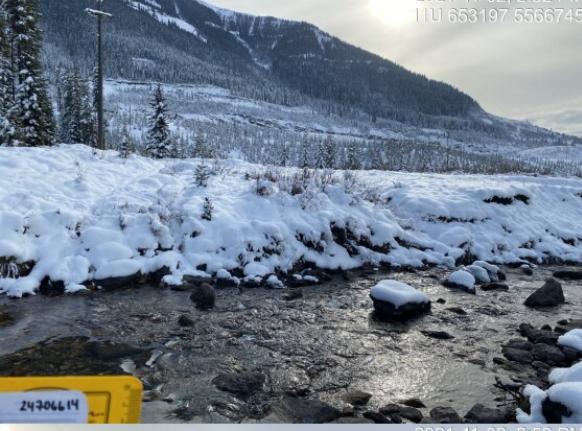
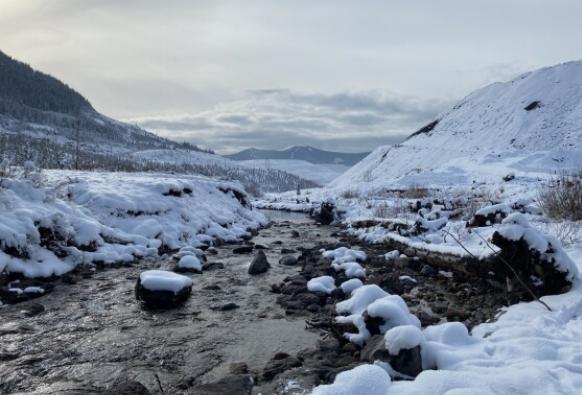
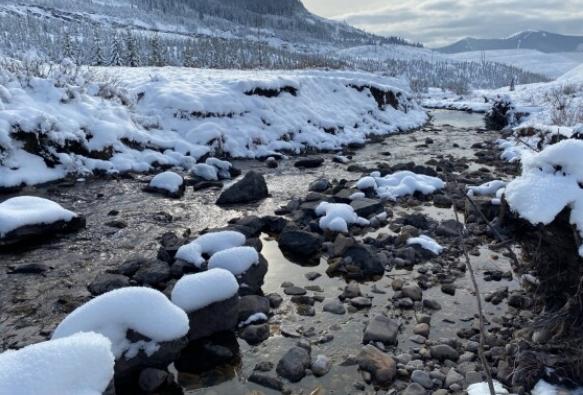
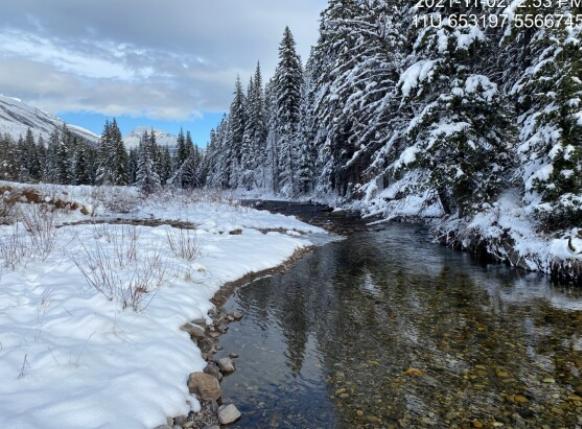
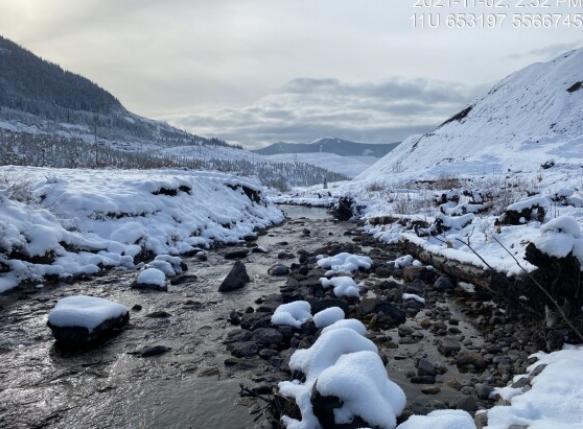
Location and Stream Data	Crossing Characteristics
Photos: PSCIS ID 197823. From top left clockwise: Road/Site Card, Barrel, Outlet, Downstream, Upstream, Inlet.

Comments: Transmission line crossing. May have been a bridge historically. 14:49

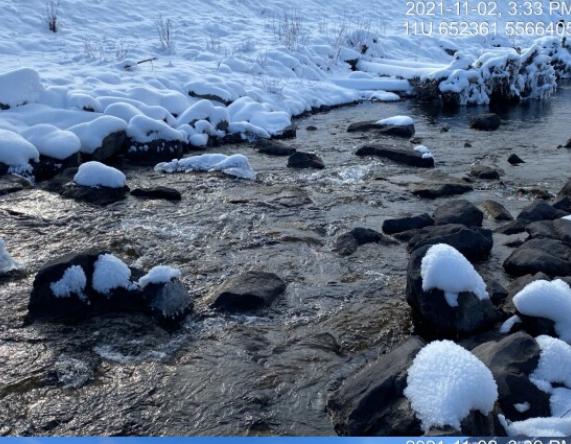
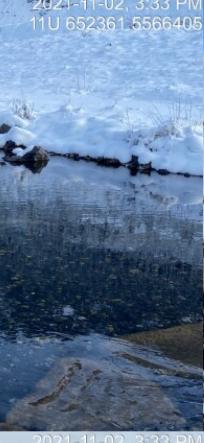
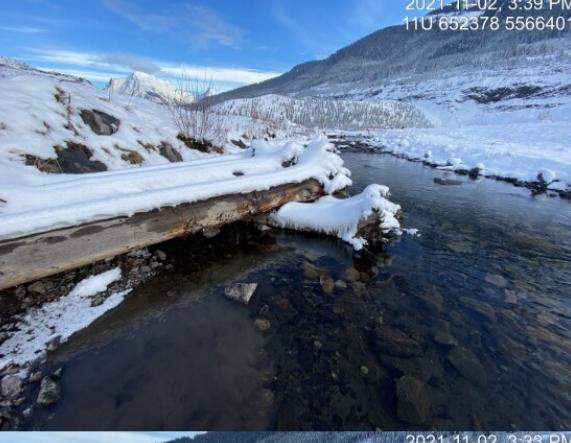
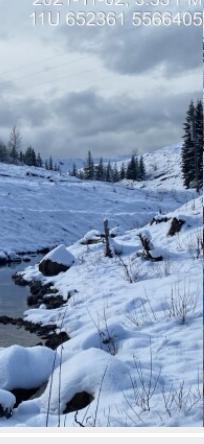
Location and Stream Data	•	Crossing Characteristics	-
Photos: PSCIS ID 197824. From top left clockwise: Road/Site Card, Barrel, Outlet, Downstream, Upstream, Inlet.

2021-11-02, 3:33 PM 11U 652361 5566405
Comments: Approximately 60m downstream of modelled location. 15:25

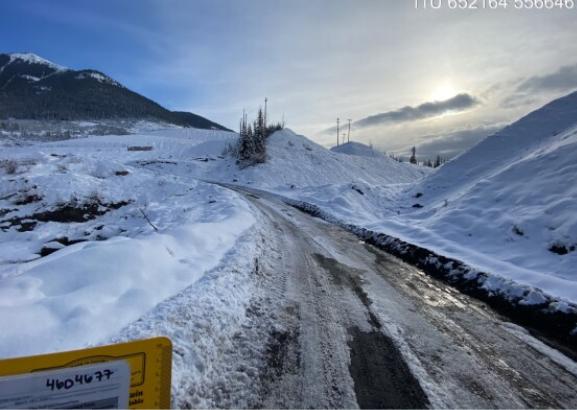
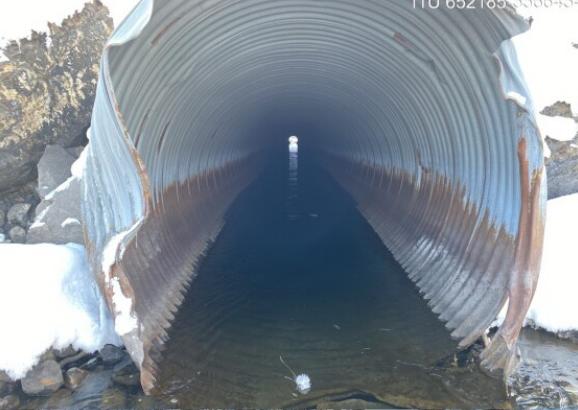
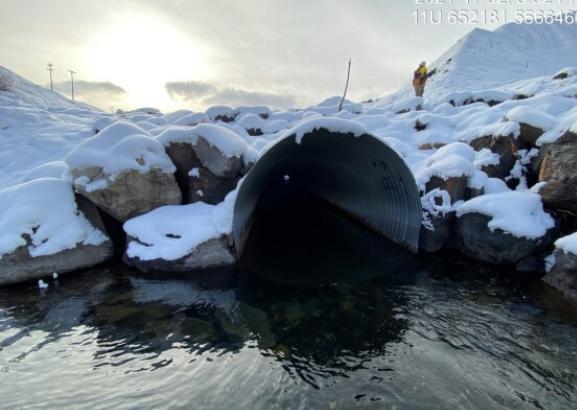
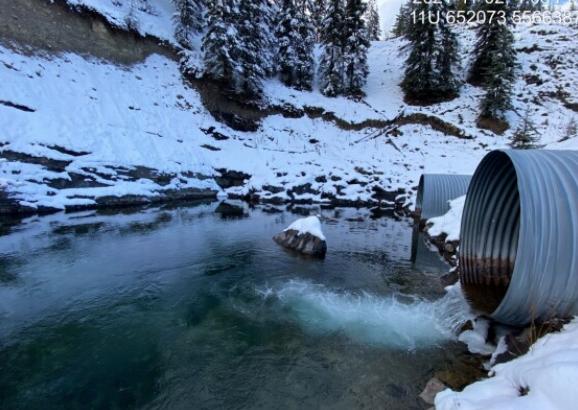
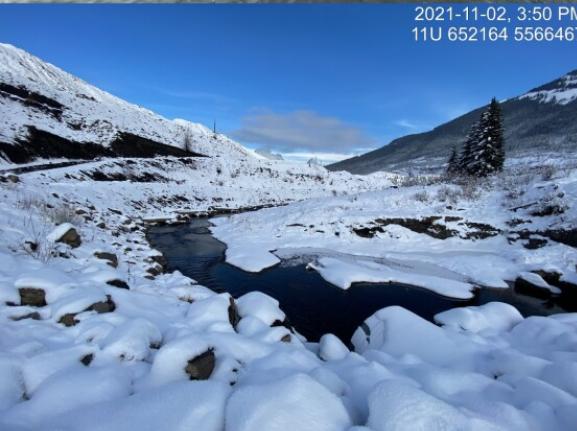
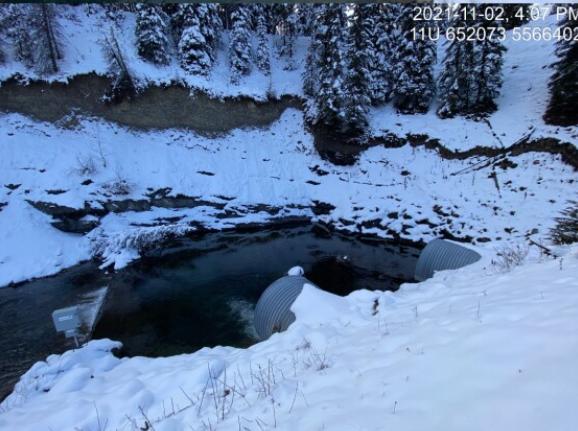
Location and Stream Data	Crossing Characteristics
Photos: PSCIS ID 197825. From top left clockwise: Road/Site Card, Barrel, Outlet, Downstream, Upstream, Inlet.

Location and Stream Data		Crossing Characteristics	
Date	2021-11-02	Crossing Sub Type	Round Culvert
PSCIS ID	197825	Diameter (m)	2.7
External ID	4604677	Length (m)	99
Crew	AI SS RA	Embedded	No
UTM Zone	11	Depth Embedded (m)	—
Easting	652123.3	Resemble Channel	No
Northing	5566424	Backwatered	Yes
Stream	Henretta Creek	Percent Backwatered	100
Road	—	Fill Depth (m)	2.4
Road Tenure	Teck	Outlet Drop (m)	0
Channel Width (m)	12	Outlet Pool Depth (m)	0.4
Stream Slope (%)	3.5	Inlet Drop	No
Beaver Activity	No	Slope (%)	0.5
Habitat Value	High	Valley Fill	Deep Fill
Final score	22	Barrier Result	Barrier
Fix type	Replace with New Open Bottom Structure	Fix Span / Diameter	18

Comments: Two pipes (2.7 x 2.2). Length of pipes is 130m! Biomark station installed to document fish movement through culvert. Four concrete weirs (~0.3m drops) located downstream of outlet. 15:50

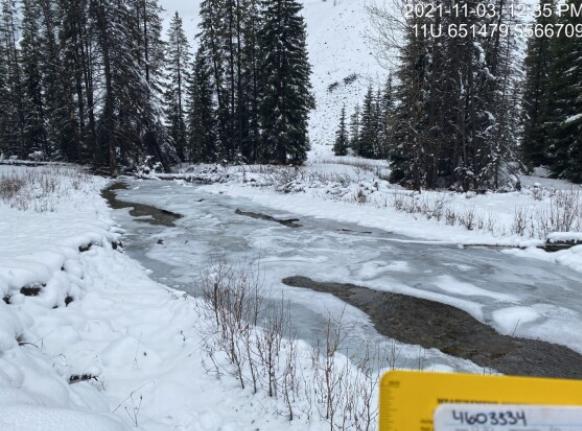
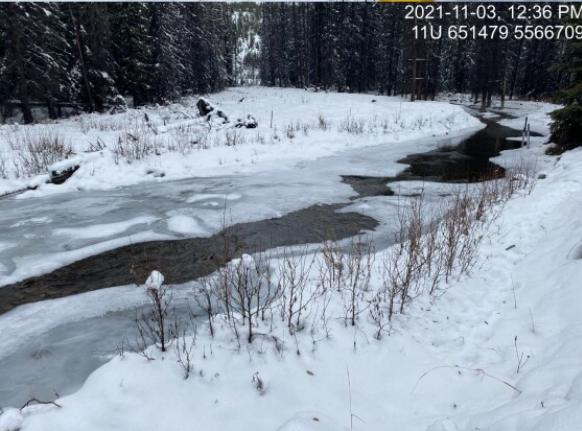
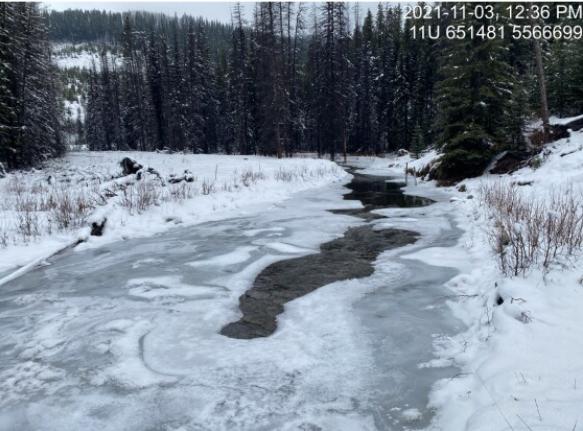
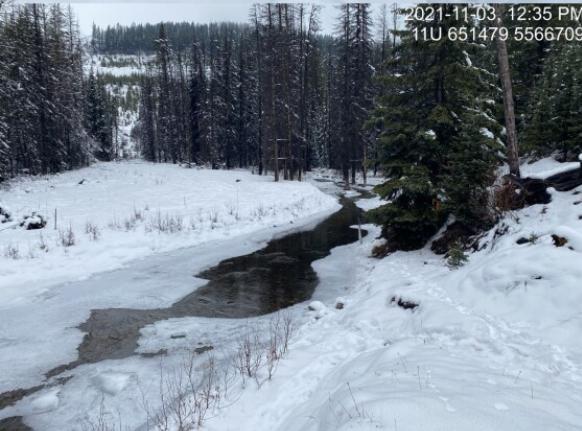
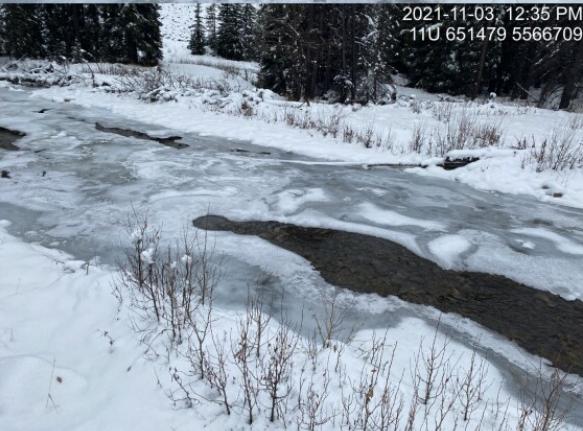
Location and Stream Data	•	Crossing Characteristics	-
Photos: PSCIS ID 197826. From top left clockwise: Road/Site Card, Barrel, Outlet, Downstream, Upstream, Inlet.

Comments: Staff gauge and transducer upstream. 12:30

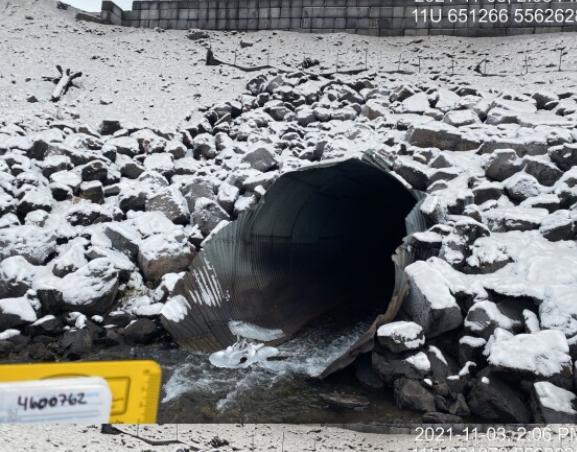
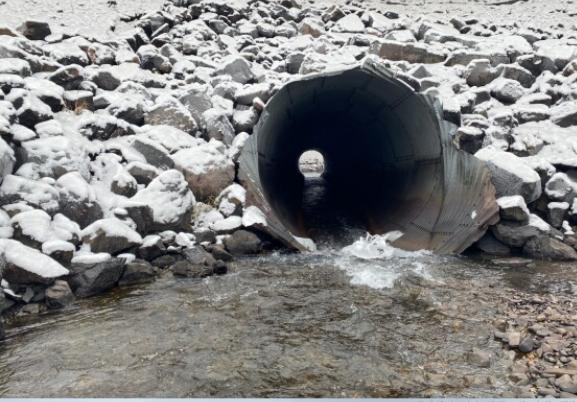
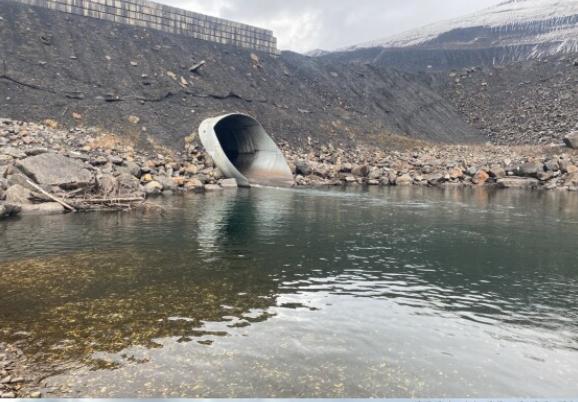
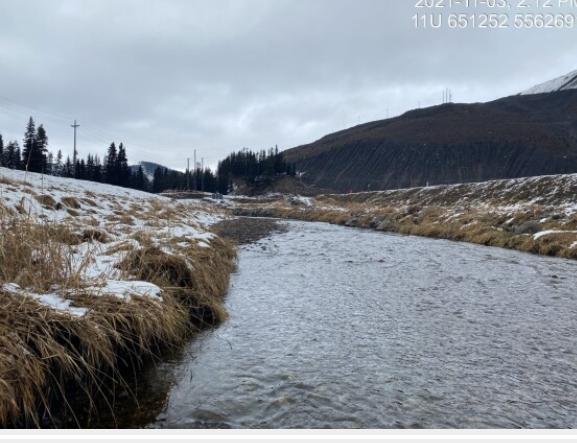
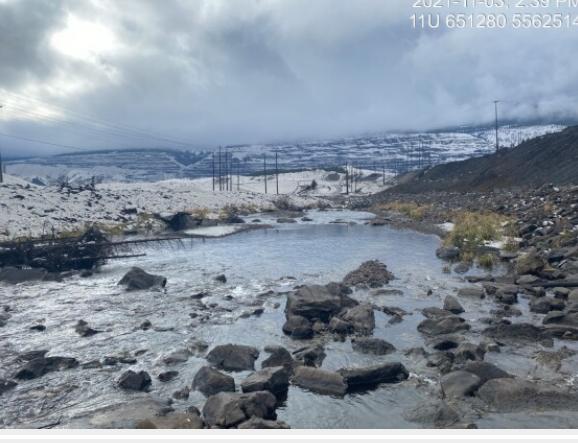
Location and Stream Data	Crossing Characteristics
Photos: PSCIS ID 197827. From top left clockwise: Road/Site Card, Barrel, Outlet, Downstream, Upstream, Inlet.

Location and Stream Data		Crossing Characteristics	
Date	2021-11-03	Crossing Sub Type	Round Culvert
PSCIS ID	197827	Diameter (m)	5
External ID	4600762	Length (m)	40
Crew	AI SS RA	Embedded	No
UTM Zone	11	Depth Embedded (m)	—
Easting	651282	Resemble Channel	No
Northing	5562574	Backwatered	No
Stream	Fording River	Percent Backwatered	—
Road	FRO Coal Haul	Fill Depth (m)	9.99
Road Tenure	Teck	Outlet Drop (m)	0
Channel Width (m)	16	Outlet Pool Depth (m)	4
Stream Slope (%)	2	Inlet Drop	Yes
Beaver Activity	No	Slope (%)	2
Habitat Value	High	Valley Fill	Deep Fill
Final score	27	Barrier Result	Barrier
Fix type	Replace with New Open Bottom Structure	Fix Span / Diameter	33

Comments: Very large culvert on main coal haul road. Outlet appears to have been backwatered by downstream wiers.  
14:04

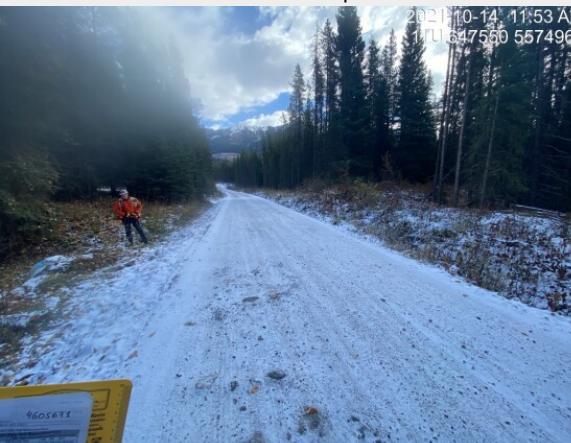
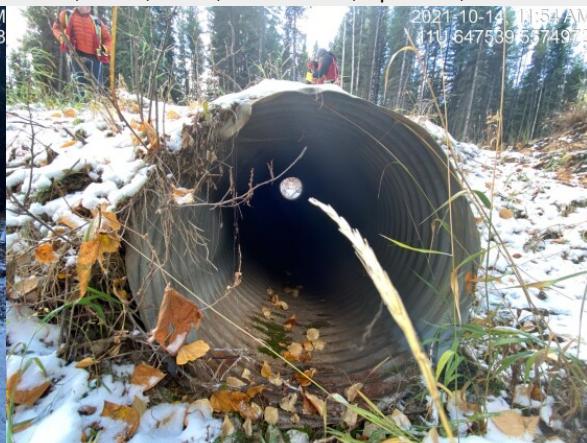
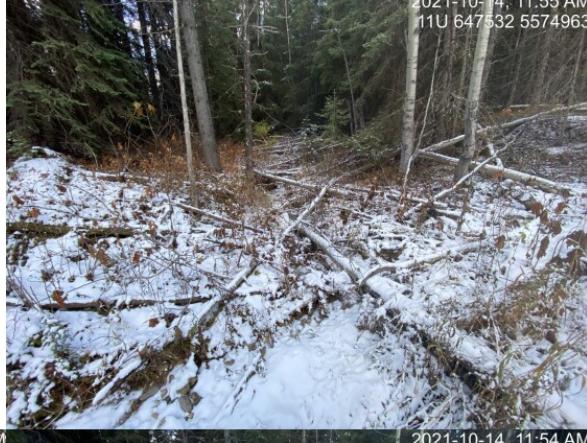
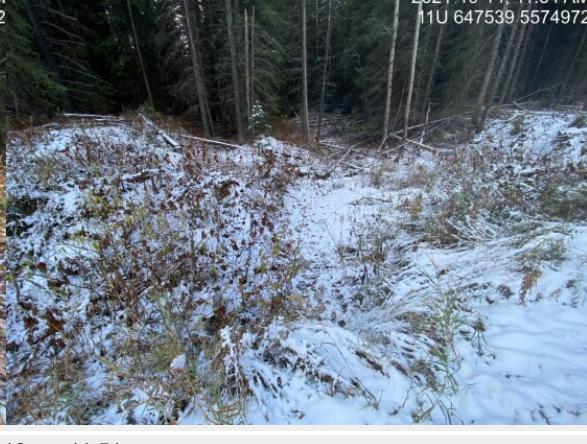
Location and Stream Data	•	Crossing Characteristics	-
Photos: PSCIS ID 197828. From top left clockwise: Road/Site Card, Barrel, Outlet, Downstream, Upstream, Inlet.

Location and Stream Data		Crossing Characteristics	
Date	2021-10-14	Crossing Sub Type	Round Culvert
PSCIS ID	197828	Diameter (m)	1.1
External ID	4605671	Length (m)	12
Crew	AI BK SS RA	Embedded	No
UTM Zone	11	Depth Embedded (m)	–
Easting	647549	Resemble Channel	No
Northing	5574967	Backwatered	No
Stream	Tributary to Elk River	Percent Backwatered	–
Road	Elk FSR	Fill Depth (m)	0.7
Road Tenure	FLNR DRM 0103	Outlet Drop (m)	0.05
Channel Width (m)	1.3	Outlet Pool Depth (m)	0.23
Stream Slope (%)	5	Inlet Drop	Yes
Beaver Activity	No	Slope (%)	3.5
Habitat Value	Low	Valley Fill	Deep Fill
Final score	23	Barrier Result	Barrier
Fix type	Replace Structure with Streambed Simulation CBS	Fix Span / Diameter	3
