## Appendix - Phase 1 Fish Passage Assessment Data and Photos

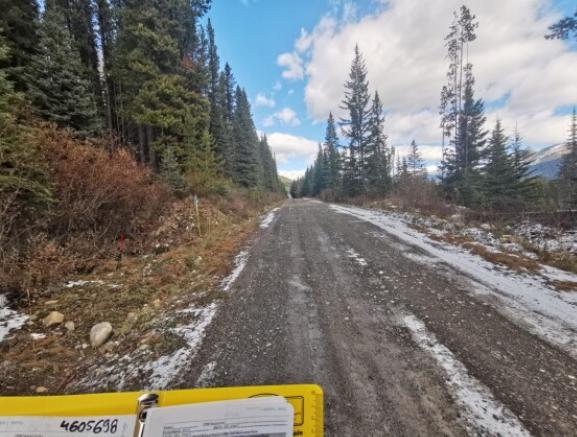
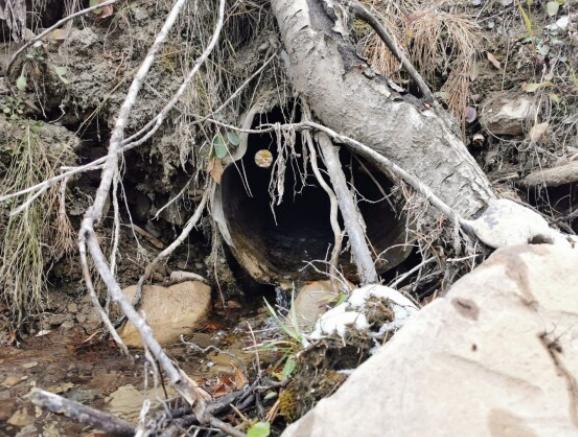
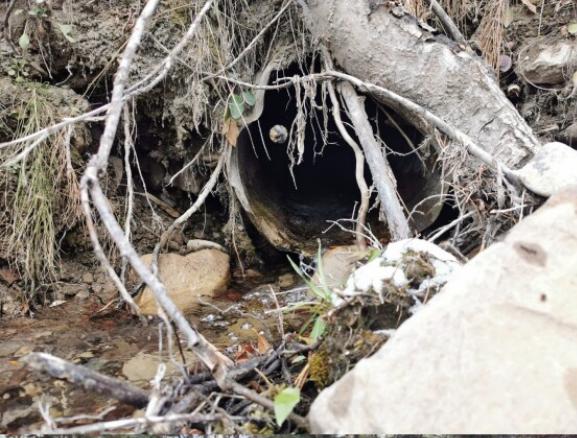
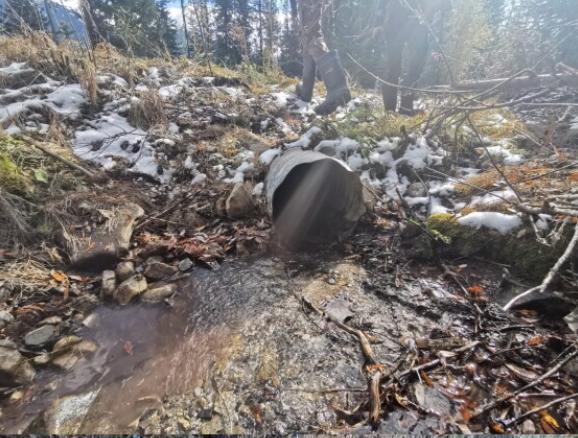
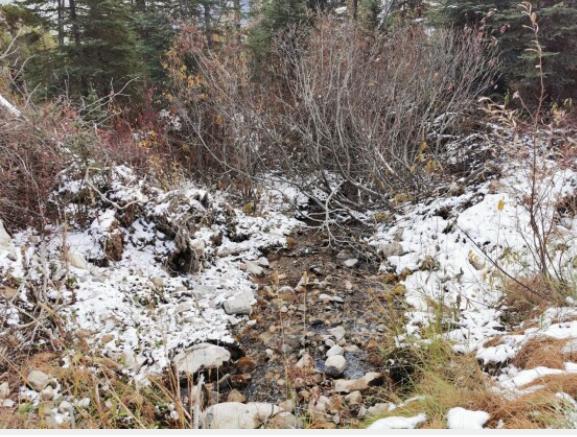
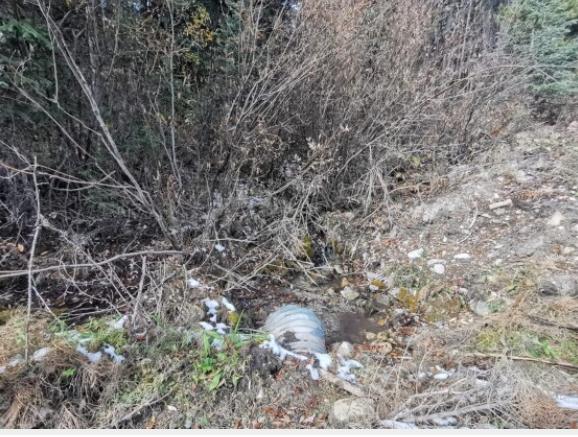
Location and Stream Data	Crossing Characteristics
Photos: PSCIS ID 197829. From top left clockwise: Road/Site Card, Barrel, Outlet, Downstream, Upstream, Inlet.

Location and Stream Data		Crossing Characteristics	
Date	2021-10-14	Crossing Sub Type	Round Culvert
PSCIS ID	197829	Diameter (m)	0.5
External ID	4605698	Length (m)	11
Crew	AI BK SS RA	Embedded	No
UTM Zone	11	Depth Embedded (m)	–
Easting	646781	Resemble Channel	No
Northing	5572308	Backwatered	No
Stream	Tributary to Elk River	Percent Backwatered	–
Road	Elk FSR	Fill Depth (m)	0.7
Road Tenure	FLNR DRM 0103	Outlet Drop (m)	0.15
Channel Width (m)	0.95	Outlet Pool Depth (m)	0.1
Stream Slope (%)	14	Inlet Drop	Yes
Beaver Activity	No	Slope (%)	2
Habitat Value	Low	Valley Fill	Deep Fill
Final score	26	Barrier Result	Barrier
Fix type	Replace Structure with Streambed Simulation CBS	Fix Span / Diameter	3

Comments: Inlet drop ~5cm. 13:15

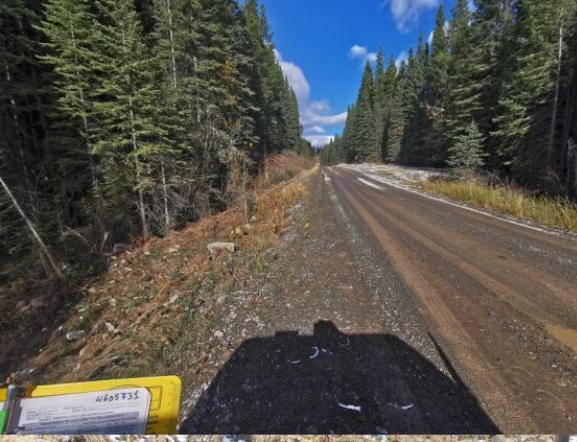
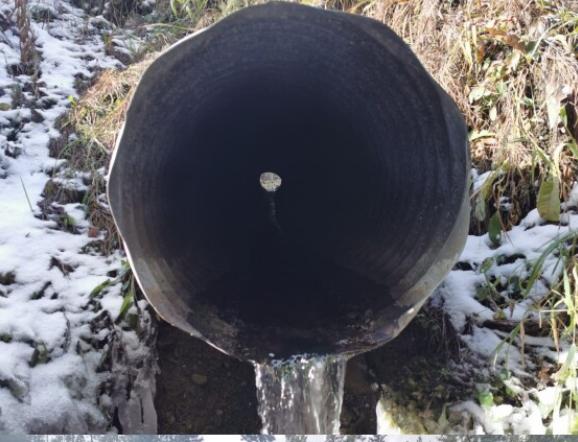
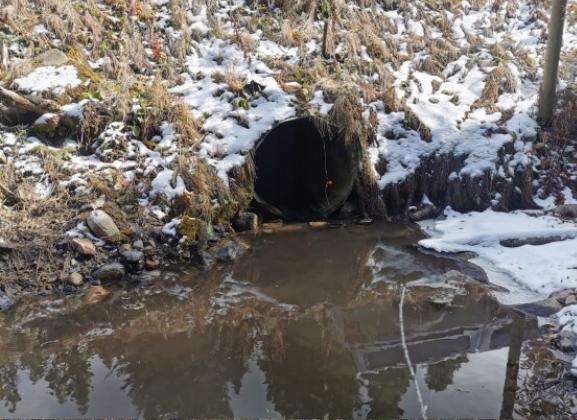
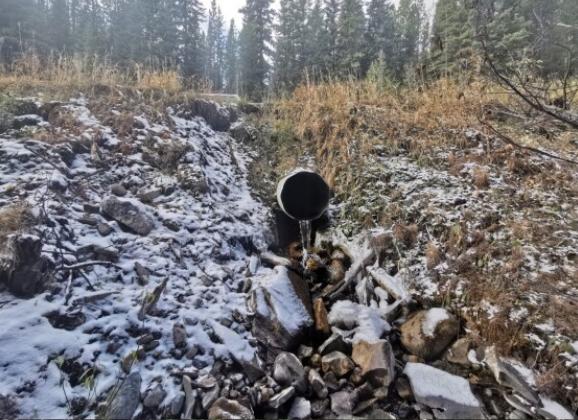
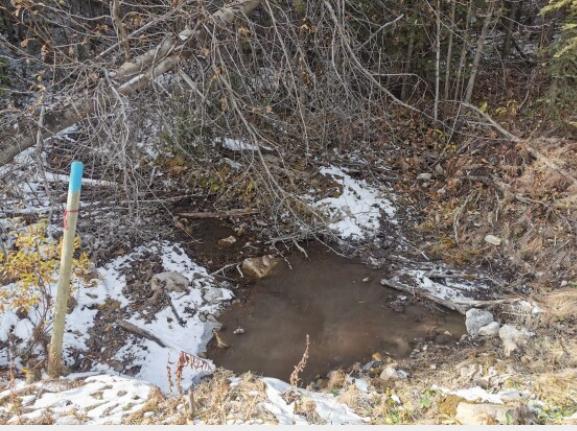
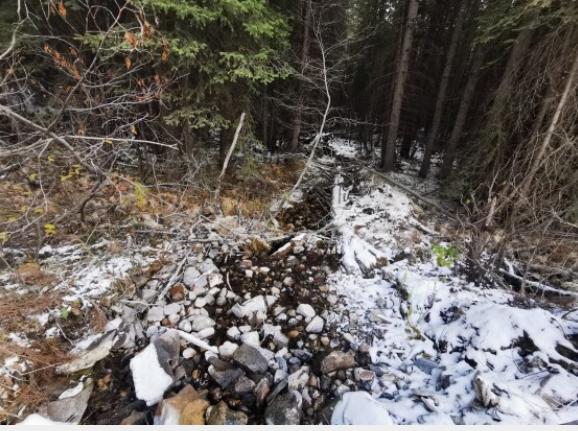
Location and Stream Data	Crossing Characteristics
Photos: PSCIS ID 197830. From top left clockwise: Road/Site Card, Barrel, Outlet, Downstream, Upstream, Inlet.

Location and Stream Data		Crossing Characteristics	
Date	2021-10-14	Crossing Sub Type	Round Culvert
PSCIS ID	197830	Diameter (m)	0.6
External ID	4605731	Length (m)	14
Crew	AI BK SS RA	Embedded	No
UTM Zone	11	Depth Embedded (m)	—
Easting	646748	Resemble Channel	No
Northing	5571001	Backwatered	No
Stream	Tributary to Elk River	Percent Backwatered	—
Road	Elk FSR	Fill Depth (m)	1.32
Road Tenure	FLNR DRM 0103	Outlet Drop (m)	0.4
Channel Width (m)	2	Outlet Pool Depth (m)	0
Stream Slope (%)	9	Inlet Drop	No
Beaver Activity	No	Slope (%)	4.5
Habitat Value	Medium	Valley Fill	Deep Fill
Final score	36	Barrier Result	Barrier
Fix type	Replace with New Open Bottom Structure	Fix Span / Diameter	12

Comments: Good flow with some decent lower gradient habitat upstream of the FSR. 13:24

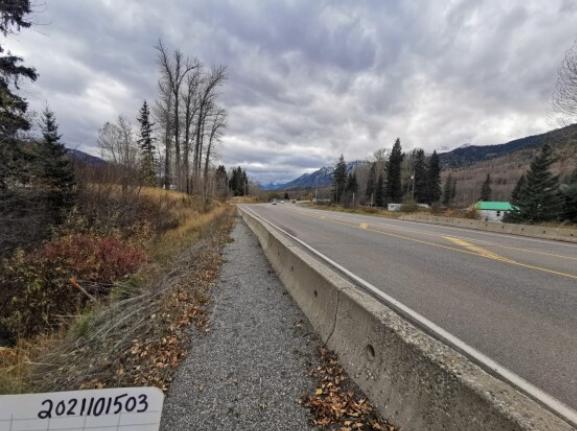
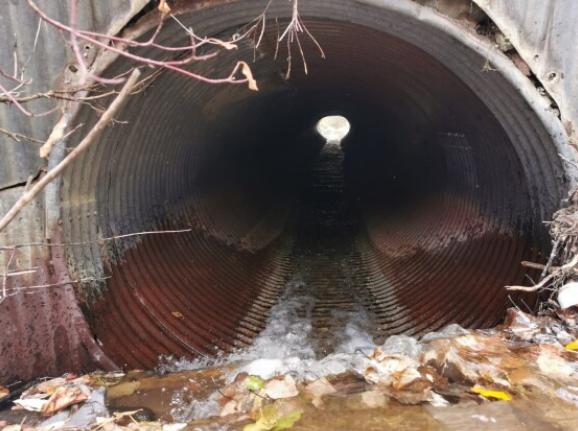
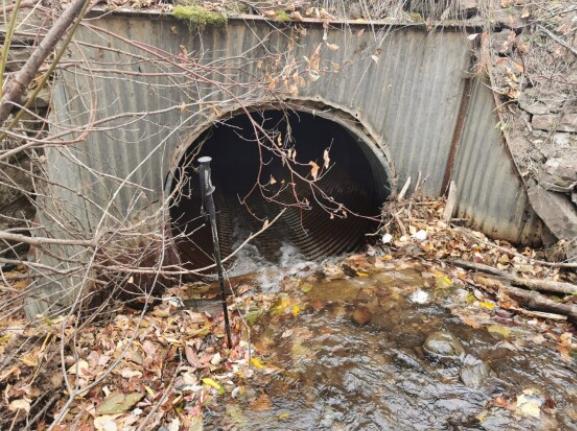
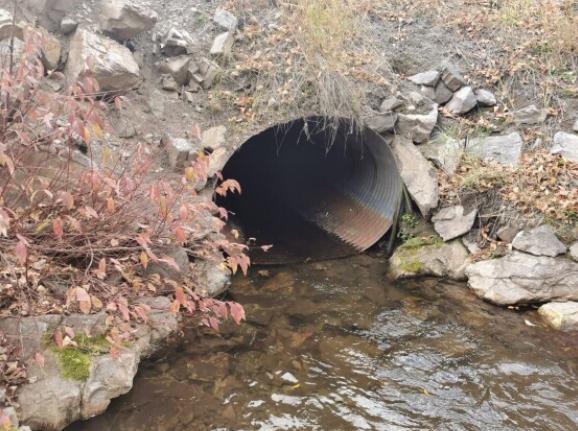
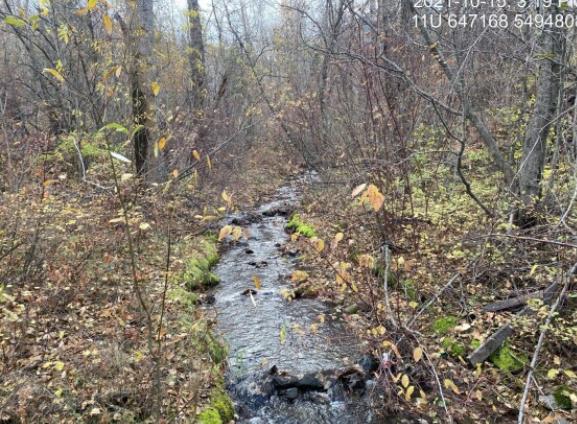
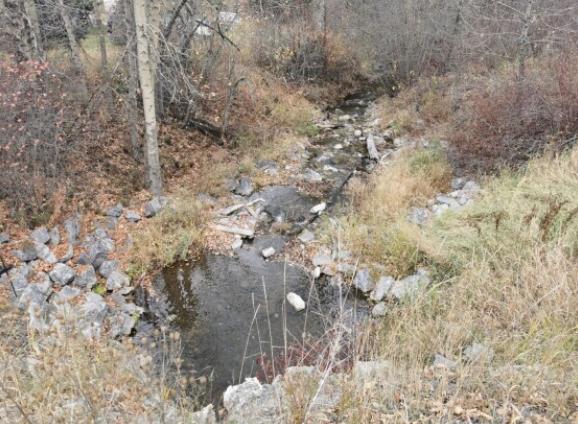
Location and Stream Data	Crossing Characteristics
Photos: PSCIS ID 197833. From top left clockwise: Road/Site Card, Barrel, Outlet, Downstream, Upstream, Inlet.

Location and Stream Data		Crossing Characteristics	
Date	2021-10-15	Crossing Sub Type	Round Culvert
PSCIS ID	197833	Diameter (m)	1.5
External ID	4600129	Length (m)	22
Crew	AI BK SS RA	Embedded	No
UTM Zone	11	Depth Embedded (m)	—
Easting	647141.4	Resemble Channel	No
Northing	5494823	Backwatered	No
Stream	Hosmer Creek	Percent Backwatered	—
Road	Highway 3	Fill Depth (m)	3
Road Tenure	MoTi Arterial	Outlet Drop (m)	0
Channel Width (m)	3	Outlet Pool Depth (m)	0.4
Stream Slope (%)	2.5	Inlet Drop	Yes
Beaver Activity	No	Slope (%)	4.5
Habitat Value	Medium	Valley Fill	Deep Fill
Final score	29	Barrier Result	Barrier
Fix type	Replace with New Open Bottom Structure	Fix Span / Diameter	12

Comments: Inlet drop ~0.75m. Backwatering done in past to reduce outlet drop. Water intake downstream from the culvert. 15:12

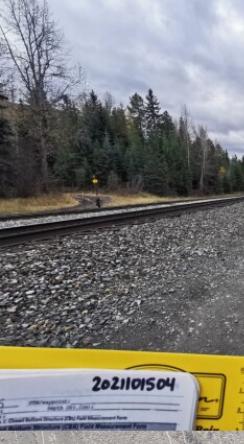
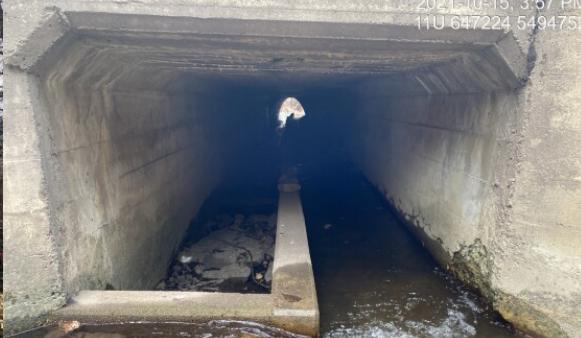
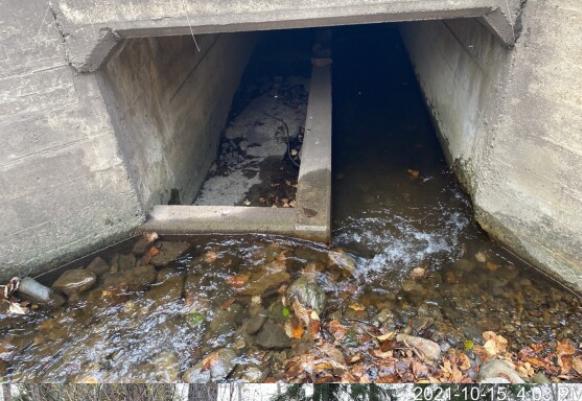
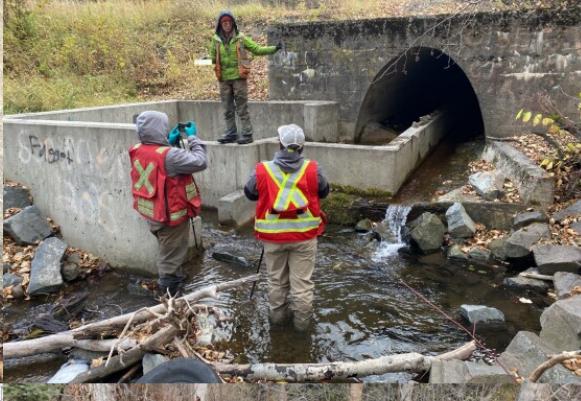
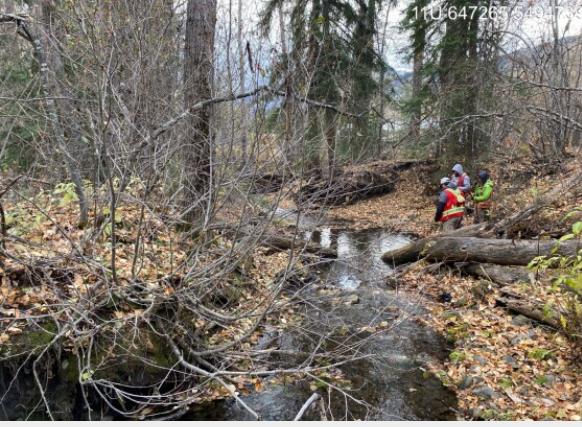
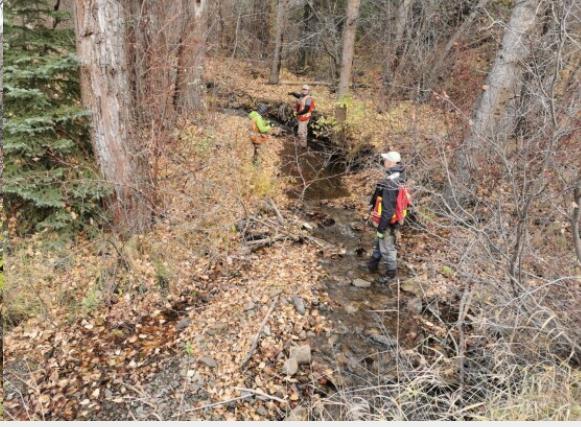
Location and Stream Data	Crossing Characteristics
Photos: PSCIS ID 197834. From top left clockwise: Road/Site Card, Barrel, Outlet, Downstream, Upstream, Inlet.

Location and Stream Data		Crossing Characteristics	
Date	2021-10-15	Crossing Sub Type	Round Culvert
PSCIS ID	197834	Diameter (m)	1.75
External ID	4606711	Length (m)	30
Crew	AI BK SS RA	Embedded	Yes
UTM Zone	11	Depth Embedded (m)	0.3
Easting	647221.7	Resemble Channel	Yes
Northing	5494759	Backwatered	No
Stream	Hosmer Creek	Percent Backwatered	—
Road	CP Railway	Fill Depth (m)	1.5
Road Tenure	Canadian Pacific	Outlet Drop (m)	0
Channel Width (m)	3.9	Outlet Pool Depth (m)	0.4
Stream Slope (%)	5	Inlet Drop	No
Beaver Activity	No	Slope (%)	2
Habitat Value	High	Valley Fill	Deep Fill
Final score	22	Barrier Result	Barrier
Fix type	Replace with New Open Bottom Structure	Fix Span / Diameter	12

Comments: Concrete structure has been built to facilitate fish passage. There are baffles and installed within one side of the culvert which embedded this area of the culvert with substrate. 15:45

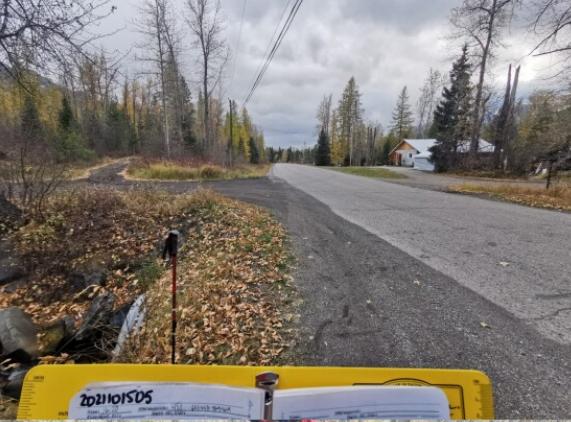
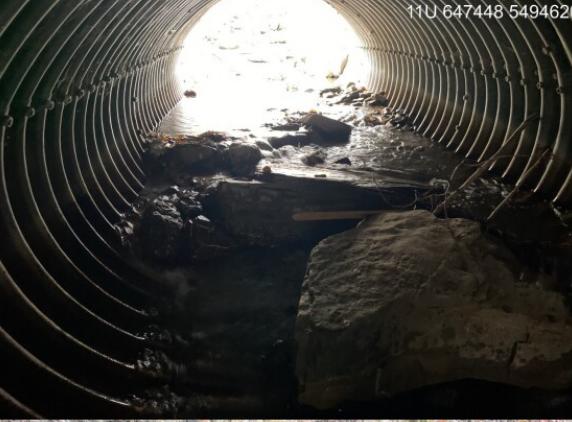
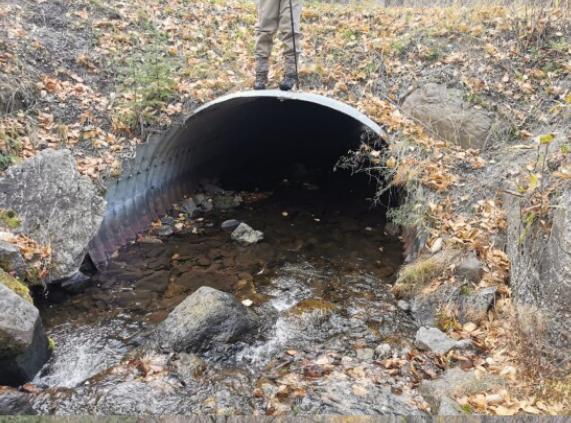
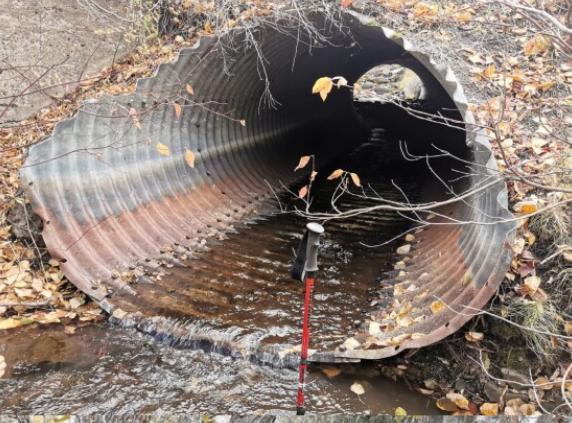
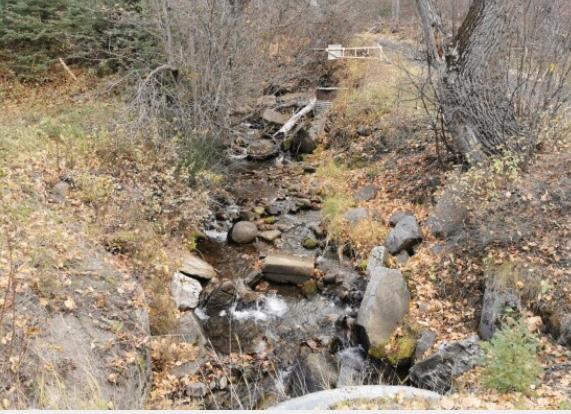
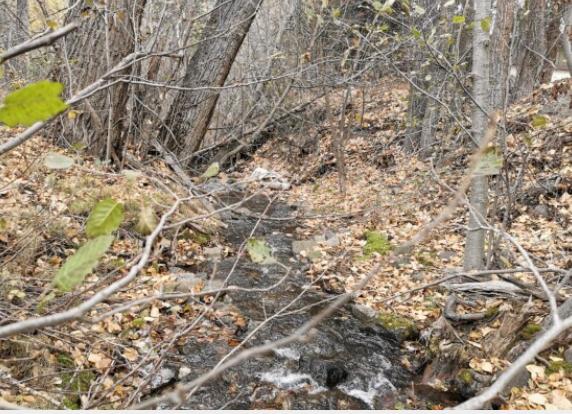
Location and Stream Data	Crossing Characteristics
Photos: PSCIS ID 197835. From top left clockwise: Road/Site Card, Barrel, Outlet, Downstream, Upstream, Inlet.

Location and Stream Data		Crossing Characteristics	
Date	2021-10-15	Crossing Sub Type	Round Culvert
PSCIS ID	197835	Diameter (m)	2.5
External ID	4600088	Length (m)	17
Crew	AI BK SS RA	Embedded	No
UTM Zone	11	Depth Embedded (m)	—
Easting	647446.7	Resemble Channel	No
Northing	5494639	Backwatered	No
Stream	Hosmer Creek	Percent Backwatered	—
Road	Stephenson Road	Fill Depth (m)	0.35
Road Tenure	MoTi Local	Outlet Drop (m)	0.24
Channel Width (m)	4.1	Outlet Pool Depth (m)	0.15
Stream Slope (%)	7	Inlet Drop	No
Beaver Activity	No	Slope (%)	3
Habitat Value	Medium	Valley Fill	Deep Fill
Final score	34	Barrier Result	Barrier
Fix type	Replace with New Open Bottom Structure	Fix Span / Diameter	12

Comments: Adjacent landowner reports that this crossing was a bridge ~50 years ago and that the culvert is known to overflow during floods. Several 1m boulders are lodged approximately 4m inside of the the pipe. 16:20

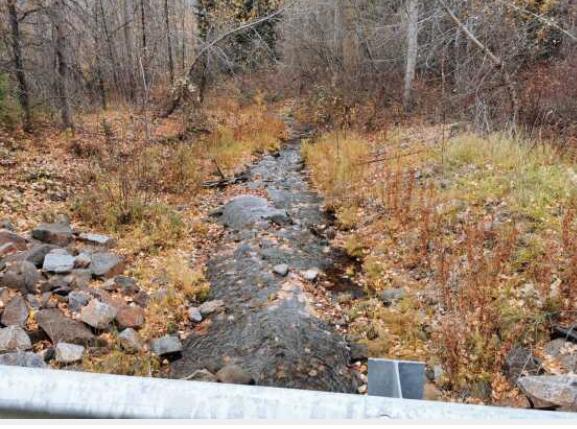
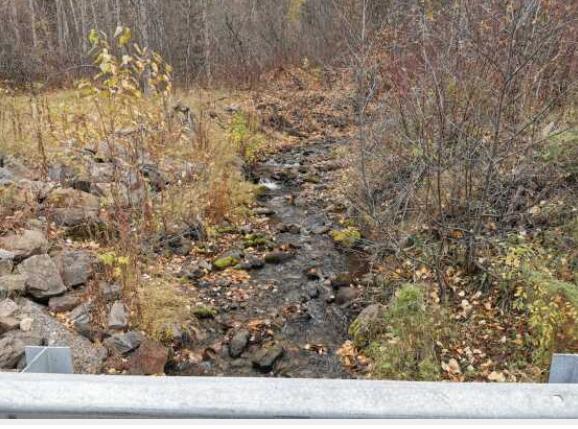
Comments: Bridge. 16:55

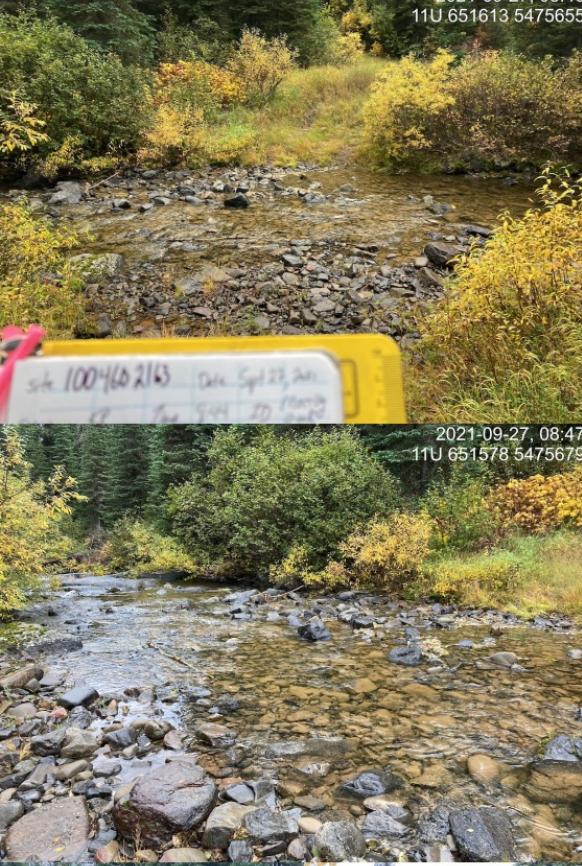
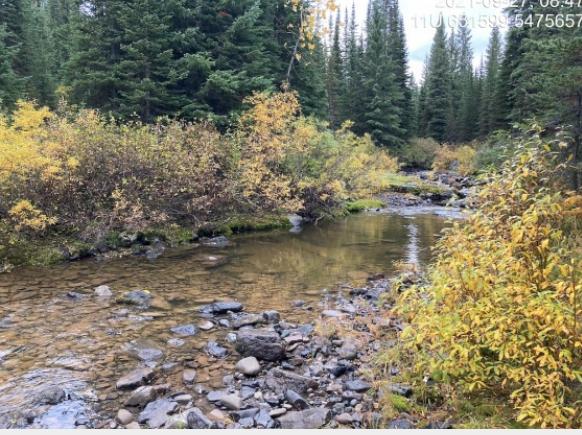
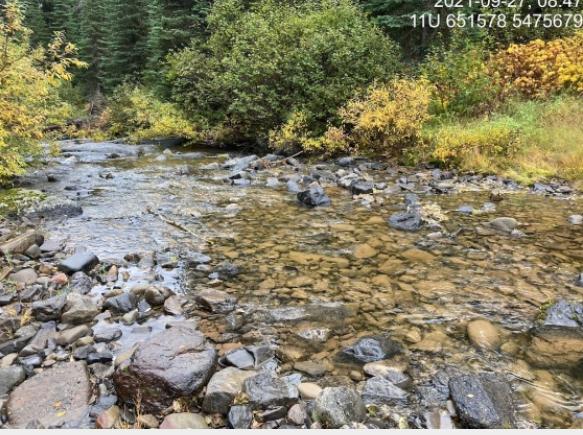
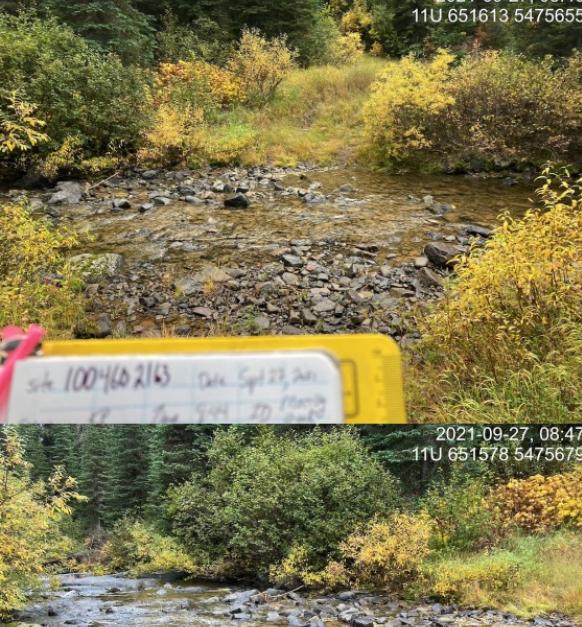
Location and Stream Data	•	Crossing Characteristics	-
Photos: PSCIS ID 197837. From top left clockwise: Road/Site Card, Barrel, Outlet, Downstream, Upstream, Inlet.

Comments: Ford on old road. Road is grassy. 8:44

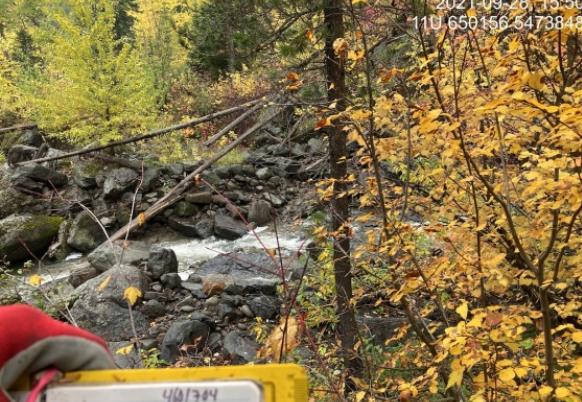
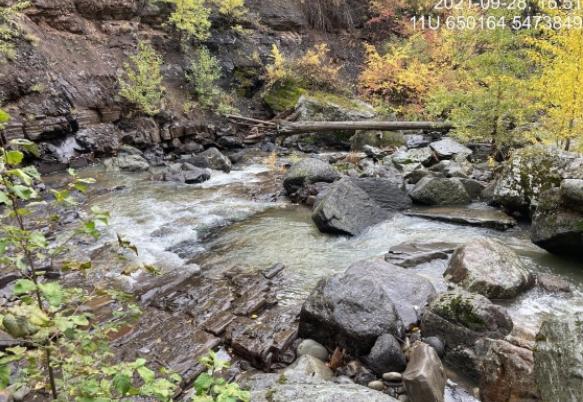
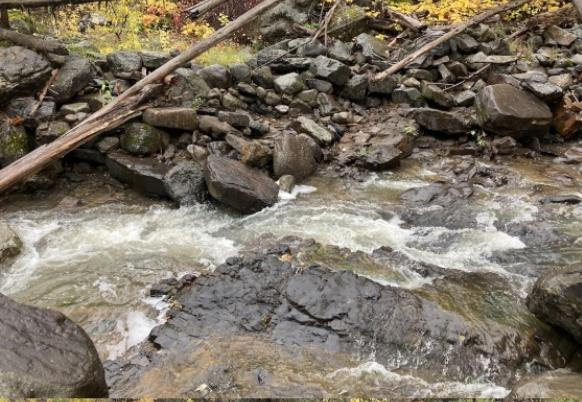
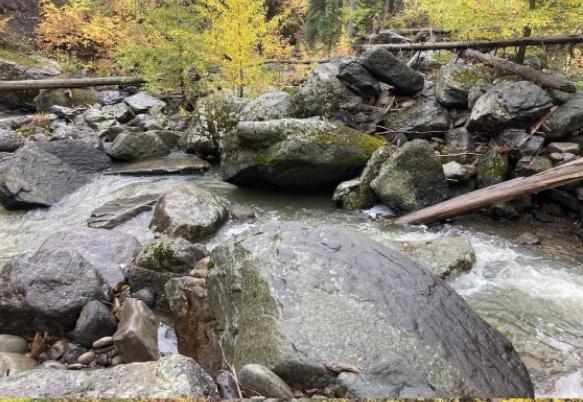
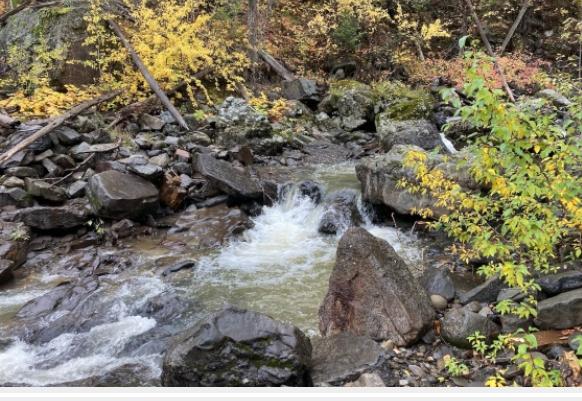
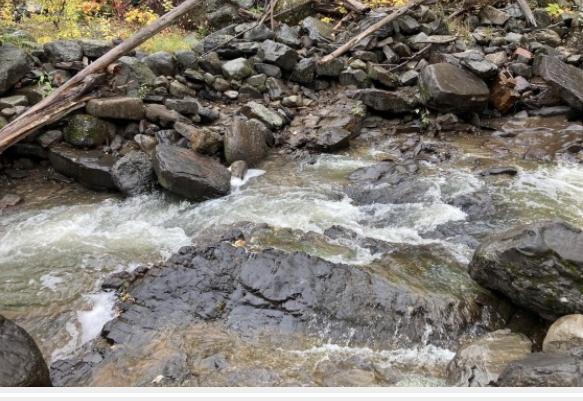
Location and Stream Data	•	Crossing Characteristics	-
Photos: PSCIS ID 197838. From top left clockwise: Road/Site Card, Barrel, Outlet, Downstream, Upstream, Inlet.

Comments: This road is not detectable in the field. There is no crossing structure. 15:48

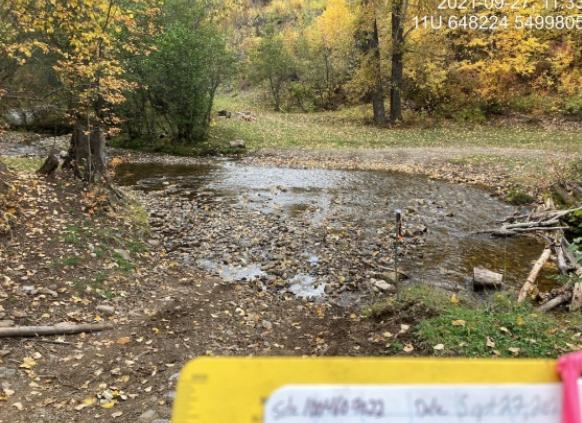
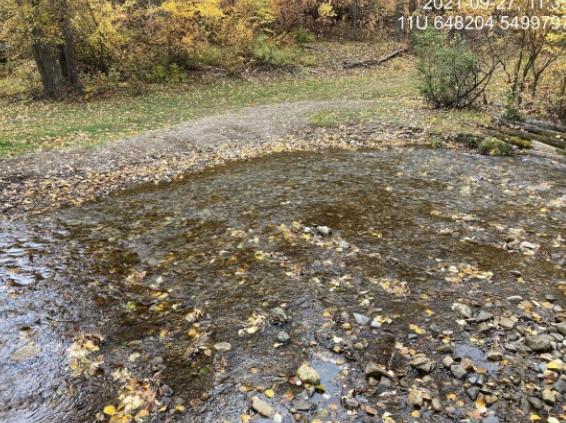
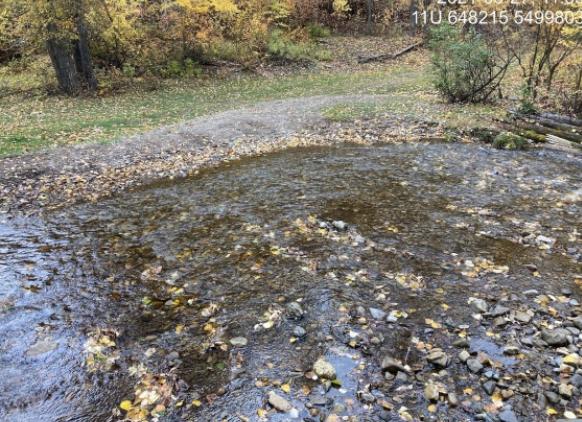
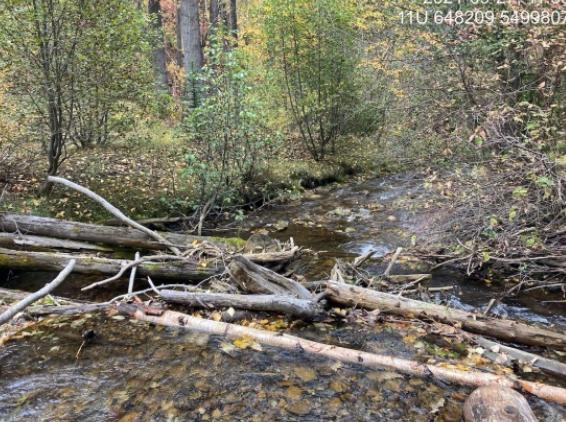
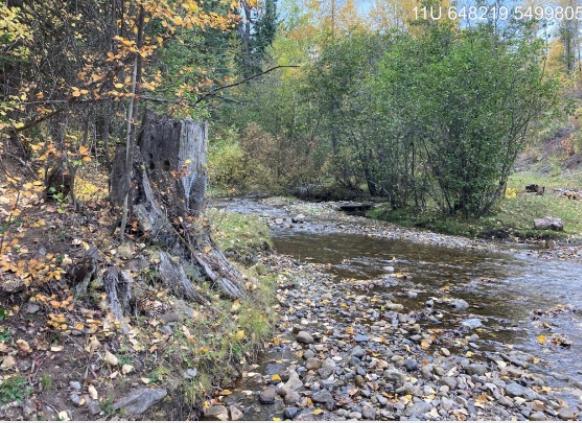
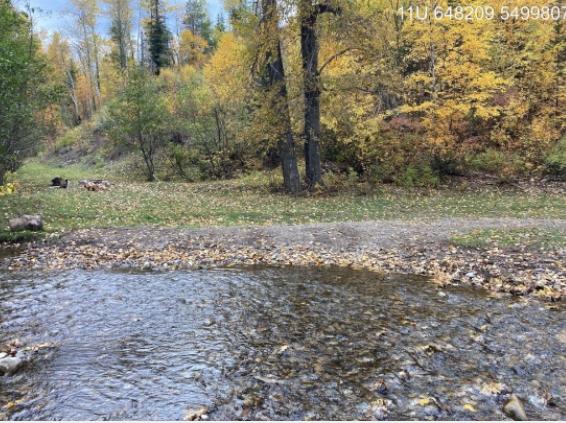
Location and Stream Data	•	Crossing Characteristics	-
Photos: PSCIS ID 197839. From top left clockwise: Road/Site Card, Barrel, Outlet, Downstream, Upstream, Inlet.

Comments: Well used ford. Actually crossing location does not align exceptionally well with modelled location but we have left the modelled location to facilitate the best modelling. Actual UTM (11U 648220 5499799). 11:29

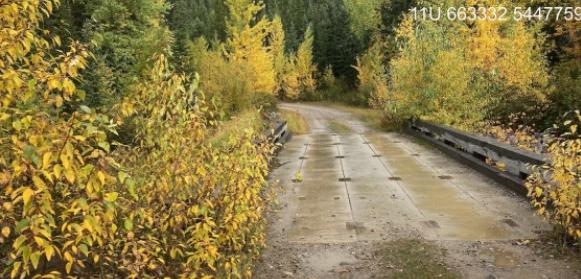
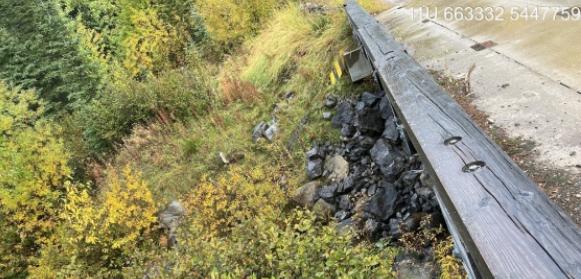
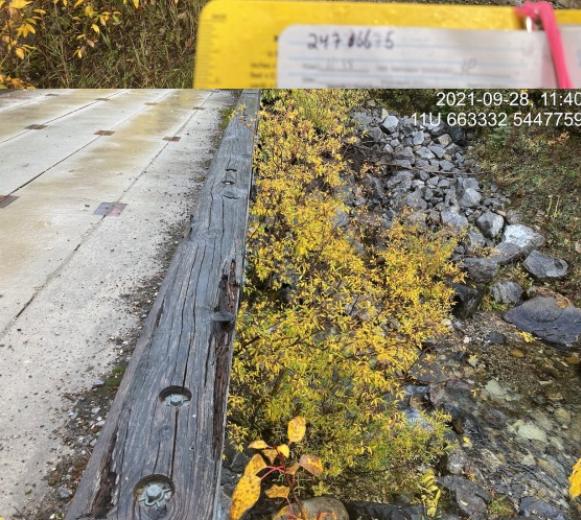
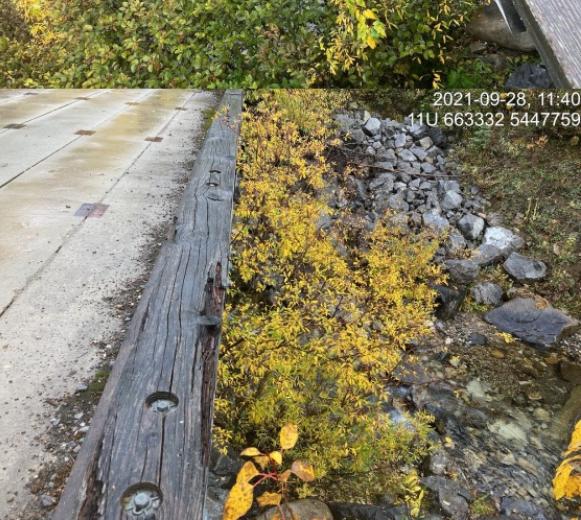
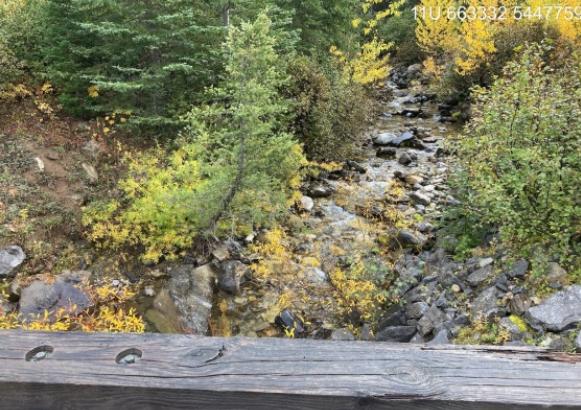
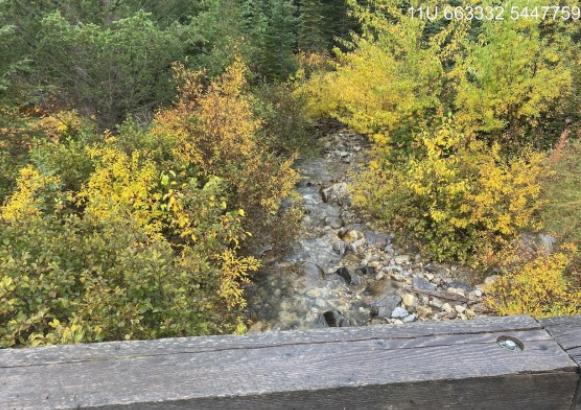
Location and Stream Data	Crossing Characteristics
Photos: PSCIS ID 197840. From top left clockwise: Road/Site Card, Barrel, Outlet, Downstream, Upstream, Inlet.

Comments: Bridge. 11:38

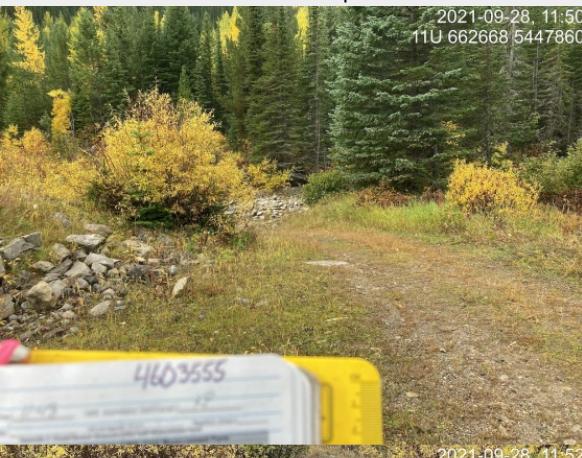
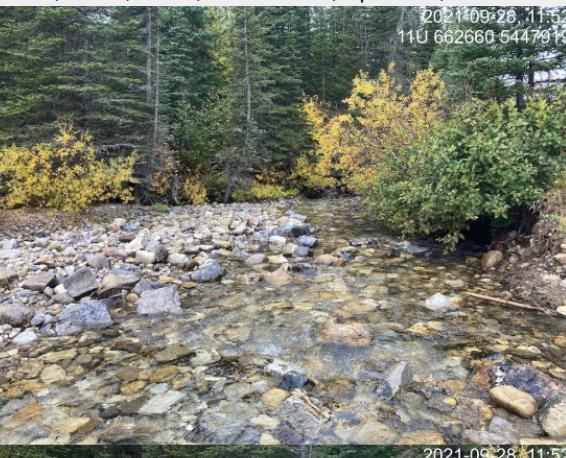
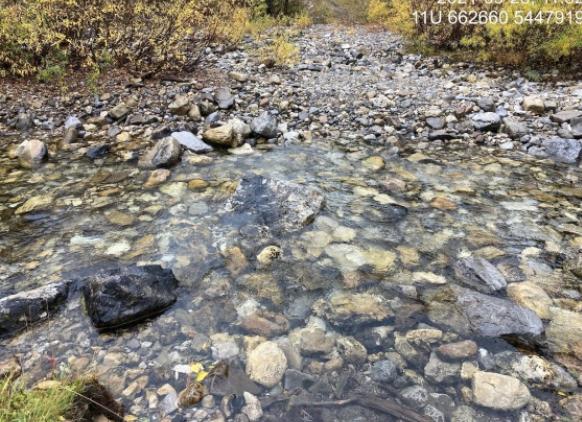
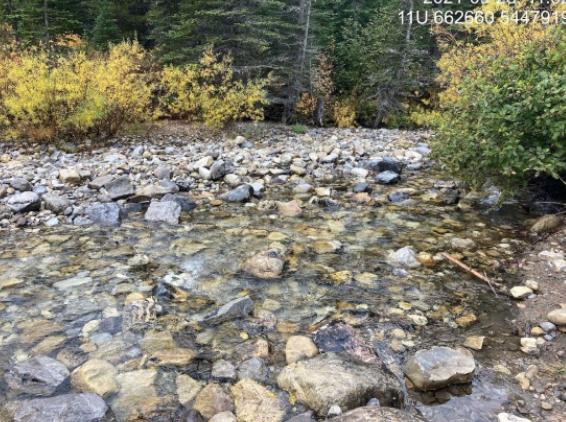
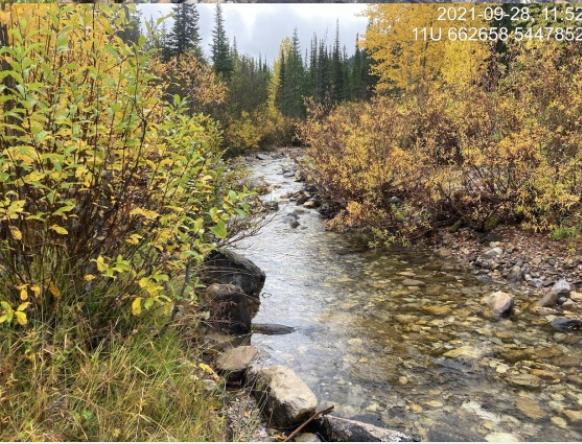
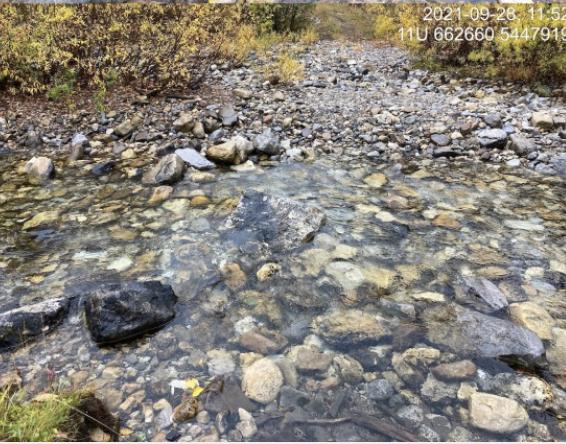
Location and Stream Data	•	Crossing Characteristics	-
Photos: PSCIS ID 197841. From top left clockwise: Road/Site Card, Barrel, Outlet, Downstream, Upstream, Inlet.

Comments: Some use of ATVs evident. Open gate on far side. 11:48

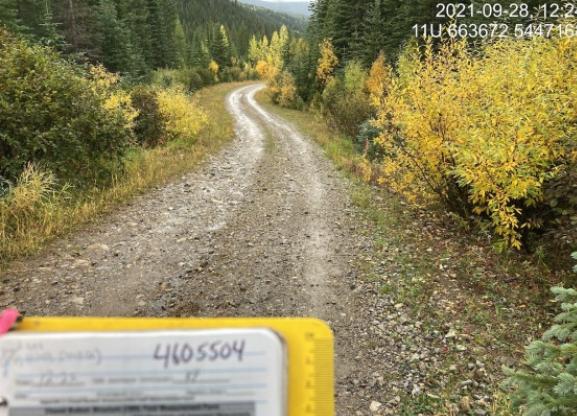
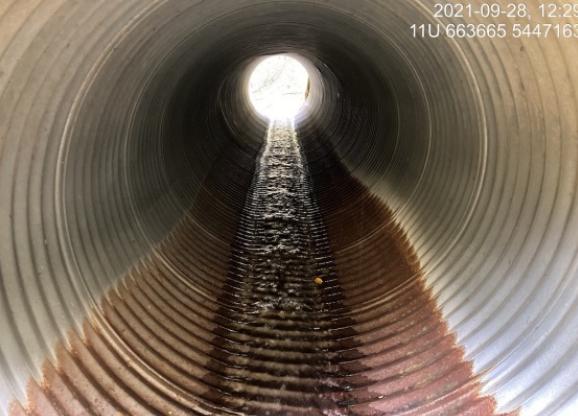
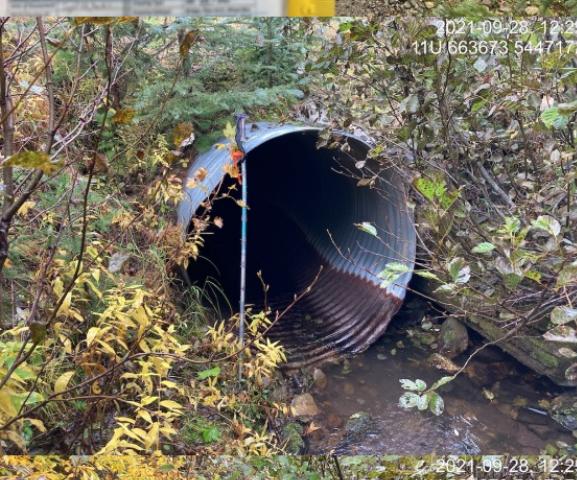
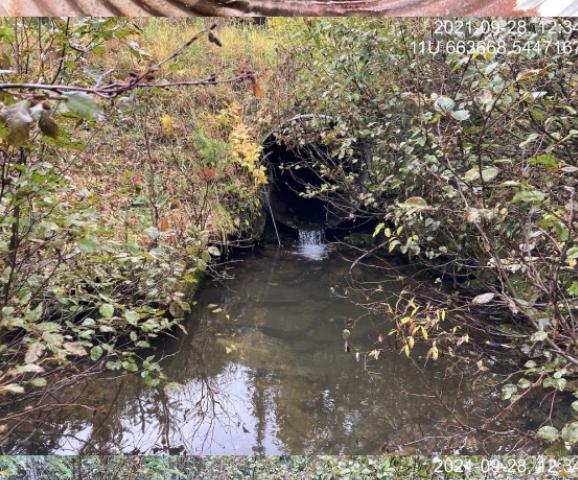
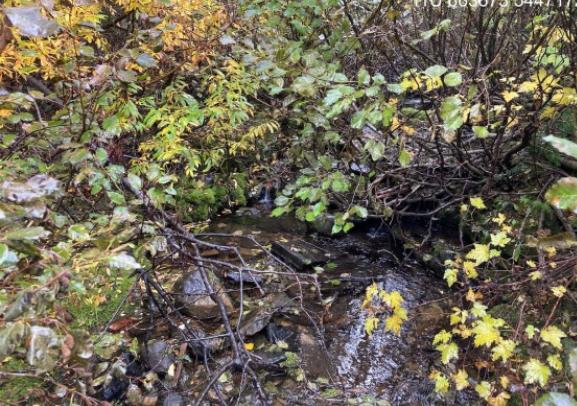
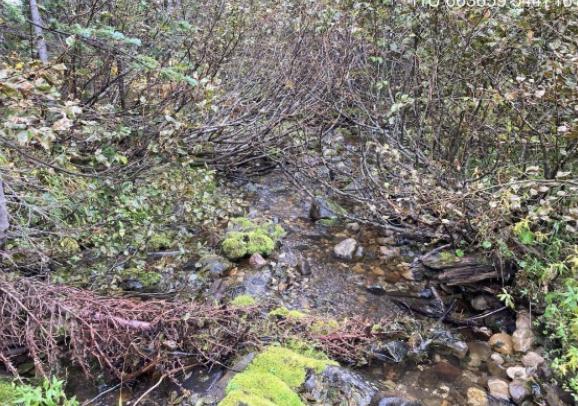
Location and Stream Data	Crossing Characteristics
Photos: PSCIS ID 197842. From top left clockwise: Road/Site Card, Barrel, Outlet, Downstream, Upstream, Inlet.

Comments: Nice stream with big pool. 12:22

Location and Stream Data		Crossing Characteristics	
Date	2021-09-28	Crossing Sub Type	Round Culvert
PSCIS ID	197842	Diameter (m)	1.15
External ID	4605504	Length (m)	12
Crew	KP	Embedded	No
UTM Zone	11	Depth Embedded (m)	—
Easting	663661.2	Resemble Channel	No
Northing	5447169	Backwatered	No
Stream	Tributary to Bighorn Creek	Percent Backwatered	—
Road	Cabin FSR	Fill Depth (m)	1
Road Tenure	FLNR DRM 5466	Outlet Drop (m)	0.21
Channel Width (m)	2.1	Outlet Pool Depth (m)	0.6
Stream Slope (%)	7.5	Inlet Drop	No
Beaver Activity	No	Slope (%)	7
Habitat Value	Medium	Valley Fill	Deep Fill
Final score	31	Barrier Result	Barrier
Fix type	Replace with New Open Bottom Structure	Fix Span / Diameter	12

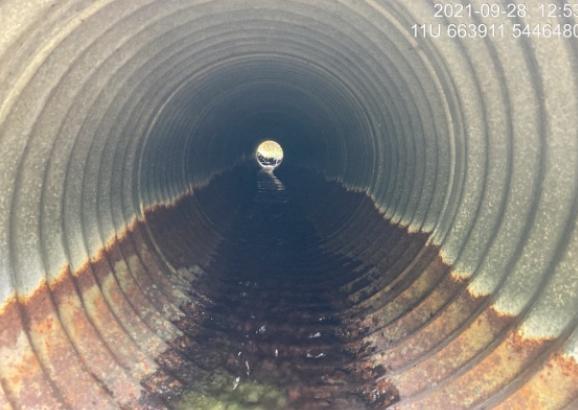
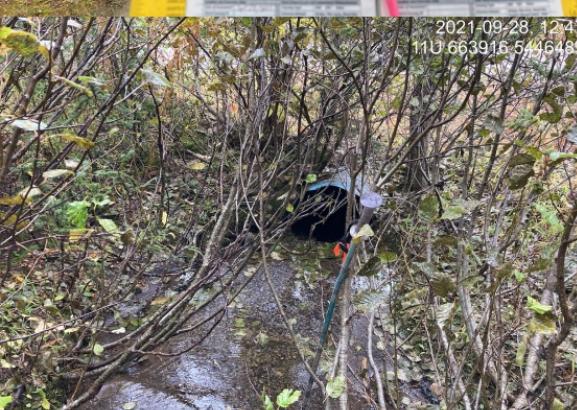
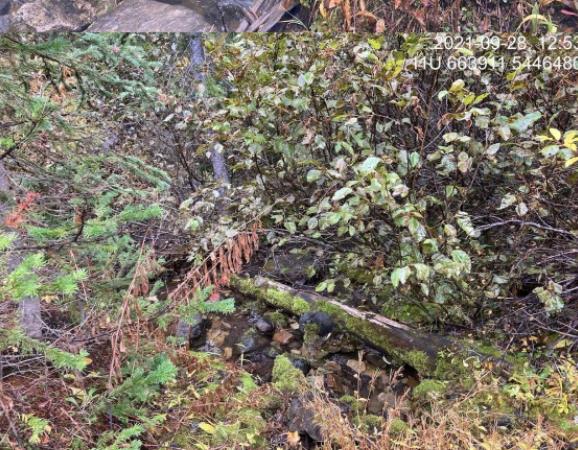
Comments: Inlet drop of 0.2m. Small stream, good flow. Steep downstream below pool. 12:42

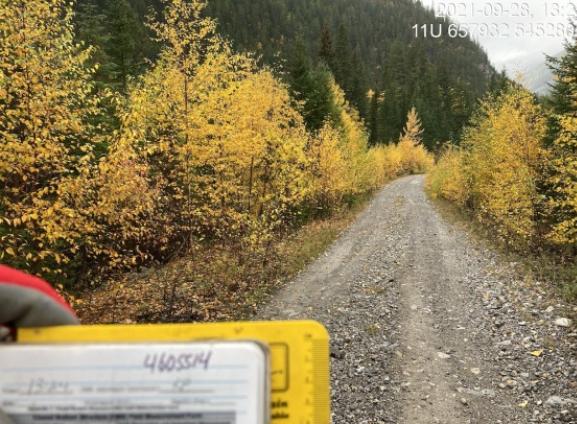
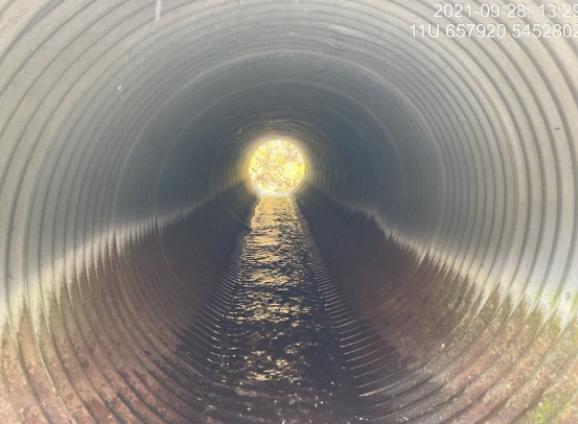
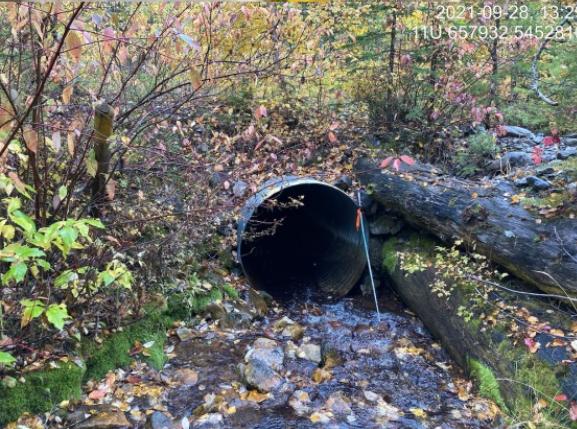
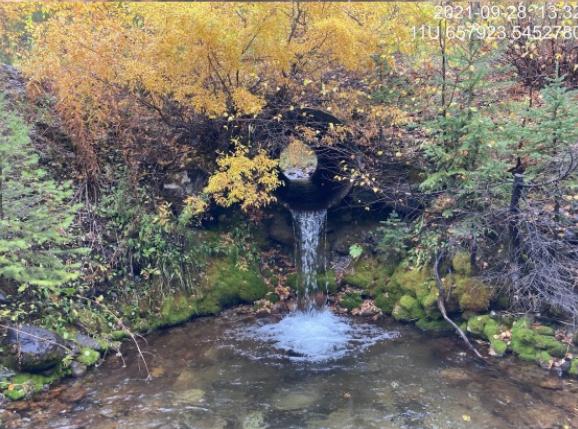
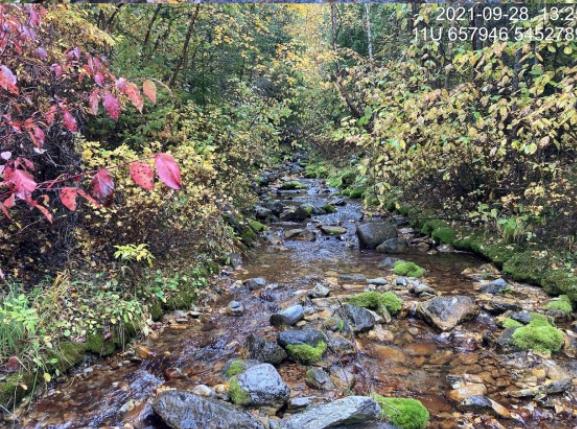
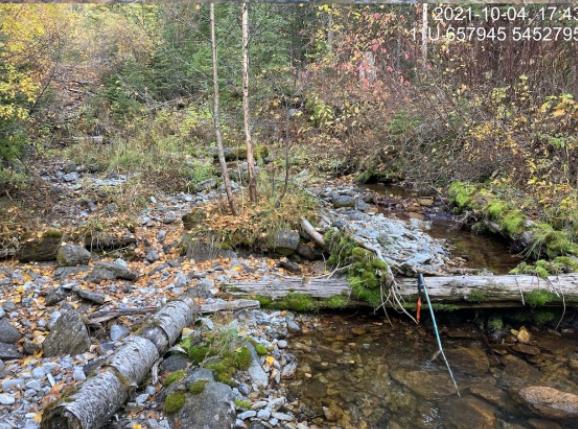
Location and Stream Data	Crossing Characteristics
Photos: PSCIS ID 197844. From top left clockwise: Road/Site Card, Barrel, Outlet, Downstream, Upstream, Inlet.

Comments: Cobble substrate and abundant overhanging vegetation. Decent sized stream. 13:24

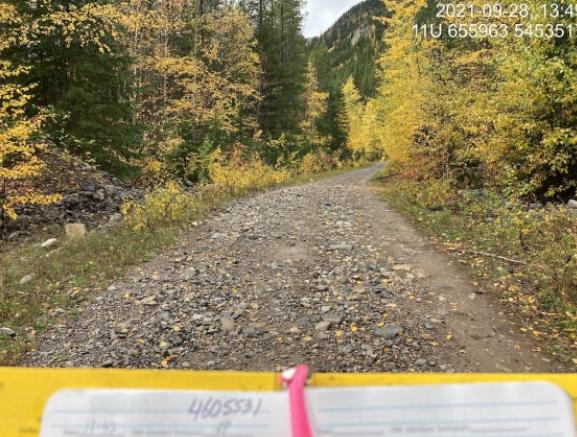
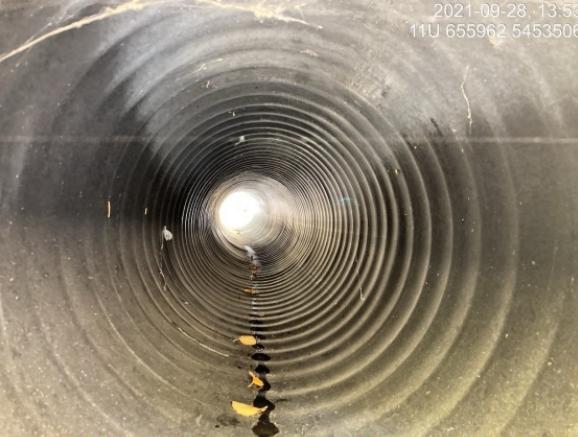
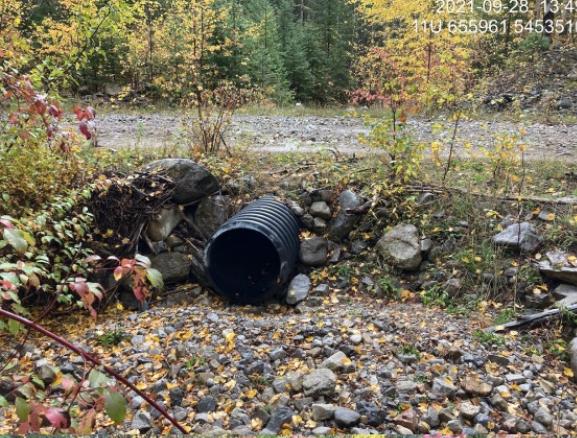
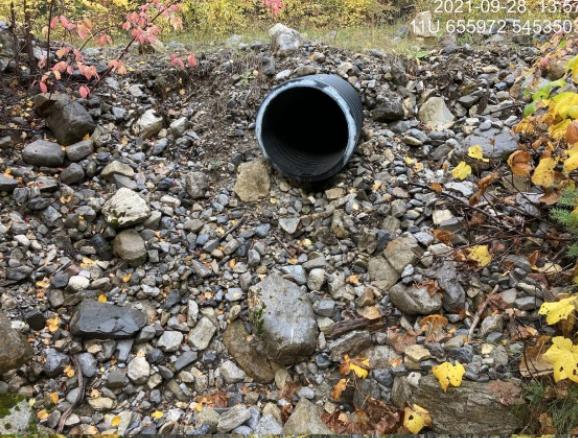
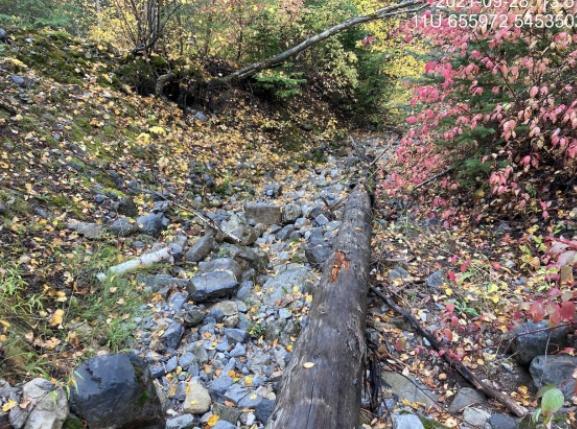
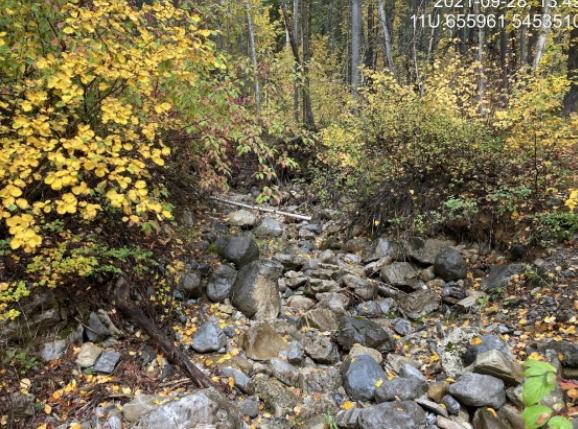
Location and Stream Data	Crossing Characteristics
Photos: PSCIS ID 197845. From top left clockwise: Road/Site Card, Barrel, Outlet, Downstream, Upstream, Inlet.

Comments: New PVC culvert. Creek appears to have been dredged often. Channel dry. Inlet drop of ~0.15m. 13:47

Location and Stream Data		Crossing Characteristics	
Date	2021-09-28	Crossing Sub Type	Round Culvert
PSCIS ID	197845	Diameter (m)	0.6
External ID	4605531	Length (m)	11
Crew	KP	Embedded	No
UTM Zone	11	Depth Embedded (m)	—
Easting	655961.7	Resemble Channel	No
Northing	5453504	Backwatered	No
Stream	Tributary to Bighorn Creek	Percent Backwatered	—
Road	Cabin FSR	Fill Depth (m)	0.3
Road Tenure	FLNR DRM 5466	Outlet Drop (m)	0.6
Channel Width (m)	2.5	Outlet Pool Depth (m)	0.5
Stream Slope (%)	13	Inlet Drop	Yes
Beaver Activity	No	Slope (%)	4
Habitat Value	Low	Valley Fill	Deep Fill
Final score	36	Barrier Result	Barrier
Fix type	Replace with New Open Bottom Structure	Fix Span / Diameter	12

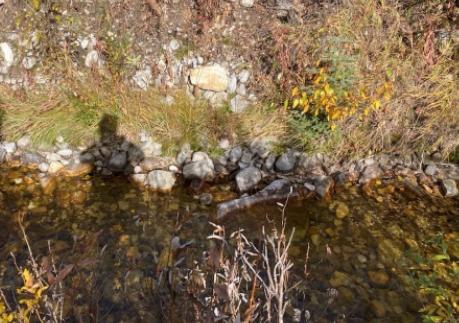
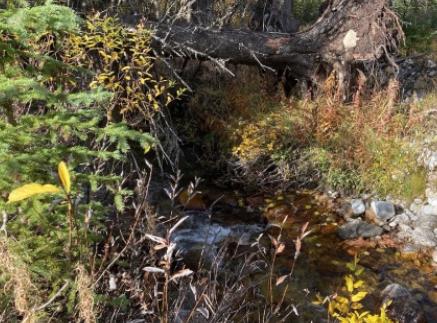
Location and Stream Data	•	Crossing Characteristics
Photos: PSCIS ID 197846. From top left clockwise: Road/Site Card, Barrel, Outlet, Downstream, Upstream, Inlet.		
2021-09-29, 10:45 11U 659289 5547539	•	2021-09-29, 10:45 11U 659289 5547539

Comments: Deactivated road. 10:43
