## Appendix - Phase 1 Fish Passage Assessment Data and Photos

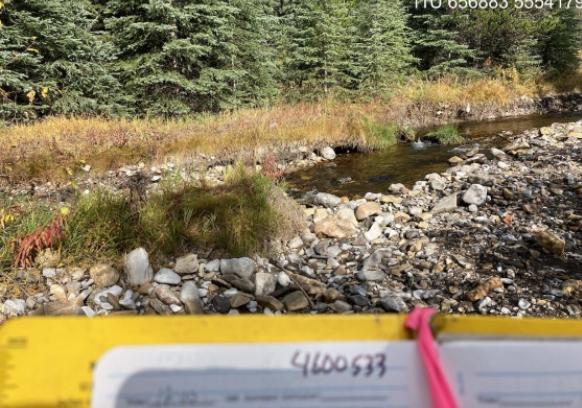
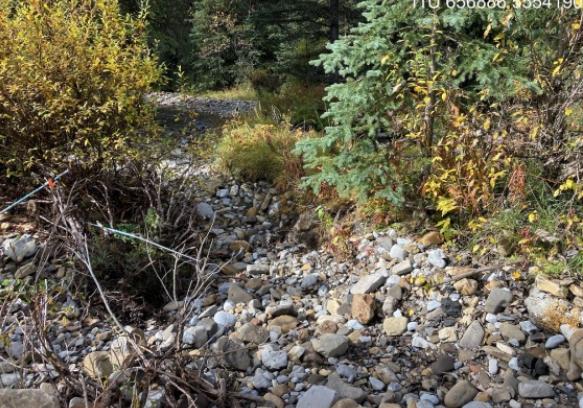
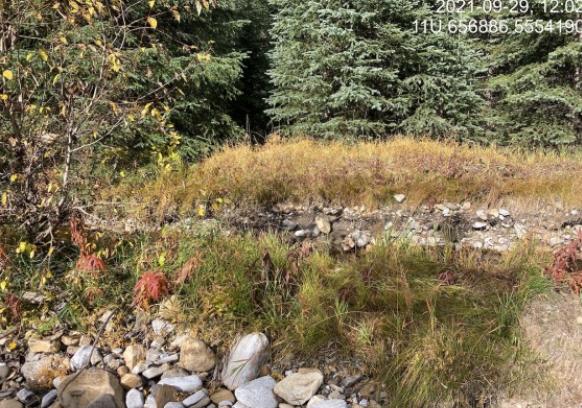
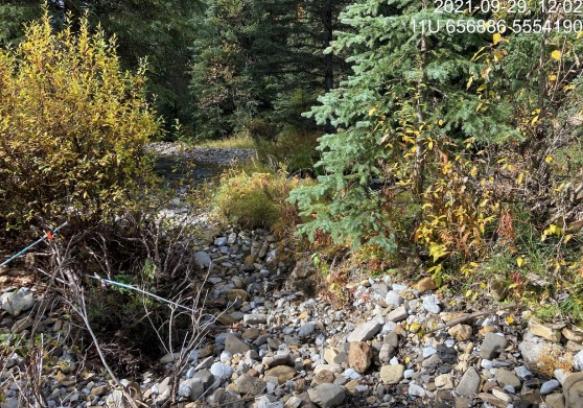
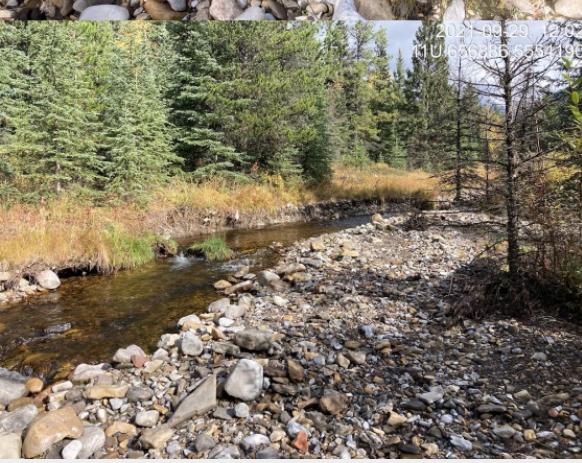
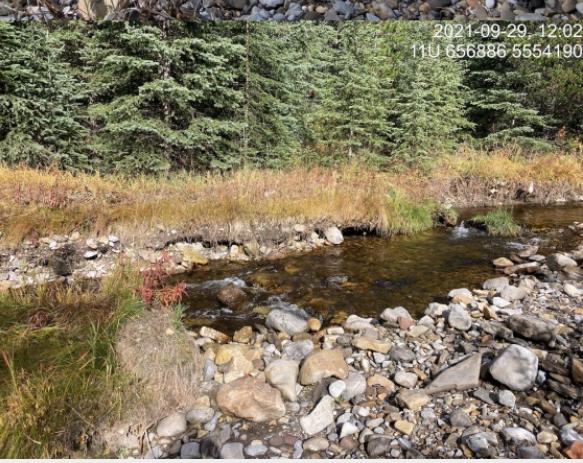
Location and Stream Data	Crossing Characteristics
Photos: PSCIS ID 197847. From top left clockwise: Road/Site Card, Barrel, Outlet, Downstream, Upstream, Inlet.

Comments: Old road but possible ford site not actually on road and road mapped on other side of creek. Access management area. Restoration site downstream. 12:00

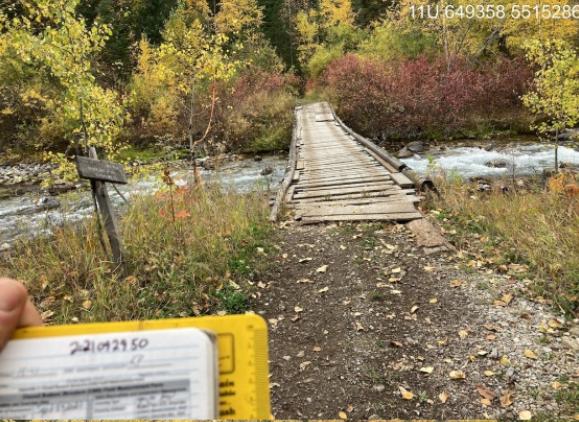
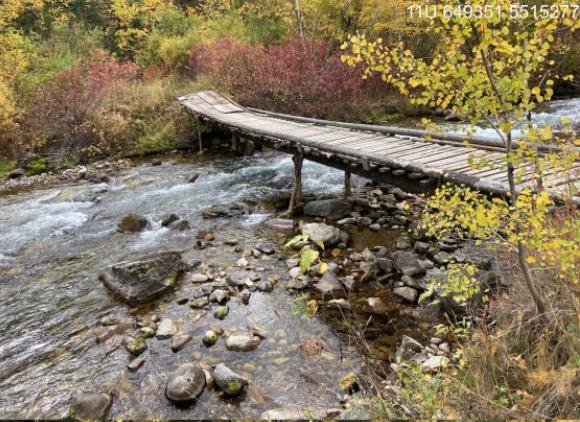
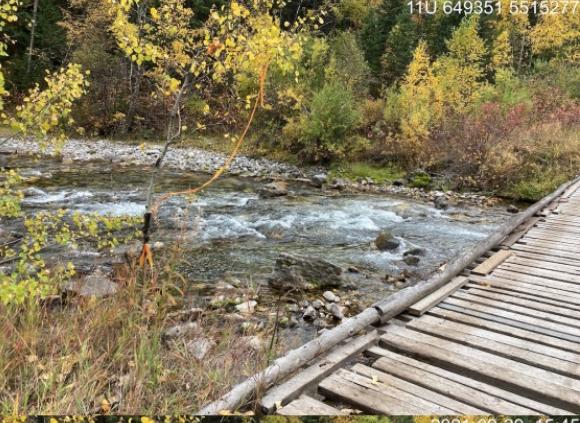
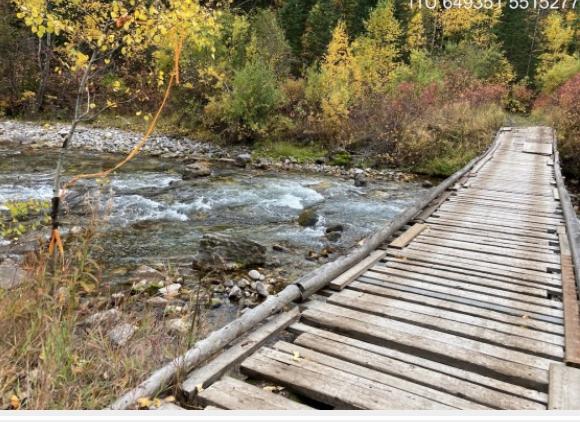
Location and Stream Data	Crossing Characteristics
Photos: PSCIS ID 197848. From top left clockwise: Road/Site Card, Barrel, Outlet, Downstream, Upstream, Inlet.

Comments: Homemade ATV bridge built with logs and slats. 15:41

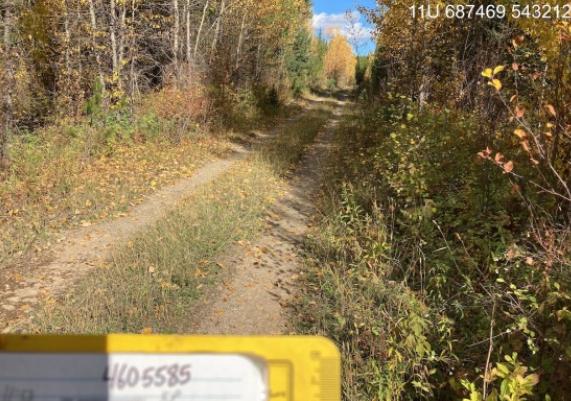
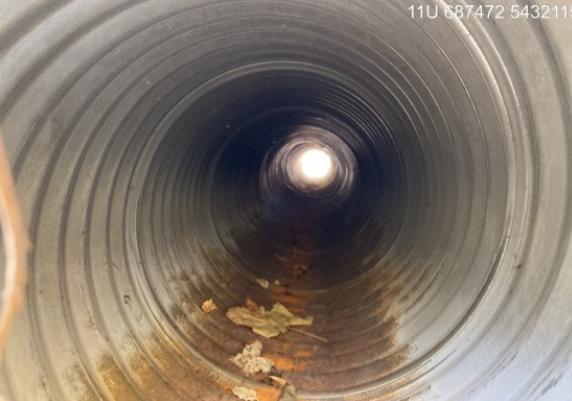
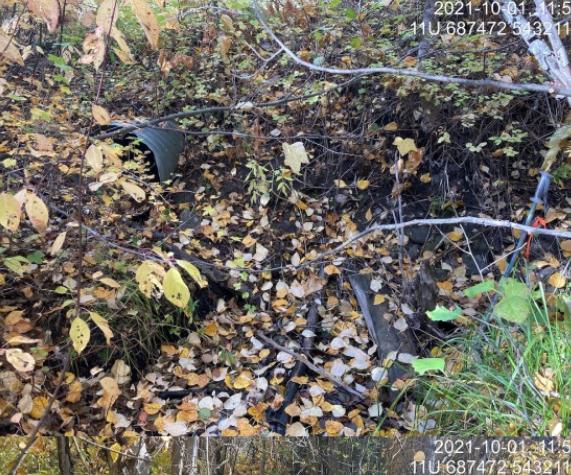
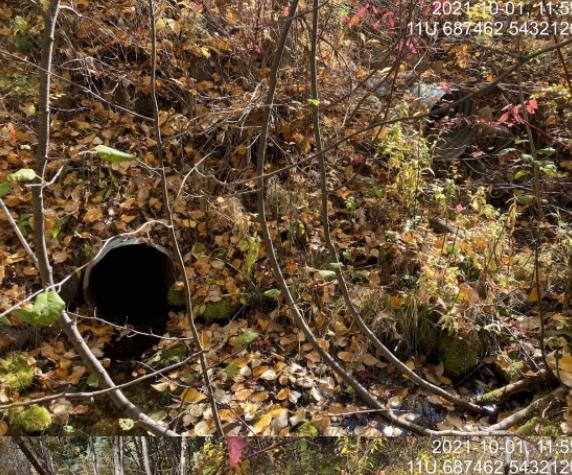
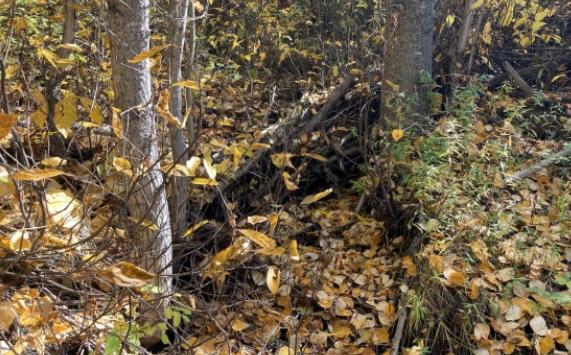
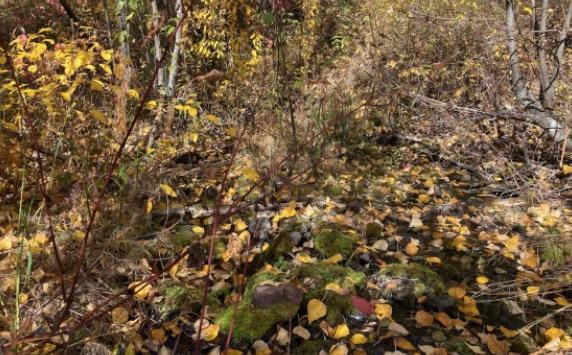
Location and Stream Data	Crossing Characteristics
Photos: PSCIS ID 197849. From top left clockwise: Road/Site Card, Barrel, Outlet, Downstream, Upstream, Inlet.

Comments: Overflow culvert is 0.12m and 2%. Almost backwatered by slowly trickling. Inlet is almost fully clogged and has inlet drop of 0.4m. Slope of primary culvert estimated as very difficult to measure. 11:41

Location and Stream Data		Crossing Characteristics	
Date	2021-10-01	Crossing Sub Type	Round Culvert
PSCIS ID	197849	Diameter (m)	0.5
External ID	4605585	Length (m)	10
Crew	KP	Embedded	No
UTM Zone	11	Depth Embedded (m)	–
Easting	687464	Resemble Channel	No
Northing	5432111	Backwatered	No
Stream	Tributary to Sage Creek	Percent Backwatered	–
Road	Flathead-Nettie FSR	Fill Depth (m)	2
Road Tenure	FLNR DRM 0030	Outlet Drop (m)	0
Channel Width (m)	1.7	Outlet Pool Depth (m)	0
Stream Slope (%)	4	Inlet Drop	Yes
Beaver Activity	No	Slope (%)	2.5
Habitat Value	Low	Valley Fill	Deep Fill
Final score	21	Barrier Result	Barrier
Fix type	Replace Structure with Streambed Simulation CBS	Fix Span / Diameter	3

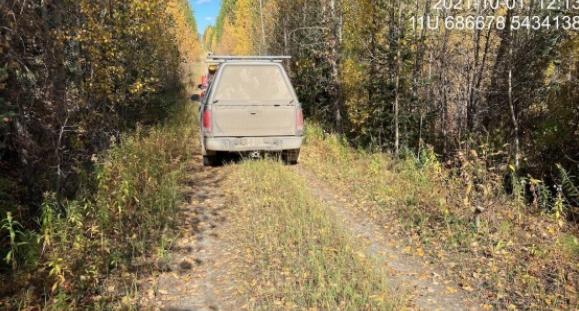
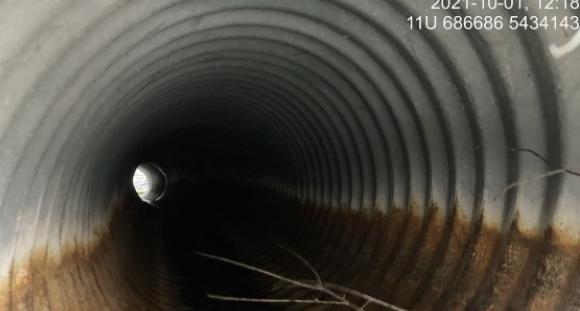
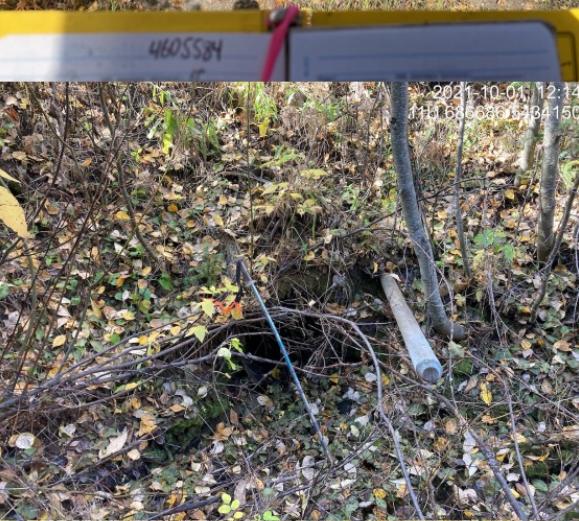
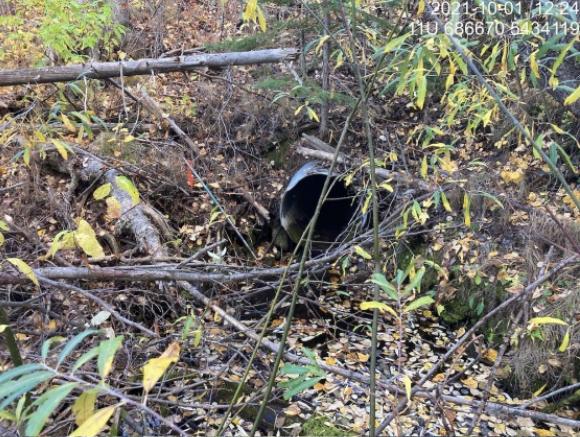
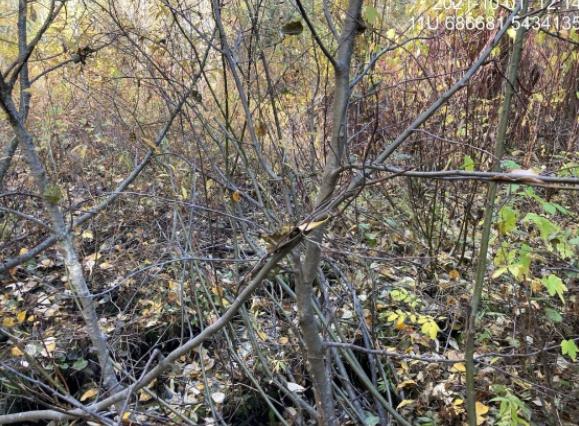
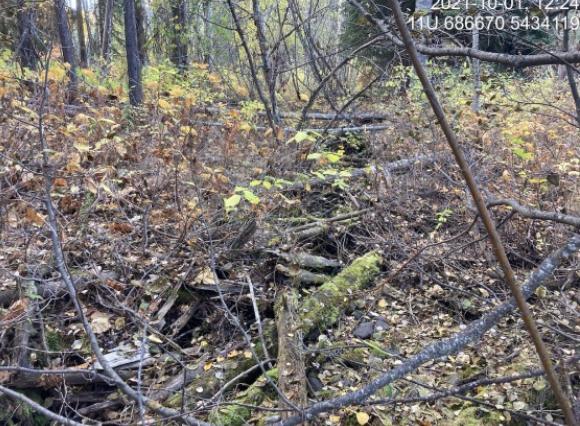
Location and Stream Data	Crossing Characteristics
Photos: PSCIS ID 197850. From top left clockwise: Road/Site Card, Barrel, Outlet, Downstream, Upstream, Inlet.

Comments: Channel heavily vegetated with moss indicating it flows intermittently. Very low flow at time of assessment.  
12:12

Location and Stream Data		Crossing Characteristics	
Date	2021-10-01	Crossing Sub Type	Round Culvert
PSCIS ID	197850	Diameter (m)	0.6
External ID	4605584	Length (m)	11
Crew	KP	Embedded	No
UTM Zone	11	Depth Embedded (m)	—
Easting	686674	Resemble Channel	No
Northing	5434139	Backwatered	No
Stream	Tributary to Sage Creek	Percent Backwatered	—
Road	Flathead-Nettie FSR	Fill Depth (m)	2
Road Tenure	FLNR DRM 0030	Outlet Drop (m)	0.13
Channel Width (m)	2.1	Outlet Pool Depth (m)	0.33
Stream Slope (%)	3.5	Inlet Drop	No
Beaver Activity	No	Slope (%)	4.5
Habitat Value	Low	Valley Fill	Deep Fill
Final score	26	Barrier Result	Barrier
Fix type	Replace with New Open Bottom Structure	Fix Span / Diameter	12

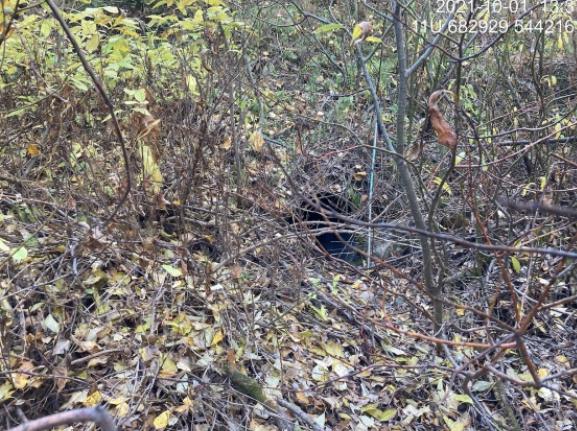
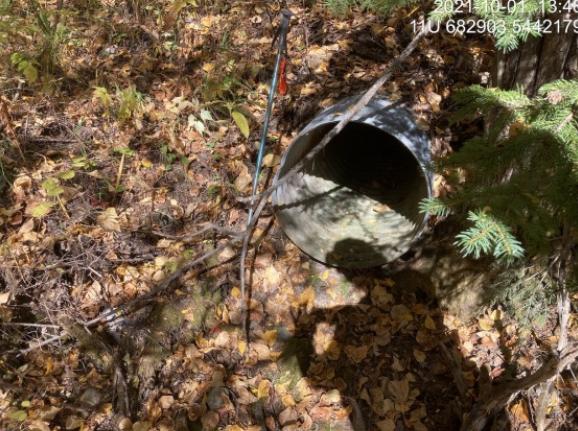
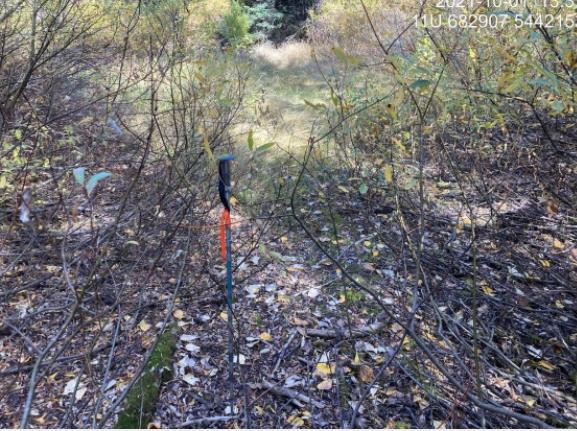
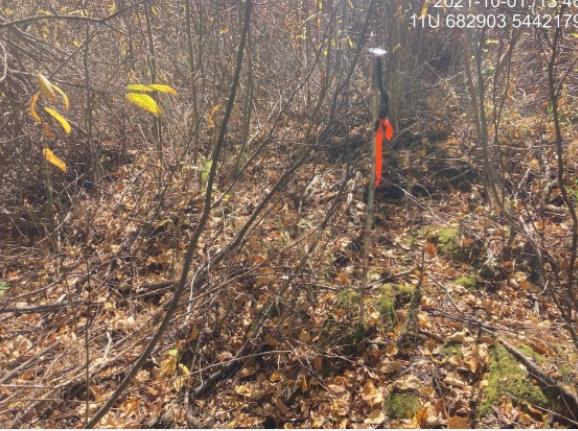
Comments: Upstream channel is wet meadow with grass, moss and willow. Inlet appears to be above where the channel would be. Downstream is willow area with poorly defined channel. Dry at time of survey. 13:36

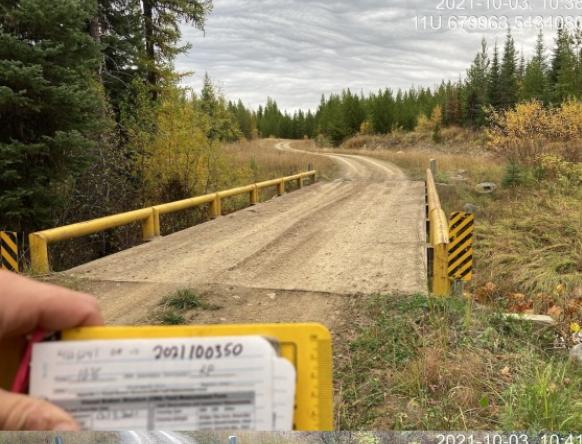
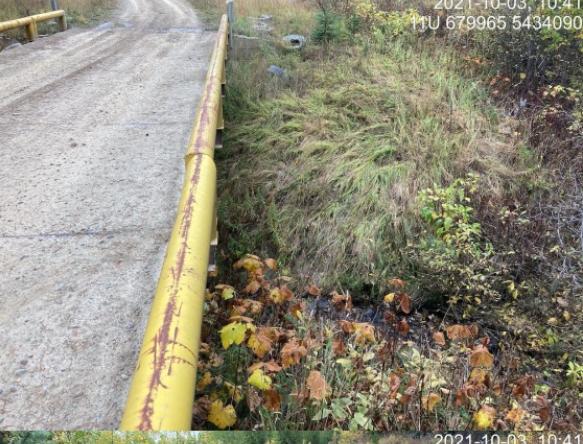
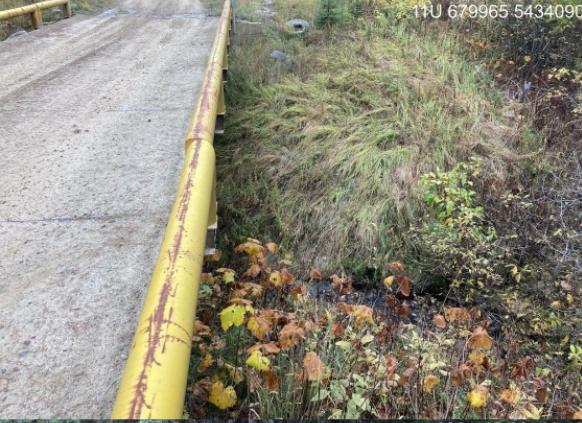
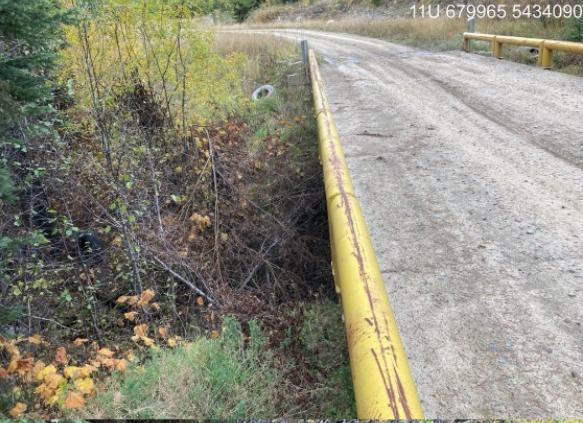
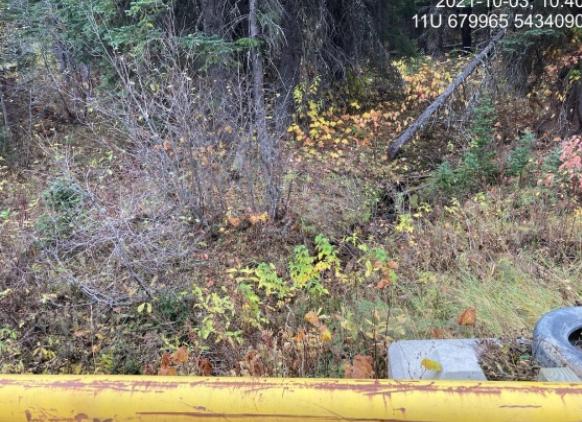
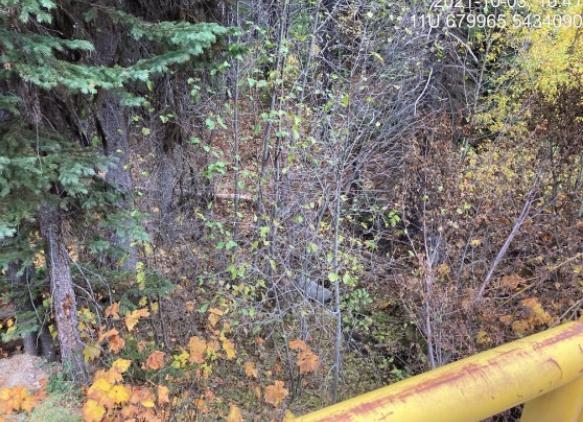
Location and Stream Data	•	Crossing Characteristics	-
Photos: PSCIS ID 197852. From top left clockwise: Road/Site Card, Barrel, Outlet, Downstream, Upstream, Inlet.

Comments: Crossing is in slightly different location than mapped. 10:35

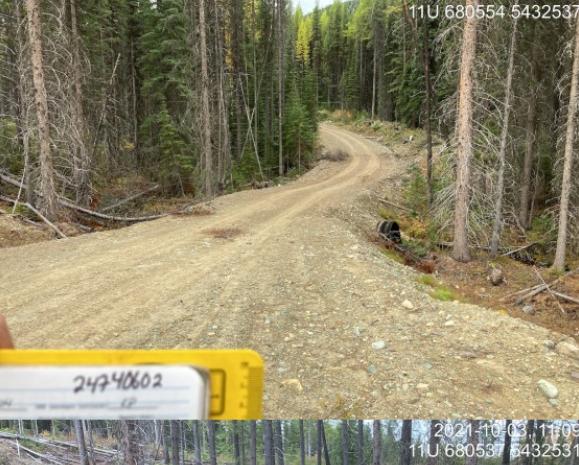
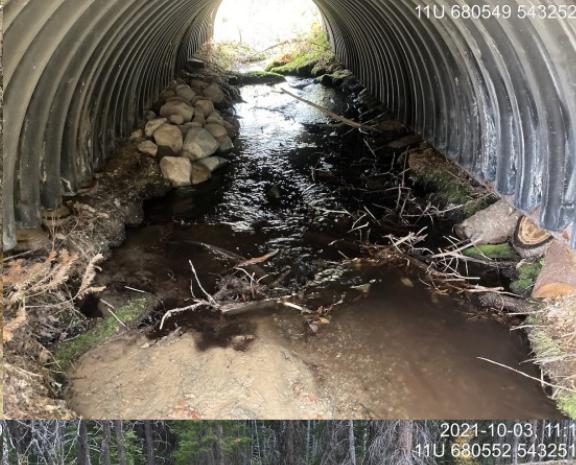
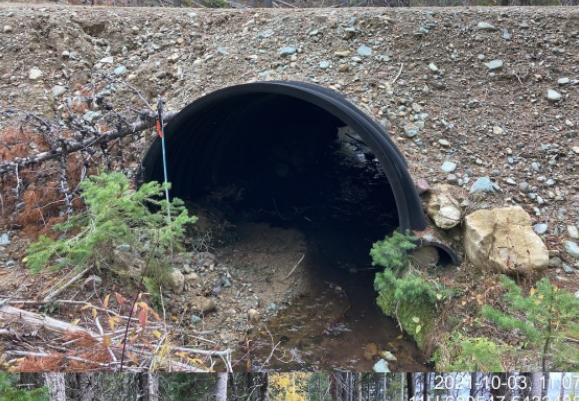
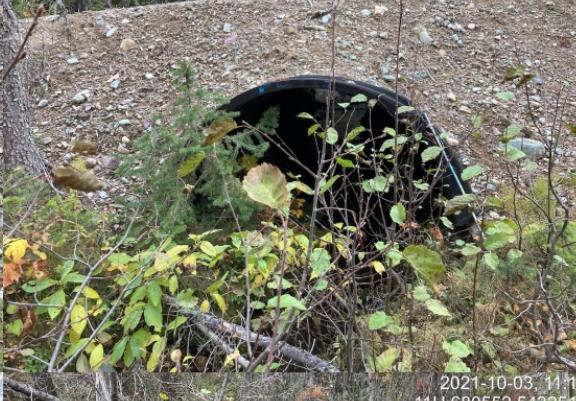
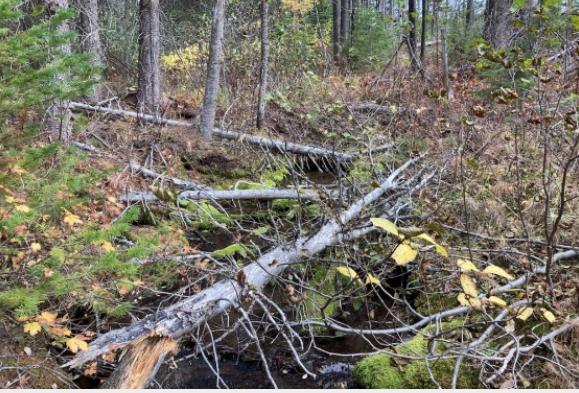
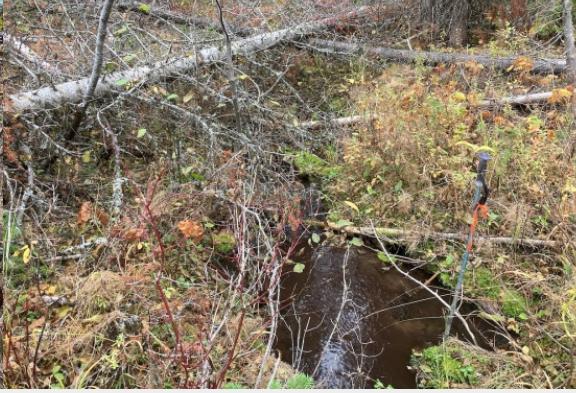
Location and Stream Data	Crossing Characteristics
Photos: PSCIS ID 197854. From top left clockwise: Road/Site Card, Barrel, Outlet, Downstream, Upstream, Inlet.

Comments: Black plastic arch. Structure appears to be lifting off ground where placed. Bend in middle of pipe where road crosses. 11:04

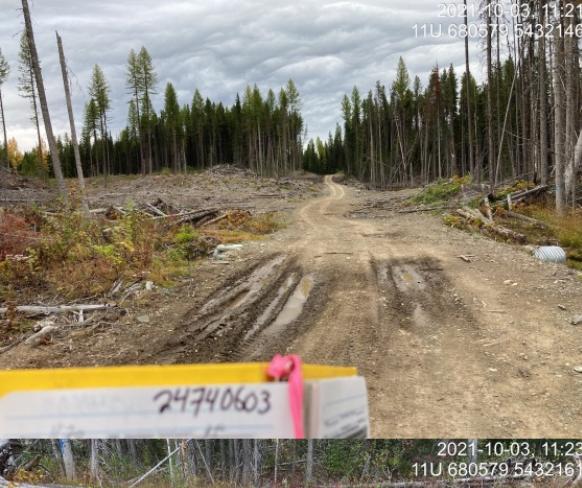
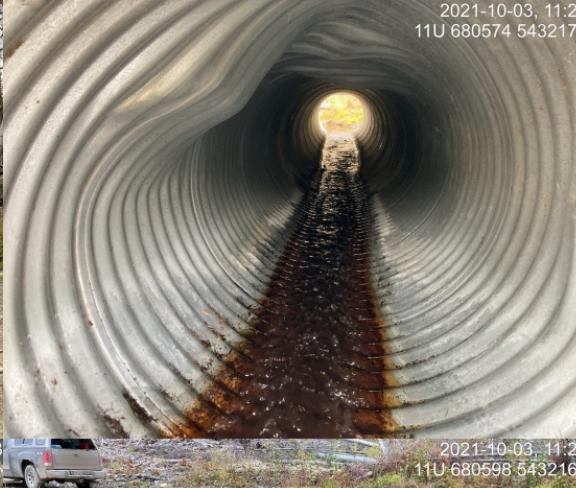
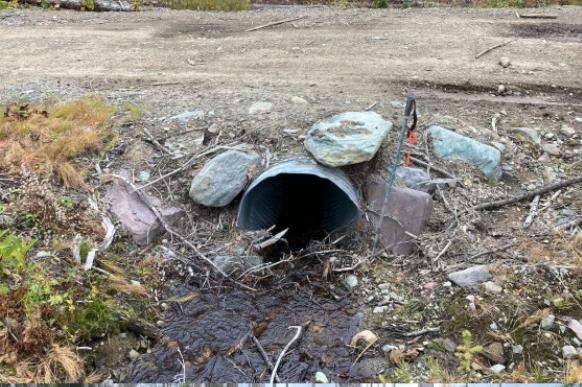
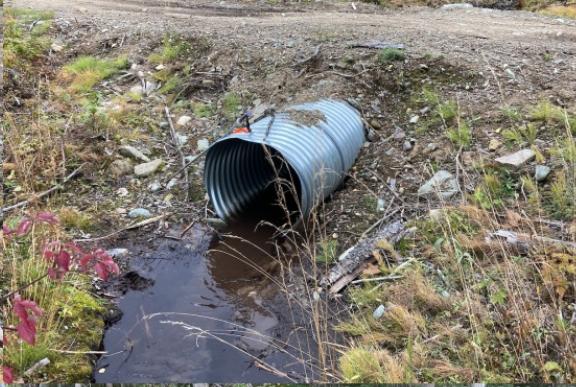
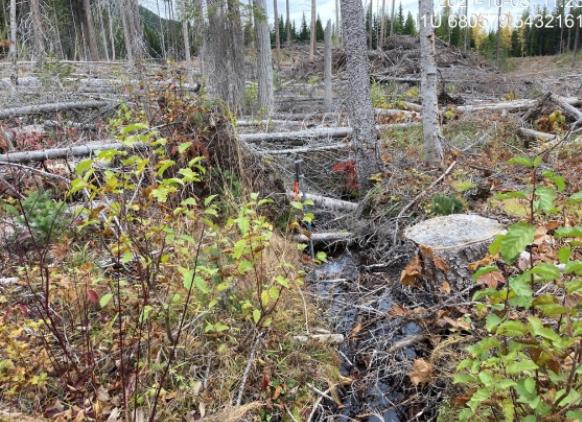
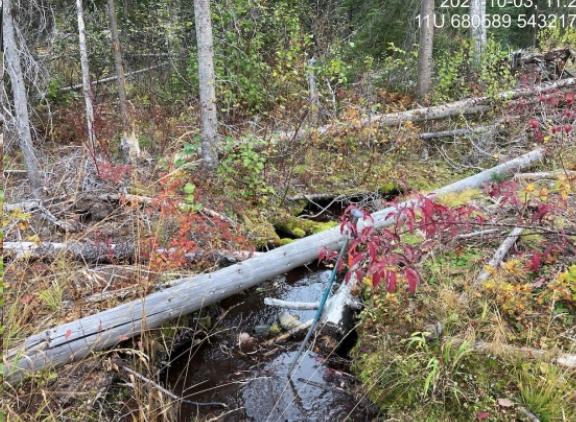
Location and Stream Data	Crossing Characteristics	-
Photos: PSCIS ID 197855. From top left clockwise: Road/Site Card, Barrel, Outlet, Downstream, Upstream, Inlet.

Comments: Inlet drop from debris ~0.35m. Heavily logged to stream upstream. Culvert is steeper for first 1/2 on upstream side. Slightly embedded on outlet but unlikely to hold due to small size of substrate. 11:20

Location and Stream Data		Crossing Characteristics	
Date	2021-10-03	Crossing Sub Type	Round Culvert
PSCIS ID	197855	Diameter (m)	0.8
External ID	24740603	Length (m)	10
Crew	KP	Embedded	No
UTM Zone	11	Depth Embedded (m)	–
Easting	680584.5	Resemble Channel	No
Northing	5432219	Backwatered	No
Stream	Tributary to Calder Creek	Percent Backwatered	–
Road	Spur 1000	Fill Depth (m)	0.3
Road Tenure	Unknown	Outlet Drop (m)	0
Channel Width (m)	0.8	Outlet Pool Depth (m)	0
Stream Slope (%)	2.5	Inlet Drop	Yes
Beaver Activity	No	Slope (%)	4
Habitat Value	Low	Valley Fill	Deep Fill
Final score	23	Barrier Result	Barrier
Fix type	Replace Structure with Streambed Simulation CBS	Fix Span / Diameter	3

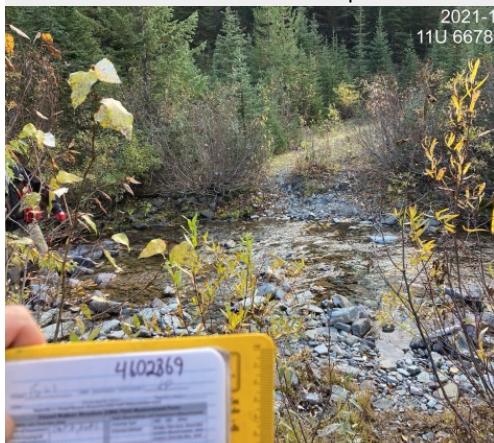
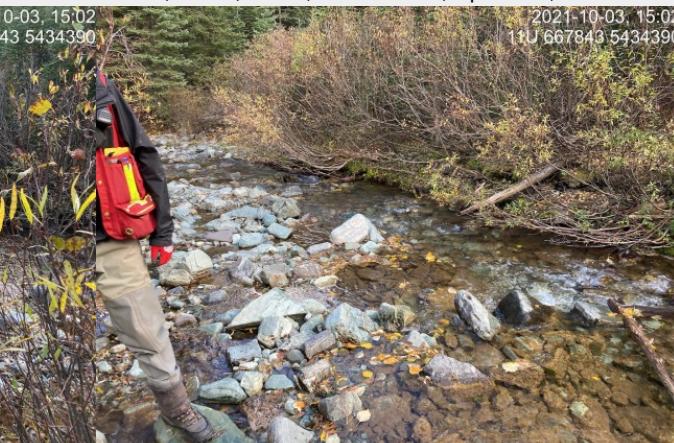
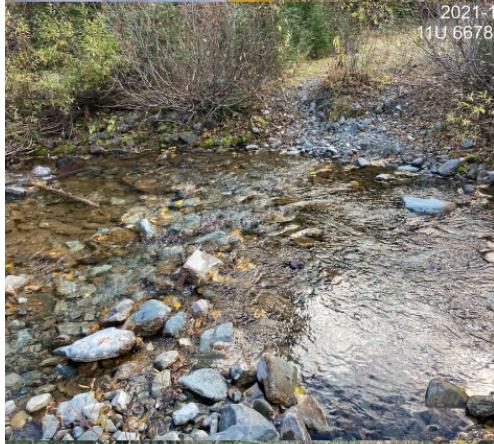
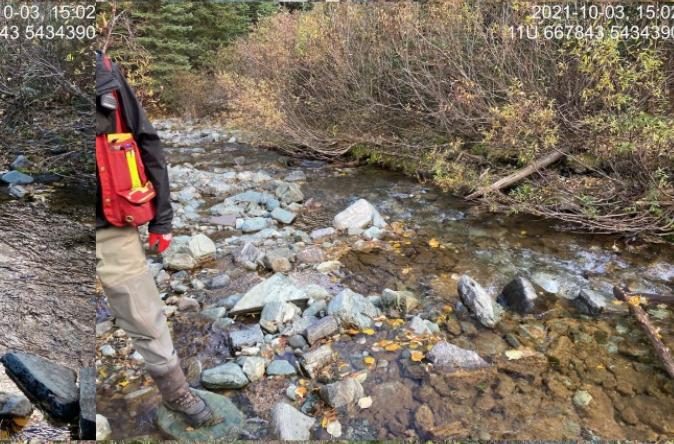
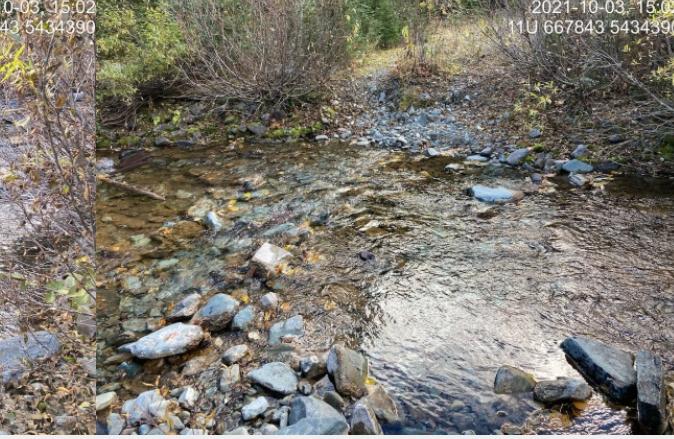
Location and Stream Data	Crossing Characteristics
Photos: PSCIS ID 197856. From top left clockwise: Road/Site Card, Barrel, Outlet, Downstream, Upstream, Inlet.

Comments: Ford. Adjacent stream channel dry. 15:01

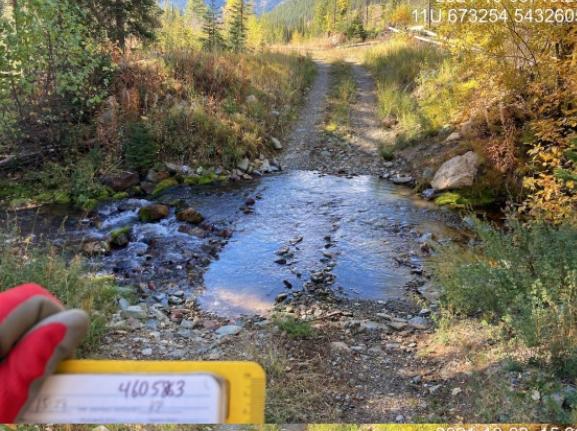
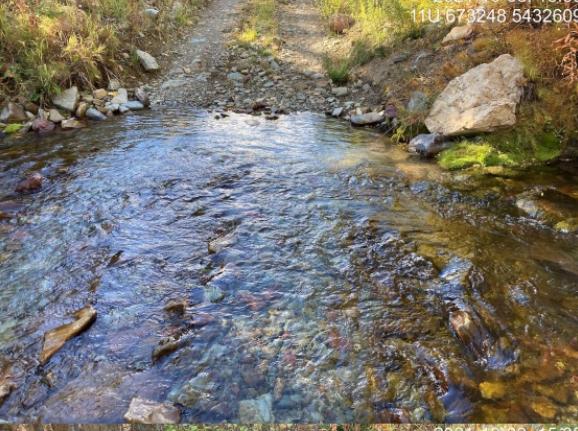
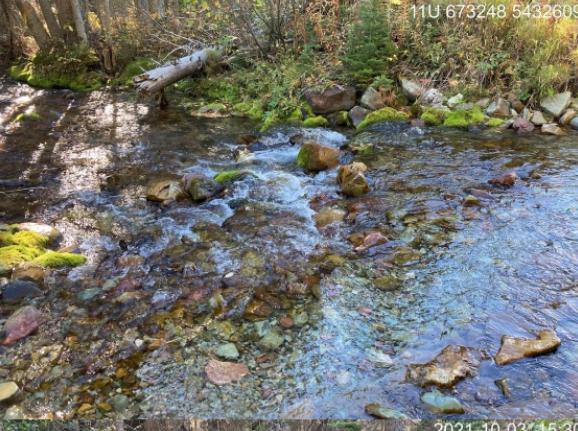
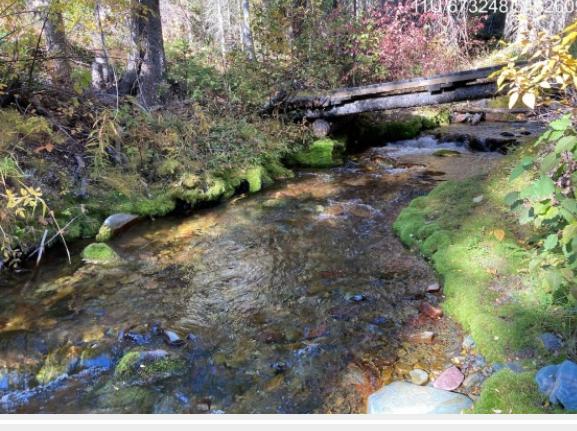
Location and Stream Data	Crossing Characteristics
Photos: PSCIS ID 197858. From top left clockwise: Road/Site Card, Barrel, Outlet, Downstream, Upstream, Inlet.

Comments: Good flow. 15:28

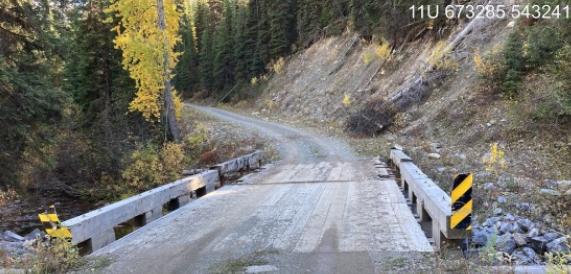
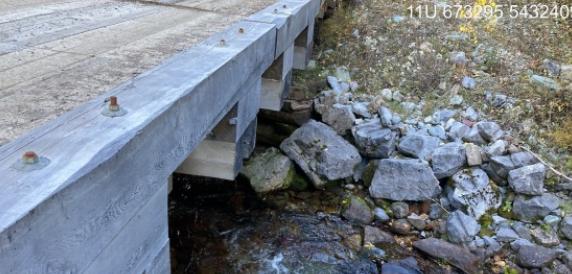
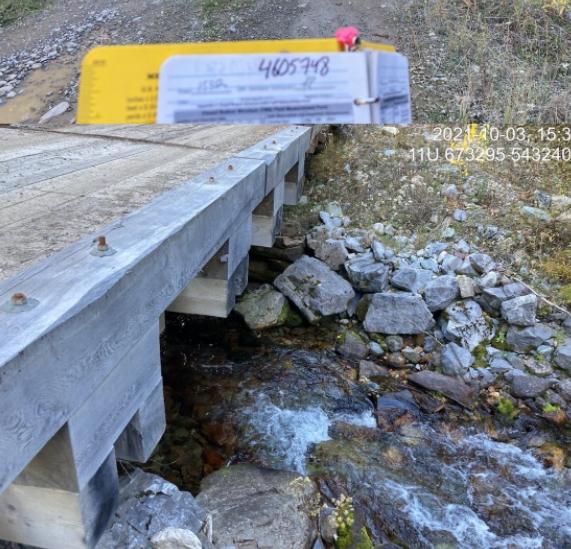
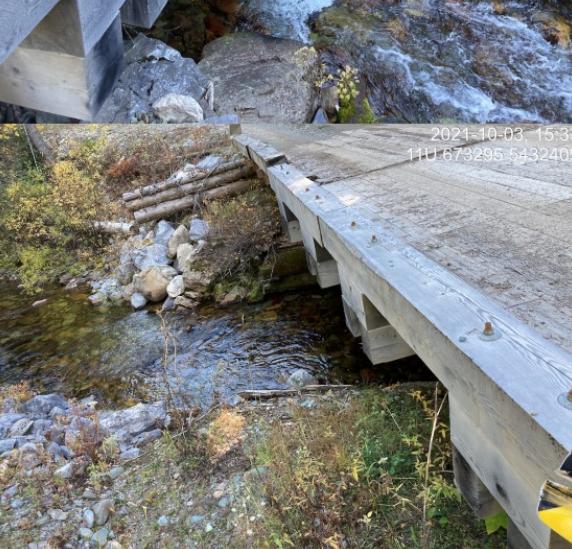
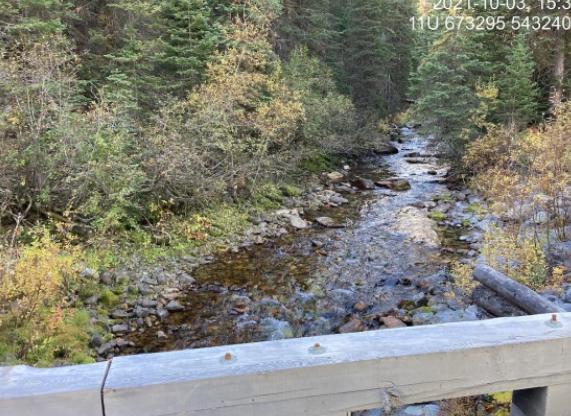
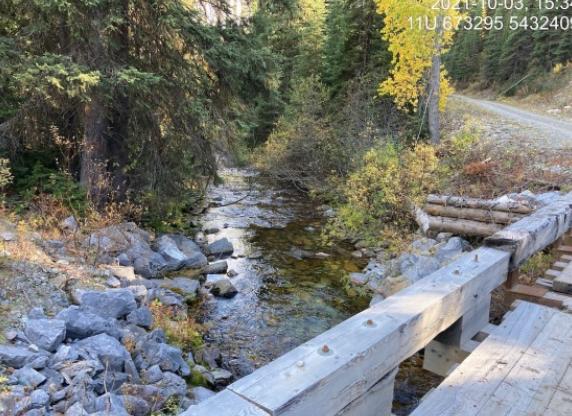
Location and Stream Data	Crossing Characteristics
Photos: PSCIS ID 197859. From top left clockwise: Road/Site Card, Barrel, Outlet, Downstream, Upstream, Inlet.

Comments: Bridge. 15:32

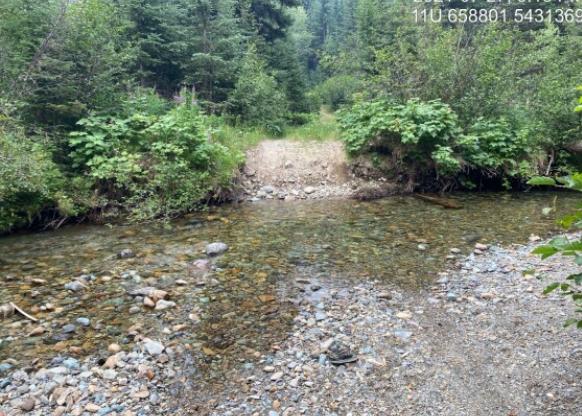
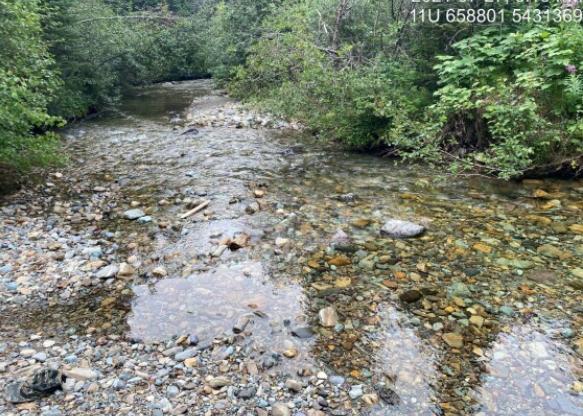
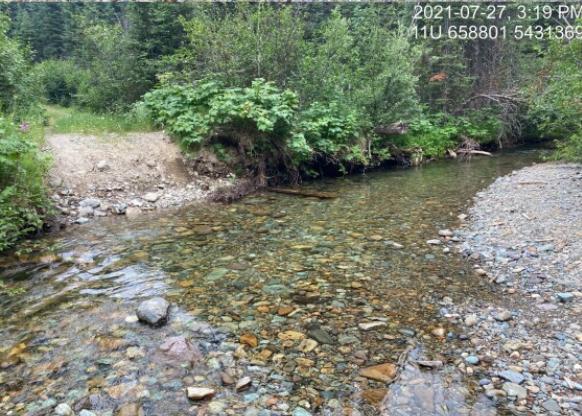
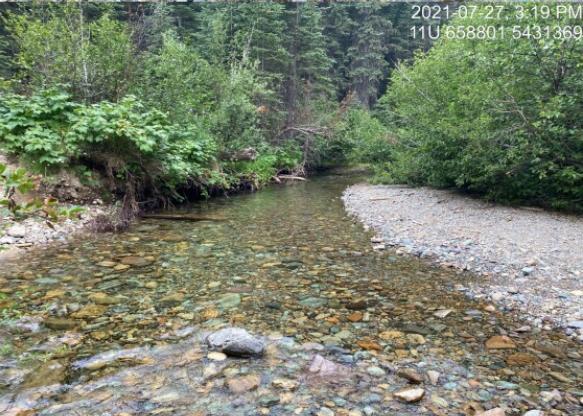
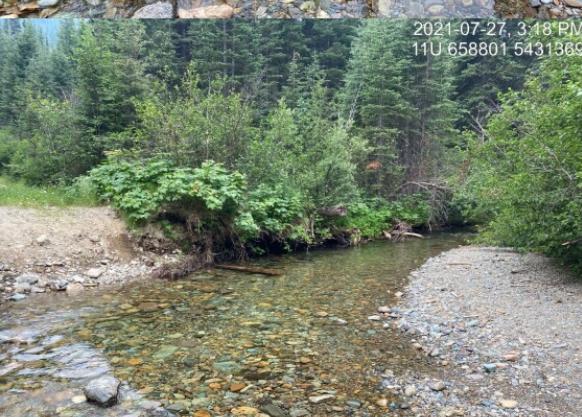
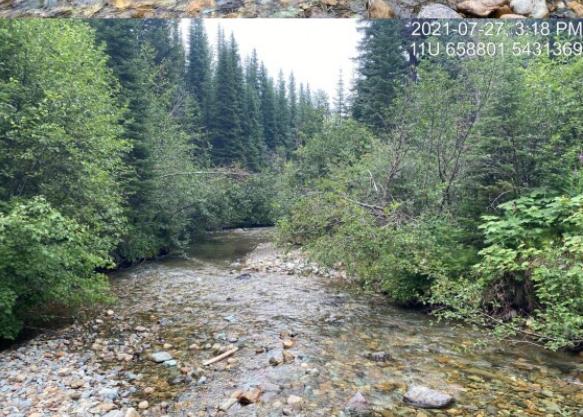
Location and Stream Data	•	Crossing Characteristics	-
Photos: PSCIS ID 197860. From top left clockwise: Road/Site Card, Barrel, Outlet, Downstream, Upstream, Inlet.

Comments: Ford. No card filled out. 15:17

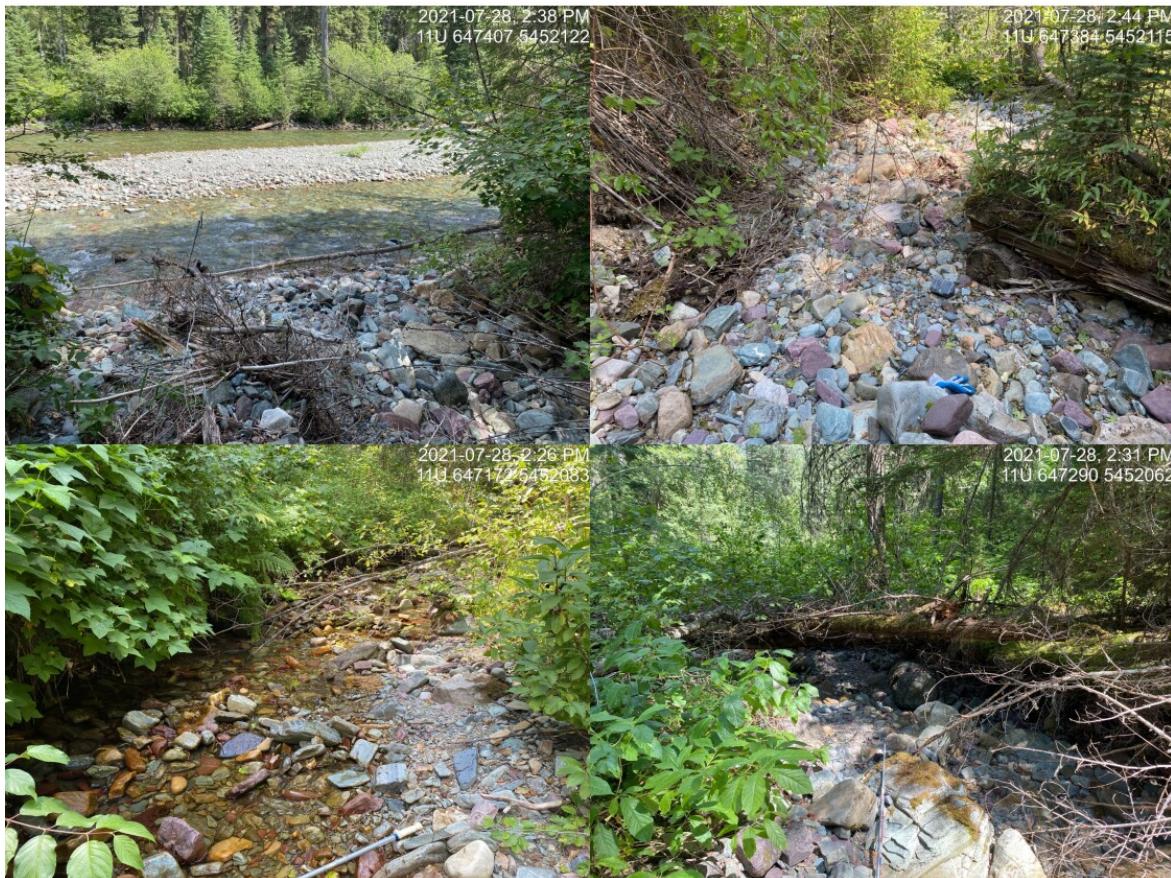
Location and Stream Data	•	Crossing Characteristics	-
Photos: PSCIS ID 197861. From top left clockwise: Road/Site Card, Barrel, Outlet, Downstream, Upstream, Inlet.

Comments: No crossing present. 14:20

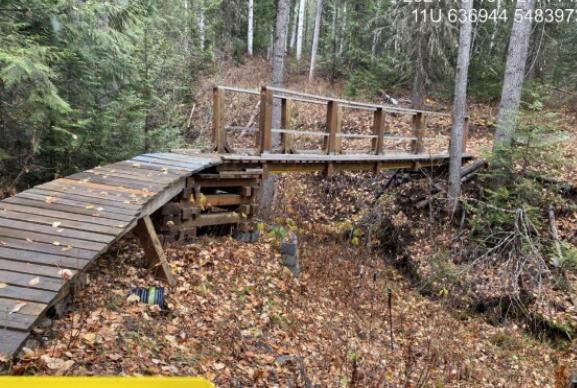
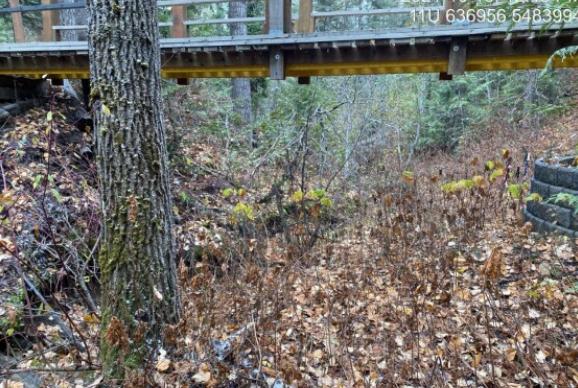
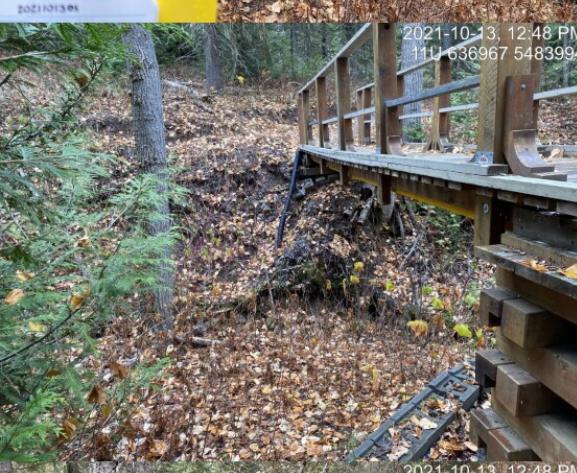
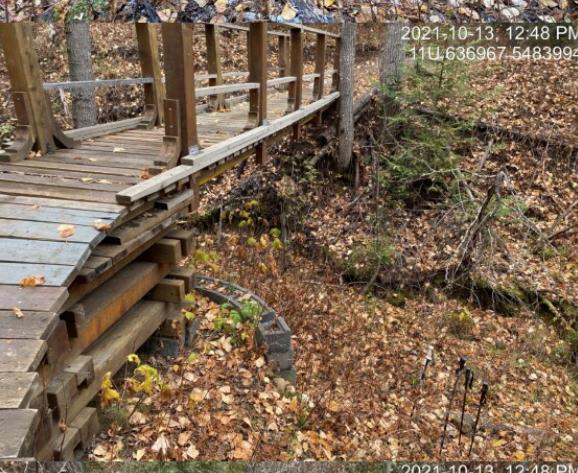
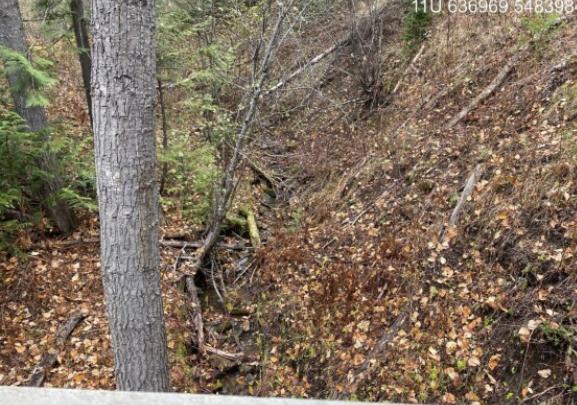
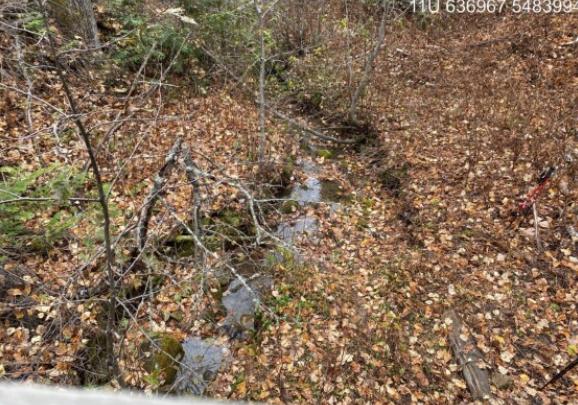
Location and Stream Data	Crossing Characteristics
Photos: PSCIS ID 197862. From top left clockwise: Road/Site Card, Barrel, Outlet, Downstream, Upstream, Inlet.

Comments: Bridge on walking/bike trail. 12:44

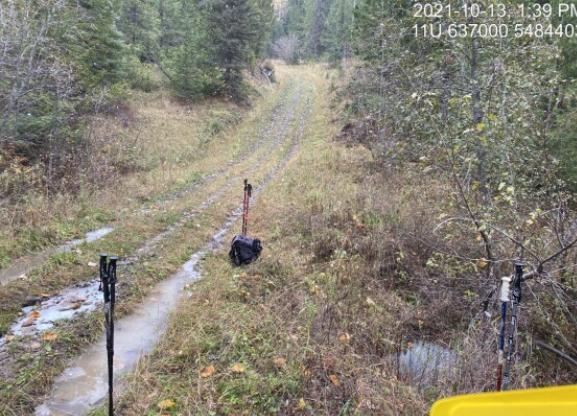
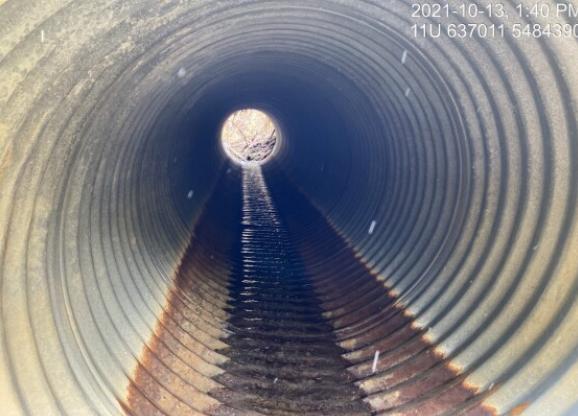
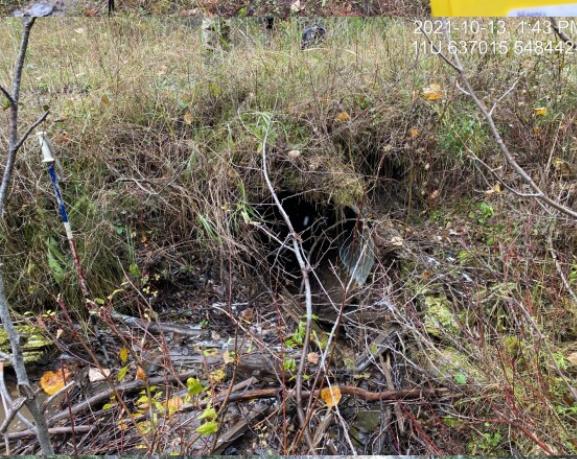
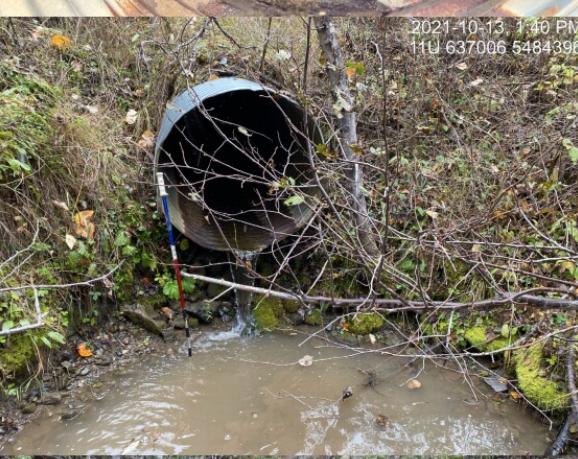
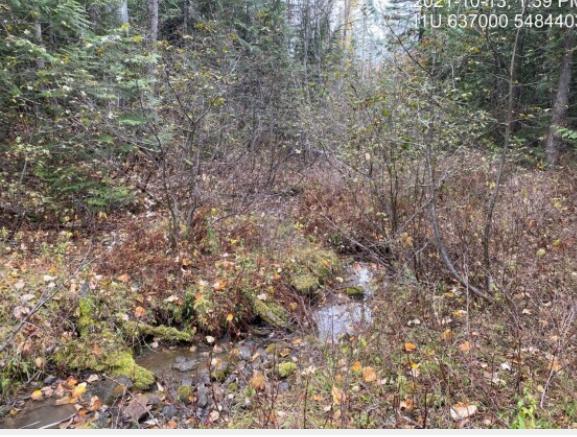
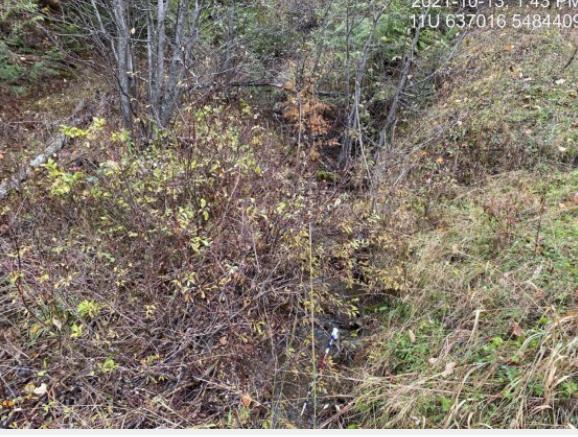
Location and Stream Data	Crossing Characteristics
Photos: PSCIS ID 197863. From top left clockwise: Road/Site Card, Barrel, Outlet, Downstream, Upstream, Inlet.

Comments: Very steep immediately upstream of crossing. 13:33

Location and Stream Data		Crossing Characteristics	
Date	2021-10-13	Crossing Sub Type	Round Culvert
PSCIS ID	197863	Diameter (m)	0.9
External ID	4600761	Length (m)	8
Crew	AI BK SS	Embedded	No
UTM Zone	11	Depth Embedded (m)	—
Easting	637007	Resemble Channel	No
Northing	5484415	Backwatered	No
Stream	Tributary to Lizard Creek	Percent Backwatered	—
Road	Unnamed	Fill Depth (m)	1
Road Tenure	Unknown	Outlet Drop (m)	0.5
Channel Width (m)	2	Outlet Pool Depth (m)	0.28
Stream Slope (%)	12.6	Inlet Drop	Yes
Beaver Activity	No	Slope (%)	6
Habitat Value	Low	Valley Fill	Deep Fill
Final score	36	Barrier Result	Barrier
Fix type	Replace with New Open Bottom Structure	Fix Span / Diameter	12

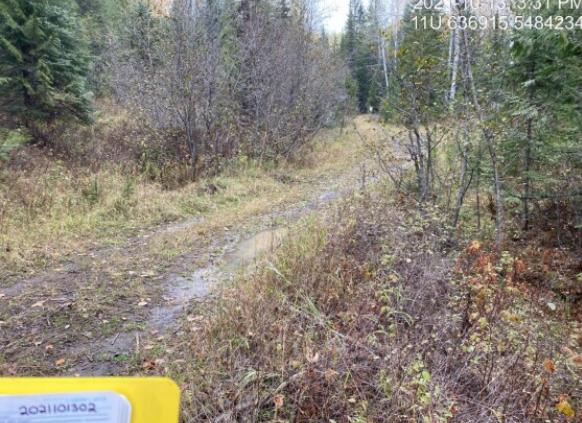
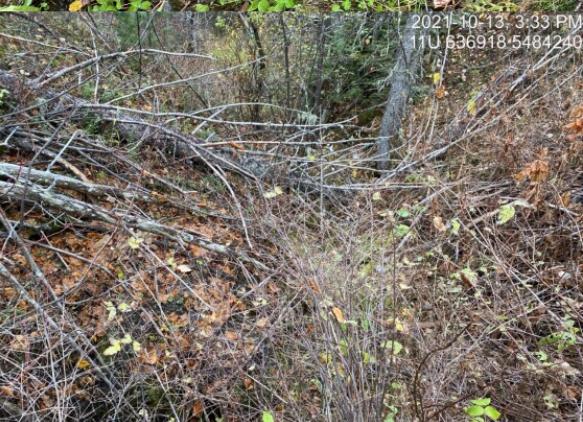
Location and Stream Data	•	Crossing Characteristics	-
Photos: PSCIS ID 197864. From top left clockwise: Road/Site Card, Barrel, Outlet, Downstream, Upstream, Inlet.

Comments: Drop of 1.1m just below outlet. Very unlikely to be fish habitat. Stream mapped incorrectly. Main channel is S and crosses road approximately 200m up the road. 15:30

Location and Stream Data		Crossing Characteristics	
Date	2021-10-13	Crossing Sub Type	Round Culvert
PSCIS ID	197864	Diameter (m)	0.6
External ID	2021101302	Length (m)	9
Crew	AI BK SS	Embedded	No
UTM Zone	11	Depth Embedded (m)	–
Easting	636912	Resemble Channel	No
Northing	5484249	Backwatered	No
Stream	Tributary to Lizard Creek	Percent Backwatered	–
Road	Unnamed	Fill Depth (m)	1
Road Tenure	Unknown	Outlet Drop (m)	0.29
Channel Width (m)	0.5	Outlet Pool Depth (m)	0.21
Stream Slope (%)	11	Inlet Drop	Yes
Beaver Activity	No	Slope (%)	2
Habitat Value	Low	Valley Fill	Deep Fill
Final score	20	Barrier Result	Barrier
Fix type	Replace Structure with Streambed Simulation CBS	Fix Span / Diameter	3

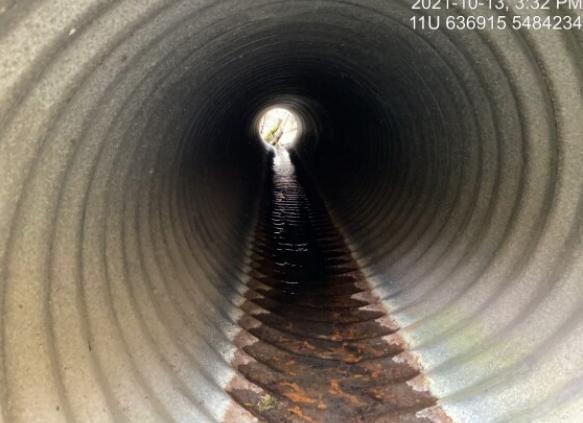
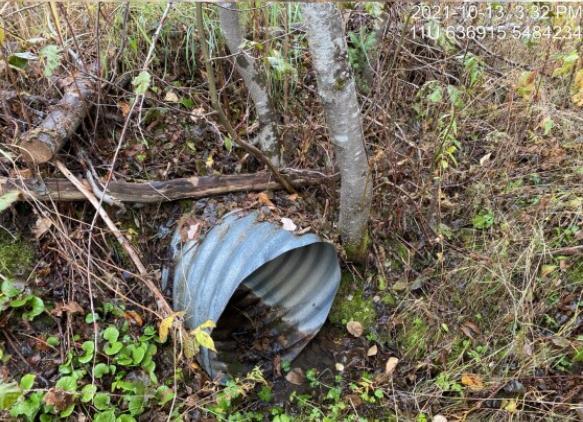
Comments: Very steep stream. Culvert failing just downstream of inlet. Stream braids upstream. 13:15
